GEOHAZARD RISK MANAGEMENT PROGRAM

North Central Region – Edson / Stony Plain Area

2020 Inspection Report

Site Number	Site Name		Hwy	km
NC31	Deer Lodge		22:32	28.9
Legal Land Description	NW 21-56-8-W5M			
UTM Coordinates (NAD 83)	Zone 11U	N5968640	E630978	
Operational Site Instrumentation	Slope Inclinometers		0	
	Pneumatic Piezometers		0	
	Vibrating Wire Piezometers		2	
	Standpipe Piezometers		0	
Date of Last Instrumentation Readings	May 21, 2020

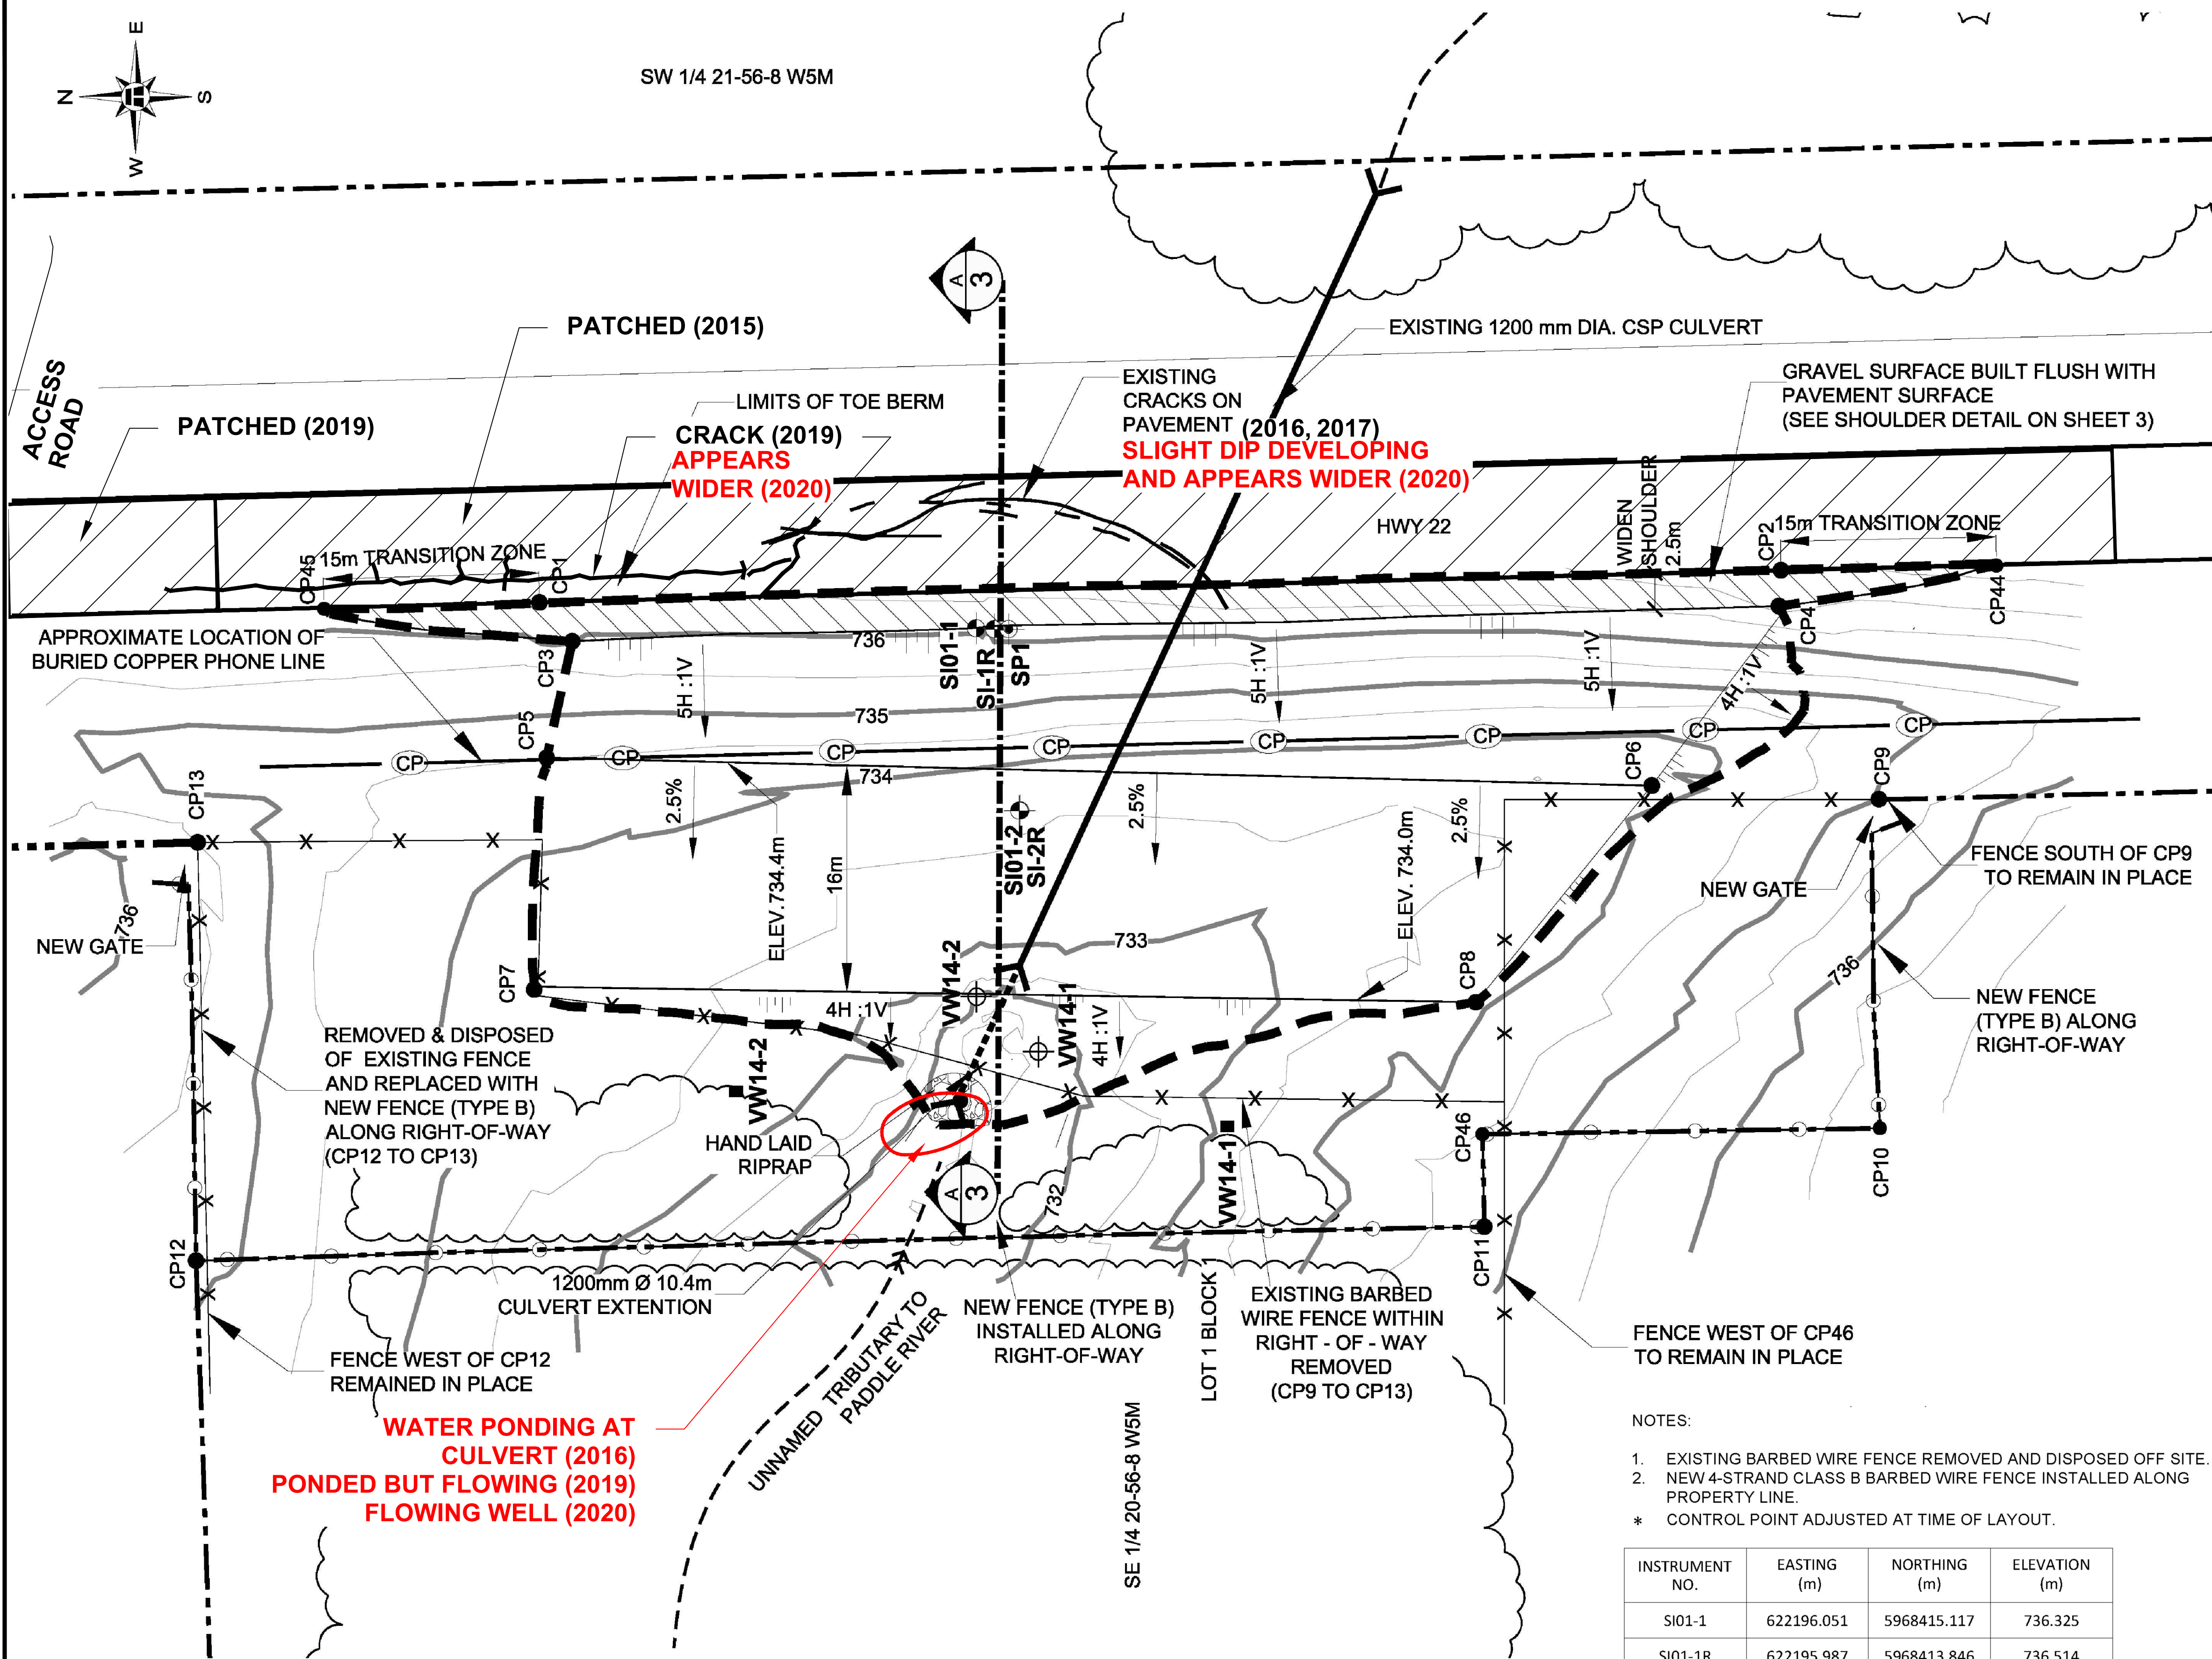
FIGURE - 1

- PREVIOUS OBSERVATIONS SHOWN IN BLACK
- 2020 OBSERVATIONS SHOWN IN RED

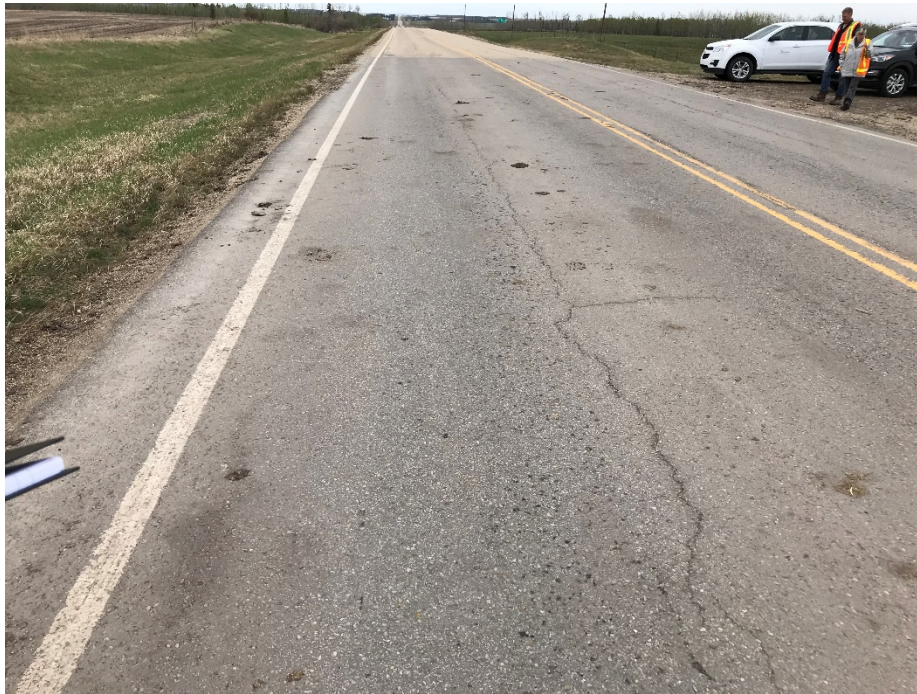
Discussion	<p>The pavement cracking on the southbound (SB) lane observed in front of the farm access road appeared wider than in 2019 as shown in Photo 1. The limits of the circular crack on the SB lane near SI10-appears similar to 2019 as shown in Photos 2 to 4. However, the crack appears wider and dip more towards the west.</p> <p>The west embankment slope was well vegetated following construction in 2016 with no obvious signs of slope instability as shown in Photo 5.</p> <p>The 1200 mm diameter culvert appears to be in good condition as shown in Photo 6. Slow flowing water was observed at the outlet.</p>
Assessment	<p>High groundwater levels continue to be observed at the site with current readings showing the water level approximately 1.5 m to 2.5 m below ground surface. High water table along with relatively poor foundation soils are likely contributors to the slope movements.</p> <p>Currently, there are no operational slope inclinometers remaining at the site. The wider appearance of the circular crack along with potential dipping towards the west suggests ongoing slope movements.</p>

Photo 1: New pavement cracking reflected through recent patch on southbound lane in front of access road. Looking north.

Recommendations	<p>Short term recommendations include sealing cracks to reduce surface water infiltration into the slope and pavement structure.</p> <p>Since a toe berm was recently constructed, long term remediation is unnecessary at this time.</p> <p>Consideration may be given to installing replacement instrumentation to monitor the performance of the toe berm and highway.</p> <p>Site inspections are currently scheduled for every two years. Due to potential widening of the pavement cracks, consideration for annual inspections may be given.</p> <p>Instrumentation readings at the site should continue to be collected during both spring and fall reading cycles.</p>

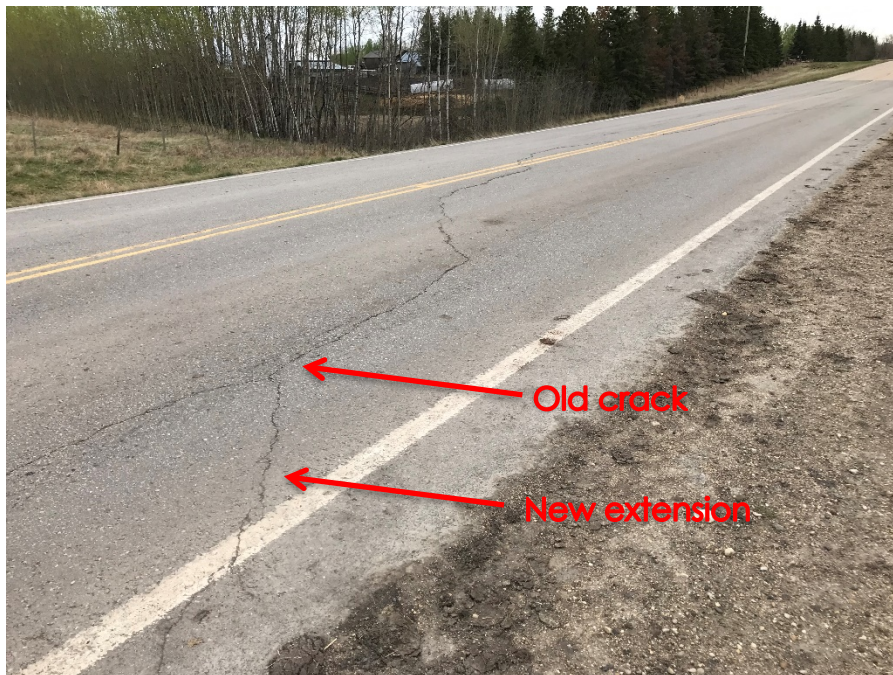
Photo 2: New extension of circular crack on southbound lane near S110-1. Looking southeast.

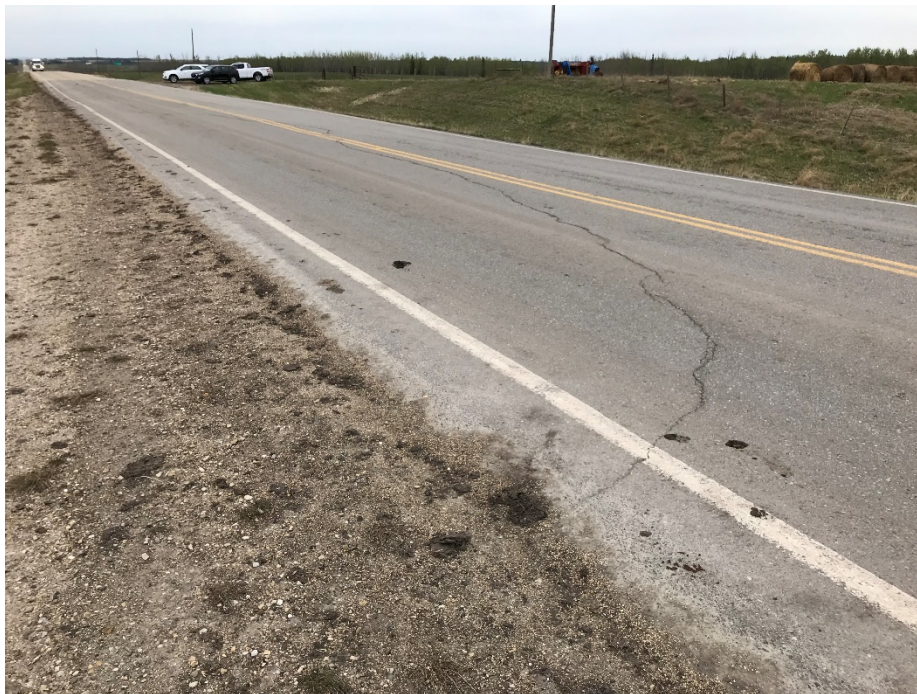
Photo 3: Circular crack near S110-1. Looking northeast.

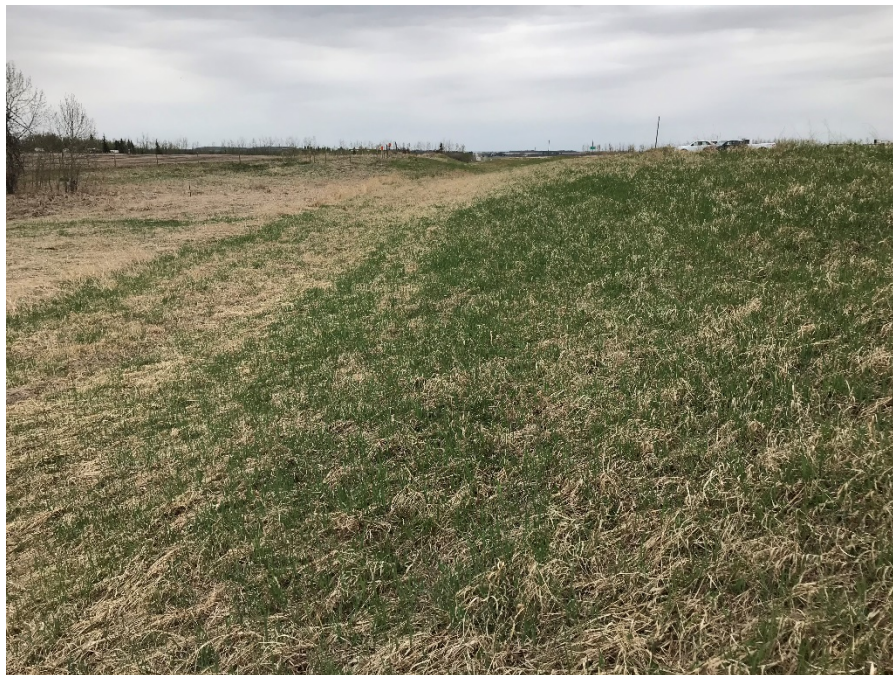
Photo 4: Overall west embankment slope. Looking north.

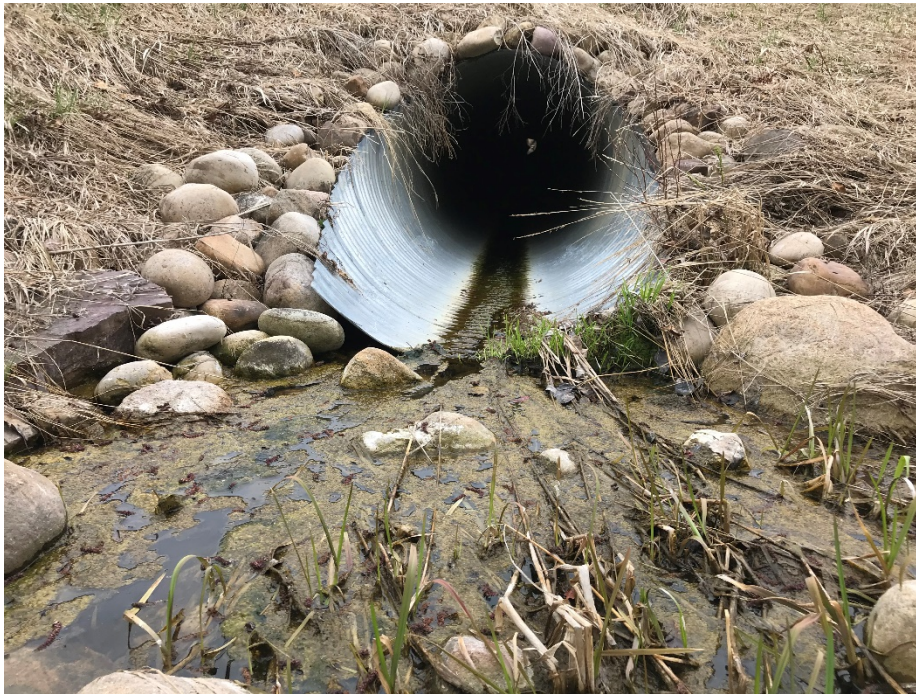
Photo 5: The 1200 mm diameter culvert is in good condition. Slow draining at outlet. Looking south.
