| SITE NUMBER AND NAME: NC031 – Deer Lodge | HIGHWAY AND KM: 22:32, km 28.857 | PREVIOUS INSPECTION: May 25, 2020 | CURRENT INSPECTION: July 14, 2021 |

**NORTH CENTRAL REGION GRMP
EDSON / STONY PLAIN
SITE INSPECTION FORM**

2021 Site Inspection Photos at NC031

ALBERTA TRANSPORTATION
 GEOHAZARD MONITORING PROGRAM
 NC31 DEER LODGE
 SITE PLAN

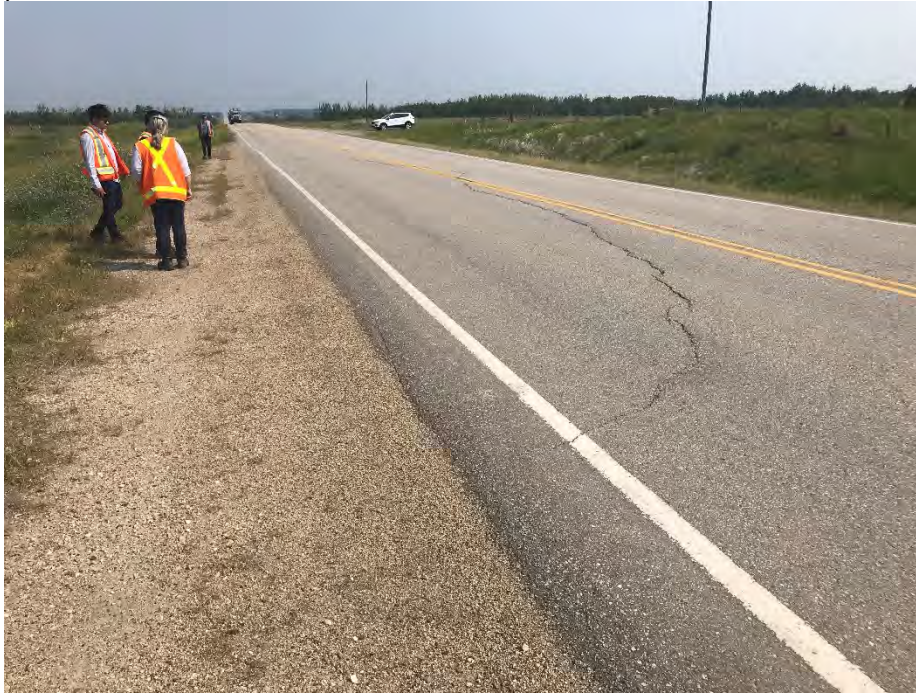
| ITEM | CONDITIONS EXIST | | DESCRIPTION AND LOCATION | NOTICEABLE CHANGE FROM LAST INSPECTION | |
|---|---|---|---|--|---|
| Pavement Distress | X | | Semi-circular pavement cracking near SI-1R / SP1. | | X |

Photo 1: South limits of semi-circular crack. Looking north.

- Pavement cracks should be sealed to reduce surface water infiltration into the embankment.
- SI-1R and SP1 could not be located since 2018 and was likely buried as a result of highway maintenance activities. The highway maintenance contractor (HMC) should attempt to locate the two instruments so that the landslide can be further monitored, if functional. Otherwise, replacement slope inclinometers can be considered to monitor the site.
- Site inspections should continue to be completed annually.
- Instrumentation monitoring should continue to be completed annually in the spring.

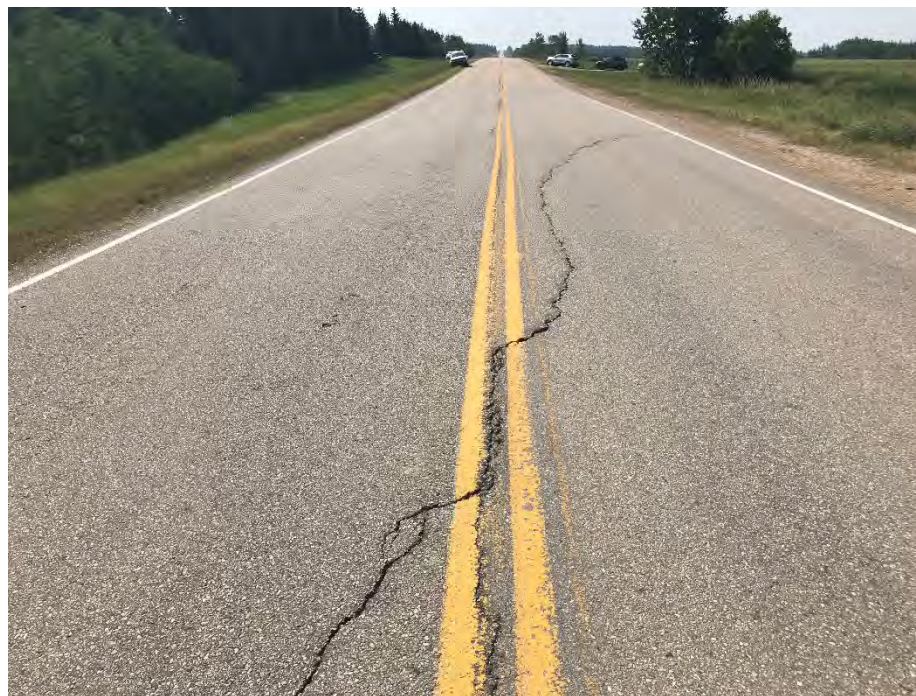
| ITEM | CONDITIONS EXIST | | DESCRIPTION AND LOCATION | NOTICEABLE CHANGE FROM LAST INSPECTION | |
|---|---|---|---|--|---|
| Slope Movement | X | | Pavement crack with dip towards southbound lane (SBL). | | X |

Photo 2: Approximately midway of semi-circular crack near SI-1R. Looking south.

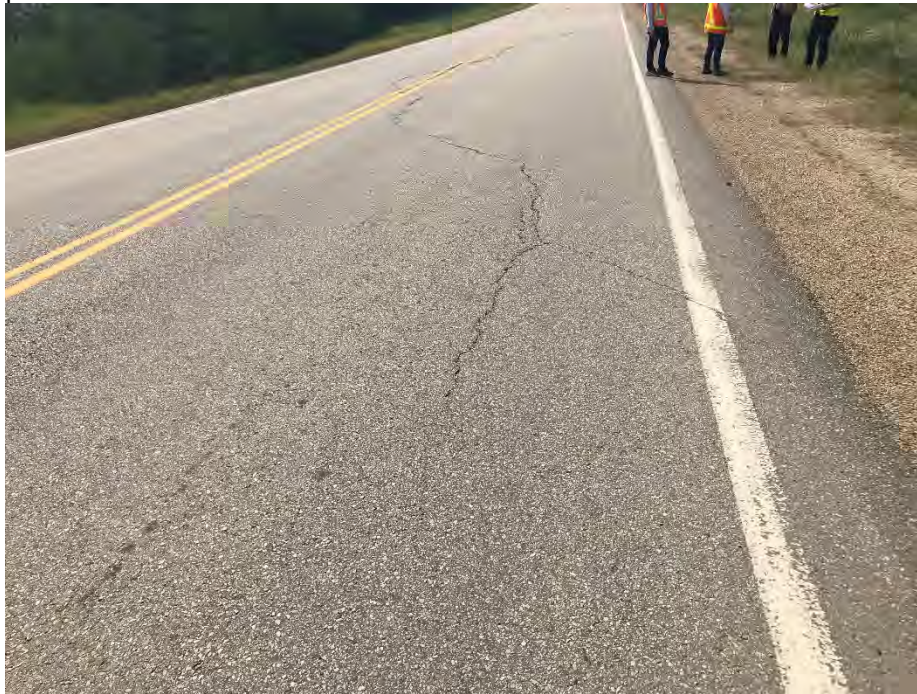
Photo 3: North limits of semi-circular crack. Looking south.

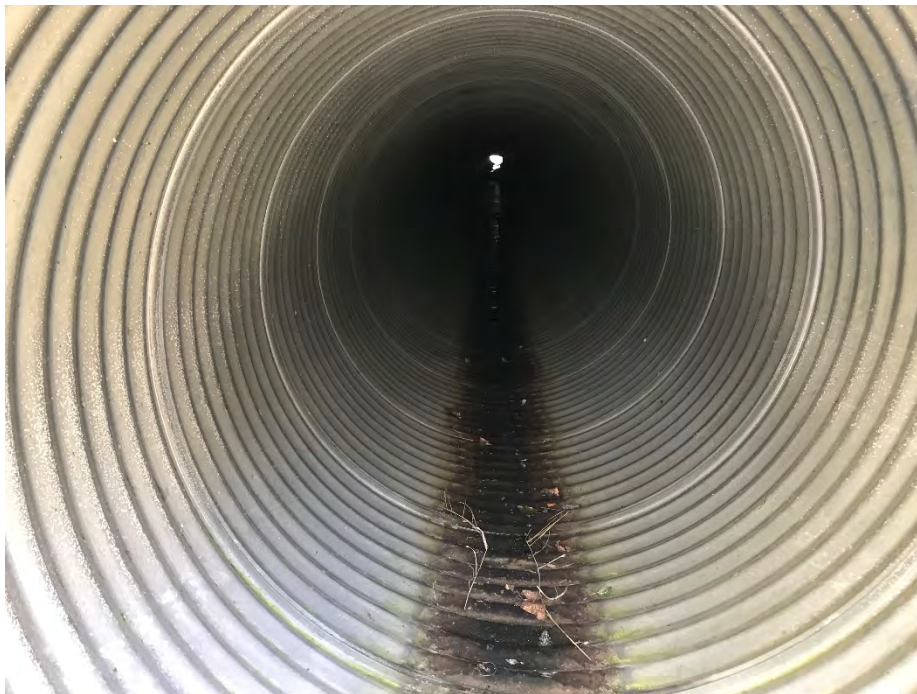
| ITEM | CONDITIONS EXIST | | DESCRIPTION AND LOCATION | NOTICEABLE CHANGE FROM LAST INSPECTION | |
|---|---|---|---|--|---|
| Bridge/Culvert Distress | X | | Sag in culvert, approximately one-third to one-quarter of the way in from outlet, likely under highway. | | X |

Photo 4: Culvert outlet. Looking southeast.

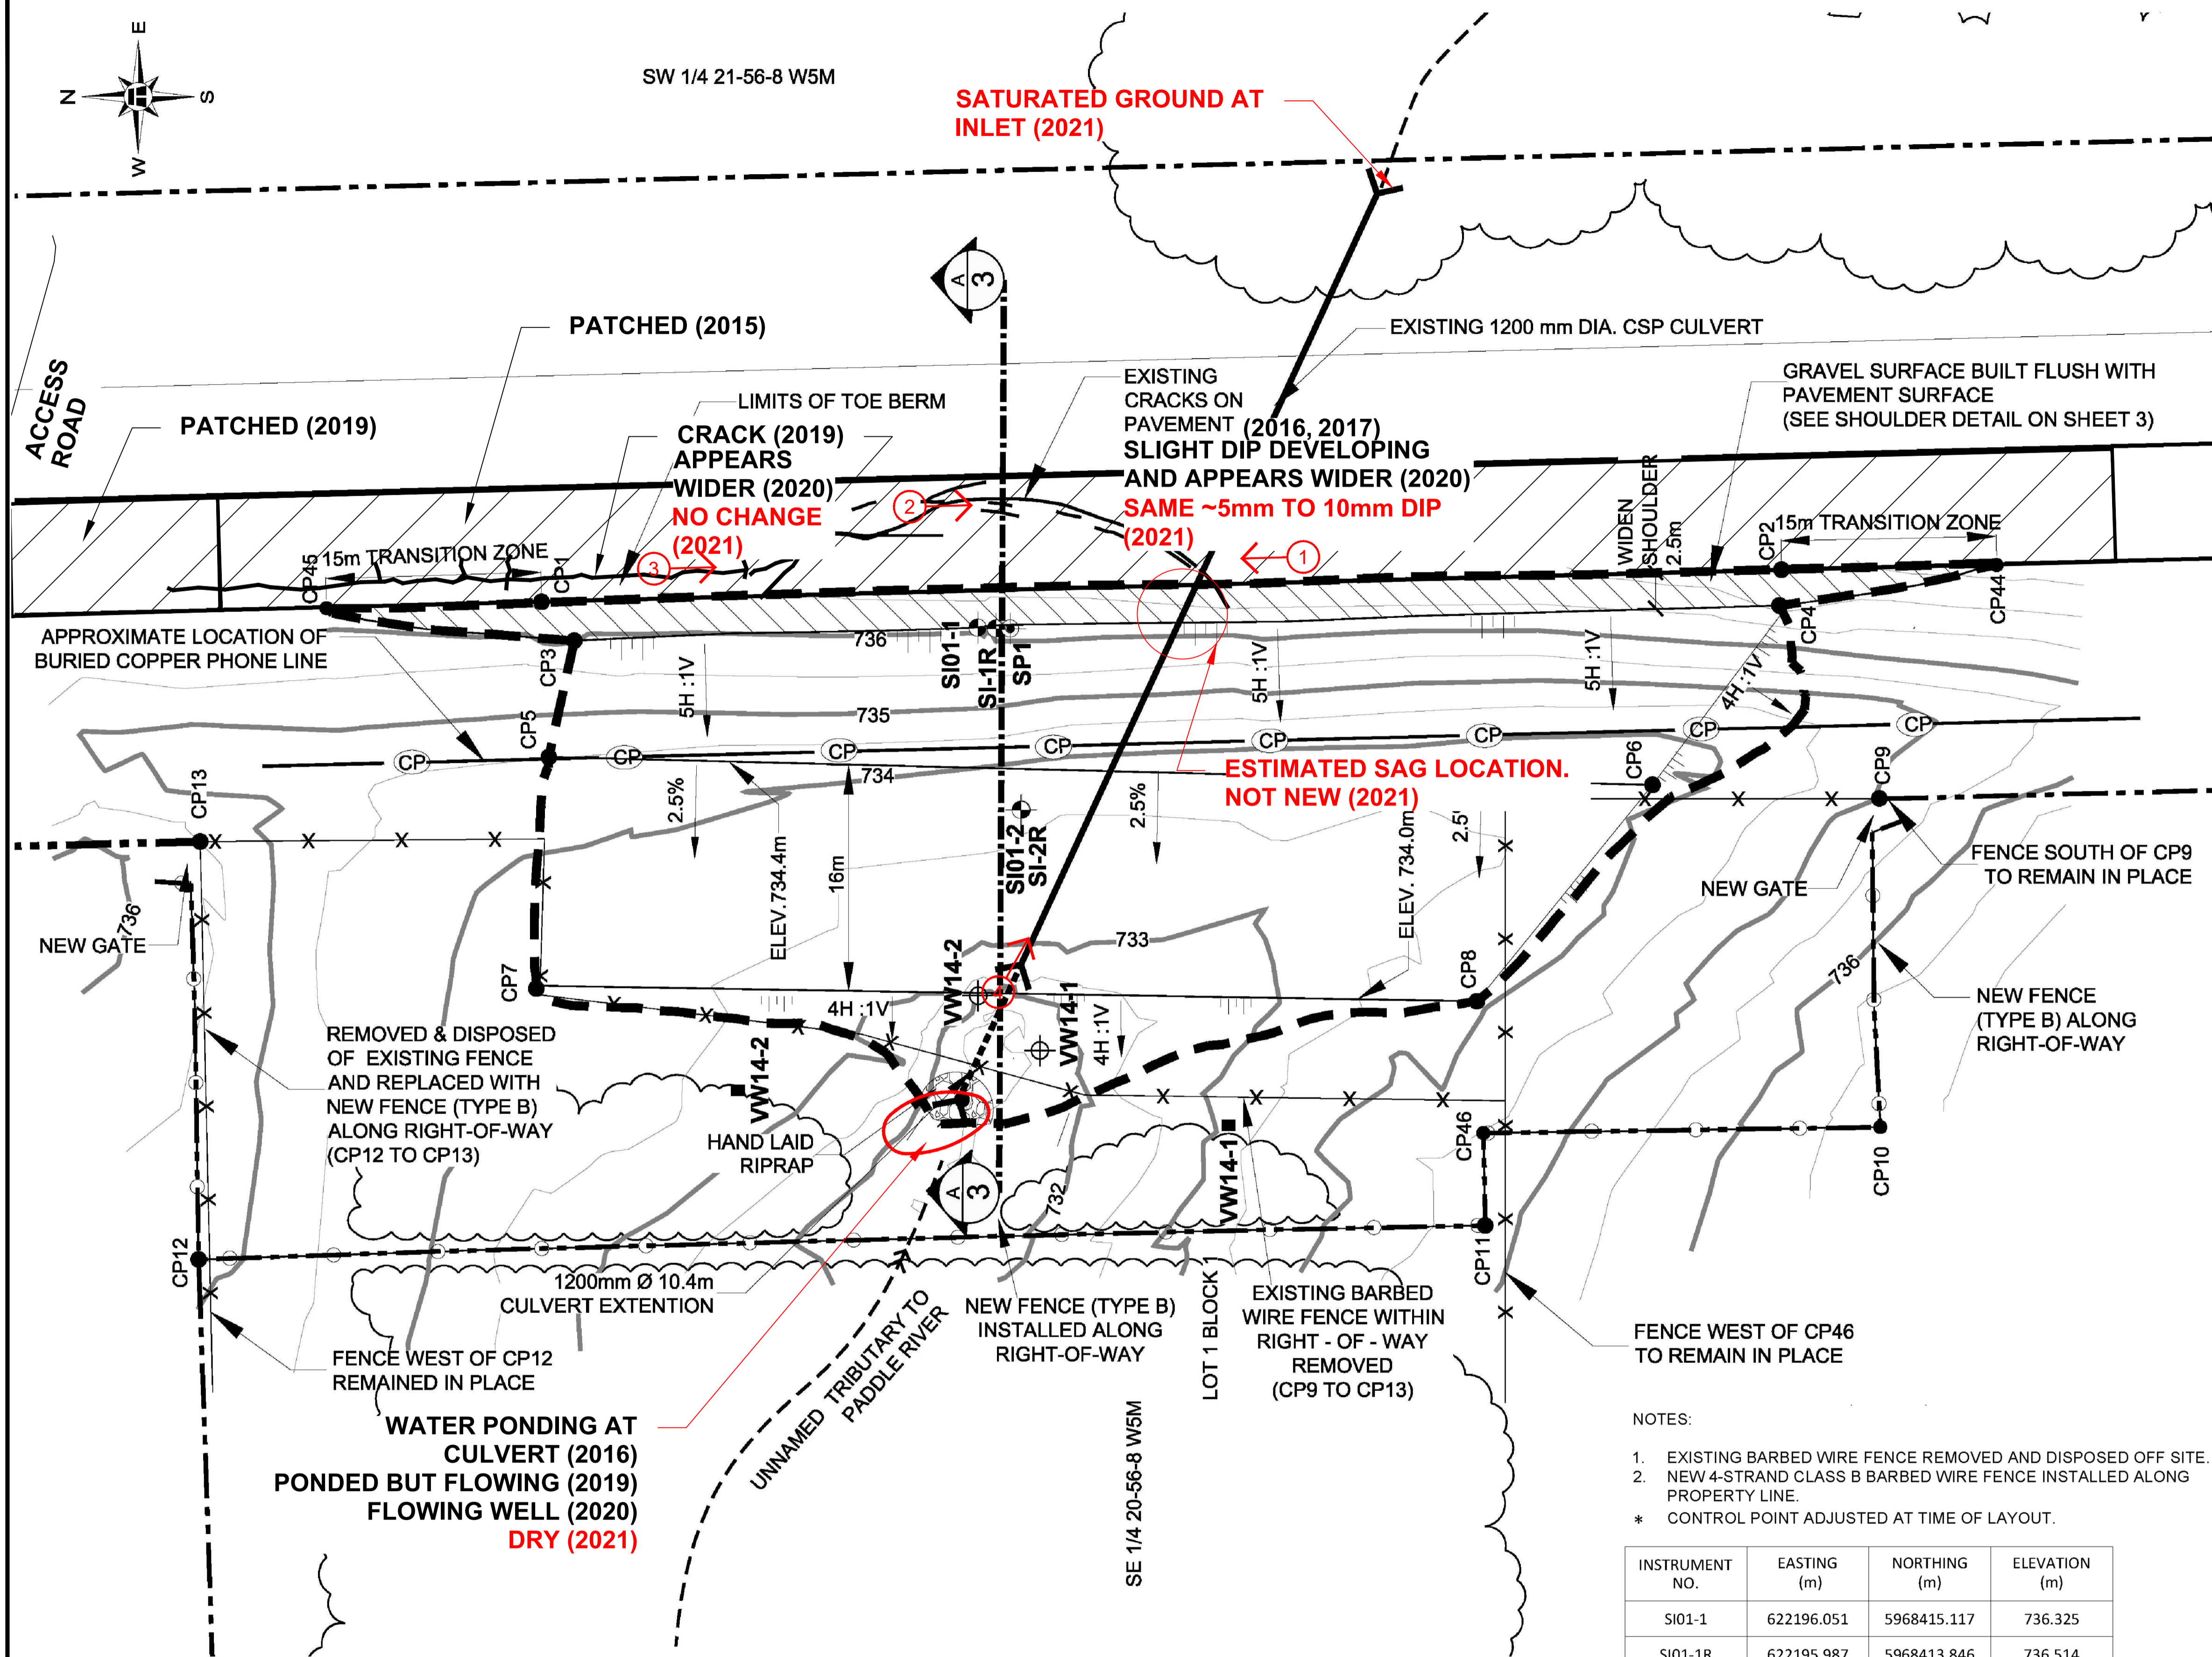
FIGURE - 1

SATURATED GROUND AT INLET (2021)

WATER PONDING AT CULVERT (2016) PONDED BUT FLOWING (2019) FLOWING WELL (2020) DRY (2021)

ESTIMATED SAG LOCATION. NOT NEW (2021)
