SITE NUMBER AND NAME: NC031 – Deer Lodge	HIGHWAY AND KM: 22:32, km 28.857	PREVIOUS INSPECTION: July 14, 2021	CURRENT INSPECTION: May 31, 2023
LEGAL DESCRIPTION: SE 20-56-08-W5M	NAD83 COORDINATES: UTM11U 5968389N, 622217E		RISK ASSESSMENT: PF: 3 CF: 5 Total: 15
AVERAGE ANNUAL DAILY TRAFFIC (AADT): 1,160 (2022)		CONTRACTOR MAINTENANCE AREA (CMA): 509

2023 Site Inspection Photos at NC031

TRANSPORTATION AND ECONOMIC CORRIDORS
 GEOHAZARD MONITORING PROGRAM
 NC31 HWY 22-32
 SITE PLAN

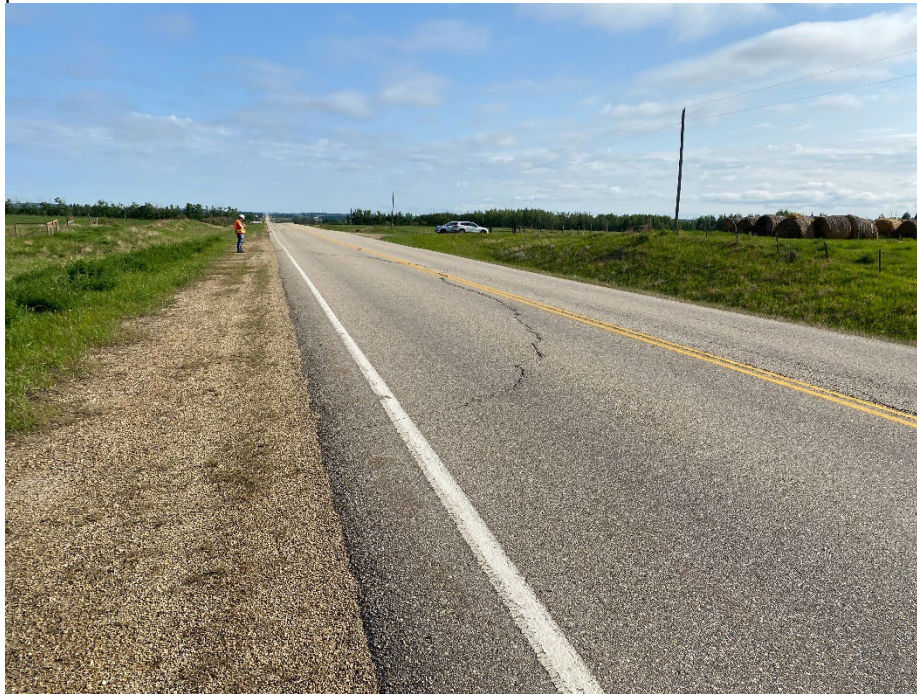
COMMENTS
<ul style="list-style-type: none"> • The site appears similar to the previous inspection. <ul style="list-style-type: none"> – A semi-circular pavement crack was observed north of SI-1R. A slight dip of about 5 mm to 10 mm towards the west was observed since 2020. The crack is mostly contained within the SBL with a small section (about 1 m to 2 m long) that encroaches into the northbound lane (NBL) by about 0.3 m (Photos 1 to 3). – Longitudinal cracking observed on the SBL in front of the farm access at the north limits of the site. Additional longitudinal cracks within the NBL in front of the farm access were noted during the recent site visit. These new cracks do not appear to be related to landslide activity. – A longitudinal crack and a transverse crack have formed within the pavement at the south end of the site, in the NBL. These new cracks do not appear to be related to landslide activity. • The culvert was not flowing during the current inspection. There was ponded water at both the inlet and outlet. The invert at the outlet appears to be graded backwards. • As previously observed, a sag exists about one-quarter to one-third of the way in from the outlet, approximately below the west highway edge (Photo 4). • A shallow groundwater table continues to be observed at the site with current readings showing the water level approximately 0.2 m to 2.8 m below ground surface.

Photo 1: South limits of semi-circular crack. Looking north.

- Pavement cracks should be sealed to reduce surface water infiltration into the embankment.
- Both SIs are inoperable, therefore replacement slope inclinometers could be considered to monitor the site.
- Site inspections should continue to be completed annually.
- Instrumentation monitoring should continue to be completed annually in the spring.

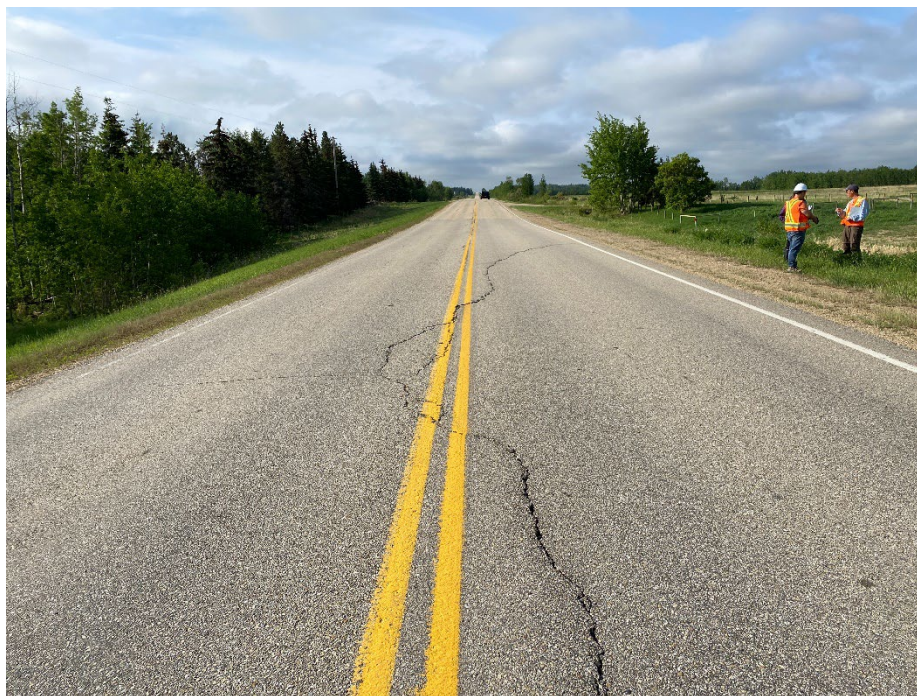
Photo 2: Approximately midway of semi-circular crack near SI-1R. Looking south.

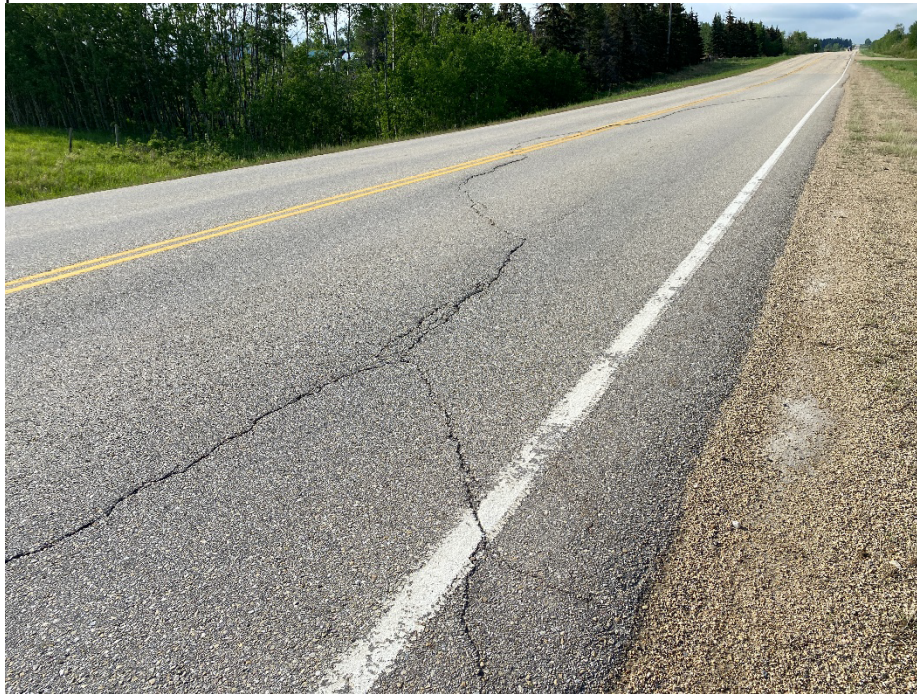
Photo 3: North limits of semi-circular crack. Looking southeast.

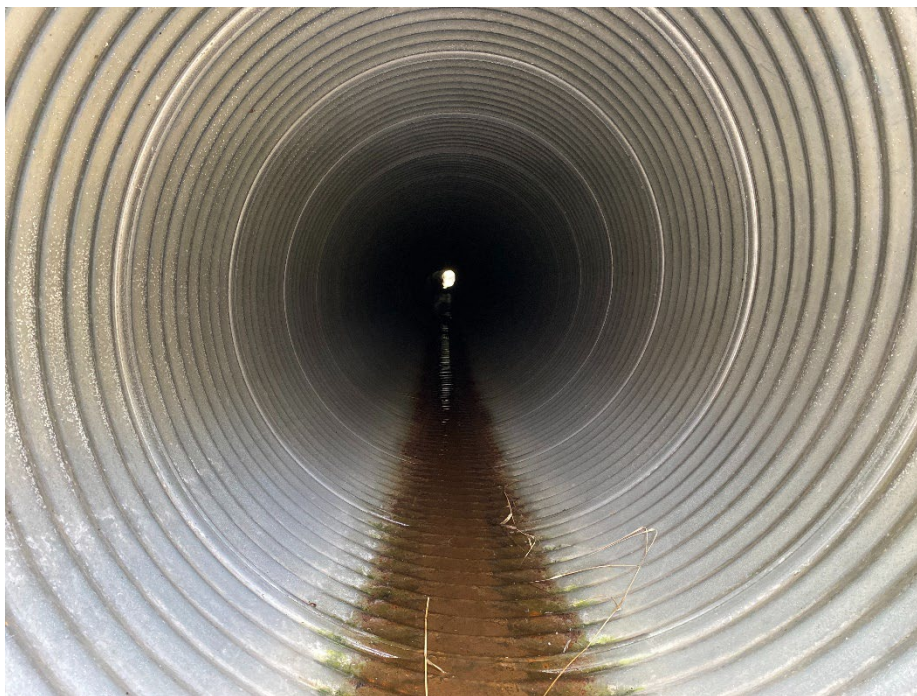
Photo 4: Culvert outlet. Looking southeast.

ESTIMATED SAG LOCATION. NOT NEW (2021)

WATER PONDING AT CULVERT (2016) PONDED BUT FLOWING (2019) FLOWING WELL (2020) DRY (2021)
PONDING. INVERT GRADED BACKWARDS. NO FLOW (2023)
