GEOHAZARD RISK MANAGEMENT PROGRAM

North Central Region – Edson / Stony Plain Area

2018 Inspection Report

Site Number	Site Name		Hwy	km
NC36	Lazy 'S' Slide		22:32	30.2
Legal Land Description	SW28-56-8-W5M			
UTM Coordinates (NAD 83)	Zone 11U	N5969791	E622172	
Operational Site Instrumentation	Slope Inclinometers		0	
	Pneumatic Piezometers		0	
	Vibrating Wire Piezometers		0	
	Standpipe Piezometers		1	
Date of Last Instrumentation Readings	May 8, 2018

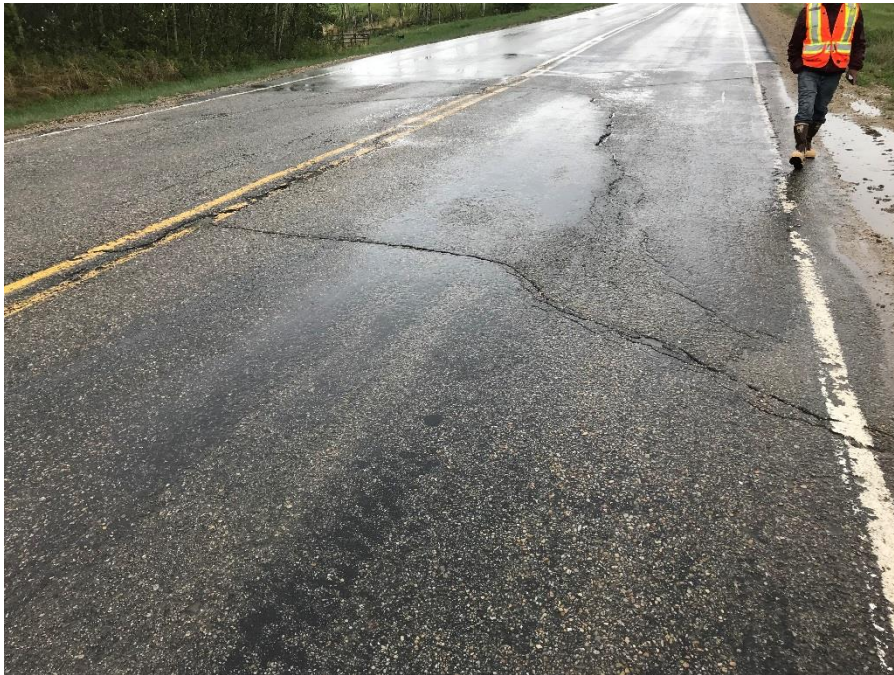
Discussion	<p>Pavement cracking appeared to be relatively unchanged as shown in Photo 1 and 2.</p> <p>The previous culverts at the site were removed and reconstructed in 2016 as directed through AT's bridge department. It was noted during the Spring 2017 readings that instruments were destroyed consisting of SP2, SP3, and SI1. SI1 was also noted to be infilled with soil. As part of the reconstruction, a saw cut was used to remove a portion of the roadway. The southern saw cut location can be seen in Photo 2. The new culverts now drain into and out of a riprap lined channel as shown in Photo 3. Straw rolls were placed upslope and to the west of the new drainage channel.</p> <p>The previous twin culvert outlet was replaced by a 2120 mm diameter SPCSP culvert and lined with riprap as shown in Figure 4. Straw rolls were placed upslope from the culvert outlet. A new beaver dam was observed during this inspection. Similar to the 2016 inspection, a treed gully was observed downstream from the culvert outlet.</p> <p>Significant erosion was observed along the natural swale to the south and along the northeast and southern edge of the drainage channel as shown in Photos 5 and 6.</p> <p>The seepage on the west shoulder of the road noted in 2015 was not observed at the time of this inspection.</p> <p>A possible tension crack appeared to be developing south of SI1 as shown in Photo 7. The crack was approximately 10 mm wide and about 200 mm long.</p> <p>Photos of the overall slope are shown in Photos 8 and 9.</p>

Photo 1: Pavement cracking on northbound lane. Looking north.

Recommendations	<p>It is recommended that short-term remediation measures should be taken. This may include sealing pavement cracks to reduce surface water infiltration into the slope and pavement structure. Clearing of the treed gully downstream from the culvert may also help to promote drainage.</p> <p>It is recommended that replacement instruments be installed to monitor pore pressure and slope movements.</p> <p>Remediation strategies at this site may include flattening the slope or constructing a berm on the east side of the highway. Installation of a pile wall may also be considered. Due to the high groundwater levels on both sides of the slope, drainage measures should be considered on both sides of the road.</p> <p>On-going monitoring of this site is recommended including the semi-annual instrumentation readings and the annual inspection.</p>
------------------------	---

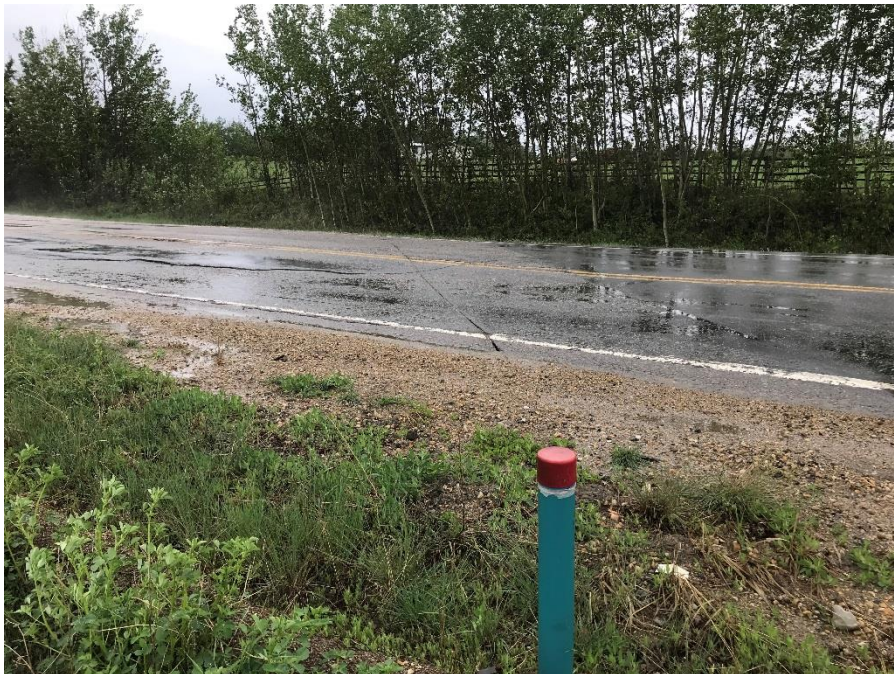
Photo 2: Dip in northbound lane unchanged. Saw cut visible. Looking west.

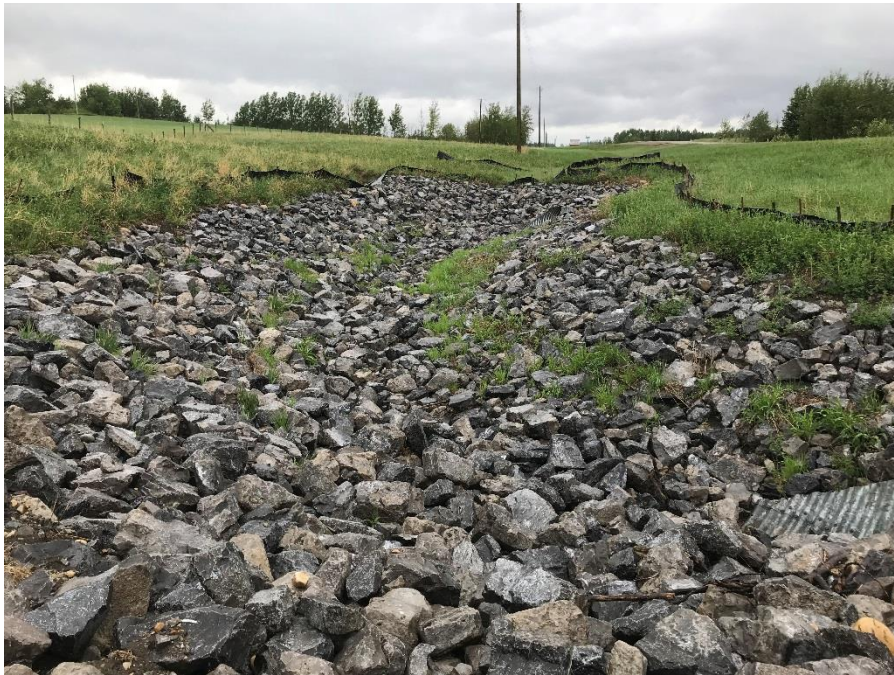
Photo 3: Culvert draining into riprap lined channel. Looking south.

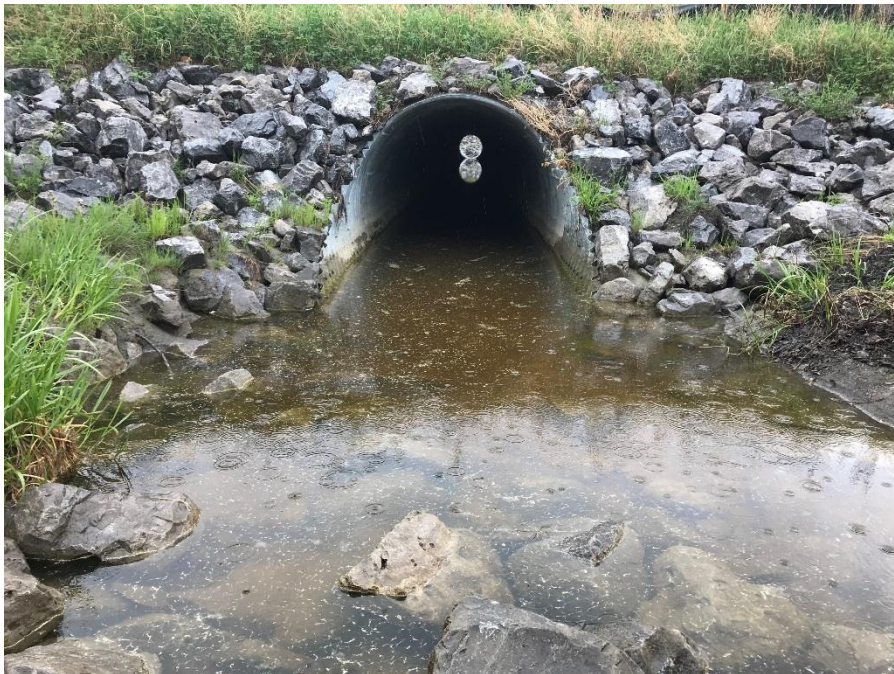
Photo 4: New 2120 mm diameter culvert outlet with riprap lining west of highway. Looking east.

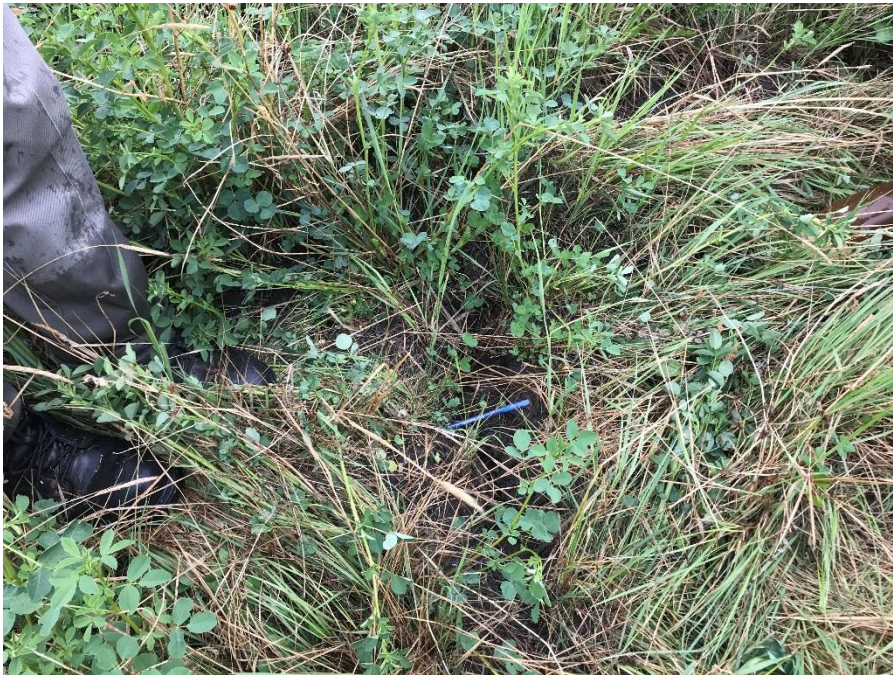
<input checked="" type="checkbox"/> Erosion	<ul style="list-style-type: none"> - Erosion along north east and south edge of riprap drainage channel 	<input checked="" type="checkbox"/> Yes	<input type="checkbox"/> No
<input type="checkbox"/> Seepage		<input type="checkbox"/> Yes	<input type="checkbox"/> No
<input type="checkbox"/> Other		<input type="checkbox"/> Yes	<input type="checkbox"/> No

Photo 5: Erosion approximately 150 mm wide at northeast side of riprap channel.

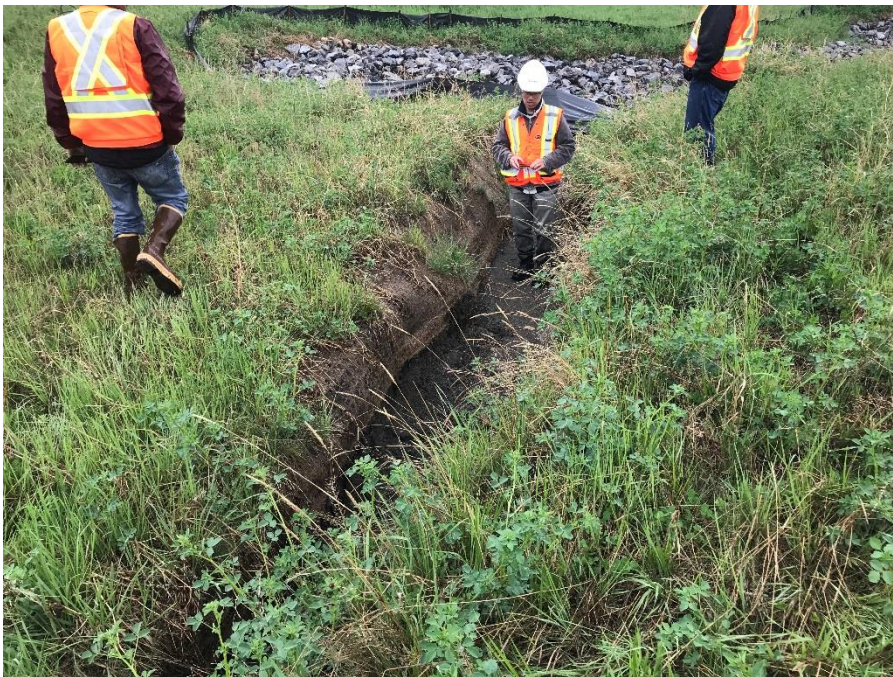
Photo 6: View of east slope. Erosion channel leading to rip rap. Looking south

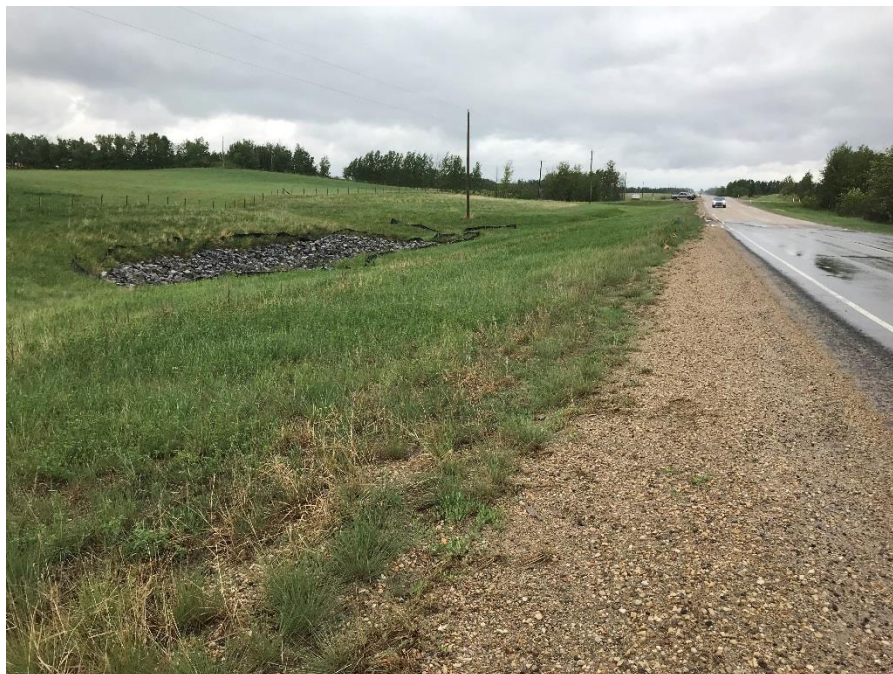
Photo 8: View of east slope. Looking south.

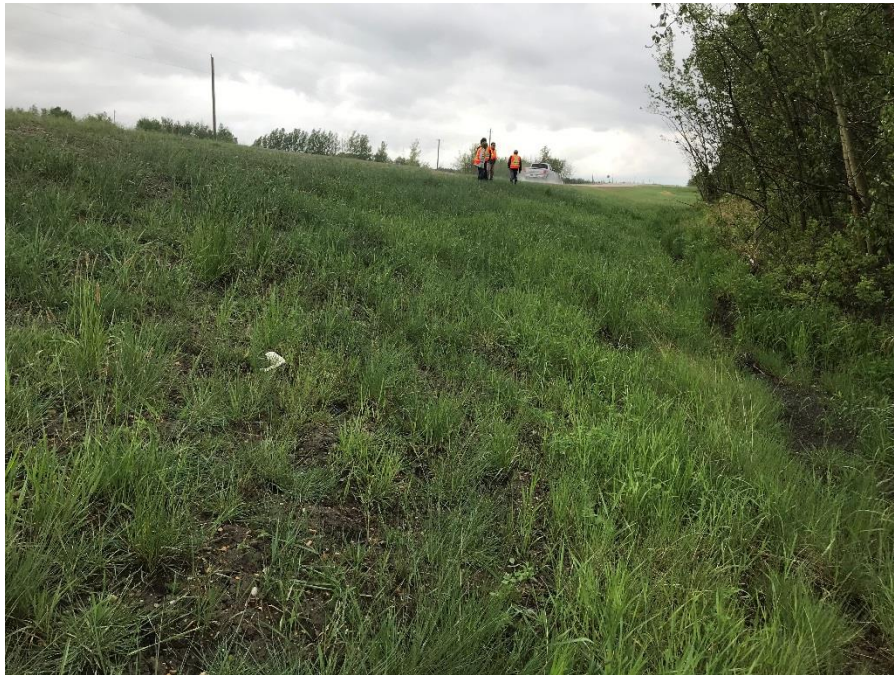
Photo 9: View of west slope. Looking south.
