GEOHAZARD RISK MANAGEMENT PROGRAM

North Central Region – Edson / Stony Plain Area

2019 Inspection Report

Site Number	Site Name		Hwy	km
NC36	Lazy 'S' Slide		22:32	30.2
Legal Land Description	SW28-56-8-W5M			
UTM Coordinates (NAD 83)	Zone 11U	N5969791	E622172	
Operational Site Instrumentation	Slope Inclinometers			0
	Pneumatic Piezometers			0
	Vibrating Wire Piezometers			0
	Standpipe Piezometers			1
Date of Last Instrumentation Readings	May 8, 2018

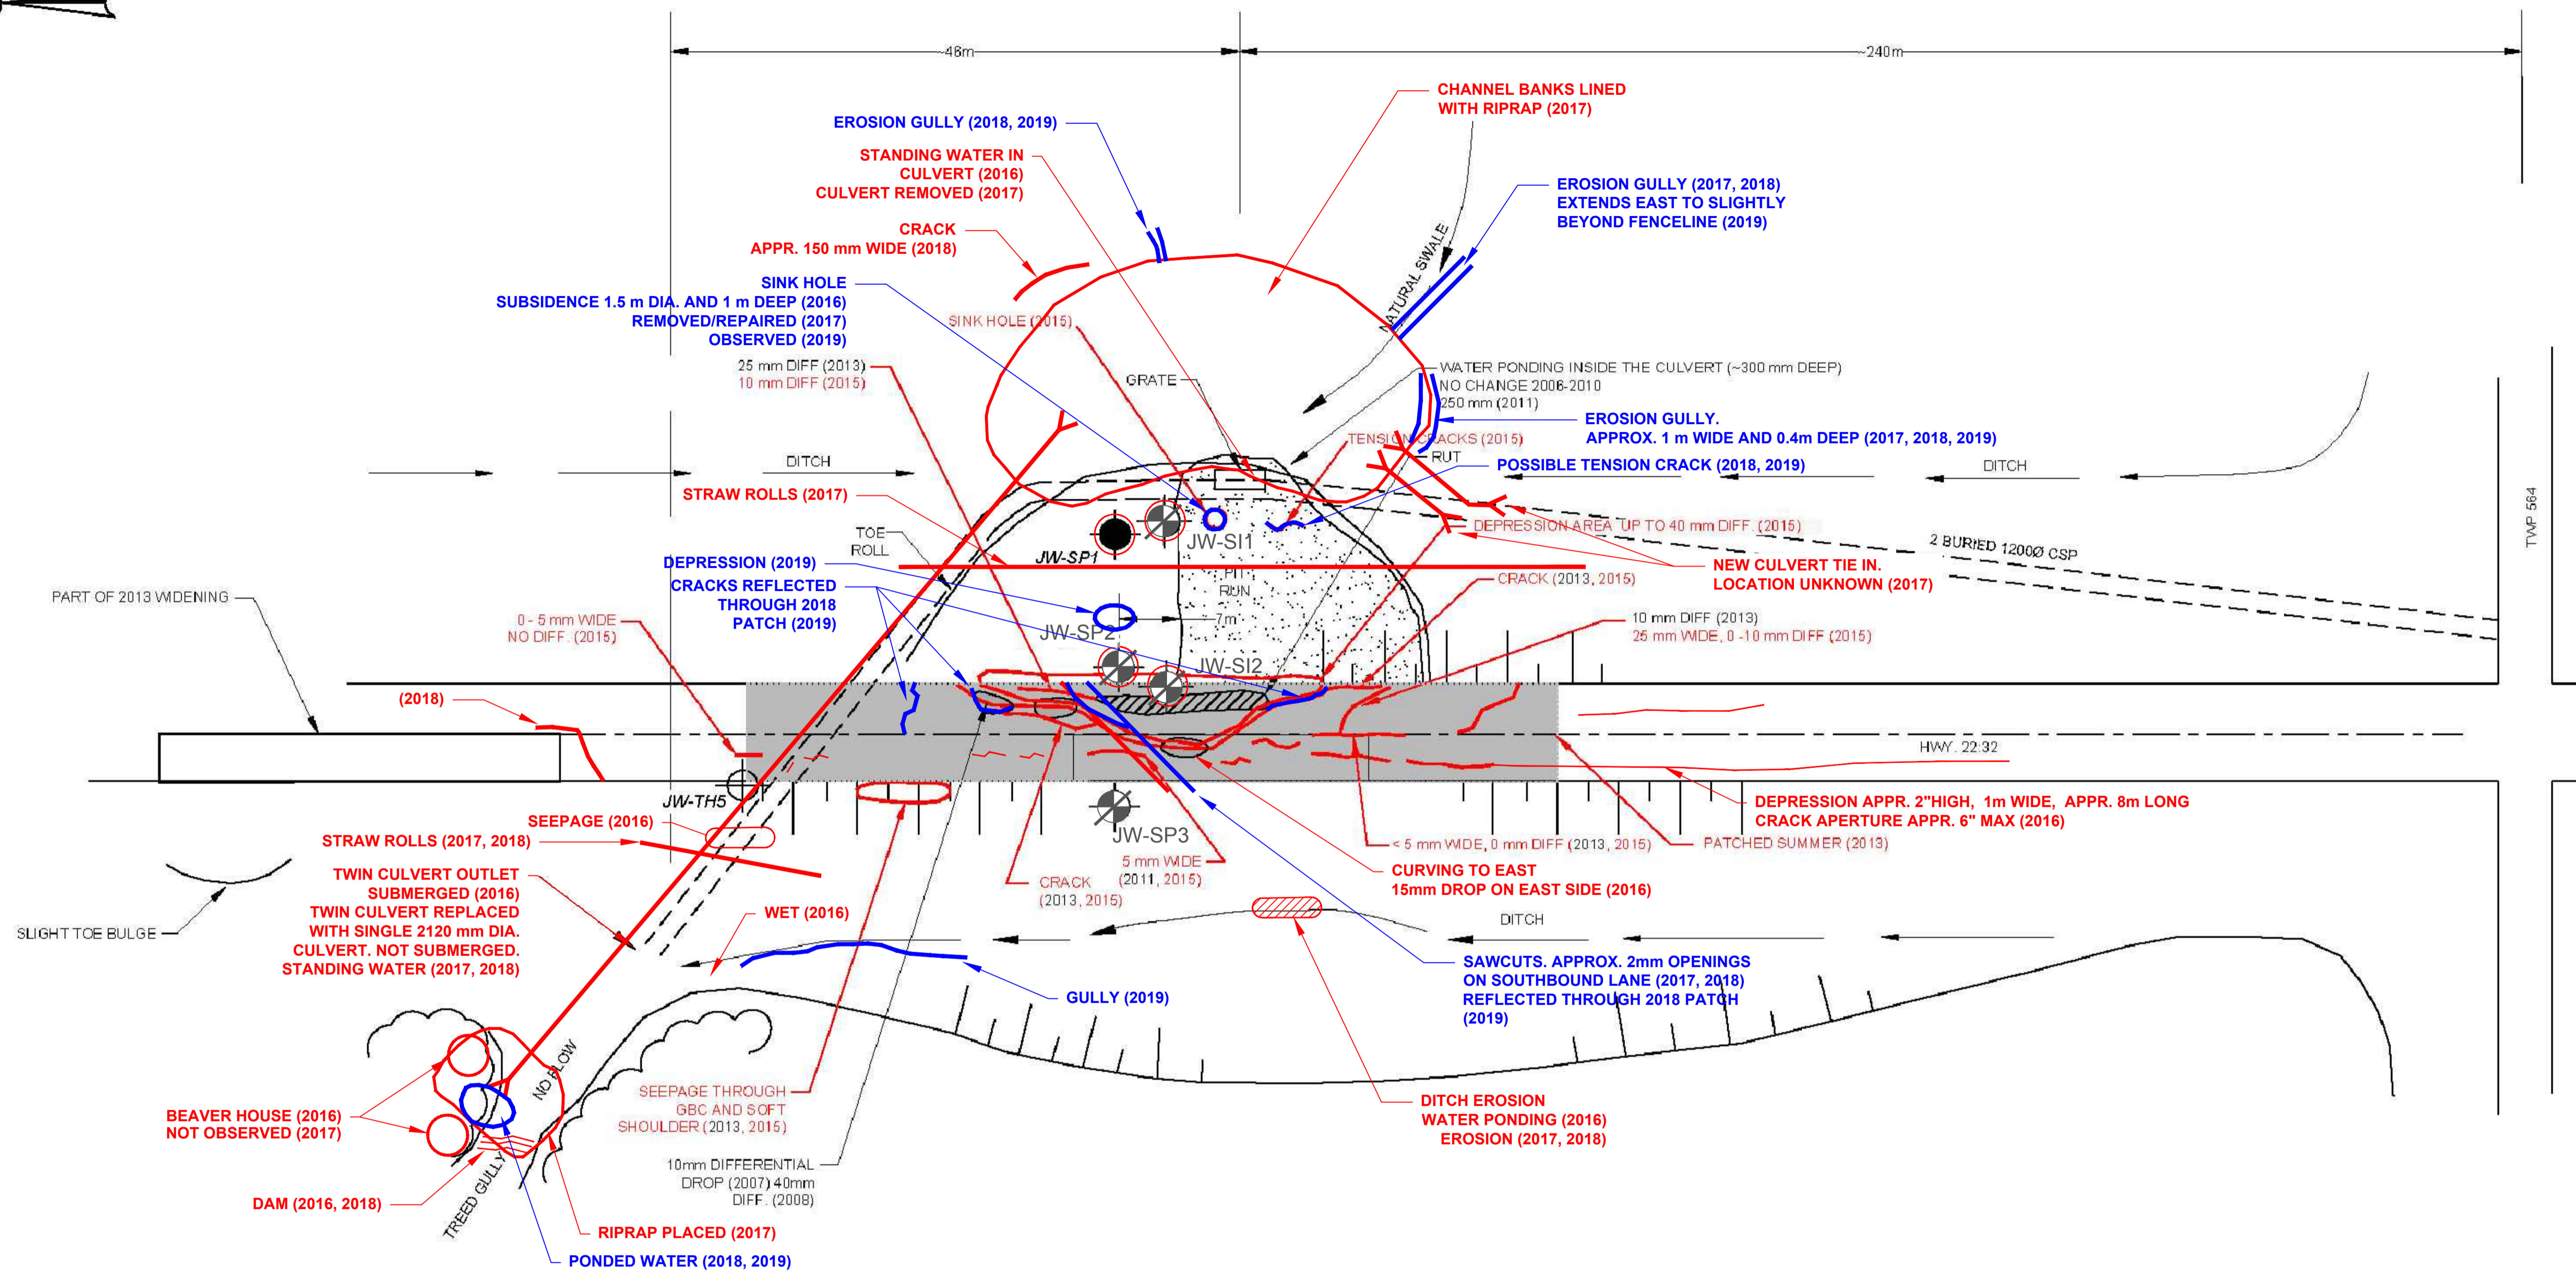
FIGURE - 1

drainage channel constructed to replace previous twin culvert.		
Recent Maintenance	Asphalt patch in 2010, 2013, and Fall 2018		
Primary Site Issue	High groundwater table, slope instability		
Observations	Description and Location	Change from Previous Inspection	
<input checked="" type="checkbox"/> Pavement Distress	- Pavement cracks reflecting through 2018 patch.	<input type="checkbox"/> Yes	<input checked="" type="checkbox"/> No
<input checked="" type="checkbox"/> Culvert Distress	- Standing water at culvert outlet.	<input type="checkbox"/> Yes	<input checked="" type="checkbox"/> No
<input type="checkbox"/> Bridge Distress		<input type="checkbox"/> Yes	<input type="checkbox"/> No
<input checked="" type="checkbox"/> Slope Movement	- Pavement cracks reflecting through 2018. - More pronounced ground cracks south of JW-SI1 - New depression east of JW-SP2.	<input checked="" type="checkbox"/> Yes	<input type="checkbox"/> No

<input checked="" type="checkbox"/> Erosion	- Erosion along northeast and south edge of riprap drainage channel - New erosion gully in west ditch leading to creek	<input checked="" type="checkbox"/> Yes	<input type="checkbox"/> No
<input type="checkbox"/> Seepage		<input type="checkbox"/> Yes	<input type="checkbox"/> No
<input type="checkbox"/> Other		<input type="checkbox"/> Yes	<input type="checkbox"/> No

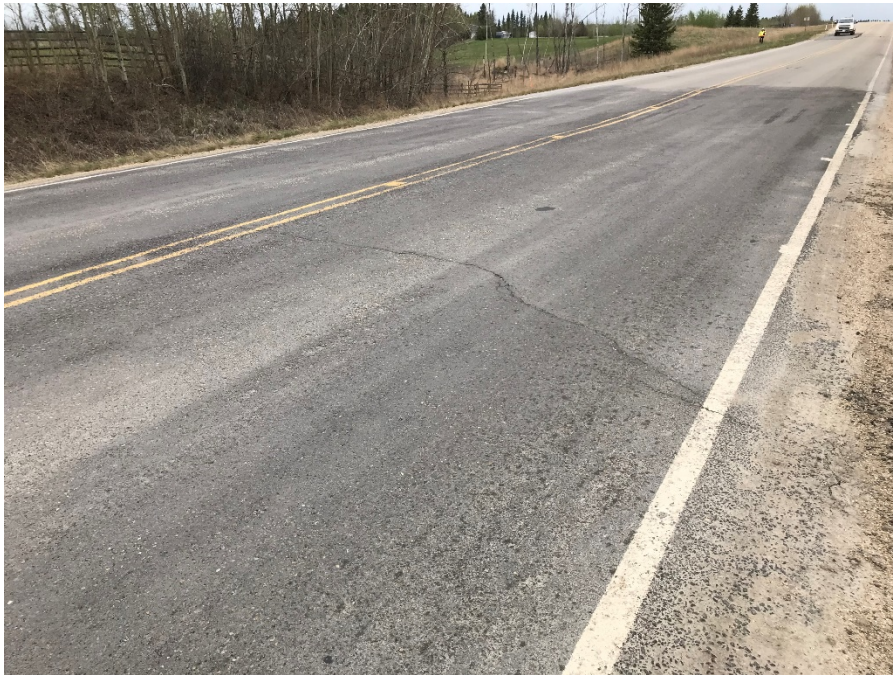
Discussion	<p>Highway 22 was recently patched in late Fall 2018. Previously observed pavement cracks have already resurfaced as shown in Photos 1 to 3.</p> <p>The previous culverts at the site were removed and reconstructed in 2016 through AT's bridge department. It was noted during the Spring 2017 readings that instruments were destroyed consisting of SP2, SP3, and S11. S11 was also noted to be infilled with soil. As part of the reconstruction, a saw cut was used to remove a portion of the roadway. The southern saw cut location can be seen in Photo 2. The new culverts now drain into and out of a riprap lined channel as shown in Photo 4.</p> <p>The previous twin culvert outlet was replaced by a 2120 mm diameter SPCSP culvert and lined with riprap as shown in Figure 5. Straw rolls were placed upslope from the culvert outlet. Similar to previous inspections, a treed gully was observed downstream from the culvert outlet.</p> <p>Significant erosion was observed along the natural swale to the south and along the northeast and southern edge of the drainage channel. The erosion channel at the southeast side of the riprap channel has now extended to beyond the fence line as shown in Photo 6.</p> <p>The seepage on the west shoulder of the road noted in 2015 was not observed at the time of this inspection.</p> <p>The tension crack appeared to be more pronounced south of JW-S11 as shown in Photo 7.</p> <p>A depression in the ground immediately downslope from JW-SP2 was observed as shown in Photo 8.</p> <p>A new erosion gully in the west ditch leading into the treed gully area was observed as shown in Photo 9.</p>

Photo 1: Old pavement crack reflected through 2018 patch. on northbound lane. Looking north.

Recommendations	<p>It is recommended that short term remediation measures should be taken. This may include sealing pavement cracks to reduce surface water infiltration into the slope and pavement structure. Clearing of the treed gully downstream from the culvert may also help to promote drainage.</p> <p>It is recommended that replacement instruments be installed to monitor pore pressure and slope movements.</p> <p>Remediation strategies at this site may include constructing a berm on the east side of the highway or installation of a pile wall. Due to the high groundwater levels on both sides of the slope, drainage measures should be considered on both sides of the road.</p> <p>Annual inspections should be continued at this site.</p>
------------------------	---

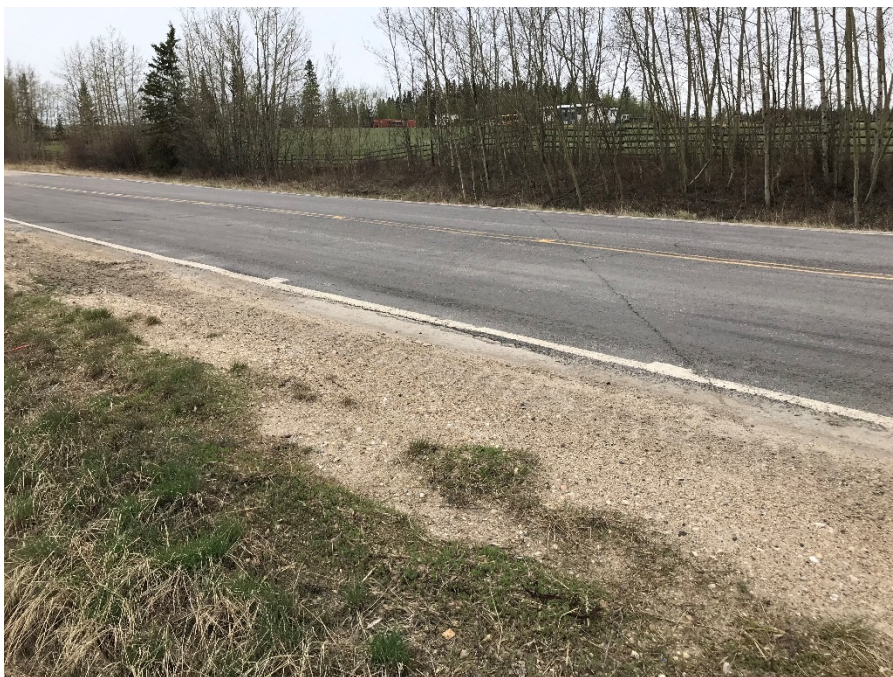
Photo 2: Dip in northbound lane repaired during 2018 patch. Saw cut visible. Looking west.

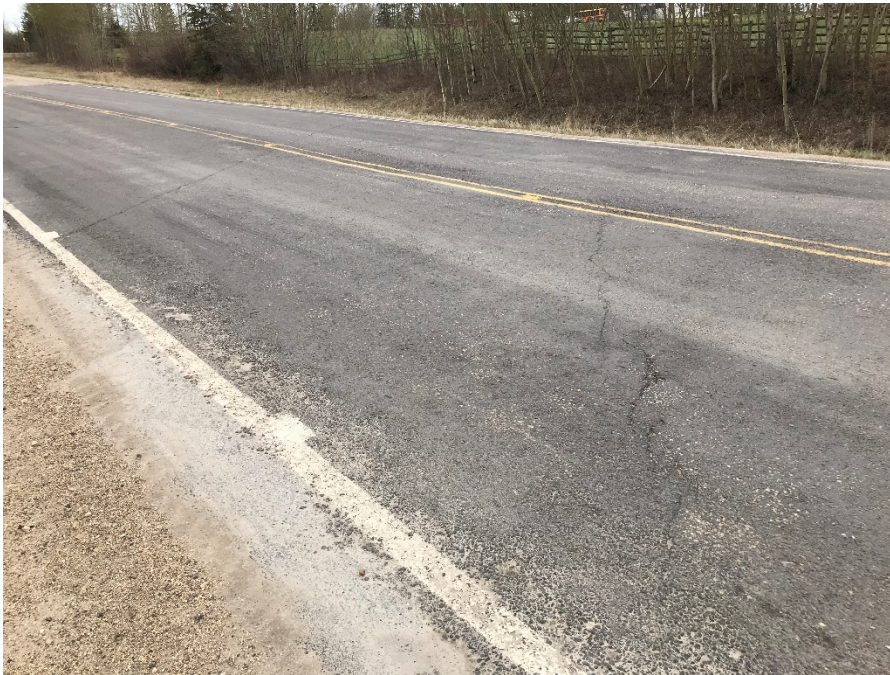
Photo 3: Crack reflecting through 2018 patch. Looking southwest.

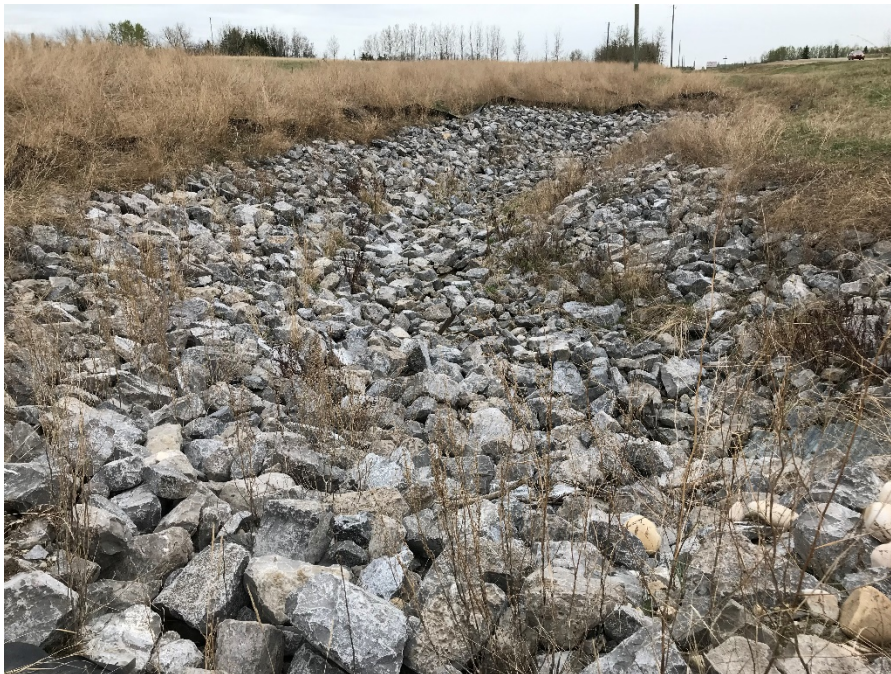
Photo 4: Culvert draining into riprap lined channel. Looking south.

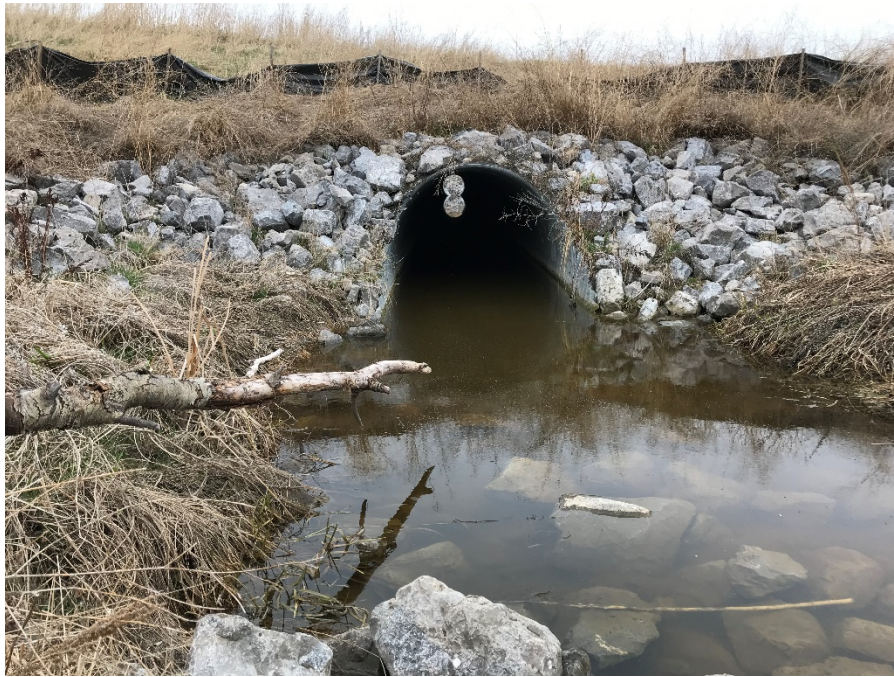
Photo 5: New 2120 mm diameter culvert outlet with riprap lining west of highway. Looking east.

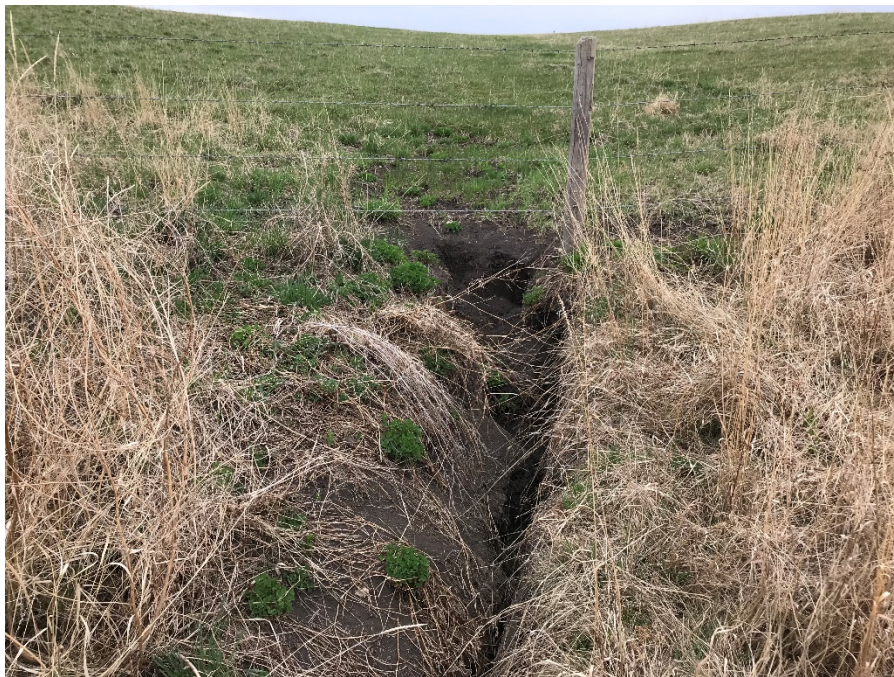
Photo 6: Erosion channel leading from rip rap to fence line. Looking east.

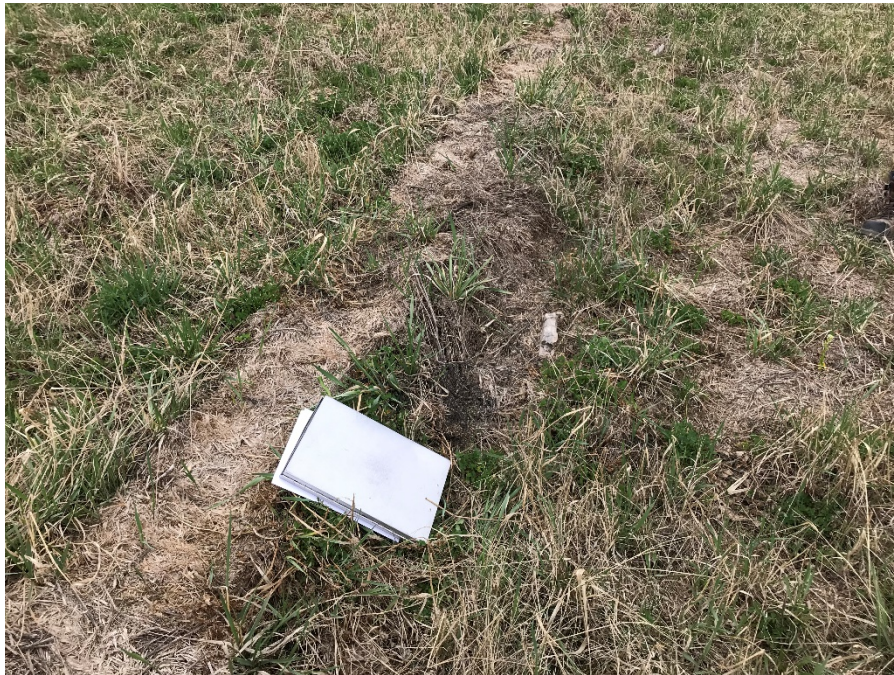
Photo 7: Ground crack more pronounced south of JW-S11.

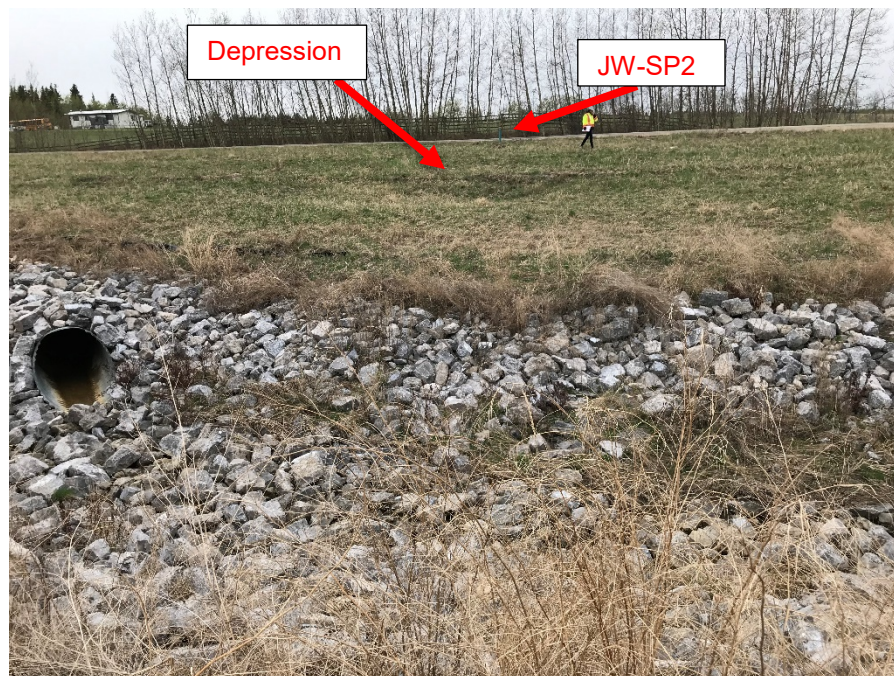
Photo 8: Depression in ground east of JW-SP2. Looking west.

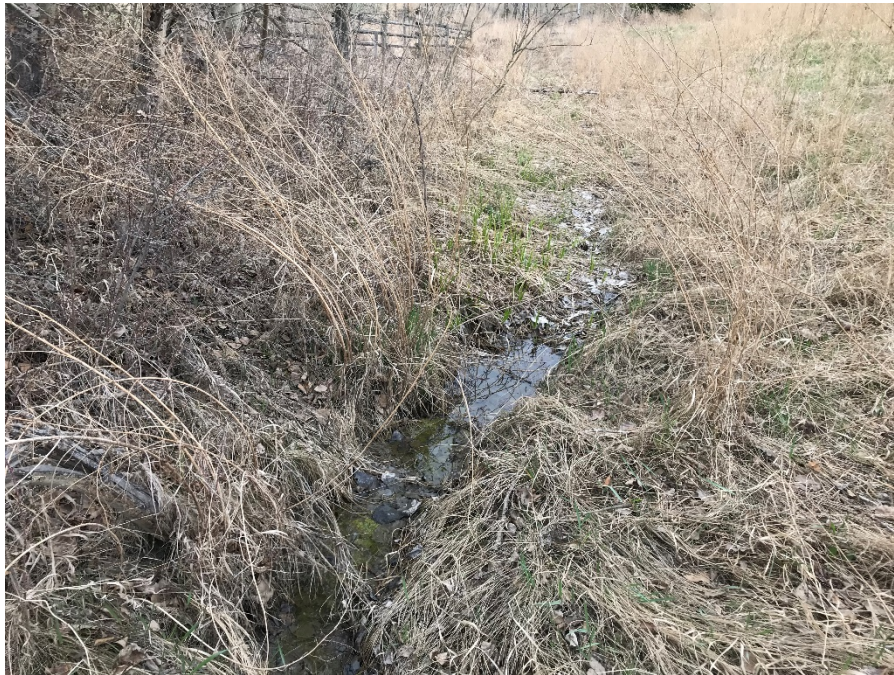
Photo 9: Erosion gully with flowing water in west ditch. Looking north.
