<b>SITE NUMBER AND NAME:</b> NC036-2 – Lazy “S” Slide	<b>LOCATION:</b> On Highway 22 approximately 80 m south of Township Road 564	<b>HIGHWAY:</b> 22:32	<b>KM:</b> 30.000
<b>LEGAL DESCRIPTION:</b> NW-32-52-25-W4	<b>NAD83 COORDINATES:</b> UTM11U 5935400N, 323784E		
<b>AVERAGE ANNUAL DAILY TRAFFIC (AADT):</b> 3,670 (2021, Traffic from West Turning Left)		<b>CONTRACTOR MAINTENANCE AREA (CMA):</b> AHD

<b>PRIMARY SITE ISSUE:</b> Landslide with arc-shaped cracks on highway affecting the northbound lane (NBL).
<b>APPROXIMATE DIMENSIONS:</b> 30 m wide x 15 m long x 3 m high
<b>SITE HISTORY:</b> No files were available from AT for review at this location. Borehole information for the original NC036-1 site approximately 250 m north of the current site suggests the subsurface condition consists of approximately 4 m of firm to stiff high plastic clay fill, overlying 4.5 m of firm high plastic clay, underlain by firm to stiff medium plastic clay till. Piezometric levels at NC036-1 were generally 2 m below ground surface.

Client/Project: Alberta Transportation  
 Geohazard Monitoring Program  
 NC036-2 Highway 22 Lazy "S" Slide

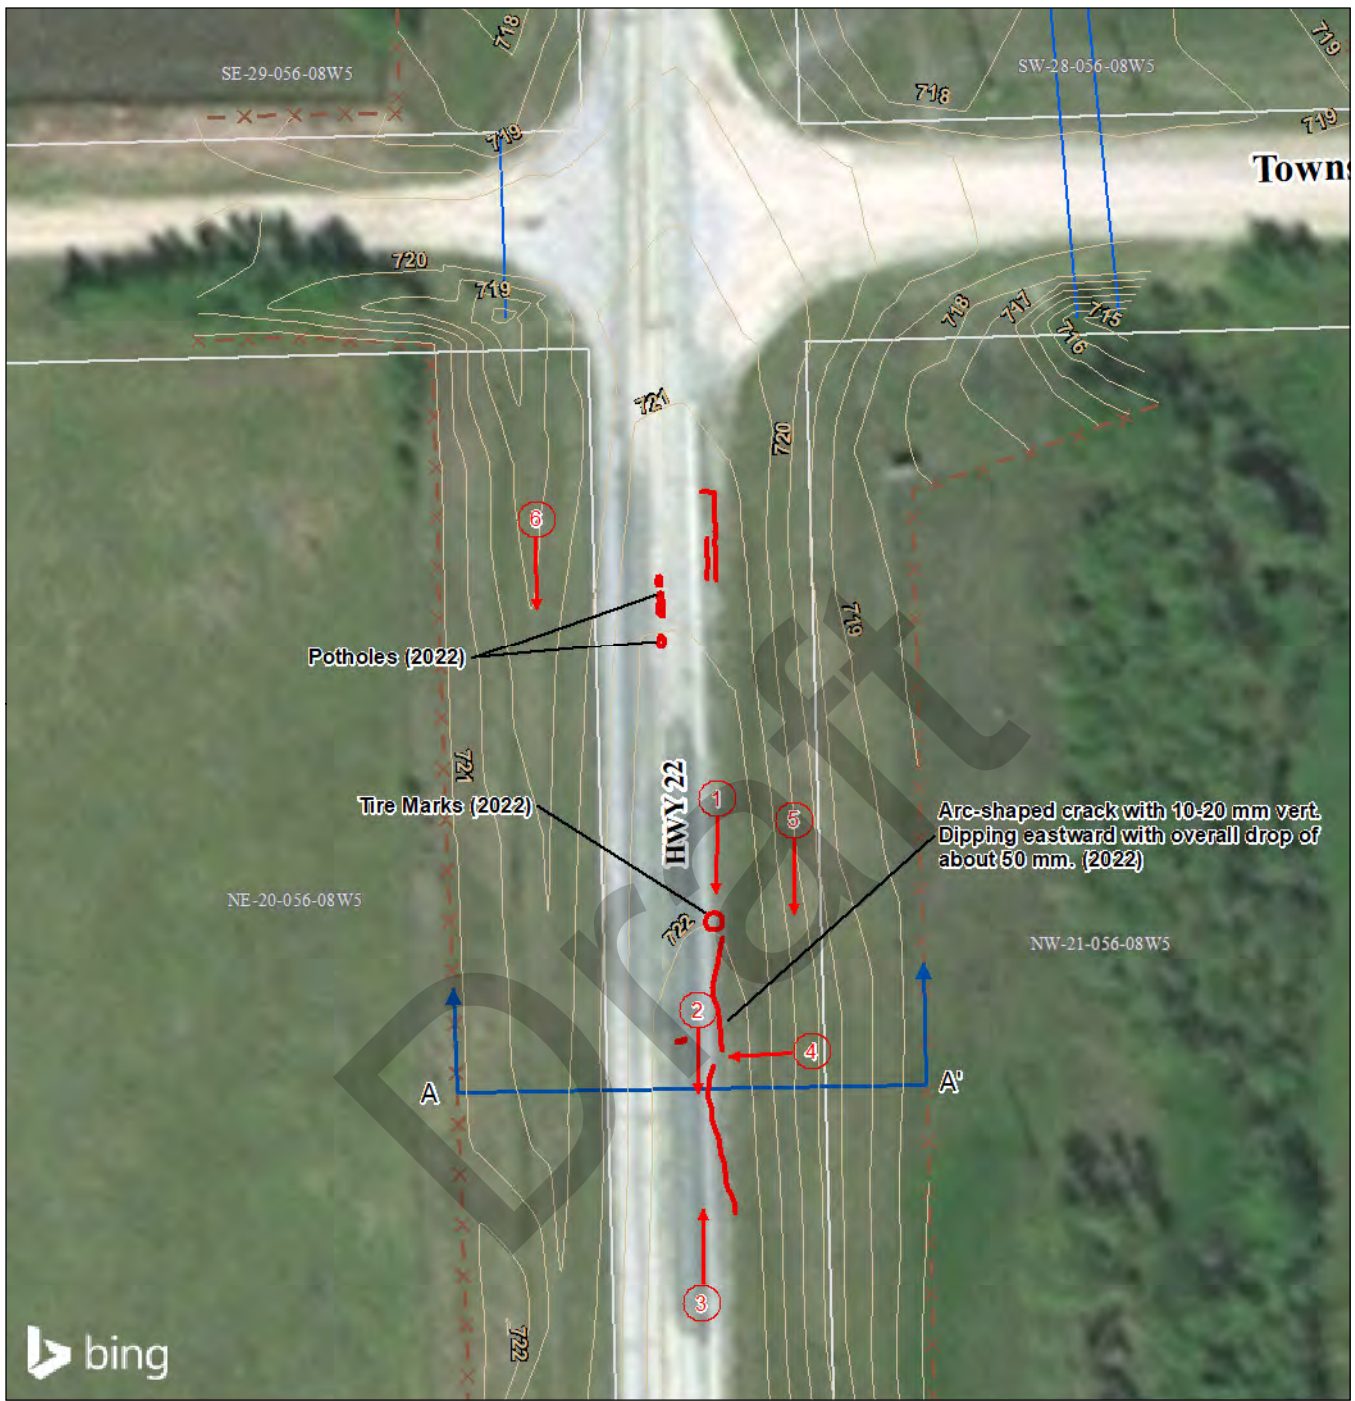
Figure No. 1  
 Title: Site Plan

<b>ASSESSMENT</b>
<ul style="list-style-type: none"> <li>The overall embankment is about 3 m high with possible toe bulging observed at the base of the embankment.</li> <li>An arc-shaped crack was observed on the NBL approximately 25 m long with a vertical difference of about 10 mm to 20 mm. An apparent dip towards the east of about 50 mm was observed along the crack.</li> </ul>

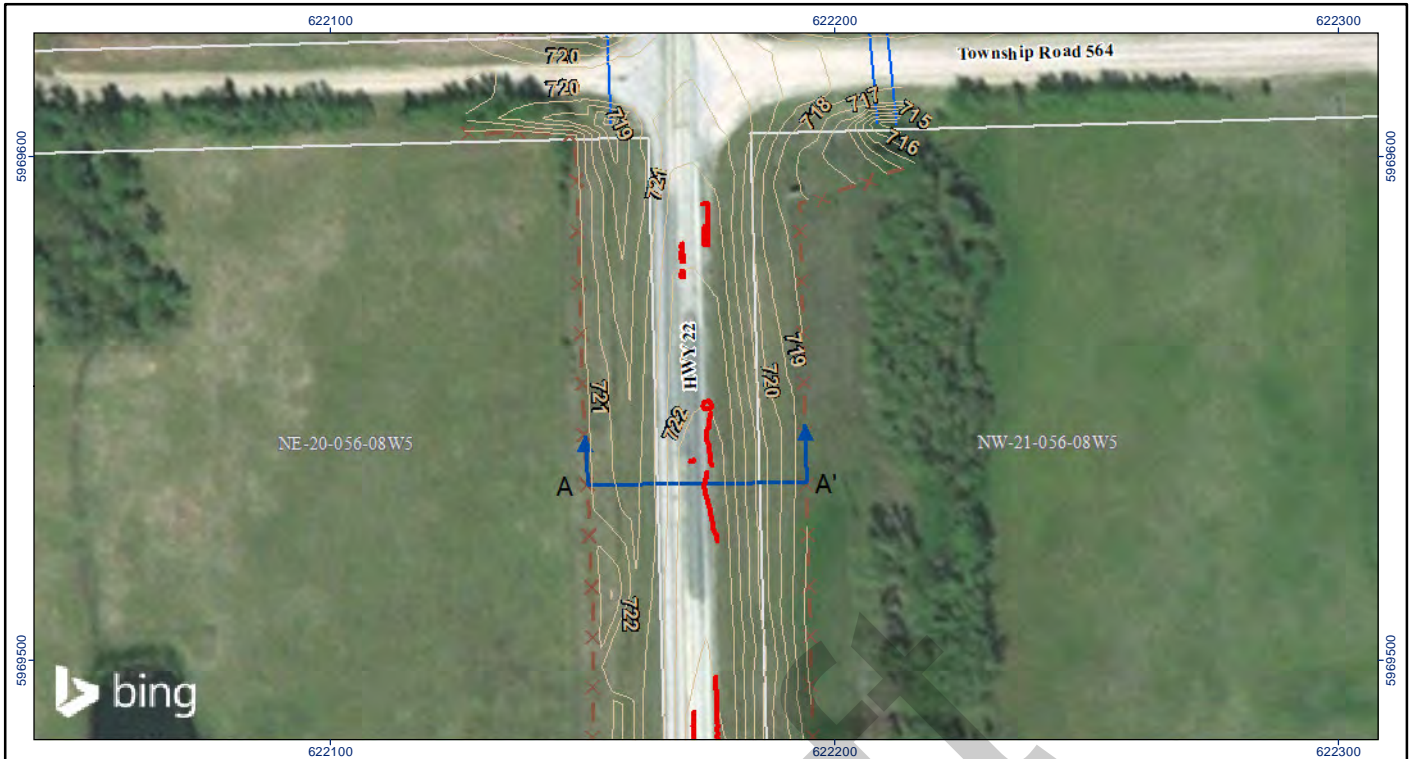
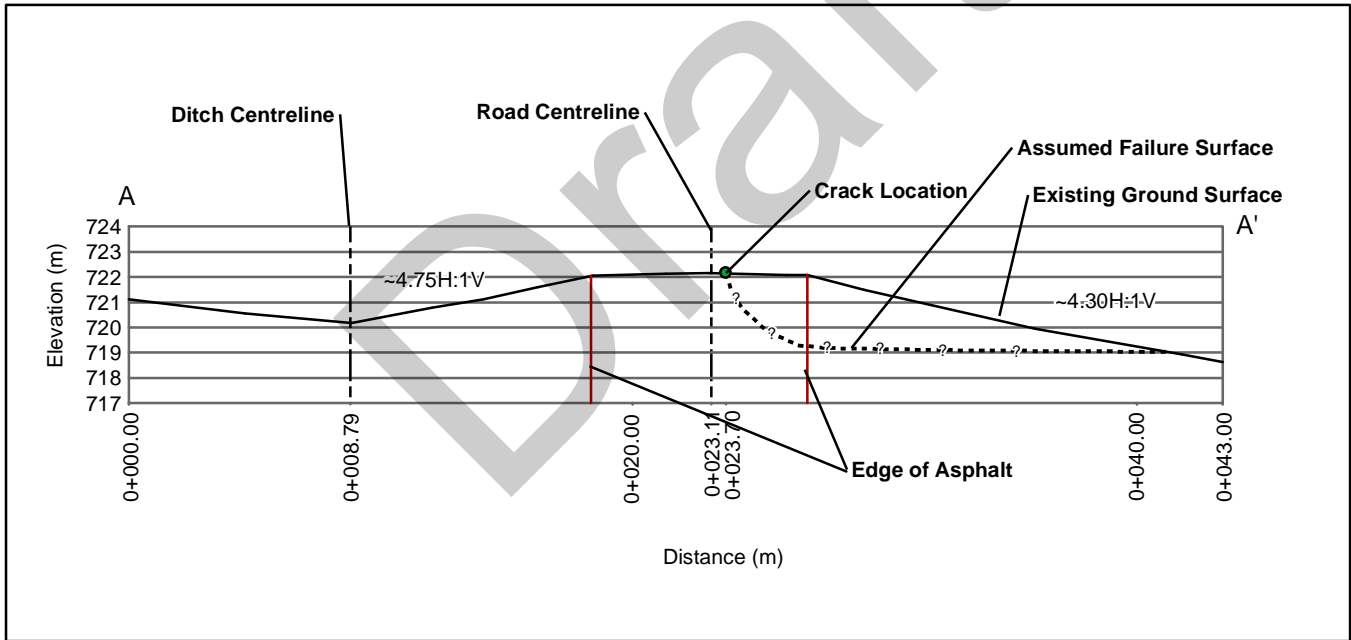
Figure No. 2  
 Title: **Ground Profile of Section A - A'**

- Both embankment slopes were well vegetated with grass.
- The landslide appears to be a shallow failure limited to the embankment fill. It is possible that the landslide historically began due to softening of the toe along the east embankment near the watercourse. Once pavement cracking began, subsequent pavement patches increased the net load on the landslide resulting in increased landslide movement.

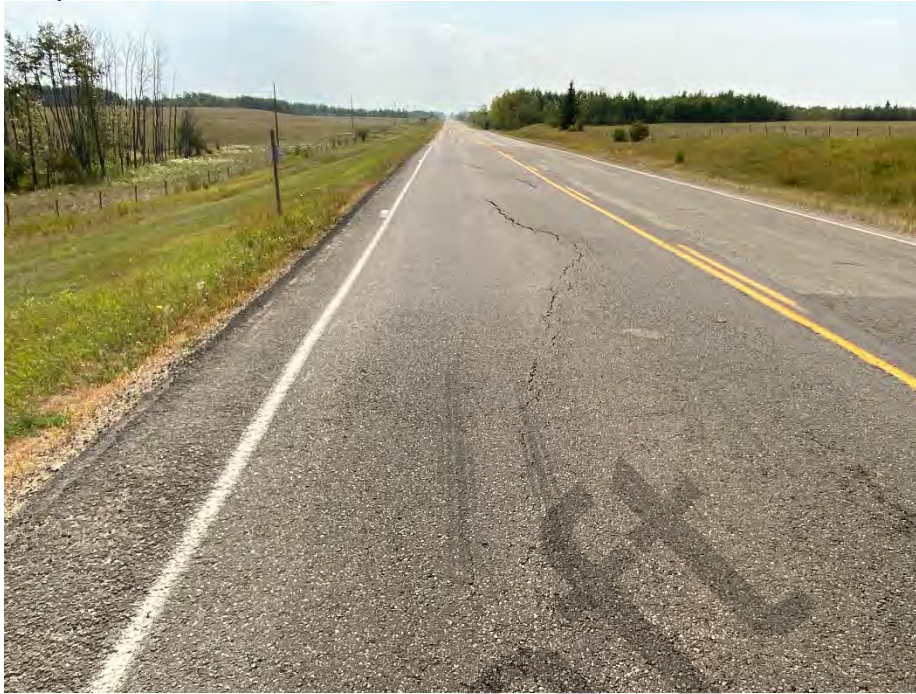
- Northbound vehicles were observed to travel into the southbound lane (SBL), presumably to avoid the sudden dip in pavement. Tire marks were also observed on the NBL possibly due to vehicles hard braking after driving over the dip.

**Photo 1:** Pavement cracking at north extent. Tire marks visible. Looking south.

- The pavement cracks should be sealed to reduce surface water infiltration into the embankment. This could include milling and paving to improve rideability. Paving should be conducted such that the final highway surface should match the existing elevation or lower (i.e., no net addition of loads).

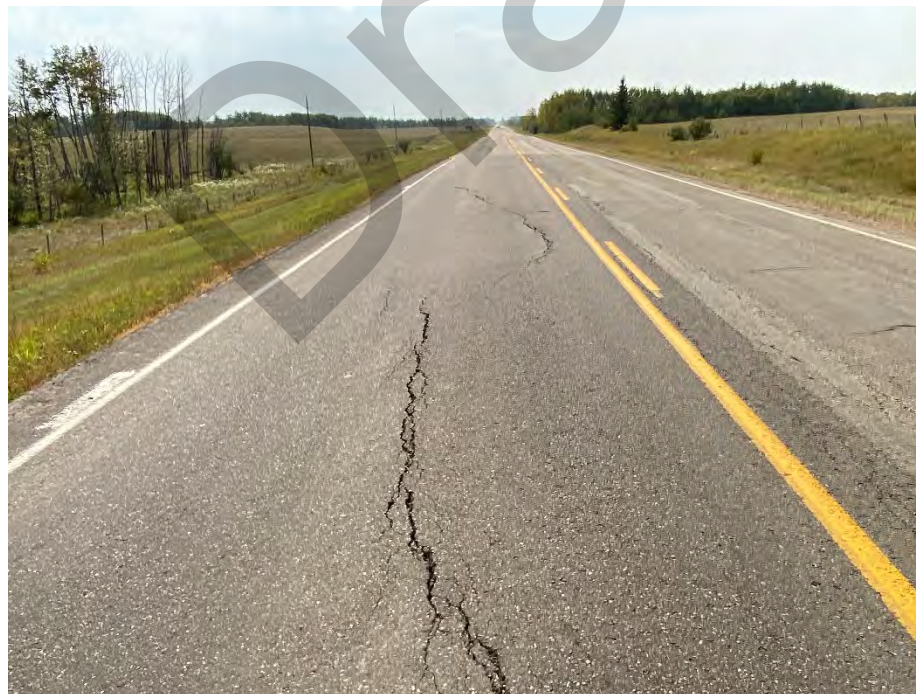
**Photo 2:** Pavement cracking on northbound lane. Dip towards east. Looking south.

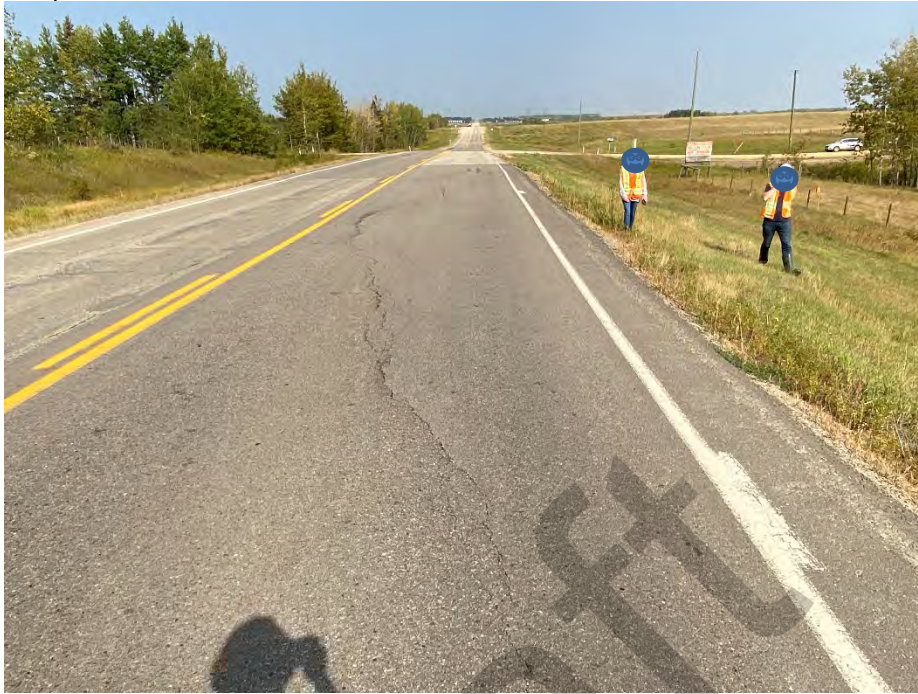
**Photo 3:** Pavement cracking approximately at south extent. Looking north.

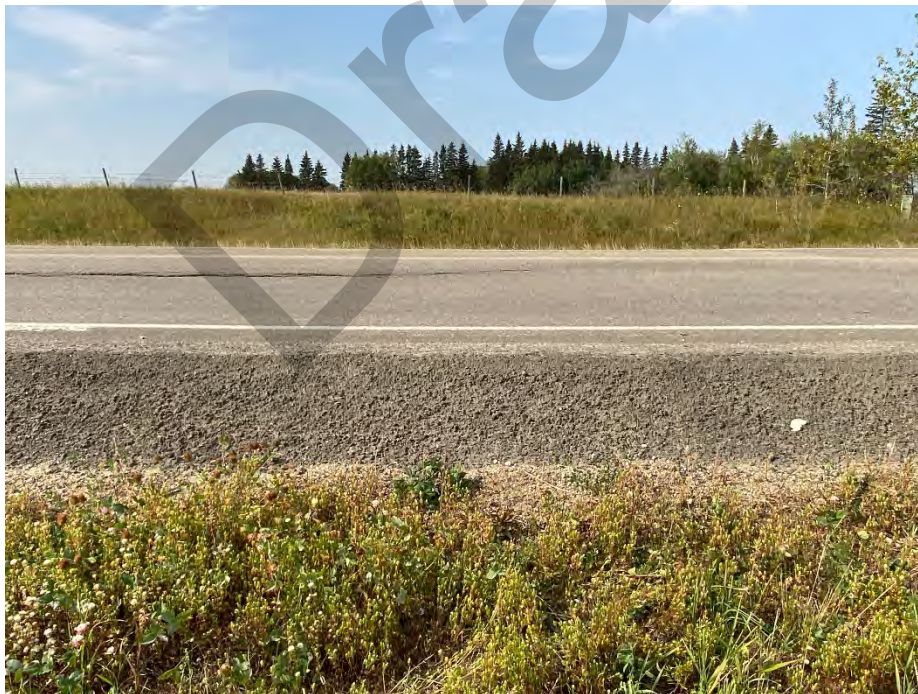
**Photo 4:** Northbound lane dipping to the east. Looking west.

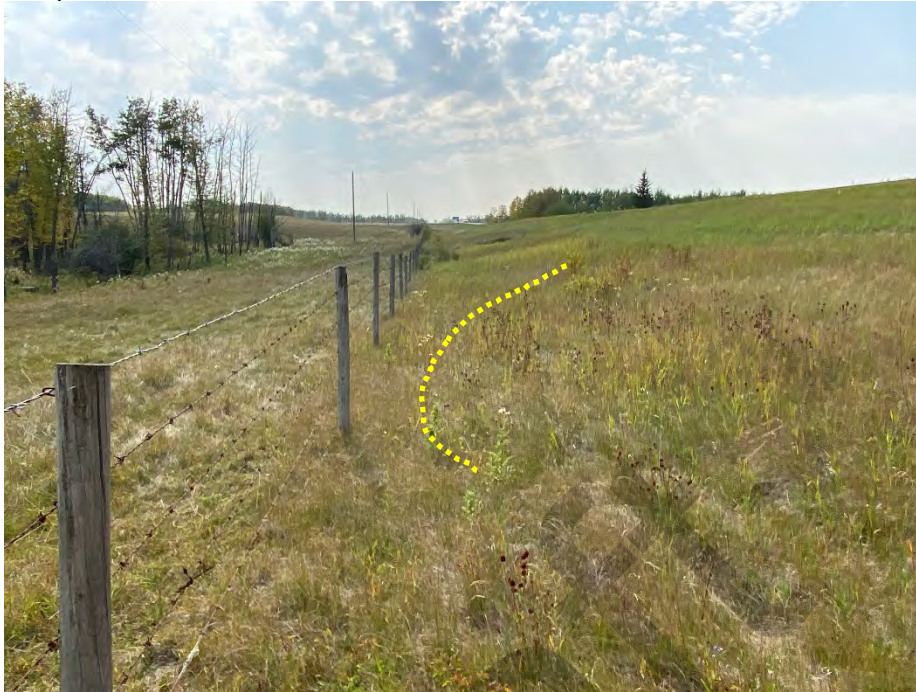
**Photo 5:** Slight toe bulging at base of embankment. Looking south.

- Construction of a toe berm. The approximate dimensions required for a toe berm is 40 m wide x 10 m long x 2 m high. Land agreement or purchase may be required depending on the size of toe berm required. In addition, the toe berm may encroach into an adjacent watercourse which may trigger environmental approval. The high-level cost for toe berm construction is \$150,000 to \$200,000 excluding engineering and land purchase.

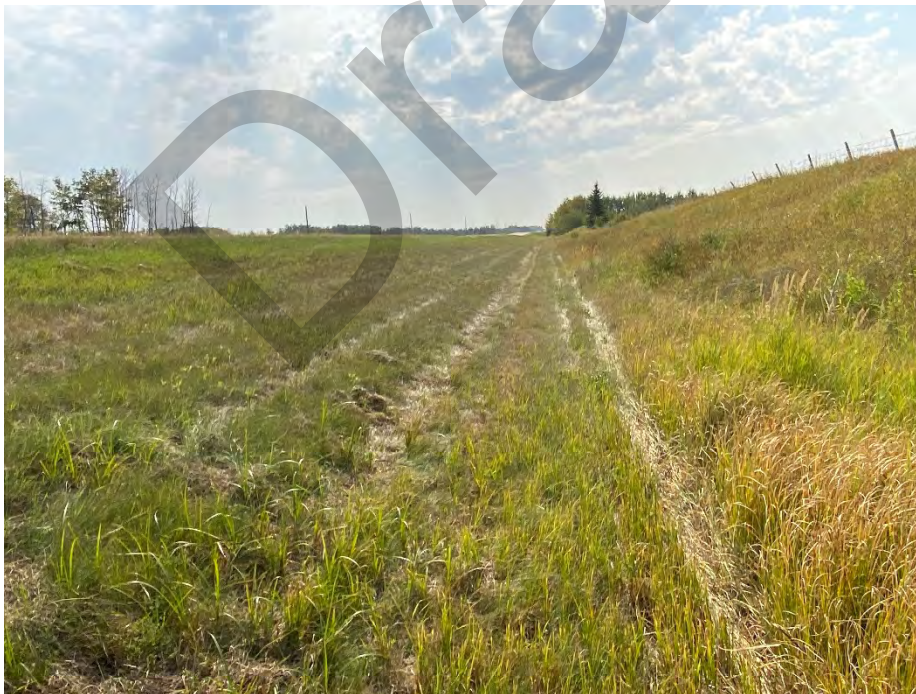
**Photo 6:** Overall west embankment. Looking south.
