From: Leslie Cho and Carrie Murray
Stantec Consulting Ltd.

File: 123315222

Reference: North Central Region, Edson/Stony Plain, Site NC036 – Highway 22:32 Lazy “S” Slide, Spring 2022 Instrumentation Monitoring Report

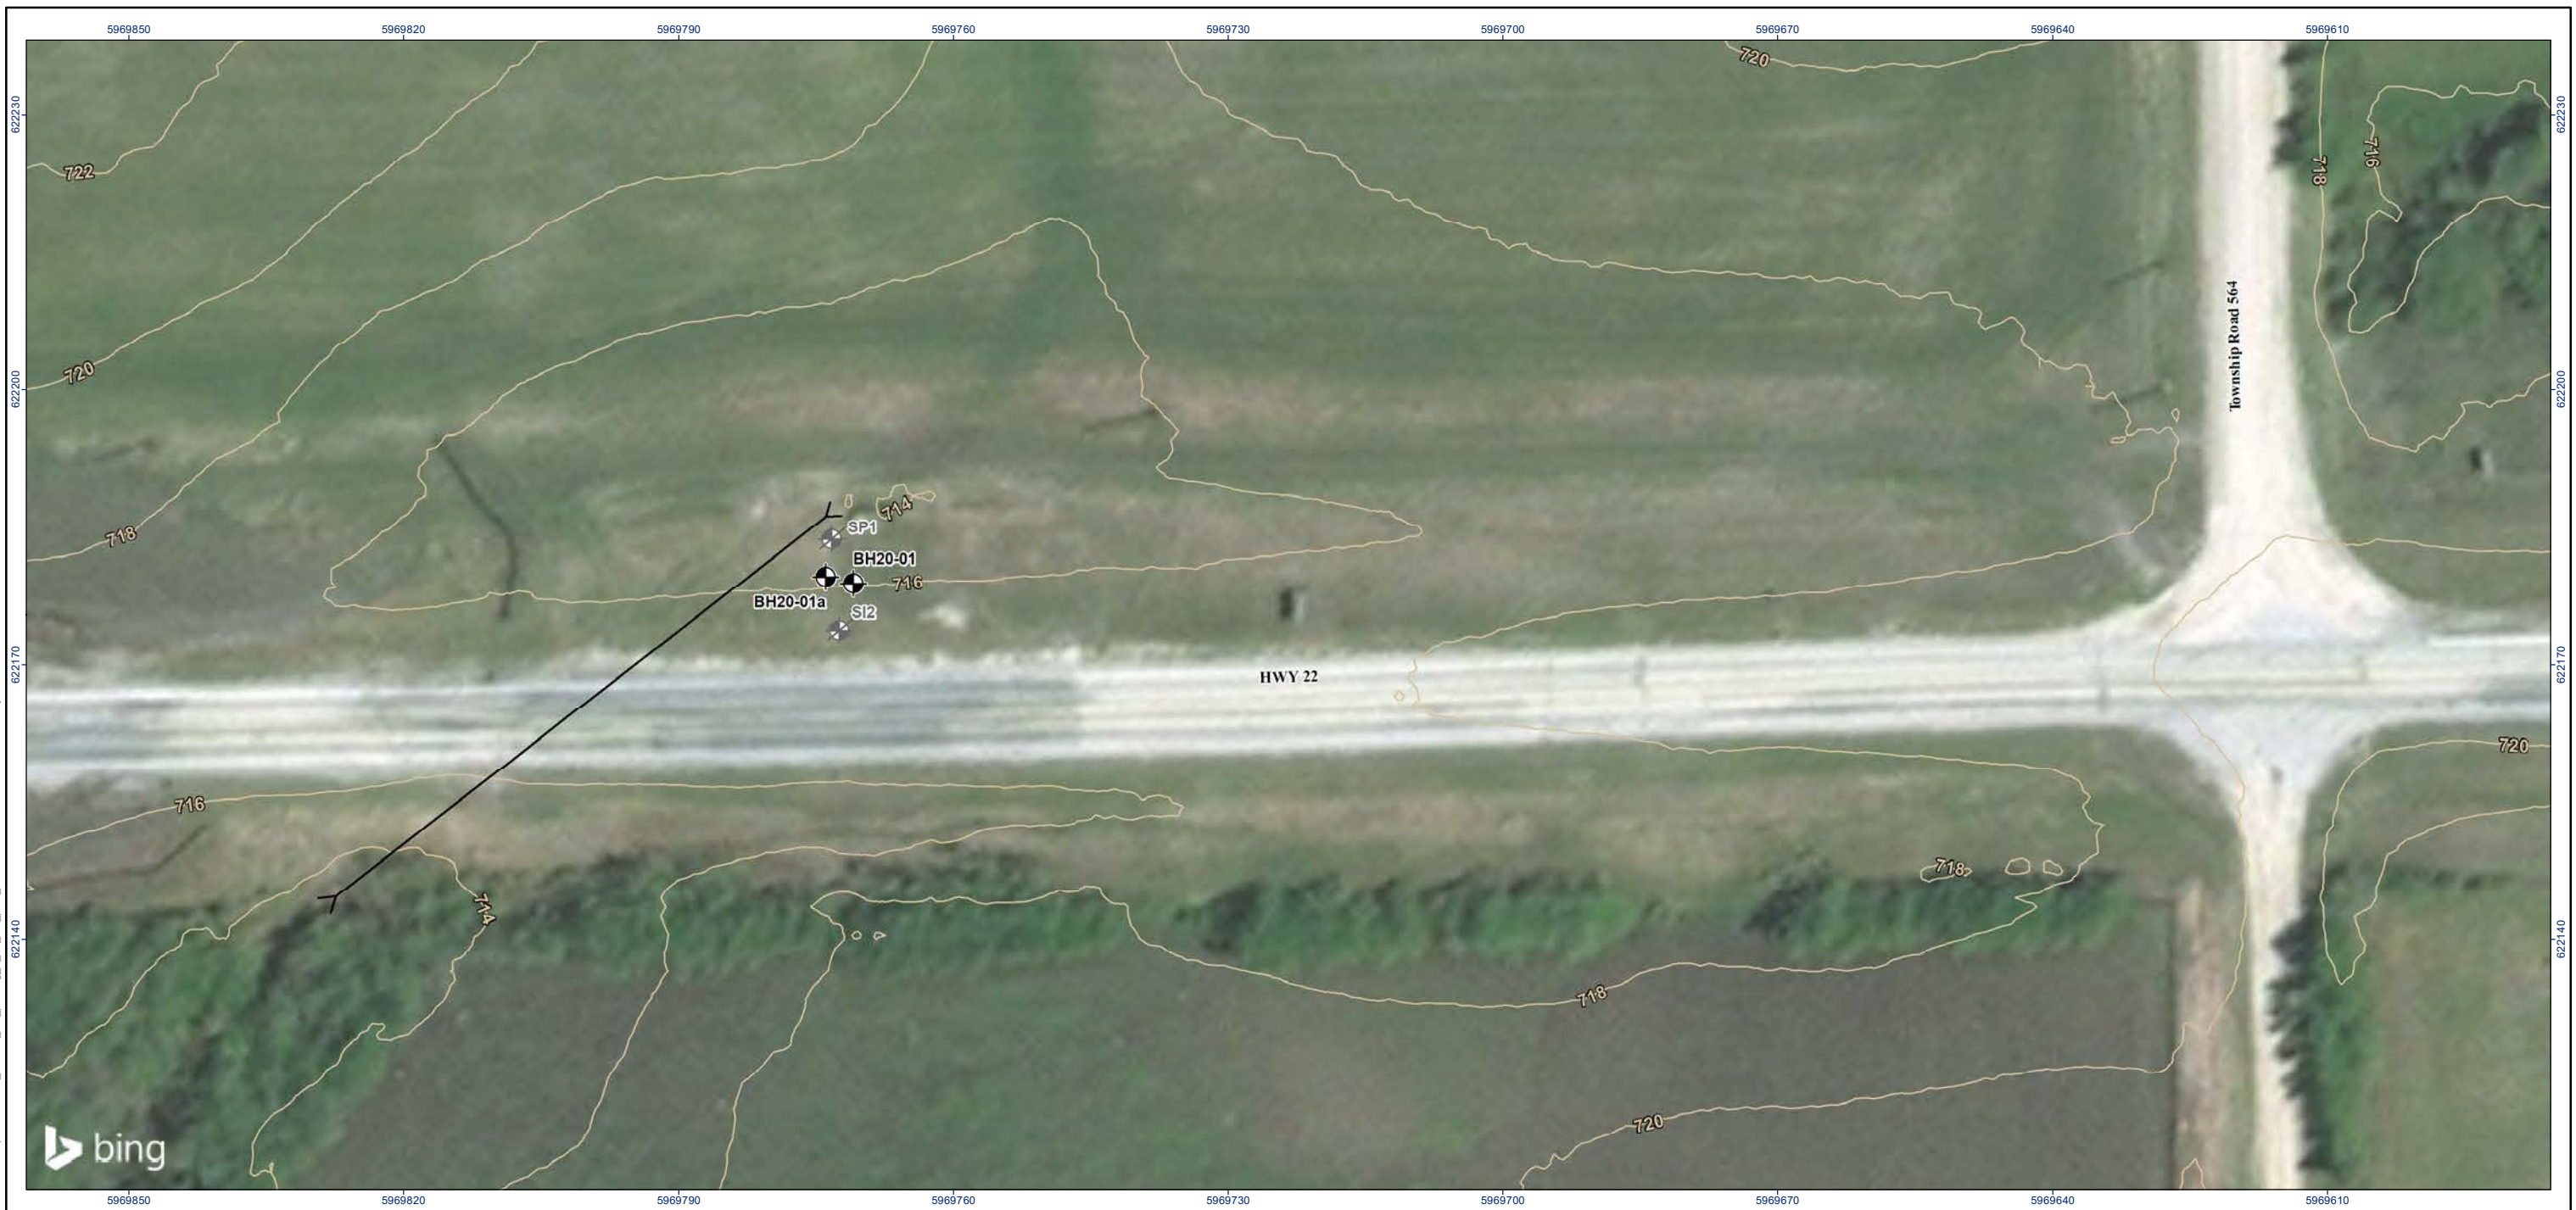
Figure No.
1

The Spring 2022 reading cycle consisted of reading one standpipe (BH20-01a) and one slope inclinometer (BH20-01). The site plan is shown on **Figure 1** attached. The instruments were read by Mahendran Senthoooran, M.Eng., EIT and Akintola Fakinlede, M.Sc., Engineering Technologist on May 4, 2022.

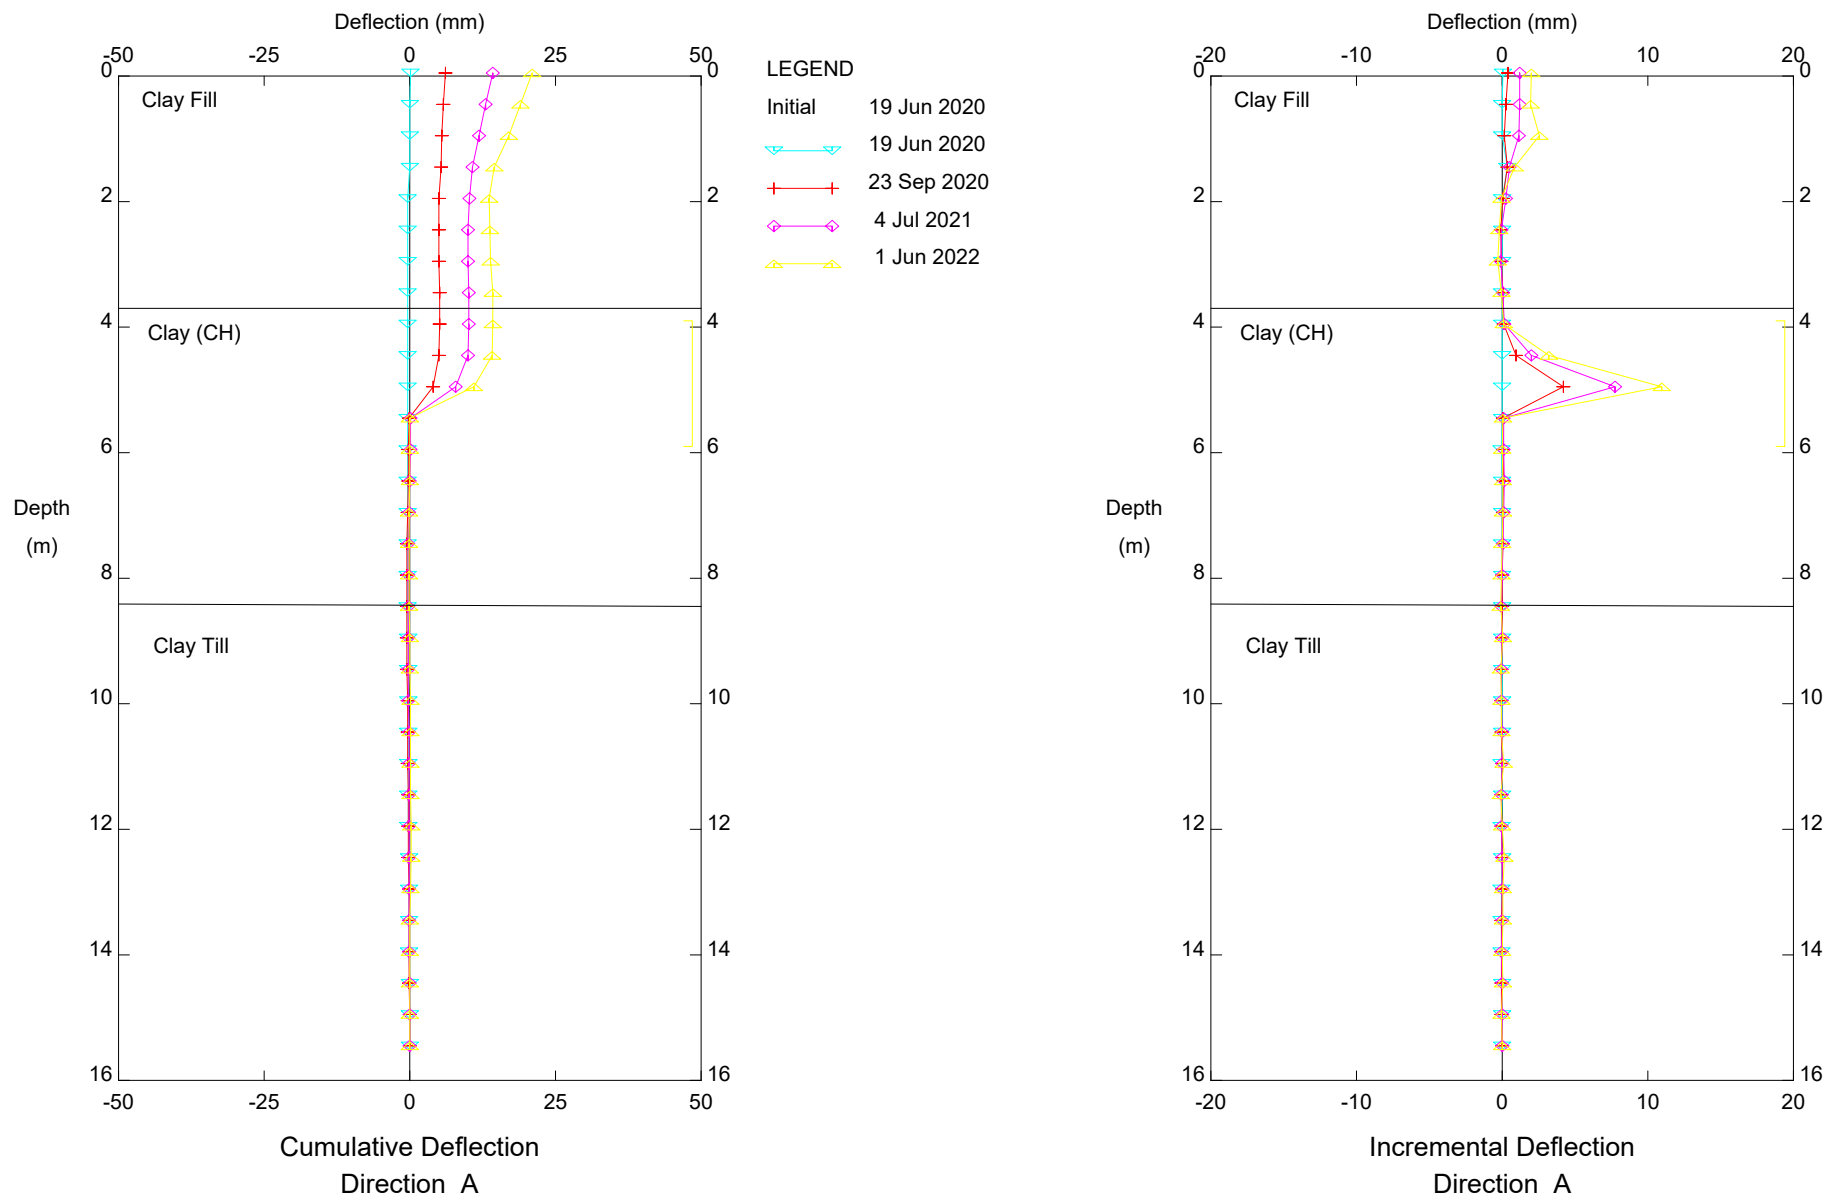
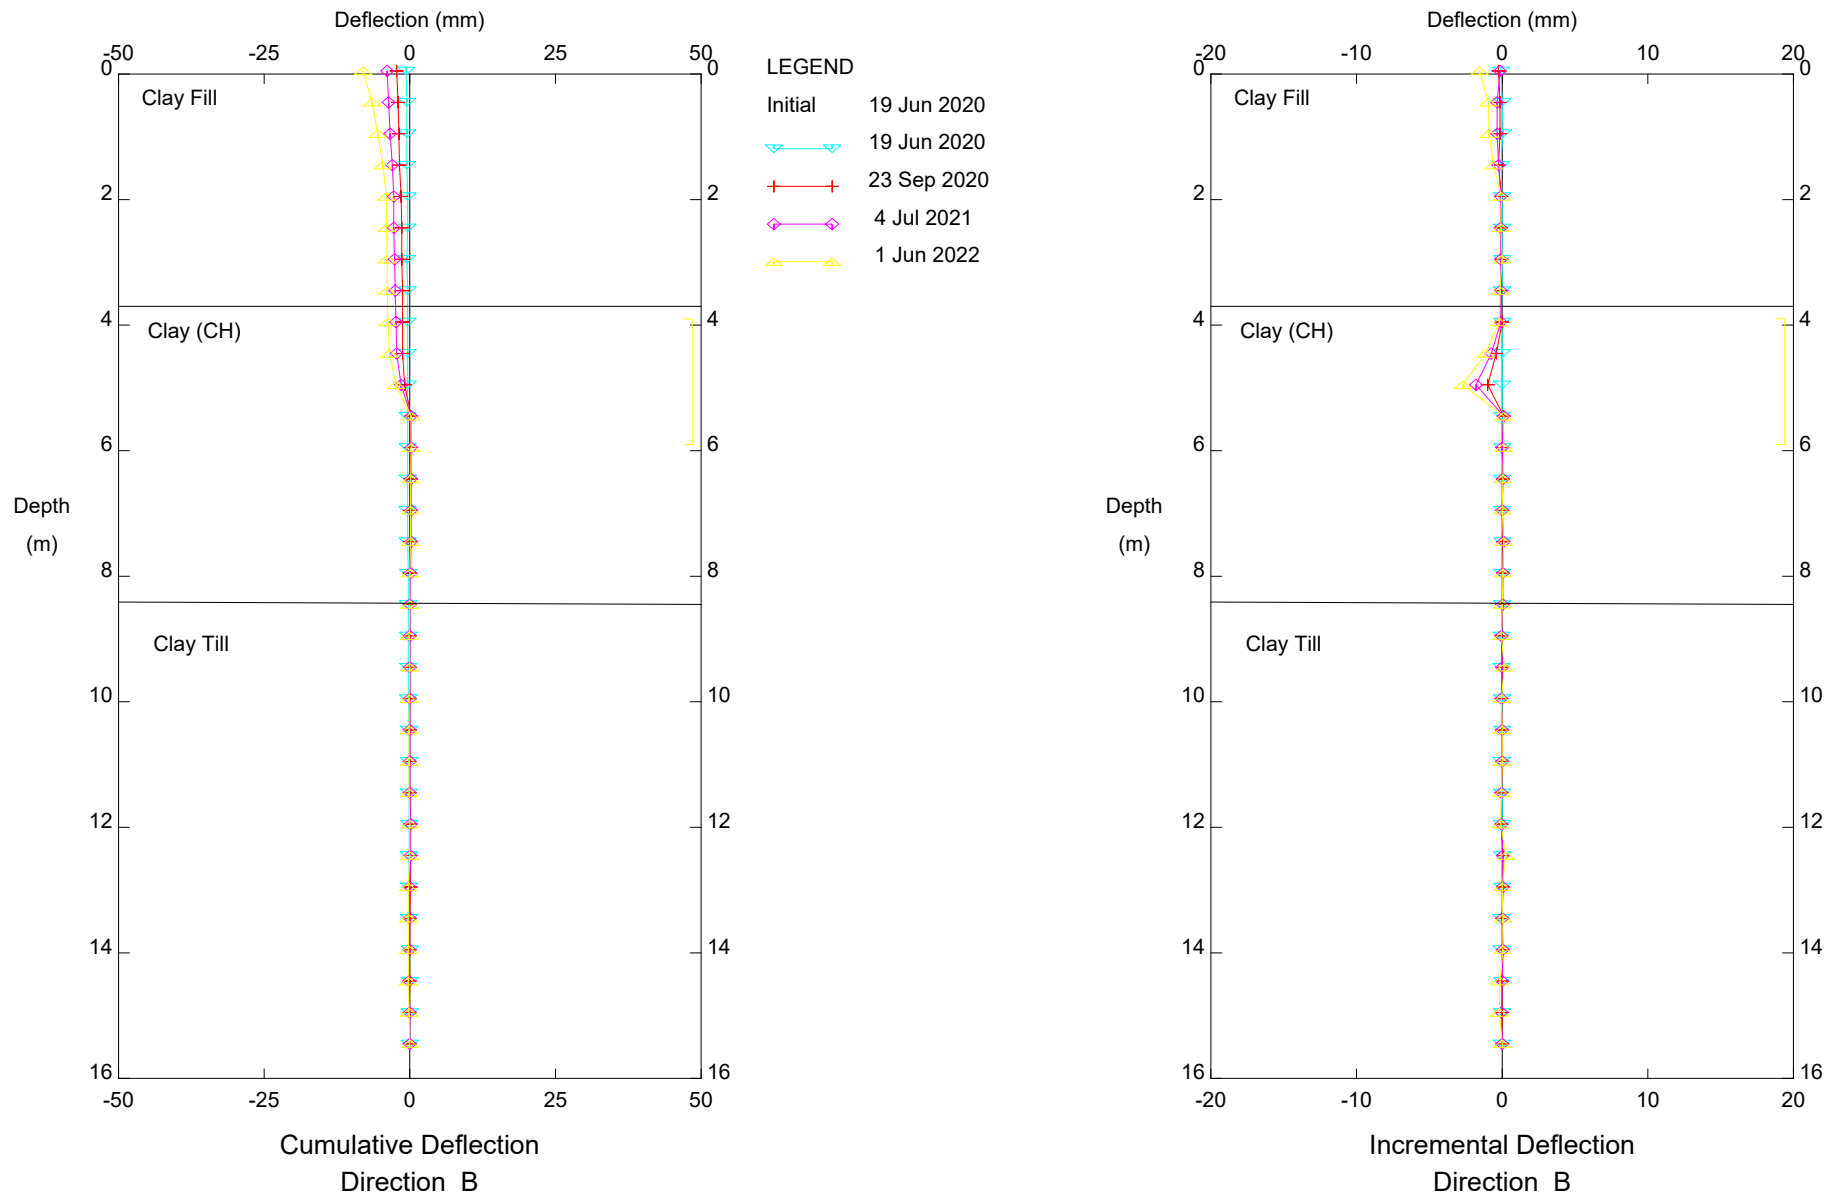
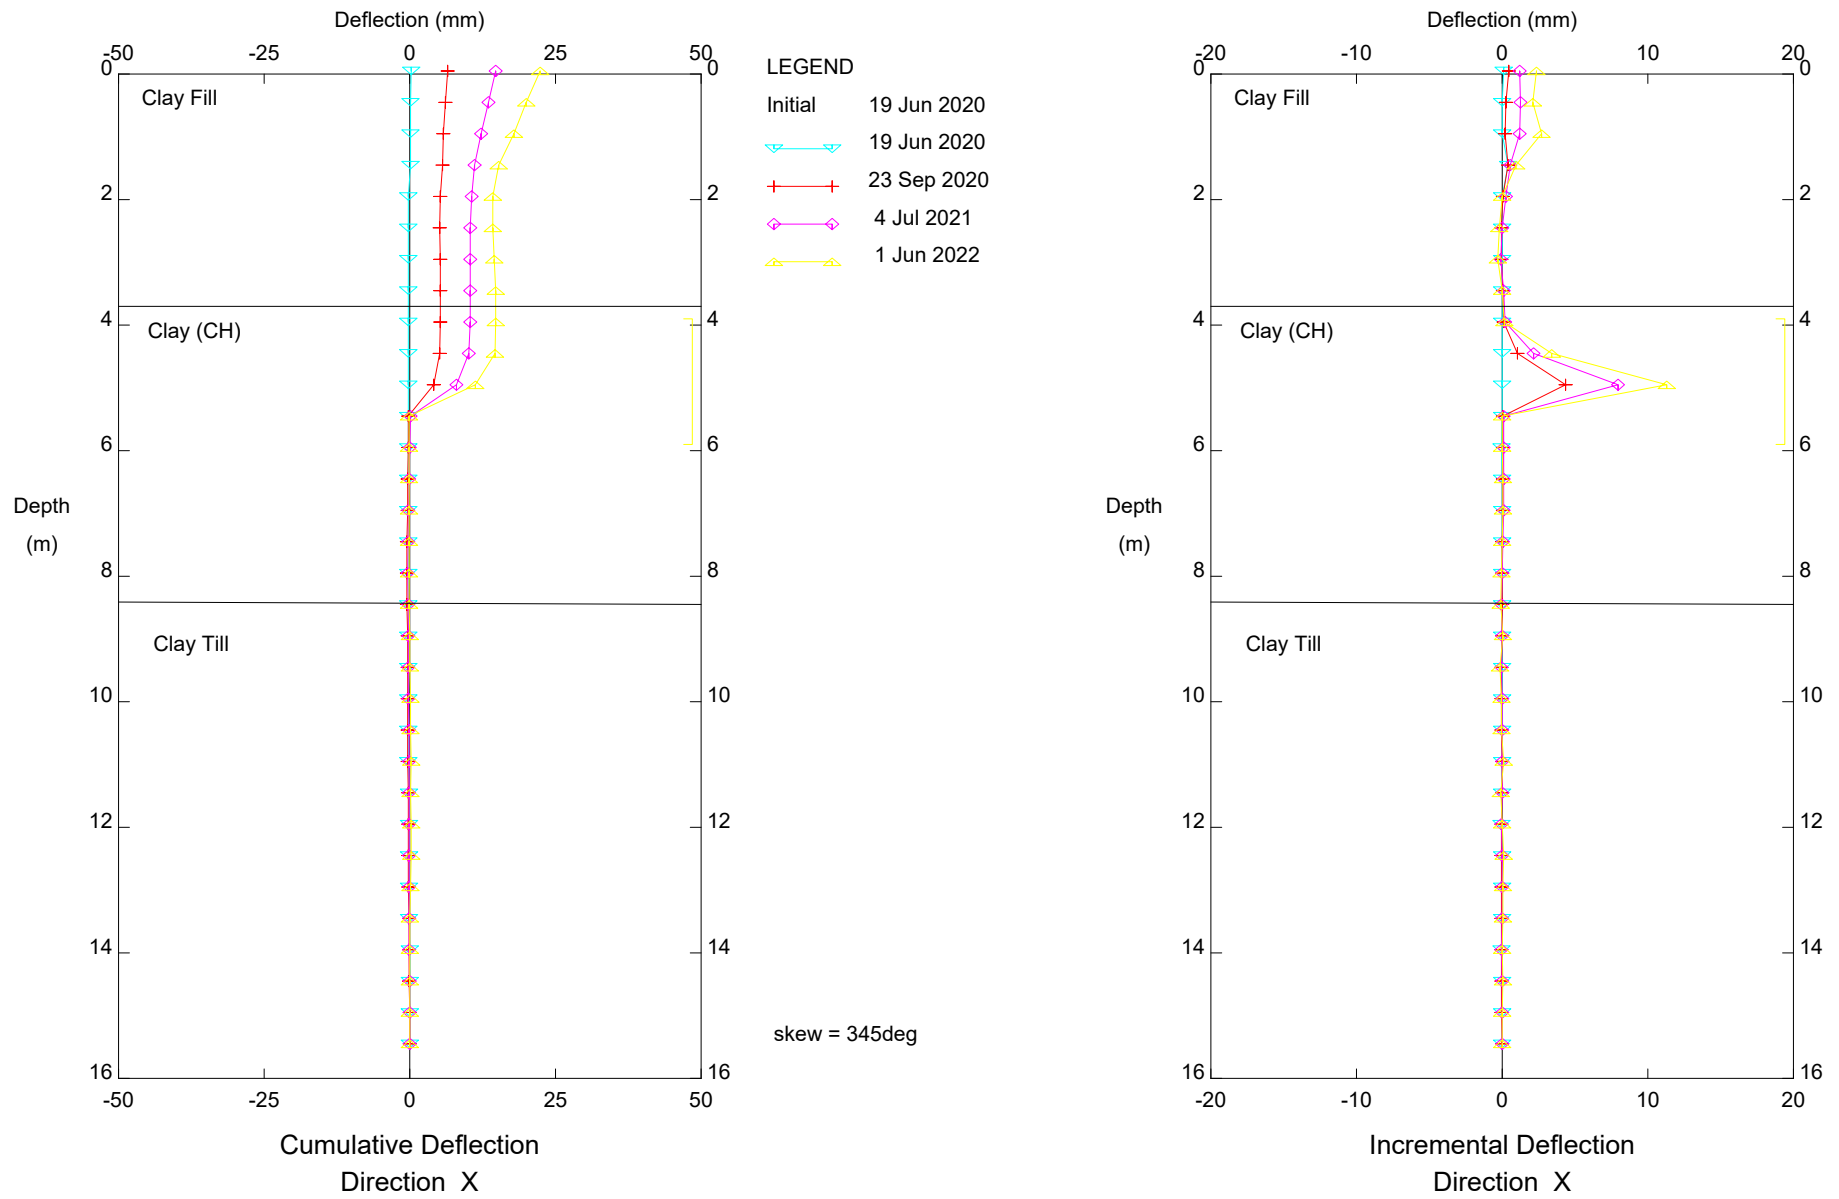
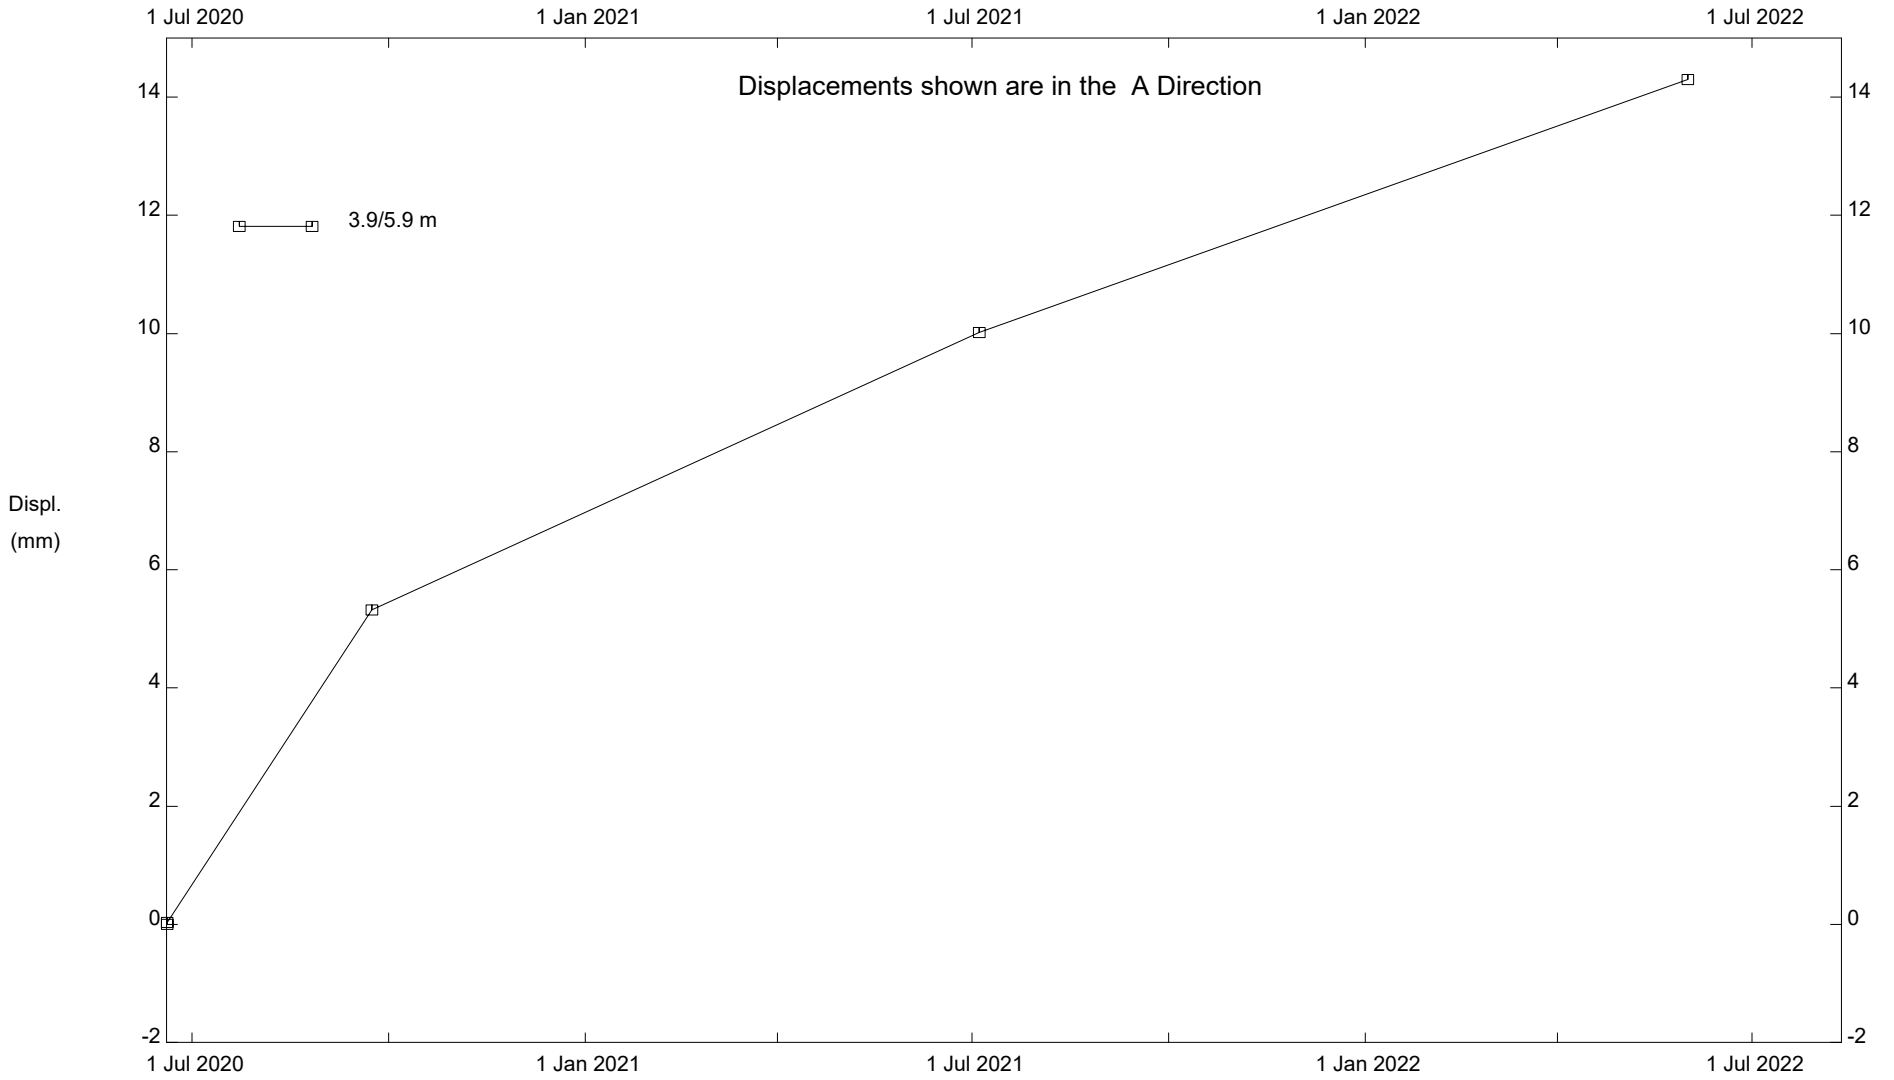
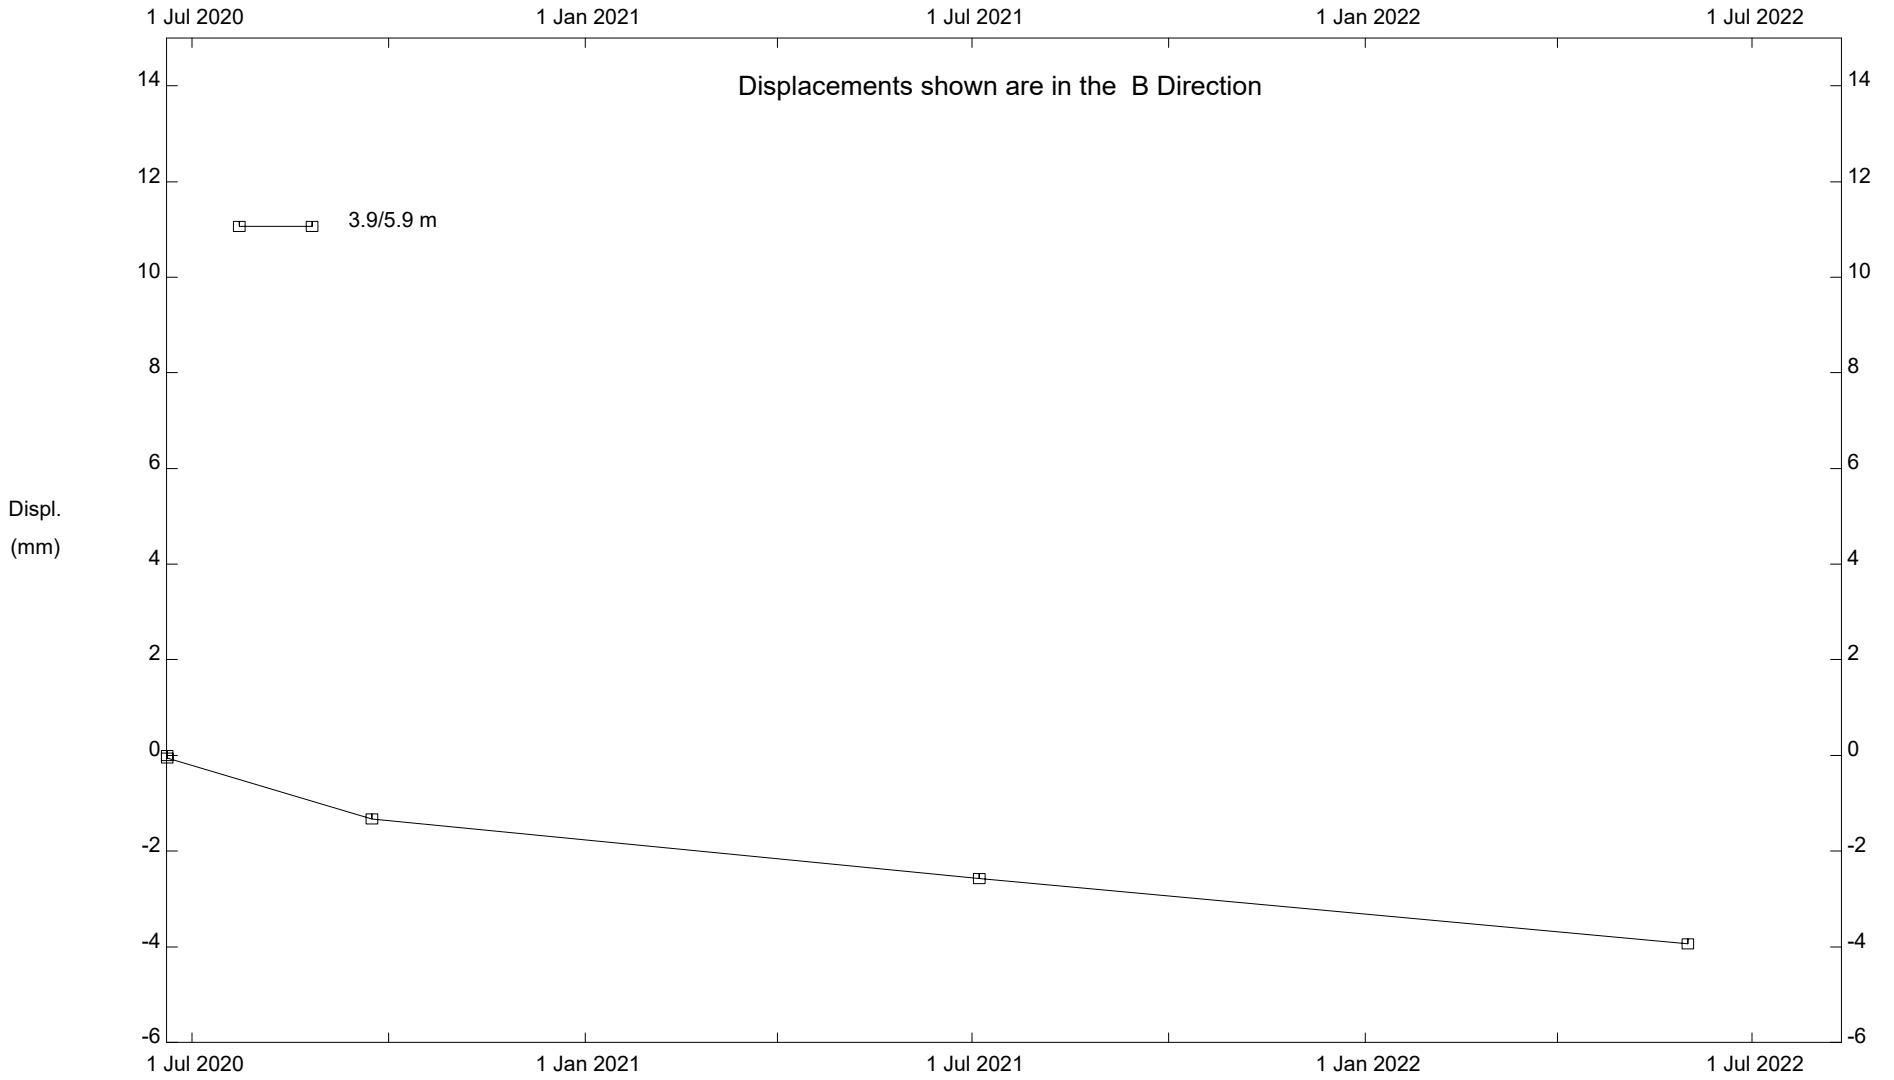
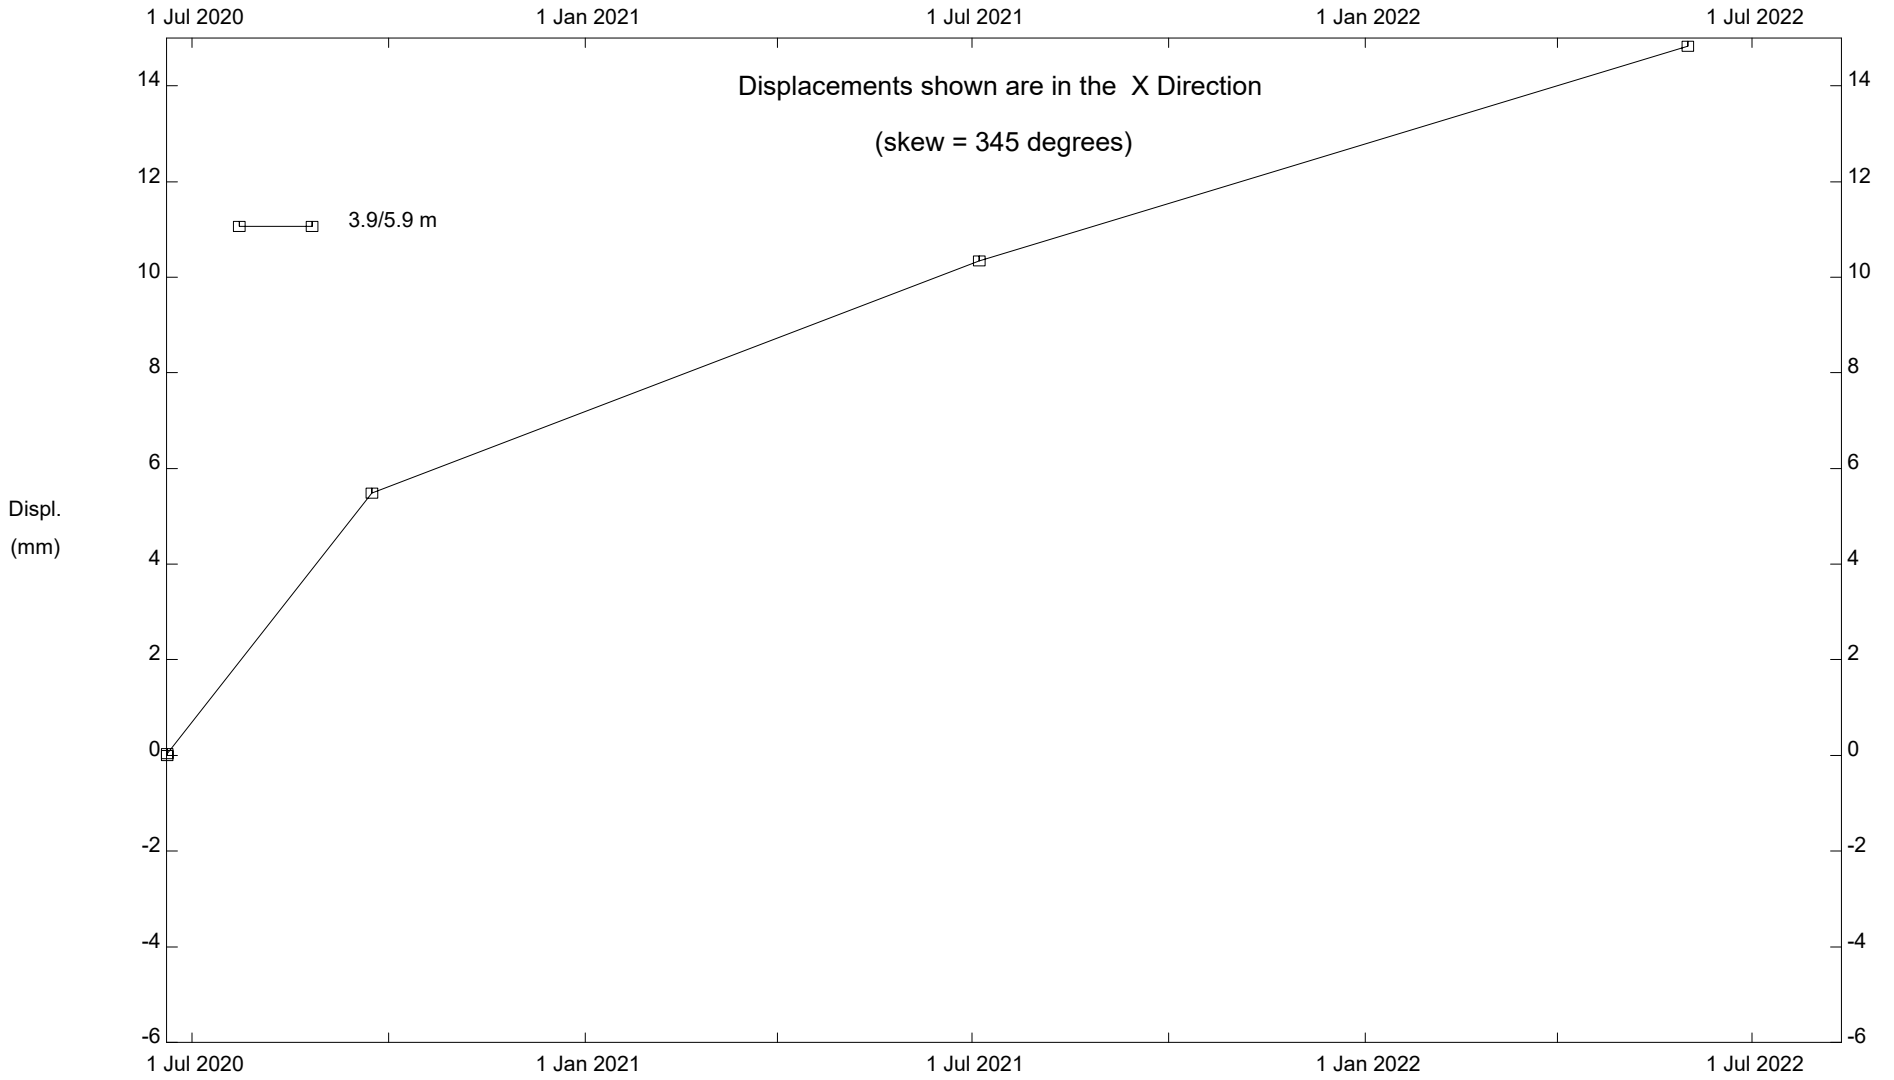
NC036, Inclinator SI20-01

BH20-01 showed about 5 mm of movement at approximate 5.5 m depth since Spring 2021, corresponding to a rate of movement of 6 mm/yr, which is similar to Spring 2021 rate of movement.

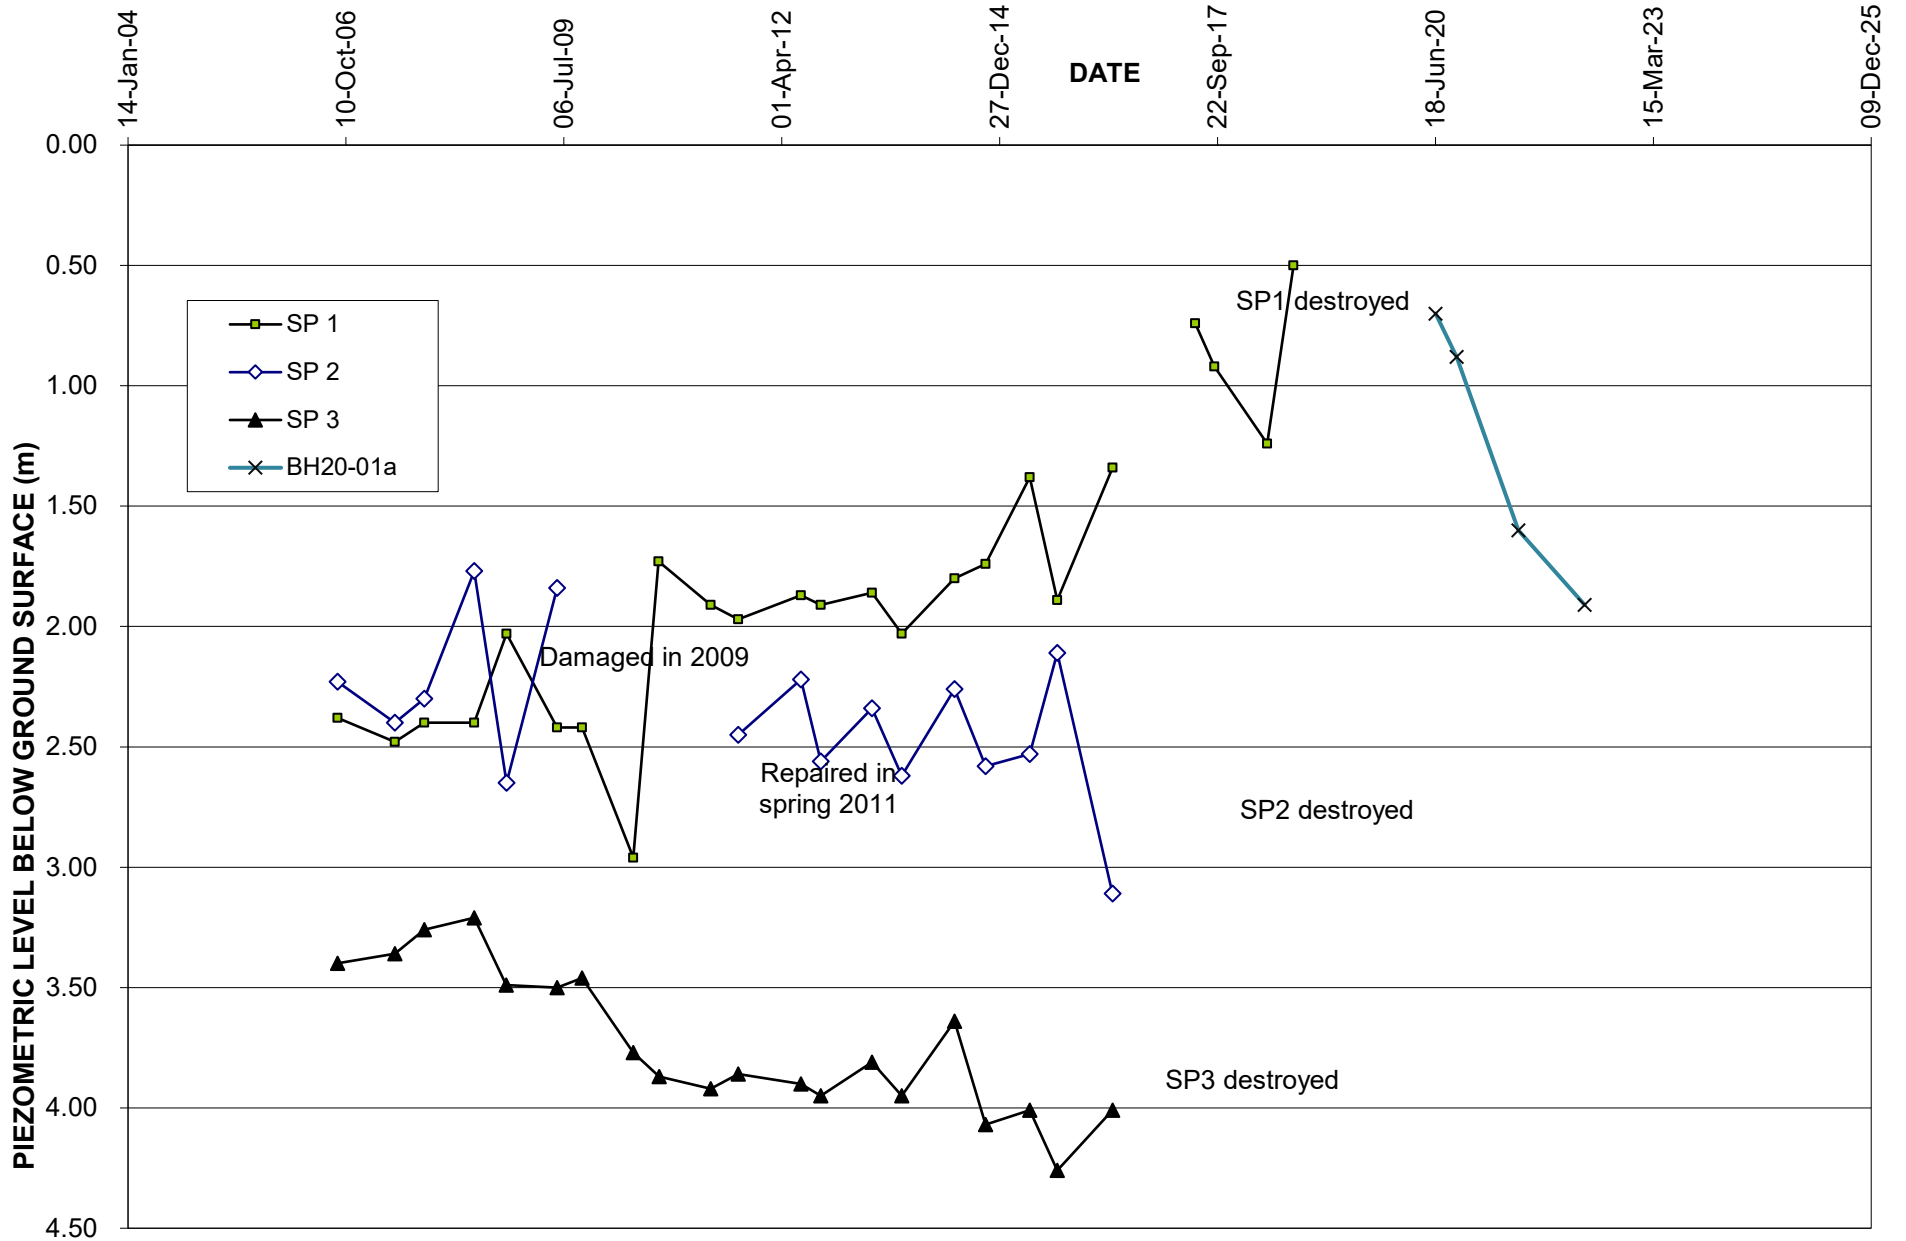
Piezometric levels in **BH20-01a** decreased about 0.3 m since the Spring 2021 measurement and has been decreasing since initialization.
