SITE NUMBER AND NAME: NC036 – Lazy “S” Slide	HIGHWAY AND KM: 22:32, km 30.338	PREVIOUS INSPECTION: June 16, 2022	CURRENT INSPECTION: June 13, 2024
LEGAL DESCRIPTION: SW-28-56-08-W5M (NC036-1) NW 21-56-08-W5M (NC036-2)	NAD83 COORDINATES: UTM11U 5969791N, 622172E		RISK ASSESSMENT: PF: 9 CF: 6 Total: 54
AVERAGE ANNUAL DAILY TRAFFIC (AADT): 1,340 (2023)		CONTRACTOR MAINTENANCE AREA (CMA): 509

**NORTH CENTRAL REGION GRMP
EDSON / STONY PLAIN
SITE INSPECTION FORM**

Client/Project
 Transportation and Economic Corridors
 Geohazard Monitoring Program
 NC36-1 Lazy "S" Slide

2024 Site Inspection Photos at NC036

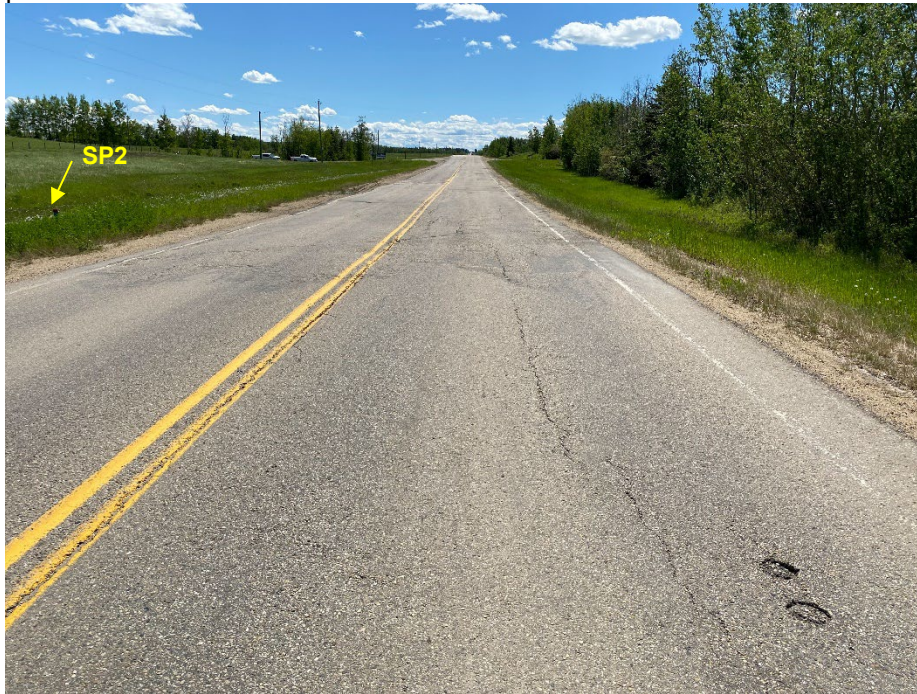
COMMENTS
<u>NC036-1</u>
<ul style="list-style-type: none"> Previously observed pavement cracks continue to resurface through the 2018 patch. Cracking has progressed near the south end of the site compared to the 2022 site inspection (Photos 1 to 3).

Photo 1: Longitudinal pavement cracks at north end of south bound lane at NC36-1. Looking south.

- It is recommended that short term remediation measures should be taken. This may include:
 - Sealing pavement cracks to reduce surface water infiltration into the slope and pavement structure.

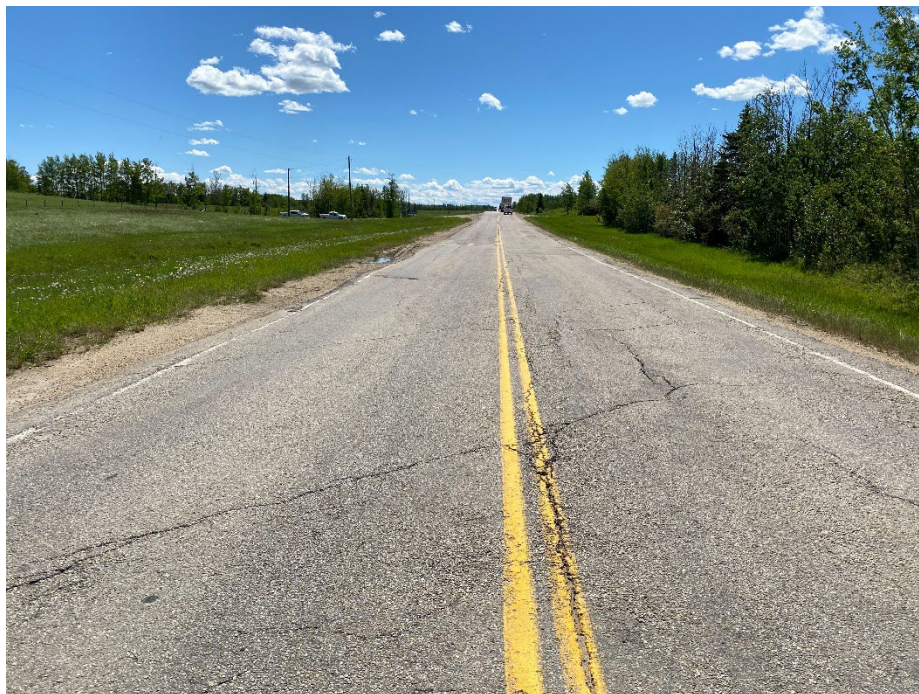
Photo 2: Cracks reflecting through 2018 pavement patch at NC36-1. Looking south.

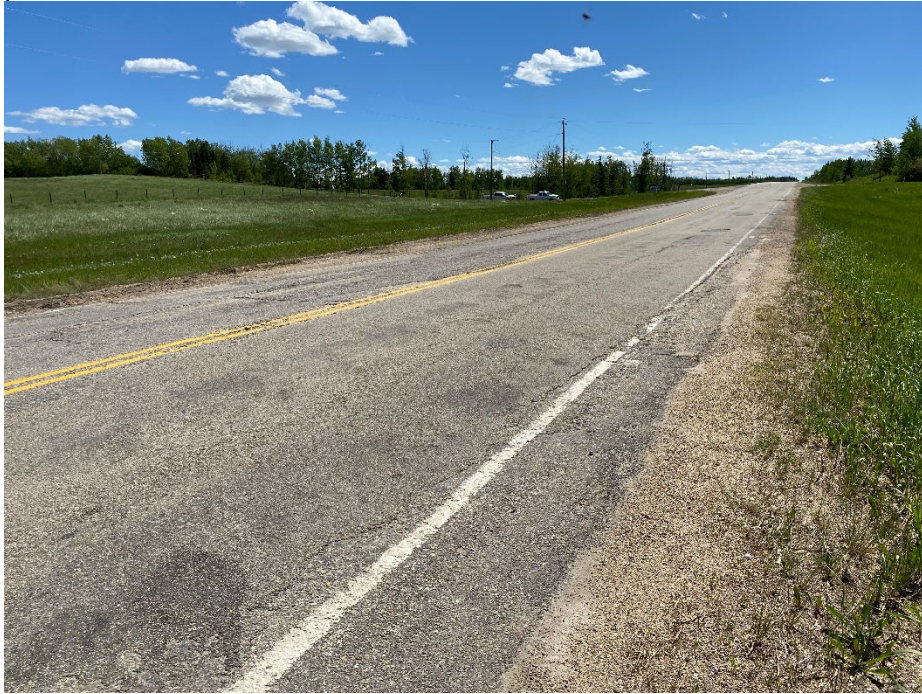
- A pothole has formed in the western wheel path in the south bound lane (SBL) at the south end of the site.
- The riprap lined channel appeared to be in working condition (Photo 4).

Photo 3: Pavement condition at south end of NC36-1. Looking southeast.

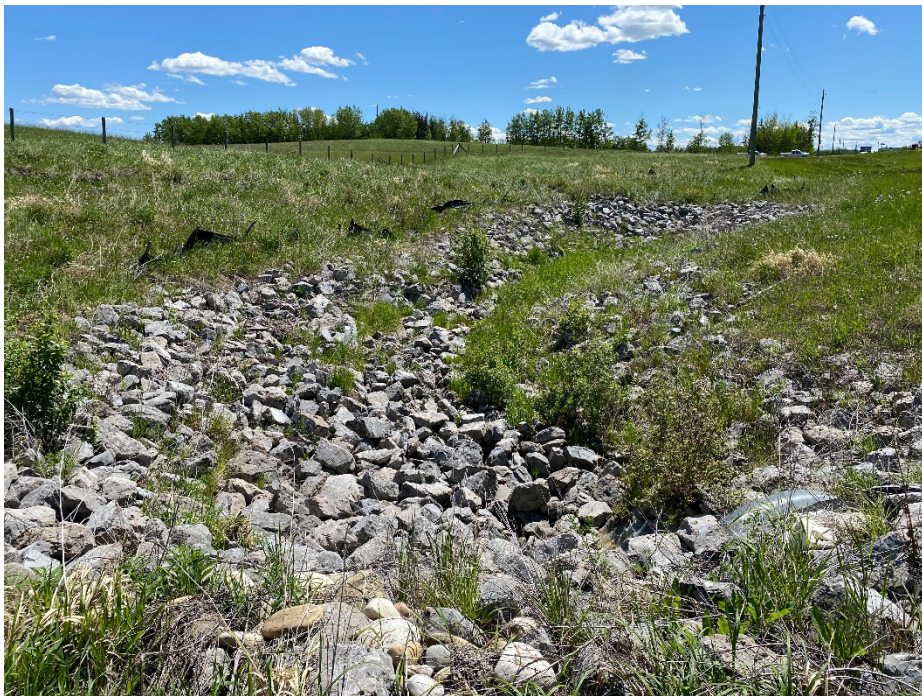
Photo 4: Riprap lined channel. Looking south.

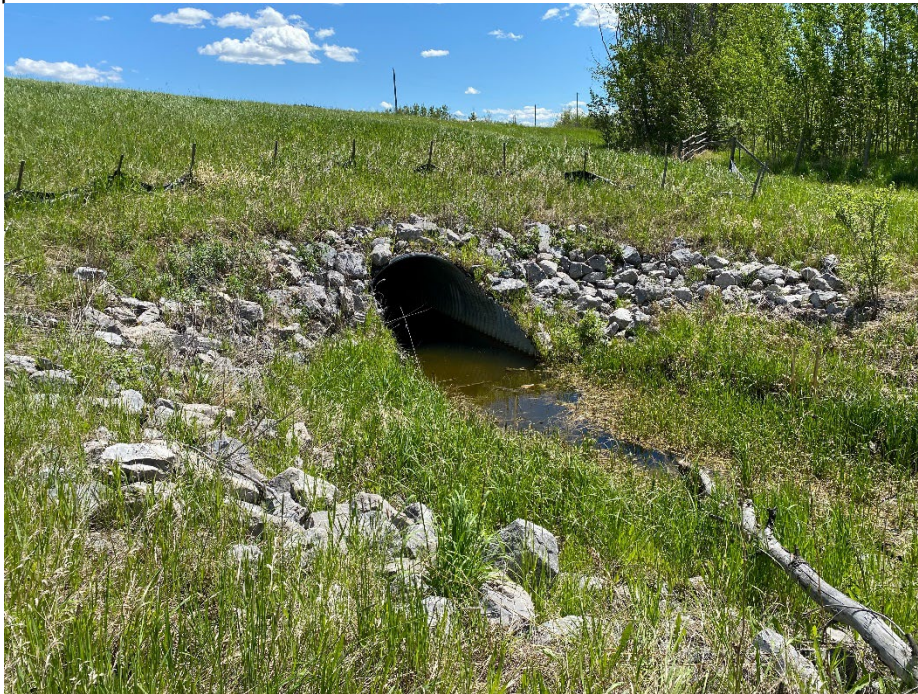
- Ponded water continues to be observed at the outlet of the 2120 mm diameter culvert as shown in Photo 5.
- A ground crack about 300 mm wide by 150 mm deep by 1.1 m long was observed north of the 2120 mm diameter culvert outlet. The crack appeared relatively unchanged since the previous inspection in 2022.

Photo 5: 2120 mm diameter culvert outlet with riprap lining on west side of highway. Looking south.

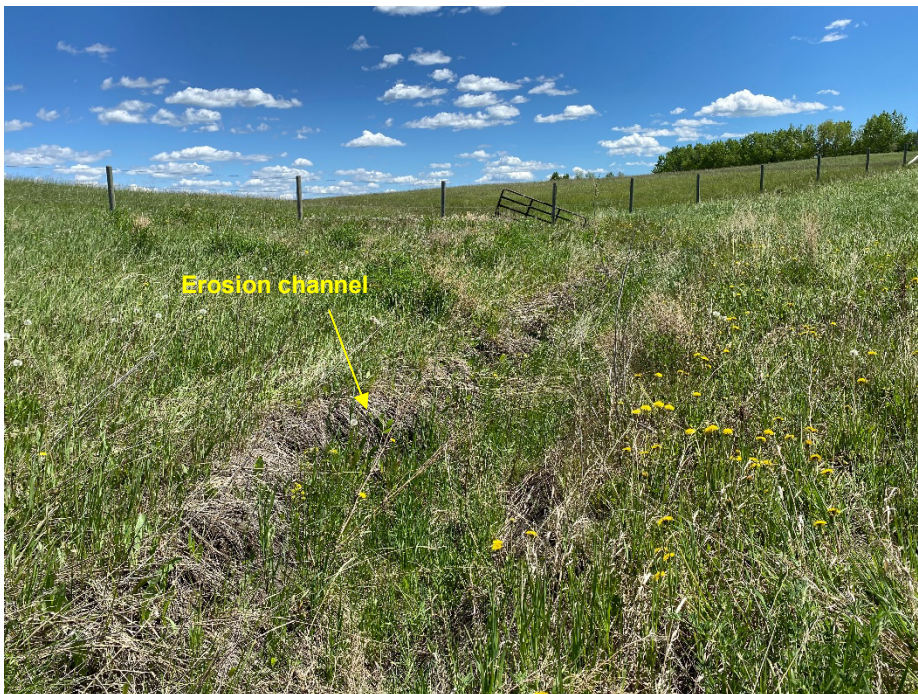
- On-going erosion of the natural swale southeast of the riprap channel was observed as shown in Photo 6. The erosion channel was up to 1.8 m wide and 0.8 m deep, similar as measured in 2022. The erosion channel extends past the fence line (i.e. TEC's right-of-way). Vegetation is growing within the channel.

Photo 6: Erosion channel leading from riprap to fence line on east side of highway. Looking southeast.

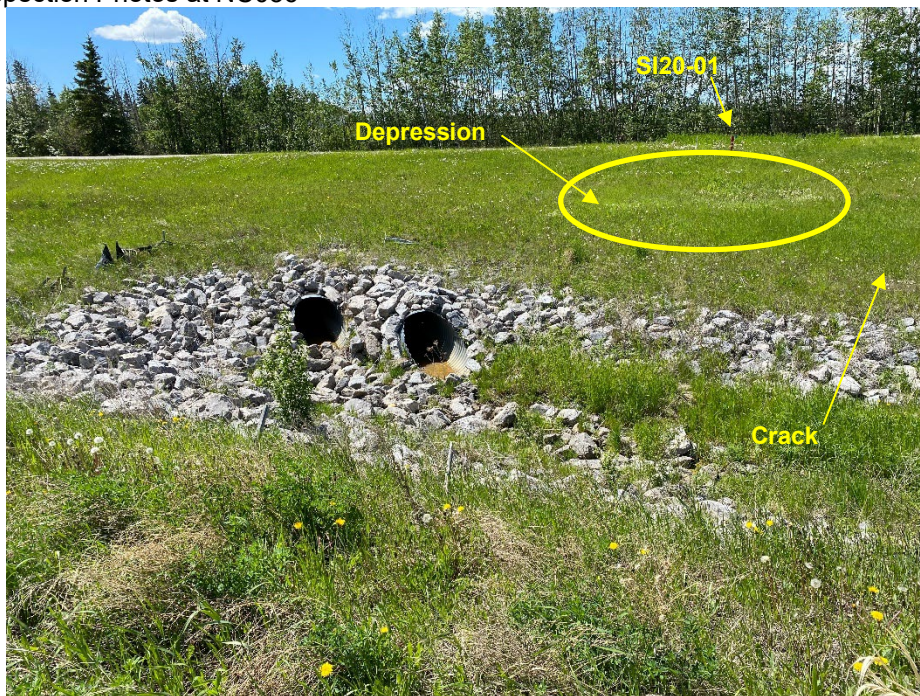
- A depression and ground crack was observed downslope from SI20-1 as shown on Photo 7.
- The scarp on the east side of the riprap lined channel was observed to be approximately 300 mm tall and 2.5 m from the fence, similar to 2022 (Photo 8). Tension cracks were observed behind the scarp.

Photo 7: East side of highway embankment at south end of riprap lined channel. Looking southwest.

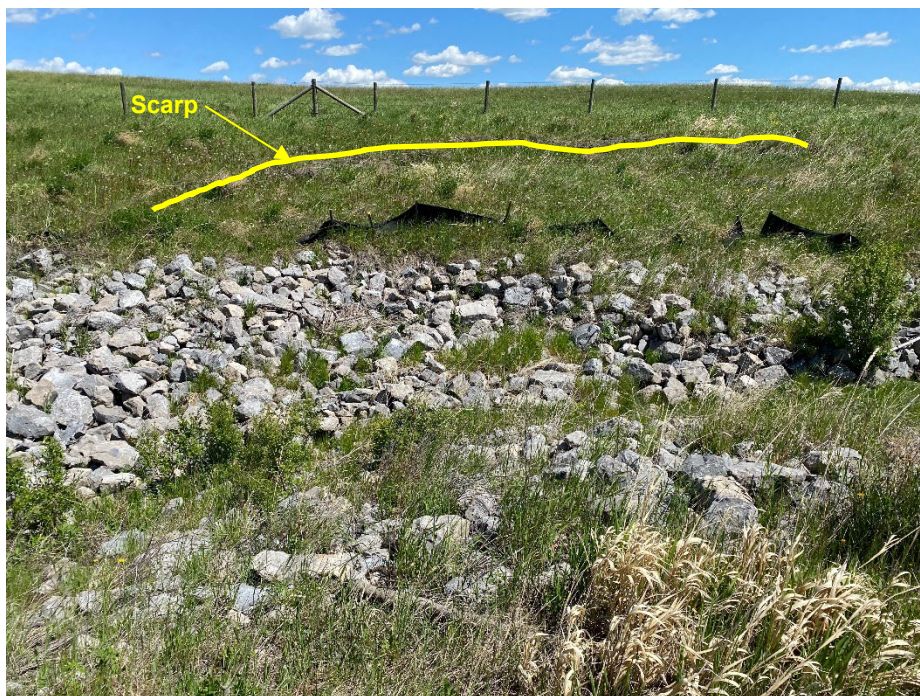
Photo 8: Scarp on east side of riprap lined channel. Looking east.

- Milling and filling the highway to avoid adding more surcharge weight on the slope.
 - Re-grading the slopes around the riprap channel at NC036-1 to seal any pavement cracks.

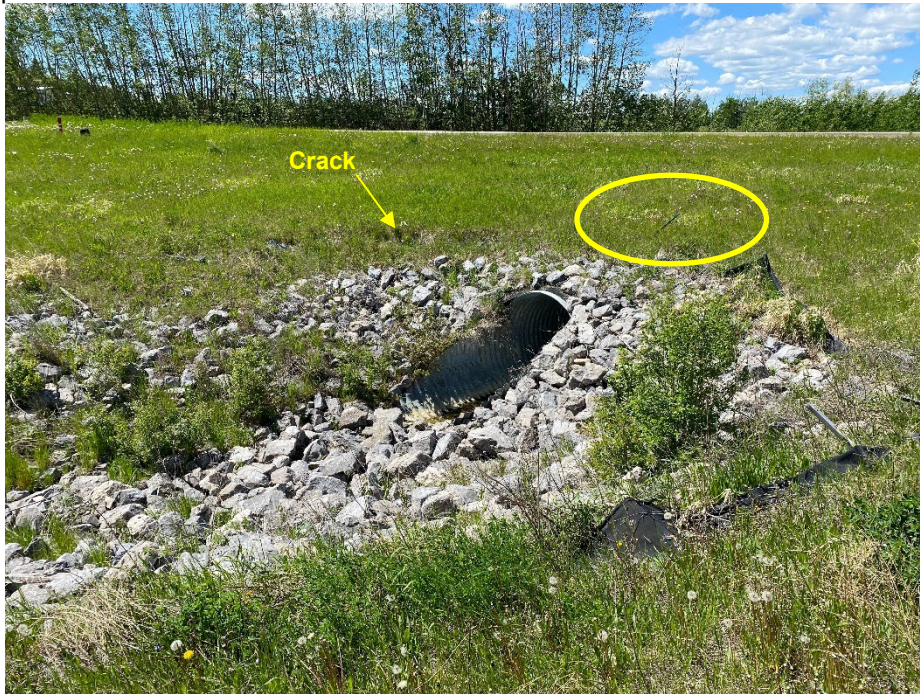
Photo 9: Depression and crack above 2120 mm diameter culvert and riprap, looking northwest.

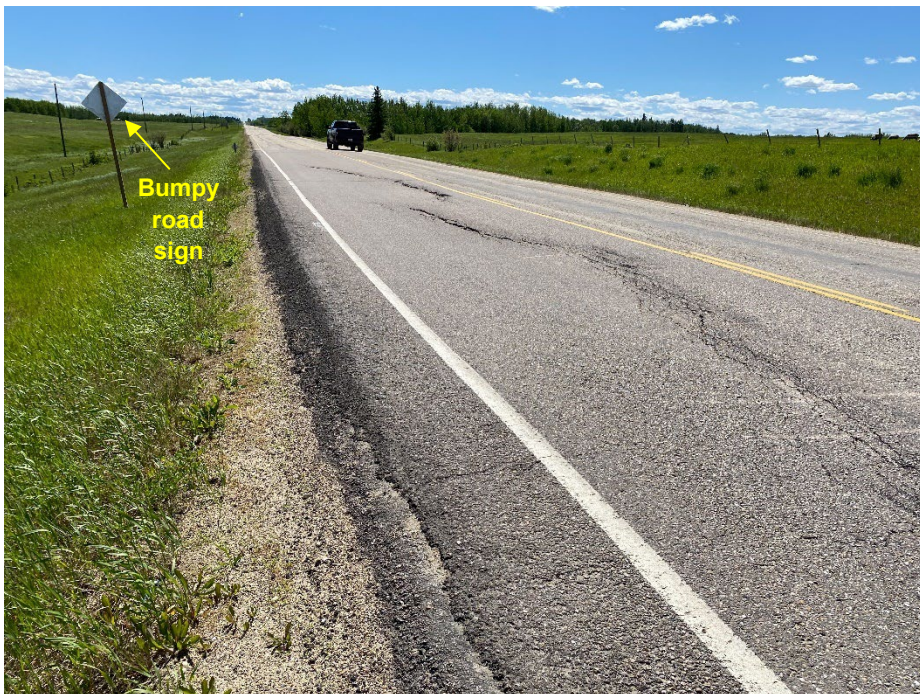
- The semi-circular crack on the NBL remains approximately 25 m long, and the vertical difference has increased since the 2022 call-out inspection to between 20 and 50 mm. The crack is between 5 and 20 mm wide. An apparent dip towards the east of approximately 60 to 80 mm was observed along the crack (Photos 10 to 12).

- The asphalt thickness within the landslide area is about 400 mm thick. Outside of the landslide limits, the pavement thickness is approximately 150 mm thick, suggesting pavement patches have been historically placed. Google Earth imagery suggests historical pavement patching dates to at least 2012.

Photo 10: Pavement cracking at approximately north extent of NC36-2. Looking southwest.

- The design for NC036-2 has been completed. The selected remediation option includes removal of the landslide mass and replacement with granular backfill and geogrid. The granular backfill will be underlain by a gravel drainage blanket daylighting at the toe of the slope.

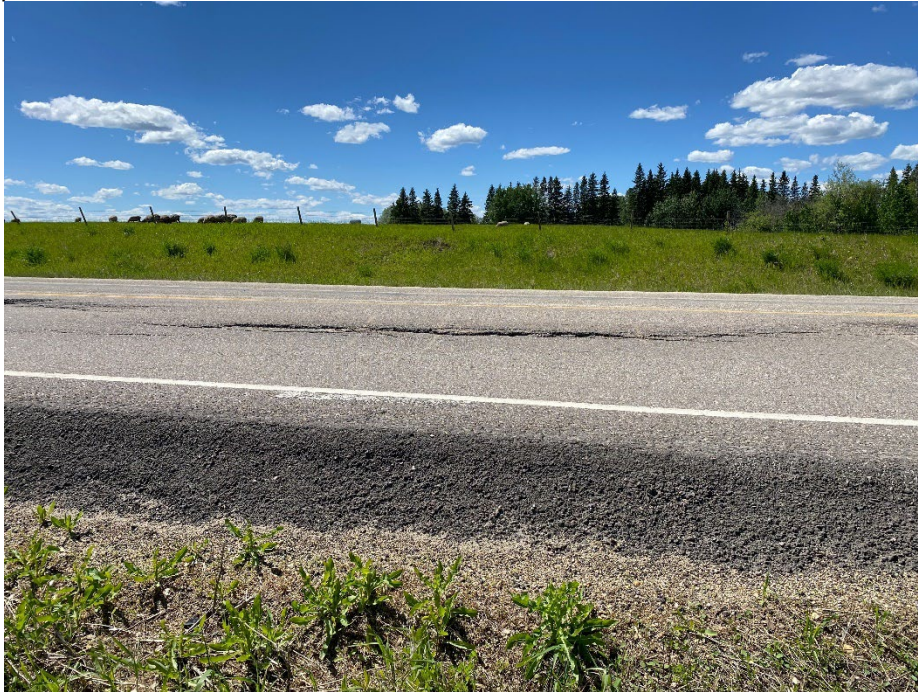
Photo 11: Northbound lane dipping to the east. Looking west.

- The 'bumpy road' warning sign should be moved further south of the semi-circular cracking to provide advance warning of the dipping pavement.
- Long term remediation measures at NC036-1 may include:

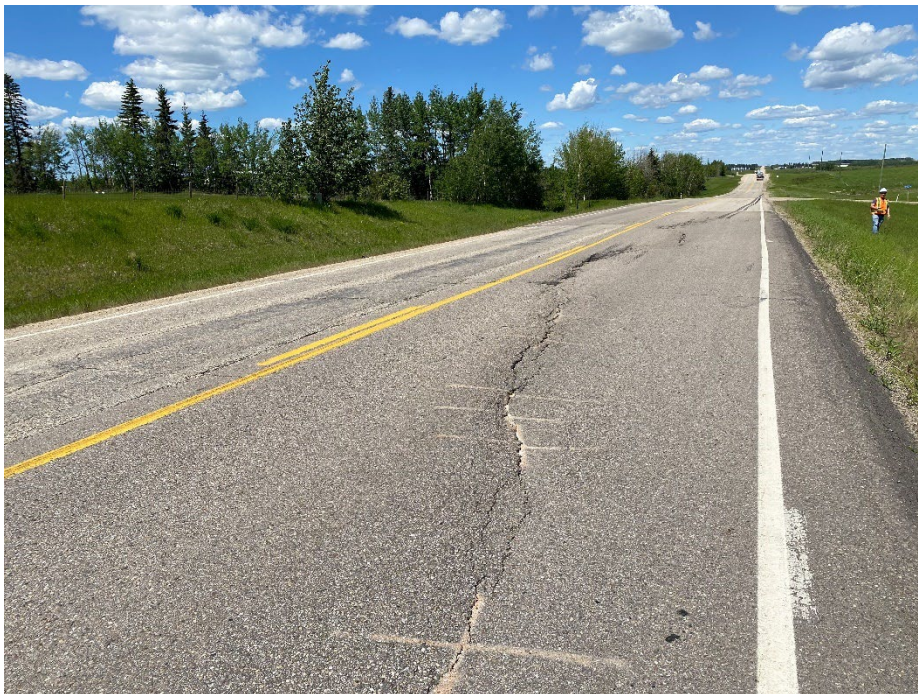
Photo 12: Pavement cracking approximately at south extent of NC36-2. Looking north.

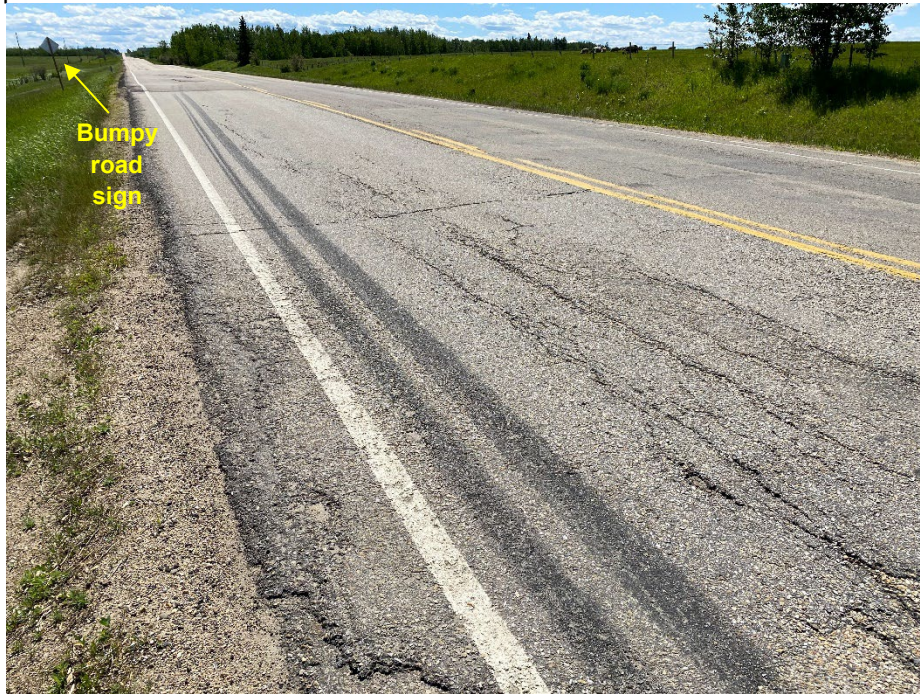
- Tire marks were observed in the NBL, north of (after) the semi-circular crack. The longitudinal cracking north of the semi-circular cracking has also progressed, and is up to 20 mm wide (Photo 13).

Photo 13: Cracking and tire marks visible north of (after) semi-circular cracking. Looking southwest.

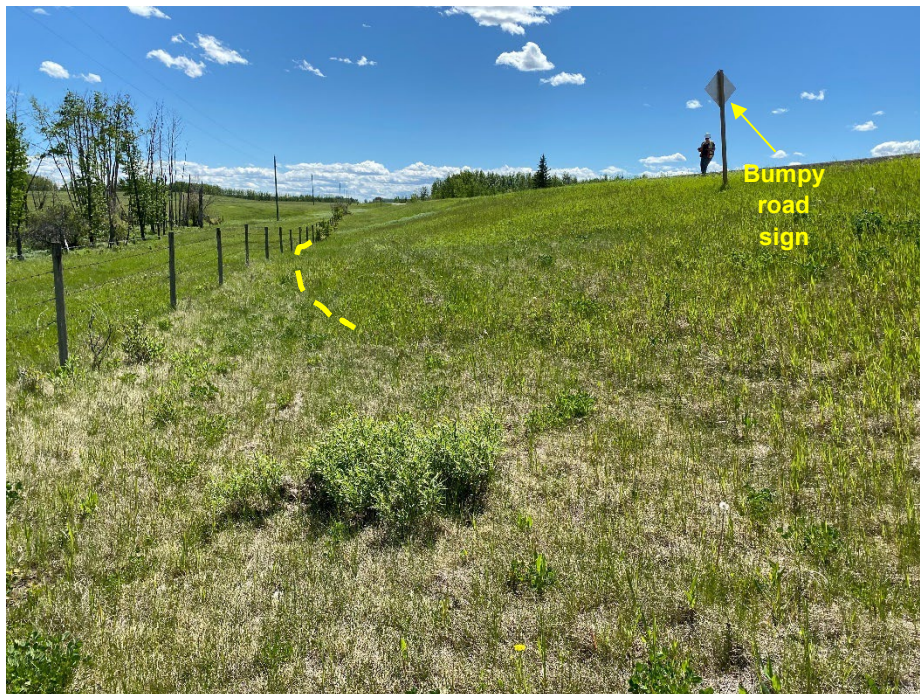
- The possible toe bulge observed at the base of the east embankment, at the fence line, appears similar to the previous observation (Photo 14).
- A 'bumpy road' warning sign was installed on the east side of the highway, near the south extent of the semi-circular cracking.

Photo 14: Slight toe bulging at base of embankment. Looking south.

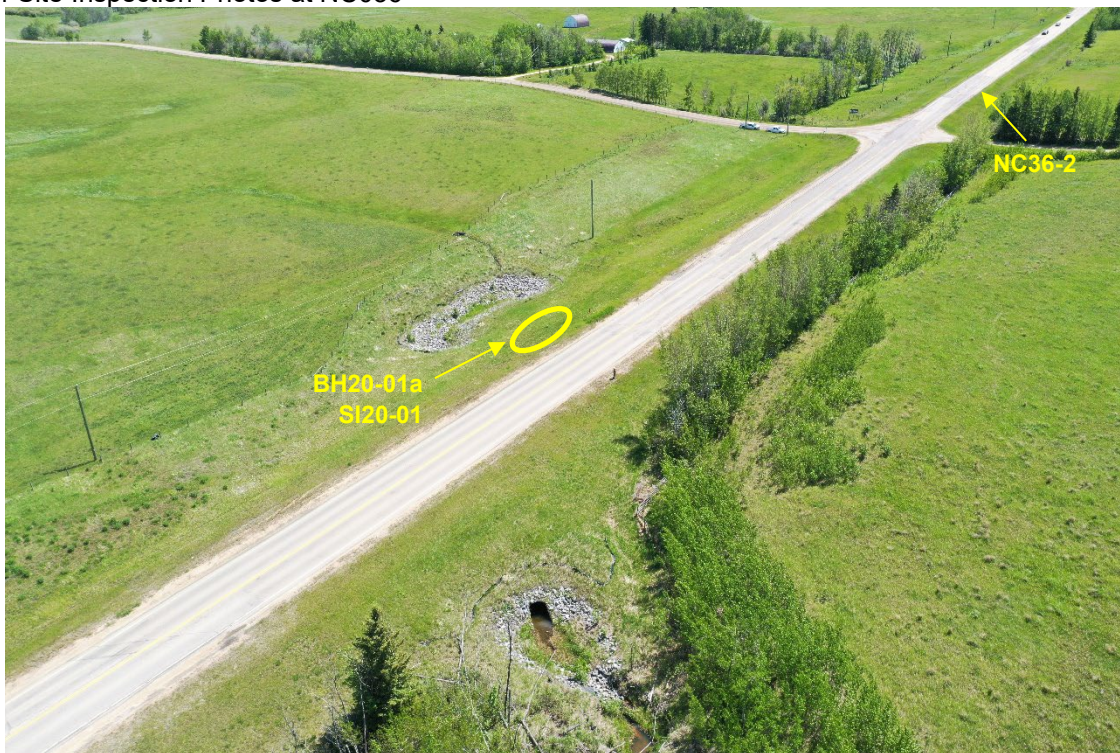
Photo 15: Site overview of NC036-1, taken by drone. Looking southeast.

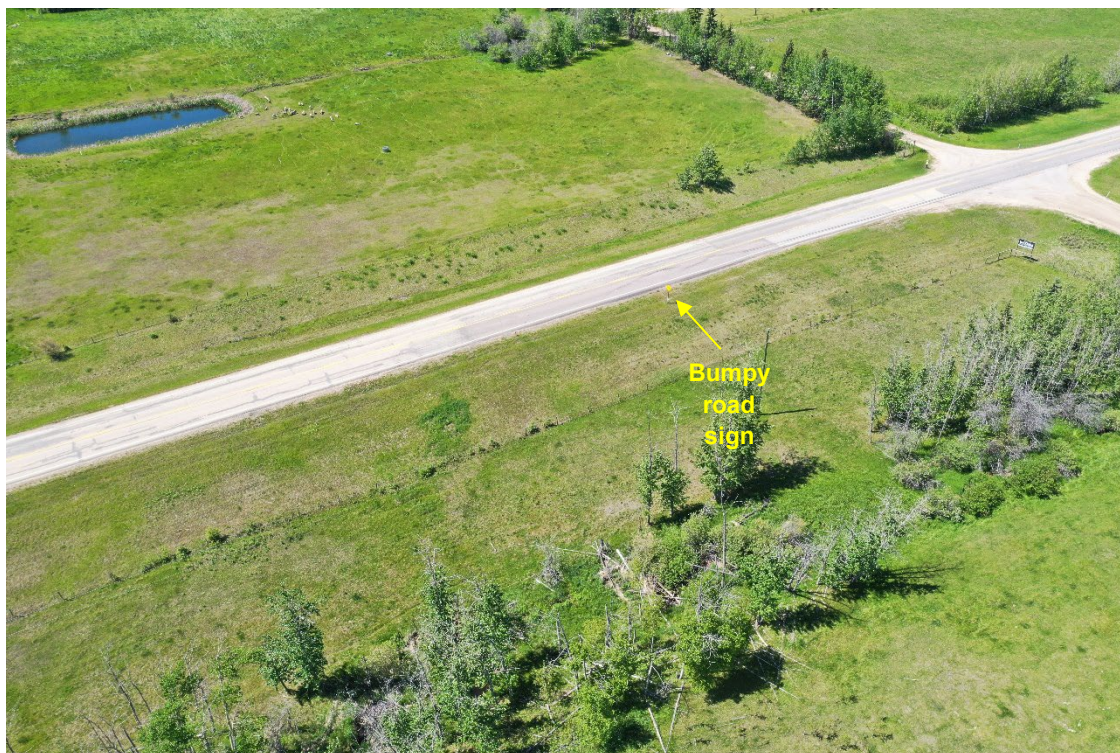
Photo 16: Site overview of NC36-2, taken by drone. Looking northwest.
