Reference: North Central Region, Edson/Stony Plain, Site NC036 – Highway 22:32 Lazy “S” Slide, Spring 2024 Instrumentation Monitoring Report

1.0 OBSERVATIONS

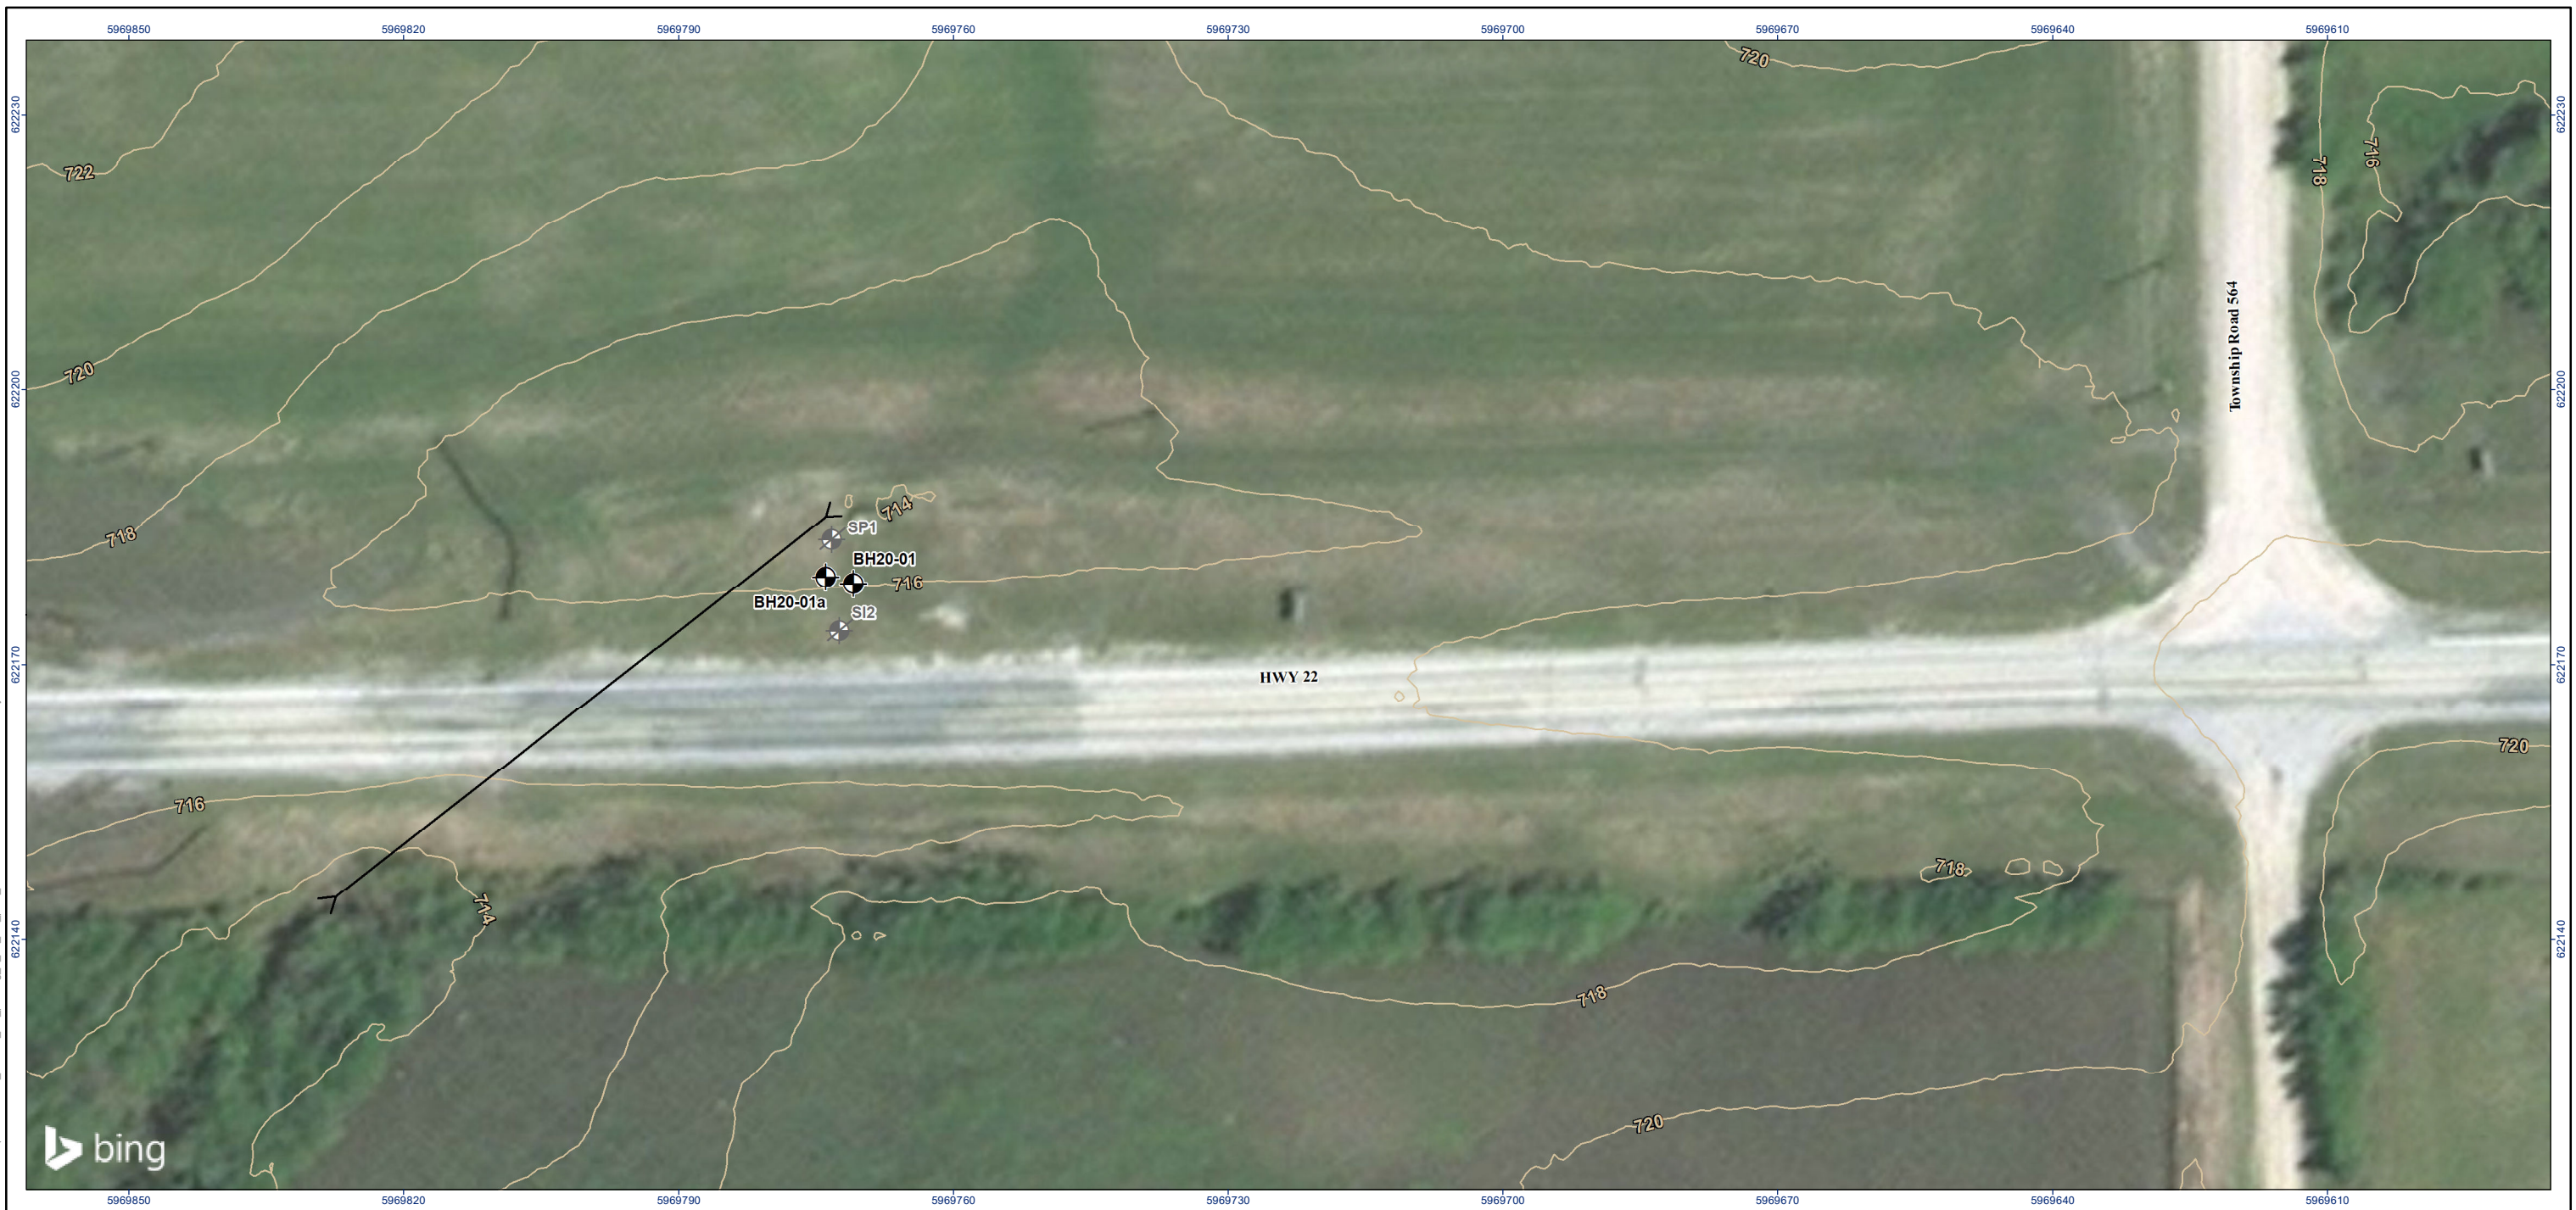
Figure No.: 1

The Spring 2024 reading cycle consisted of reading one standpipe (BH20-01a) and one slope inclinometer (BH20-01). The site plan is shown on Figure 1 attached. The instruments were read by Andres Padros, Technician and Olawale Odusi, Geotechnical Technologist on May 15, 2024.

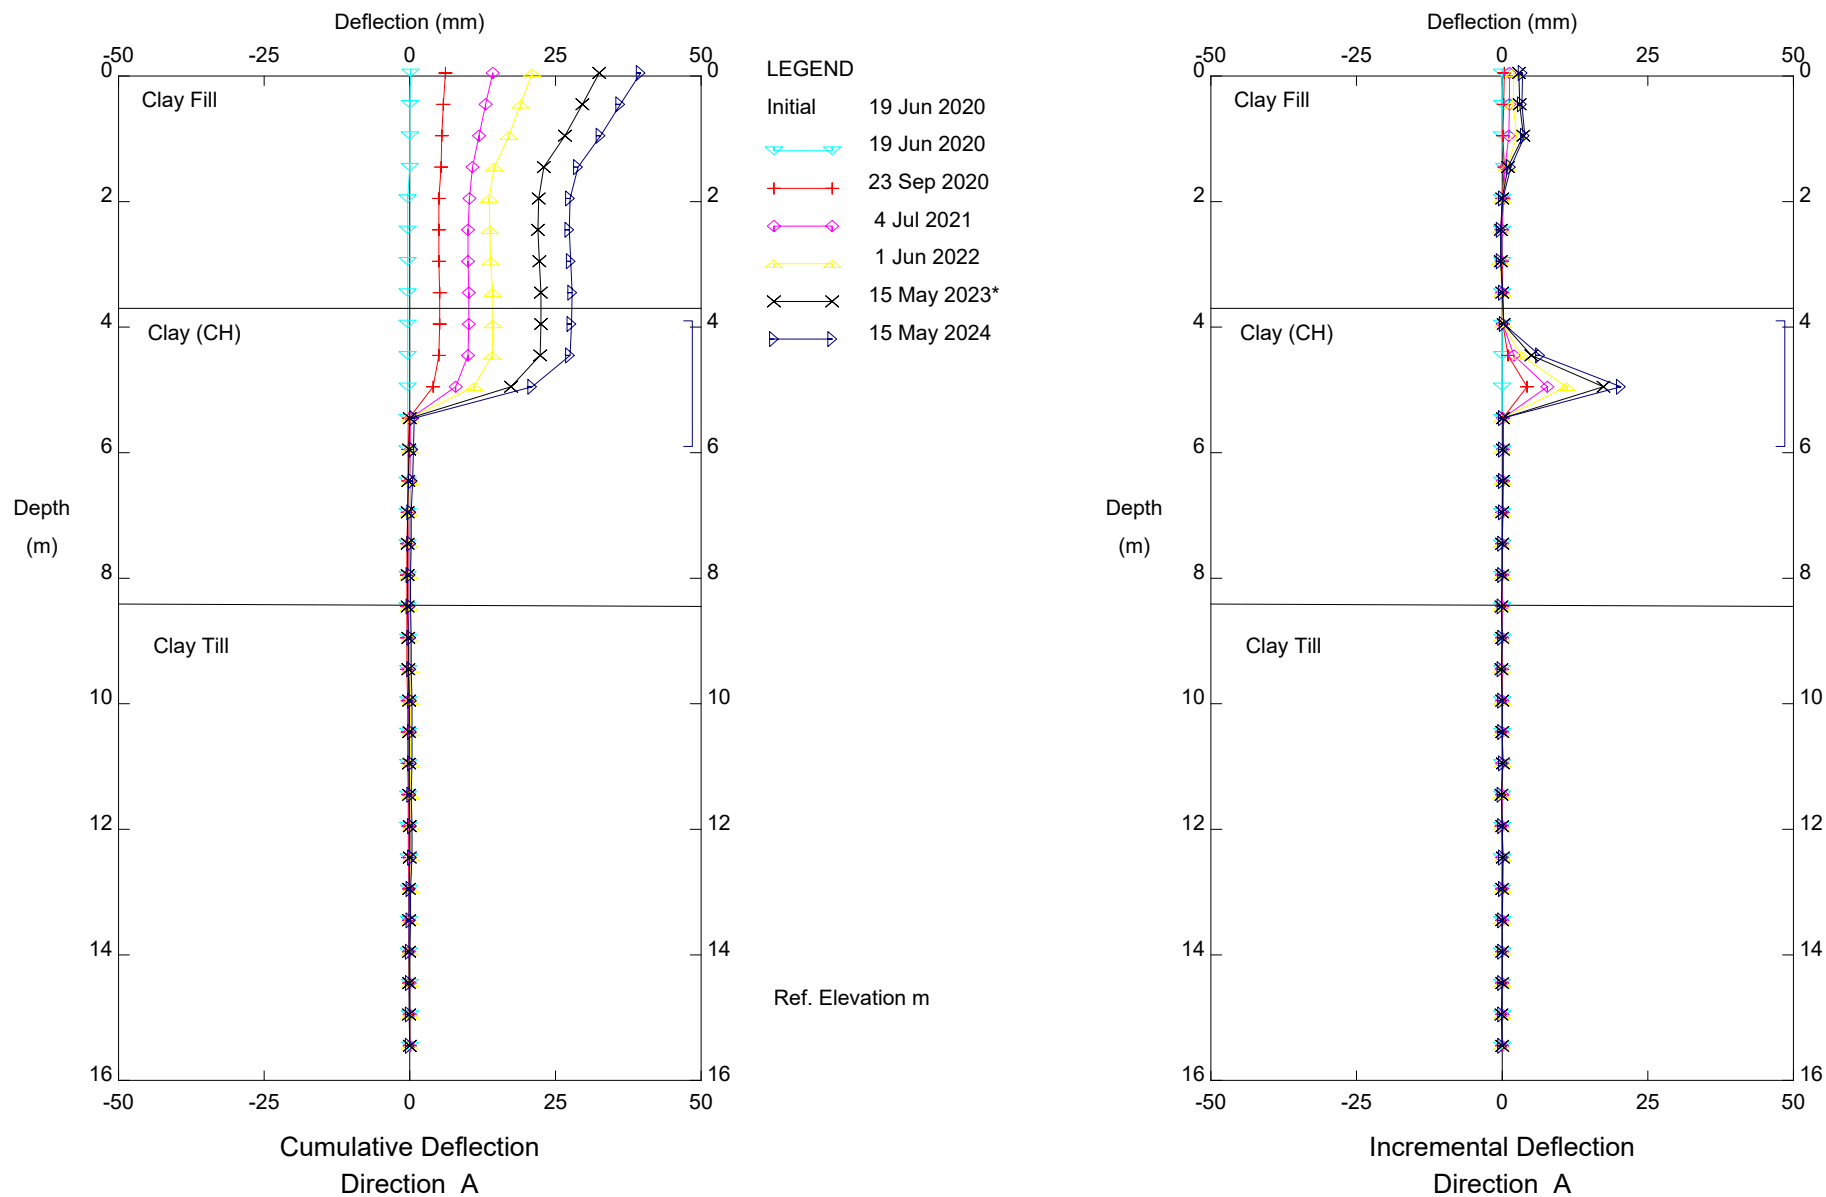
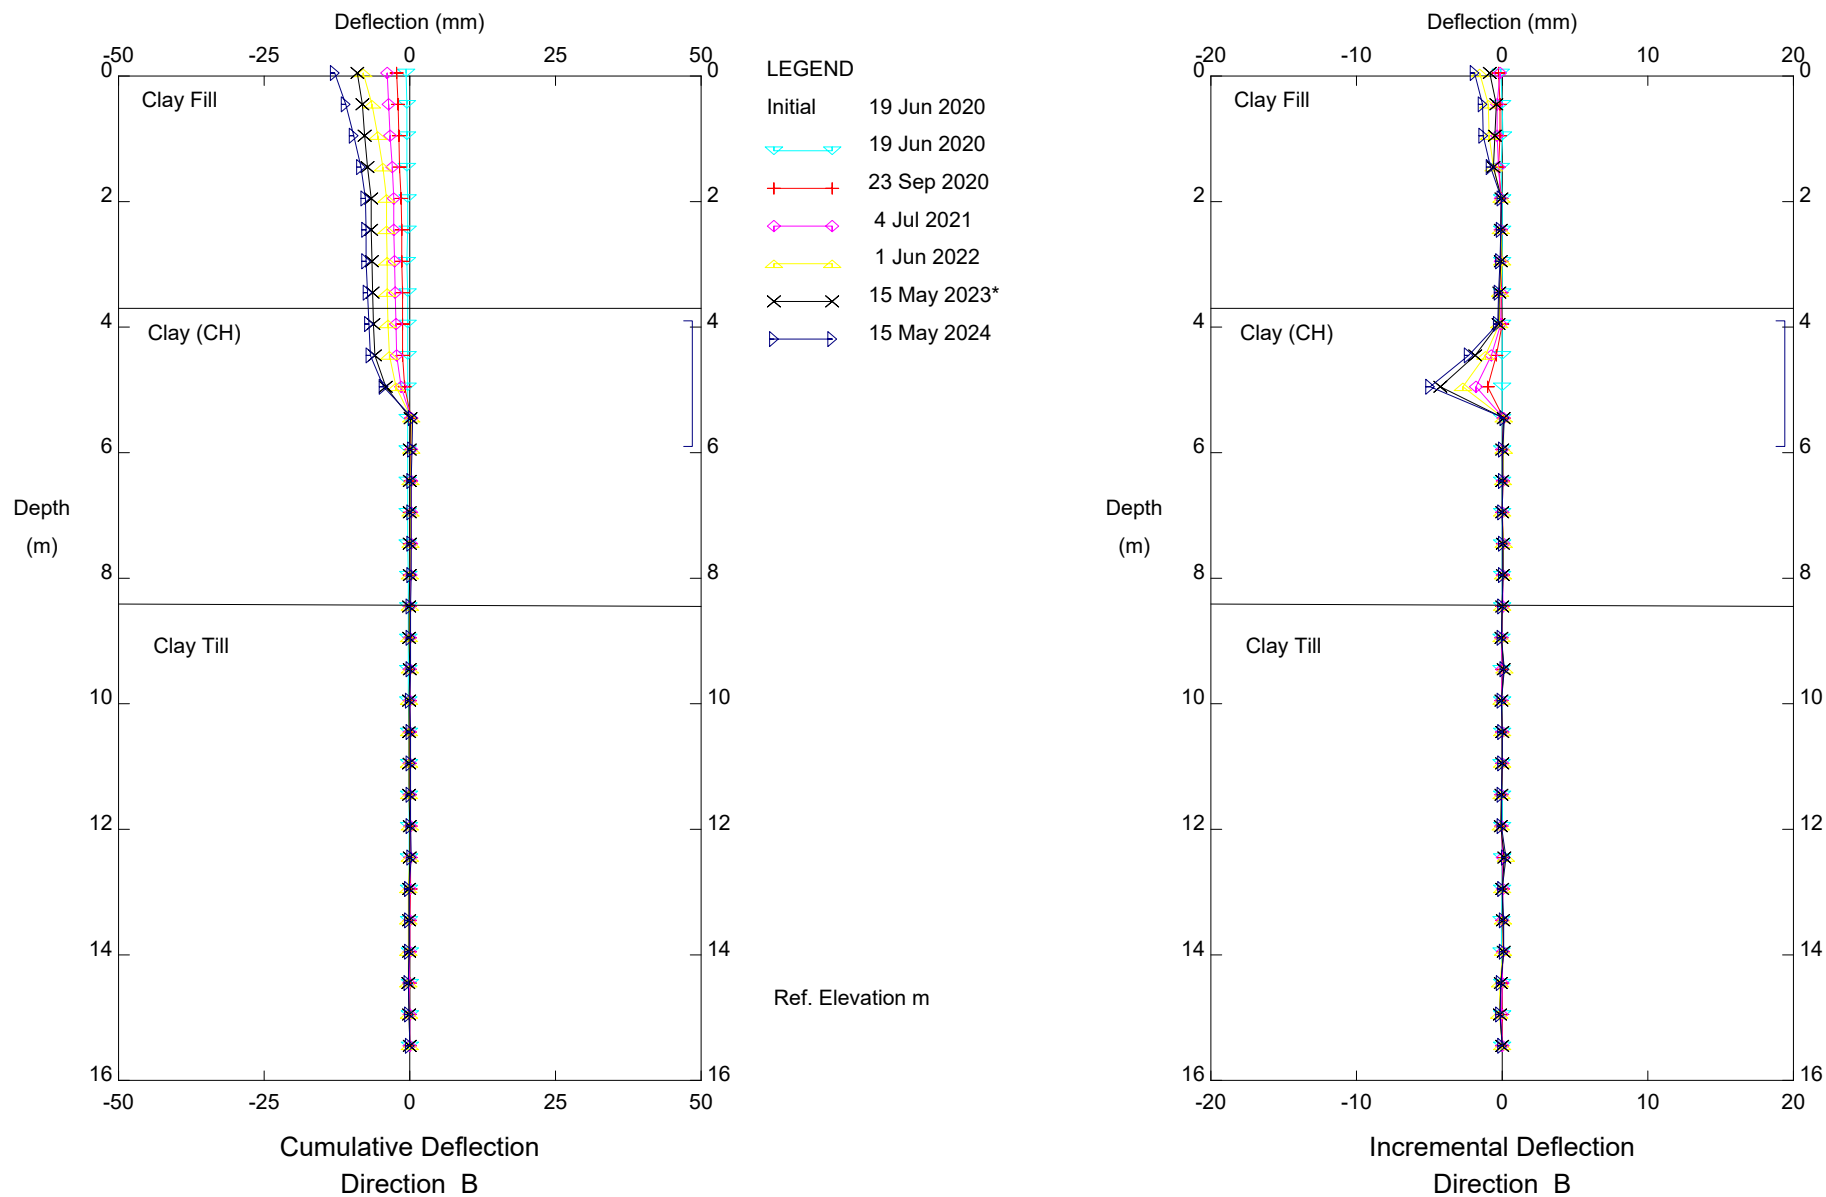
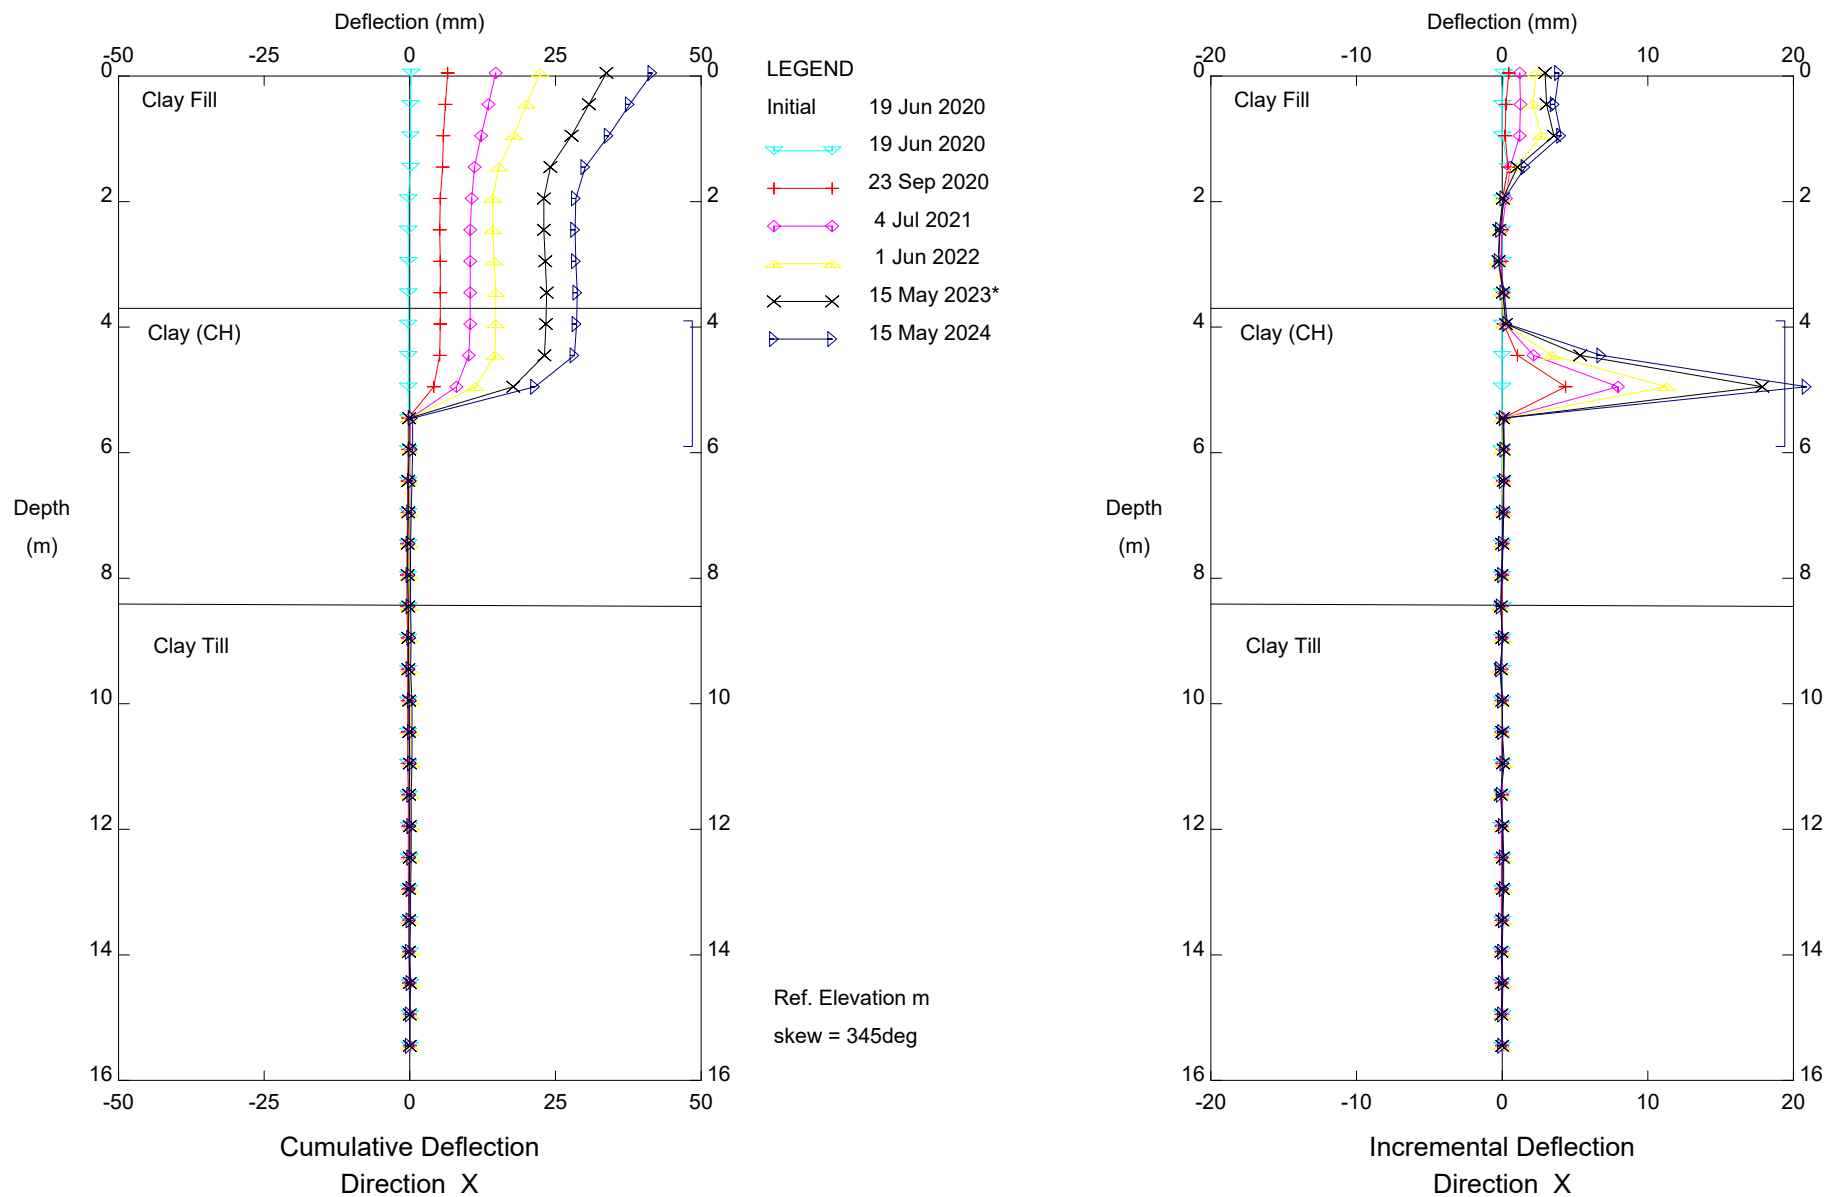
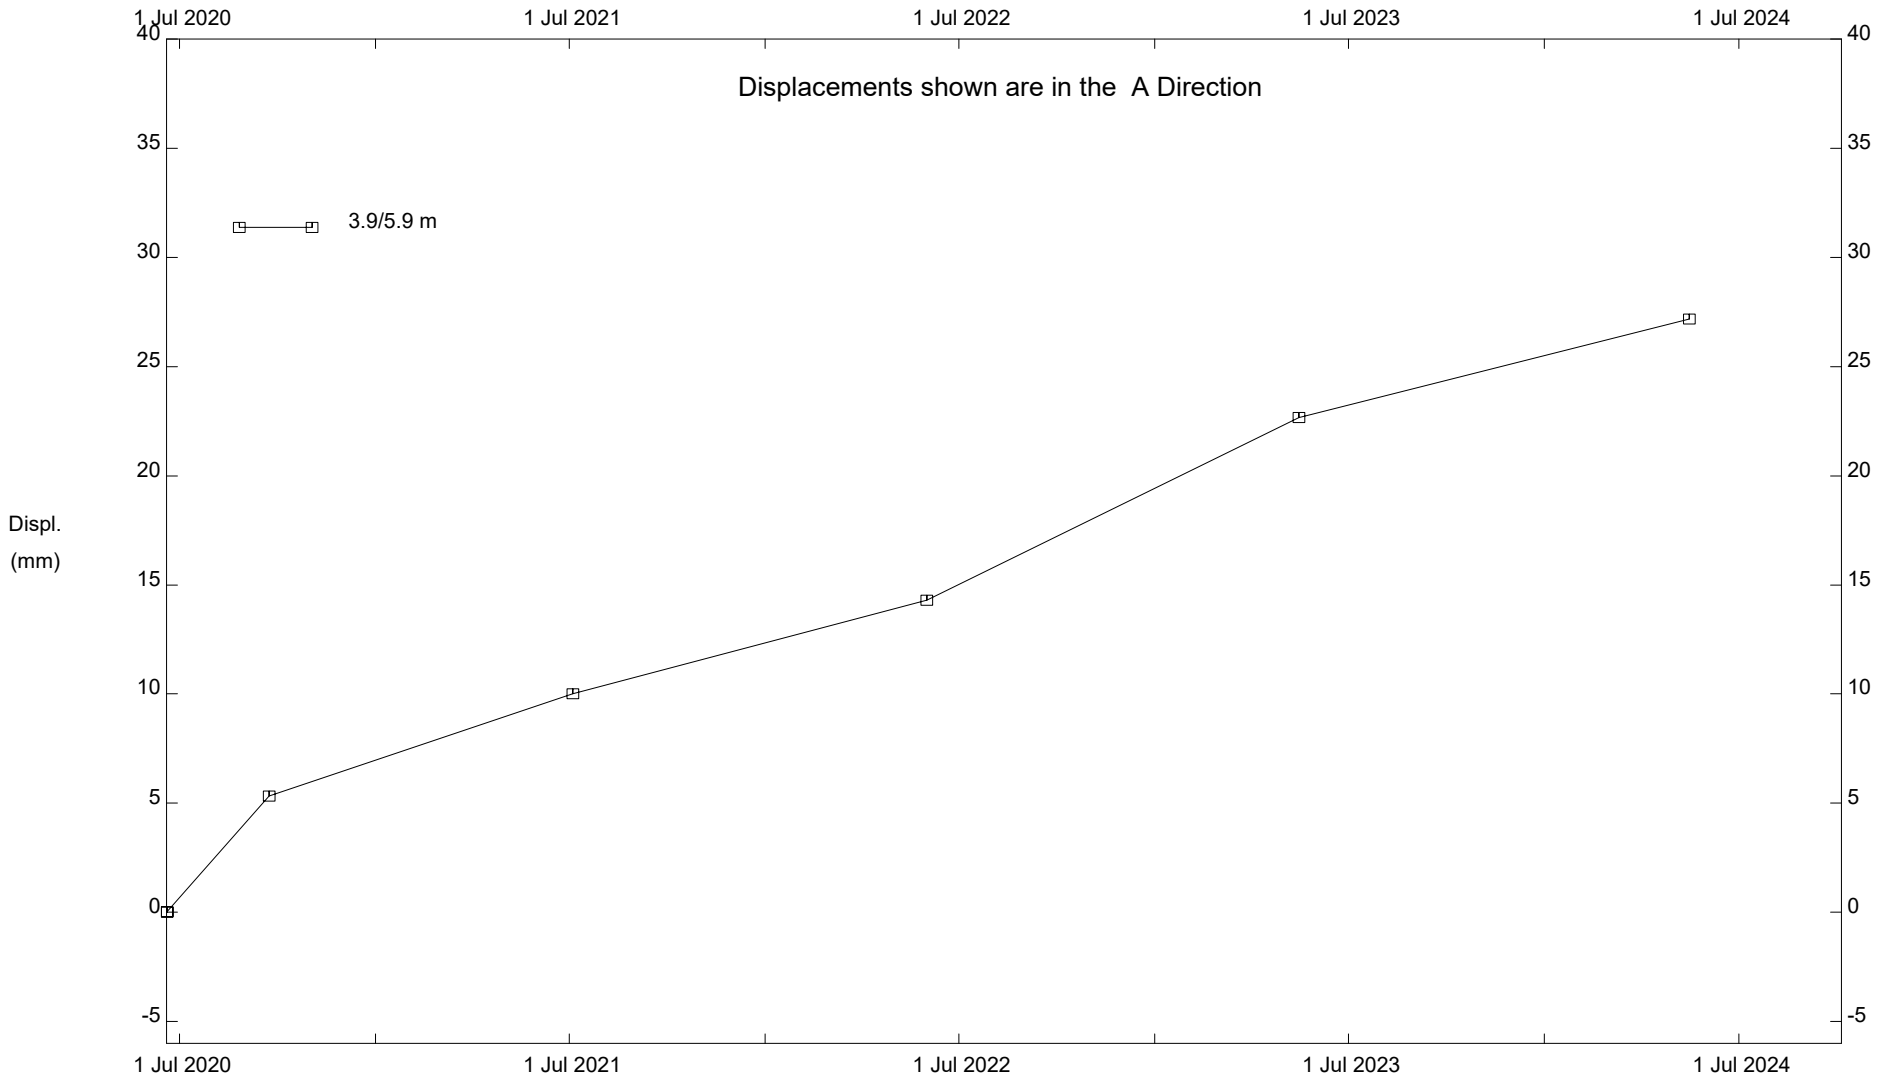
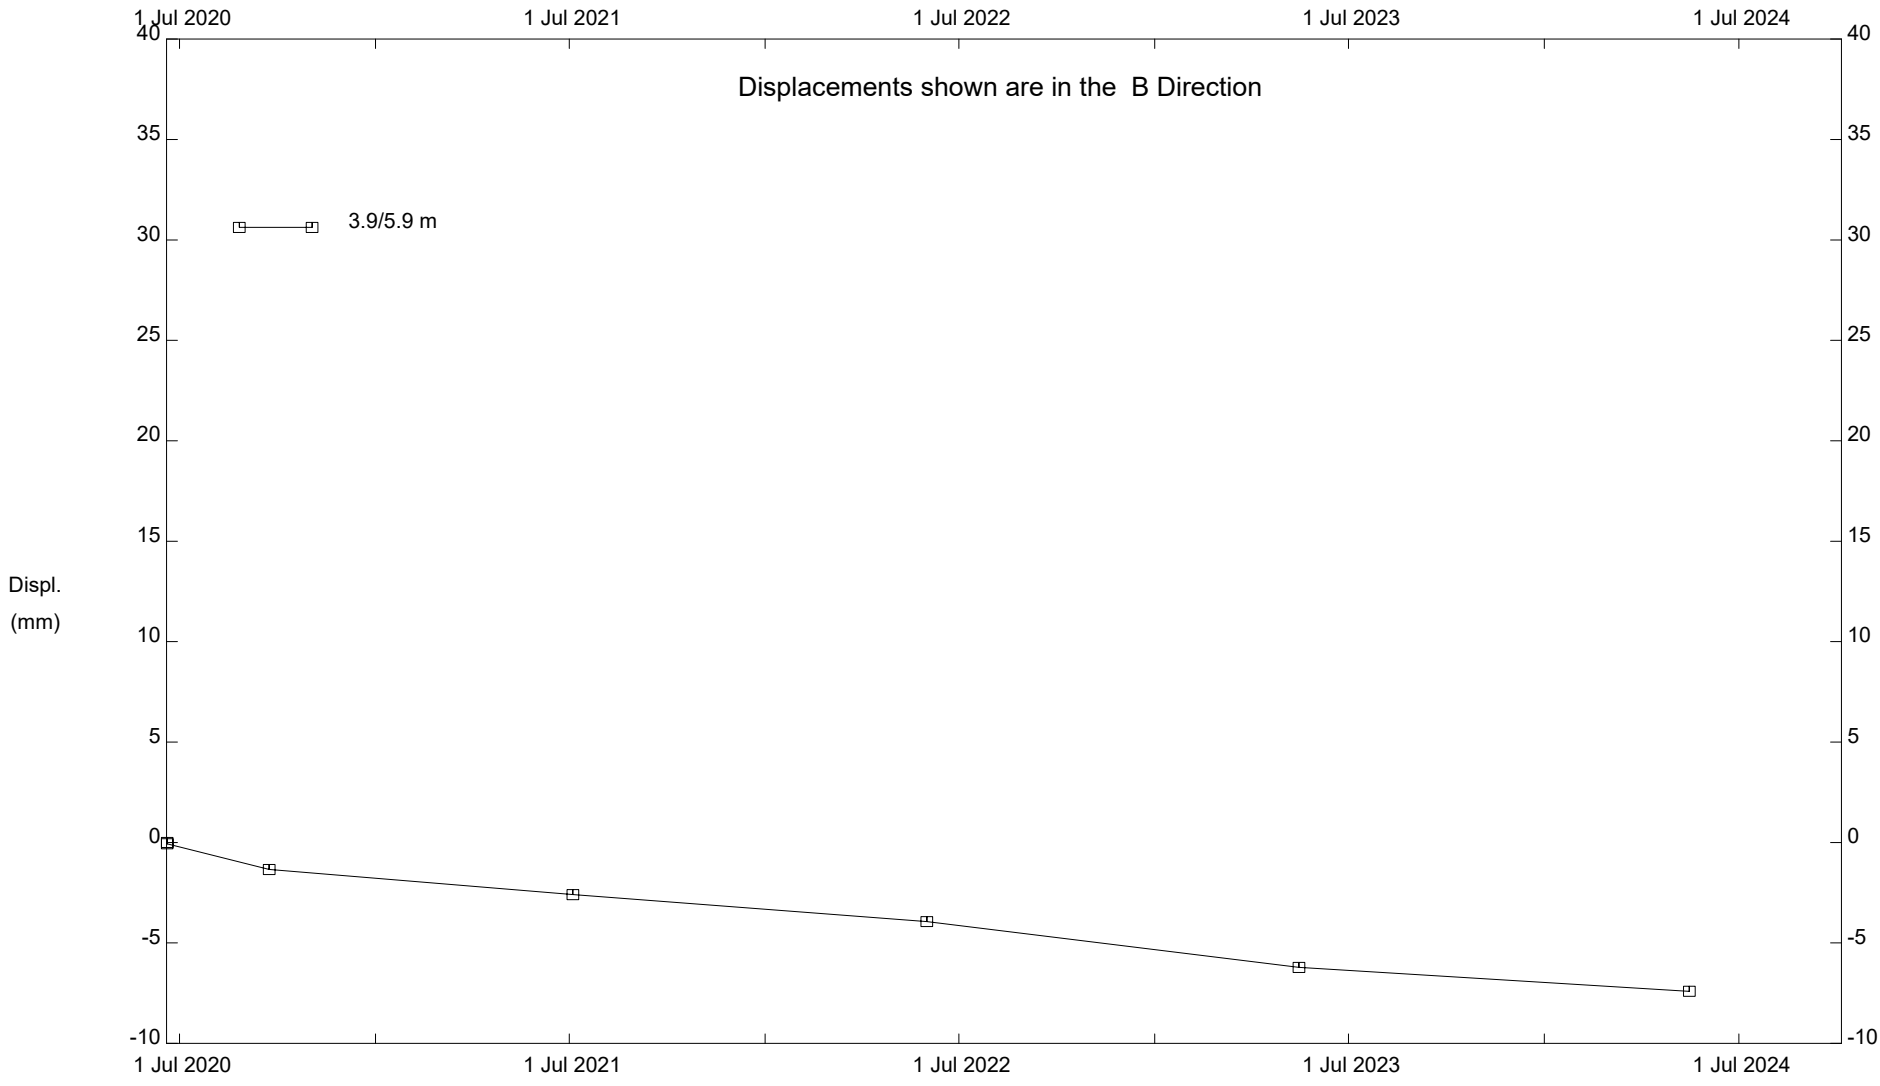
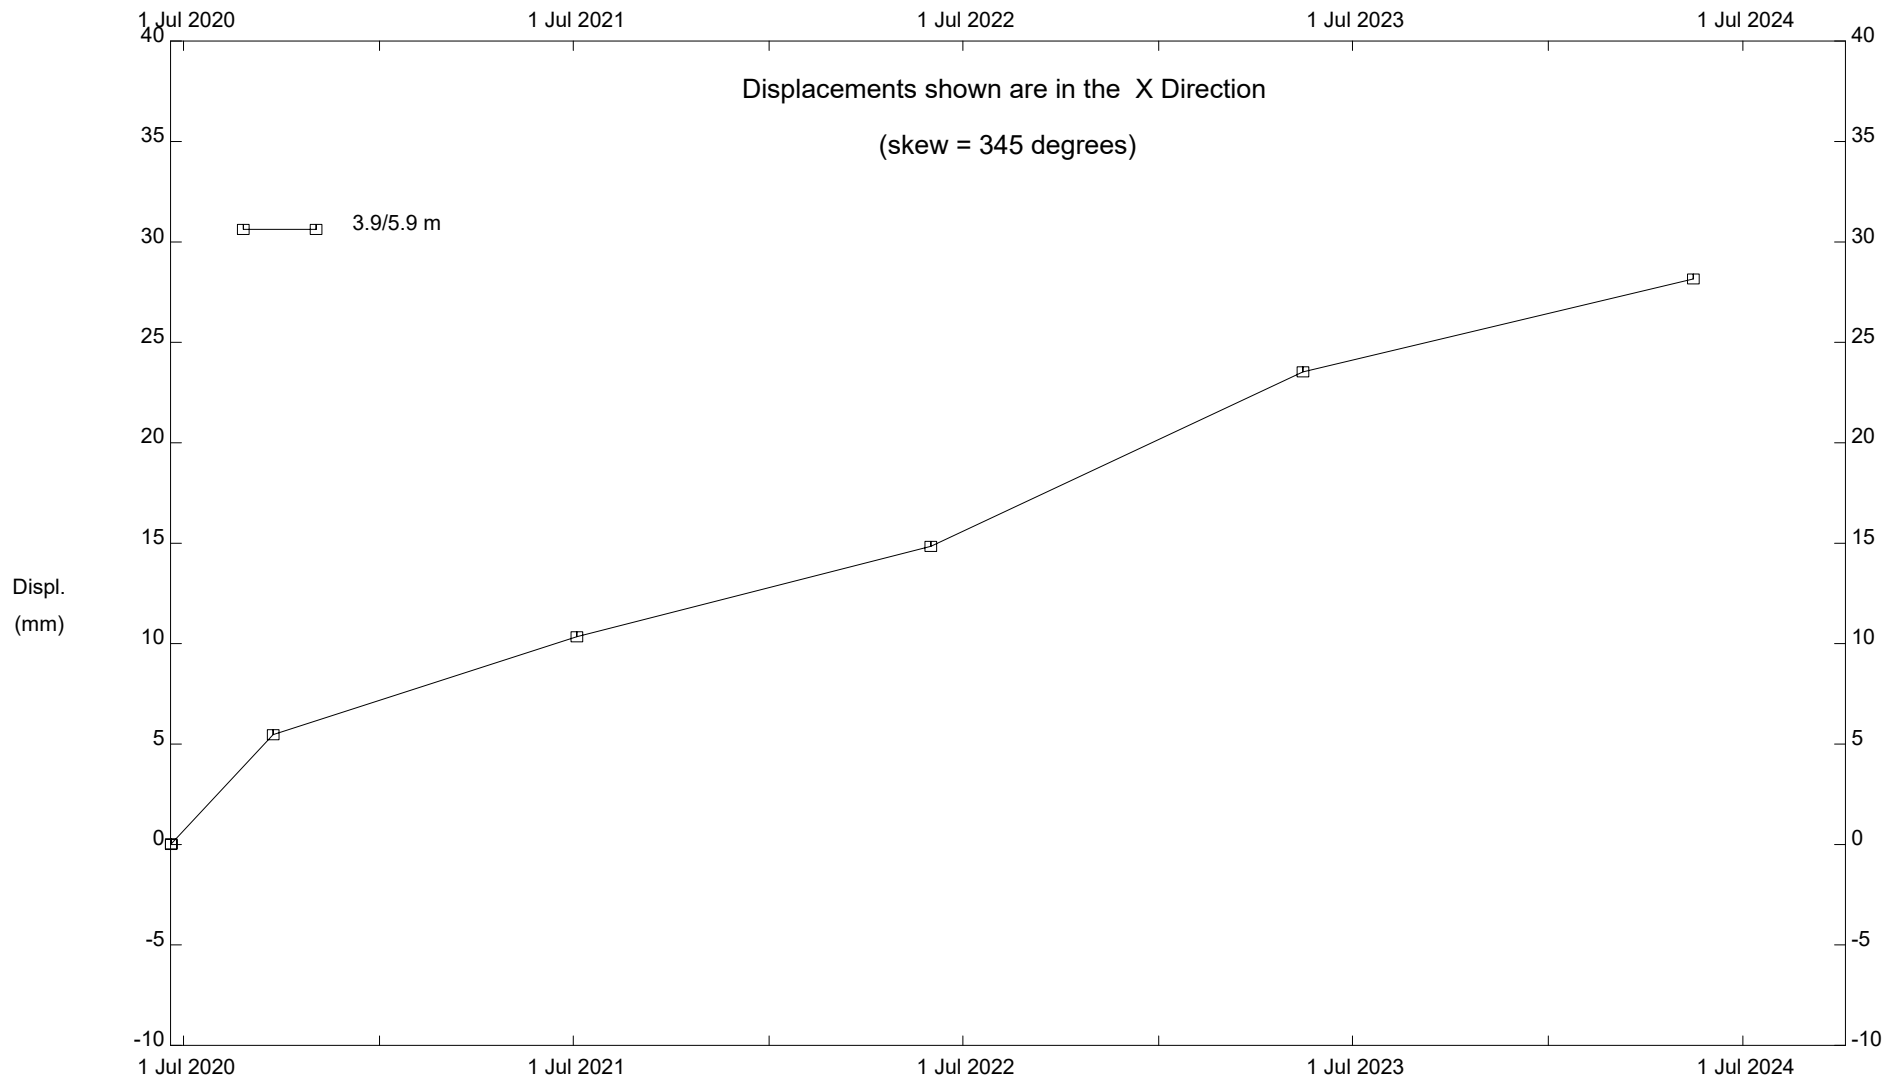
NC36, Inclinator SI20-01

BH20-01 showed about 5 mm of incremental movement at approximate 5.5 m depth since Spring 2023, corresponding to a rate of movement of 5 mm/yr.

The instruments at NC036 should be read again during the Spring 2025 reading cycle.

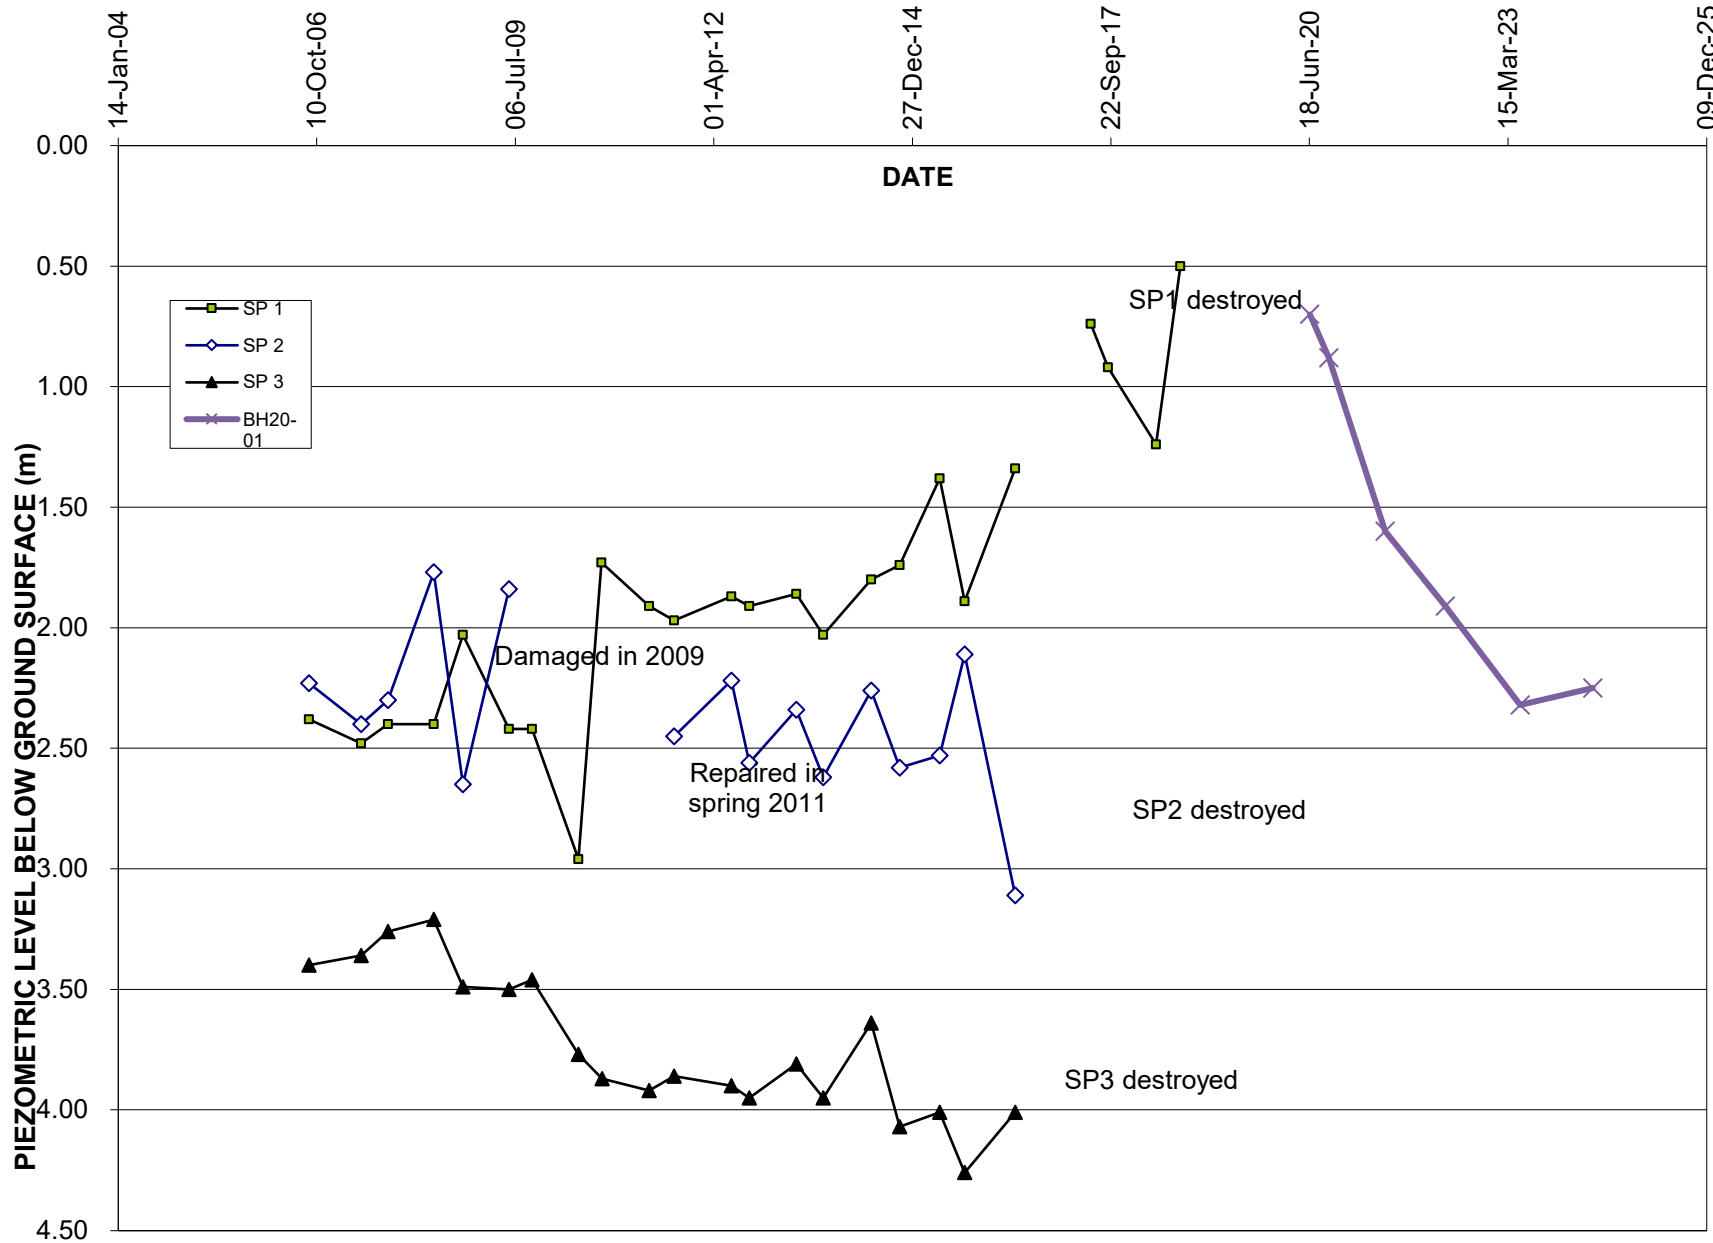
Piezometric levels in BH20-01a increased by less than 0.1 m since the Spring 2023 measurement which marked the first time the water level increased since initializing in 2020.
