<b>SITE NUMBER AND NAME:</b> NC108 – Highway 32 Slide	<b>HIGHWAY AND KM:</b> 32:10, 23.7 km	<b>PREVIOUS INSPECTION:</b> October 18, 2022	<b>CURRENT INSPECTION:</b> June 12, 2024
<b>LEGAL DESCRIPTION:</b> NE-2-59-13-W5M	<b>NAD83 COORDINATES:</b> UTM11U 5992905N, 576550E		<b>RISK ASSESSMENT:</b> PF: 5 CF: 7 Total: 35
<b>AVERAGE ANNUAL DAILY TRAFFIC (AADT):</b> 2,160 (2023)		<b>CONTRACTOR MAINTENANCE AREA (CMA):</b> 508

NORTH CENTRAL REGION GRMP  
EDSON / STONY PLAIN  
SITE INSPECTION FORM

**Client/Project** Transportation and Economic Corridors  
 Geohazard Monitoring Program,  
 NC108 HWY 32:10, 23.7 km

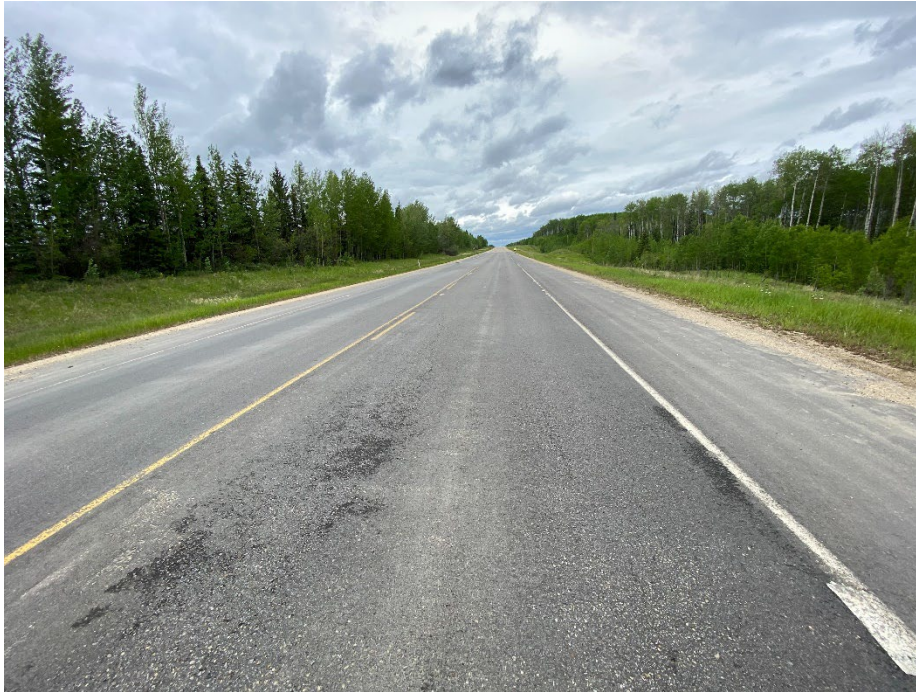
<b>COMMENTS</b>
<ul style="list-style-type: none"> <li>Several pavement cracks have reflected through the 2023 patch. The cracks observed during this inspection were all under 10 mm wide within the patched area (Photos 1 to 6).</li> <li>The semi-circular pavement cracks at the north and south flanks of the slide have begun to reflect through the patch, however no vertical difference was observed (Photos 4 &amp; 5).</li> <li>Rutting along the wheel tracks was observed in both lanes, with some accompanying cracking. Significant rutting was visible in the SBL approximately 20 m north from the northern semi-circular crack. No tire marks were observed during the current inspection (Photo 6).</li> <li>The east slope is well vegetated.</li> <li>A potential toe bulge was observed along the fence line as shown on Photo 10. The fence in this area was also leaning east.</li> </ul>

**Photo 1:** South extent of pavement cracking on Highway 32. Looking northeast.

- In the short-term, Stantec recommends that all pavement cracks should be sealed to reduce surface water infiltration into the embankment and landslide. This could include milling and paving to improve rideability. Paving should be conducted such that the final highway surface should match the existing elevation or lower (i.e., no net addition of loads).

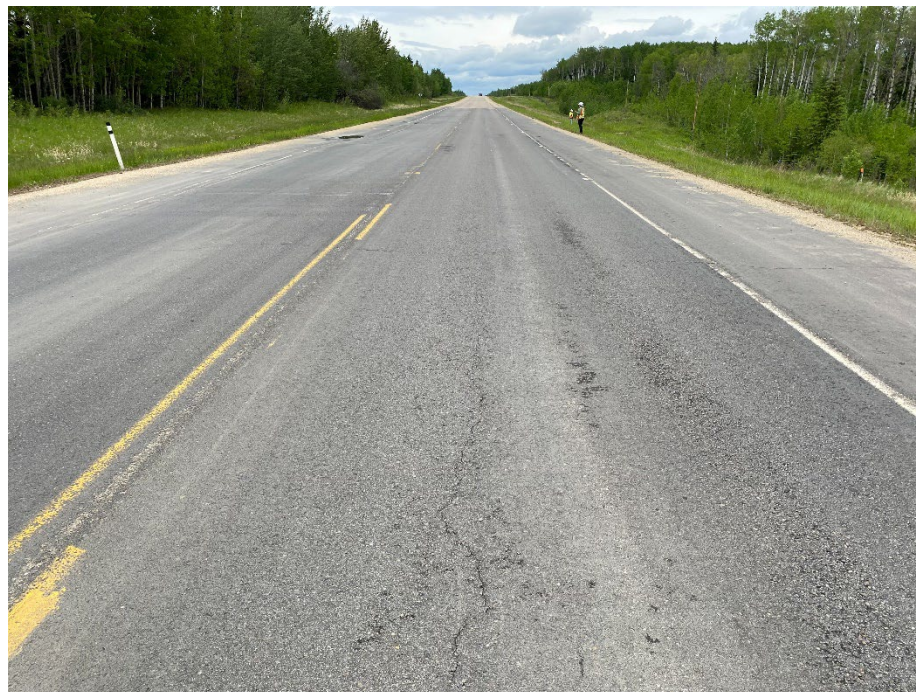
**Photo 2:** Pavement condition in NBL. Looking northeast.

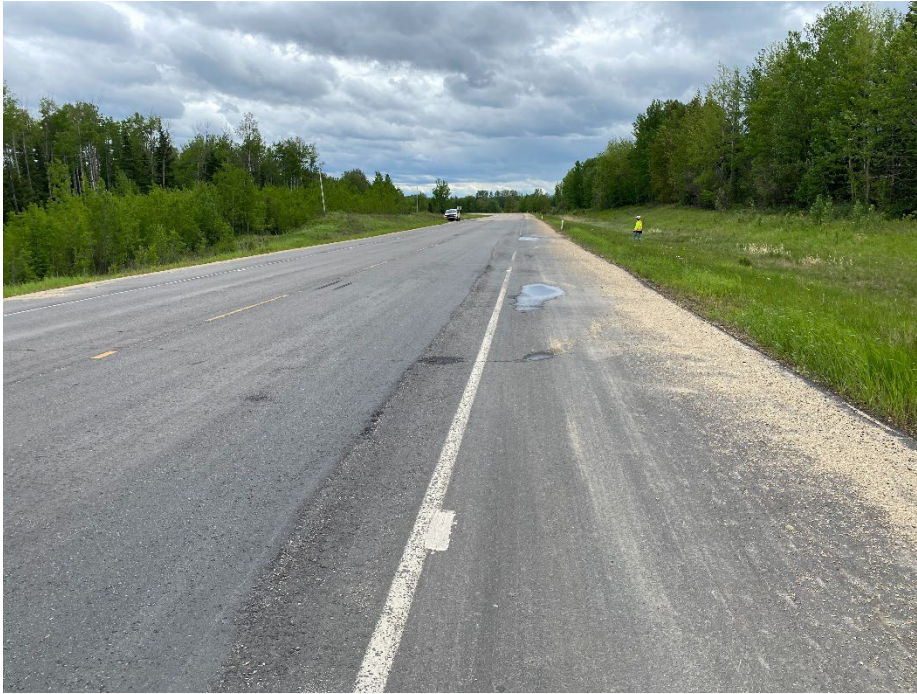
**Photo 3:** Condition of SBL, looking southwest. Wide cracking repaired.

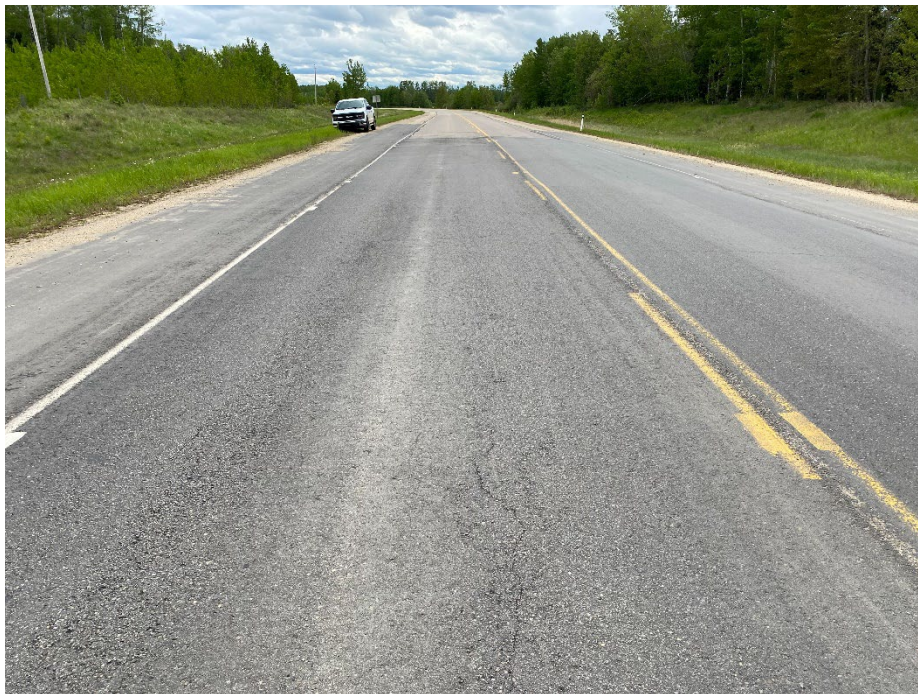
**Photo 4:** Thin cracks at south flank of landslide. Looking southwest.

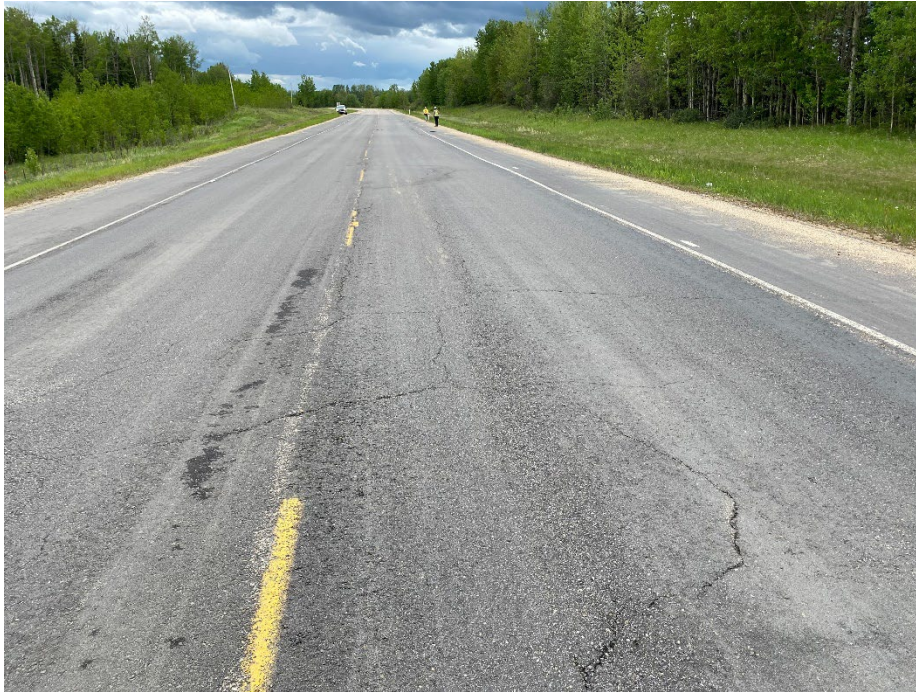
**Photo 5:** Cracking at the north flank of landslide. Looking south.

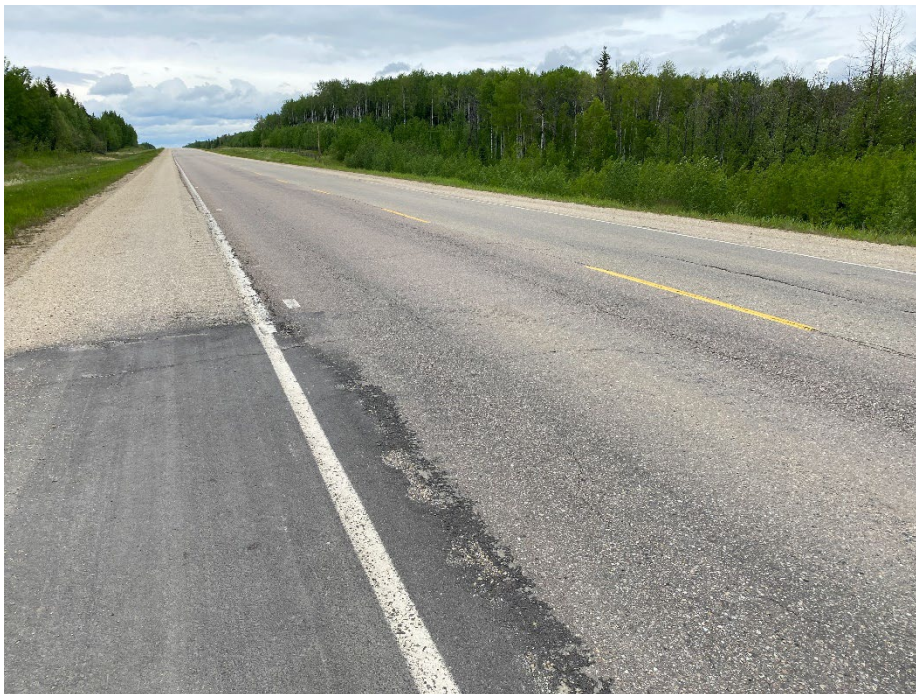
**Photo 6:** Rutting in SBL north from the pavement patch. Looking northeast.

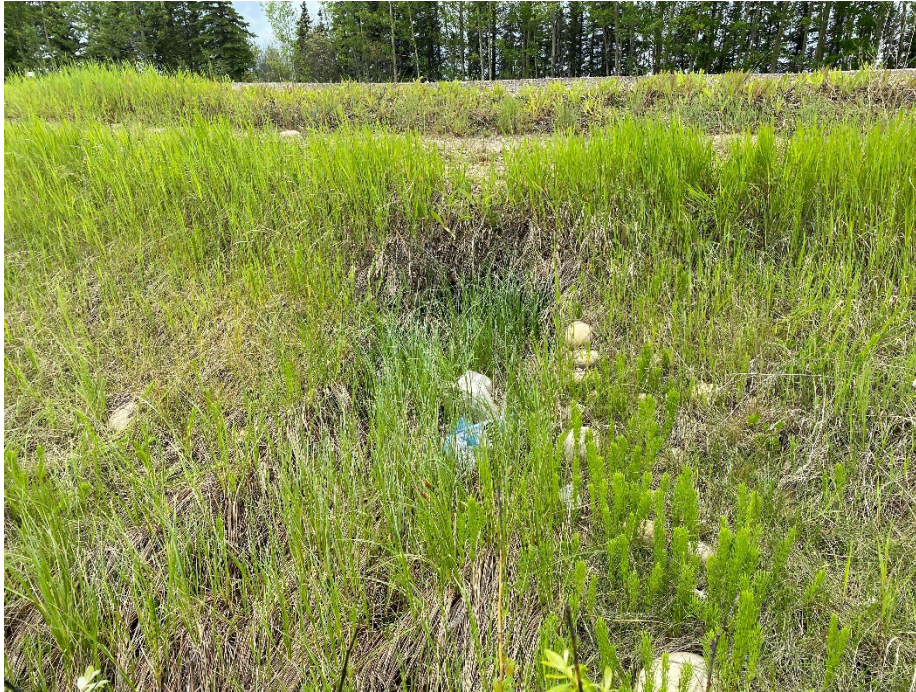
- The 900 mm diameter centerline culvert was observed to be dry, with some grass growing inside the beveled end of the outlet (Photo 7). Some riprap/cobbles was observed at the outlet; however, an erosion gully was observed below the outlet approximately 0.15 m by 0.15 m deep. The gully was vegetated and infilled with cobbles.

**Photo 7:** Culvert outlet becoming grown-in. Looking west.

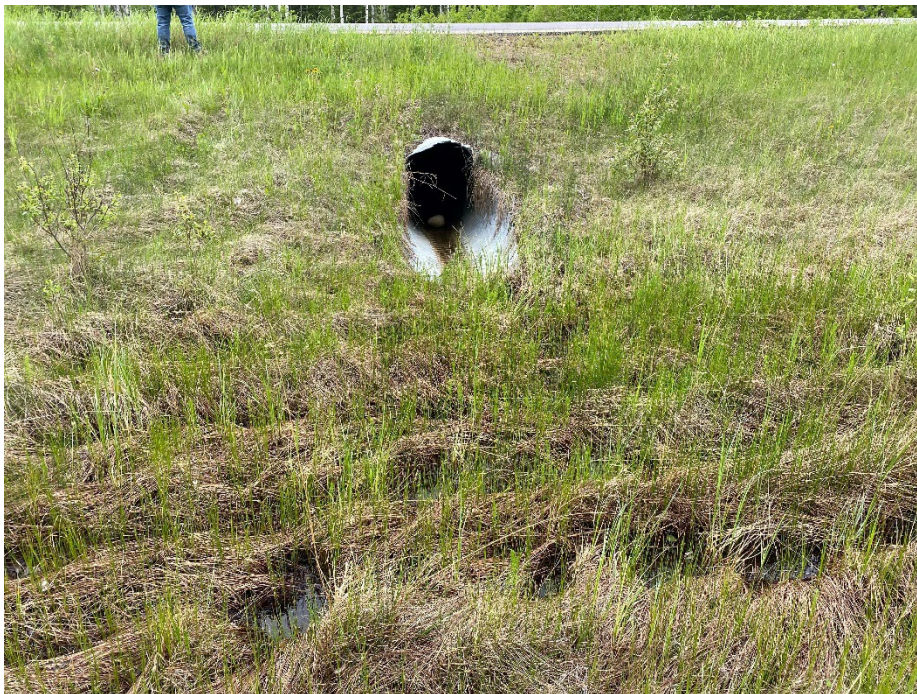
- At the inlet on the west side, a possible separation was noted between the first and second segments of culvert (Photos 8 & 9).
- The ditch on the west side near the culvert inlet contained ponded water (Photo 8).

**Photo 8:** Culvert inlet and ponded water in ditch, looking east.

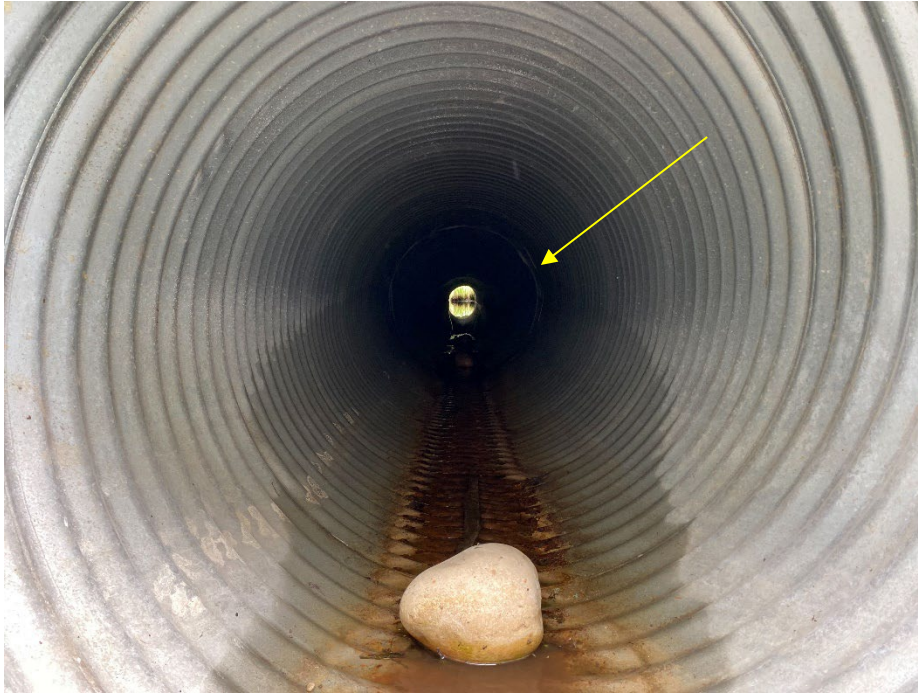
**Photo 9:** Possible separation between first and second segments of culvert inlet, looking east.

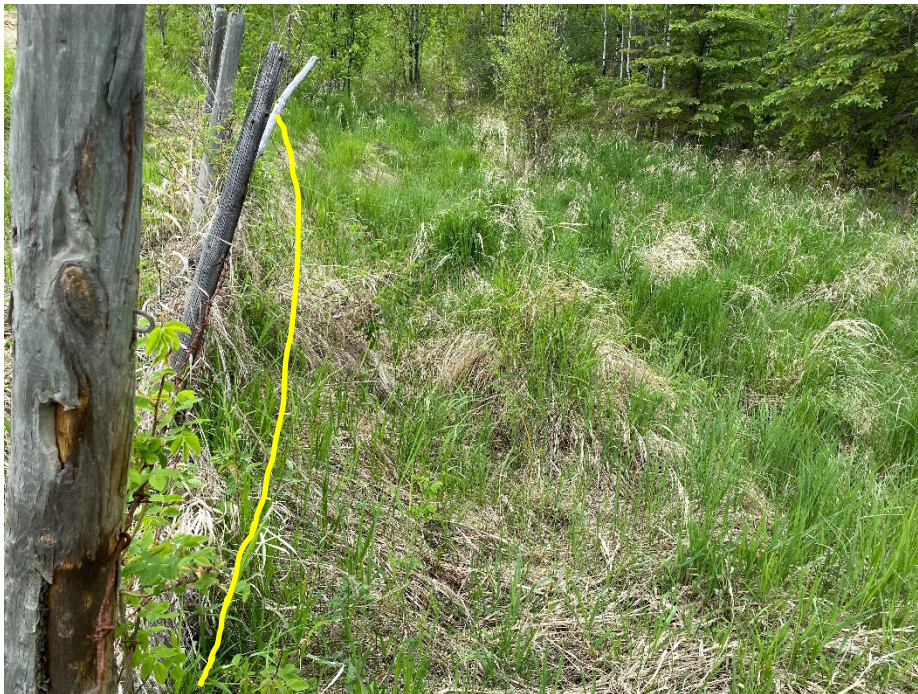
**Photo 10:** Possible toe bulge and leaning fence on east side of site. Looking northeast.
