SITE NUMBER AND NAME: NC108 - Highway 32 Slide 1.7 km south of TWP592	LOCATION: On Highway 32 approximately 1.7 km south of Township Road 592	HIGHWAY: 32:10	KM: 23.700
LEGAL DESCRIPTION: NE-2-59-13-W5M	NAD83 COORDINATES: UTM11U 5992905N, 576550E		
AVERAGE ANNUAL DAILY TRAFFIC (AADT): 1,790 (2021)		CONTRACTOR MAINTENANCE AREA (CMA): 508

PRIMARY SITE ISSUE: Failure of the east embankment causing pavement distress along Highway 32.
APPROXIMATE DIMENSIONS: 150 m wide. Unclear where the toe is.
SITE HISTORY: No files were available from AT for review. Google Earth images suggest that both lanes were last patched in 2020 over an approximately 480 m long section of Highway 32. St-Onge (1973) ¹ suggests surficial deposits along this section of Highway 32 consists of deltaic sand deposits. Fenton et al. (2013) ² indicates glaciofluvial sediment deposited by glacial meltwater streams. Sediment ranges from massive to stratified, poor to well sorted, coarse to fine grained. Till may also be included. The estimated overburden thickness at the site is in the order of 30 m (Carlson and Green 1976) ³ . LiDAR data suggests this section of Highway 32 is located along the crest of an ancient landsli

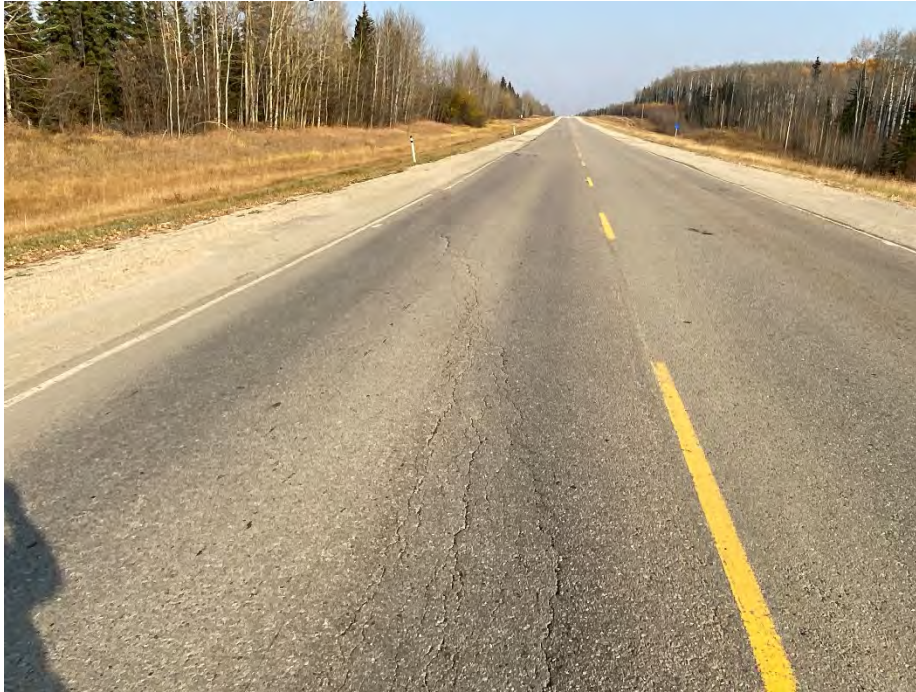
Photo 1: South extent of pavement cracking on Highway 32. Looking northeast.

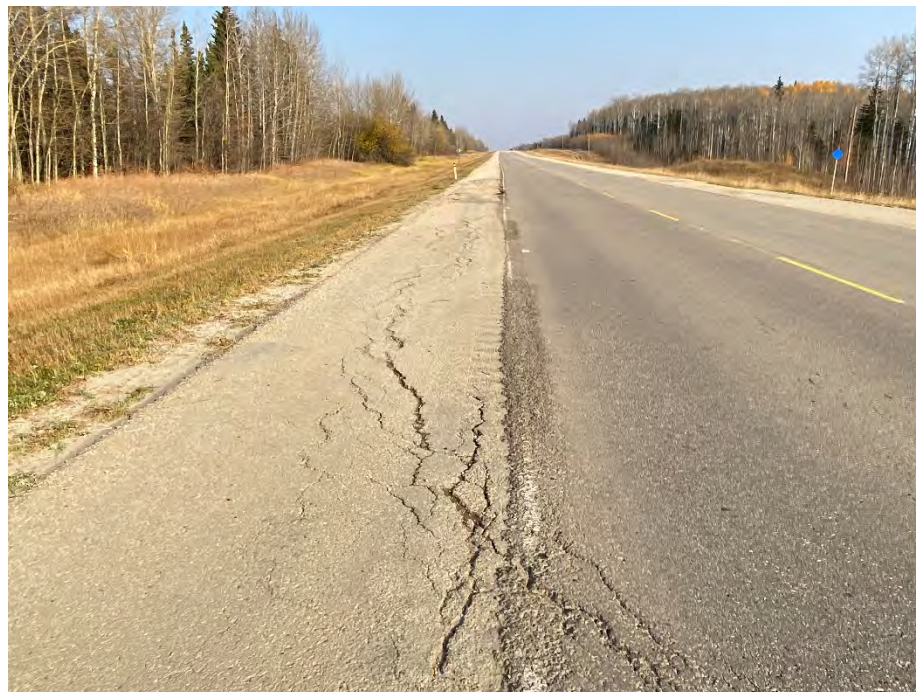
- Significant cracking and pavement distress has resurfaced since the 2020 patch.
- Pavement cracks were observed to be between 5 to 50 mm wide, with most of the wider cracks occurring on the shoulder of the southbound lane (SBL) (Photo 2). One crack on the SBL shoulder on the north side of the culvert was measured to be up to 125 mm deep (Photo 3).

Photo 2: Wider cracks developing on shoulder of SBL. Looking northeast

- In the short-term, Stantec recommends that all pavement cracks should be sealed to reduce surface water infiltration into the embankment and landslide. This could include milling and paving to improve rideability. Paving should be conducted such that the final highway surface should match the existing elevation or lower (i.e., no net addition of loads).

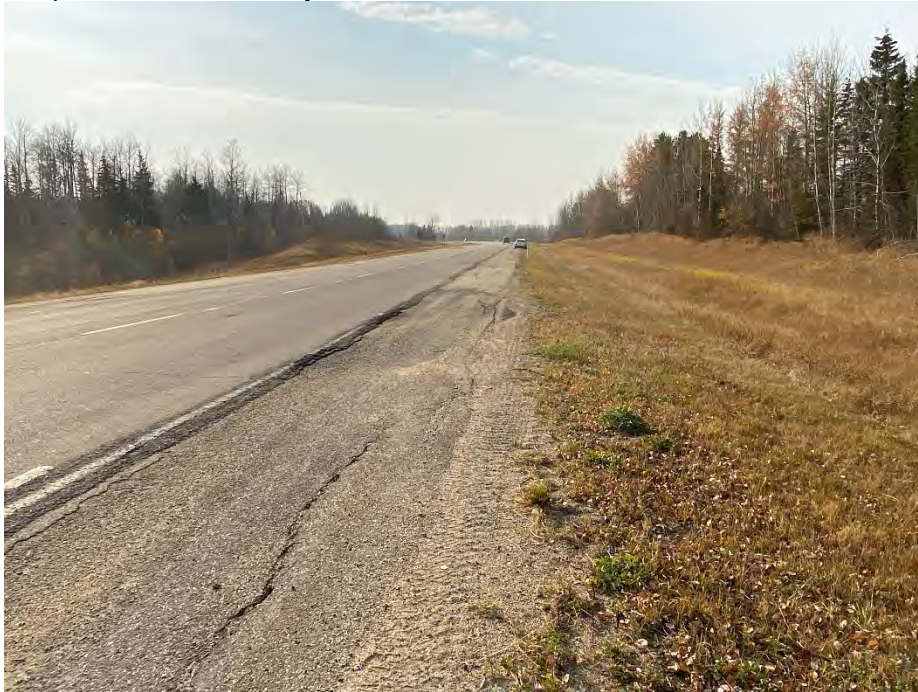
Photo 3: Cracking of SBL, looking southwest. Crack in left corner is approx. 125 mm deep.

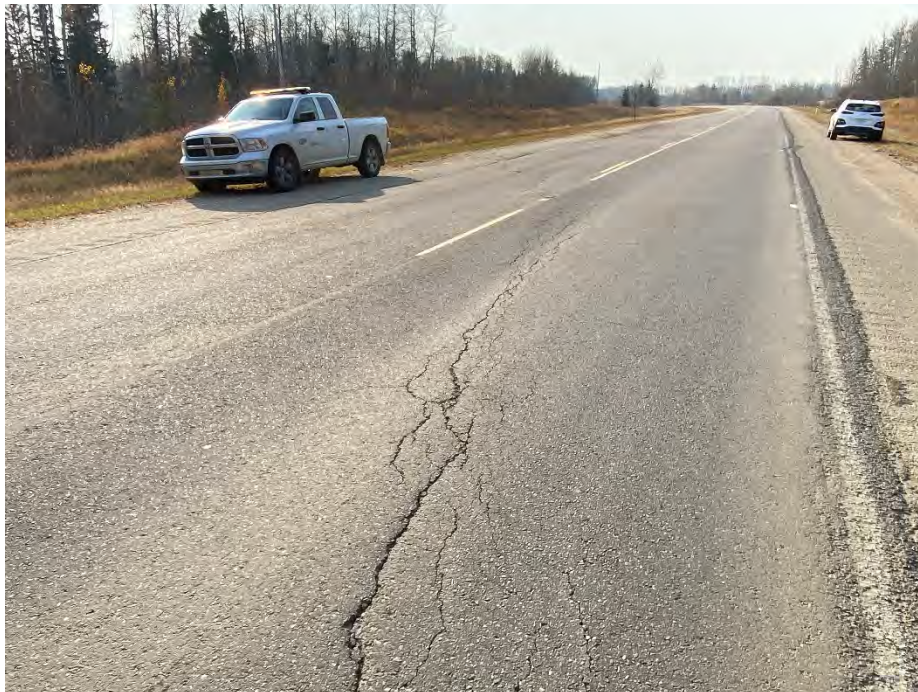
- The semi-circular pavement cracks at the north and south flanks of the slide have vertical displacements of up to approximately 100 mm (Photos 4 & 5).

Photo 4: Crack at south flank of landslide. Pavement dipping to the east. Looking southwest.

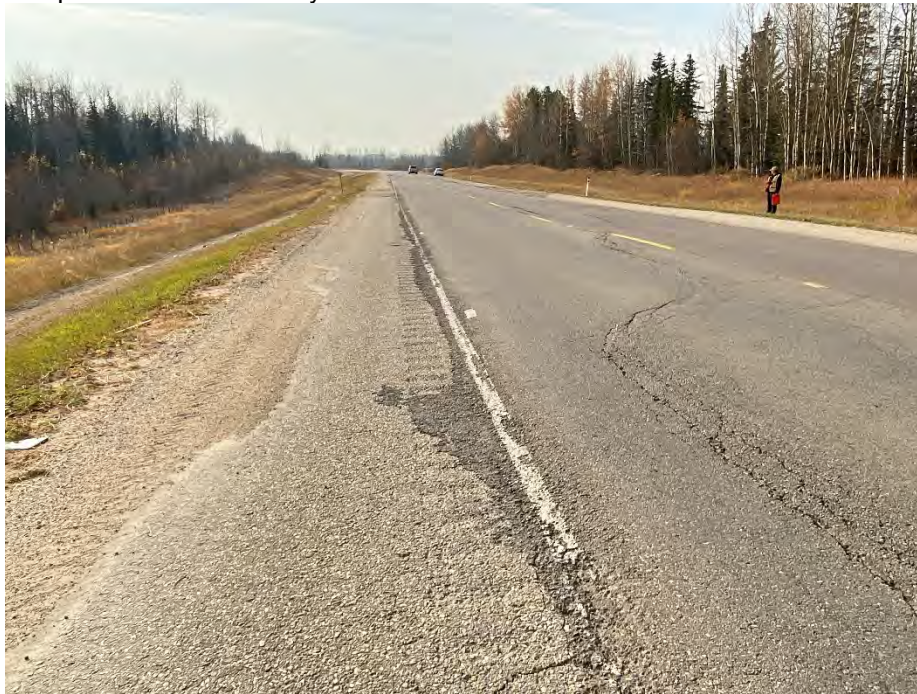
Photo 5: Cracking at the north flank of landslide. Pavement dipping to the east. Looking south.

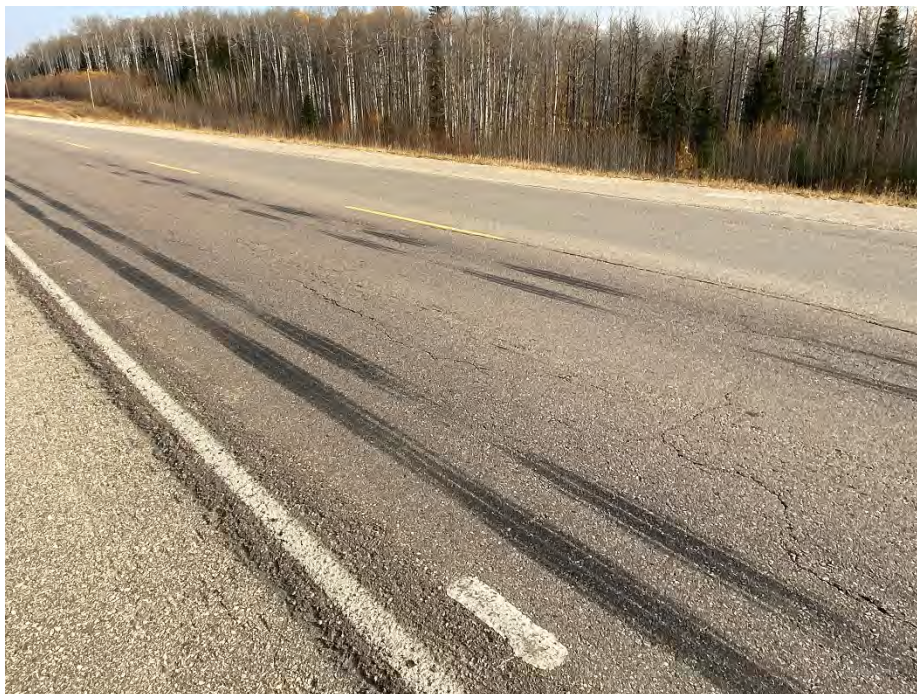
- Rutting along the wheel tracks was observed in both lanes, with some accompanying cracking. Tire marks were visible in the SBL approximately 20 m north from the northern semi-circular crack (Photo 6).

Photo 6: Tire marks and rutting in SBL. Looking northeast.

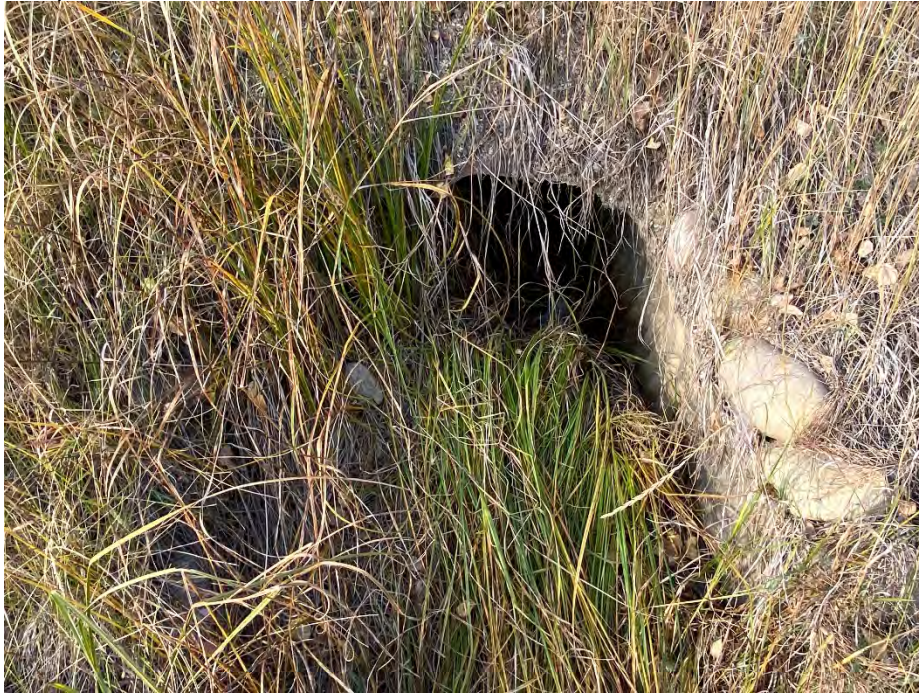
- The 900 mm diameter centerline culvert was observed to be dry, with some grass growing inside the beveled end of the outlet (Photo 7). Riprap lined the slope below the outlet. At the inlet on the west side, a possible separation was noted between the first and second segments of culvert as a thin ring of light was seen (Photos 8 & 9).

Photo 7: Culvert outlet becoming grown-in. Looking west.

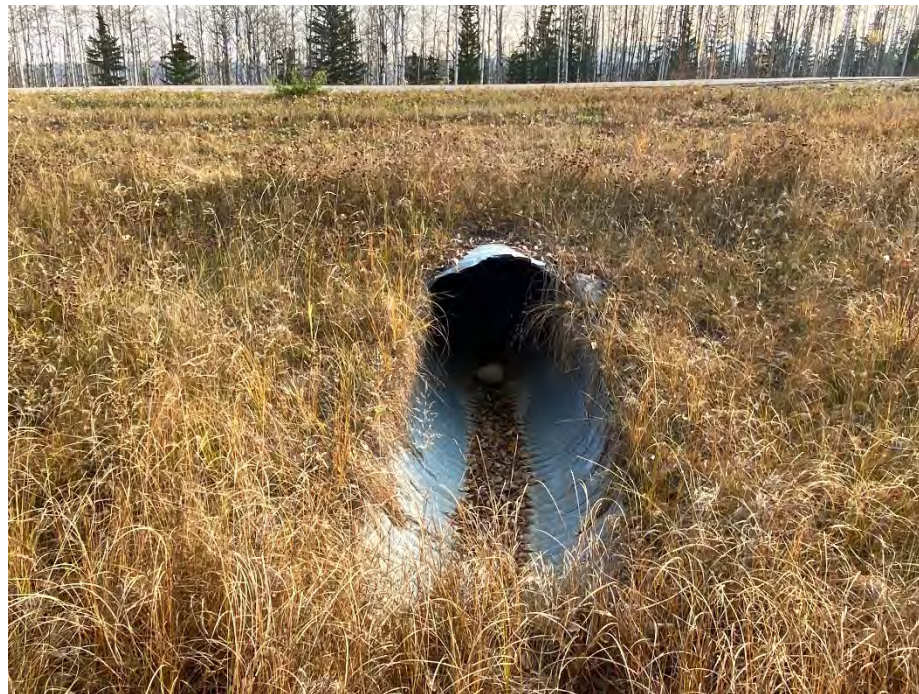
Photo 8: Culvert inlet, looking east.

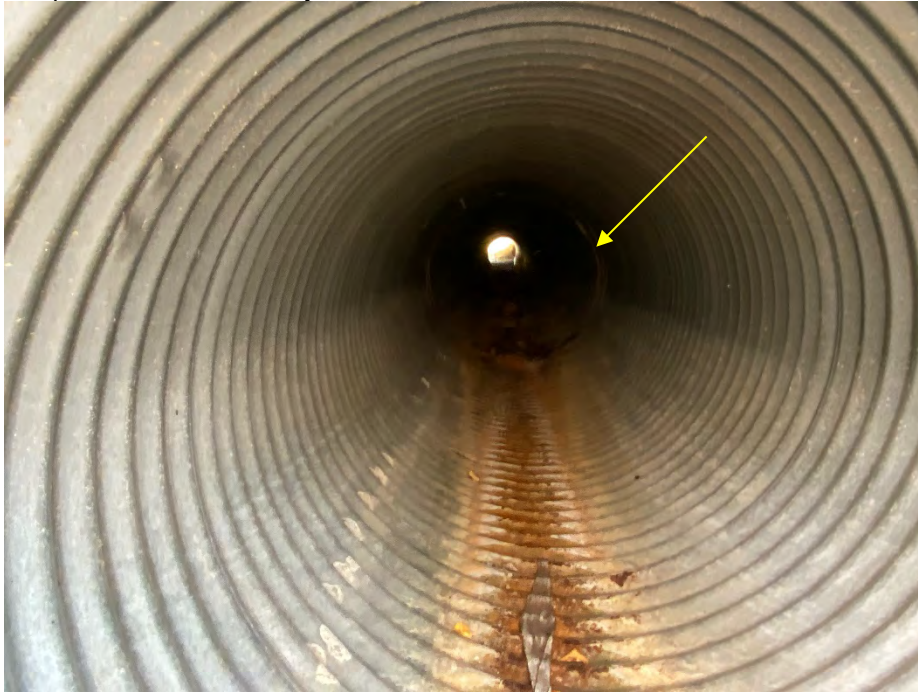
Photo 9: Possible separation between first and second segments of culvert inlet, looking east.

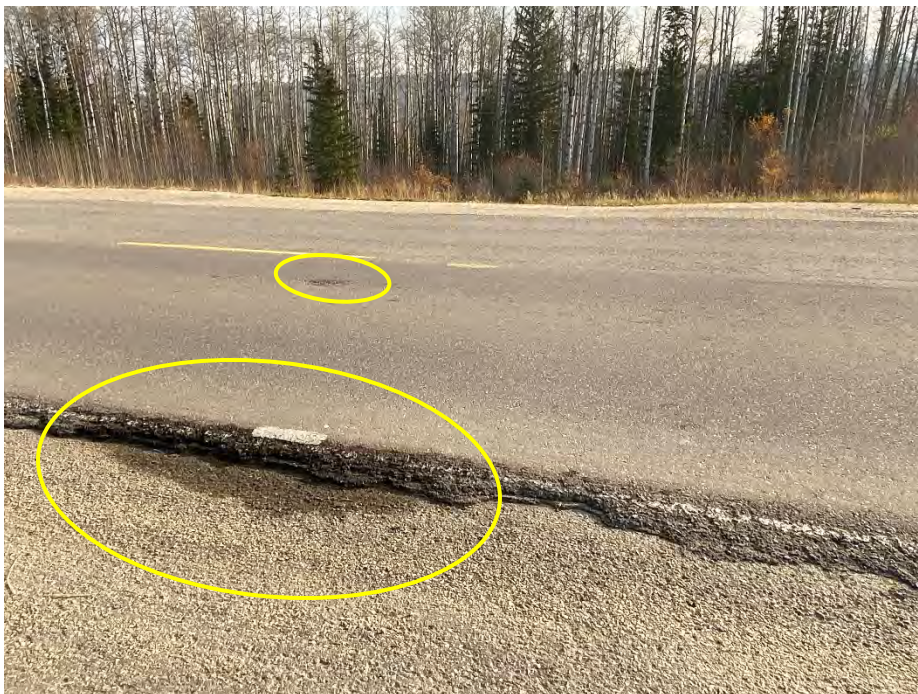
- Two wet spots were observed on the pavement, to the south of the inlet. One spot was in the centre of the SBL and approximately 100 mm in diameter. The second spot was at the shoulder of the SBL, where moisture appeared to be coming out from between the pavement patch and the underlying pavement (Photo 9).

- Weather data from Carrot Creek weather station approximately 58 km south of Whitecourt indicated no precipitation was recorded in the week prior to the call-out inspection. As such, it is possible that the observed wet spots may be related to seepage or a spring under the highway.

Photo 10: Wet spots on pavement, looking east.
