GEOHAZARD RISK MANAGEMENT PROGRAM

North Central Region – Edson / Stony Plain Area

2019 Inspection Report

Site Number	Site Name		Hwy	km
NC37	South of Whitecourt		32:10	34.6
Legal Land Description	NW 27-59-12-W5M			
UTM Coordinates (NAD 83)	Zone 11U	N5999427	E583507	
Operational Site Instrumentation	Slope Inclinometers		9	
	Pneumatic Piezometers		4	
	Vibrating Wire Piezometers		5	
	Standpipe Piezometers		4	
Date of Last Instrumentation Readings	May 8, 2019

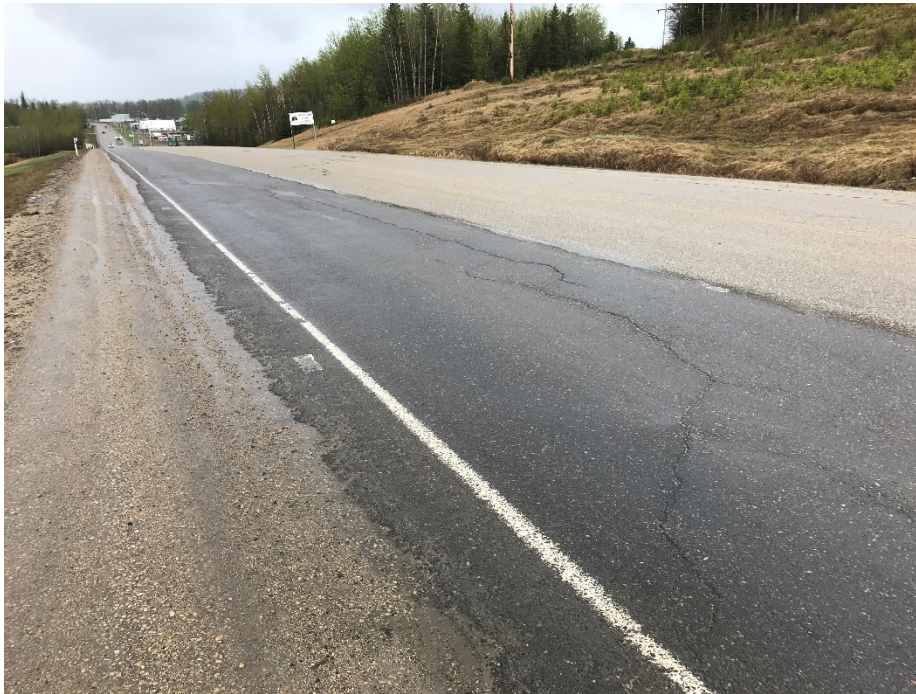
Discussion	<p><u>Power Line Site:</u></p> <p>The westbound lane was overlaid in 2017 and patched again in 2018. The pavement crack observed in 2017 at about Station 34+875 has reflected through the new patch as shown in Photo 1. Currently, the crack is up to 10 mm wide with no vertical differential. Two new circular pavement cracks up to 10 mm wide were observed reflecting through the new patch at about Station 34+900 and 34+850 as shown in Photos 2 and 3, respectively.</p> <p>The scarp at approximately Station 34+700 appeared to have a larger toe bulge than in previous years as shown in Photo 4.</p> <p>Slope movement in the backscarp from approximately Station 34+750 to 34+950 is ongoing. Previously observed ground cracks appeared larger than the previous inspection with evidence of fresh cracks as shown in Photo 5. This may be contributing to further leaning of the “photo radar” sign in the south ditch as shown in Photo 6. The toe bulge at the base of the slide was about 1.2 m high and encroached further into the drainage ditch to the point of contact with the sign as shown in Photo 7.</p> <p>No change was observed to the leaning power pole north of the highway. Both power poles were measured to have a 2° lean towards the east.</p> <p>A new erosion gully east of the power line near Station 35+000 was observed as shown in Photo 8. The erosion gully was measured to be about 30 m long, 2 m wide, and 0.6 m deep.</p> <p>Toe bulging continues to be progressing into the south ditch as shown in Photo 9. Wet/saturated ground was observed in the ditch.</p> <p><u>Main Slide (Berm) Site:</u></p> <p>The upper and lower toe berms appear unchanged since the previous inspection. The overall views of the upper and lower toe berms are shown in Photos 10 and 11, respectively.</p> <p>The culvert outlet at approximately Station 34+475 was observed to be flowing as shown in Photo 12. Immediately upslope and southwest of the culvert outlet, a vegetated gully about 200 mm high was observed as shown in Photo 13. Approximately midway upslope from the culvert a sinkhole feature was observed along the culvert alignment as shown in Photos 14 and 15. The sinkhole was measured to be about 6 m wide and 2 m deep with a gully-like feature leading downslope. The sinkhole appeared to have increased in size towards the south compared to the 2018 inspection.</p> <p>A series of erosion gullies were observed west of about Station 34+400. The deepest gullies were approximately 1 m deep as shown in Photo 16.</p>

Photo 1: Circular cracks reflecting through 2018 patch. Cracks about 10 mm wide. Looking east.

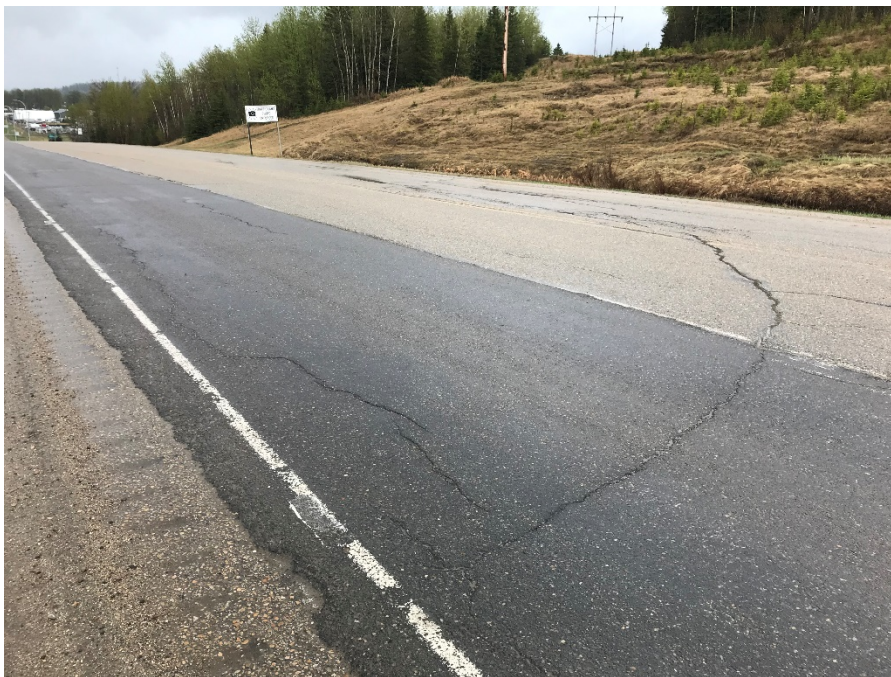
Photo 2: New circular crack up to 10 mm wide reflecting through 2018 patch at about Sta 34900. Looking southeast.

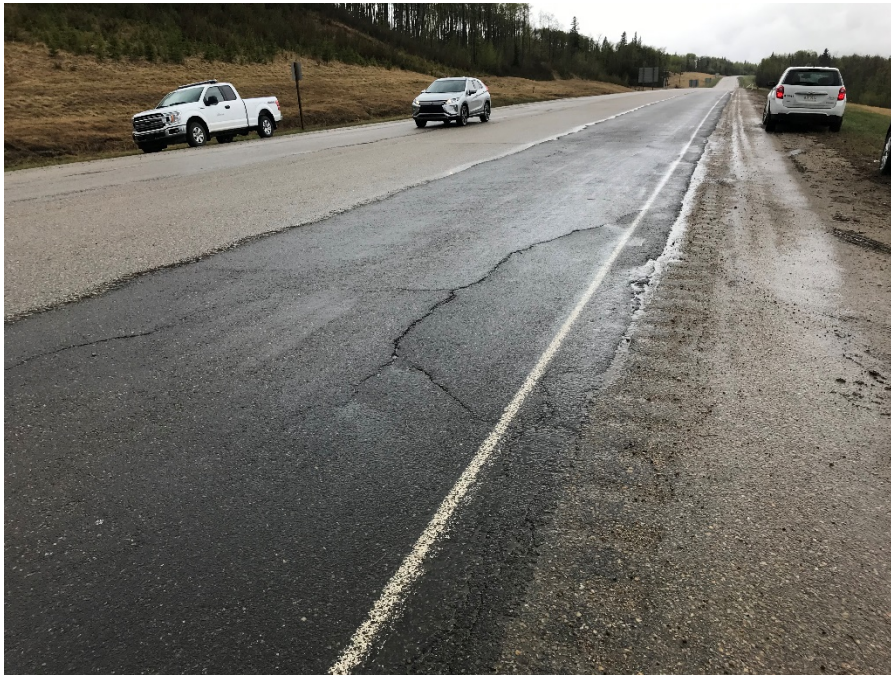
Photo 3: New circular crack up to 10 mm wide reflecting through 2018 patch. Looking west.

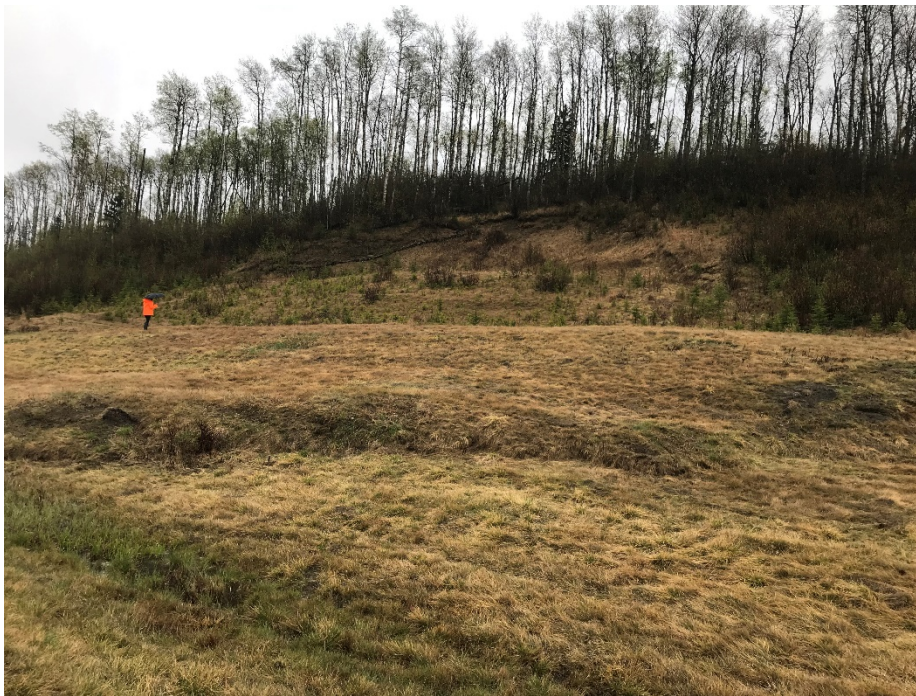
Photo 4: Scarp south of the highway at approximately Sta 34+700. Increased toe bulging. Looking south.

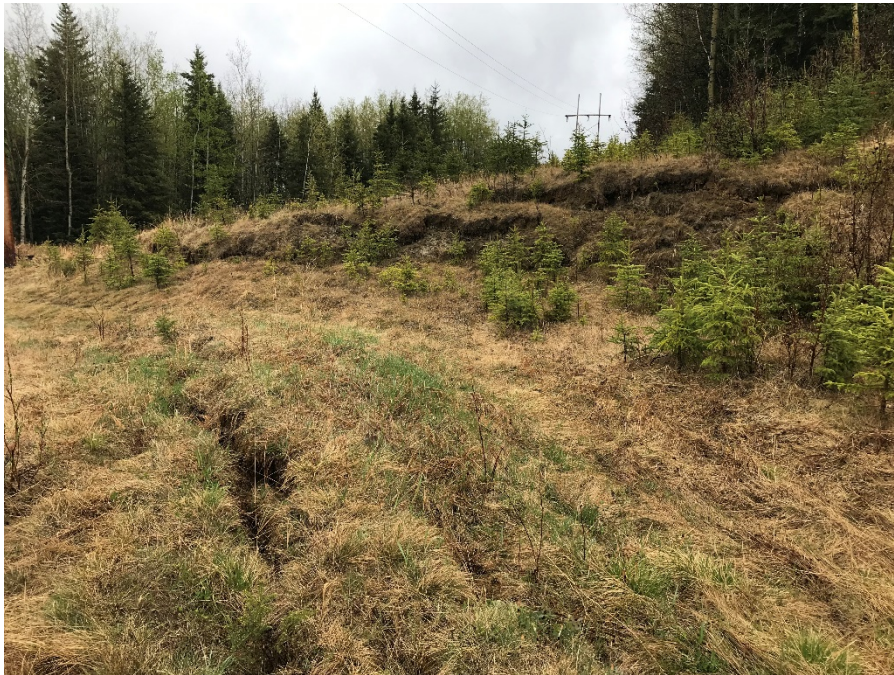
Photo 5: Fresh scarps with larger ground cracks west of the power pole south of the highway. Looking southeast.

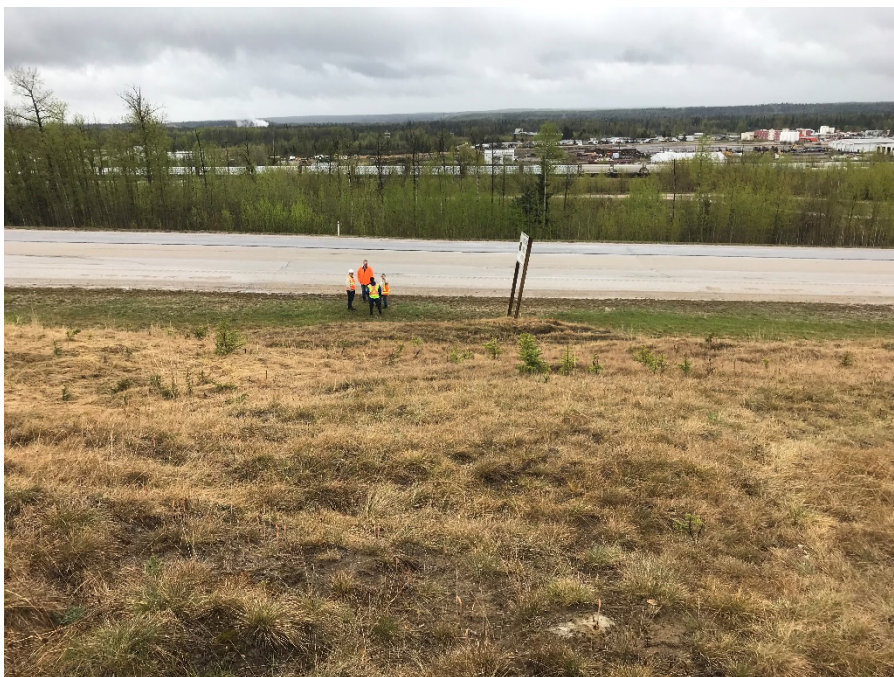
Photo 6: Leaning "Photo Radar" sign at power line site. Appears to be leaning more than previous inspection. Looking north.

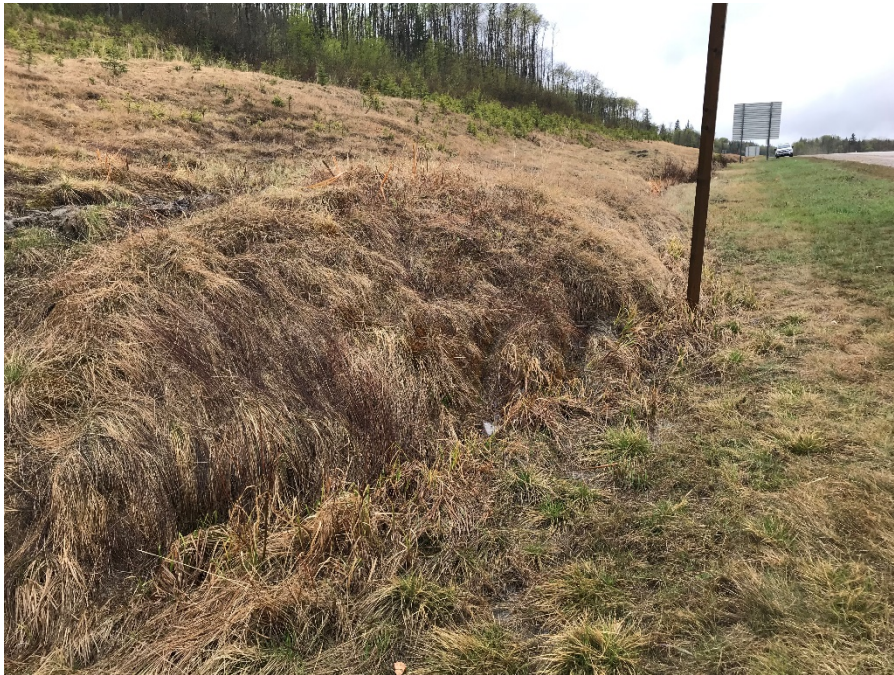
Photo 7: Toe bulge encroaching onto south ditch and sign post at Photo 6. Looking west.

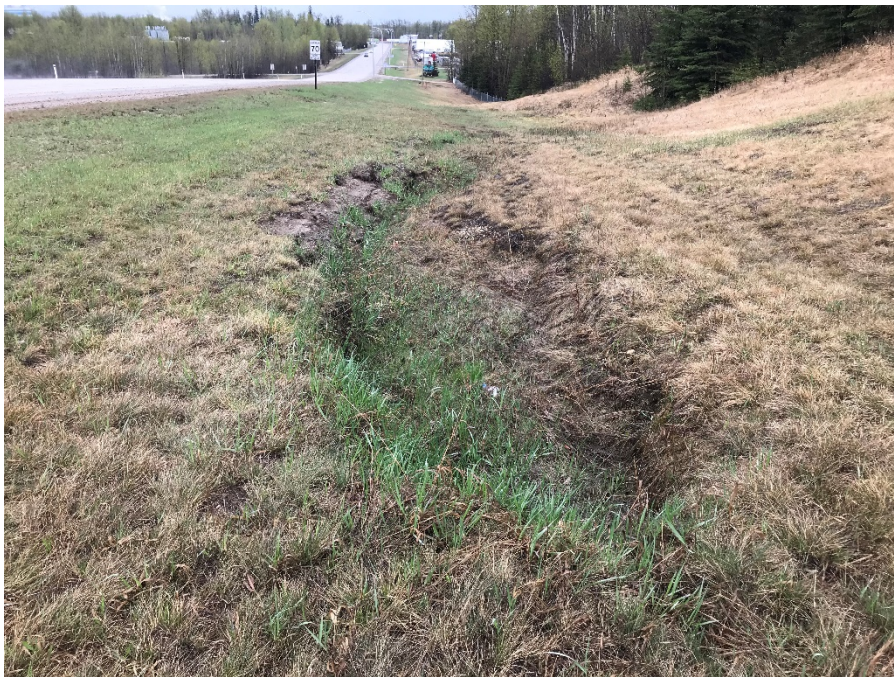
Photo 8: Erosion gully east of sign in Photo 6. Looking east.

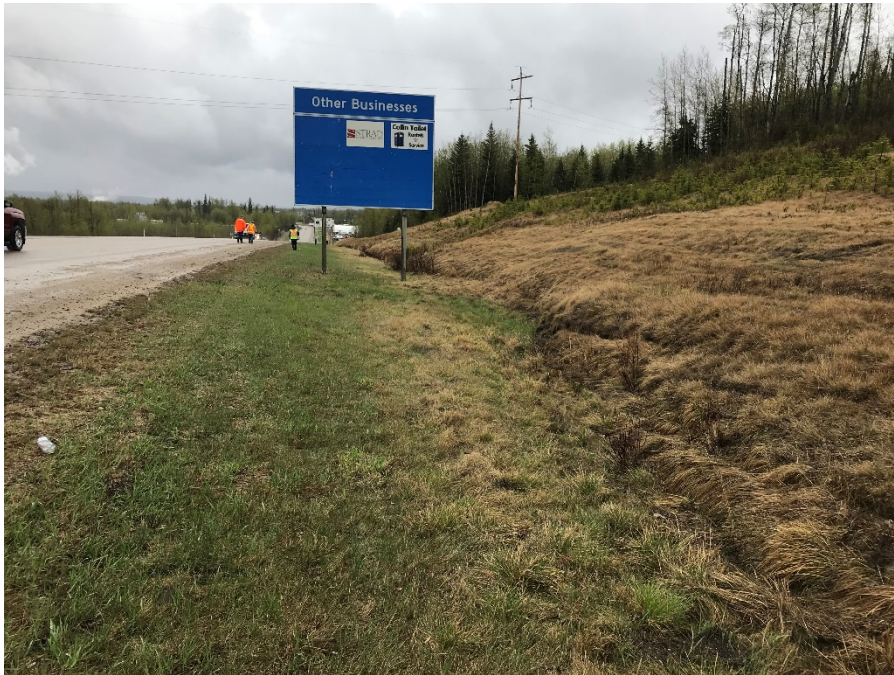
Photo 9: Toe bulging at "other businesses" sign. Looking east.

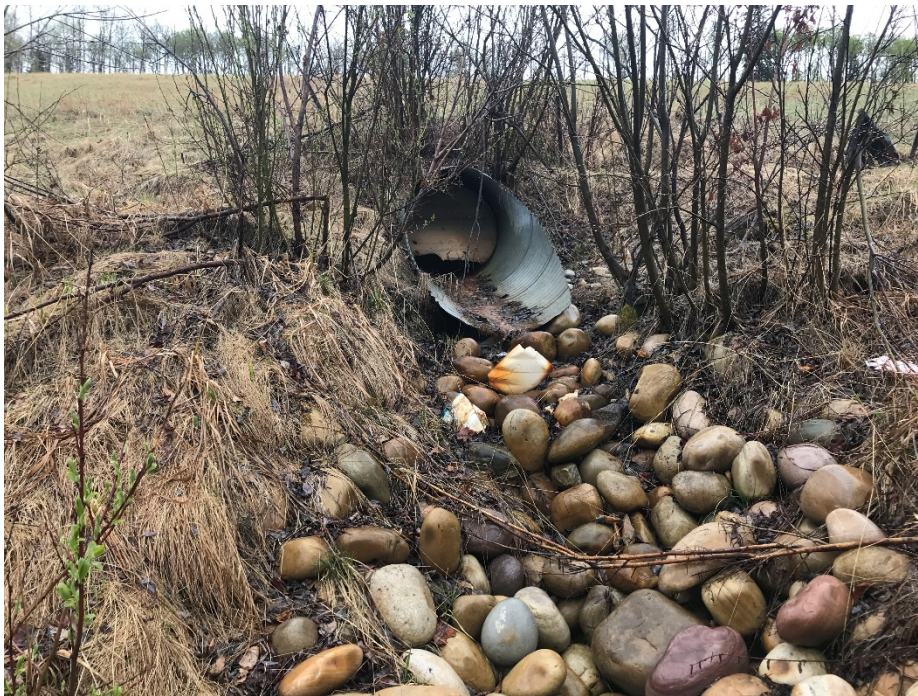
Photo 12: Culvert outlet adjacent to west extents of upper toe berm. Slumping immediately upslope of culvert. Looking south.

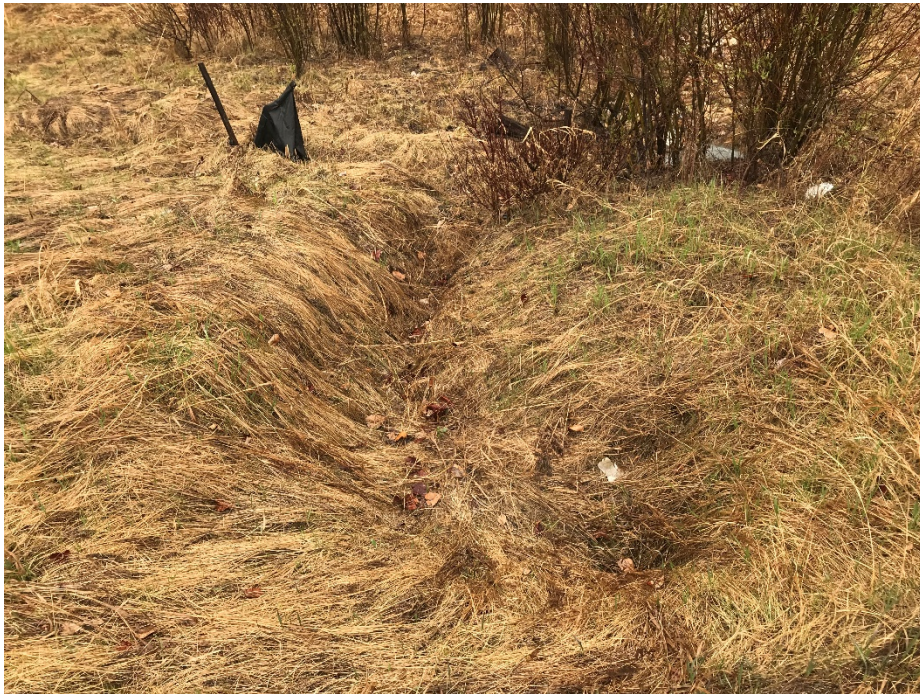
Photo 13: Vegetated gully immediately upslope of culvert in Photo 12. Looking north.

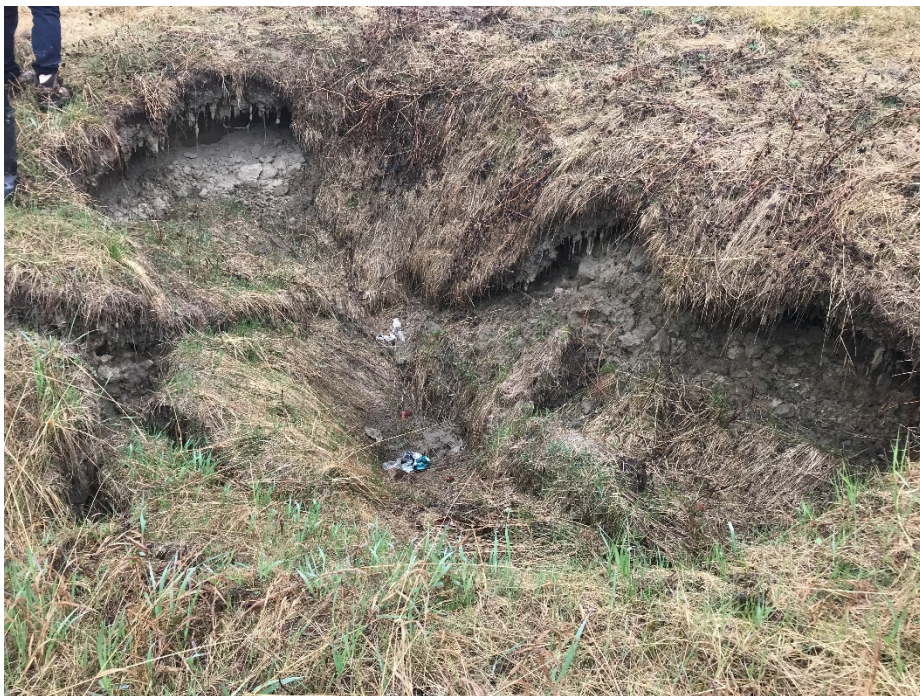
Photo 14: Slump/sinkhole along culvert alignment further upslope of culvert in Photo 12 and 13. Approximately 6 m wide by 2 m deep. Looking south.

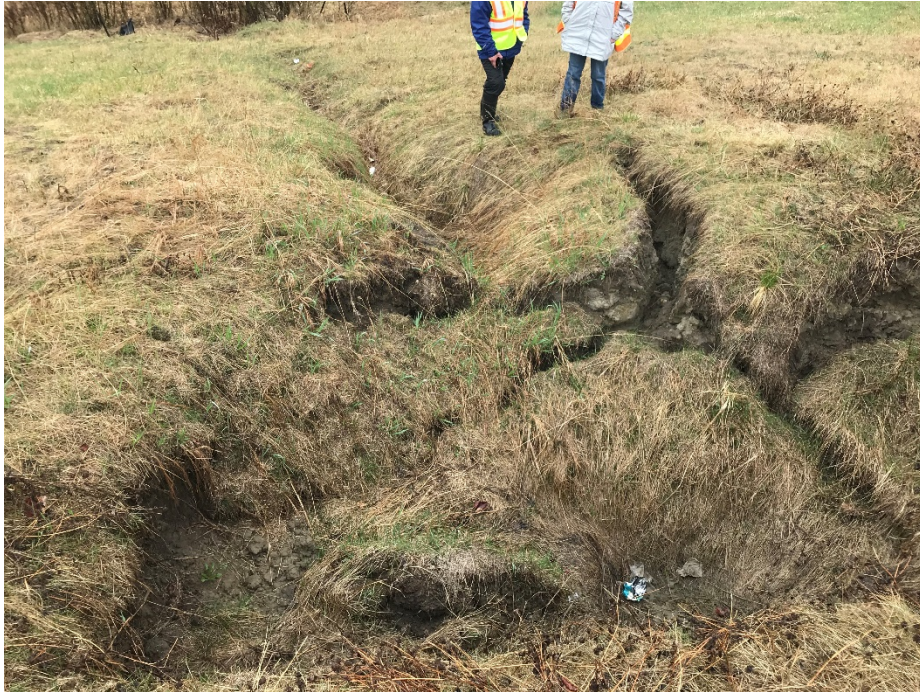
Photo 15: Erosion gully leading from sinkhole in Photo 14. Looking north.

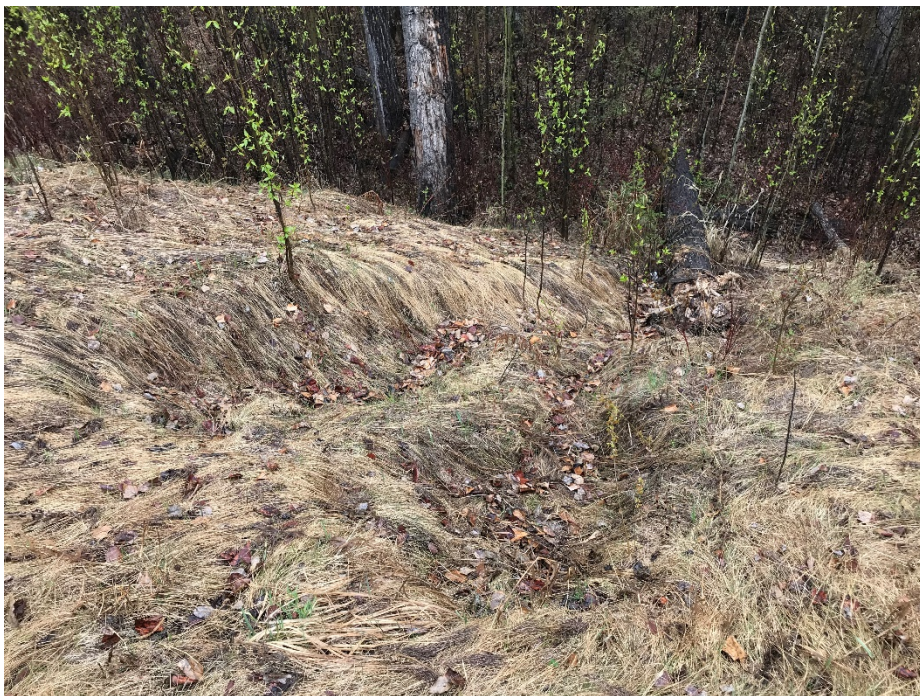
Photo 16: One of a series of about 10 slump/erosion features about 150 m west of Photo 12 at toe of slope. Looking north.

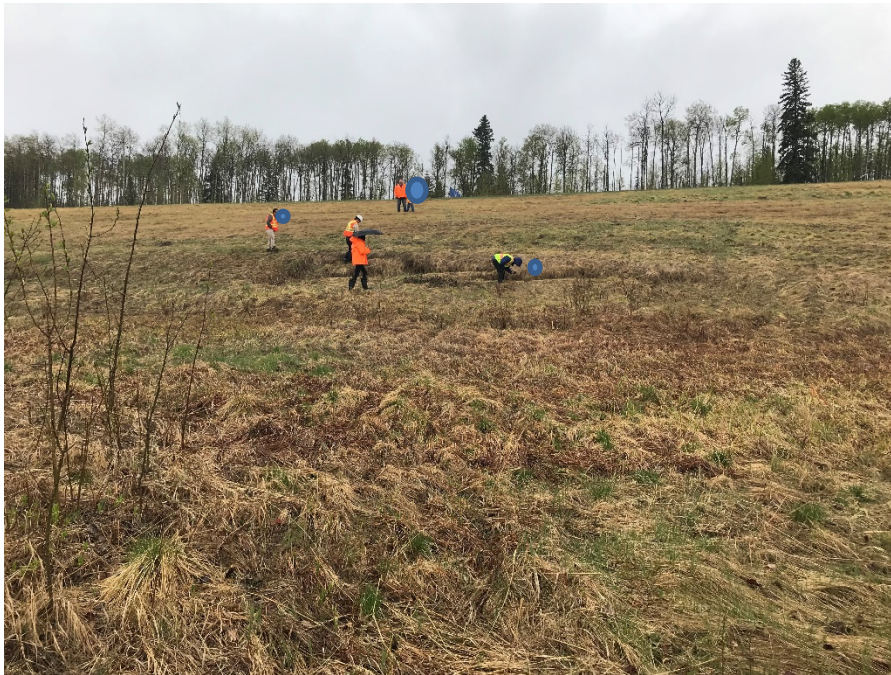
<p>Scarps up to about 1 m high were observed about 40 m west of the culvert outlet at Station 34 475 as shown in Photo 17. This scarp appears unchanged from previous inspection.</p> <p>The westbound lane was recently patched near S110-6 with no pavement cracks observed as shown in Photo 18.</p>
--	---

Photo 17: Tension crack/slump about 40 m west of Photo 12. Scarp about 1 m high. Looking south.

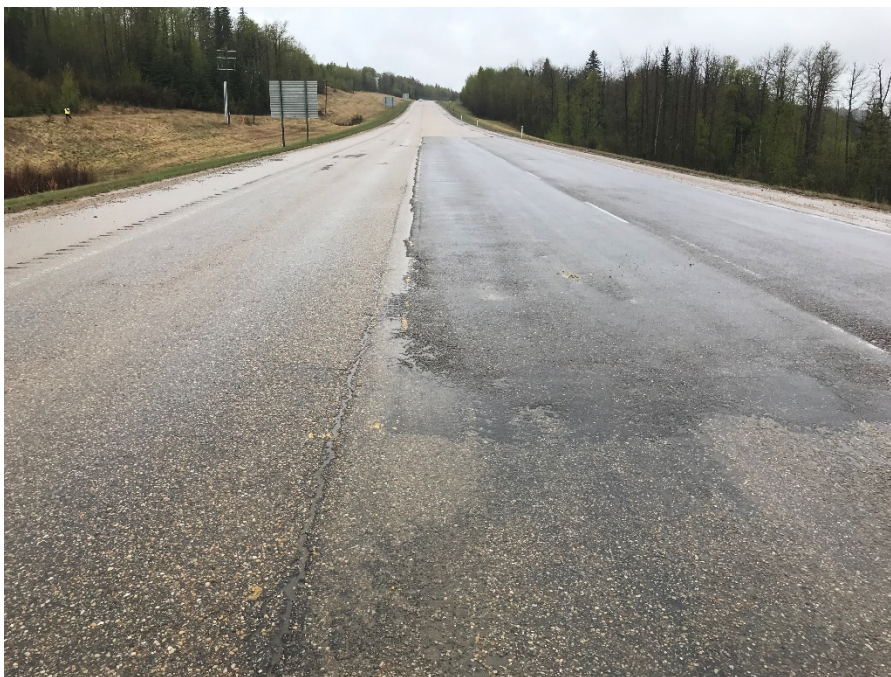
Photo 18: New patch on westbound lane at main slide site near S110-6. No cracks observed. Looking west.
