GEOHAZARD RISK MANAGEMENT PROGRAM

North Central Region – Edson / Stony Plain Area

2020 Inspection Report

Site Number	Site Name		Hwy	km
NC37	South of Whitecourt		32:10	34.6
Legal Land Description	NW 27-59-12-W5M			
UTM Coordinates (NAD 83)	Zone 11U	N5999427	E583507	
Operational Site Instrumentation	Slope Inclinometers (SI)		8	
	Pneumatic Piezometers		4	
	Vibrating Wire Piezometers		4	
	Standpipe Piezometers		4	
Date of Last Instrumentation Readings	May 22, 2020

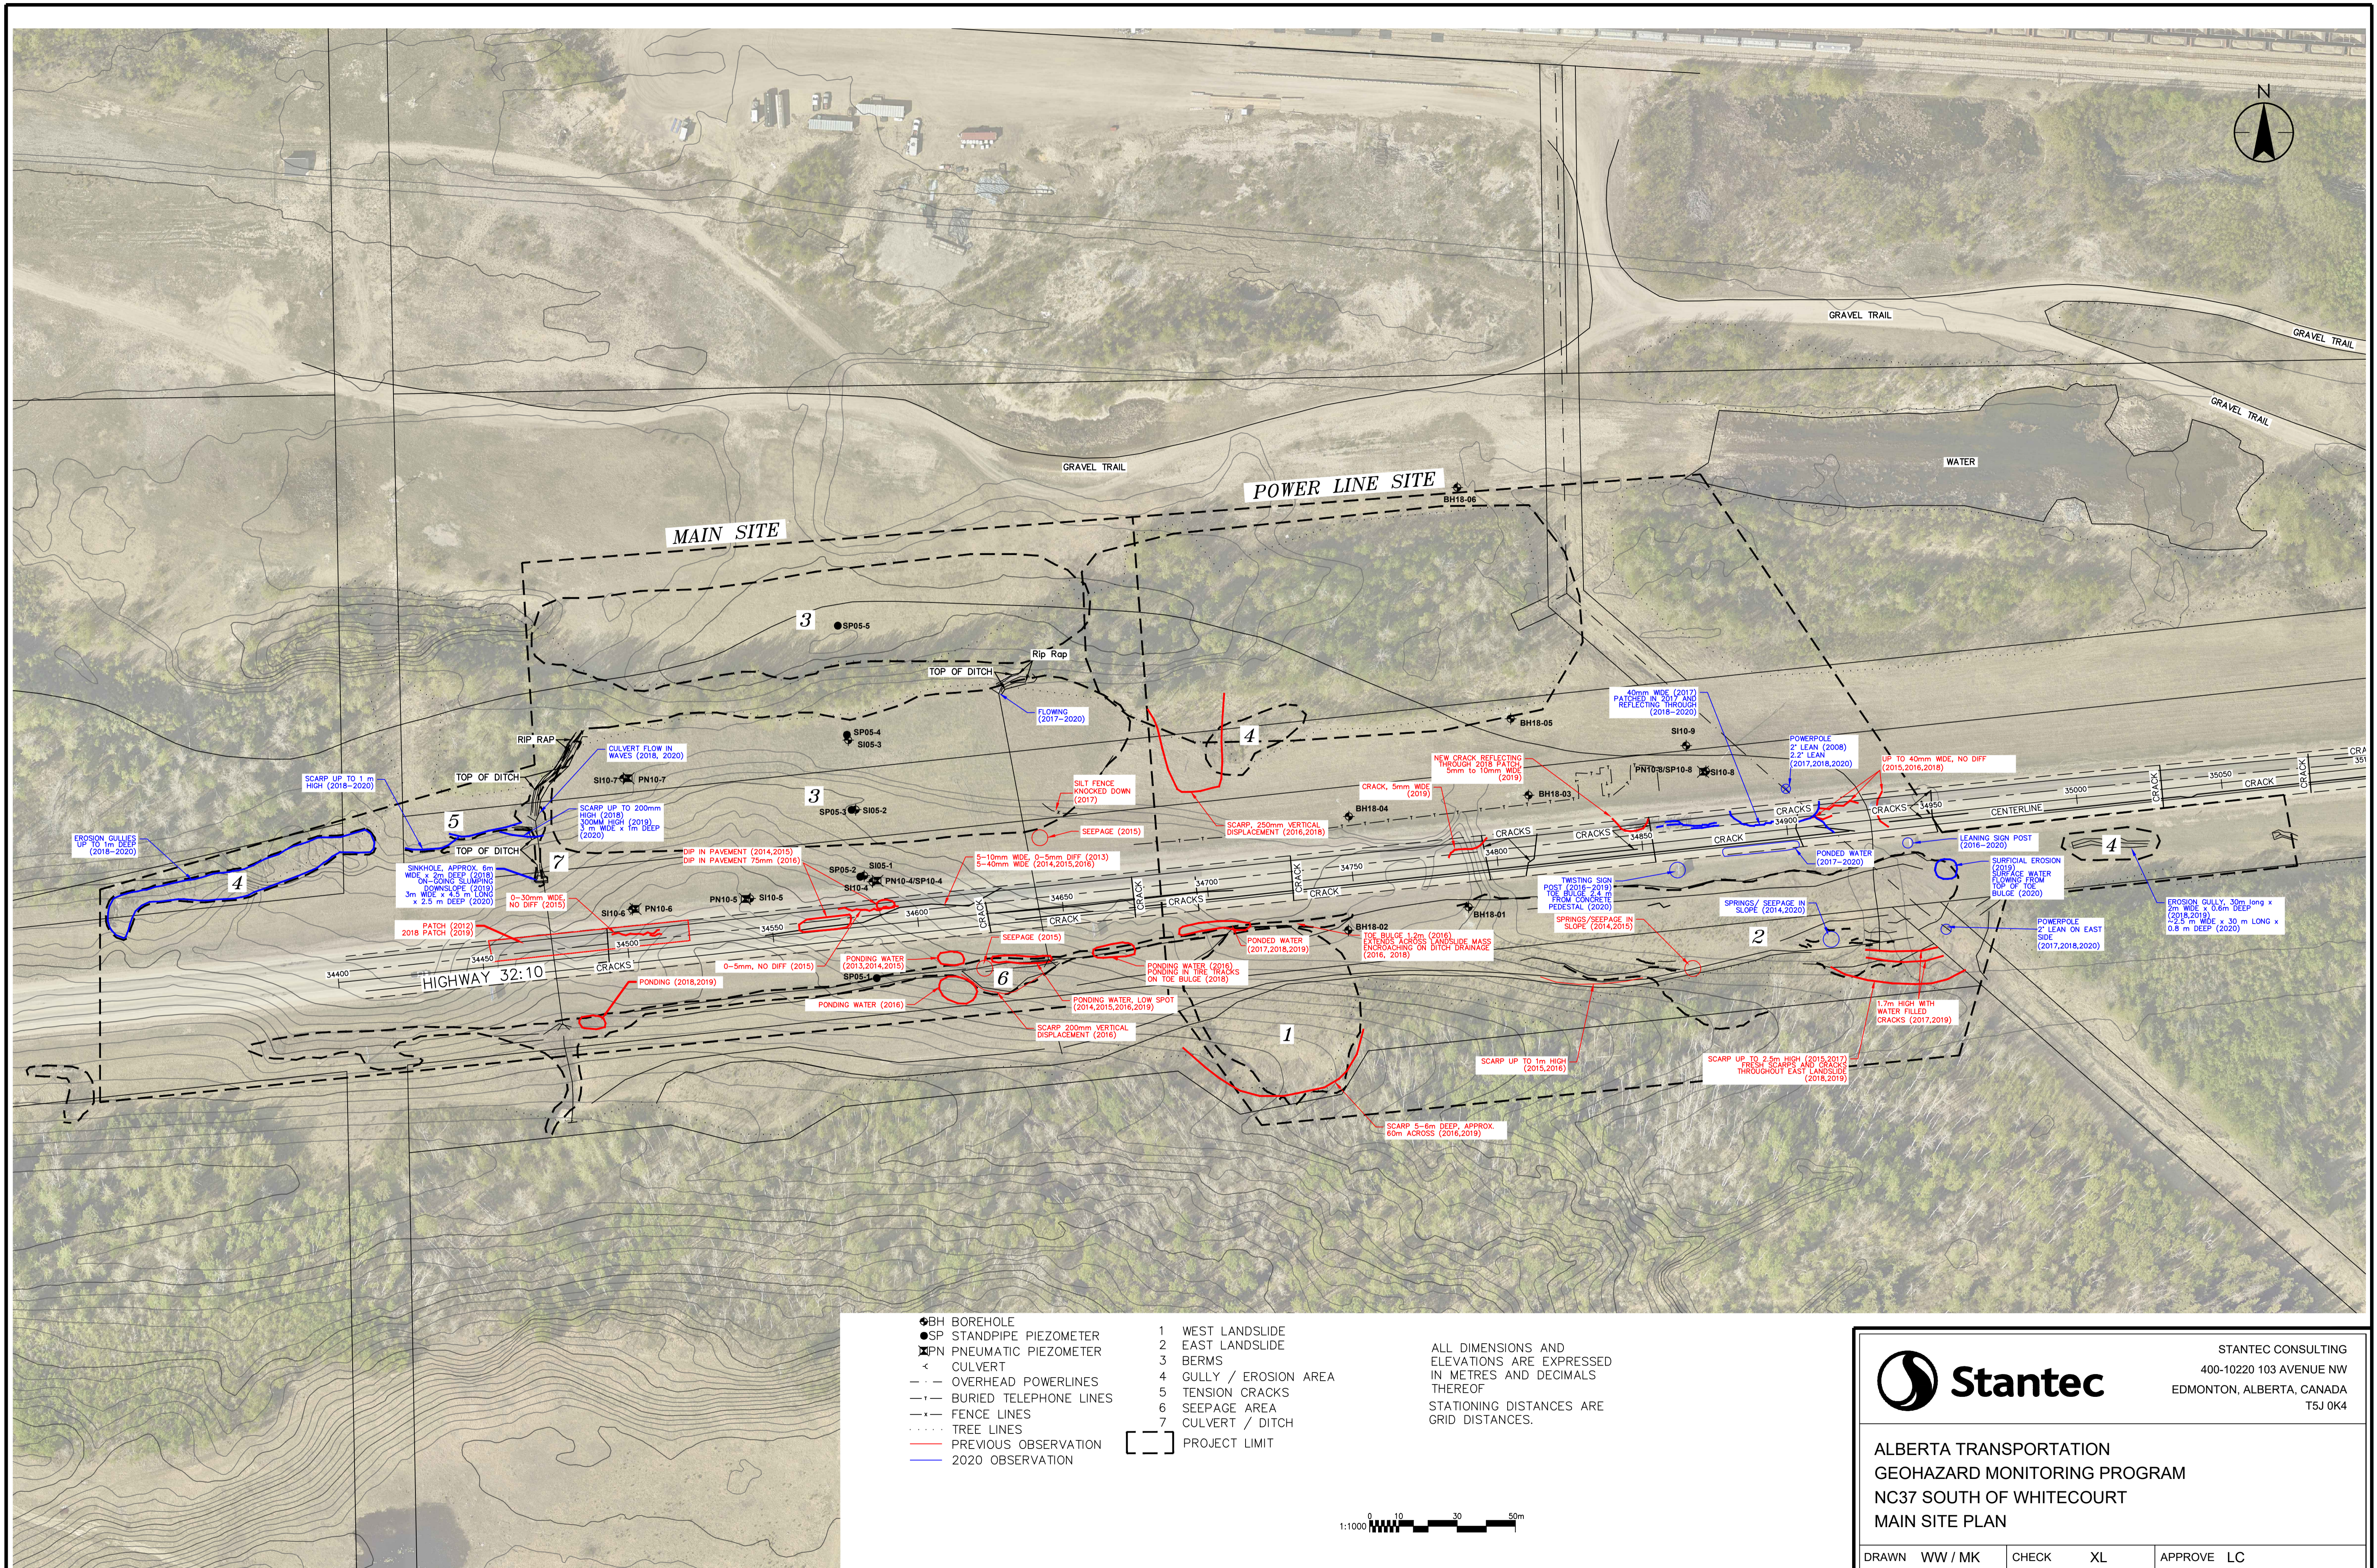
FIGURE -1

**ALBERTA TRANSPORTATION
GEOHAZARD MONITORING PROGRAM
NC37 SOUTH OF WHITECOURT
MAIN SITE PLAN**

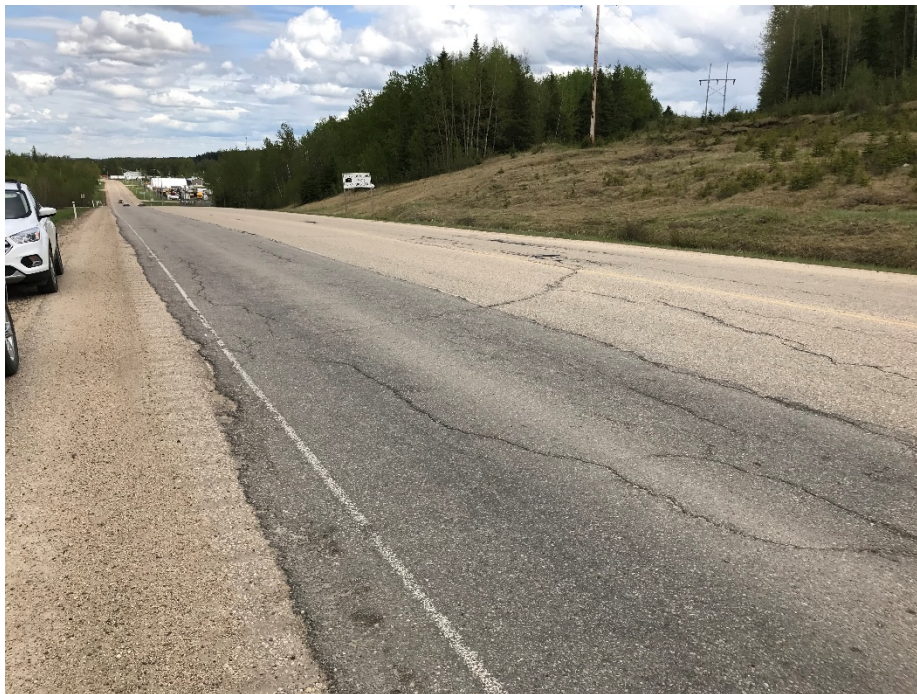
Photo 1: Circular crack observed in 2018 directly under powerline. Looking east.

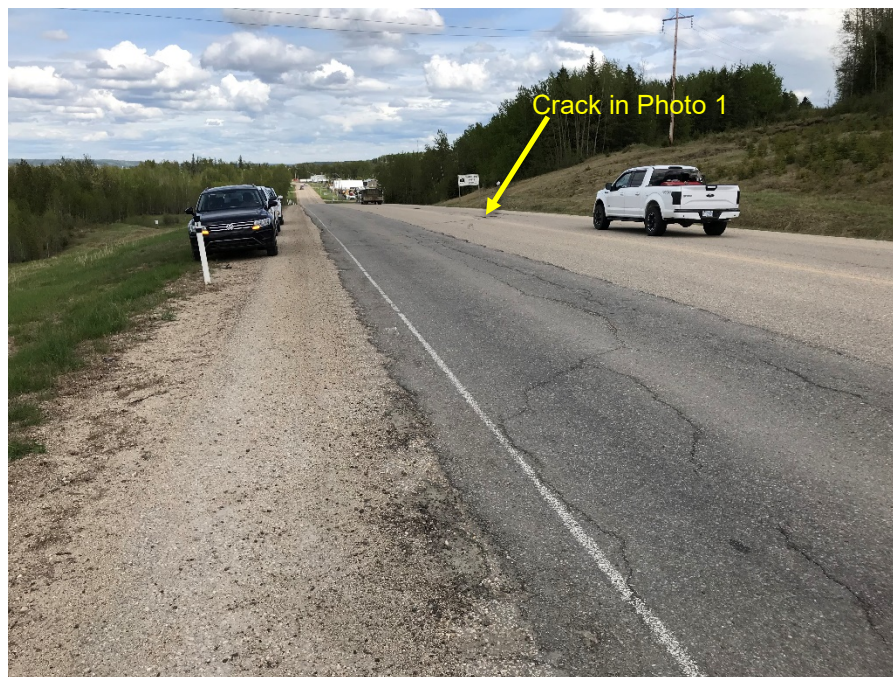
Photo 2: Pavement cracking at about Sta 34875 Looking east.

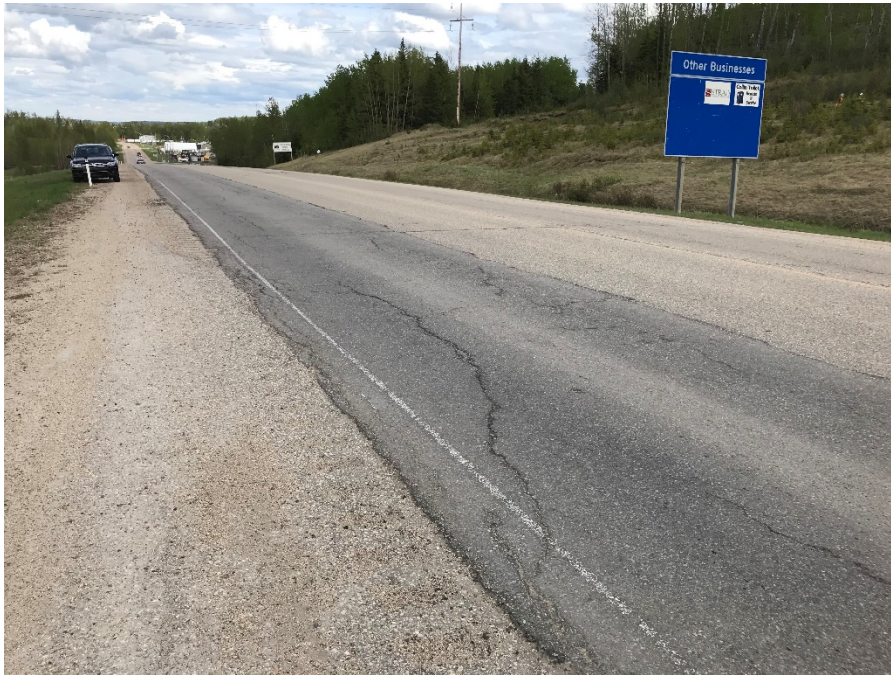
Photo 3: Pavement cracking at about Sta 34+850. Looking east.

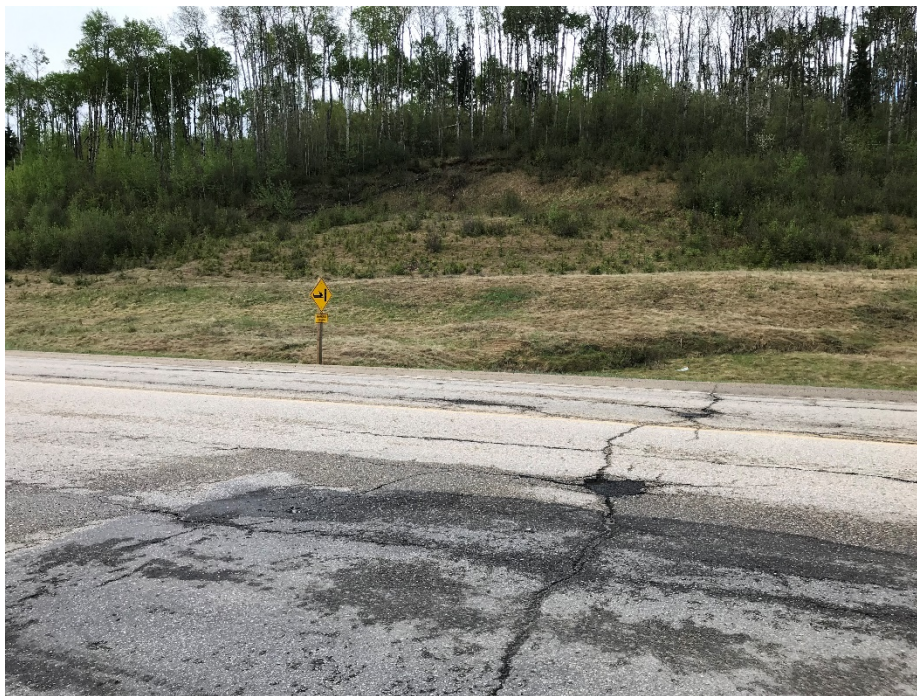
Photo 4: Scarp south of the highway at approximately Sta 34+700. Looking south.

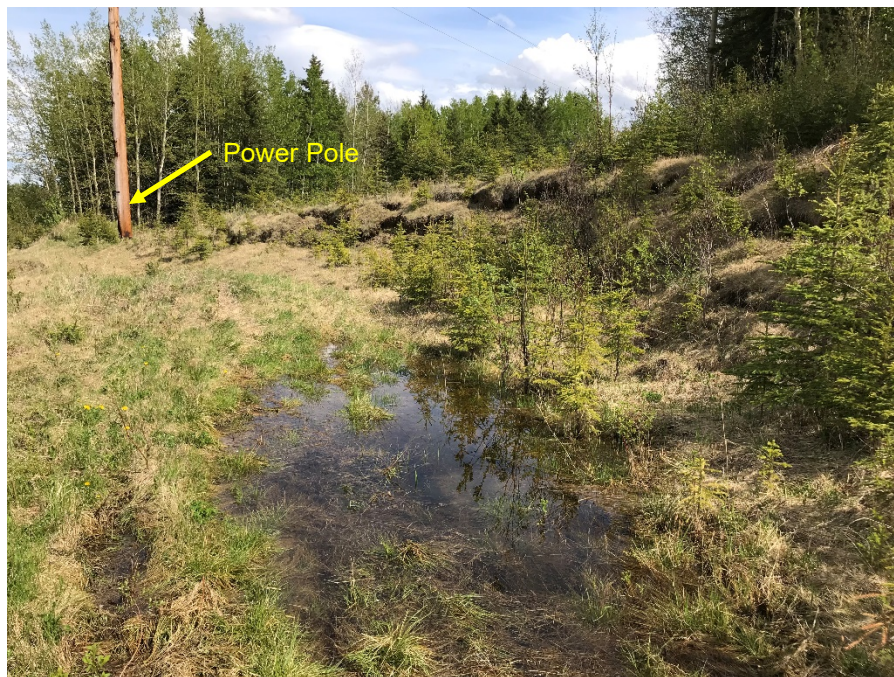
Photo 5: Fresh scarps and slumping on backslope. Ponding along base of scarp. Looking east.

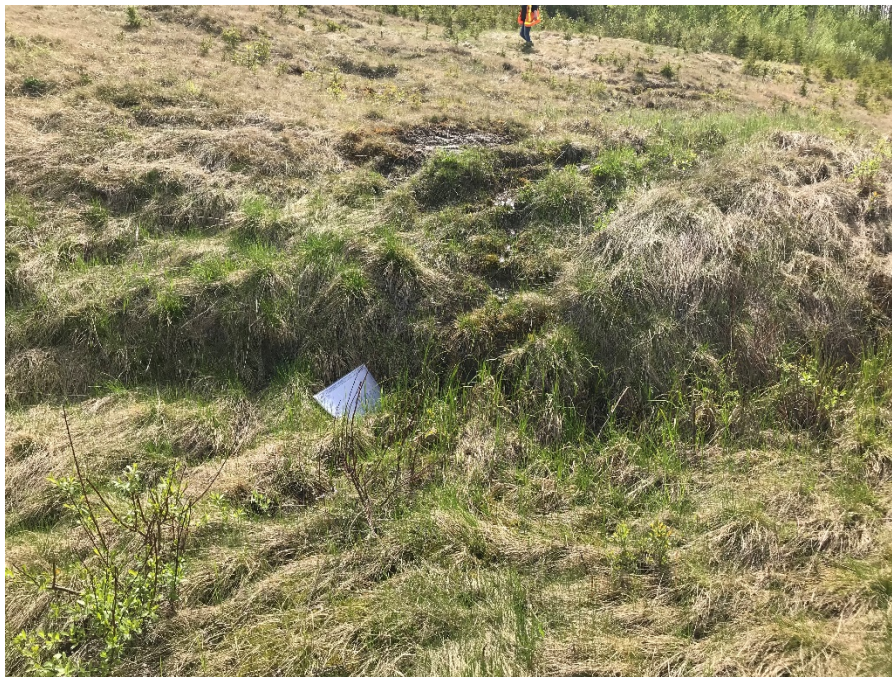
Photo 6: Potential spring or seepage with water flowing from top of toe bulge southeast of photoradar sign. Looking west.

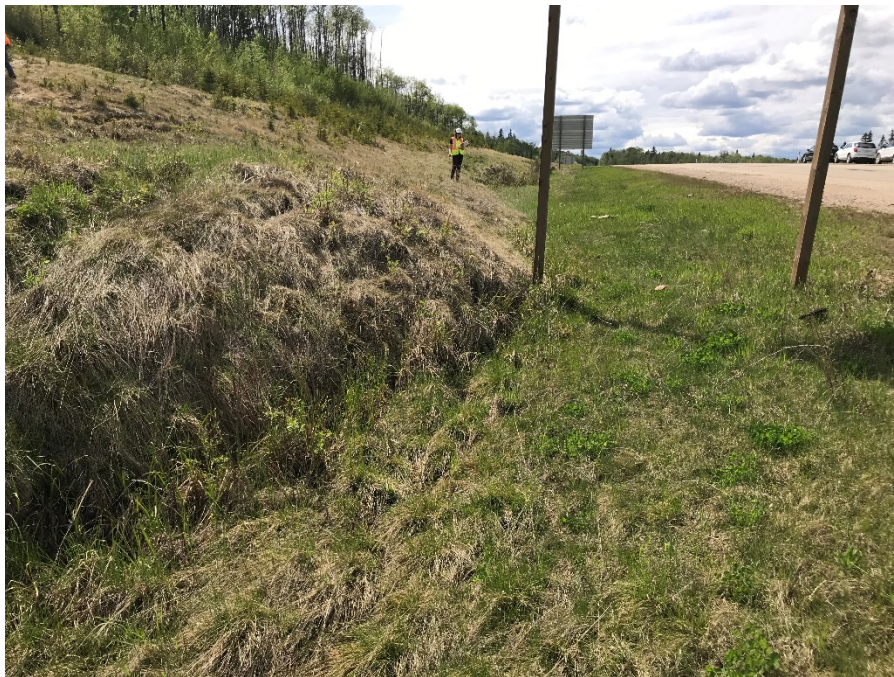
Photo 7: Toe bulge encroaching onto south ditch and signpost. Looking west.

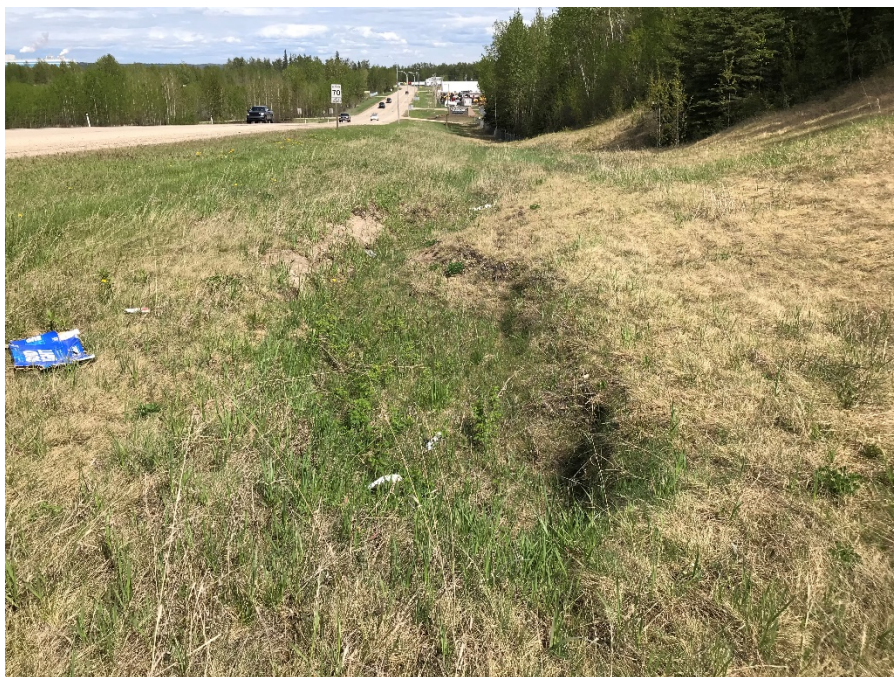
Photo 8: Erosion gully east of sign in Photo 6. Looking east.

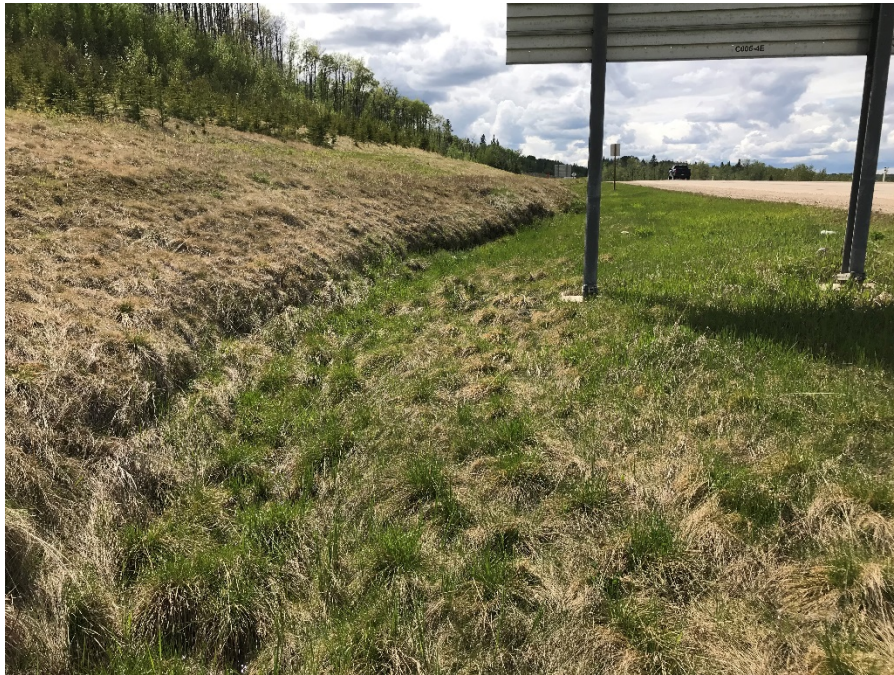
Photo 9: Toe bulging at "other businesses" sign. Looking east.

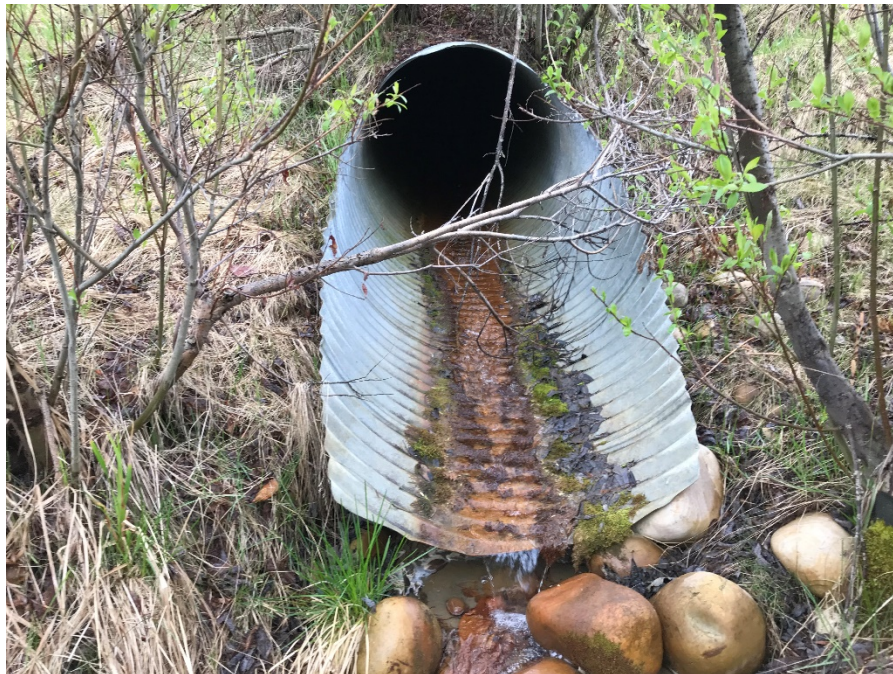
Photo 10: Culvert outlet adjacent to west extents of upper toe berm. Slumping immediately upslope of culvert. Looking south.

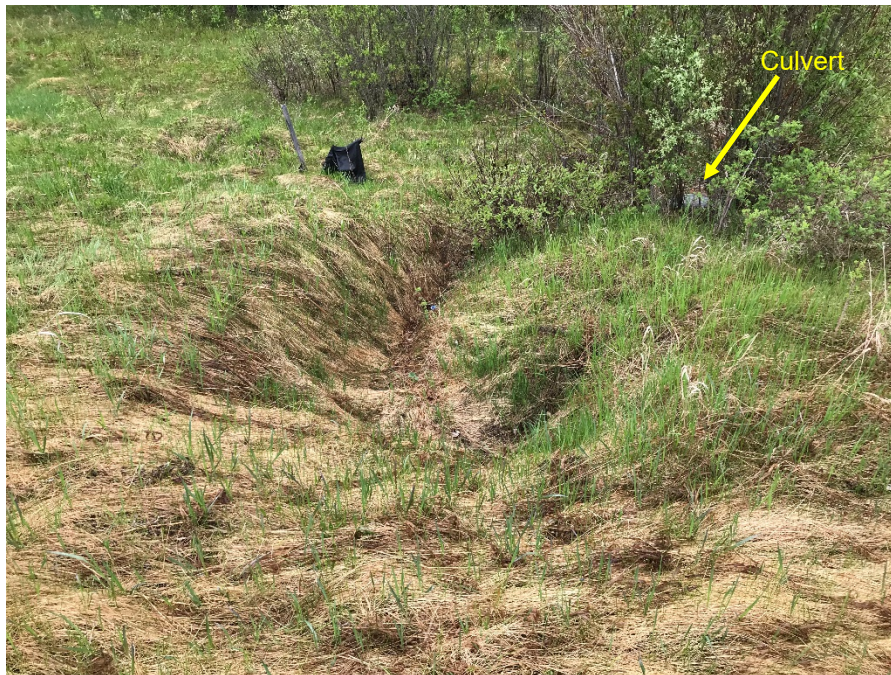
Photo 11: Vegetated gully immediately upslope of culvert in Photo 10. Looking north.

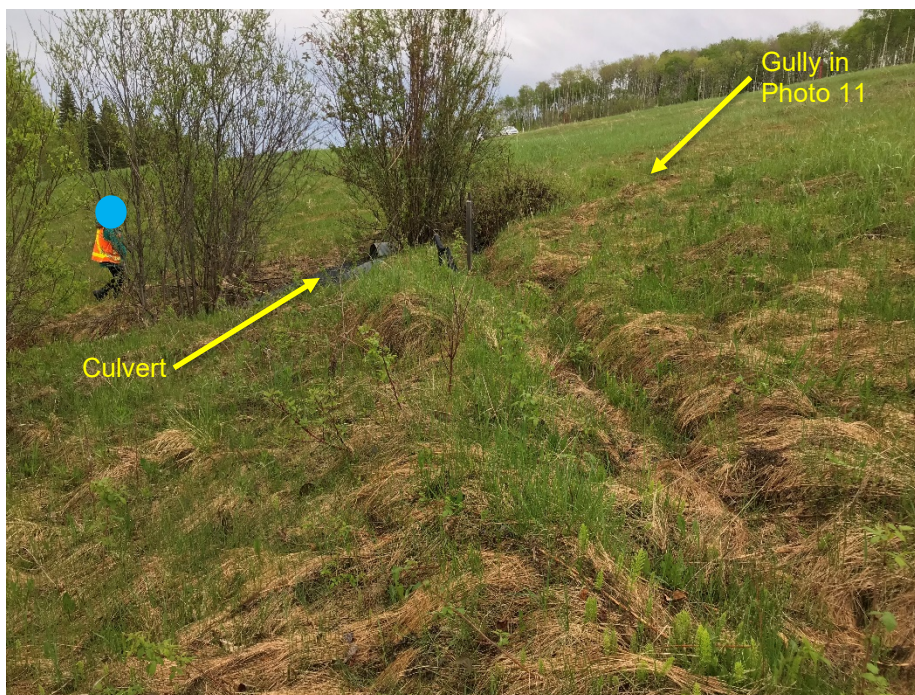
Photo 12: Small scarp west of culvert. Looking east.

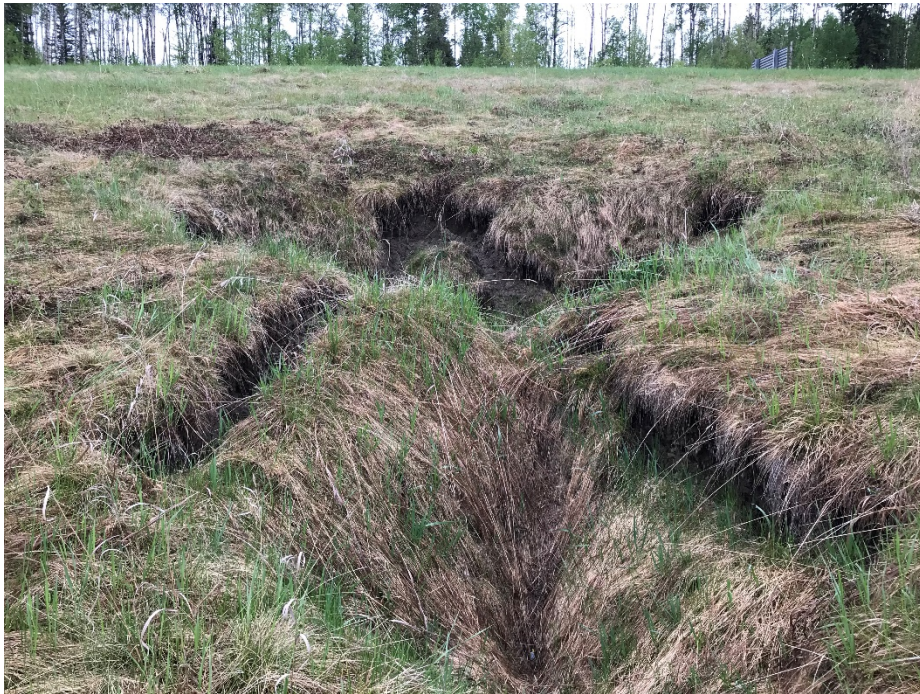
Photo 13: Slump/sinkhole along culvert alignment further upslope of culvert from Photos 10 and 11. Looking south.

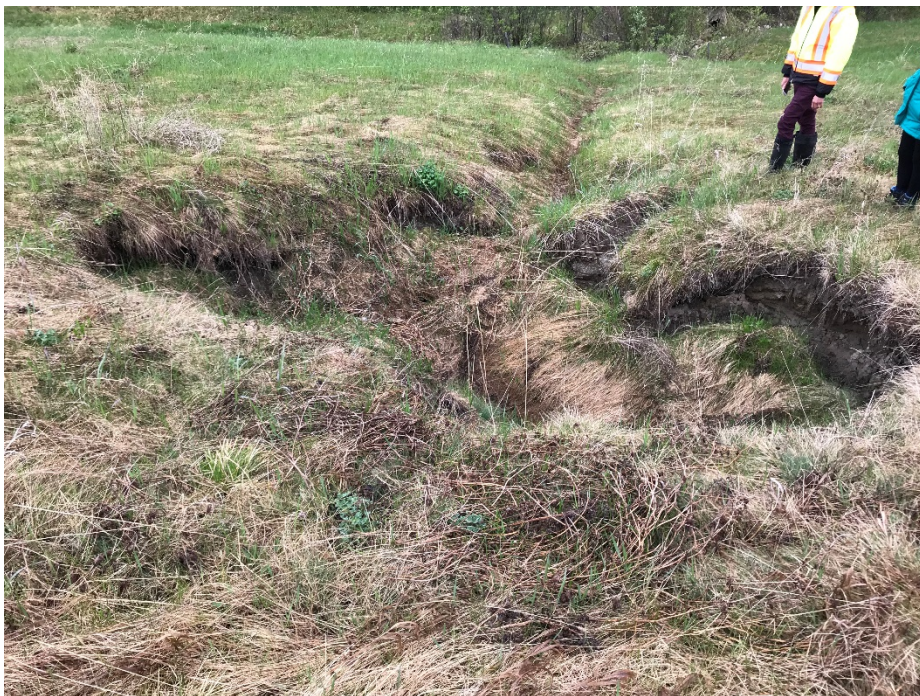
Photo 14: Erosion gully leading from sinkhole in Photo 12. Looking north.

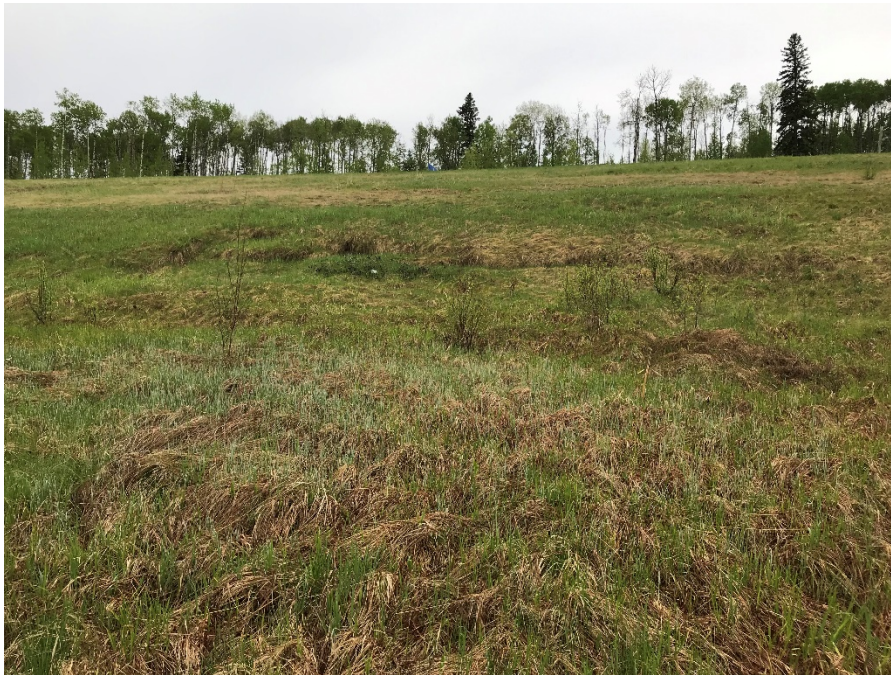
Photo 15: Tension crack/slump about 40 m west of Photo 12. Scarp up to about 1 m high. Looking south.

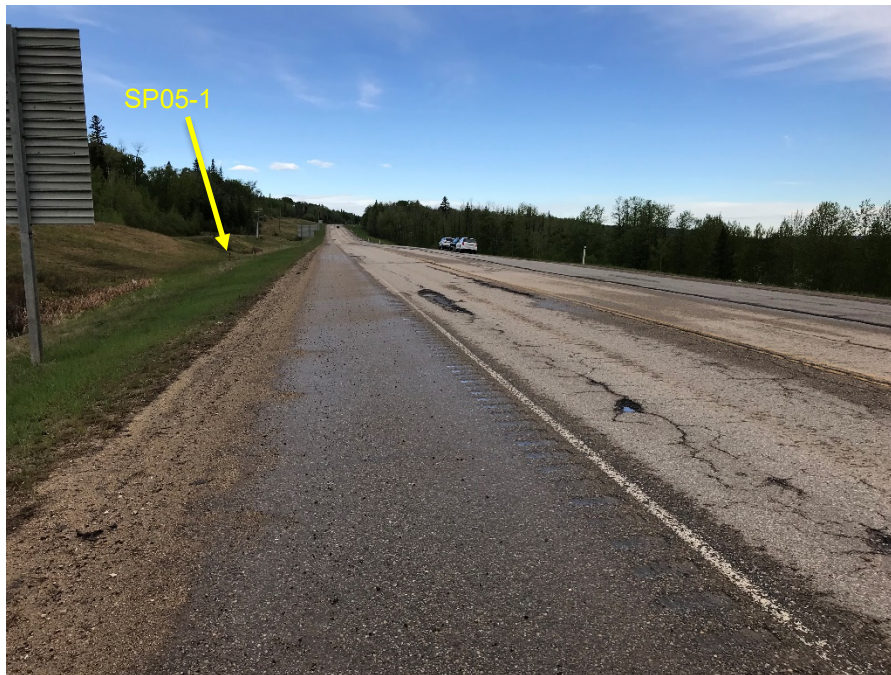
Discussion	<p><u>Power Line Site:</u></p> <p>The westbound lane was overlaid in 2017 and patched again in 2018. Similar pavement cracking patterns were observed again during the 2018 annual inspection and does not appear to have changed significantly since. Generally, the pavement cracks were up to 10 mm wide with no vertical differential. The pavement is shown in Photos 1 to 3.</p> <p>The scarp at approximately Station 34+700 appeared to be unchanged from 2019 and is shown in Photo 4.</p> <p>Slope movement in the backscarp from approximately Station 34+750 to 34+950 is ongoing with indication of fresh scarps, especially closer to the powerline as shown in Photo 5. Localized ponding along the base of the scarps was also observed. Potential seepage zones were observed within the toe bulge as shown in Photo 6. The toe bulge at the base of the slide was about 1.2 m high and encroached further into the drainage ditch to the point of contact with the sign as shown in Photo 7.</p> <p>No change was observed to the leaning power pole north of the highway. Both power poles were measured to have a 2° lean towards the east.</p> <p>The erosion gully east of the power line near Station 35+000 increased in size to about 2.5 m wide by 30 m long by 0.8 m deep as shown in Photo 8.</p> <p>Toe bulging continues to be progressing into the south ditch as shown in Photo 9. Wet/saturated ground was observed in the ditch.</p> <p><u>Main Slide (Berm) Site:</u></p> <p>The upper and lower toe berms appear unchanged since the previous inspection.</p> <p>The west culvert outlet at approximately Station 34475 was observed to be flowing as shown in Photo 10. Water flow was again coming out in waves as documented during the 2018 inspection. Immediately upslope and southwest of the culvert outlet, the vegetated gully has grown to approximately 1 m deep as shown in Photo 11. A small scarp about 300 mm high was also observed west of the culvert outlet as shown in Photo 12. Approximately midway upslope from the culvert a sinkhole feature was observed along the culvert alignment as shown in Photos 13 and 14. The sinkhole appeared to have increased in size towards the north compared to the 2019 inspection.</p> <p>Scarps up to about 1 m high were observed about 40 m west of the culvert outlet at Station 34+475 as shown in Photo 15. This scarp appears unchanged from previous inspection.</p> <p>Longitudinal cracking and along with minor potholes were observed along Highway 32 as shown in Photos 16 to 18.</p>

Photo 17: Highway condition at about Sta 34+675. Looking west.

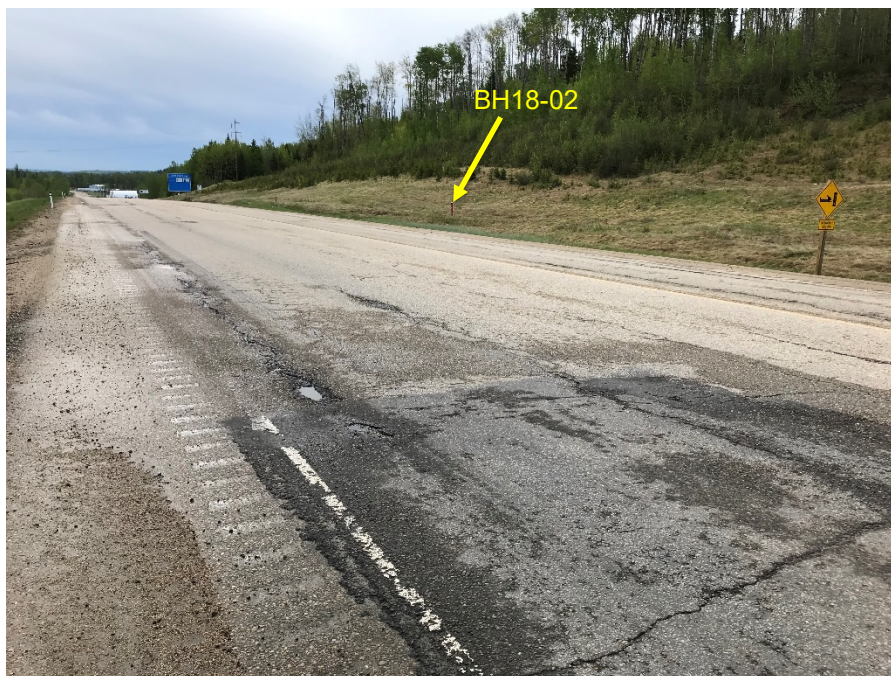
Photo 18: Pavement distress at about Sta 34+700. Looking east.
