To: Amy Driessen
Alberta Transportation
File: 123315222

From: Leslie Cho and Carrie Murray
Stantec Consulting Ltd.
Date: June 12, 2022

Reference: North Central Region, Edson, Site NC037 - Highway 32:10 South of Whitecourt, Spring 2022 Instrumentation Monitoring Report

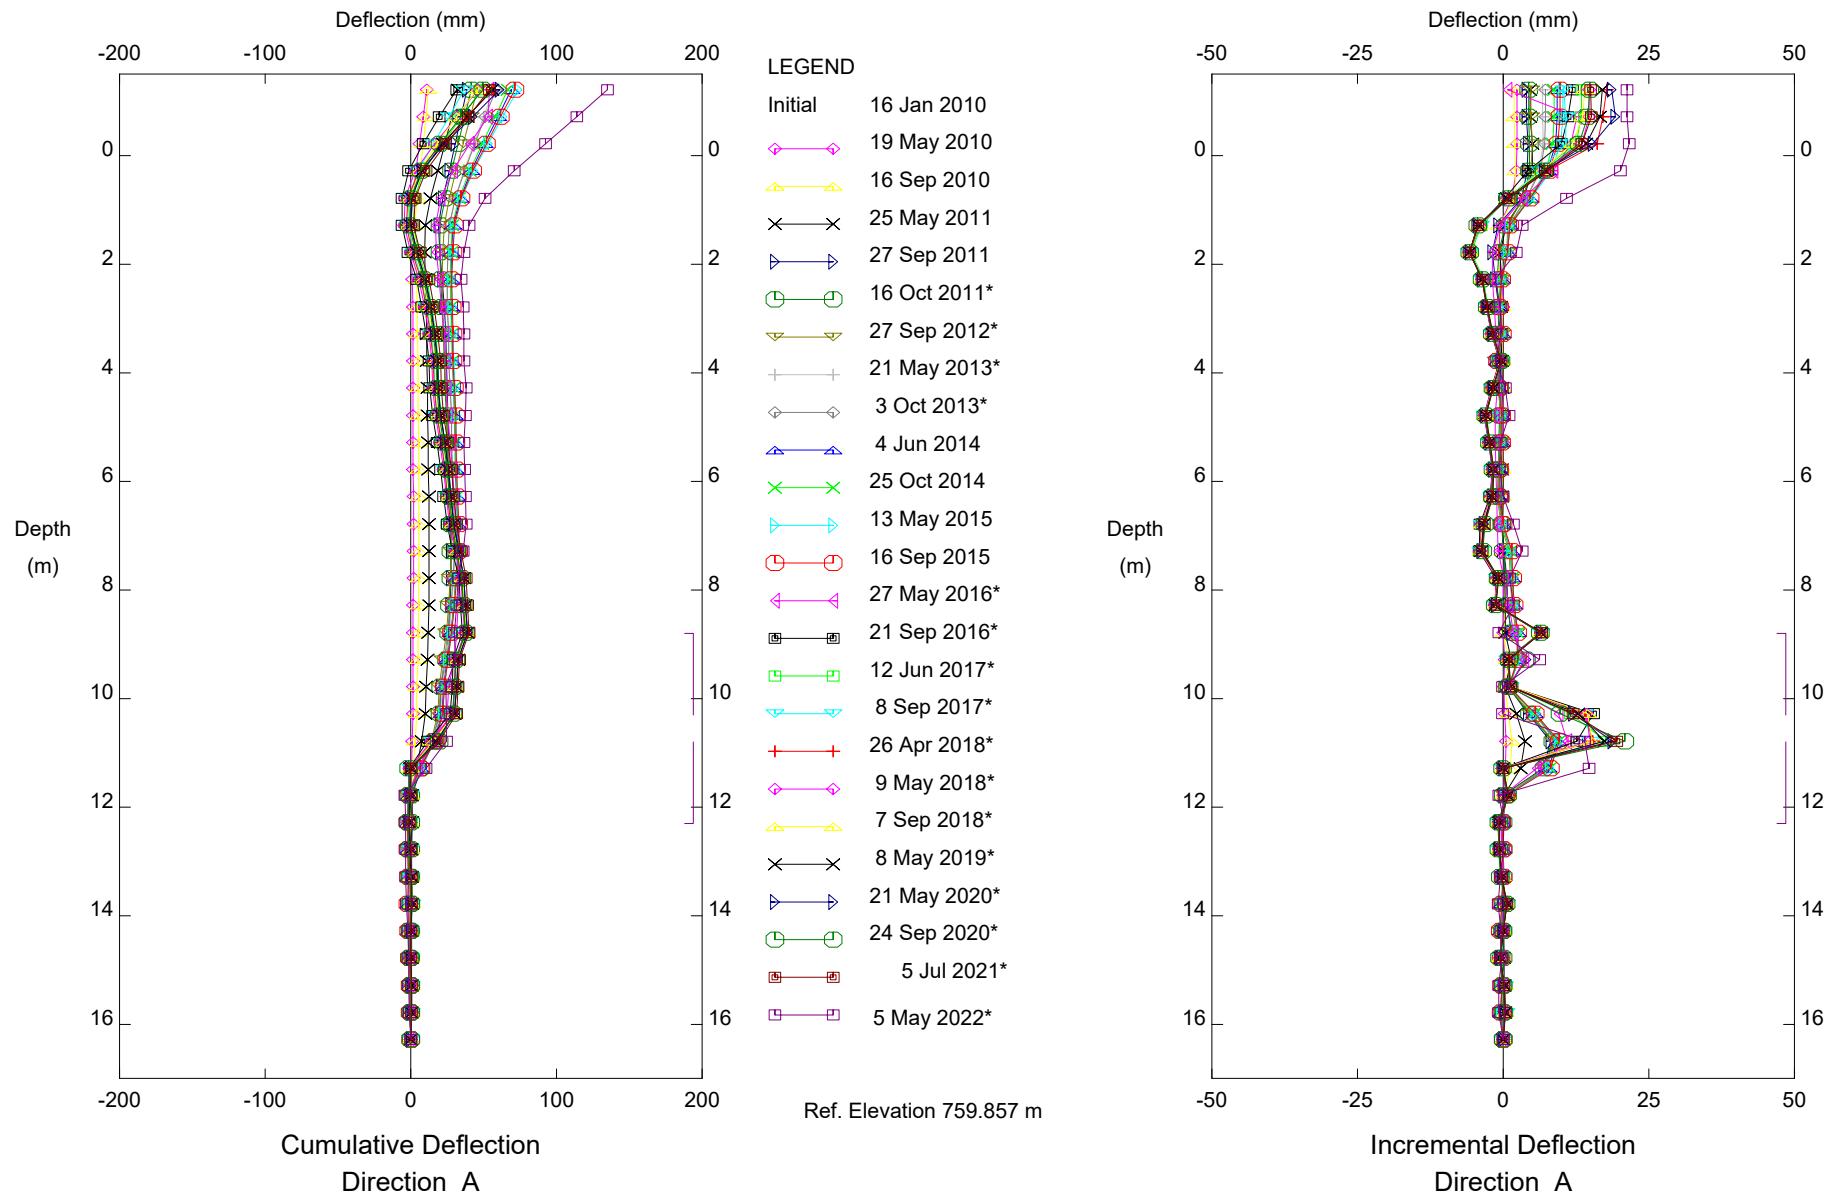
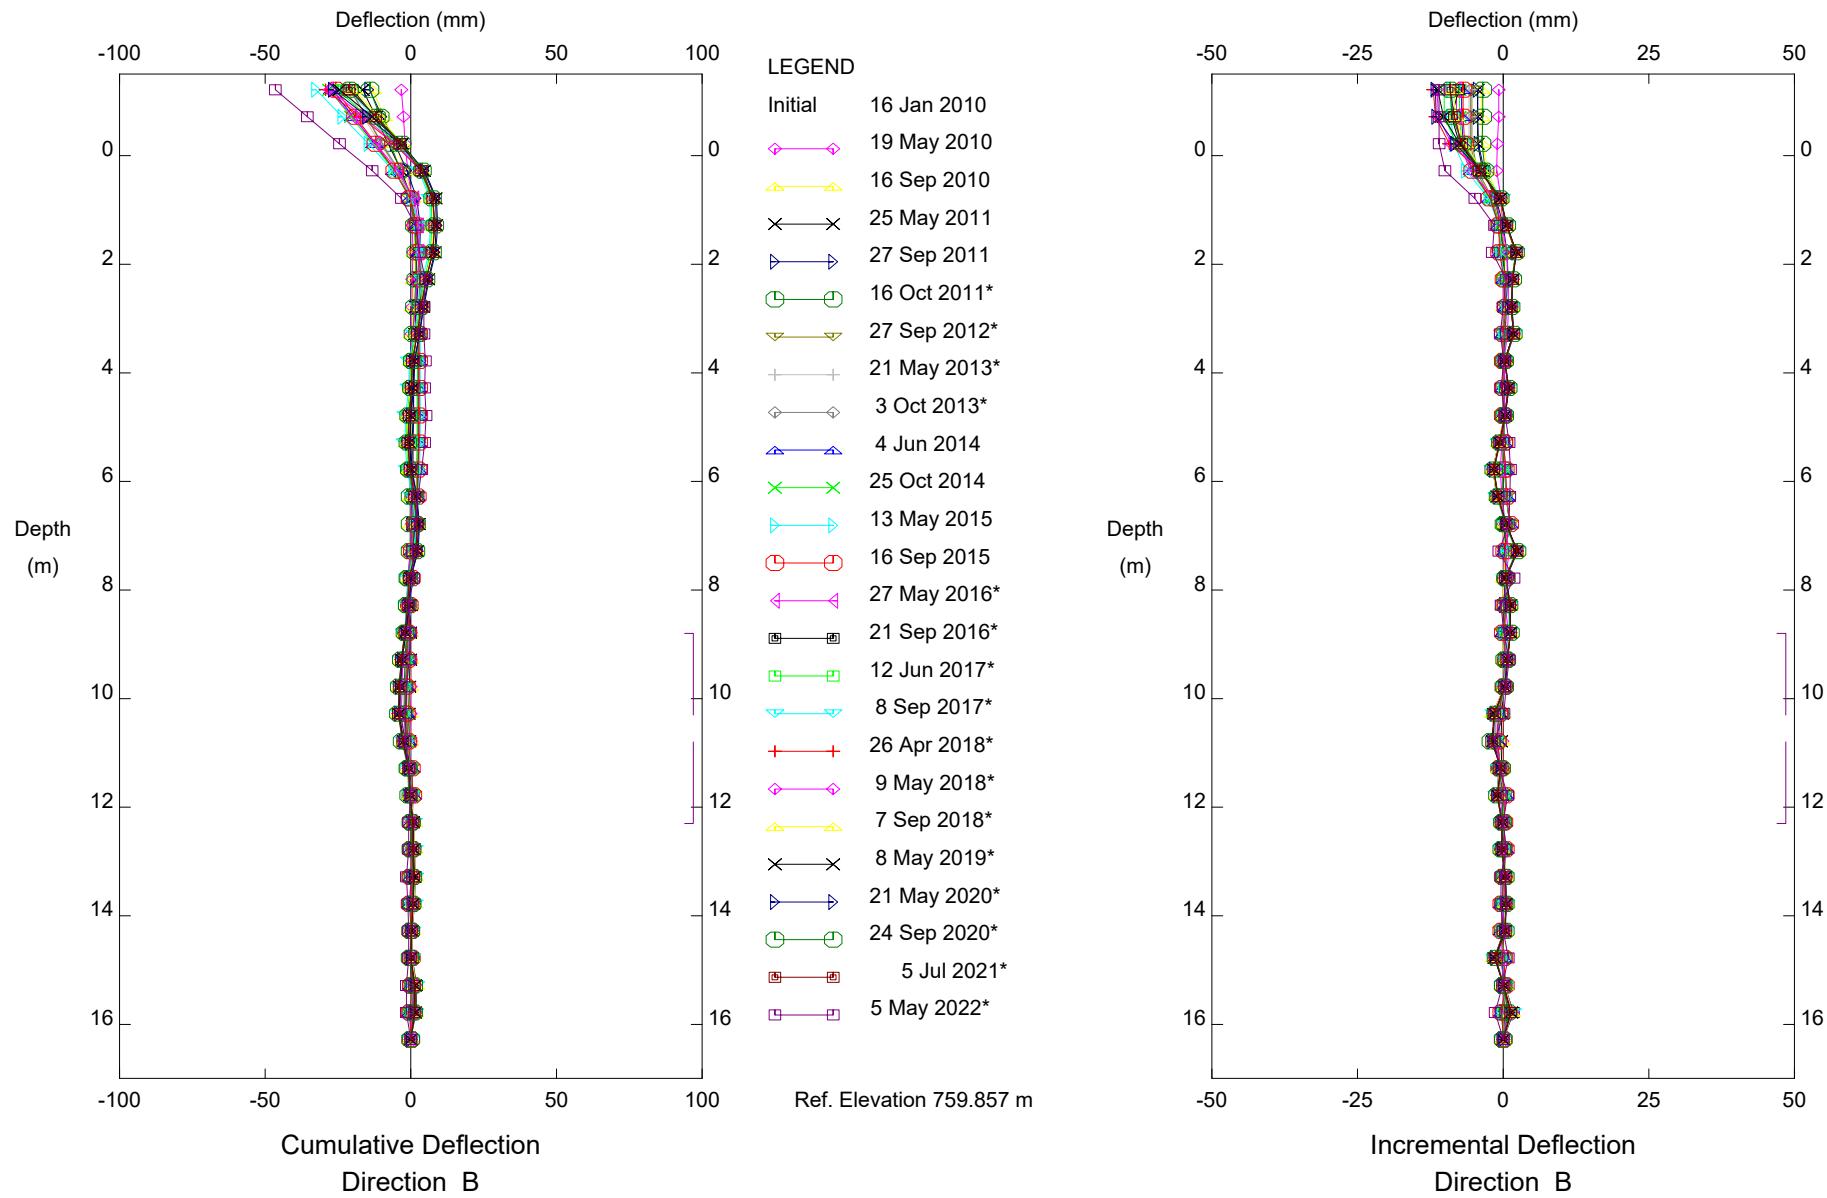
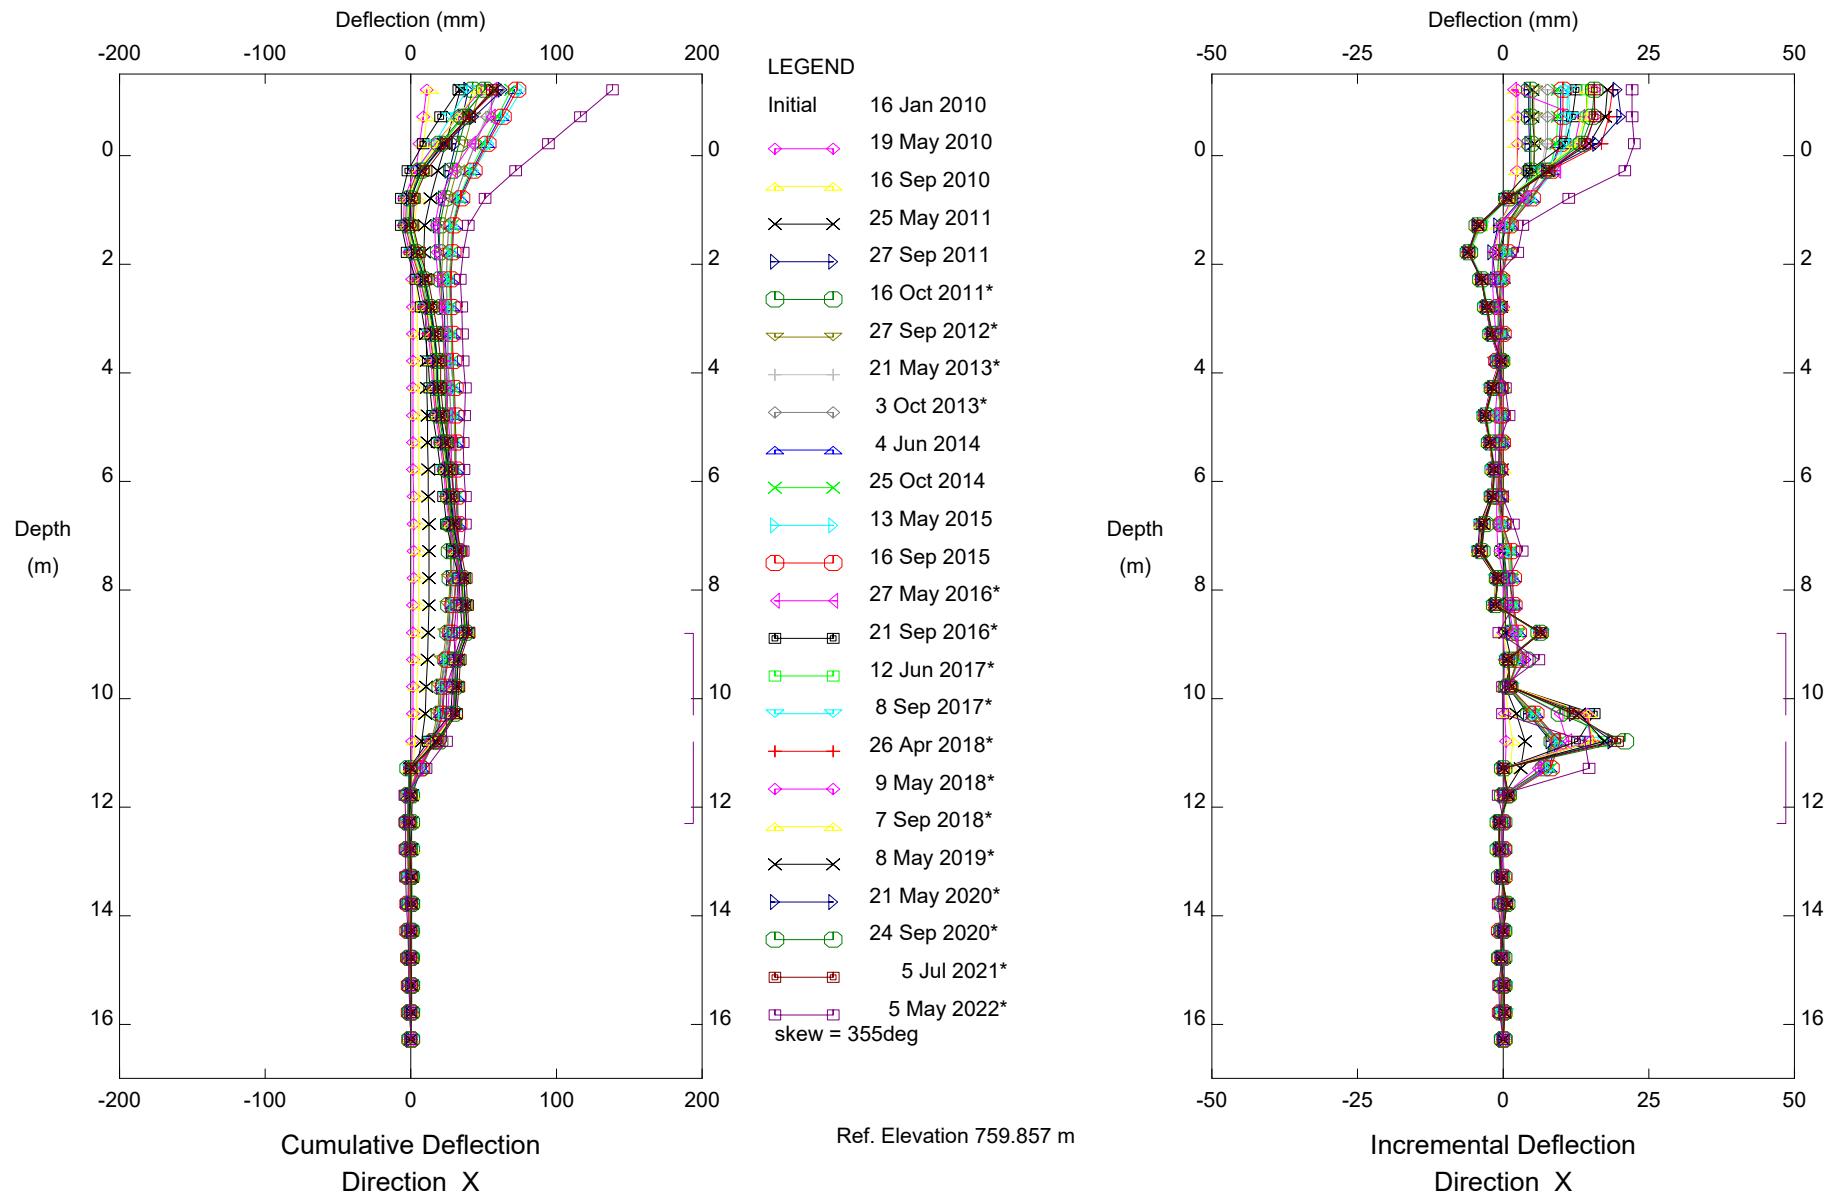
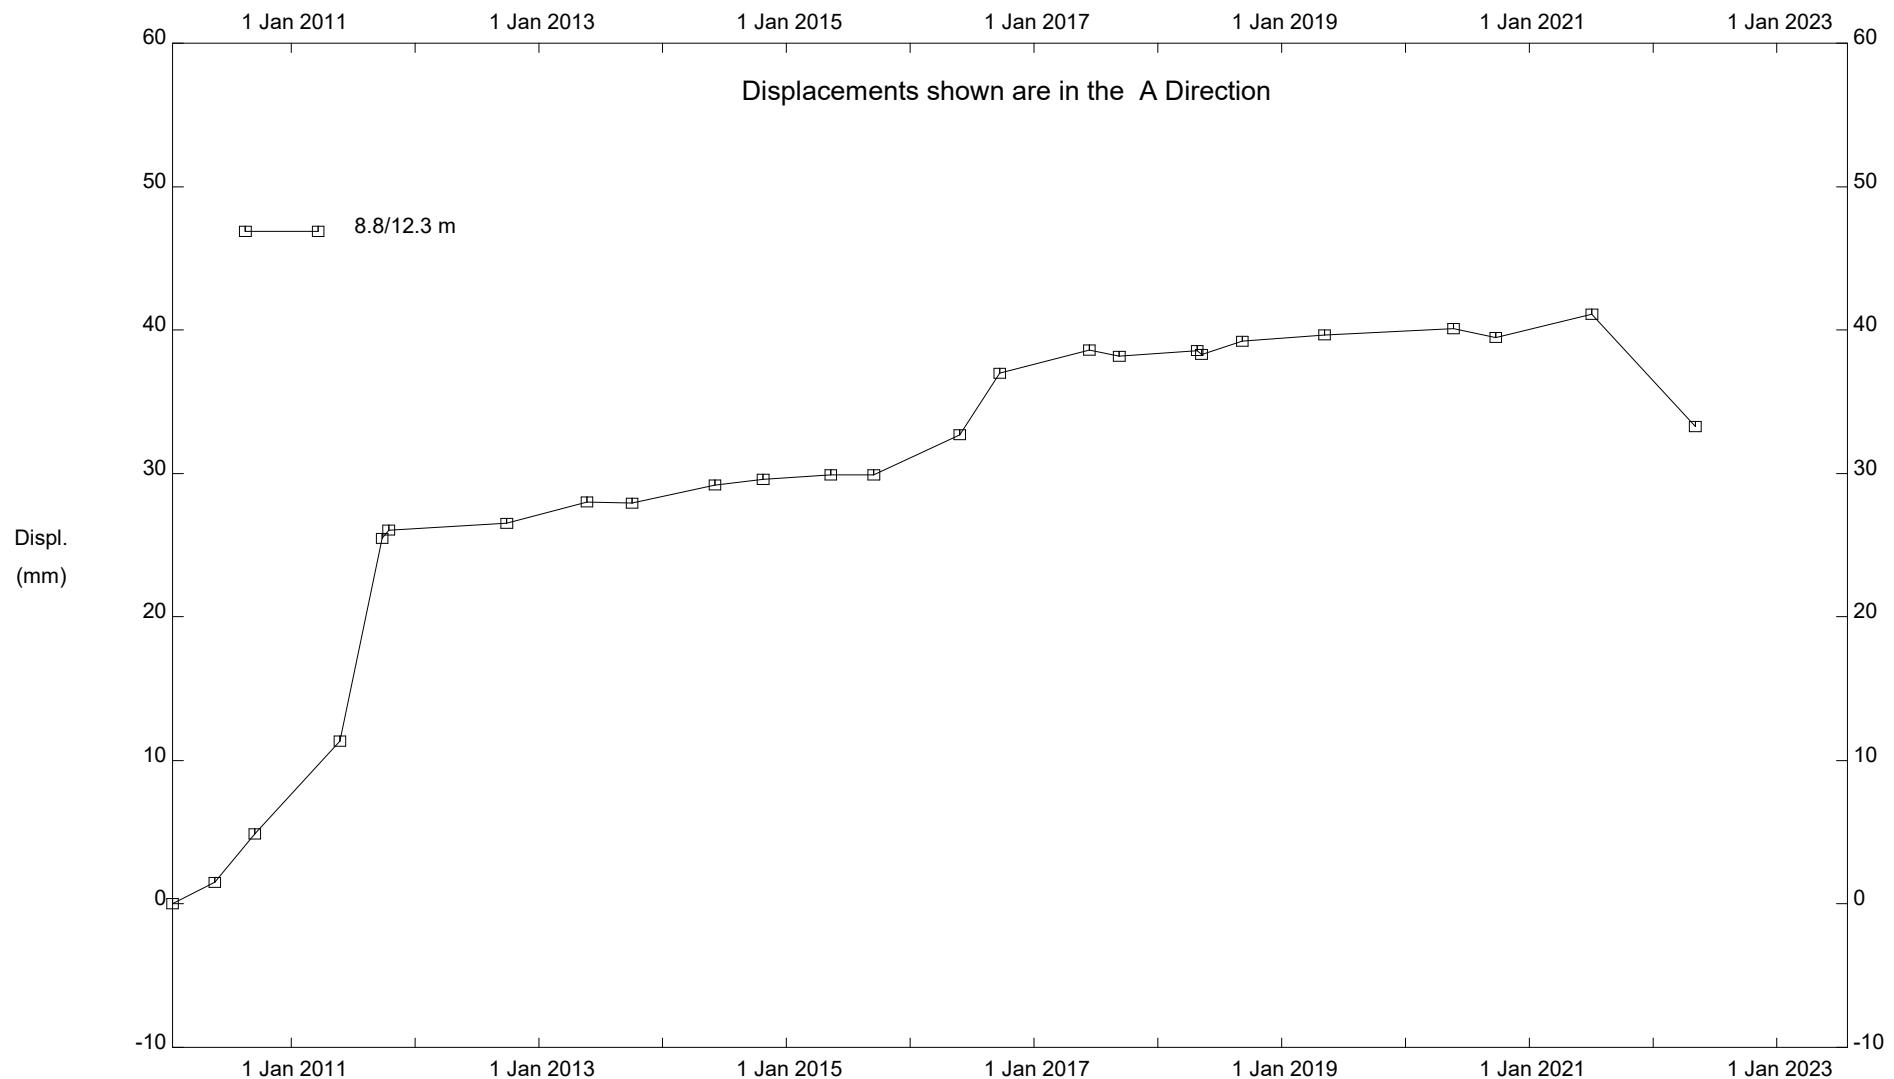
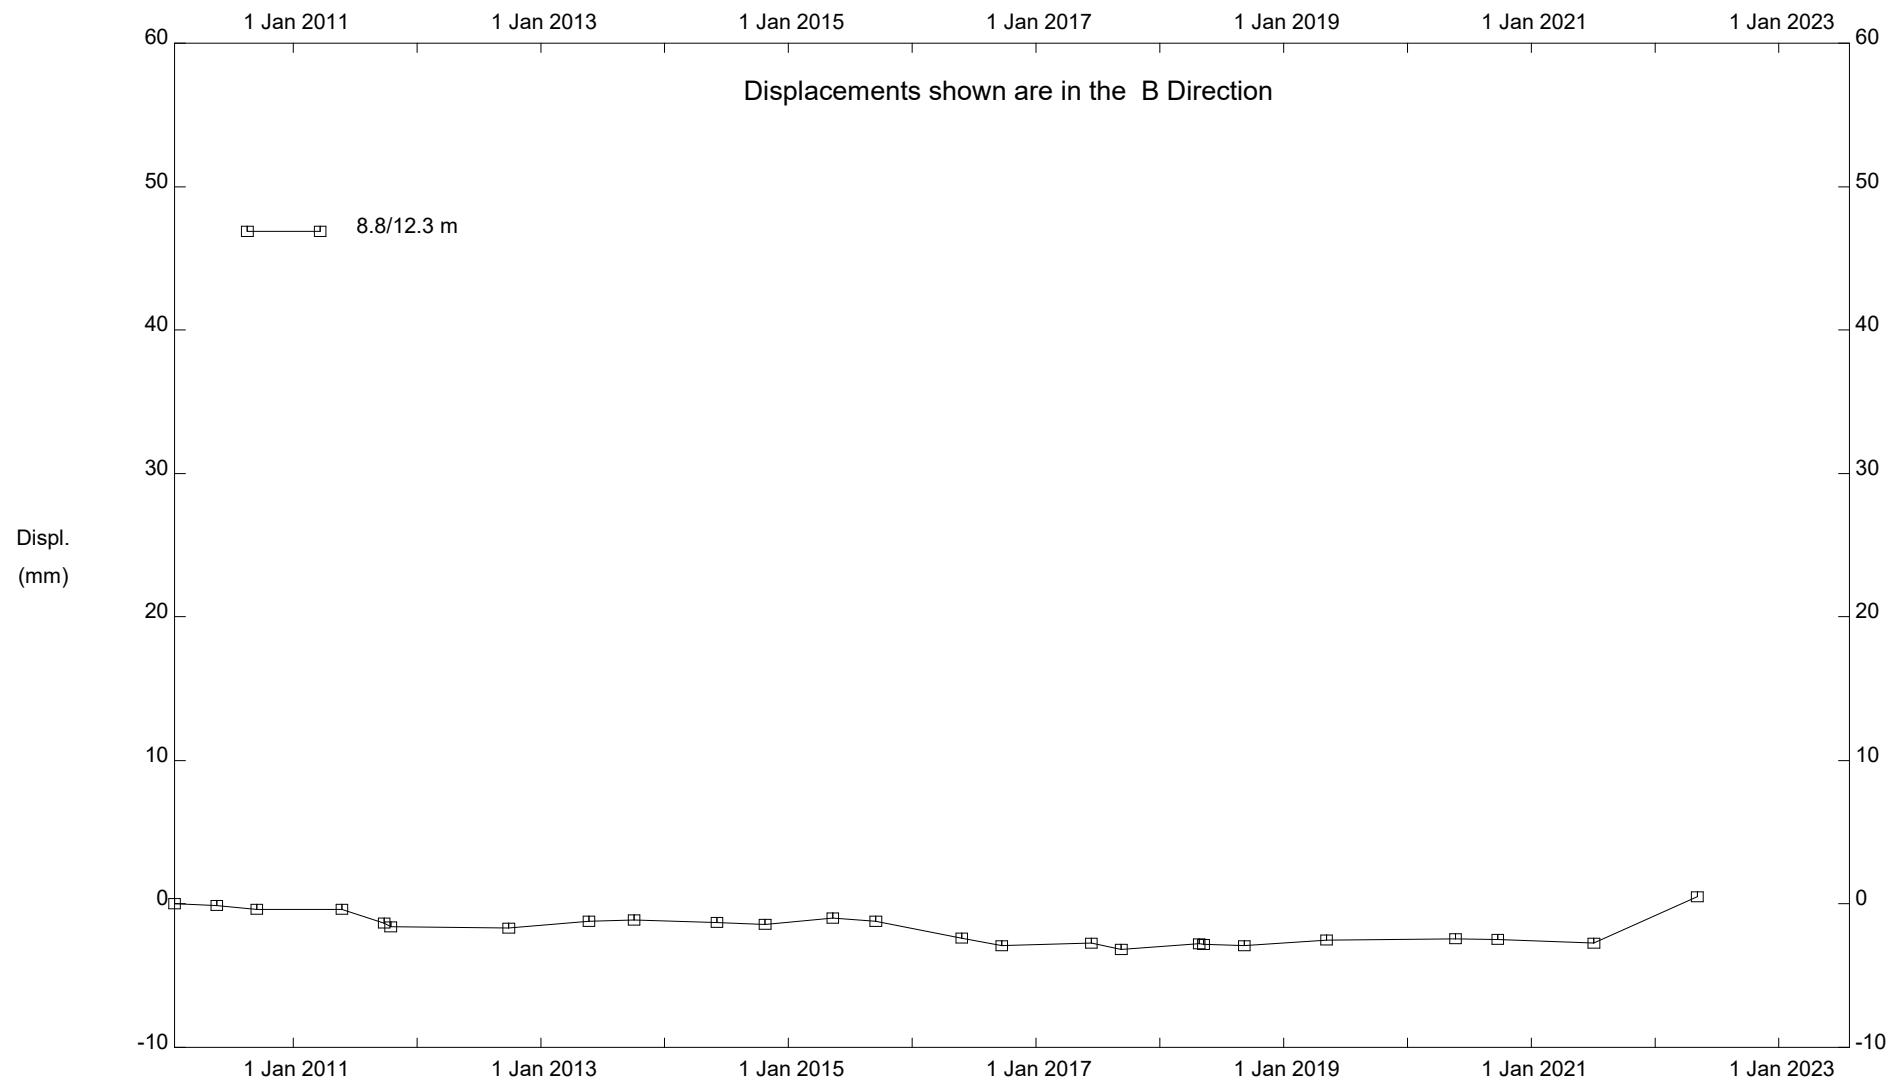
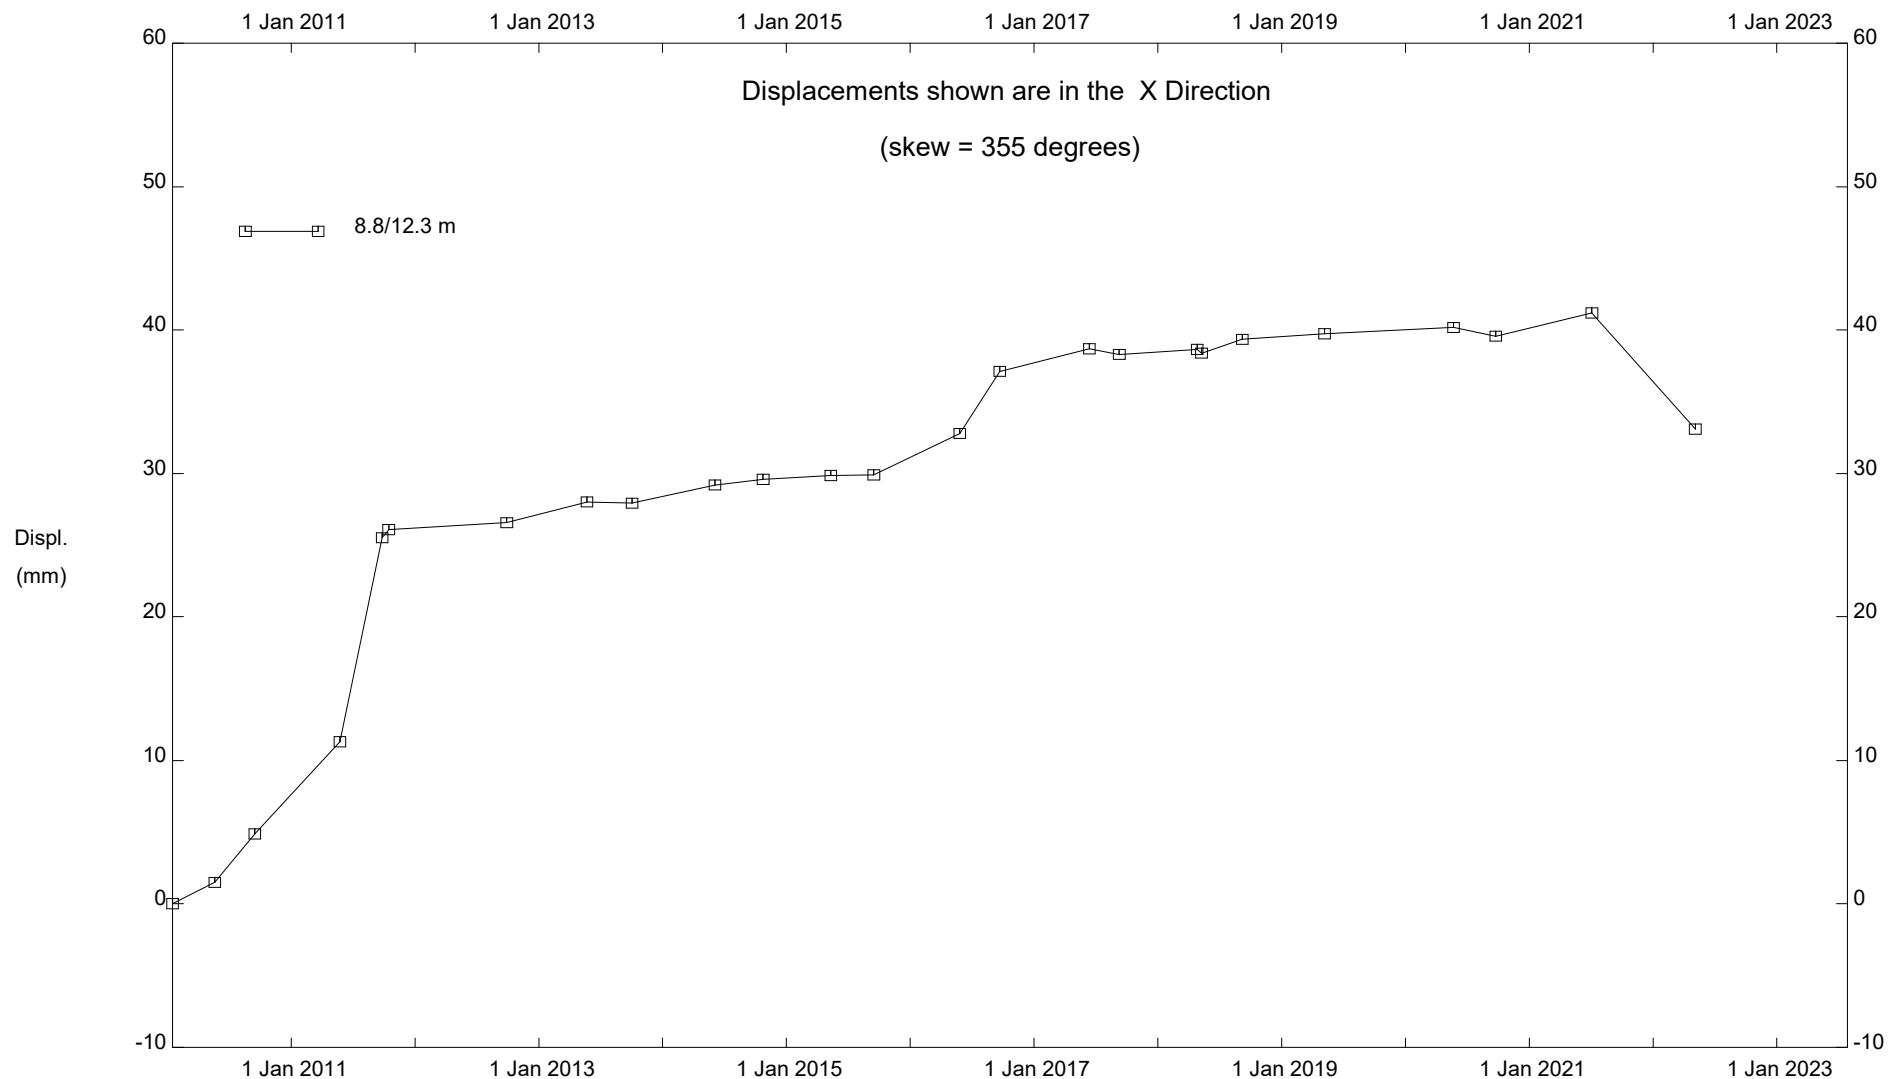
HWY32:10 South of Whitecourt (NC037), Inclinometer SI10-5

SI10-5 shows a zone of movement from about 8.8 m to 12.3 m depth. The movement zone appears to be creeping at an overall rate of less than 1 mm/yr since berm construction in 2011. The current movement rate is 10 mm/yr; however, the cumulative movement decreased by 8 mm to 33 mm.
