To: Amy Driessen
Alberta Transportation
File: 123315222

From: Leslie Cho and Carrie Murray
Stantec Consulting Ltd.
Date: June 12, 2022

Reference: North Central Region, Edson, Site NC037 - Highway 32:10 South of Whitecourt, Spring 2022 Instrumentation Monitoring Report

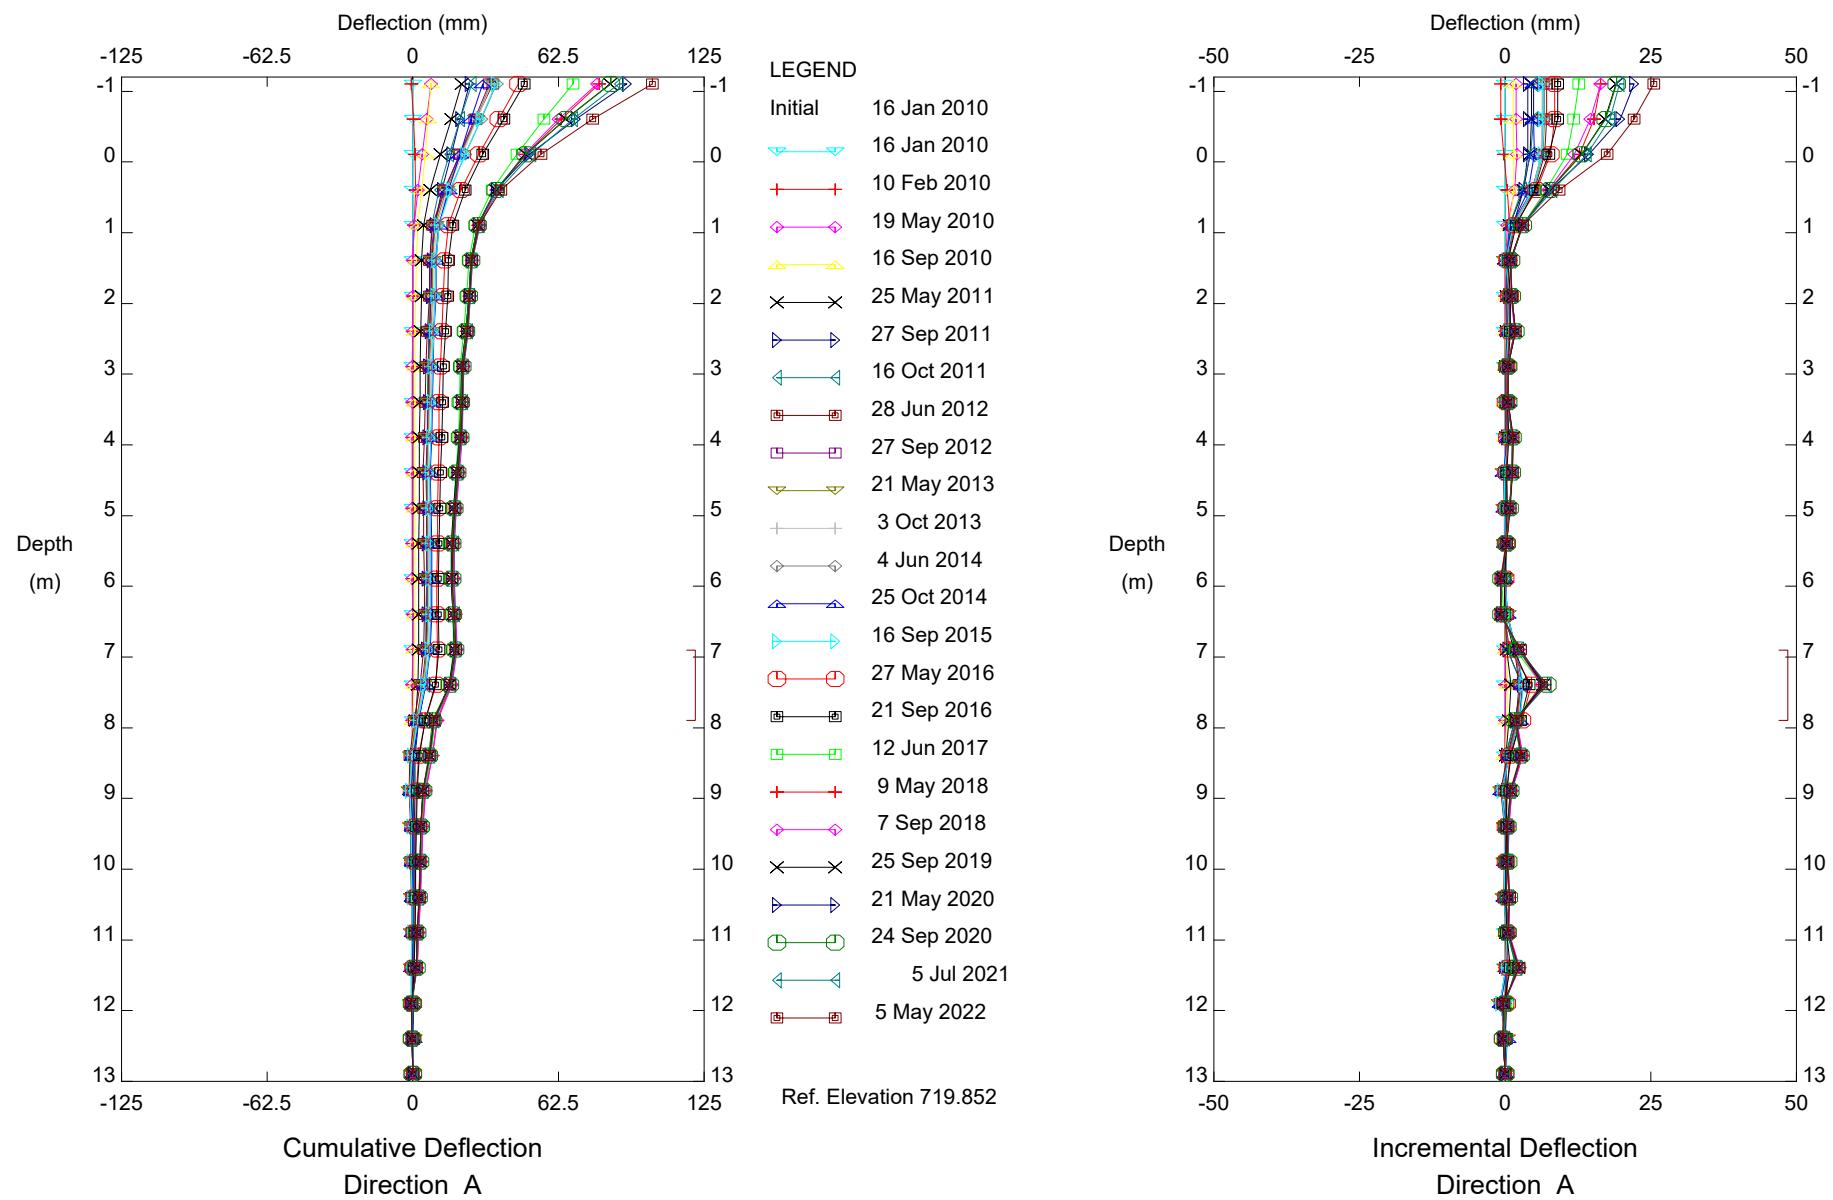
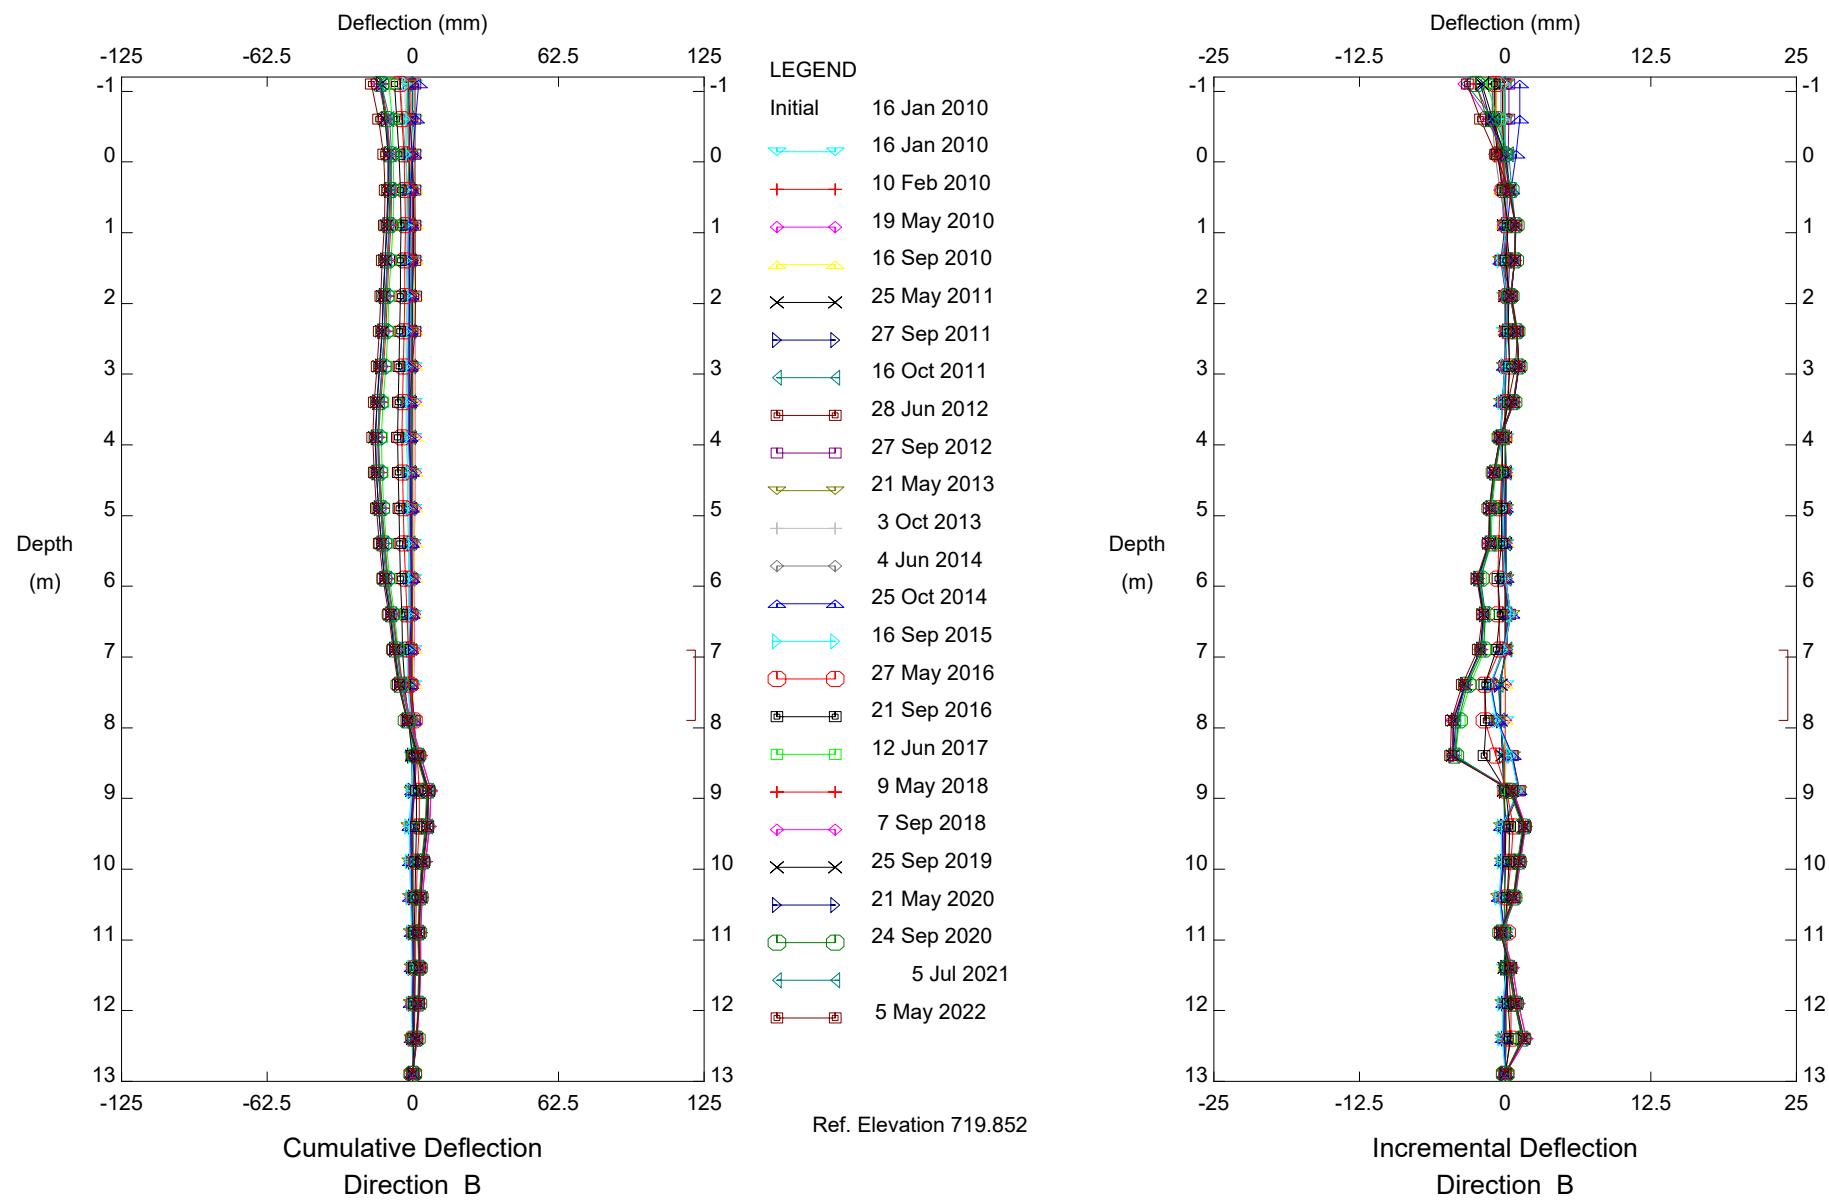
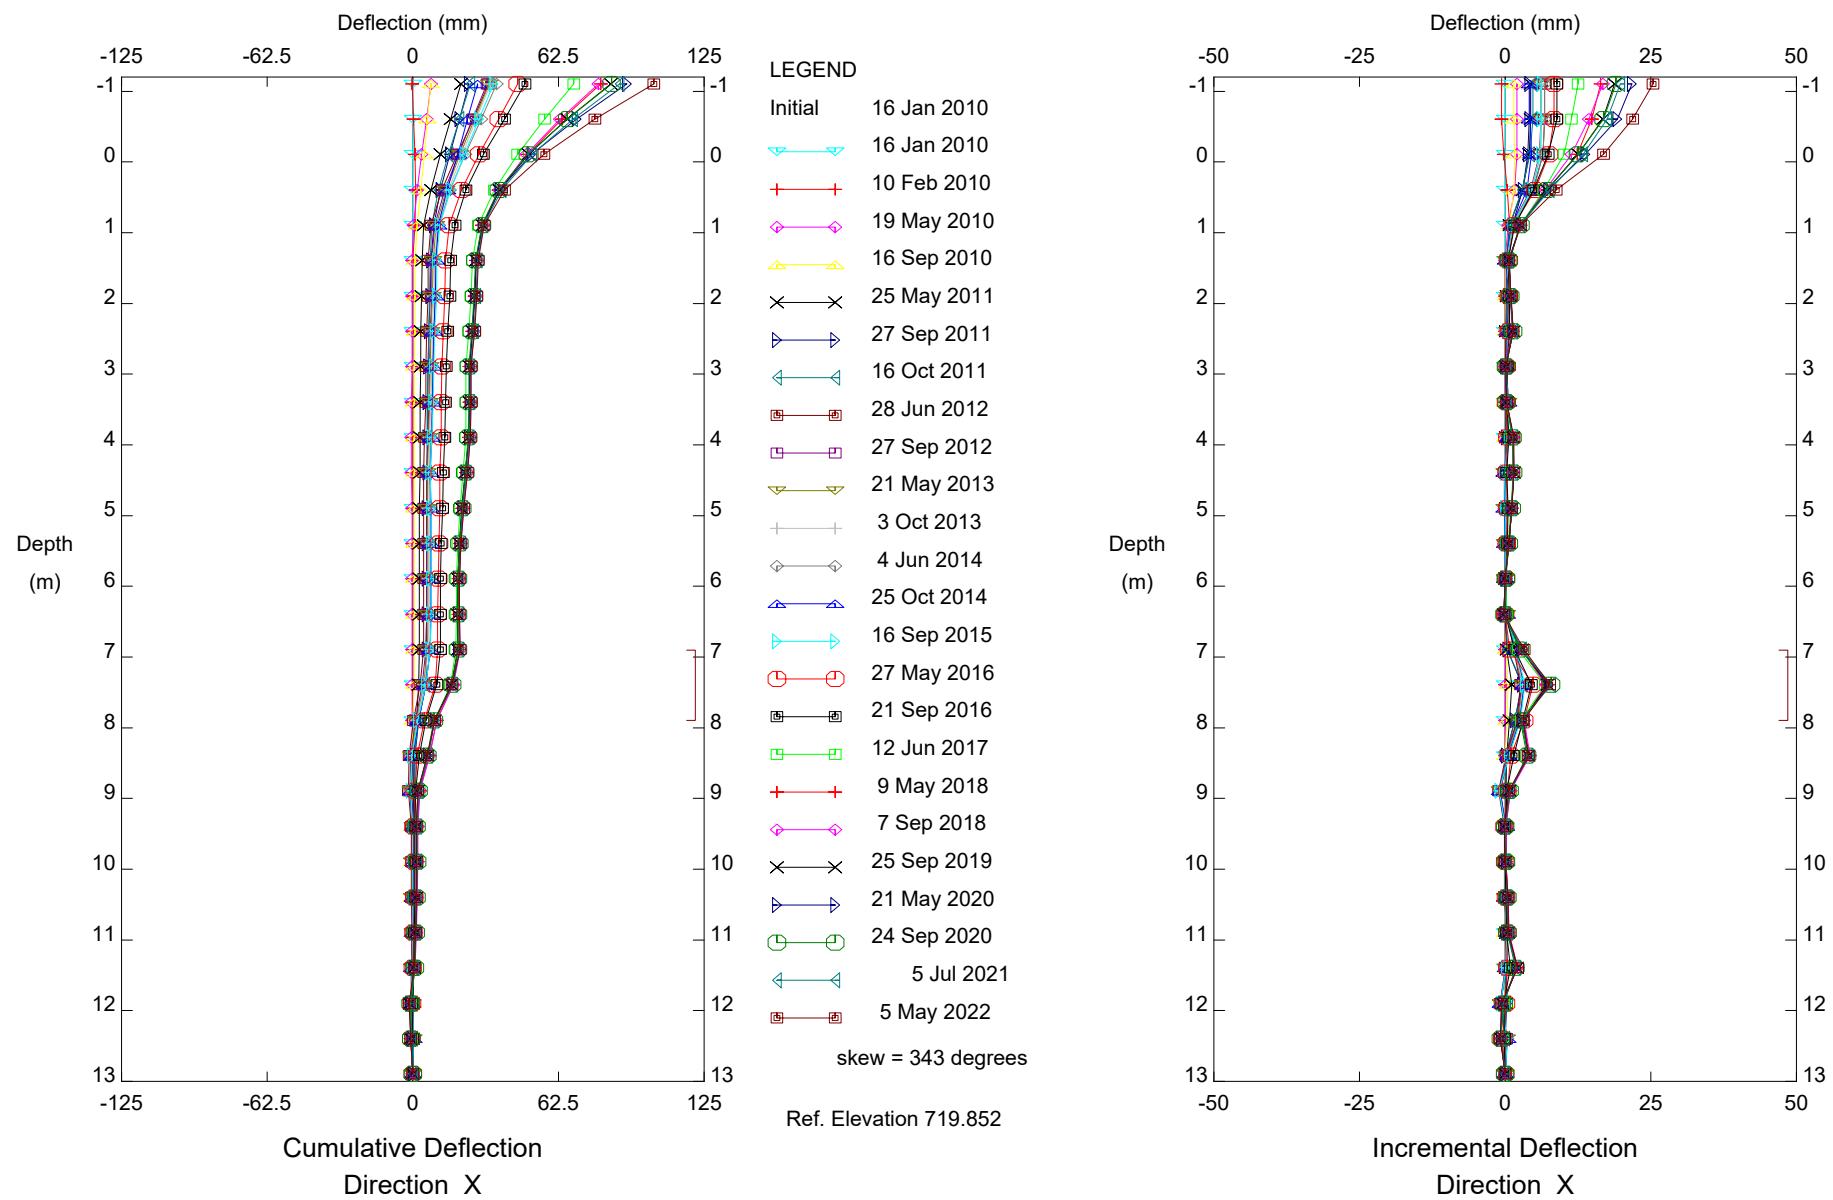
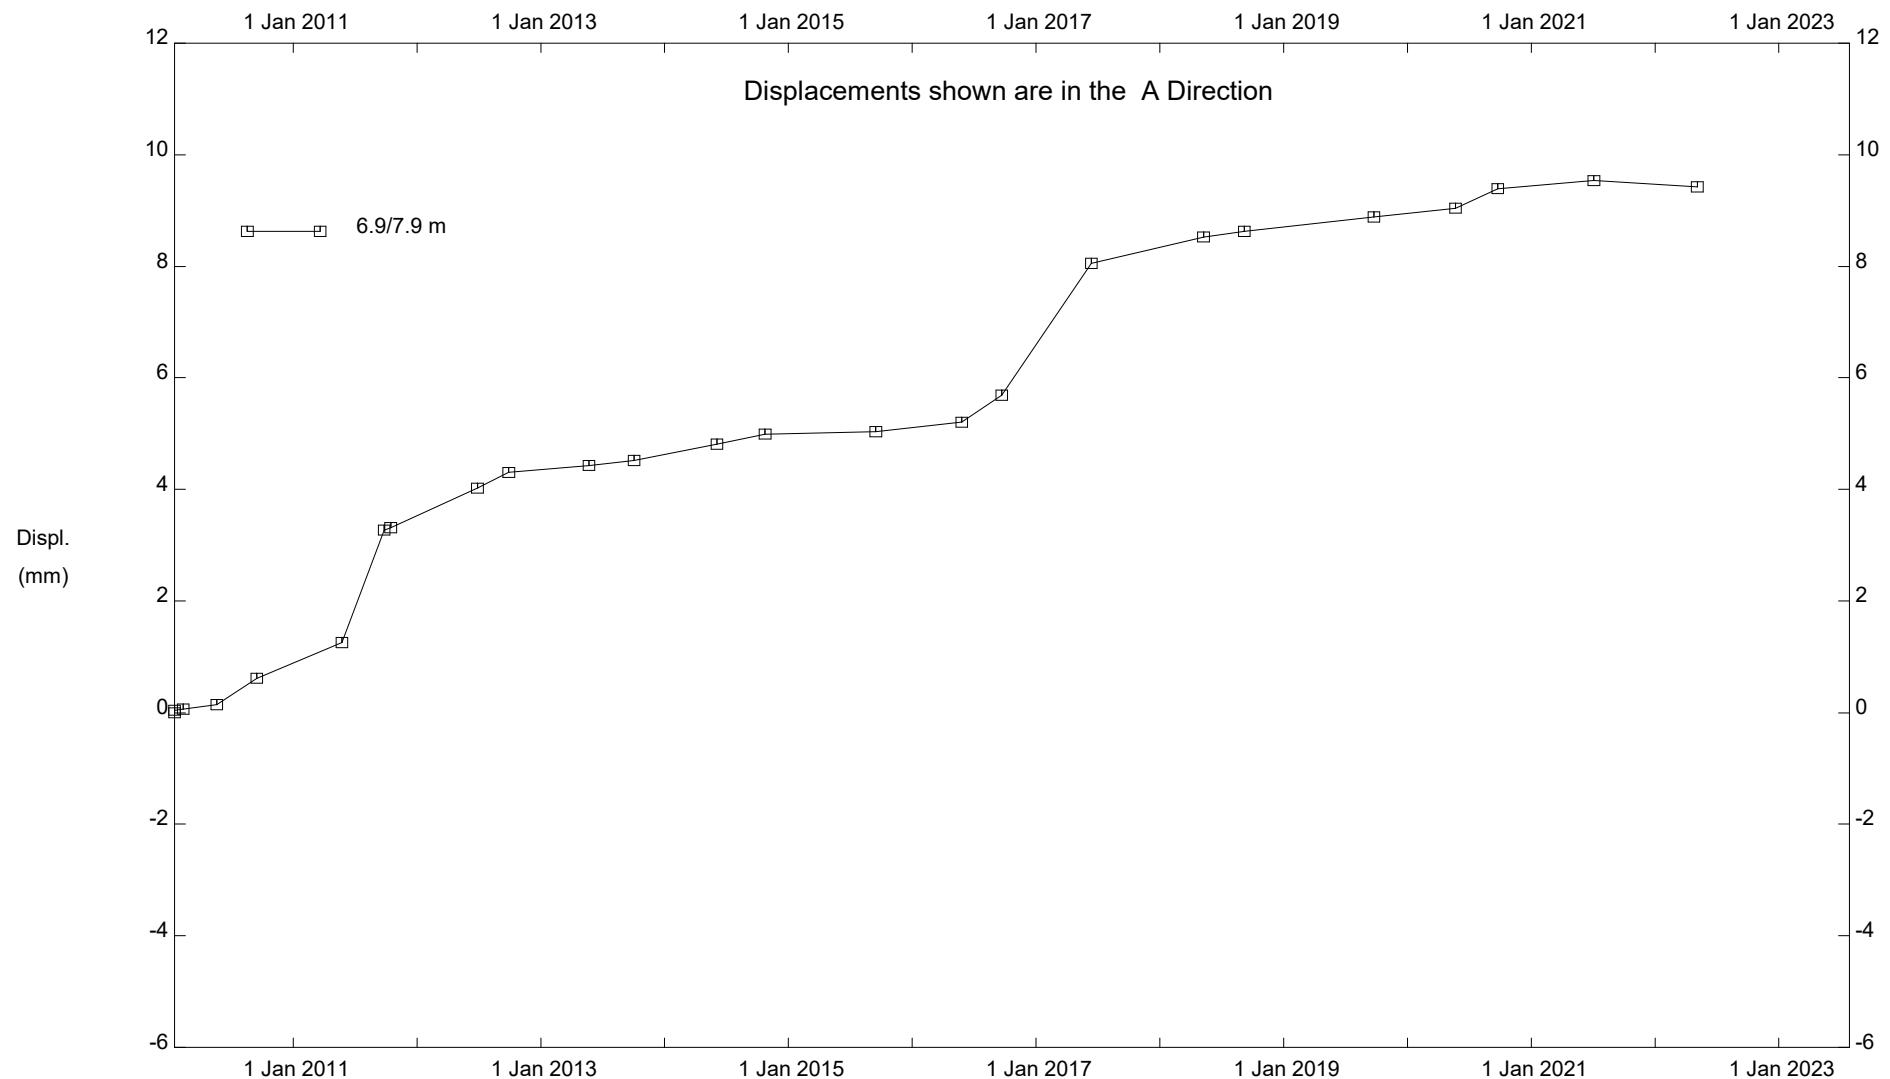
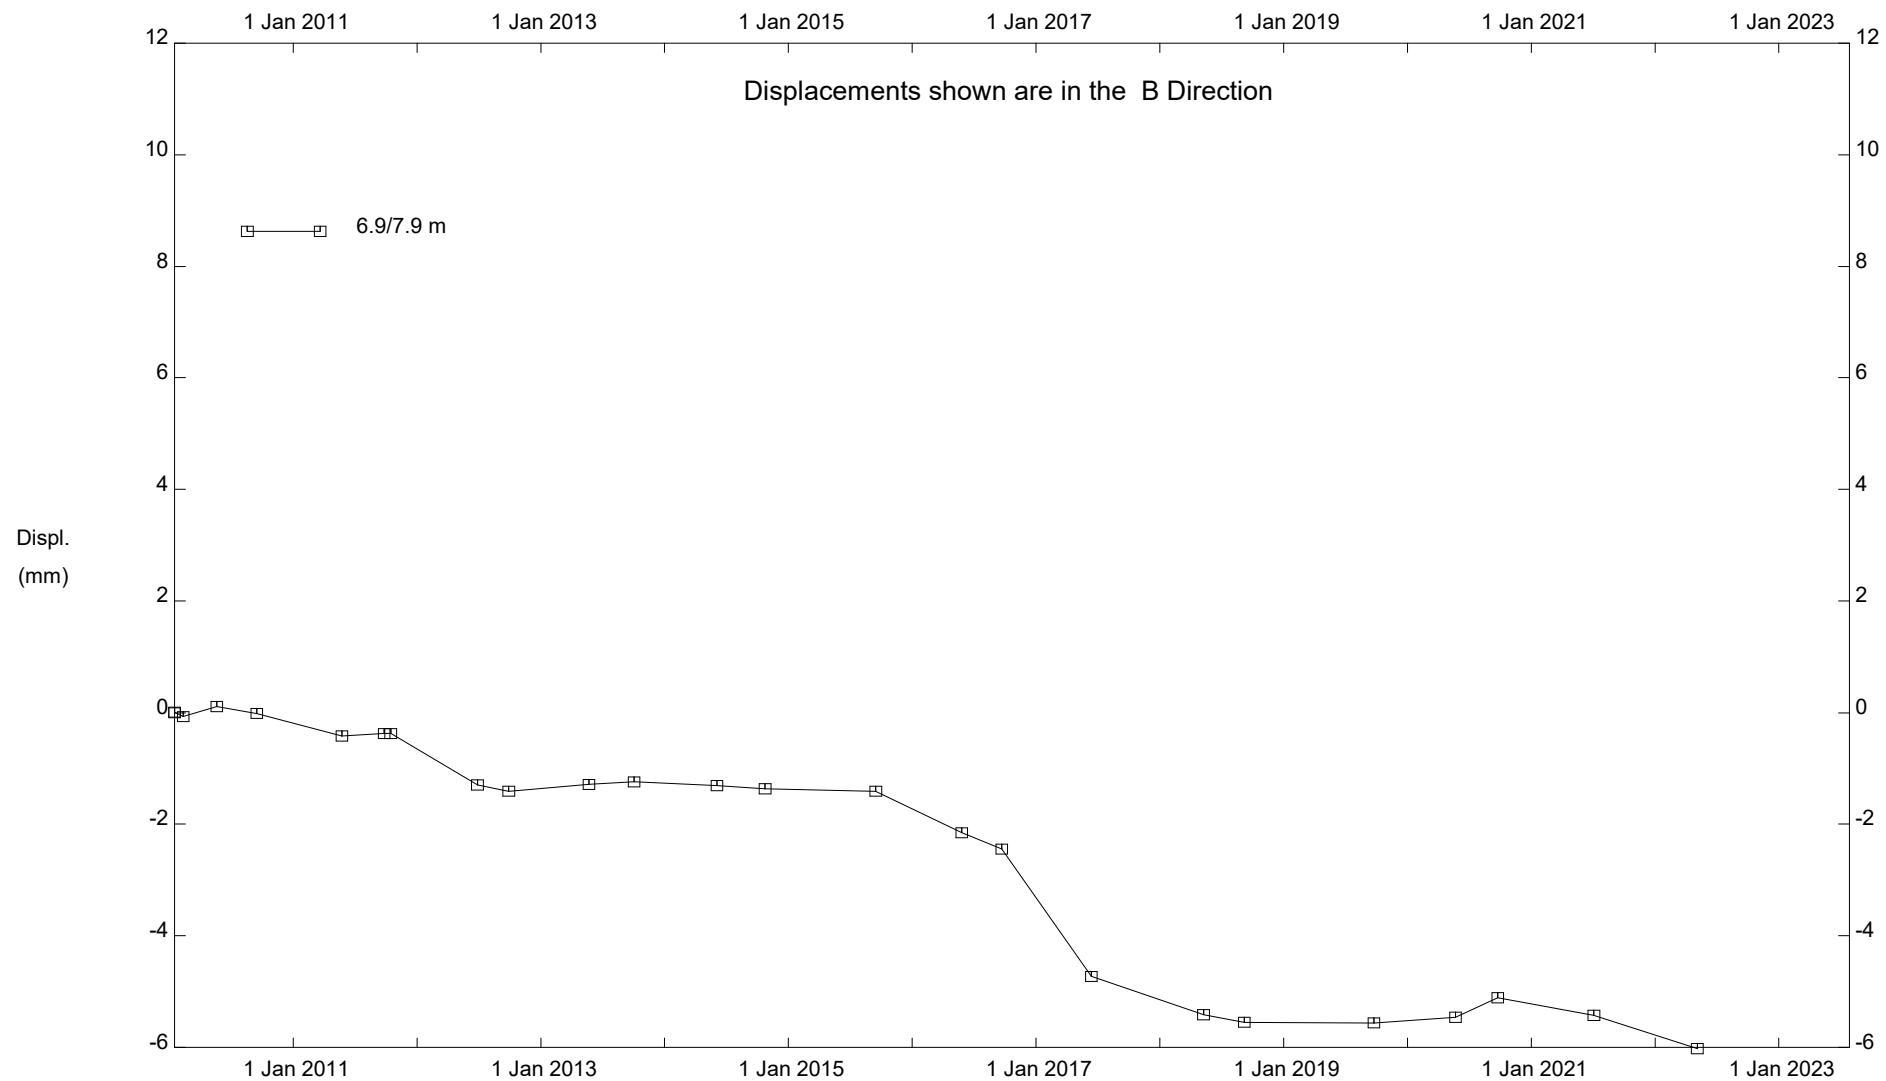
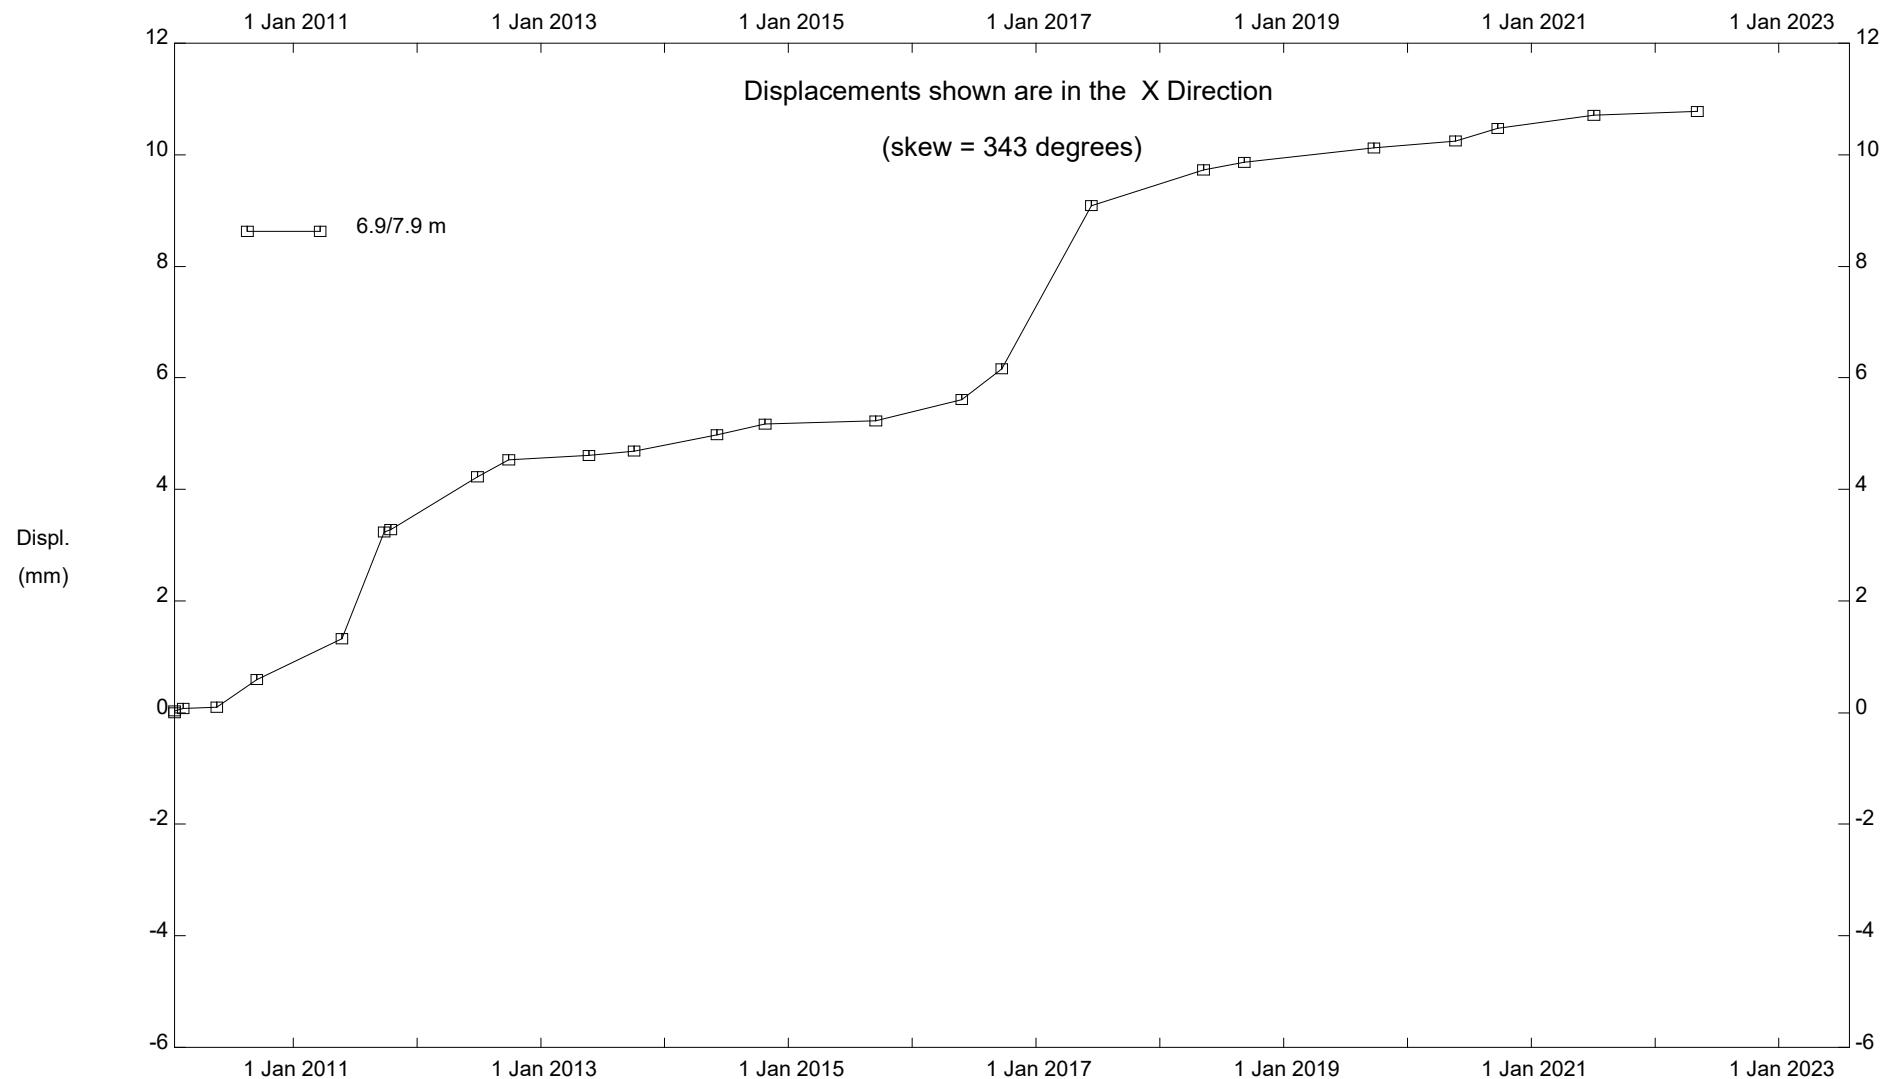
HWY32:10 South of Whitecourt (NC037), Inclinometer SI10-6

SI10-6 has a movement zone between 6.9 m and 7.9 m depth and appears to be creeping at a rate of less than 1 mm/yr since berm construction in 2011. An increase to 3 mm/yr rate of movement was observed during Fall 2017. Since then, the rate has returned to less than 1 mm/yr.
