To: Amy Driessen
Alberta Transportation
File: 123315222

From: Leslie Cho and Carrie Murray
Stantec Consulting Ltd.
Date: June 12, 2022

Reference: North Central Region, Edson, Site NC037 - Highway 32:10 South of Whitecourt, Spring 2022 Instrumentation Monitoring Report

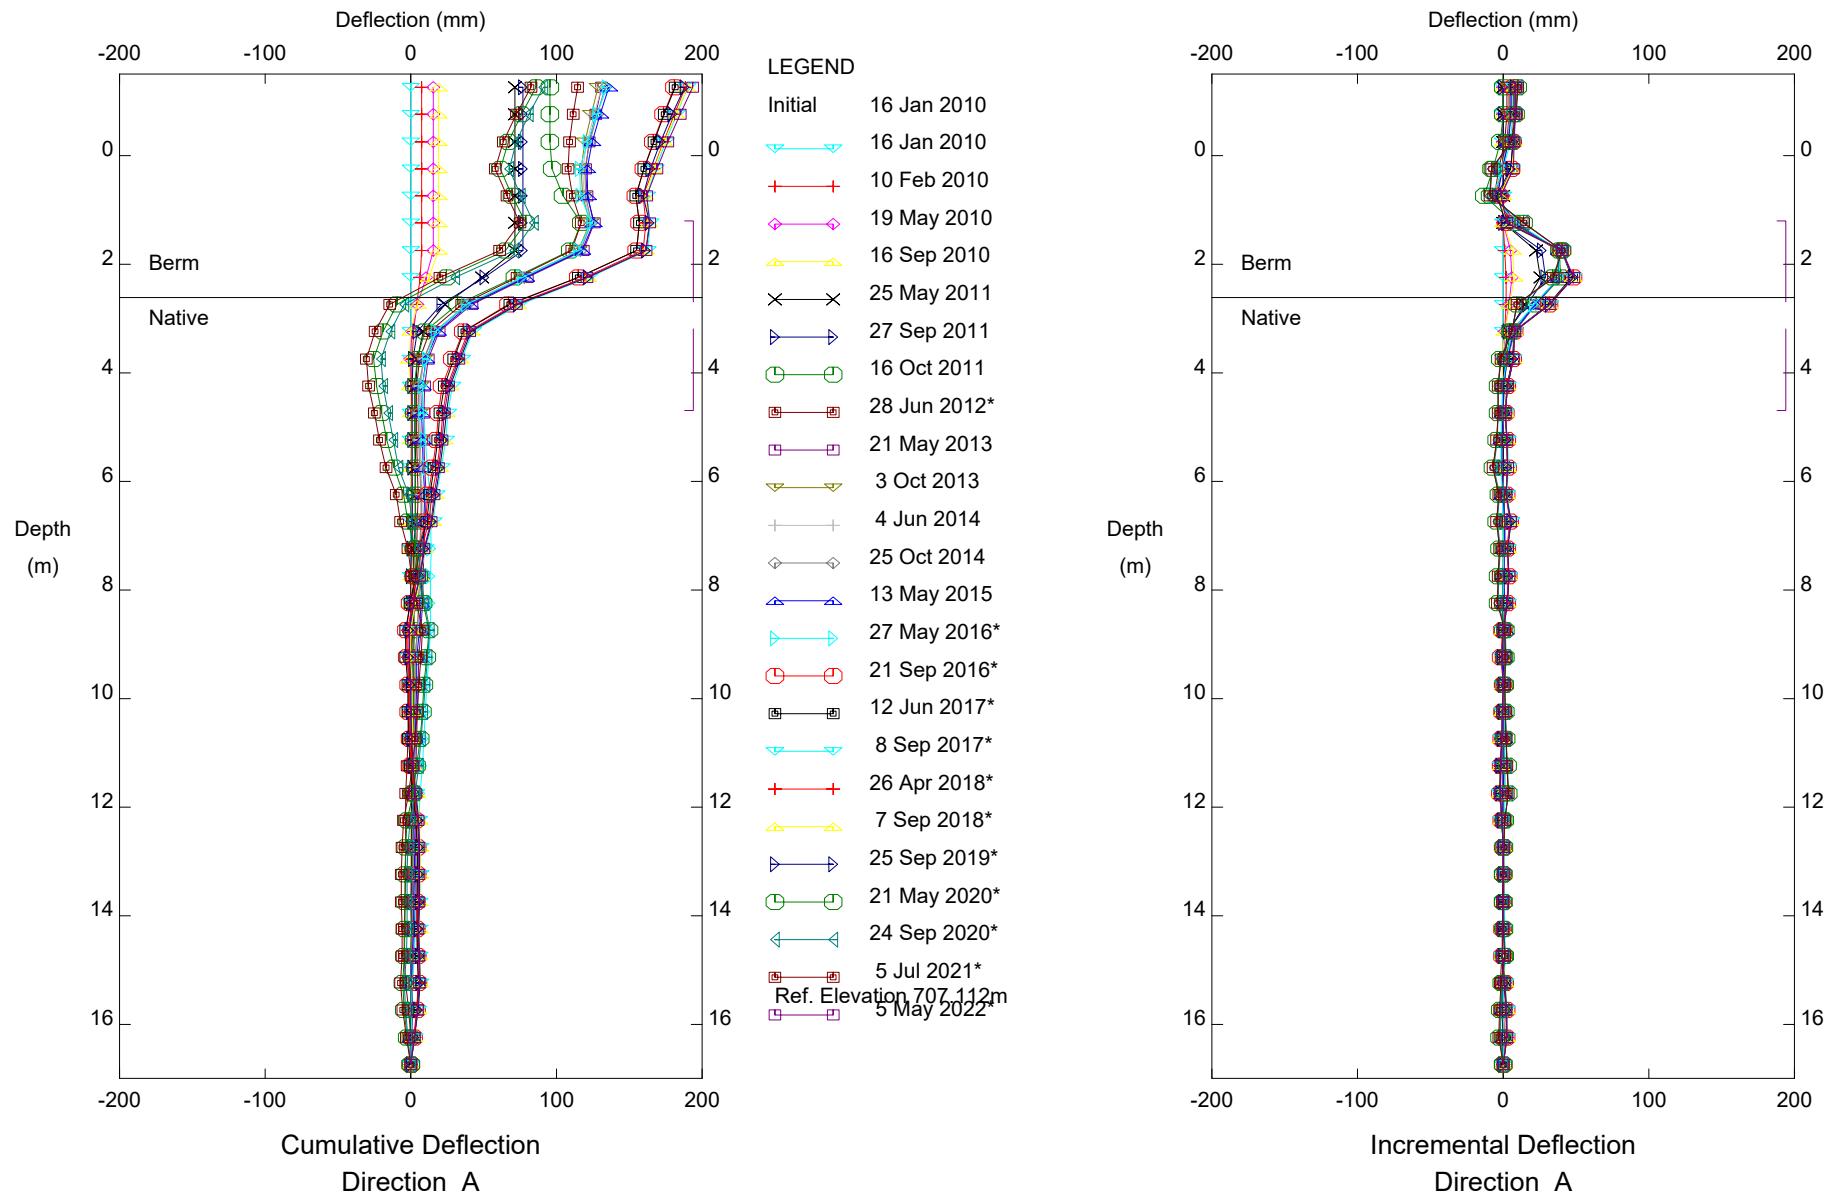
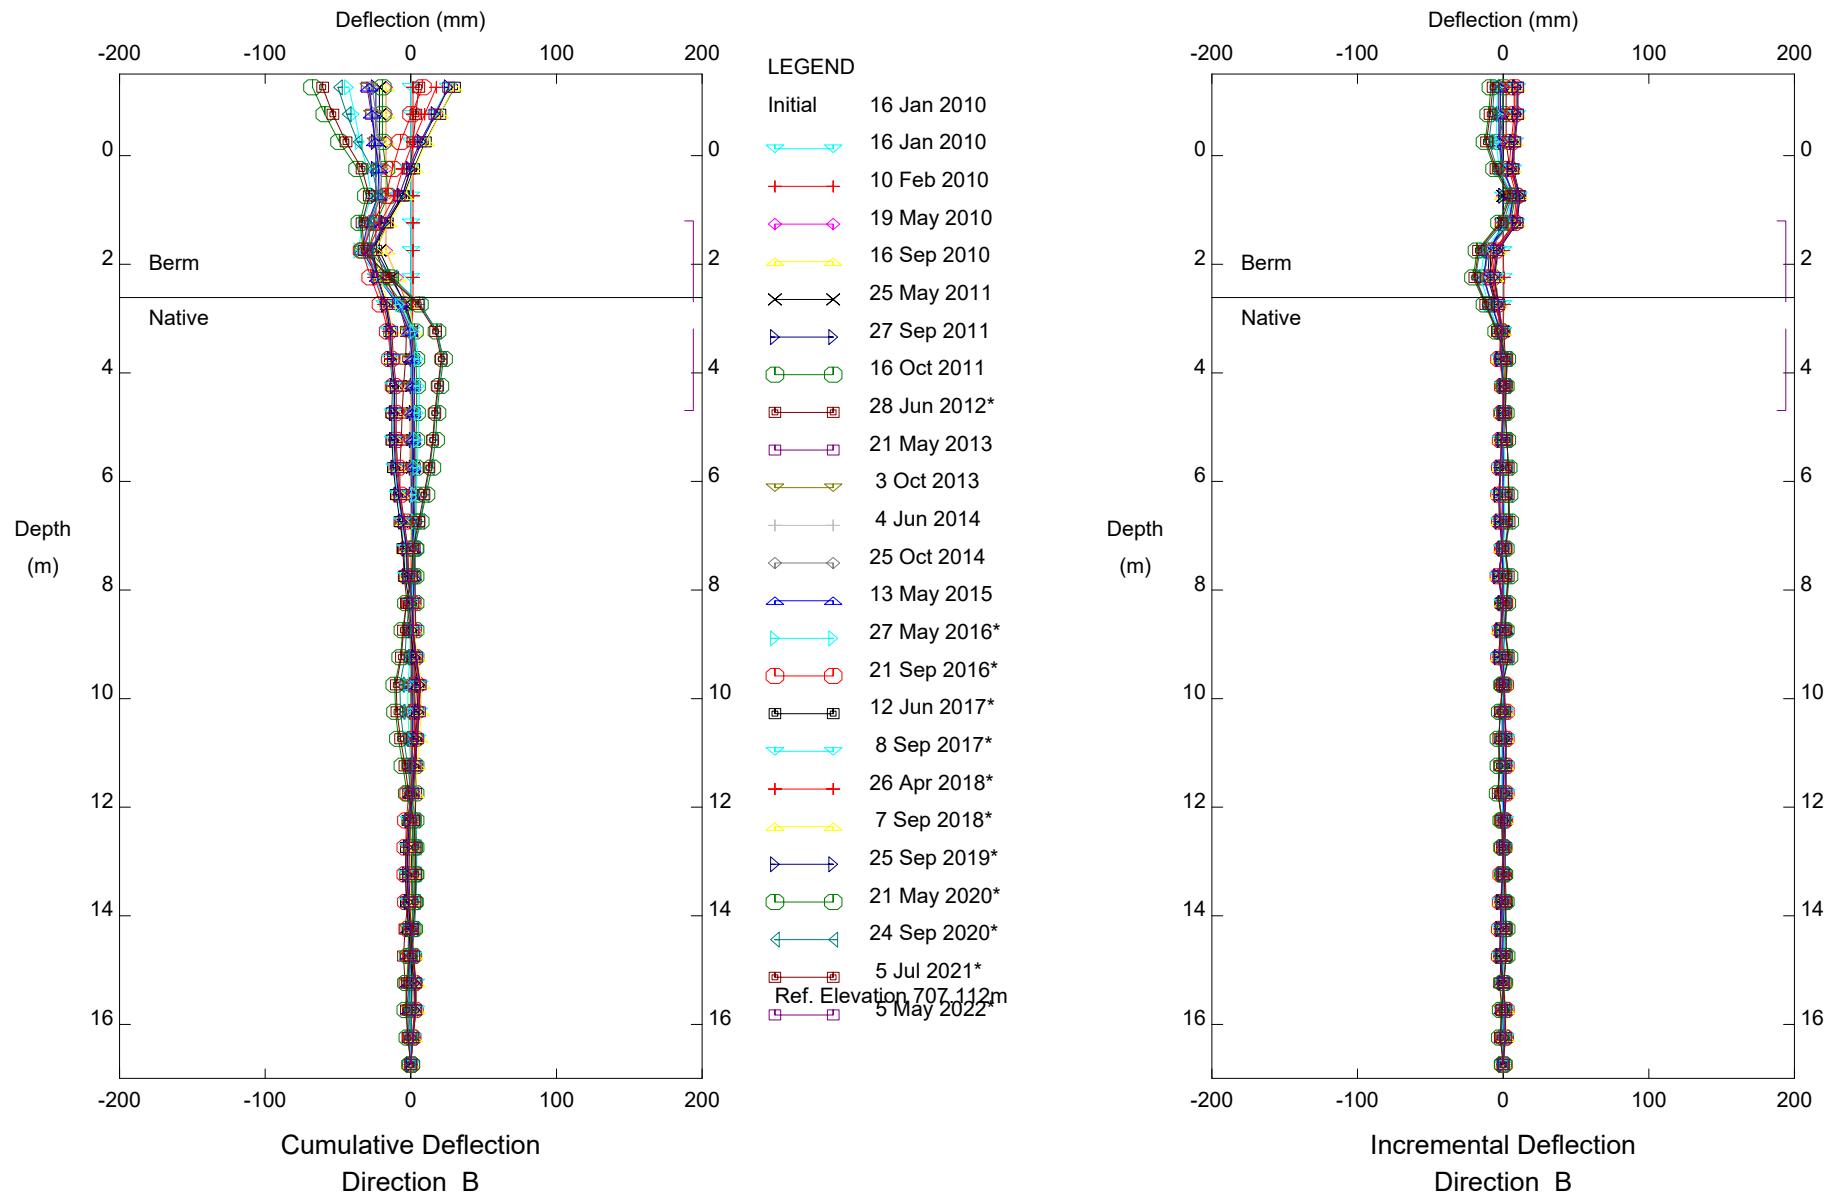
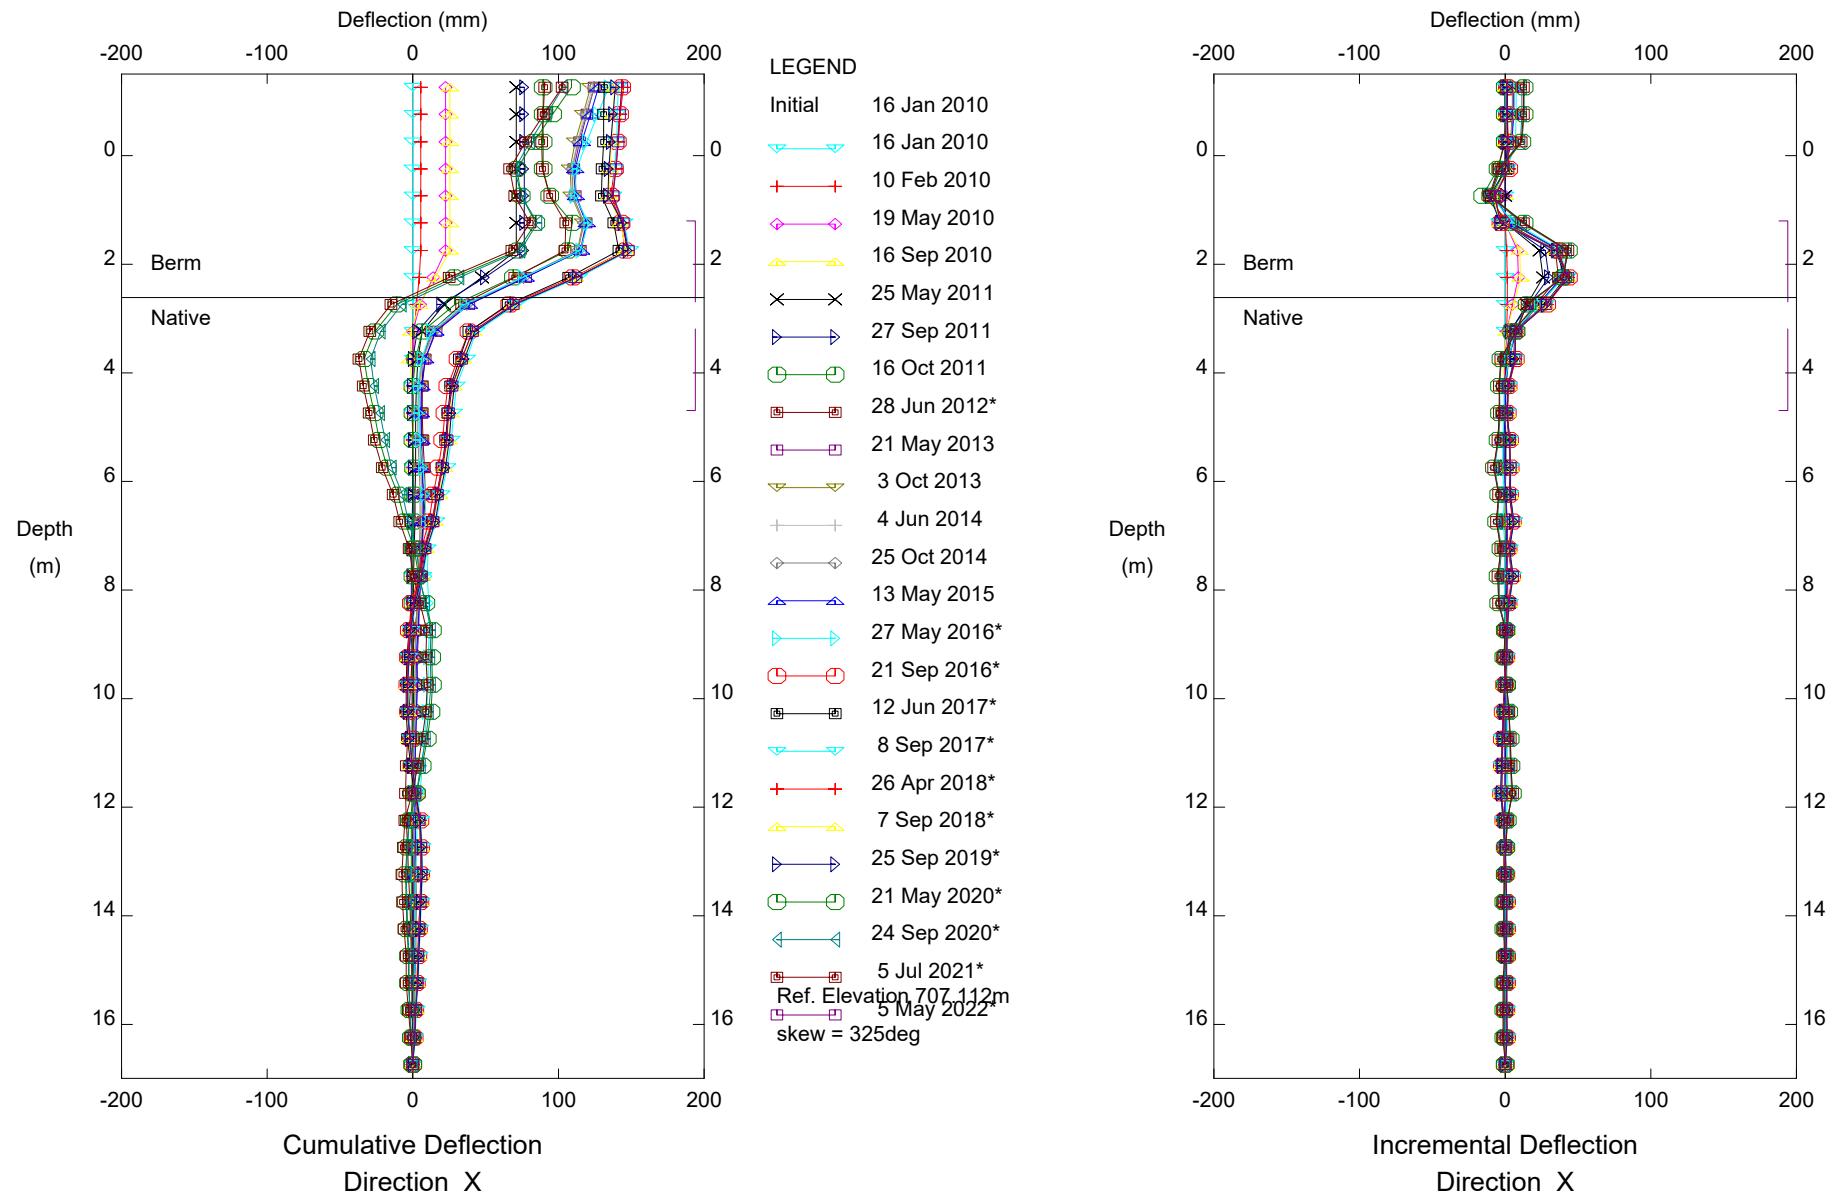
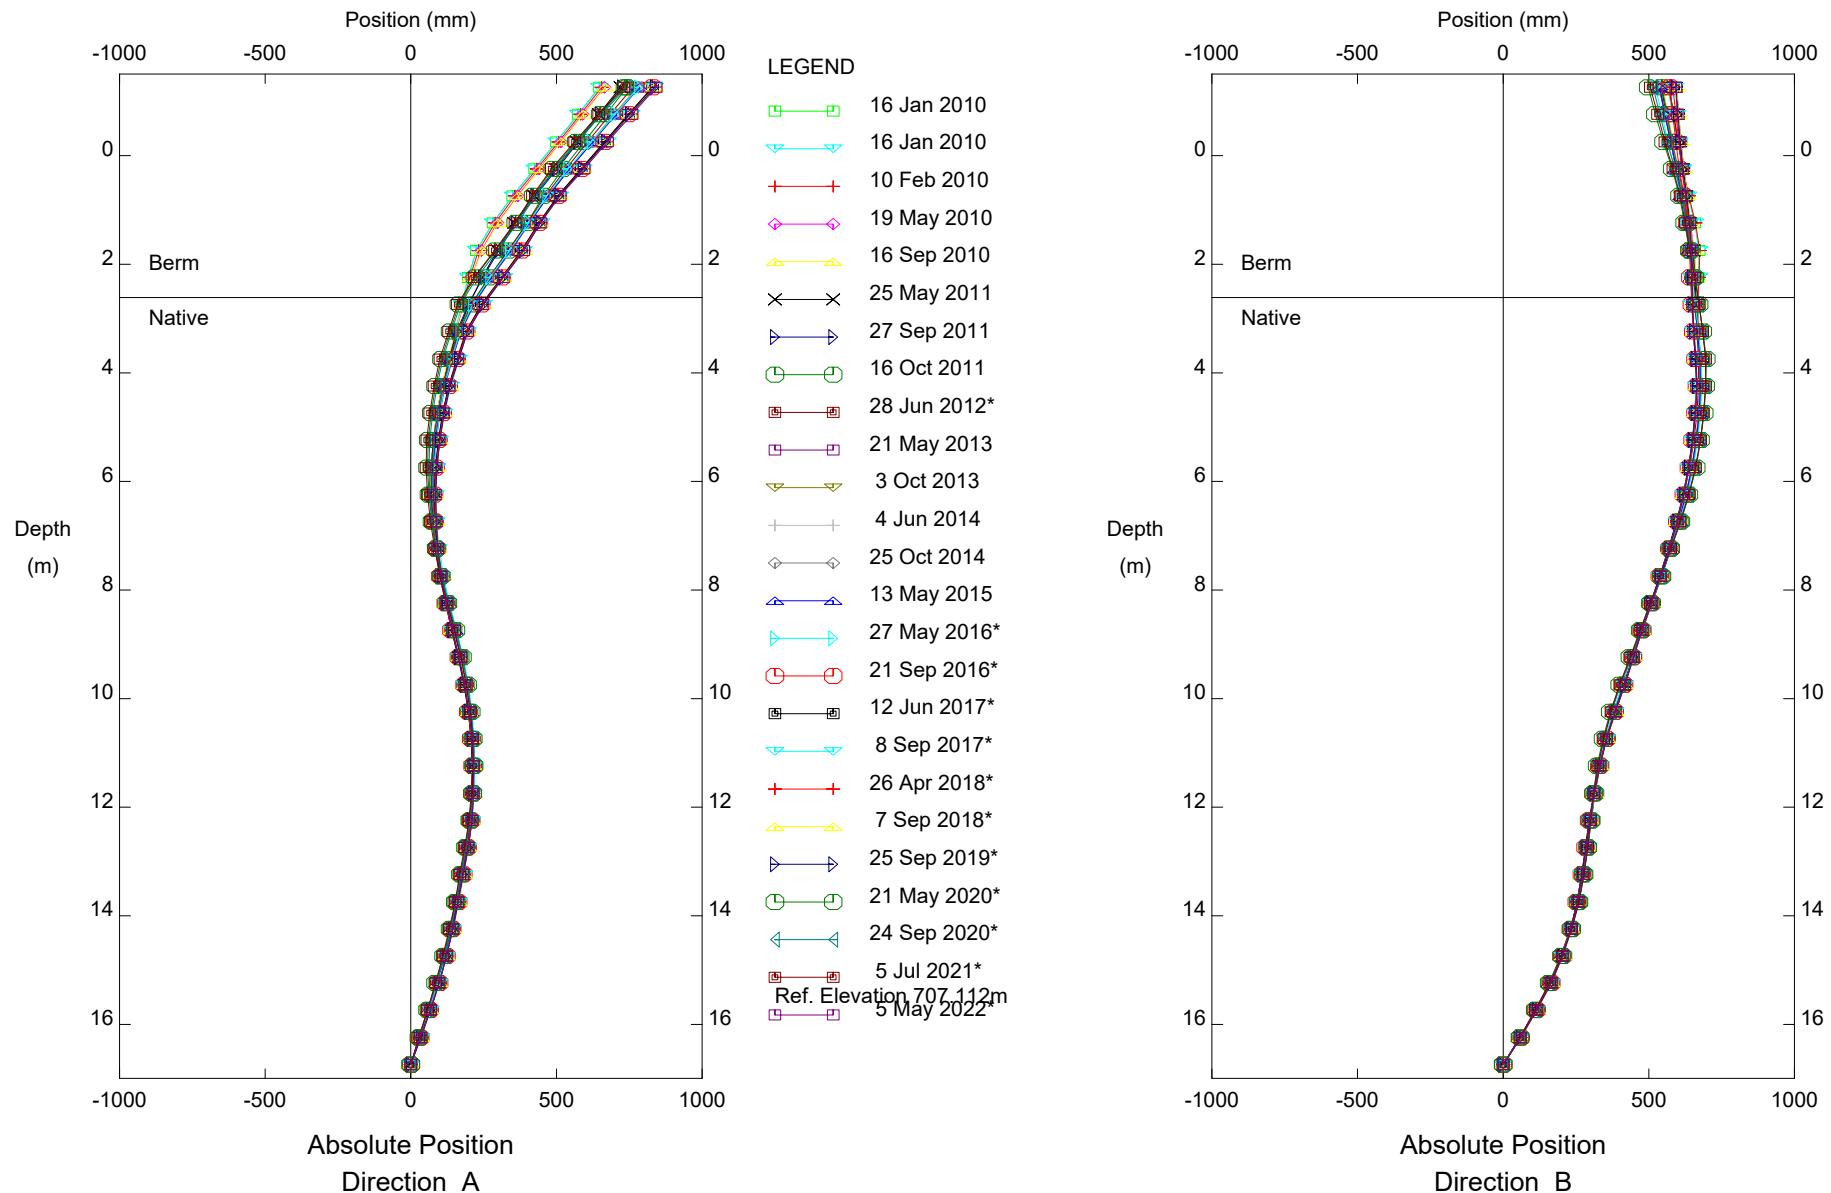
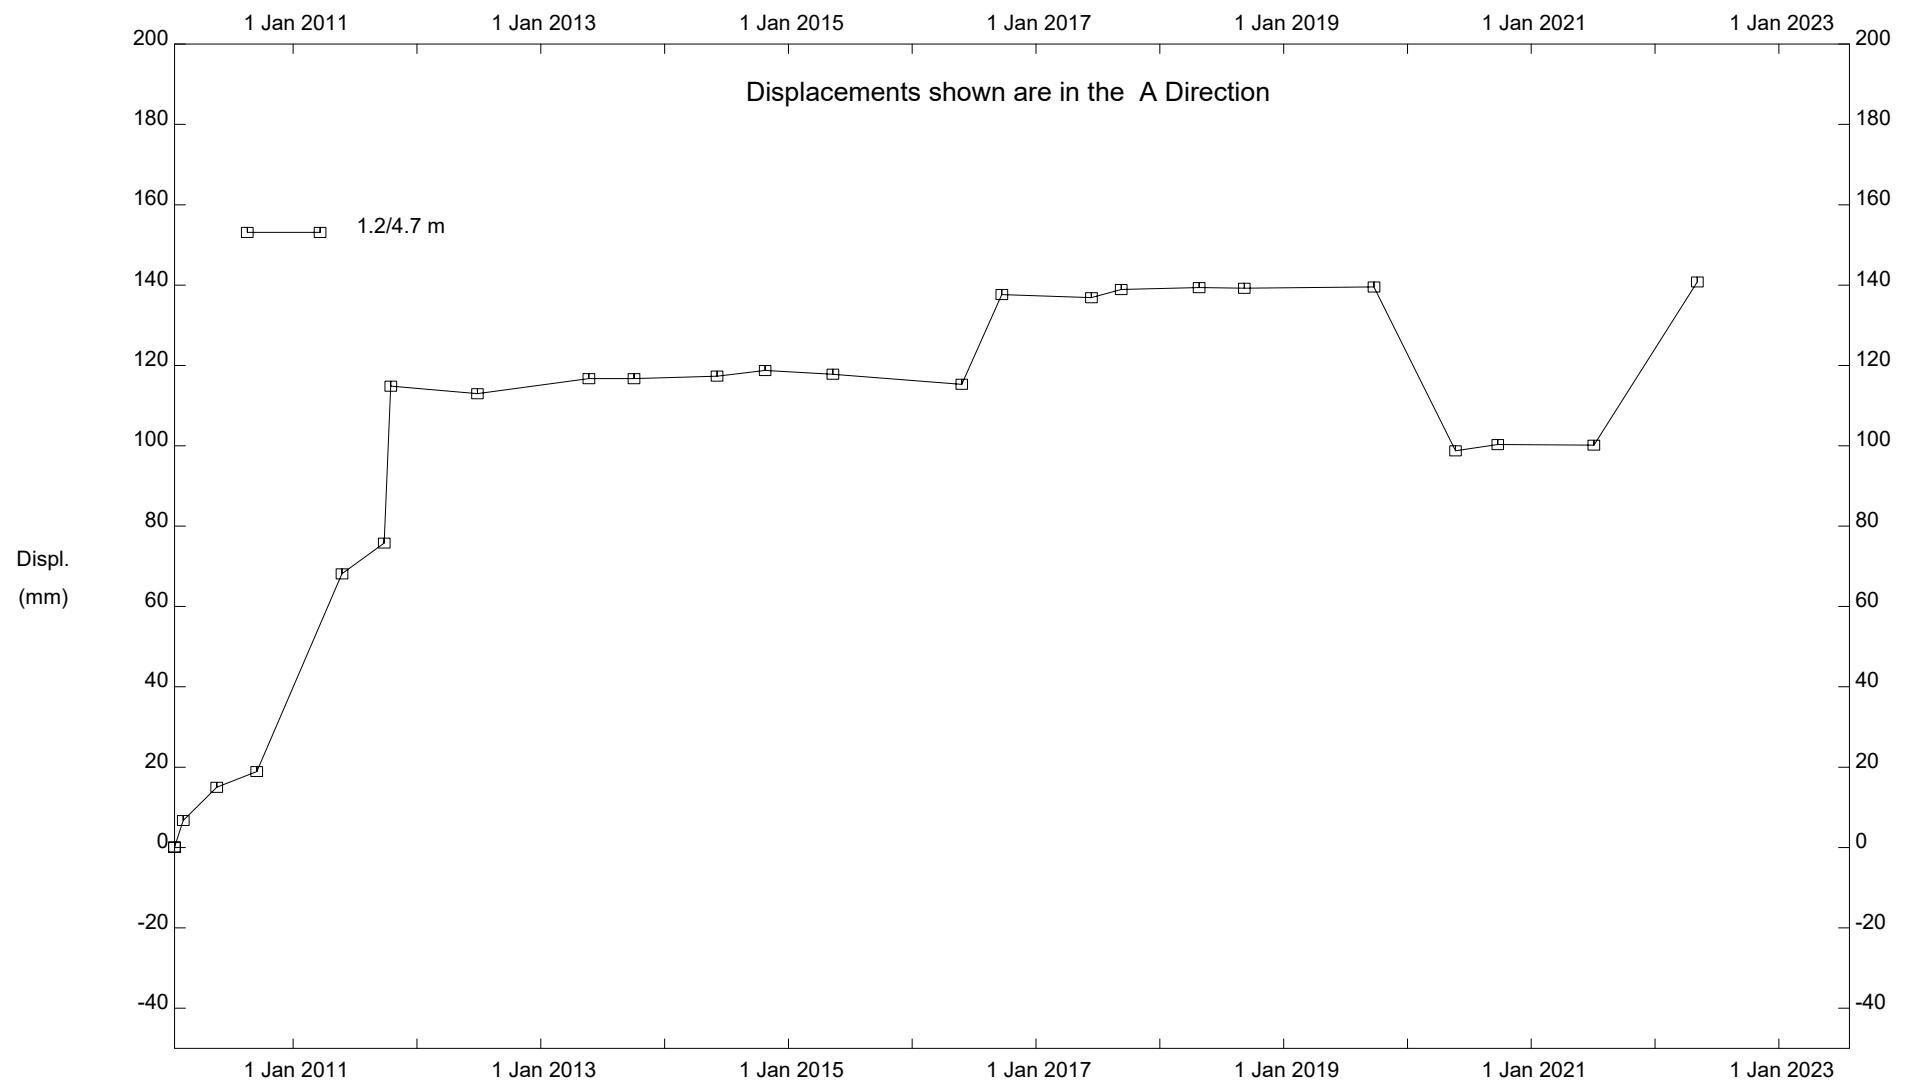
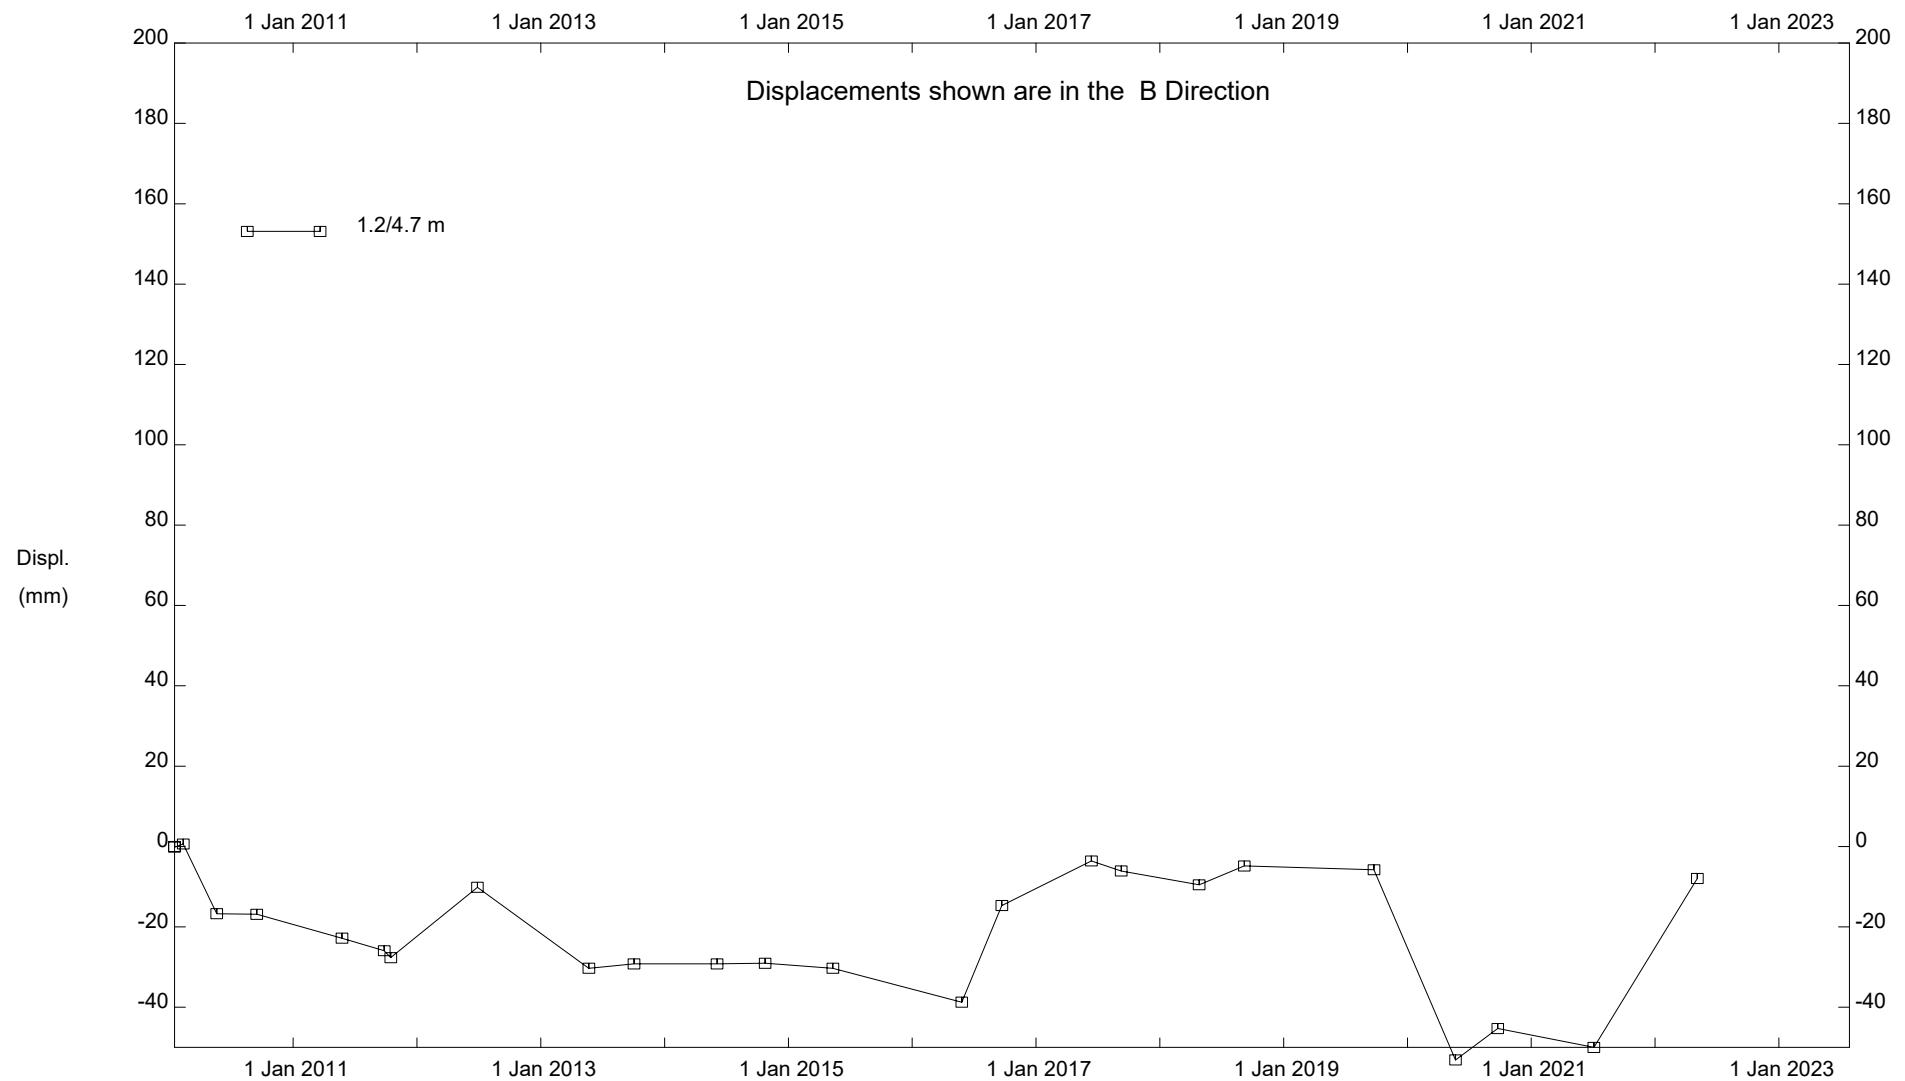
HWY32:10 South of Whitecourt (NC037), Inclinometer SI10-7

SI10-7 shows movement between 1.2 m to 4.7 m and is moving at an average rate of 2 mm/yr since berm construction in 2011. Spring 2022 reading cycle resulting in a current rate of movement of 1 mm/yr and a cumulative movement of 120 mm.

The absolute position plot for SI10-7 suggests there is disturbance of about 40 mm in the soil surrounding the inclinometer casing between 6 m to 15 m depth. This disturbance may be causing the erratic movement observed in the incremental and cumulative movement plots.
