To: Amy Driessen
Alberta Transportation
File: 123315222

From: Leslie Cho and Carrie Murray
Stantec Consulting Ltd.
Date: June 12, 2022

Reference: North Central Region, Edson, Site NC037 - Highway 32:10 South of Whitecourt, Spring 2022 Instrumentation Monitoring Report

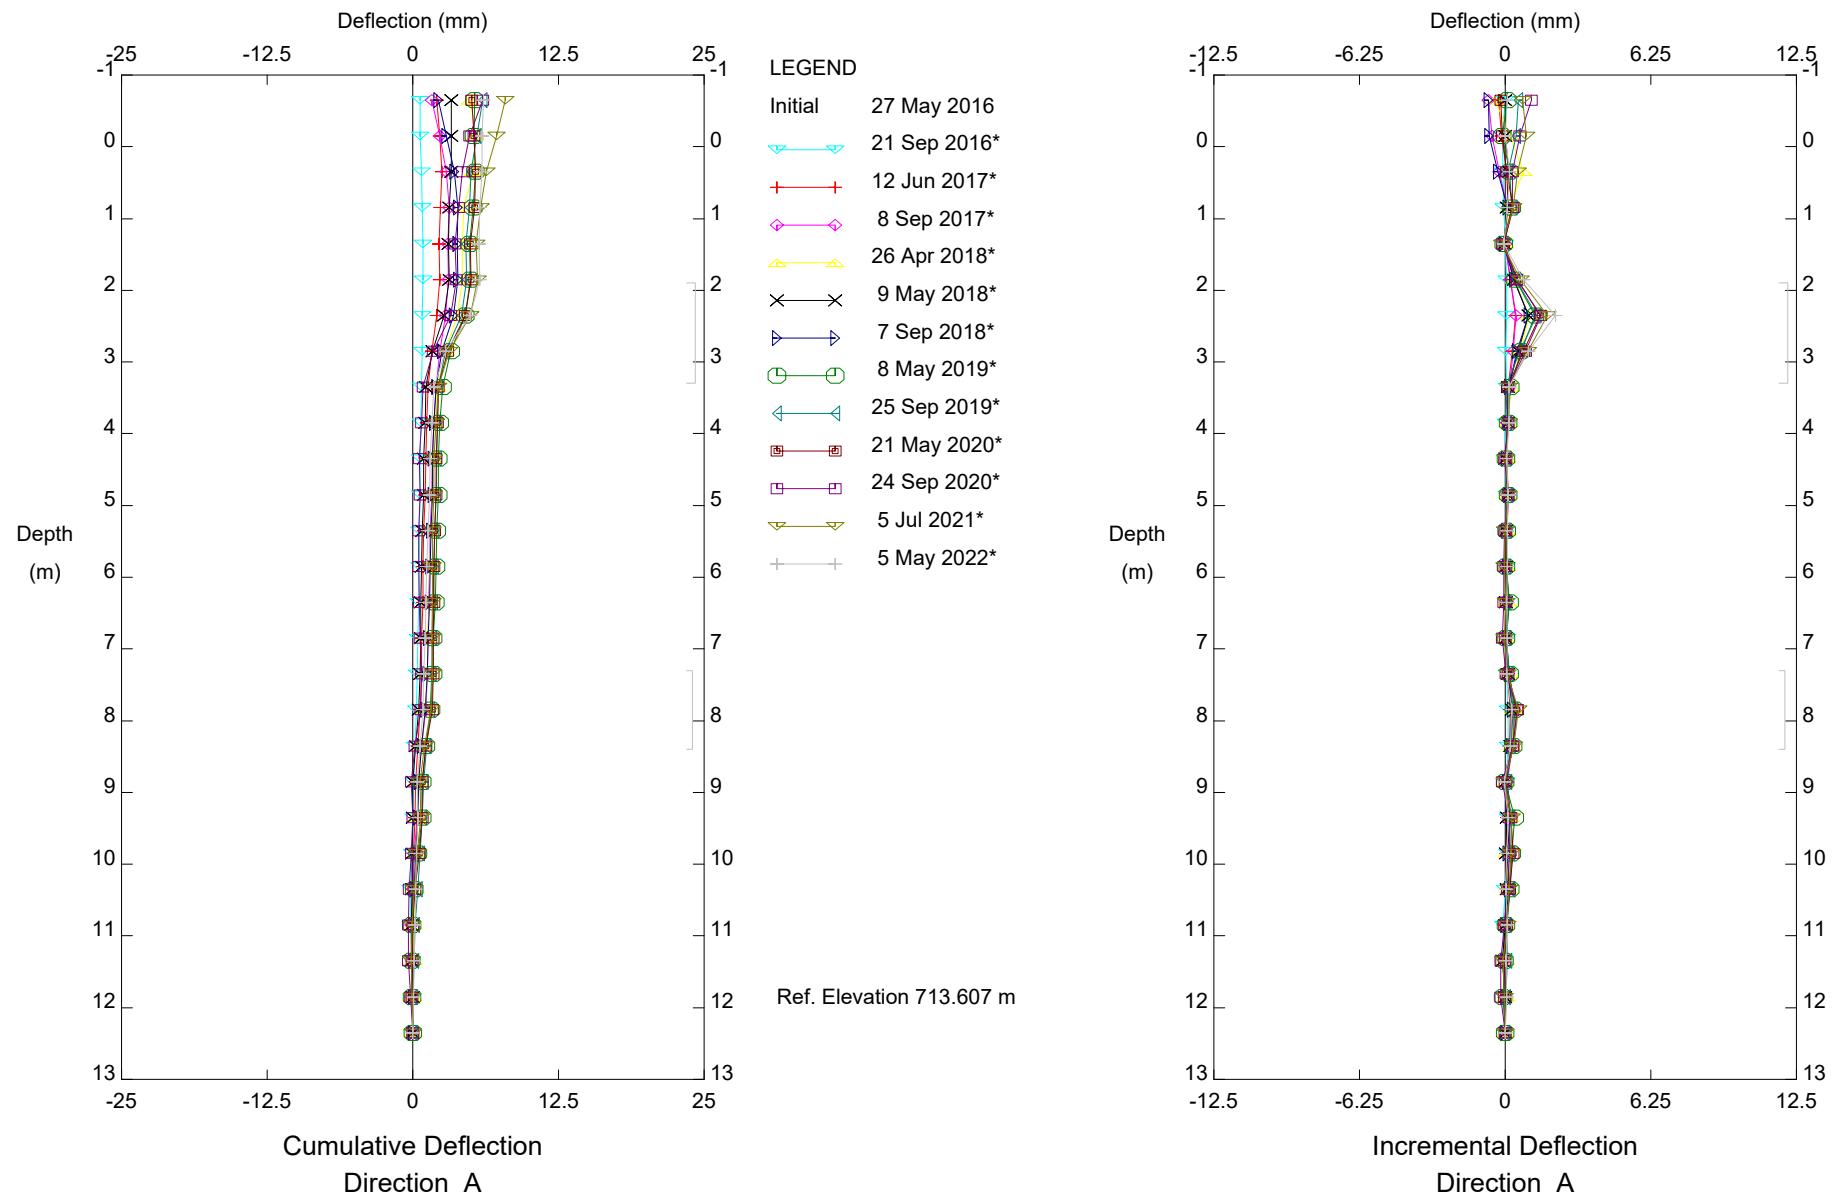
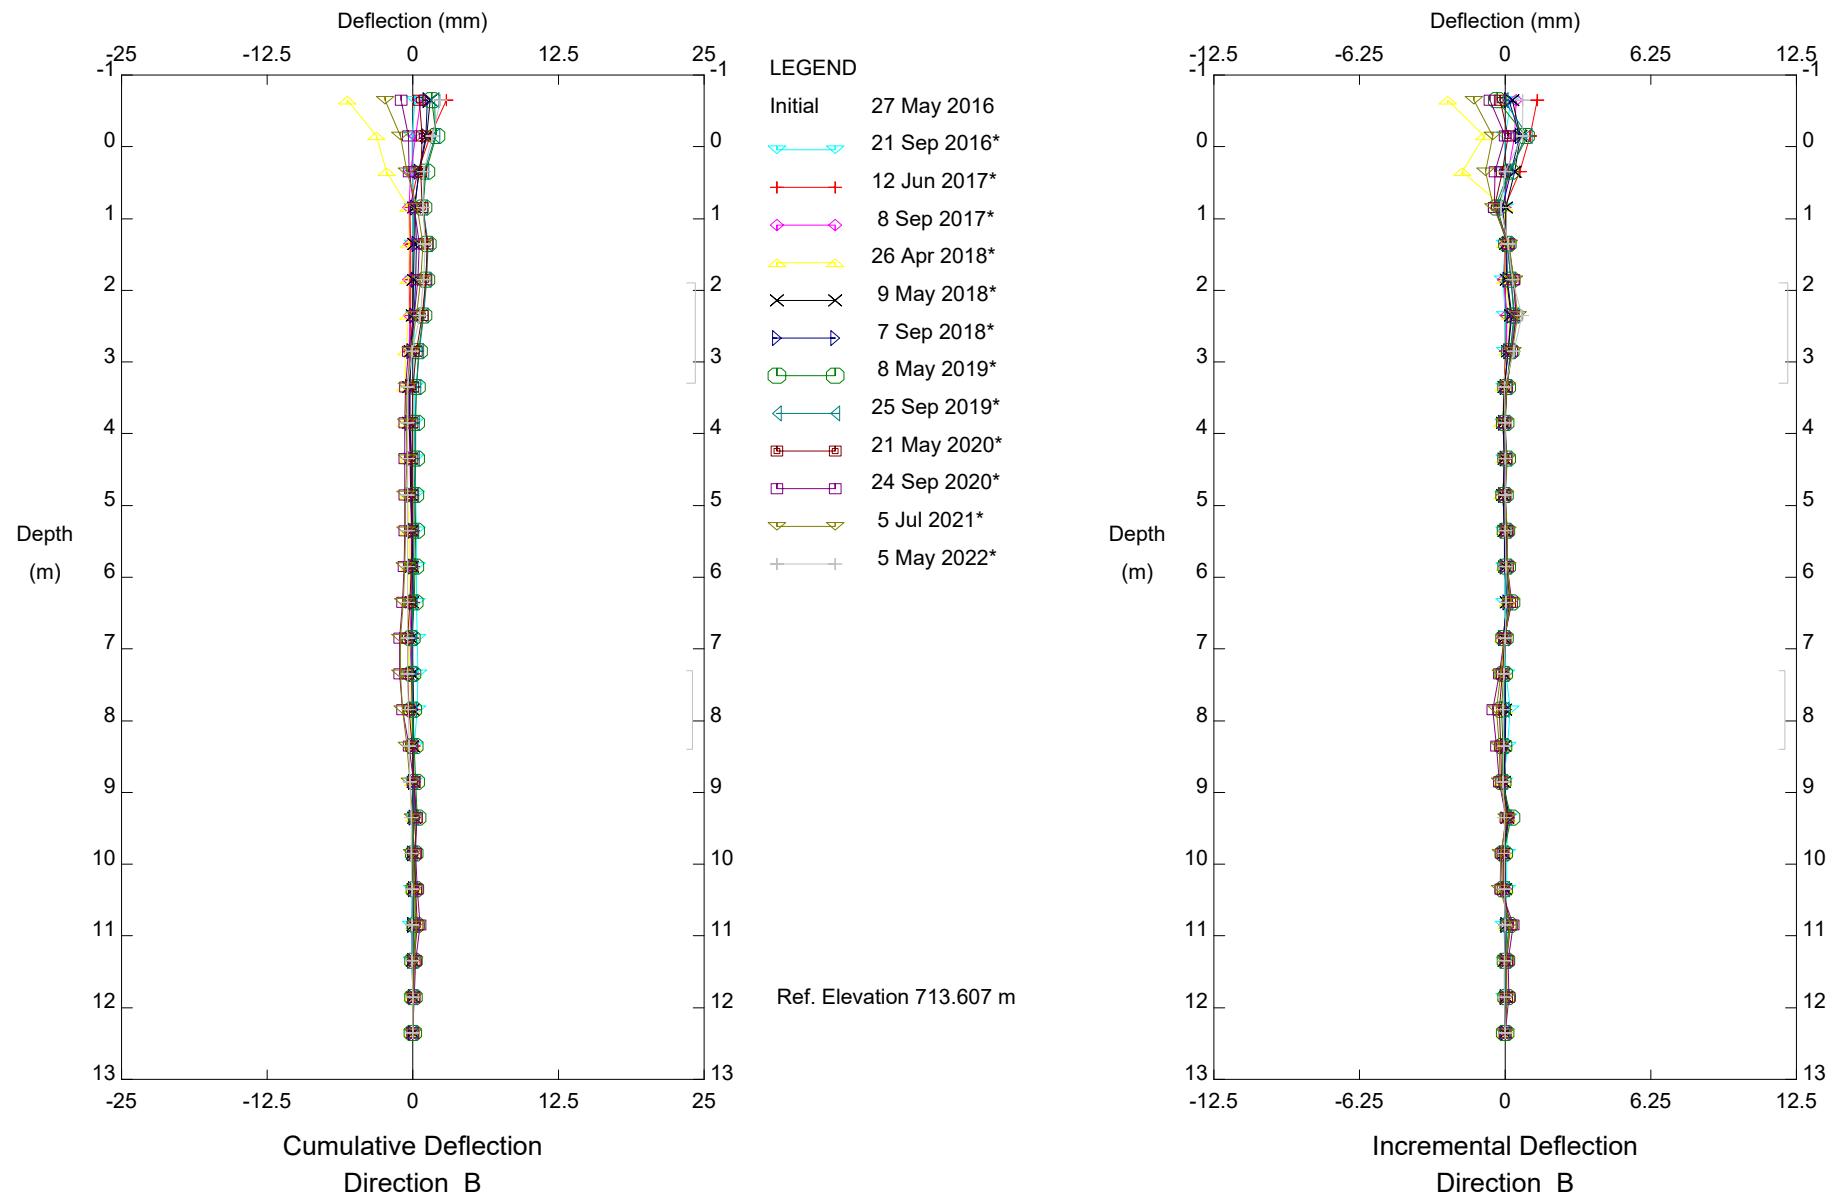
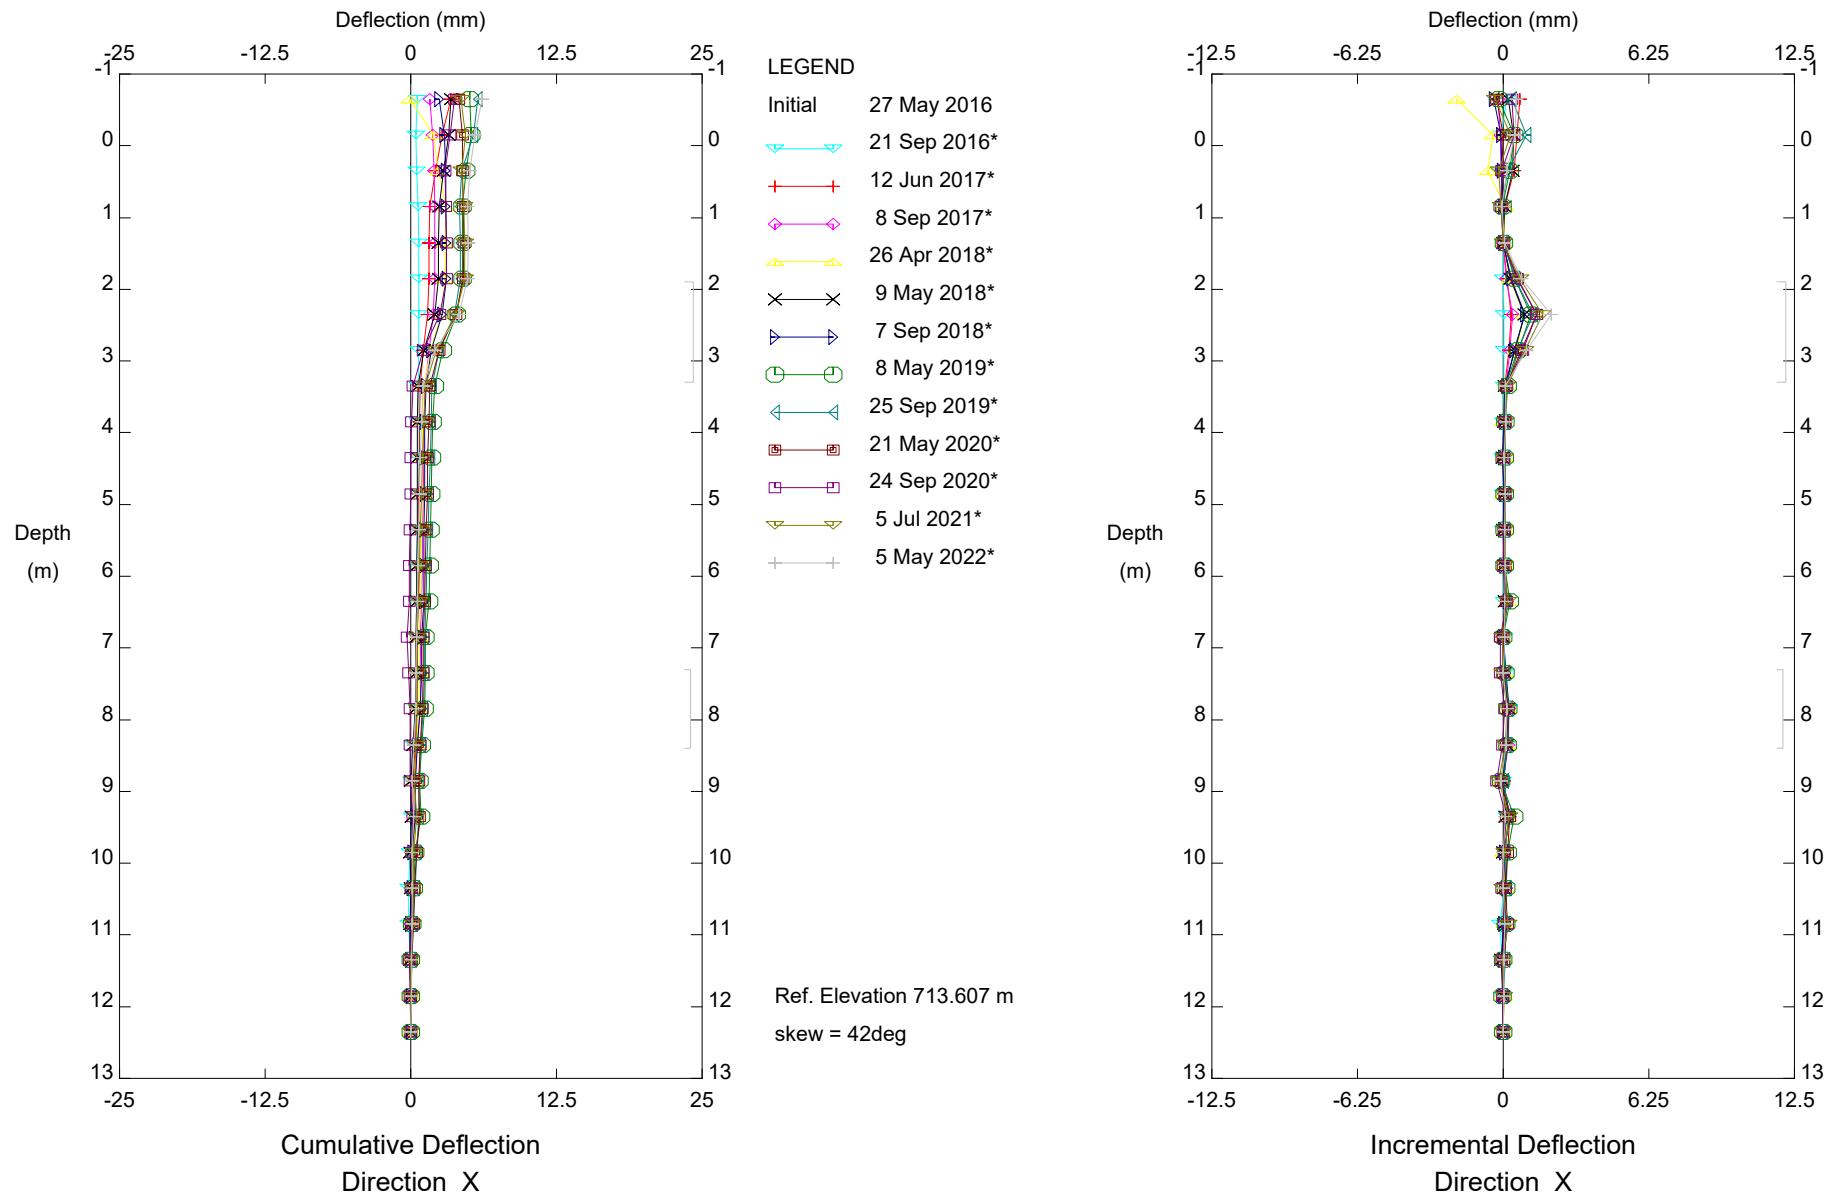
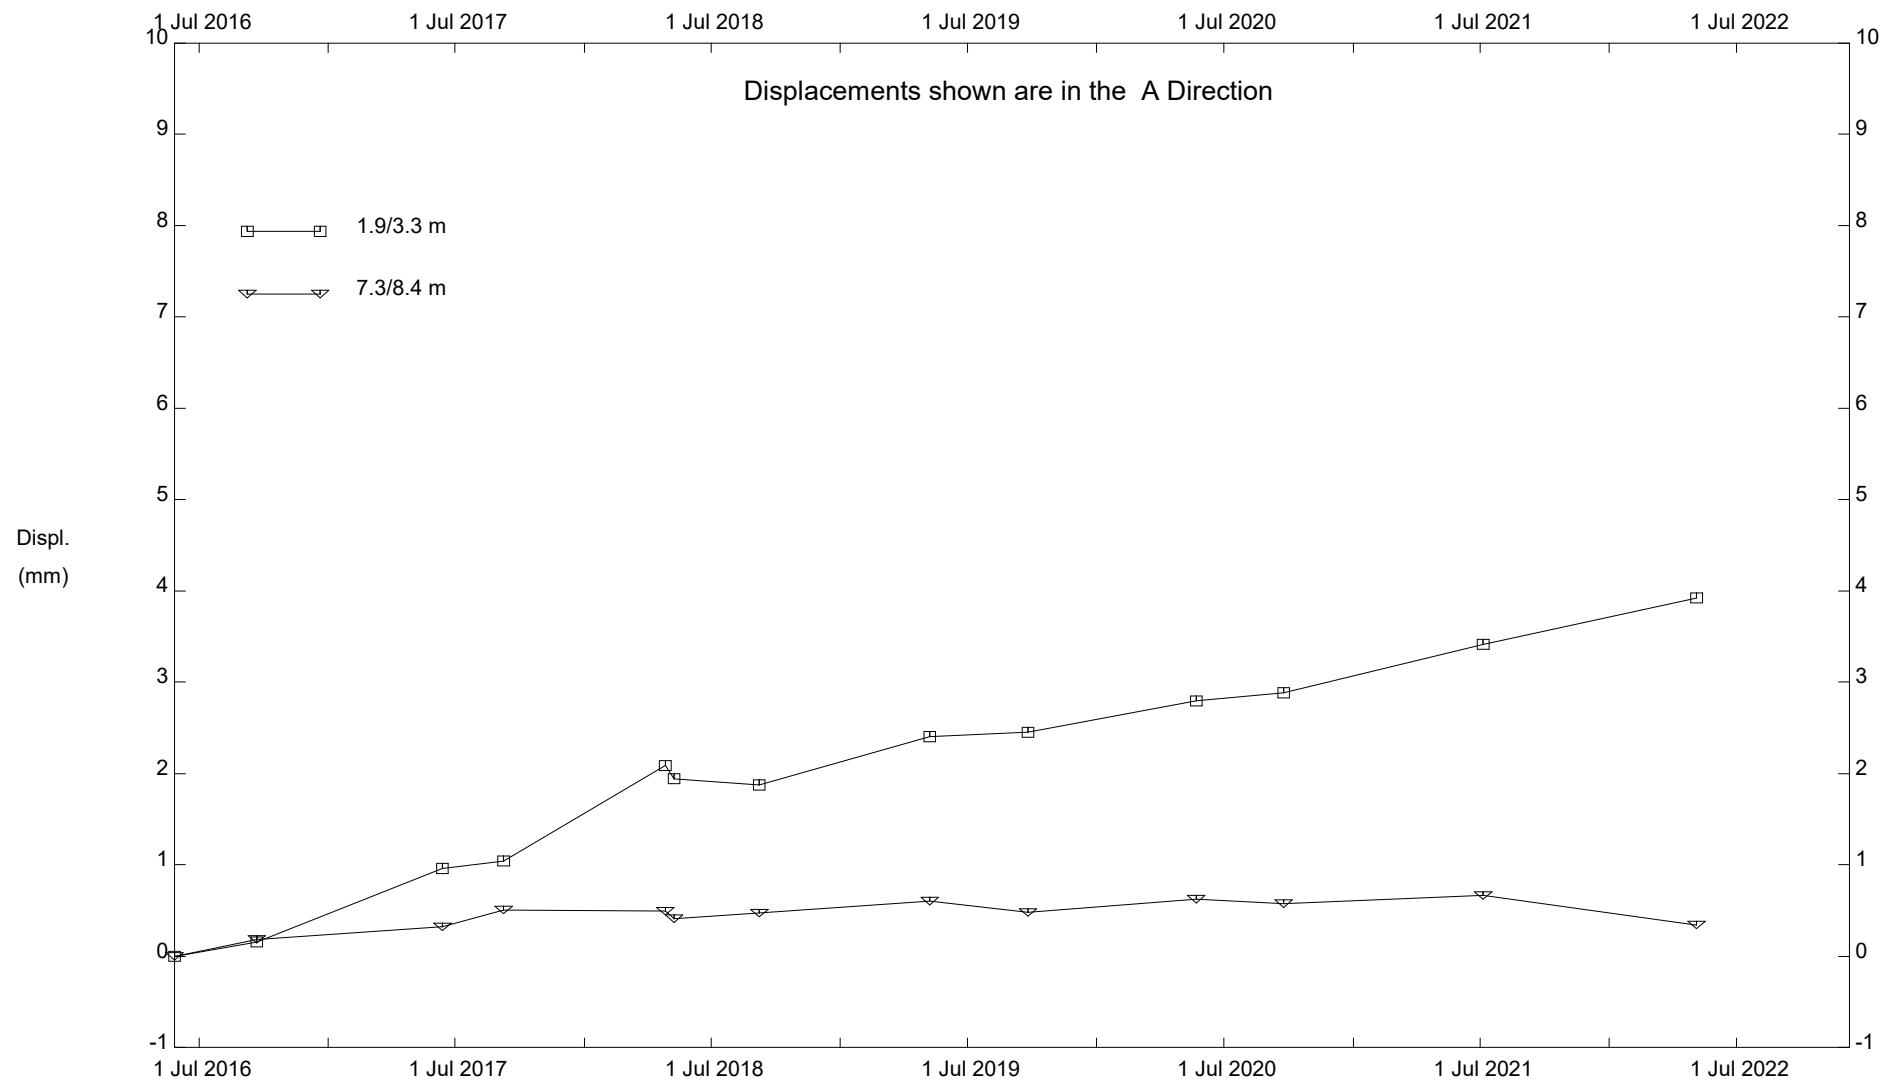
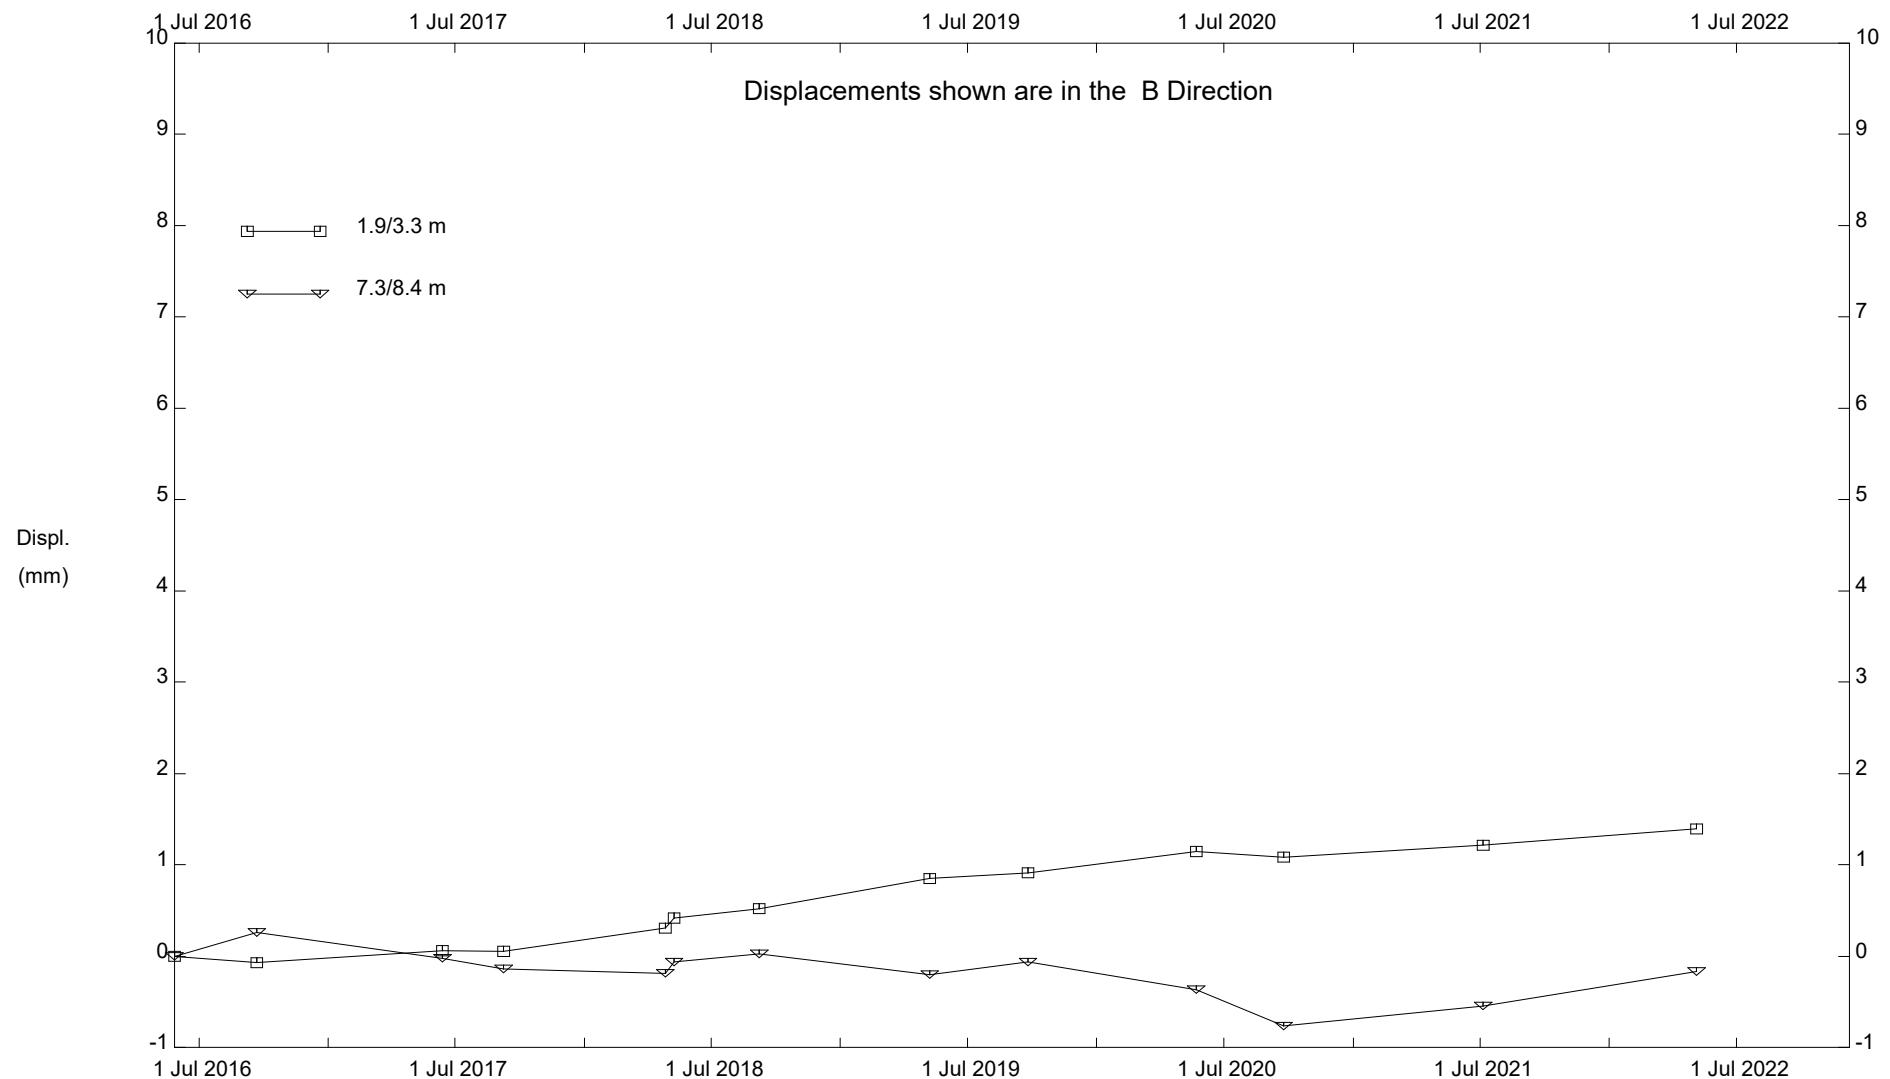
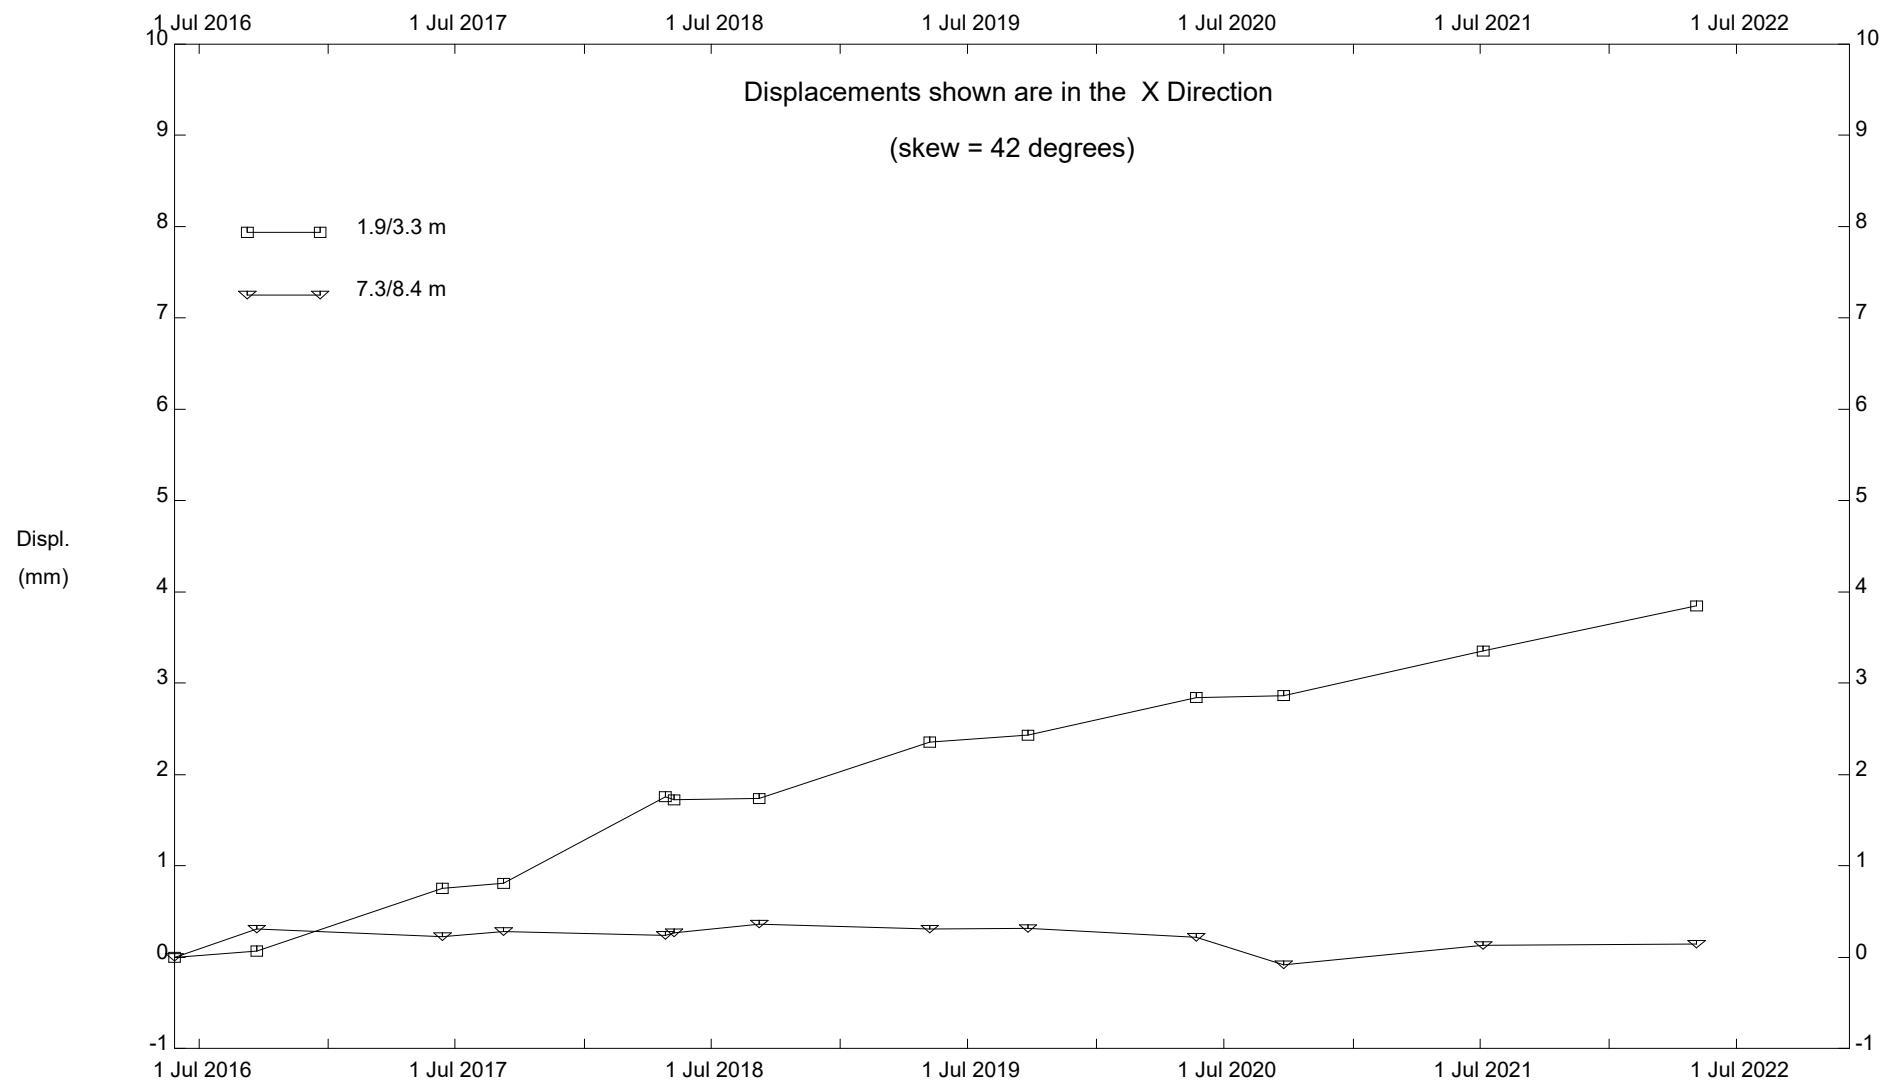
HWY32:10 South of Whitecourt (NC037), Inclinometer SI10-8

SI10-8 has two zones of movement at approximately 2.5 m and 8.0 m depth. The deeper movement zone has recorded less than 1 mm of movement since 2016 while the upper zone has cumulative movement up to 3 mm. The current movement rate in the upper zone is less than 1 mm/yr and appears to be creeping.

Note that during the work transfer to Stantec in 2016, a slight depth discrepancy was observed in SI10-8 due to different units of measurement used during data collection. To present more accurate information, data prior to 2016 was excluded from the SI plots and the cumulative movement since initialization included on Table NC37-1.
