To: Amy Driessen
Alberta Transportation
File: 123315222

From: Leslie Cho and Carrie Murray
Stantec Consulting Ltd.
Date: June 12, 2022

Reference: North Central Region, Edson, Site NC037 - Highway 32:10 South of Whitecourt, Spring 2022 Instrumentation Monitoring Report

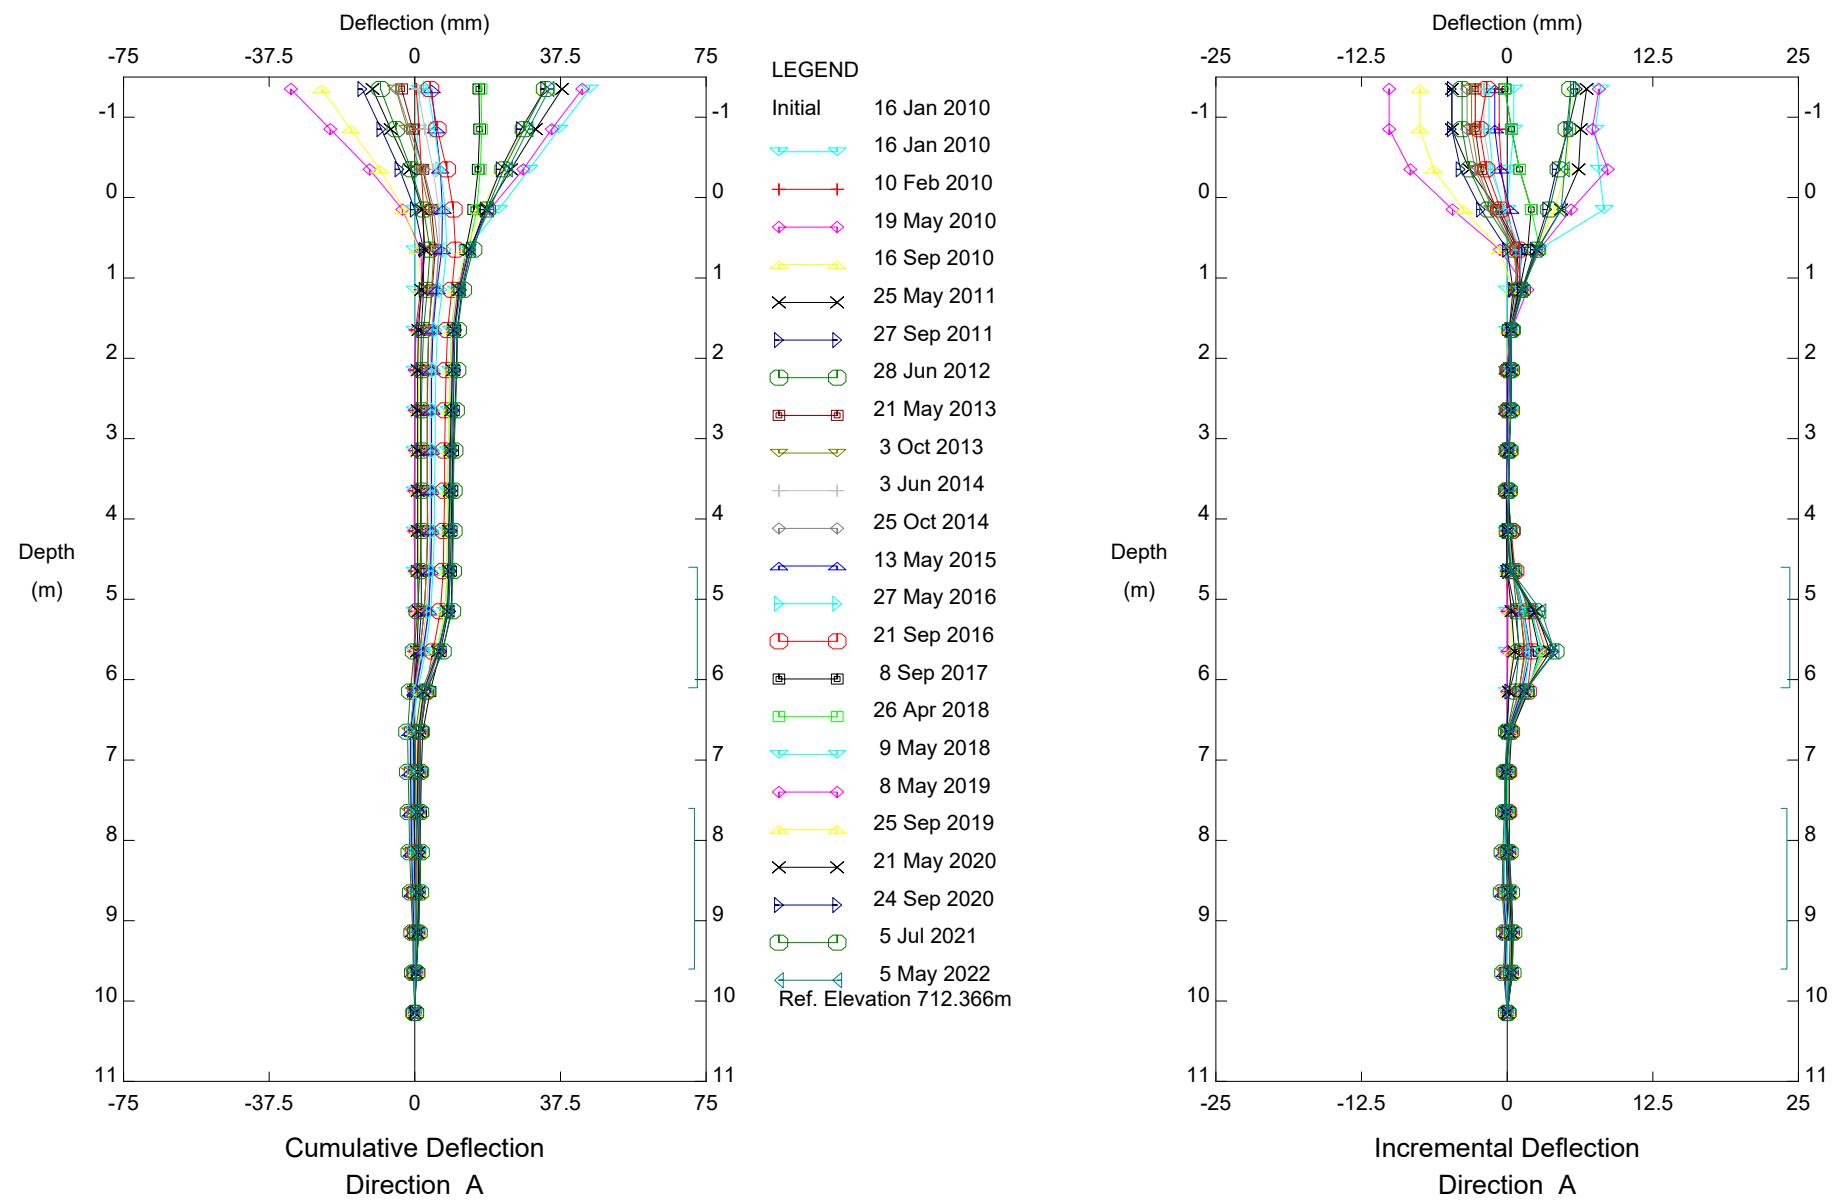
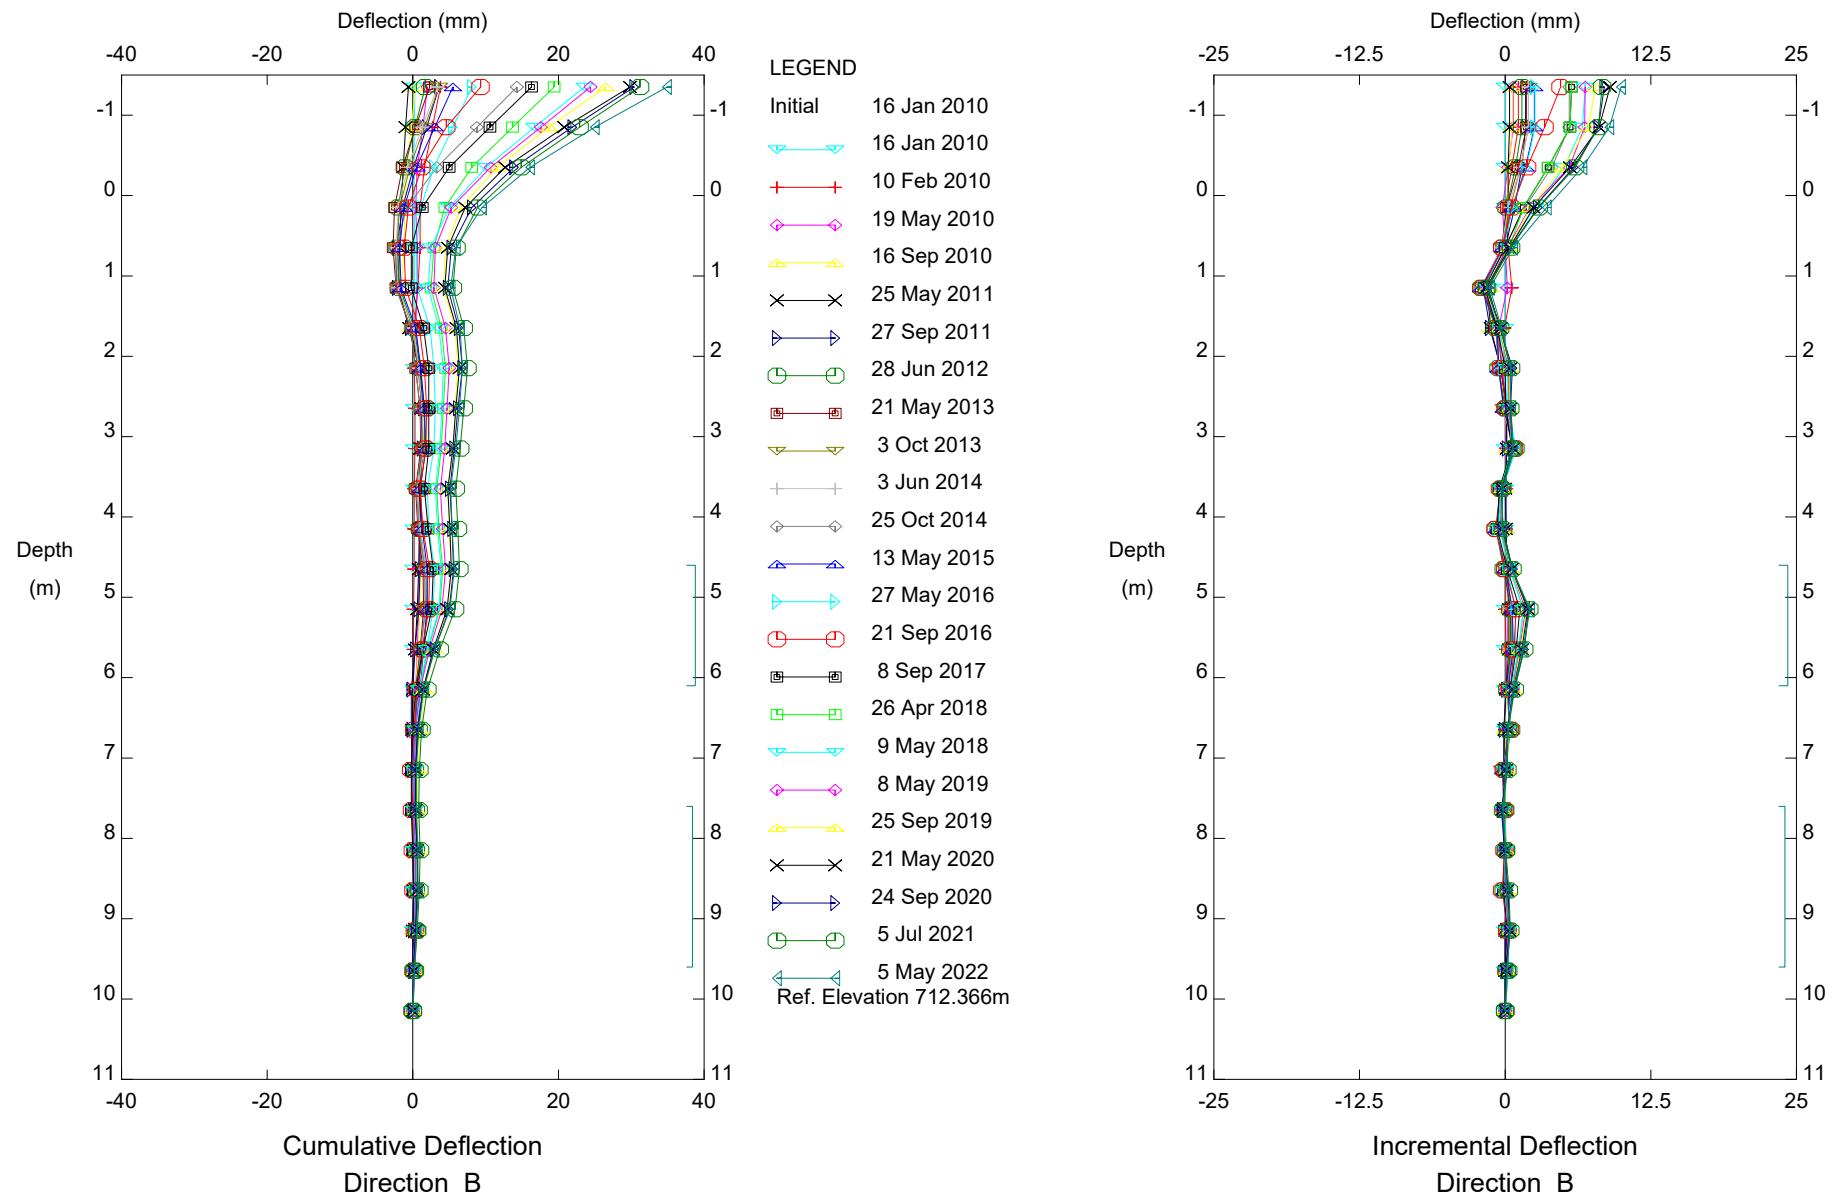
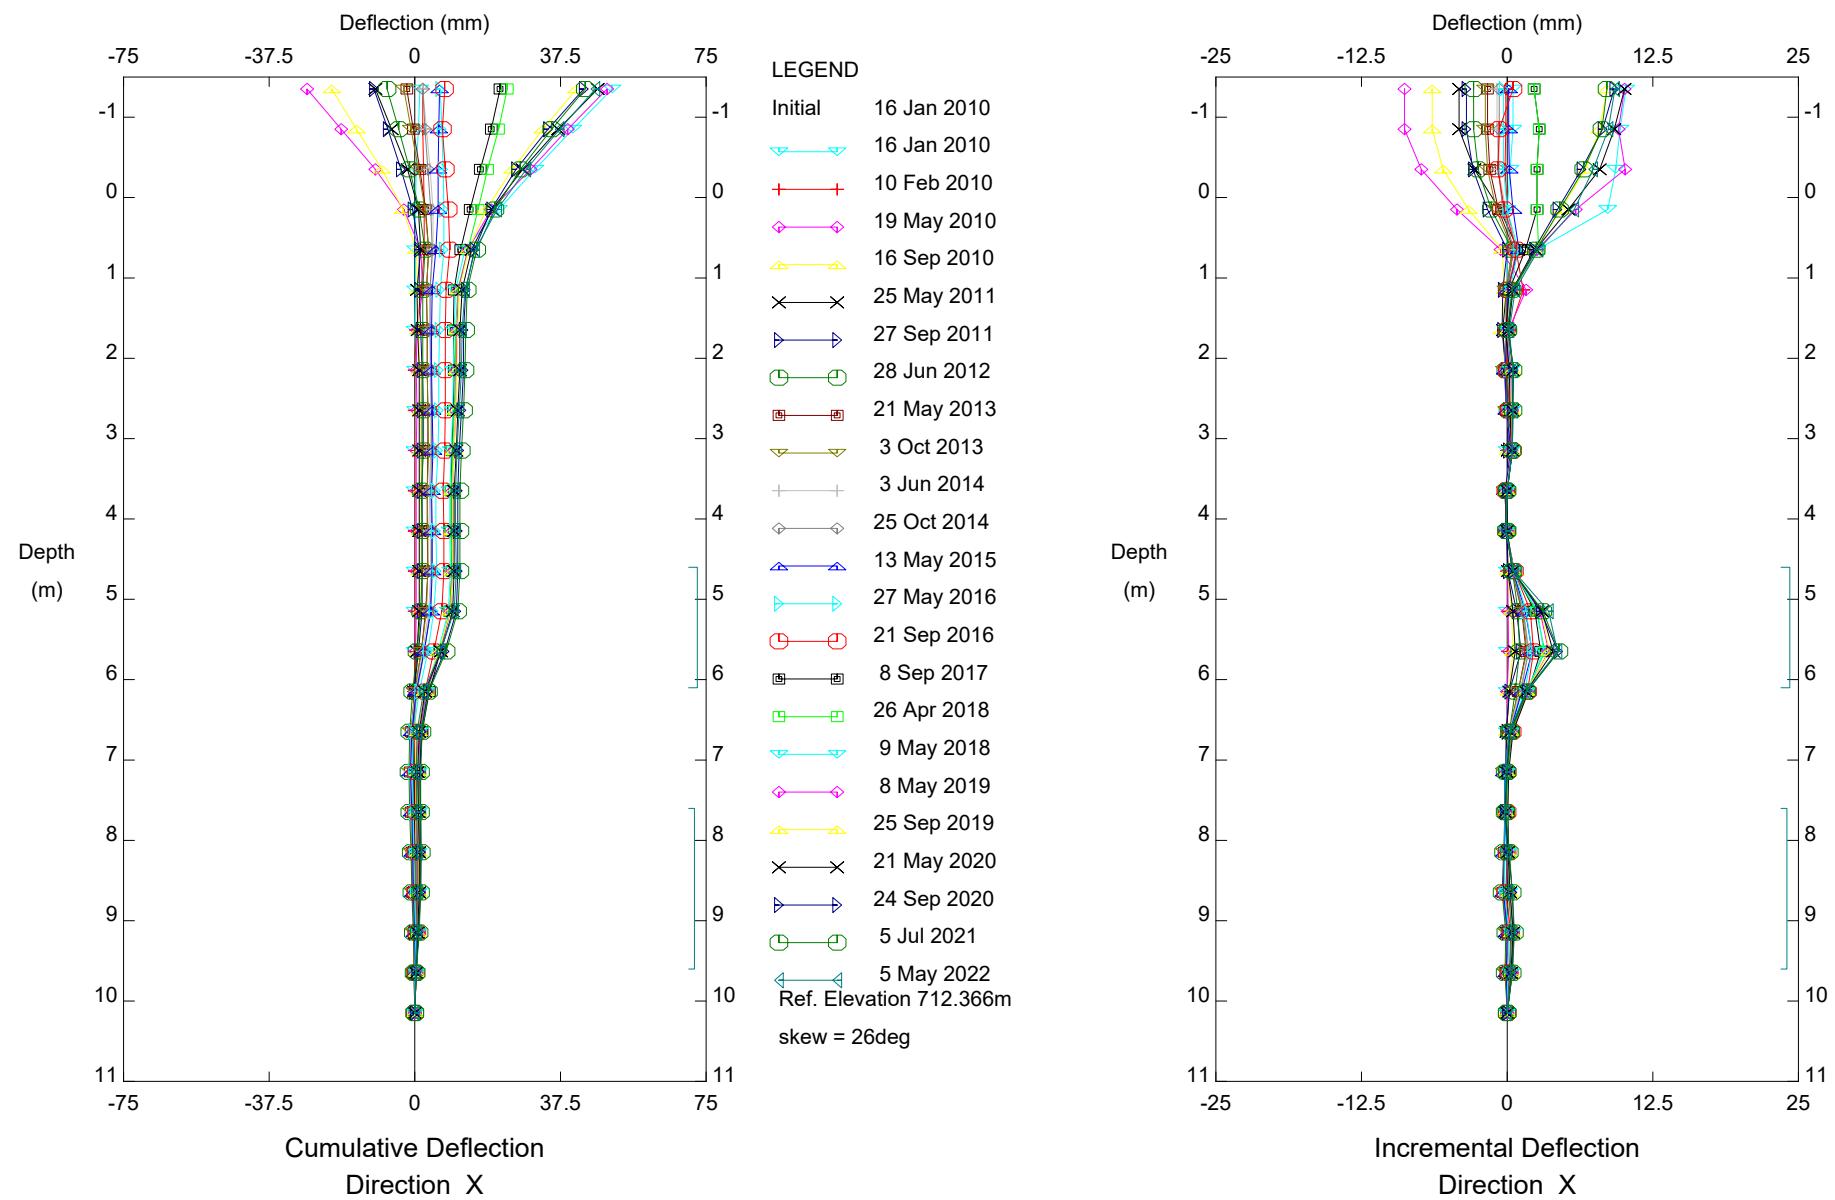
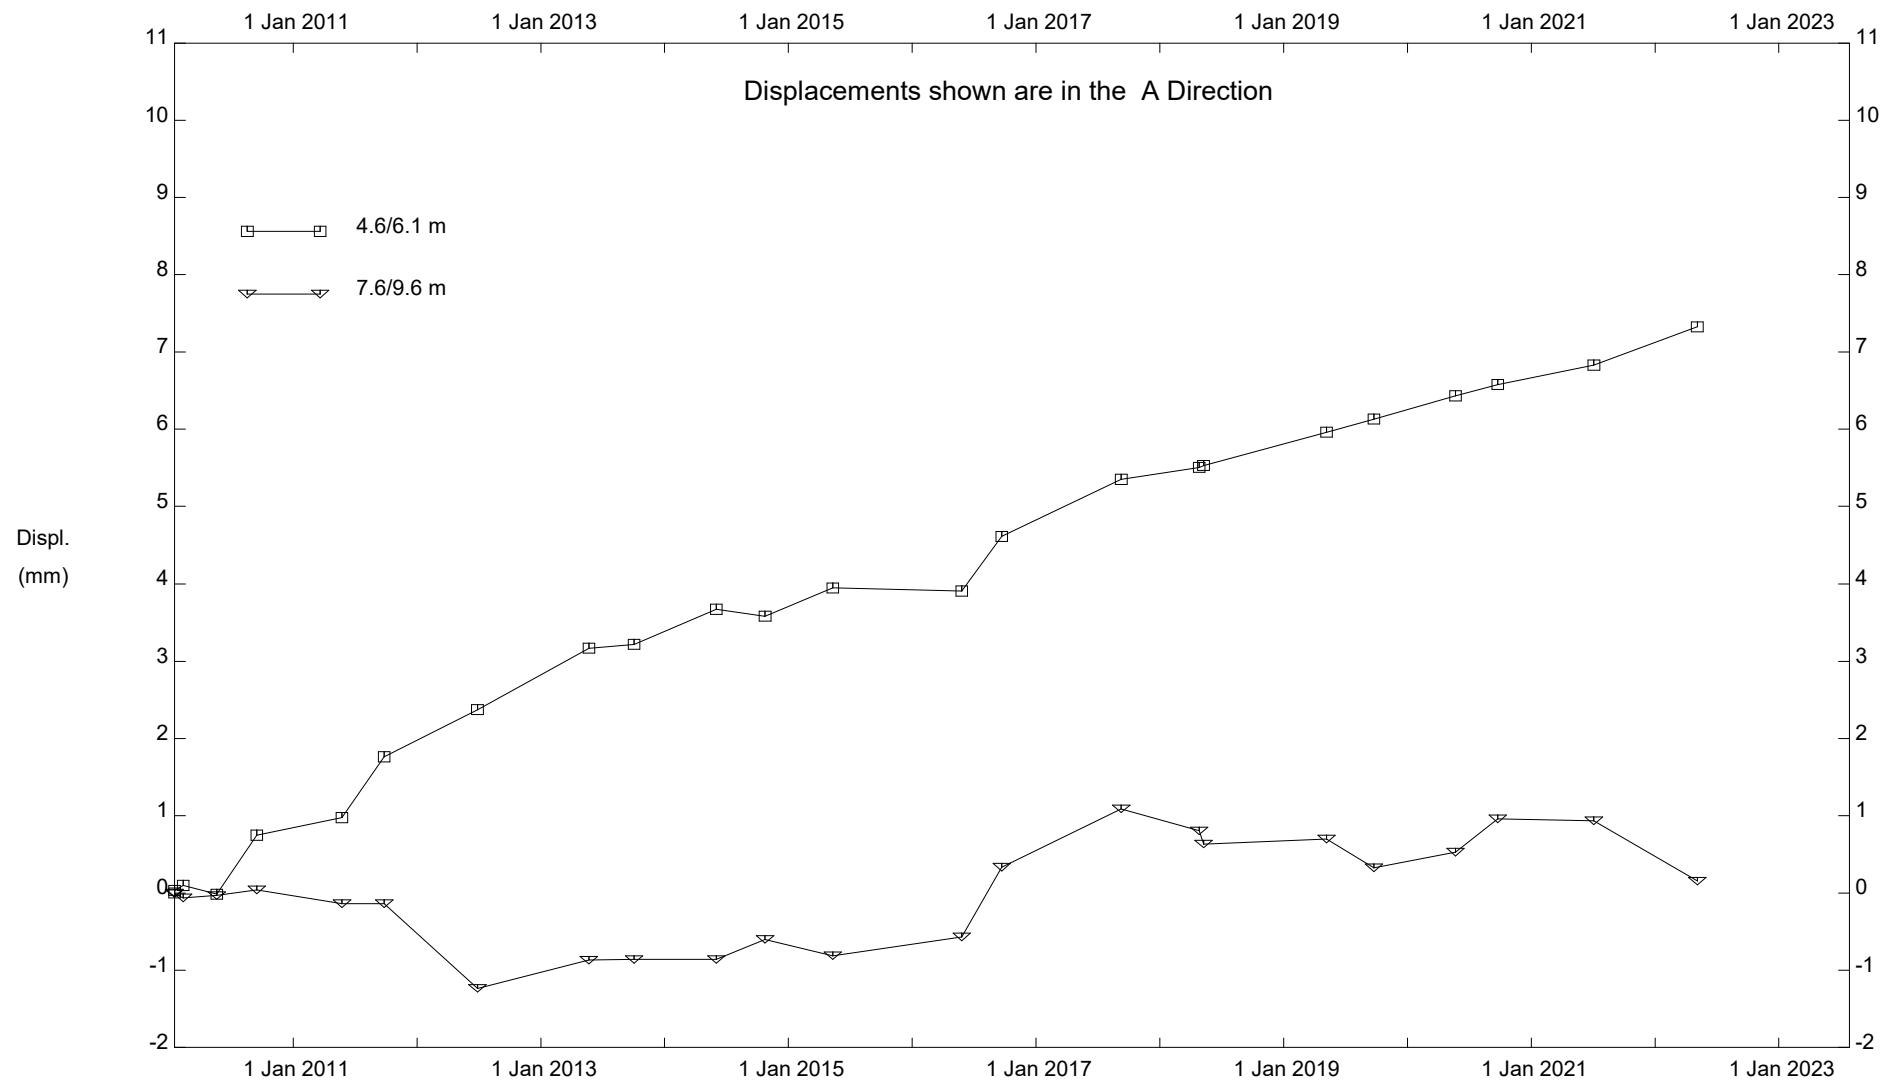
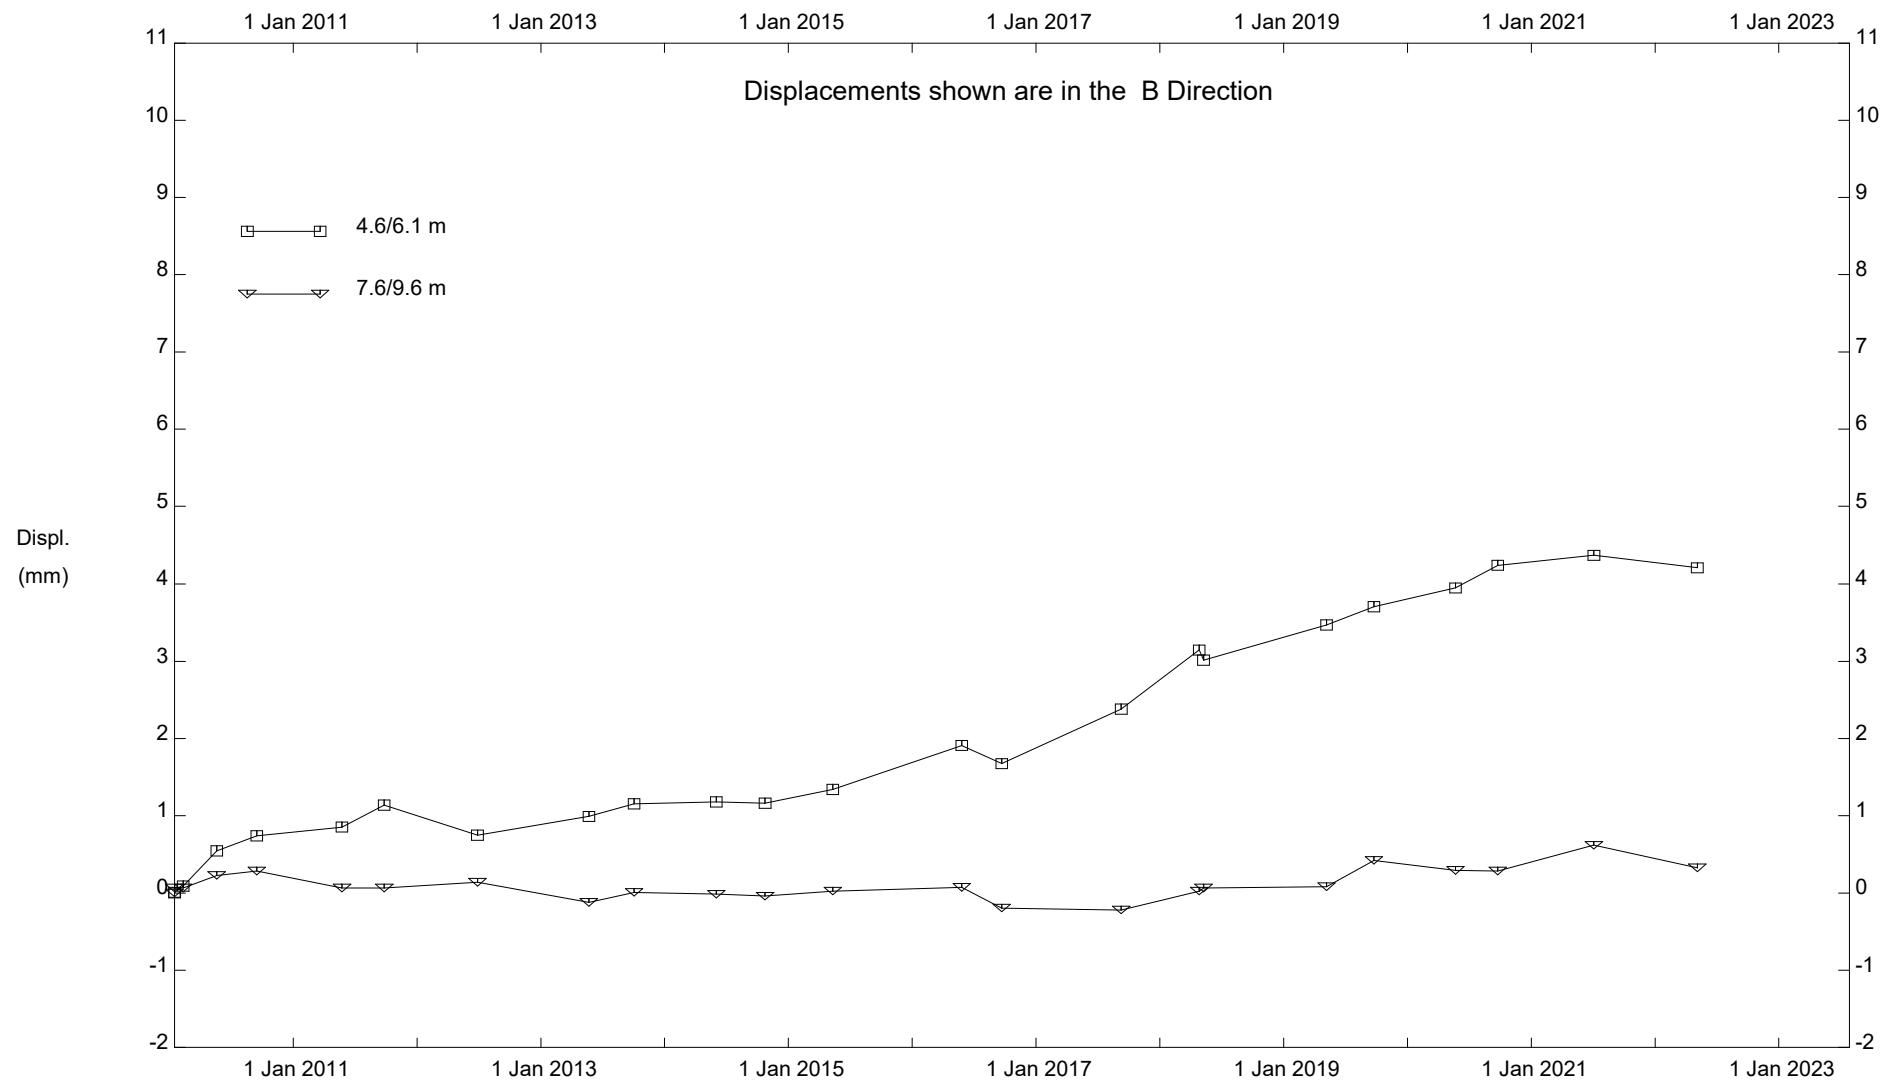
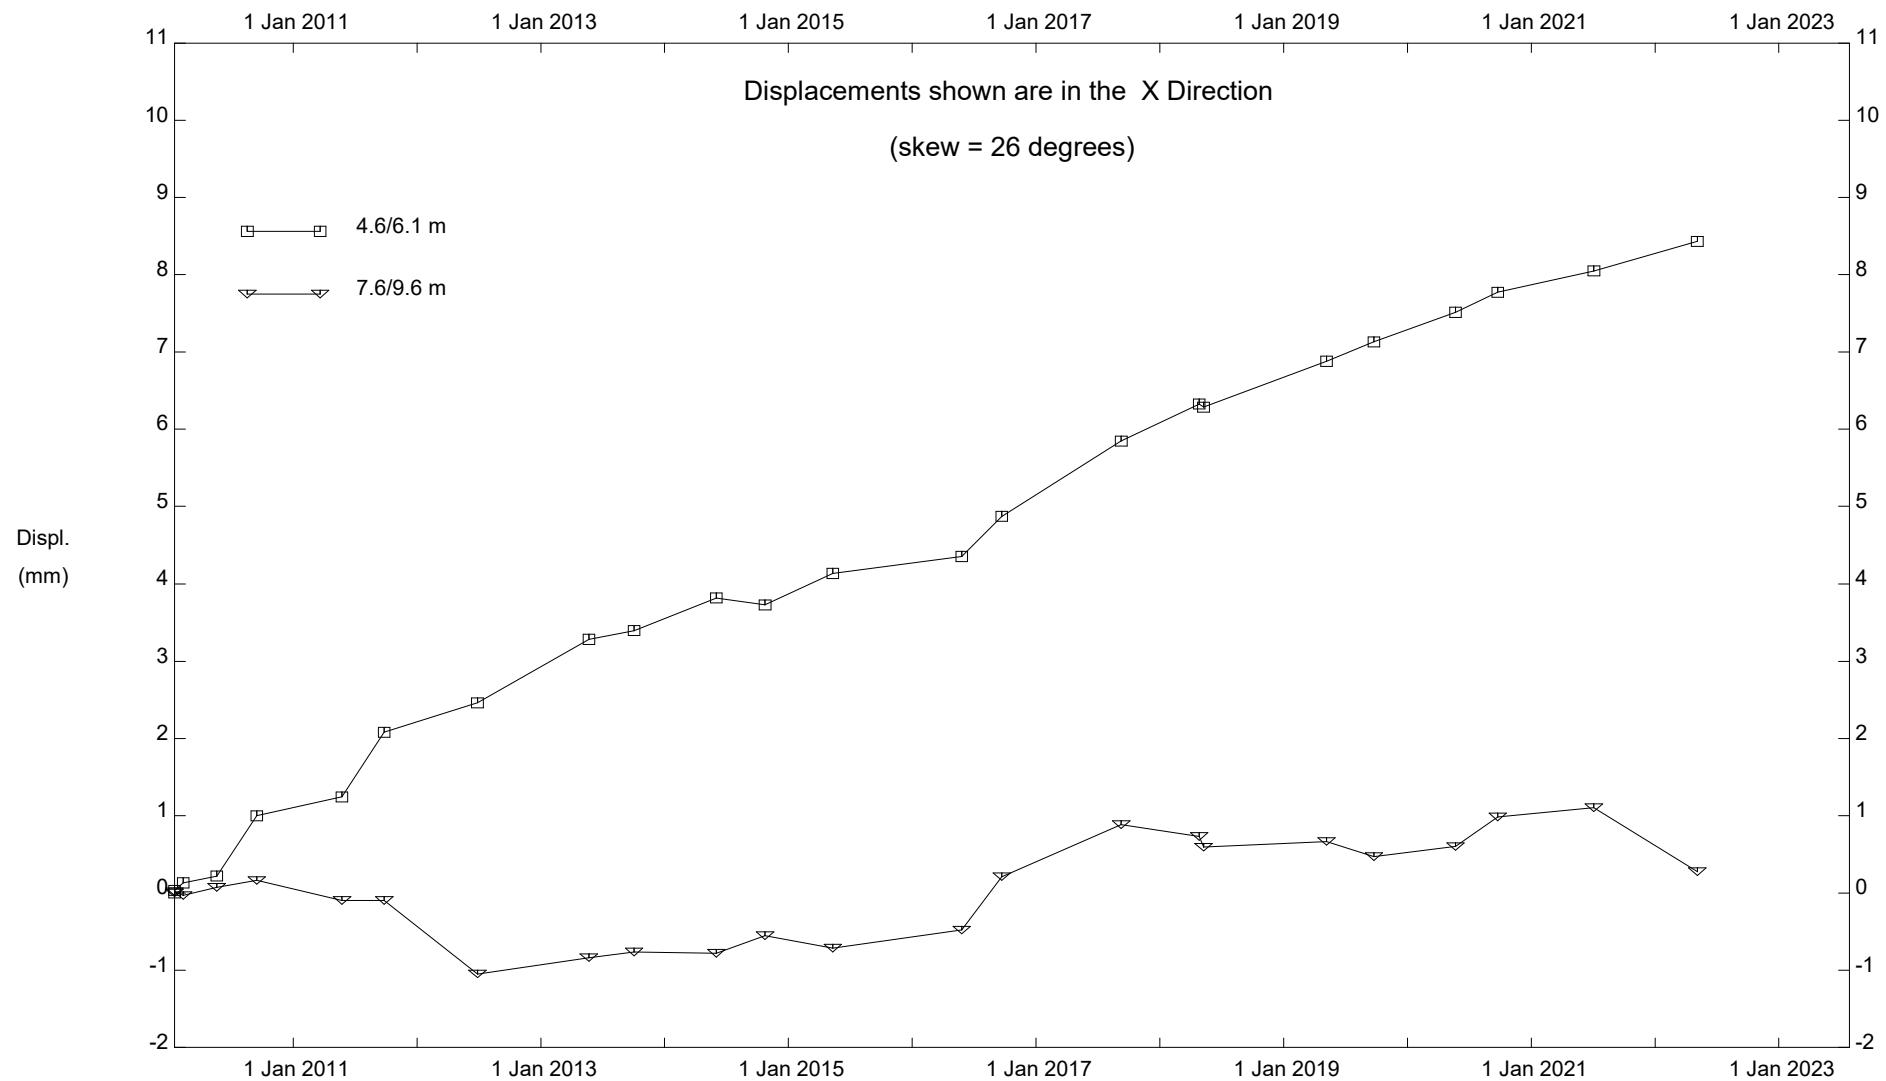
HWY32:10 South of Whitecourt (NC037), Inclinometer SI10-9

SI10-9 has two zones of movement at approximately 4.6 m to 6.1 m and 7.6 m to 9.6 m depth. The upper movement zone shows creep movement since 2011 with movement rates of less than 1 mm/yr. Negligible movement was observed in the lower movement zone since initialization.

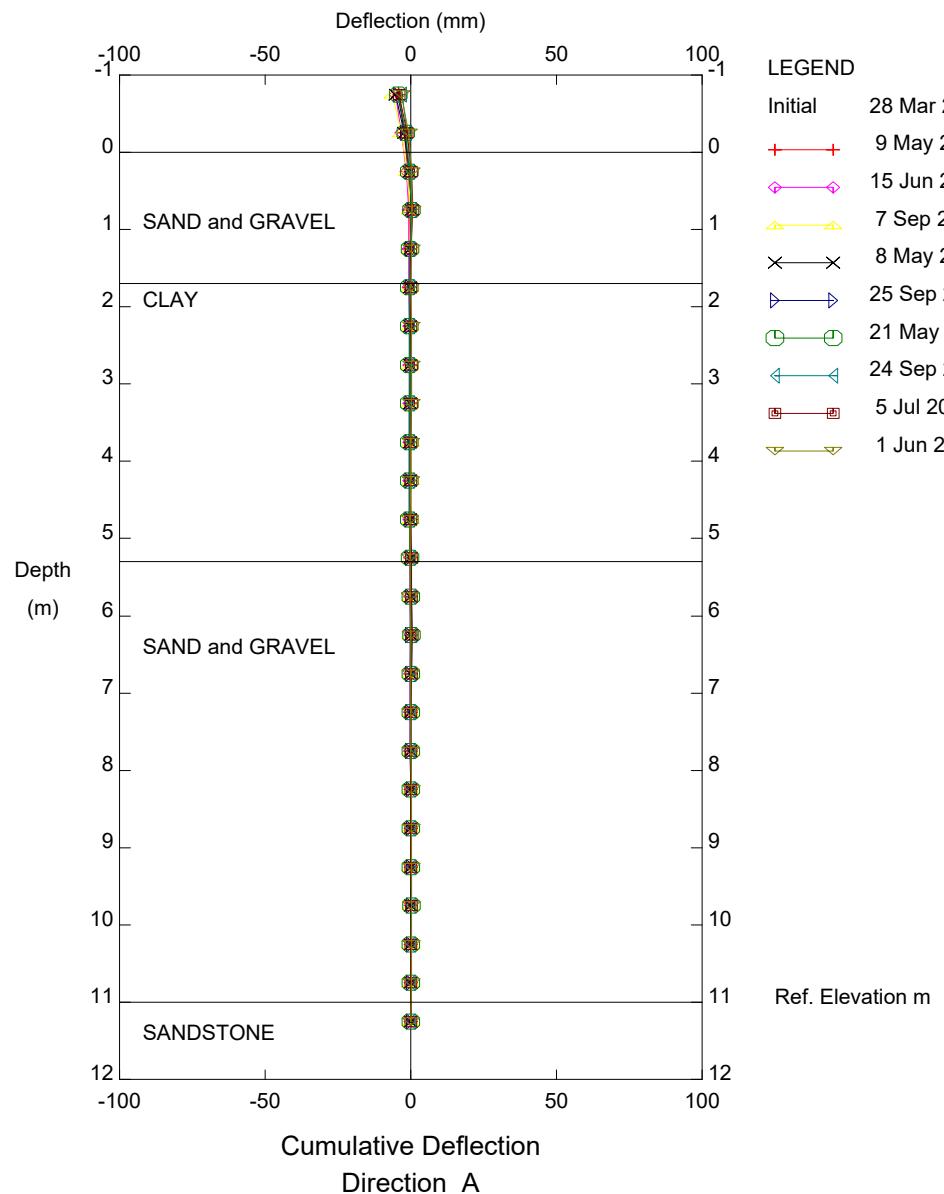
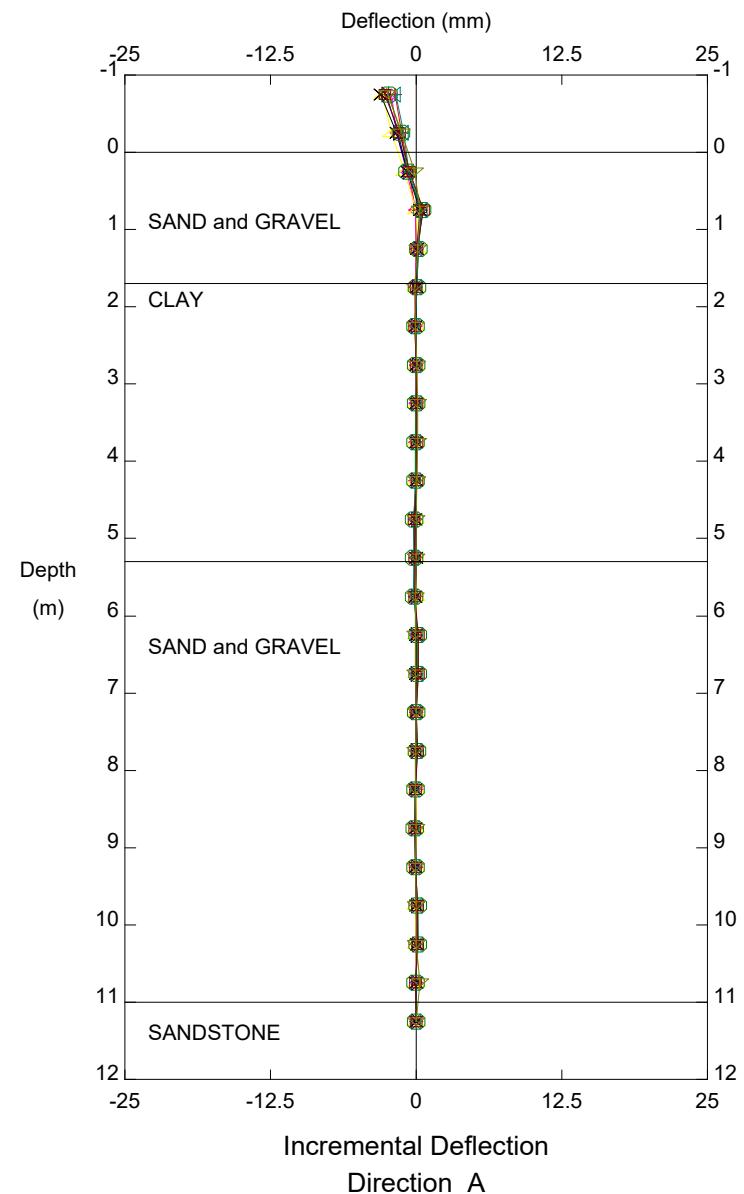
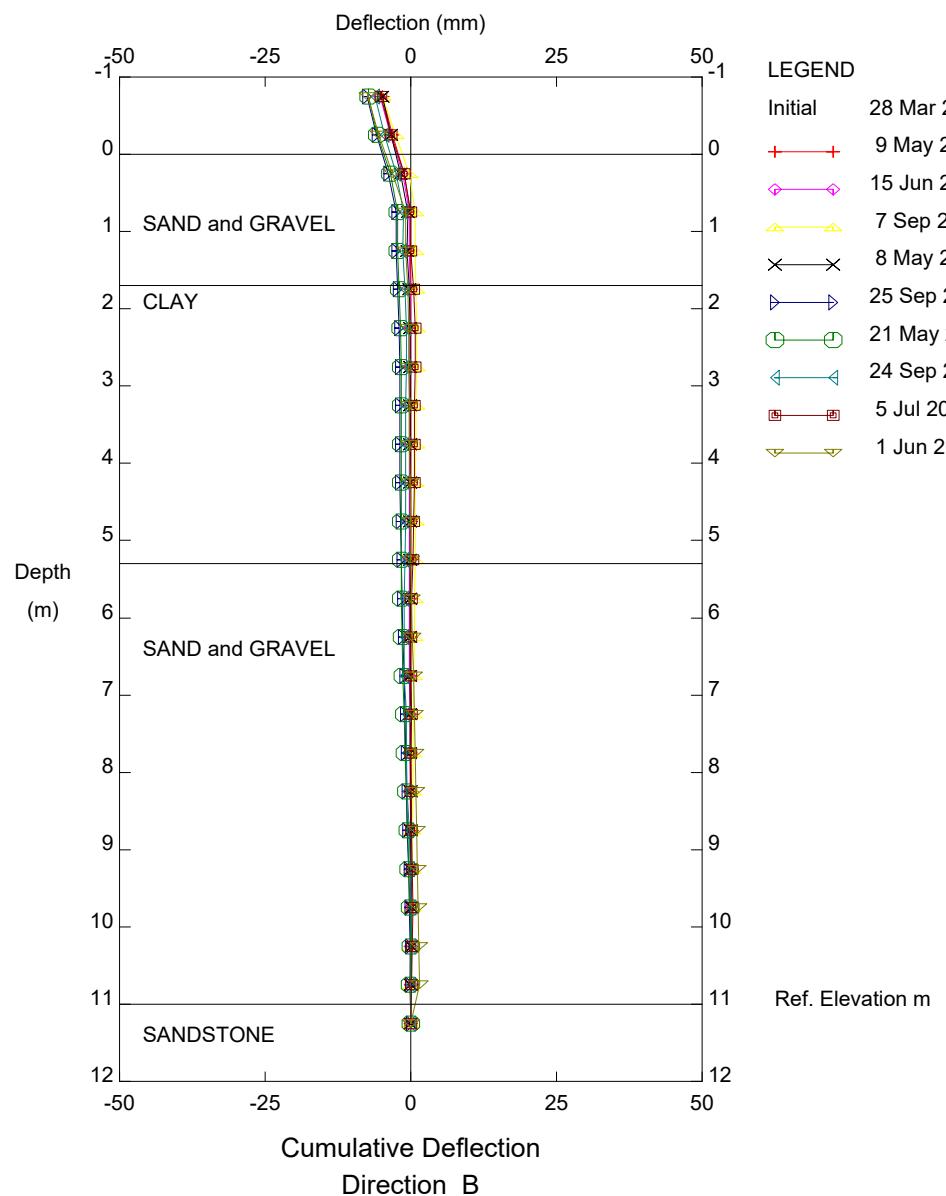
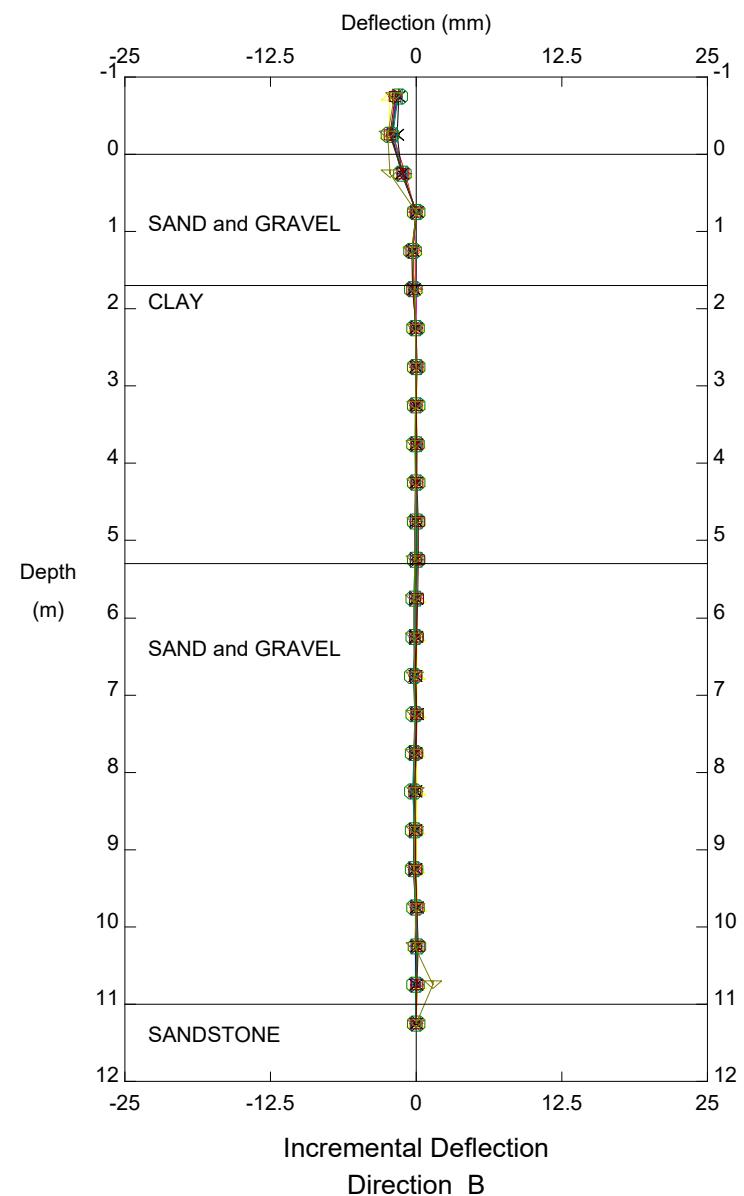
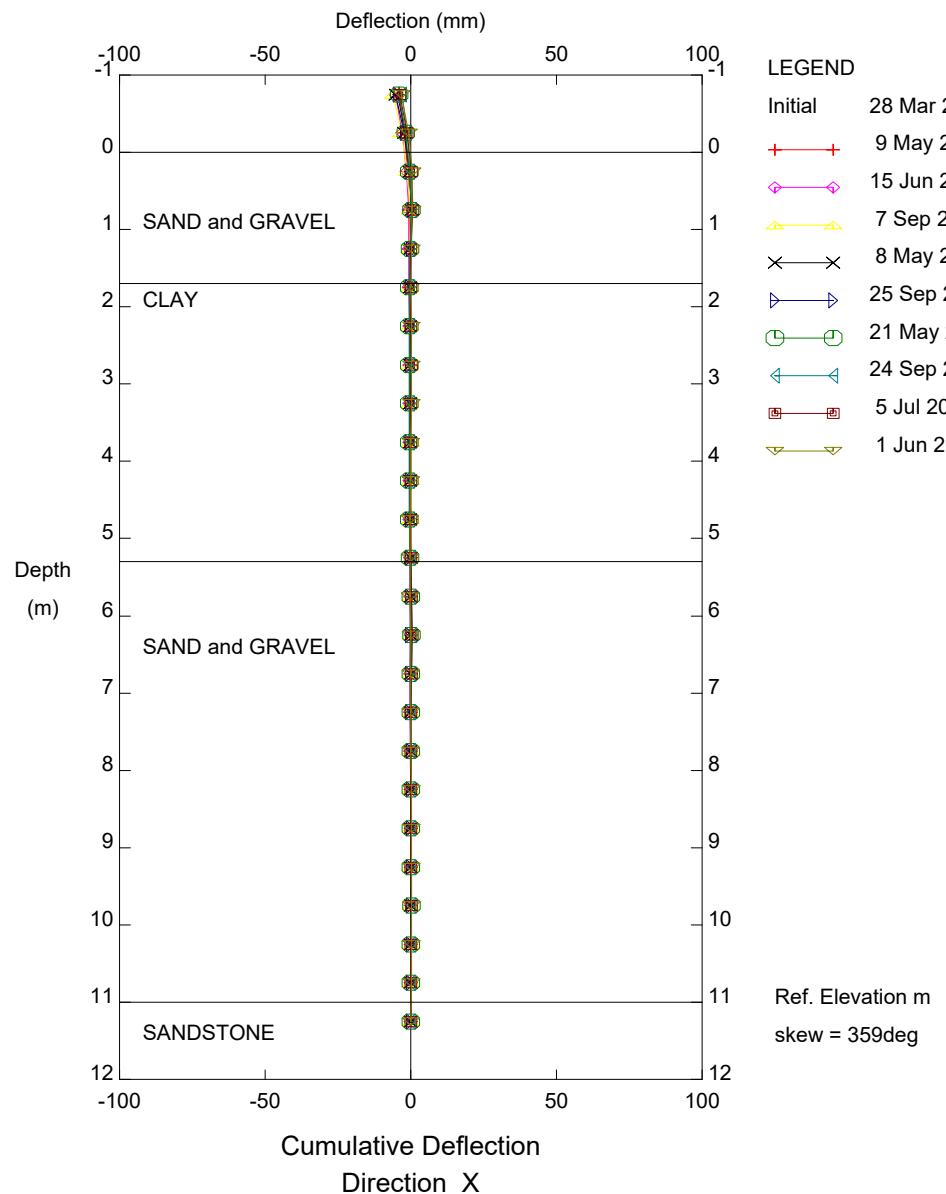
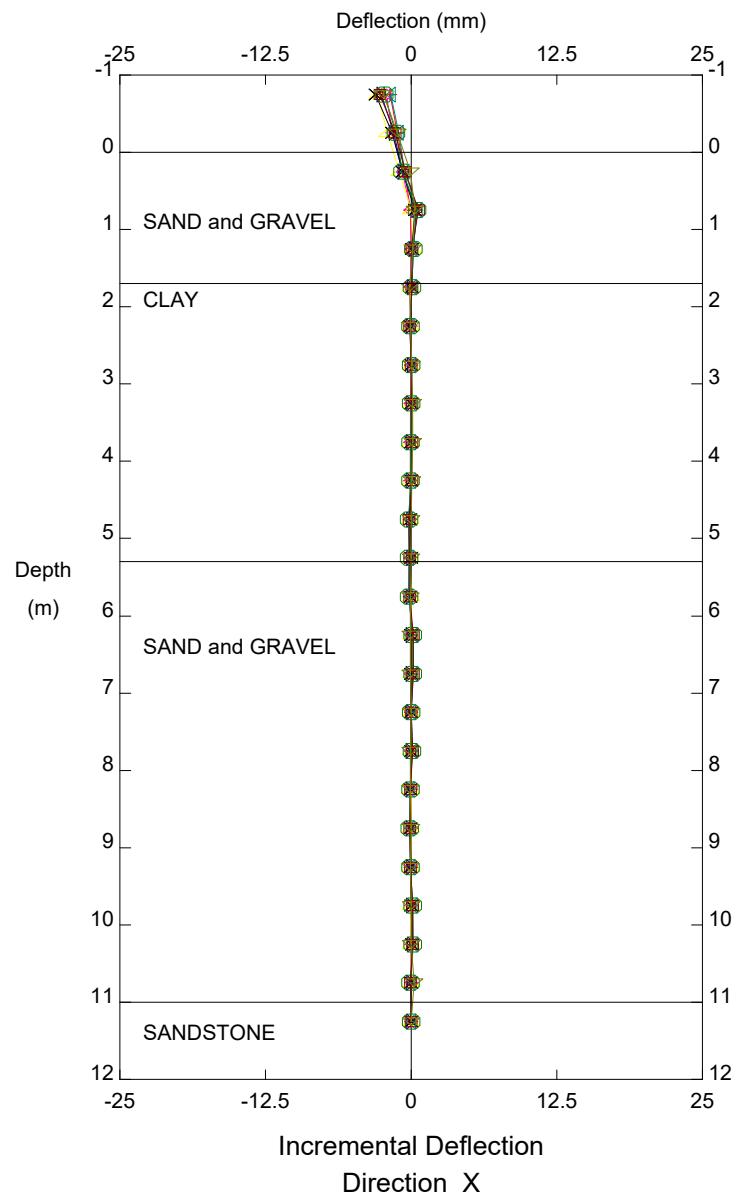
NC037, Inclinometer SI18-03

No discernable movement was observed in **SI18-03** and **SI18-05**.
