To: Amy Driessen
Alberta Transportation
File: 123315222

From: Leslie Cho and Carrie Murray
Stantec Consulting Ltd.
Date: June 12, 2022

Reference: North Central Region, Edson, Site NC037 - Highway 32:10 South of Whitecourt, Spring 2022 Instrumentation Monitoring Report

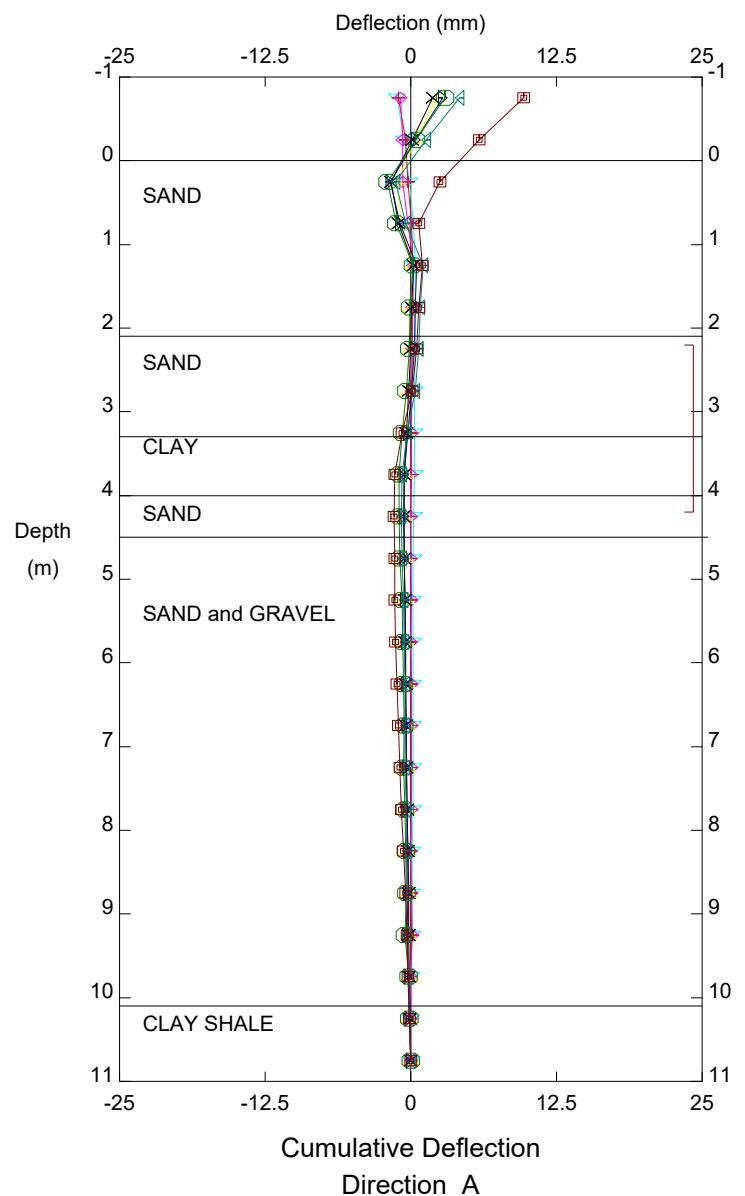
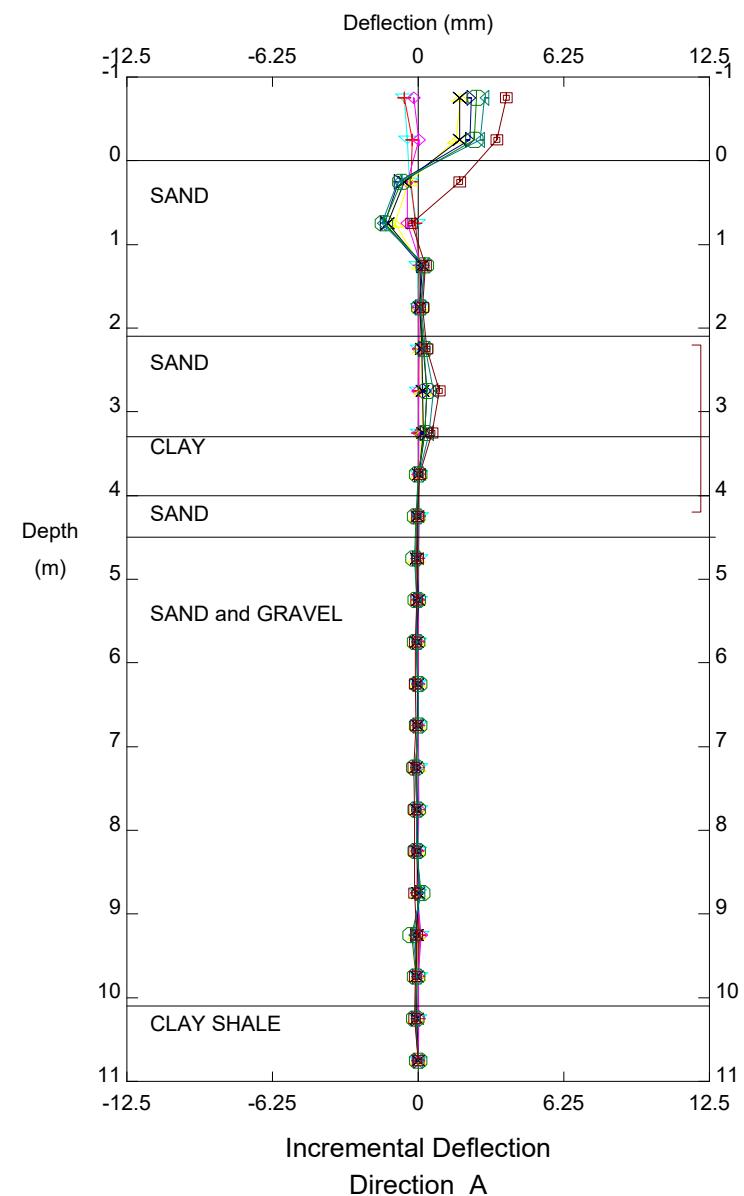
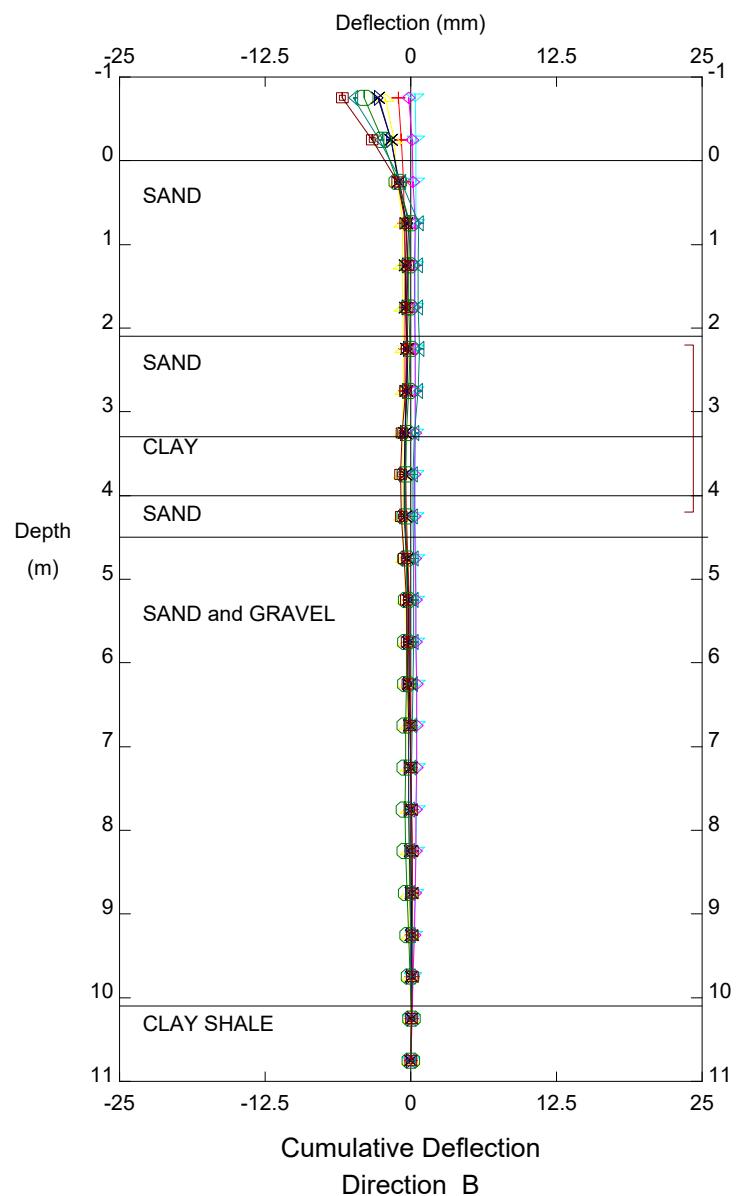
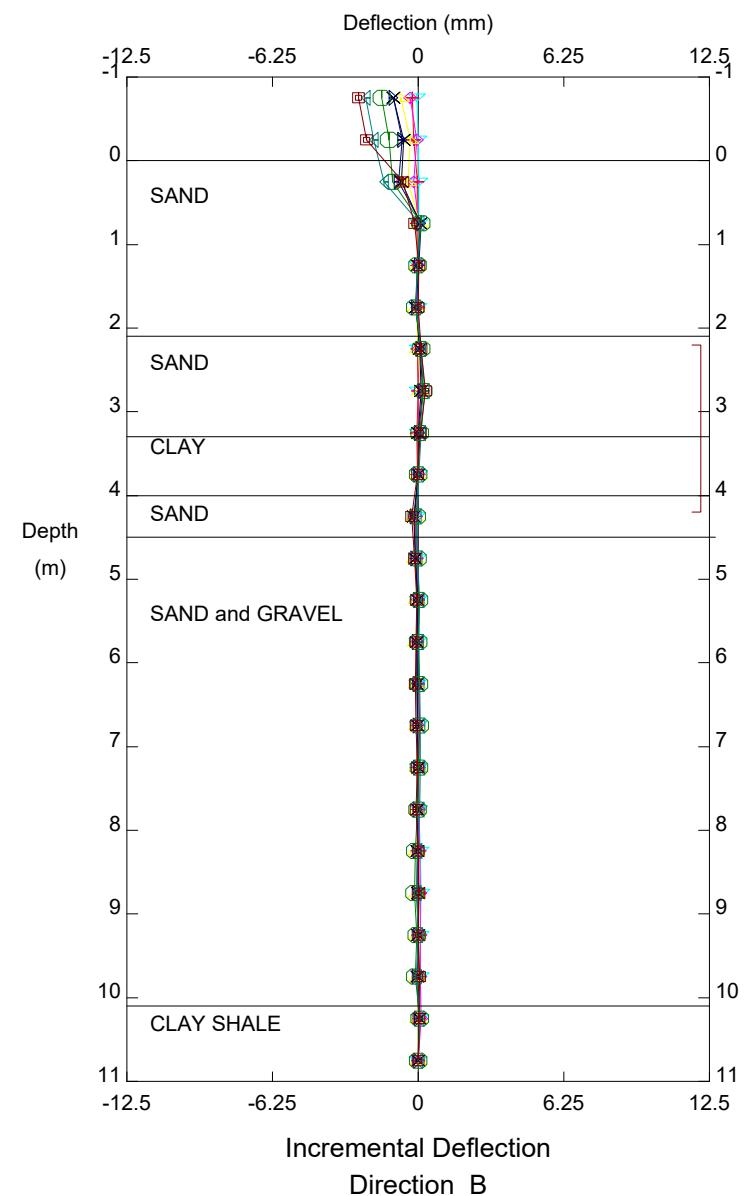
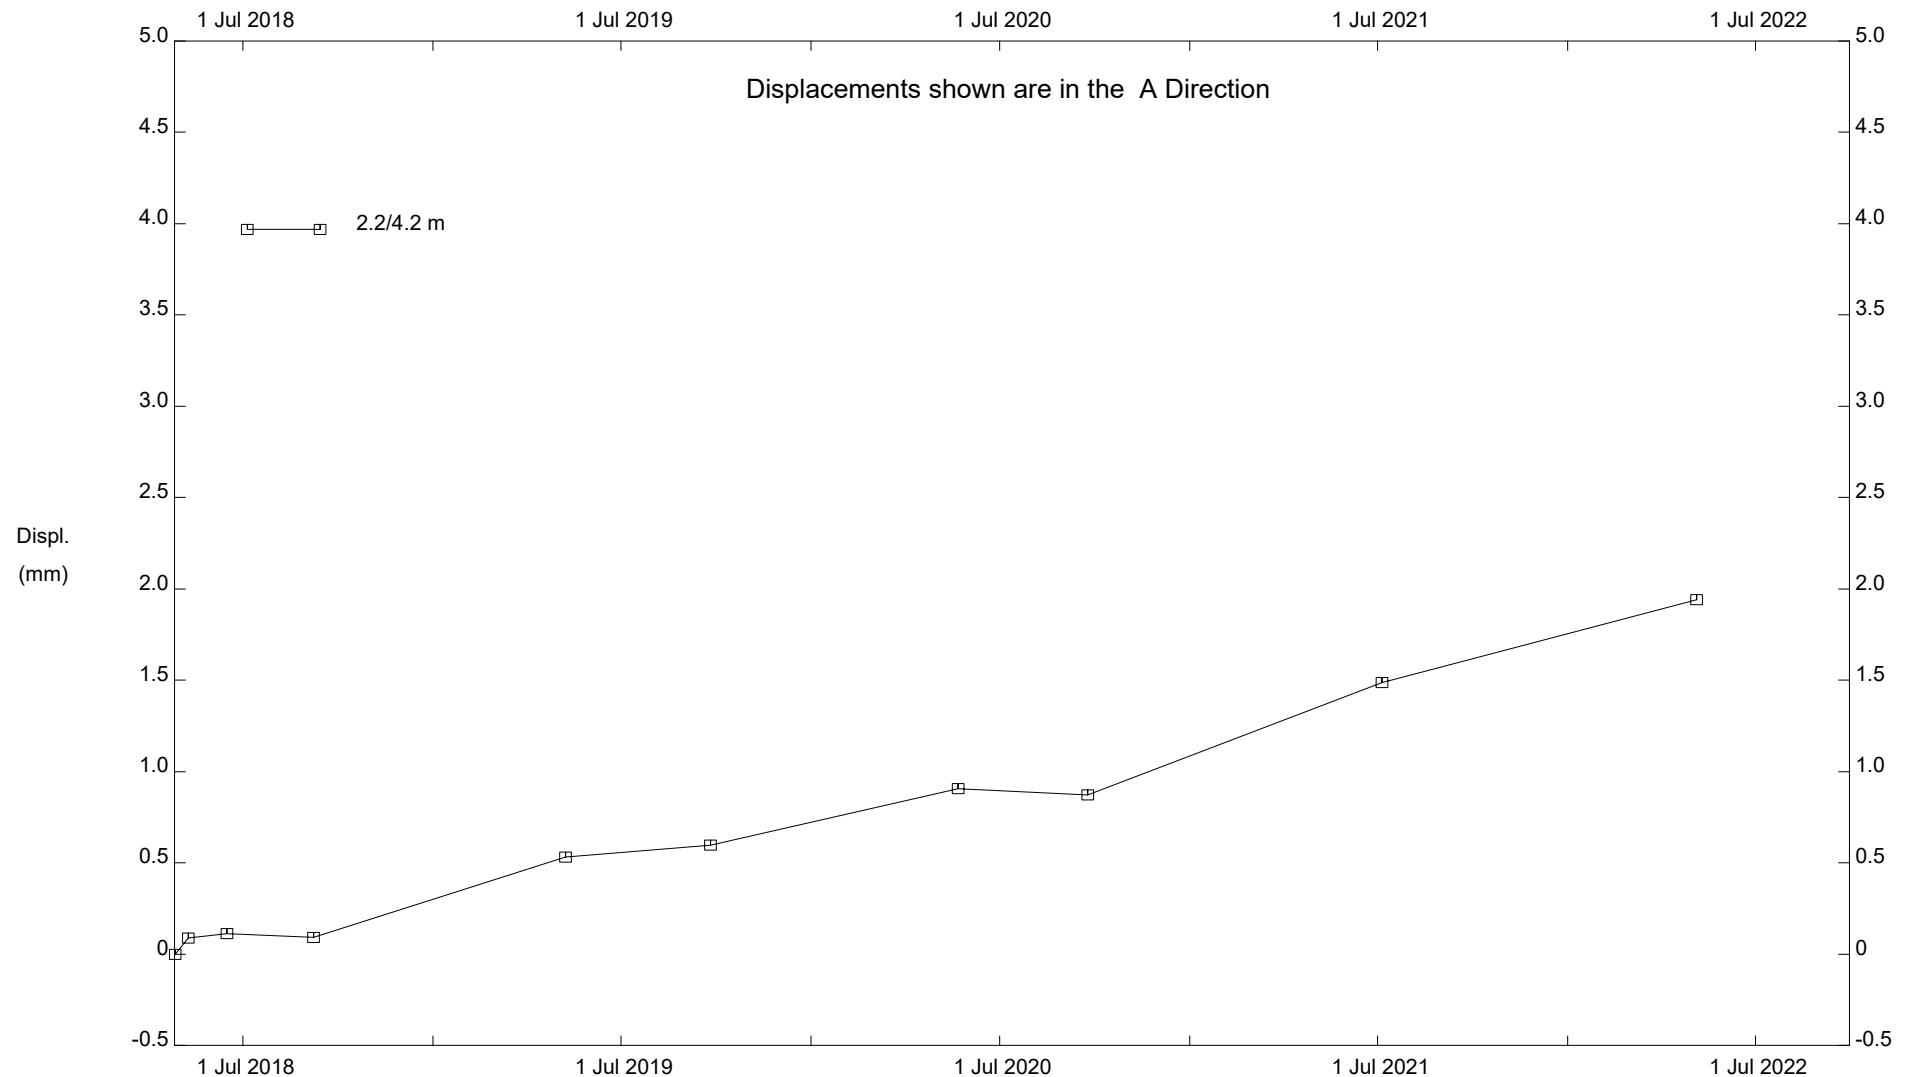
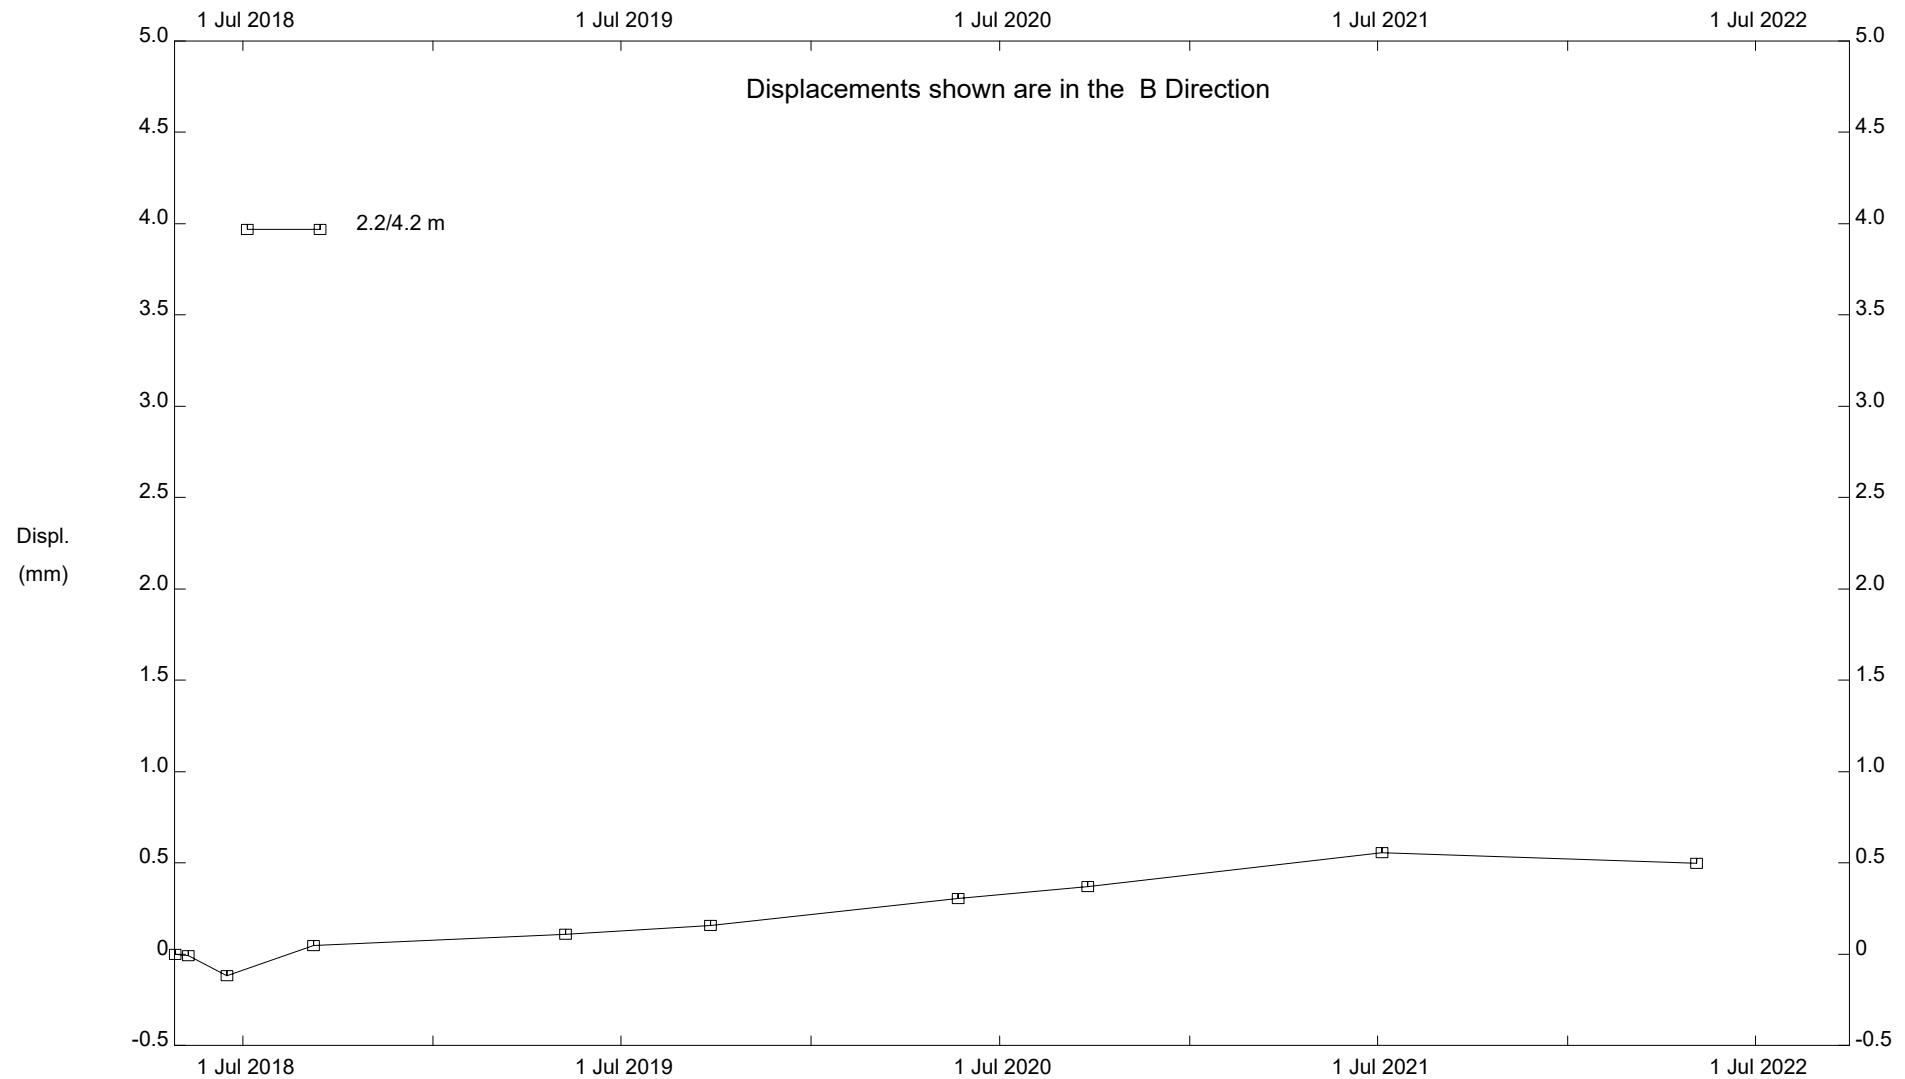
NC037, Inclinometer SI18-04

SI18-04 has a potential movement zone between 2 m and 4 m. The current rate of movement is less than 1 mm/yr with total cumulative movement of about 2 mm since 2018.

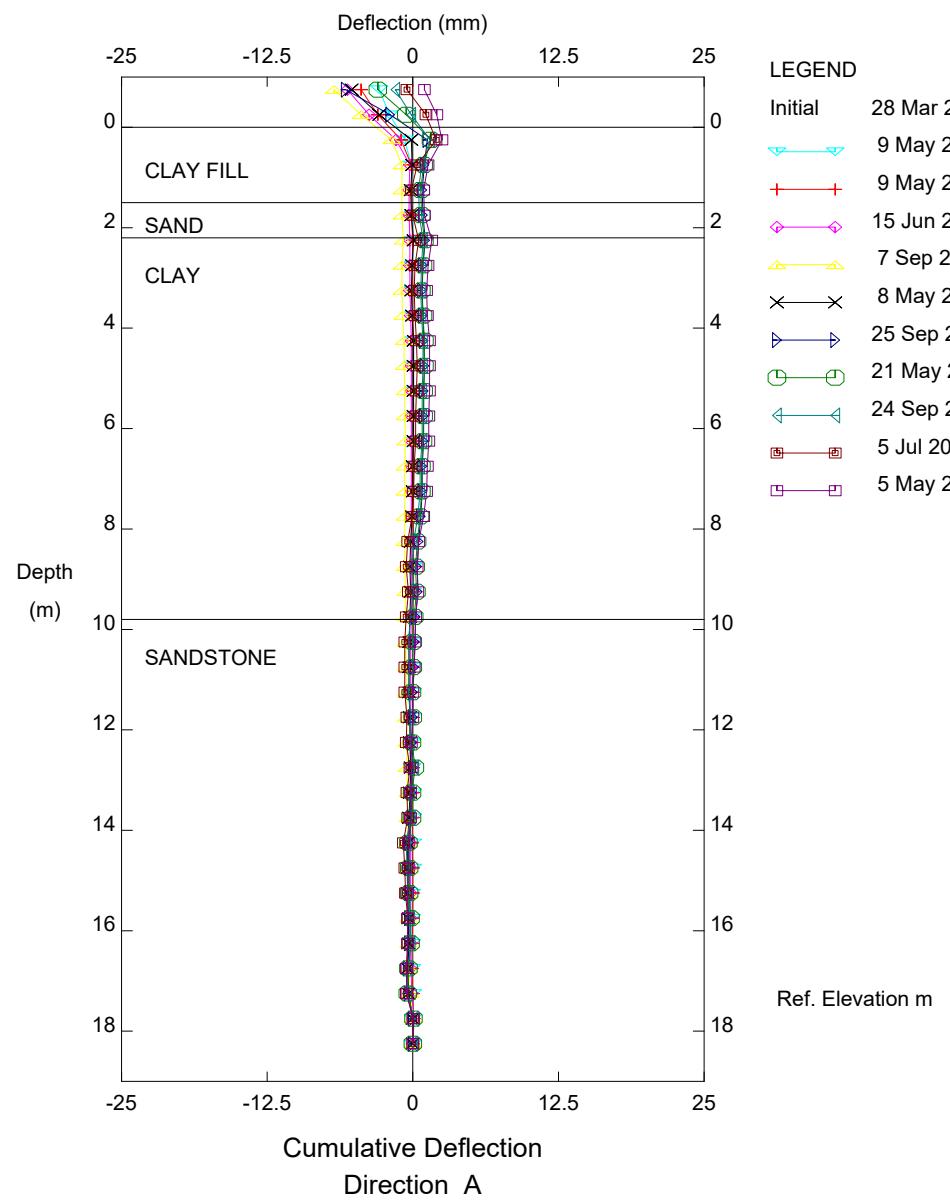
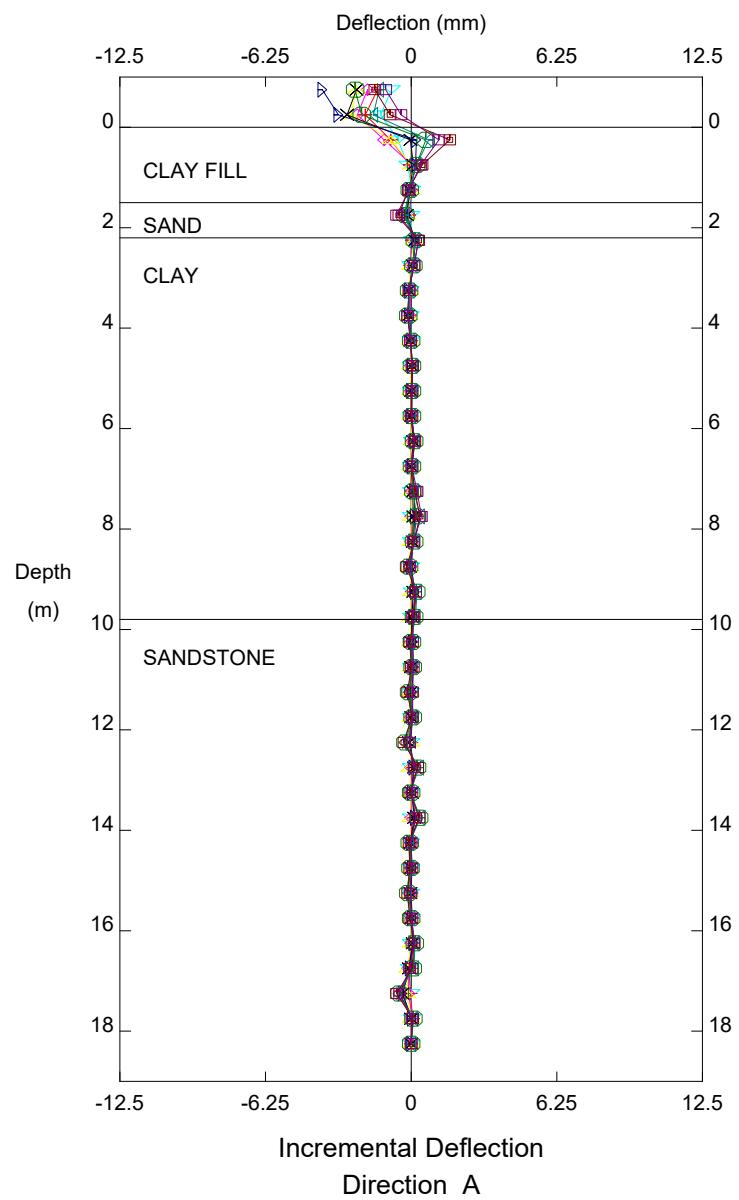
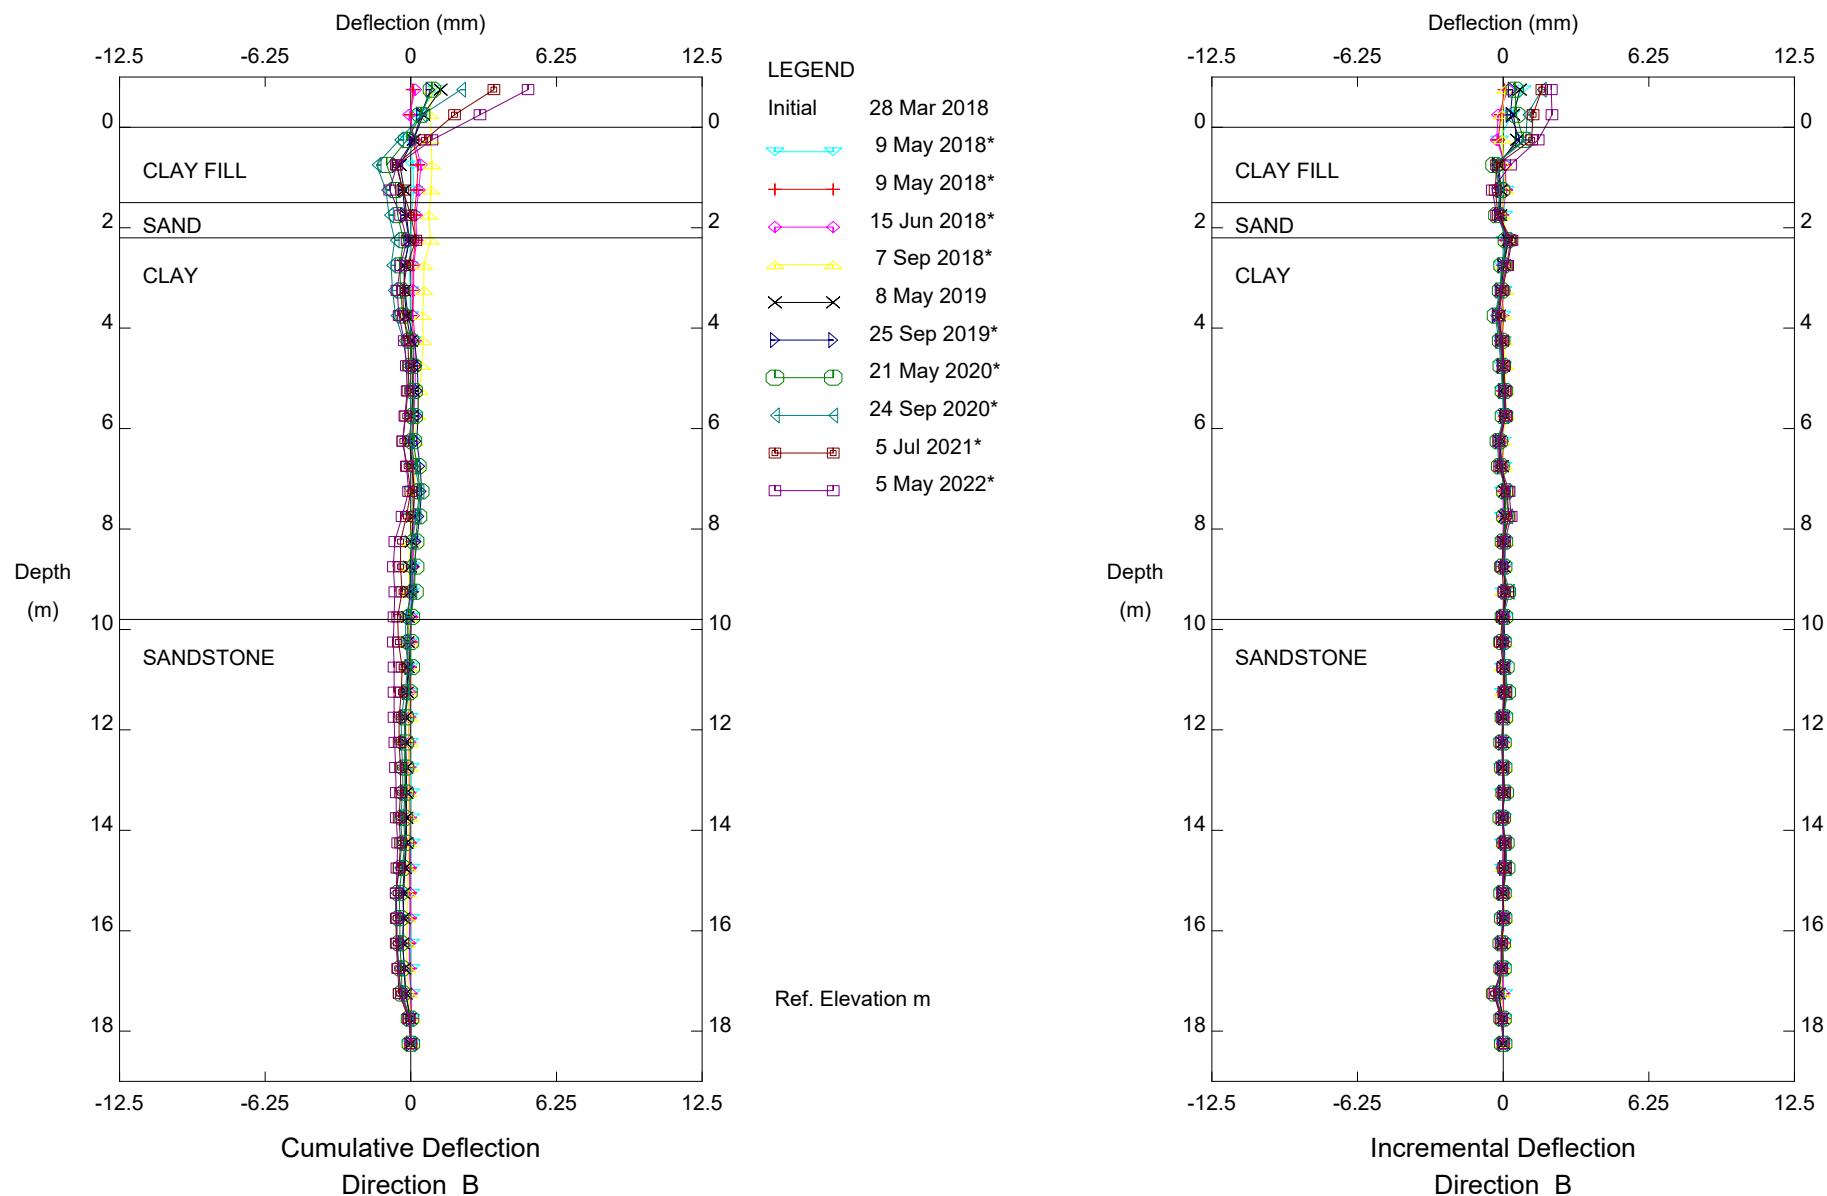
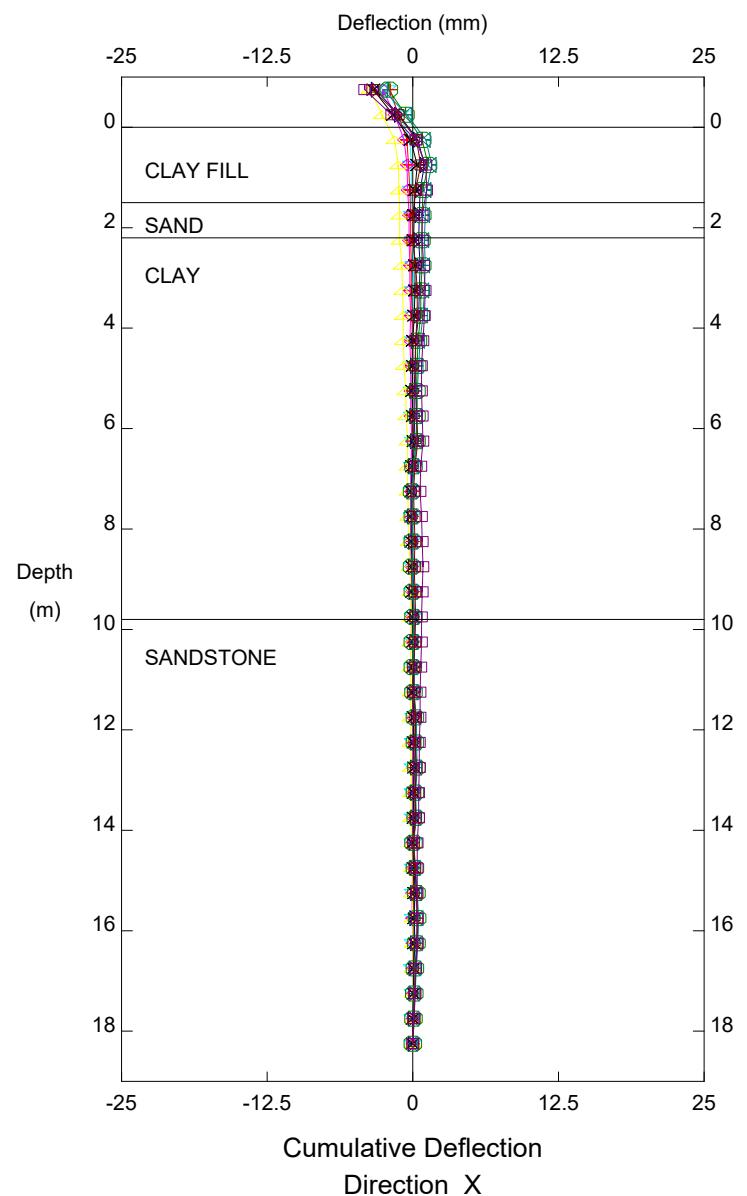
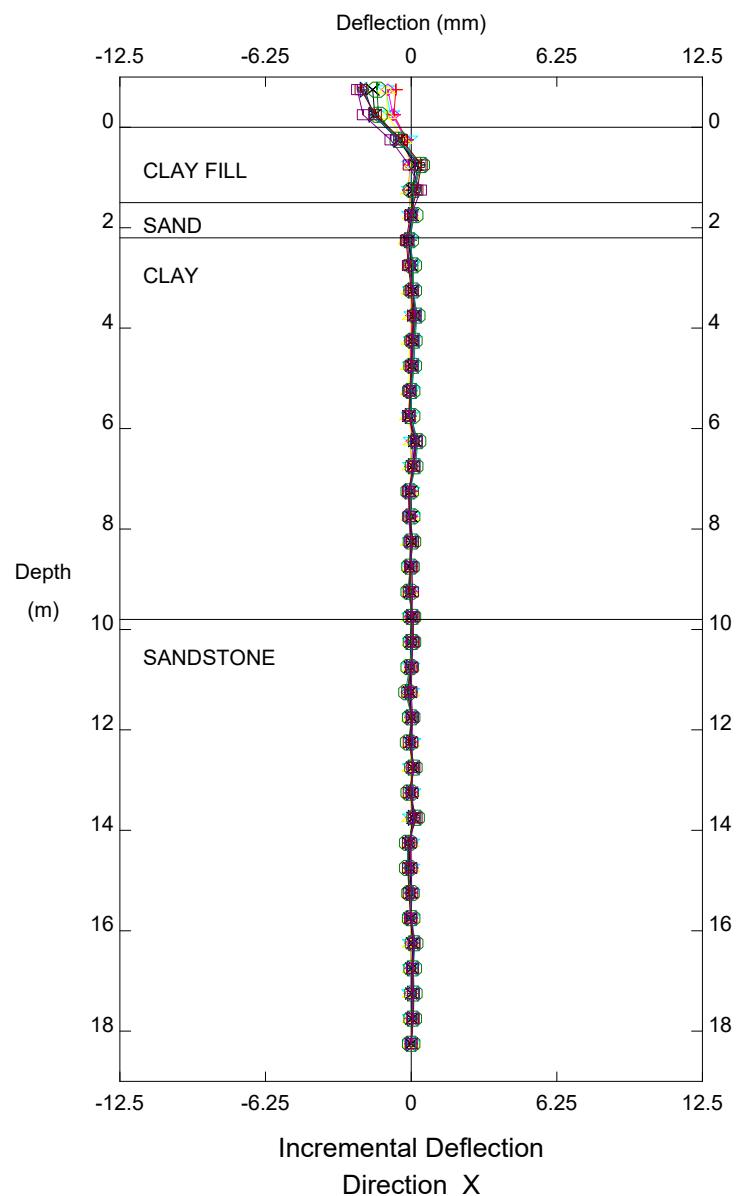
NC037, Inclinometer SI18-05

No discernable movement was observed in **SI18-03** and **SI18-05**.

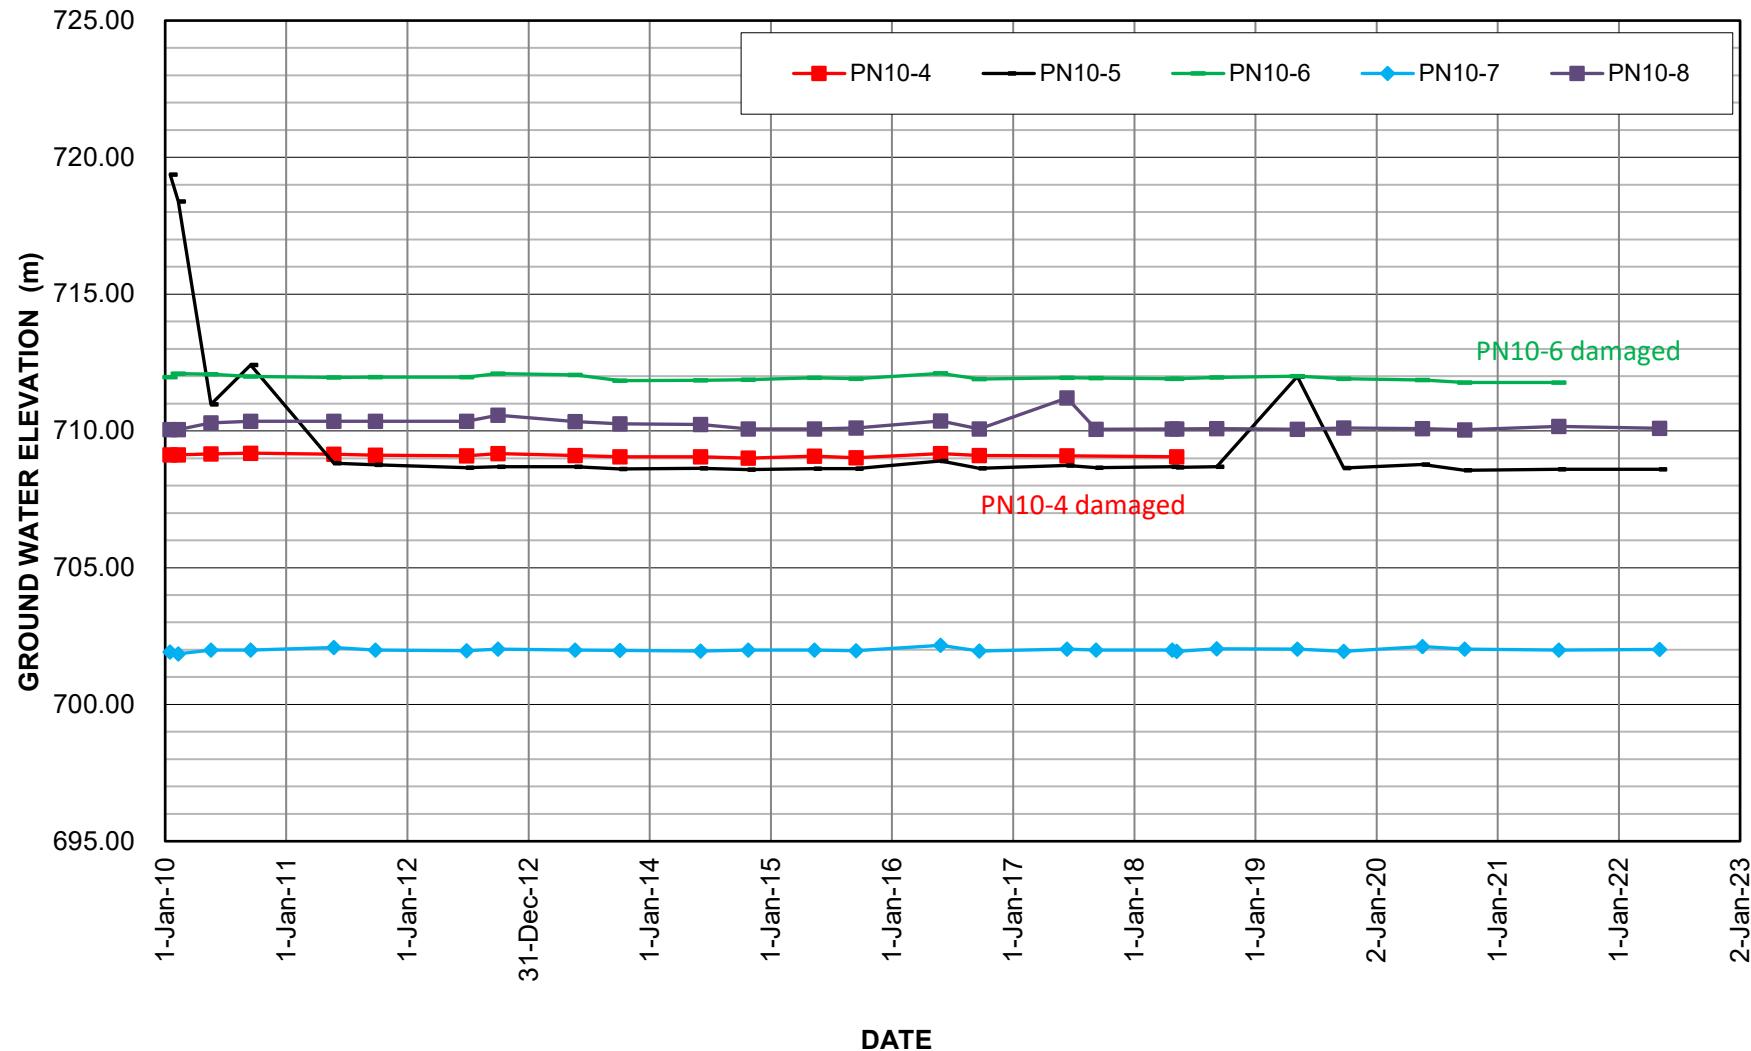
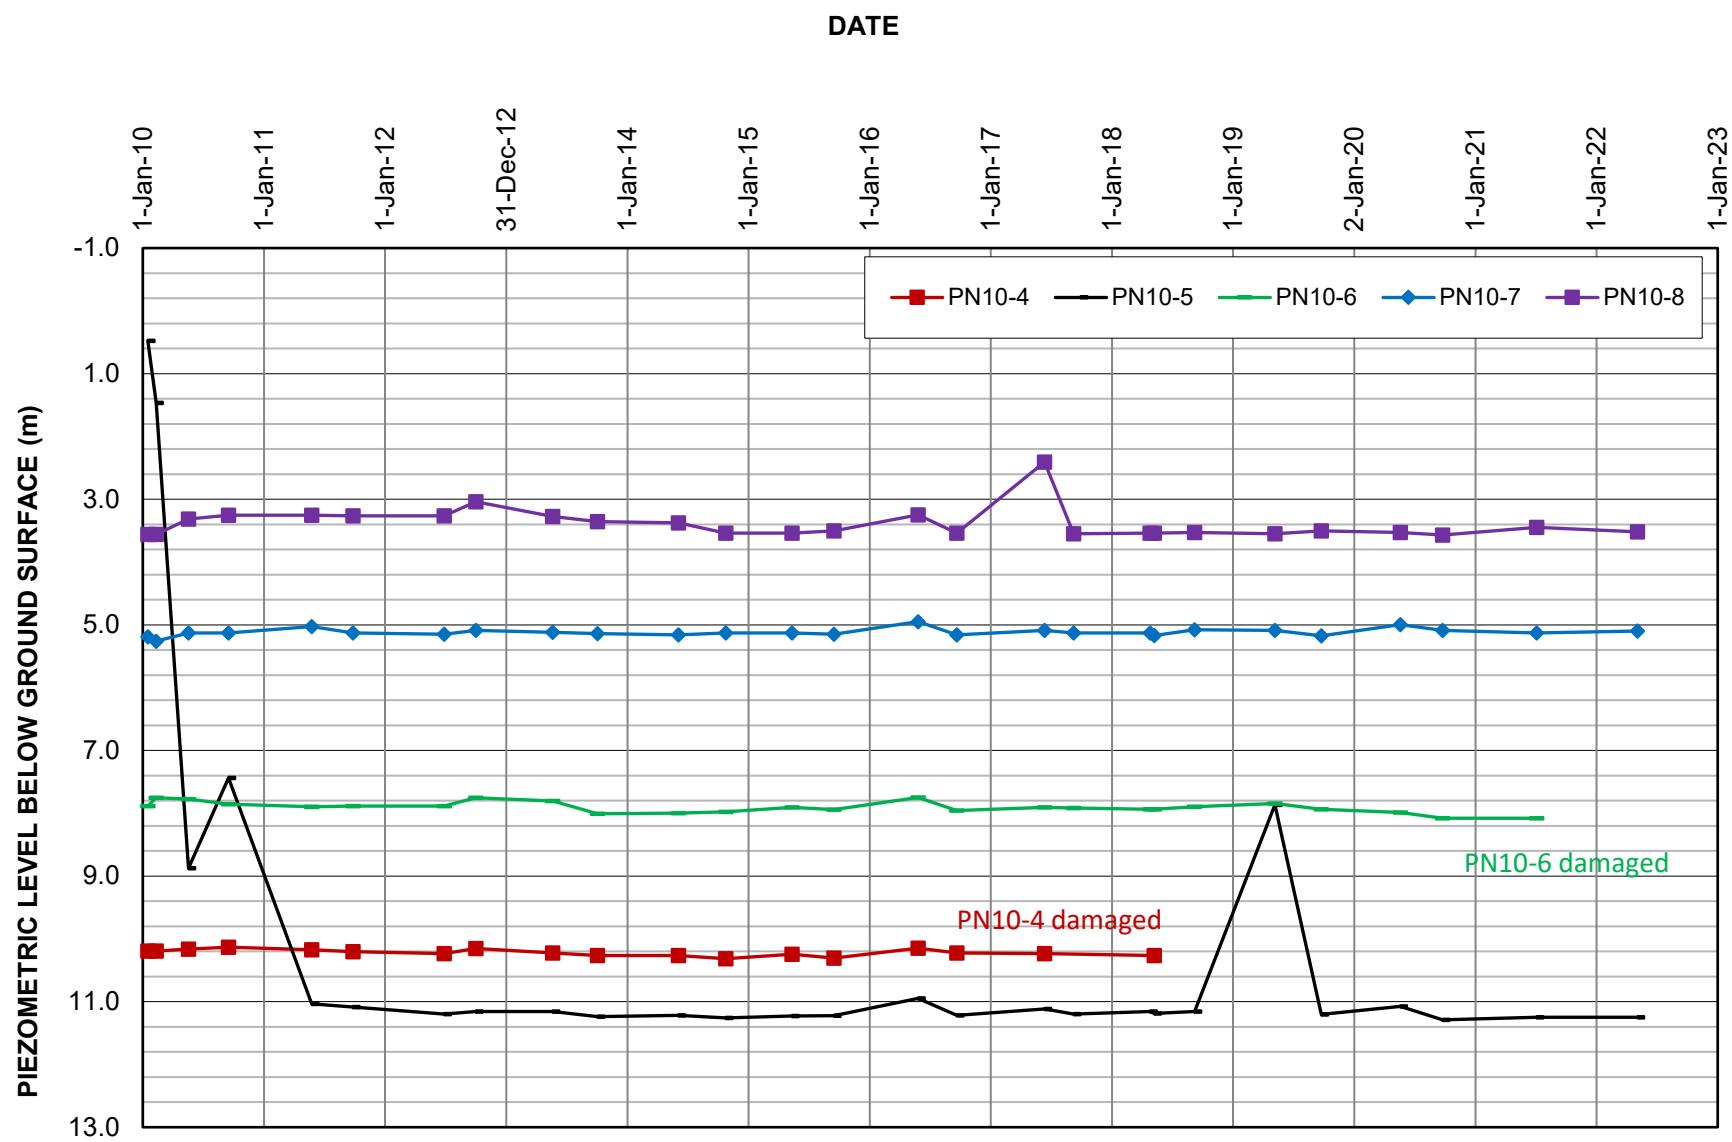
PNEUMATIC PIEZOMETER DATA
NC037: HWY 32:10 South of Whitecourt

Most of the PNs have remain consistent since Spring 2011 showing very little to no change (<0.1 m) in groundwater level.

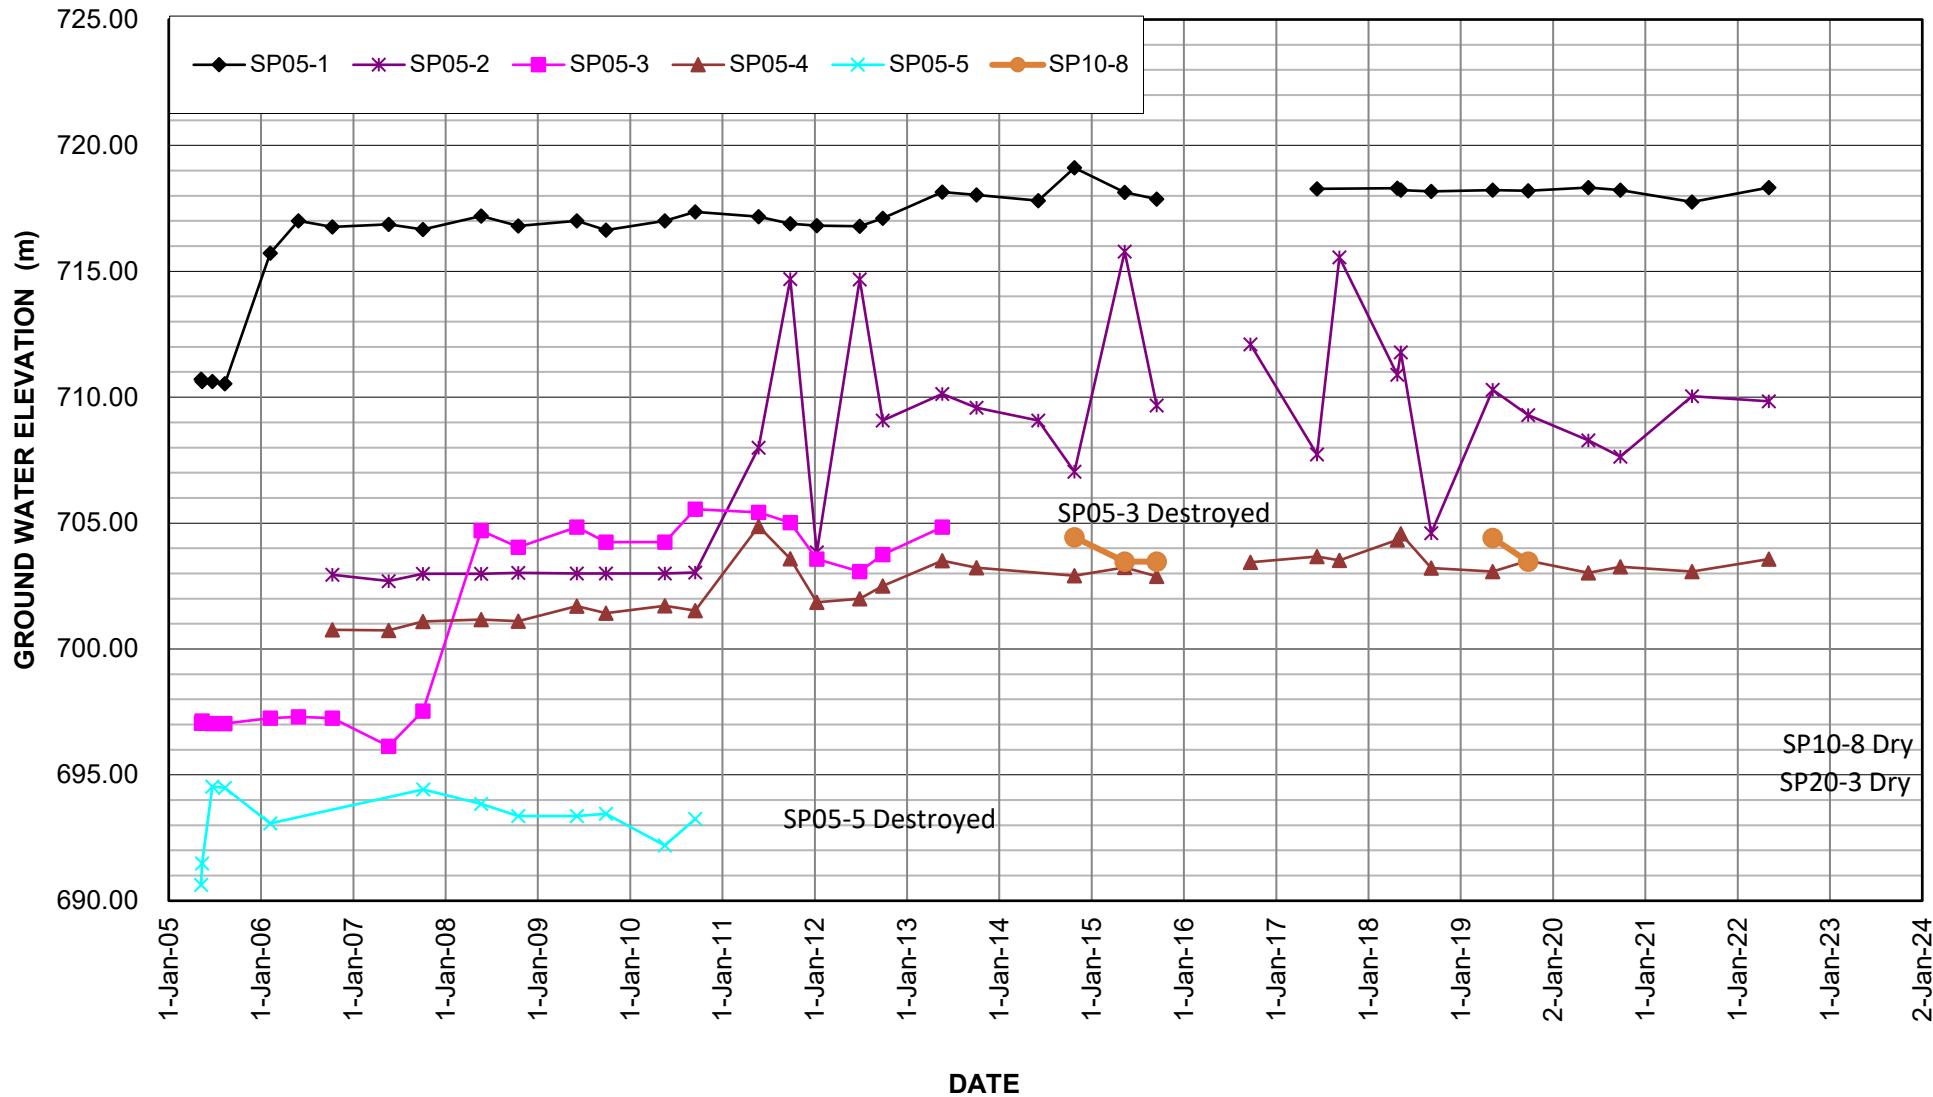
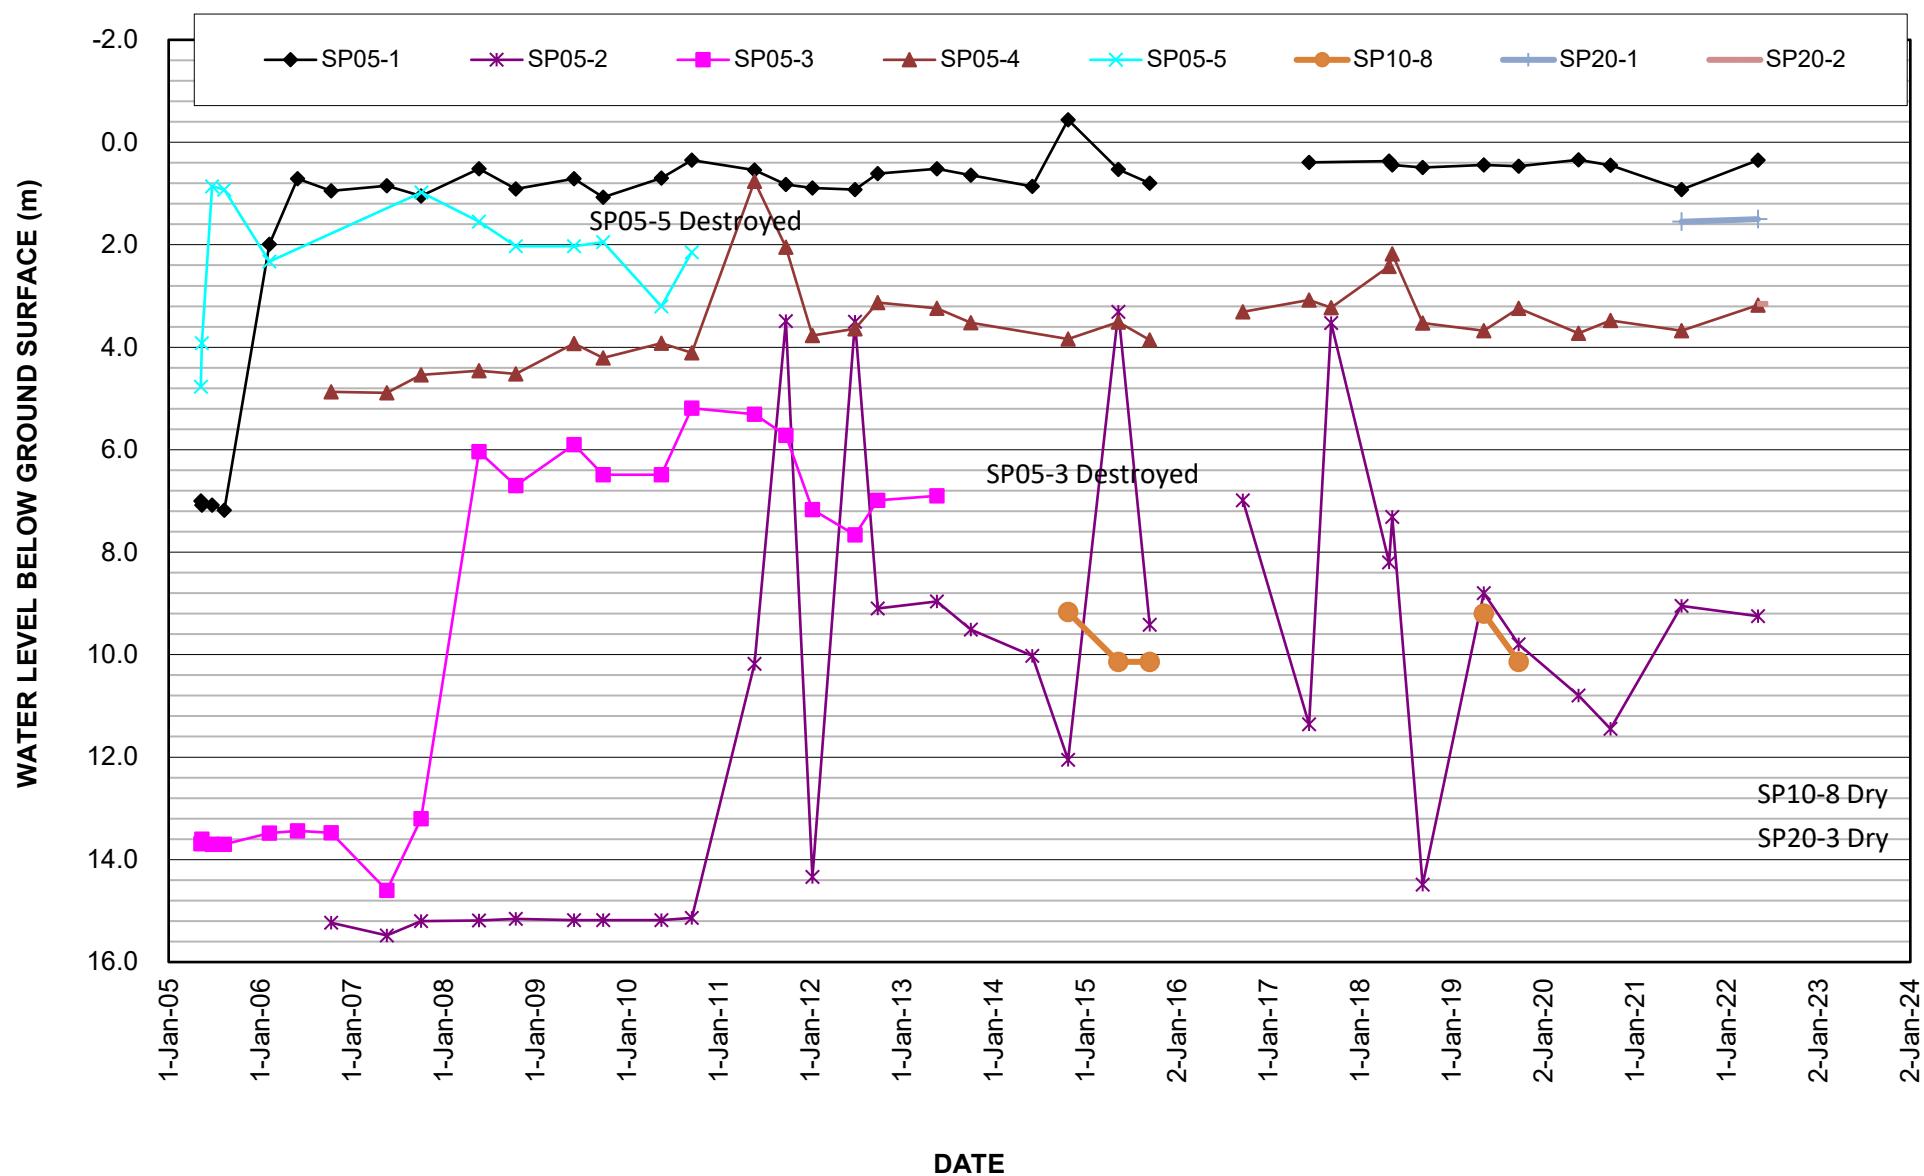
STANDPIPE PIEZOMETER DATA
NC037: HWY 32:10 South of Whitecourt

SP05-01 shows an increase in water level by approximately 0.6 m since the Spring 2021 reading cycle.

SP05-2 shows a decrease in water level by approximately 0.2 m since the Spring 2021 reading cycle. This SP has historically experienced variability on the order of ± 5 m in water level since 2011.

SP05-4 shows an increase in water level by 0.5 m.

SP10-8 is dry and has not changed from the previous reading cycle.

The water level was at 1.5 m bgs in **SP20-1** and at 2.0 m in **SP20-2** while **SP20-3** remained dry.
