SITE NUMBER AND NAME: NC037 – South of Whitcourt	HIGHWAY AND KM: 32:10, km 34.589	PREVIOUS INSPECTION: June 16, 2022	CURRENT INSPECTION: June 12, 2024
LEGAL DESCRIPTION: NW 27-59-12-W5M	NAD83 COORDINATES: UTM11U 5999427N, 583507E		RISK ASSESSMENT: PF: 5 CF: 4 Total: 20
AVERAGE ANNUAL DAILY TRAFFIC (AADT): 2,160 (2023)		CONTRACTOR MAINTENANCE AREA (CMA): 508

NORTH CENTRAL REGION GRMP
EDSON / STONY PLAIN
SITE INSPECTION FORM

**TRANSPORTATION AND ECONOMIC CORRIDORS
GEOHAZARD MONITORING PROGRAM
NC37 HWY 32:10 SOUTH OF WHITECOURT
MAIN SITE PLAN**

2024 Site Inspection Photos at NC037

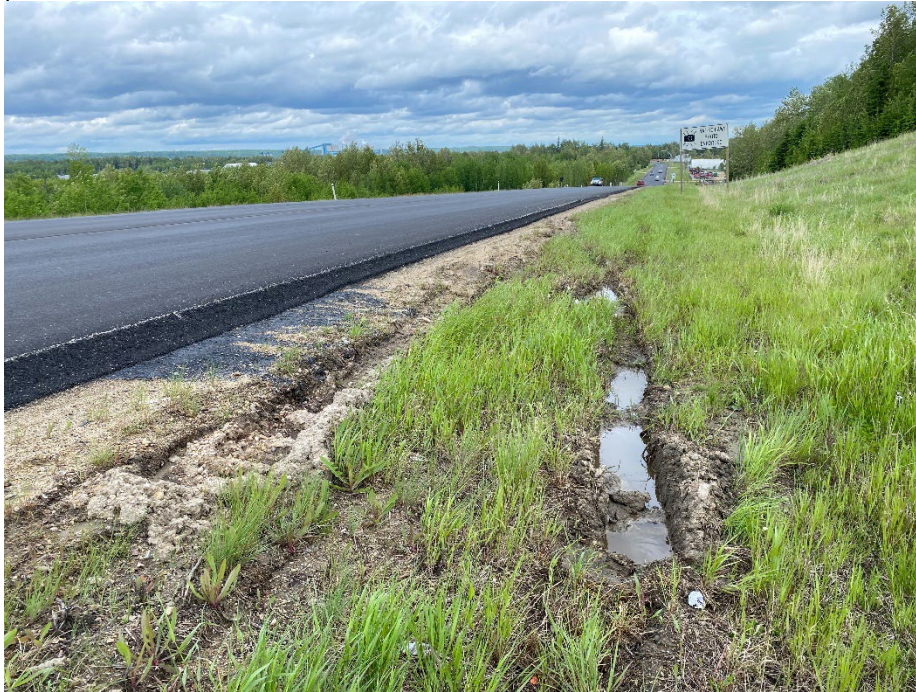
COMMENTS
<p><u>Power Line Site:</u></p> <ul style="list-style-type: none"> No pavement cracks, dips or otherwise were observed during the site inspection due to recent paving (Photos 2 to 4). Tire tracks were observed near the south edge of the highway near STA 34+950. The tracks were approximately 100 mm deep and the track furthest in the ditch was full of water (Photo 1). The ground crack observed adjacent to the tree line from about STA 34+960 to 34+980 during the 2022 inspection was barely visible and vegetated (Photo 5). It is surmised this crack was due to removal of an old silt fence since remnants of a silt fence was observed along portions of the open crack.

Photo 1: Tire tracks with ponded water in ditch near STA 34+950. Looking east.

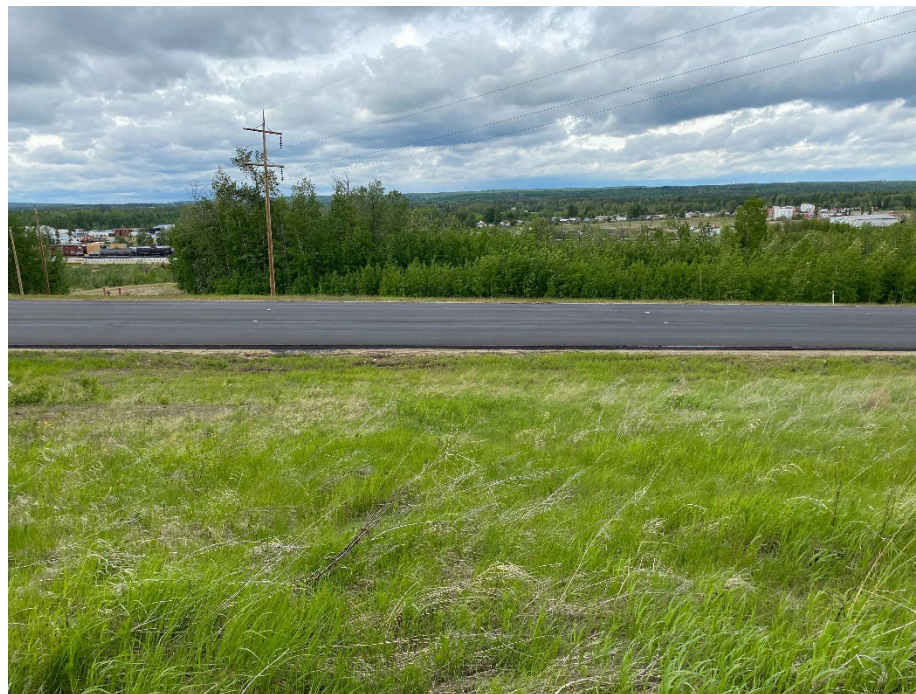
Photo 2: Fresh pavement below powerlines. Looking north from south slope.

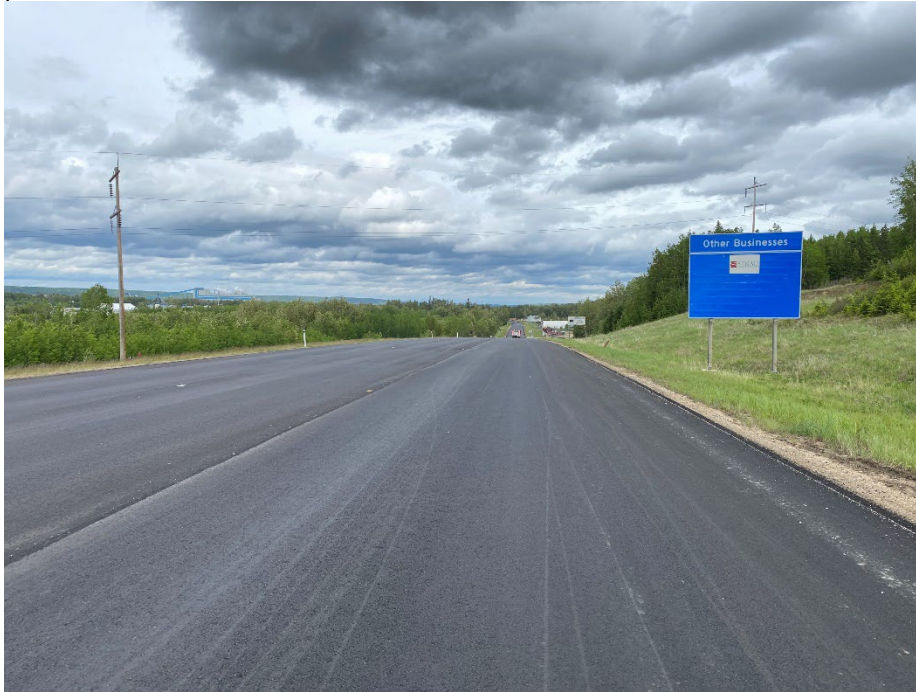
Photo 3: Pavement condition at approximately STA 34+850. Looking east.

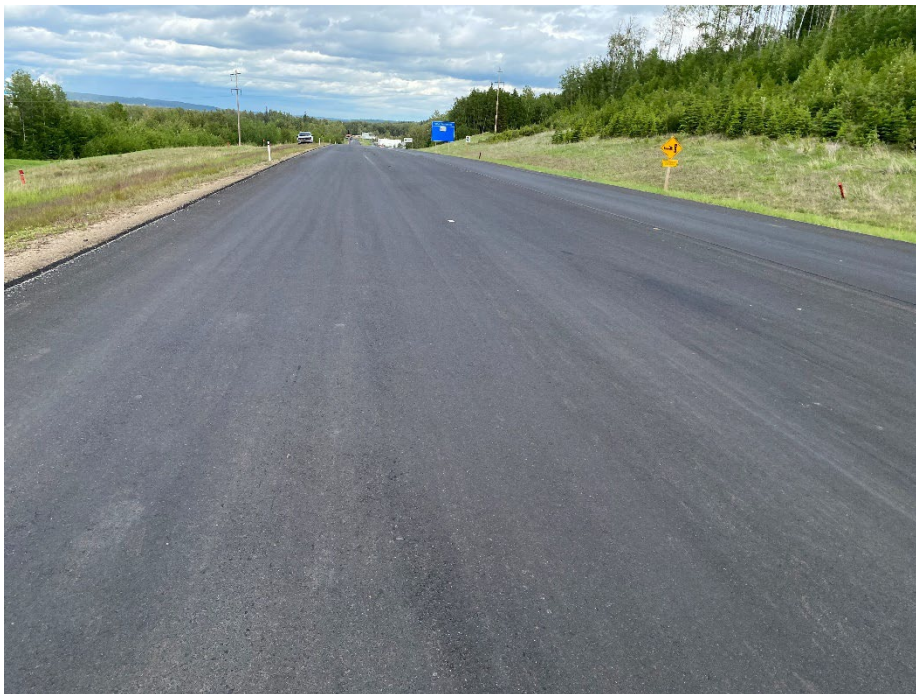
Photo 4: Pavement condition at approximately STA 34+775. Looking east.

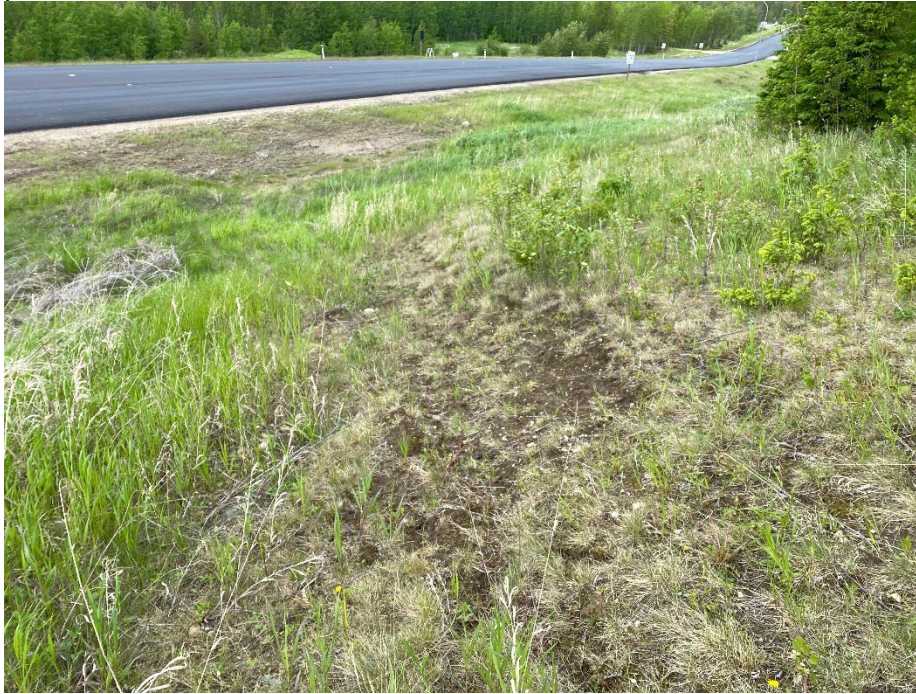
Photo 5: Old ground crack due to silt fence removal at approx. STA 34+960 not visible. Looking northeast.

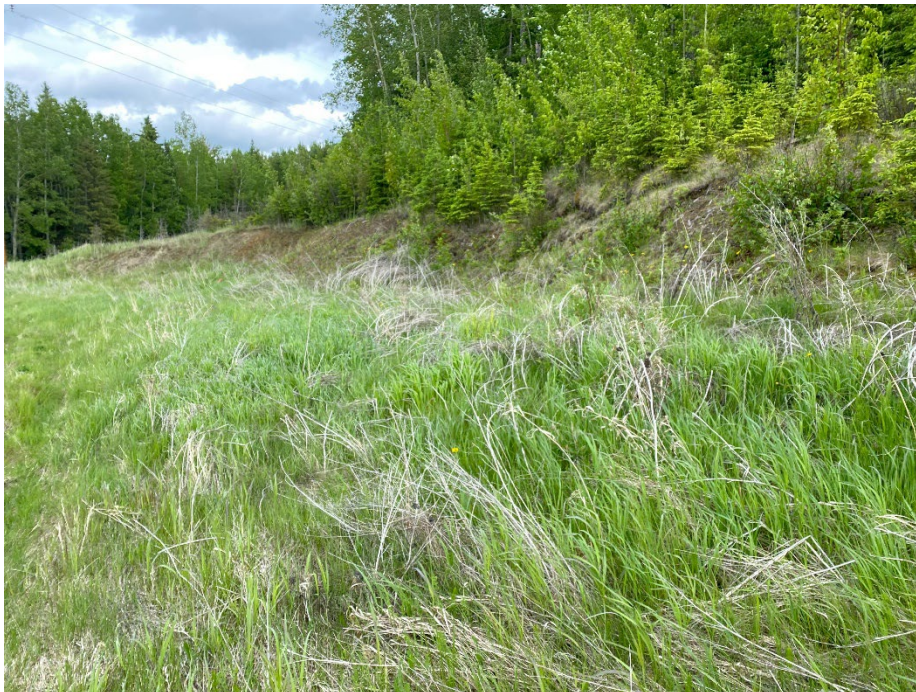
- The scarps and slumping on the backslope west of the powerline were observed to be more vegetated when compared to the 2022 inspection. No new erosion was visible on the exposed scarps (Photo 6).

Photo 6: Increased vegetation on scarps. Old slumping on backslope. Looking southeast.

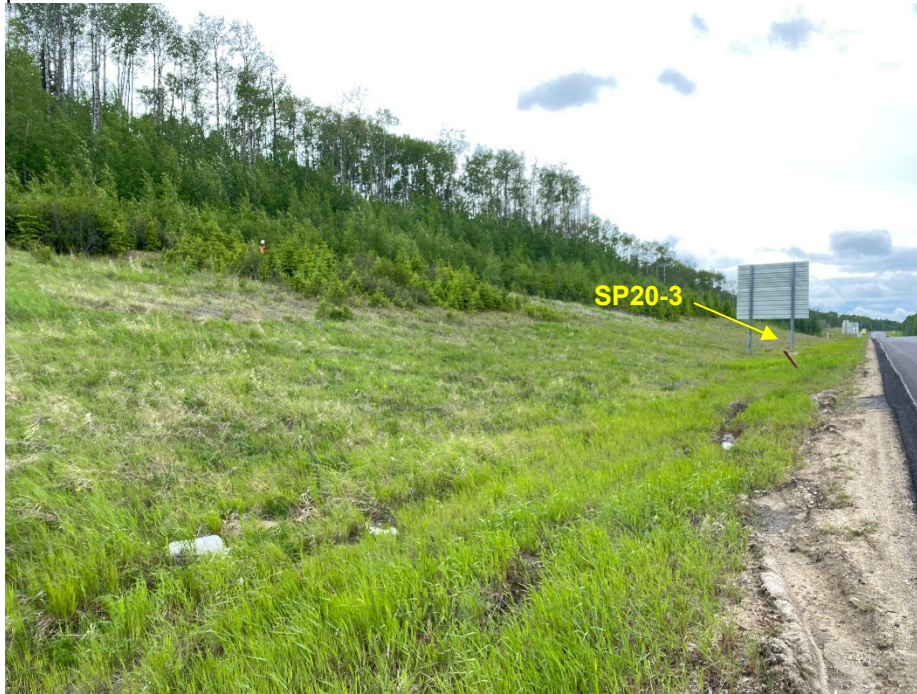
- Ditch erosion was observed at about STA 34+880 (Photo 7). The channel approximately 100 mm wide and deep was observed to be similar to the 2022 inspection, with increased vegetation.

- SP20-3 was observed to be leaning significantly south into the ditch (Photo 9). This is likely due to snow clearing activities.
- During this inspection, the localized ponding along the base of the scarps was not observed.

Photo 7: Erosion gully in the south ditch at approximately STA 34+880. SP20-3 casing leaning significantly. Looking west.

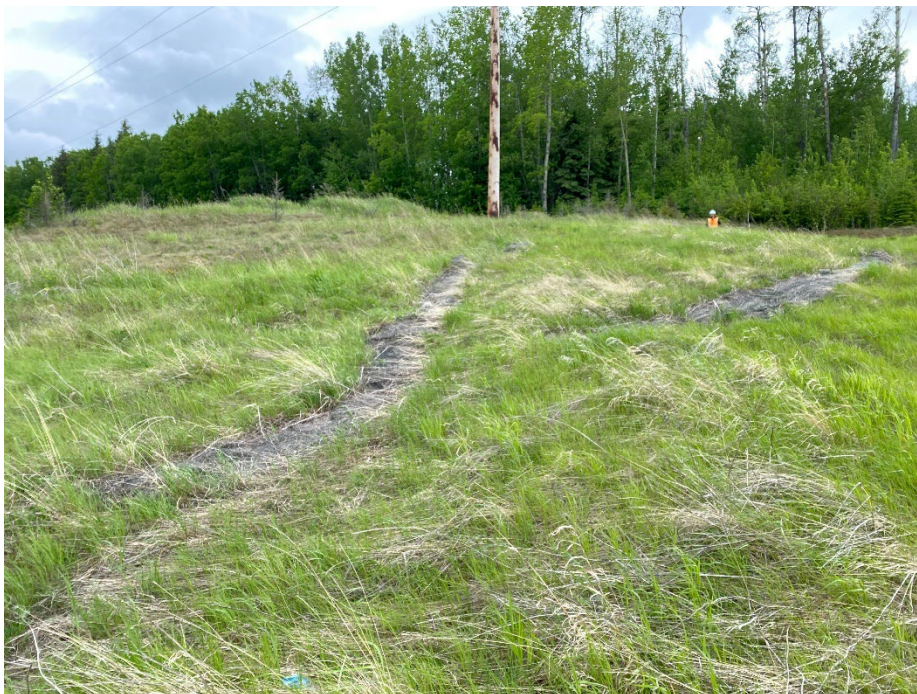
- Erosion control matting was bunching up along the backslope at various locations (Photo 8).
- The ditch and toe bulge was regraded as part of remediation in 2020. Vegetation has grown in the areas that were observed to be bare in 2022. (Photo 9).

Photo 8: Repaired and vegetated south slope with bunched erosion control matting at approx. STA 34+950. Looking southeast.

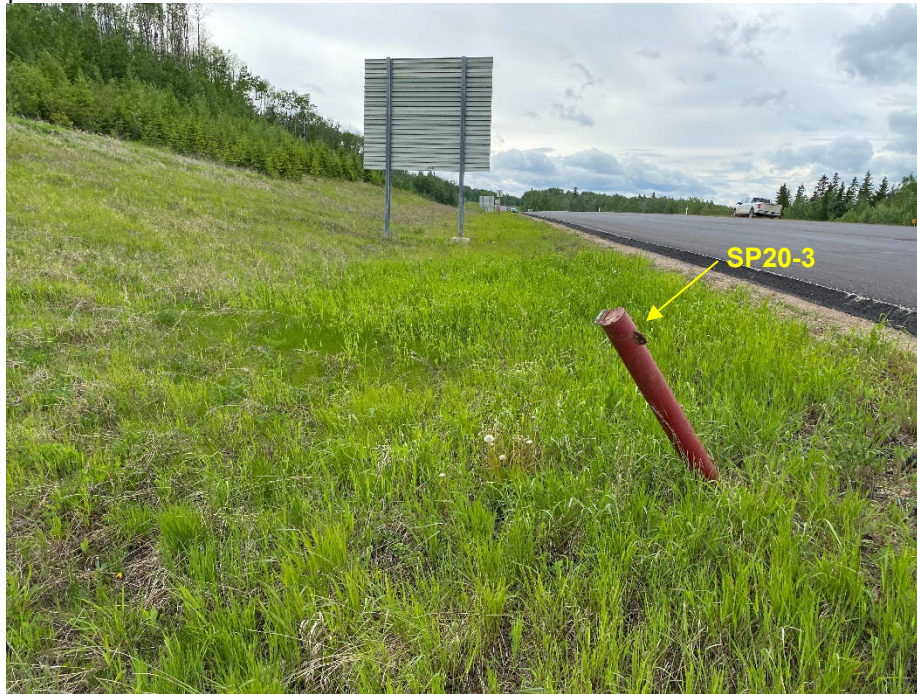
Photo 9: Repaired south slope and toe at approx. STA 34+875. Looking west.

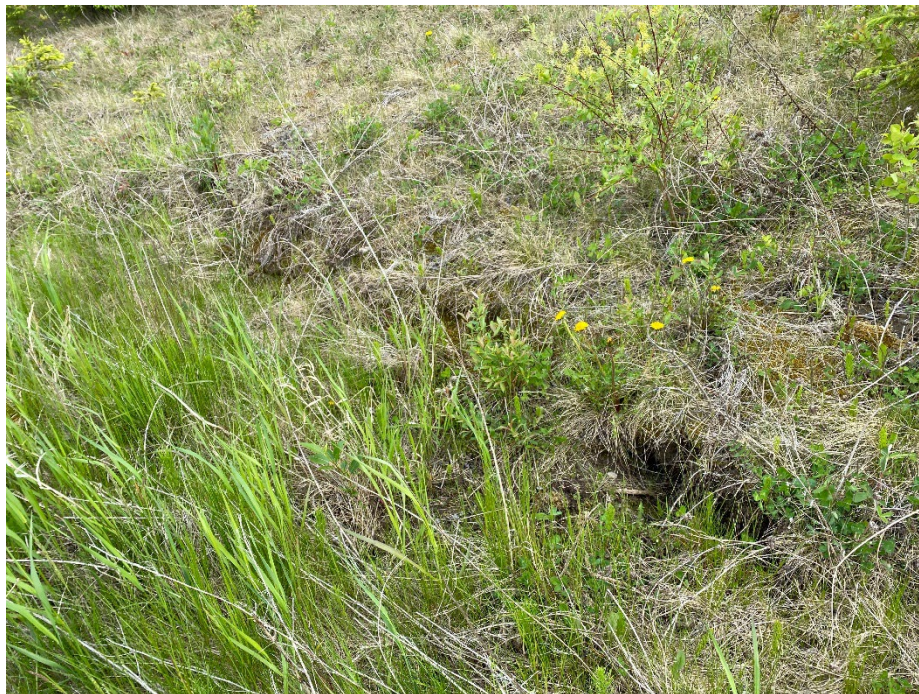
- The regraded backslope from about STA 34+750 to 34+950 appeared to be performing well with grass establishing on the slope. An old ground crack was observed again near STA 34+850 in an unrepaired area, and a newly observed ground crack was found near the lower tree line on the slope near STA 34+875 (Photo 10). The new ground crack was approximately 3 m long.

Photo 10: Cracking on slope near lower tree line, near STA 34+875. Looking southeast.

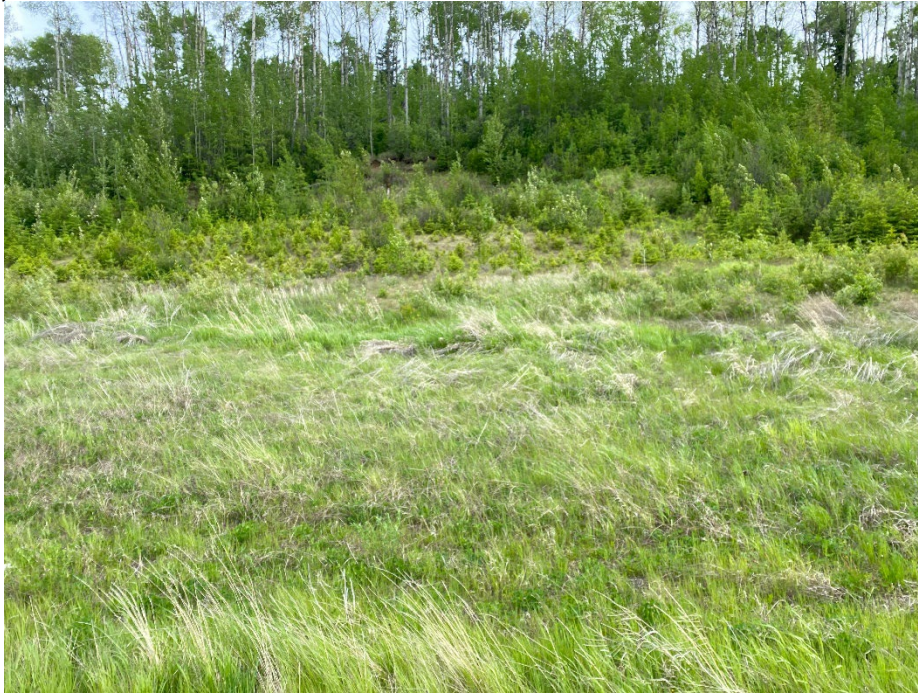
- The scarp on the south slope at approximately Station 34+700 appeared to be unchanged (Photo 11).
- Existing SIs within the Power Line site indicate creep movement of less than 1 mm/yr between 3 and 6 m deep. The SI installed in 2018 has only recorded 3 mm of movement in total, suggesting slope movements may be localized to the area upslope from SI10-8 and SI10-9.

Photo 11: Scarp on south side of highway at approx. STA 34+700. Looking south.

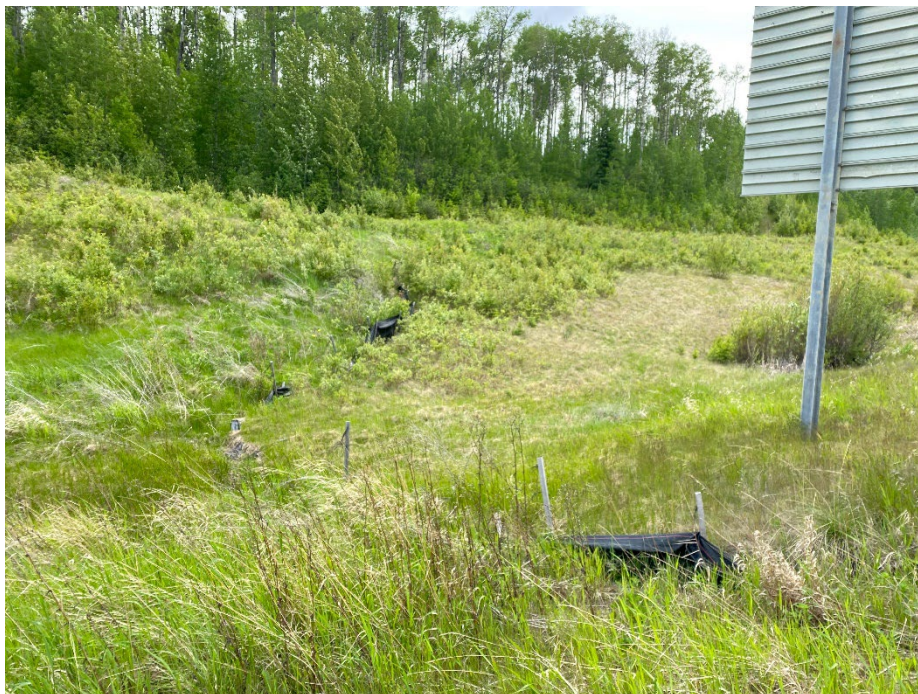
Photo 12: Silt fencing left on south slope at approx. STA 34+675. Looking south.

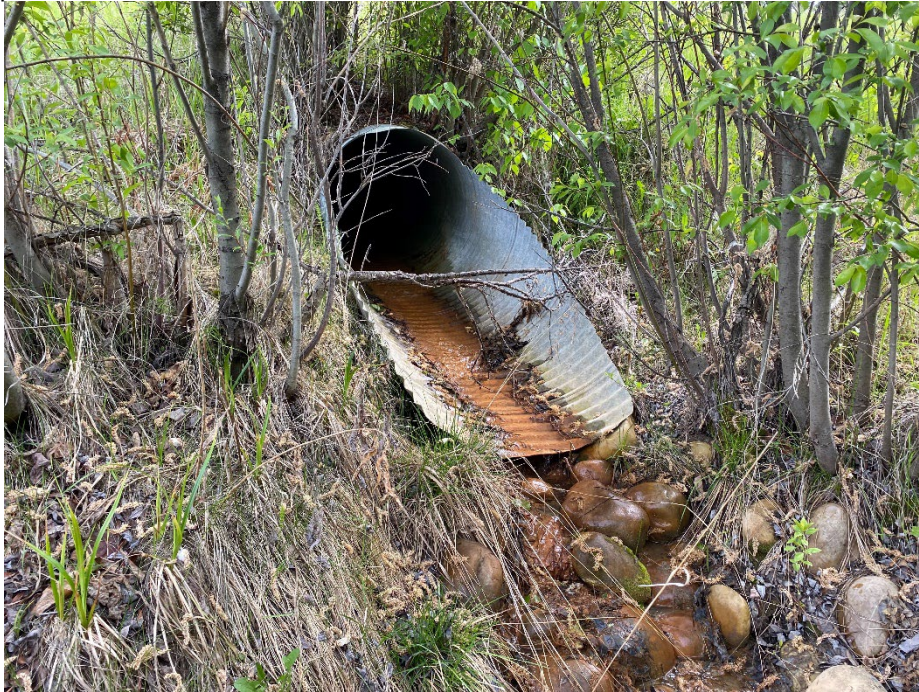
- The upper and lower toe berms appear unchanged since the previous inspection.
- The west culvert outlet at approximately Station 34+475 was observed to be flowing (Photo 13). Water flow was steadily trickling, and occasionally flowed in waves, similar to the 2020 inspection.

Photo 13: Culvert outlet adjacent to west extent of upper toe berm. Looking southwest.

- It is recommended that a CCTV inspection be completed for the west culvert at Station 34+475 to inform design of potential remedial measures for the culvert. Additional boreholes may be required to support culvert remediation.
- The toe berms at the Main Slide Site may be extended, if warranted.
- Site inspections should continue every two years.
- Instruments should continue to be read annually in the spring.

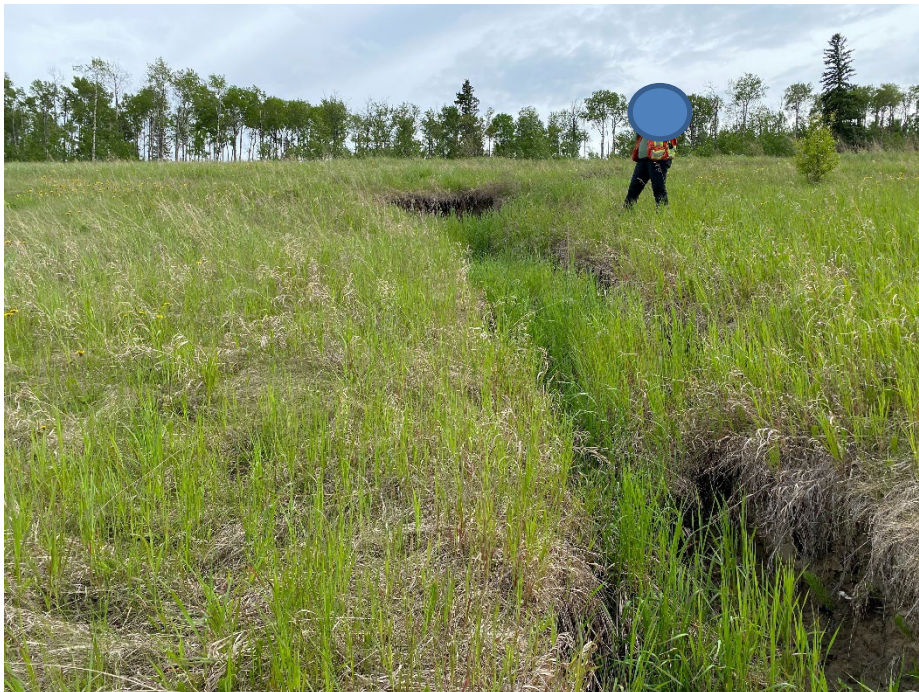
- Immediately upslope and southwest of the culvert outlet, the vegetated gully appears to have increased in width to a maximum of 1.2 m wide. The gully remains up to 1 m deep (Photo 14).

- Approximately midway upslope from the culvert outlet, the sinkhole feature was observed along the culvert alignment (Photos 14 and 15). The sinkhole appears to have increased in length towards the south compared to the 2022 inspection, and is now 3.0 m wide, 5.3 m long and 2.5 m deep. This sinkhole feature is possibly due to a break in the west culvert at Station 34+475 that runs beneath it.

Photo 14: Gully and sinkhole directly upslope from west culvert. Looking south.

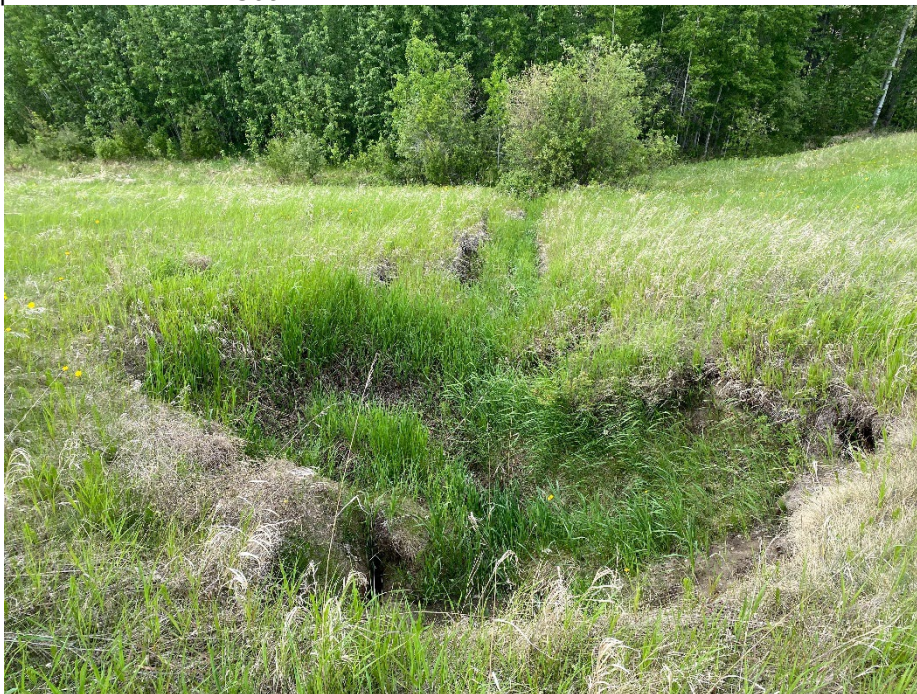
Photo 15: Sinkhole and gully directly upslope from the west culvert. Looking north.

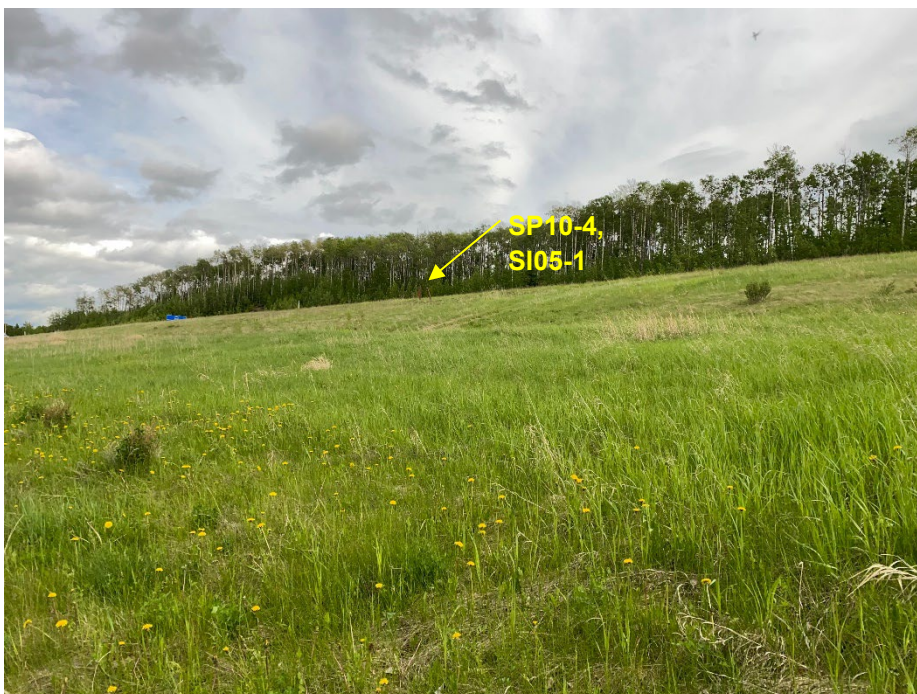
Photo 16: Slope at main site, looking upslope towards the southeast.

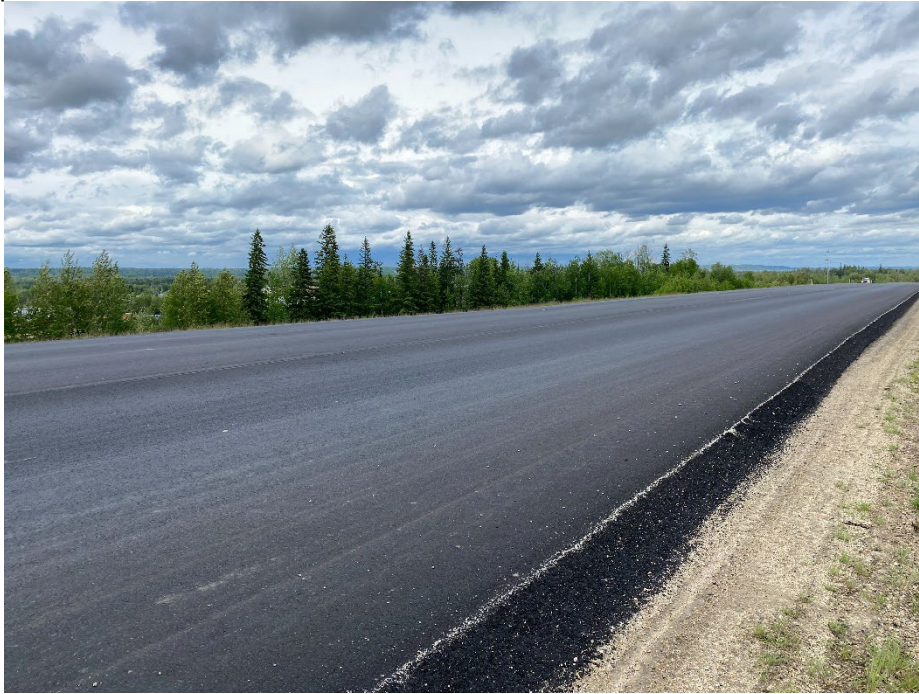
- No pavement cracks or dips were observed during the site inspection due to recent paving (Photos 17 & 18).
- SI movement historically suggests the slope is creeping at a rate of less than 1 mm/year; however, slope inclinometer SI10-5 has a current rate of movement of 8 mm/year.

Photo 17: Pavement condition in WBL at approximately 34+575. Looking northeast.

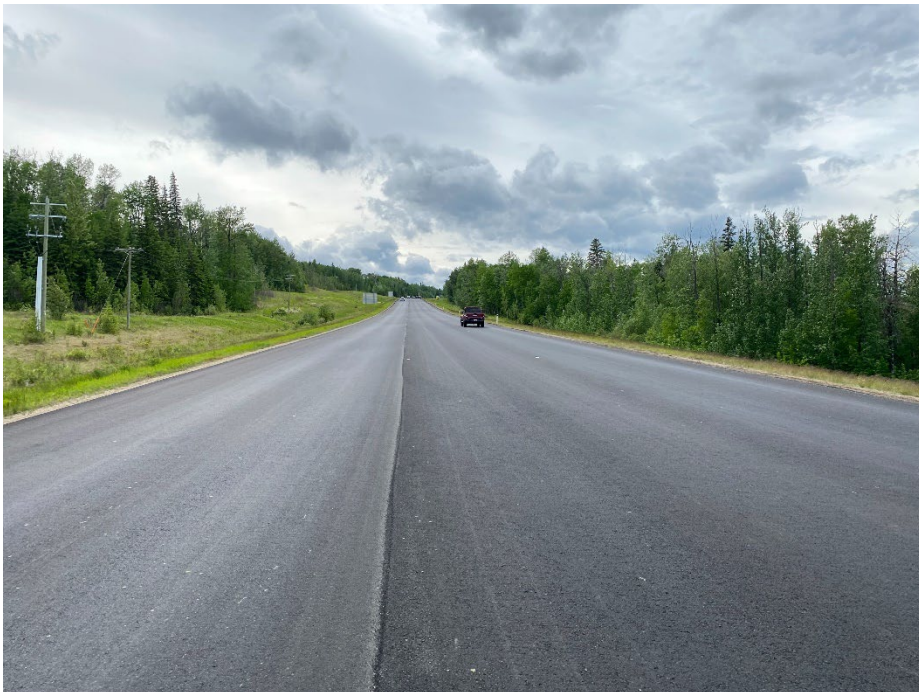
Photo 18: Pavement condition from approx. STA 34+450. Looking west.
