To: Amy Driessen  
Transportation and Economic Corridors  
File: 123315222

From: Leslie Cho and Xiteng Liu  
Stantec Consulting Ltd.  
Date: June 18, 2024

**Reference: North Central Region, Edson, Site NC037 - Highway 32:10 South of Whitecourt, Spring 2024 Instrumentation Monitoring Report**

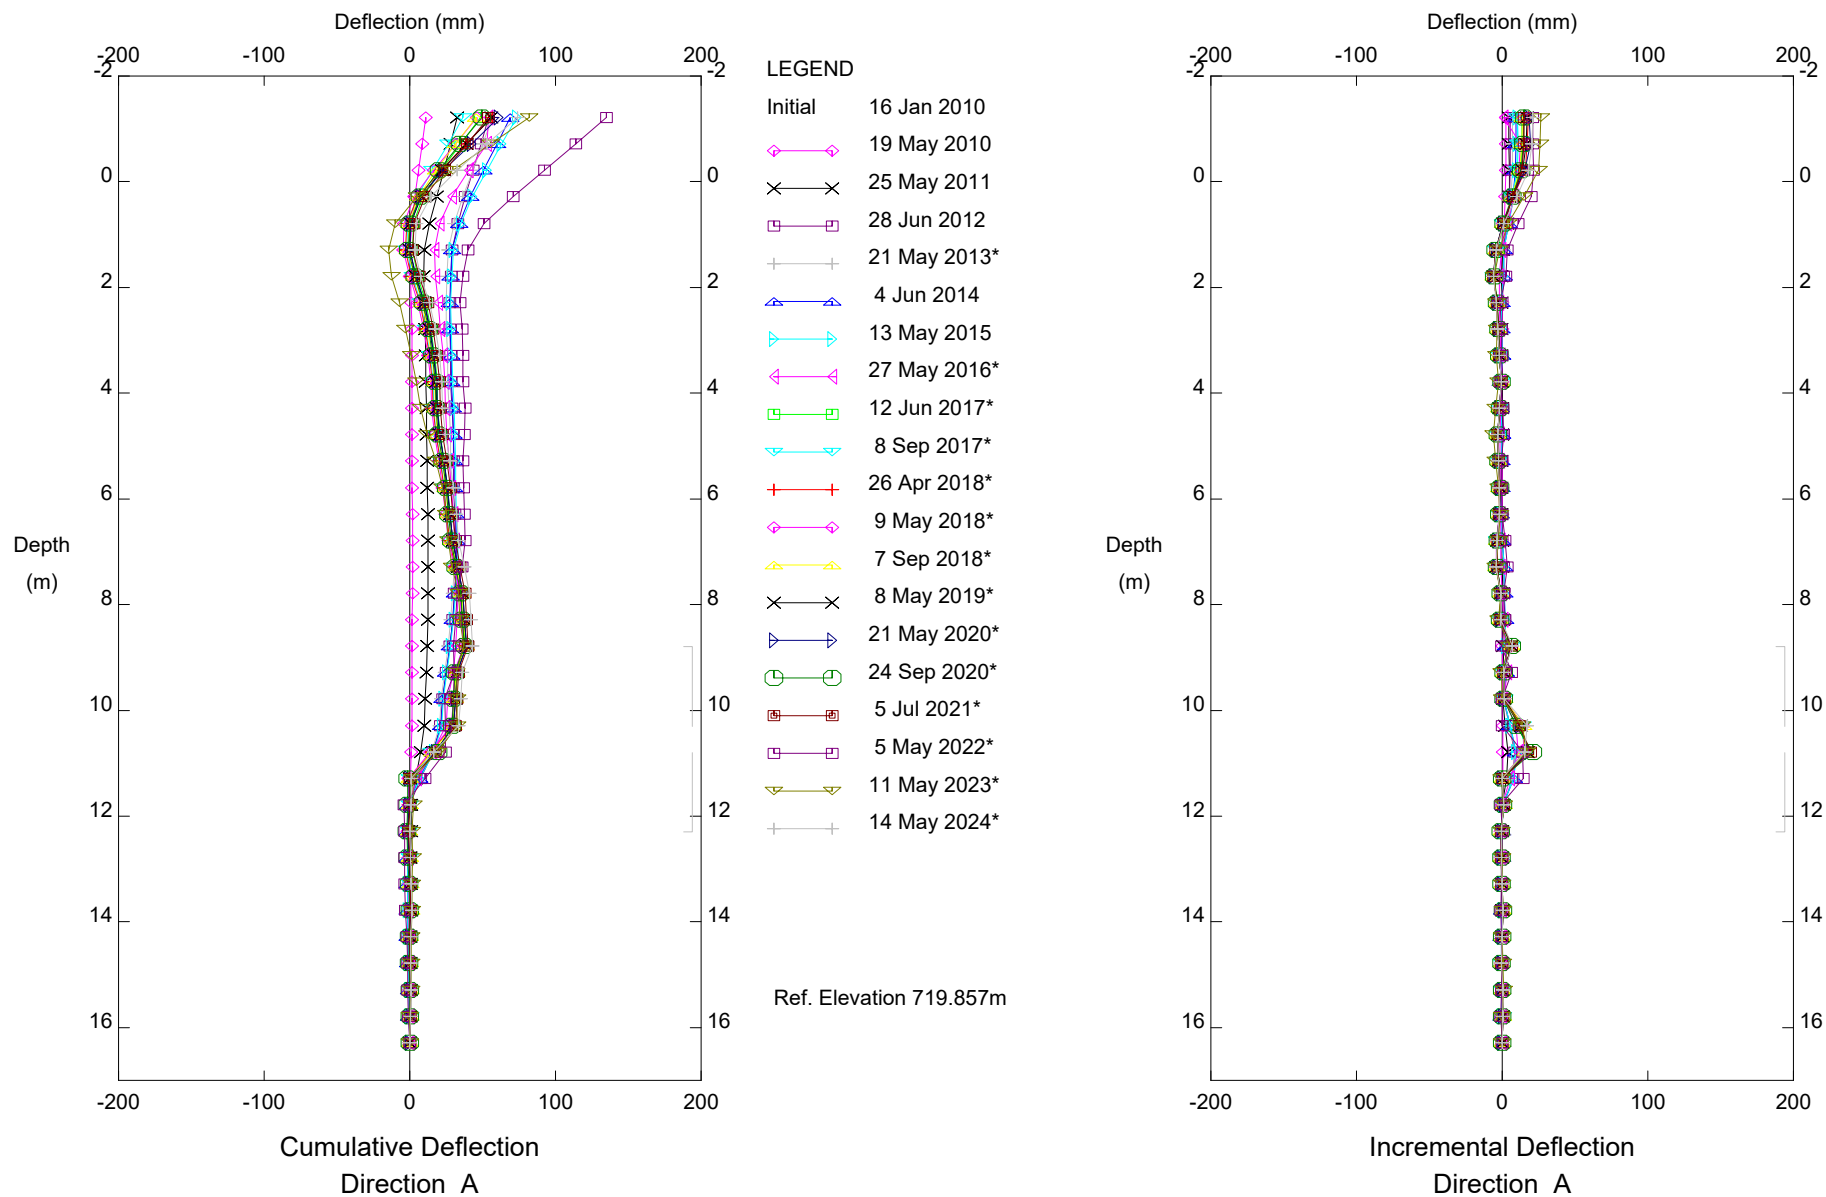
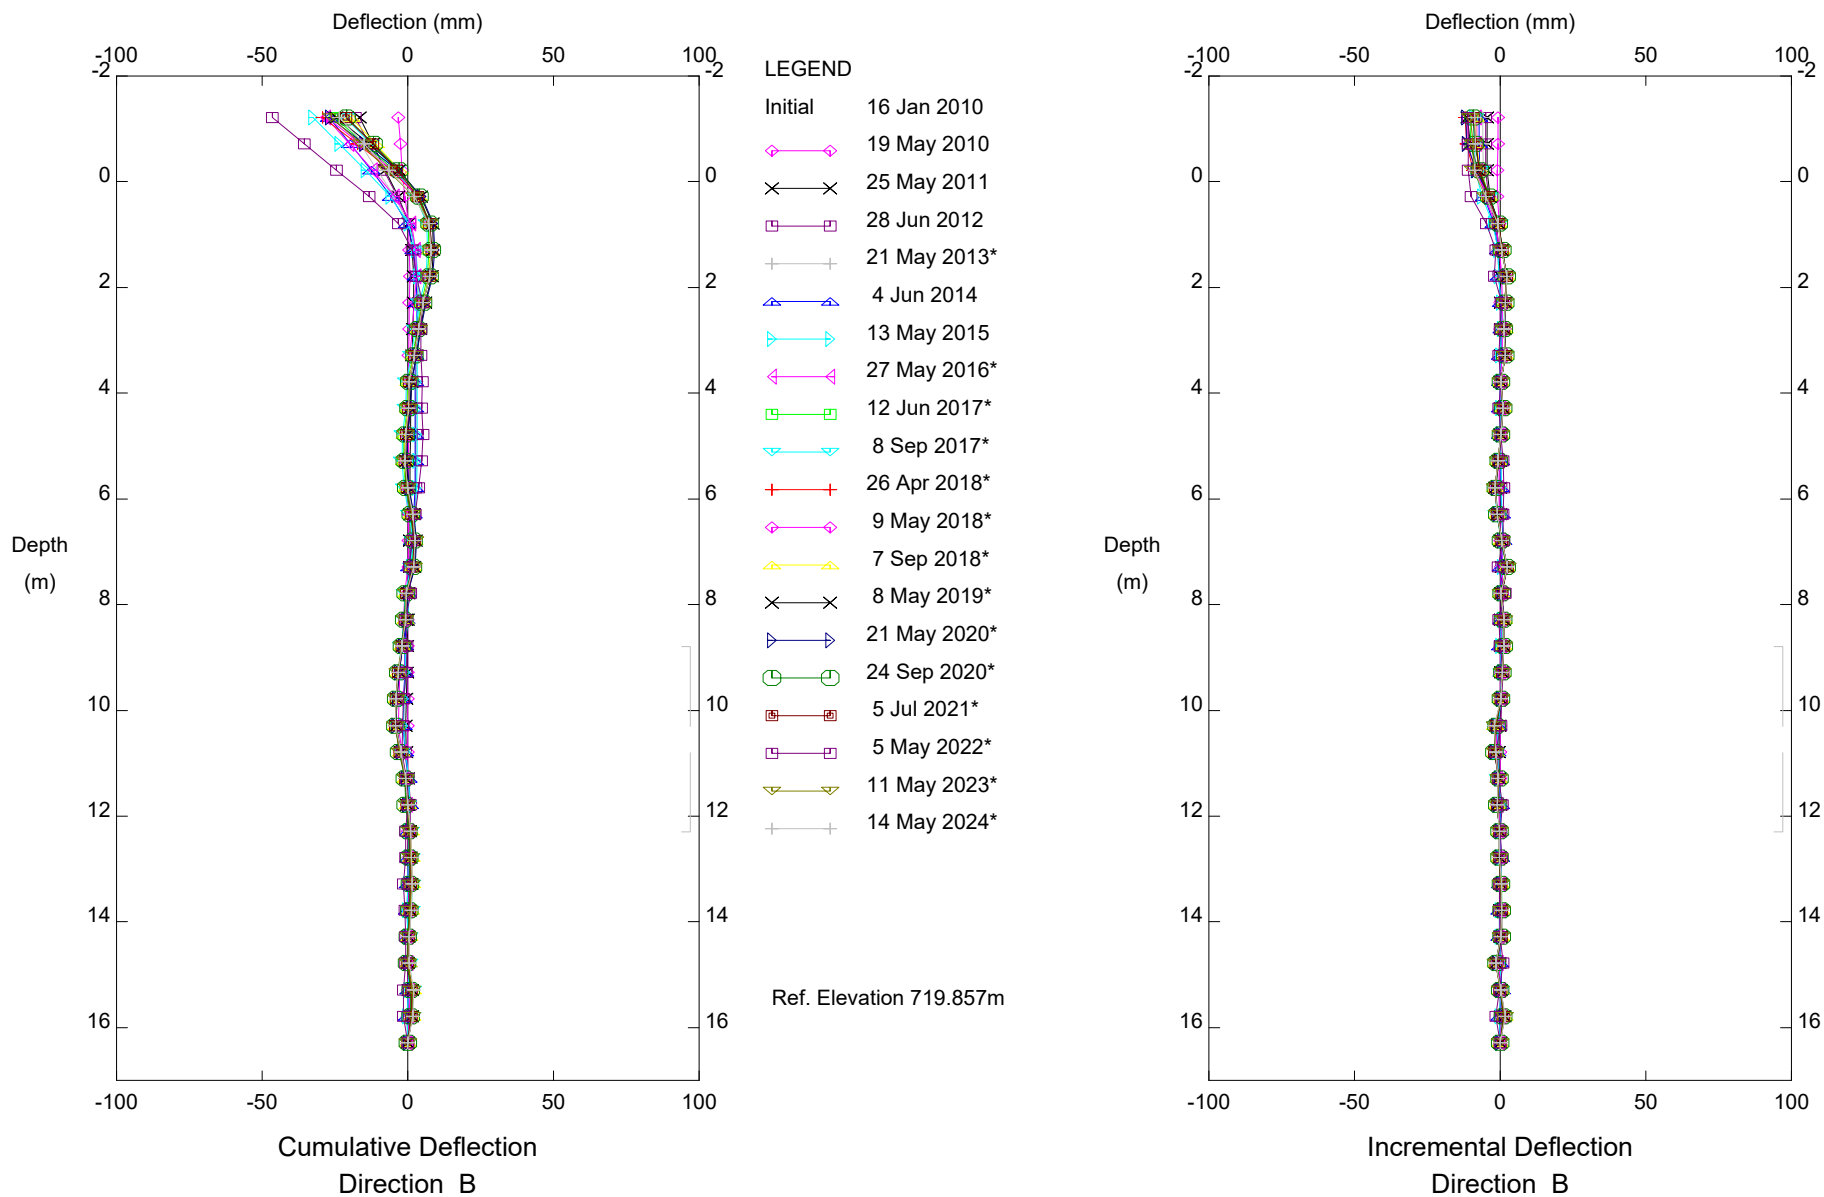
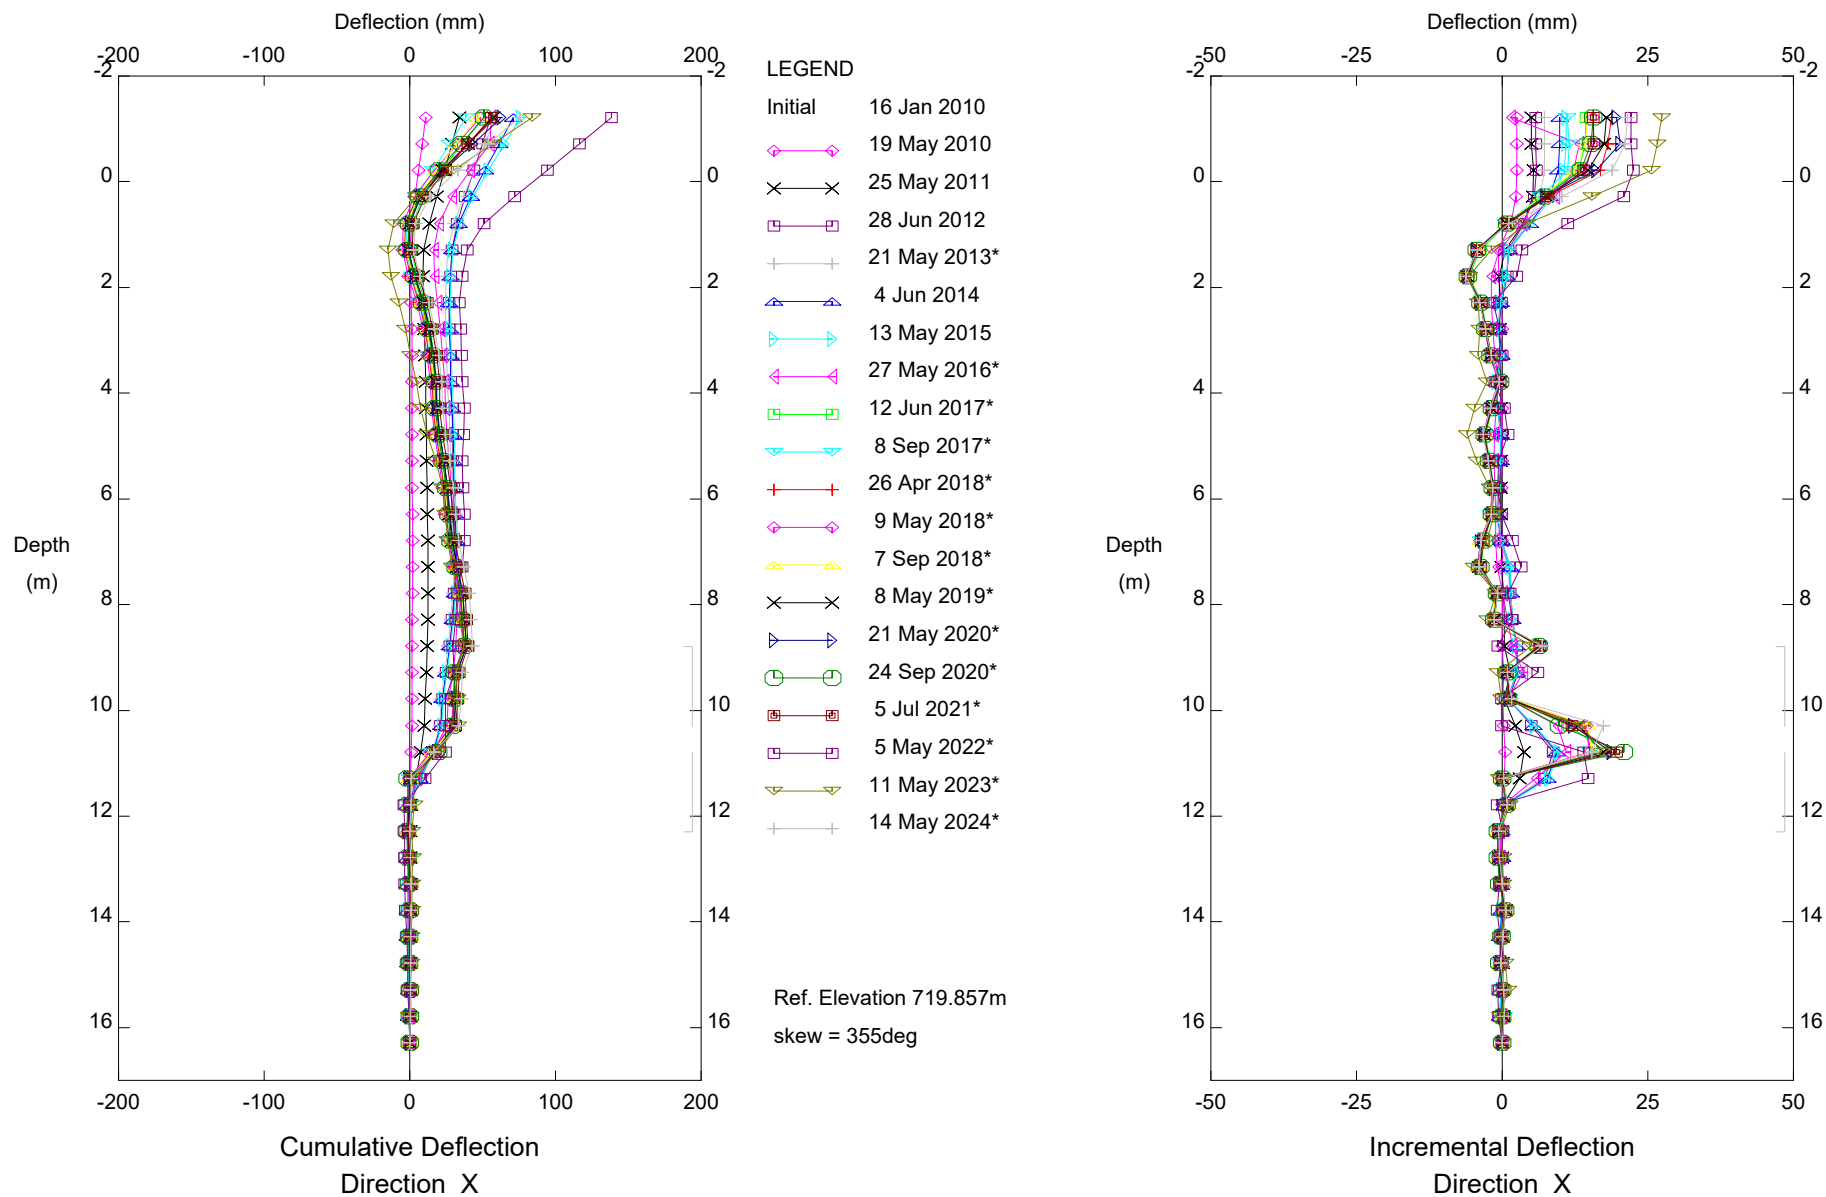
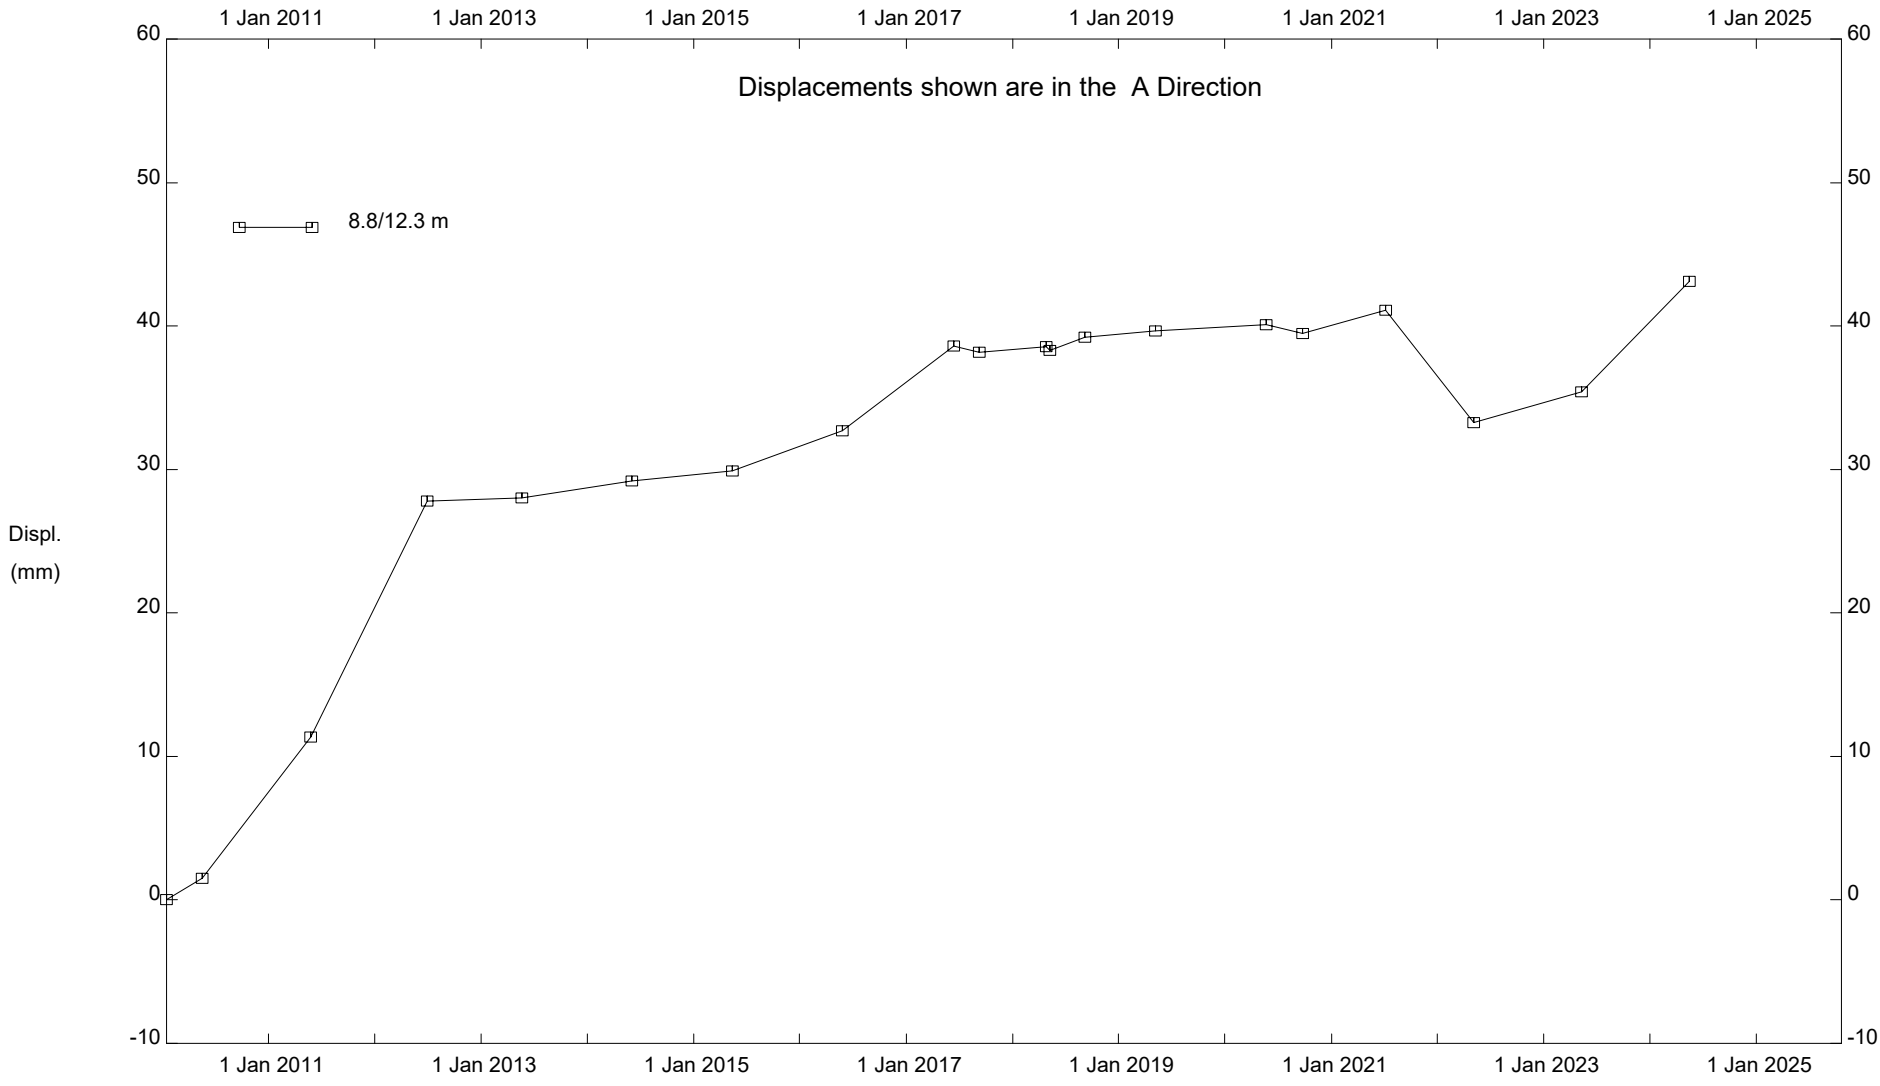
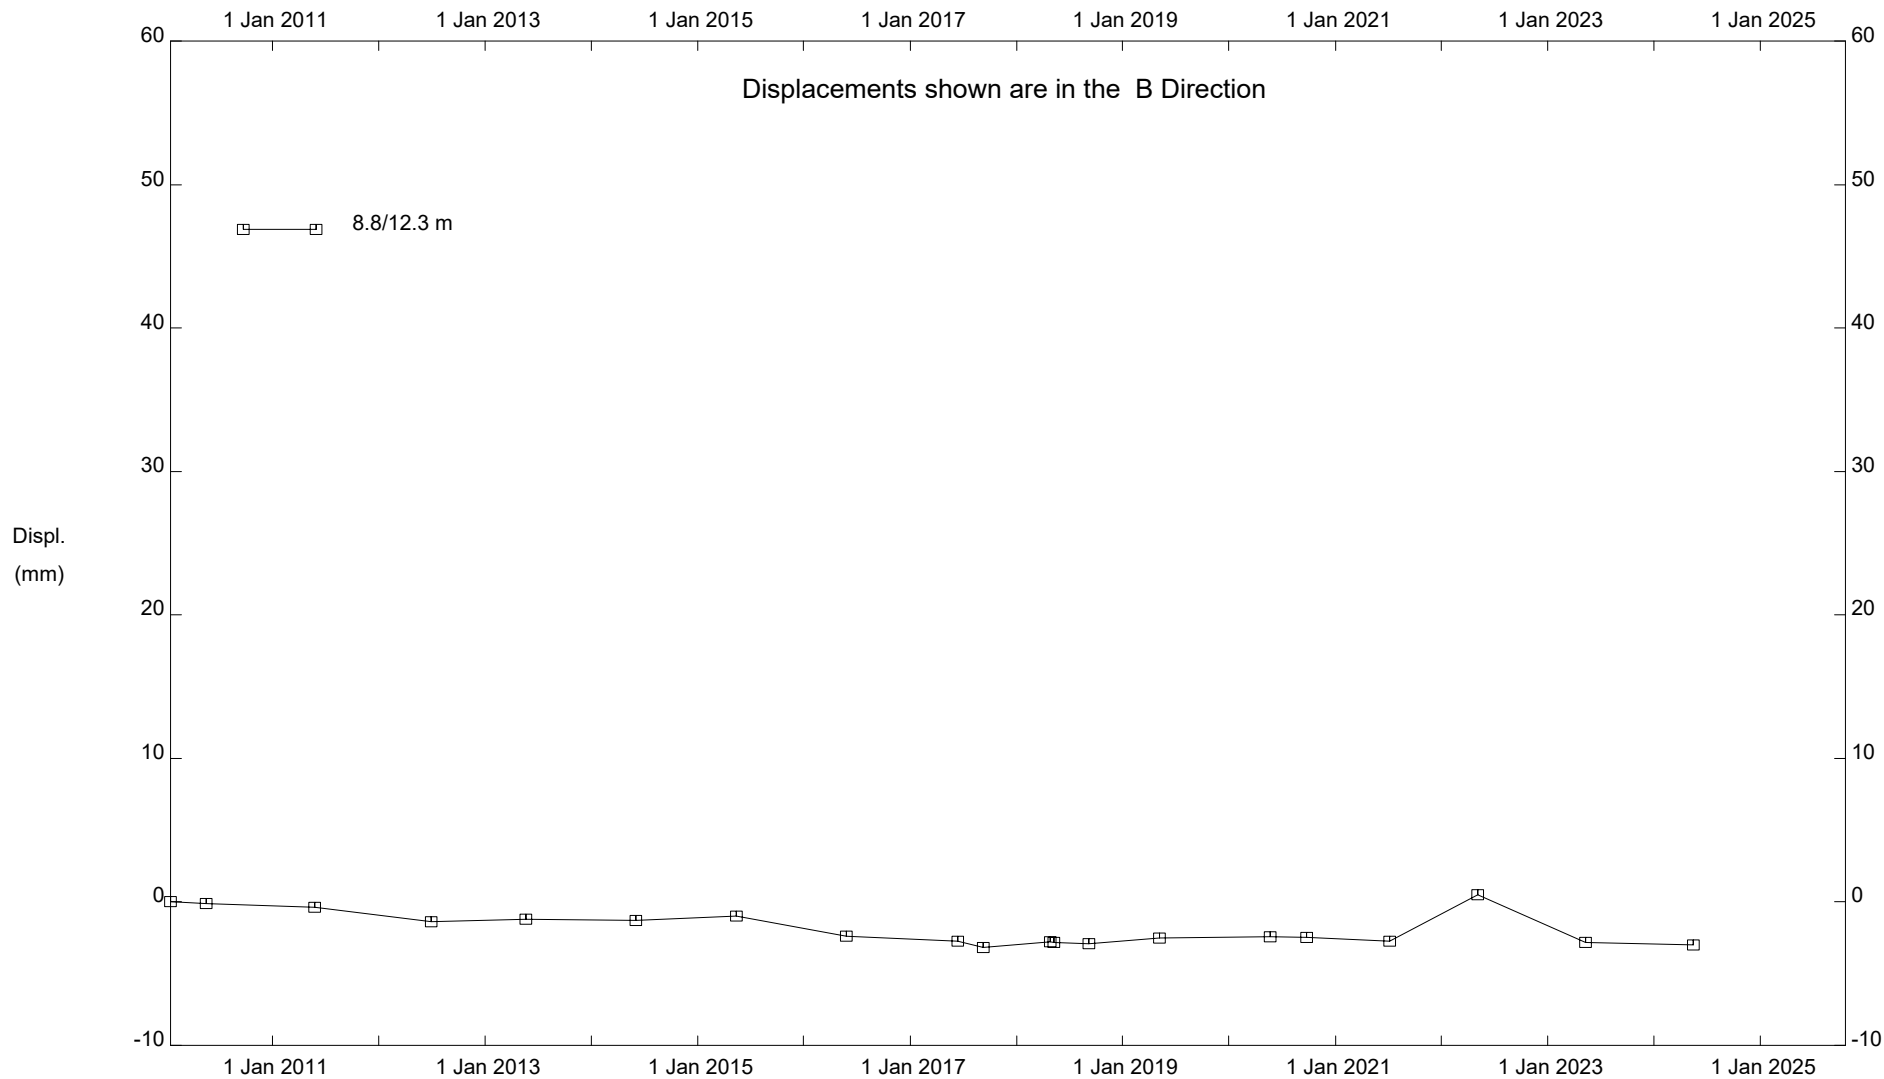
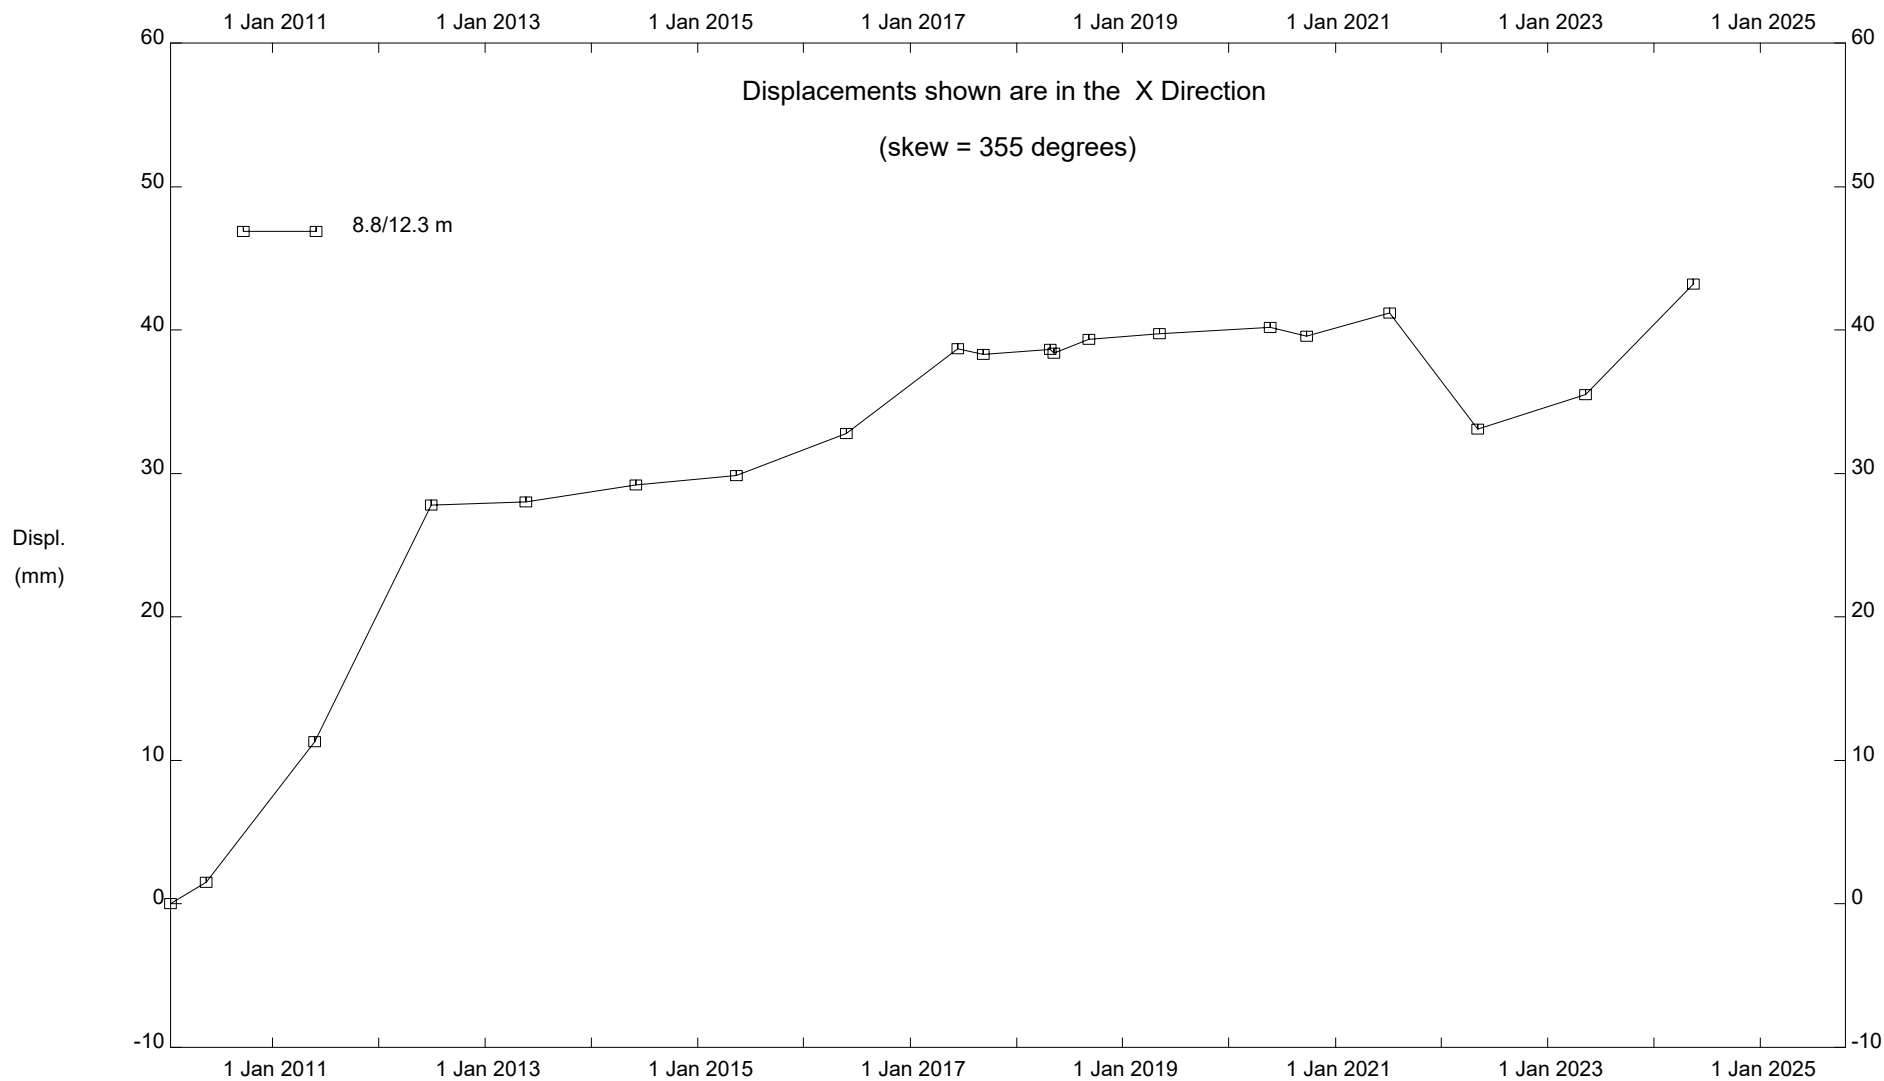
HWY32:10 South of Whitecourt (NC37), Inclinometer SI10-5

SI10-5 shows a zone of movement from about 8.8 m to 12.3 m depth. The movement zone appears to be creeping at an overall rate of less than 1 mm/yr since berm construction in 2011. The current movement rate is 8 mm/yr, and the cumulative movement increased by 8 mm to 43 mm.
