To: Amy Driessen  
Transportation and Economic Corridors  
File: 123315222

From: Leslie Cho and Xiteng Liu  
Stantec Consulting Ltd.  
Date: June 18, 2024

**Reference: North Central Region, Edson, Site NC037 - Highway 32:10 South of Whitecourt, Spring 2024 Instrumentation Monitoring Report**

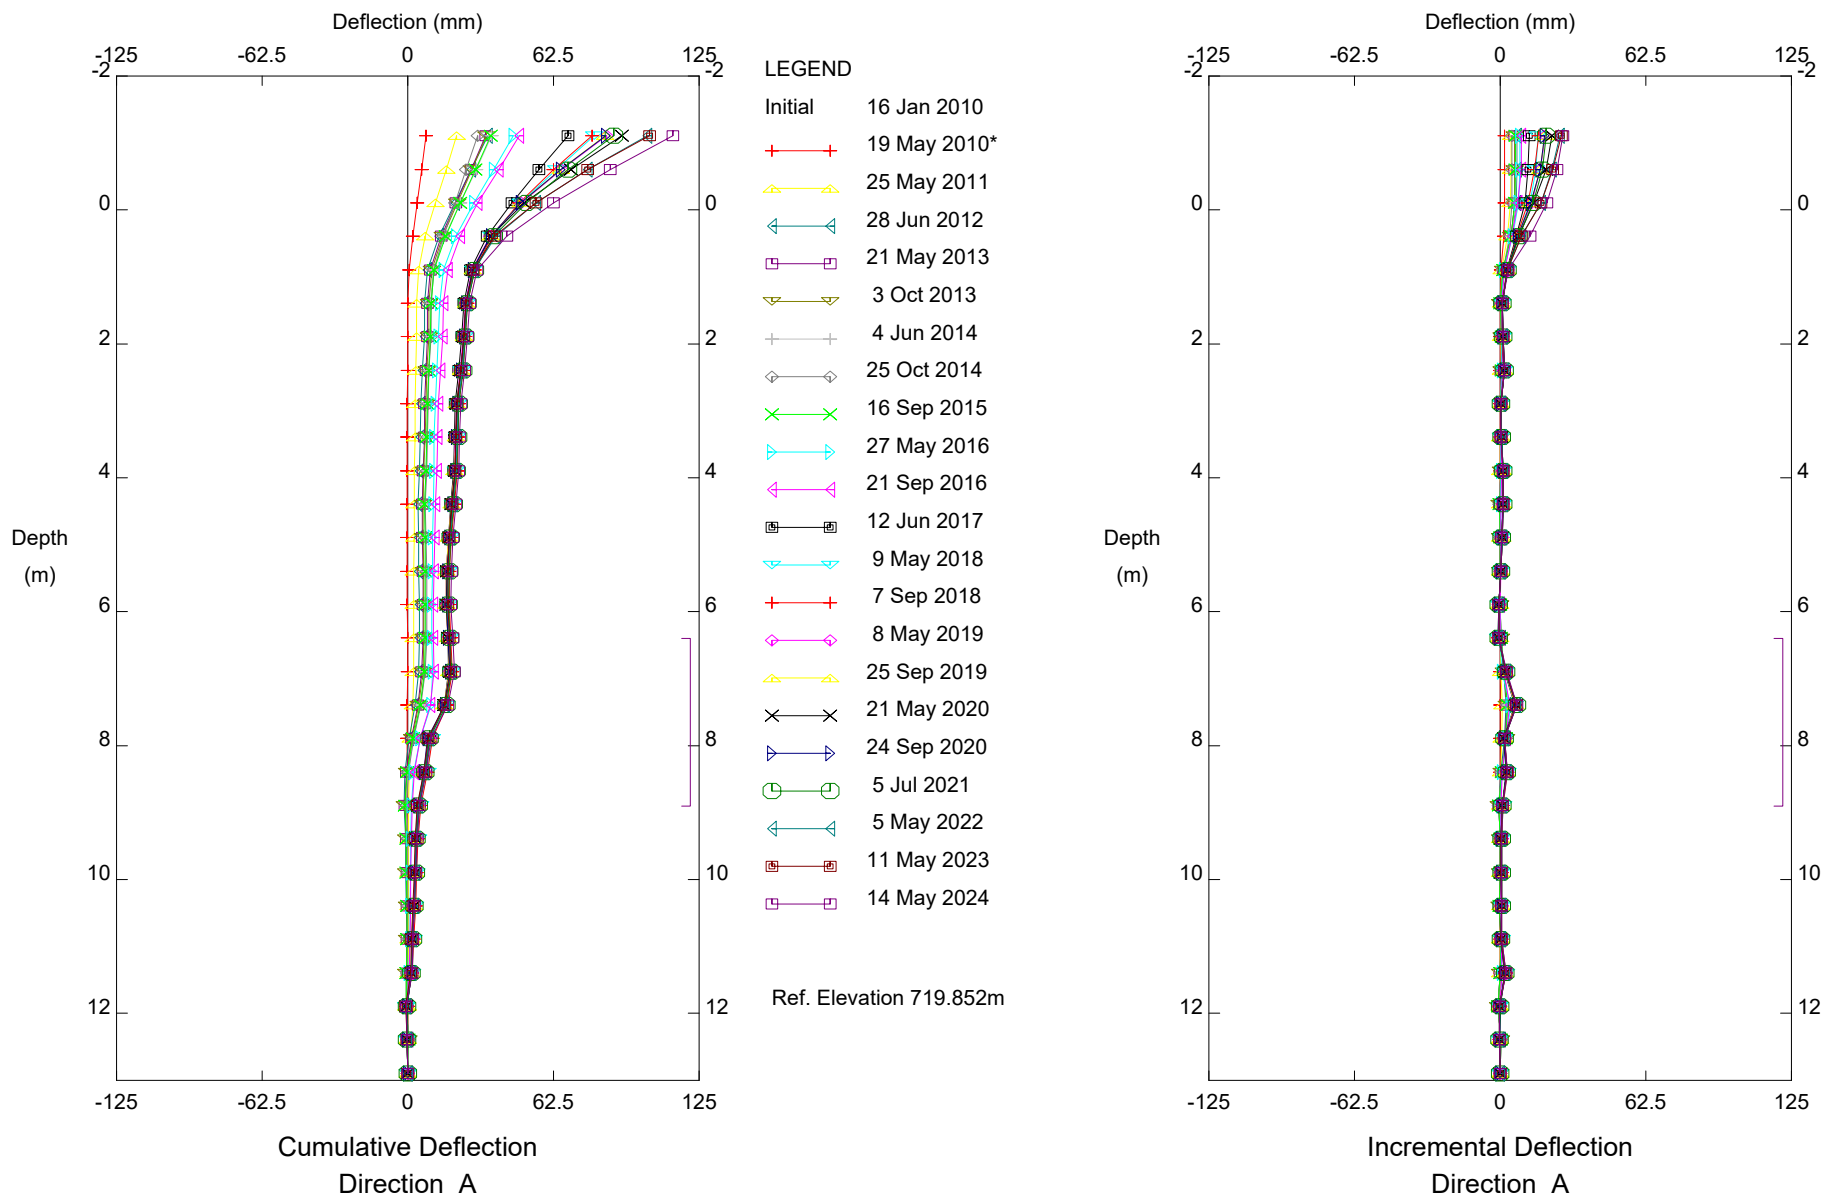
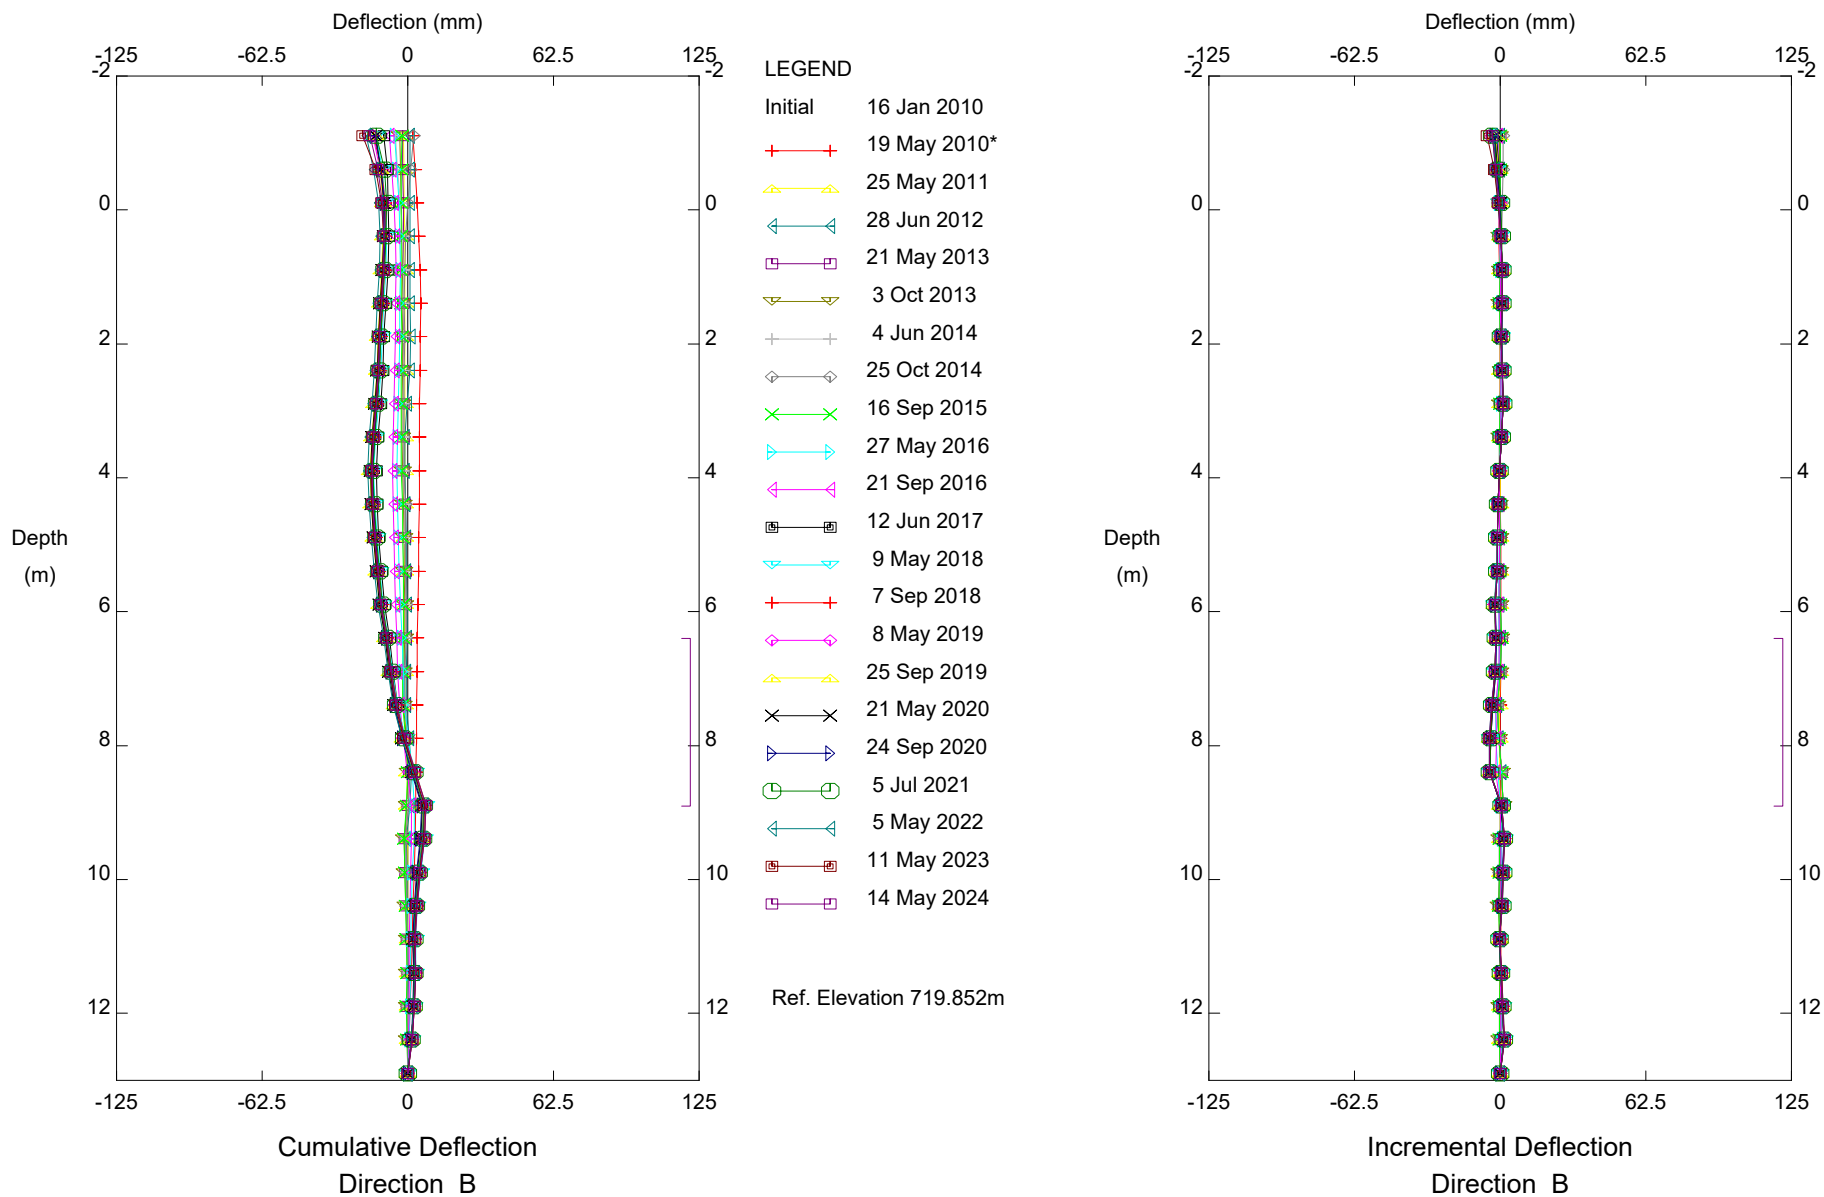
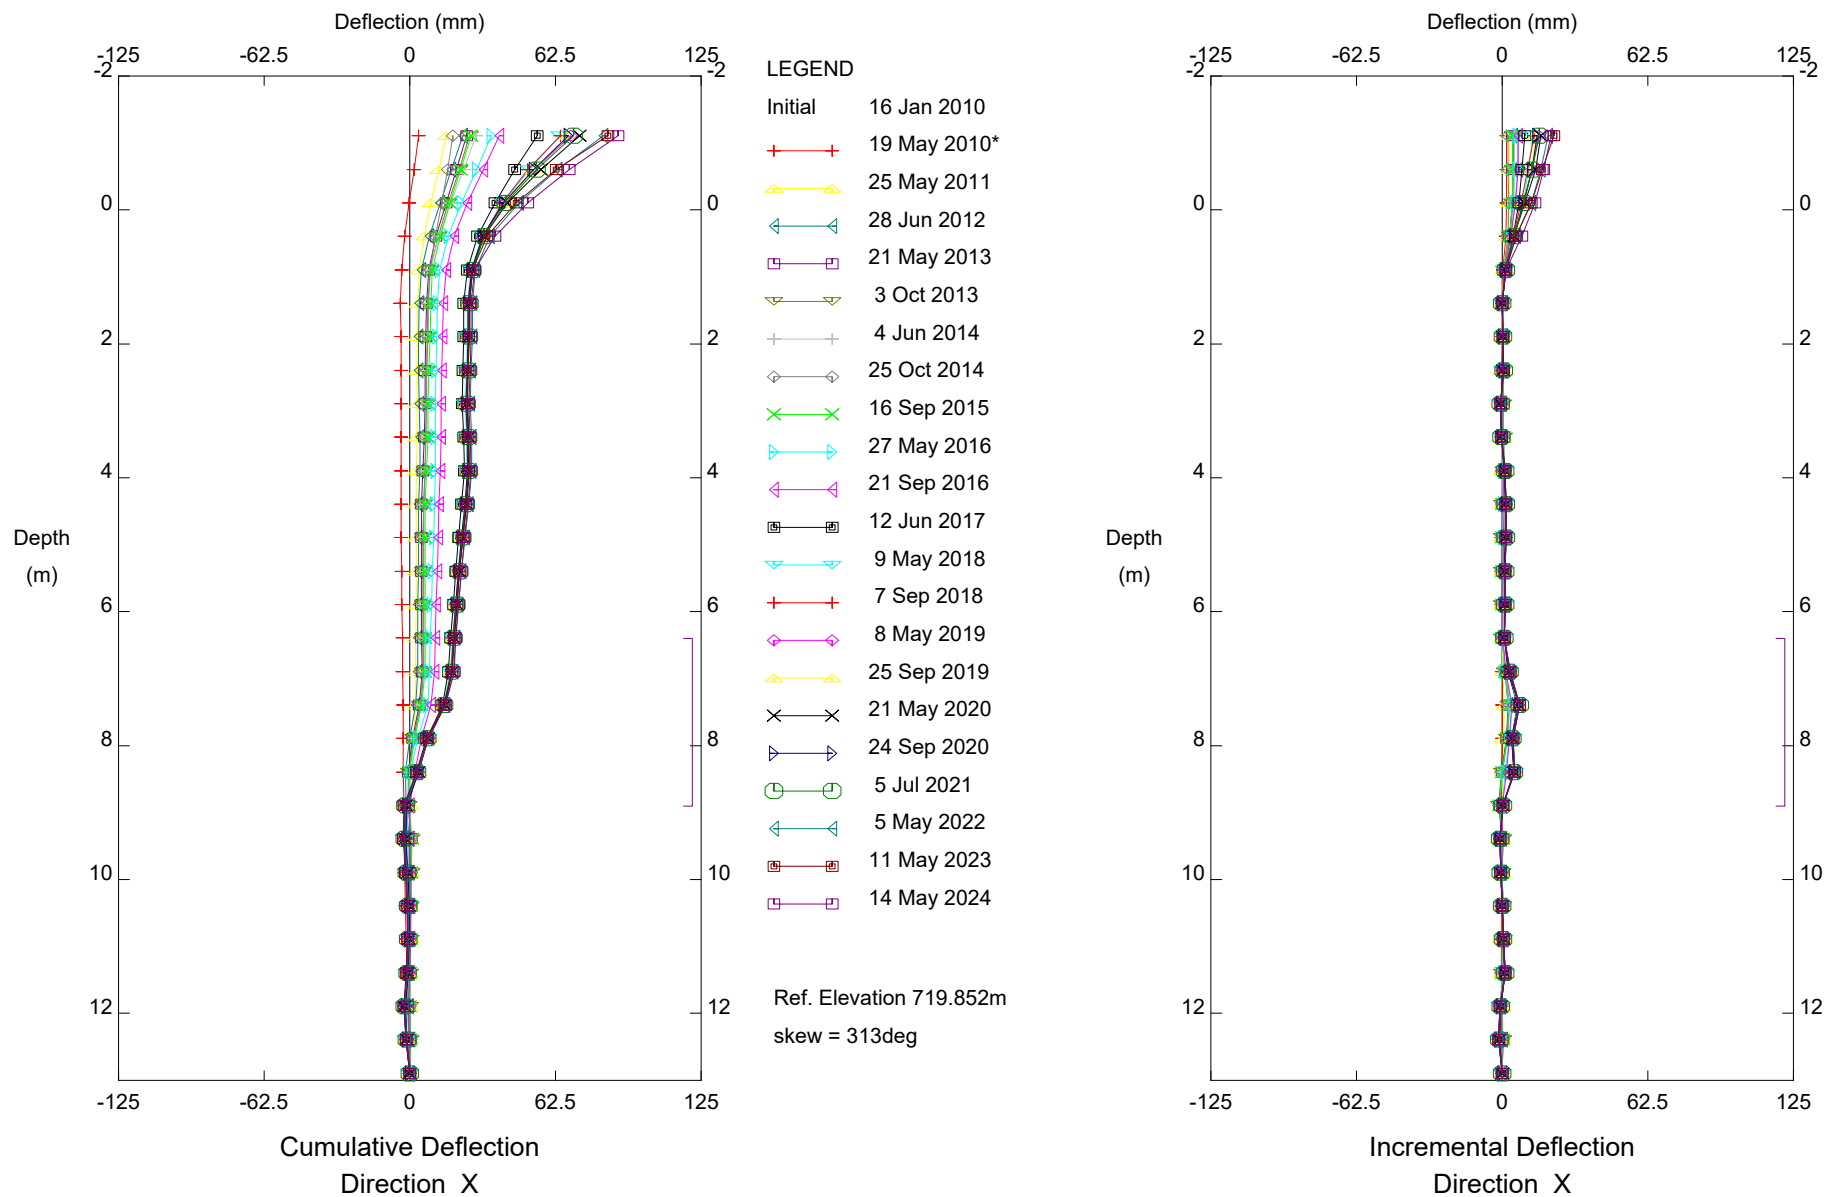
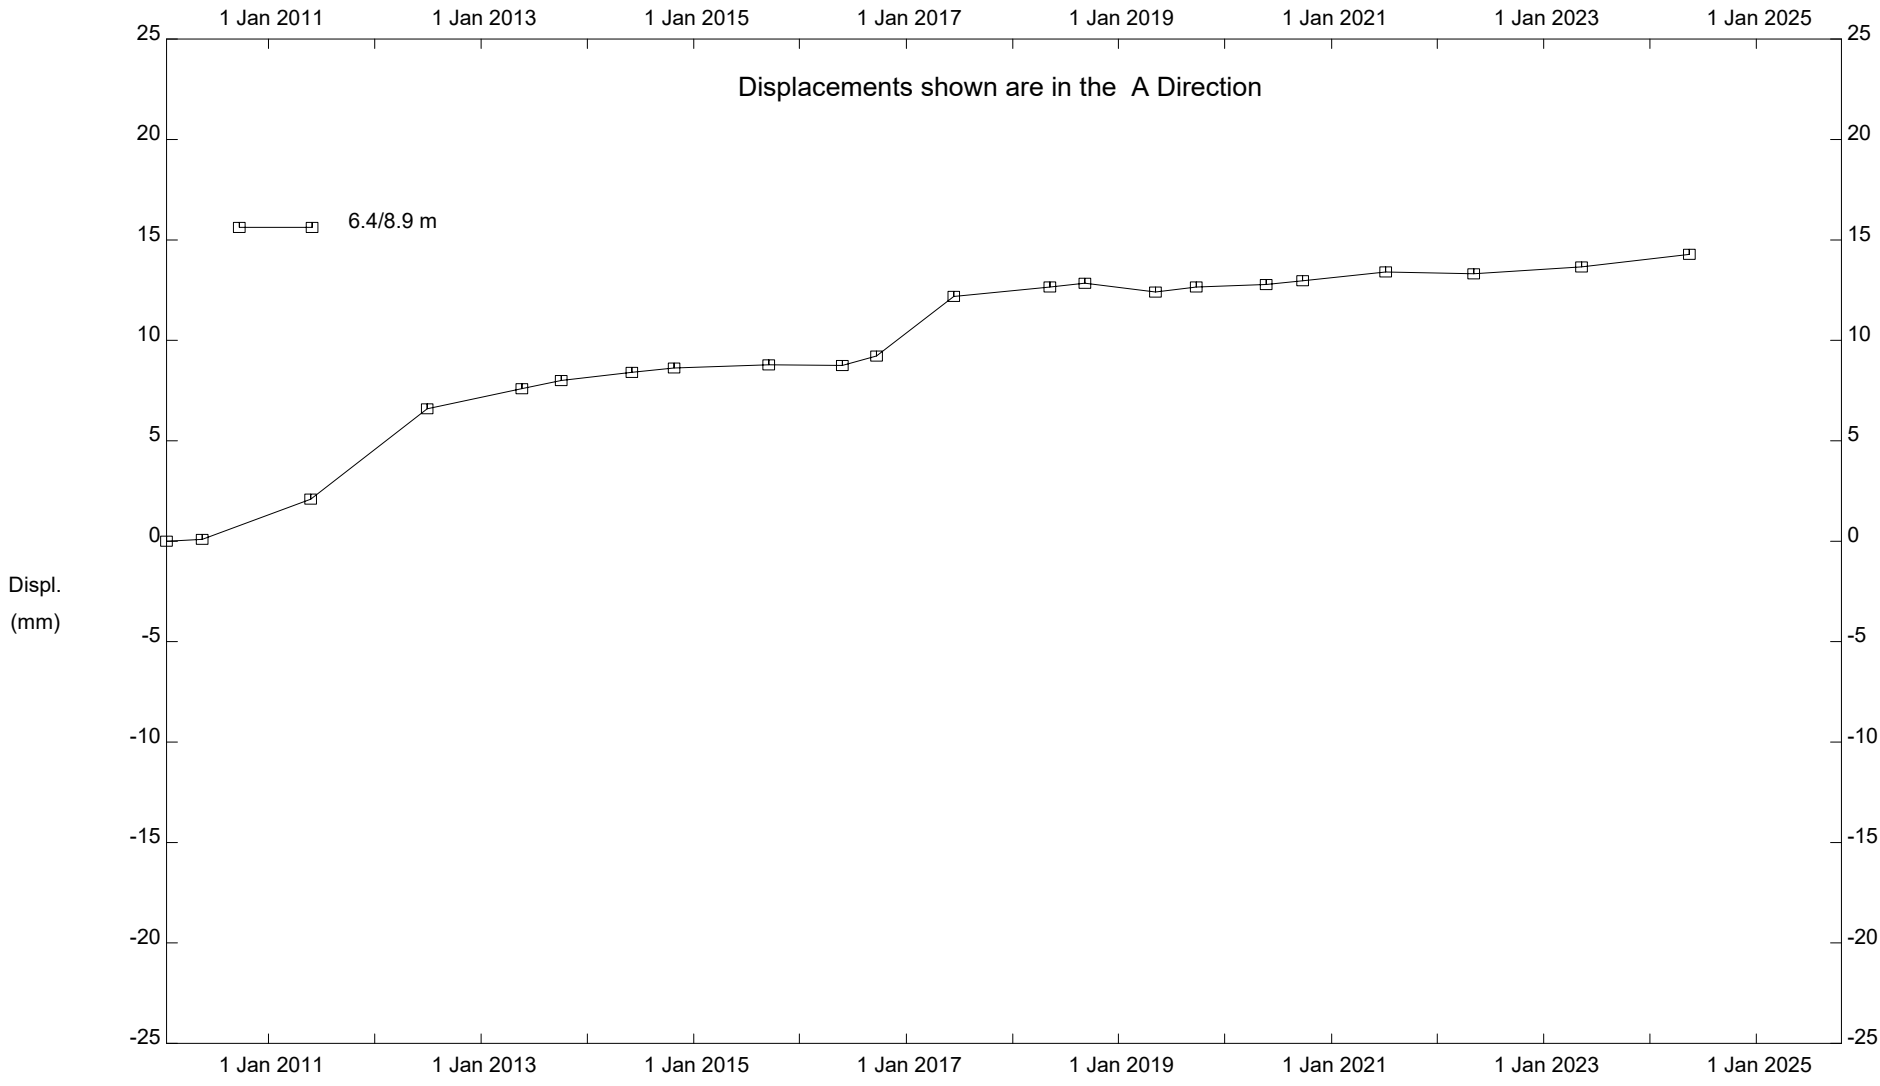
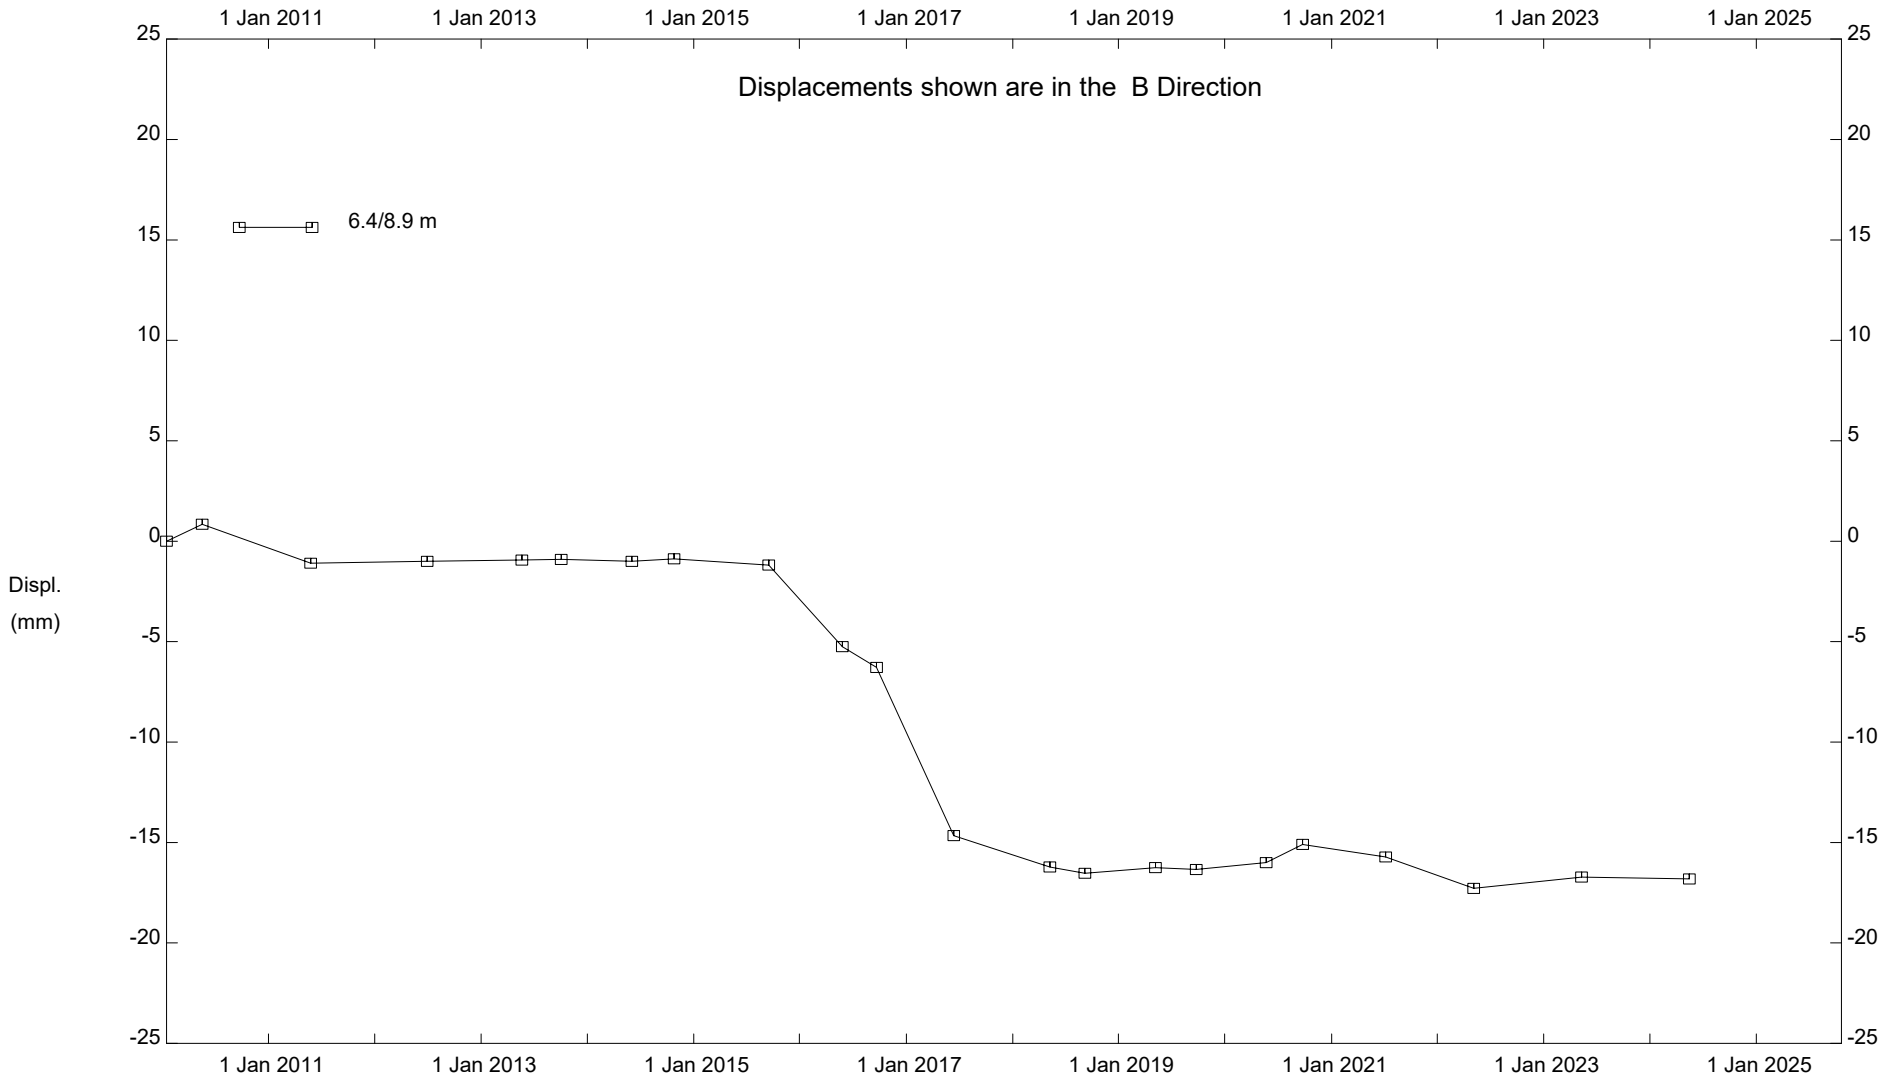
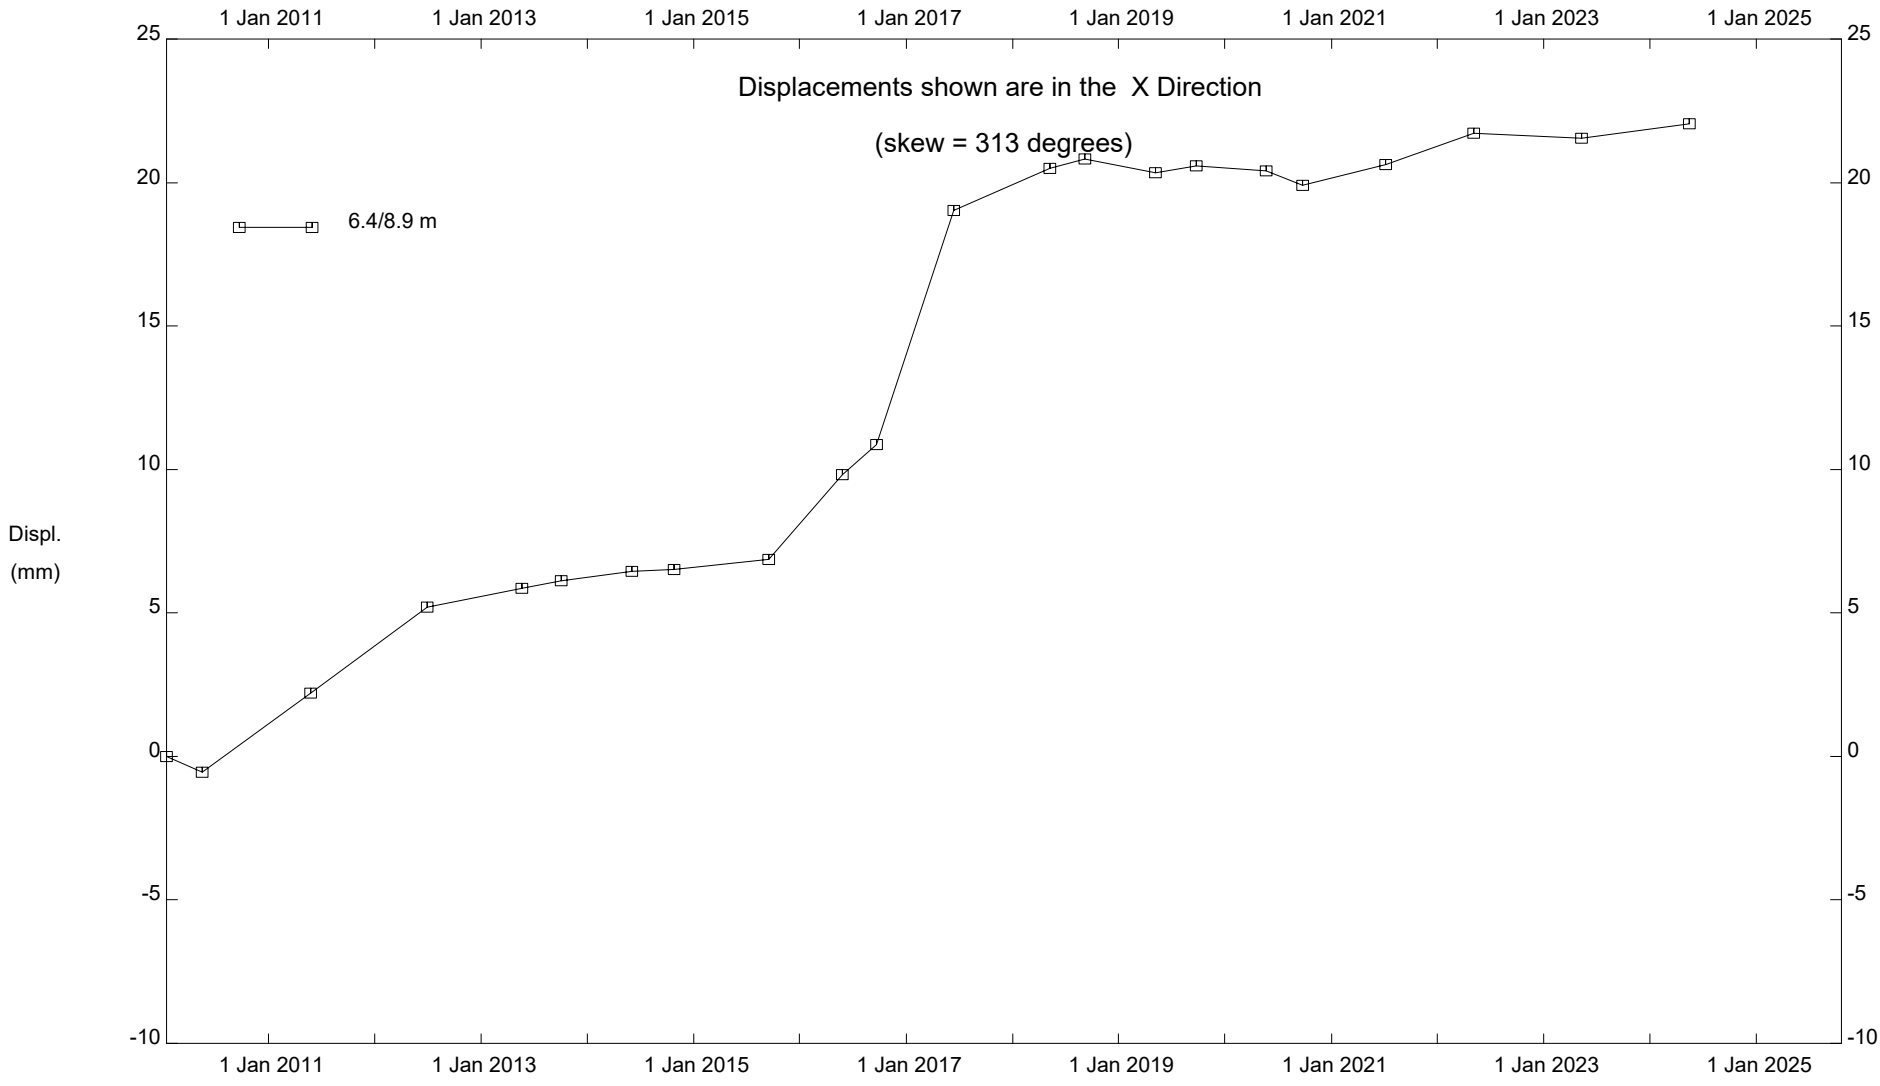
HWY32:10 South of Whitecourt (NC37), Inclinometer SI10-6

SI10-6 has a movement zone between 6.4 m and 8.9 m depth and appears to be creeping at a rate of less than 1 mm/yr since berm construction in 2011. An increase to 3 mm/yr rate of movement was observed during Fall 2017. Since then, the rate has returned to less than 1 mm/yr.
