To: Amy Driessen  
Transportation and Economic Corridors  
File: 123315222

From: Leslie Cho and Xiteng Liu  
Stantec Consulting Ltd.  
Date: June 18, 2024

**Reference: North Central Region, Edson, Site NC037 - Highway 32:10 South of Whitecourt, Spring 2024 Instrumentation Monitoring Report**

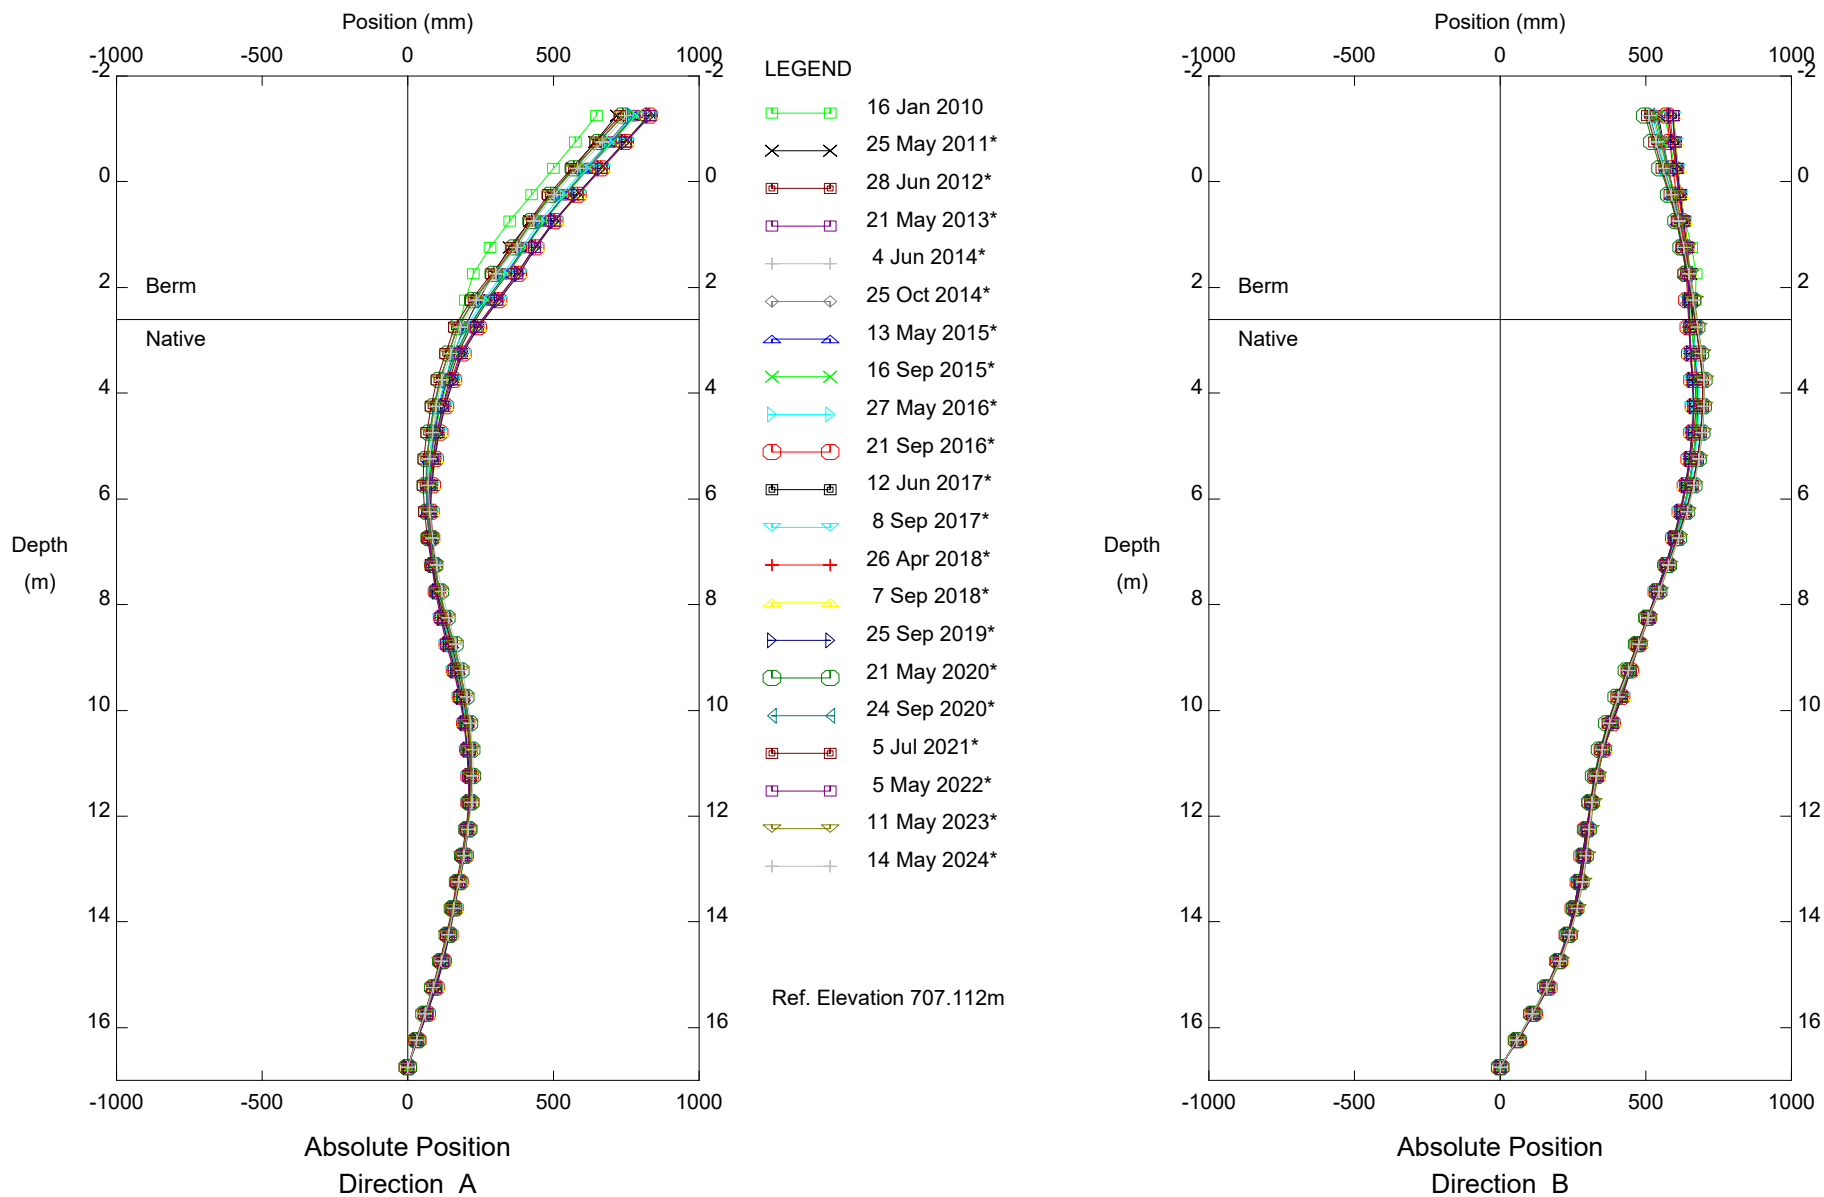
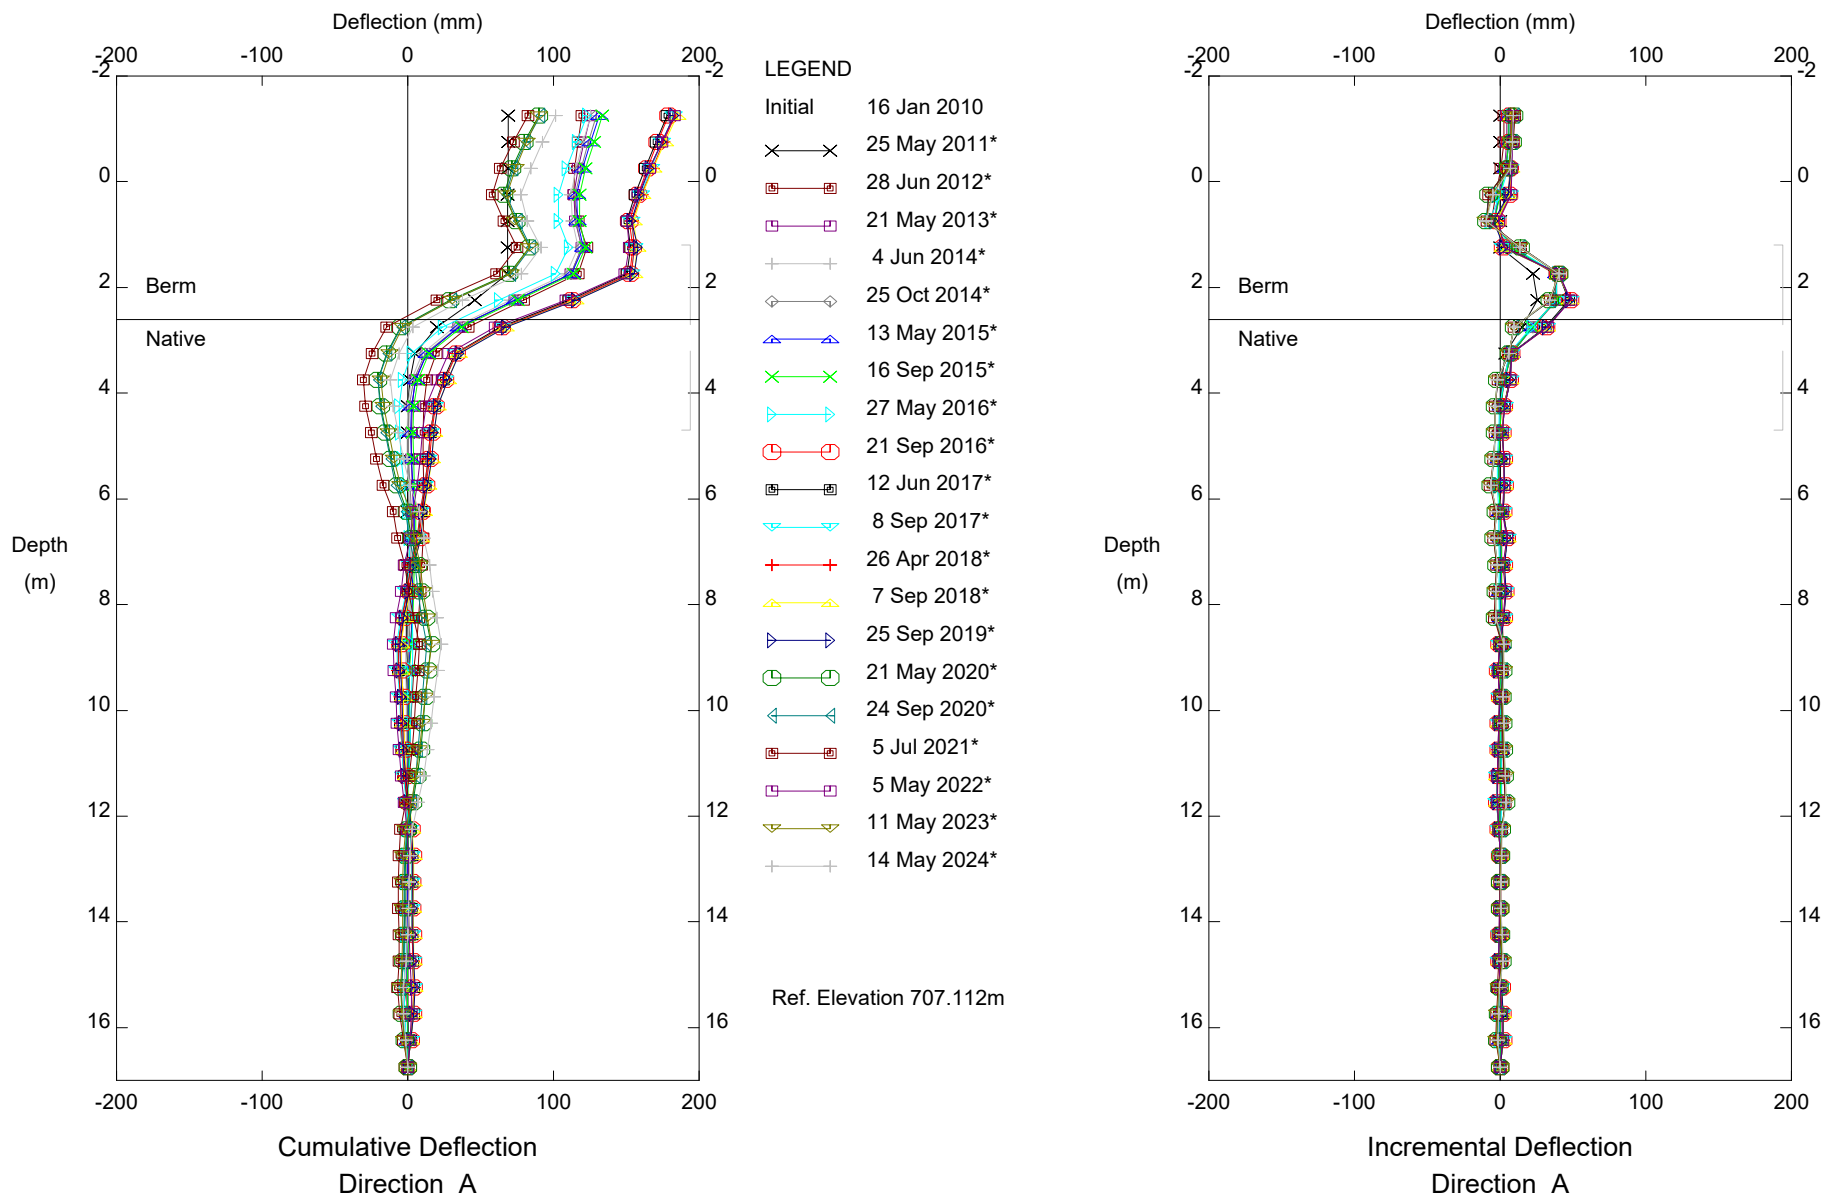
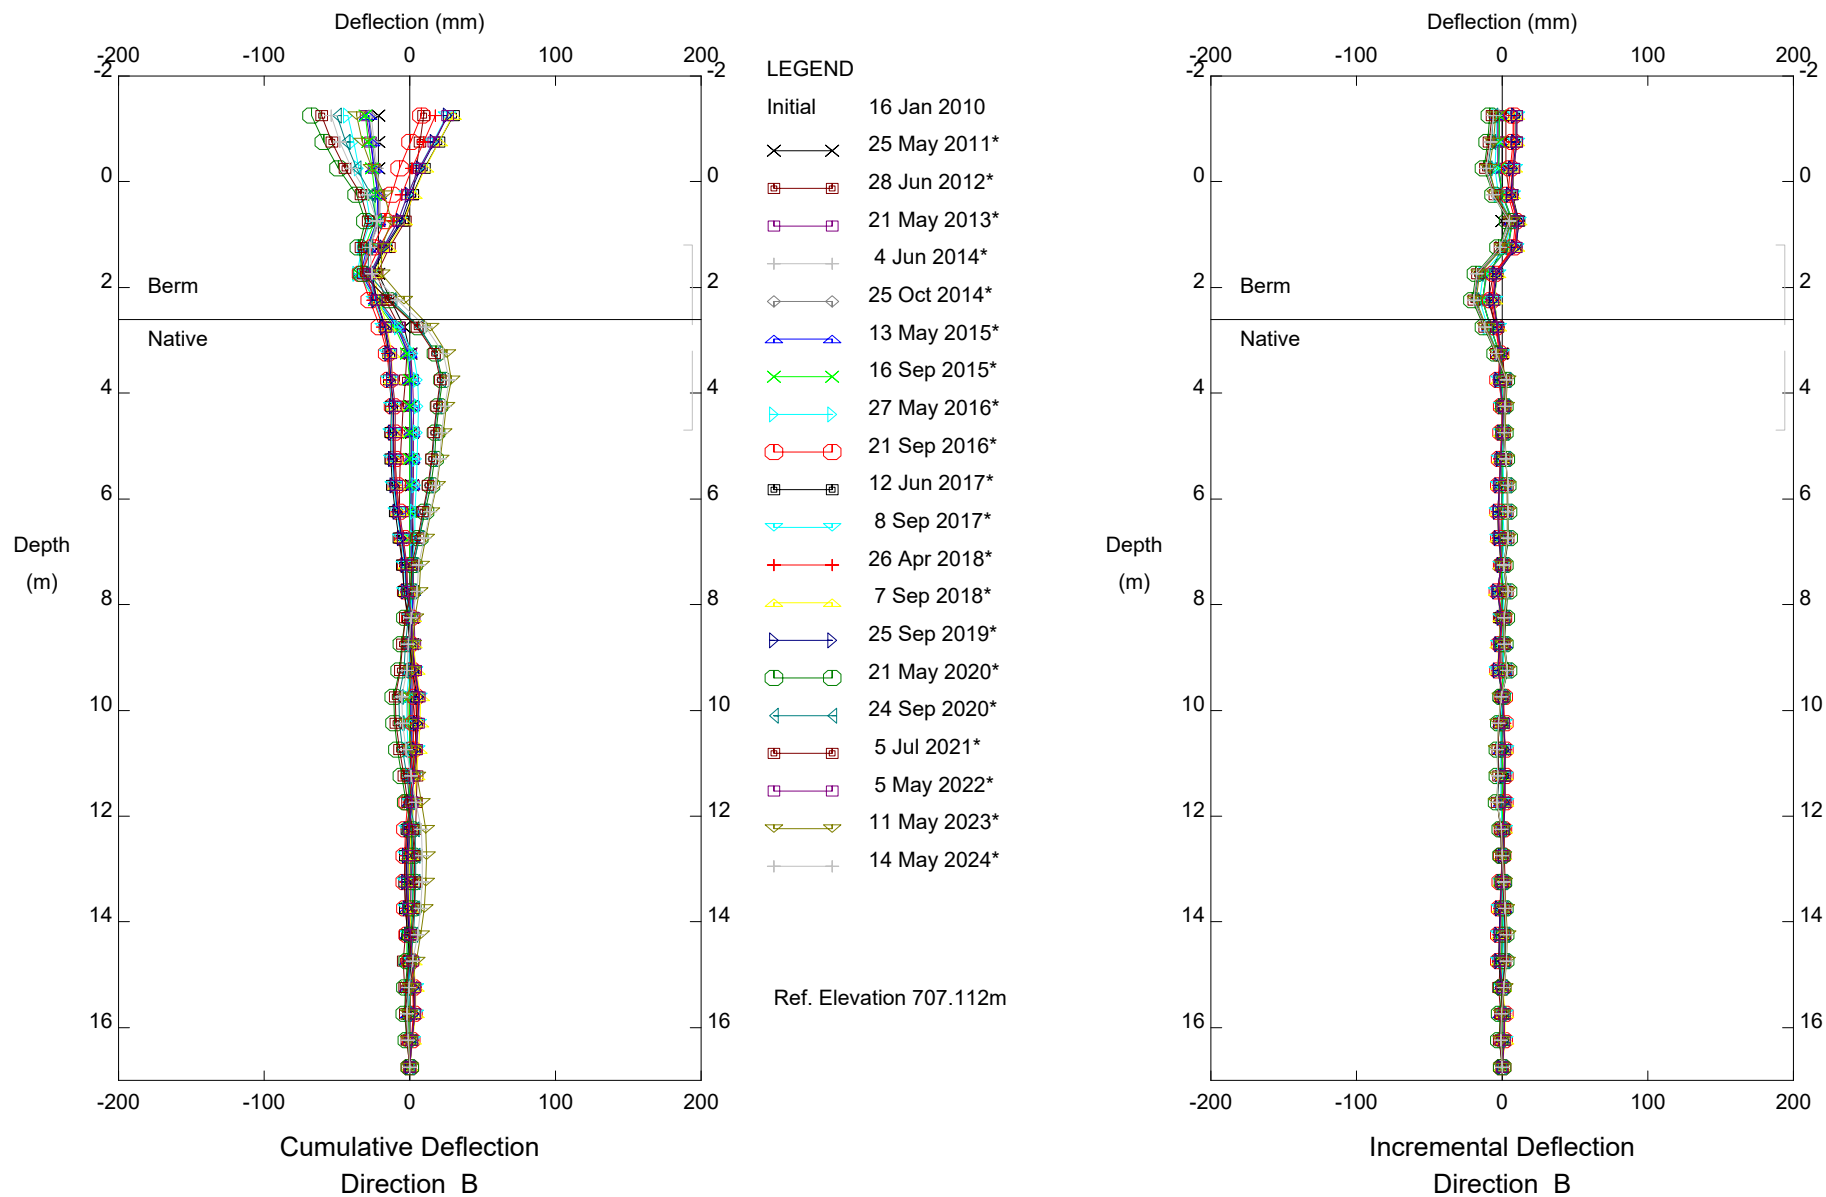
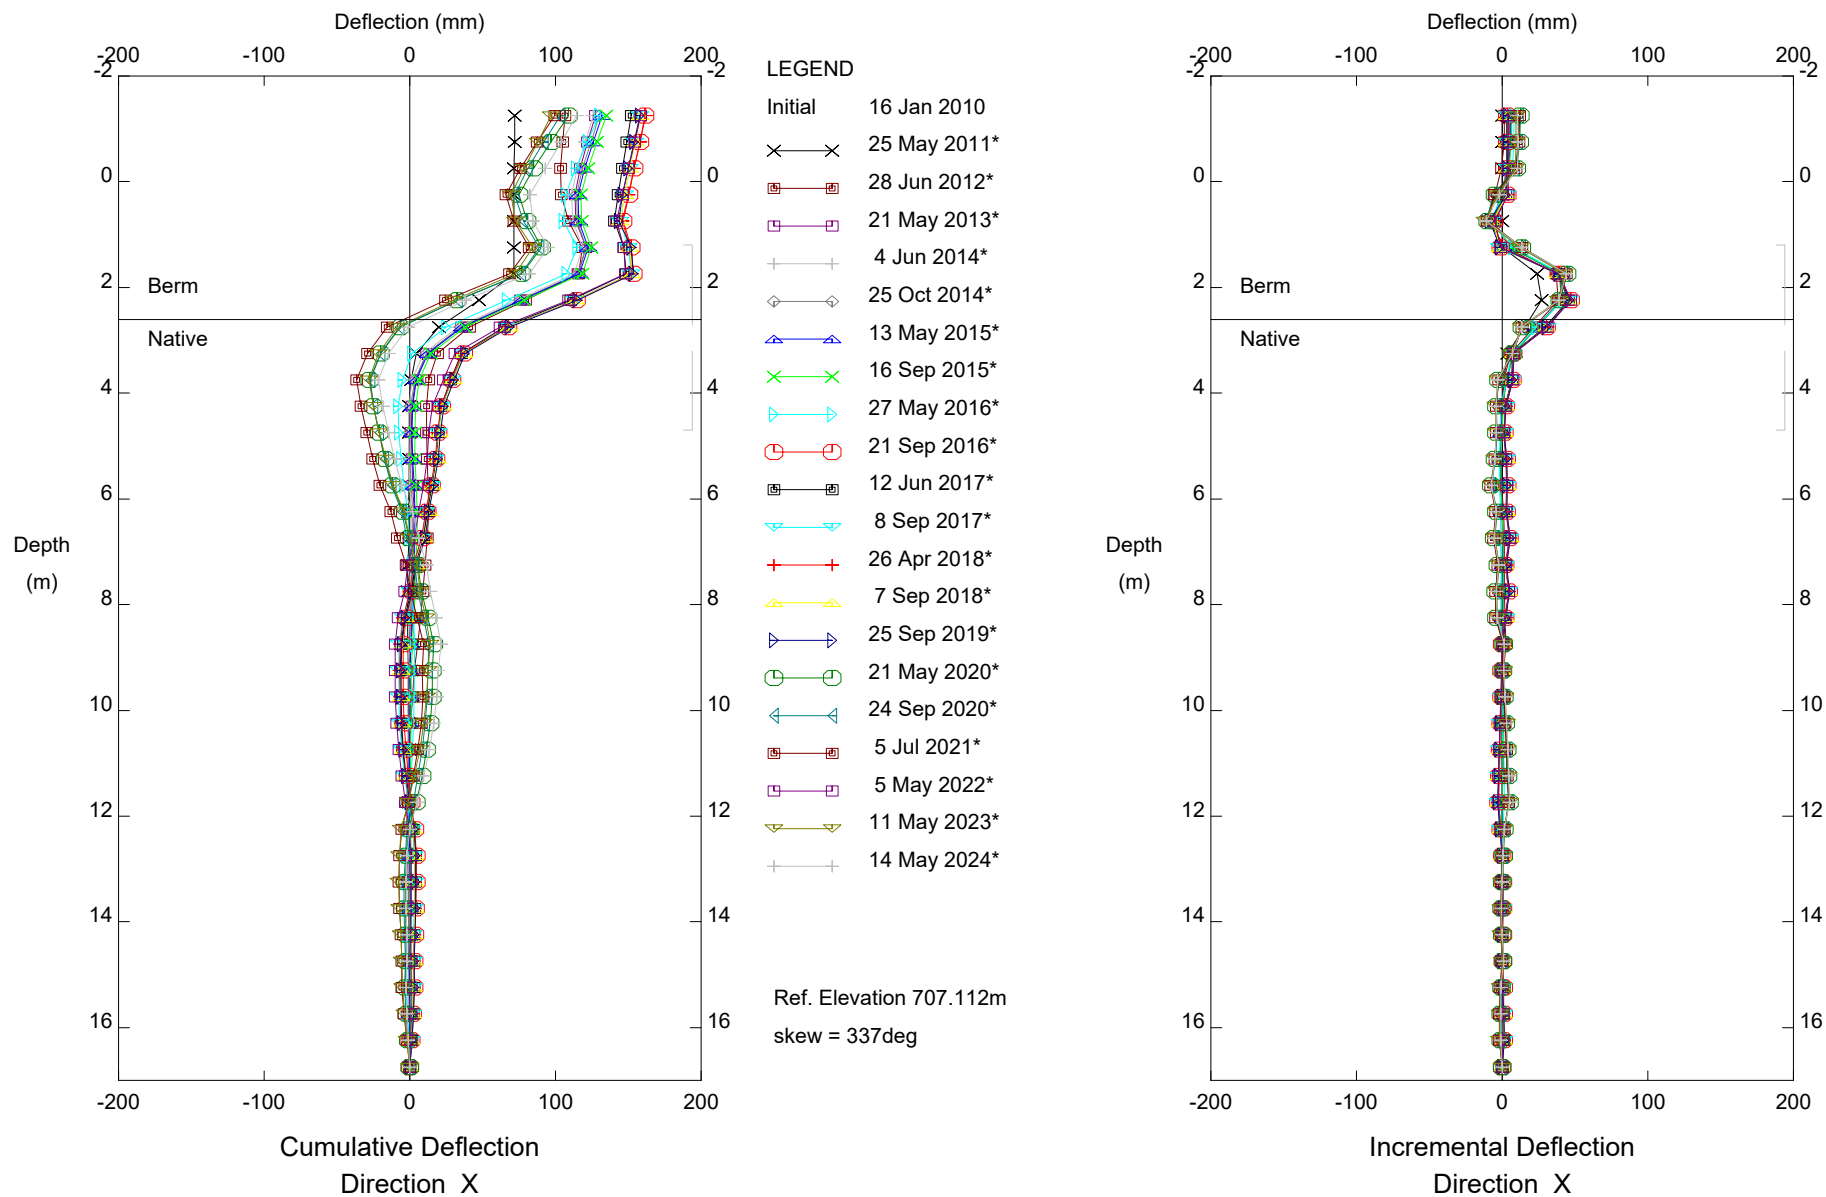
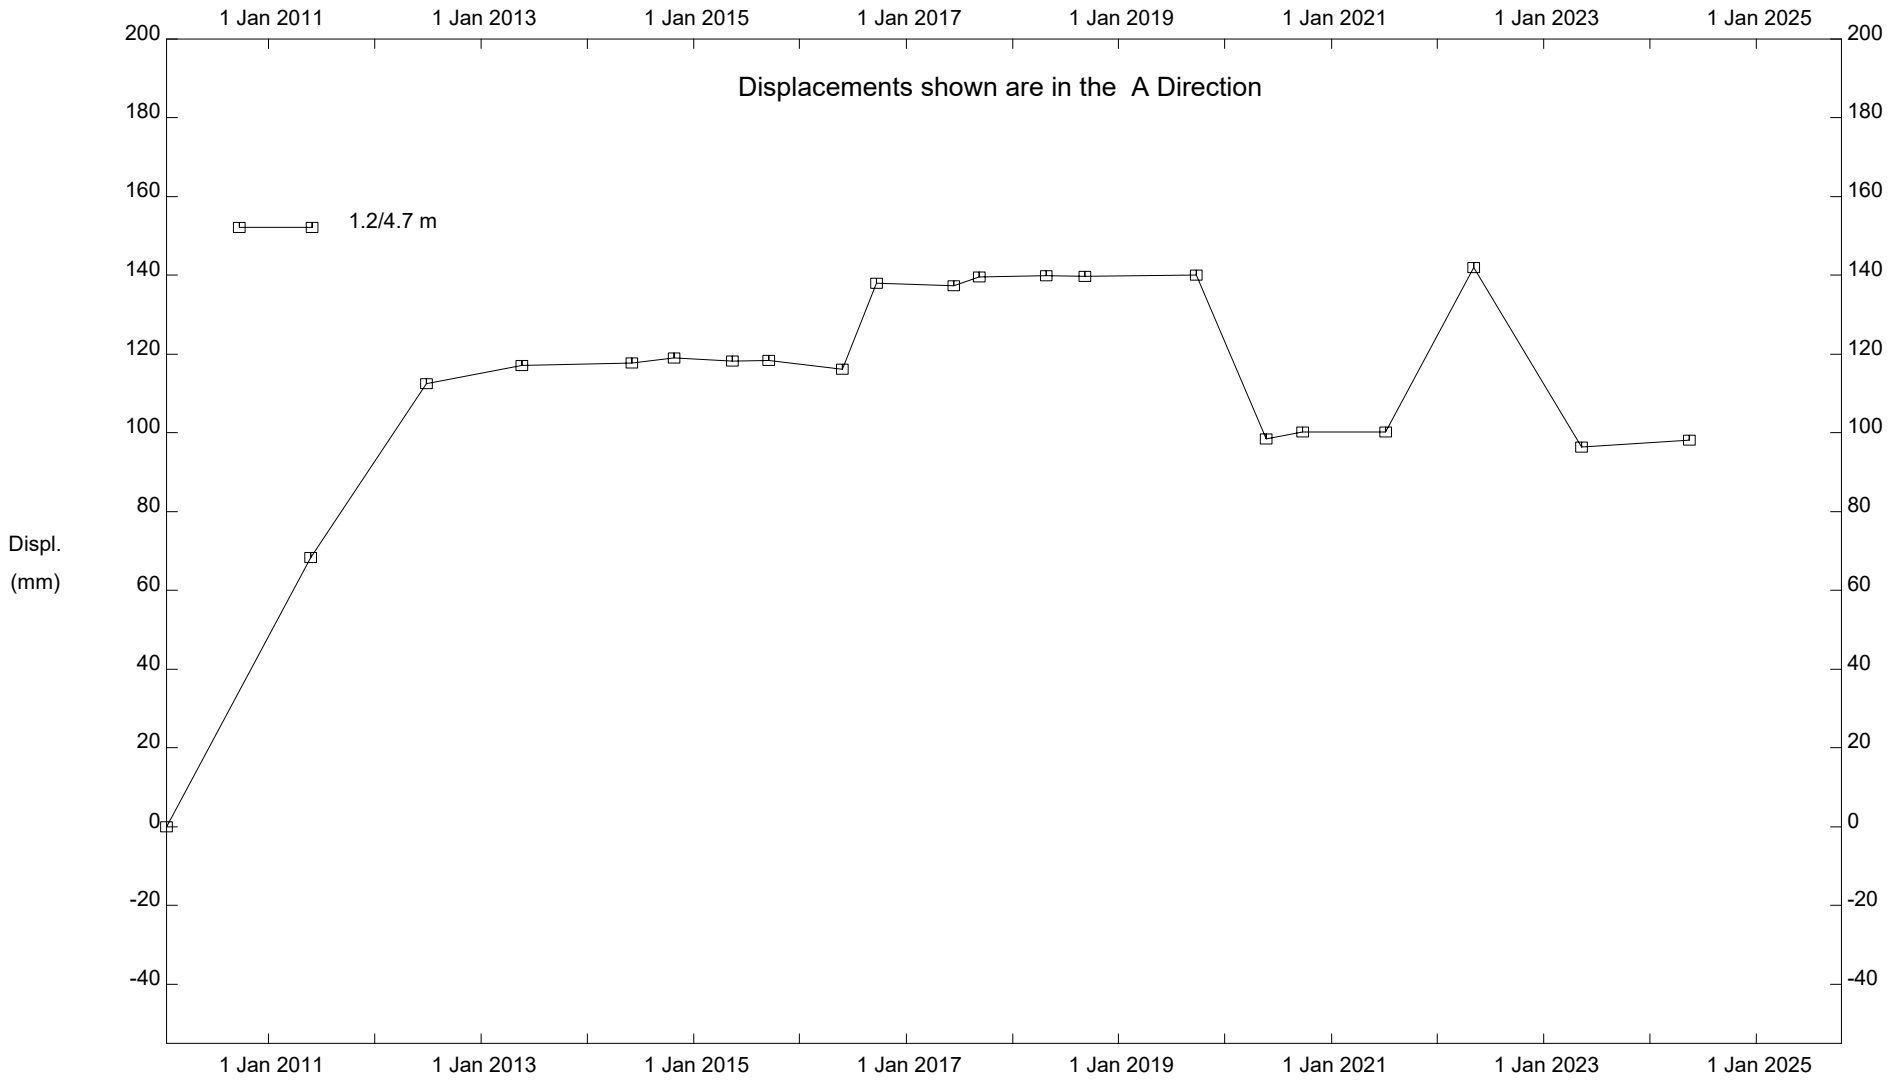
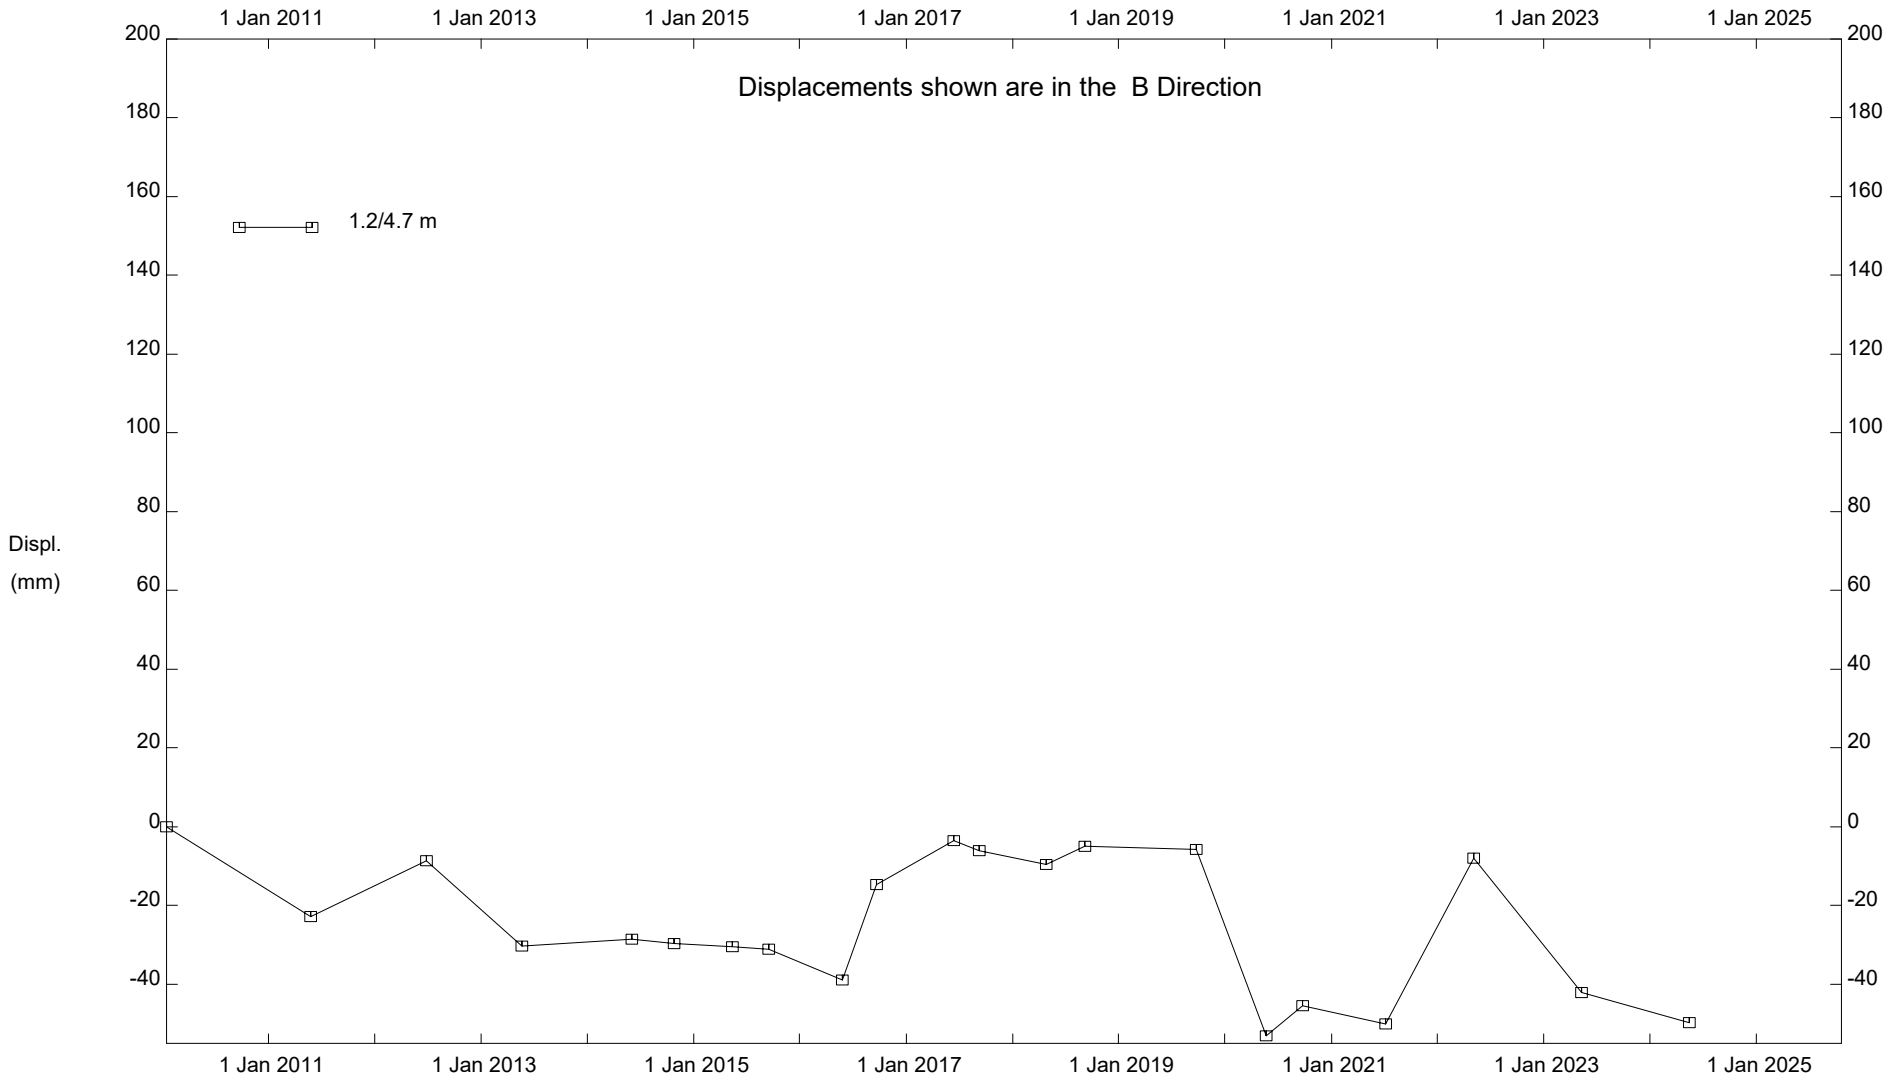
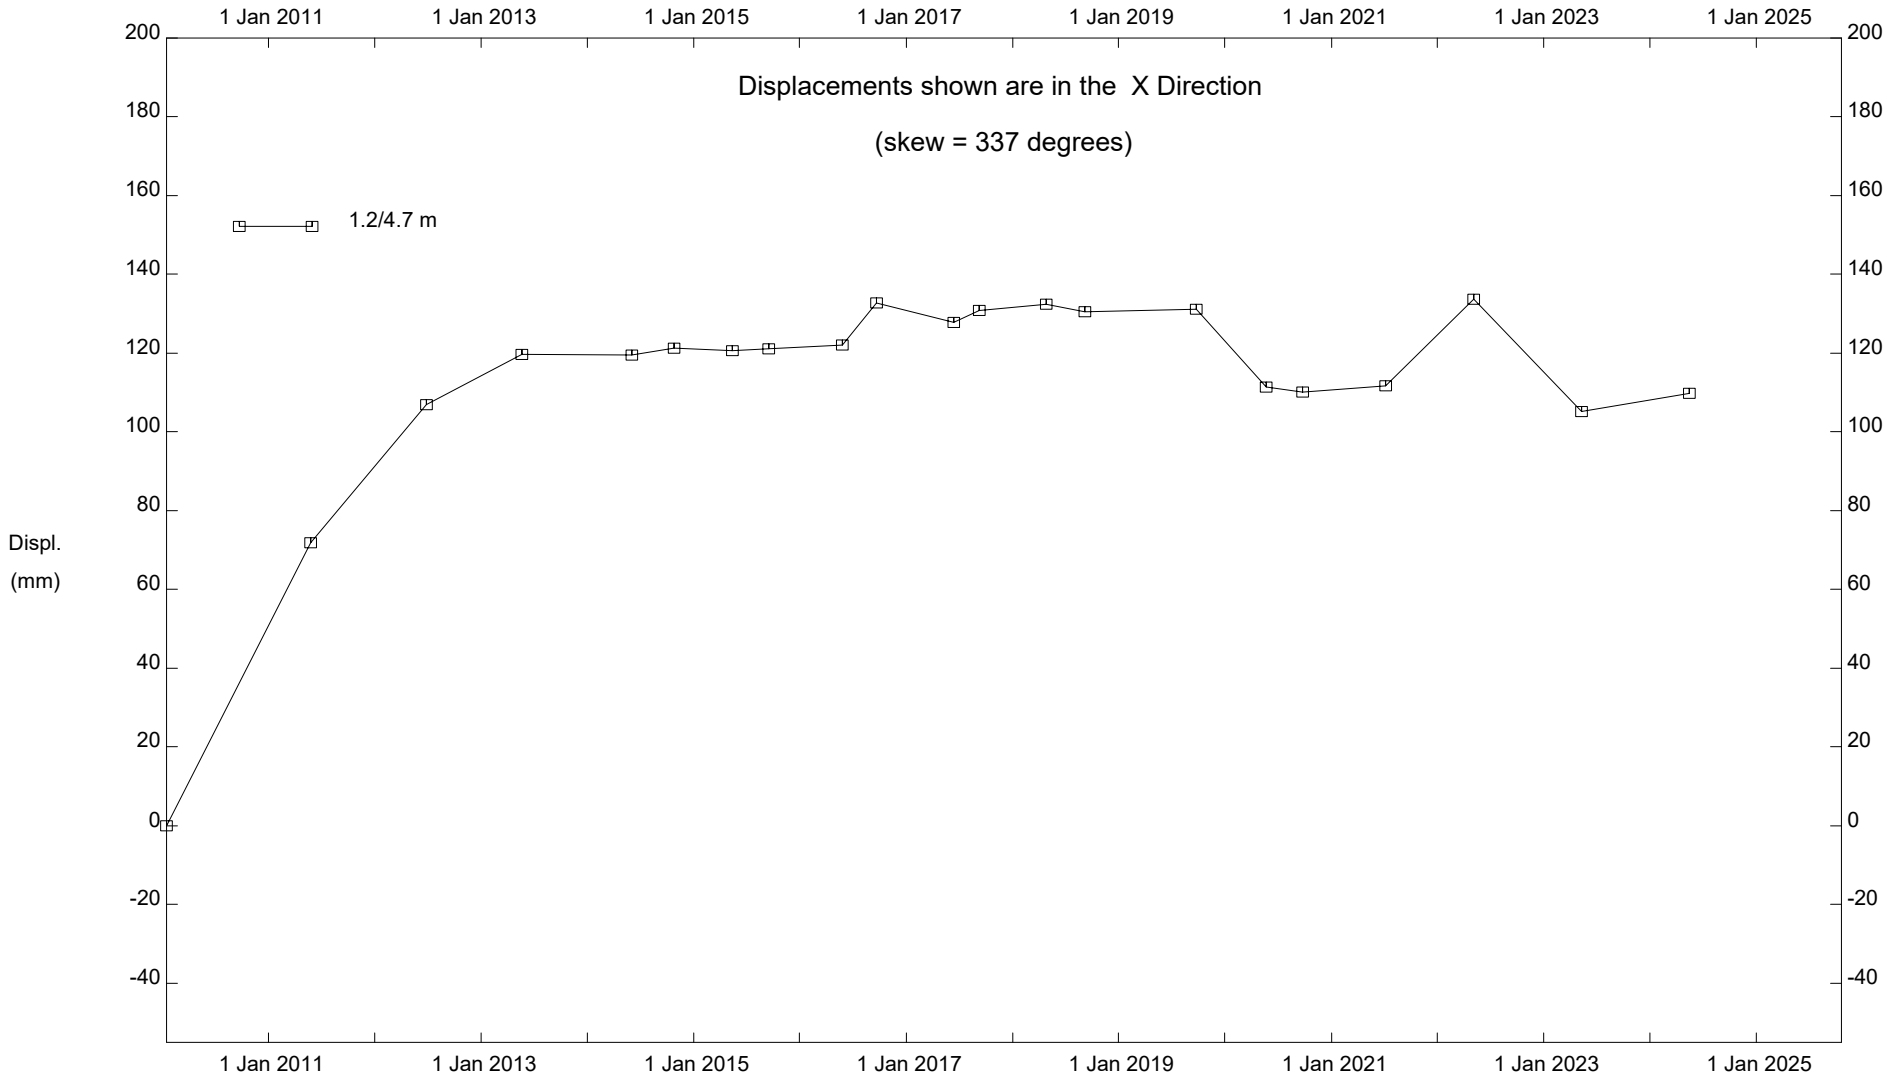
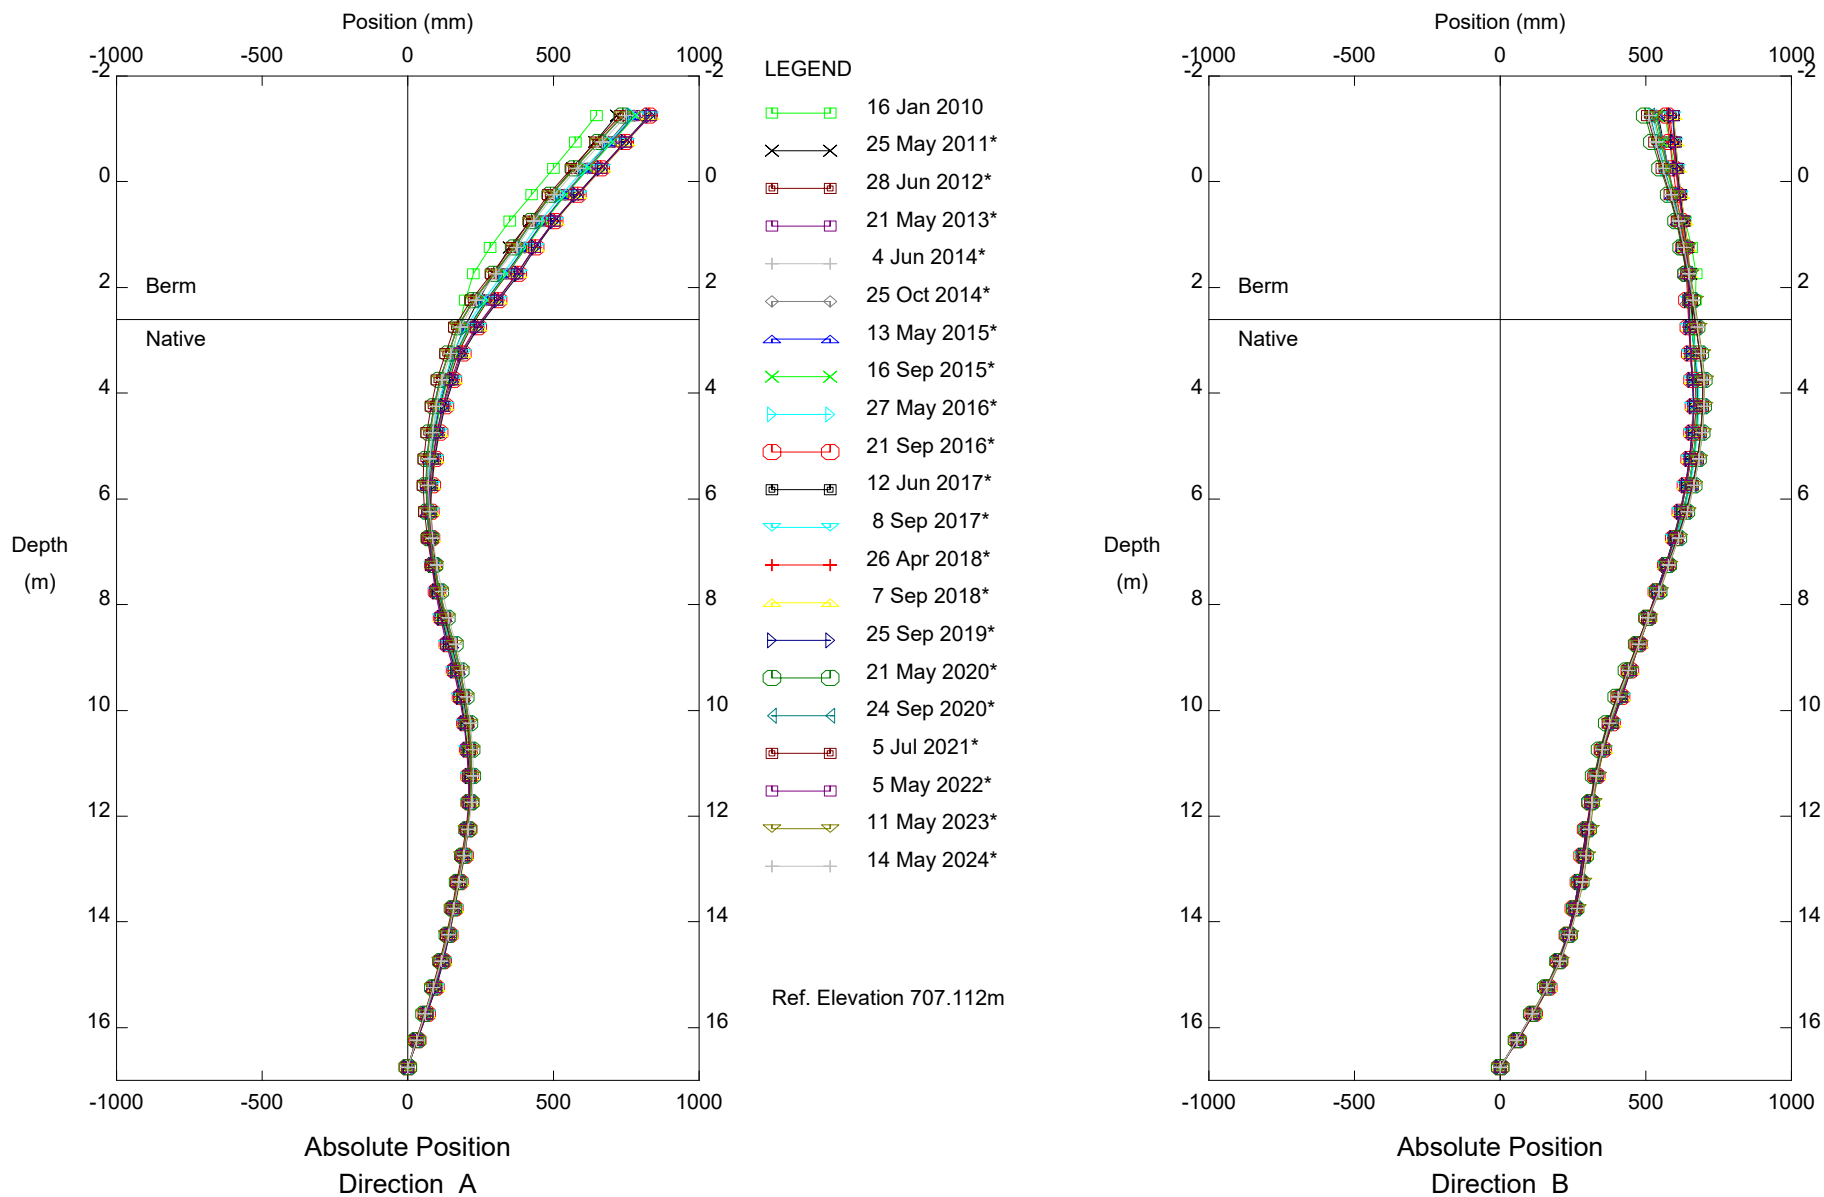
HWY32:10 South of Whitecourt (NC37), Inclinometer SI10-7

SI10-7 shows movement between 1.2 m to 4.7 m with an average rate of movement of 2 mm/yr from 2013 to 2019. The Spring 2024 reading cycle shows a current rate of movement of 5 mm/yr and total cumulative movement of 110 mm. The direction of movement observed in the current instrumentation cycle was opposite to that observed in Spring 2023, and the cumulative movement returned to values similar to the ones prior to that cycle.

The absolute position plot for SI10-7 suggests there is disturbance of about 40 mm in the soil surrounding the inclinometer casing between 6 m to 15 m depth. This disturbance may be causing the erratic movement observed in the incremental and cumulative movement plots.
