To: Amy Driessen  
Transportation and Economic Corridors  
File: 123315222

From: Leslie Cho and Xiteng Liu  
Stantec Consulting Ltd.  
Date: June 18, 2024

**Reference: North Central Region, Edson, Site NC037 - Highway 32:10 South of Whitecourt, Spring 2024 Instrumentation Monitoring Report**

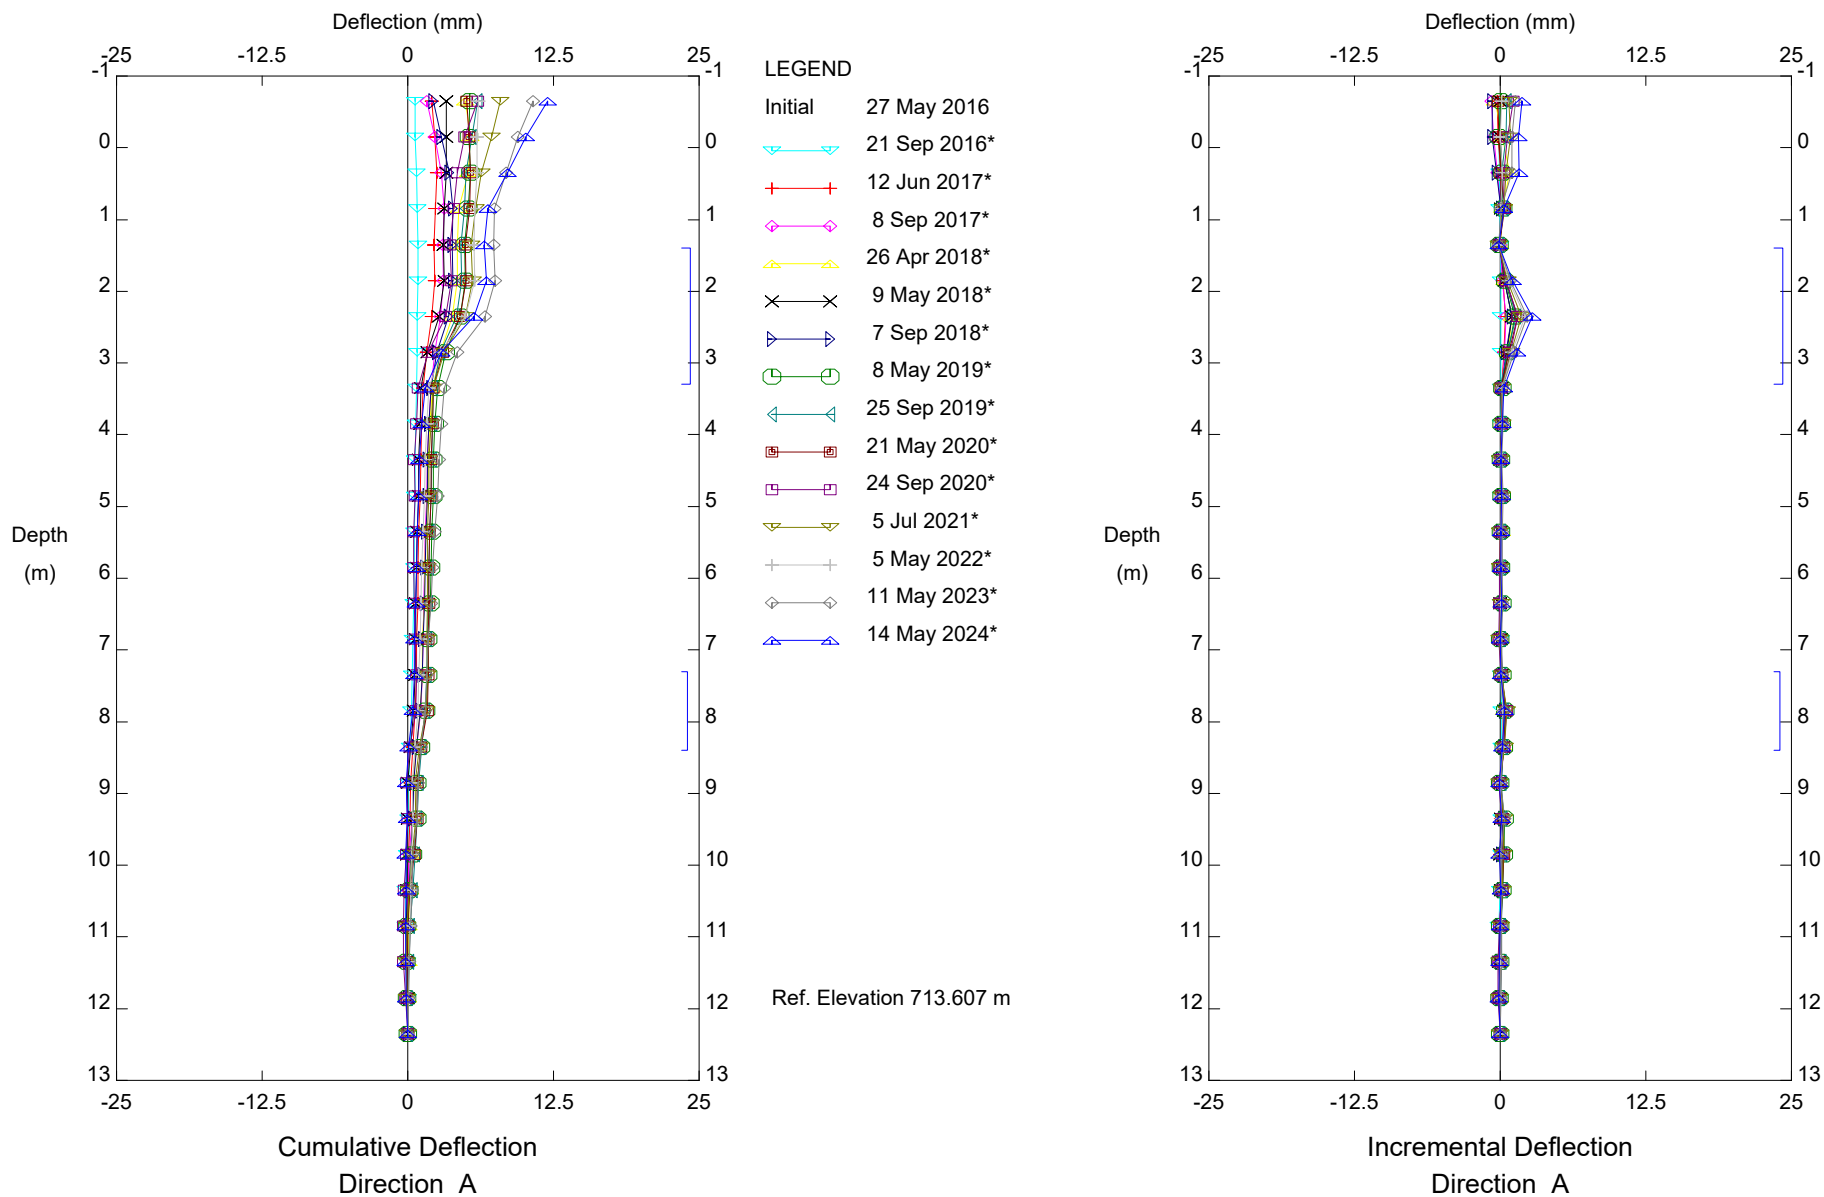
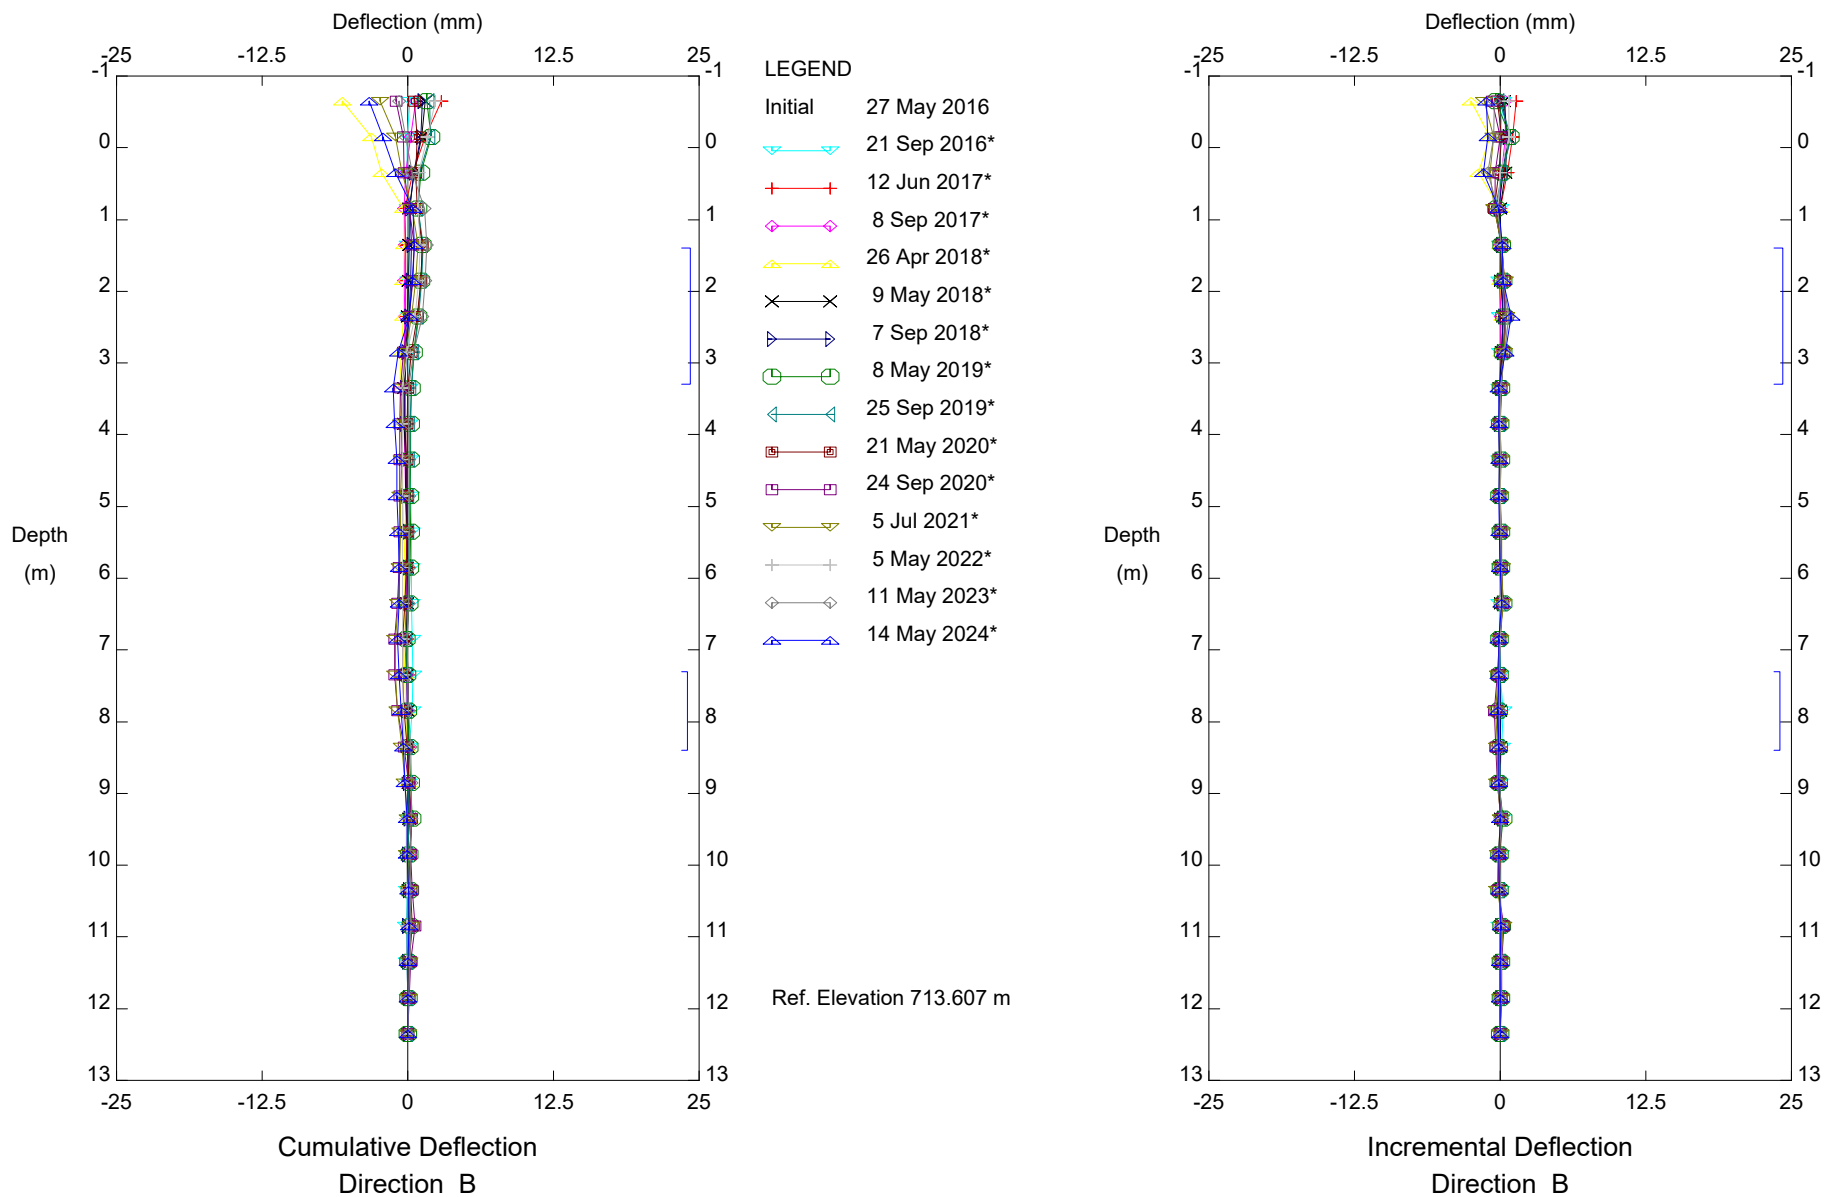
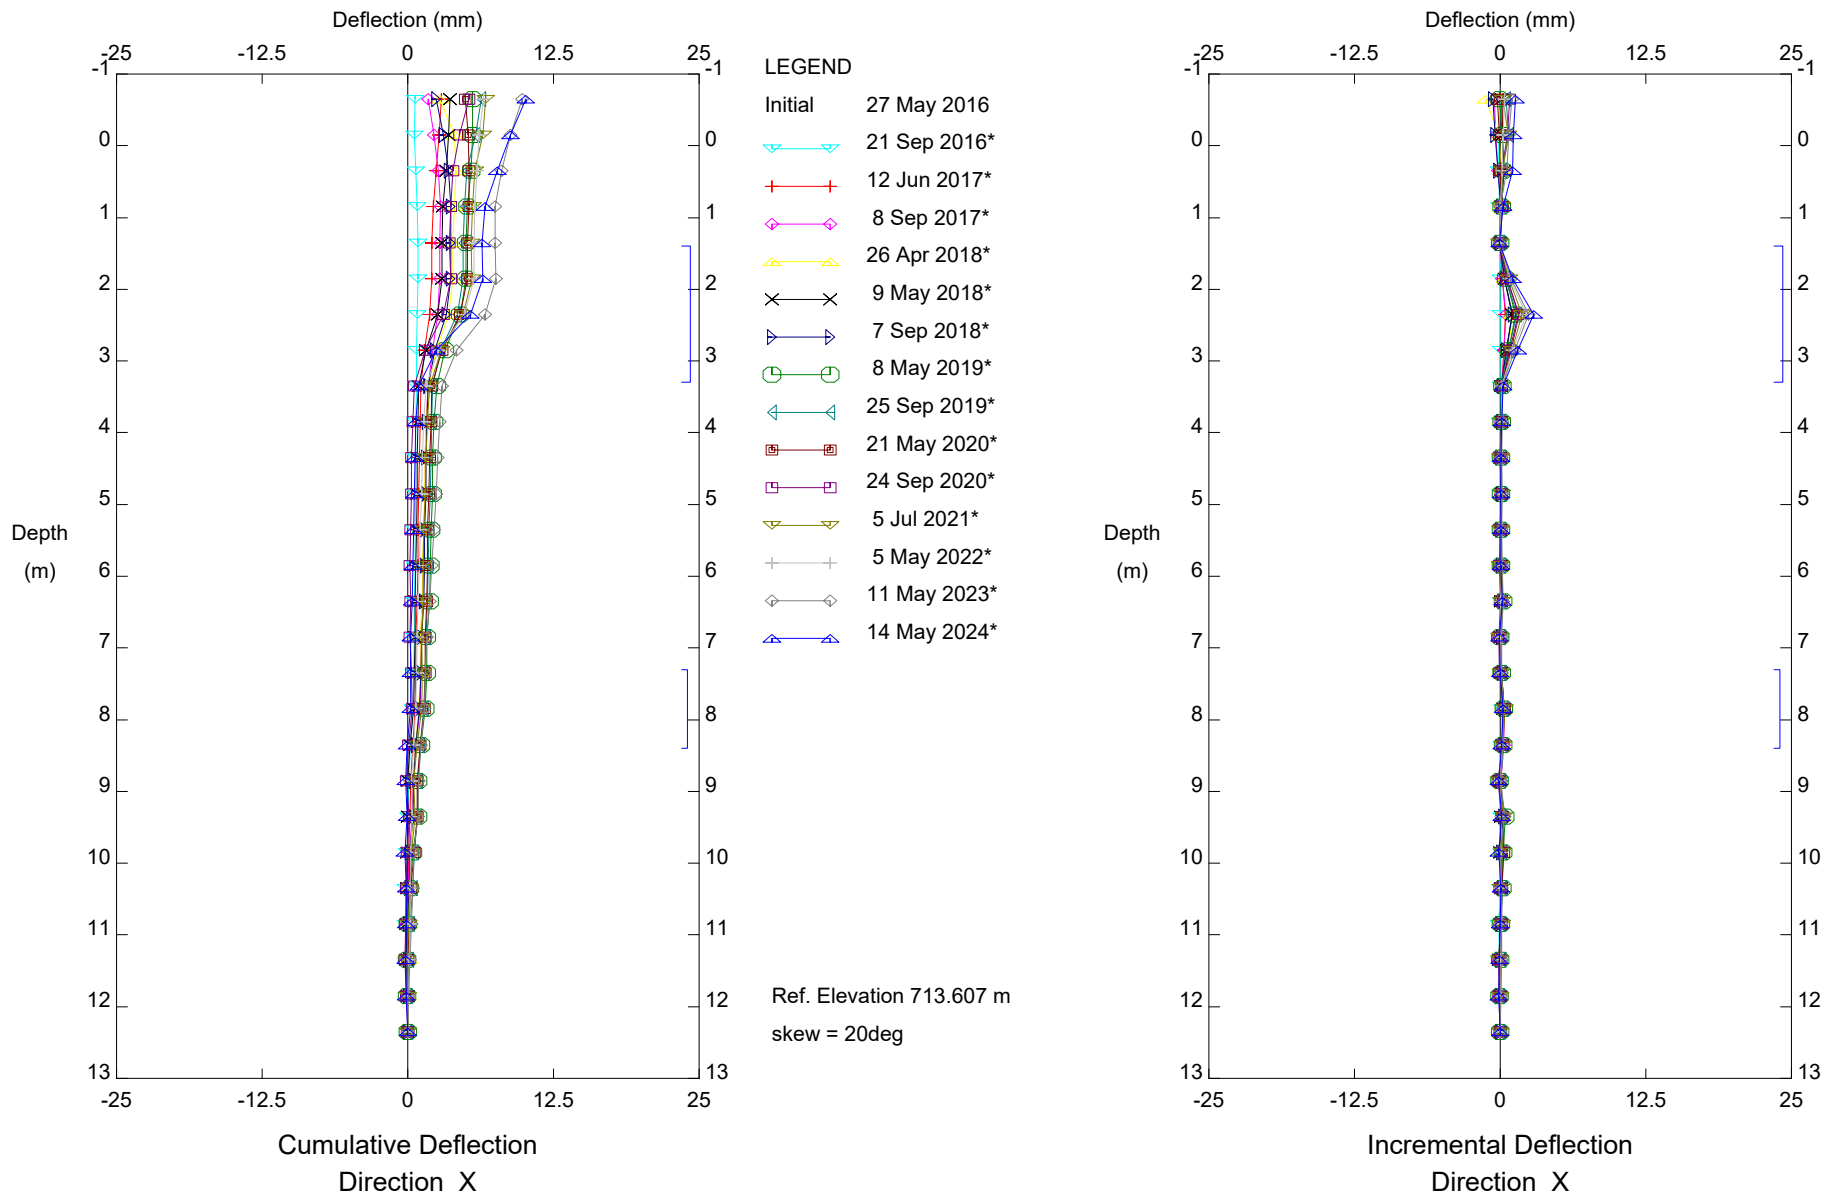
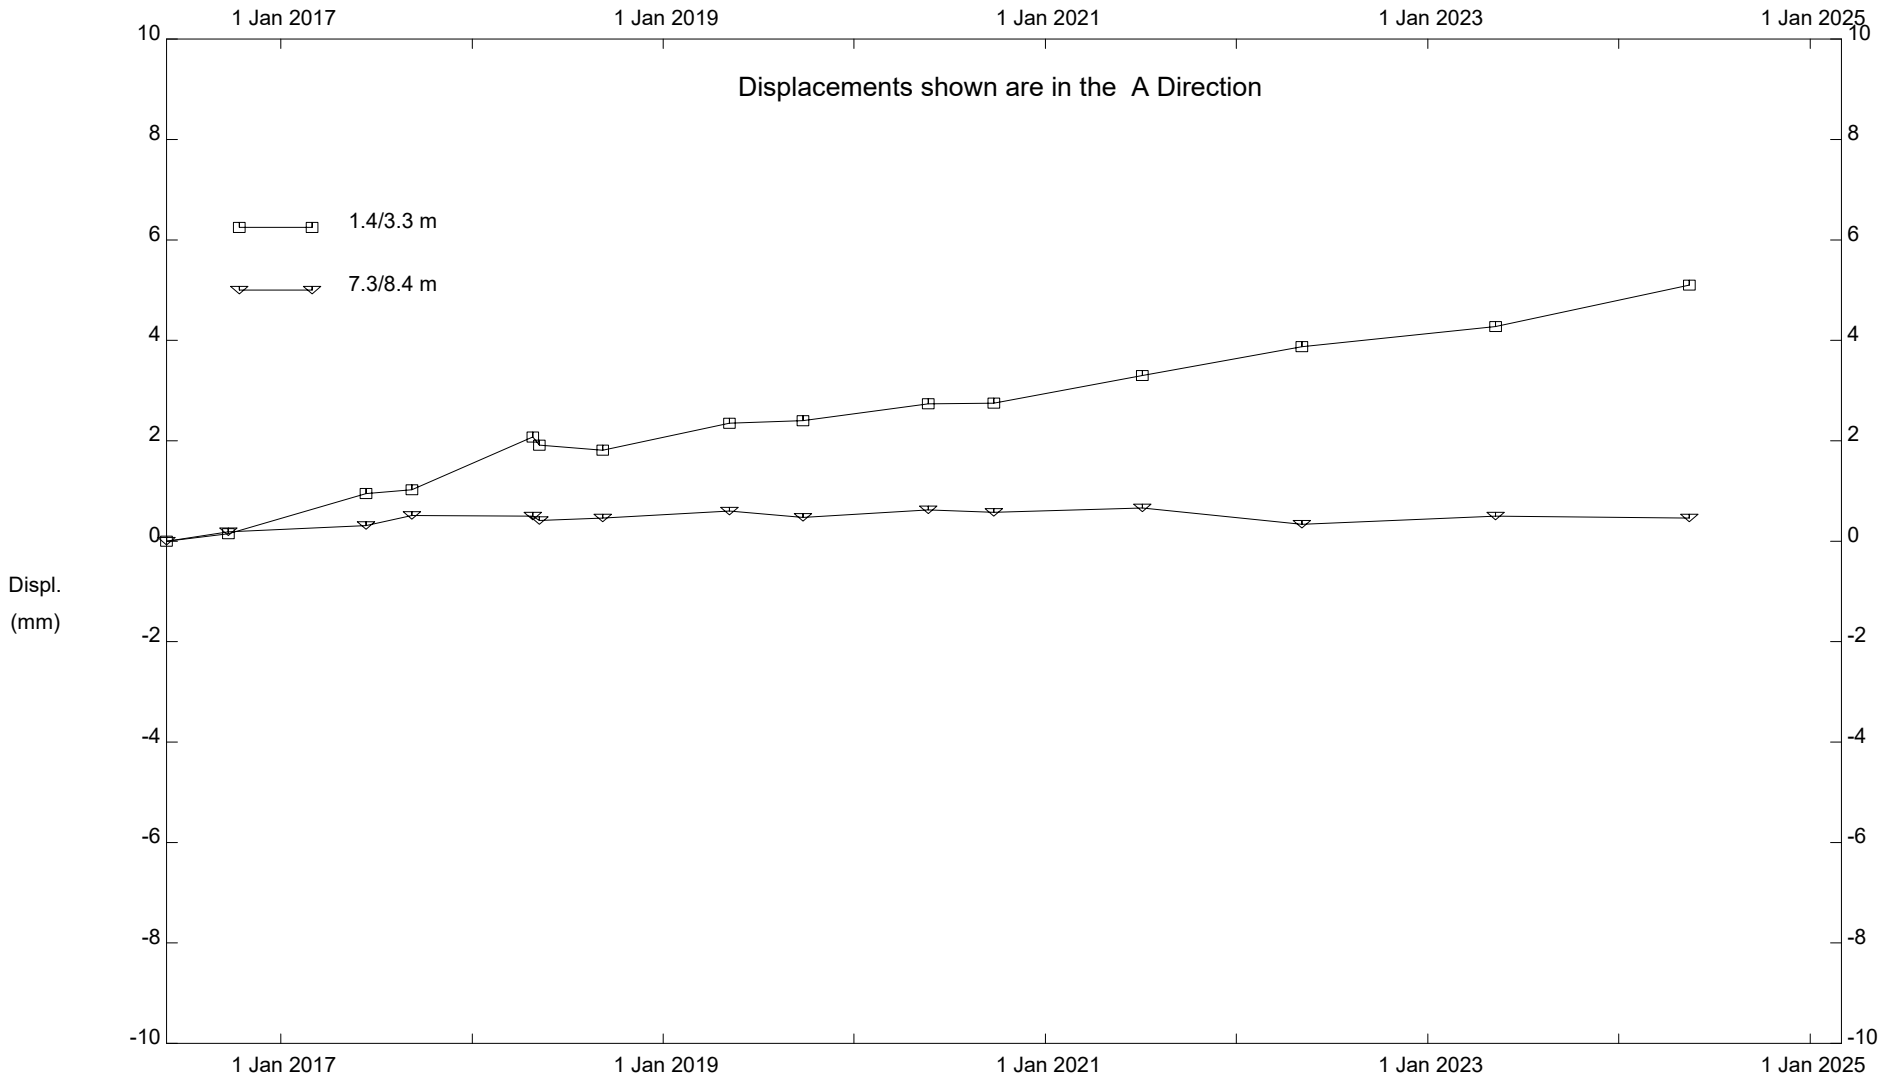
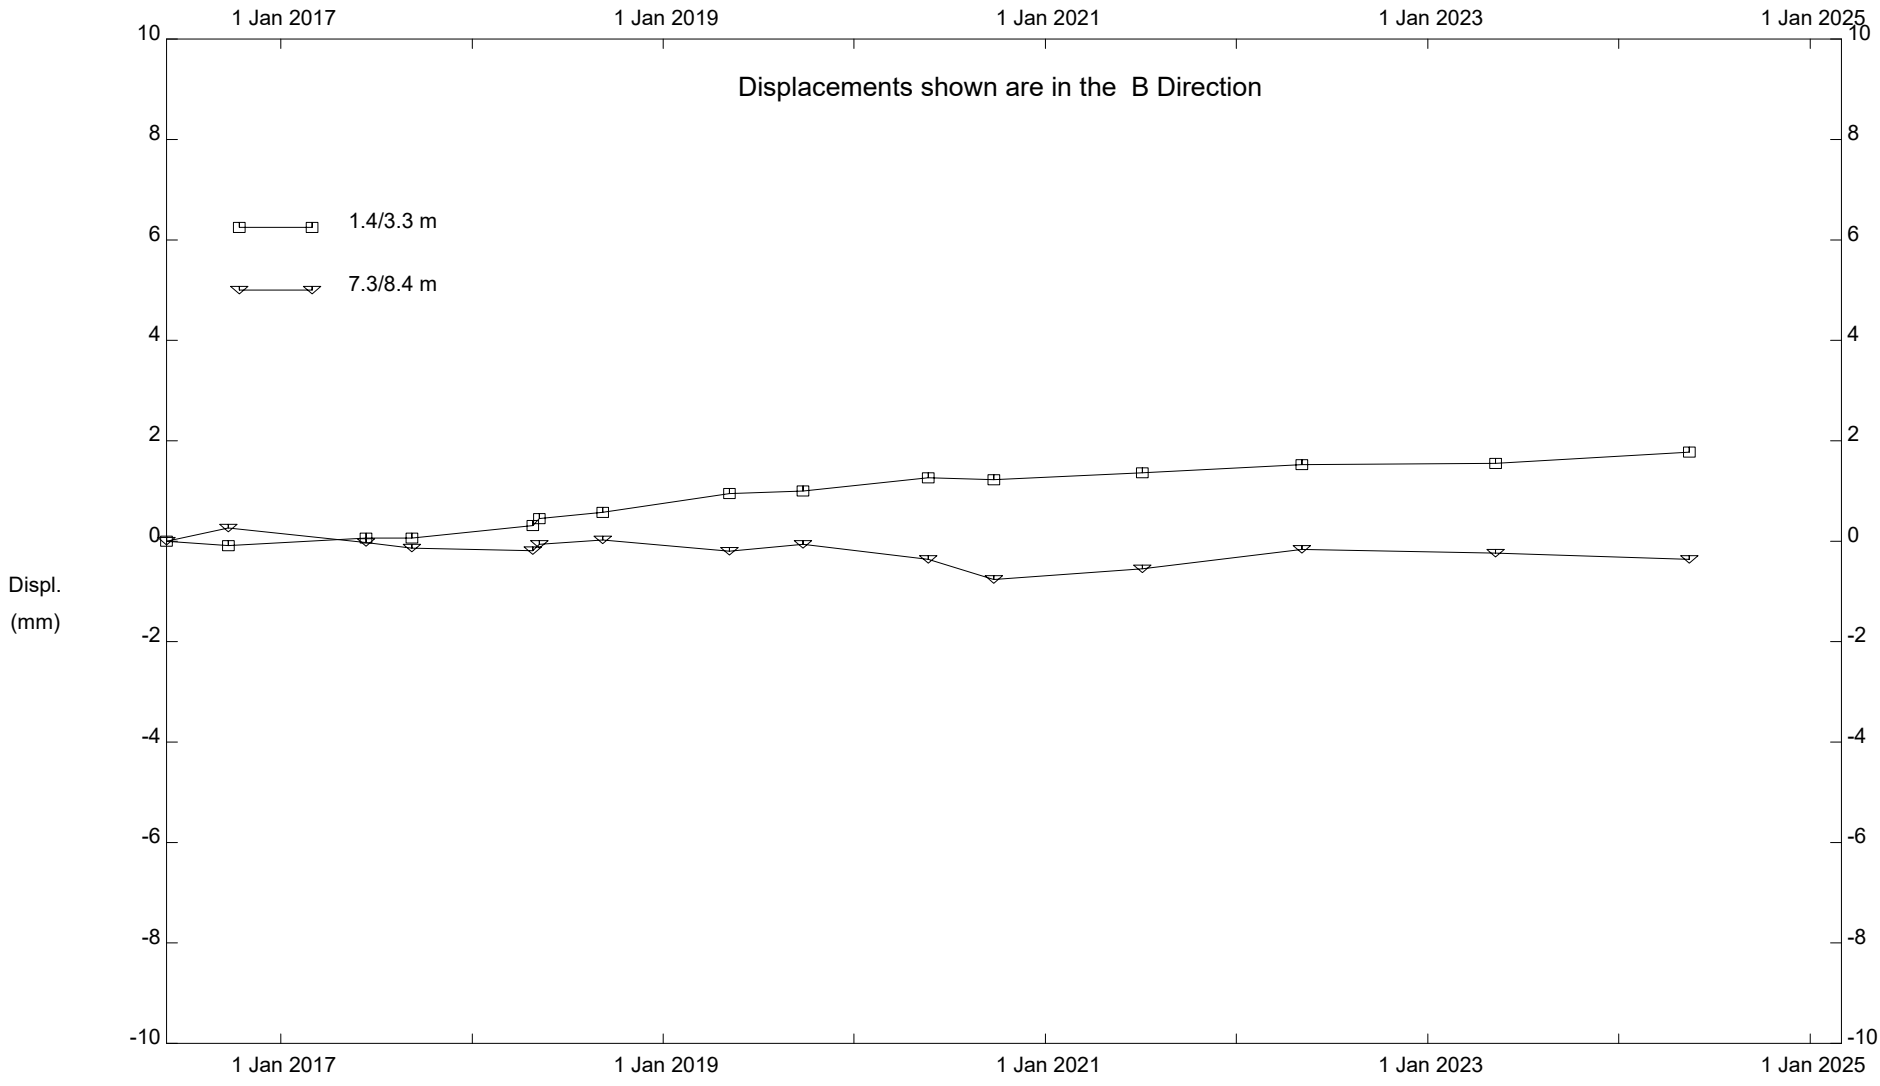
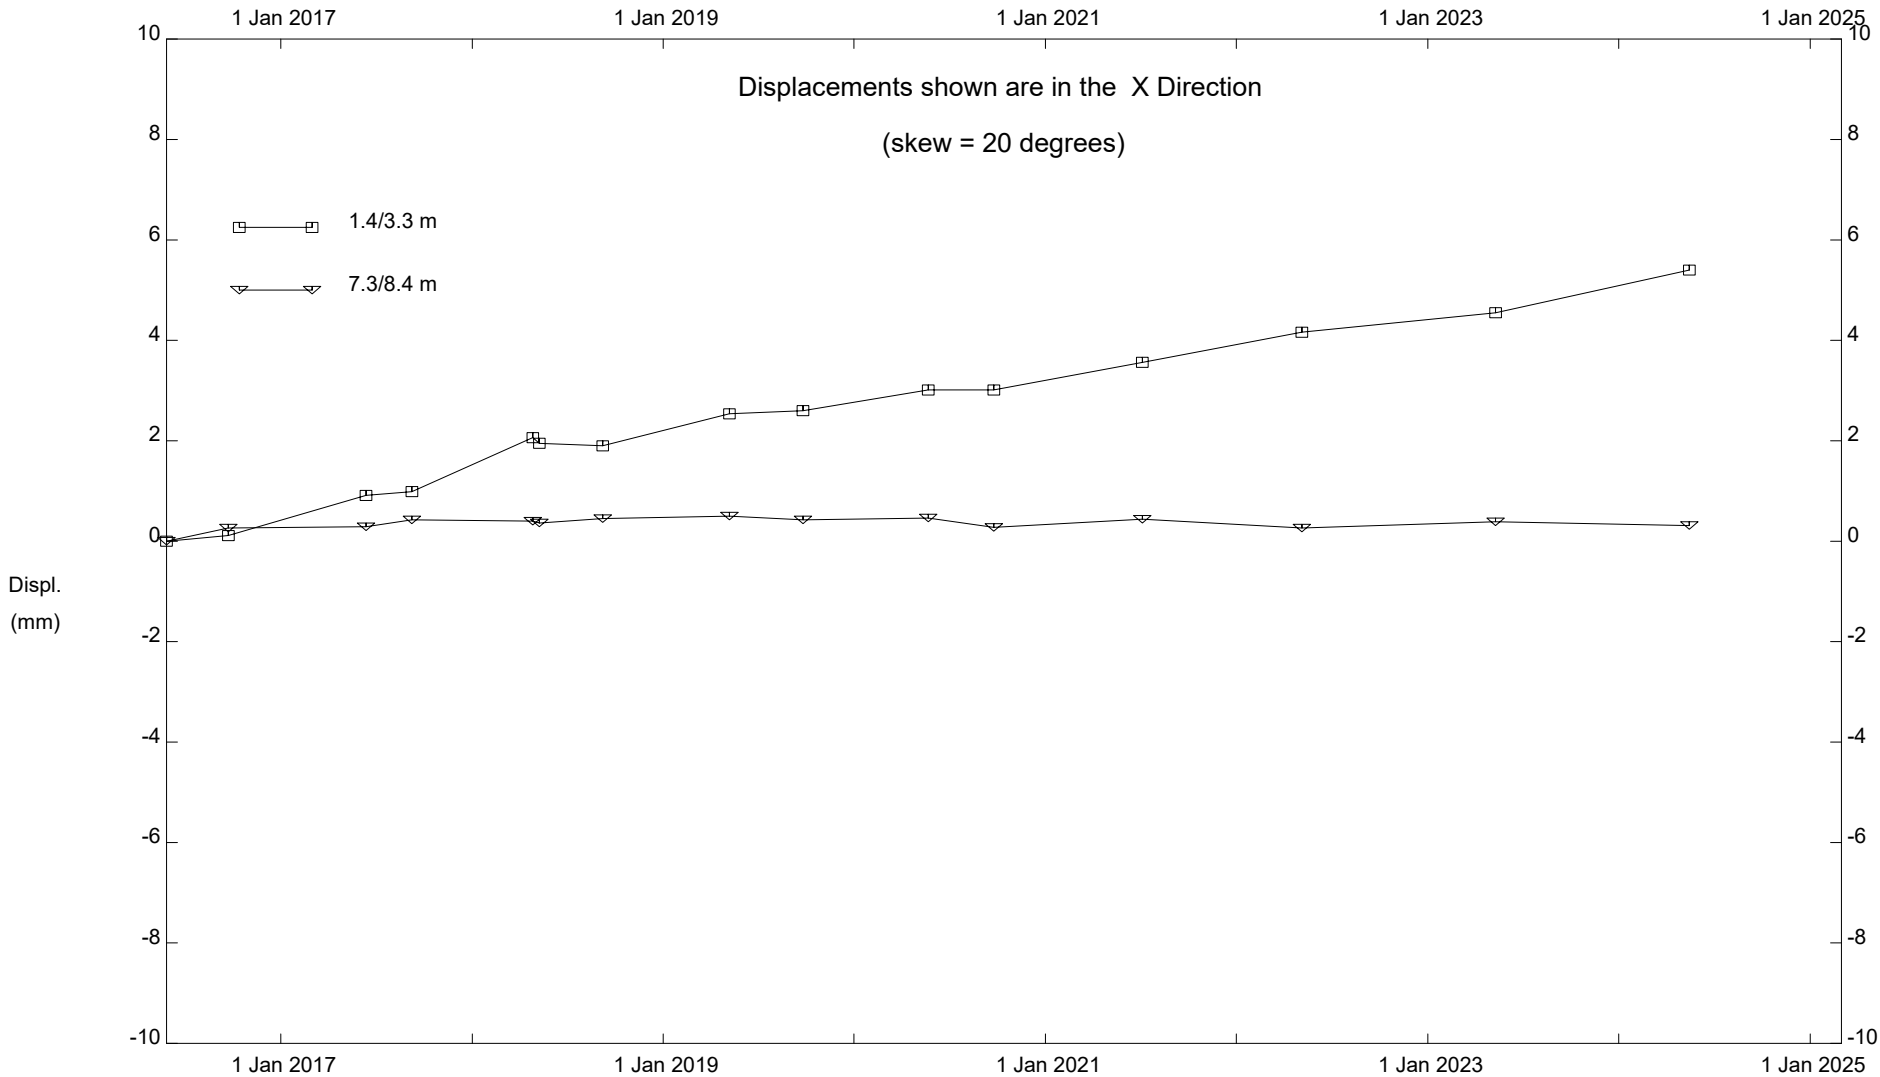
HWY32:10 South of Whitecourt (NC37), Inclinometer SI10-8

SI10-8 has two zones of movement at approximately 2.5 m and 8.0 m depth. The deeper movement zone has recorded less than 1 mm of movement since 2016 while the upper zone has cumulative movement up to about 5 mm. The current movement rate in the upper zone is less than 1 mm/yr and appears to be creeping.

Note that during the work transfer to Stantec in 2016, a slight depth discrepancy was observed in SI10-8 due to different units of measurement used during data collection. To present more accurate information, data prior to 2016 was excluded from the SI plots and the cumulative movement since initialization included on Table NC037-1.
