To: Amy Driessen  
Transportation and Economic Corridors  
File: 123315222

From: Leslie Cho and Xiteng Liu  
Stantec Consulting Ltd.  
Date: June 18, 2024

**Reference: North Central Region, Edson, Site NC037 - Highway 32:10 South of Whitecourt, Spring 2024 Instrumentation Monitoring Report**

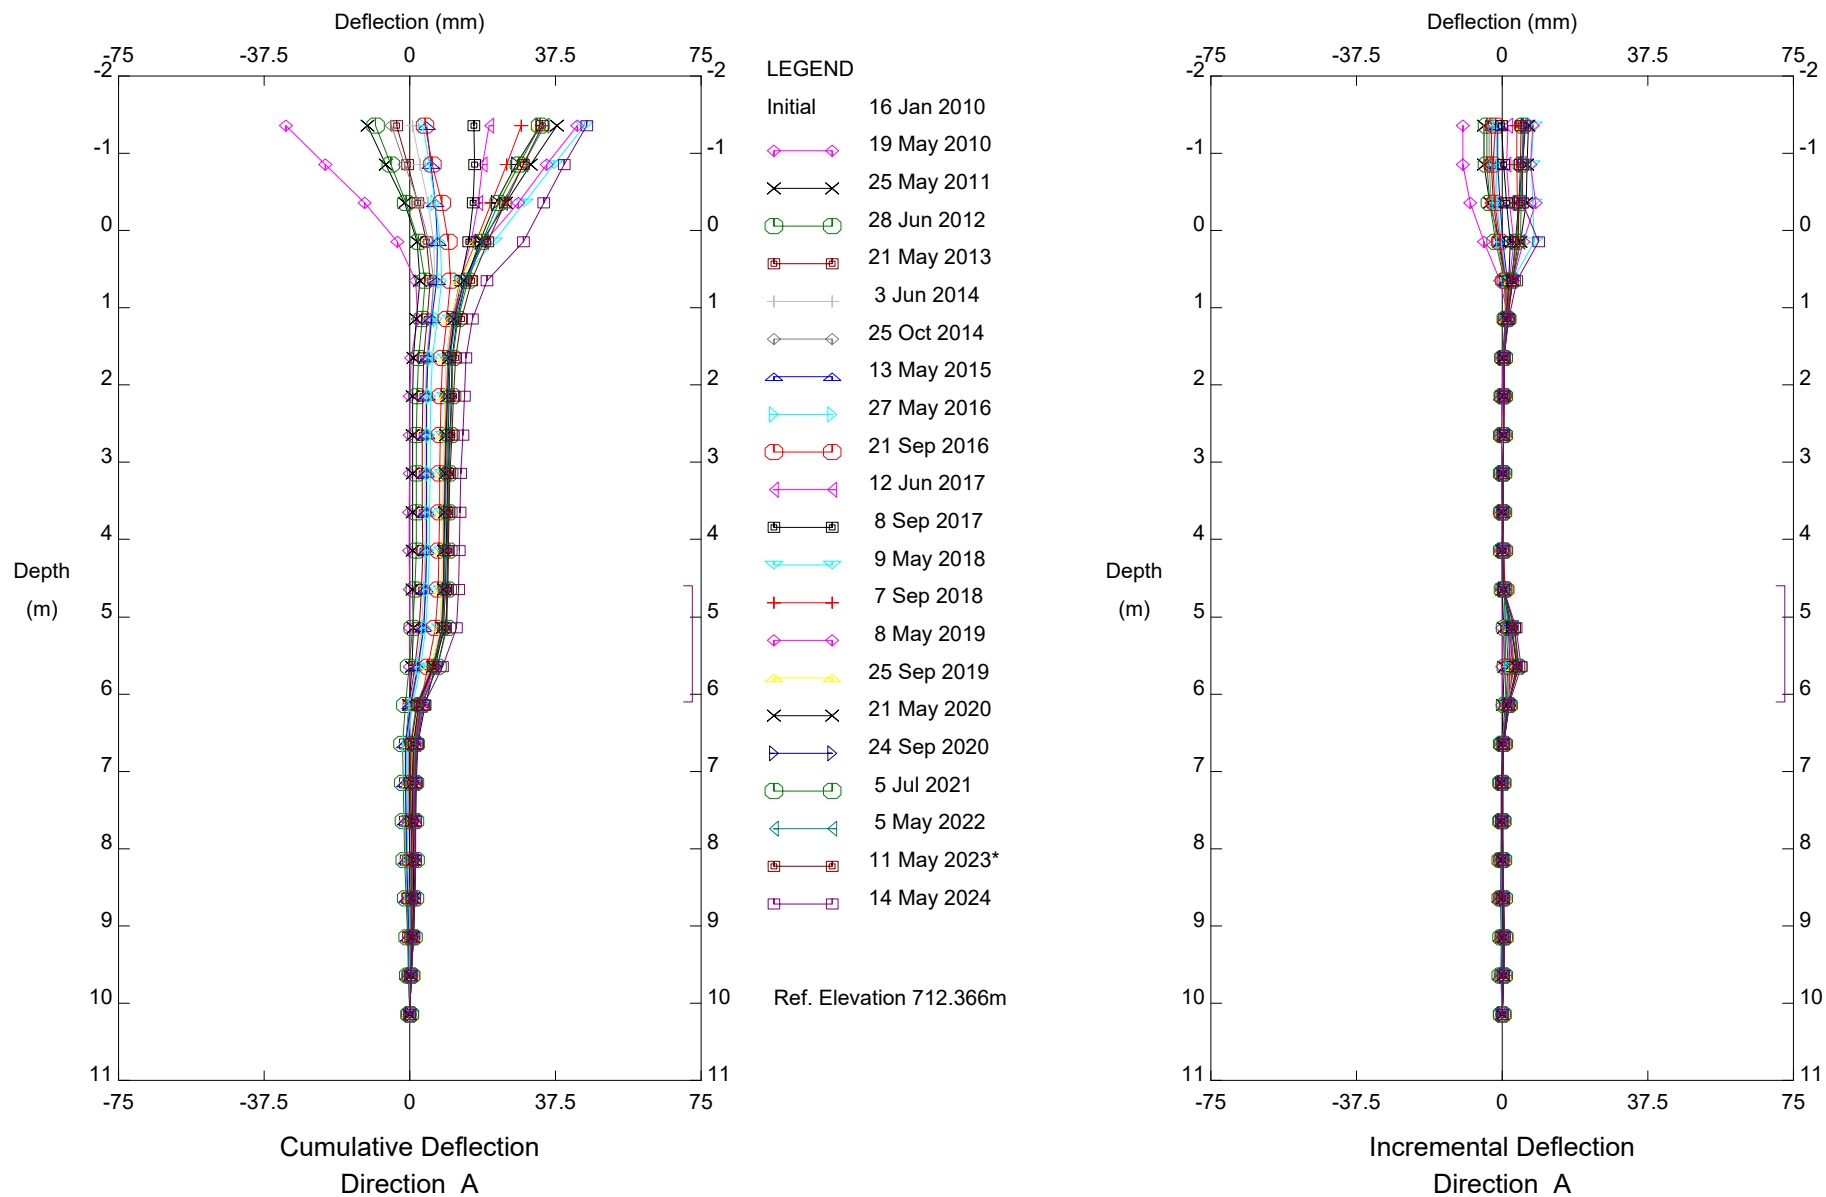
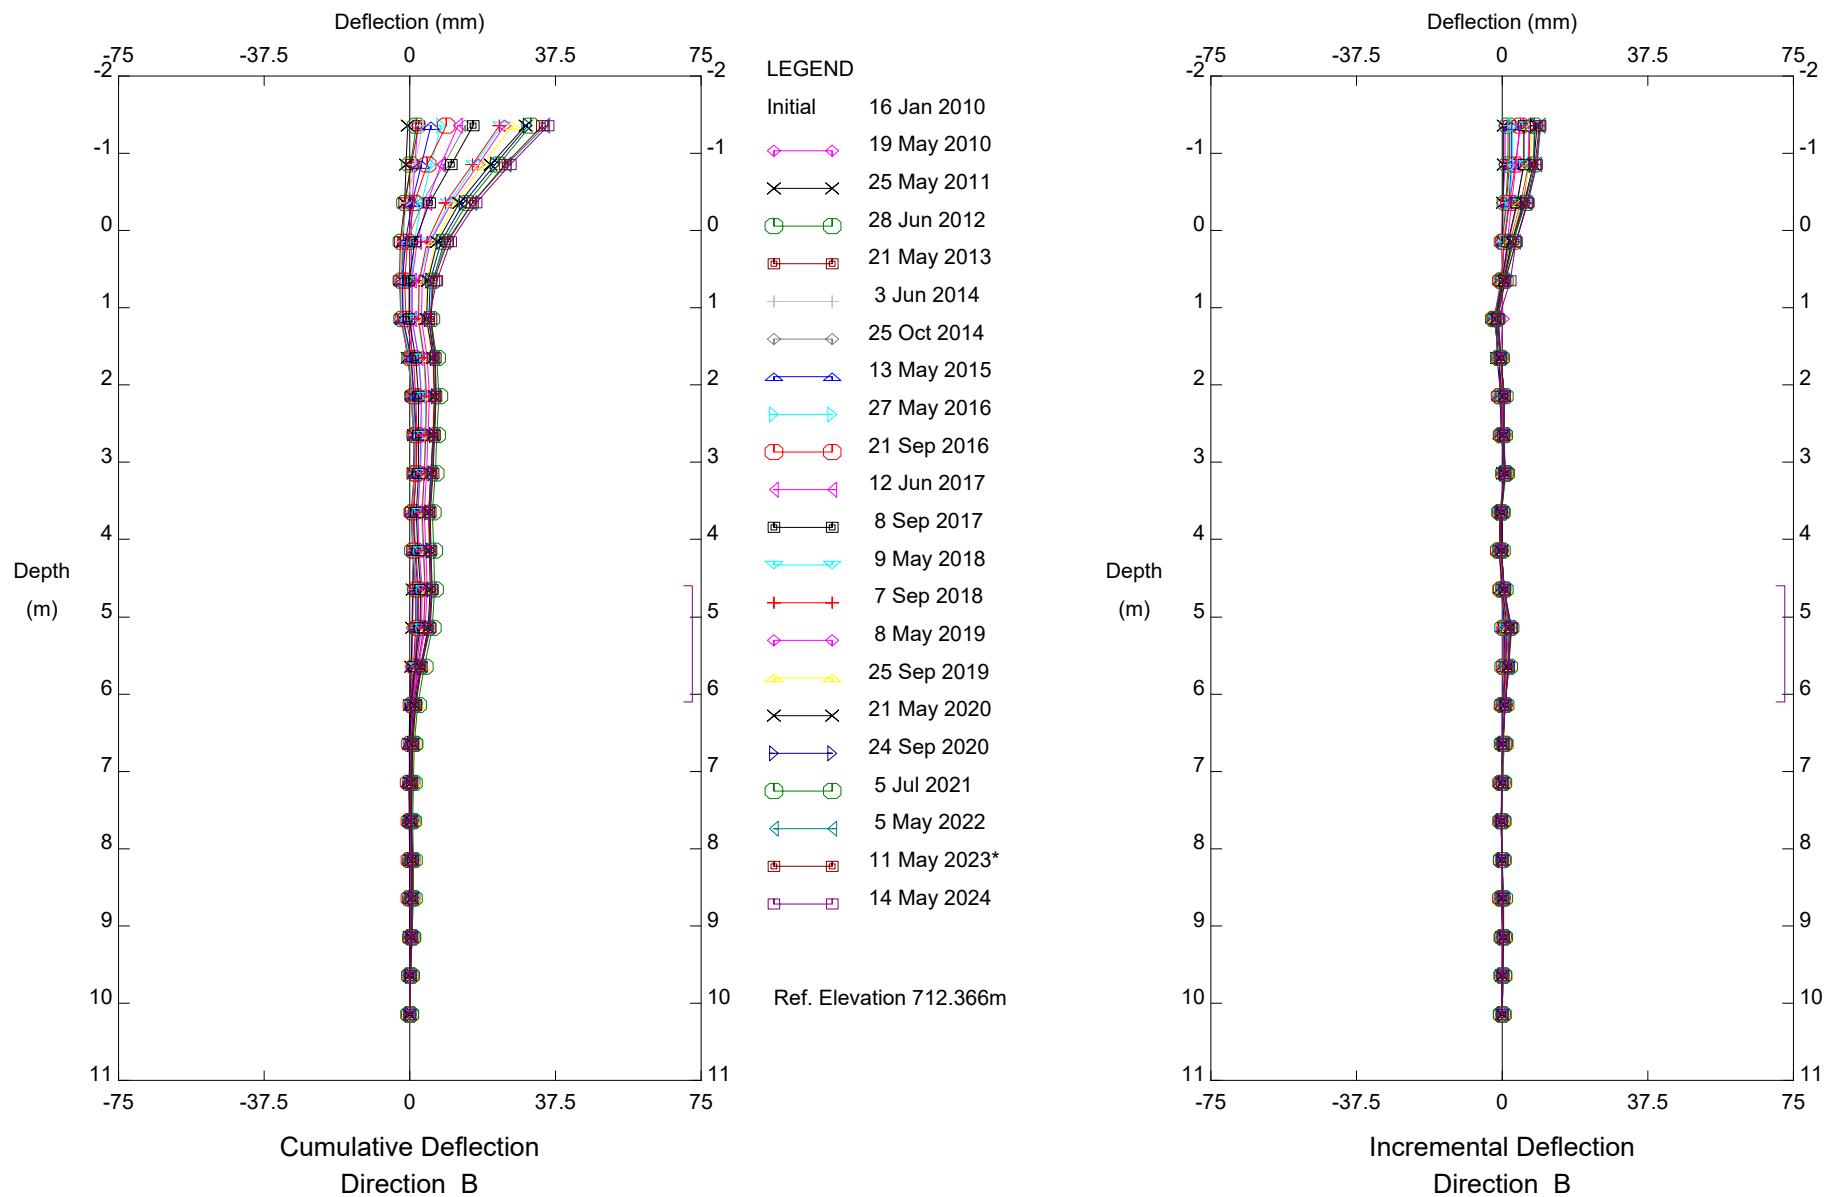
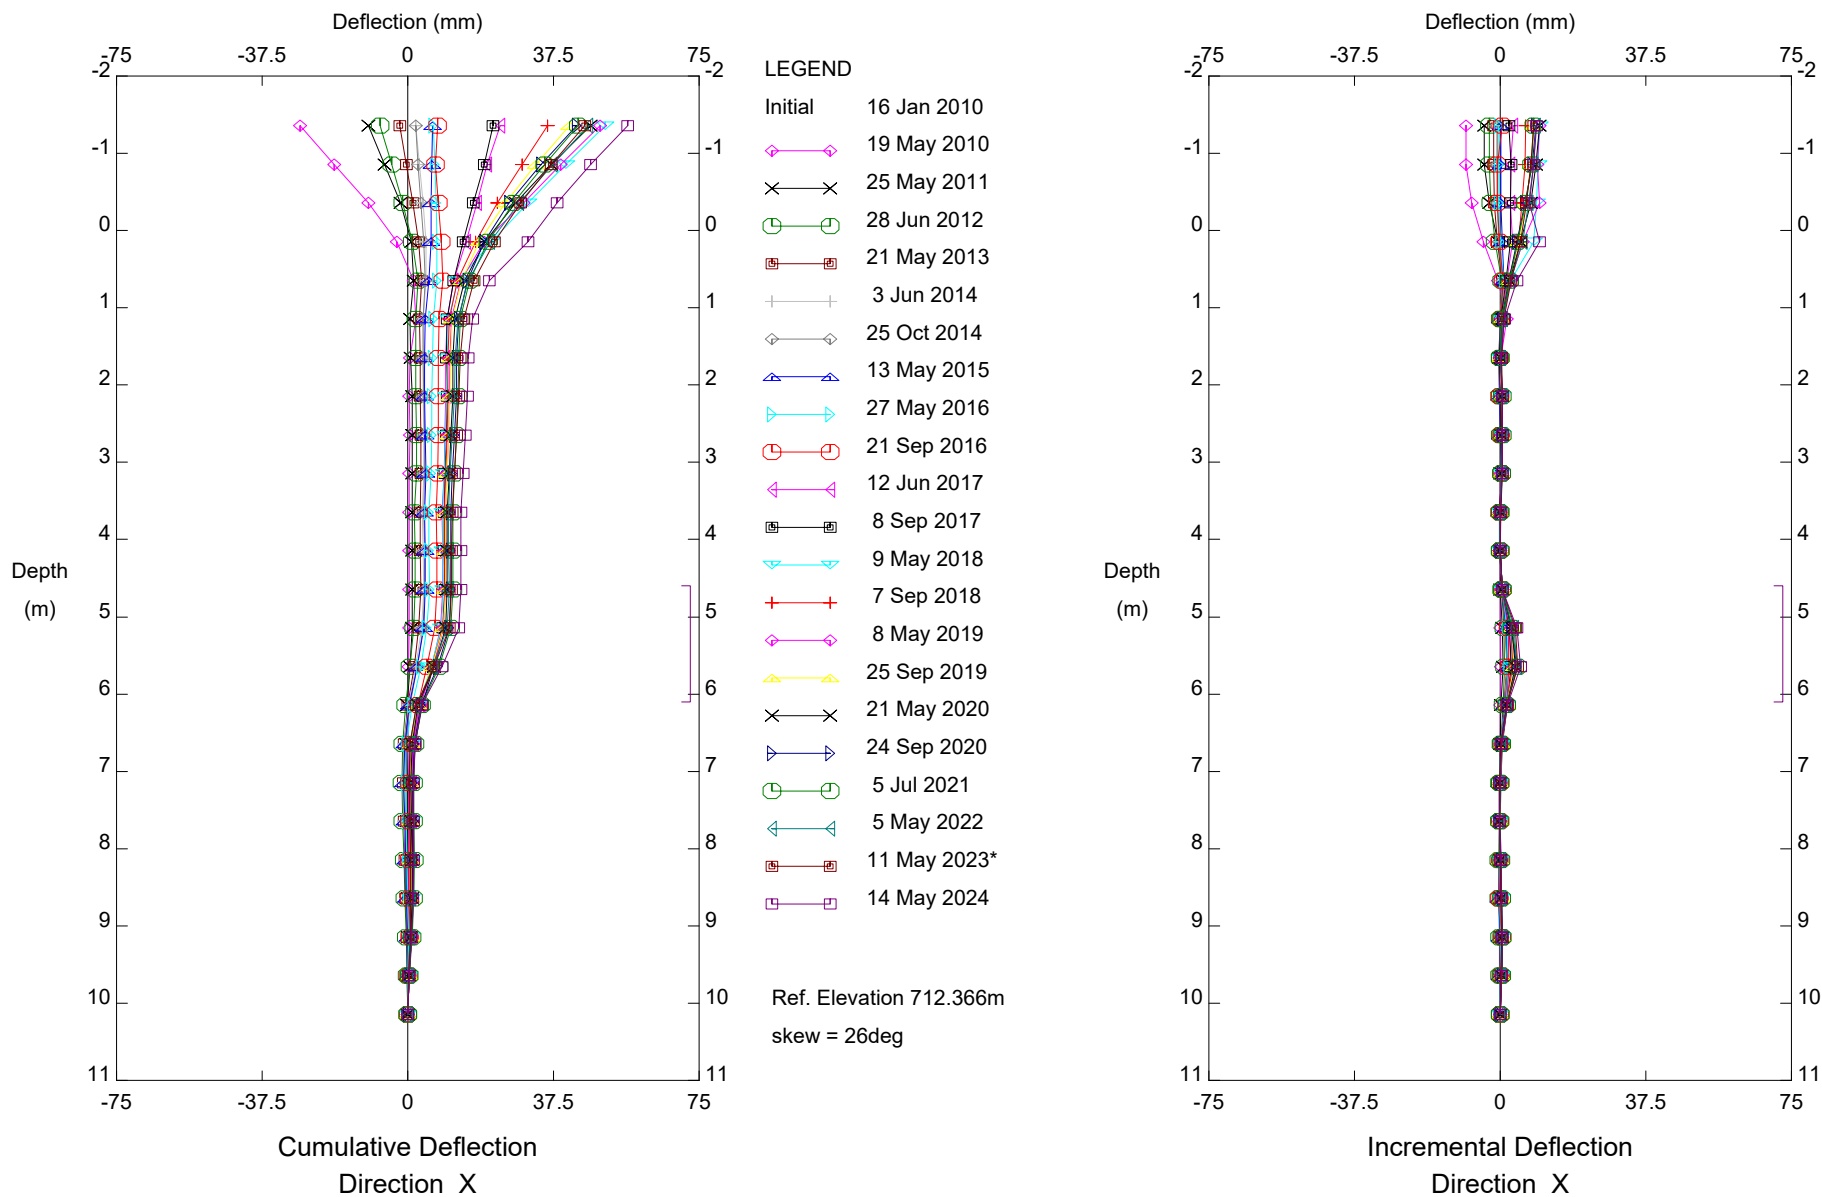
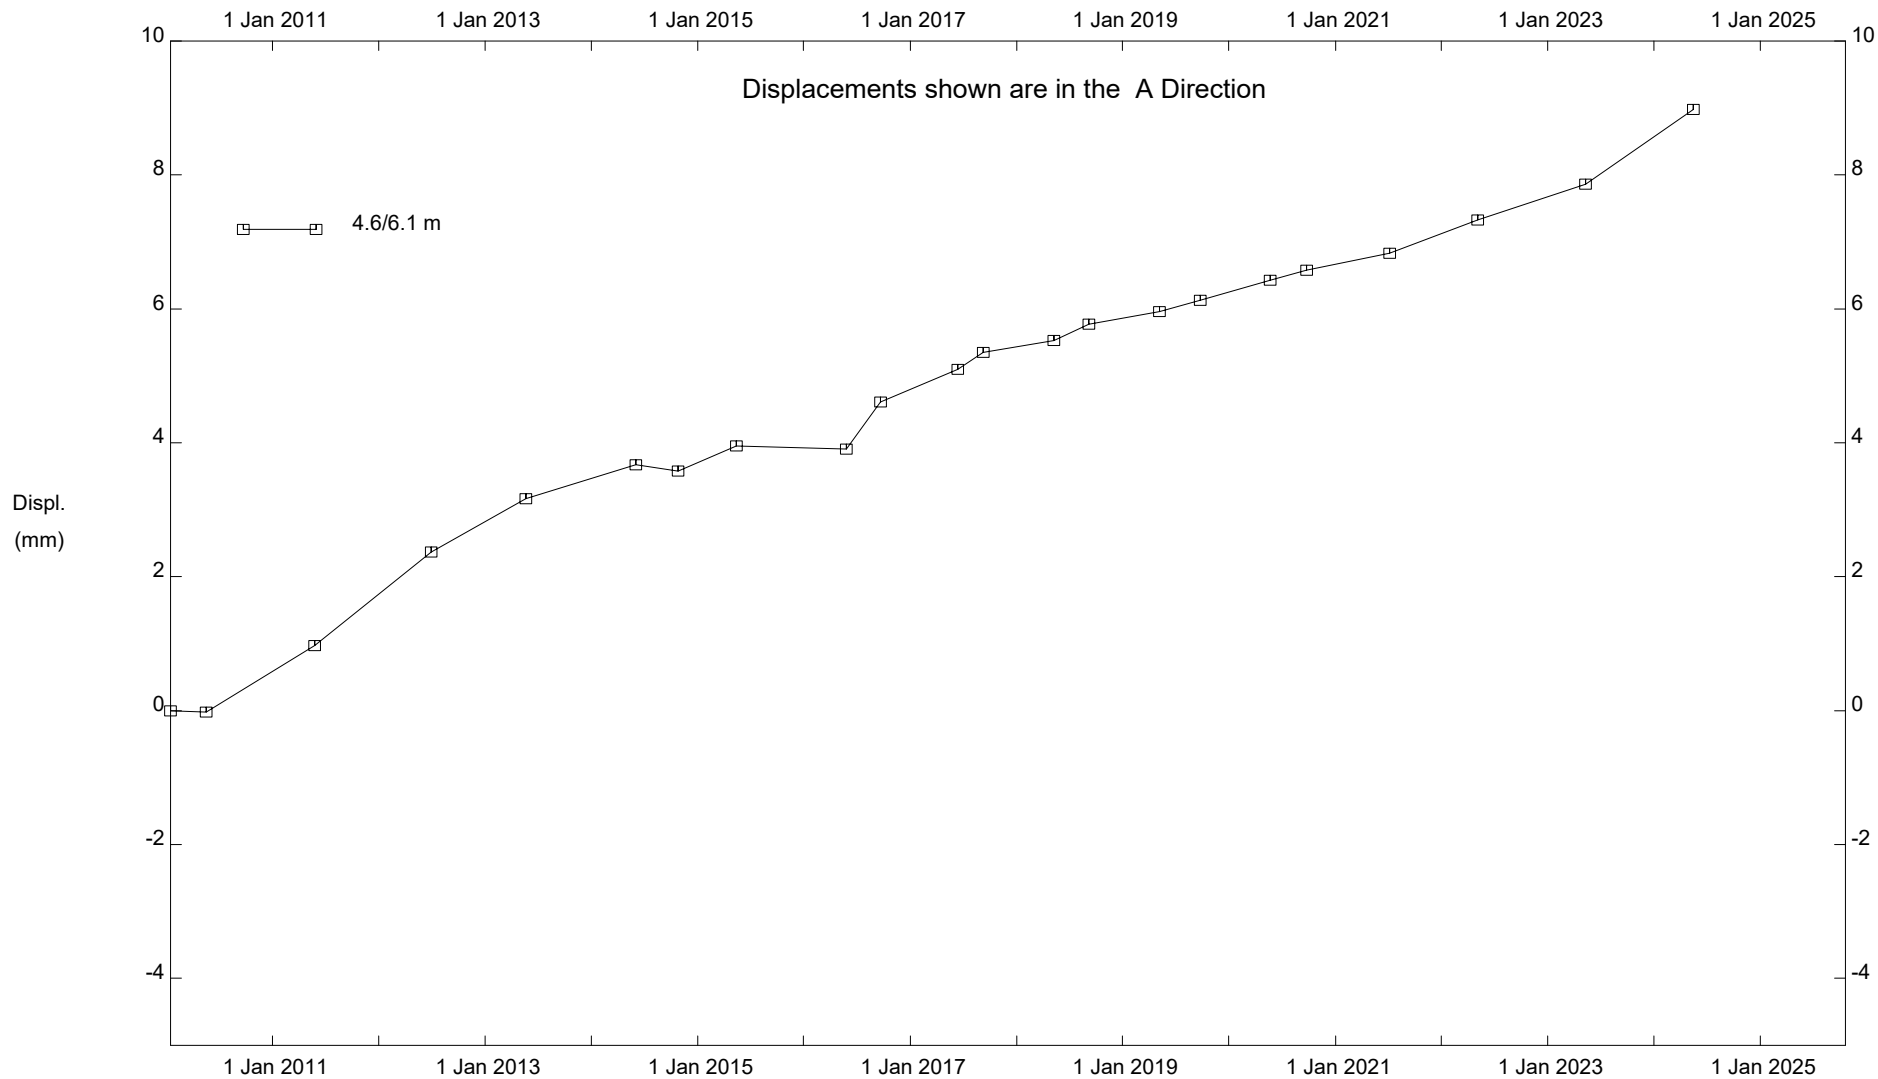
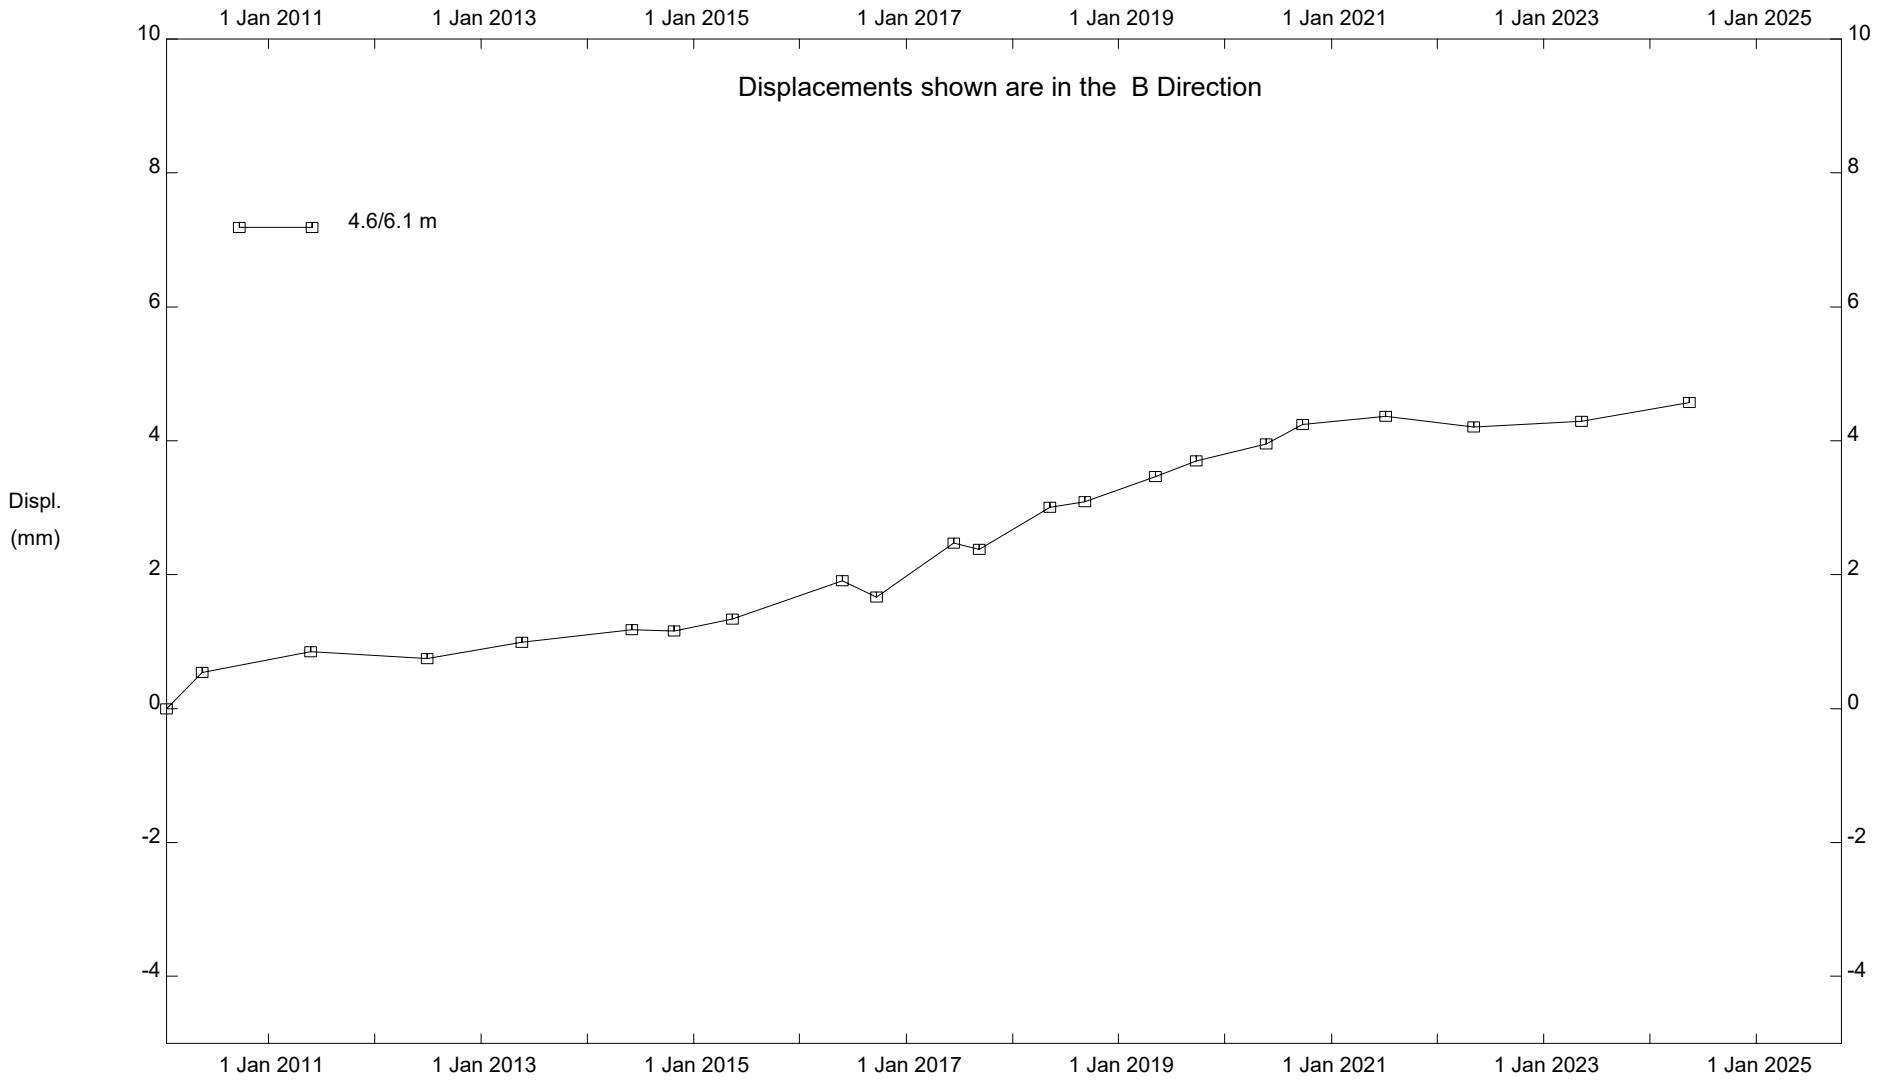
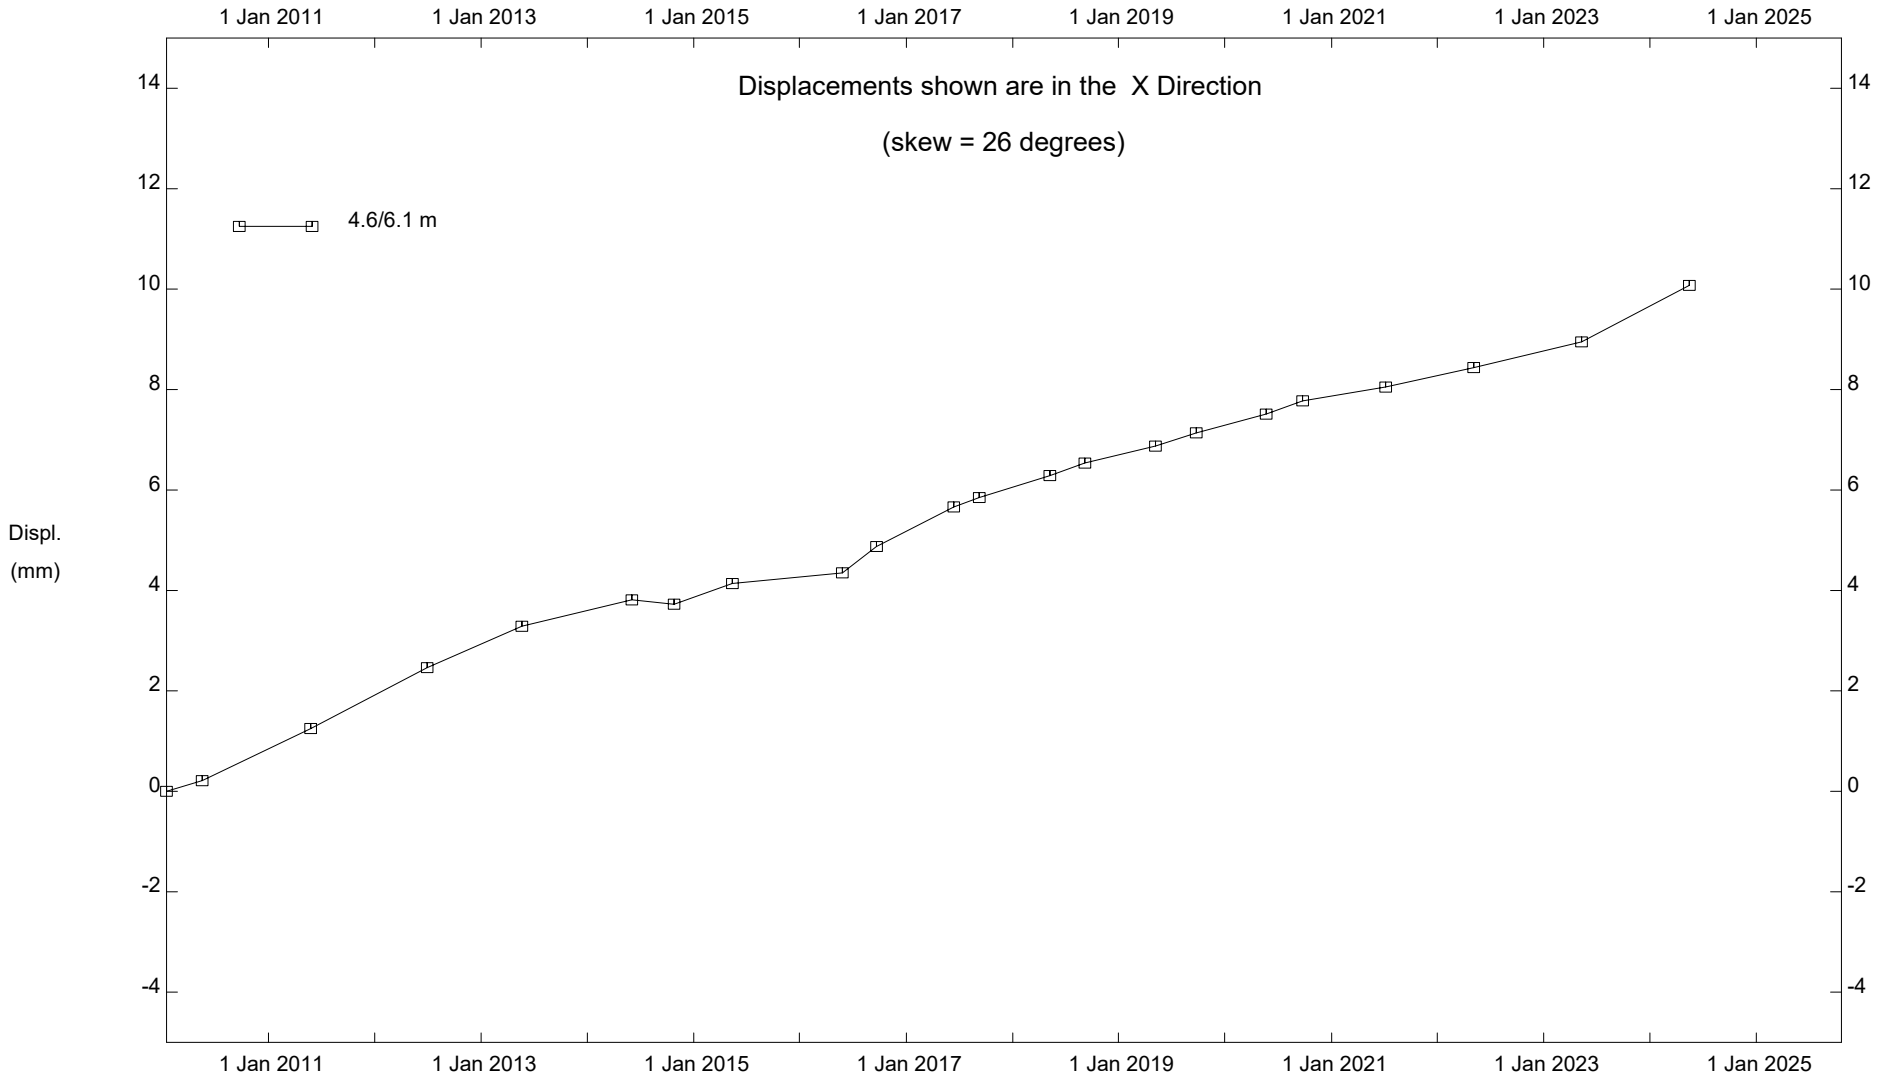
HWY32:10 South of Whitecourt (NC37), Inclinometer SI10-9

SI10-9 has a zone of movement at approximately 4.6 m to 6.1 m depth. The movement zone shows creep movement since 2011 with a movement rate of about 1 mm/yr.

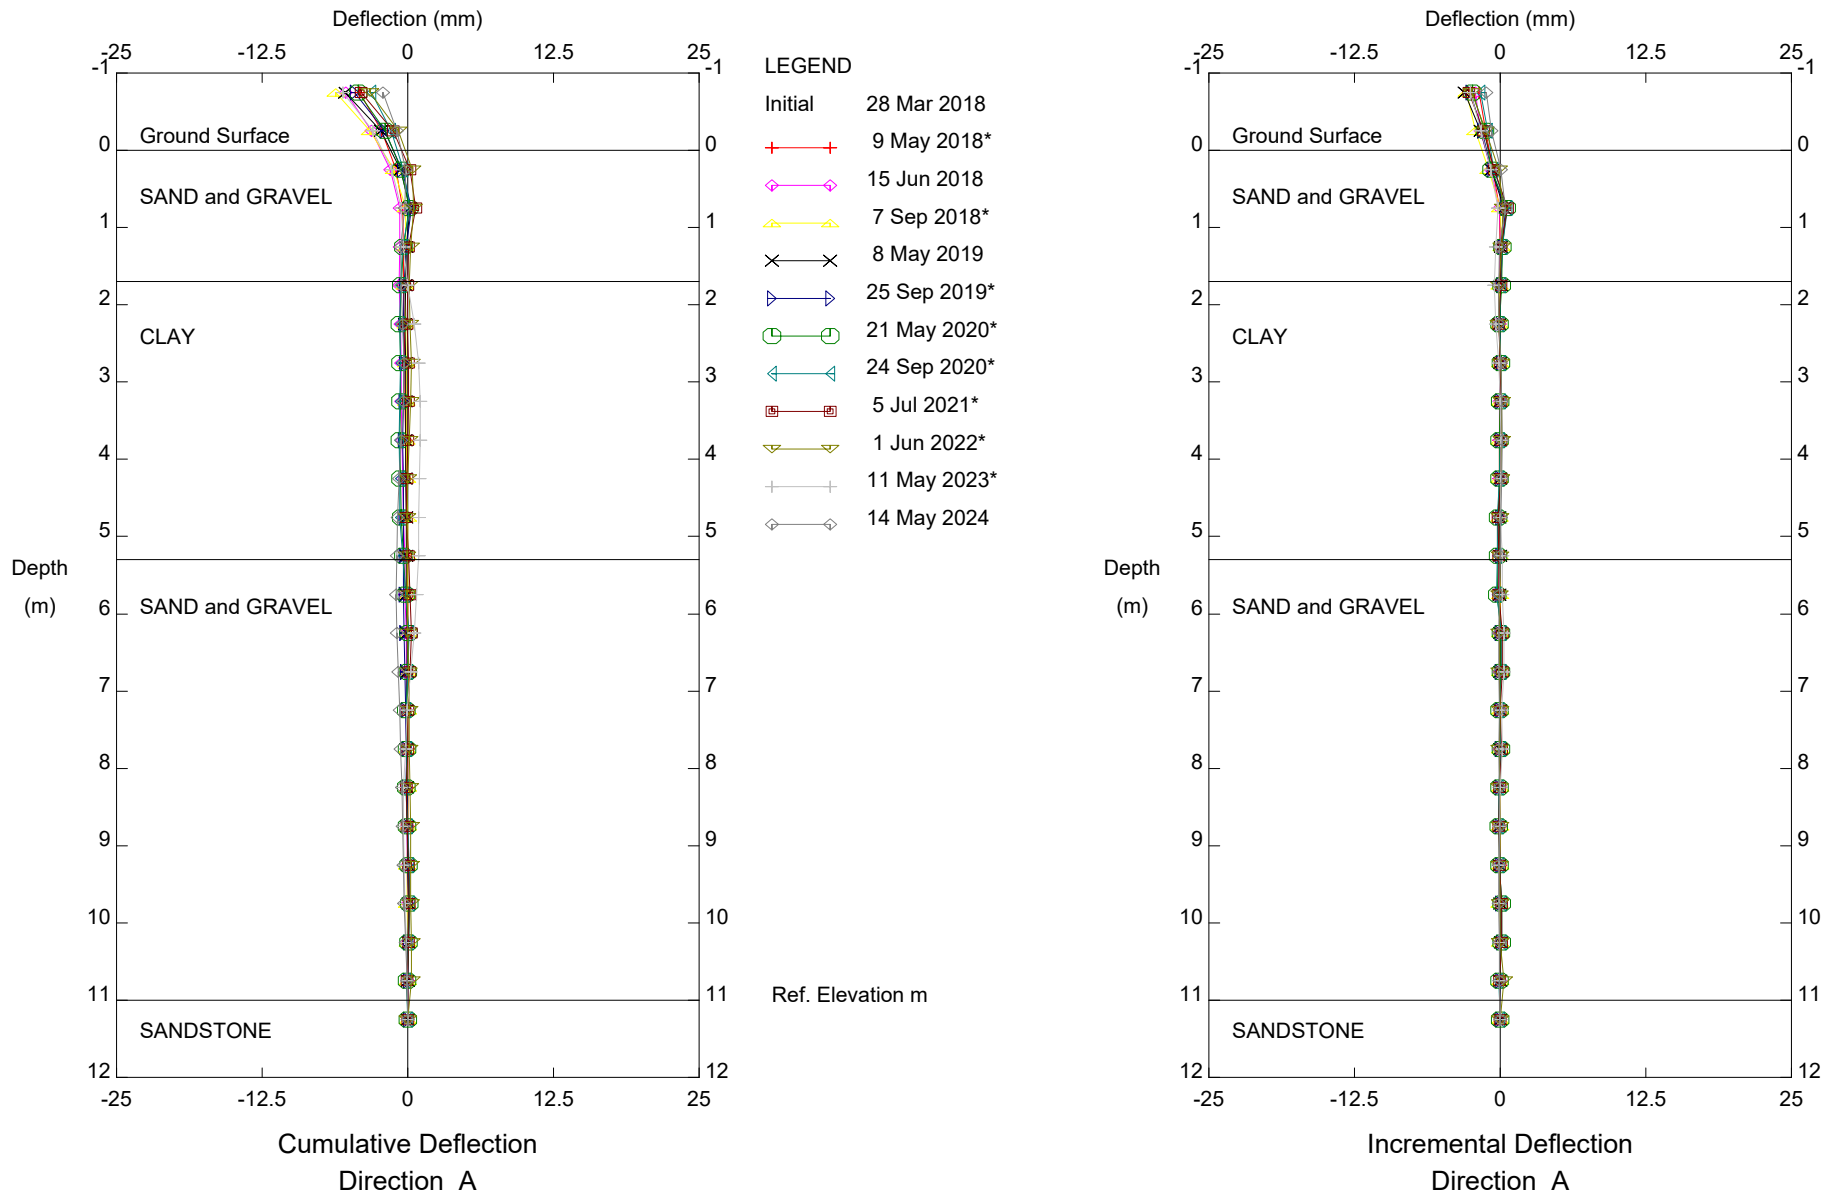
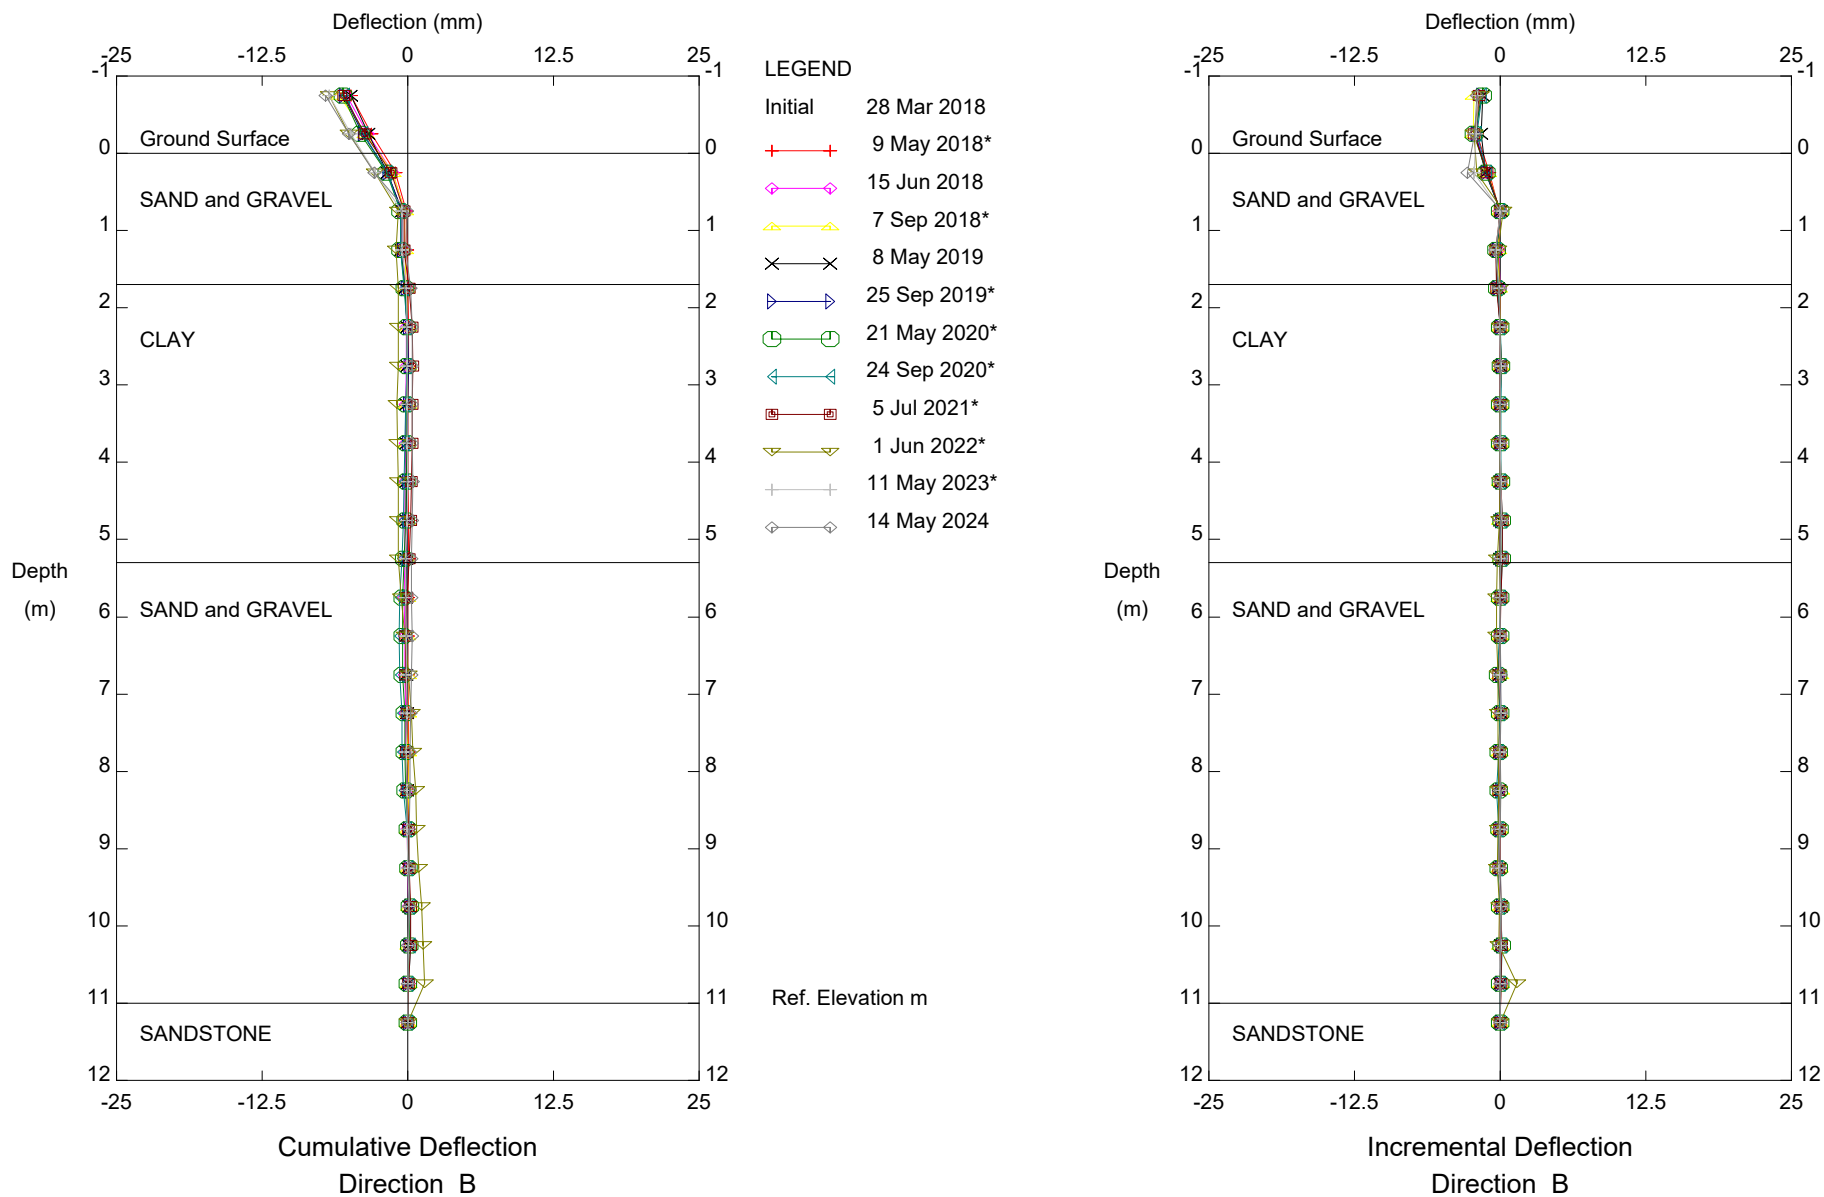
Hwy 32:10 South of Whitecourt (NC37), Inclinometer SI18-03

No discernable movement was observed in SI18-03 and SI18-05.
