To: Amy Driessen  
Transportation and Economic Corridors  
File: 123315222

From: Leslie Cho and Xiteng Liu  
Stantec Consulting Ltd.  
Date: June 18, 2024

**Reference: North Central Region, Edson, Site NC037 - Highway 32:10 South of Whitecourt, Spring 2024 Instrumentation Monitoring Report**

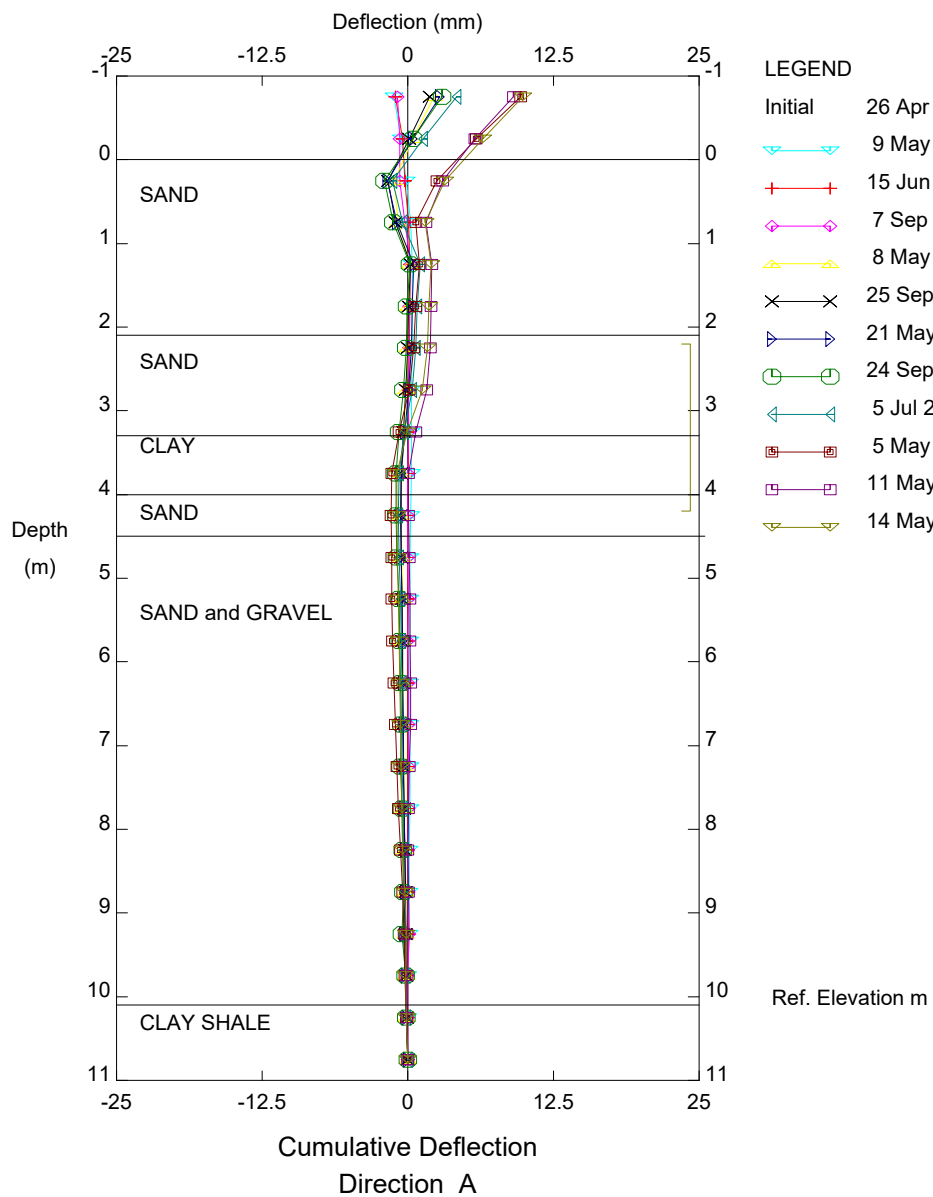
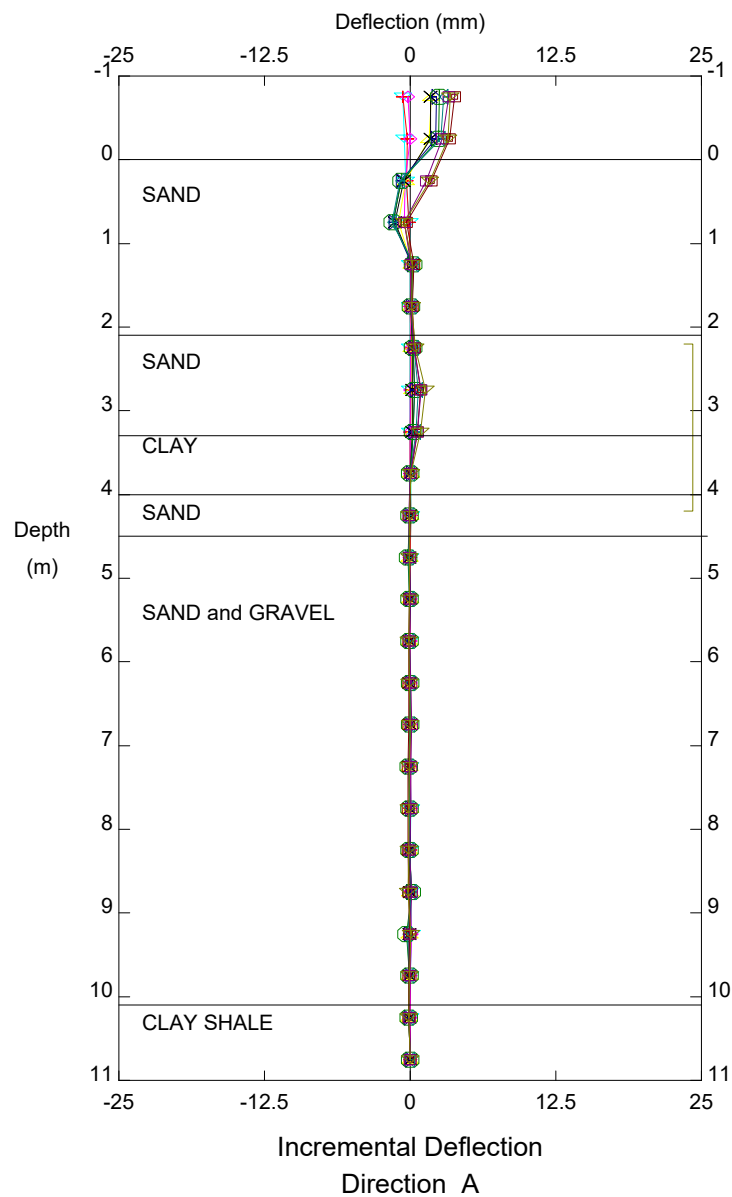
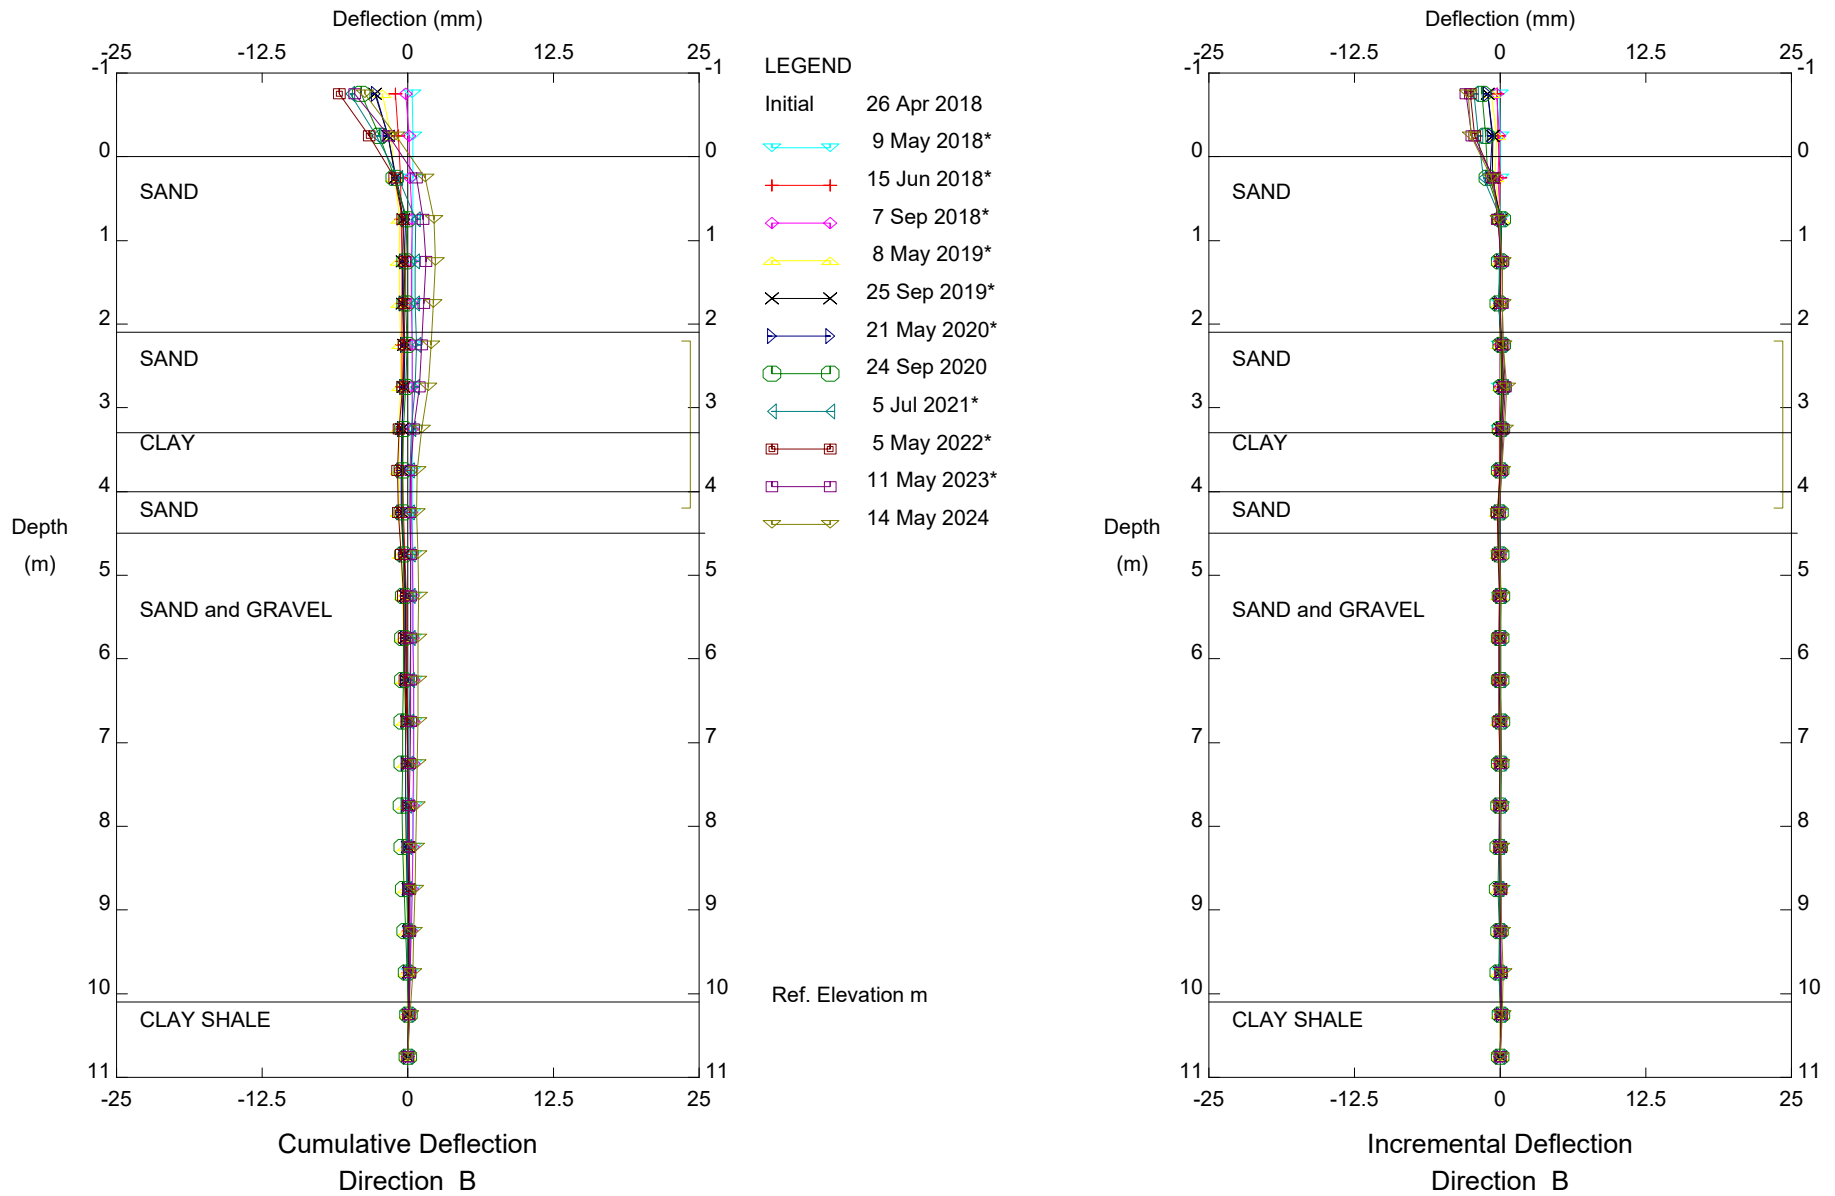
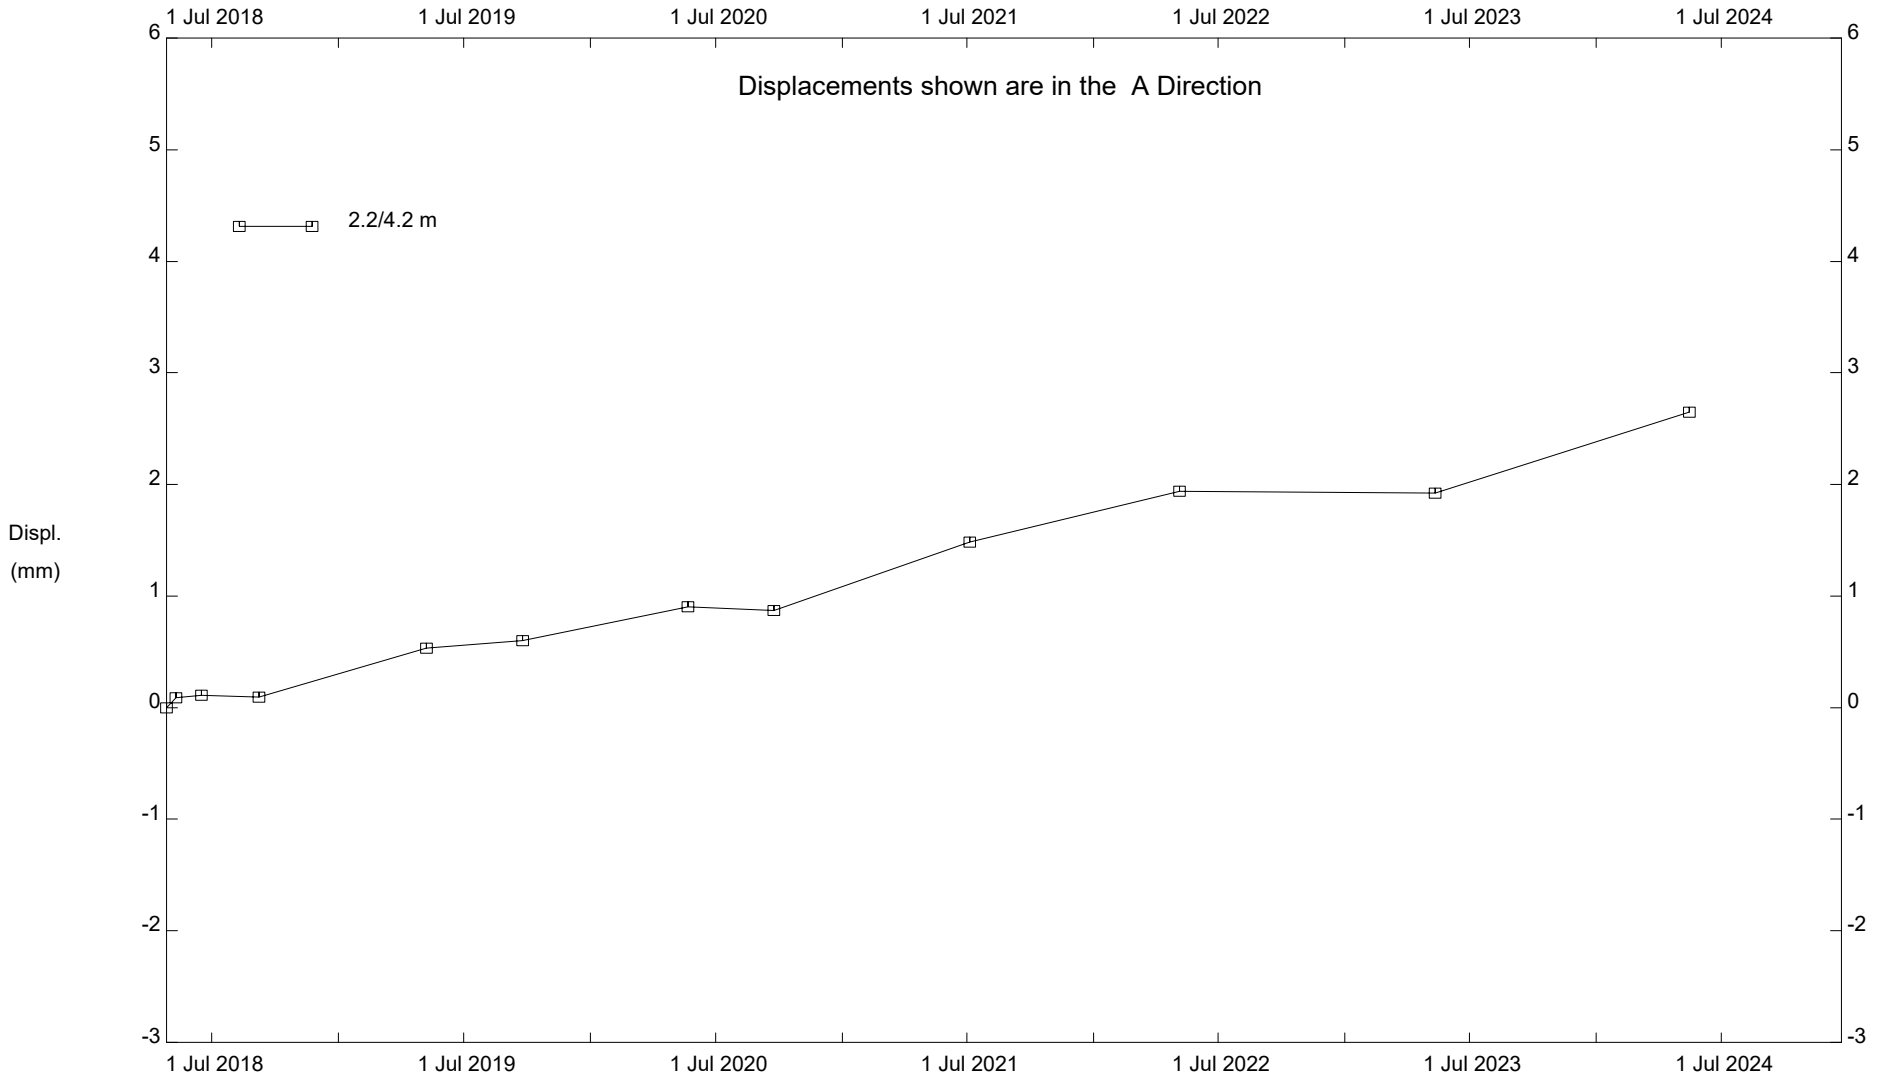
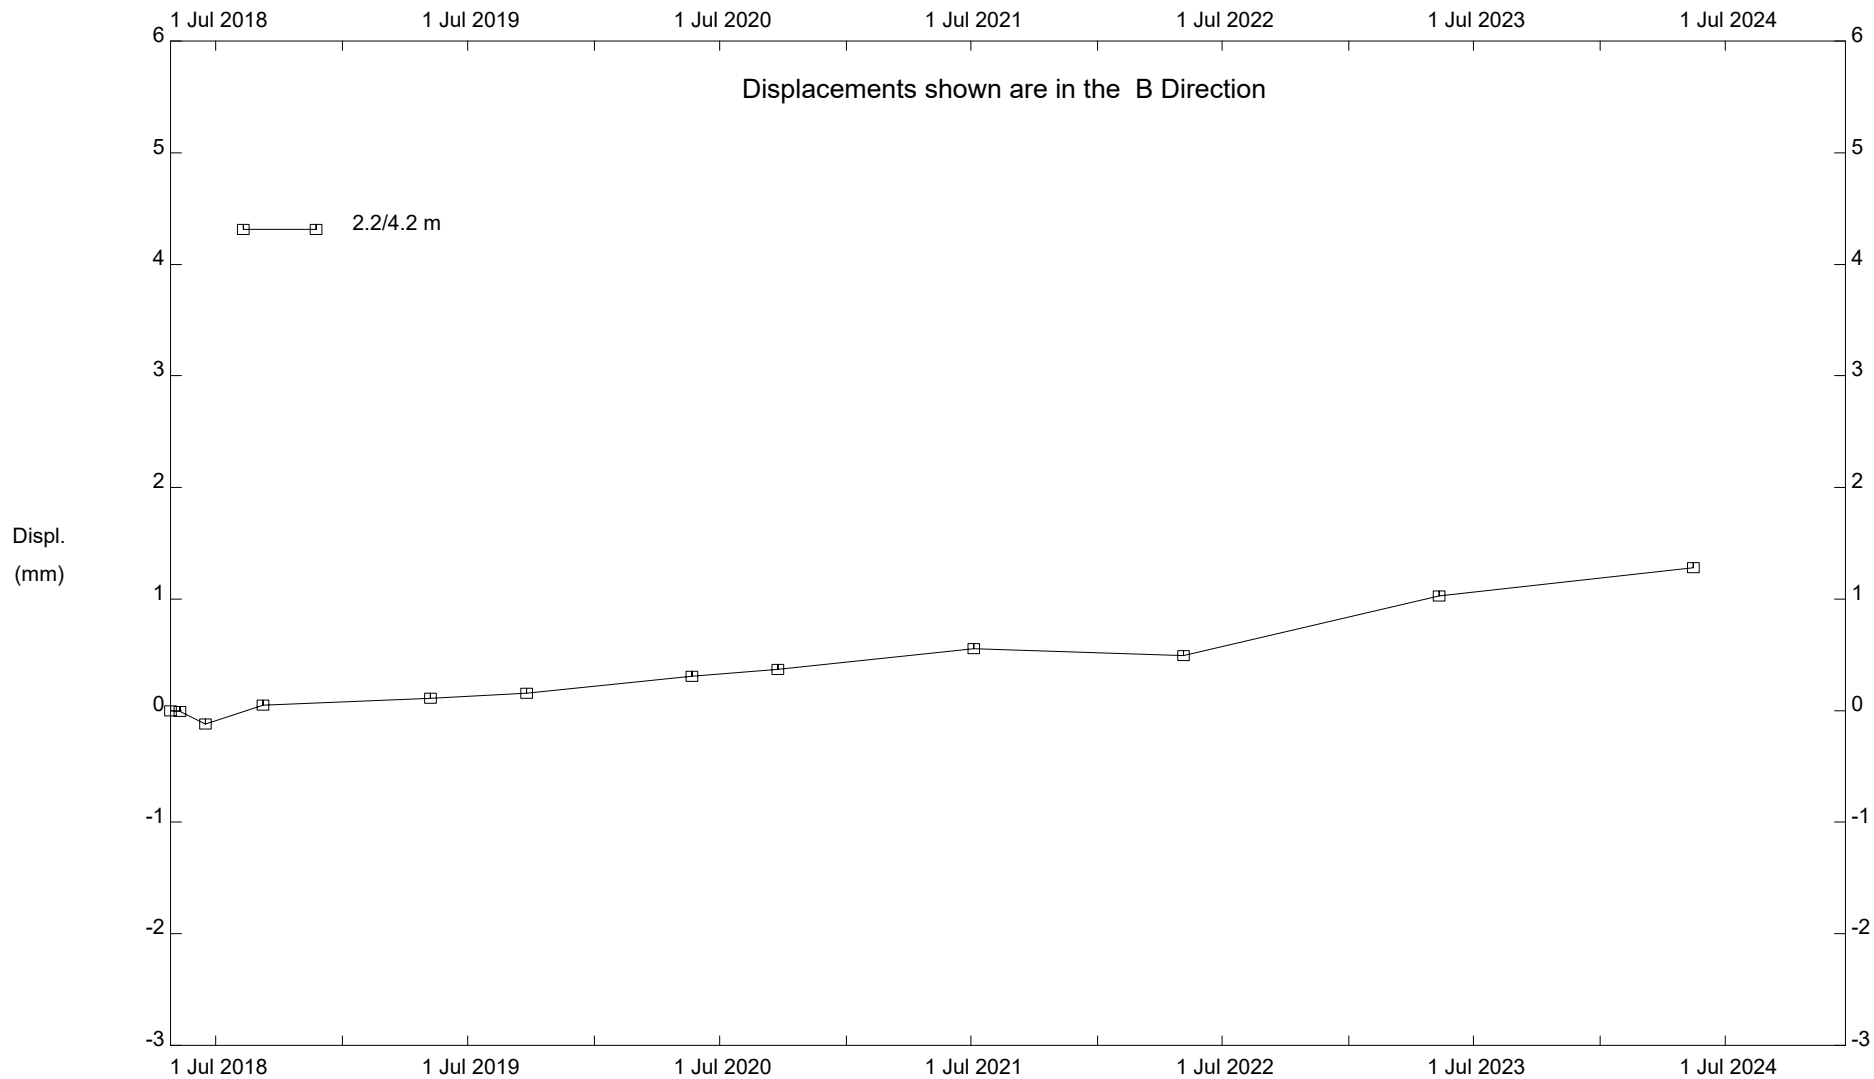
Hwy 32:10 South of Whitecourt (NC37), Inclinometer SI18-04

SI18-04 has a potential movement zone (creeping) between 2 m and 4 m. The current rate of movement is less than 1 mm/yr with total cumulative movement of about 3 mm since 2018.

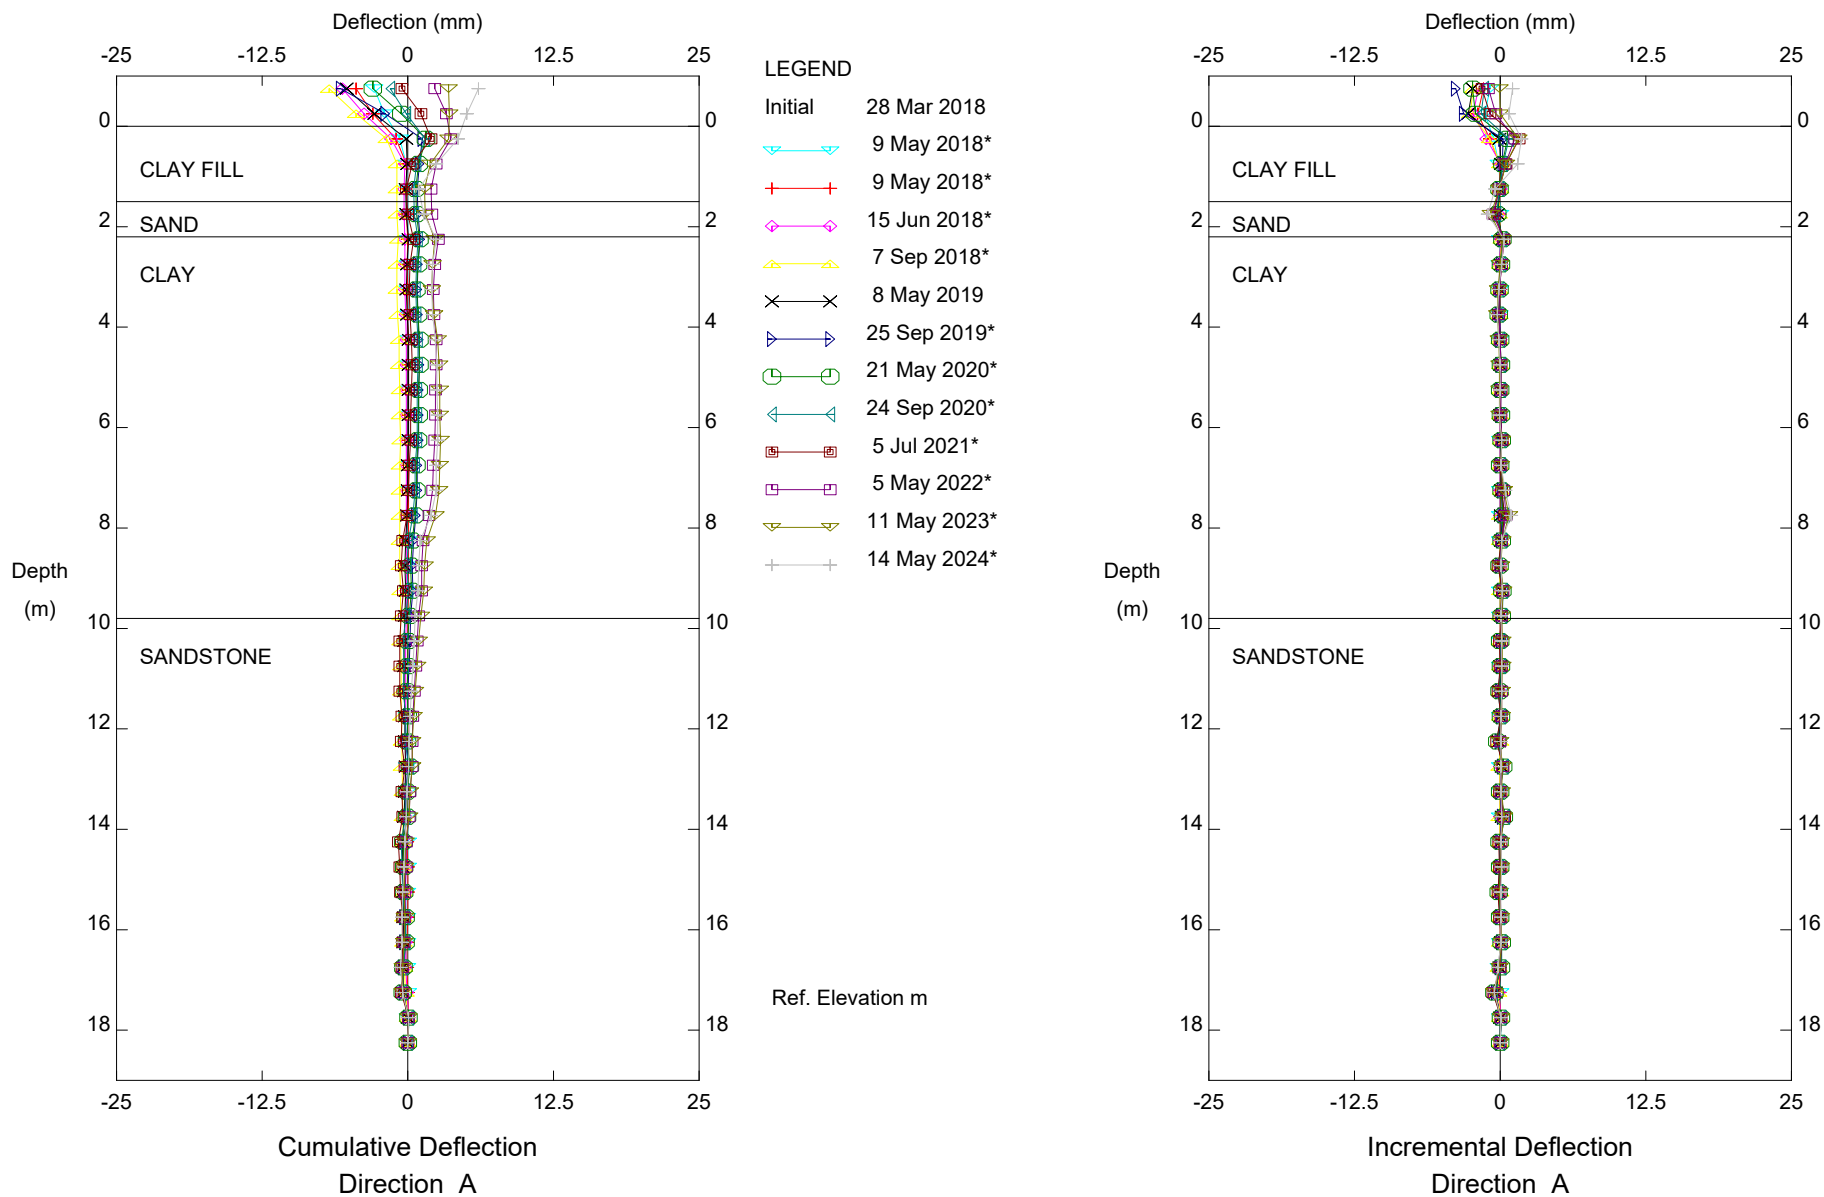
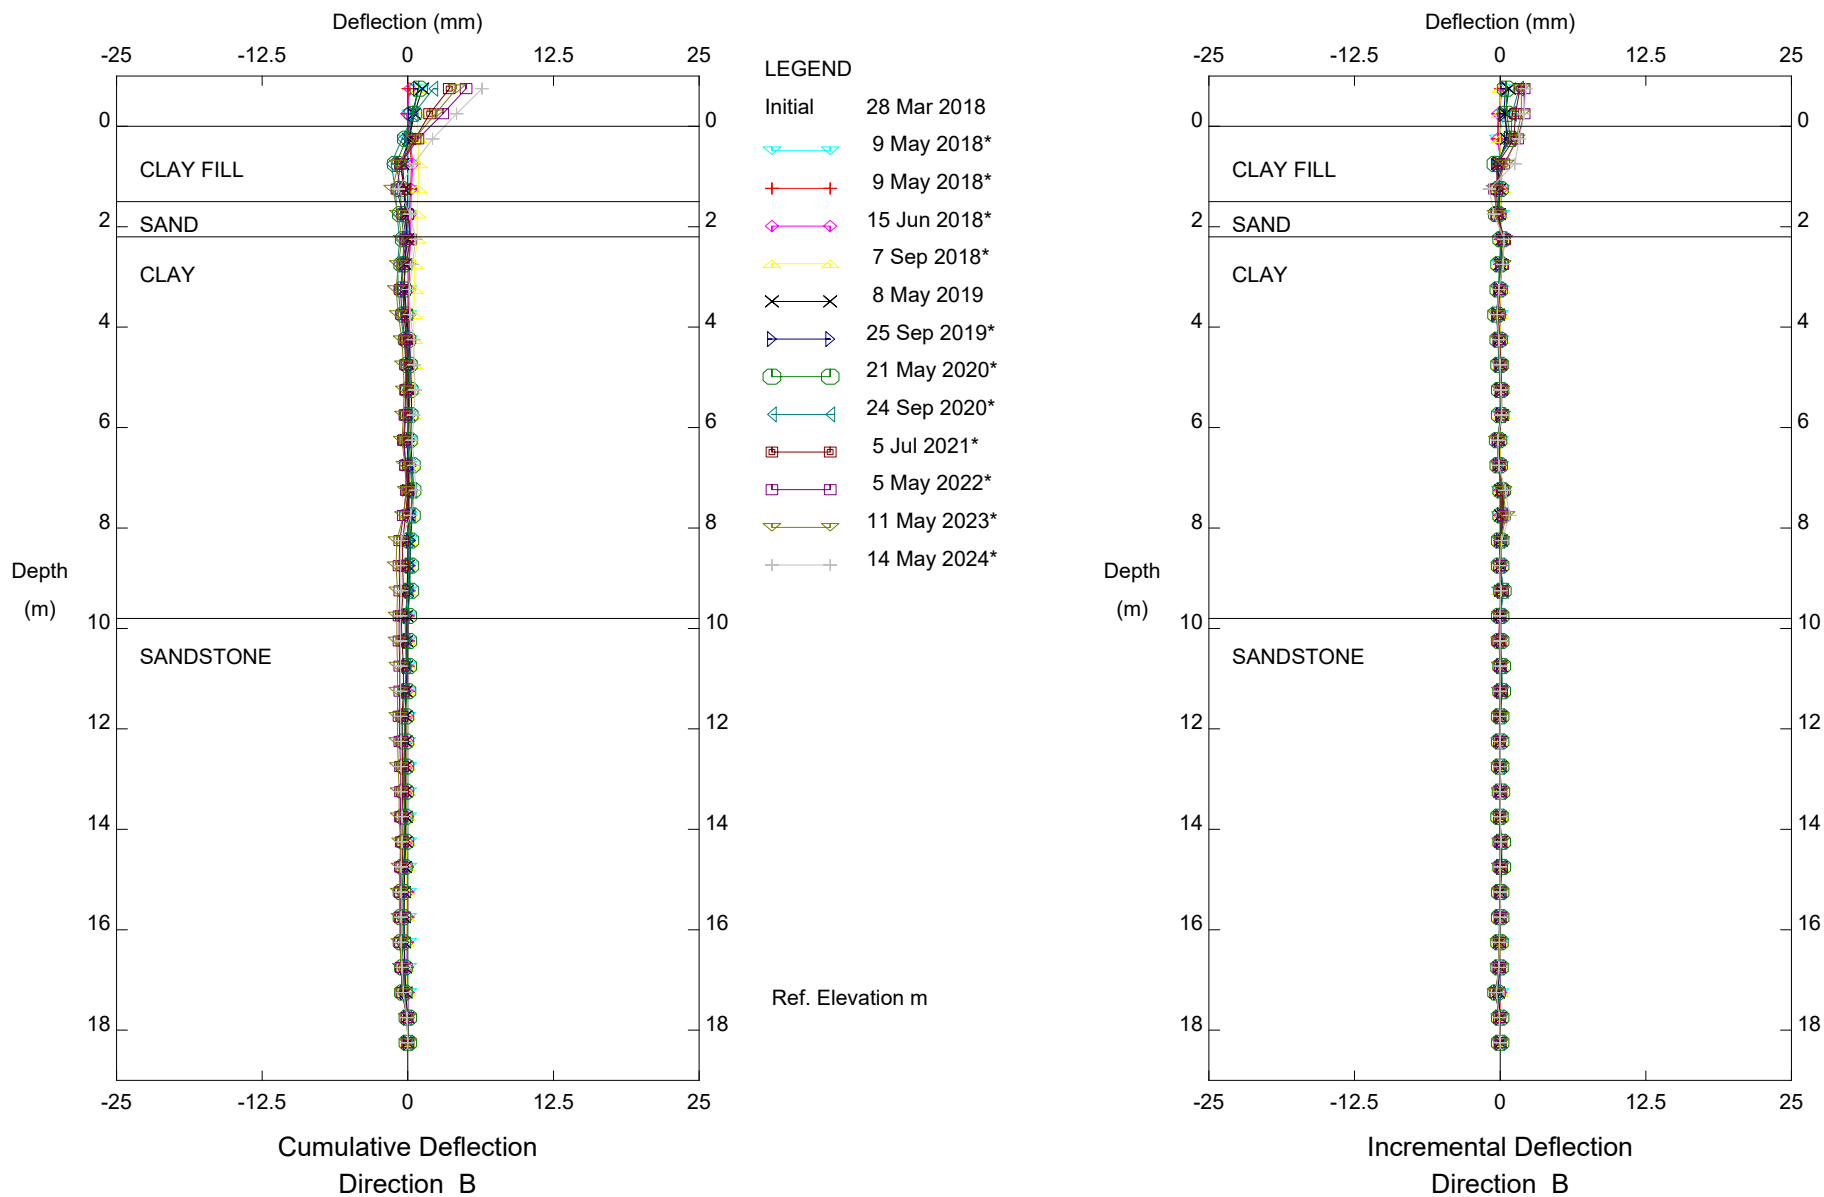
Hwy 32:10 South of Whitecourt (NC37), Inclinometer SI18-05

No discernable movement was observed in SI18-03 and SI18-05.
