GEOHAZARD RISK MANAGEMENT PROGRAM

North Central Region – Edson / Stony Plain Area

2019 Inspection Report

Site Number	Site Name	Hwy	km
NC50	Gregg River Slide (North of Cadomin)	40:28	11.7
Legal Land Description	NW 33-47-24-W5M		
UTM Coordinates (NAD 83)	Zone 11U	N5883275	E469398
Operational Site Instrumentation	Slope Inclinometers	4	
	Pneumatic Piezometers	3	
	Vibrating Wire Piezometers	0	
	Standpipe Piezometers	0	
Date of Last Instrumentation Readings	May 9, 2019

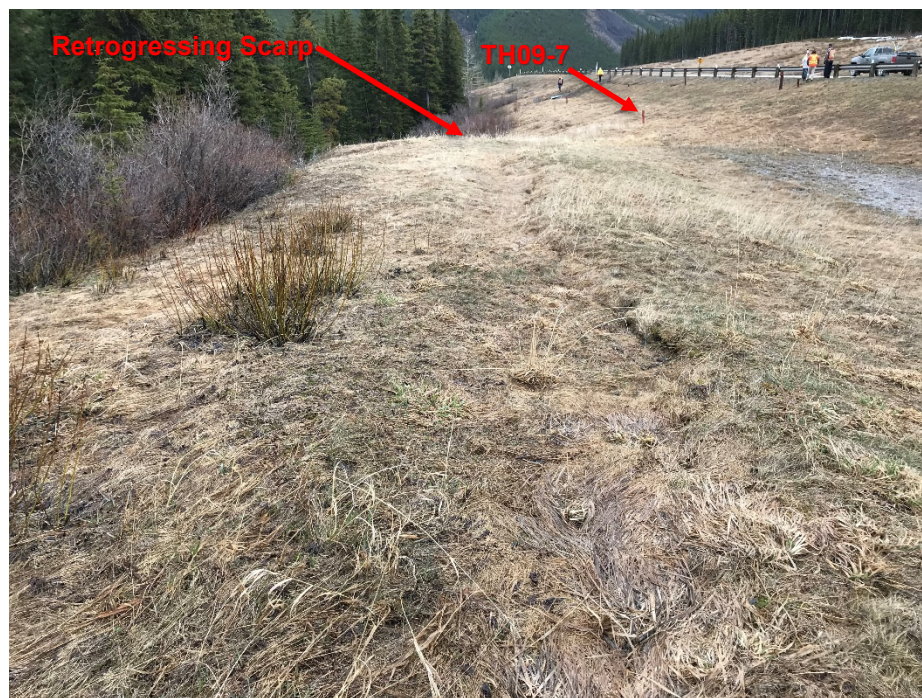
Discussion	<p><u>Pile Wall Site:</u></p> <p>No new pavement cracks were observed around the pile wall as shown in Photo 1.</p> <p>New ground cracks approximately 40 m west of the retrogressive scarp was observed as shown in Photo 2. The crack locations are in similar locations of previously observed cracks. It is unknown which year the crack was first observed.</p> <p>In general, the old retrogressive scarp appeared to be in similar condition to the 2015 inspection. A new crack was observed several meters upslope from the scarp as shown in Photo 3. The vertical differential in the original scarp ranged from 600 mm to 1700 mm.</p> <p>Soft wet ground with minor surficial erosion was observed in the ditches west of SI10-13 as shown in Photo 4. At localized spots, seepage from the ground was observed to be orange.</p> <p>The culvert east of SI10-11 was flowing and in good condition as shown in Photo 5. The erosion gully at this culvert appeared similar to the 2018 inspection as shown in Photo 6.</p> <p>An erosion gully east of SI10-11 leading upslope from the culvert to Highway 40 was observed as shown in Photo 7.</p> <p>At the base of SI10-11, a slump/crack feature about 300 mm high was observed as shown in Photos 5 and 7. This appeared to be similar to the 2018 inspection.</p> <p>New cracks along the approximate pile wall alignment was observed between SI10-11 and SI10-13 as shown in Photo 8.</p> <p>Skin slides along the back slope with ponded water in the ditch continued to be observed south of Highway 40 as shown in Photo 9. No obvious changes to the skin slides were observed.</p> <p><u>Culvert Site:</u></p> <p>The pavement cracks remain relatively unchanged since the previous inspection.</p> <p>The scarps in the upper half of the slope appear to be relatively unchanged as shown in Photo 10 and 11. Seepage continued to be observed within the slope. The lower half of the slope was obscured with ice and snow and could not be observed.</p> <p>The slump east of the broken culvert and in the trees appeared unchanged as shown in Photo 10.</p> <p>The slump north of SI09-10 as shown in Photo 12 appeared to be slightly larger with fresh scarps approximately 2 m high.</p> <p>The old scarp south of SI09-10 appeared to be similar to previous inspections with no obvious changes as shown in Photo 13.</p> <p>Although the south ditch was recently regraded, the ground continued to be wet with occasional ponded water.</p> <p>Design with community in mind</p> <p>The half culverts could not be observed during this inspection due to ice cover as shown in Photo 14. However, the sound of flowing water can be heard at the half culverts.</p>

Photo 2: New ground cracks west of retrogressing scarp in Photo 3. Looking west.

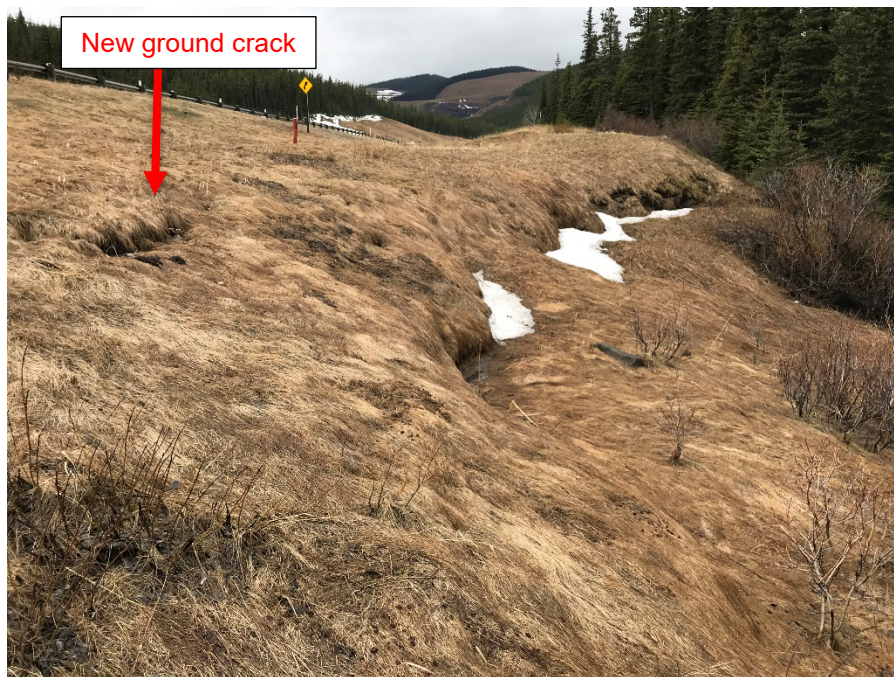
Photo 3: Retrogressive scarp from 2015 with vegetation growing in. New ground crack developing left of centre. Looking west.

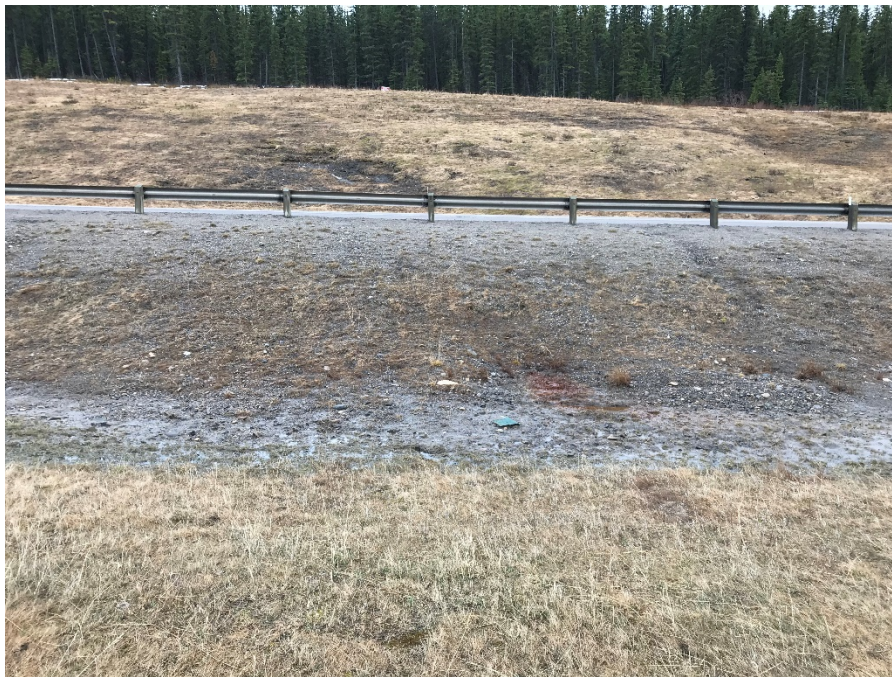
Photo 4: Soft saturated ground with minor erosion leading from culvert site to pile wall site. Orange seepage. Looking south.

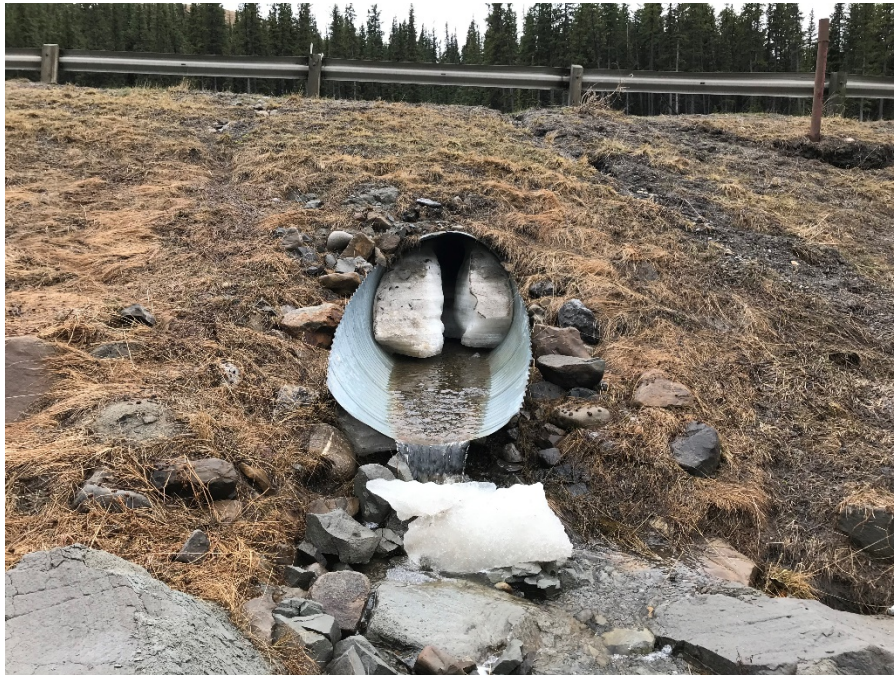
Photo 5: Culvert east of SI10-11 in flowing and in good condition. Ice in culvert. Slump at base of SI10-11 in top right about 300 mm high. Looking north.

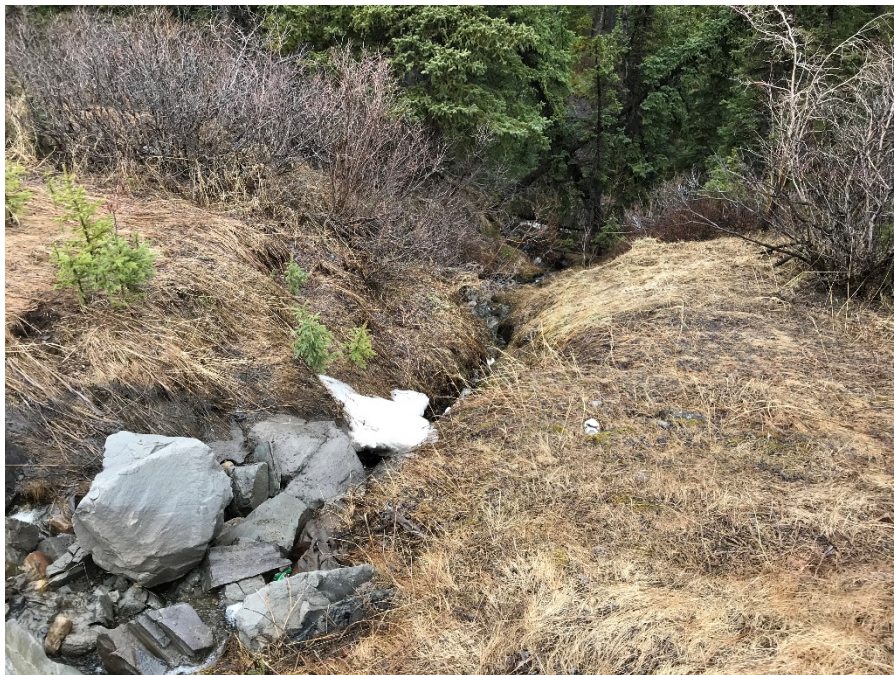
Photo 6: Erosion gully beyond the rip rap channel at the culvert outlet. Vegetation growing into gully. Looking north.

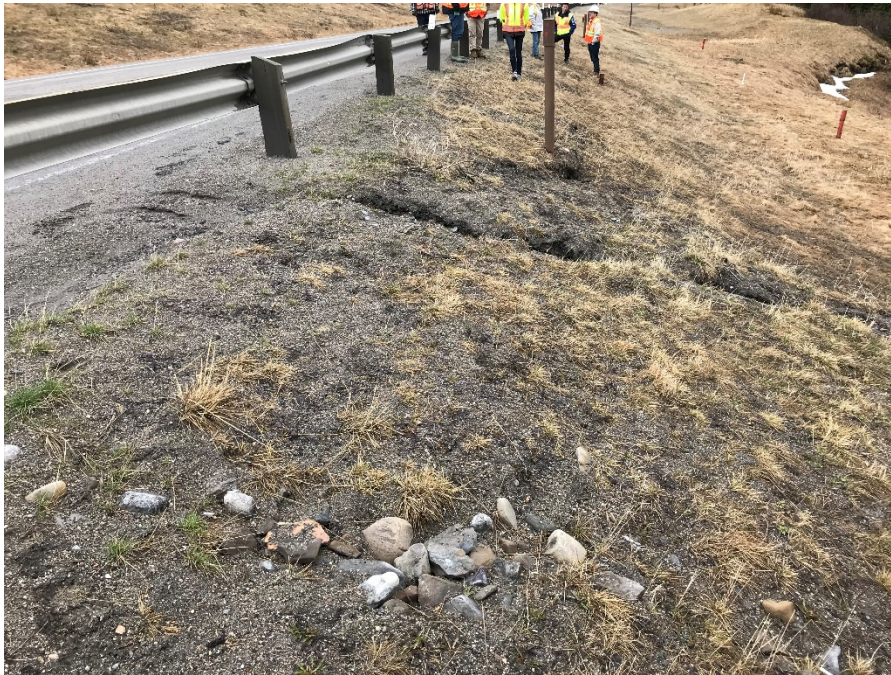
Photo 7: Erosion gully east of SI10-11. Slump/crack feature at base of SI10-11. Looking southwest.

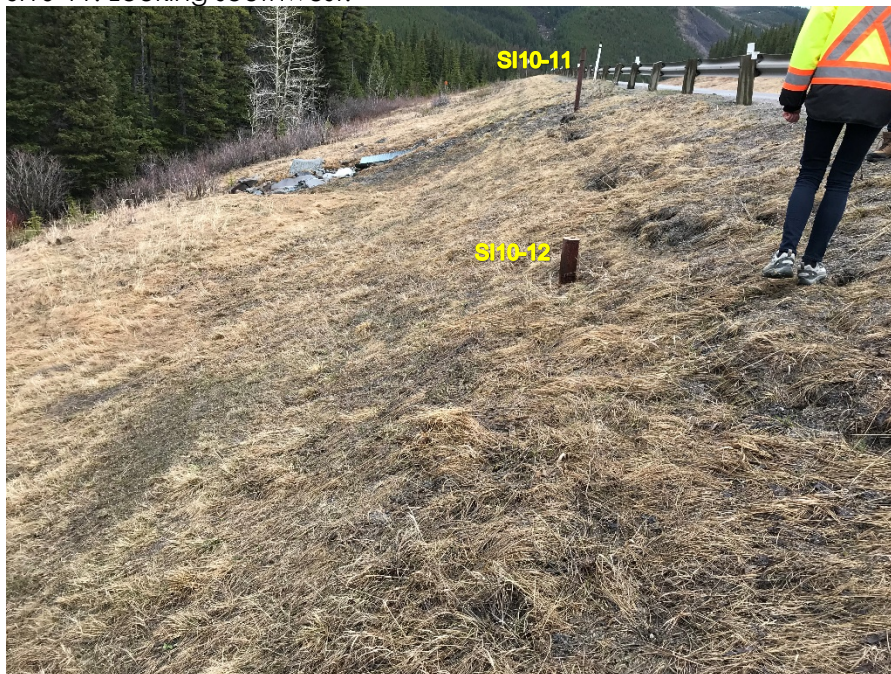
Photo 8: Ground cracking along approximate pile wall location. Looking east.

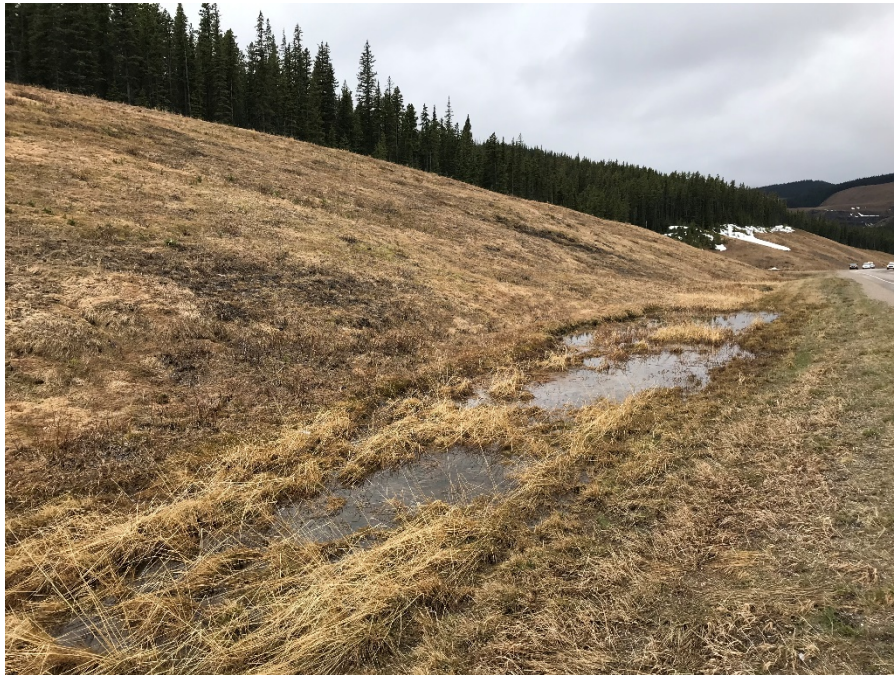
Photo 9: Skin slide south of Highway 40. Ponding in ditch. Looking southeast.

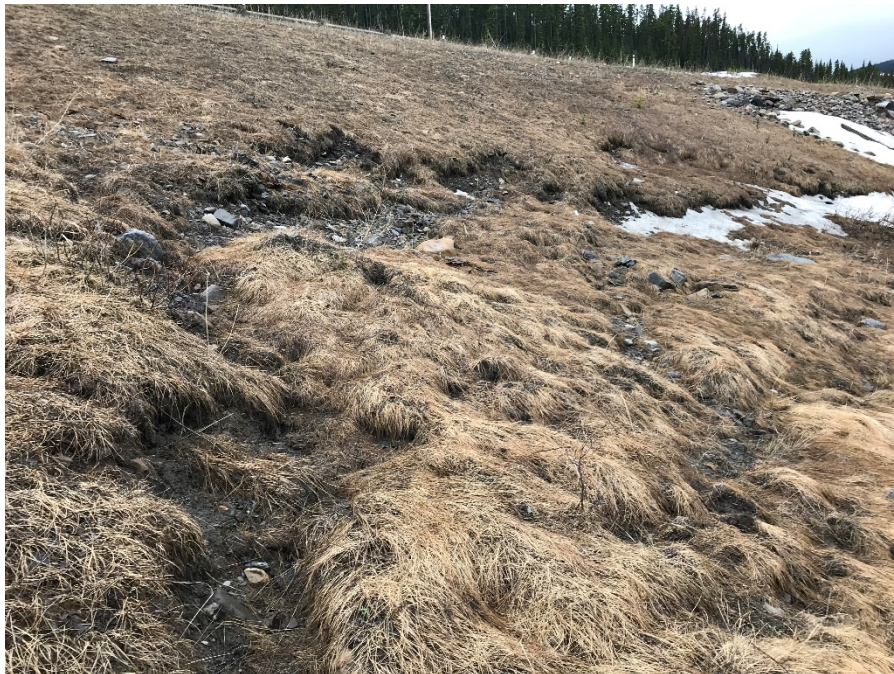
Photo 10: Highest scarp east of the half-round culverts. Looking west.

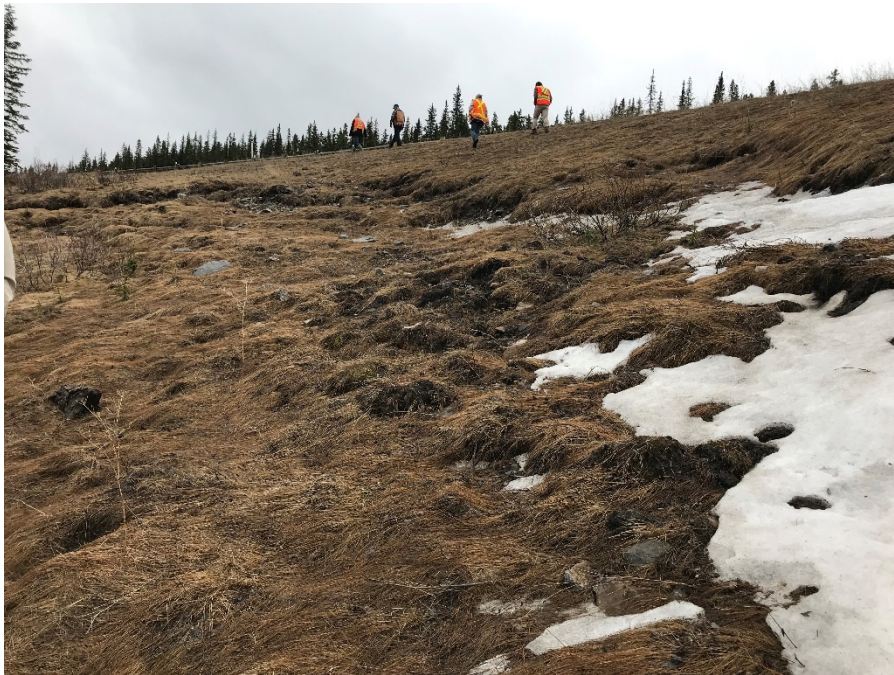
Photo 11: Highest scarp east of the broken culvert. Looking southeast.

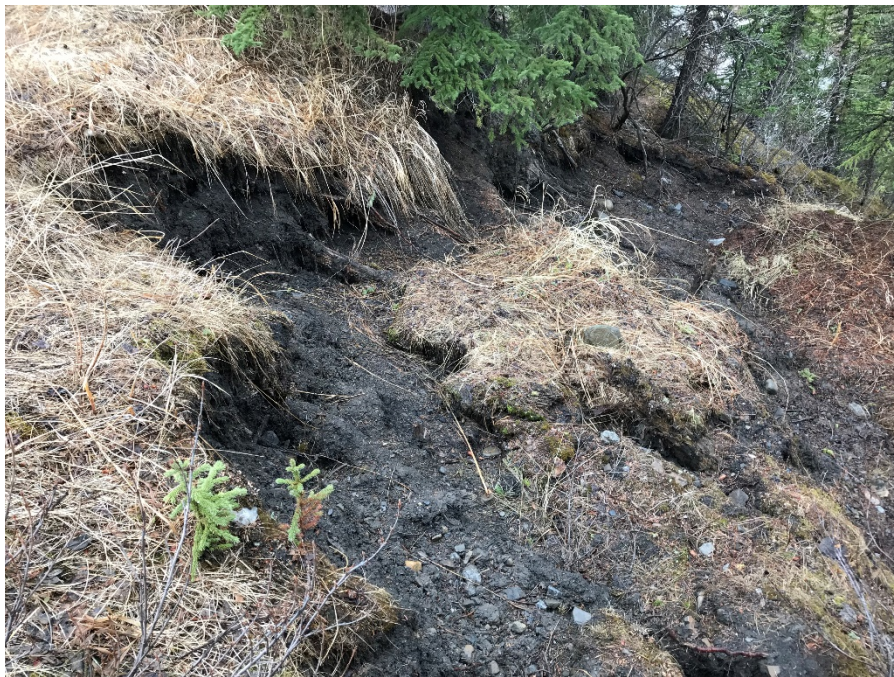
Photo 12: Retrogressing 2 m scarp north of S109-10. Looking west.

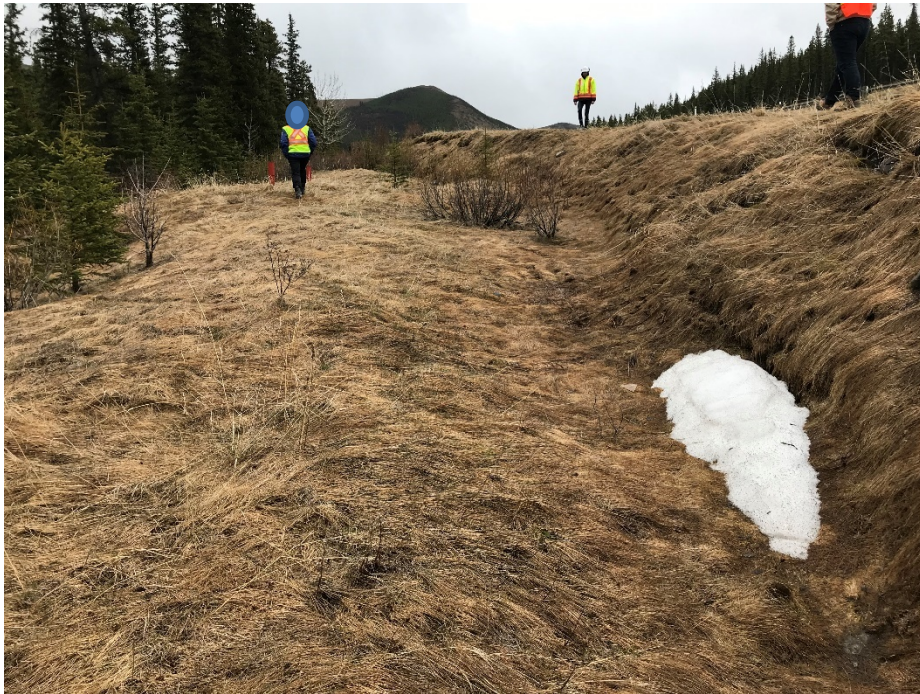
Photo 13: Old scarp south of SI09-10 appears unchanged. Looking west.

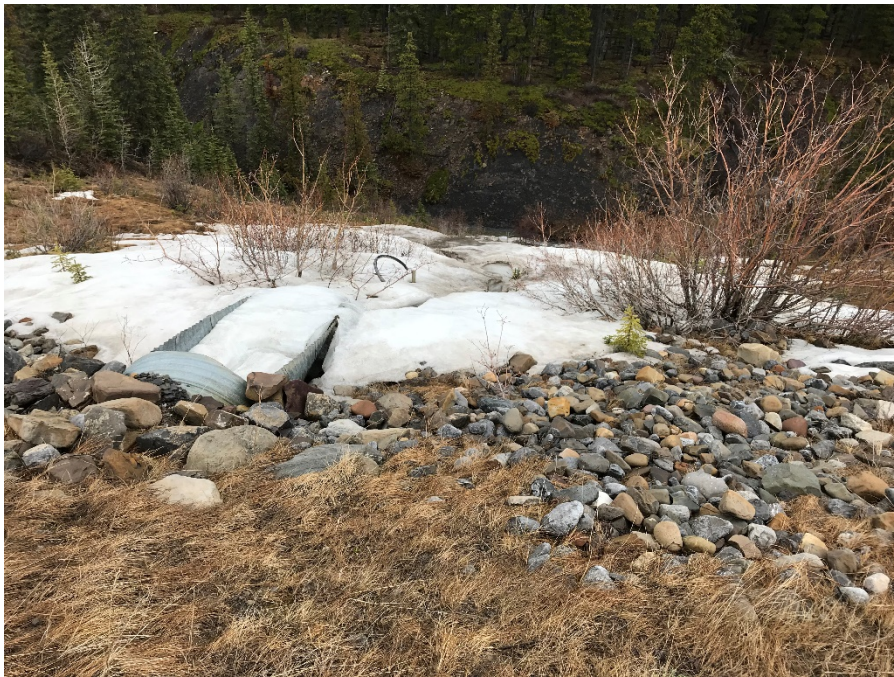
Photo 14: Snow and ice obscuring the slope. Looking north.
