**NORTH CENTRAL REGION GRMP
EDSON / STONY PLAIN
SITE INSPECTION FORM**

SITE NUMBER AND NAME: NC050 – Gregg River Slide	HIGHWAY AND KM: 40:28, km 11.752	PREVIOUS INSPECTION: May 16, 2019	CURRENT INSPECTION: July 15, 2021
LEGAL DESCRIPTION: NW-33-47-24-W5	NAD83 COORDINATES: UTM11U 5883282N, 469320E		RISK ASSESSMENT: PF: 3 CF: 4 Total: 12
AVERAGE ANNUAL DAILY TRAFFIC (AADT): 180 (2020)		CONTRACTOR MAINTENANCE AREA (CMA): 508

2021 Site Inspection Photos at NC050

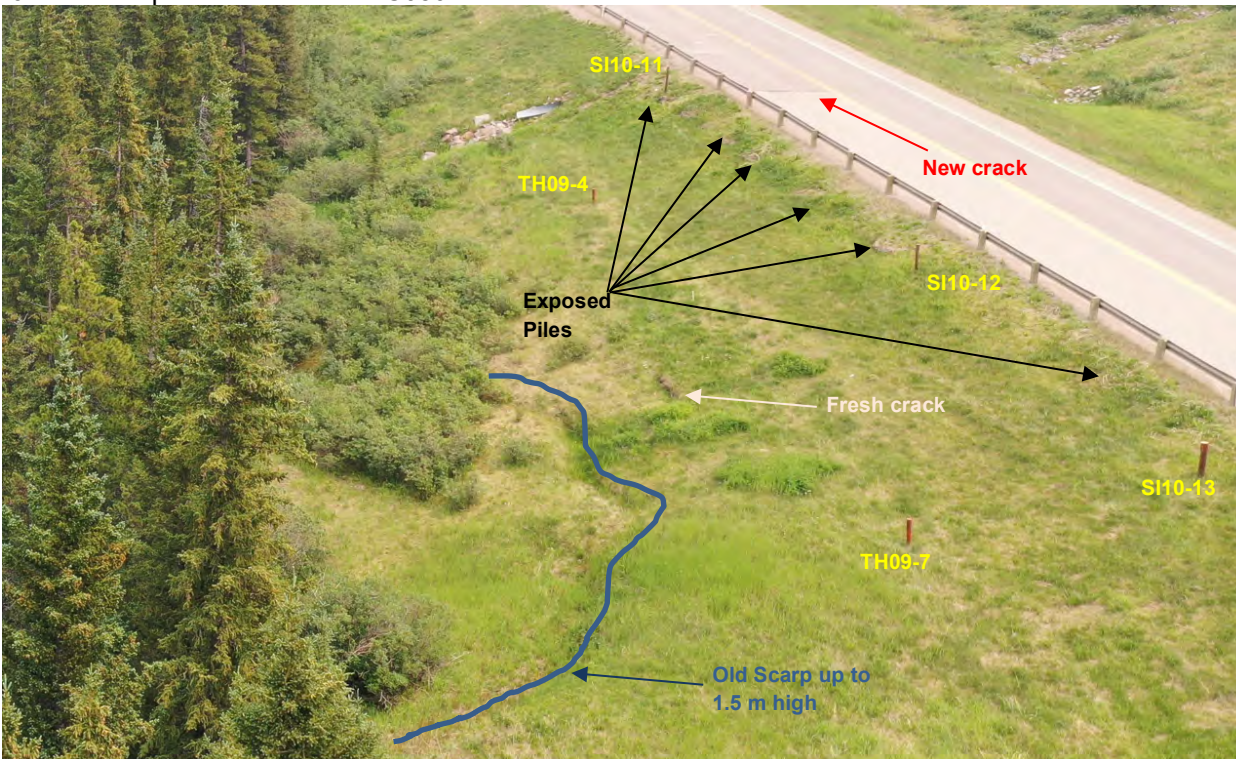
Photo 1: Taken with a drone looking southeast.

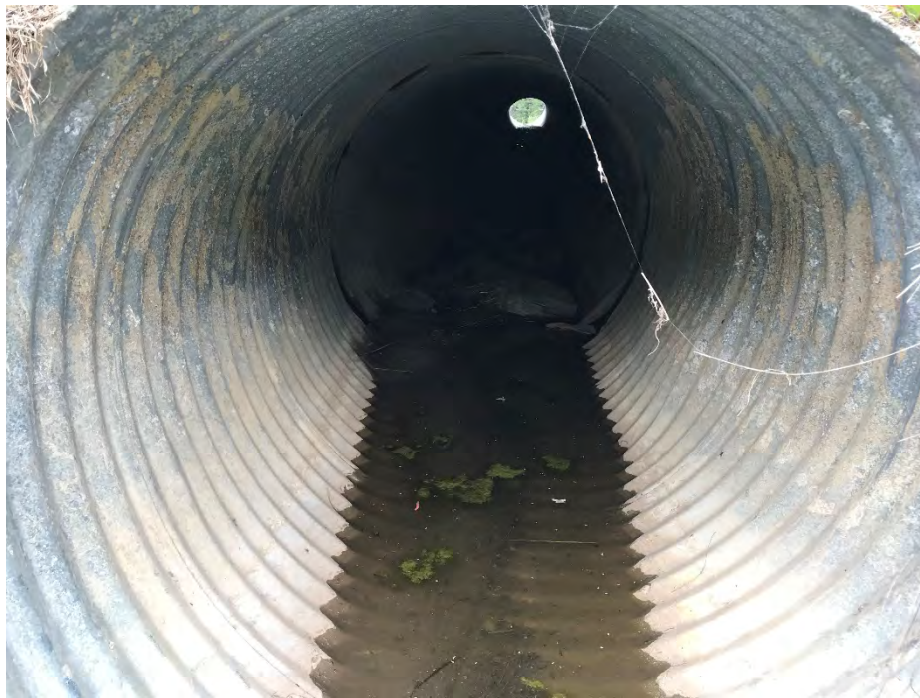
- The C/L culvert at the pile wall site had a slight sag near the outlet approximately in line with the pile wall location. The first and second segment at the inlet was also separated with water possibly ponding or infiltrating the ground at the separation

Photo 2: Separation between first and second segment of C/L culvert at inlet. Looking north.

- All culverts should be inspected to reduce the risk of water seeping into the slope.
- The separation of the C/L culvert at the pile wall site should be repaired by resetting the beveled inlet and securing it to the rest of the culvert with anchor rods.

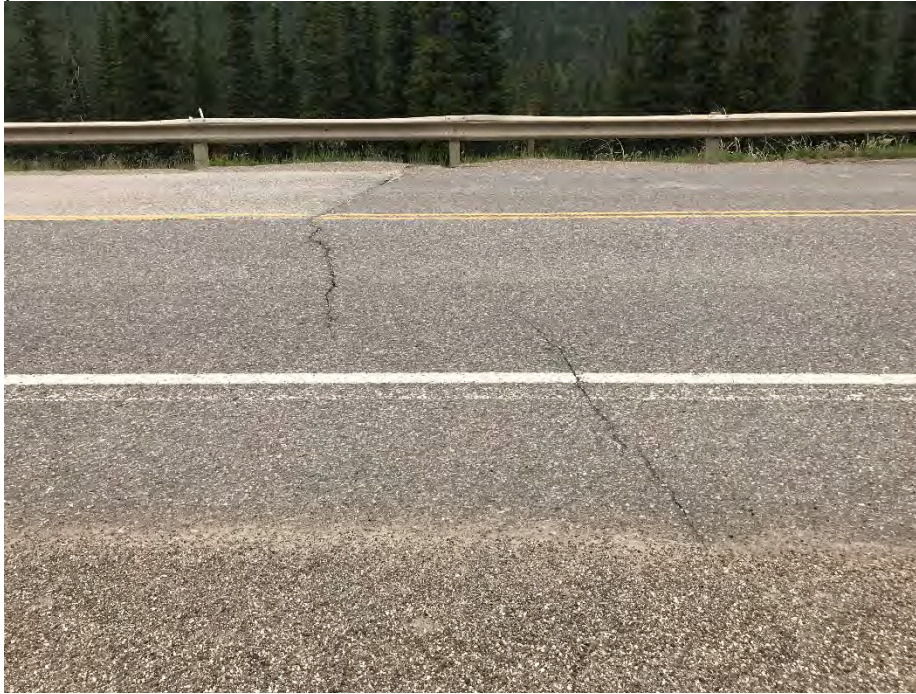
- New transverse pavement cracking was observed several meters west of the C/L culvert at pile wall site.
- Increased erosion was observed as evidenced by more concrete piles being exposed along the downslope side.

Photo 3: New pavement crack west of C/L culvert at pile wall site. Looking north.

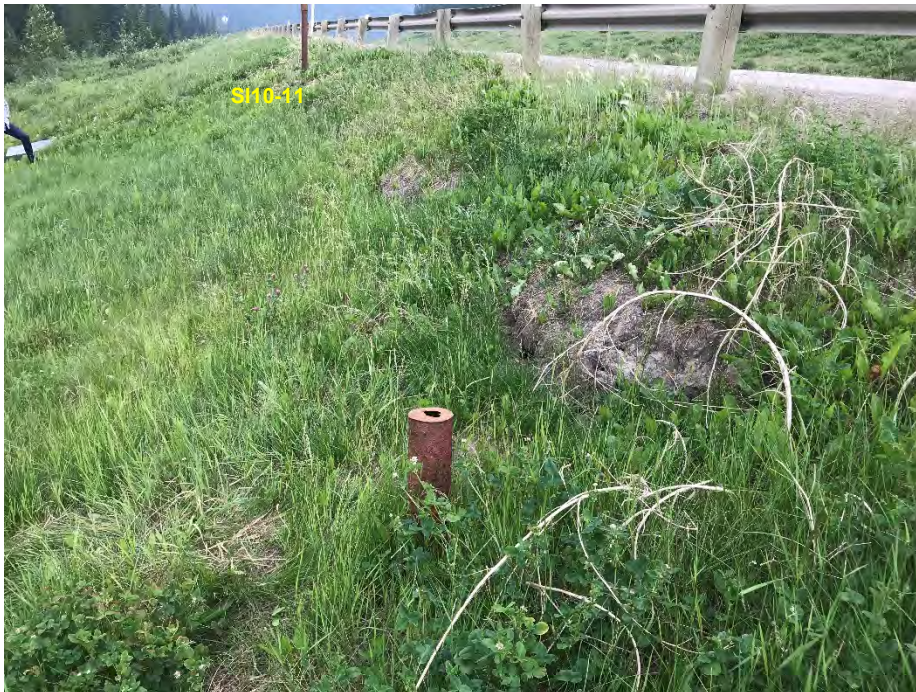
Photo 4: Exposed tops of concrete piles. Looking southeast.

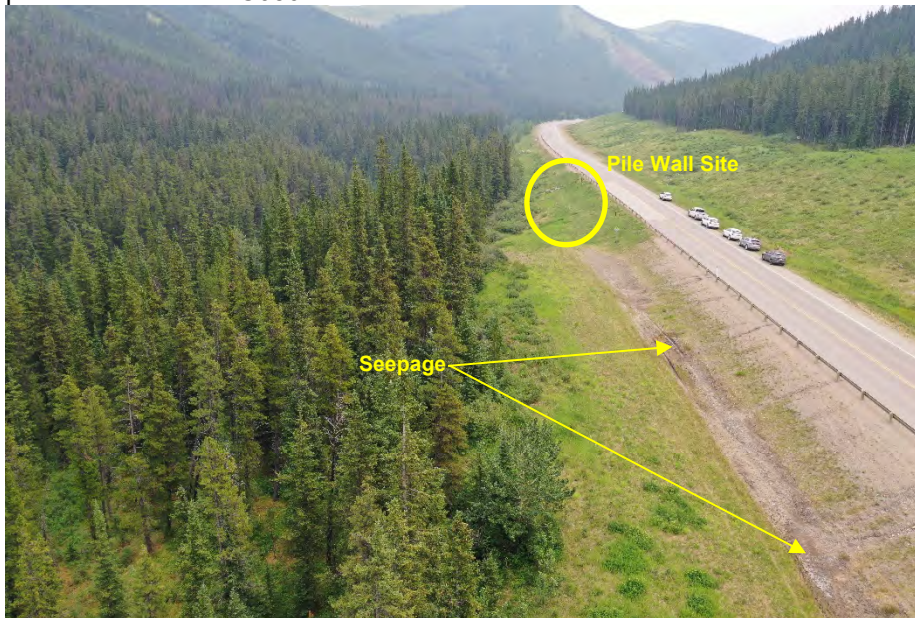
- The north ditch shoulder had numerous erosion rills between the culvert site and the pile wall site.
- The skin slides on the highway backslope were well vegetated.

Photo 5: Seepage along north ditch between pile wall site and culvert site. Multiple erosion rills along shoulder visible. Taken with drone looking east.

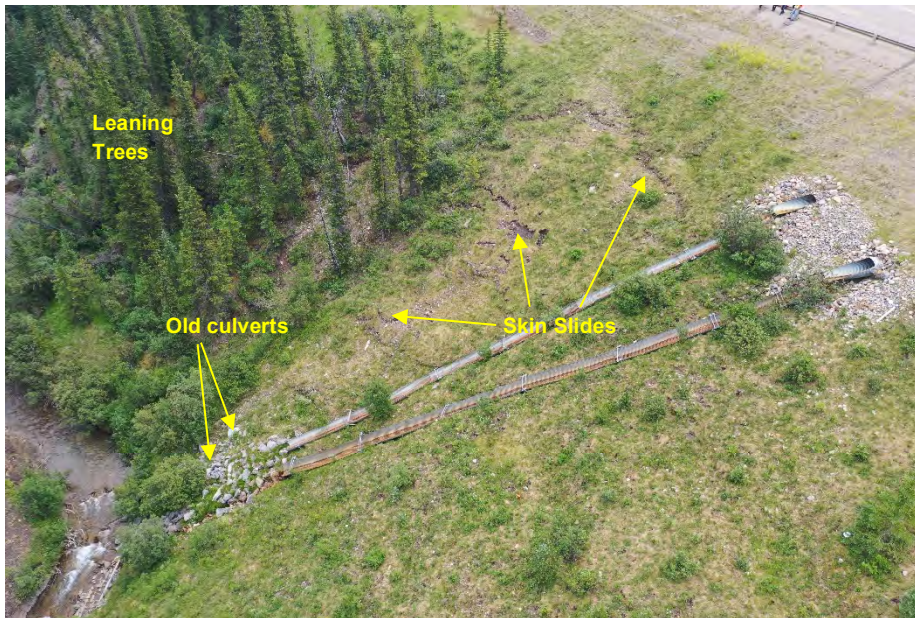
- The skin slides on both sides of the culverts appeared unchanged. Seepage at the skin slides was not observed this year.
 - The bracings along the half-round culverts appeared twisted and distressed.

Photo 6: Culvert site. Note twisted culvert bracing and skin slides. Taken with drone looking east.

- Should the landslide movement retrogress further towards the highway, or increased distress to the highway be observed, a concrete pile wall could be used to remediate the culvert site. The high-level cost estimate for a 140 m long x 20 m deep concrete pile wall is \$3.5 million, excluding engineering.

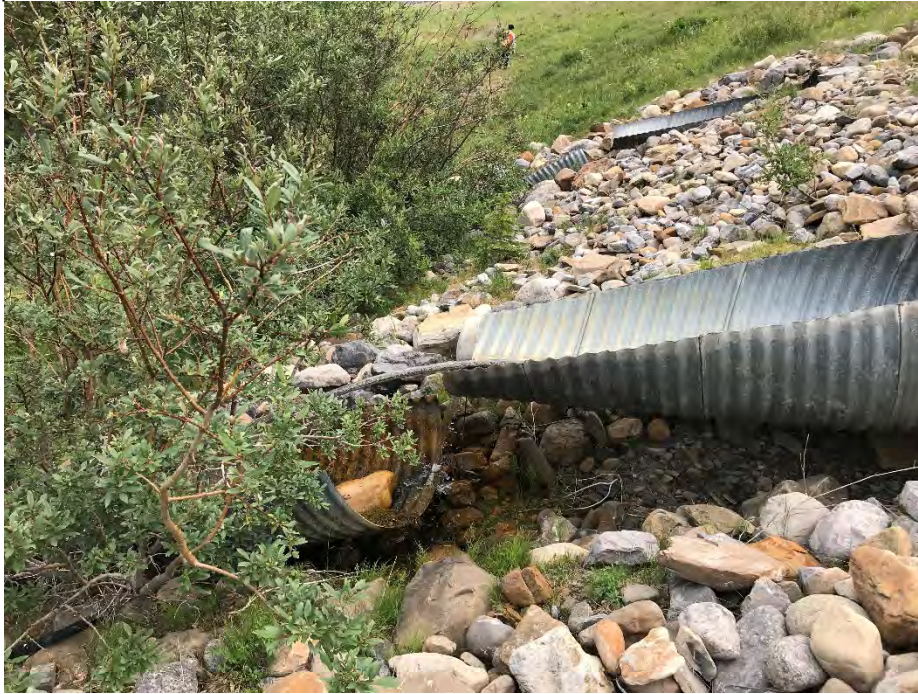
- A sag was observed in both 1000 mm dia. culverts approximately at the highway location. Culvert flow is also undermining both culverts at the transition from full-round to half-round culvert.

Photo 7: Water undermining culvert. Looking east.

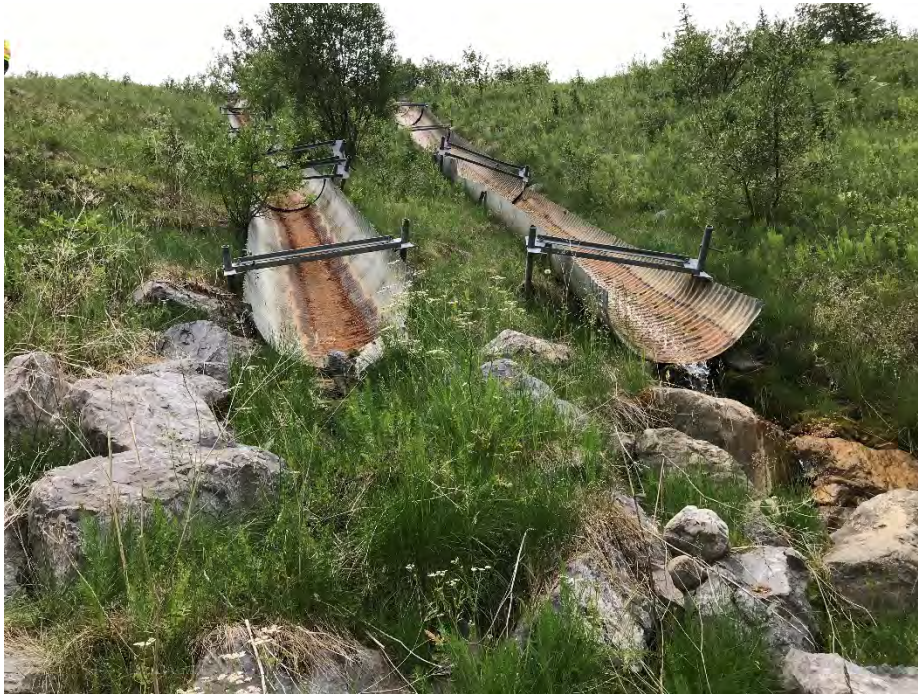
Photo 8: Twisted bracing along half-round culverts. Looking southwest.

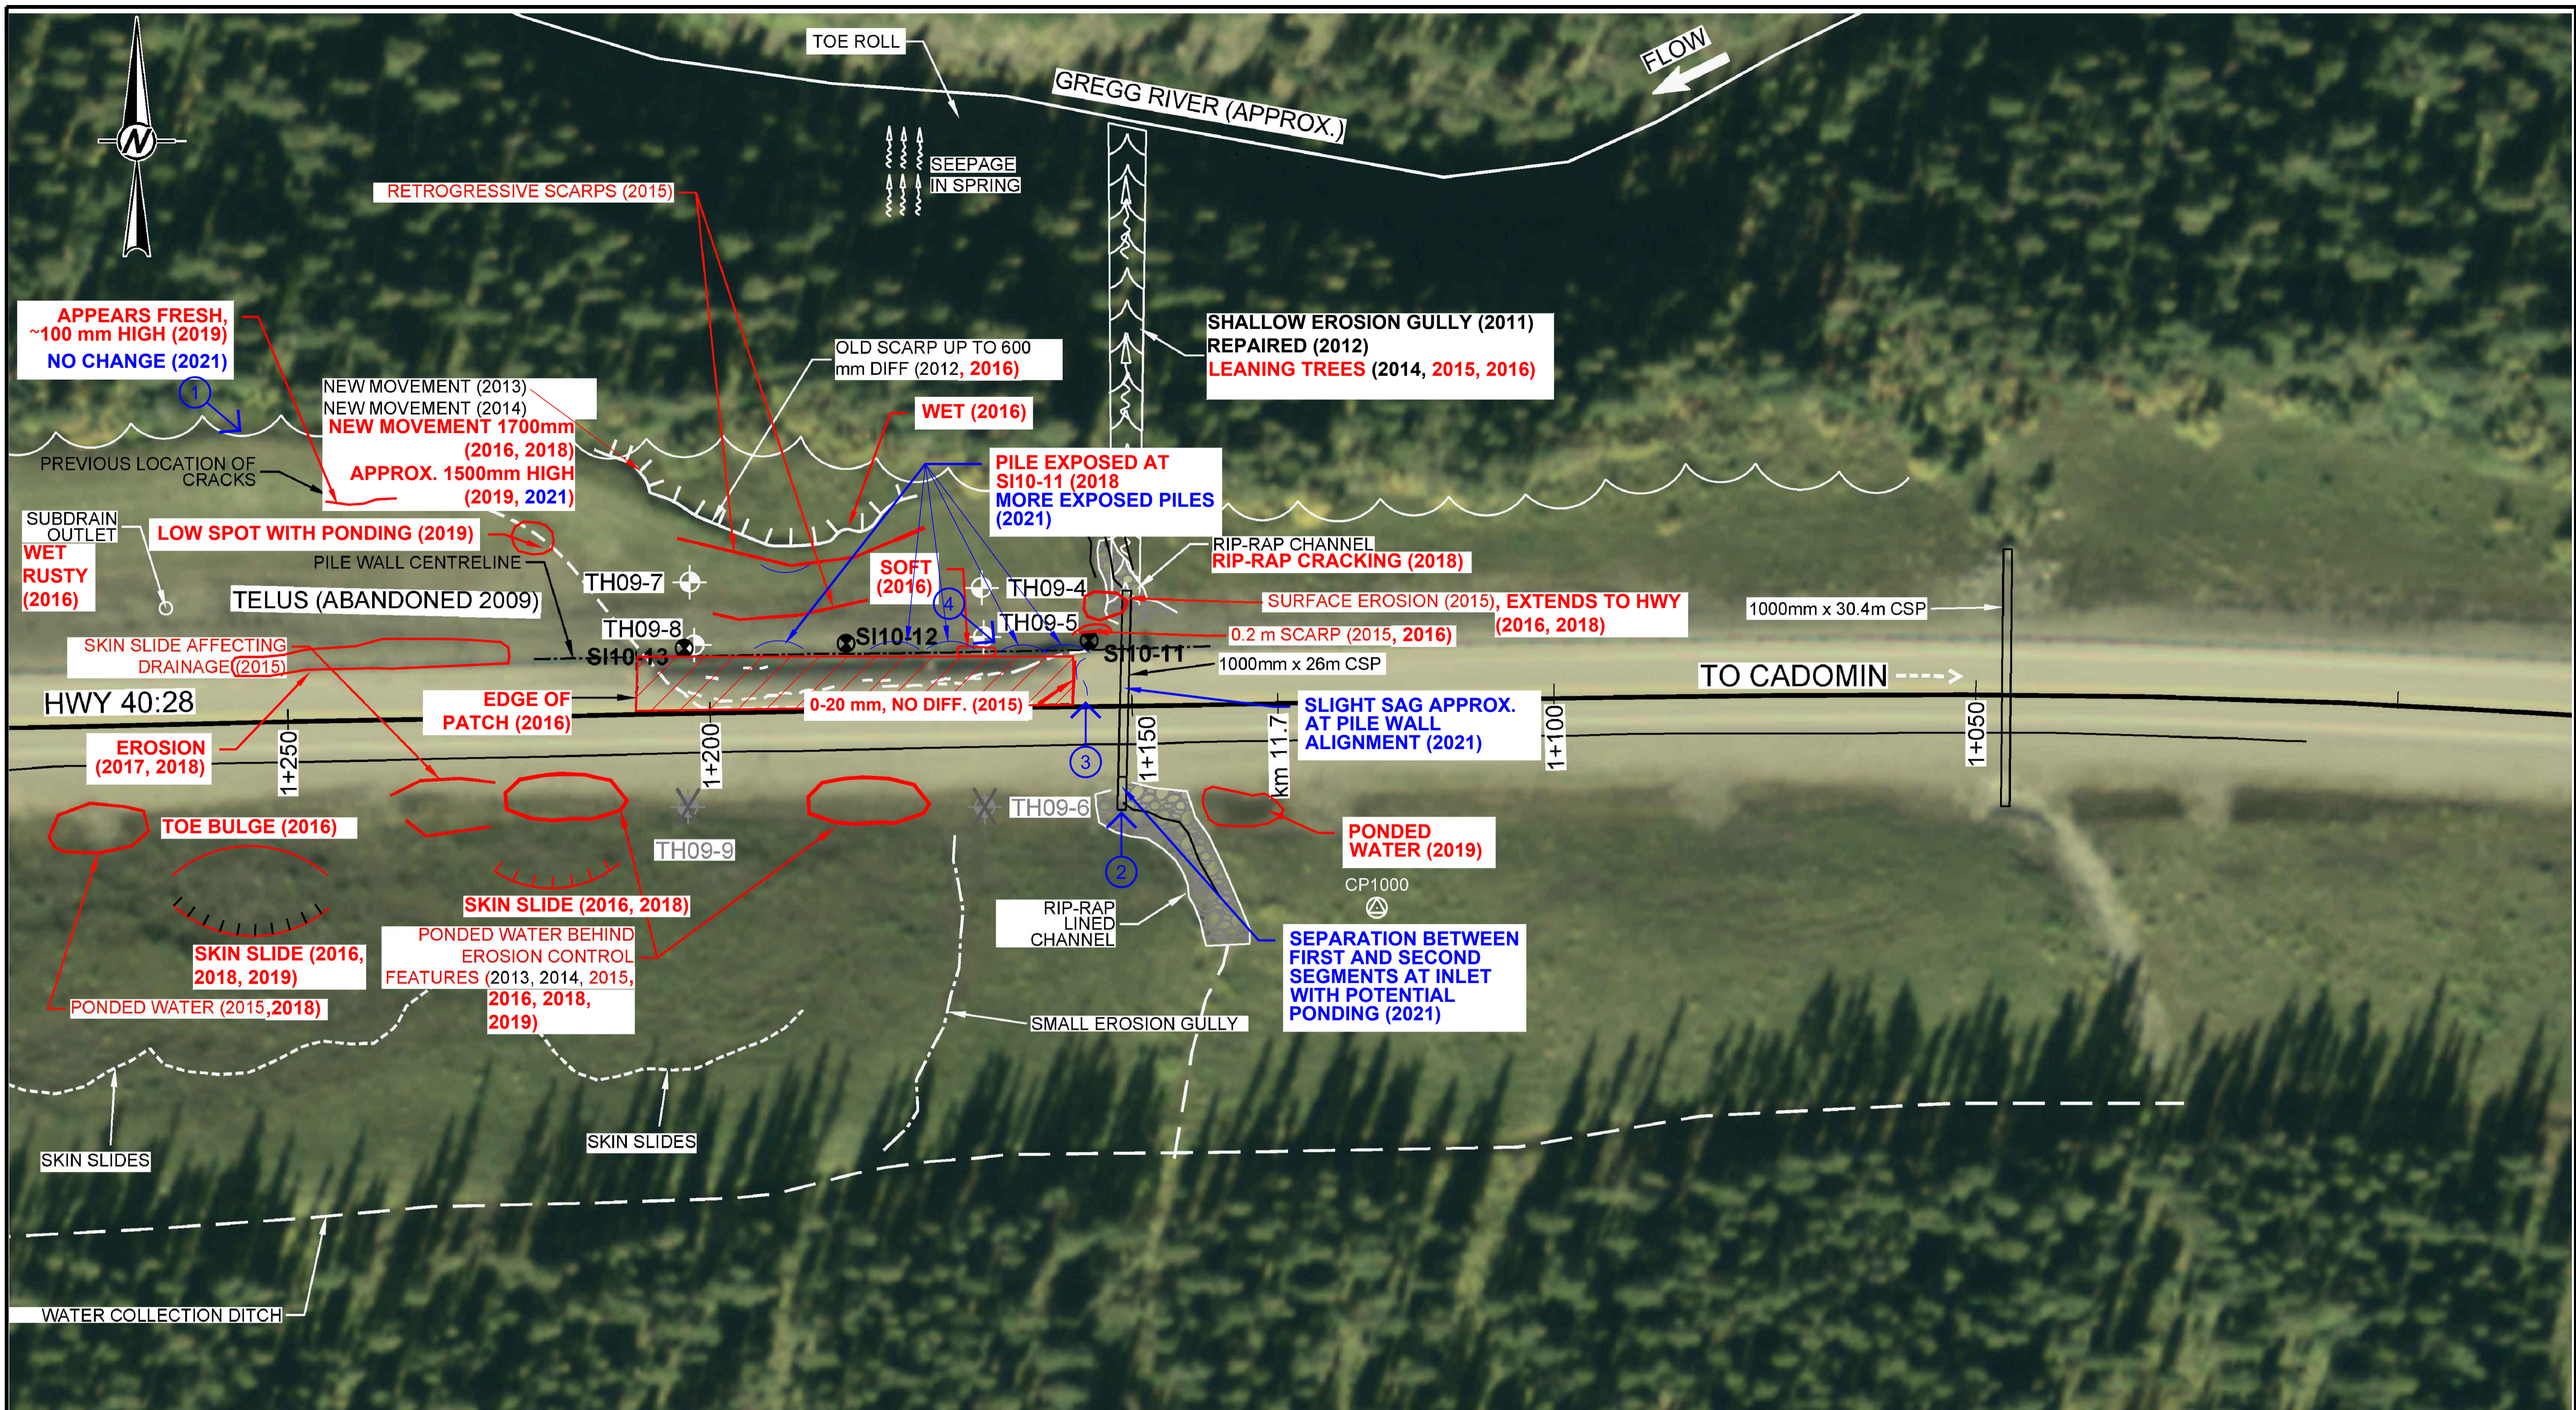
FIGURE 1

COMMENTS
<ul style="list-style-type: none"> The <u>pile wall site</u> generally remained unchanged from the previous site visit in 2019 (Figure 1). Observations include: <ul style="list-style-type: none"> An old retrogressive scarp downslope from the pile wall, about 1.5 m high. Ground crack about 40 m west of the retrogressive scarp. Several seepage locations with oxide staining in the north ditch between the culvert site and the pile wall site. The north ditch was also wet.

- SI10-11 to SI10-13 were installed in the concrete piles and monitoring results suggests the pile wall is performing well with little to no deflection in the piles. Total cumulative movement ranges from 0 mm to 7 mm since 2010.

- No long-term remediation is required at the pile wall site.
- The site should continue to be inspected every two years with the next visit in 2023. Future inspections should place more focus on the culvert site and less on the pile wall site.
