SITE NUMBER AND NAME: NC050 – Gregg River Slide	HIGHWAY AND KM: 40:28, km 11.752	PREVIOUS INSPECTION: July 15, 2021	CURRENT INSPECTION: May 30, 2023
LEGAL DESCRIPTION: NW-33-47-24-W5	NAD83 COORDINATES: UTM11U 5883282N, 469320E		RISK ASSESSMENT: PF: 3 CF: 4 Total: 12
AVERAGE ANNUAL DAILY TRAFFIC (AADT): 1120 (2022)		CONTRACTOR MAINTENANCE AREA (CMA): 508

NORTH CENTRAL REGION GRMP
EDSON / STONY PLAIN
SITE INSPECTION FORM

2023 Site Inspection Photos at NC050

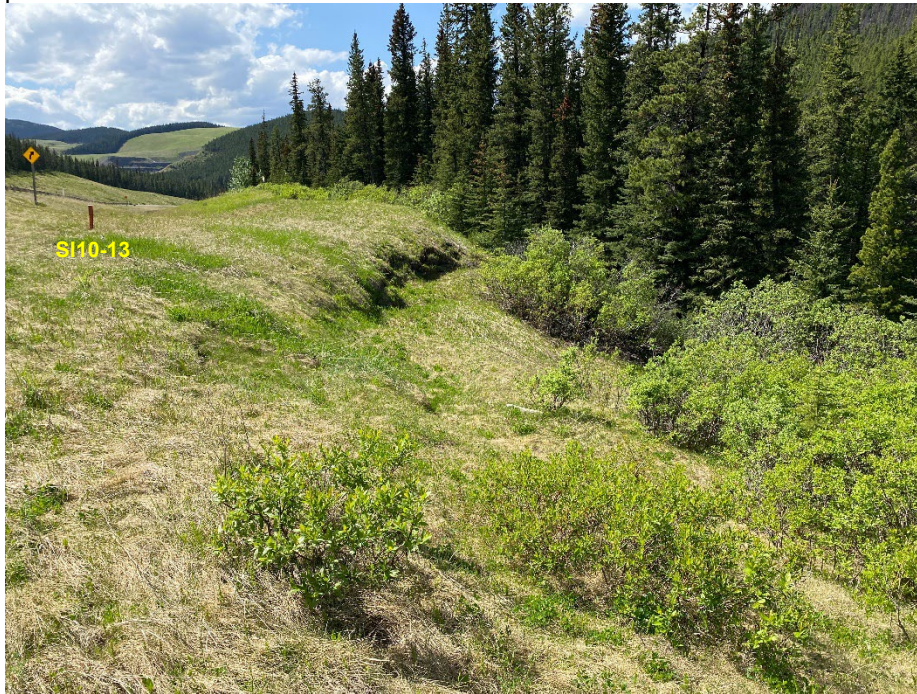
COMMENTS
<ul style="list-style-type: none"> • The <u>pile wall site</u> had little change from the previous site visit in 2021 (Figure 1). Observations include: <ul style="list-style-type: none"> – An old retrogressive scarp downslope from the pile wall, about 1.5 m high (Photo 1). – An erosion gully approximately 300 mm wide has formed within the area of surface erosion previously noted along the south ditch shoulder to the west of the C/L culvert (Photo 2). – The concrete piles are slightly exposed at ground surface. Increased erosion was observed as evidenced by more concrete piles being exposed along the downslope side since the visit in 2021 (Photo 3).

Photo 1: Retrogressive scarp on the north side of the pile wall, looking west.

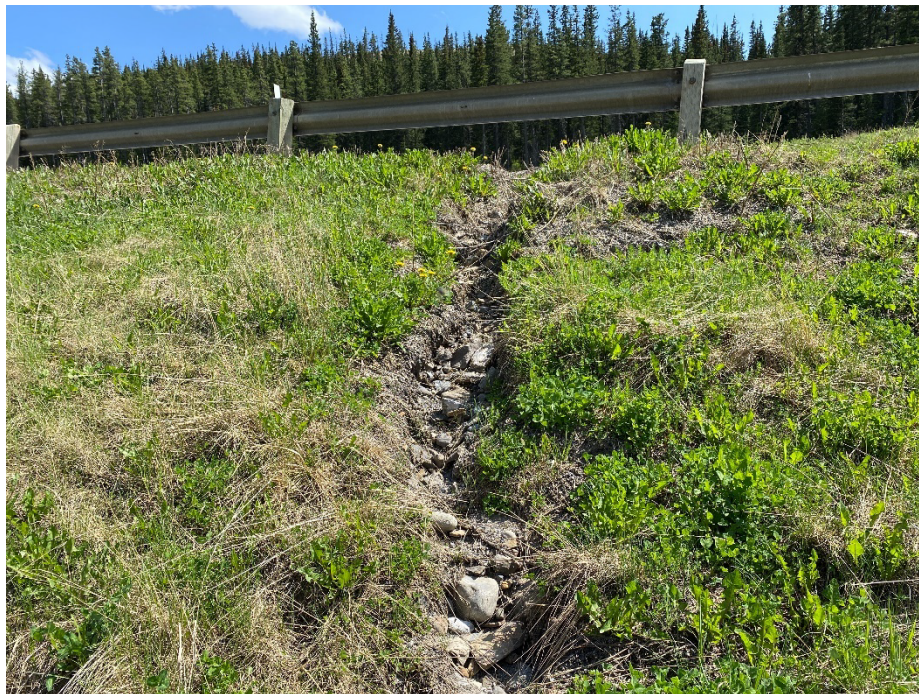
Photo 2: Gully on north side of the highway, to the west of the C/L culvert. Looking south.

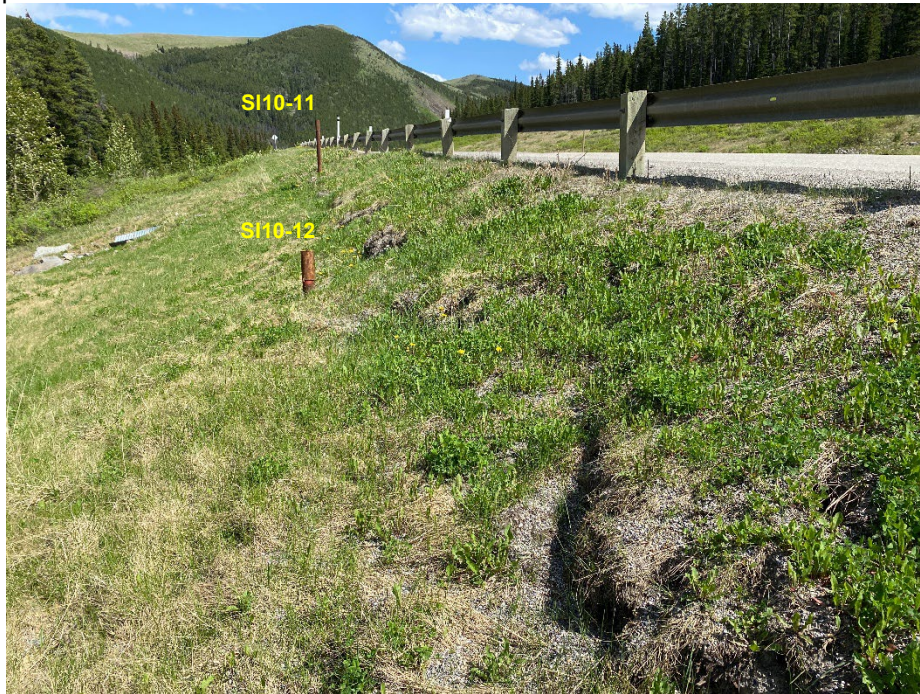
Photo 3: Exposed tops of concrete piles. Looking southeast.

- No long-term remediation is required at the pile wall site.
- The site should continue to be inspected every two years with the next visit in 2025. Future inspections should place more focus on the culvert site and less on the pile wall site.

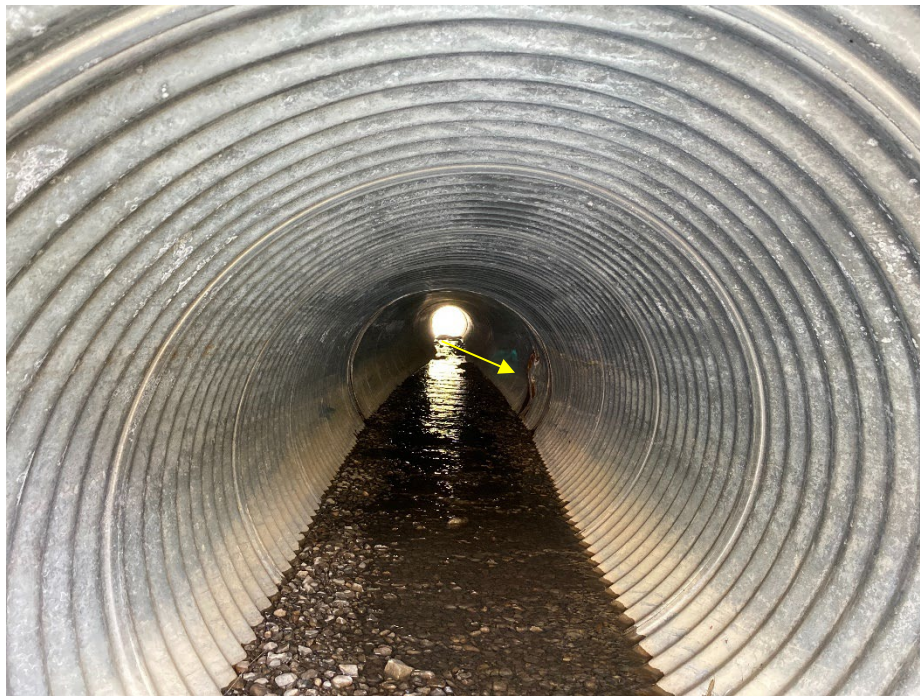
- The C/L culvert at the pile wall site had a slight bulge along the west side wall near the outlet approximately in line with the pile wall location (Photo 4). The first and second segment at the inlet was previously thought to be separated, but it was confirmed by TEC that this is a collar for an extension. It is possible from previous site observations that water is ponding or infiltrating the ground at the collar. The culvert had approximately 25 mm of water in the bottom during the site visit.

Photo 4: Bulge in west sidewall of C/L culvert. Looking south.

- All culverts should be inspected to reduce the risk of water seeping into the slope.
- The extension collar at the C/L culvert on the pile wall side should be inspected for any leaks and repaired as required.

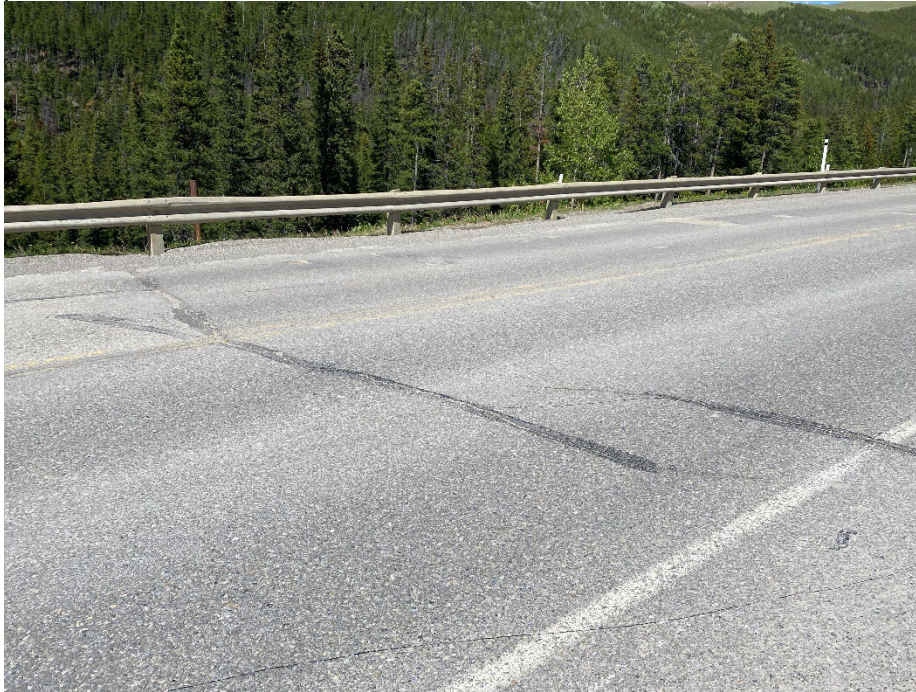
- Transverse pavement cracking was observed several meters west of the C/L culvert at pile wall site. The cracks appeared to have been sealed and relatively unchanged from the last inspection (Photo 5).

Photo 5: Pavement crack west of C/L culvert at pile wall site. Looking northeast.

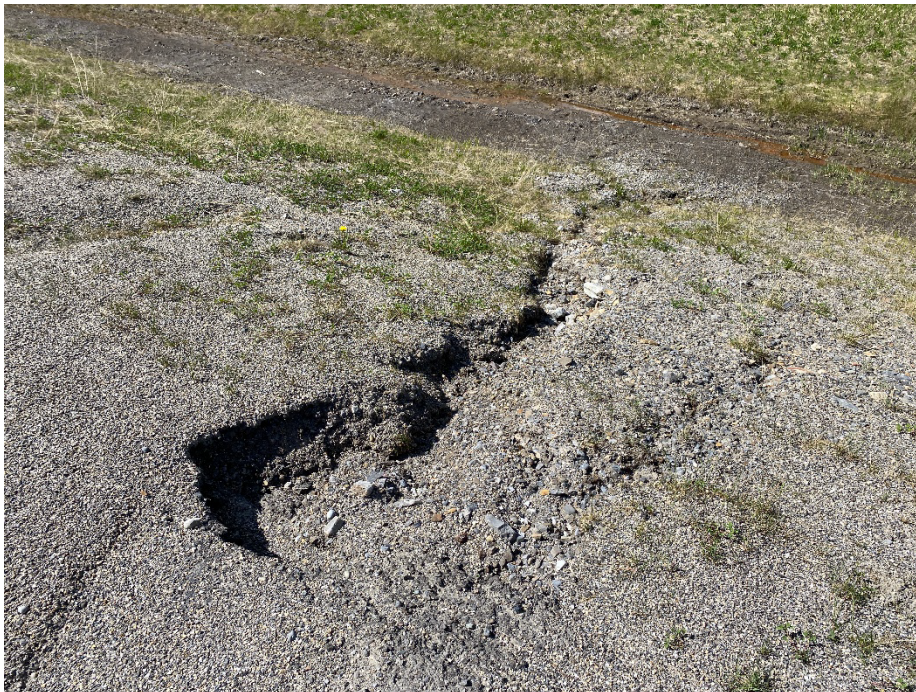
- Several seepage locations with oxide staining in the north ditch between the culvert site and the pile wall site were observed. The north ditch was also wet (Photo 6).

- The north ditch shoulder had numerous erosion rills and gullies between the culvert site and the pile wall site. Several rills have progressed to gullies and have begun to undermine the asphalt (Photo 6).

Photo 6: Seepage along north ditch between pile wall site and culvert site with erosion rills and gully on the north ditch highway shoulder. Looking northwest.

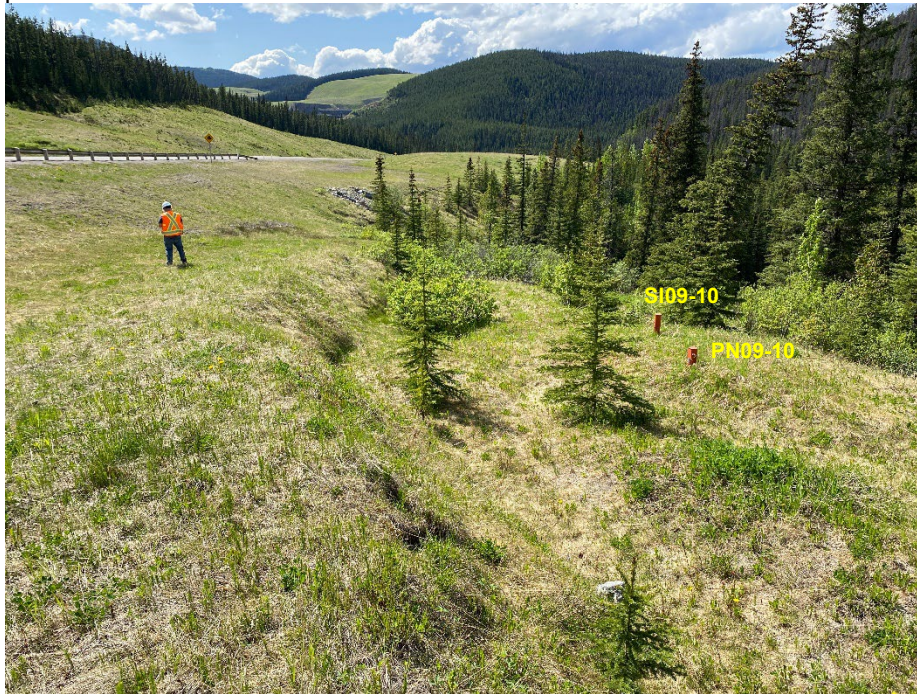
- The old scarp to the east of the culvert site appears unchanged (Photo 7).
- The skin slides on the highway backslope were well vegetated.
- The culvert site had little change since the previous inspection (Figure 2).

Photo 7: Old scarp east of culvert site, looking west.

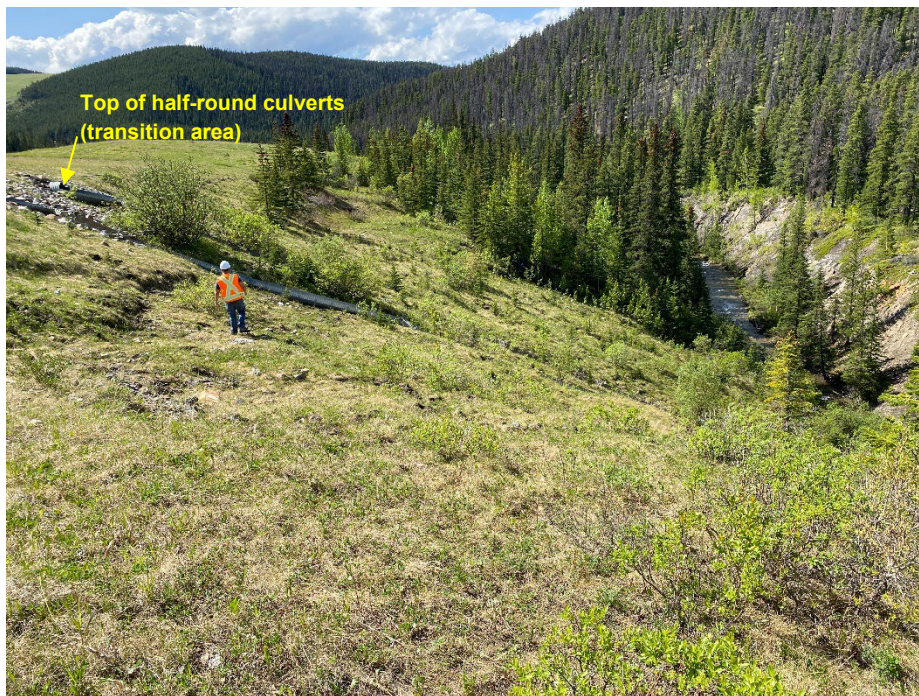
- There was no apparent change to pavement cracking upslope from the skin slides.
 - The skin slides appeared unchanged (Photo 8).
 - The west culvert had heavier flow down to the creek while the east culvert was trickling (Photo 10).

Photo 8: View of culvert site and slope, looking northwest.

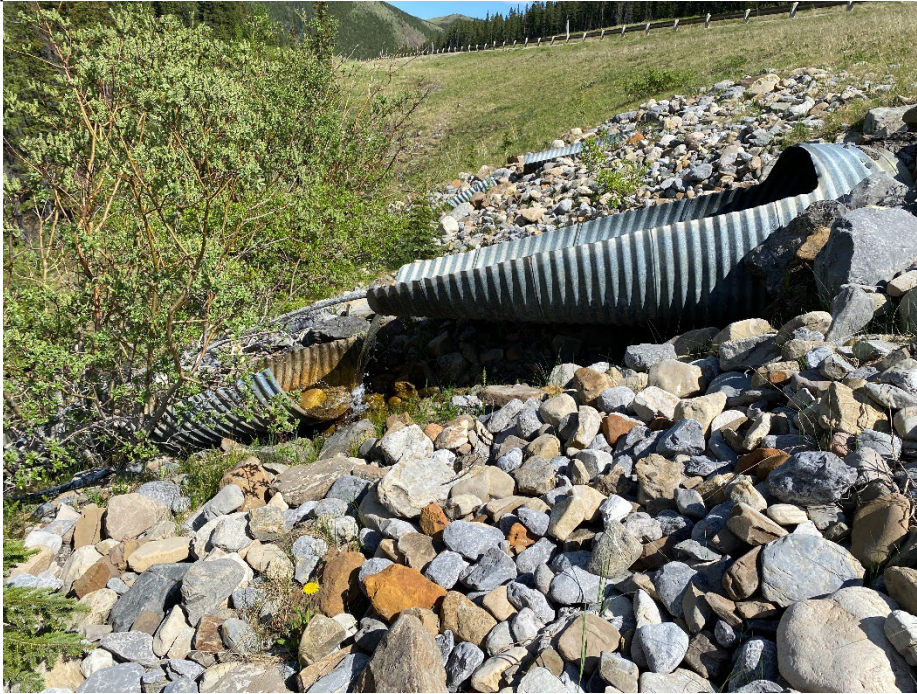
- A sag was observed in both 1000 mm dia. Culverts approximately at the highway location. Culvert flow is also undermining both culverts at the transition from full-round to half-round culvert. At the west culvert transition area, water is flowing out of the full-round and largely missing the half-round culvert (Photo 9). At the east culvert transition, water is trickling out and completely missing the half-round culvert, though some water does make it into the half-round culvert after trickling over rocks.

Photo 9: Water undermining culvert. Looking east.

- The culvert inlets and outlets at the culvert site should be re-seated to reduce the amount of water currently undermining the culverts at these locations.

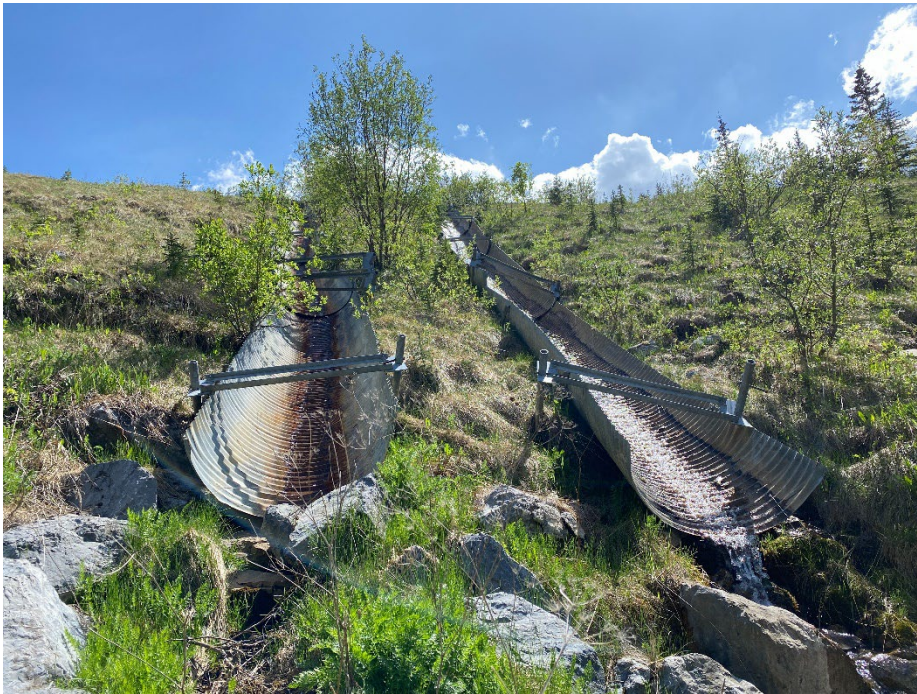
- The bracings along the half-round culverts appeared twisted and distressed (Photo 10).
 - Leaning mature coniferous trees and slumping ground were observed within the treed area to the east of the skin slides.

Photo 10: Twisted bracing along half-round culverts. Looking southwest.

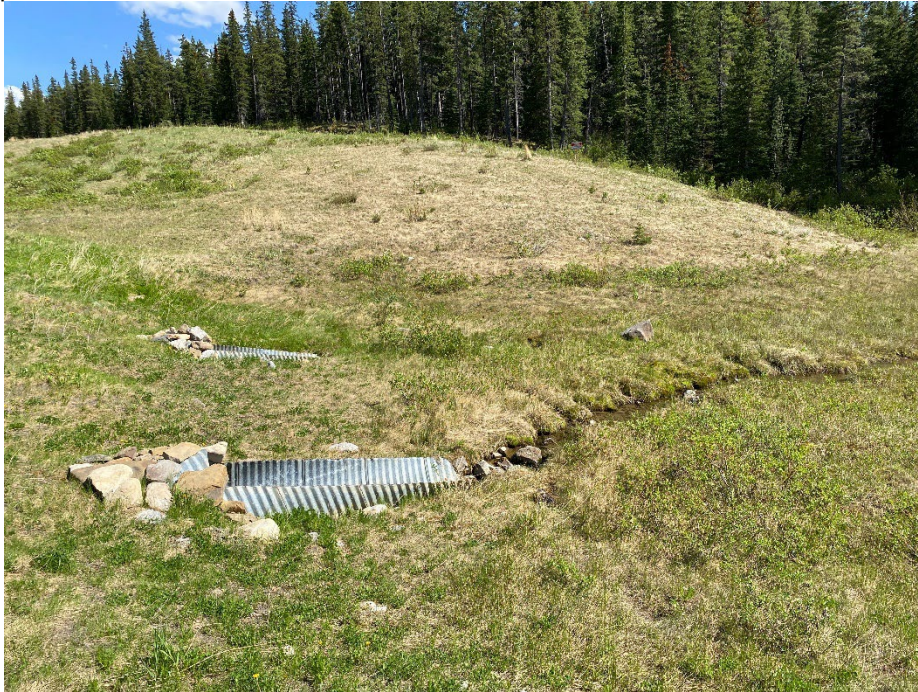
- At the culvert inlets on the south side of the highway, it was observed that the east culvert inlet was dry with vegetation growing thickly around the inlet, and the west culvert inlet was being undermined by water, which appeared to be entering the culvert from a separation between the 1st and 2nd culvert segments (Photos 11 and 12).

Photo 11: Culvert inlets on south side of highway at culvert site, looking southeast.

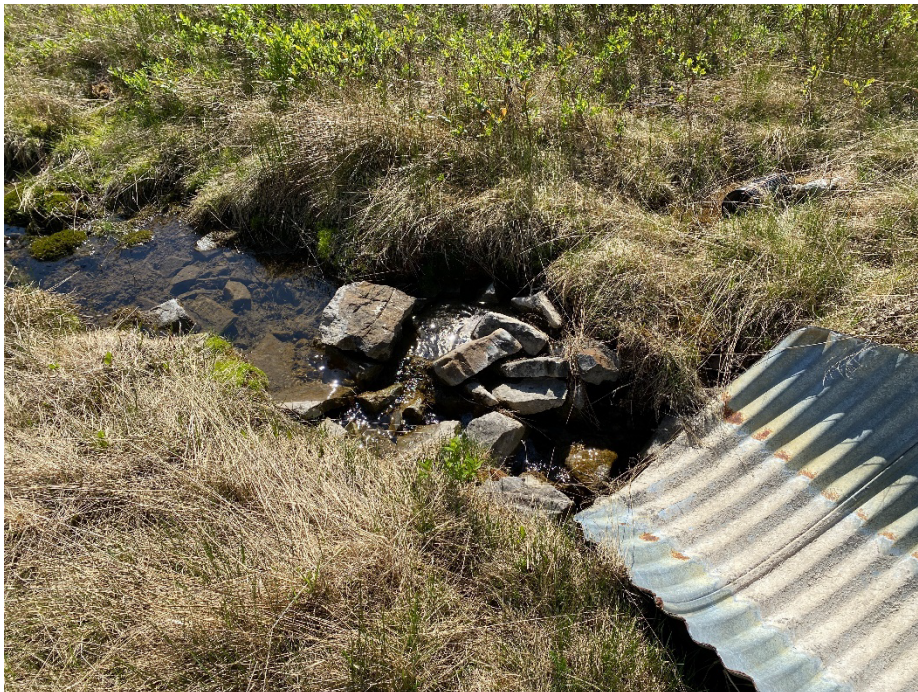
Photo 12: Water undermining the west culvert inlet at the culvert site. Looking west.
