From: Leslie Cho and Xiteng Liu
Stantec Consulting Ltd.
Date: June 18, 2024

Reference: North Central Region, Edson, Site NC050 - Highway 40:28 Gregg River Slide, Spring 2024 Instrumentation Monitoring Report

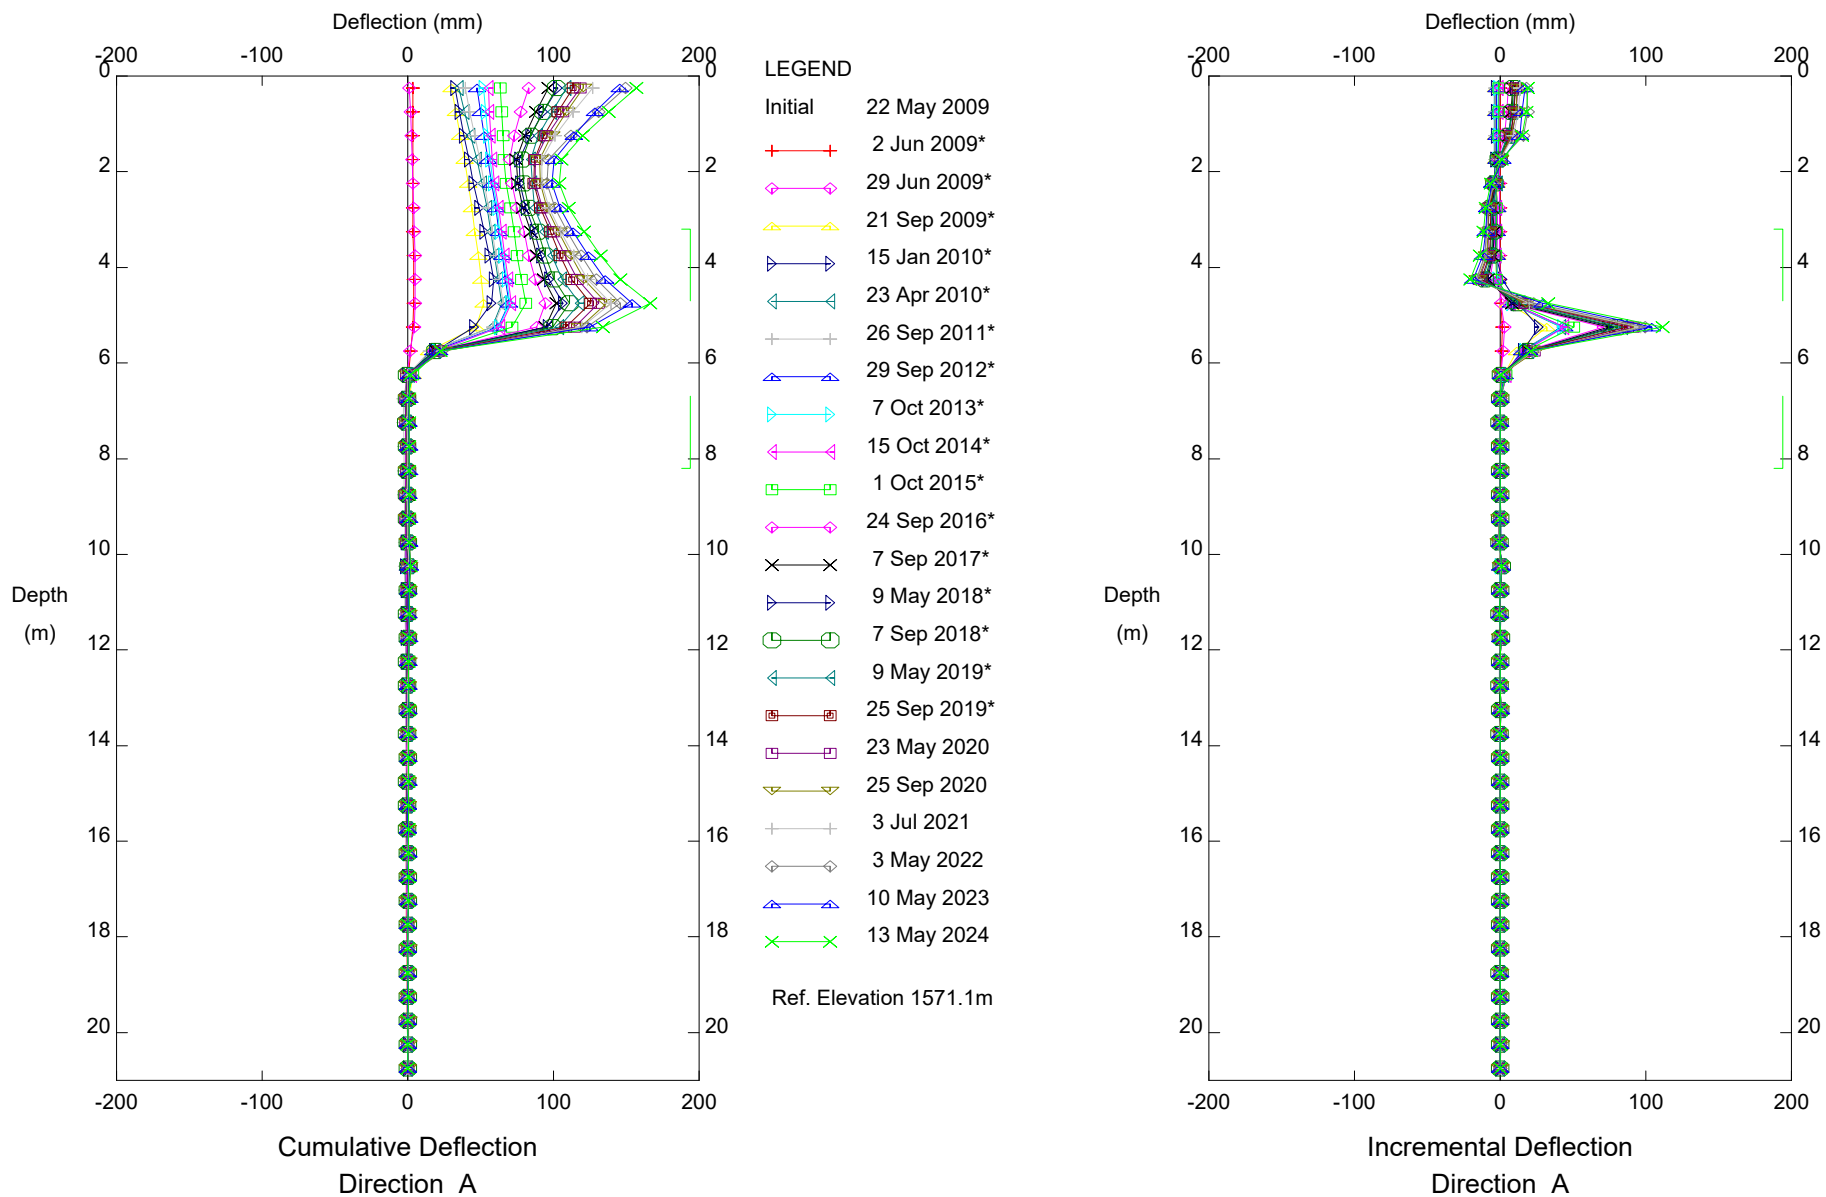
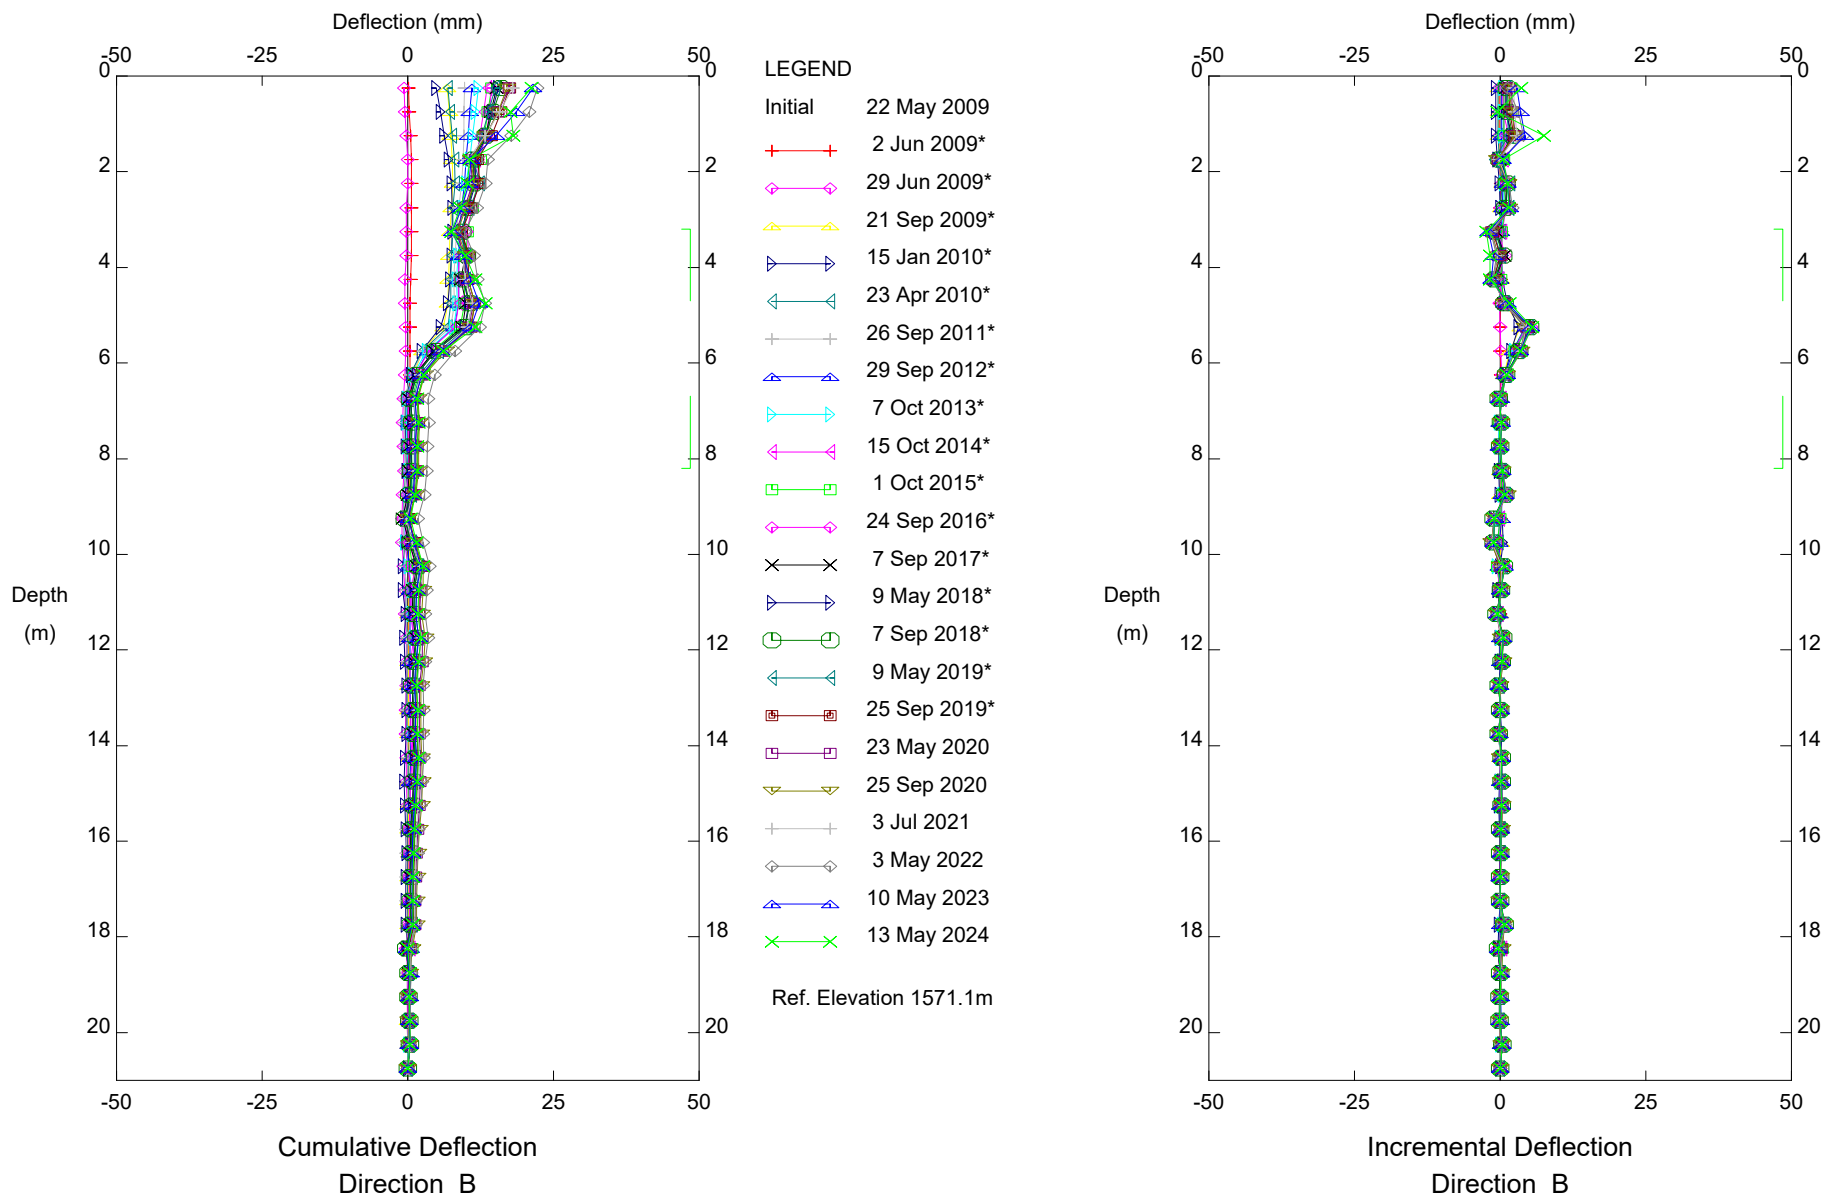
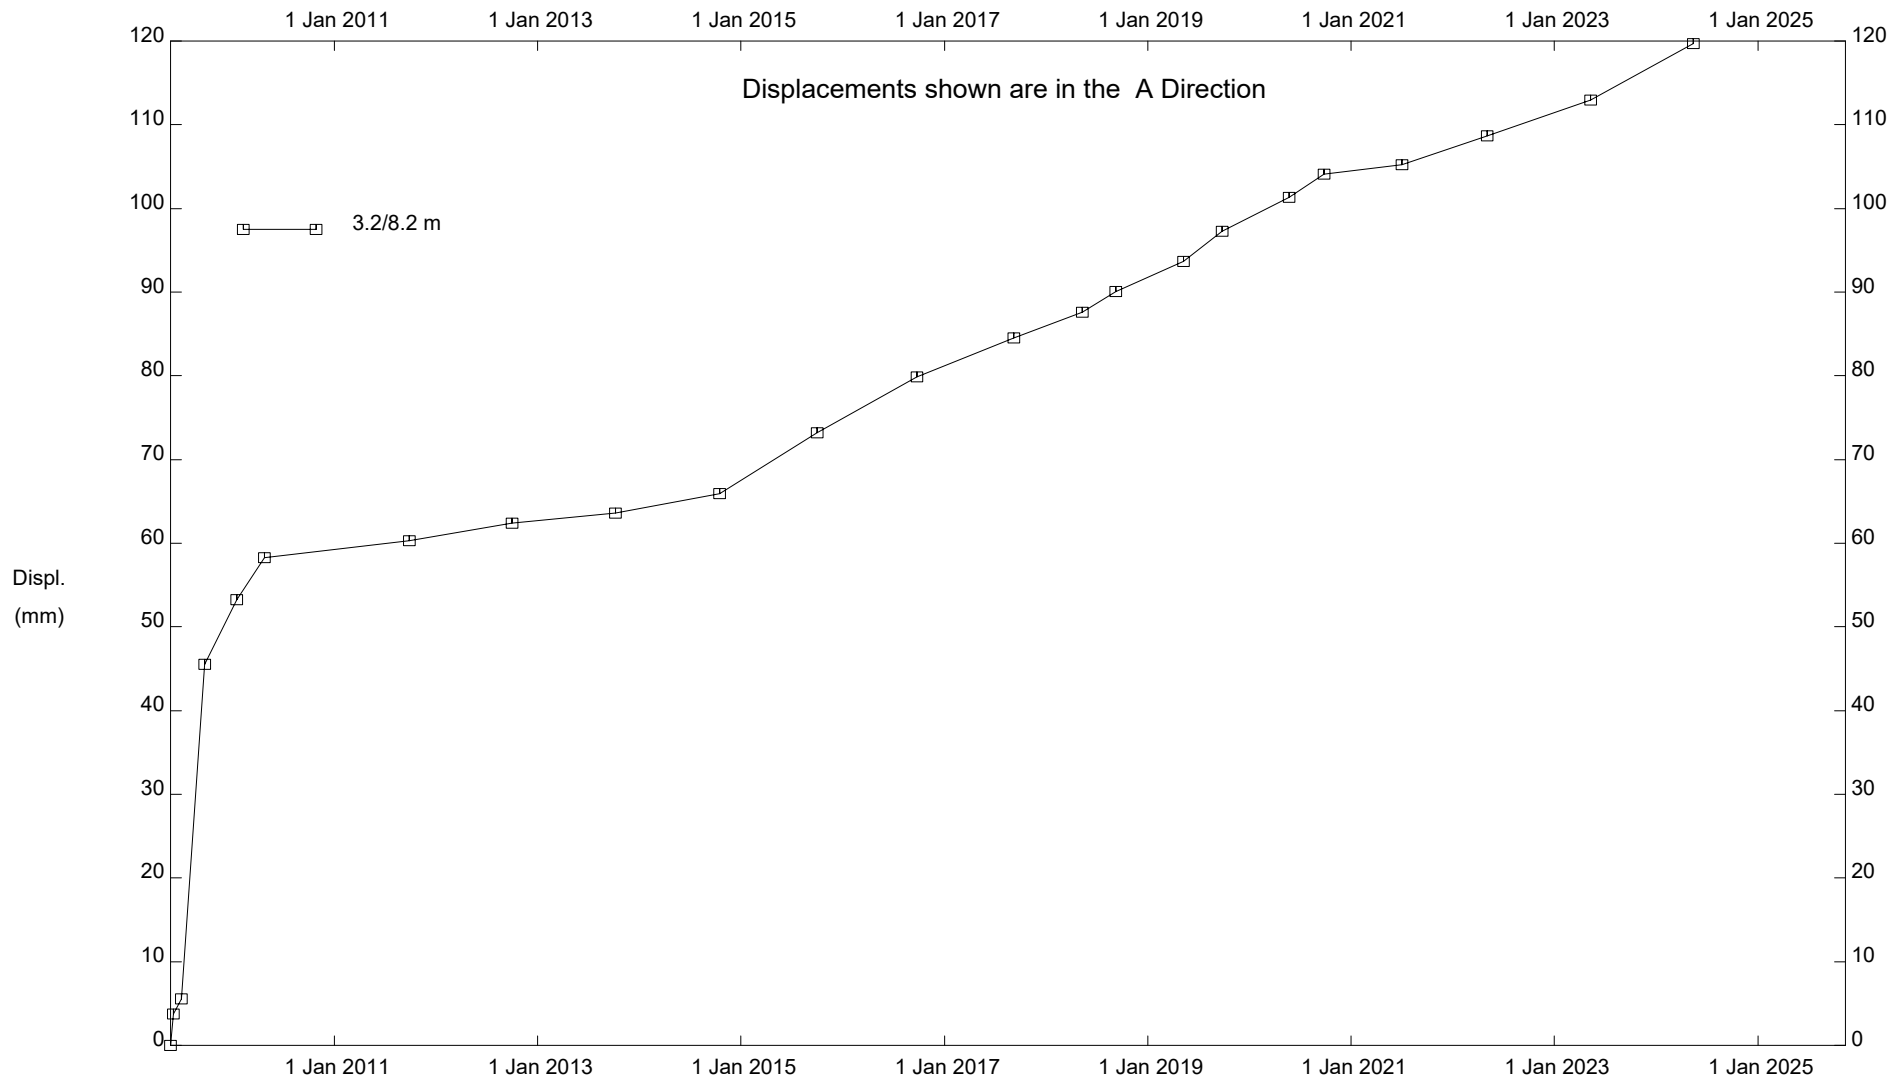
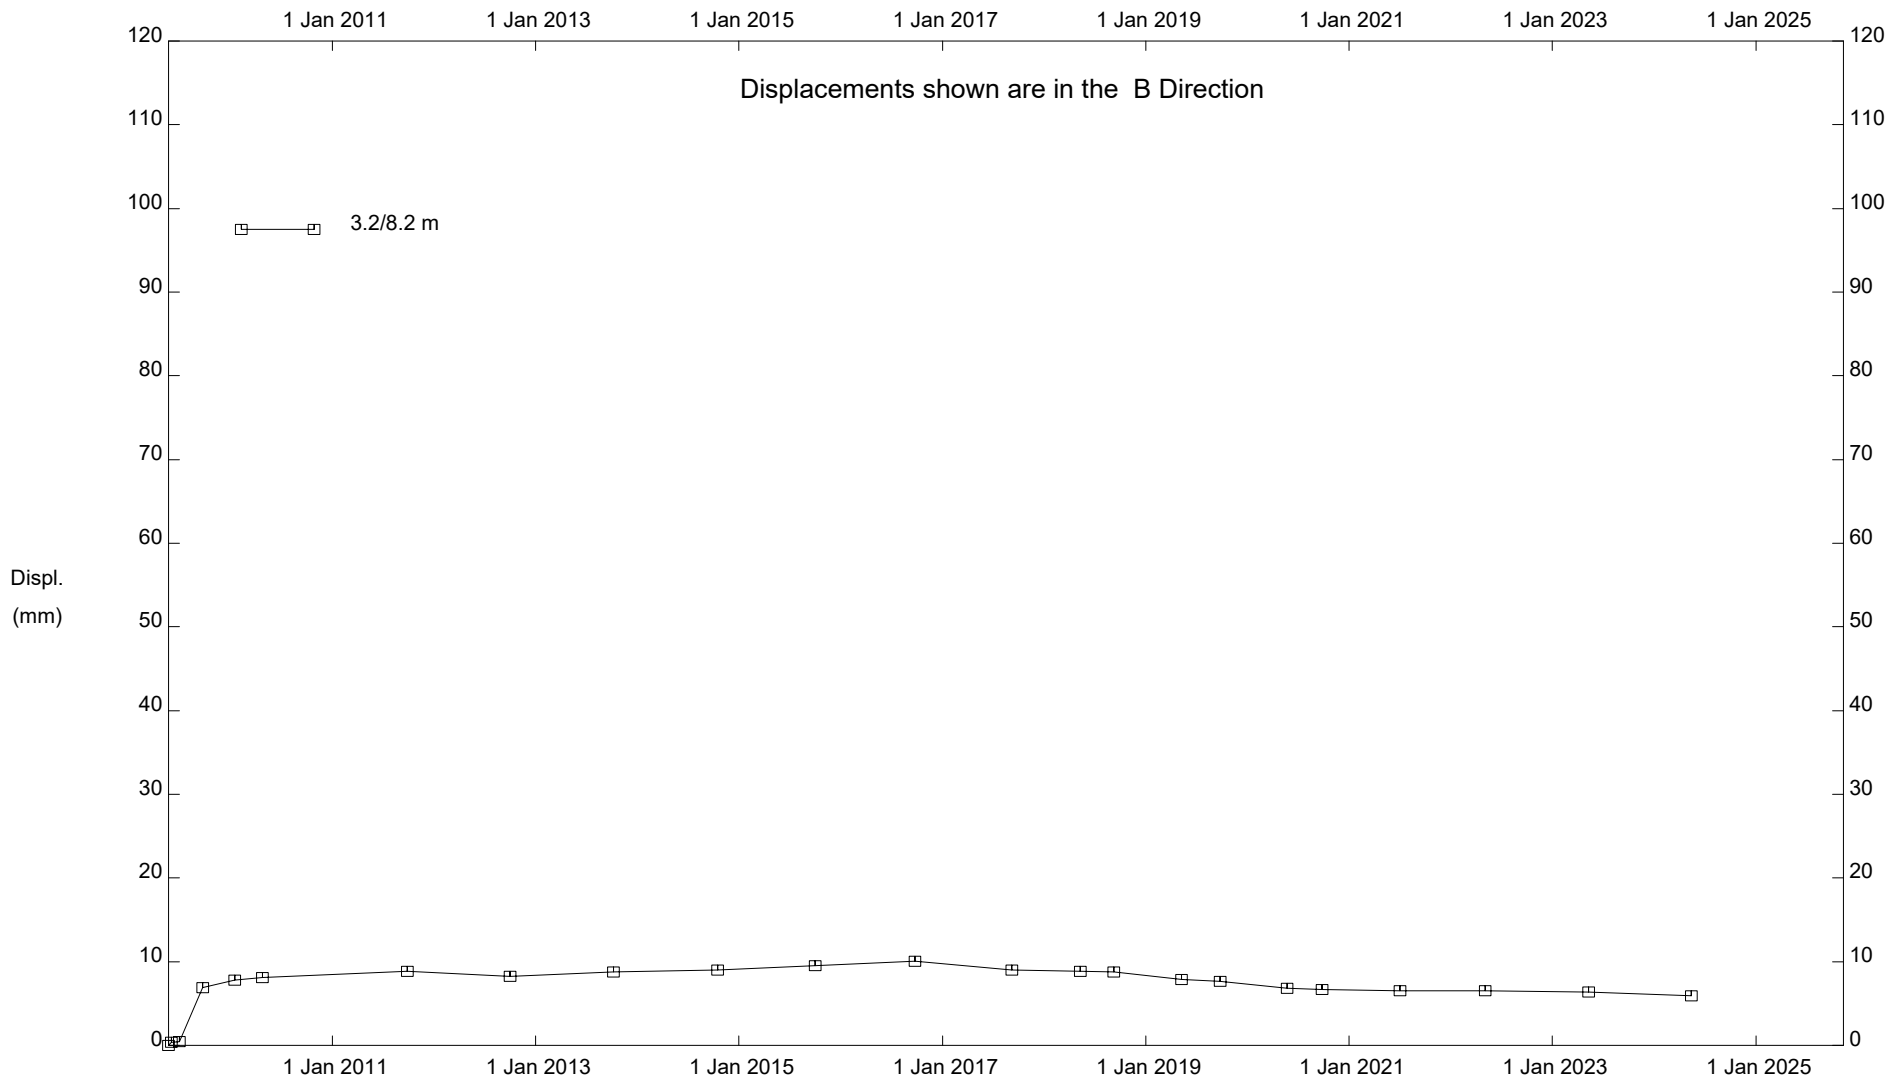
HWY 40:28 Gregg River Slide (NC50), Inclinometer SI09-5

SI09-5 had an average movement rate of about 40 mm/year prior to pile wall construction in 2010. After construction, the average movement rate decreased to approximately 2 mm/yr until 2014. Since 2014, the

average rate of movement is about 5 mm/yr. The current movement rate is about 7 mm/yr corresponding to 3 mm/yr increase in movement rate since the previous reading cycle.

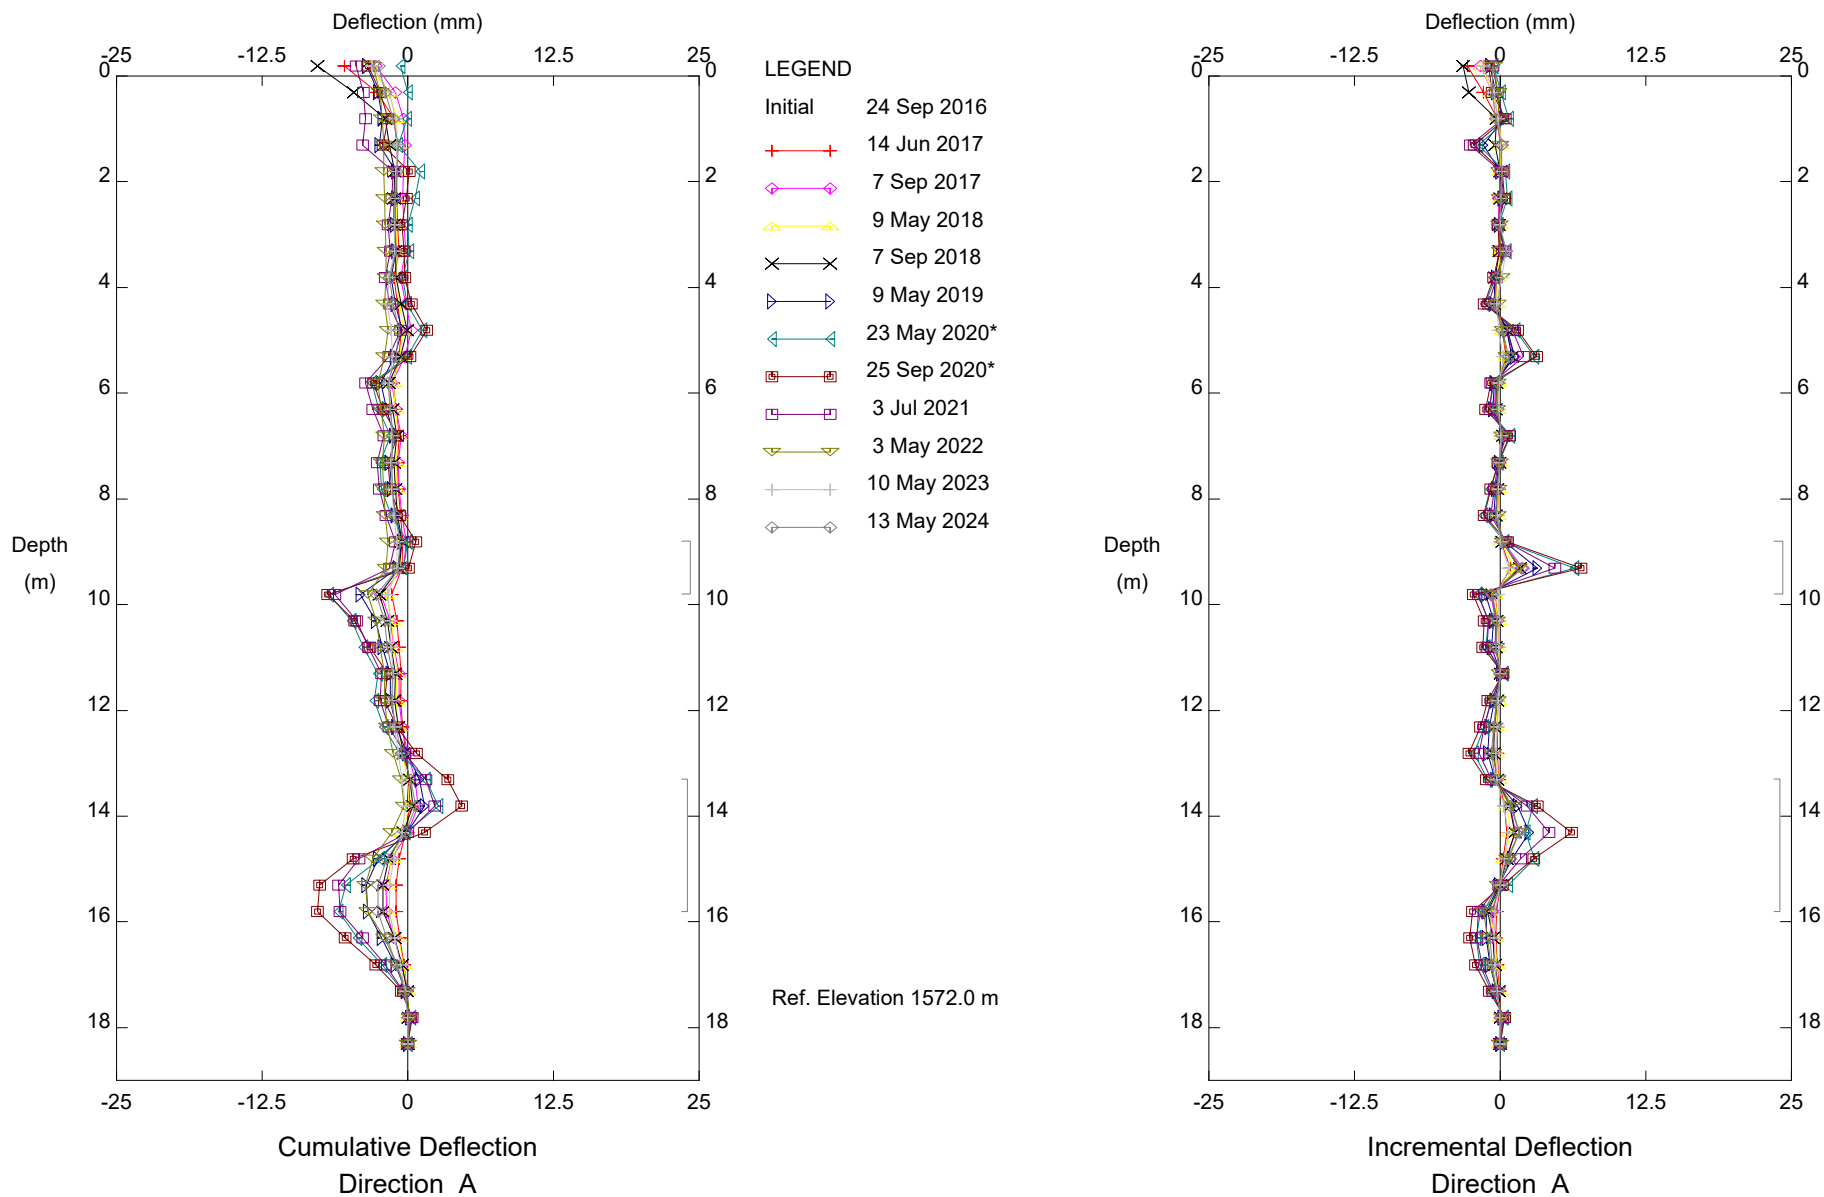
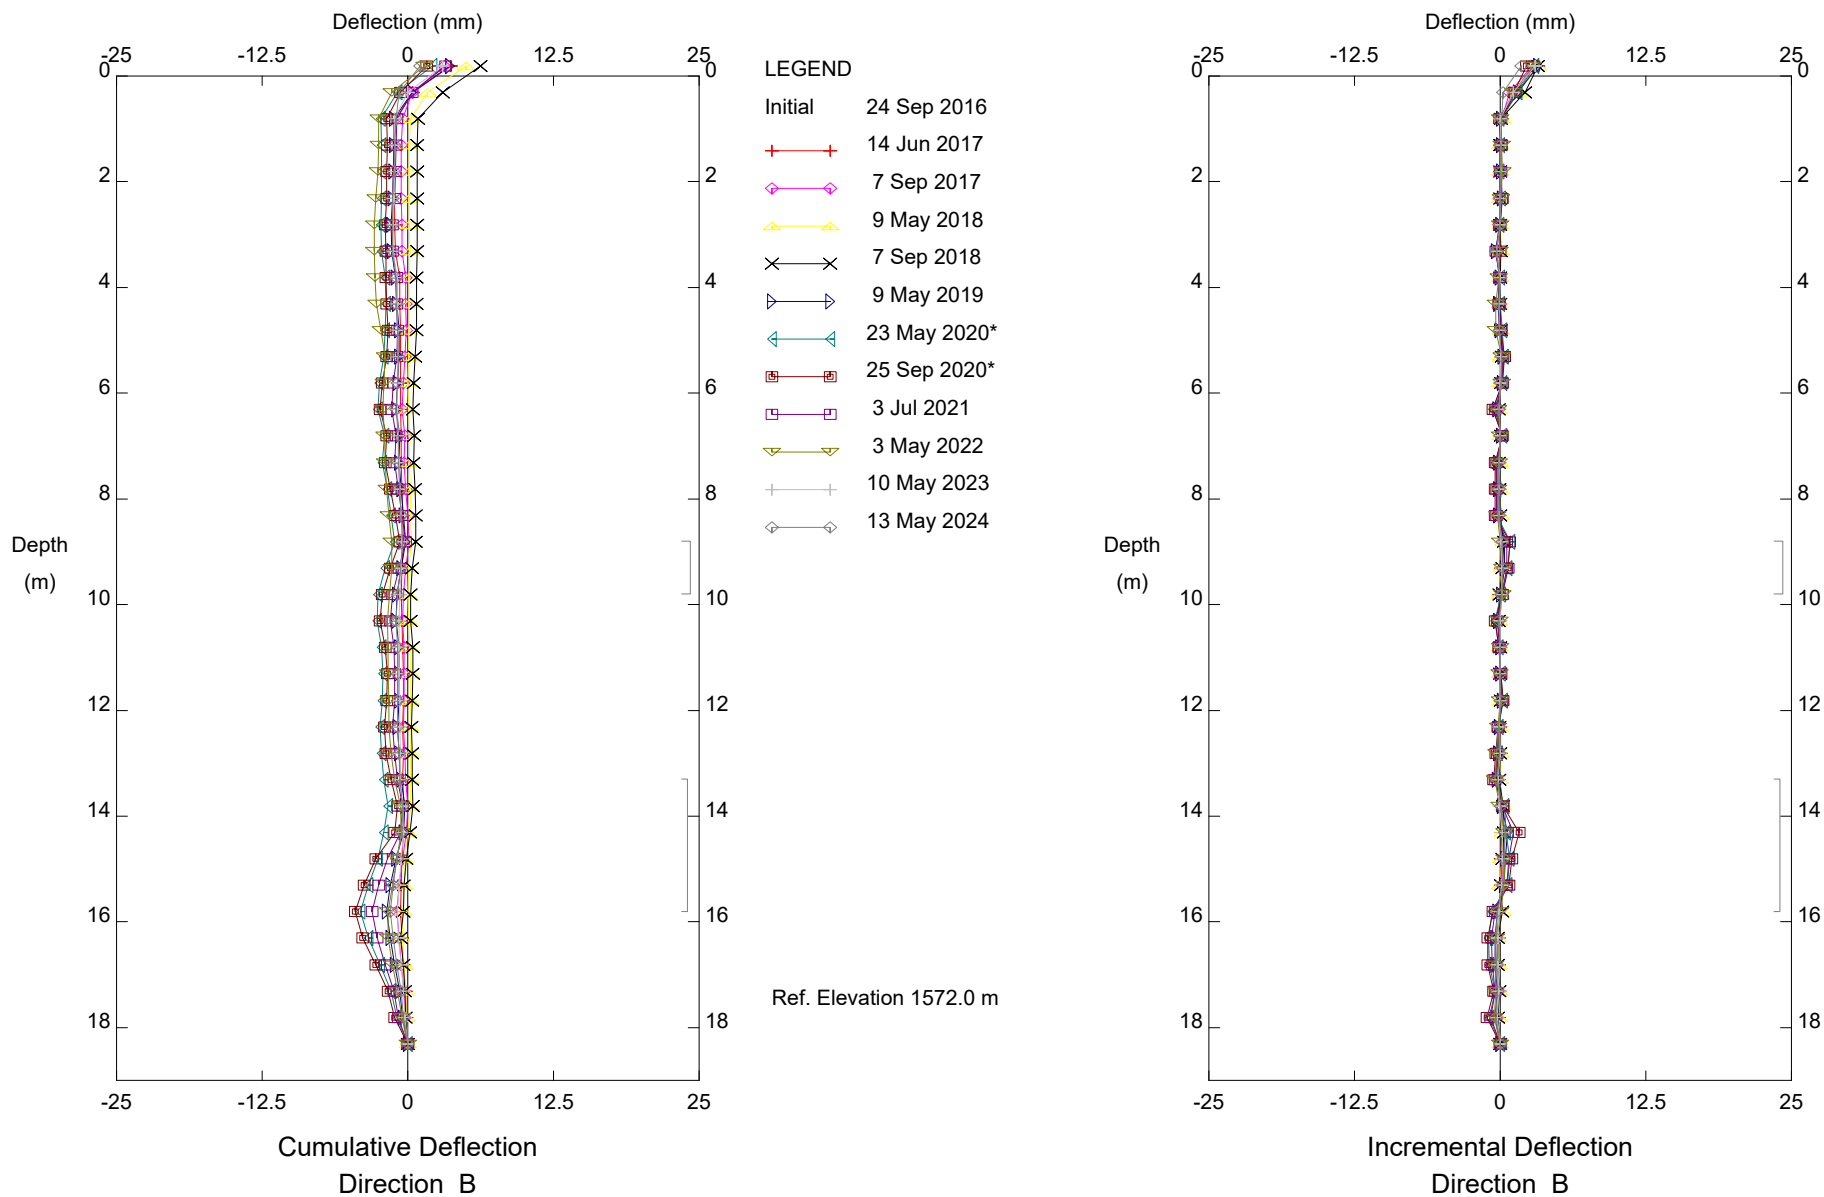
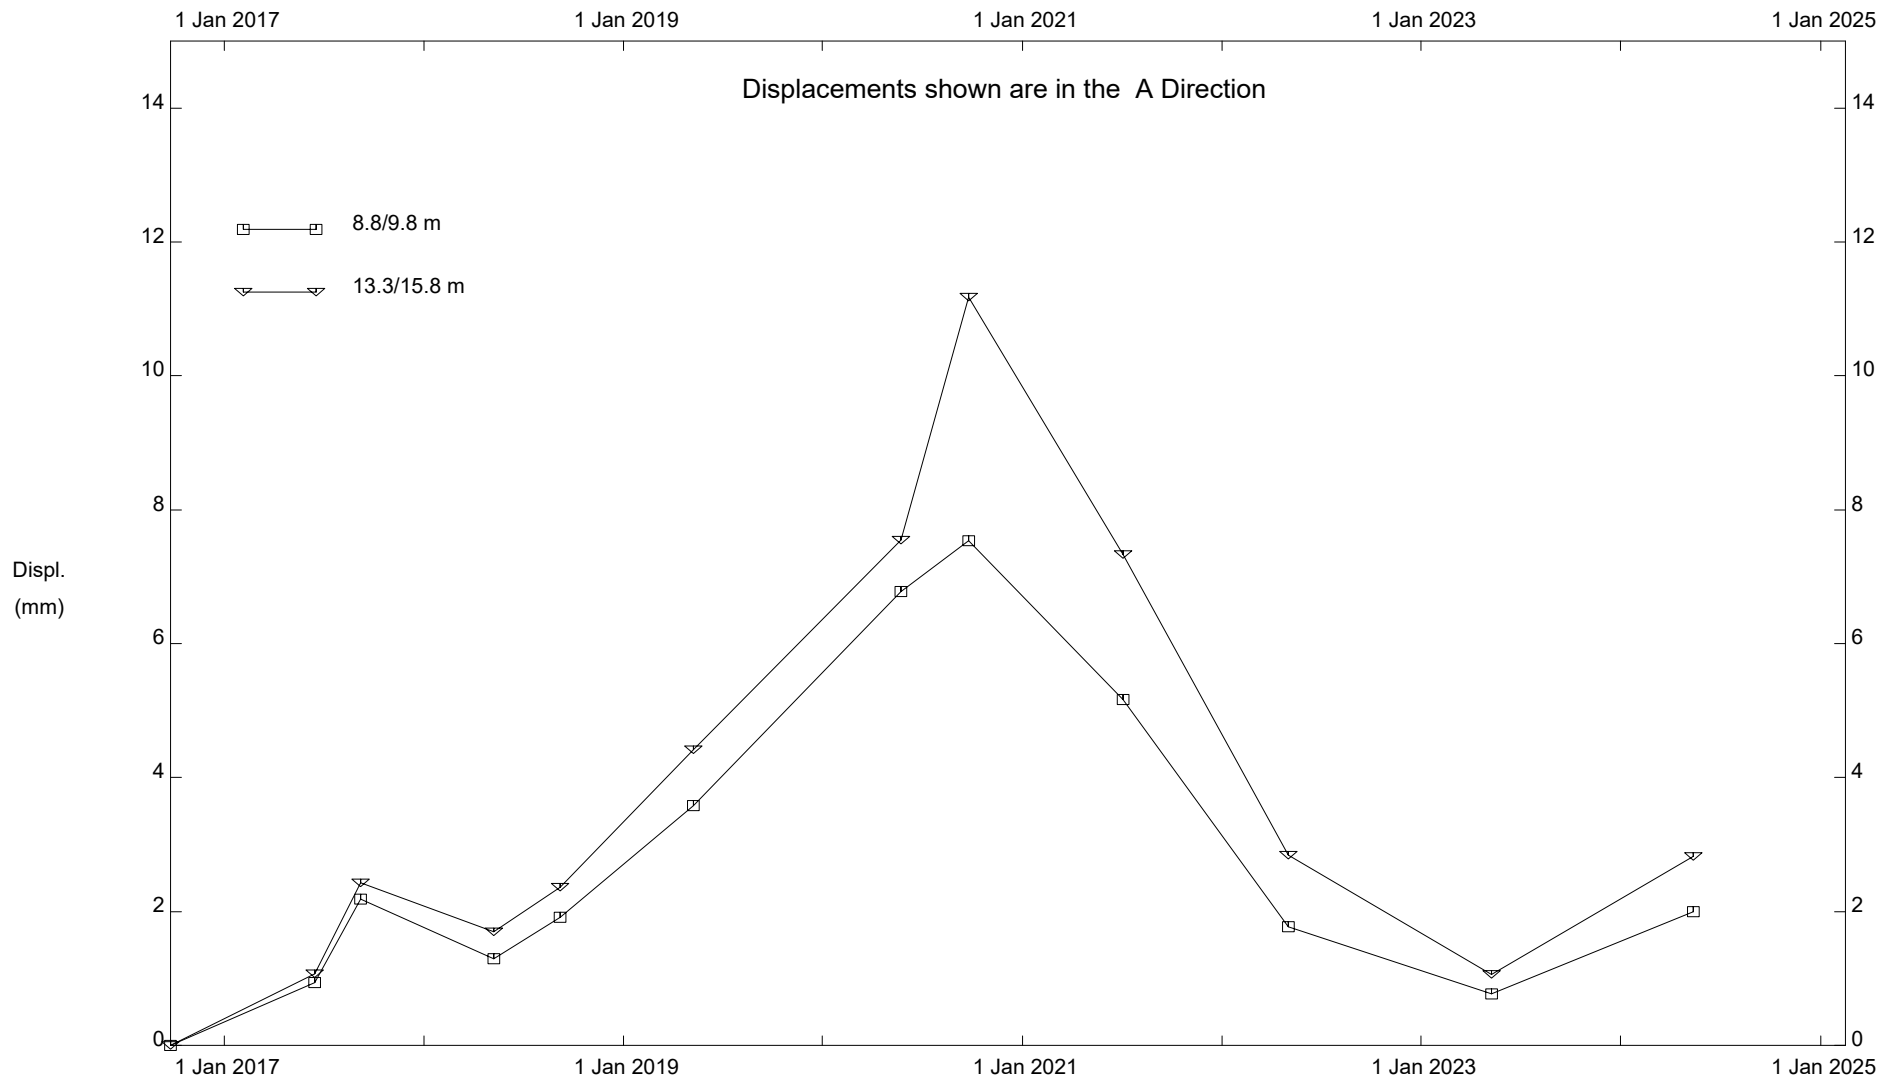
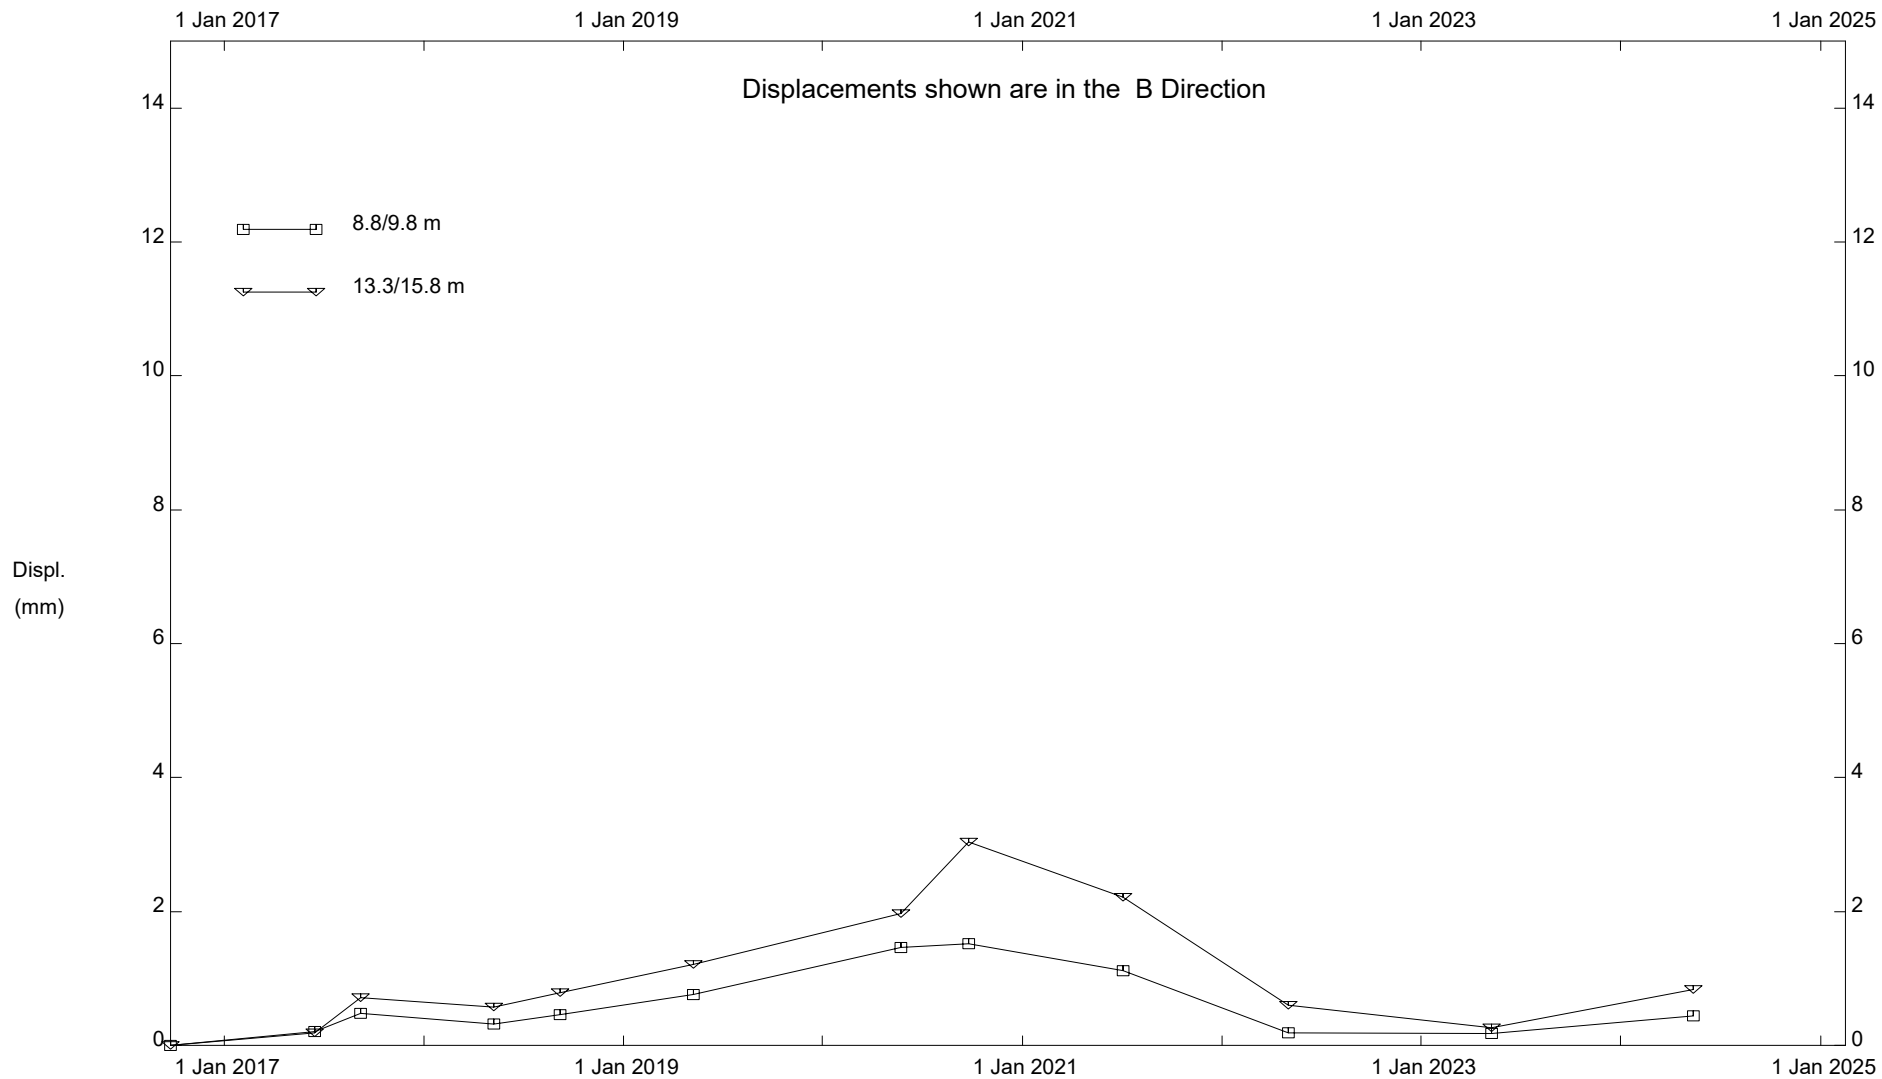
HWY 40:28 Gregg River Slide (NC50), Inclinometer SI10-11

SI10-11 was installed within the pile wall and shows two zones of fluctuating cumulative movement at depths from 8.8 m to 9.8 m and from 13.3 m to 15.8 m. The average movement rates are less than 1 mm/yr since 2016. The cumulative movement has returned to about 1 mm for both zones of movement. It is surmised that the historical fluctuations may be related to the load (bending moment) change or redistribution in the pile.
