From: Leslie Cho and Xiteng Liu
Stantec Consulting Ltd.
Date: June 18, 2024

Reference: North Central Region, Edson, Site NC050 - Highway 40:28 Gregg River Slide, Spring 2024 Instrumentation Monitoring Report

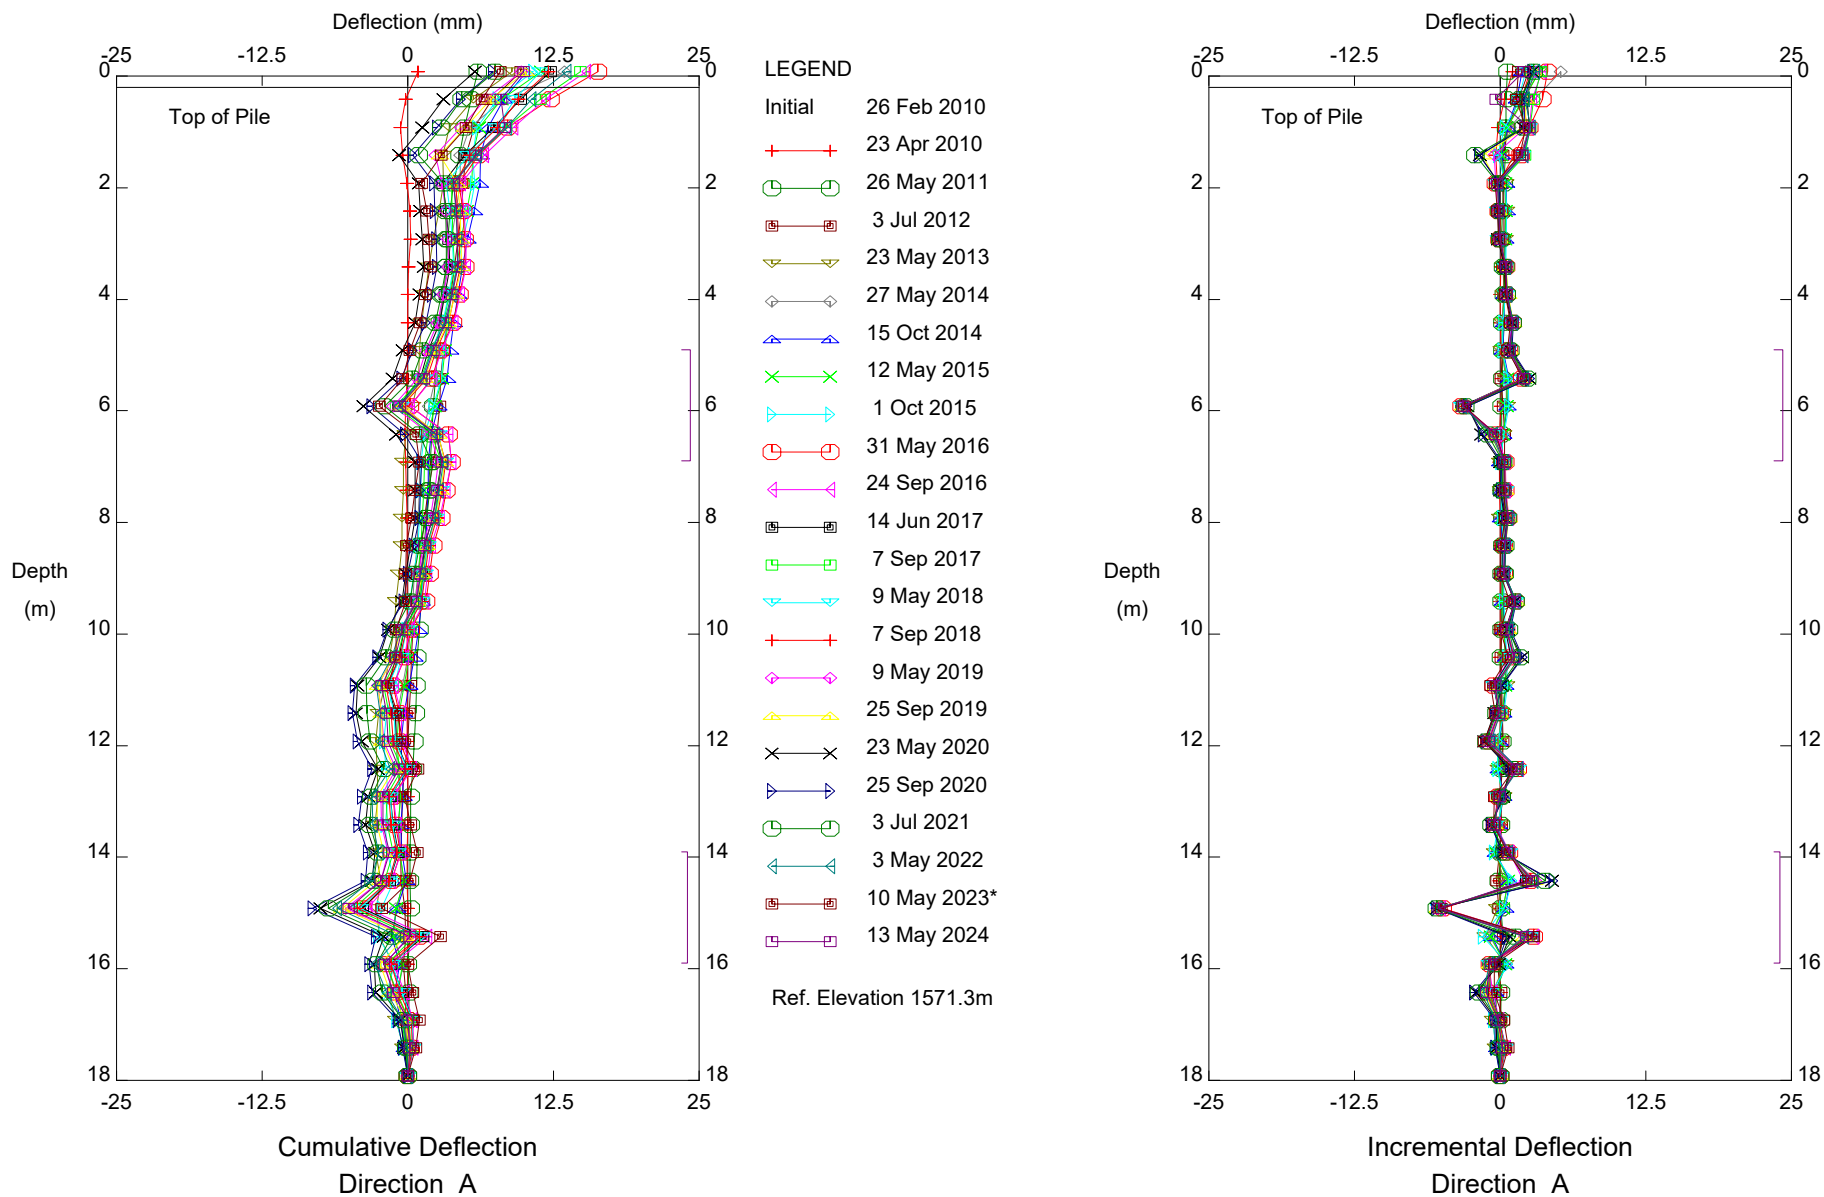
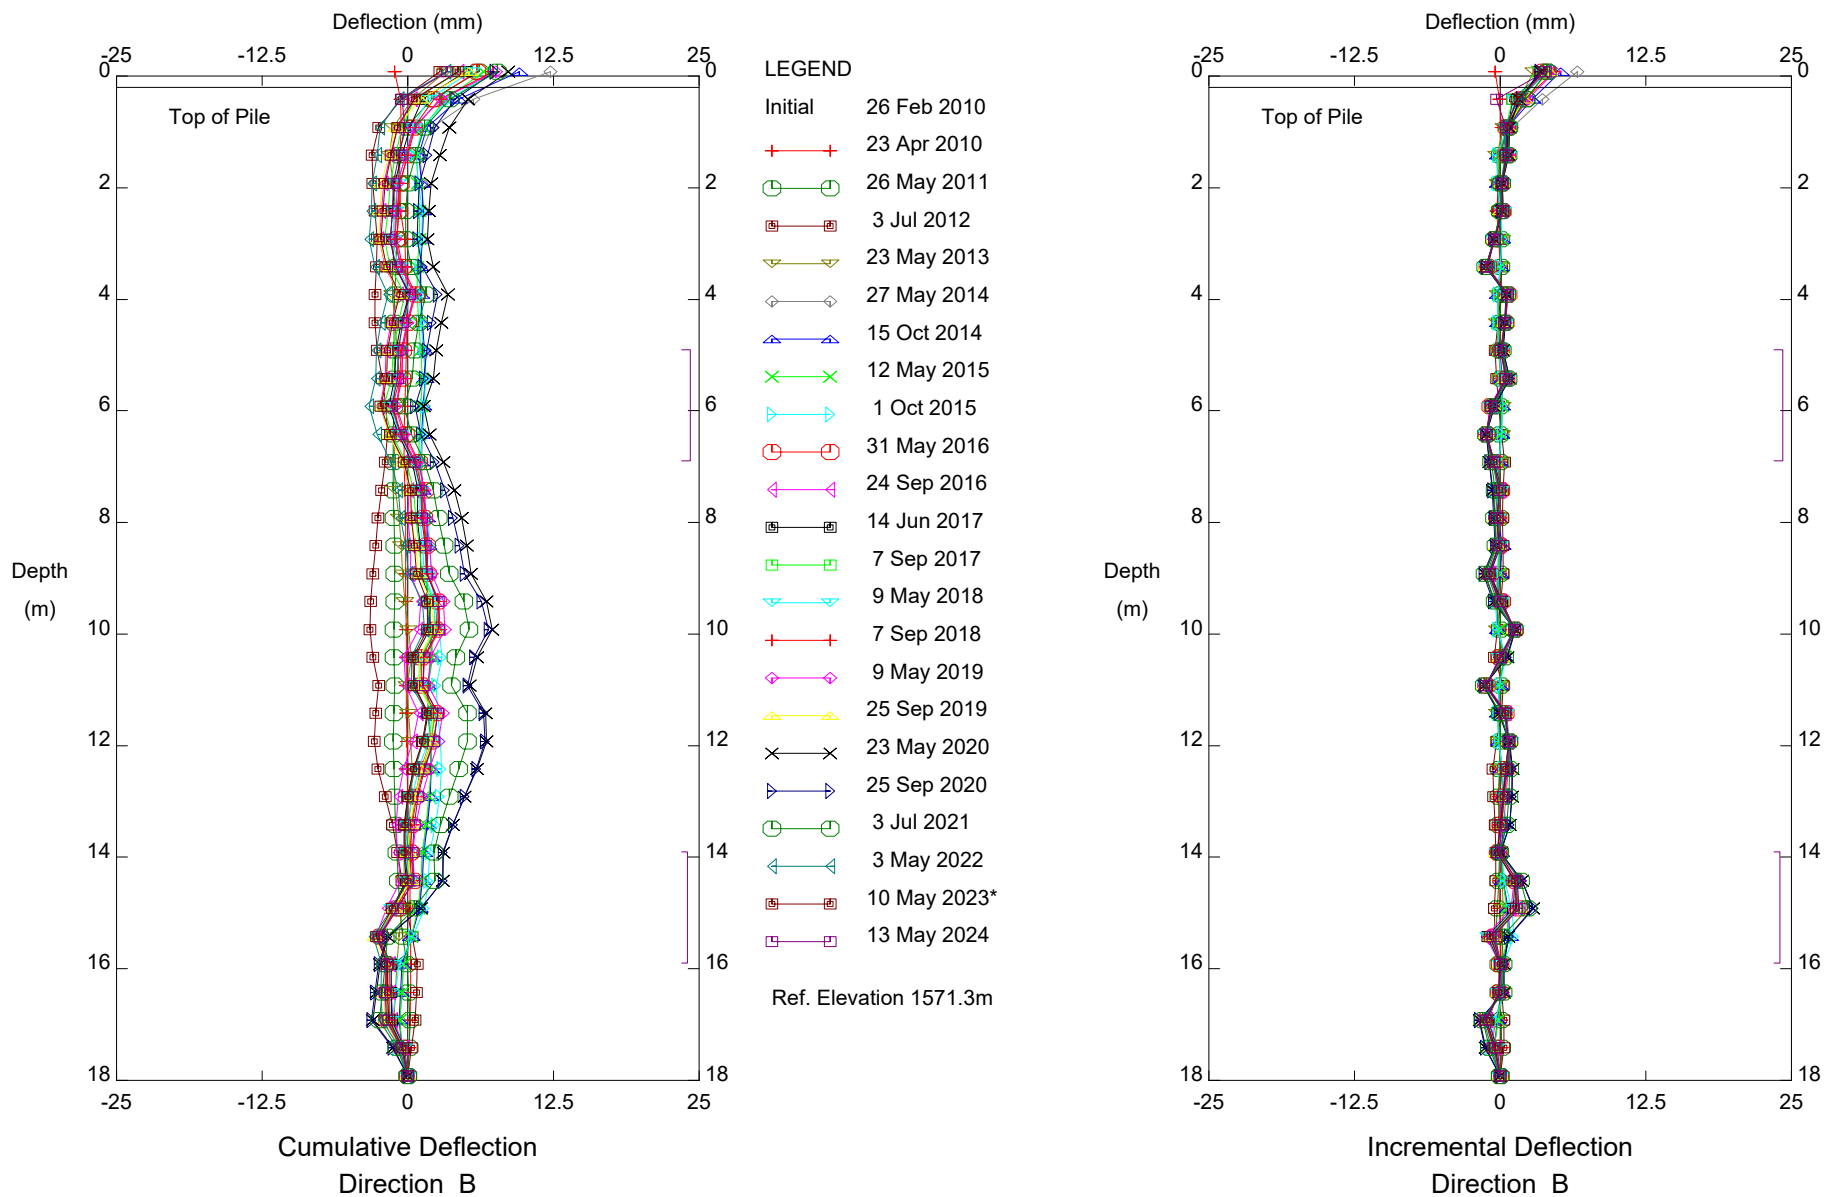
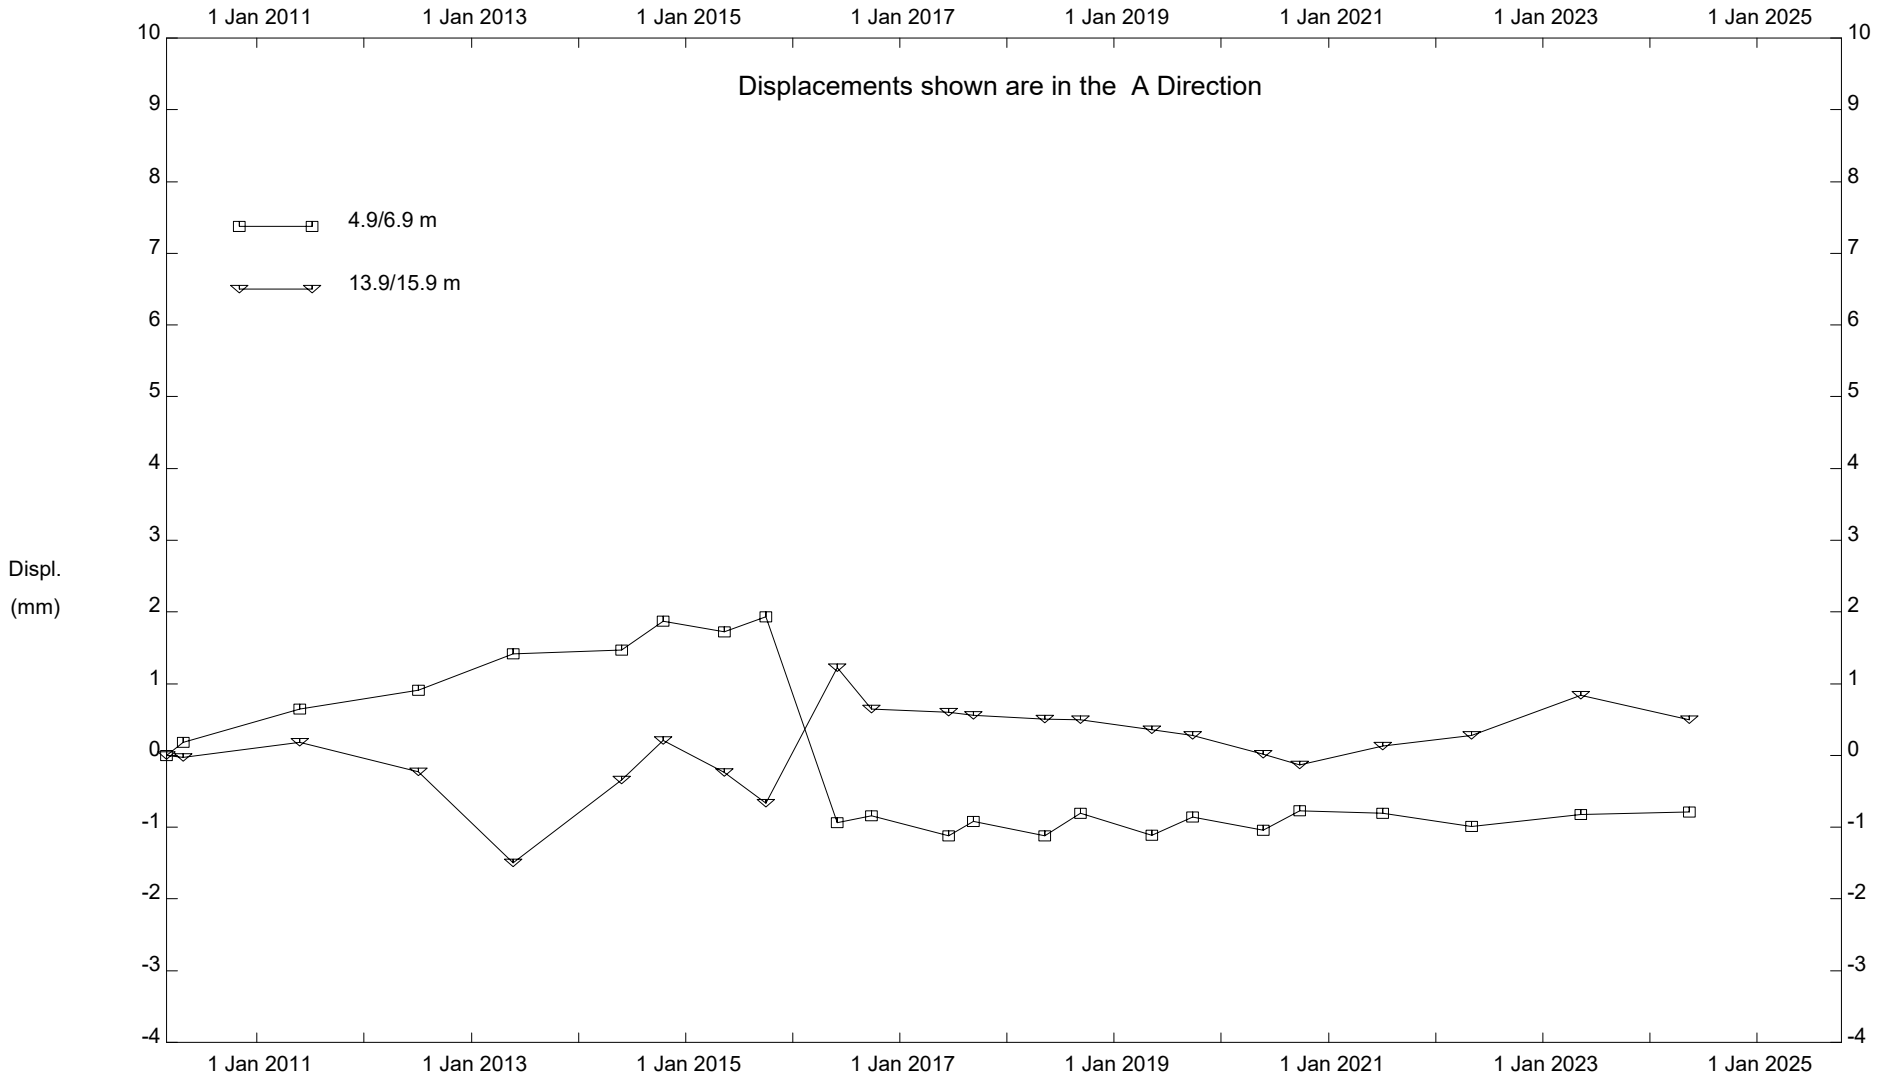
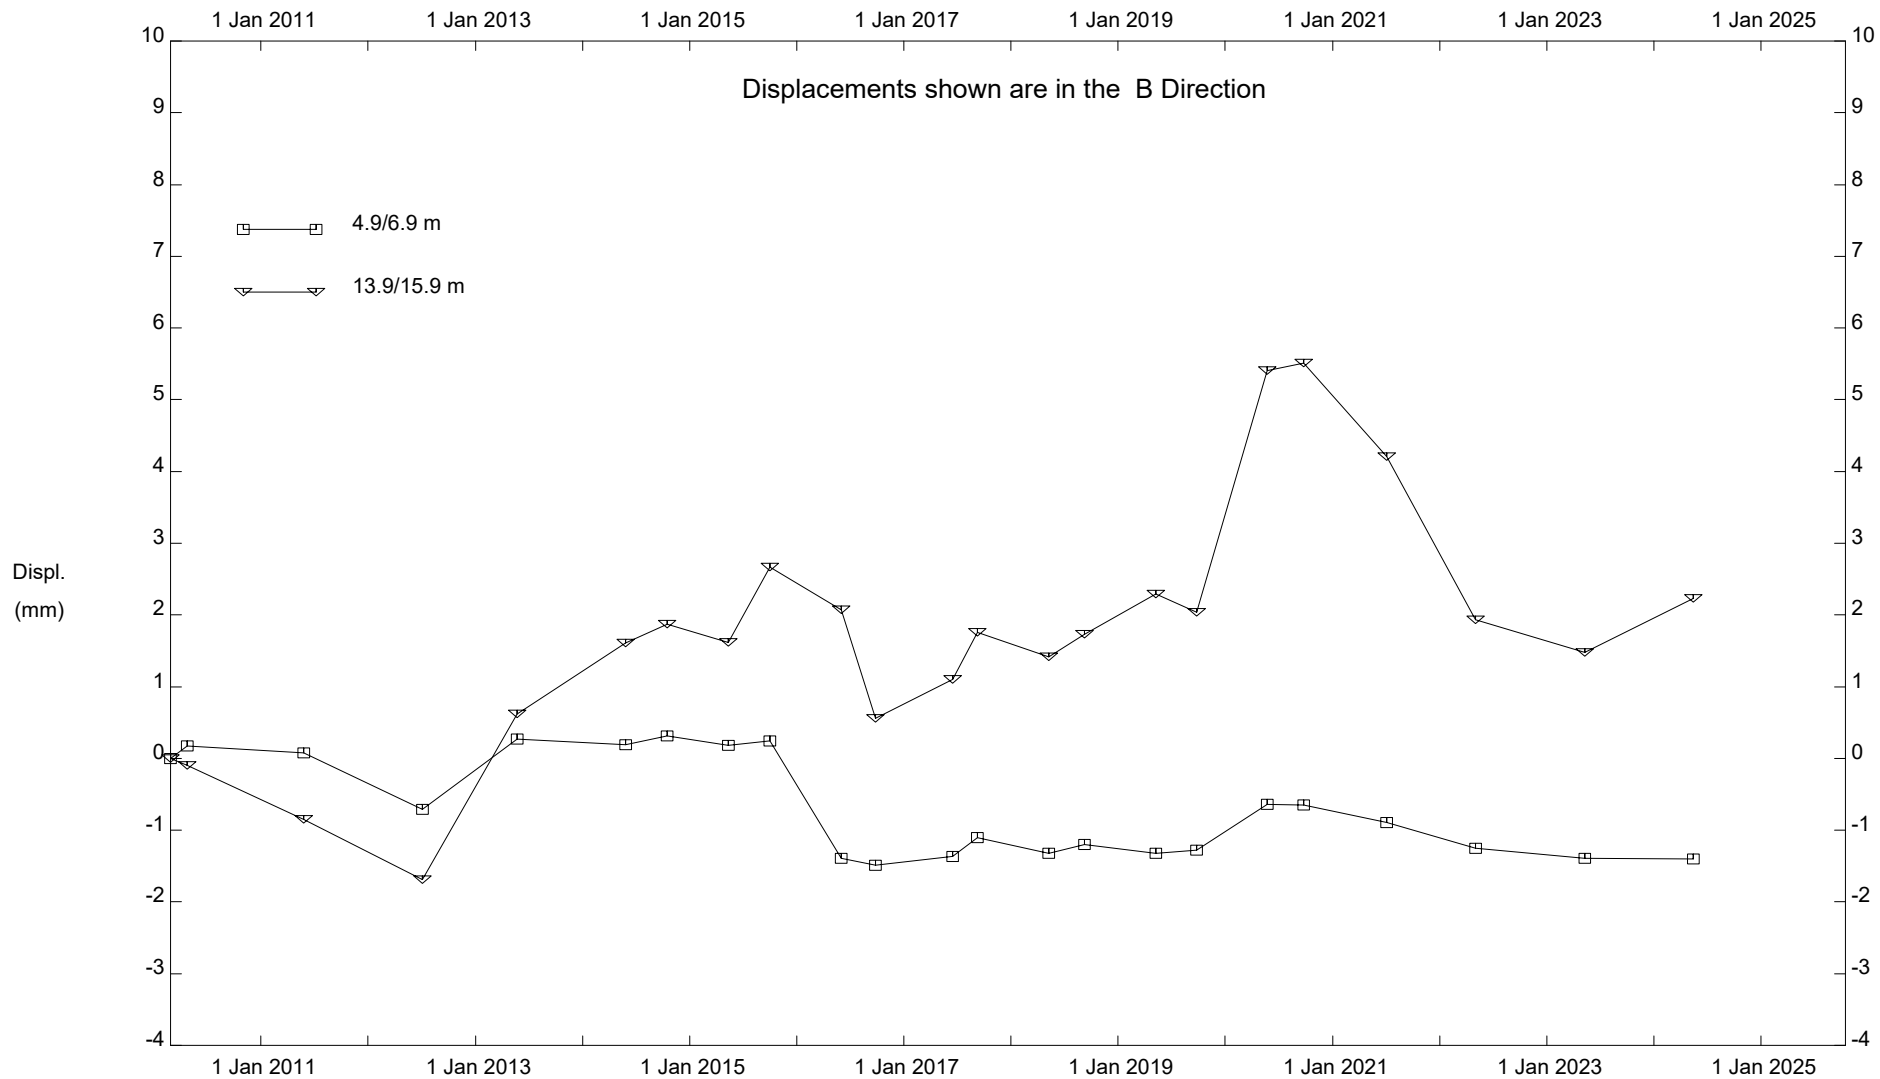
HWY 40:28 Gregg River Slide (NC50), Inclinator SI10-12

SI10-12 was installed within the pile wall and shows negligible cumulative movement (less than 1 mm) since initialization in 2010 in two movement zones at depths from 4.9 m to 6.9 m and from 13.9 m to 15.9 m. The most recent reading cycle showed incremental movement equal to about 1 mm in both zones, similar to what was observed in the previous reading cycle. Historically, SI10-12 has shown fluctuations in cumulative movement, and it is surmised that this is a result of load (bending moment) change or redistribution in the pile.

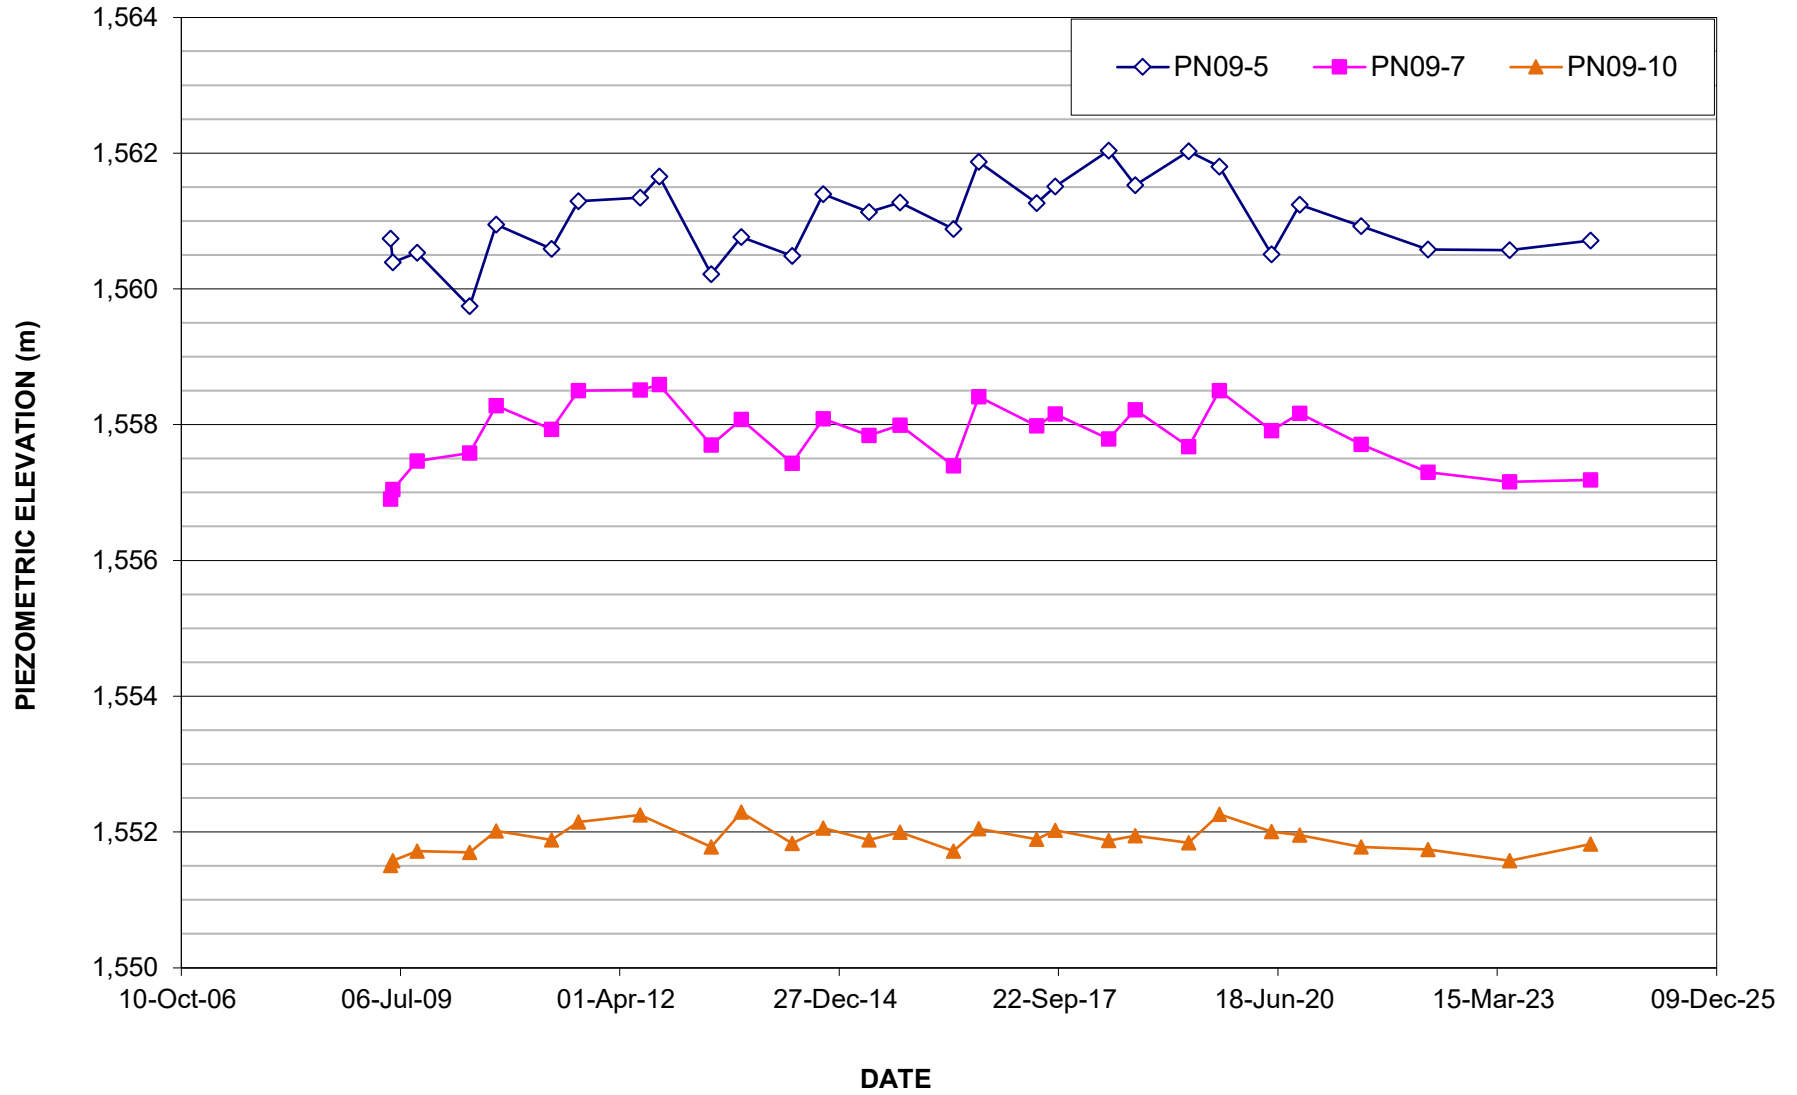
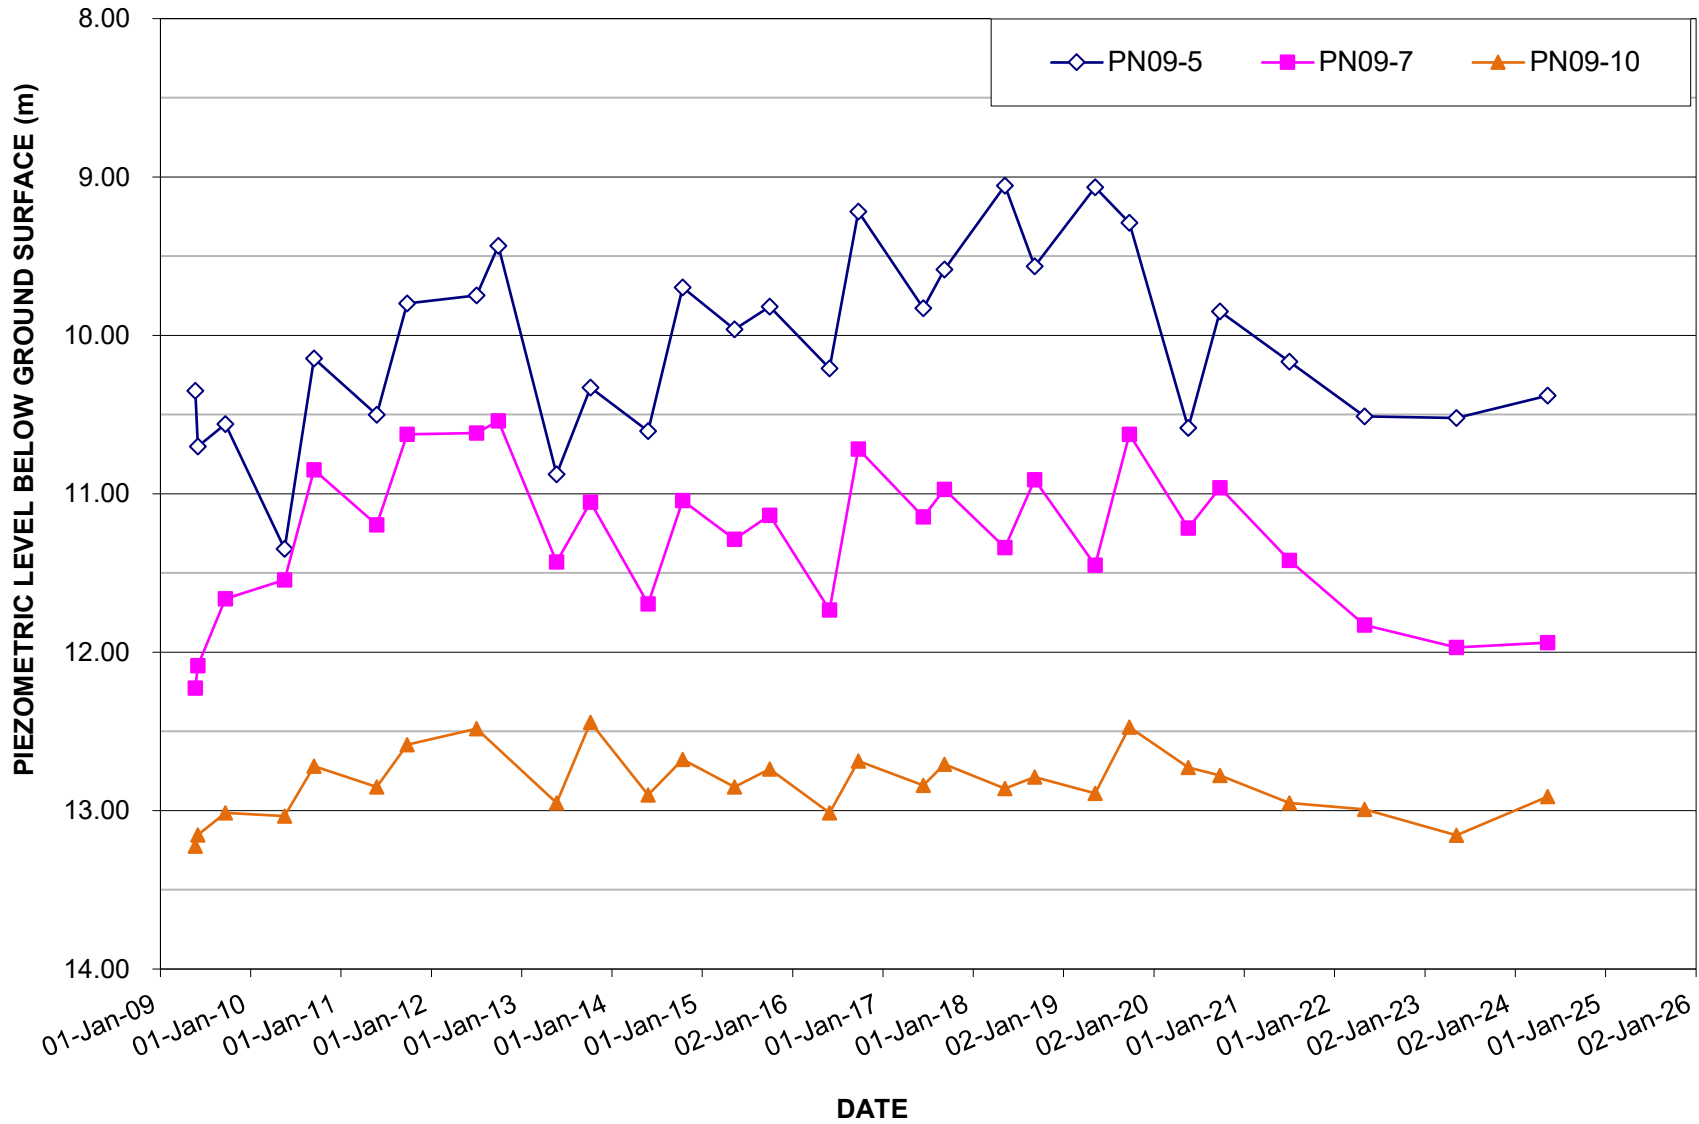
Pneumatic Piezometer Piezometric Elevation

The piezometers showed an increase in water level up to 0.3 m since the previous Spring 2023 reading cycle. The water levels at the site ranged from about 10.4 m to 12.9 m below ground surface (bgs) corresponding to elevations of 1560.7 m and 1551.8 m, respectively. Overall, all three pneumatic piezometers continue to show relatively stable piezometric levels.

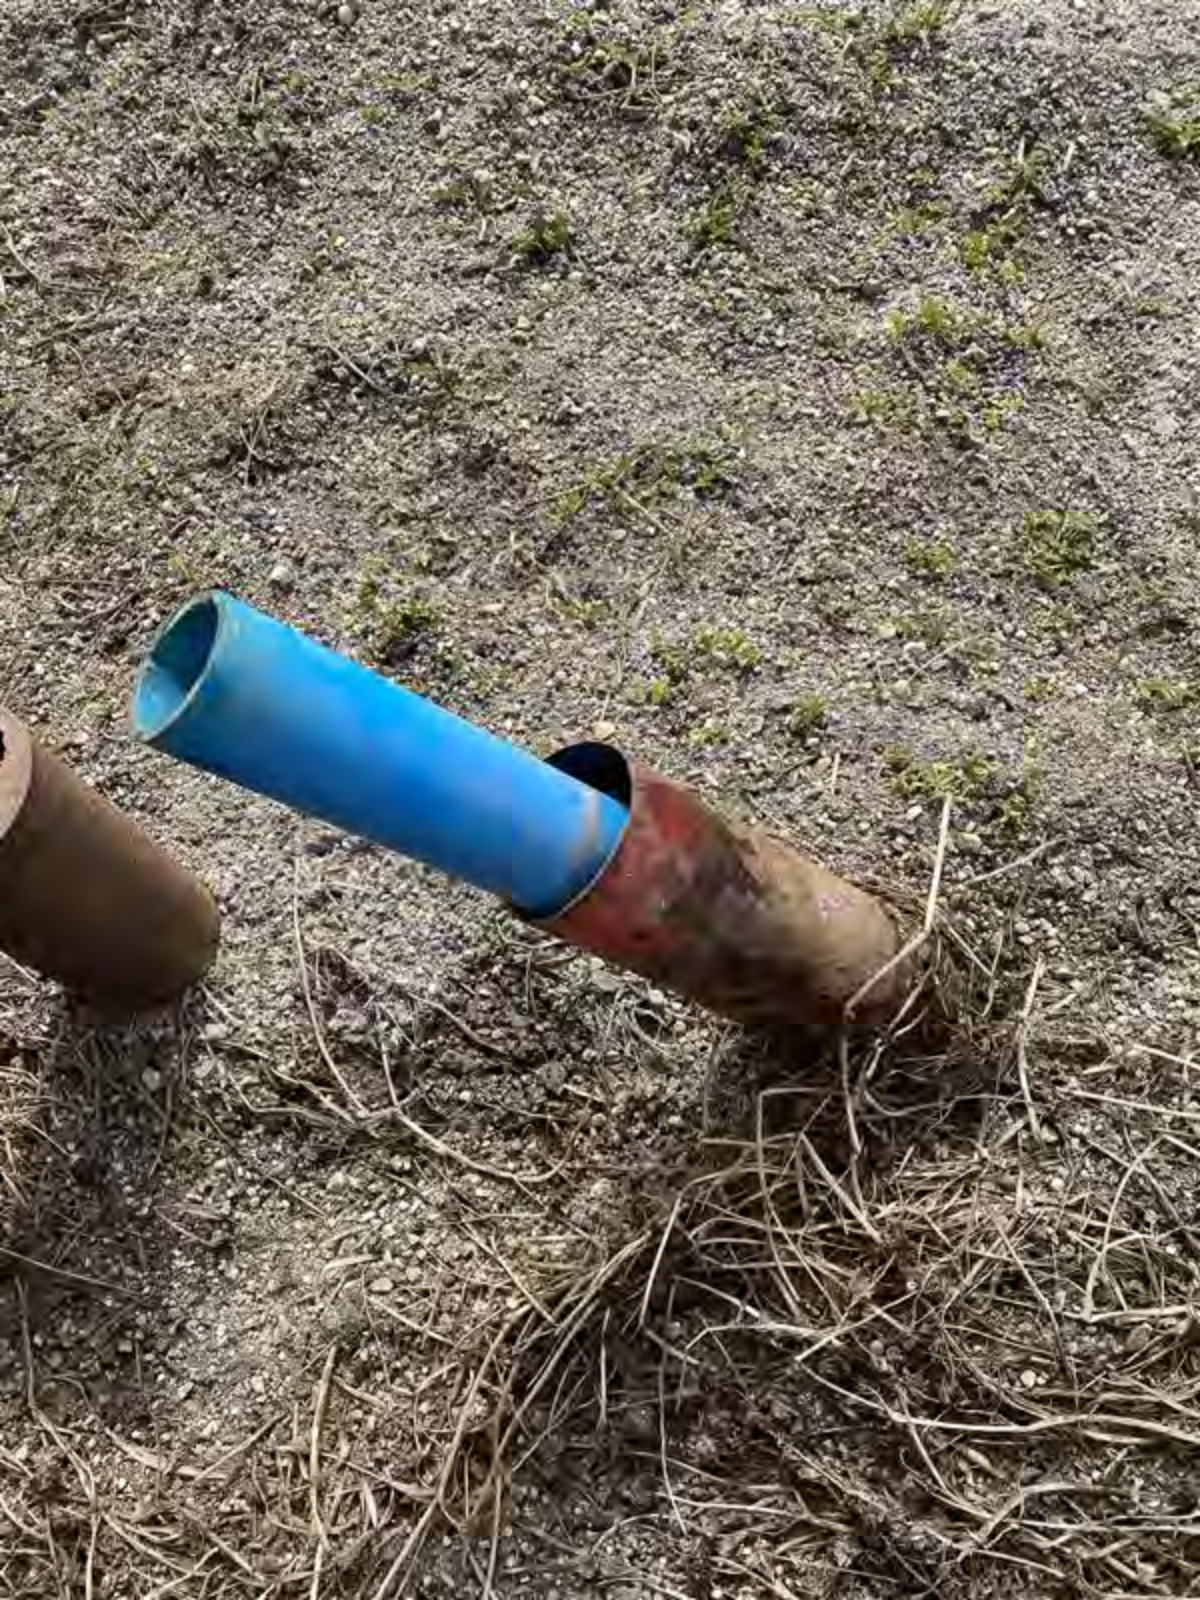
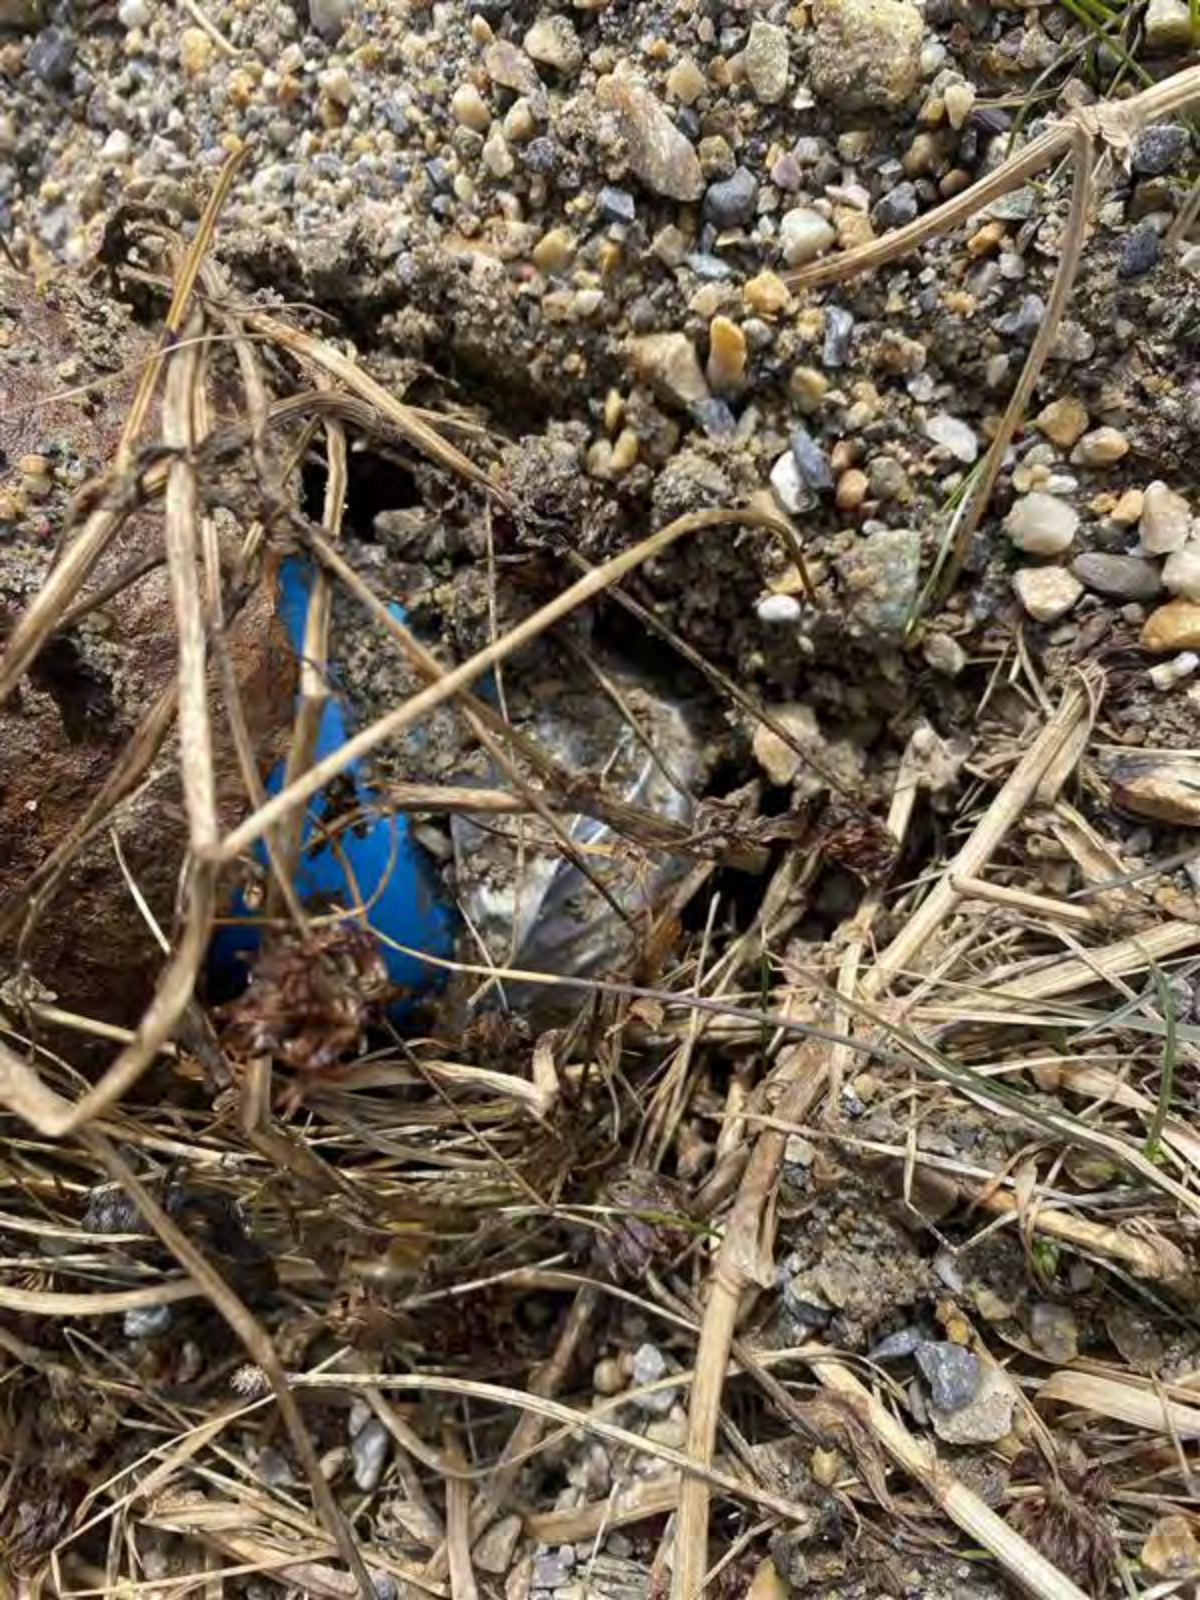
SI10-13 was found damaged in the most recent reading cycle and was not read.

SI10-13 was found damaged in Spring 2024 and was severely bent out of the ground. An attempt could be made to repair SI10-13 by digging it up and installing a coupler on the undamaged length.
