GEOHAZARD RISK MANAGEMENT PROGRAM North Central Region – Edson / Stony Plain Area

2020 Inspection Report

Site Number	Site Name		Hwy	km
NC11	North of Hinton		40:30	5.6
Legal Land Description	NW 1-51-26-W5M			
UTM Coordinates (NAD 83)	Zone 11U	N5914208	E453022	
Operational Site Instrumentation	Slope Inclinometers		2	
	Pneumatic Piezometers		0	
	Vibrating Wire Piezometers		0	
	Standpipe Piezometers		0	
Date of Last Instrumentation Readings	May 27, 2019

Client/Project
Alberta Transportation
Geohazard Monitoring Program
NC11 Highway 40 North of Hinton

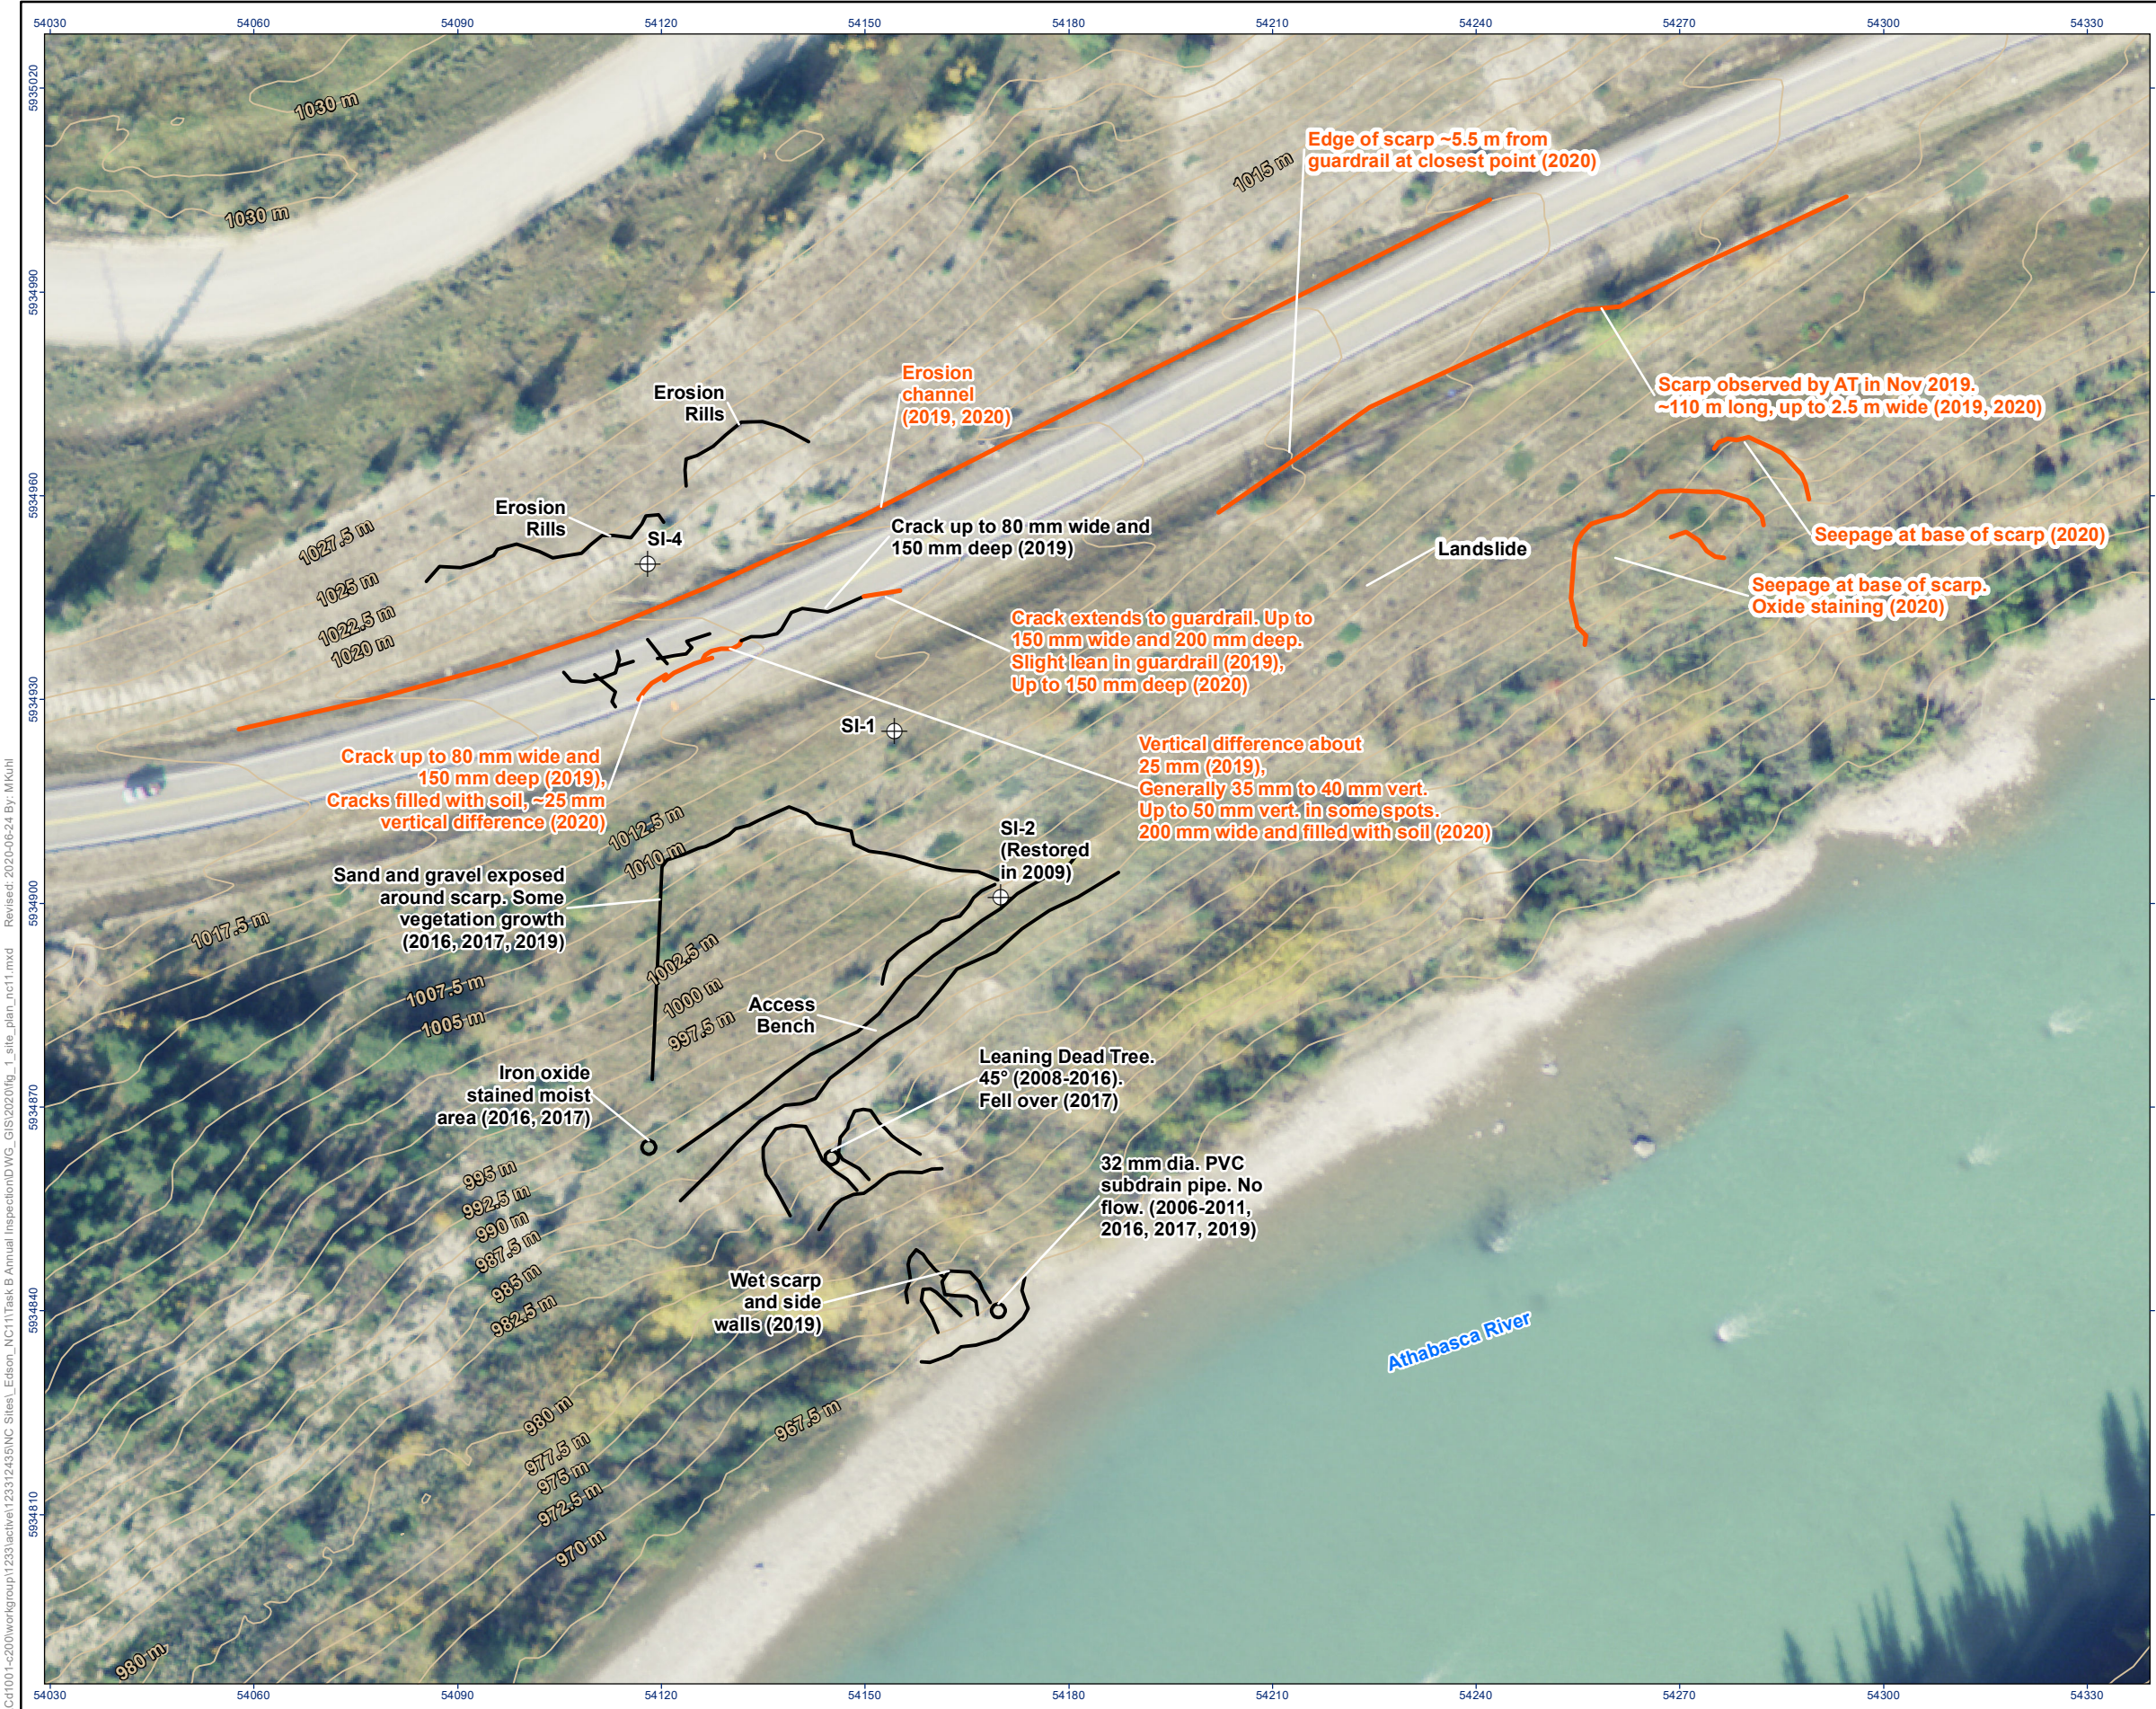
Figure No.
1

- Approximate Slope Inclinometer Location
- 2020 Observation
- Previous Observation / Site Detail

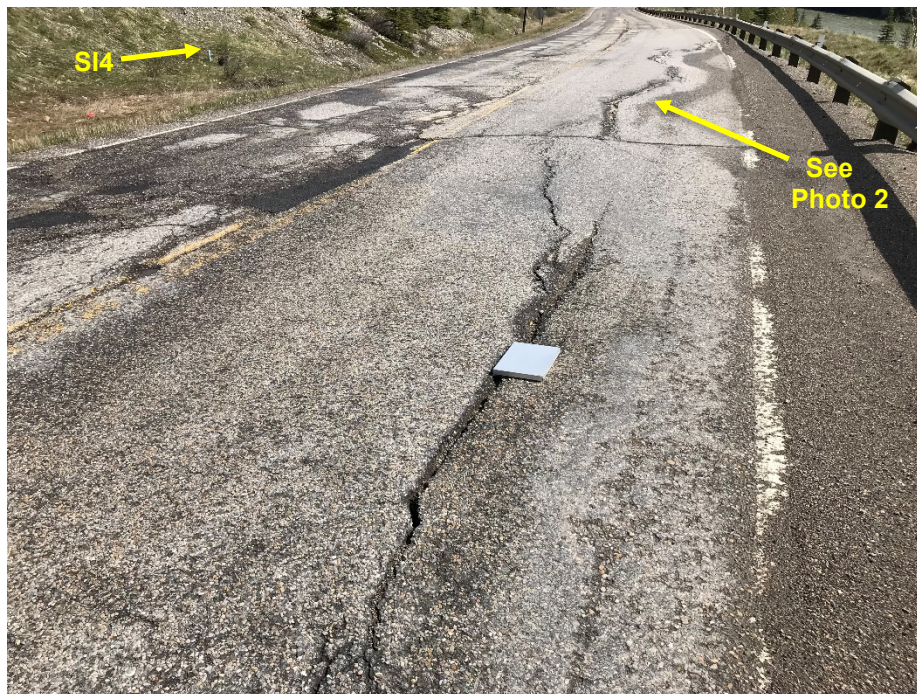
Photo 1: Pavement cracking. Looking northeast.

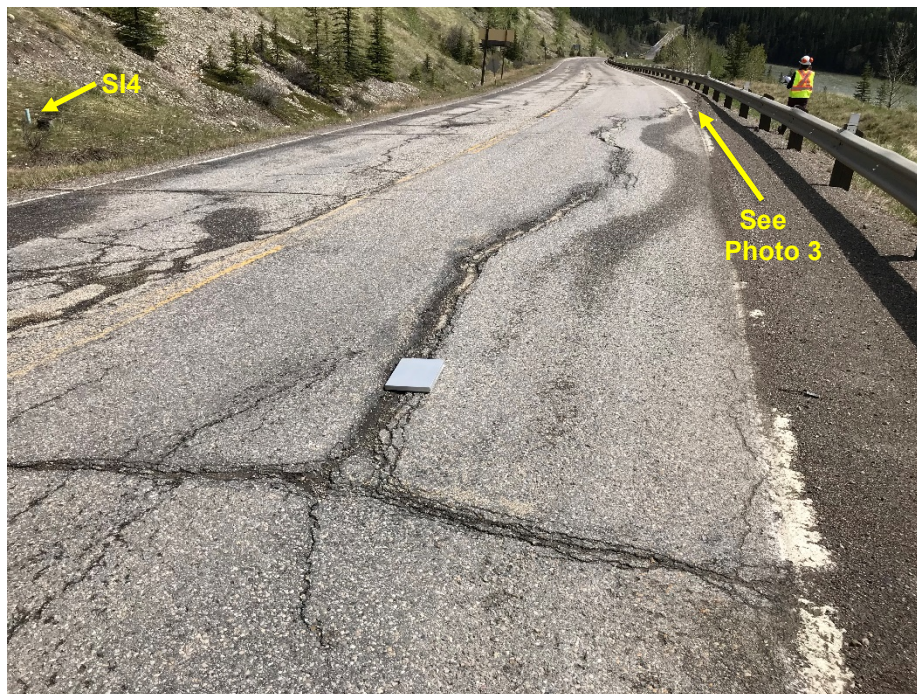
Photo 2: Pavement cracking. Looking northeast.

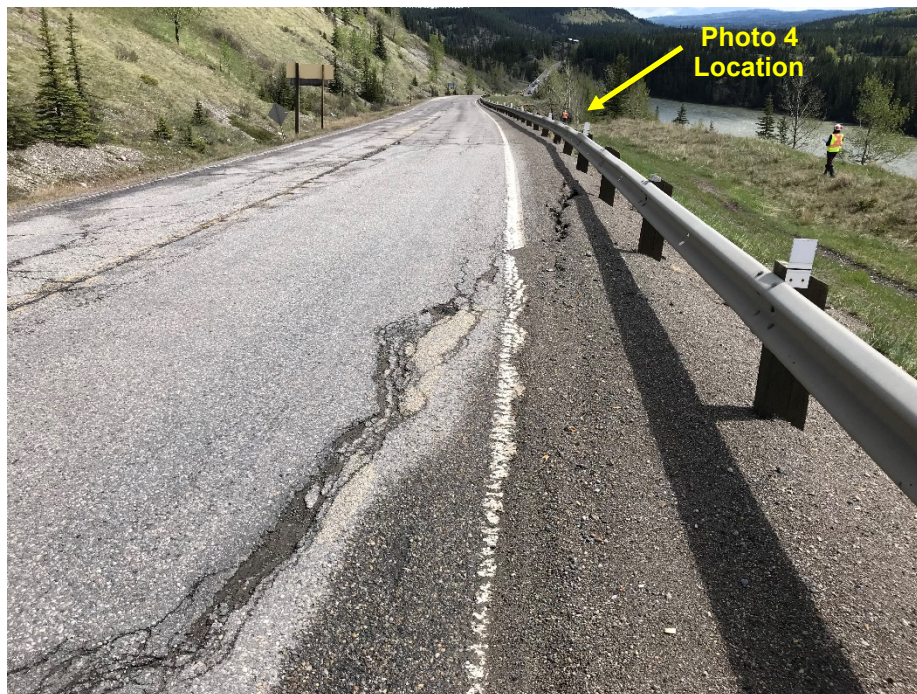
Photo 3: Pavement cracking. Looking northeast.

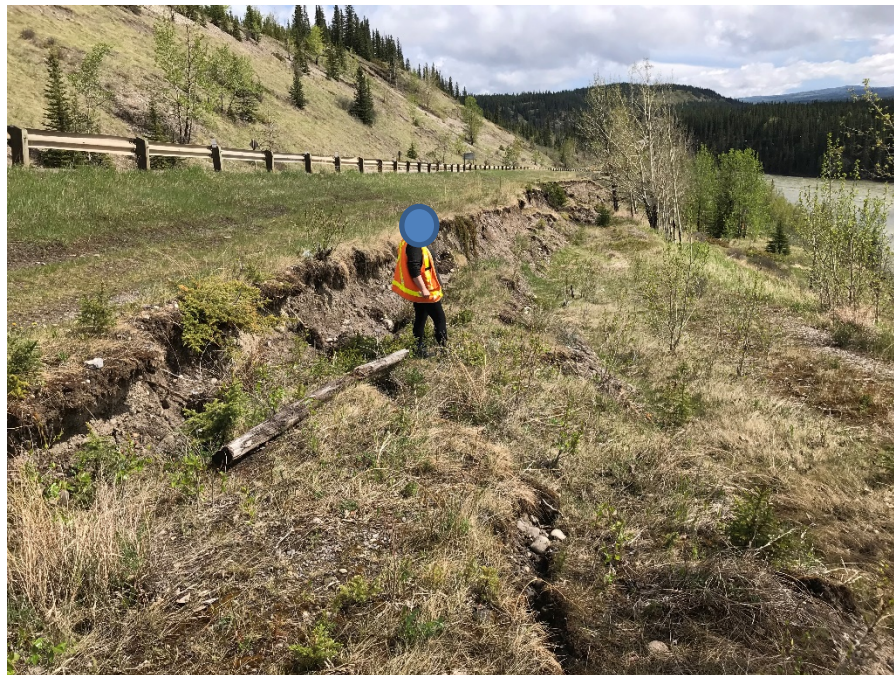
Photo 4: West end of scarp near highway. Looking northeast.

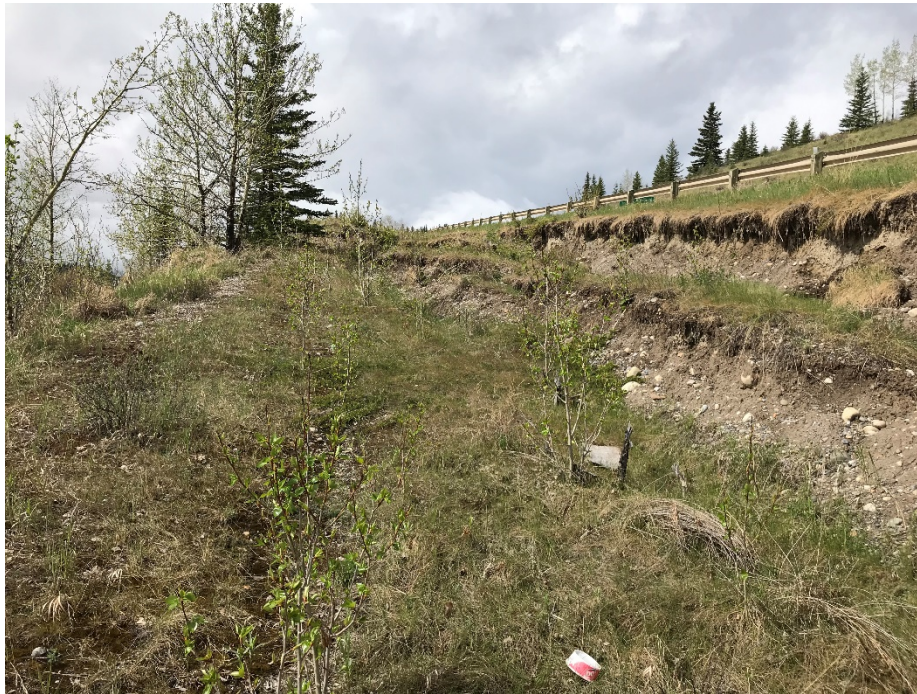
Photo 5: West end of scarp near highway. Looking southwest.

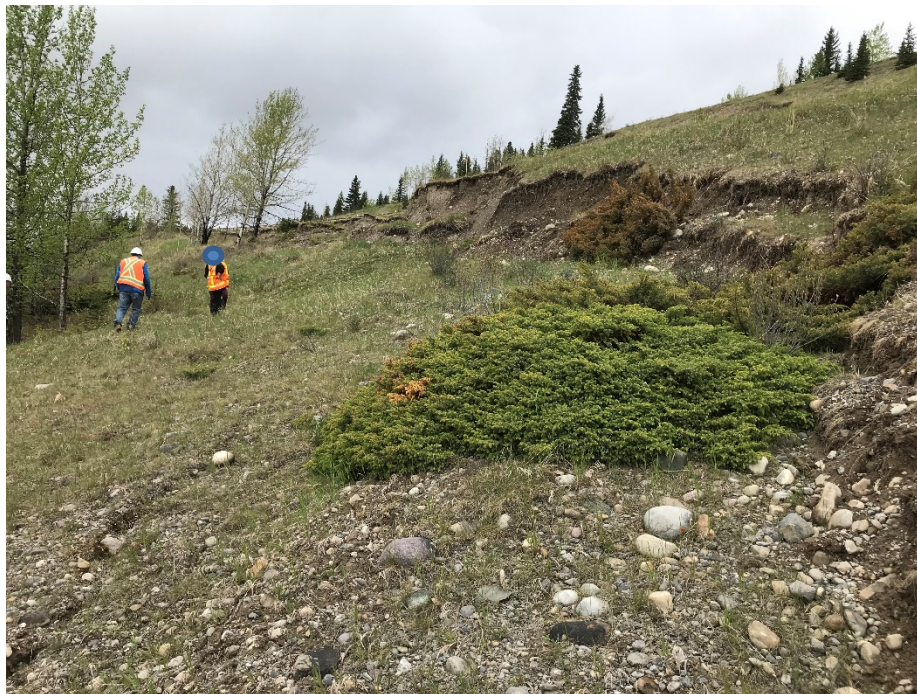
Photo 6: East end of scarp along highway. Looking west.

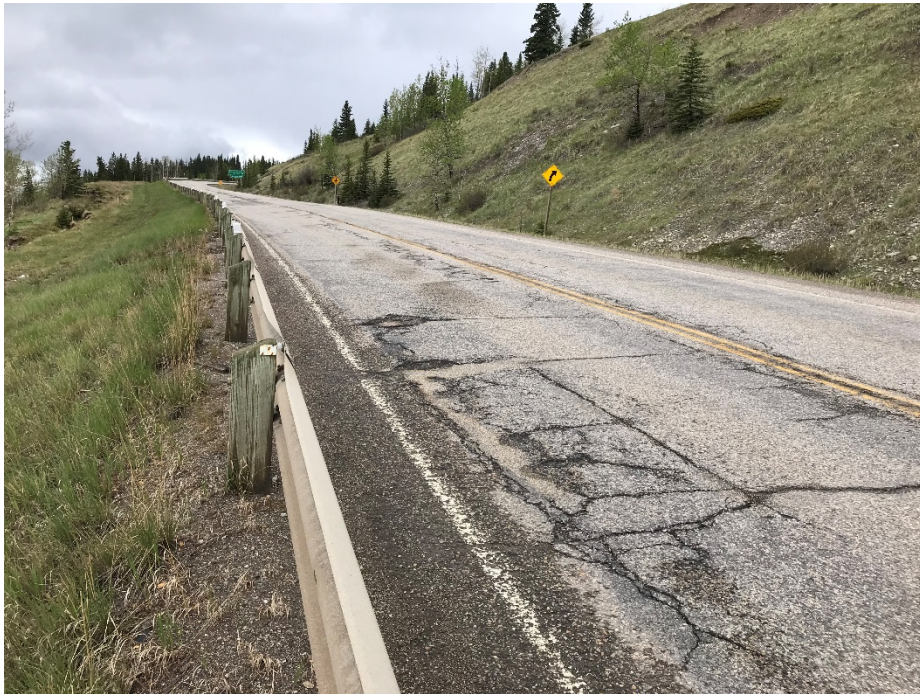
Photo 7: Highway 40 upslope from scarp. Looking west.

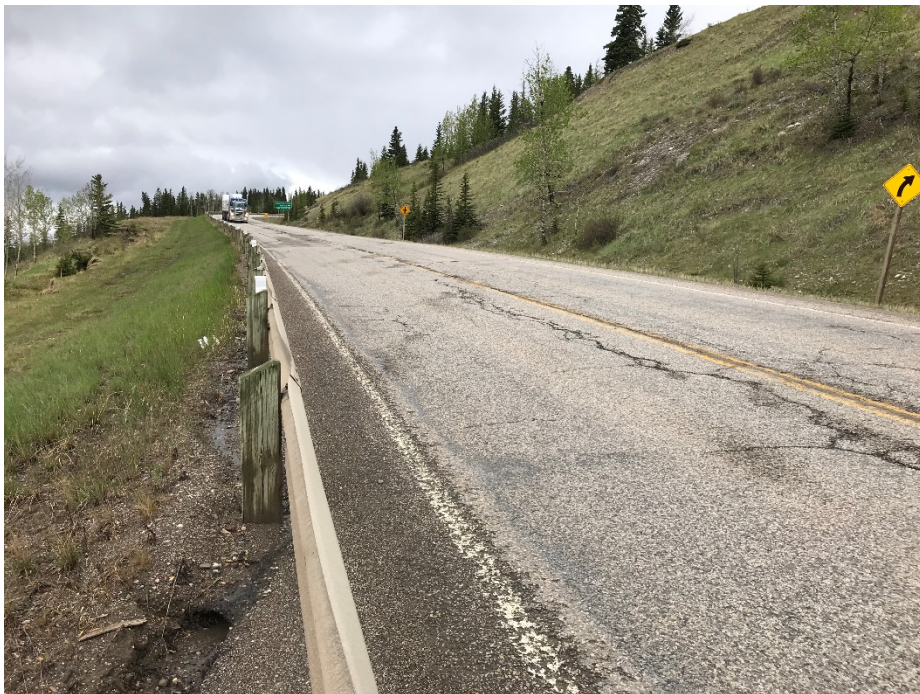
Photo 8: Highway 40 upslope from scarp. Looking west.

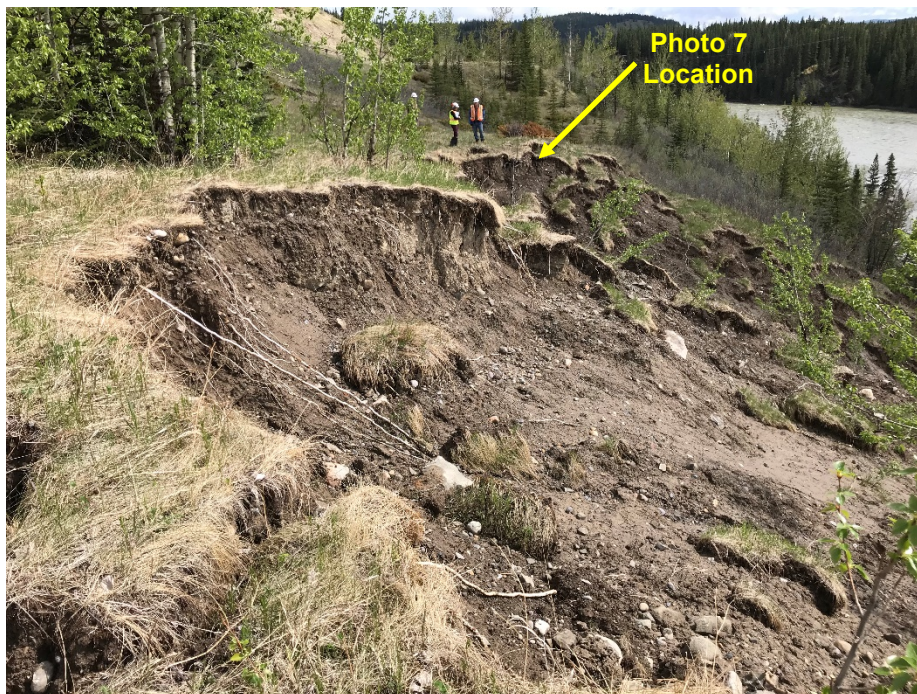
Photo 9: Series of retrogressive slides downslope from scarp near Highway 40. Looking east.

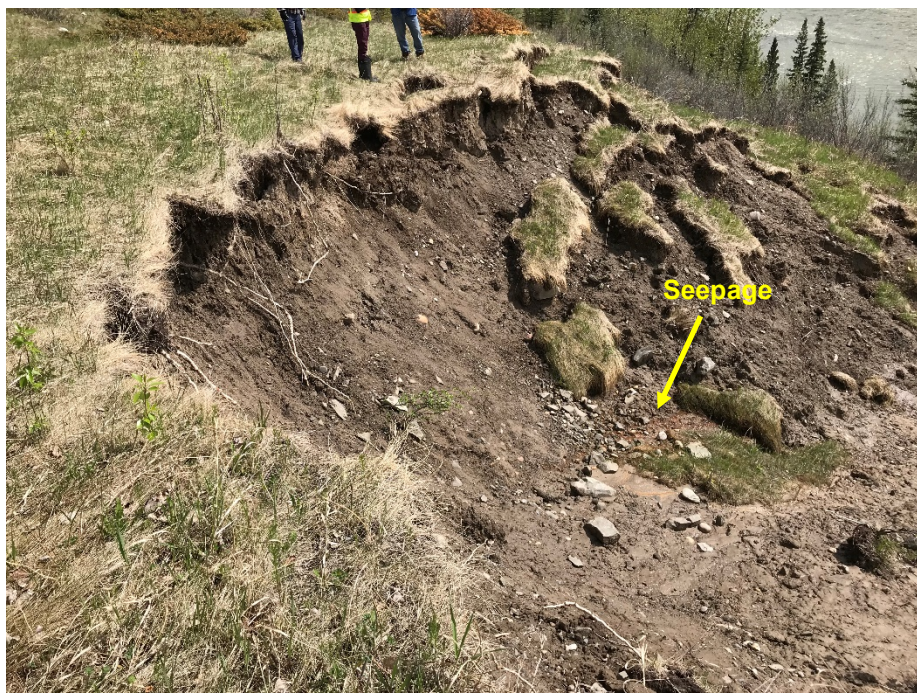
Photo 10: Seepage at base of scarp. Looking east.

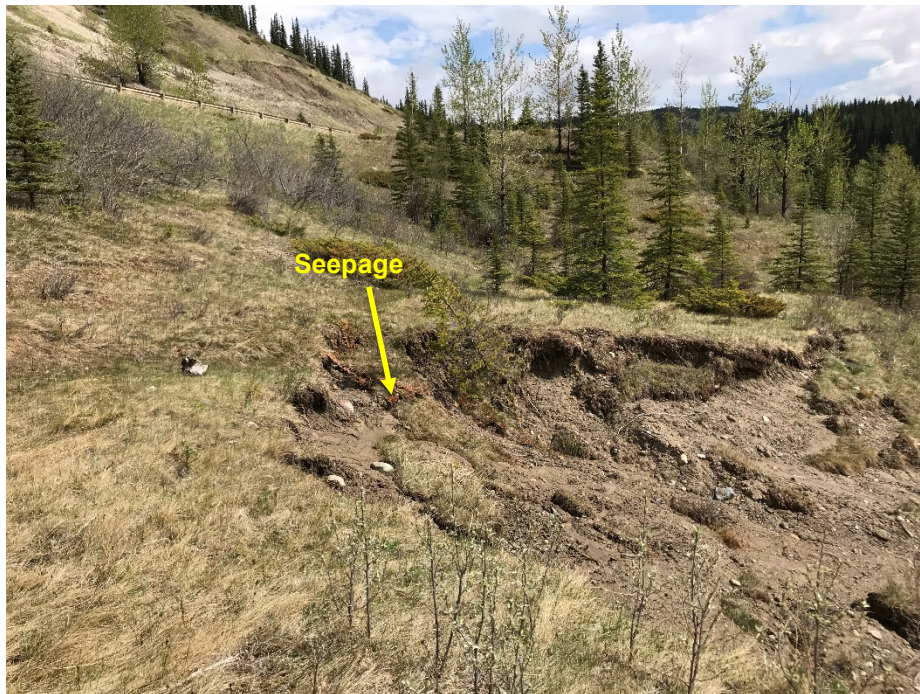
Photo 11: Slide about 20 m northeast of landslide in Photo 7. Seepage at base of scarp. Looking east.

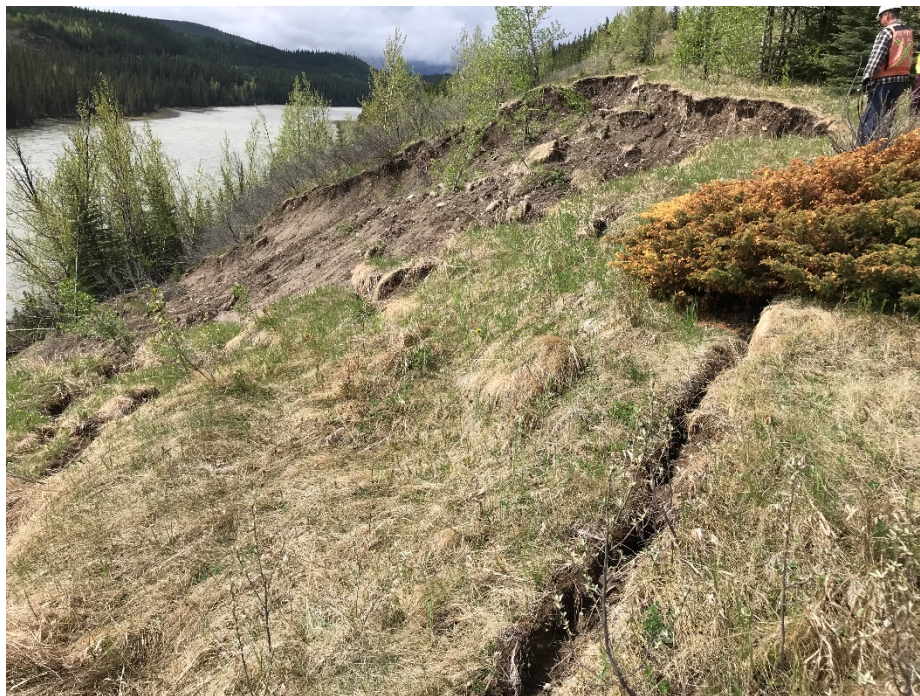
Photo 12: Between the two slides in Photos 7 and 8. Looking west.

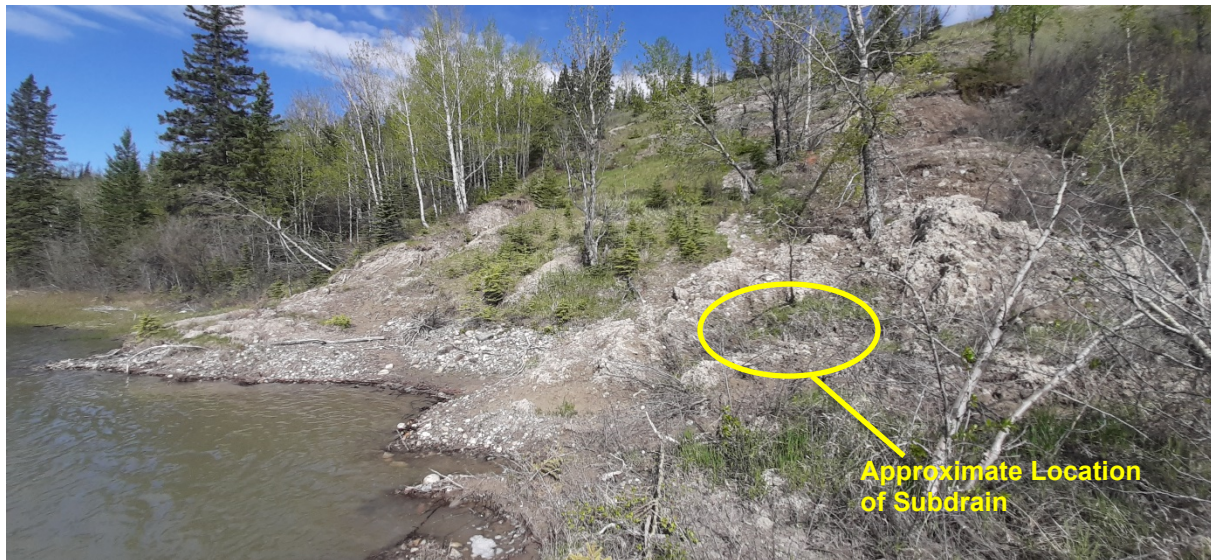
Photo 13: Overall Slope from toe. Looking northwest.

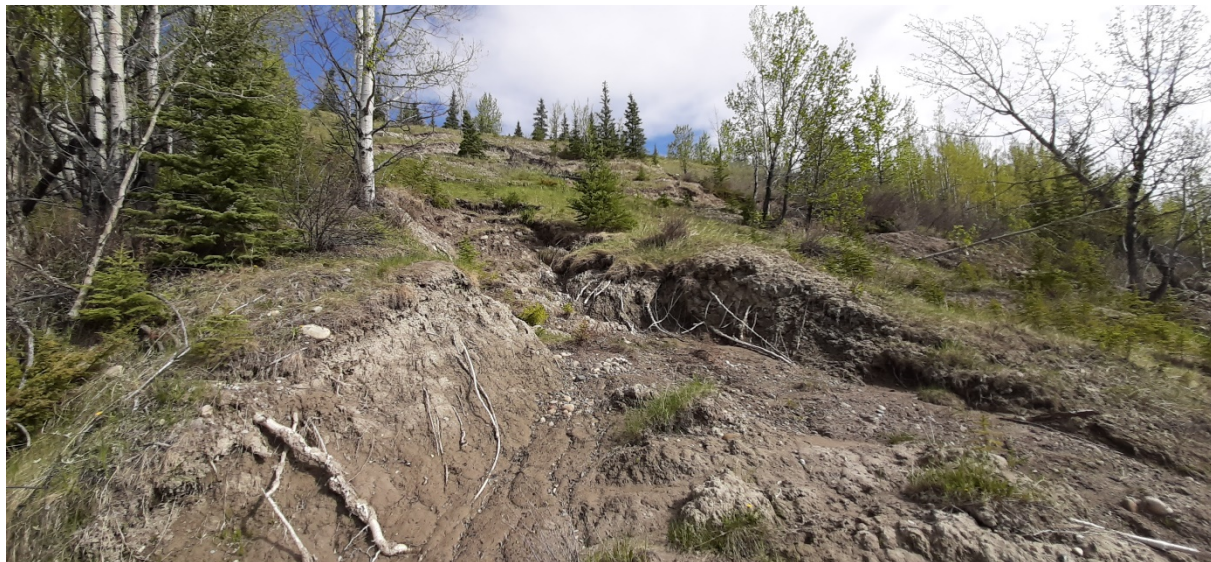
Photo 14: Overall Slope from toe. Looking north.
