**NORTH CENTRAL REGION GRMP  
EDSON / STONY PLAIN  
SITE INSPECTION FORM**

<b>SITE NUMBER AND NAME:</b> NC011 – 5.5 km North of Highway 16 (Near Hinton)	<b>HIGHWAY AND KM:</b> 40:30, km 5.617	<b>PREVIOUS INSPECTION:</b> May 26, 2020	<b>CURRENT INSPECTION:</b> July 15, 2021
<b>LEGAL DESCRIPTION:</b> NW-01-51-26-W5	<b>NAD83 COORDINATES:</b> UTM11U 5914110N, 452891E		<b>RISK ASSESSMENT:</b> PF: 13 CF: 8 Total: 104
<b>AVERAGE ANNUAL DAILY TRAFFIC (AADT):</b> 1,260 (2020)		<b>CONTRACTOR MAINTENANCE AREA (CMA):</b> 508

**Client/Project**  
 Alberta Transportation  
 Geohazard Monitoring Program  
 NC11 5.5 km North of Hwy 16 (Near Hinton)

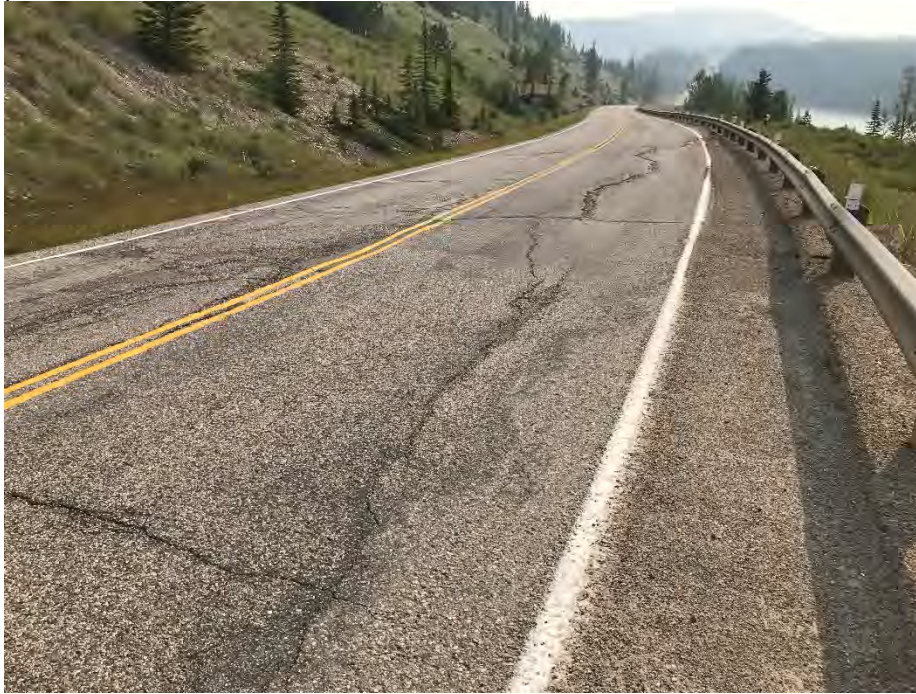
**Photo 1:** Pavement cracking at west extent. Looking east.

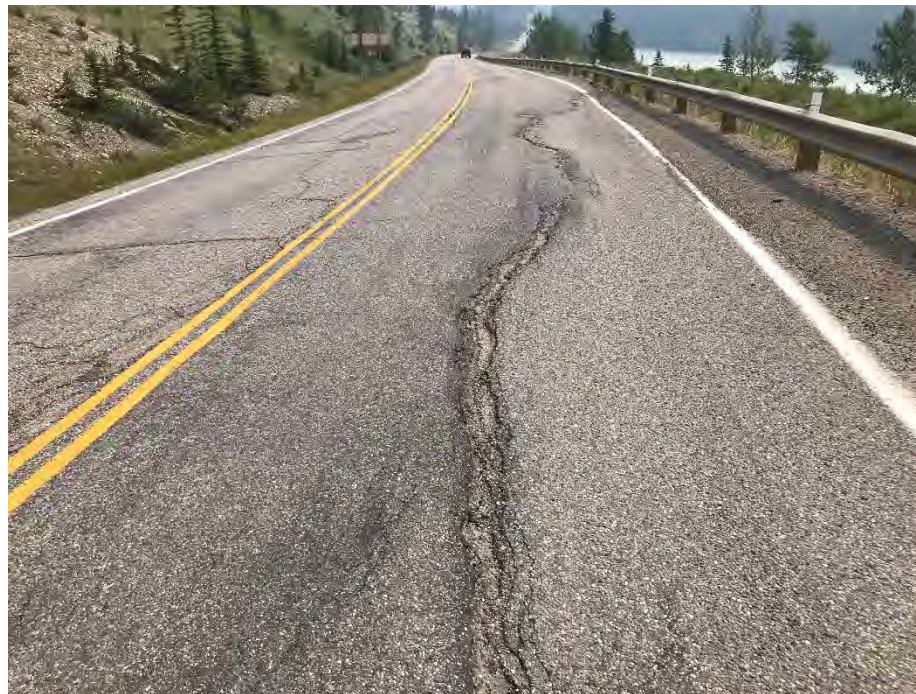
**Photo 2:** Pavement cracking approximately at midpoint. Looking east.

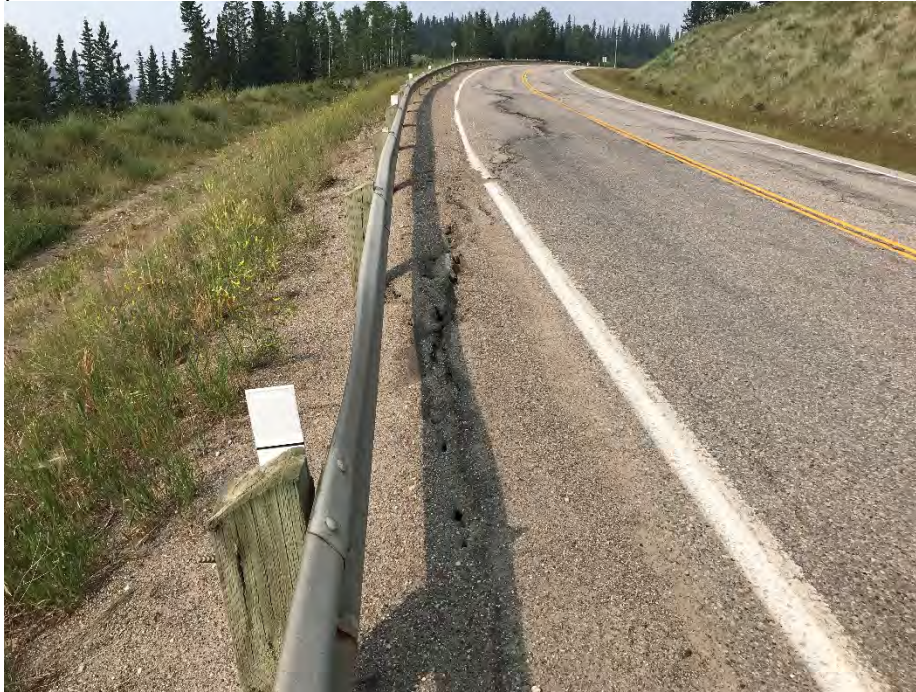
**Photo 3:** Pavement crack at east extent. Looking west.

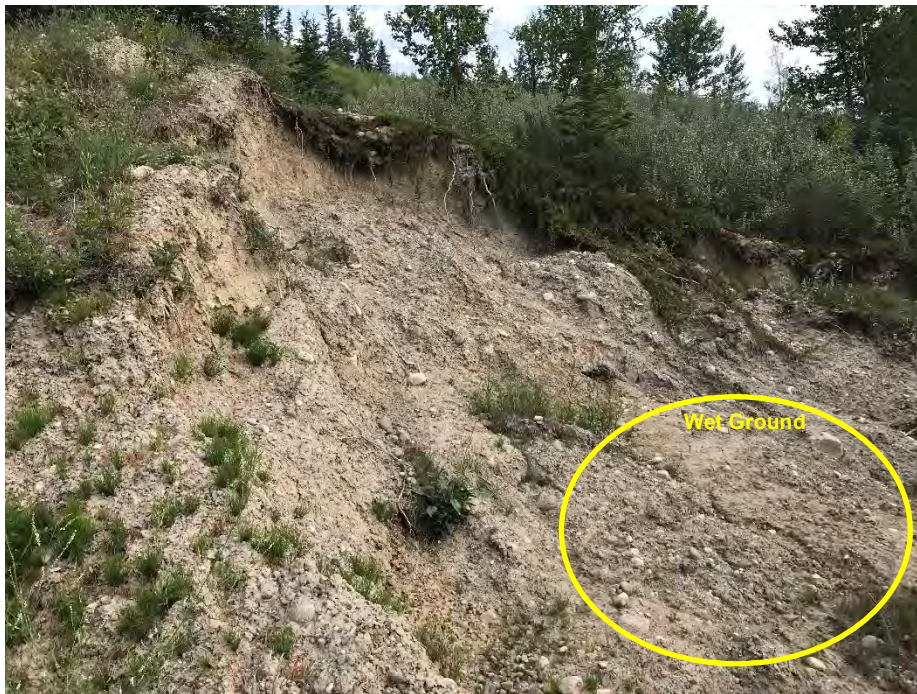
**Photo 4:** 1.5 m scarp with wet ground below access bench at west midslope slide. Looking north.

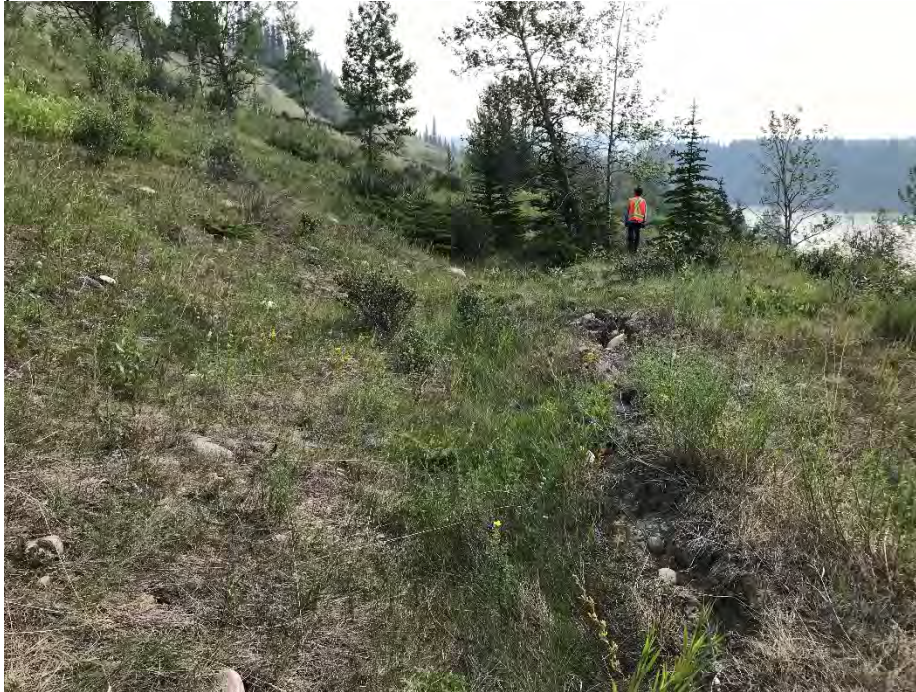
**Photo 5:** Ground crack at ridge location at the west extent of the west landslide. Leaning trees in background. Looking northeast.

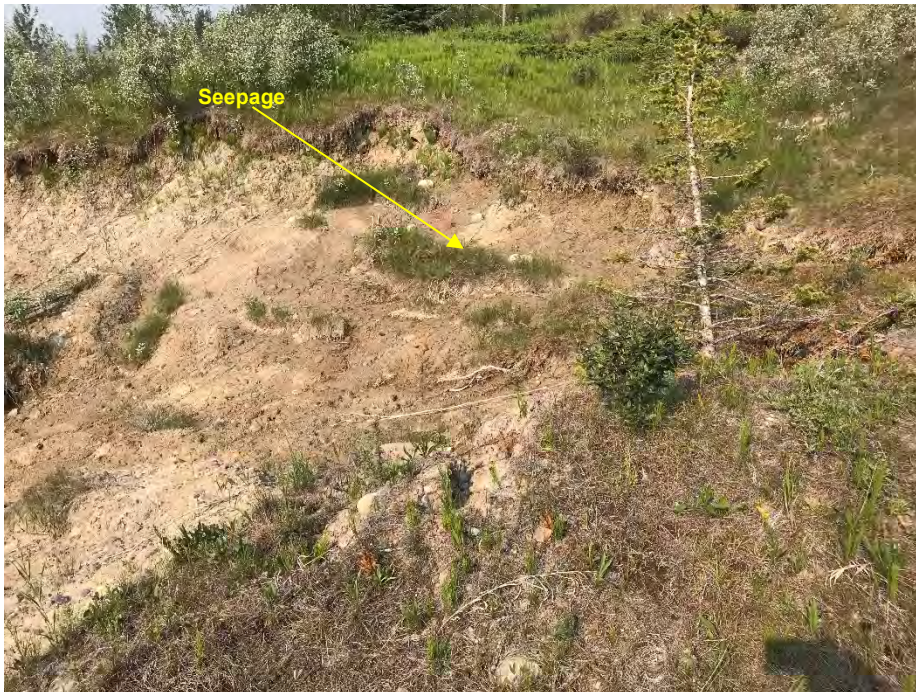
**Photo 6:** Seepage in west portion of east landslide. Looking northwest.

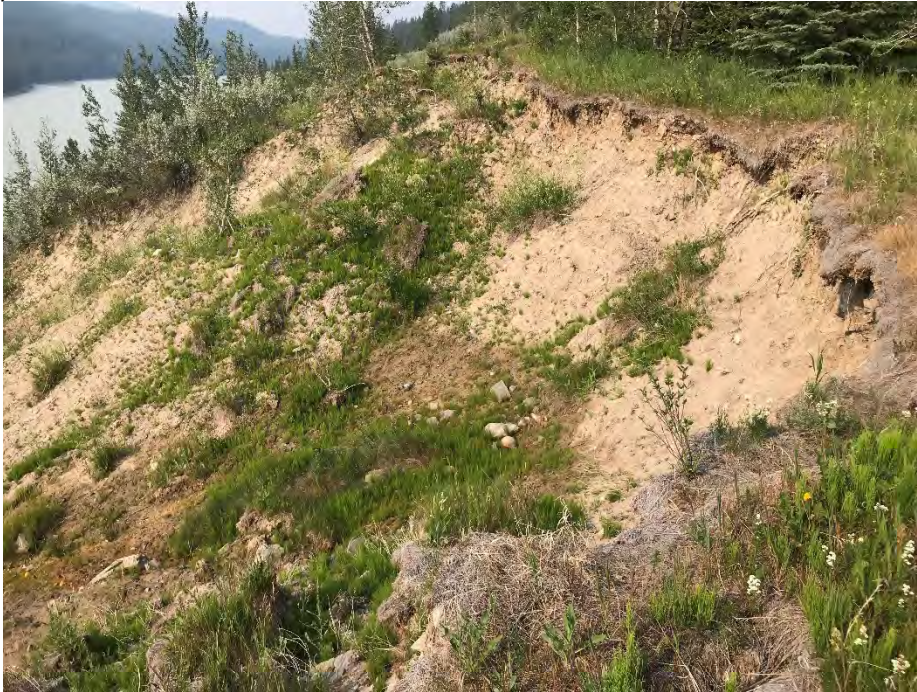
**Photo 7:** Seepage in east portion of east landslide. Looking west.

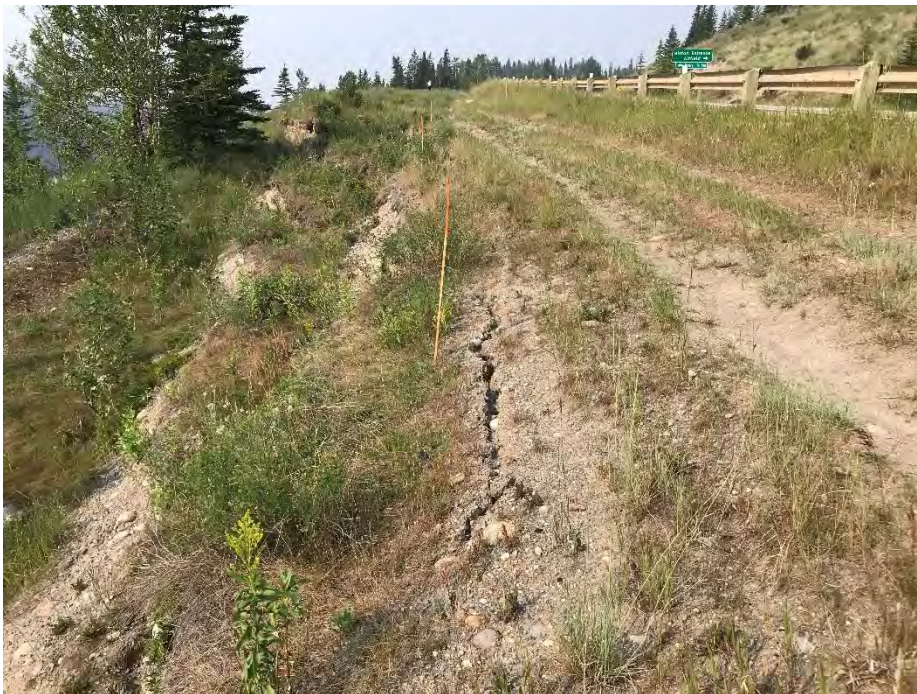
**Photo 8:** Tension crack behind south shoulder scarp. Distance to guardrail about 5.2 m. Looking southwest.

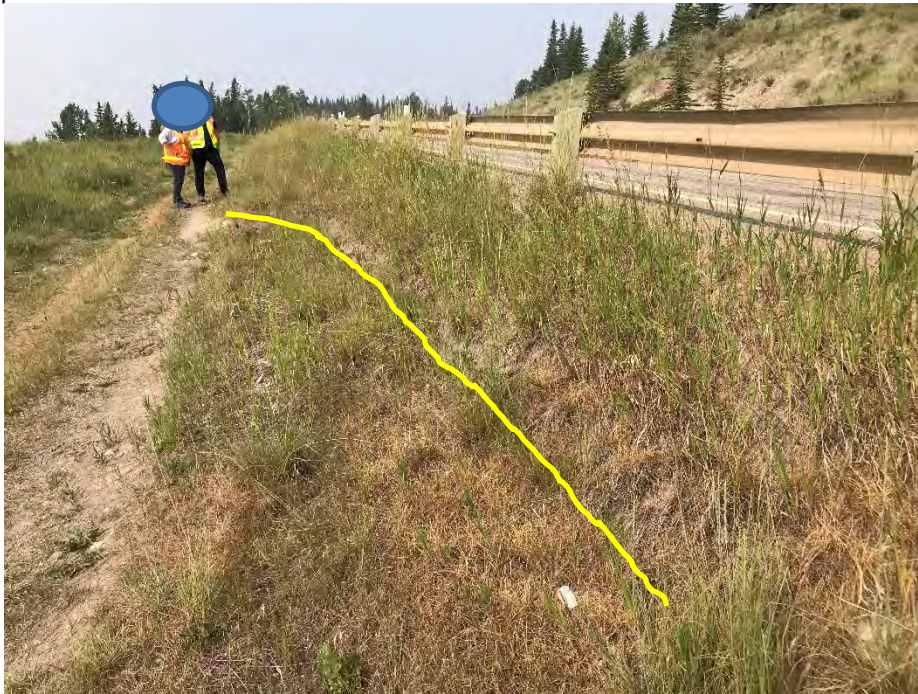
**Photo 9:** New scarp near “Hinton Entrance” sign. Looking west.

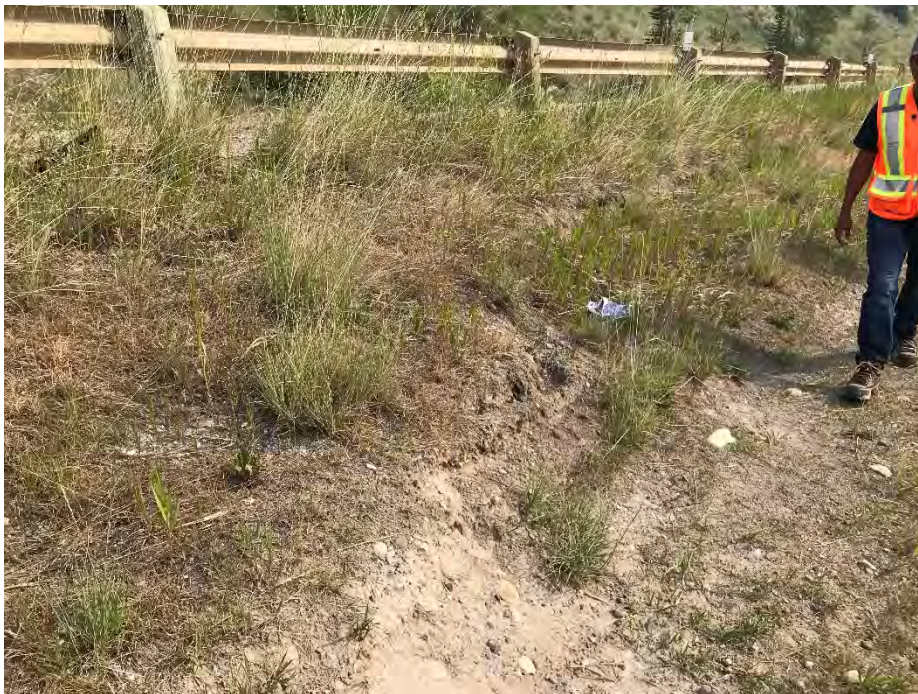
**Photo 10:** West extent of new scarp near “Hinton Entrance” sign. Looking northeast.
