To:	Amy Driessen Alberta Transportation	From:	Leslie Cho and Xiteng Liu Stantec Consulting Ltd.
File:	123315222	Date:	October 7, 2022

Reference: North Central Region, Edson/Stony Plain, Site NC011 – Highway 40:30 5.5 km North of Highway 16 (Near Hinton), Fall 2022 Instrumentation Monitoring Report

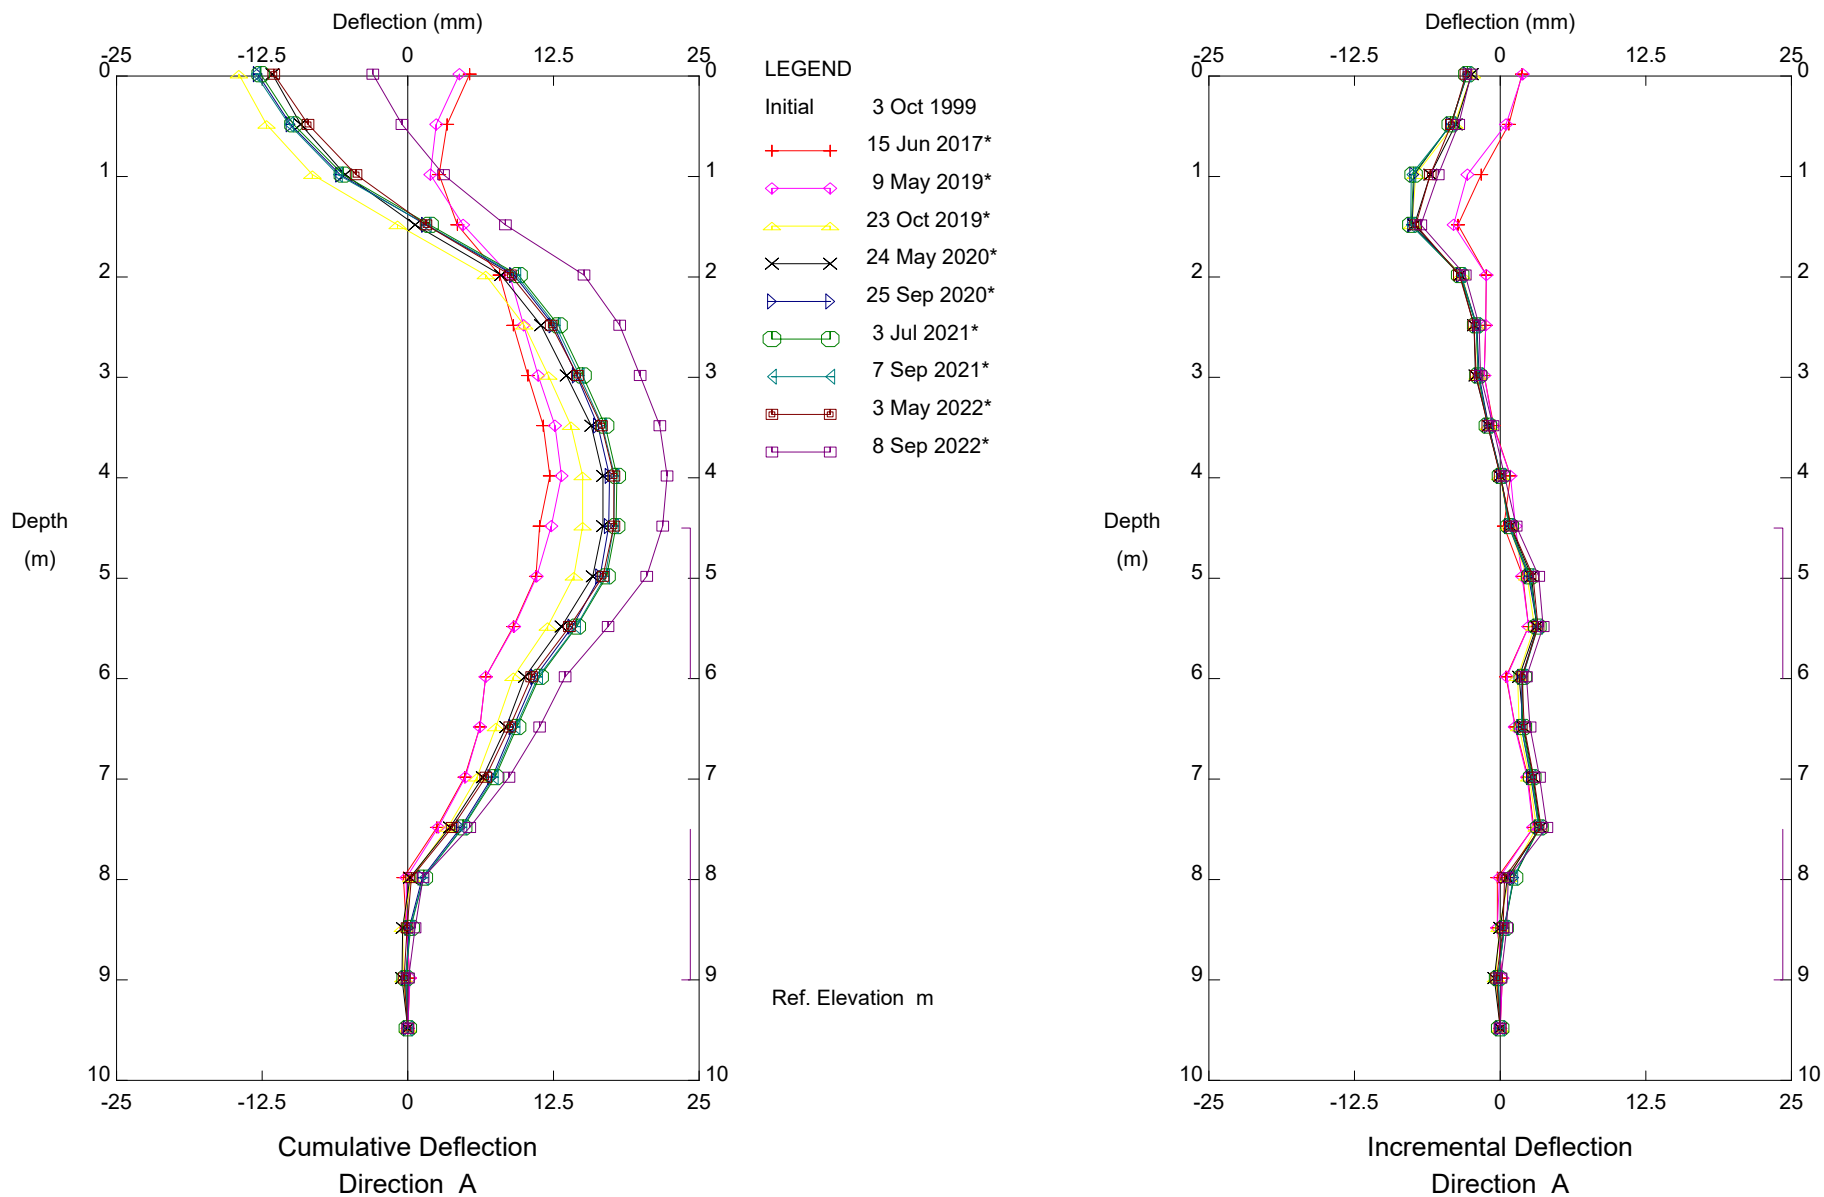
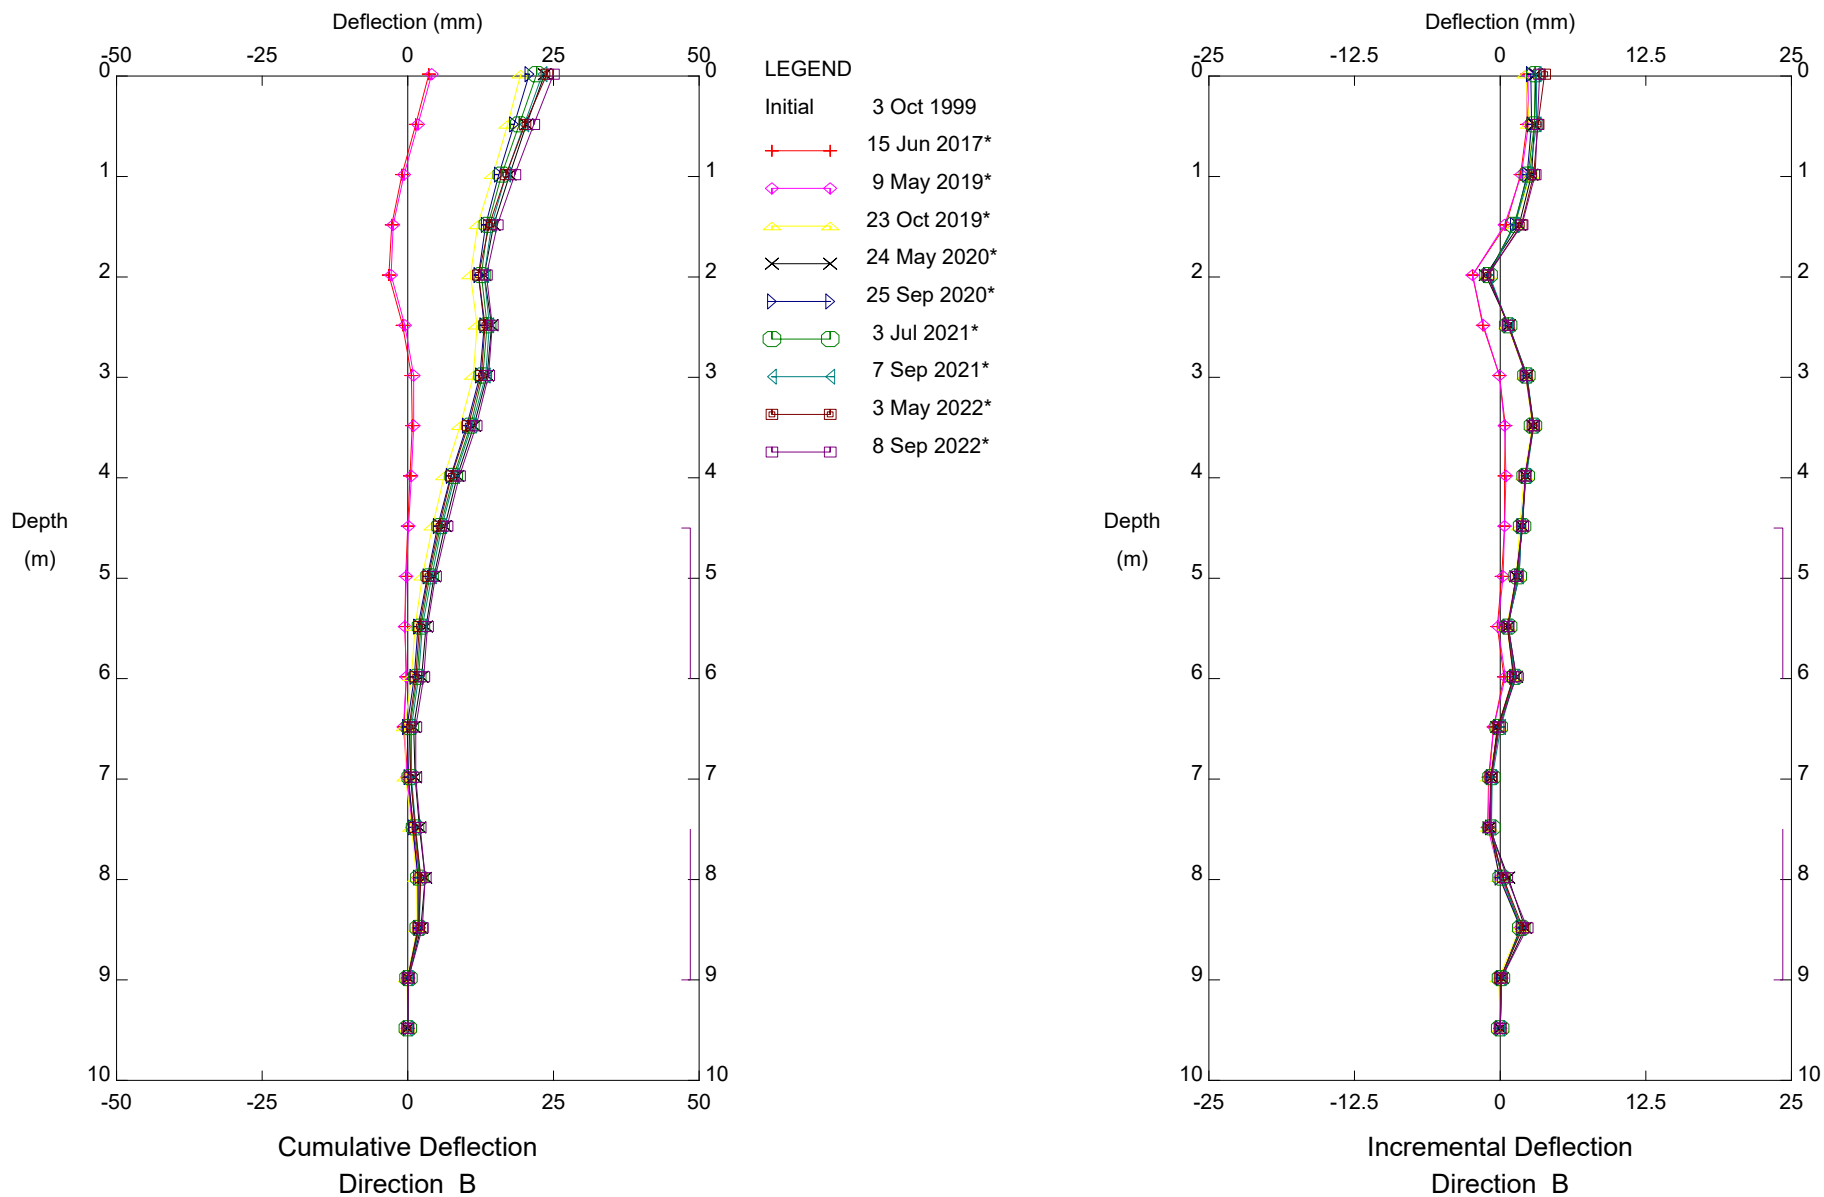
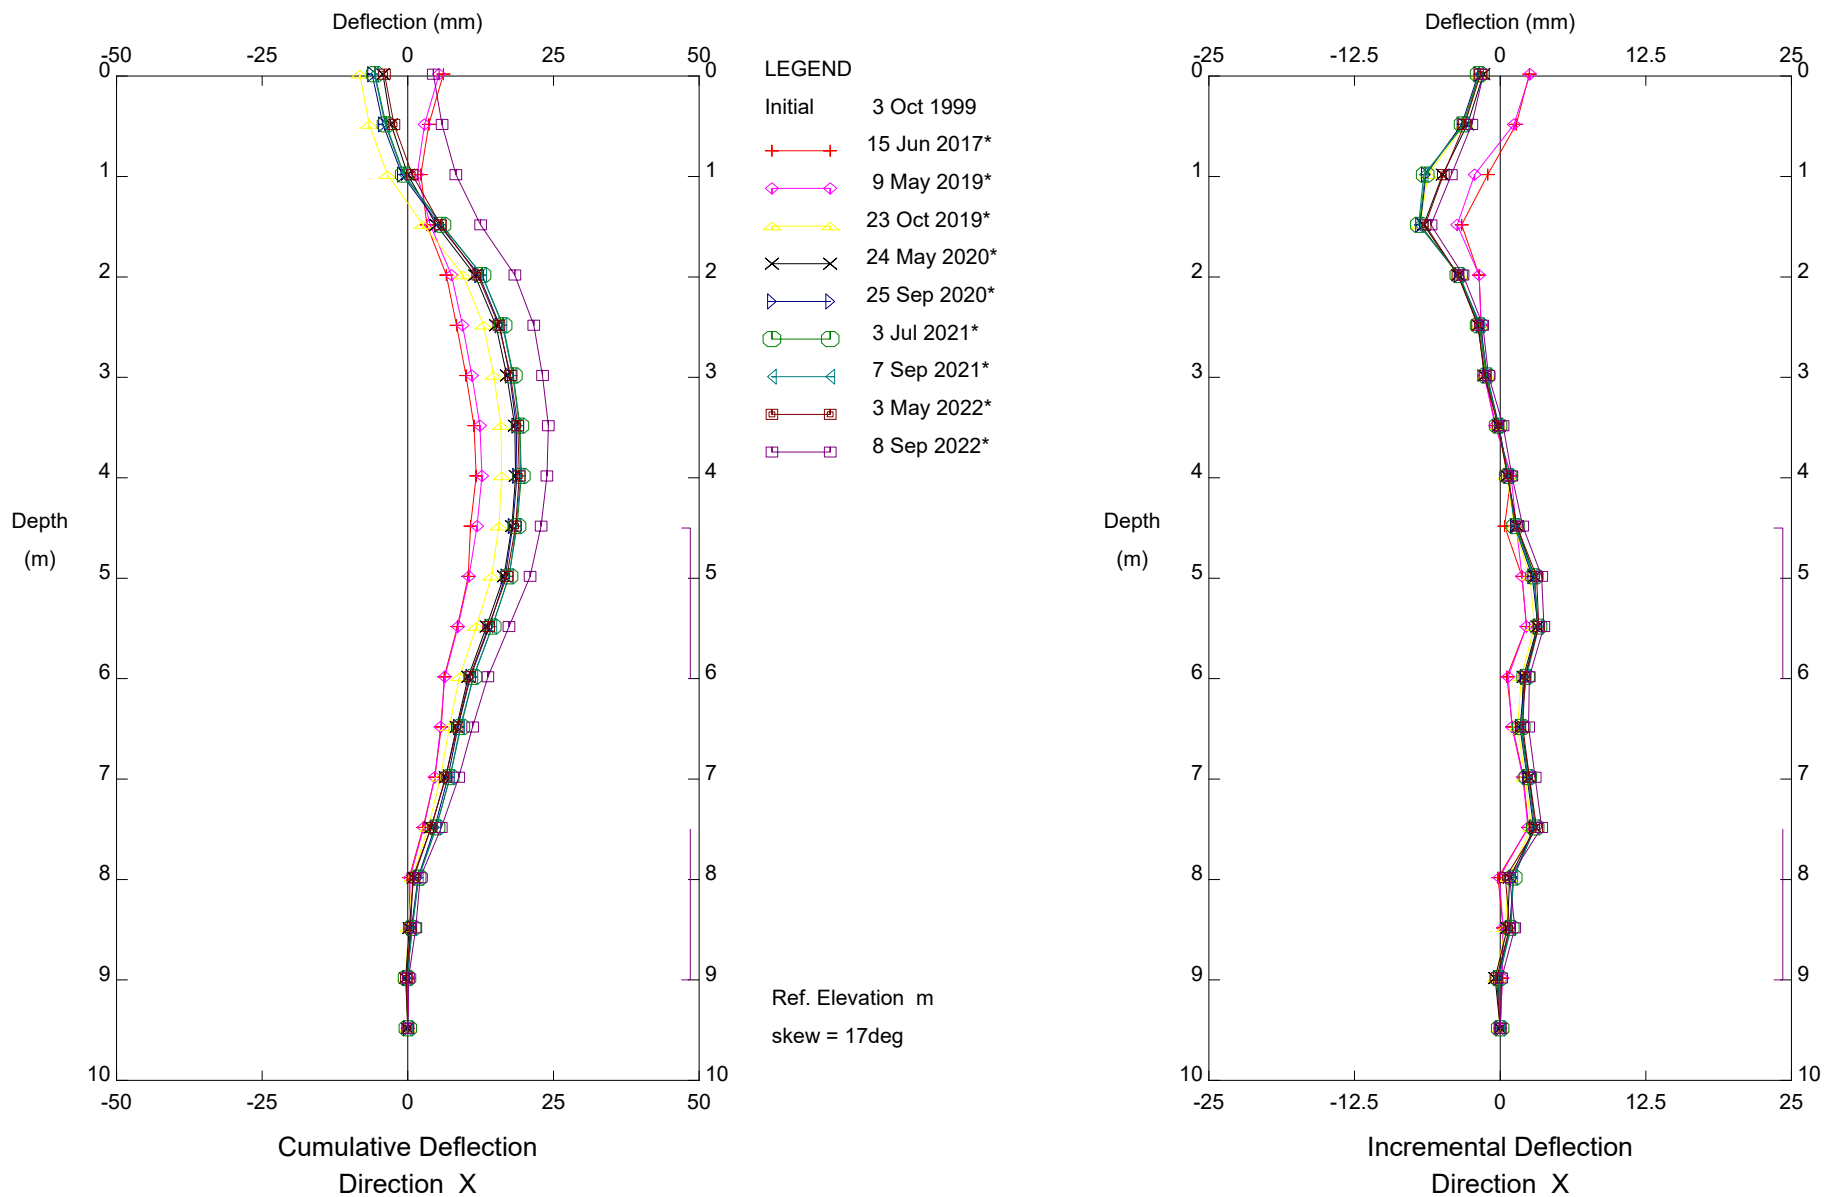
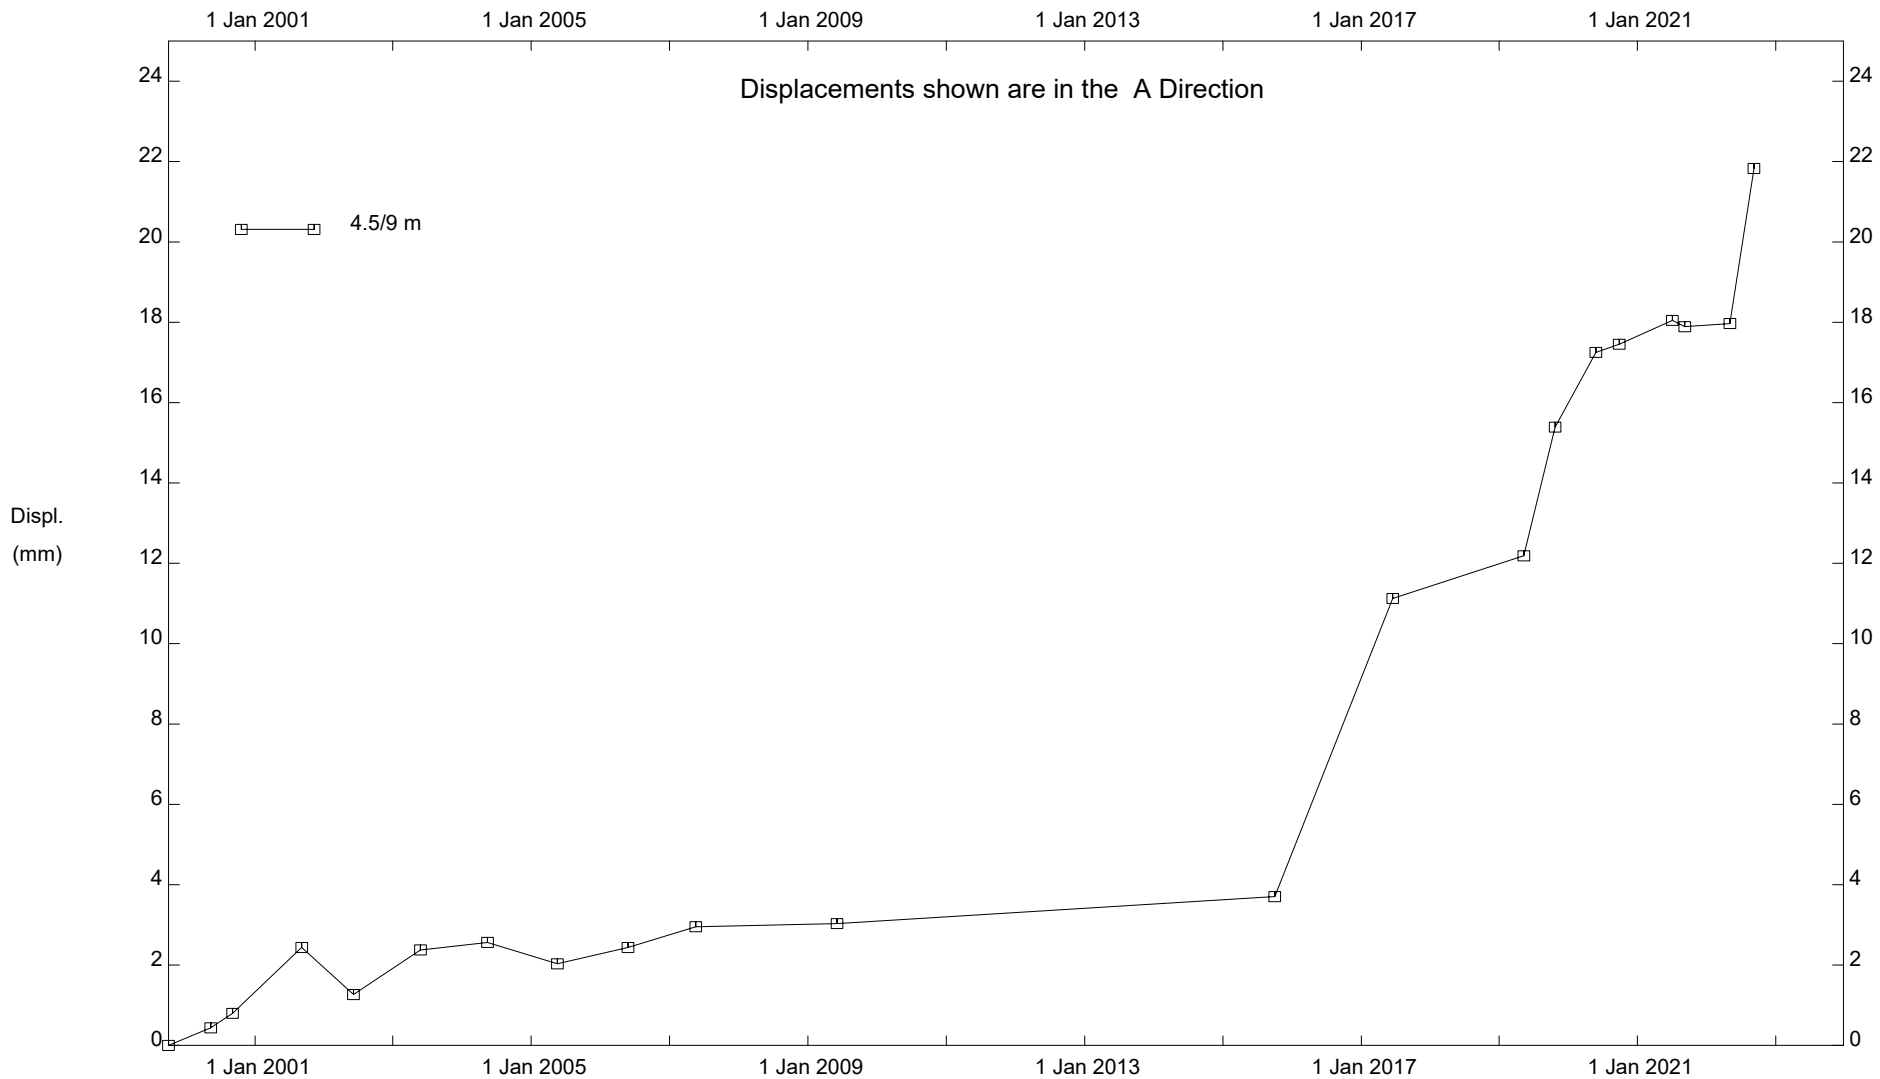
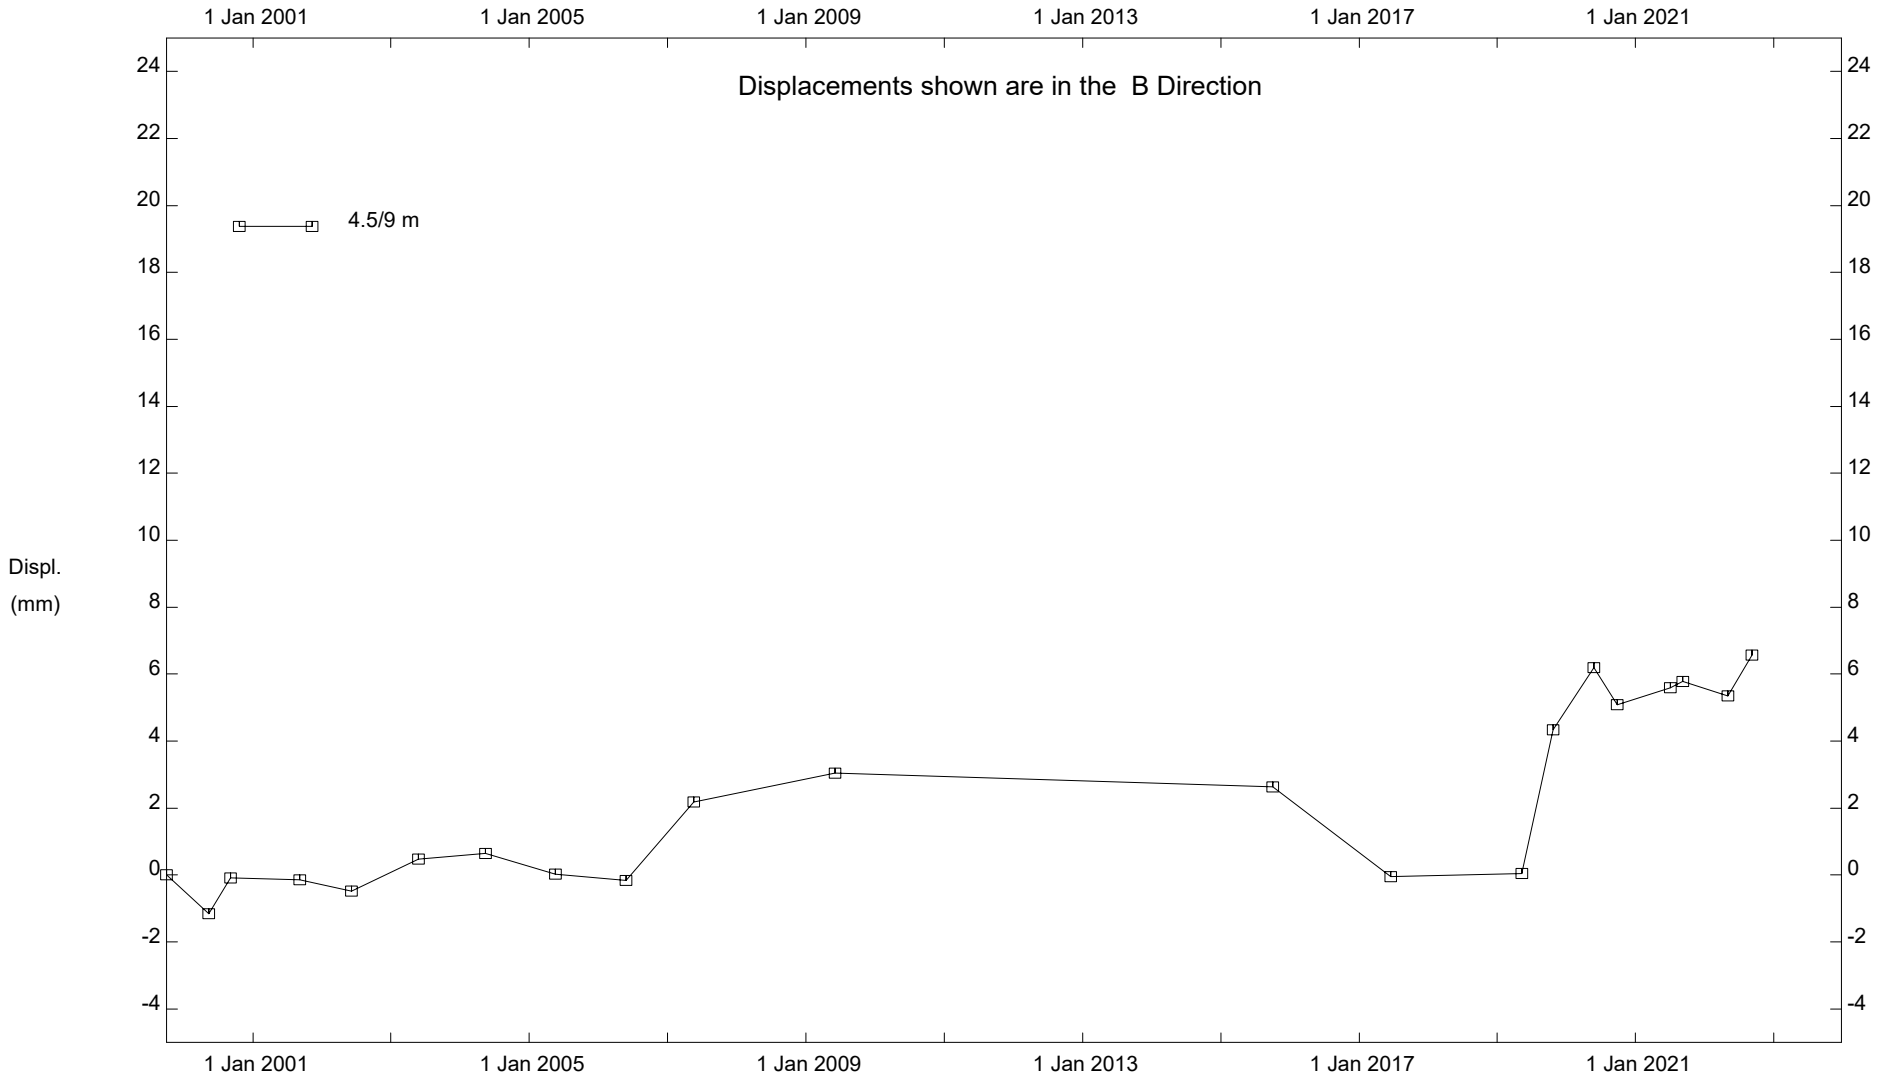
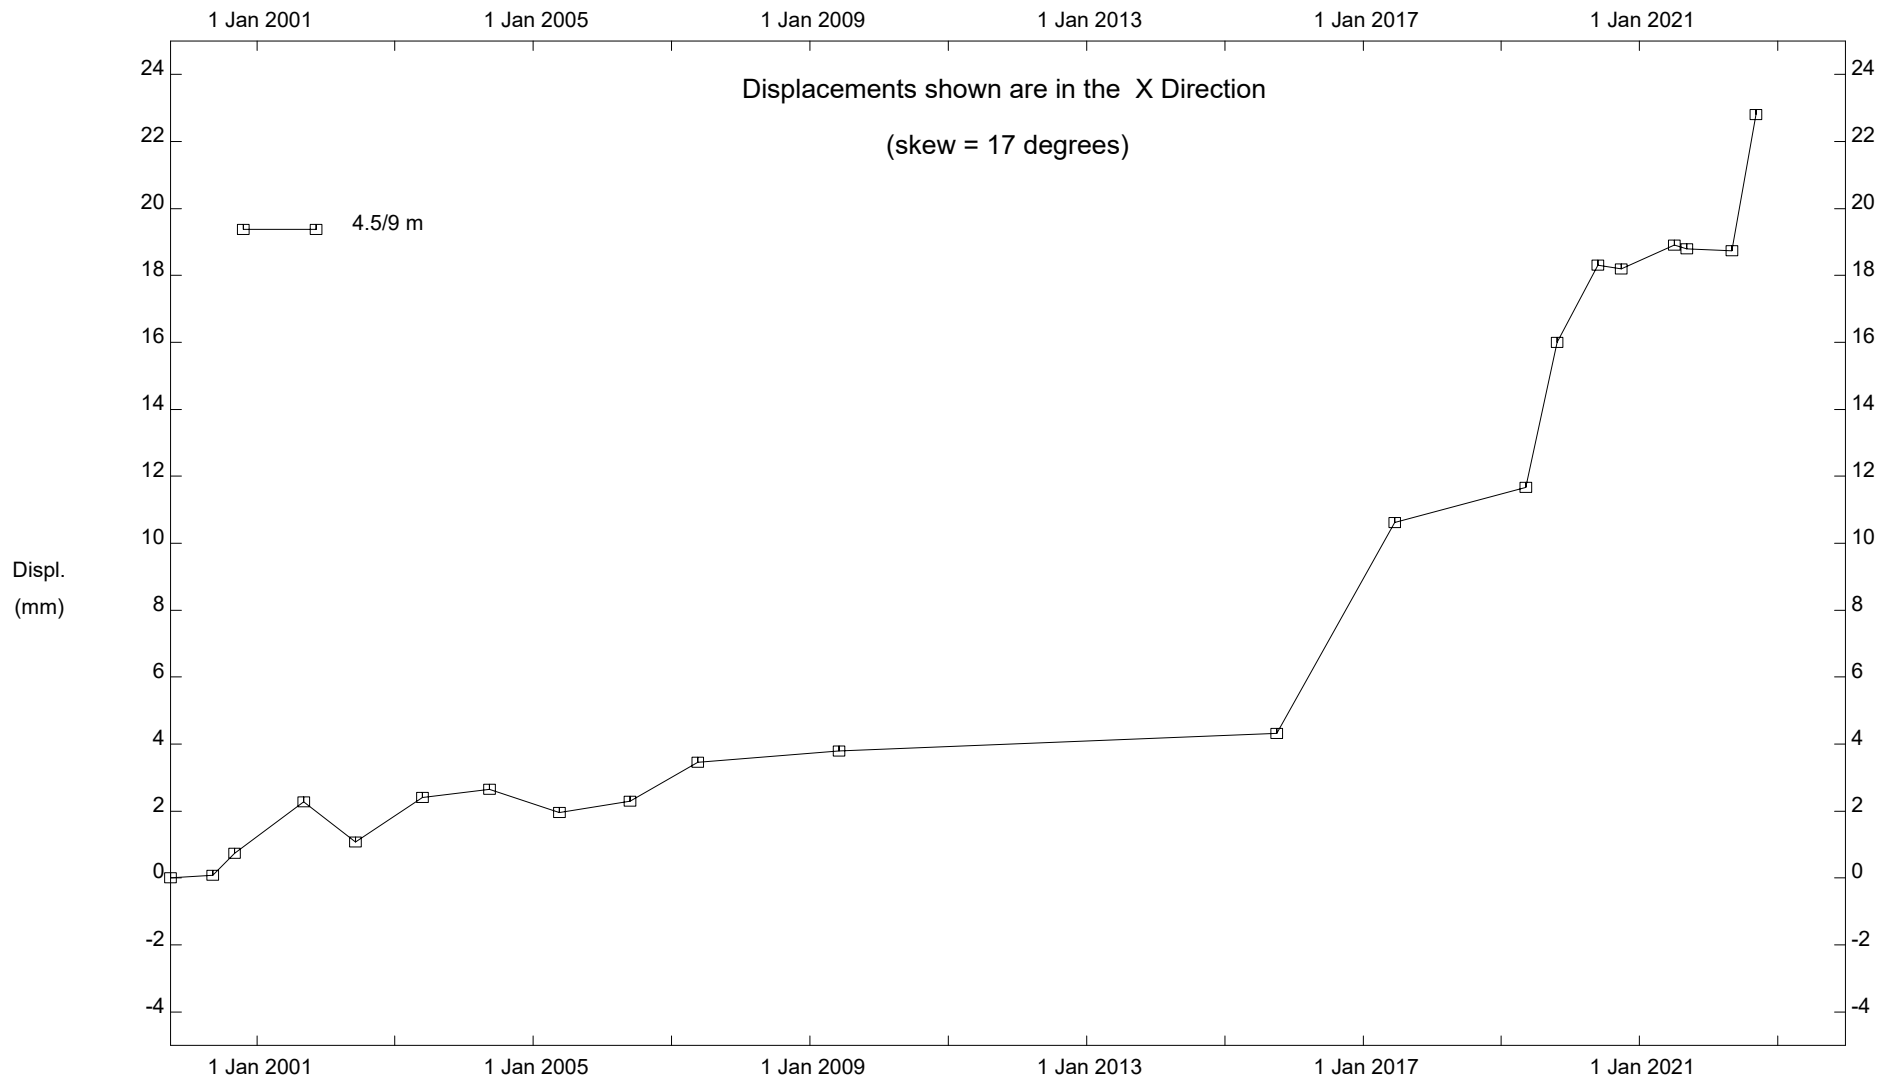
Hwy 40:30, North of Hinton (NC11), Inclinometer SI2
 Alberta Transportation

SI-2 shows incremental movement of 4 mm since the Spring 2022 reading cycle. A total cumulative resultant movement of 23 mm has been observed since installation in 1999. The current rate of movement is approximately 12 mm/yr.

It is recommended that the next reading cycle take place in Spring 2023.
