To:	Amy Driessen	From:	Leslie Cho and Xiteng Liu
	Transportation and Economic Corridors		Stantec Consulting Ltd.
File:	123315222	Date:	October 18, 2024

Reference: North Central Region, Edson/Stony Plain, Site NC011 – Highway 40:30 5.5 km North of Highway 16 (Near Hinton), Fall 2024 Instrumentation Monitoring Report

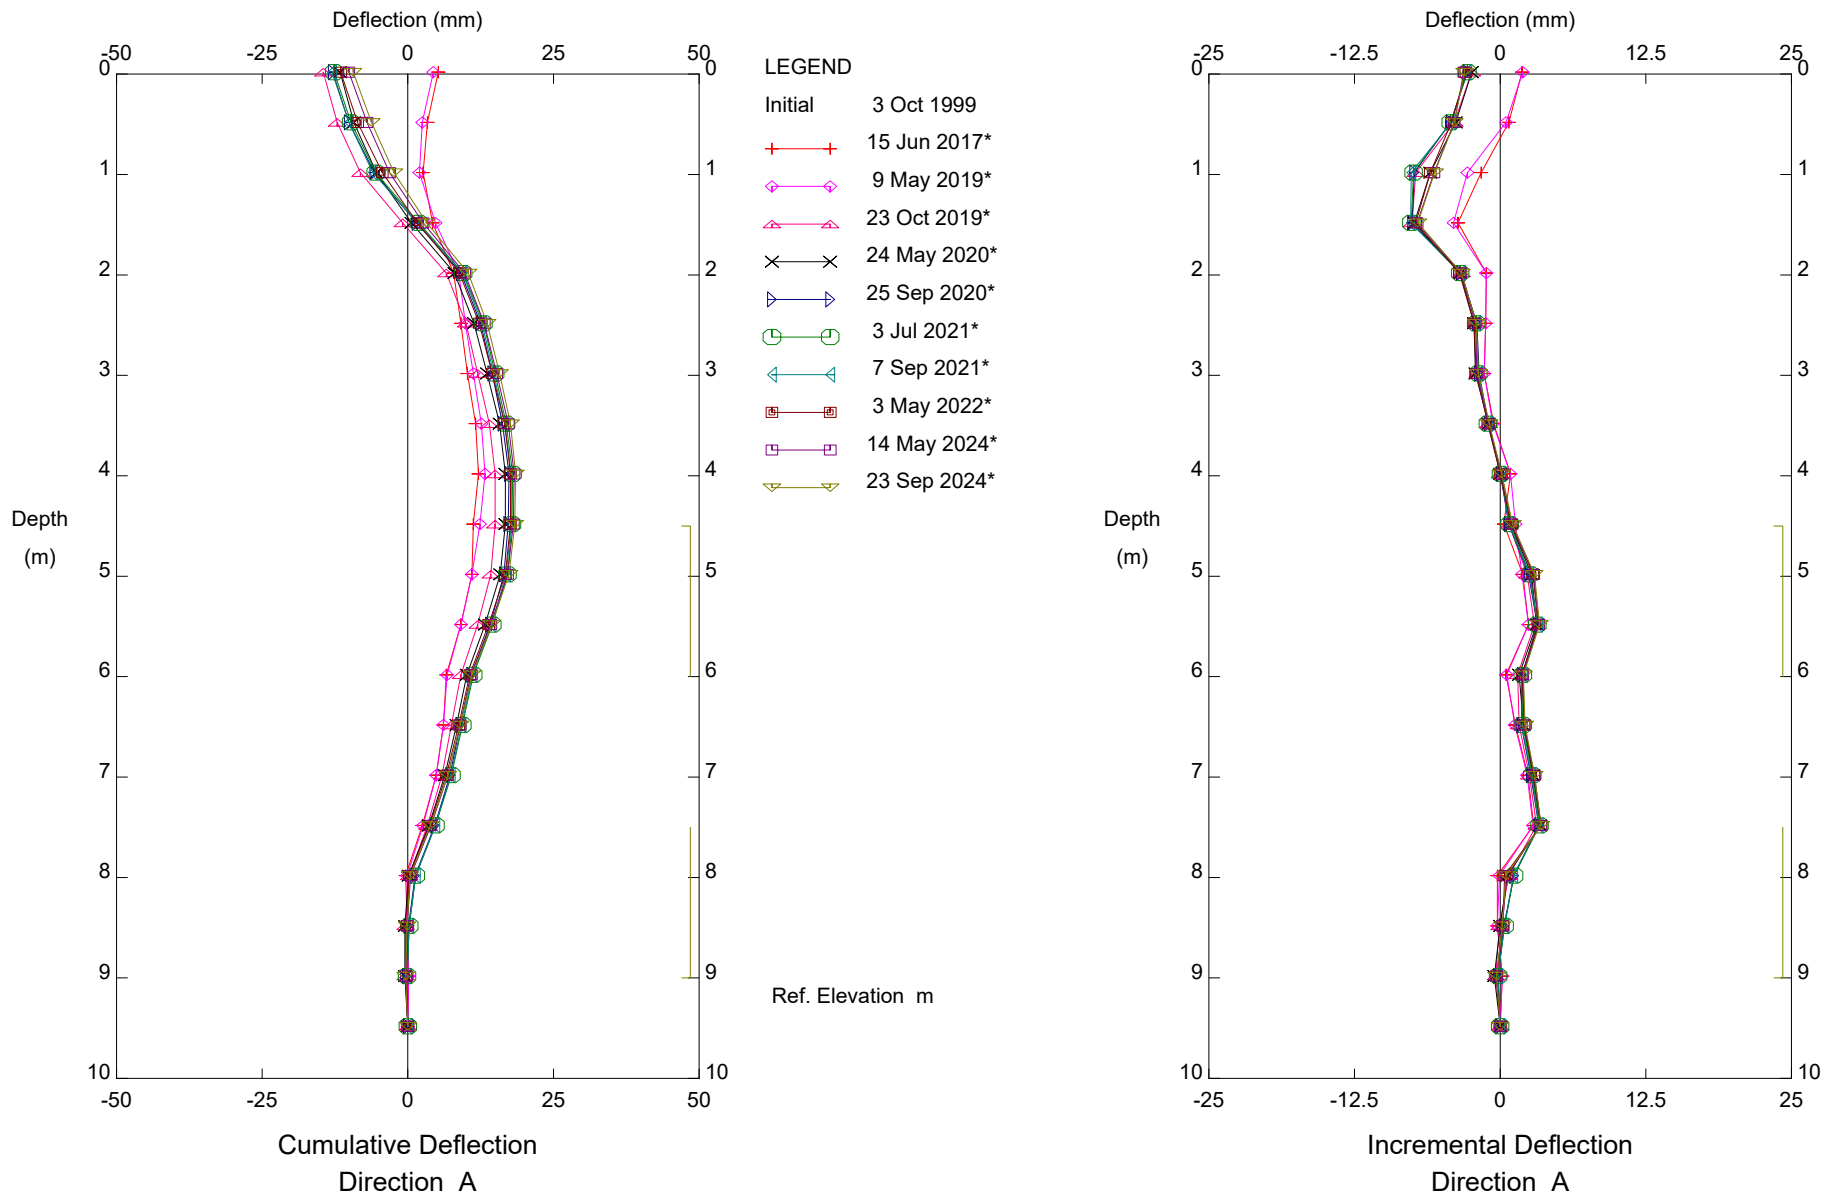
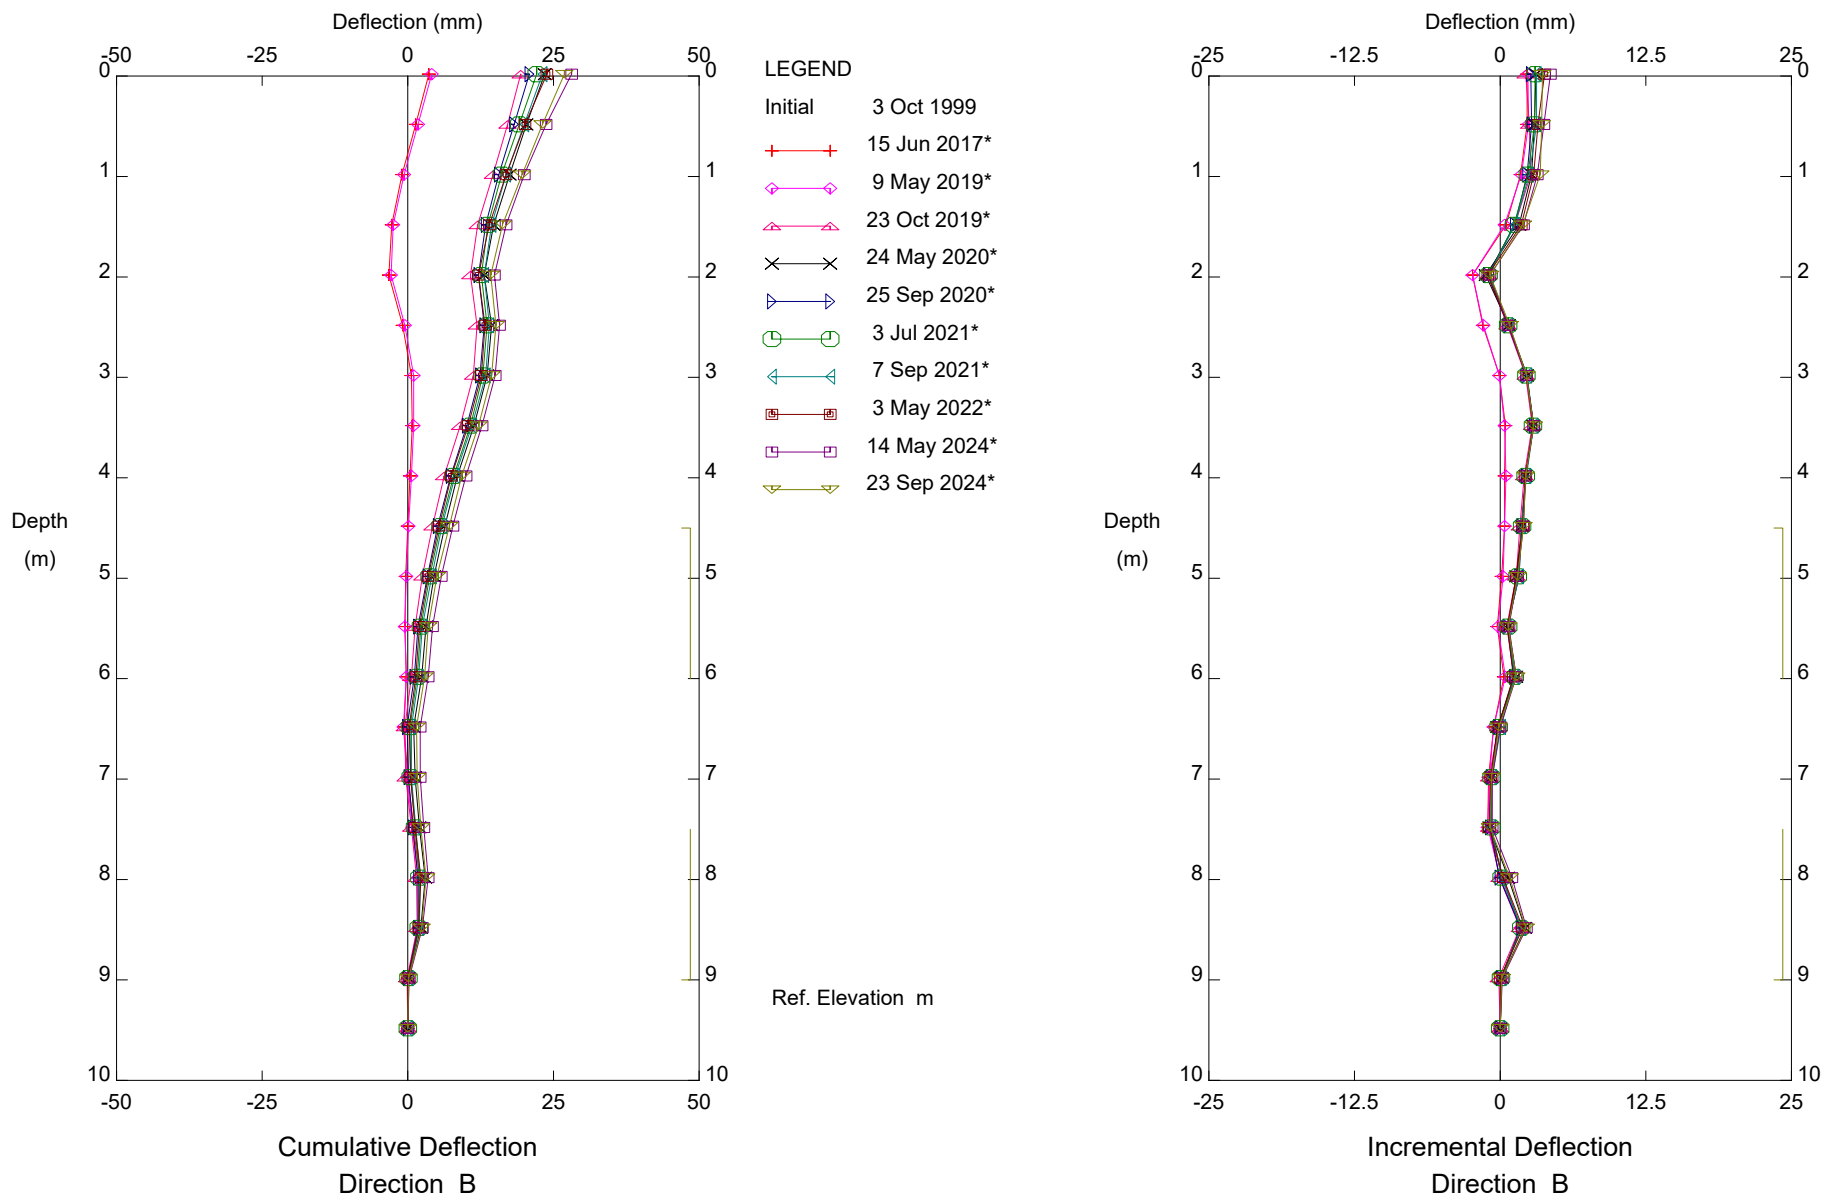
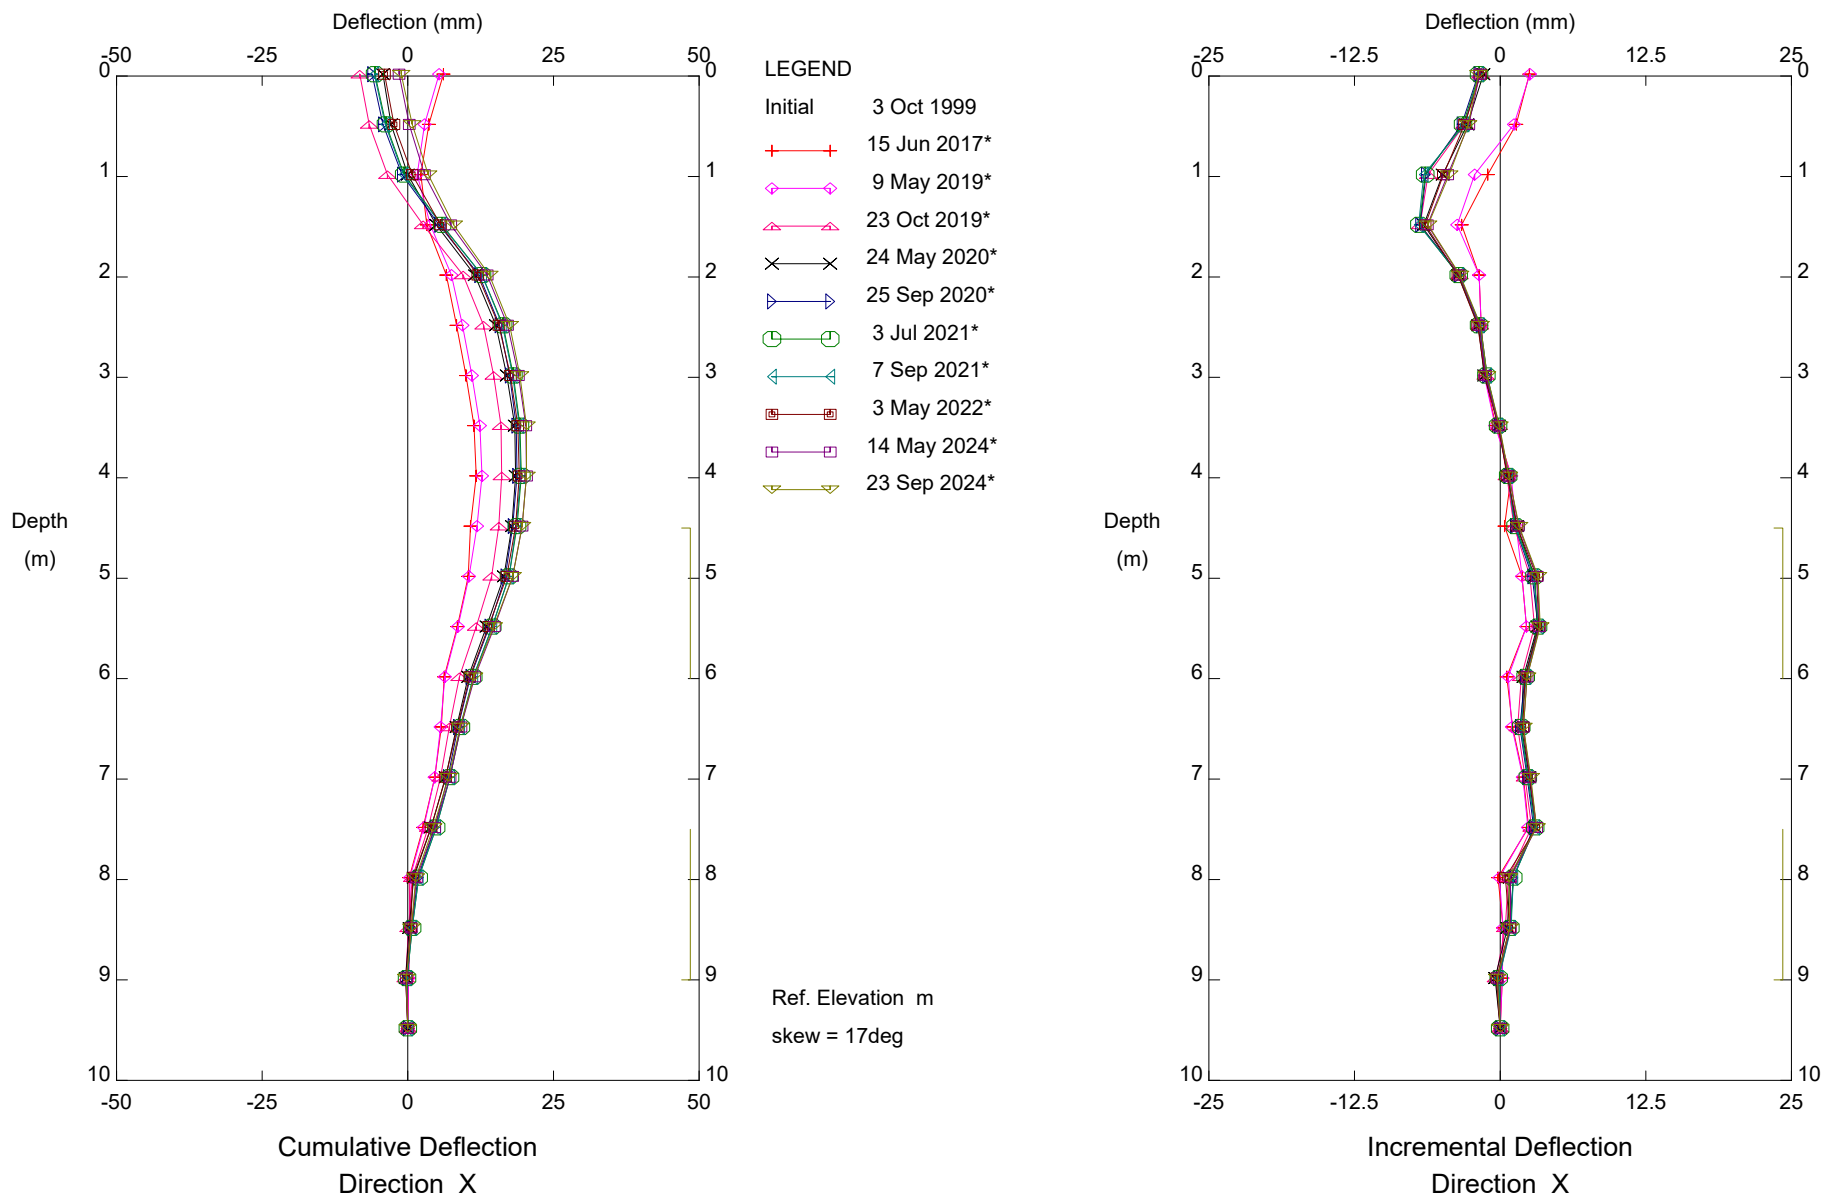
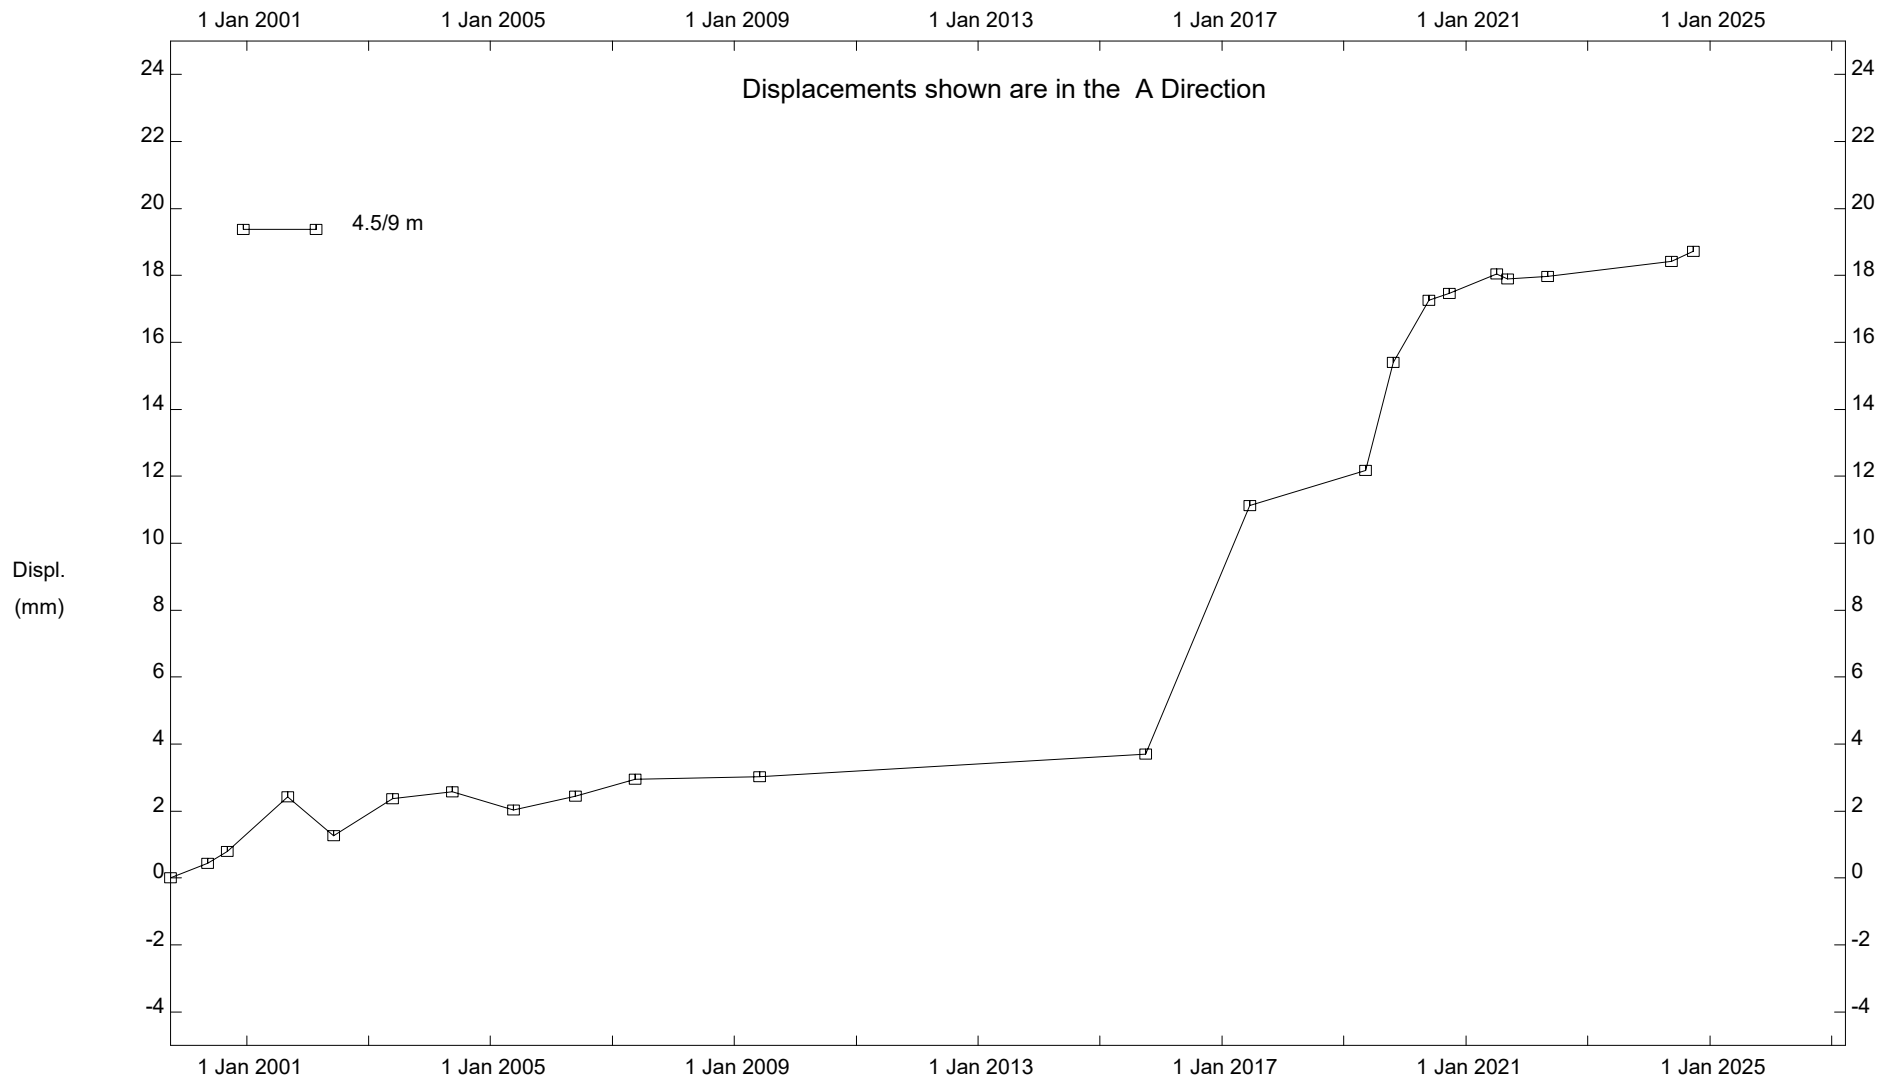
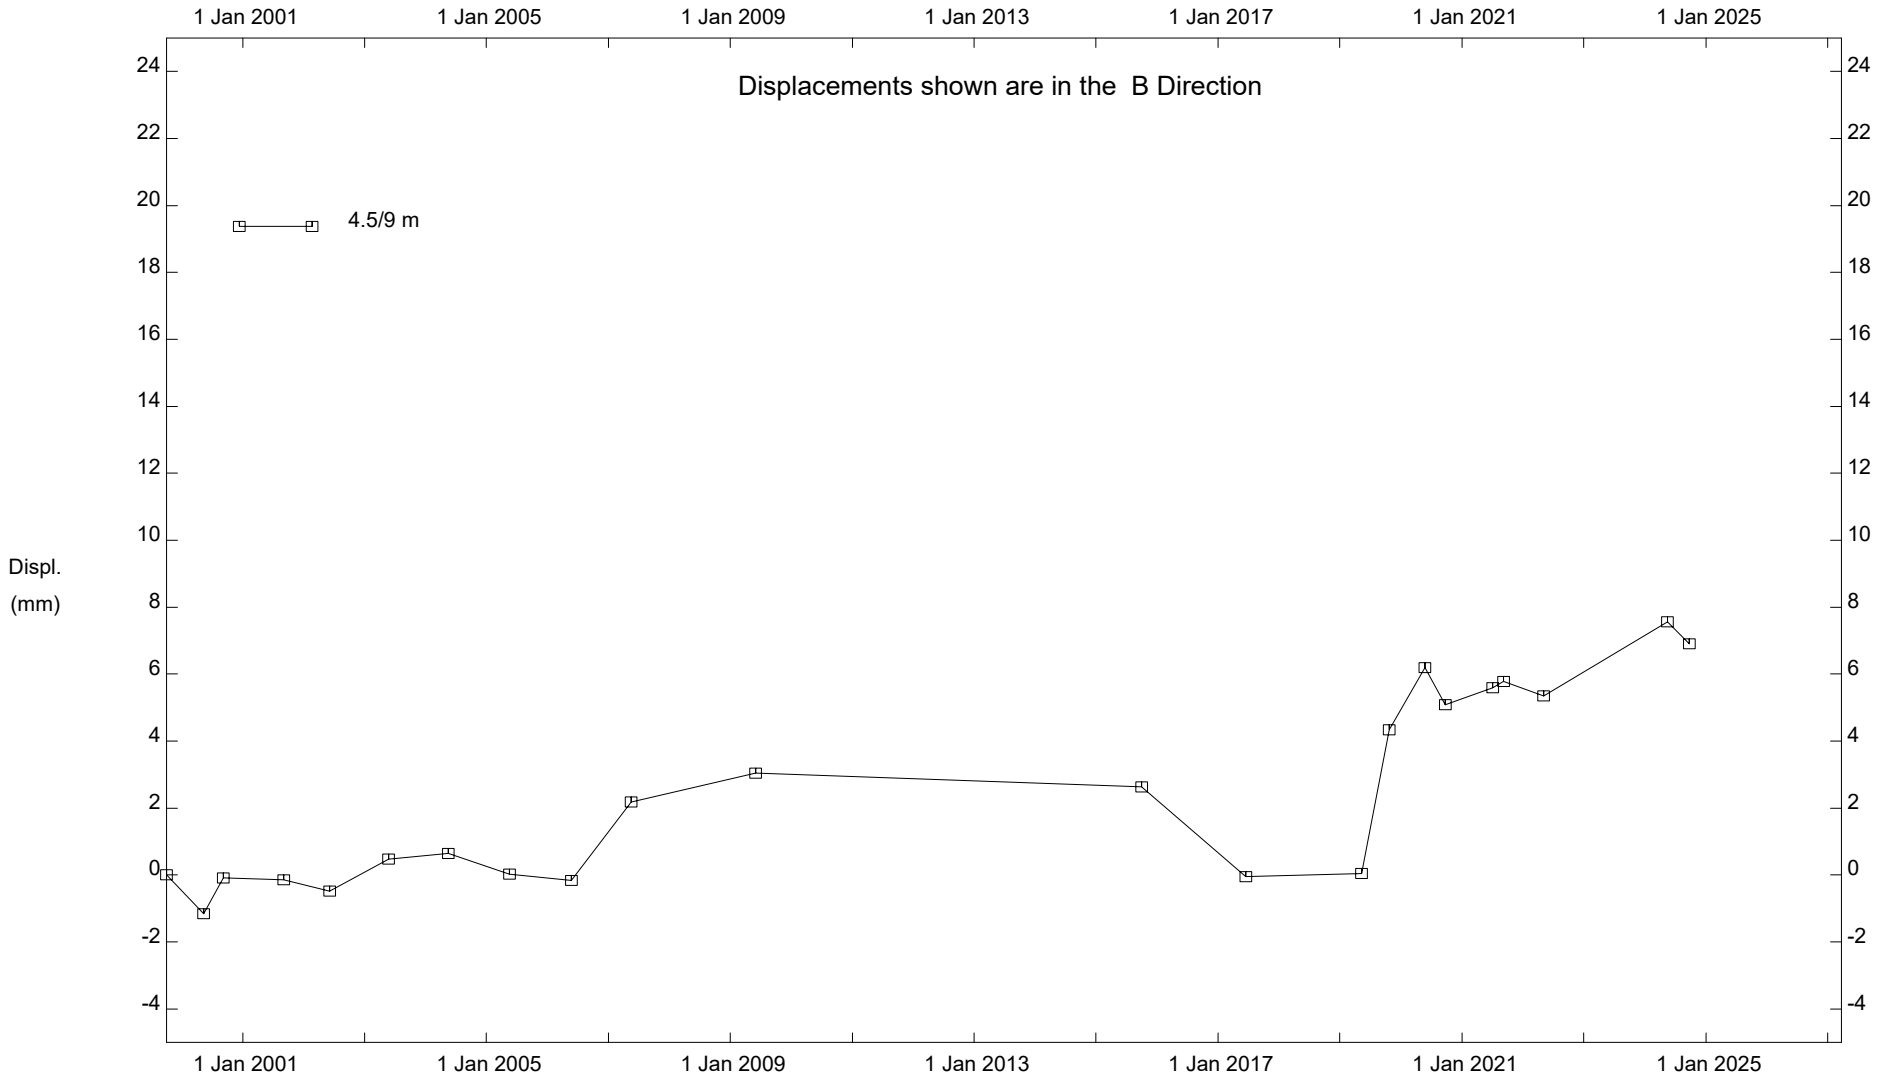
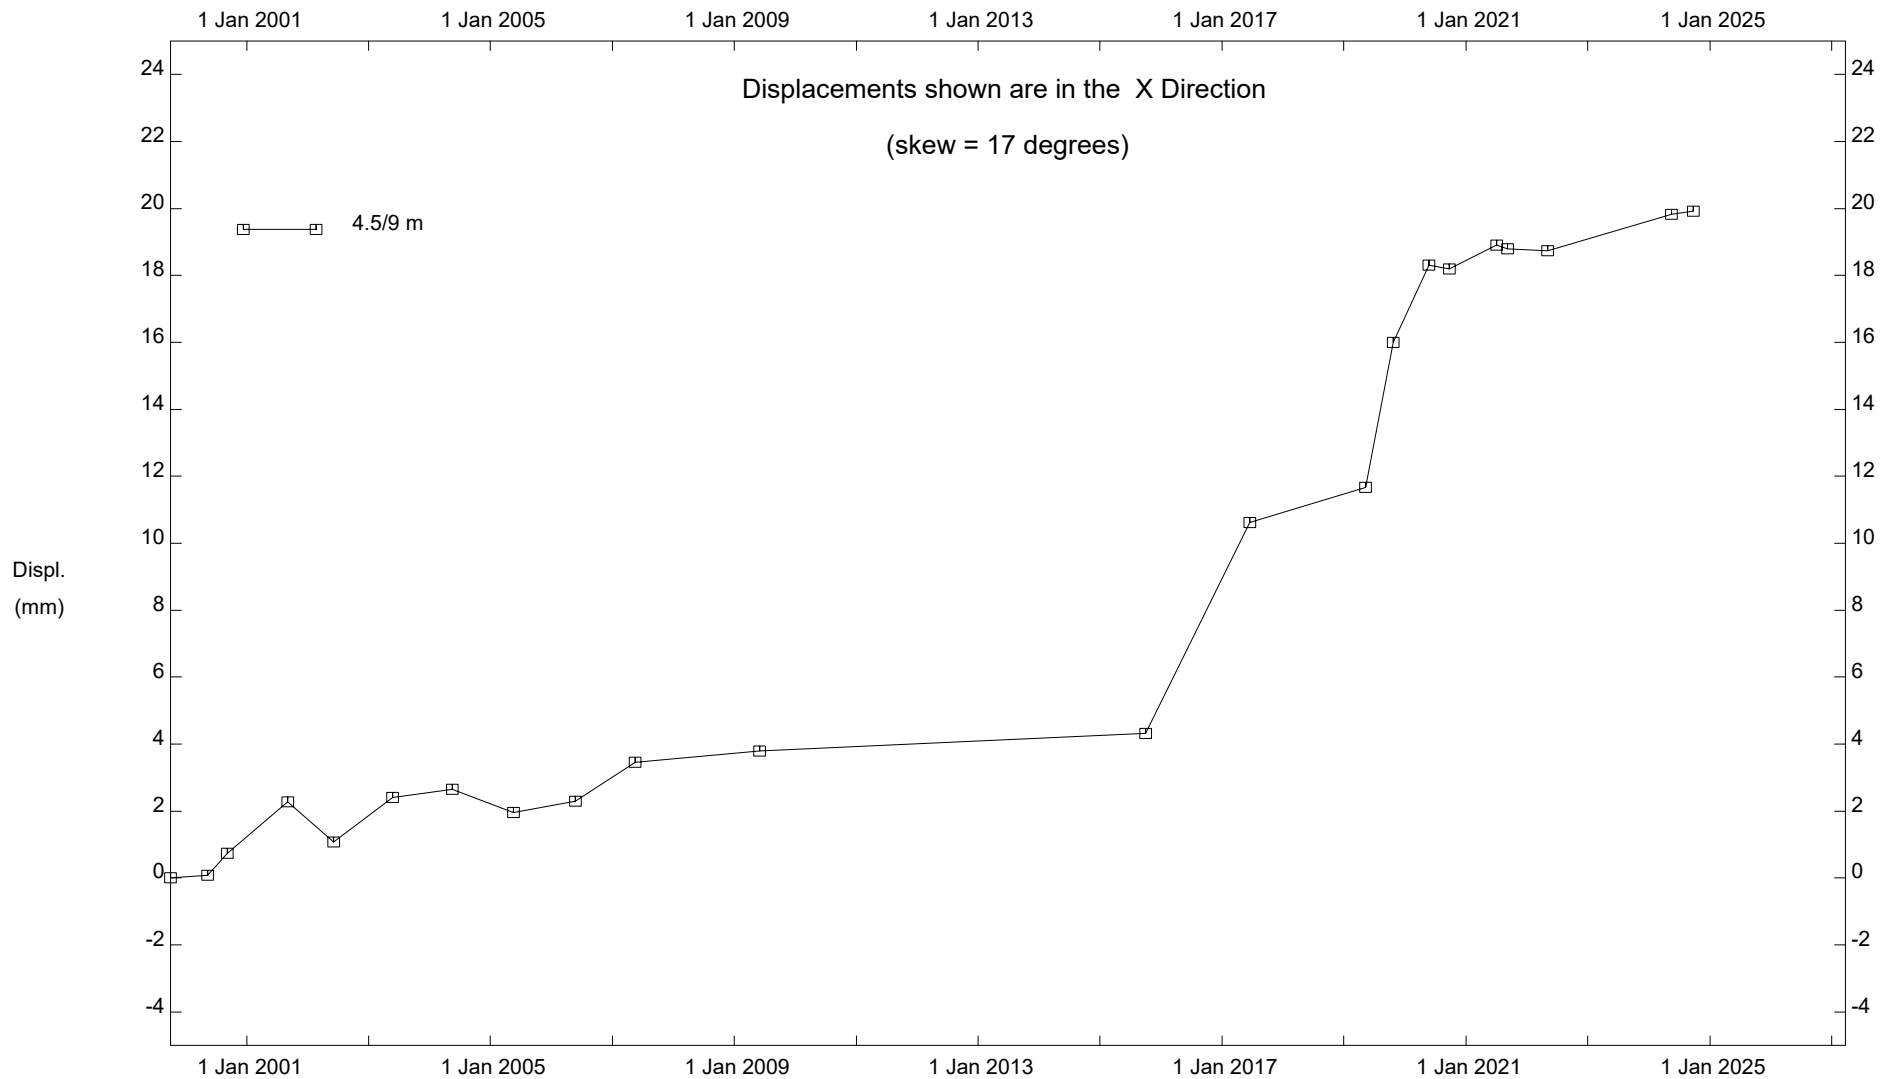
Hwy 40:30, North of Hinton (NC11), Inclinator SI2
 Alberta Transportation

SI2 showed little incremental movement (< 1 mm) since the last reading in May 2024. The current movement rate is less than 1 mm/yr.

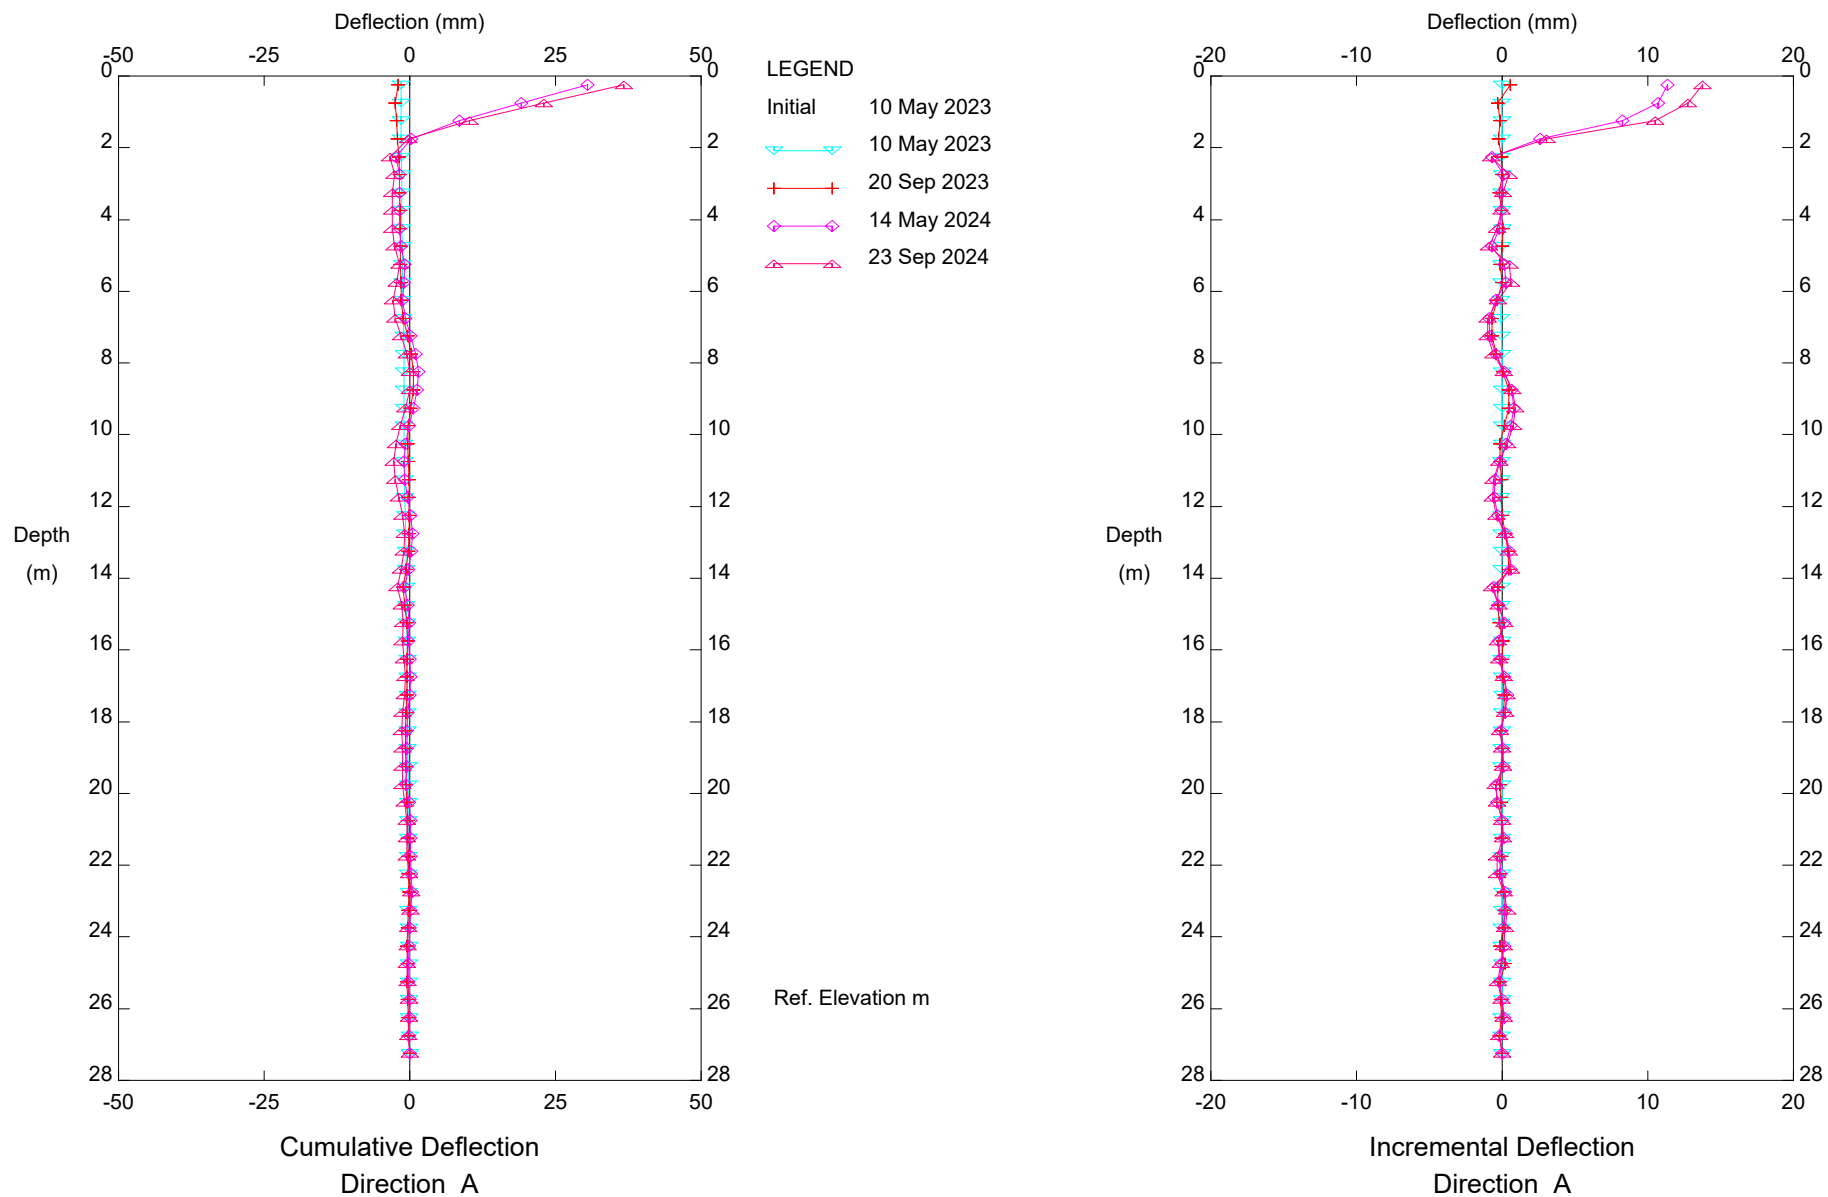
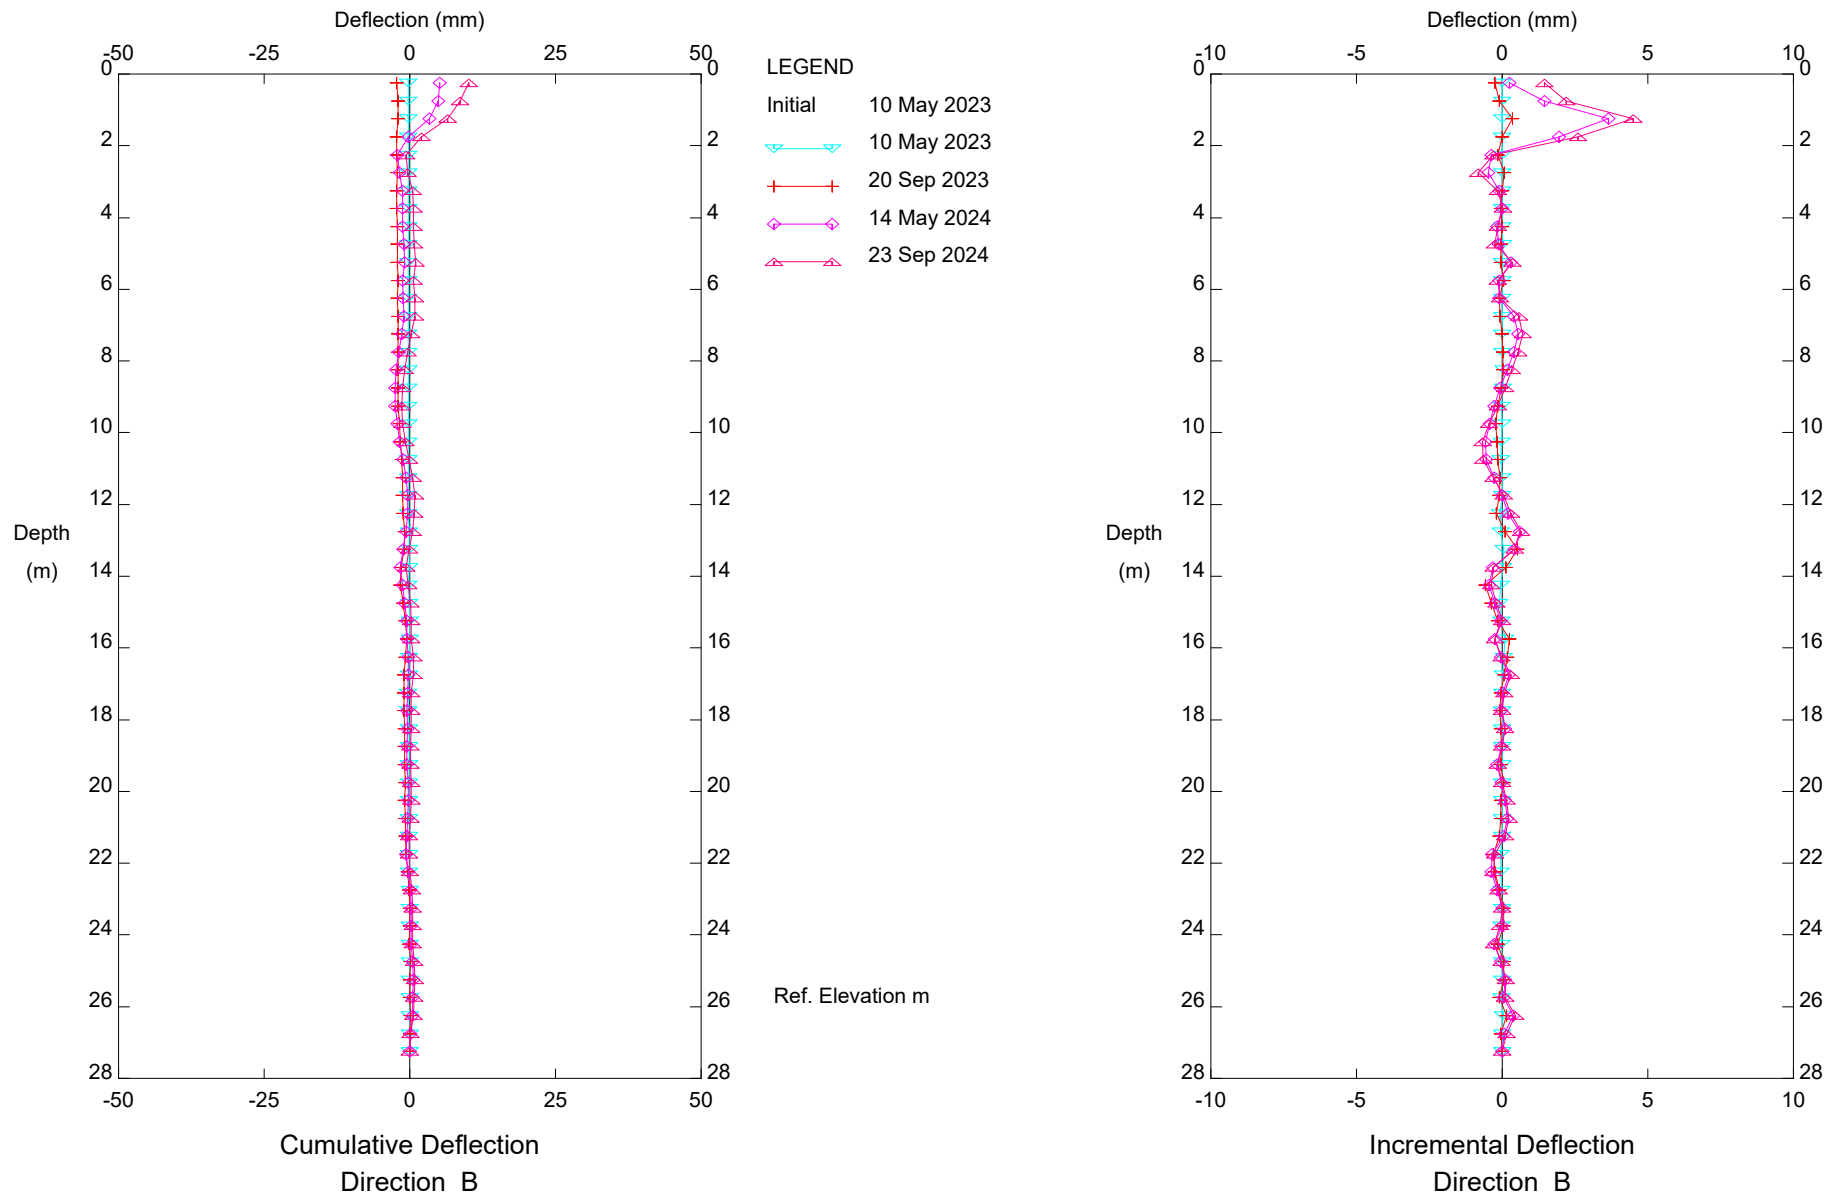
Hwy 40:30, North of Hinton (NC11), Inclinator SI22-01

No new zones of movement were observed in SI2. However, SI22-01 has shown two potential movement zones at depths of 8 to 10 m and superficially at a depth of 0 to 2 m. While the deeper movement zone is very slight, the shallow movement zone is larger and is likely due to disturbance by ongoing construction. Directions of movement are referenced to the azimuth of the “A+” groove in each SI casing in **Table NC011-1**.

SI22-01 was cut 2 m shorter due to construction for backslope flattening in April 2024. No discernible movement was observed in SI22-01. Some movement was observed in the upper 2 m of the casing and is likely due to frost effects and is likely not related to slope movement. SI22-01 may be experiencing some disturbance due to ongoing construction since spring 2024. As such, re-initialization may be required upon completion of construction.

SI22-01 may require reinitialization upon completion of construction. It is recommended that the next reading cycle take place in Spring 2025.
