To:	Amy Driessen	From:	Leslie Cho and Xiteng Liu
	Transportation and Economic Corridors		Stantec Consulting Ltd.
File:	123315222	Date:	June 18, 2024

Reference: North Central Region, Edson/Stony Plain, Site NC011 – Highway 40:30 5.5 km North of Highway 16 (Near Hinton), Spring 2024 Instrumentation Monitoring Report

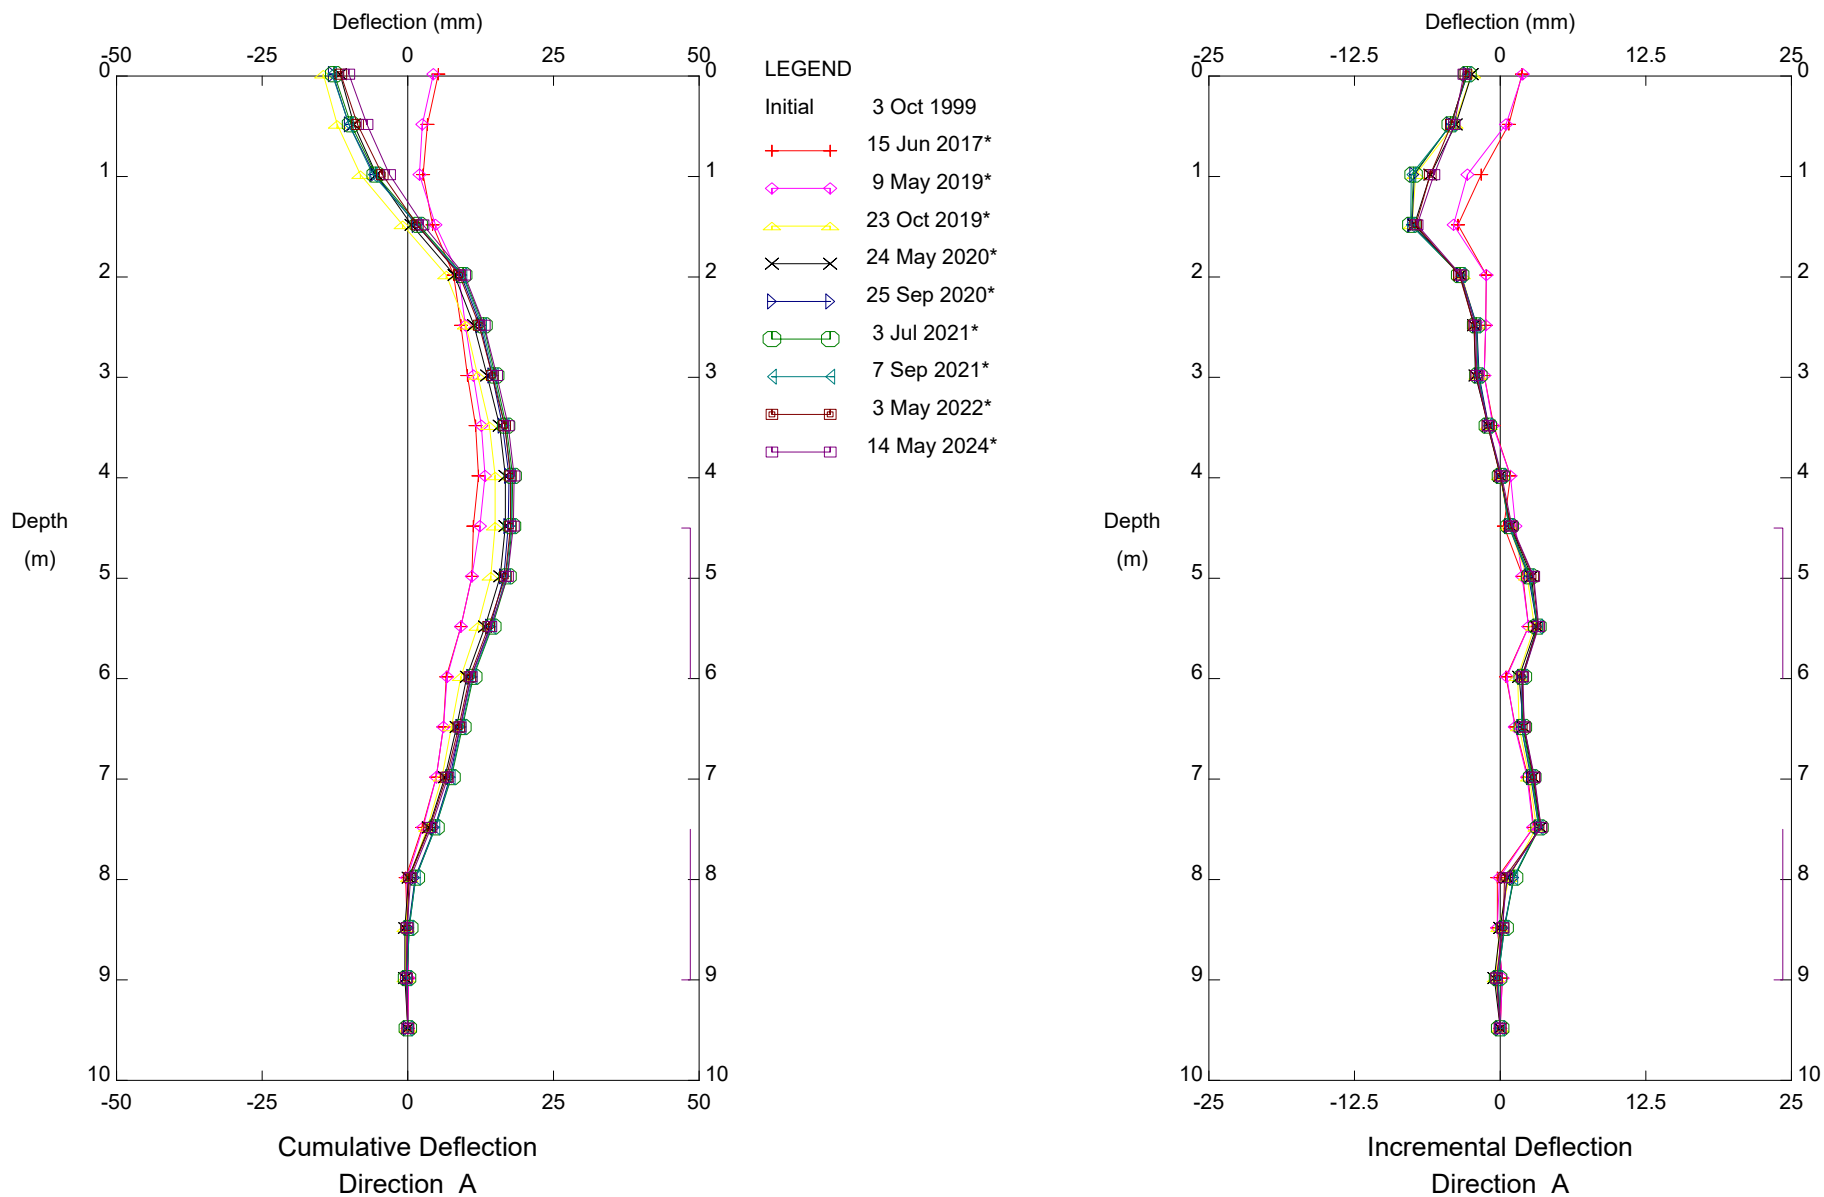
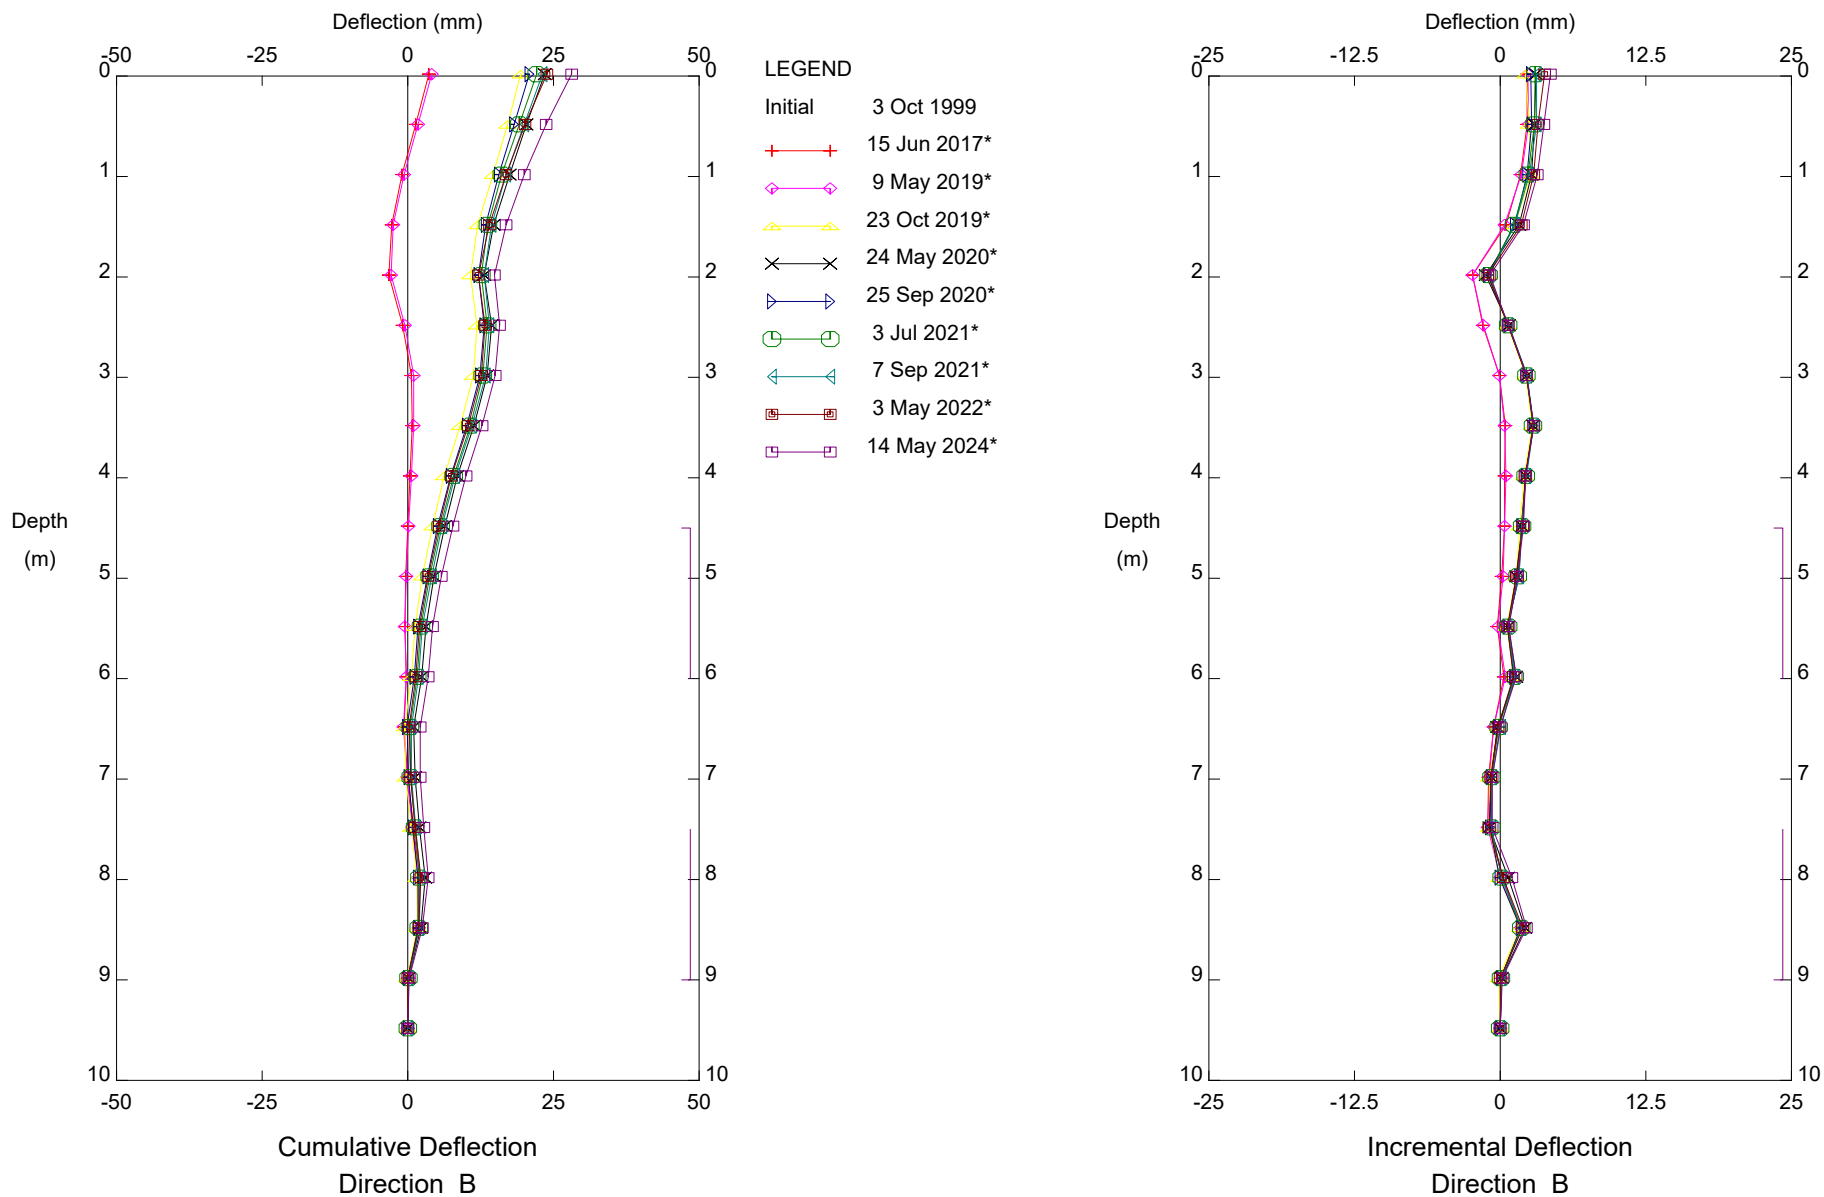
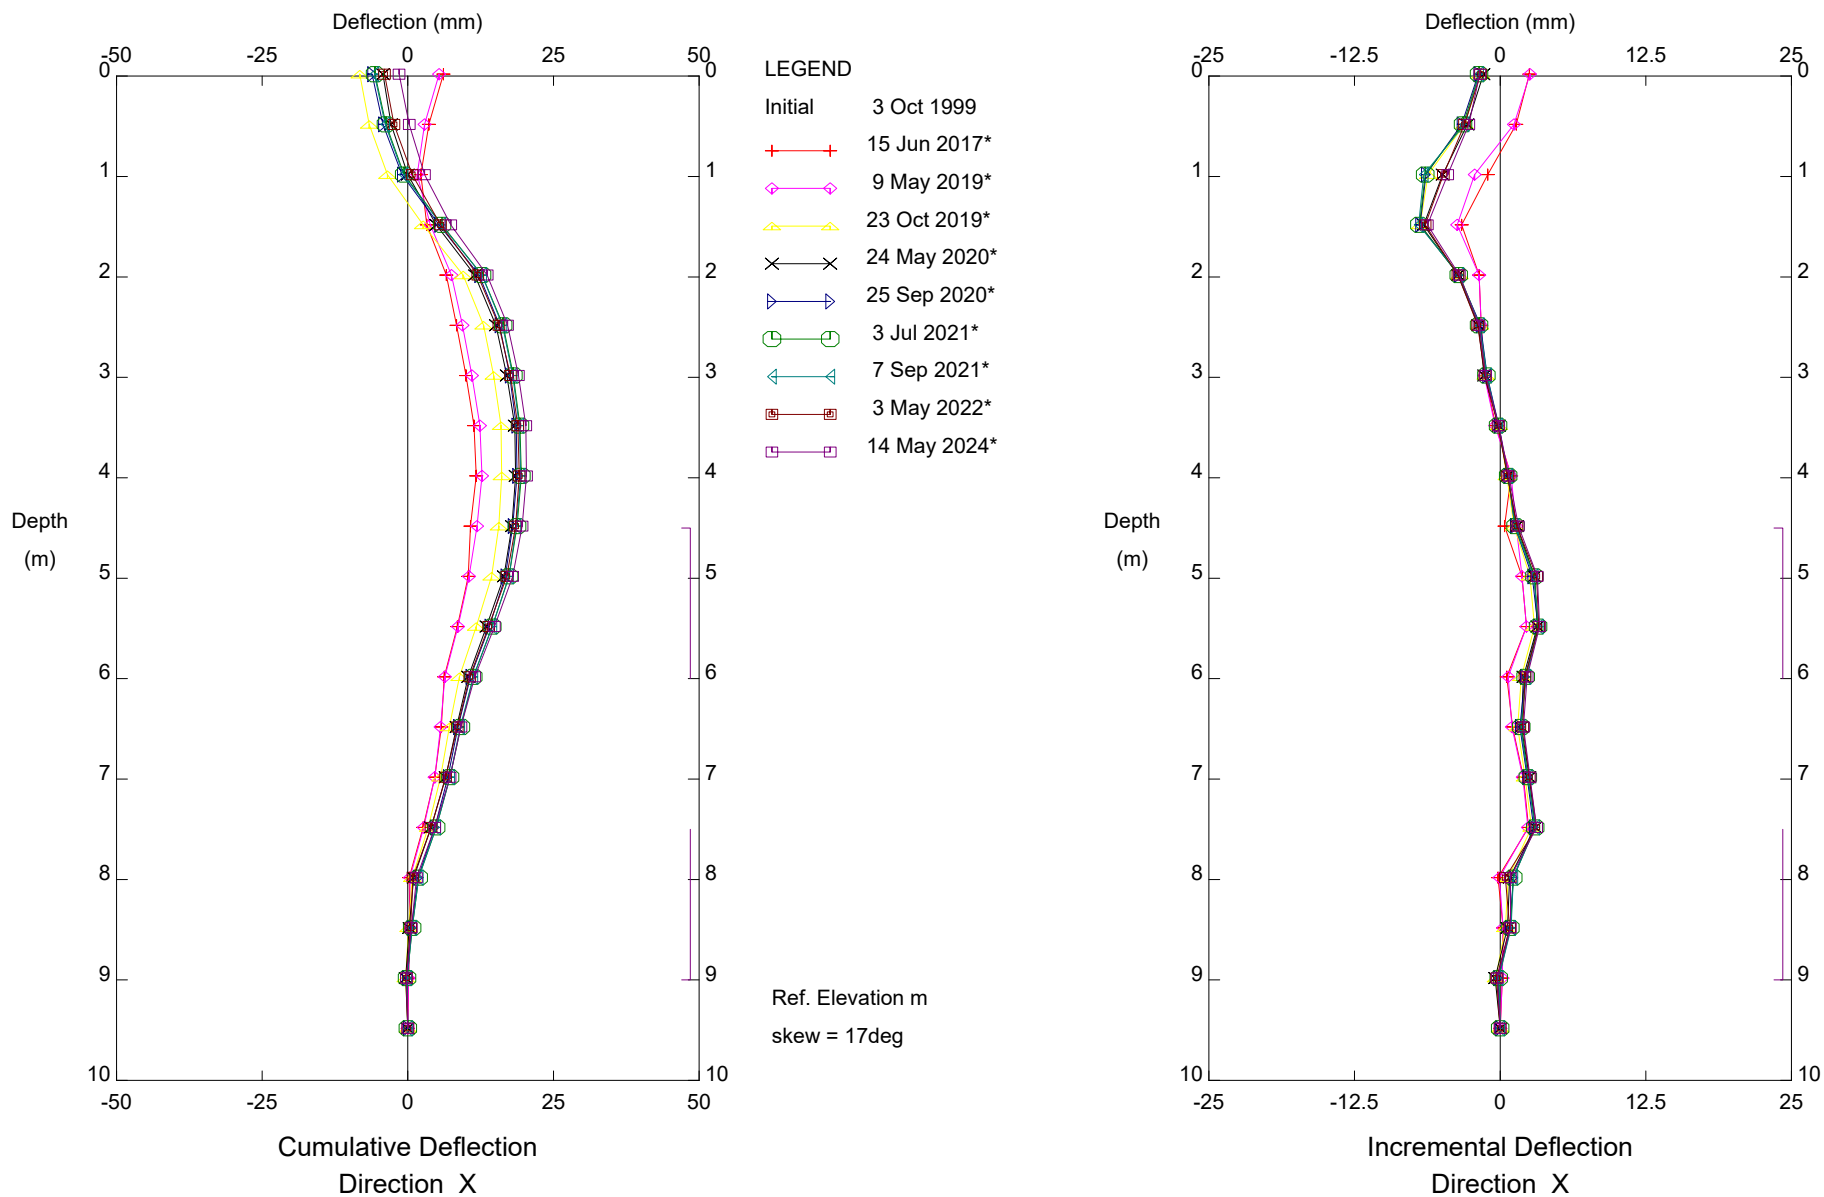
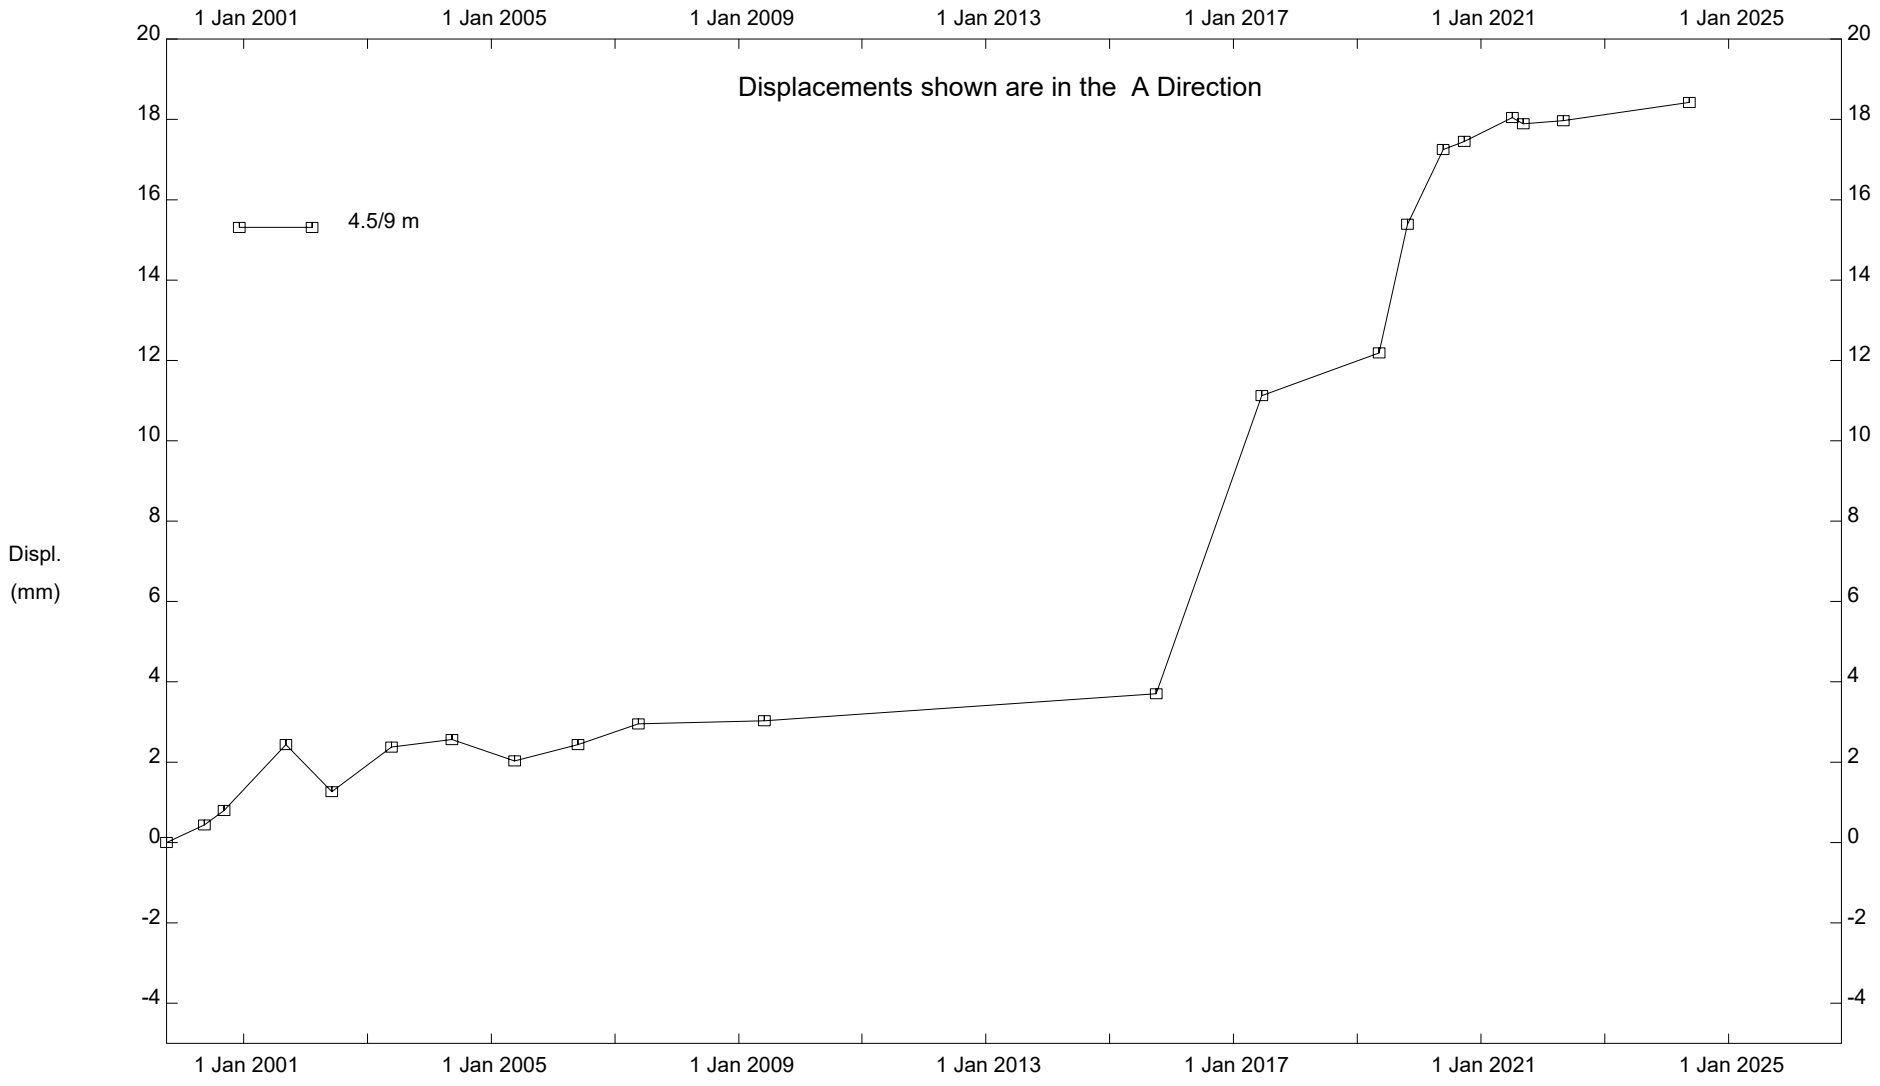
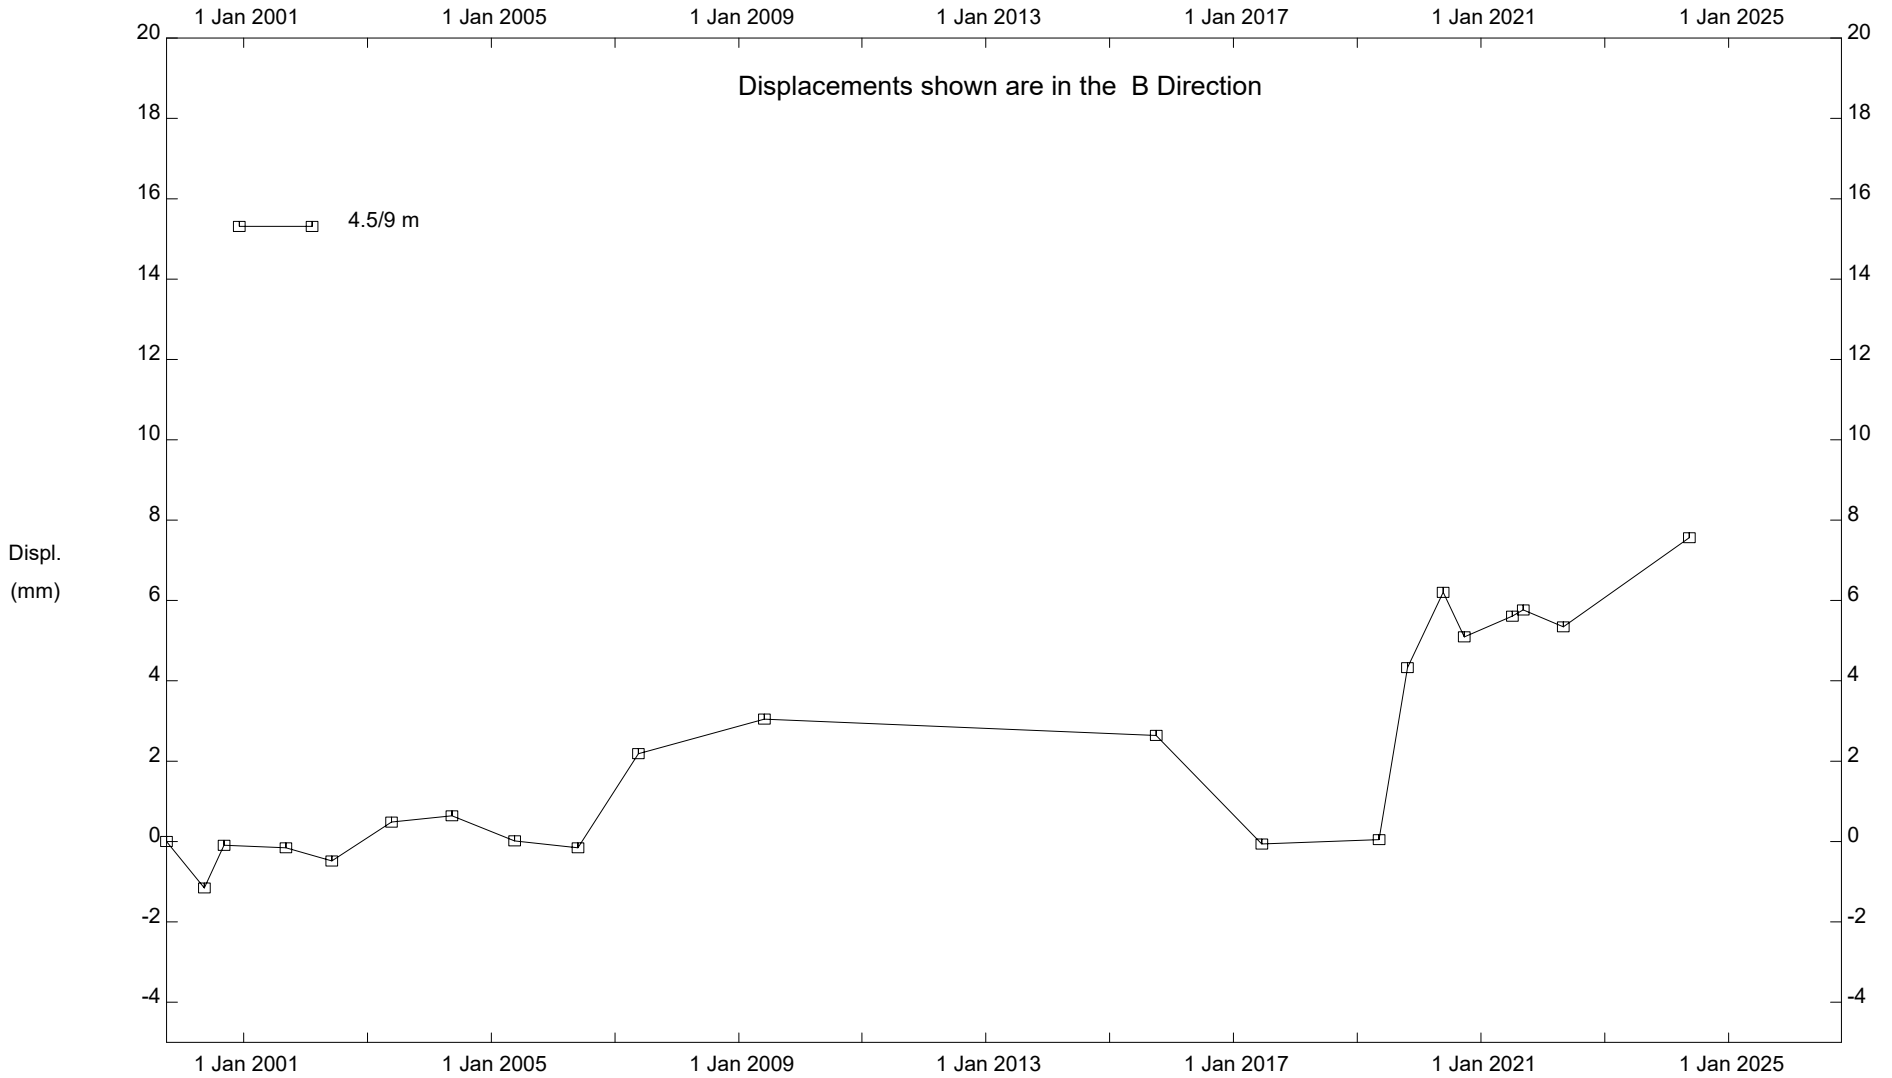
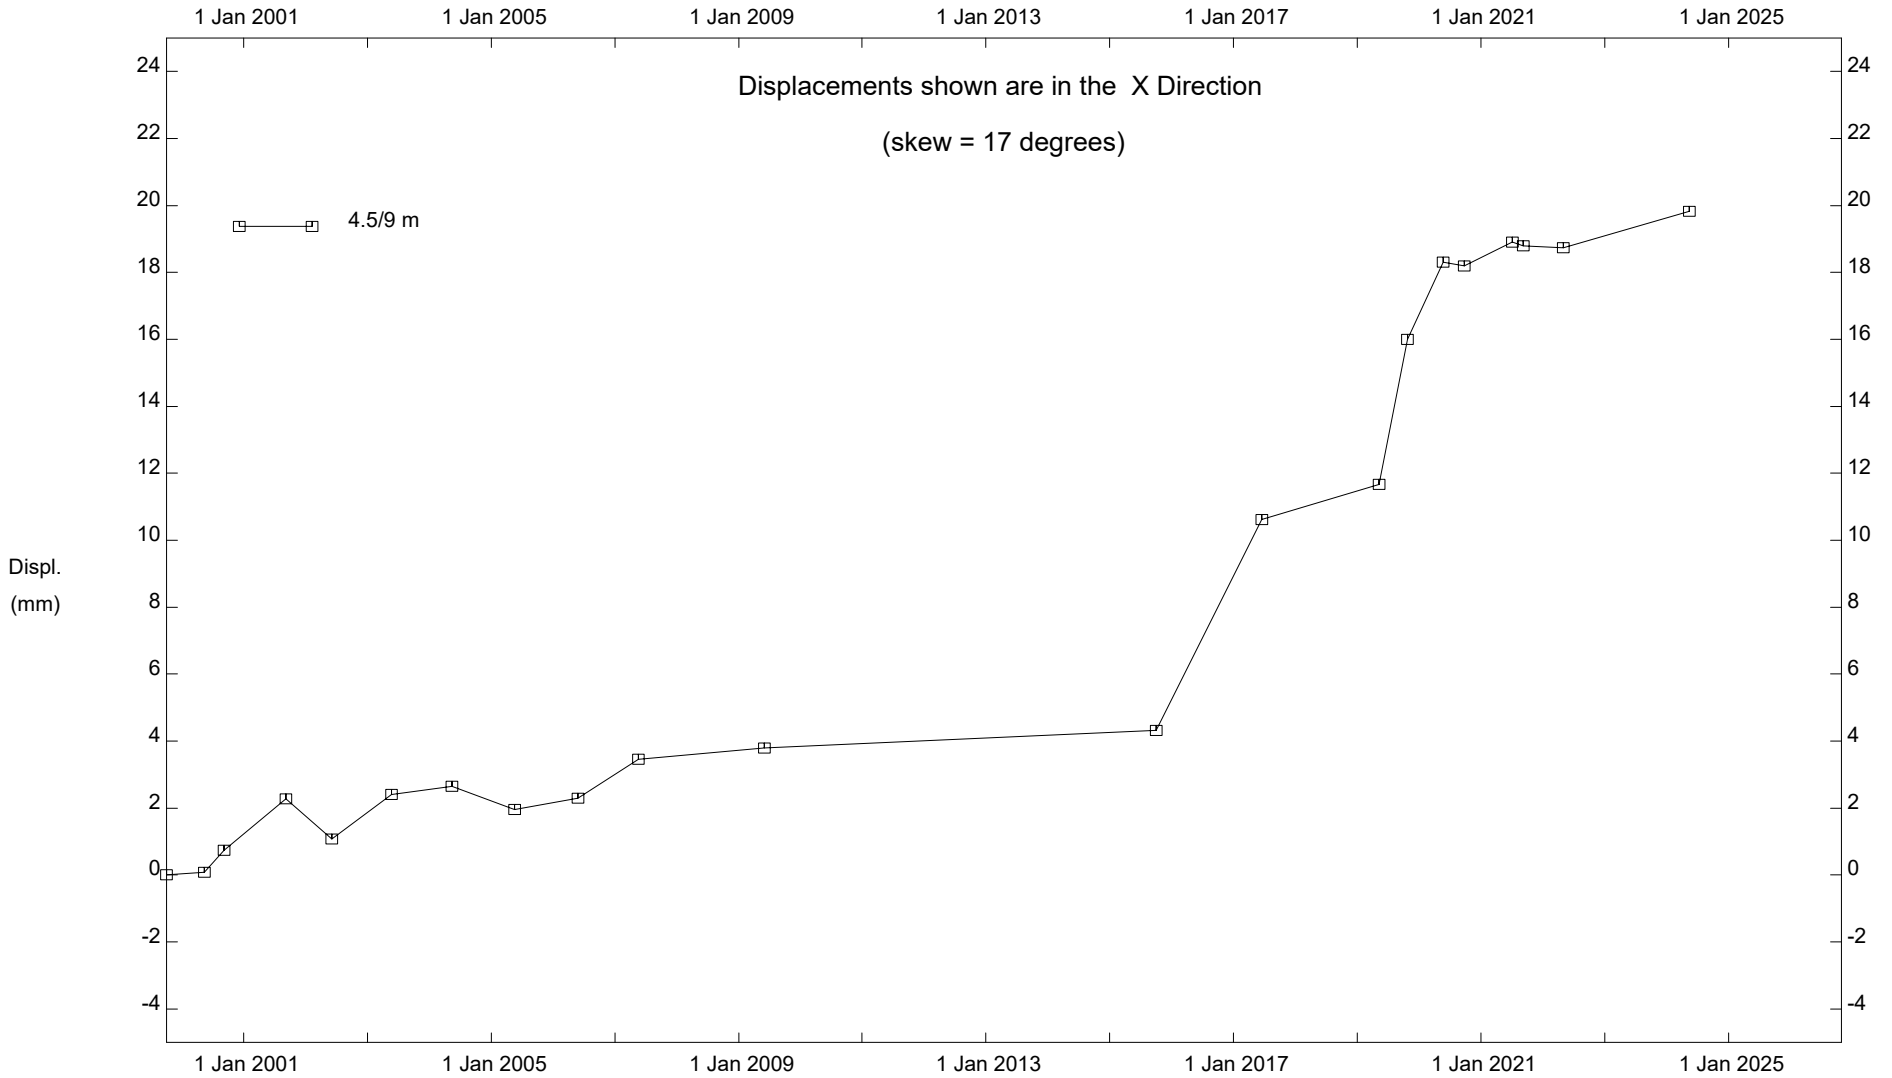
Hwy 40:30, North of Hinton (NC11), Inclinator SI2
 Alberta Transportation

SI2 was found again during the current reading cycle and showed little incremental movement (1 mm) since the last reading in May 2022. The current movement rate is 1 mm/yr.
