GEOHAZARD RISK MANAGEMENT PROGRAM

North Central Region – Edson / Stony Plain Area

2018 Inspection Report

Site Number	Site Name		Hwy	km
NC48	Fred Creek Slide		40:30	48.8
Legal Land Description	SE 28-53-1-W6M			
UTM Coordinates (NAD 83)	Zone 11U	N5940053	E428399	
Operational Site Instrumentation	Slope Inclinometers			0
	Pneumatic Piezometers			7
	Vibrating Wire Piezometers			0
	Standpipe Piezometers			0
Date of Last Instrumentation Readings	May 10, 2018

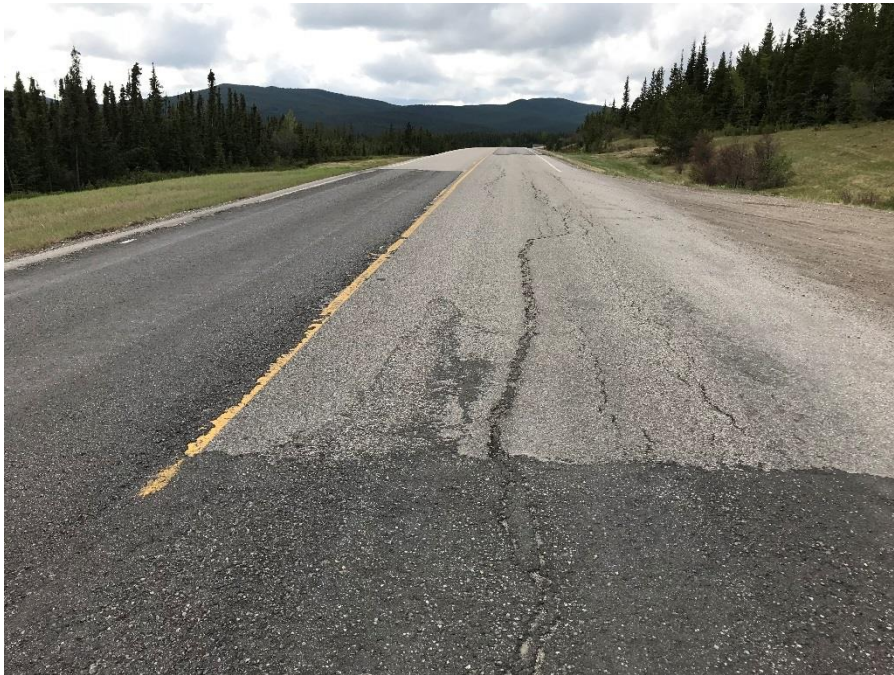
Discussion	<p>The highway appeared to have been patched since the 2017 inspection. The crack patterns appeared similar to the 2014 inspection as shown in Photos 1 and 2 and reflected through the recent patch.</p> <p>In 2016, the south slope was remediated with a berm containing a granular blanket and wick drains to promote drainage.</p> <p>Several seepage locations continued to be observed at the site. Photo 3 shows seepage at the east end of the silt fencing. Photo 4 shows a newly observed seepage location south of PZ6. The erosion rills observed south of PZ7 in 2017 appeared similar during the current inspection as shown in Photo 5.</p> <p>The ground outside of the constructed granular platform near S11 was observed to be wet and spongy. No signs of instability were observed within the rehabilitated slope. Photo 6 shows an overall view of the remediated slope near PZ2.</p> <p>Culvert BF76754 appeared to be in good working condition as shown in Photo 7. However, erosion of the ditches leading to the culvert inlet was observed as shown in Photos 8 and 9. Additionally, a new tension crack was observed southwest of the inlet at BF76754 as shown in Photo 10. The new crack was up to 100 mm wide and 7 m long.</p>

Photo 1: Pavement cracks reflecting through 2014 patch in front of access road. Looking west.

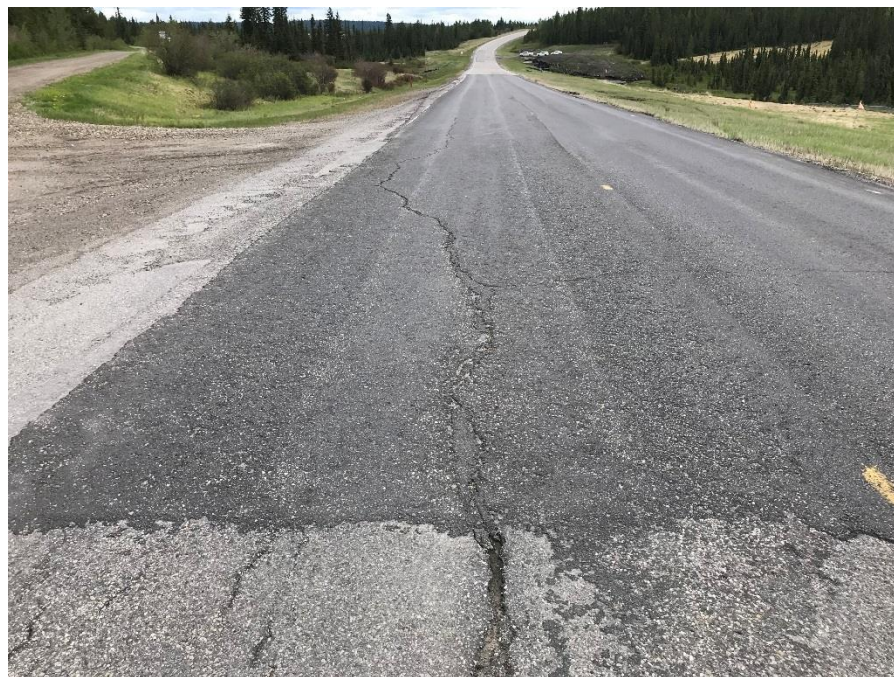
Photo 2: Pavement cracks reflecting through new patch in front of access road. Looking east.

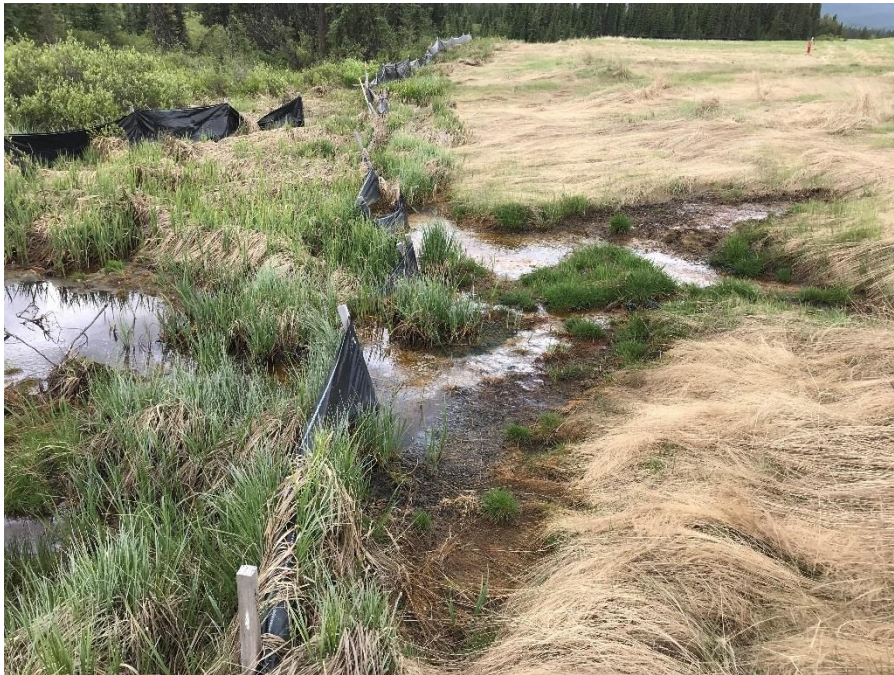
Photo 3: Flowing seepage along east end of silt fencing in repair area. Looking southwest.

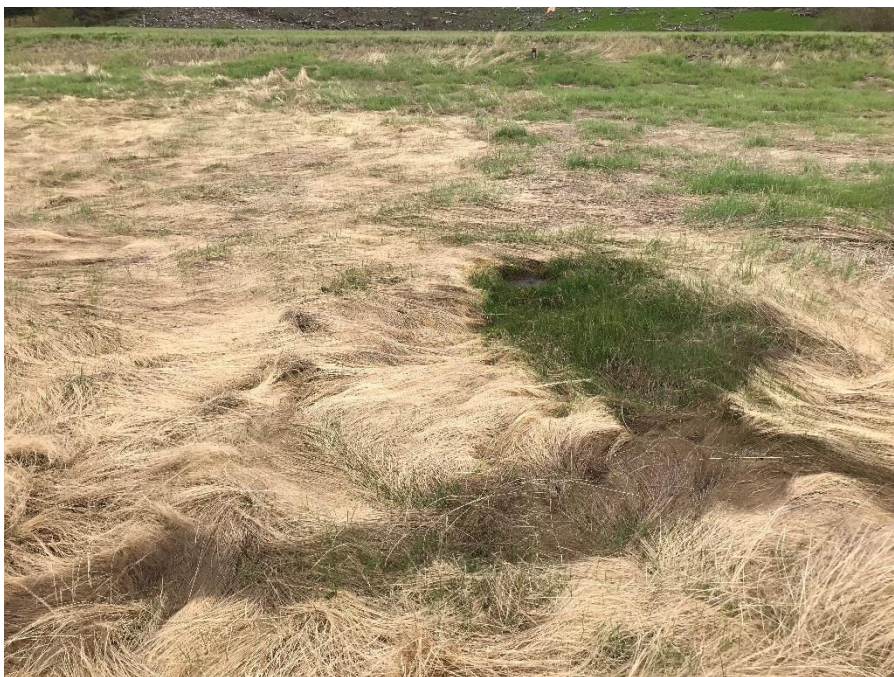
<input checked="" type="checkbox"/> Seepage	Seepage south of PZ7 near erosion rills. New seepage south of PZ6.	<input checked="" type="checkbox"/> Yes <input type="checkbox"/> No
<input type="checkbox"/> Other		<input type="checkbox"/> Yes <input type="checkbox"/> No

Photo 4: New seepage south of PZ6. Looking north.

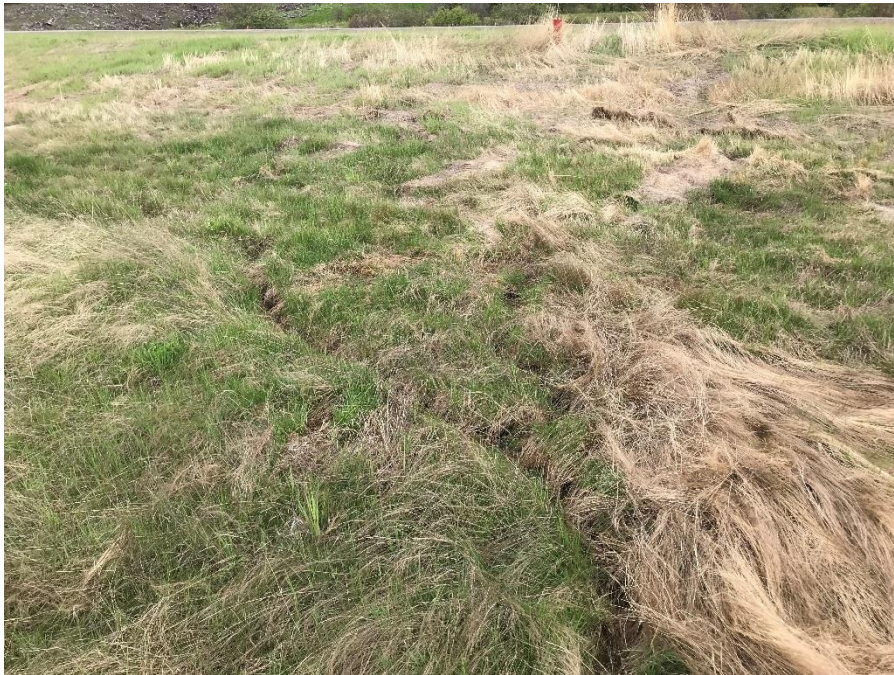
Photo 5: Erosion gully approximately 150 mm wide south of PZ7. Looking northwest.

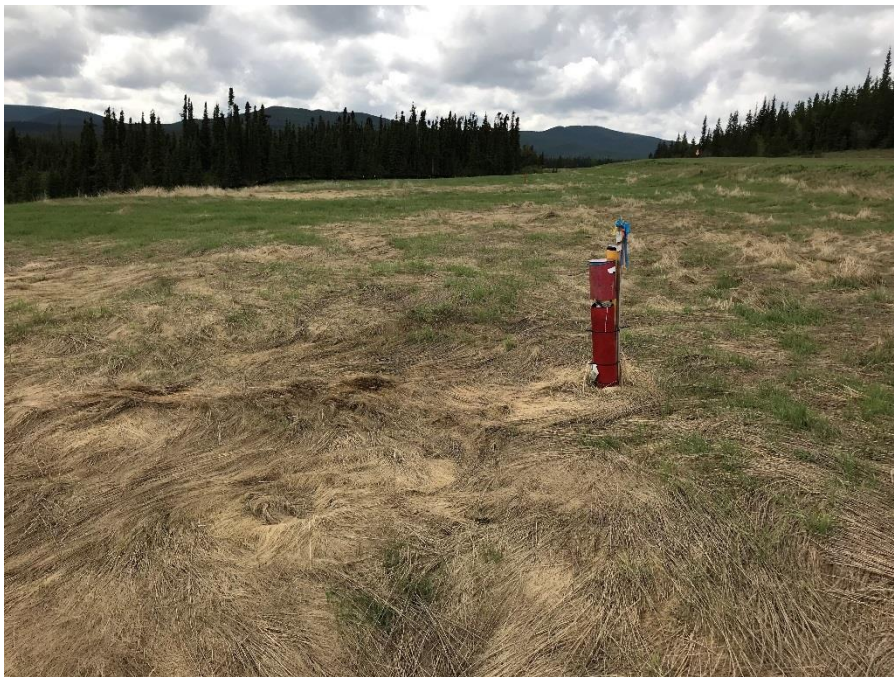
Photo 6: Rehabilitated slope near PZ2. Looking west.

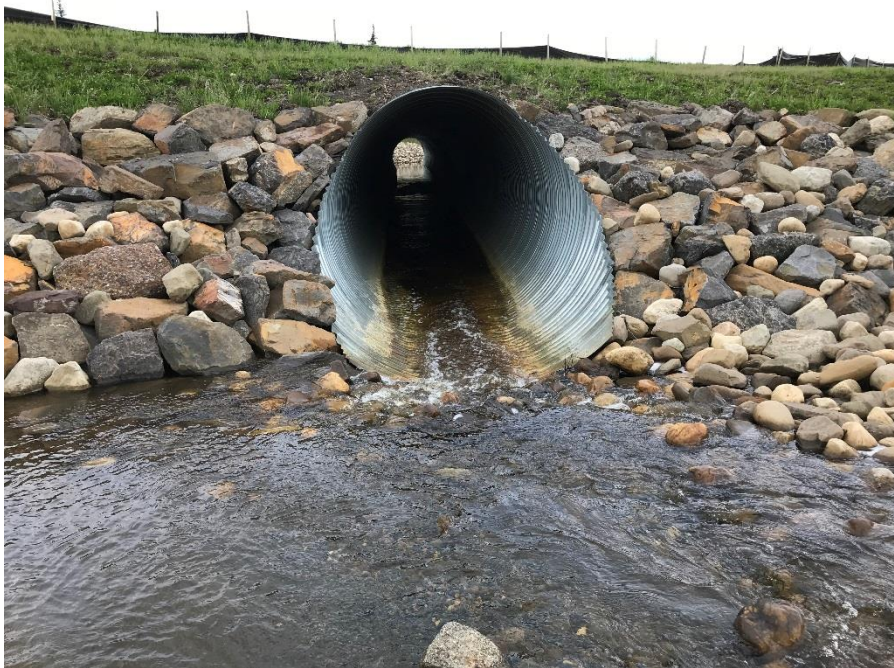
Photo 7: Culvert BF76754. Looking northeast.

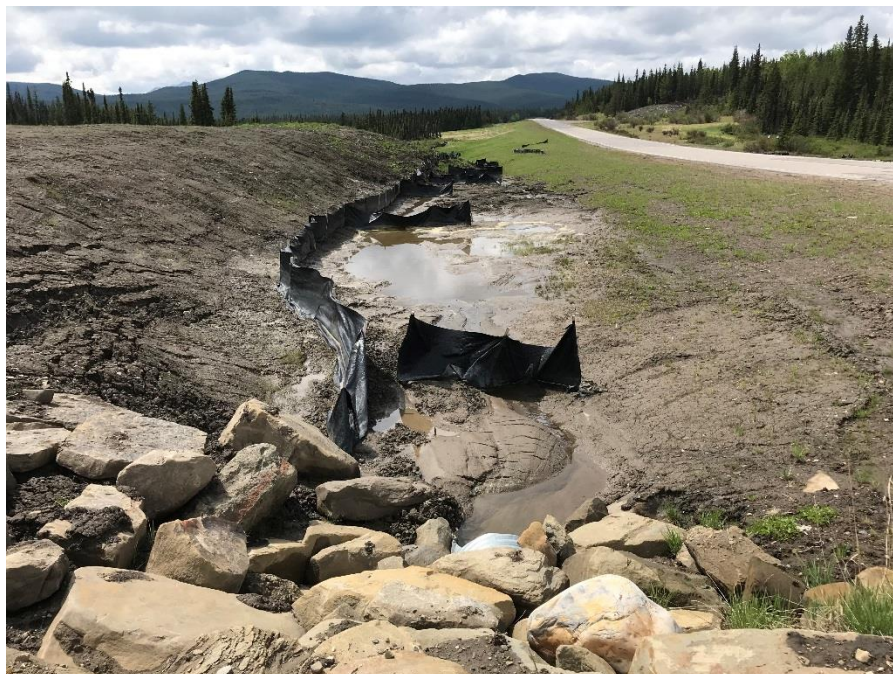
Photo 8: Erosion along drainage ditch east of culvert BF76754. Looking west.

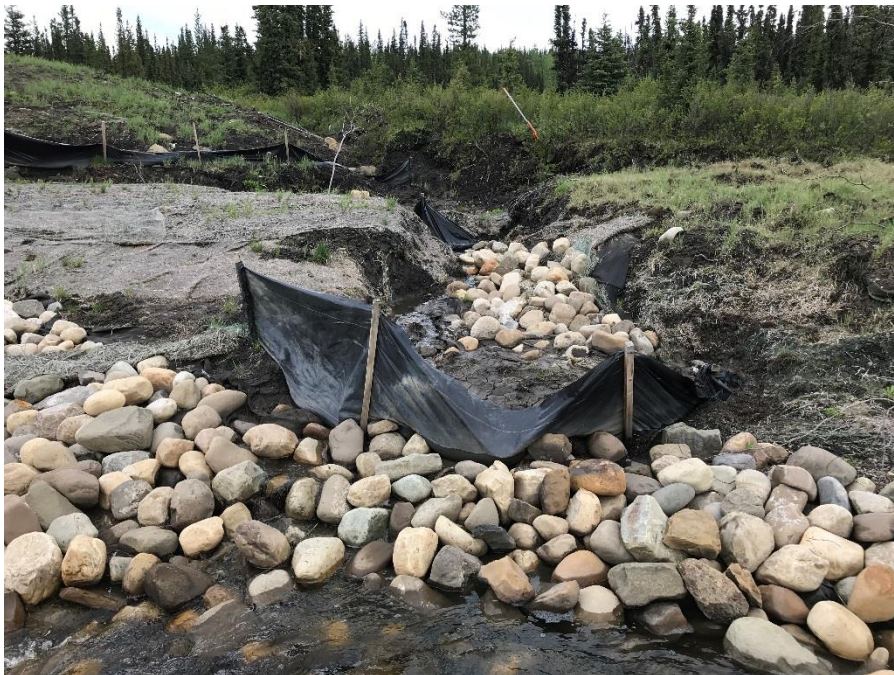
Photo 9: Rip rap to the south of BF76754 poorly placed. Erosion channel leading into culvert inlet.

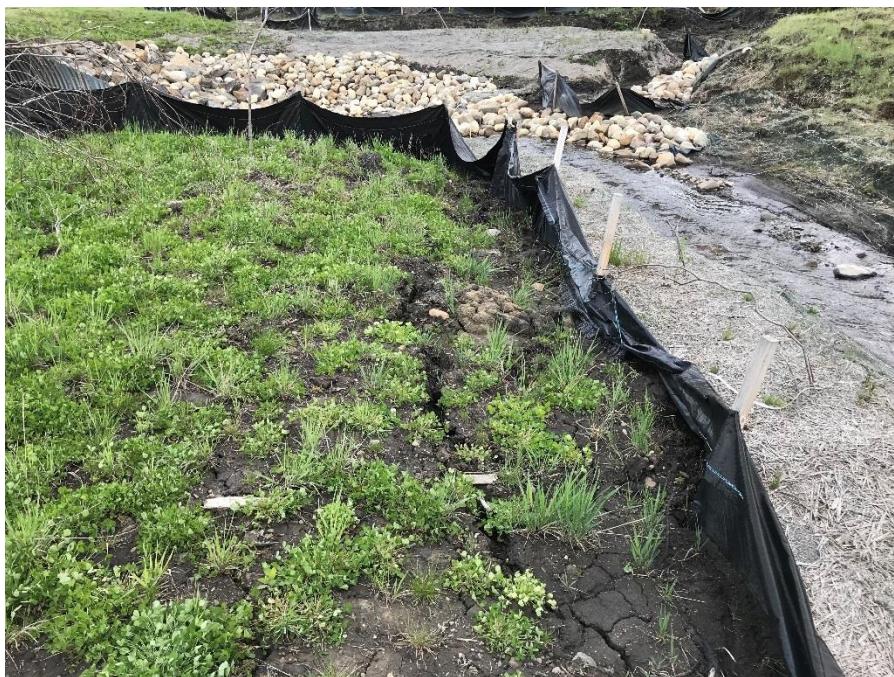
Photo 10: Tension crack about 100 mm wide southwest of BF76754. Looking east.
