GEOHAZARD RISK MANAGEMENT PROGRAM

North Central Region – Edson / Stony Plain Area

2020 Inspection Report

Site Number	Site Name		Hwy	km
NC48	Fred Creek Slide		40:30	48.8
Legal Land Description	SE 28-53-1-W6M			
UTM Coordinates (NAD 83)	Zone 11U	N5940053	E428399	
Operational Site Instrumentation	Slope Inclinometers		1	
	Pneumatic Piezometers		7	
	Vibrating Wire Piezometers		0	
	Standpipe Piezometers		0	
Date of Last Instrumentation Readings	May 26, 2020

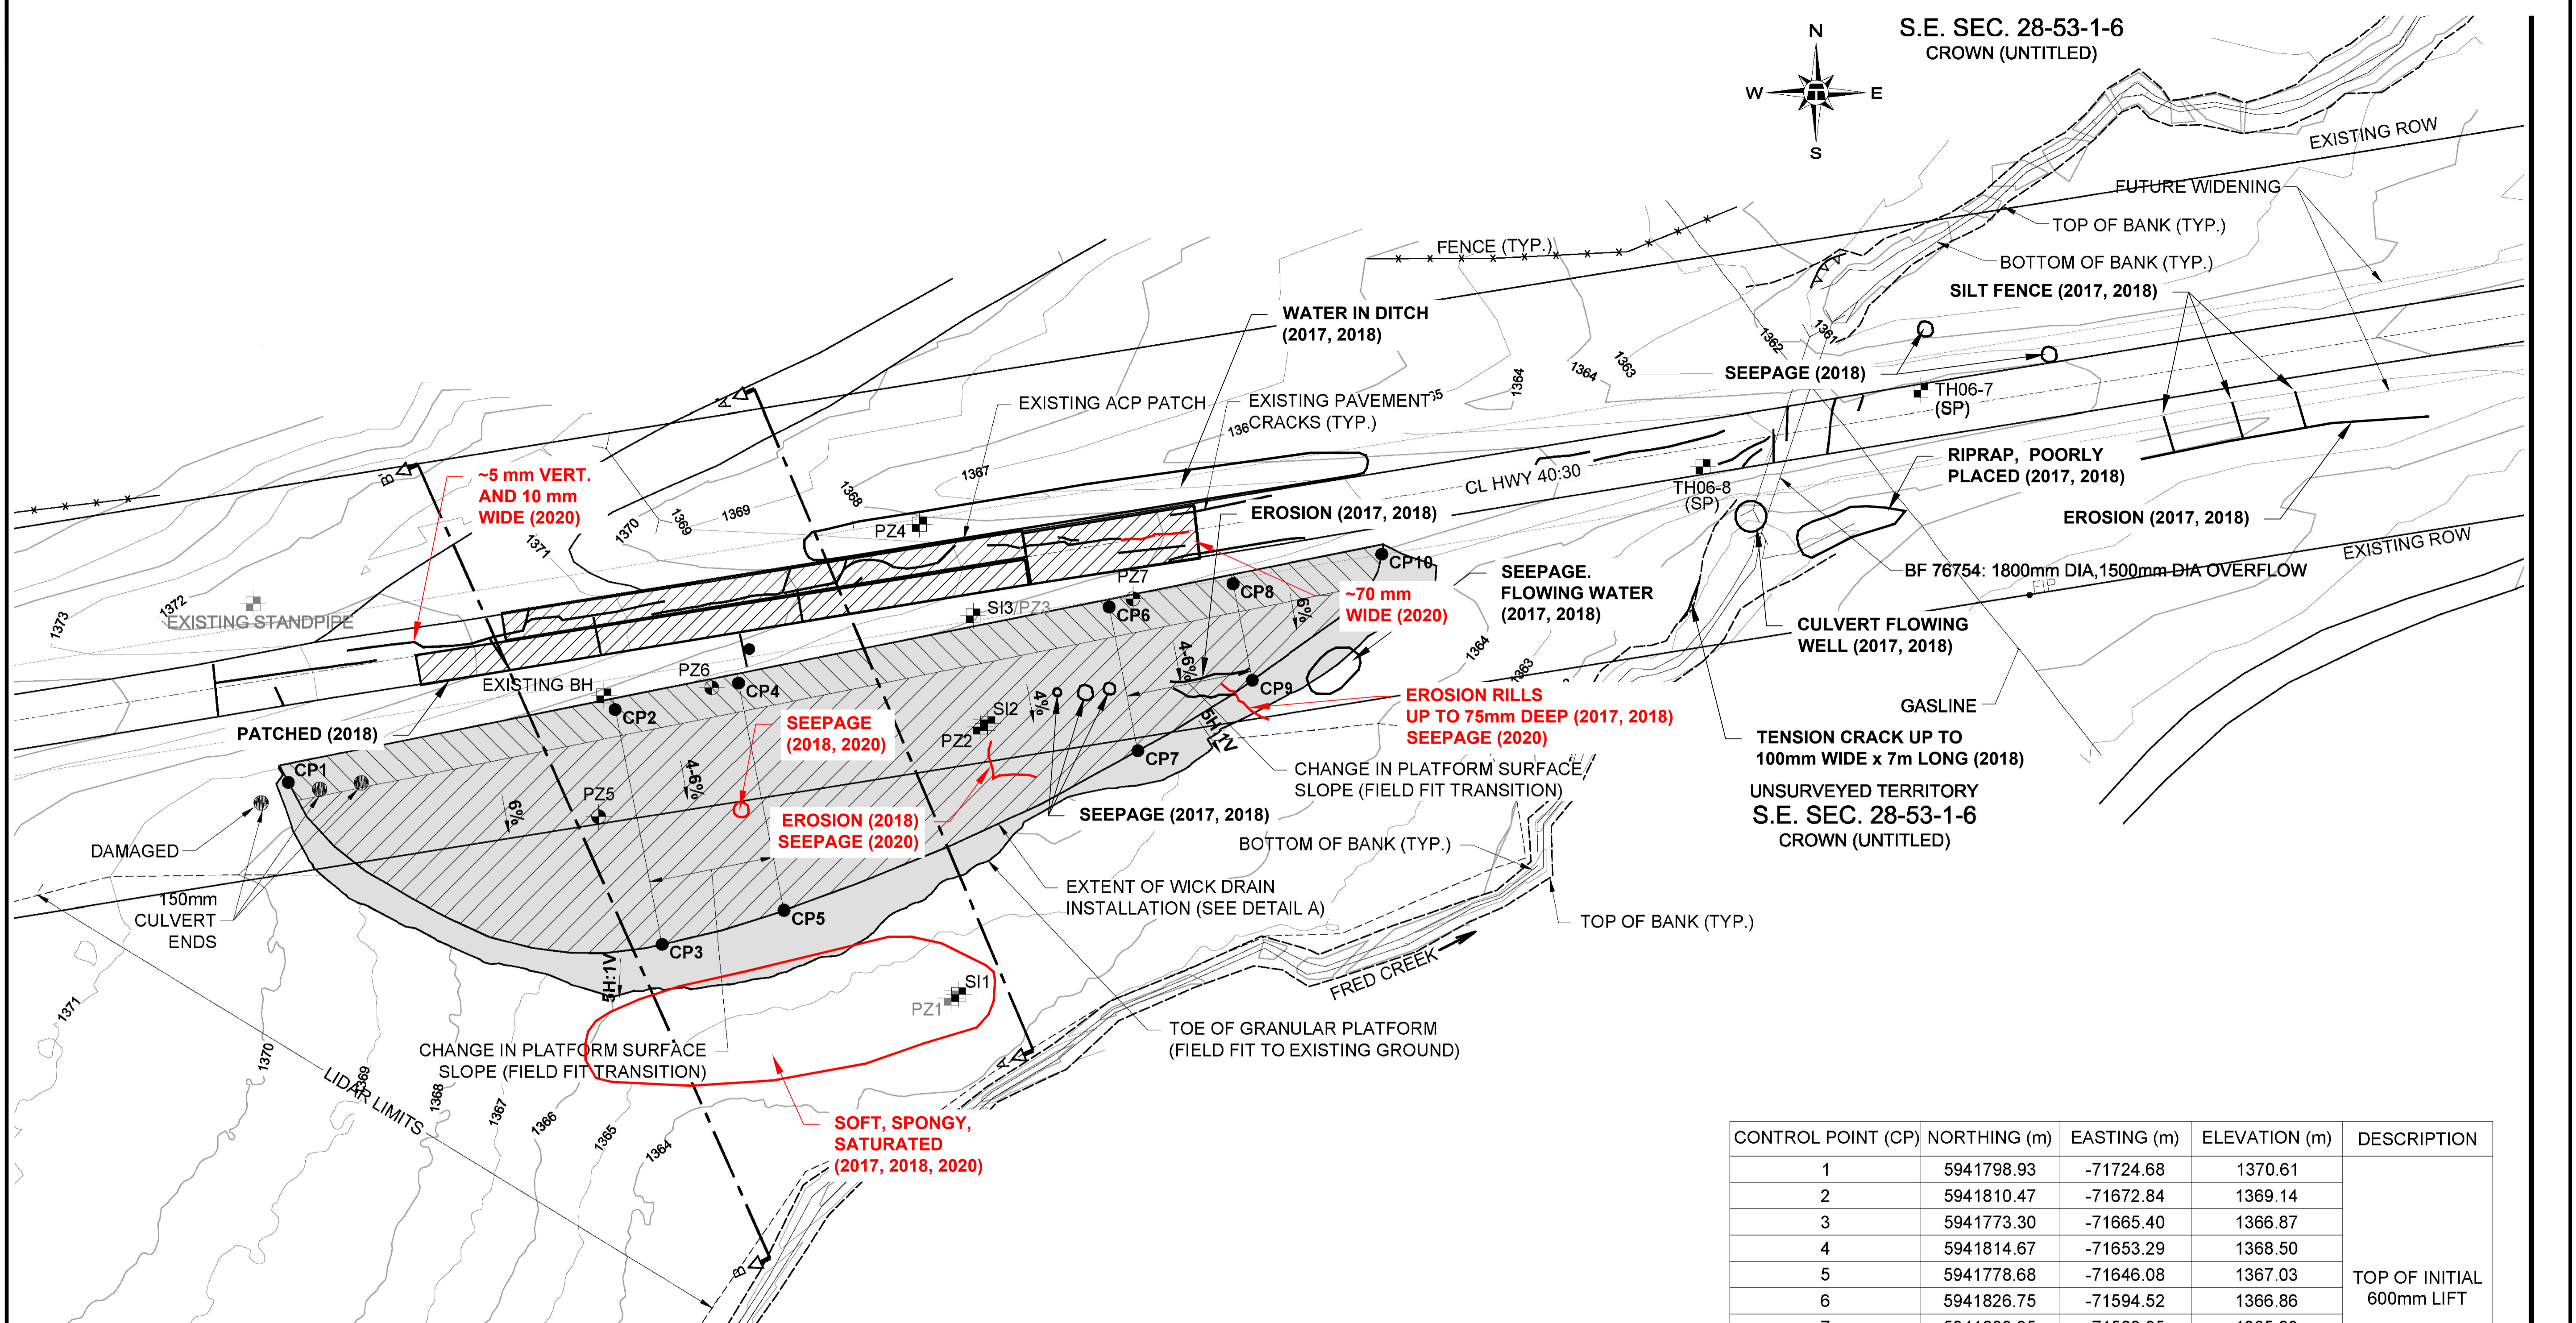
FIGURE -1

ALBERTA TRANSPORTATION
GEOHAZARD MONITORING PROGRAM
NC48 HWY 40:30, km 48.8 - FRED CREEK
SITE PLAN

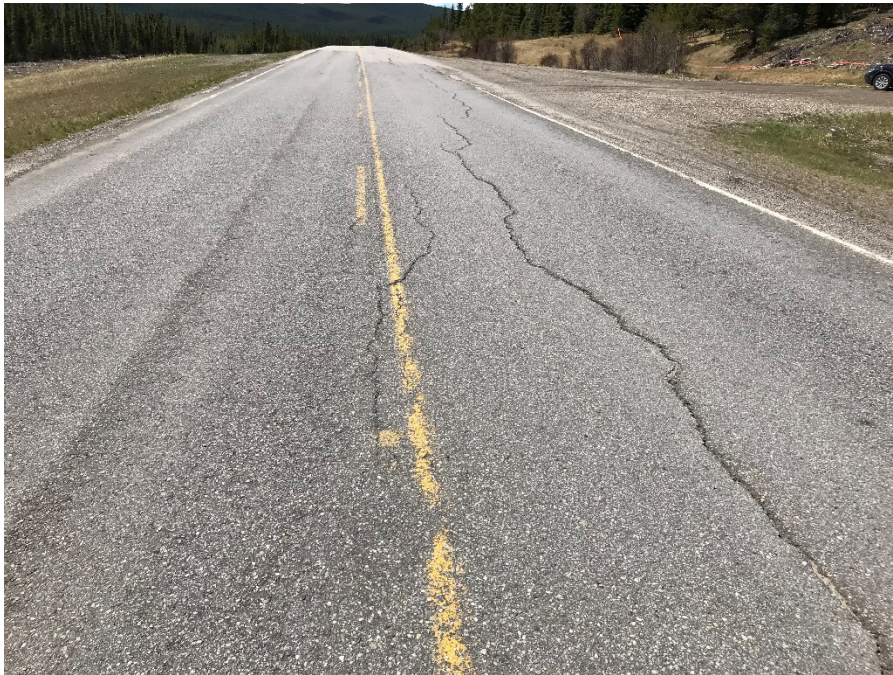
Photo 1: Pavement cracks in front of access road. Looking west.

Recommendations	<p>Short term recommendations should consist of sealing any pavement cracks to reduce surface water infiltration into the slope and pavement structure.</p> <p>During this inspection, it was discussed between AT and Stantec that the monitoring frequency of this site can be further reduced. It was suggested that the instruments continue to be monitored annually whereas inspections can occur once per contract duration (i.e. once every 4 or 5 years).</p>

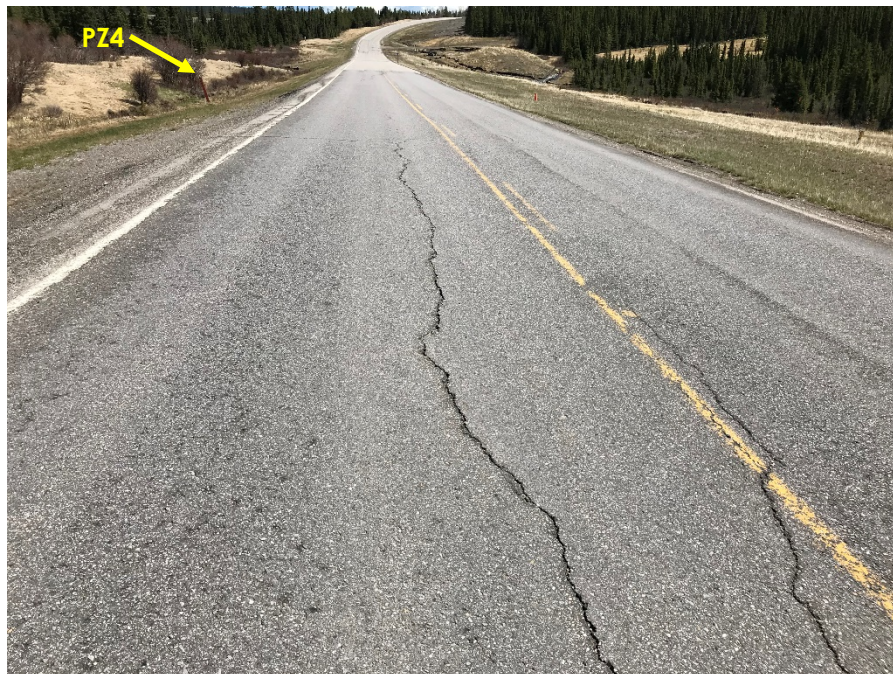
Photo 2: Pavement cracks reflecting through patch in front of access road. Looking east.

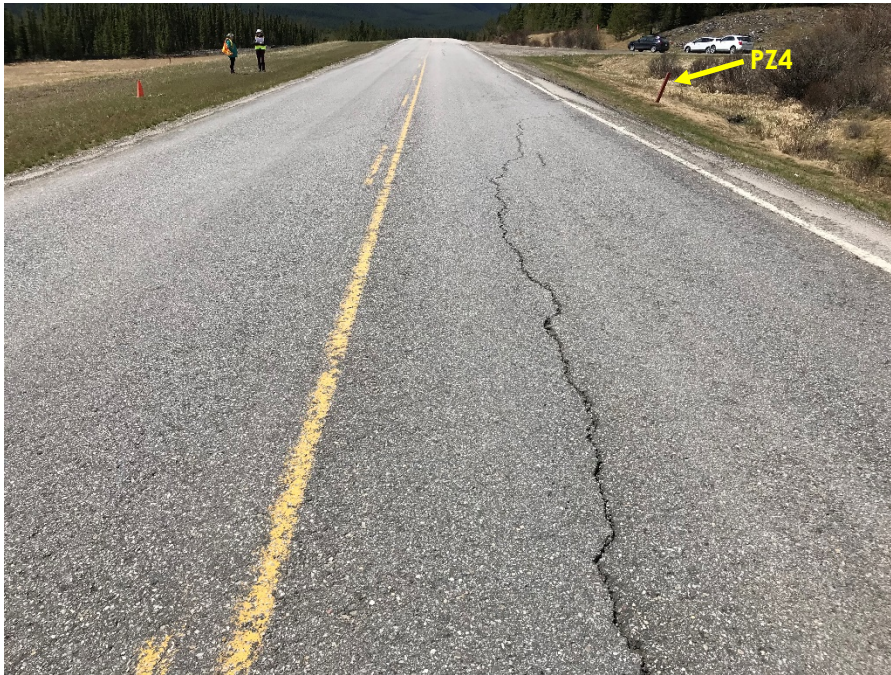
Photo 3: Pavement cracking east of PZ4. Looking west.

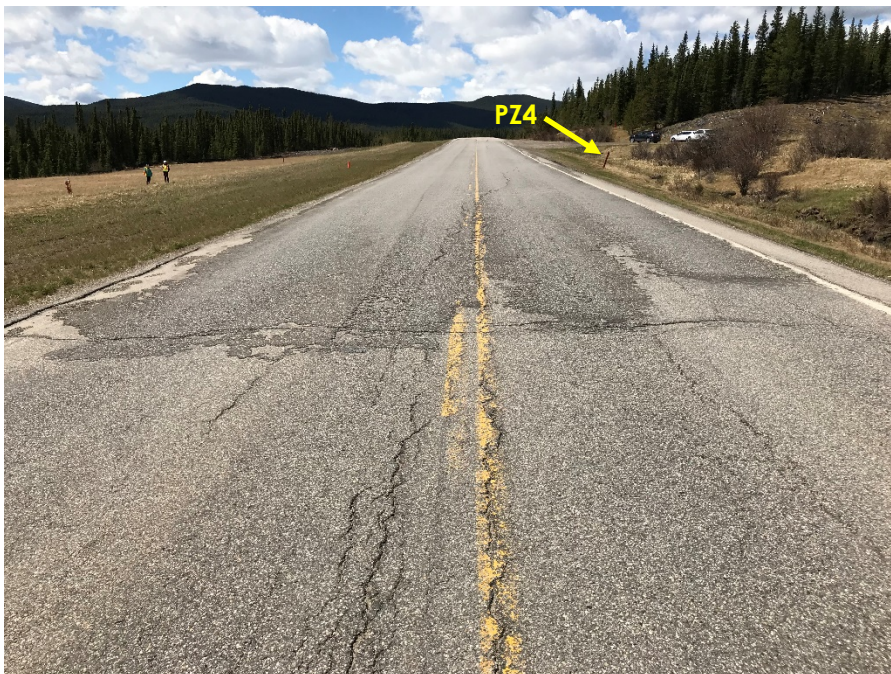
Photo 4: Pavement cracks at east end of patch. Looking west.

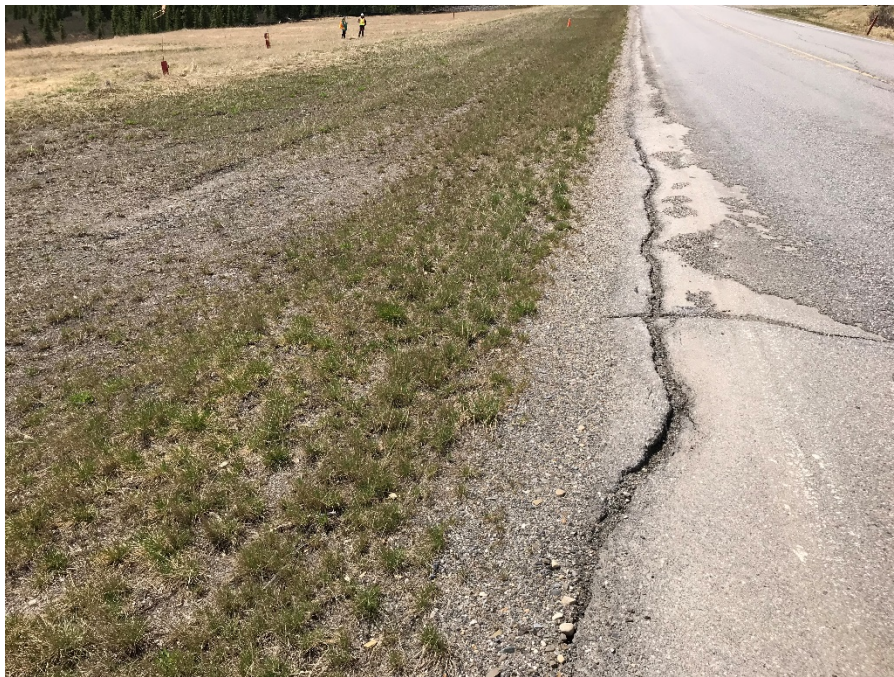
Photo 5: Pavement crack along shoulder at east end of patch. Looking west.

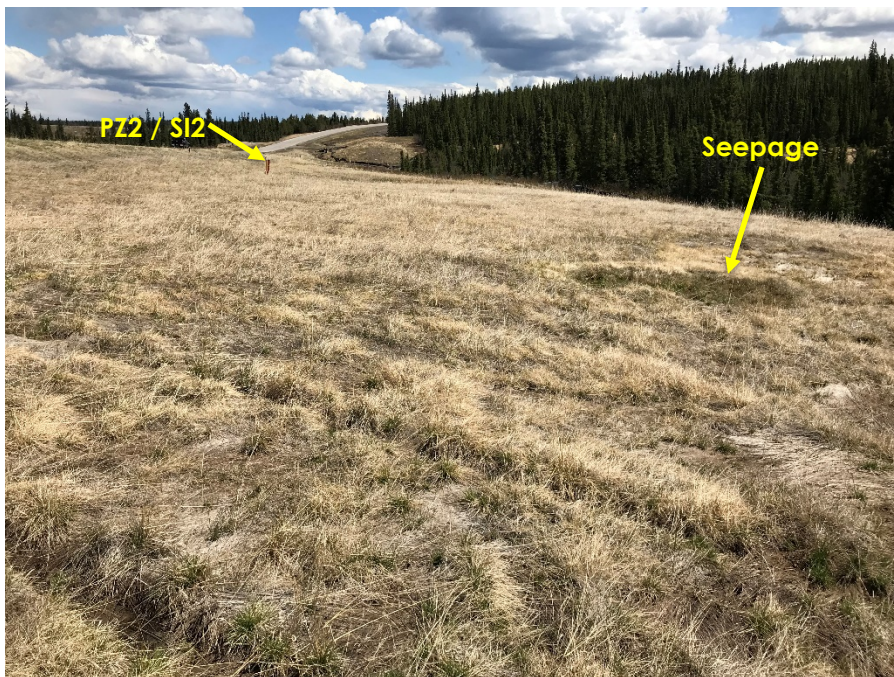
Photo 6: Seepage south of PZ6 at about mid-slope. Looking east.

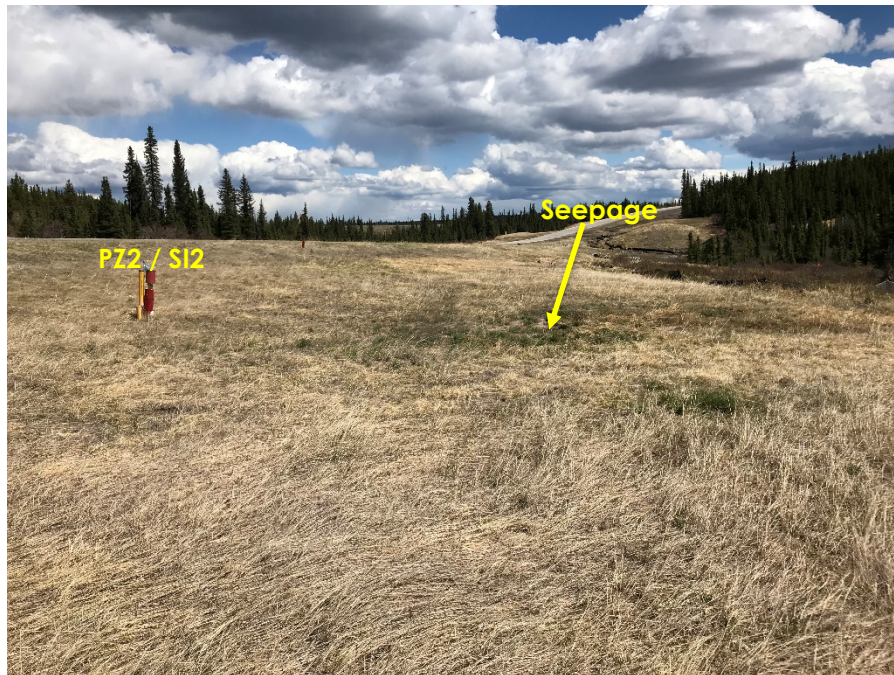
Photo 7: Seepage south of PZ2 / SI2. Looking east.

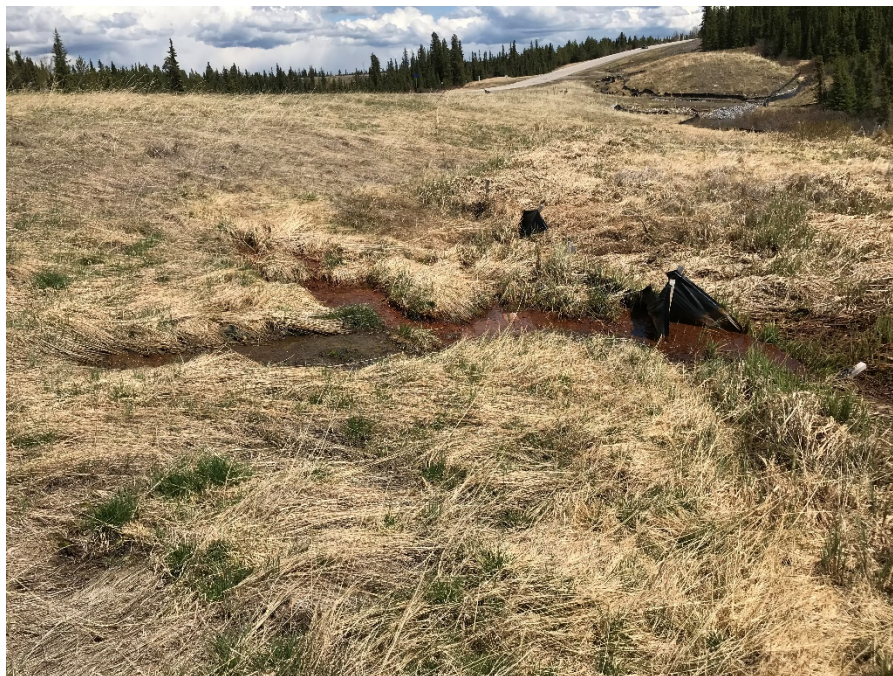
Photo 8: Seepage south of PZ7 near toe. Looking east.

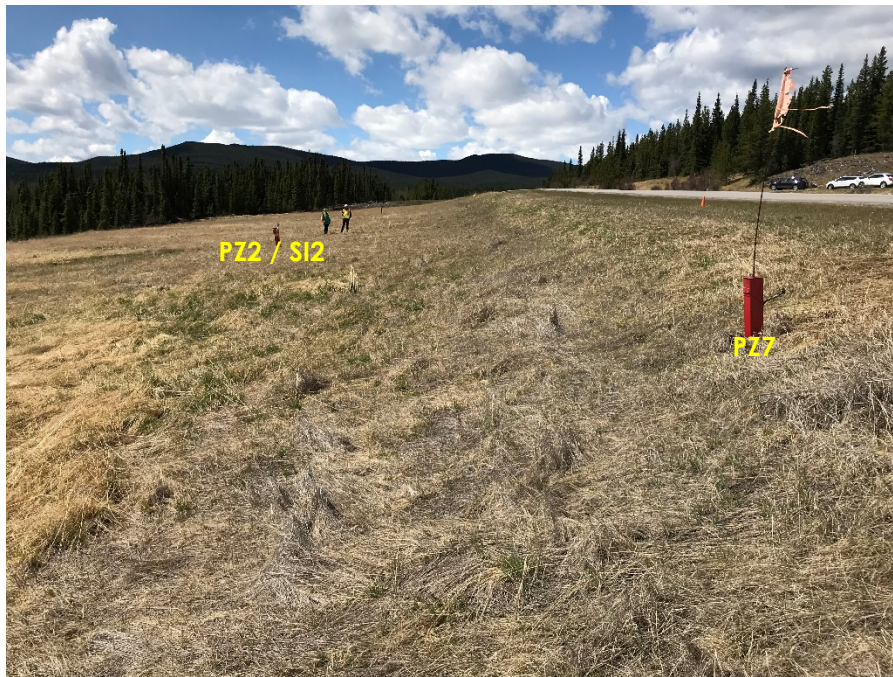
Photo 9: Overall embankment slope. Looking west.
