To:	Amy Driessen Alberta Transportation	From:	Leslie Cho and Carrie Murray Stantec Consulting Ltd.
File:	123315222	Date:	June 13, 2022

Reference: North Central Region, Edson/Stony Plain, Site NC048 – Highway 40:30 Fred Creek Slide, Spring 2022 Instrumentation Monitoring Report

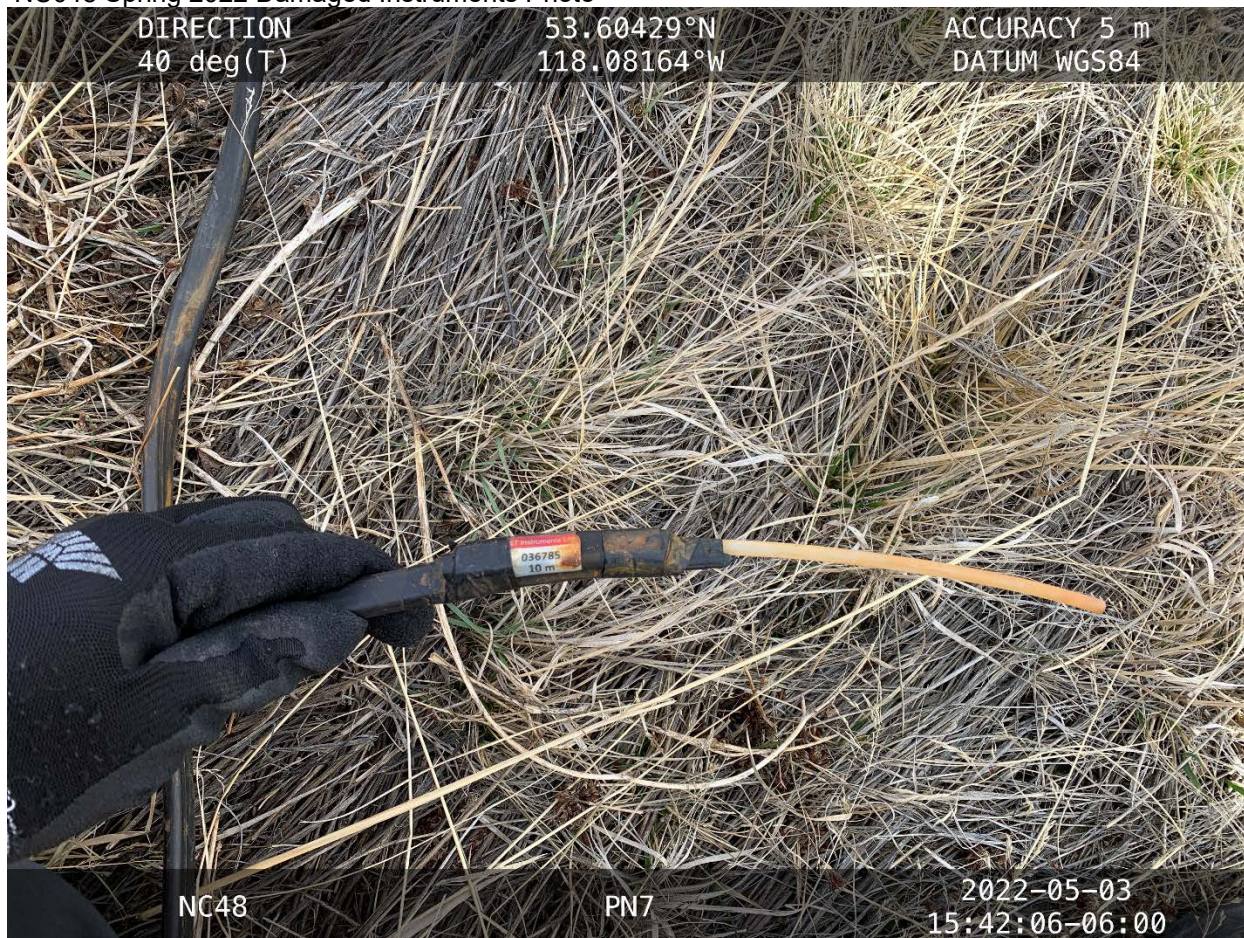
NC048 Spring 2022 Damaged Instruments Photo

Slope inclinometer SI1 and the pneumatic piezometer PZ7 were found damaged during the Spring 2022 reading cycle.

PZ7 Piezometer tubing was damaged.

SI1 was found blocked at about 1 m below ground surface (bgs) and may be potentially unrepairable without completing minor excavations around the SI, cutting the SI casing to clear the blockage, and splicing with new casing. An attempt to repair PZ7 can be made by replacing the tubing if requested.
