To:	Amy Driessen	From:	Leslie Cho and Xiteng Liu
	Transportation and Economic Corridors		Stantec Consulting Ltd.
File:	123315222	Date:	June 18, 2024

#### Reference: North Central Region, Edson/Stony Plain, Site NC048 – Highway 40:30 Fred Creek Slide, Spring 2024 Instrumentation Monitoring Report

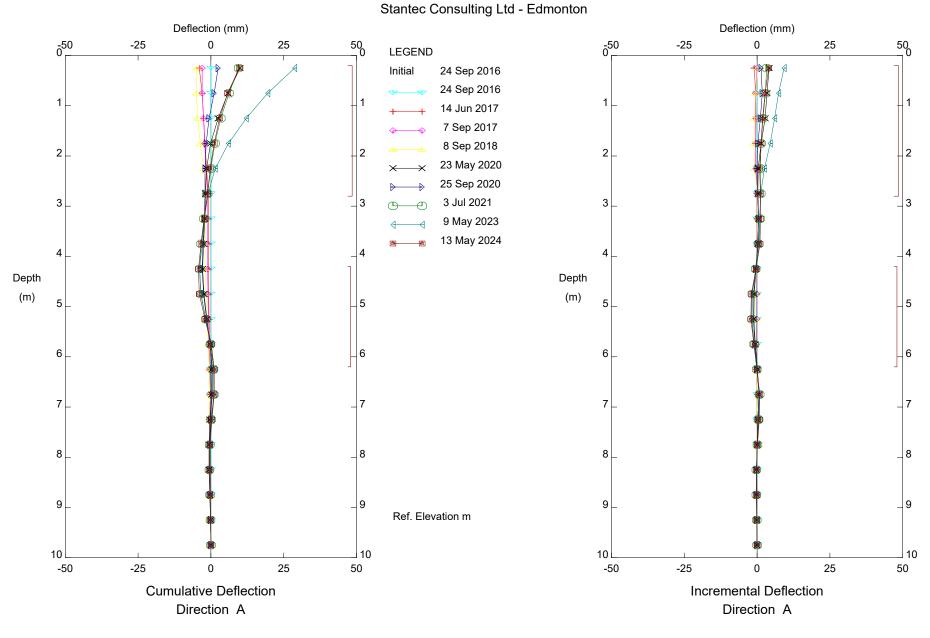
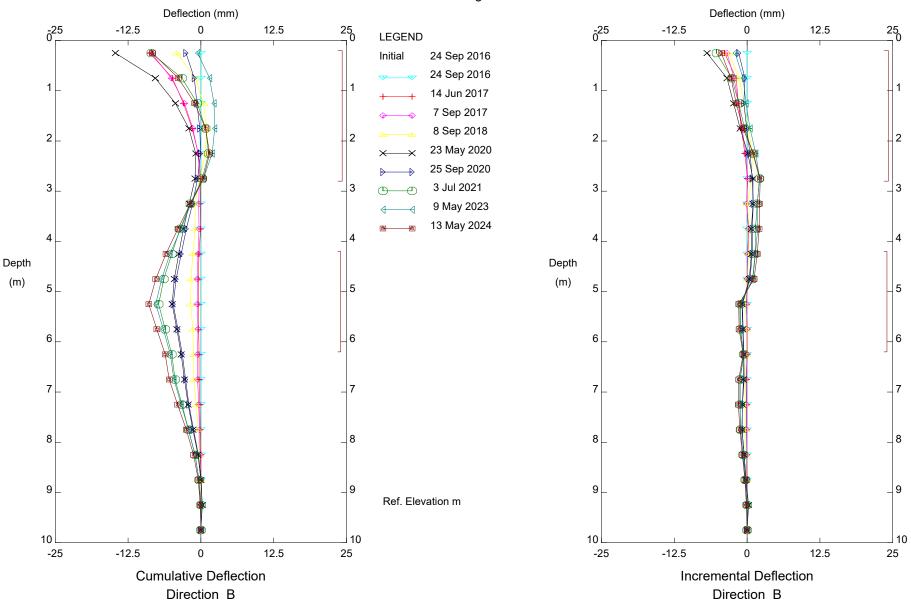
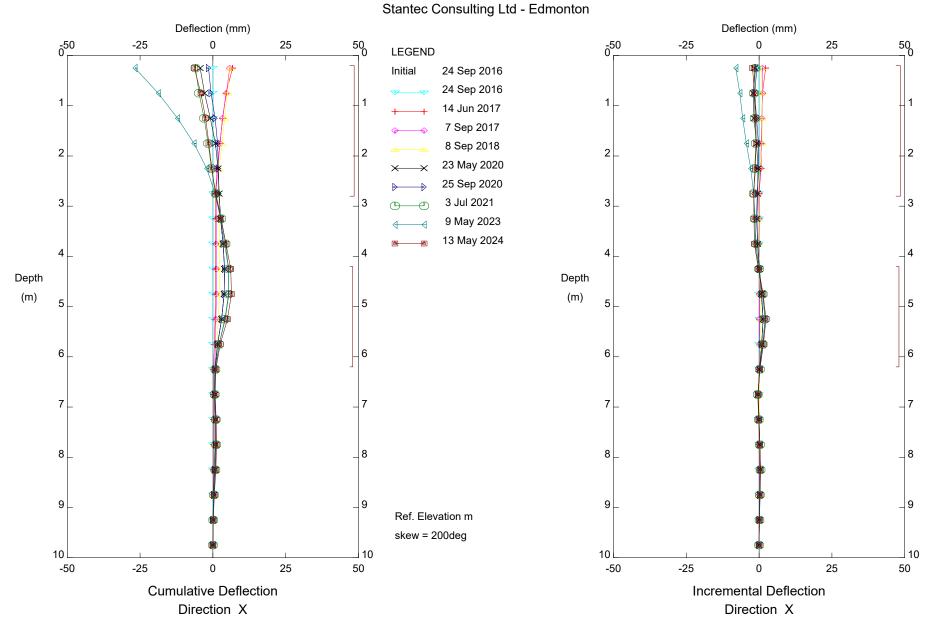
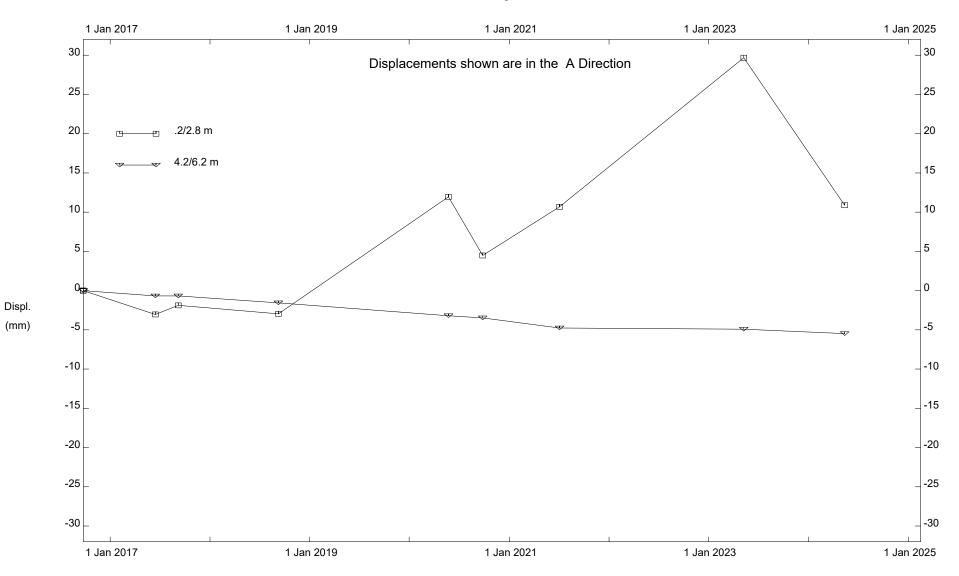
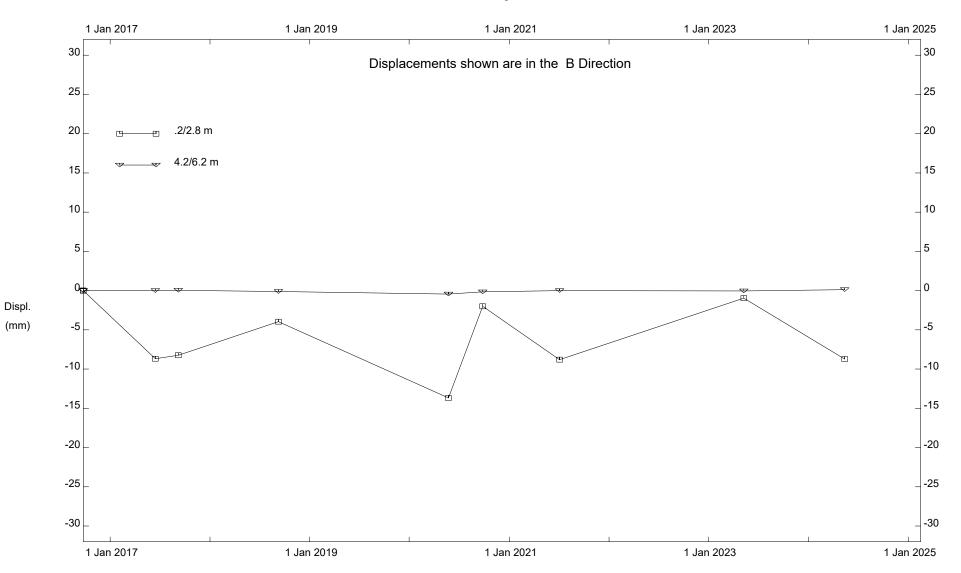
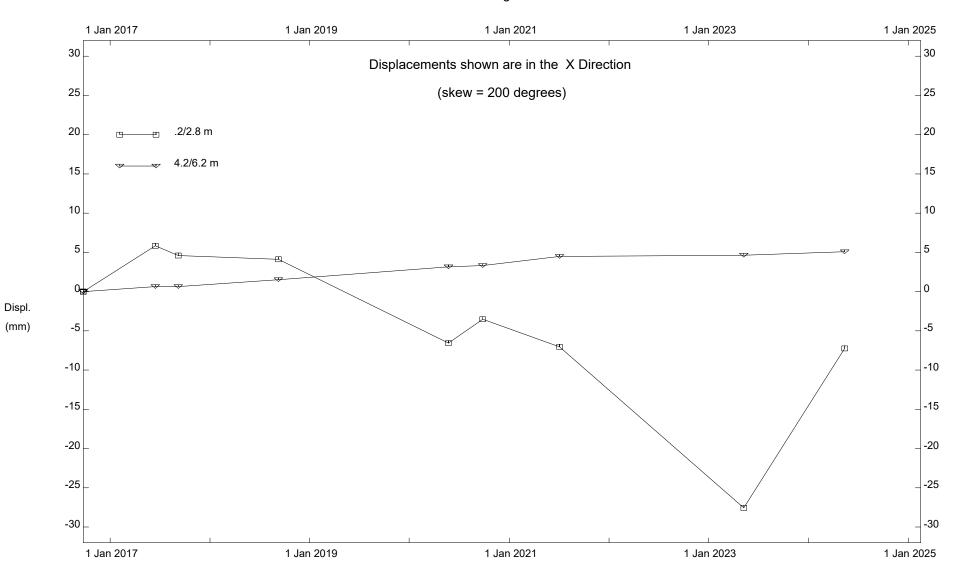
HWY40:30 Fred Creek (NC48), Inclinometer SI-1

No new zones of movement were observed in the operational SI. **Table NC48-1** summarizes the SI readings since installation. Directions of movement reported are referenced to the Azimuth of the A+ groove for the SI casing.

SI1 contains an upper and lower shear zone and showed relatively little cumulative movement since initialization in 2006. Since Spring of 2021, the cumulative displacement has remained relatively constant with 7 mm in the upper shear zone at 0.2 m to 2.8 m. The lower shear zone has about 5 mm of cumulative movement over 4.2 m to 6.2 m. Although the incremental movement and movement rates of SI1 in the upper zone appear large (20 mm/yr), it is important to note that the cumulative displacement has returned to a magnitude about the same as it was during Spring 2021.

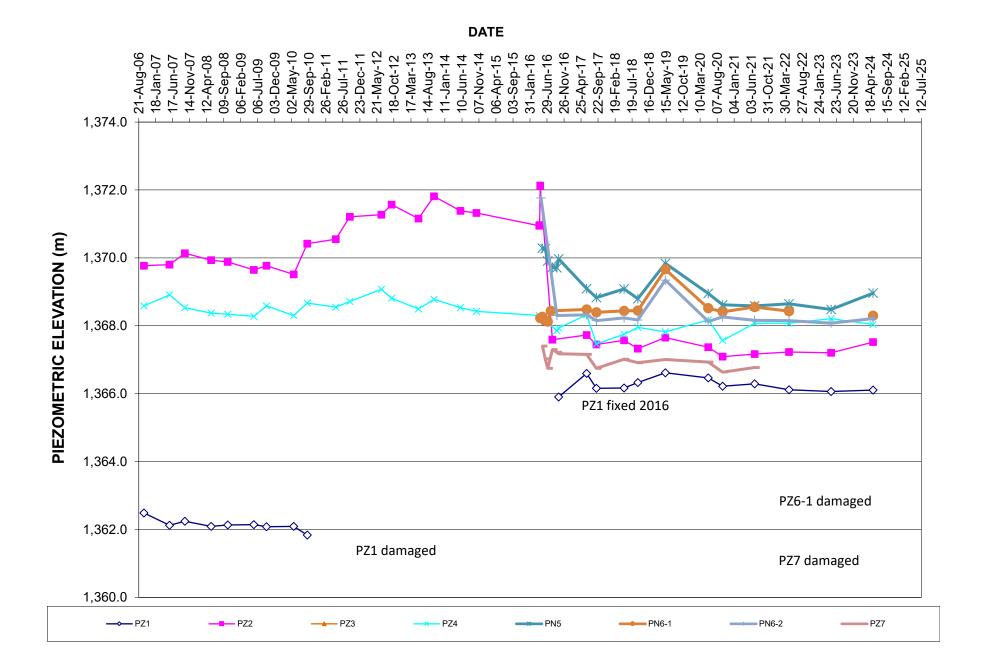
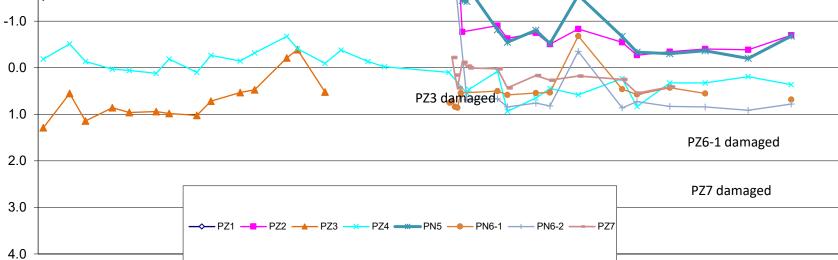
#### PNEUMATIC PIEZOMETER DATA NC048: HWY40:30, North of Fred Creek

Overall, the piezometric levels have remained relatively stable since completion of berm and wick drain construction in 2016. During the current reading cycle, the change in piezometric level ranged from an increase of 0.5 m to a decrease of 0.2 m compared to the Spring 2023 reading cycle.
