SITE NUMBER AND NAME: NC048 – Fred Creek Slide	HIGHWAY AND KM: 40:30, km 48.808	PREVIOUS INSPECTION: May 26, 2020	CURRENT INSPECTION: June 11, 2024
LEGAL DESCRIPTION: SE-28-53-1-W6M	NAD83 COORDINATES: UTM11U 594003N, 4283399E		RISK ASSESSMENT: PF: 5 CF: 3 Total: 15
AVERAGE ANNUAL DAILY TRAFFIC (AADT): 1,690 (2023)		CONTRACTOR MAINTENANCE AREA (CMA): 508

2024 Site Inspection Photos at NC048

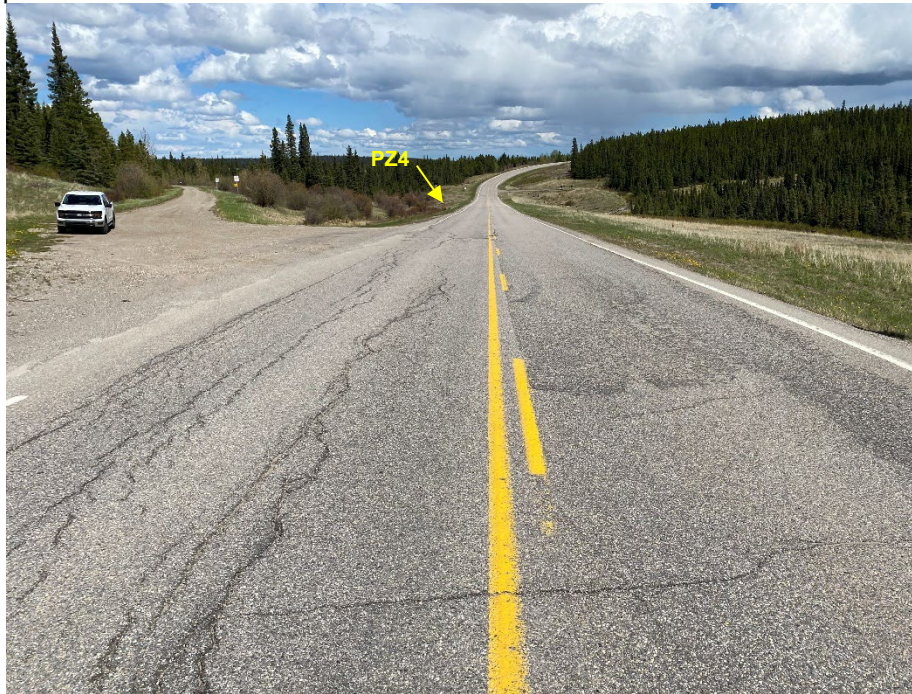
COMMENTS
<ul style="list-style-type: none"> The crack patterns appeared similar to the 2020 inspection, as shown in Photos 1 to 3, and are reflecting through the pavement patch. Several seepage locations previously observed on the south embankment were found to be dry during the 2024 inspection (Photos 4 & 5). Generally, piezometric levels have remained stable since completion of the berm and wick drain construction. However, high pore pressures continue to be observed in the piezometers at the site with 3 of 6 piezometers showing artesian conditions of up to 2.1 m above ground surface. The non-artesian piezometric levels range from 0.4 m to 0.8 m below ground surface. SI1 showed 20 mm of movement since the reading in 2023, however the cumulative displacement is similar to what was observed in 2021. Overall, SI1 has shown 7 mm of movement between 0.2 m and 2.8 m deep, and 5 mm of movement between 4.2 m and 6.2 m deep since the date of installation. A ground crack 7 m long and 0.15 m deep was observed in the north ditch, near PZ4. It is possible that the ground crack may be caused by mowing equipment; however, the toe of the highway embankment appears to

Photo 1: Pavement cracks in front of access road. Looking east.

- Short term recommendations include sealing of any cracks to reduce surface water infiltration into the slope and pavement structure. Stantec was informed by TEC that a maintenance overlay of 30 mm may be applied in summer 2024.
- The silt fence remaining from construction should be removed from the site.
- Site inspection frequency should remain at once per contract cycle with instrumentation monitoring completed annually in the spring.

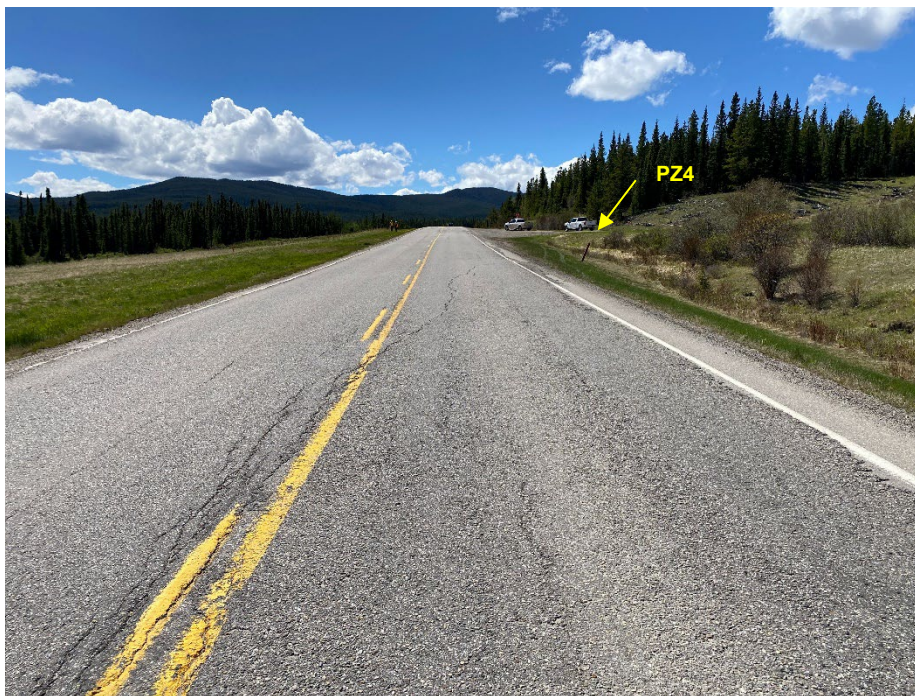
Photo 2: Pavement cracking east of PZ4. Looking west.

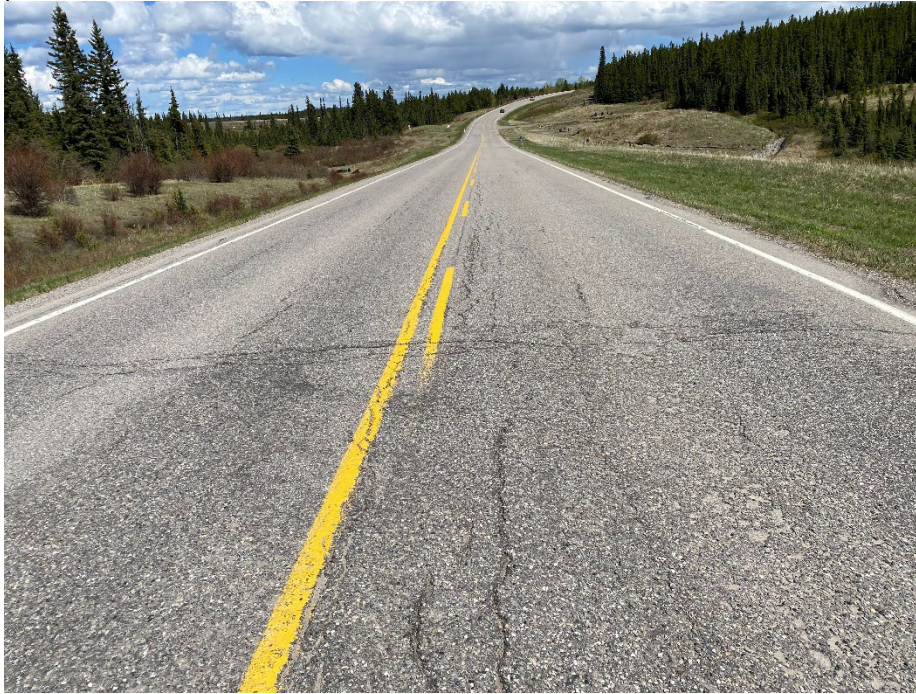
Photo 3: Pavement cracks at east end of patch. Looking east.

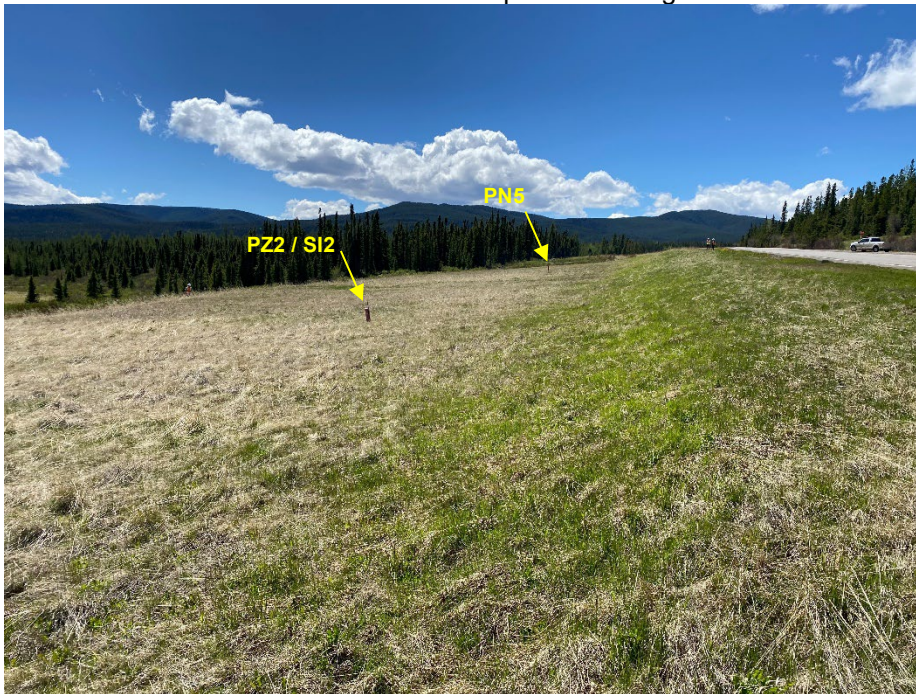
Photo 4: Overall embankment slope. Looking west.

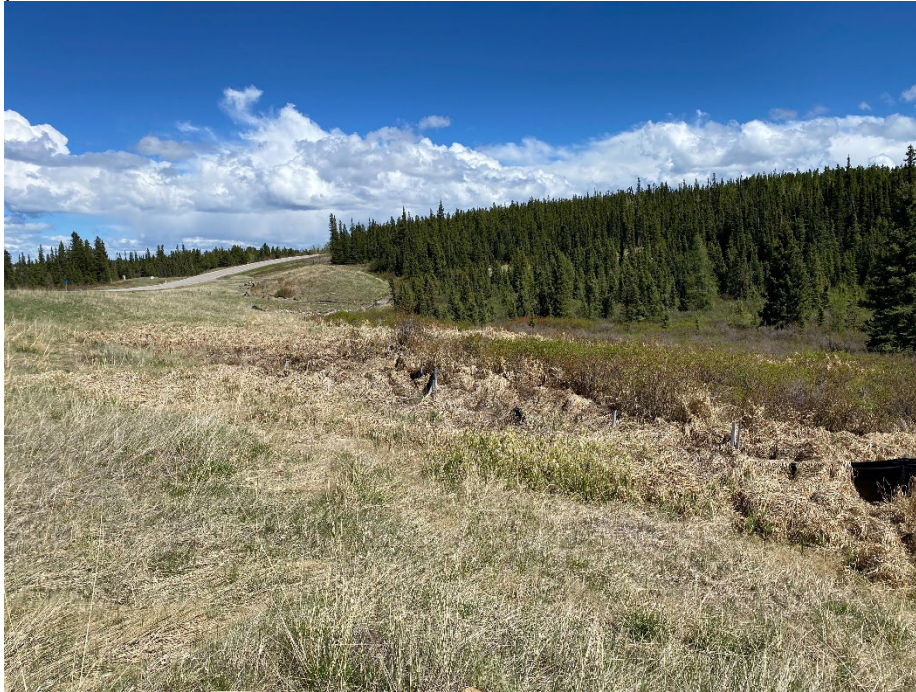
Photo 5: Previous areas of seepage were dry. Silt fence remains on site. Looking east.

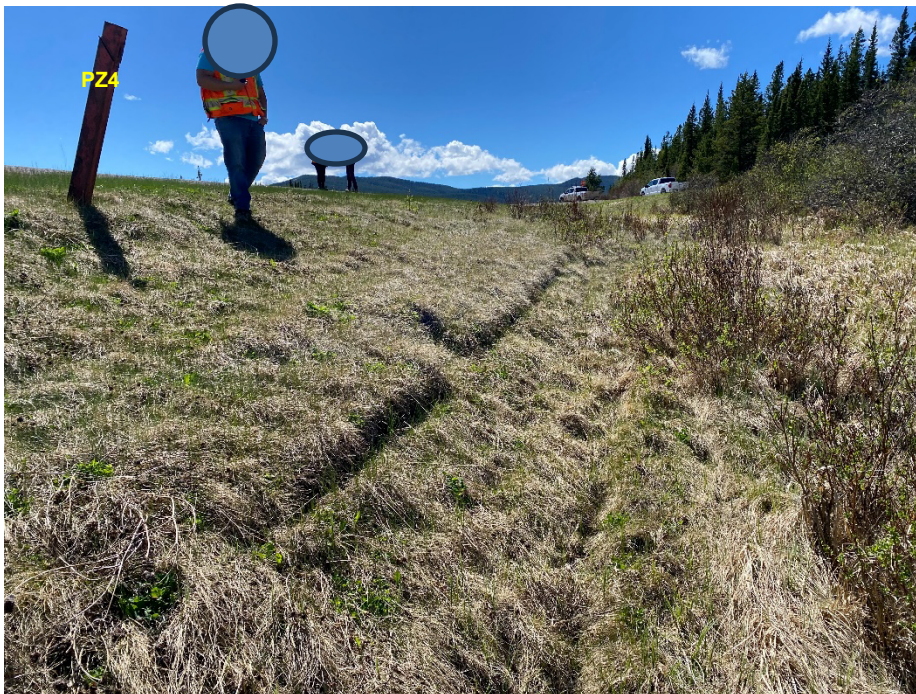
be sharply sloped which may not allow for mowing equipment within the ditch. PZ4 is also leaning into the ditch (Photo 6).

Photo 6: Ground crack in north ditch, near PZ4. Looking west.

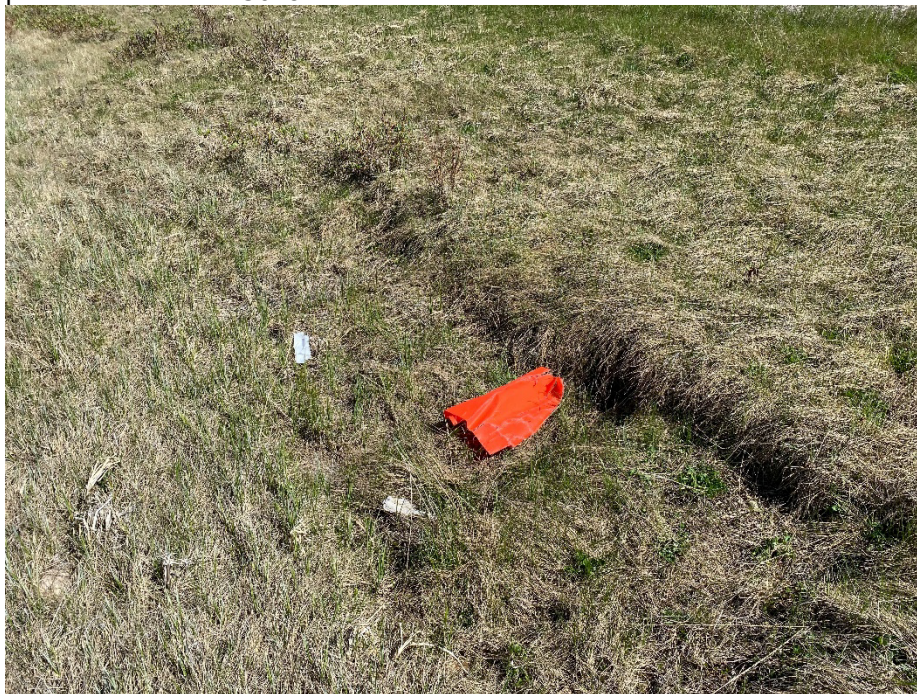
- A possible sinkhole was observed west of the ground crack, in the north ditch east from the entrance to the gravel access road. The area was approximately 3 m long, 1 m wide and 0.15 m deep (Photo 7).

Photo 7: Possible sinkhole in the north ditch. Looking southeast.

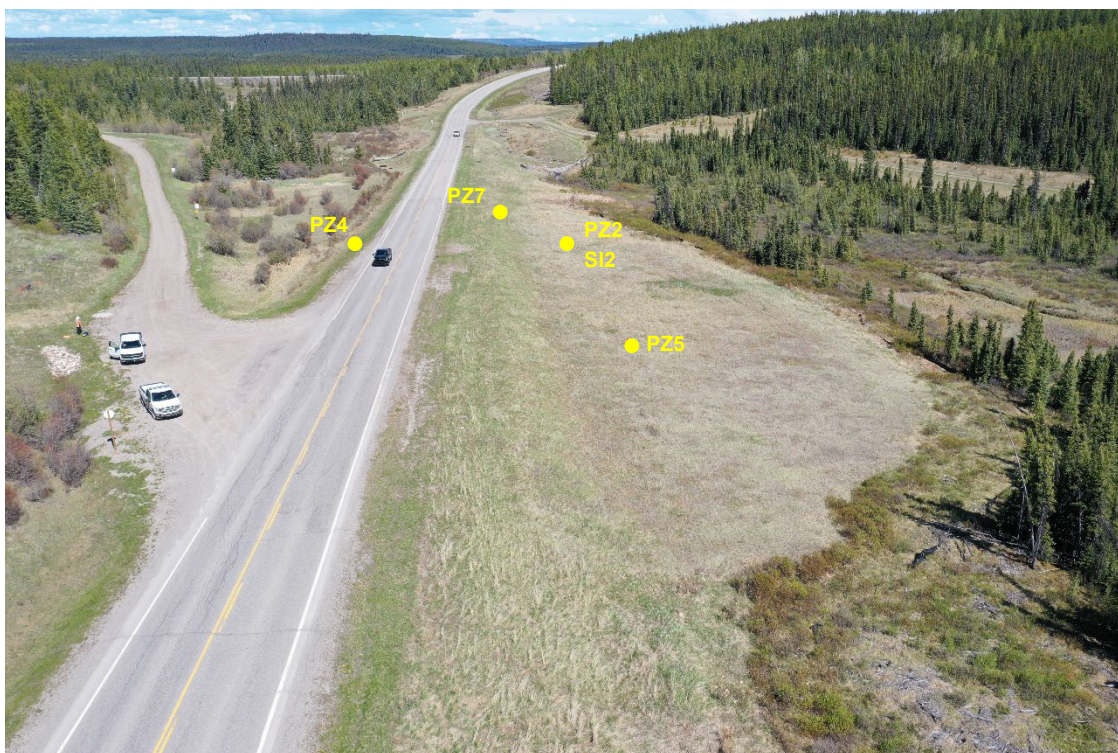
Photo 9: Overview of site. Photo taken by drone, looking east.

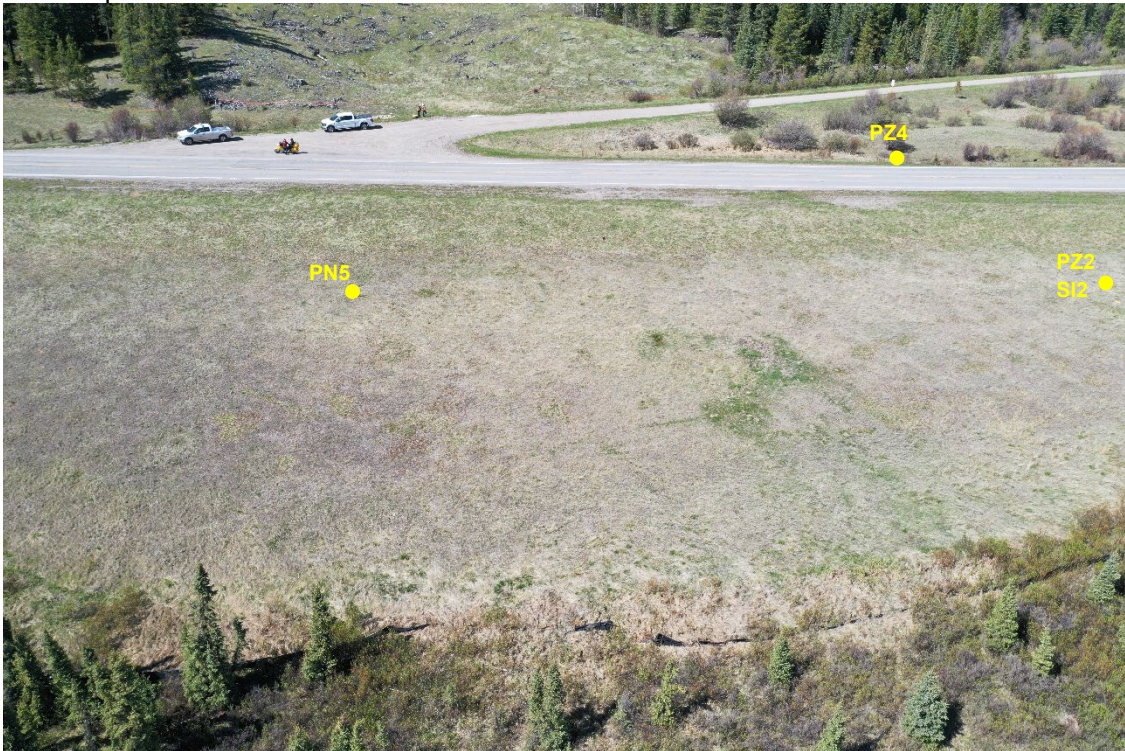
Photo 10: Overview of embankment slope. Photo taken by drone, looking north.
