**NORTH CENTRAL REGION GRMP
EDSON / STONY PLAIN
SITE INSPECTION FORM**

SITE NUMBER AND NAME: NC083 – West of Wildhay River	HIGHWAY AND KM: 40:30, km 37.368	PREVIOUS INSPECTION: May 26, 2020	CURRENT INSPECTION: July 15, 2021
LEGAL DESCRIPTION: SE-08-53-27-W5	NAD83 COORDINATES: UTM11U 5935069N, 437757E		RISK ASSESSMENT: PF: 10 CF: 4 Total: 40
AVERAGE ANNUAL DAILY TRAFFIC (AADT): 1,260 (2020)		CONTRACTOR MAINTENANCE AREA (CMA): 508

2021 Site Inspection Photos at NC083

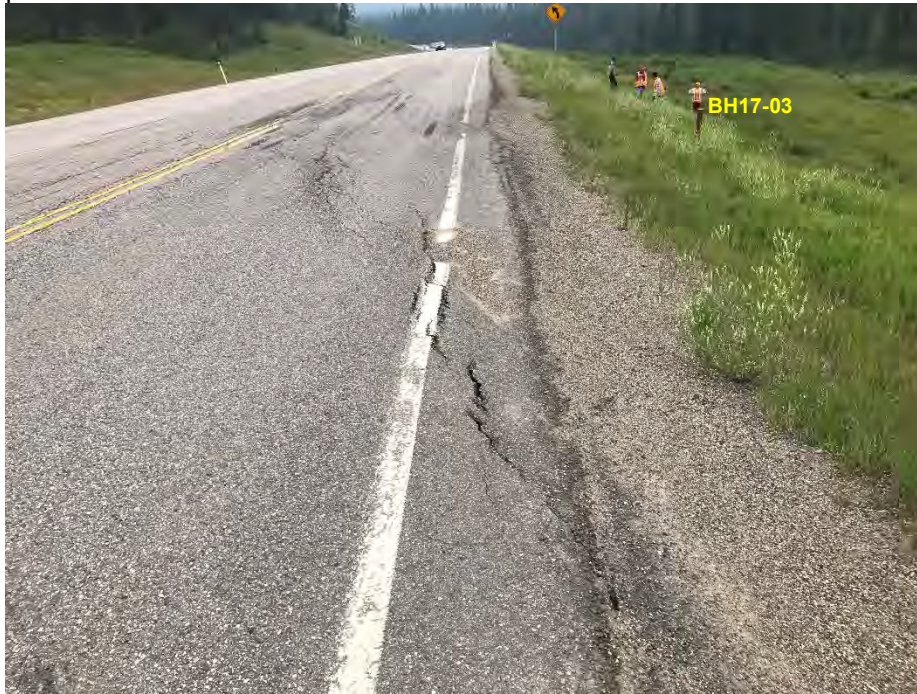
Photo 1: Pavement cracking at shoulder of SBL. Note tire marks just past the crack. Looking southeast.

- All pavement cracks should be sealed to reduce surface water infiltration into the landslide.
- Riprap or gravel should be placed at the C/L culvert outlet. If the erosion is left unchecked, it could lead to further channeling and embankment movement.
- It is understood that this section of the highway is planned to be widened, and that slope stabilization will be included with the highway widening works. Remediation options could include installing a pile wall along the south edge of pavement or constructing a gravel toe berm south of the highway and/or considering light weight fill for the highway widening work. Any remediation measures undertaken should include drainage measures such as trench drains, sand drains, or wick drains to reduce pore pressures.
- The site should continue to be inspected annually.
- Instrumentation monitoring should continue semi-annually.

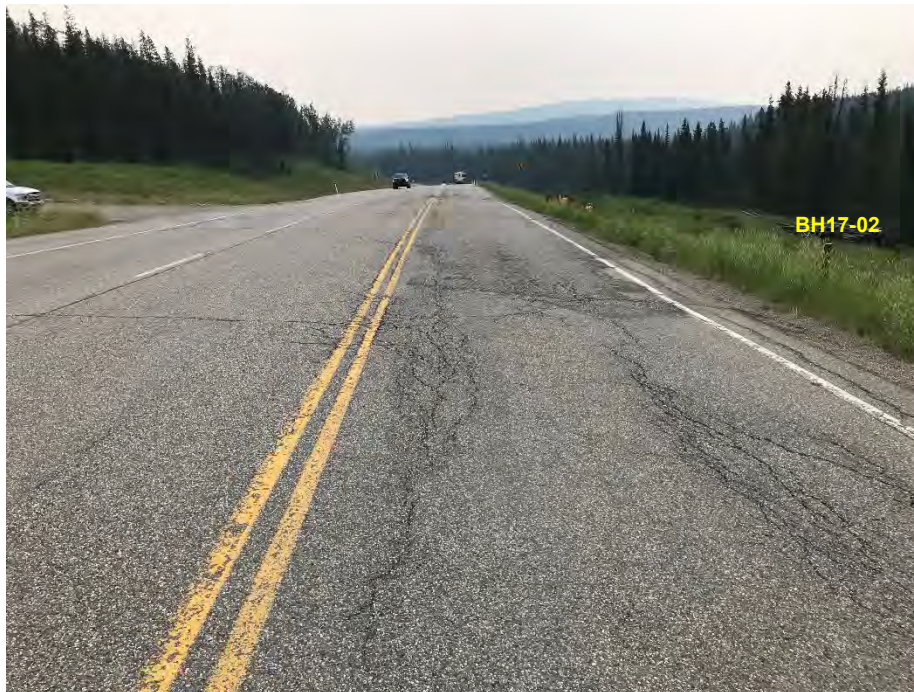
Photo 2: Pavement cracking near BH17-02. Looking southeast.

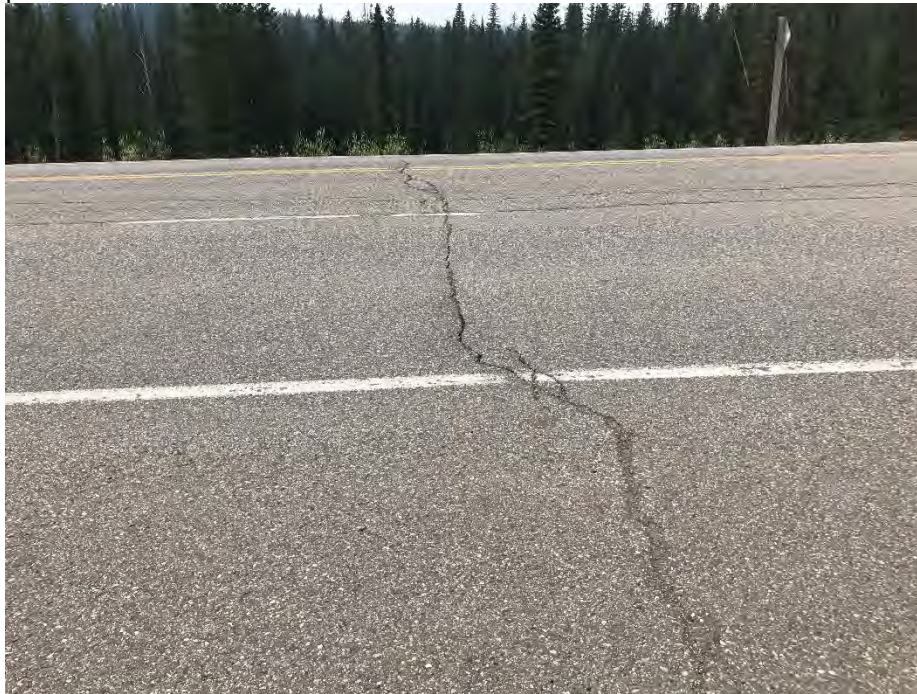
Photo 3: Pavement crack along C/L culvert alignment. Looking southwest.

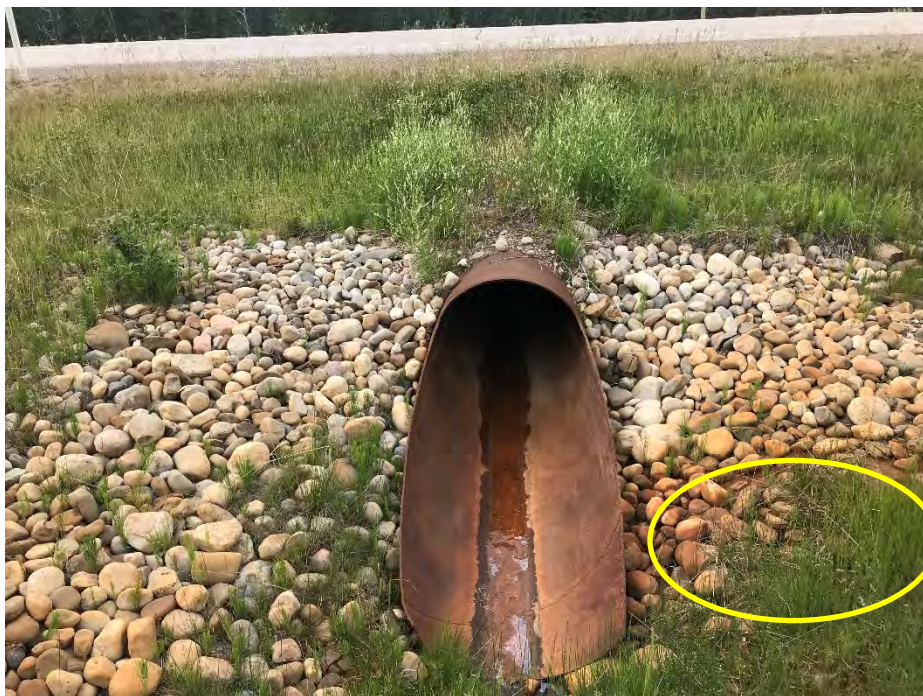
Photo 4: North ditch at C/L culvert inlet. Seepage location circled. Looking southwest.

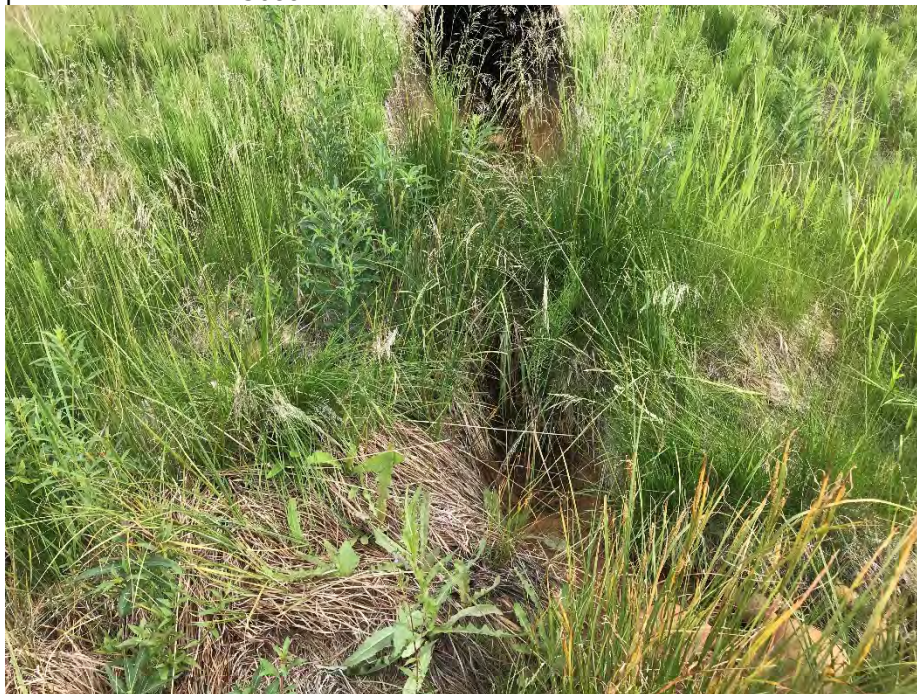
COMMENTS
<ul style="list-style-type: none"> • Pavement crack pattern appeared mostly unchanged compared to the previous inspection and consisted of: <ul style="list-style-type: none"> – 50 mm high crack along SBL shoulder northwest of BH17-03. Vehicles may be breaking hard as they travel across the crack as evidenced by tire marks on the pavement. – Semi-circular crack along SBL along between BH17-02 and BH17-03. • A new pavement crack about 20 mm wide was observed along the alignment of the C/L culvert. • The north ditch was dry during this inspection. This allowed for a new seepage location to be observed adjacent and west of the C/L culvert inlet. The seepage was draining into the culvert. • Both culverts at the site appear to be in good condition. • The south slope appeared to have a “hummocky” appearance and was soft and spongy to traverse. • An erosion channel about 400 mm wide and deep was observed at the C/L culvert outlet.

Photo 5: Erosion at C/L culvert outlet. Looking northwest.

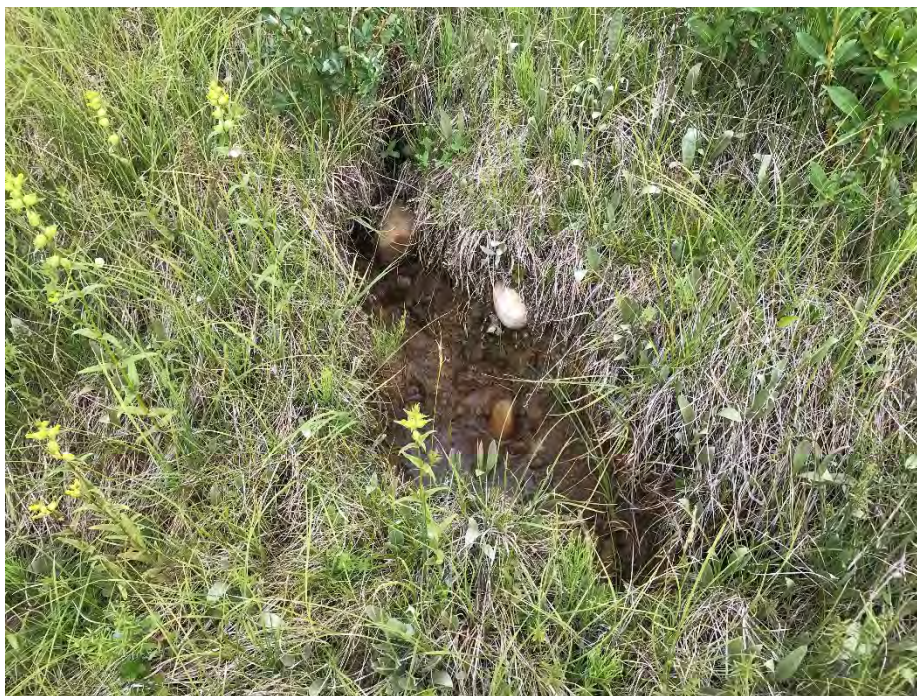
- Seepage was observed at the south slope in the previously observed vehicle tracks.
- All three SIs at the site continues to show movement with movement rates ranging from less than 1 mm/year to 10 mm/year. The rates of movement have decreased since the Fall 2020 readings, possibly due to the relatively dry year experienced in the area.
- Piezometric levels remain high ranging from 0.4 m to 0.8 m below ground surface.

Photo 6: Seepage in vehicle track. 300 mm deep track. Looking down.

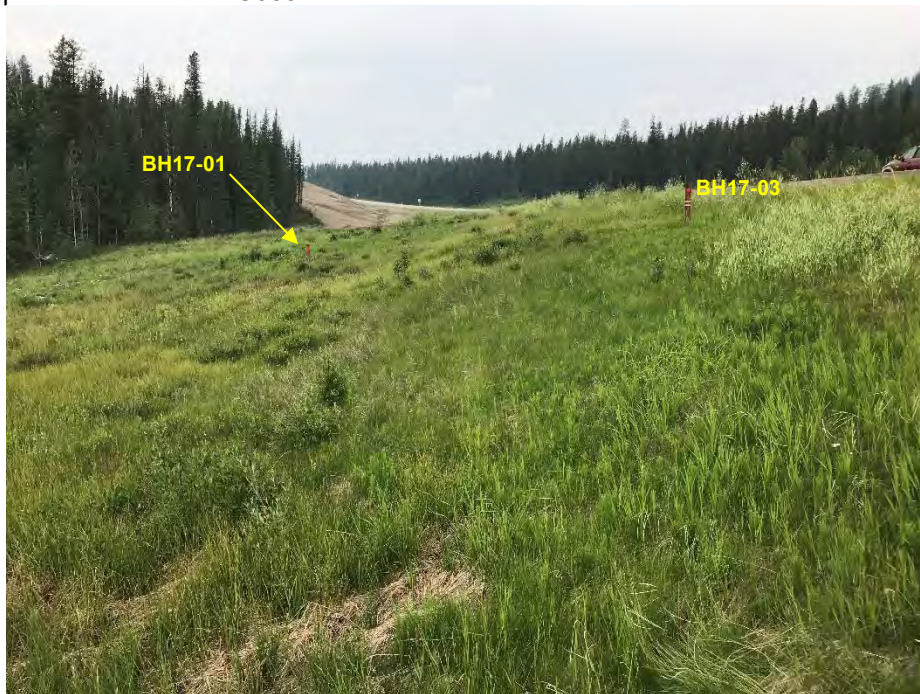
Photo 7: Overall view of south slope. Looking northwest.
