To:	Amy Driessen Alberta Transportation	From:	Leslie Cho and Xiteng Liu Stantec Consulting Ltd.
File:	123315222	Date:	October 7, 2022

Reference: North Central Region, Edson, Site NC083 - Highway 40:30 West of Wildhay River, Fall 2022 Instrumentation Monitoring Report

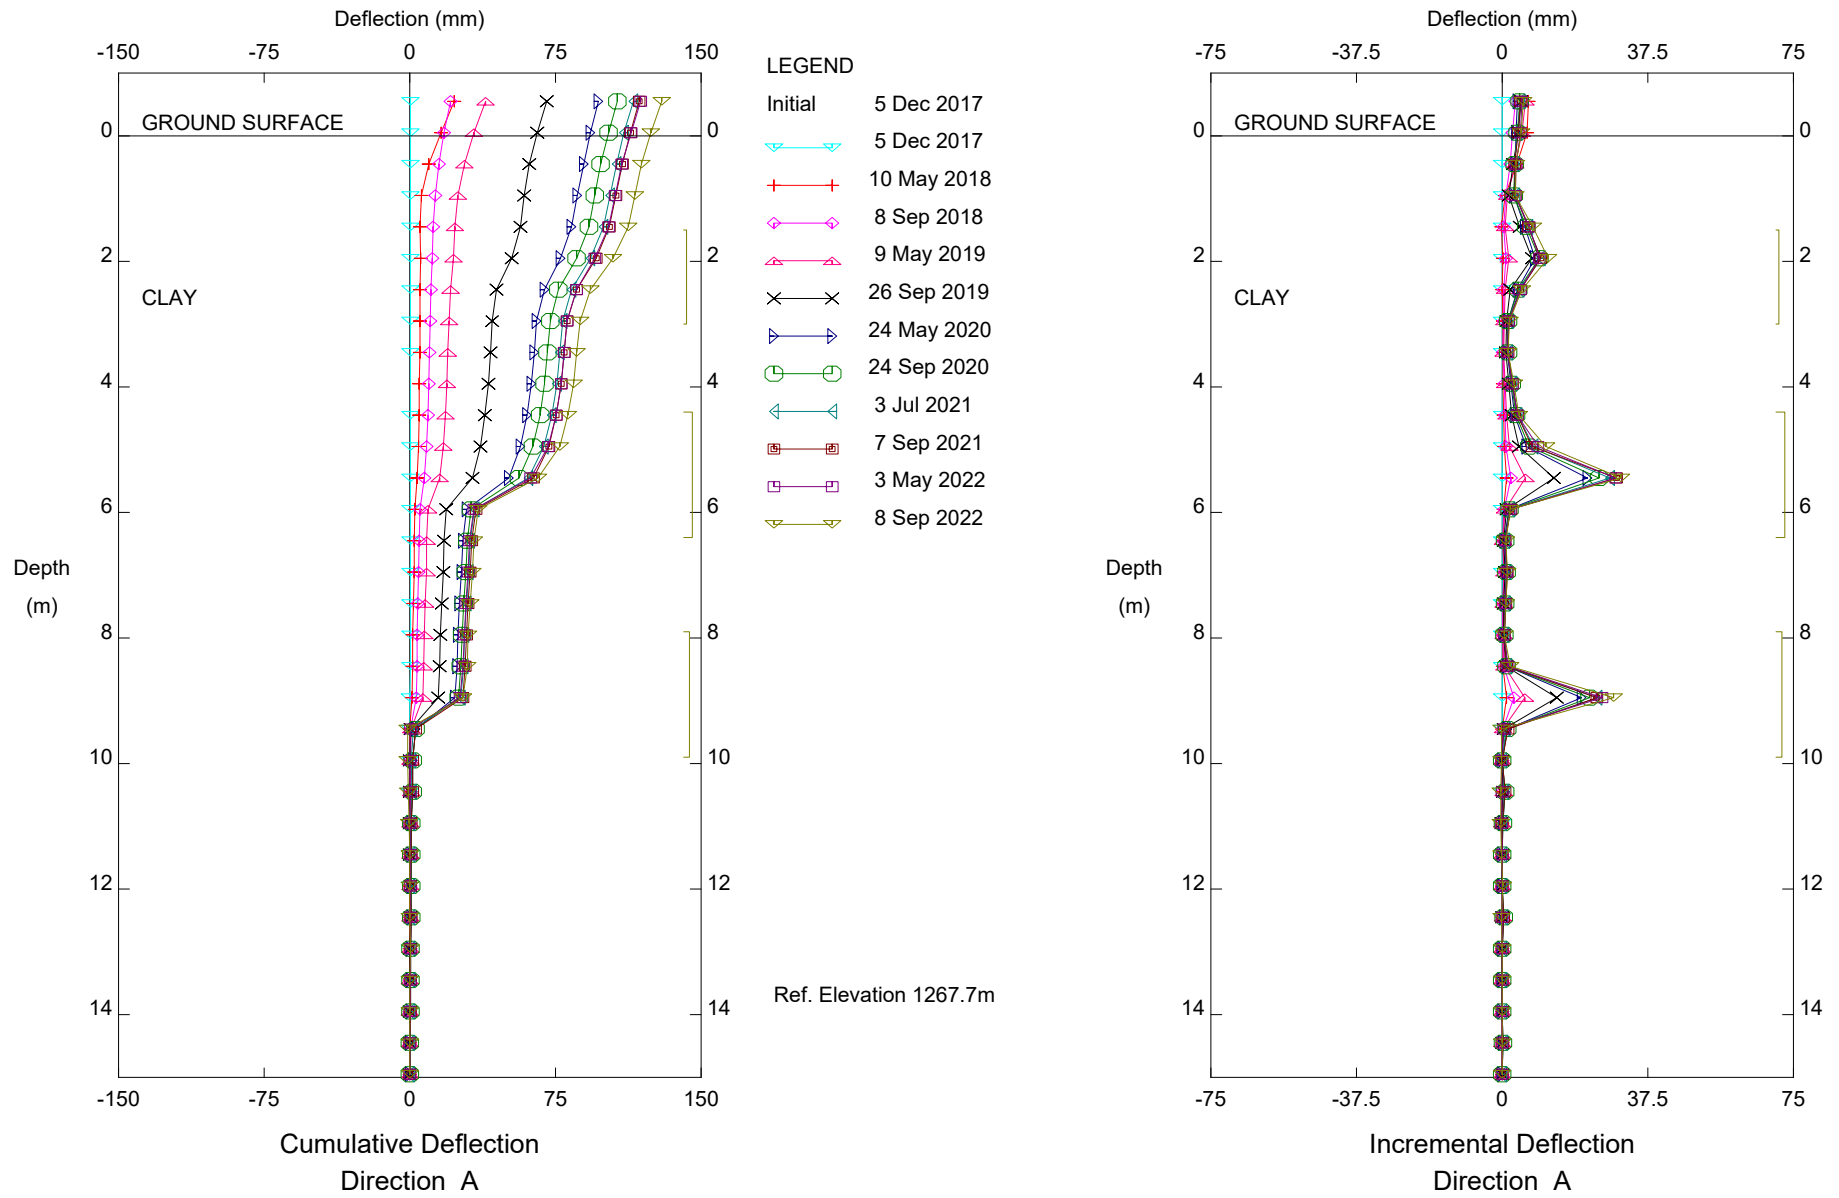
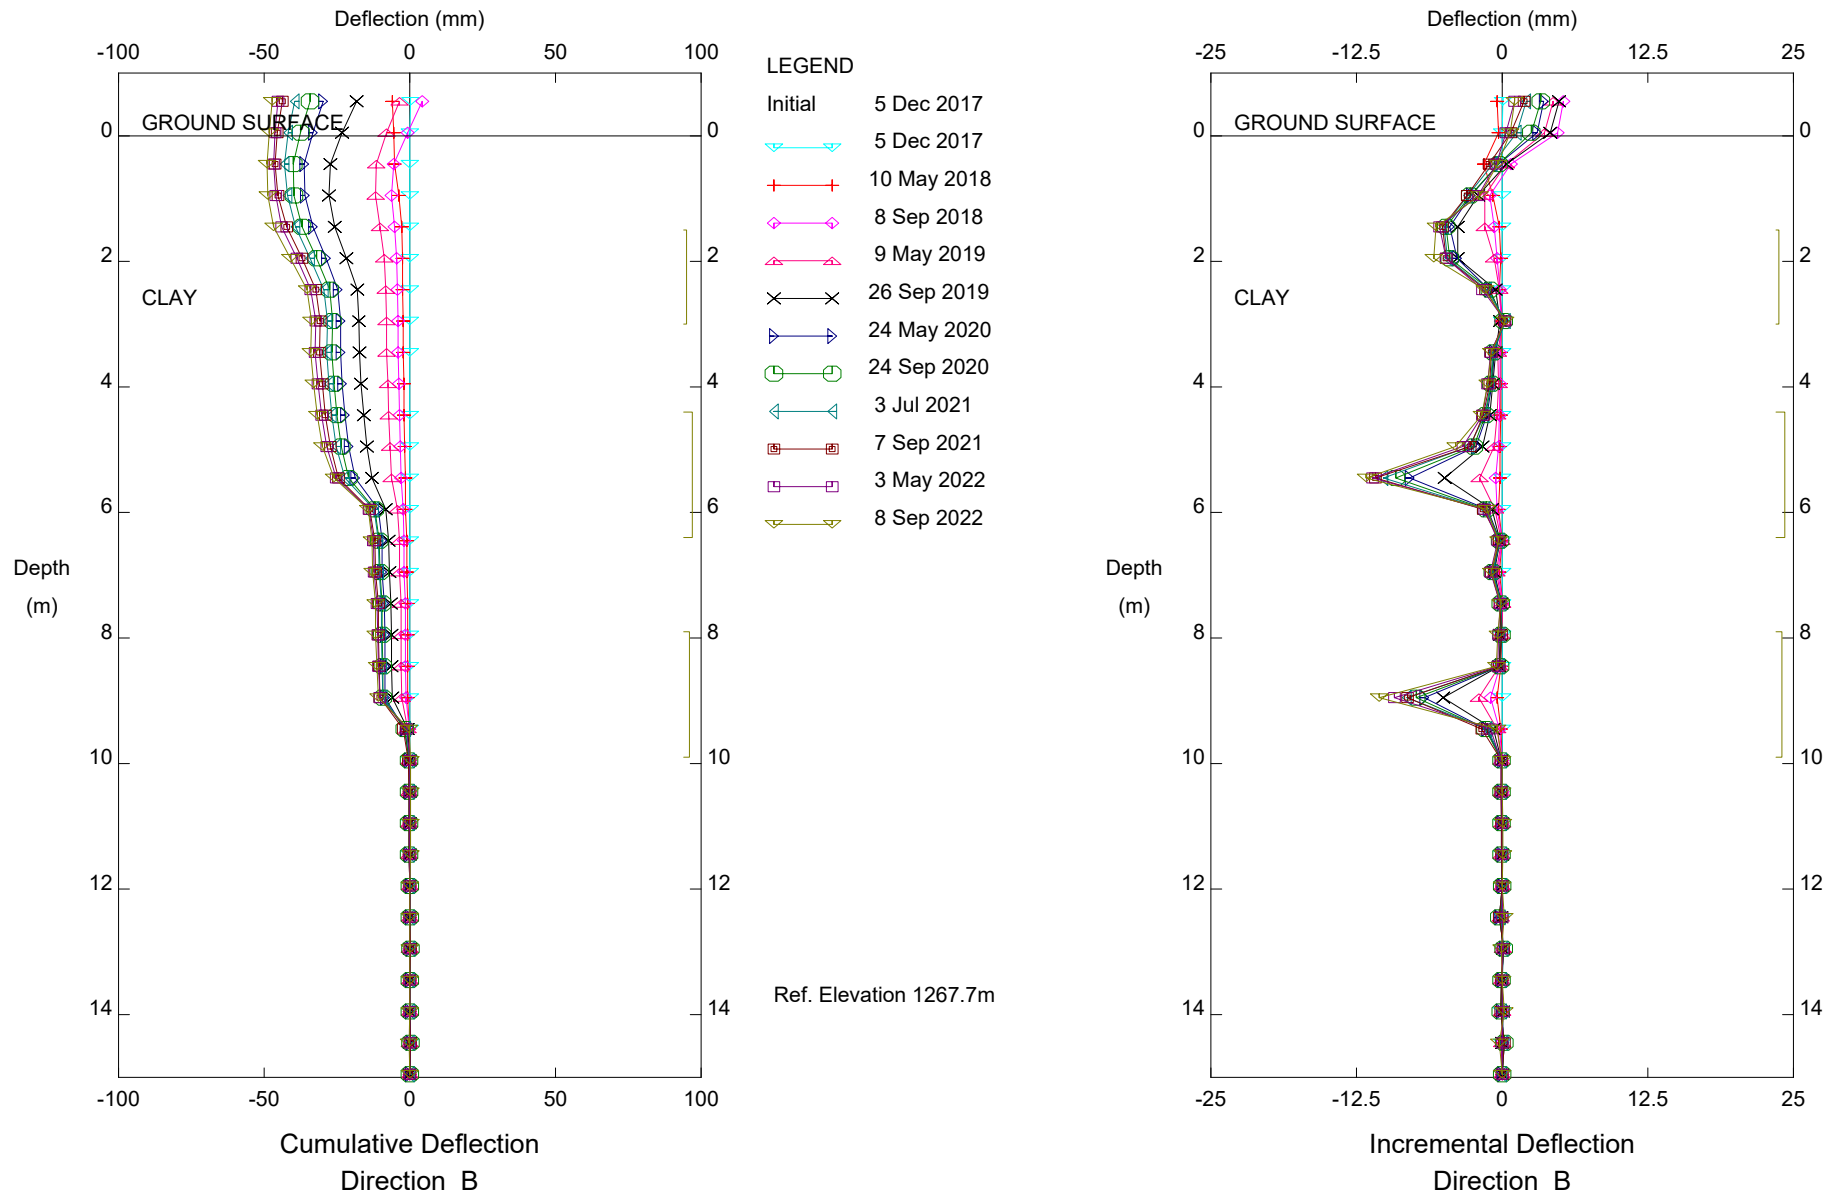
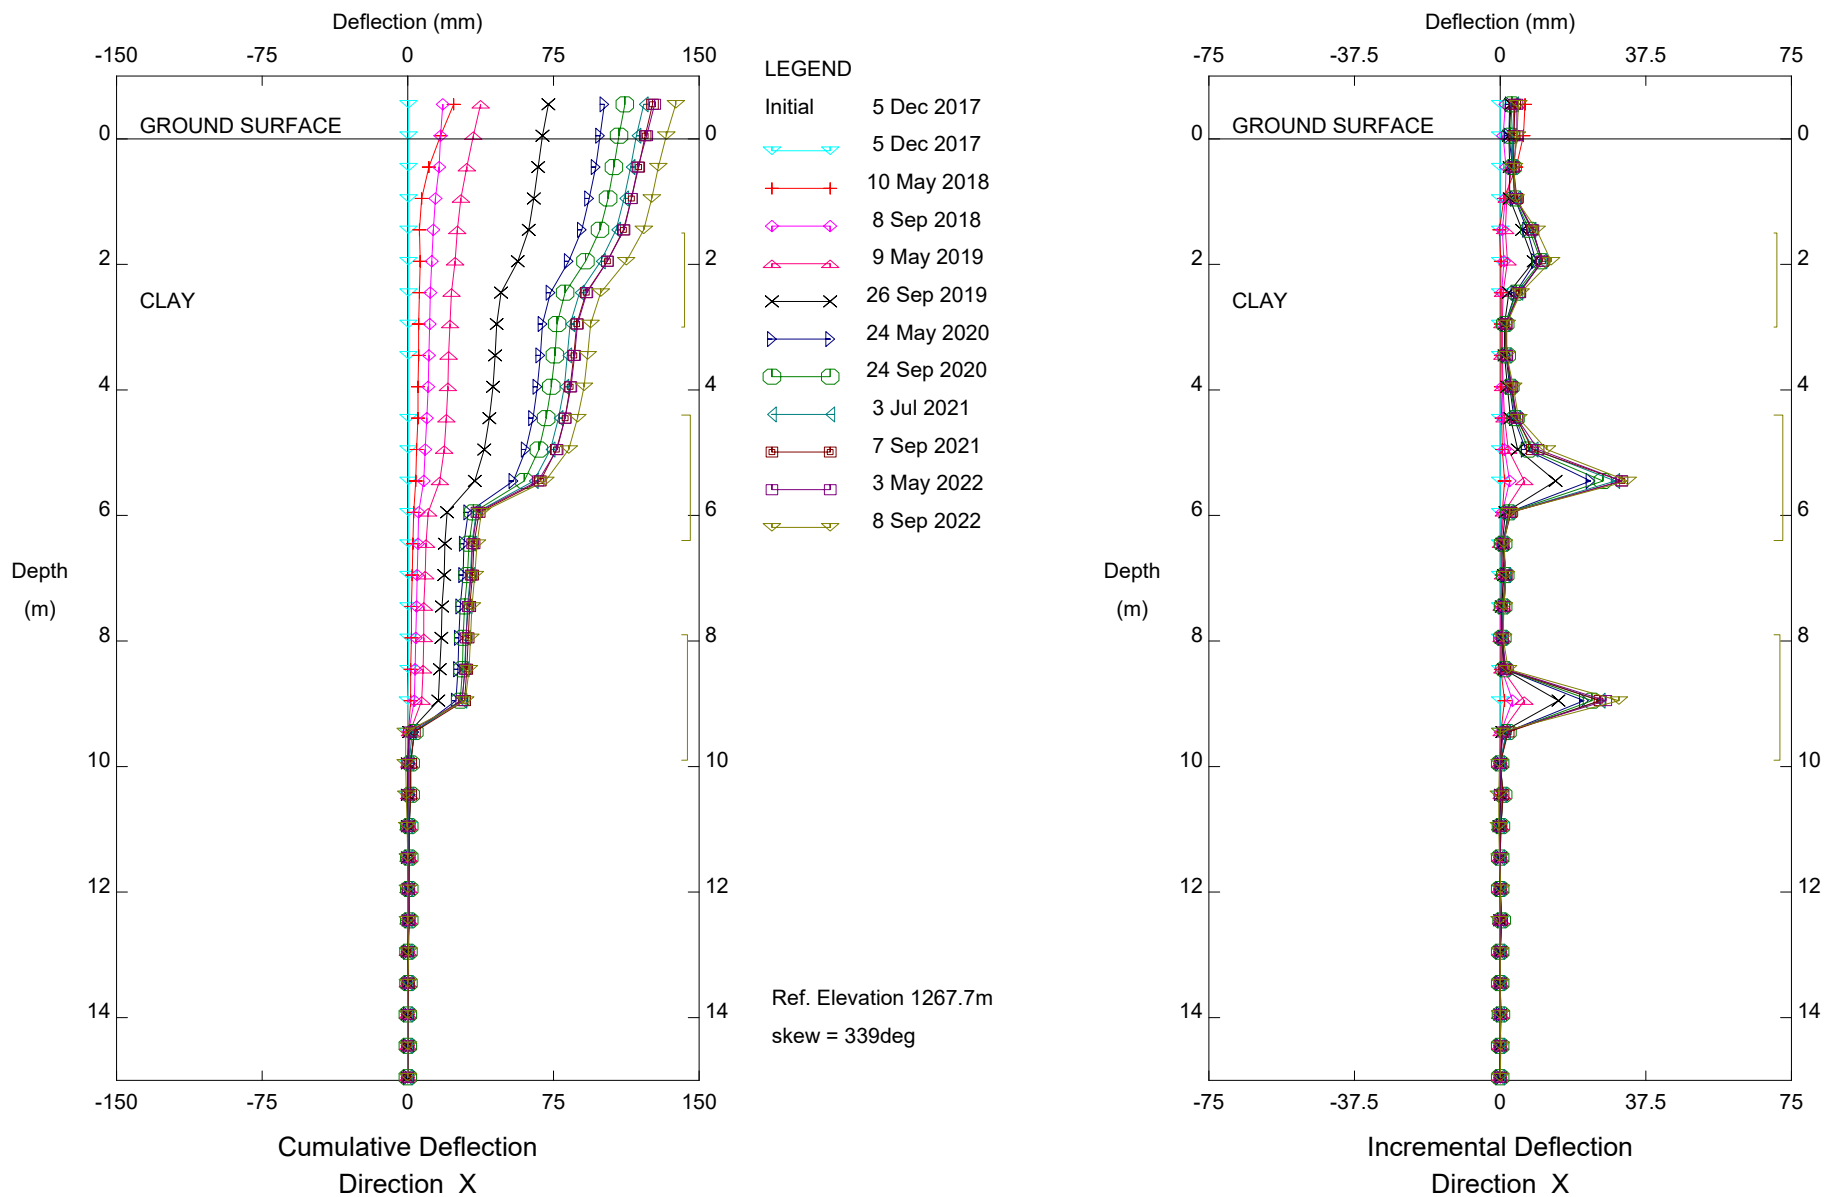
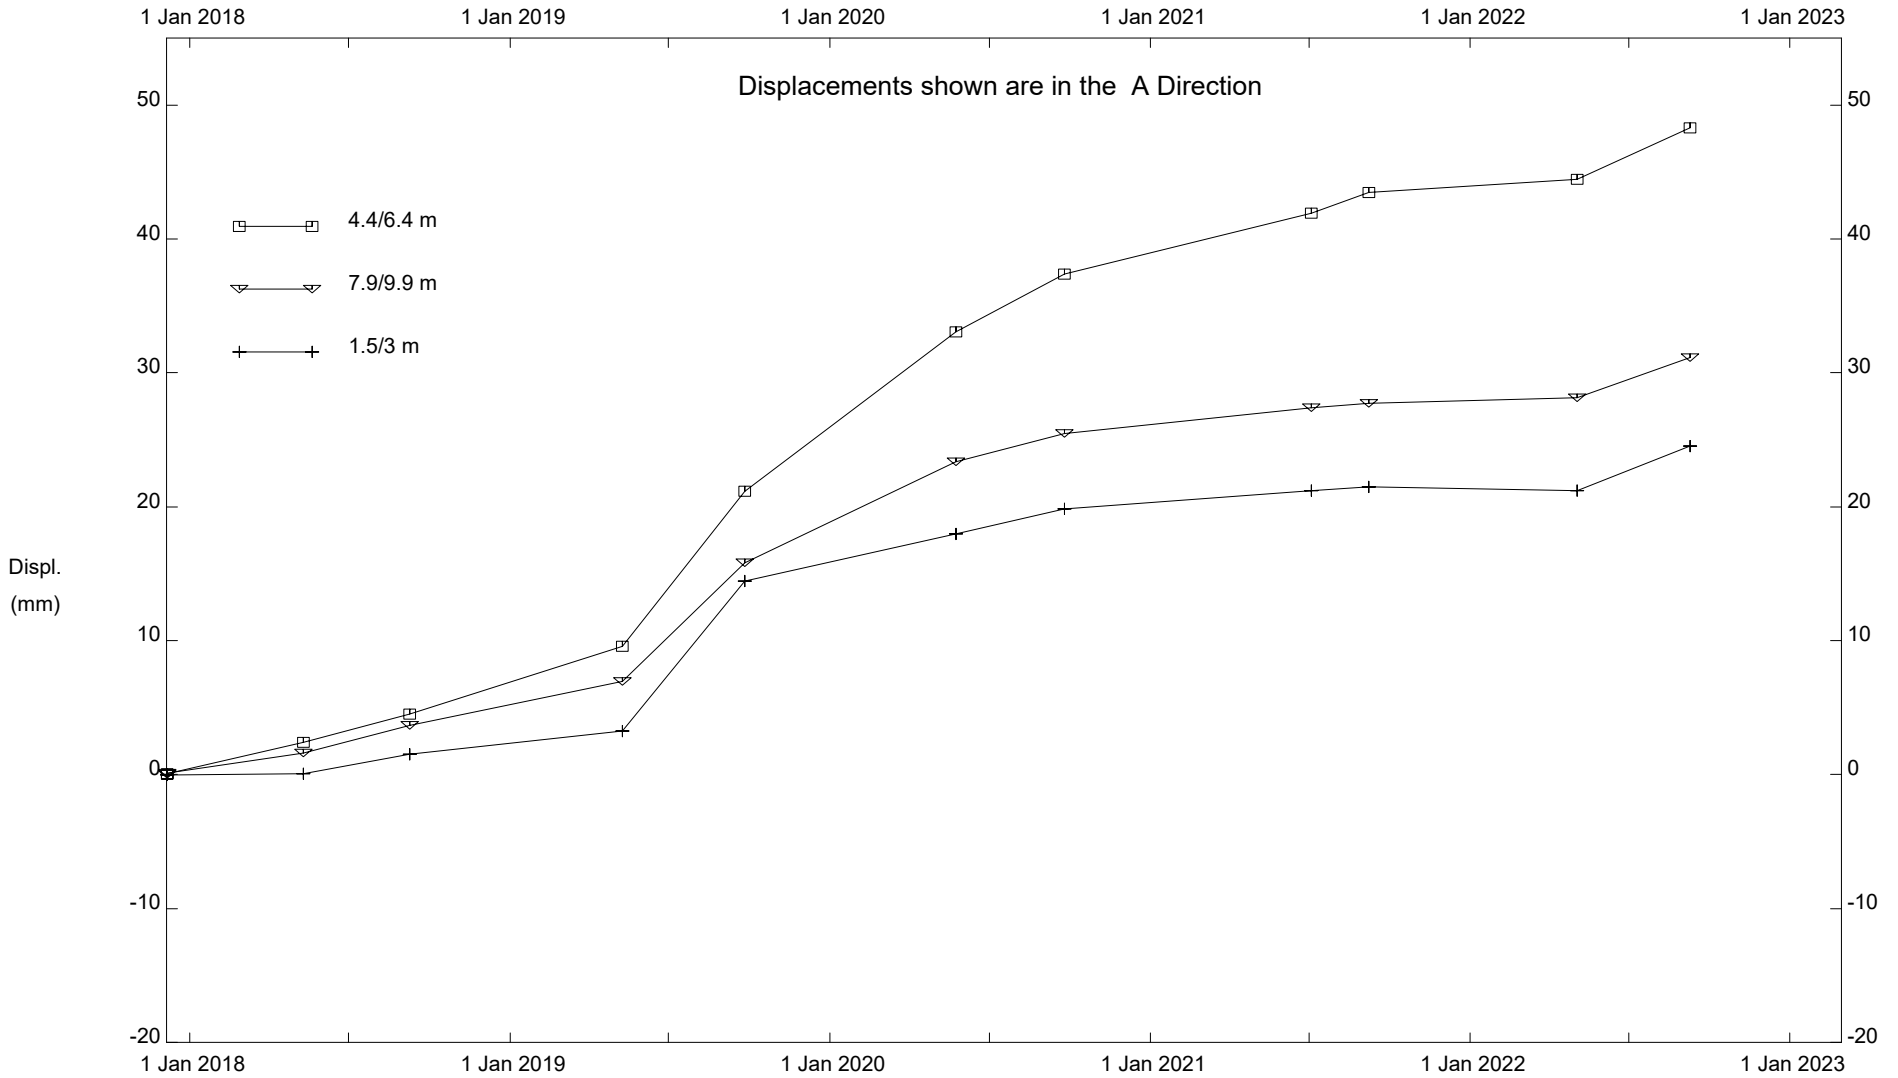
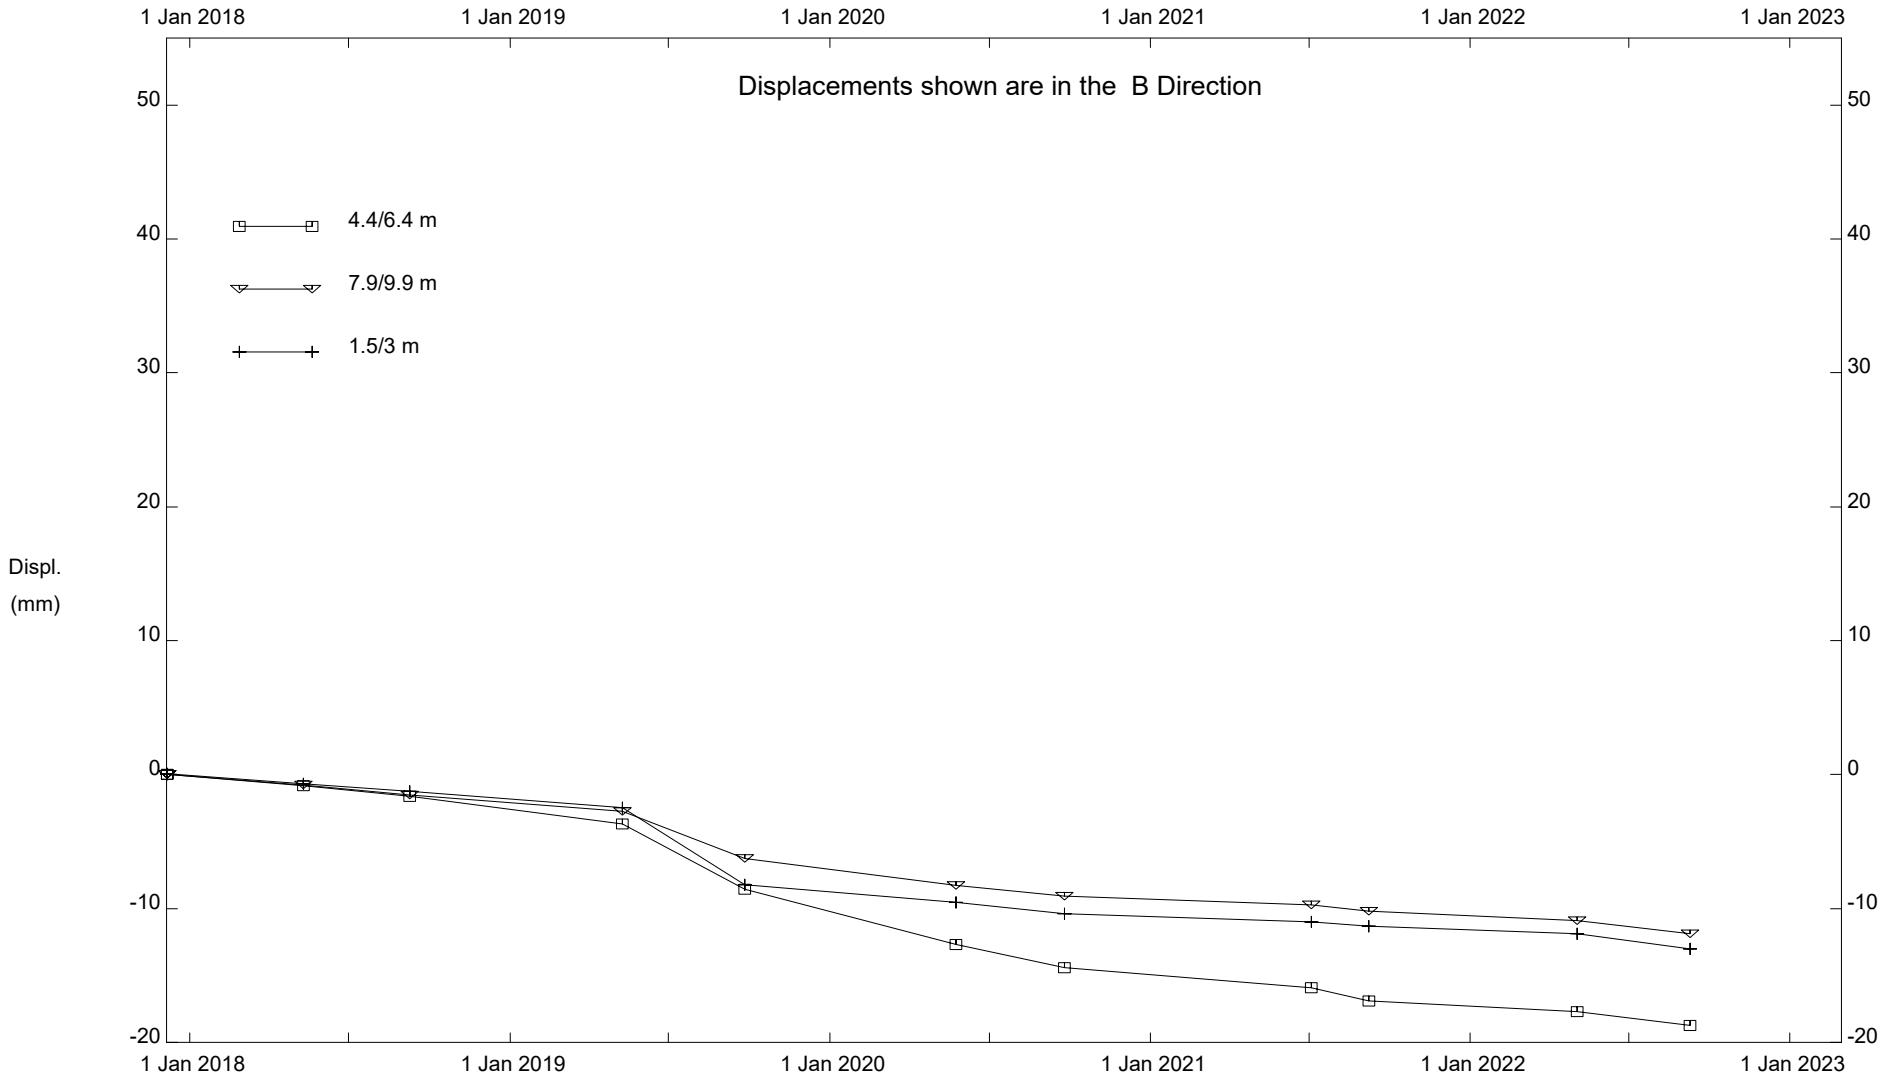
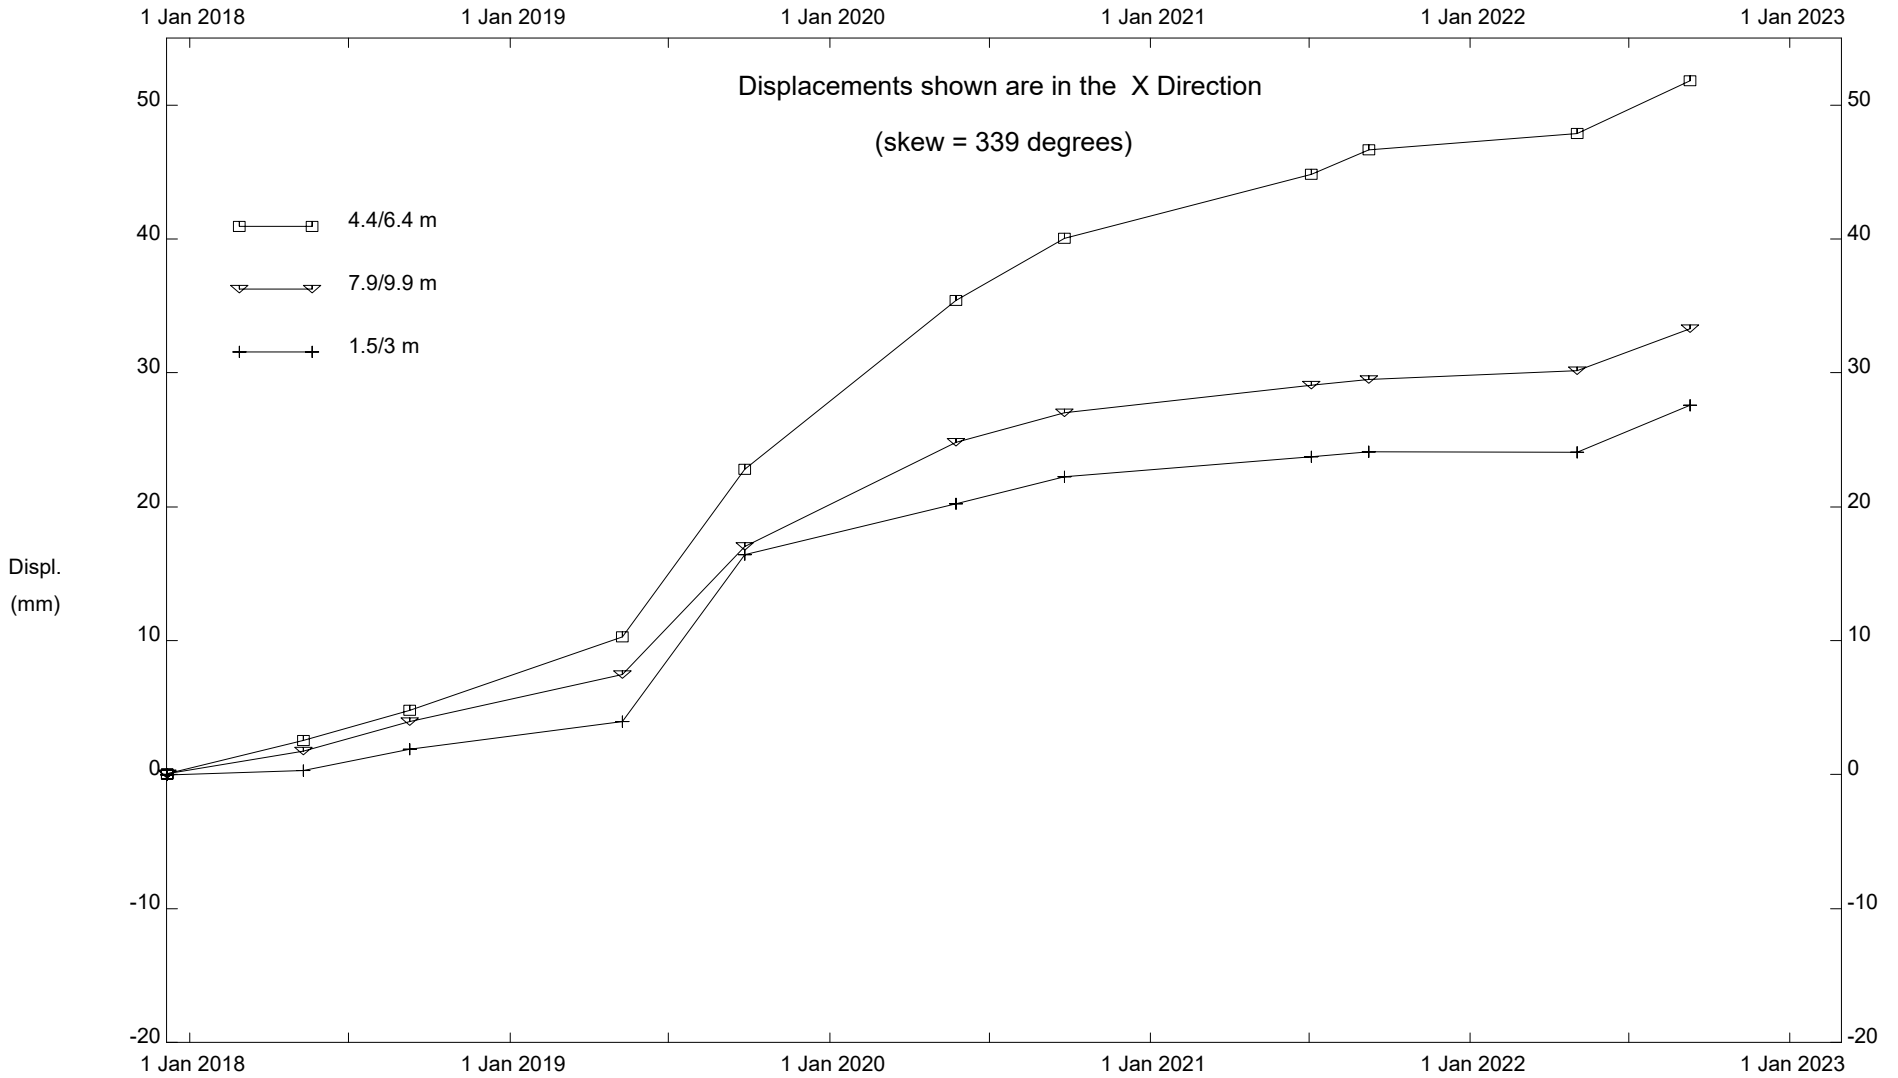
HWY 40:30 West of Wildhay River (NC83), Inclinometer SI17-01
 Alberta Transportation

SI17-01 shows three zones of movement at approximately 2 m, 6 m and 9 m below ground surface (bgs). Since initialization in December 2017, SI17-01 has accumulated 28 mm, 52 mm and 33 mm of movement in the upper, middle and lower shear zones, respectively. Their current respective rates of movement for the

three zones are 10 mm/yr, 11 mm/yr and 9 mm/yr. All three shear zones show increased rates of movement compared to the last reading cycle in Spring 2022.
