To:	Amy Driessen Alberta Transportation	From:	Leslie Cho and Xiteng Liu Stantec Consulting Ltd.
File:	123315222	Date:	October 7, 2022

Reference: North Central Region, Edson, Site NC083 - Highway 40:30 West of Wildhay River, Fall 2022 Instrumentation Monitoring Report

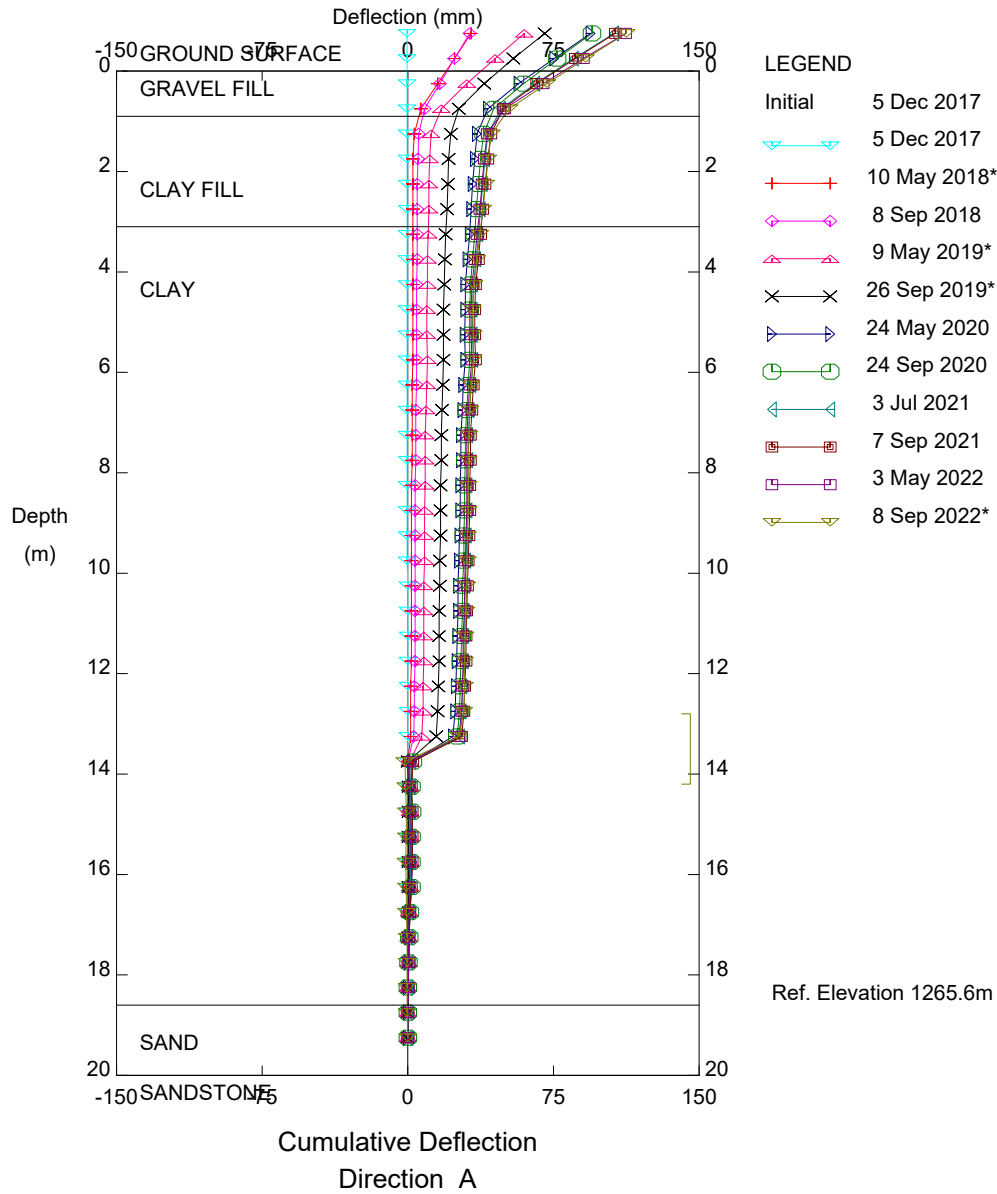
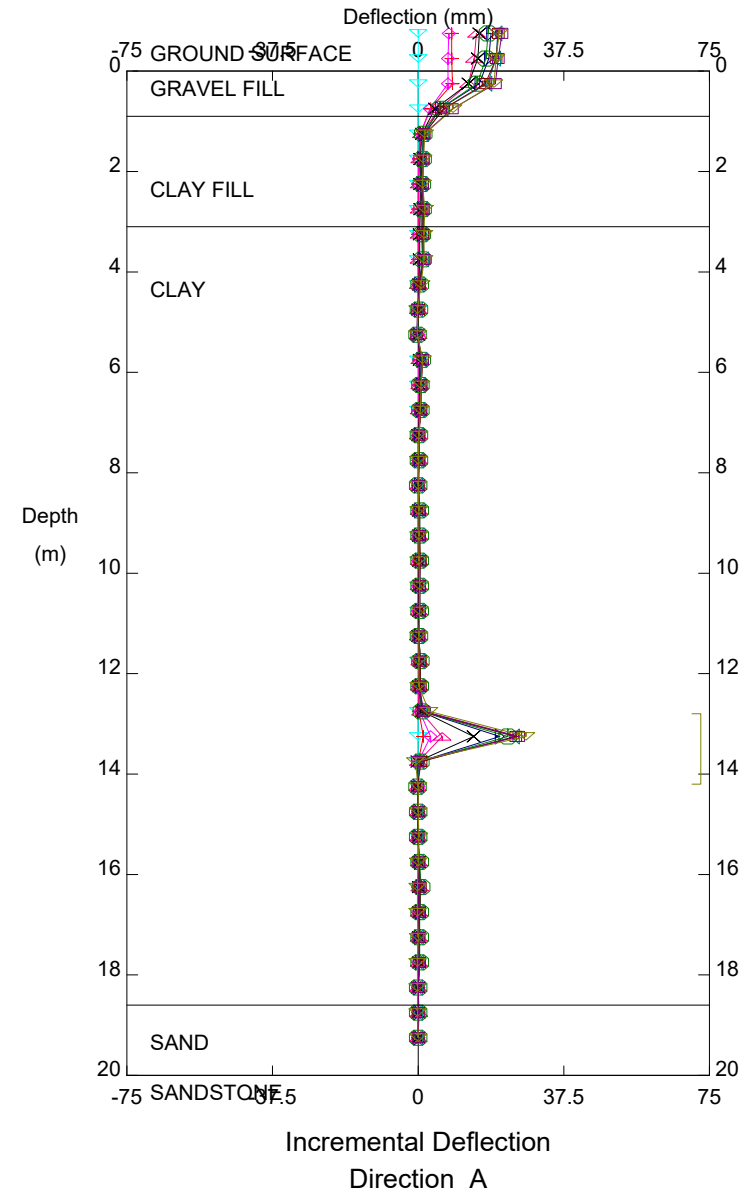
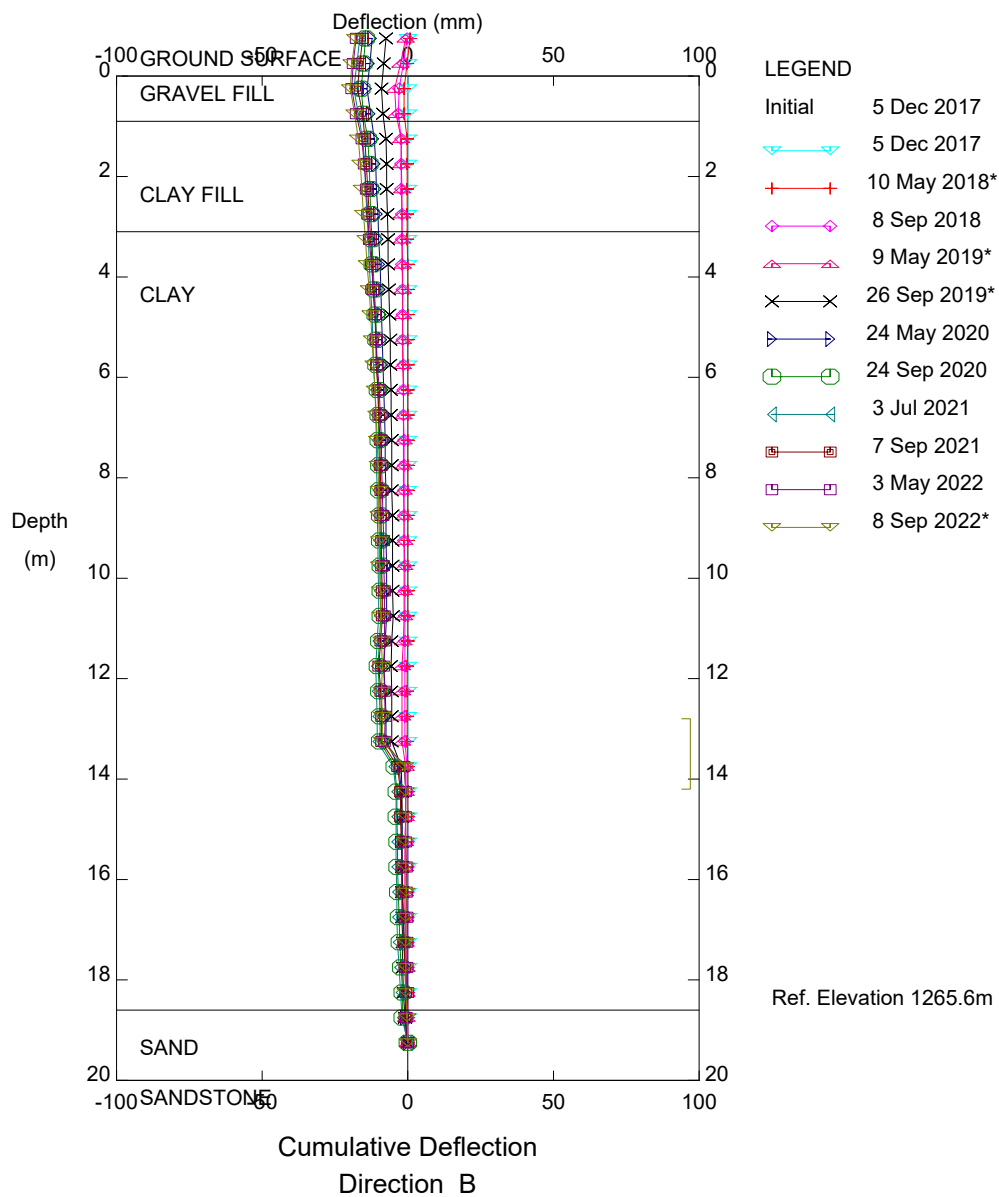
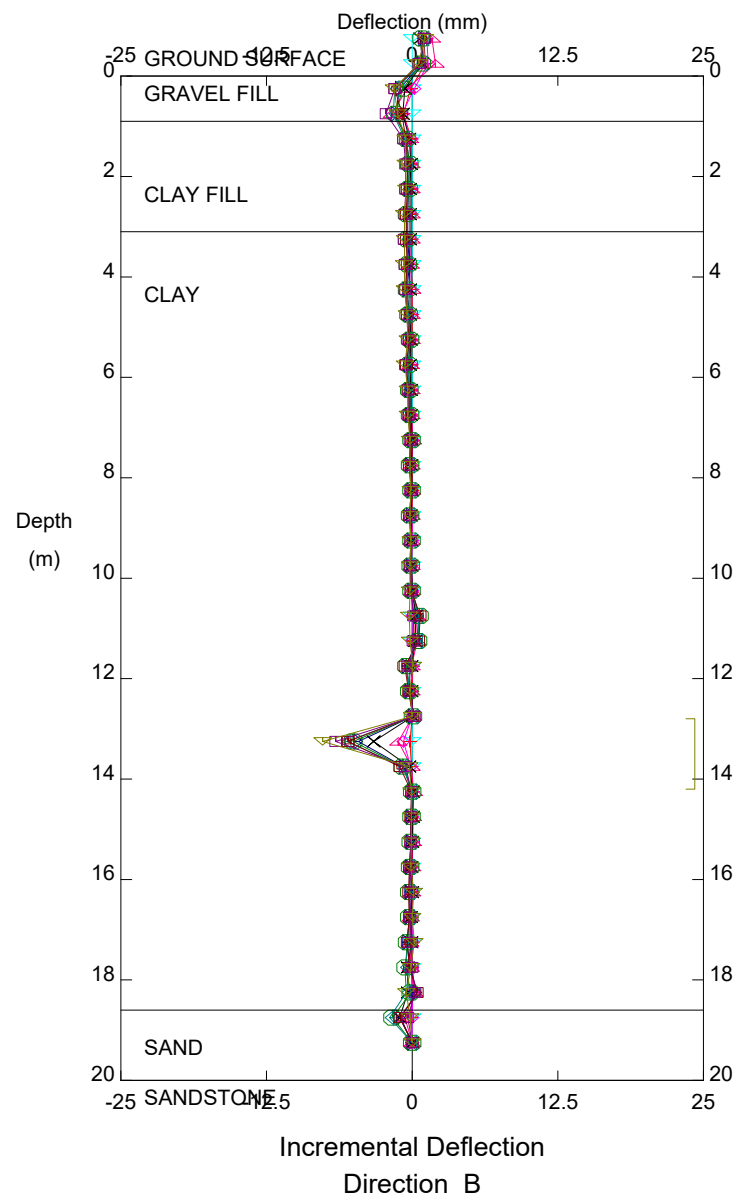
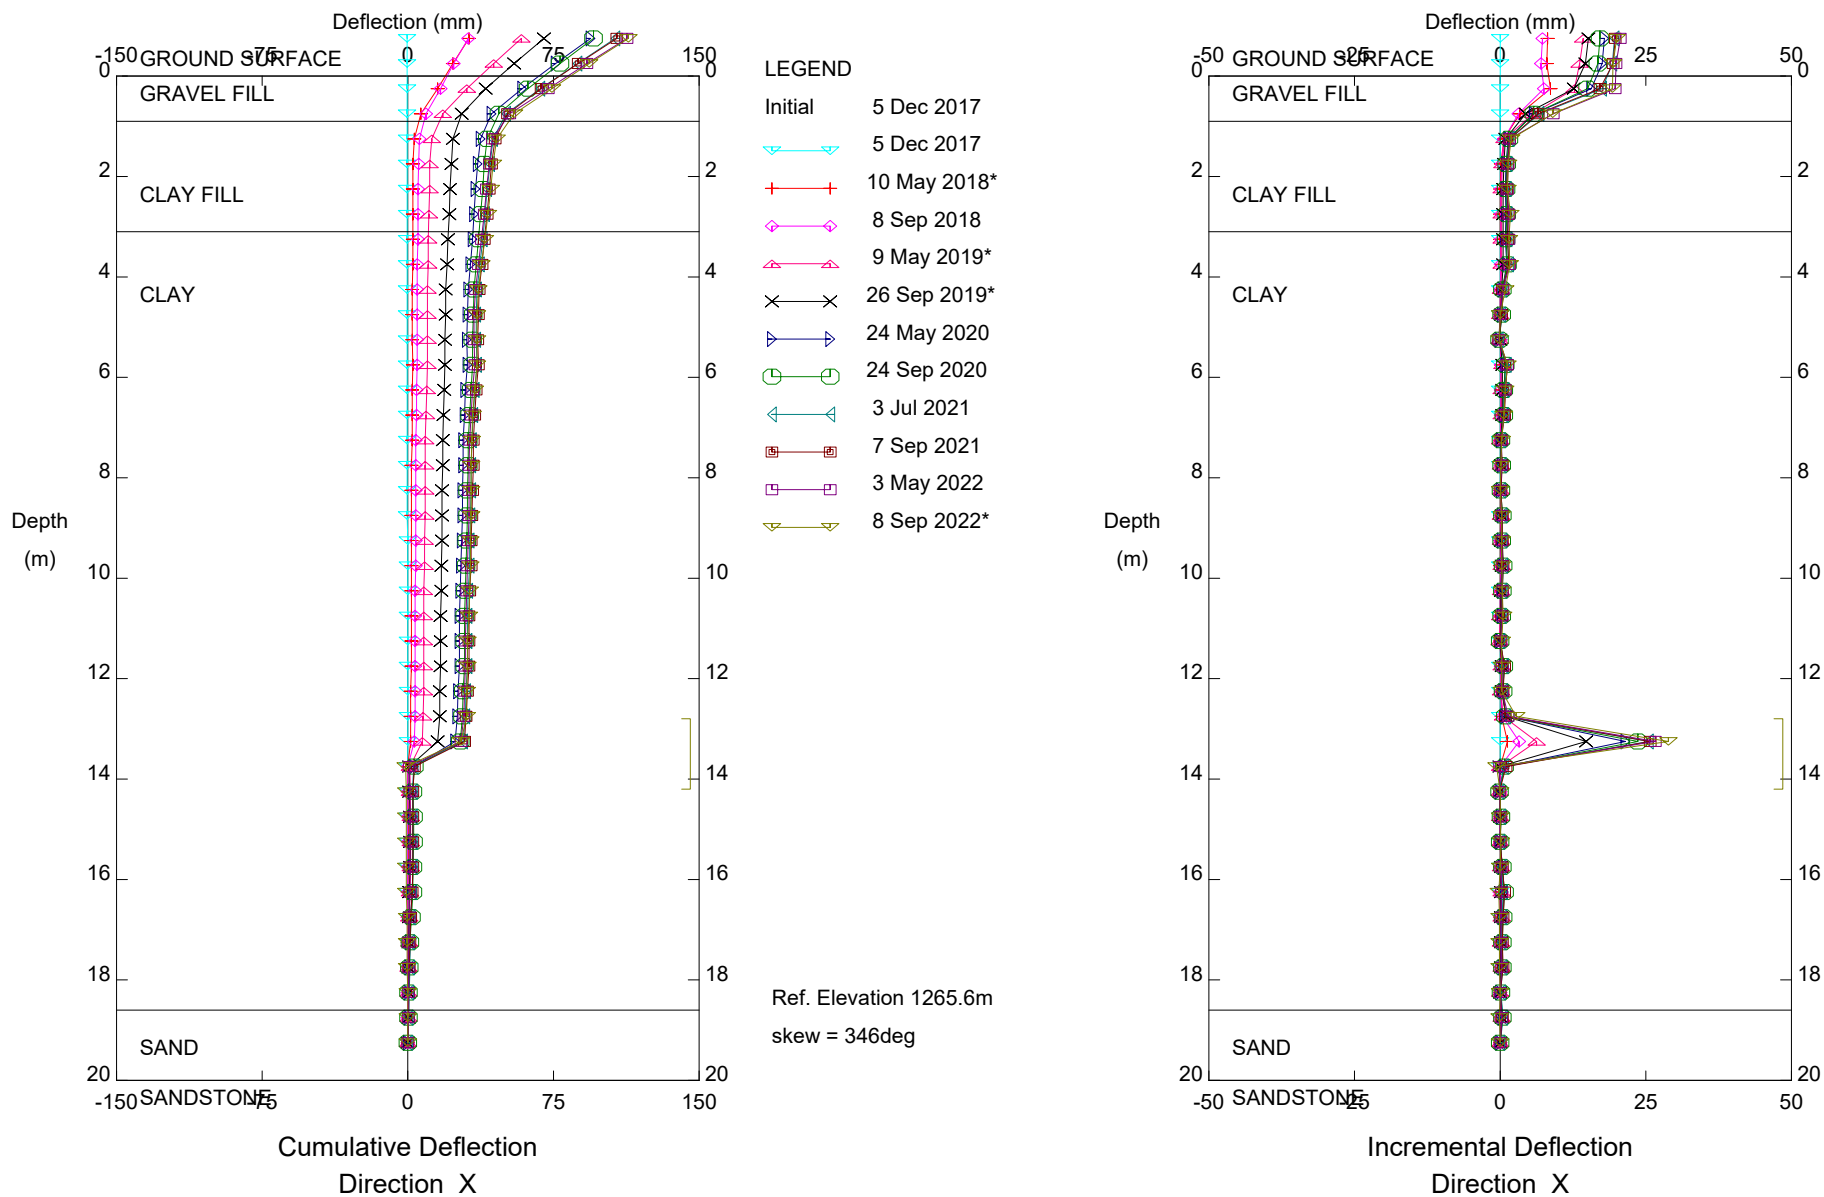
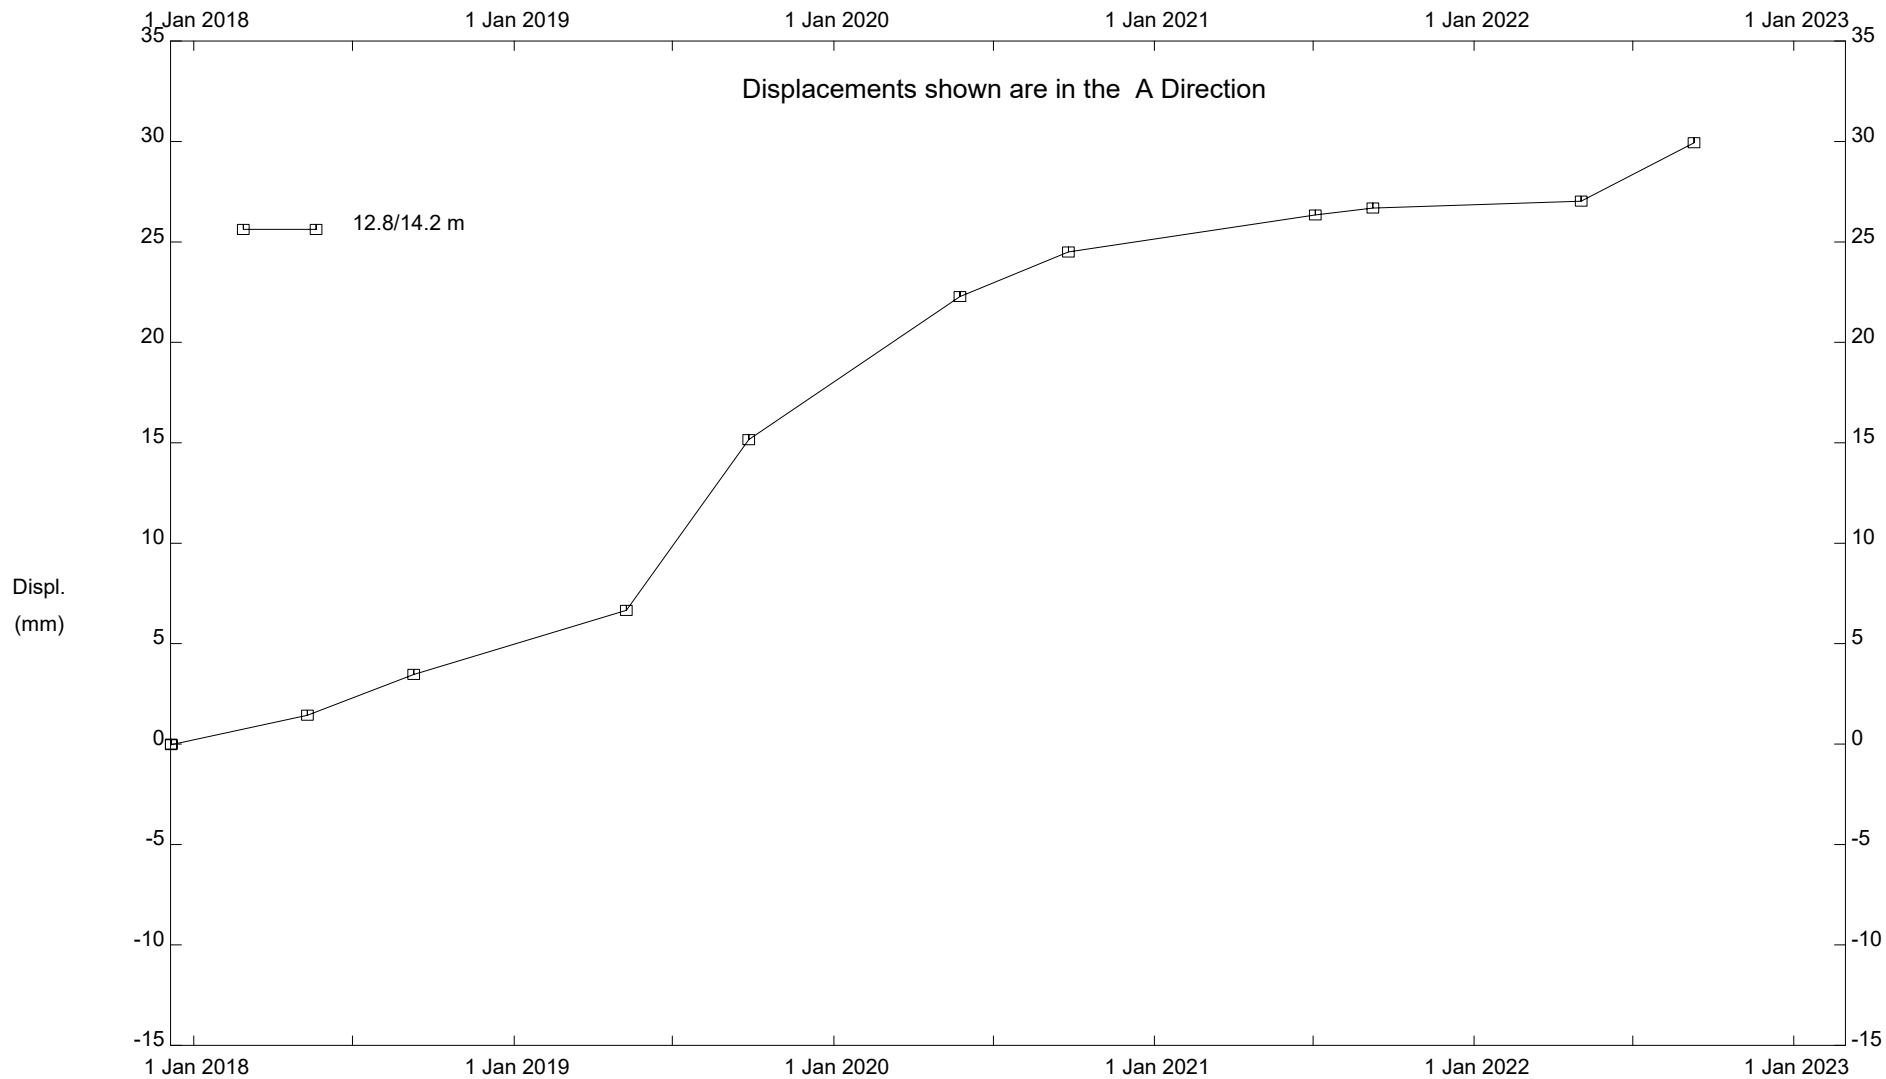
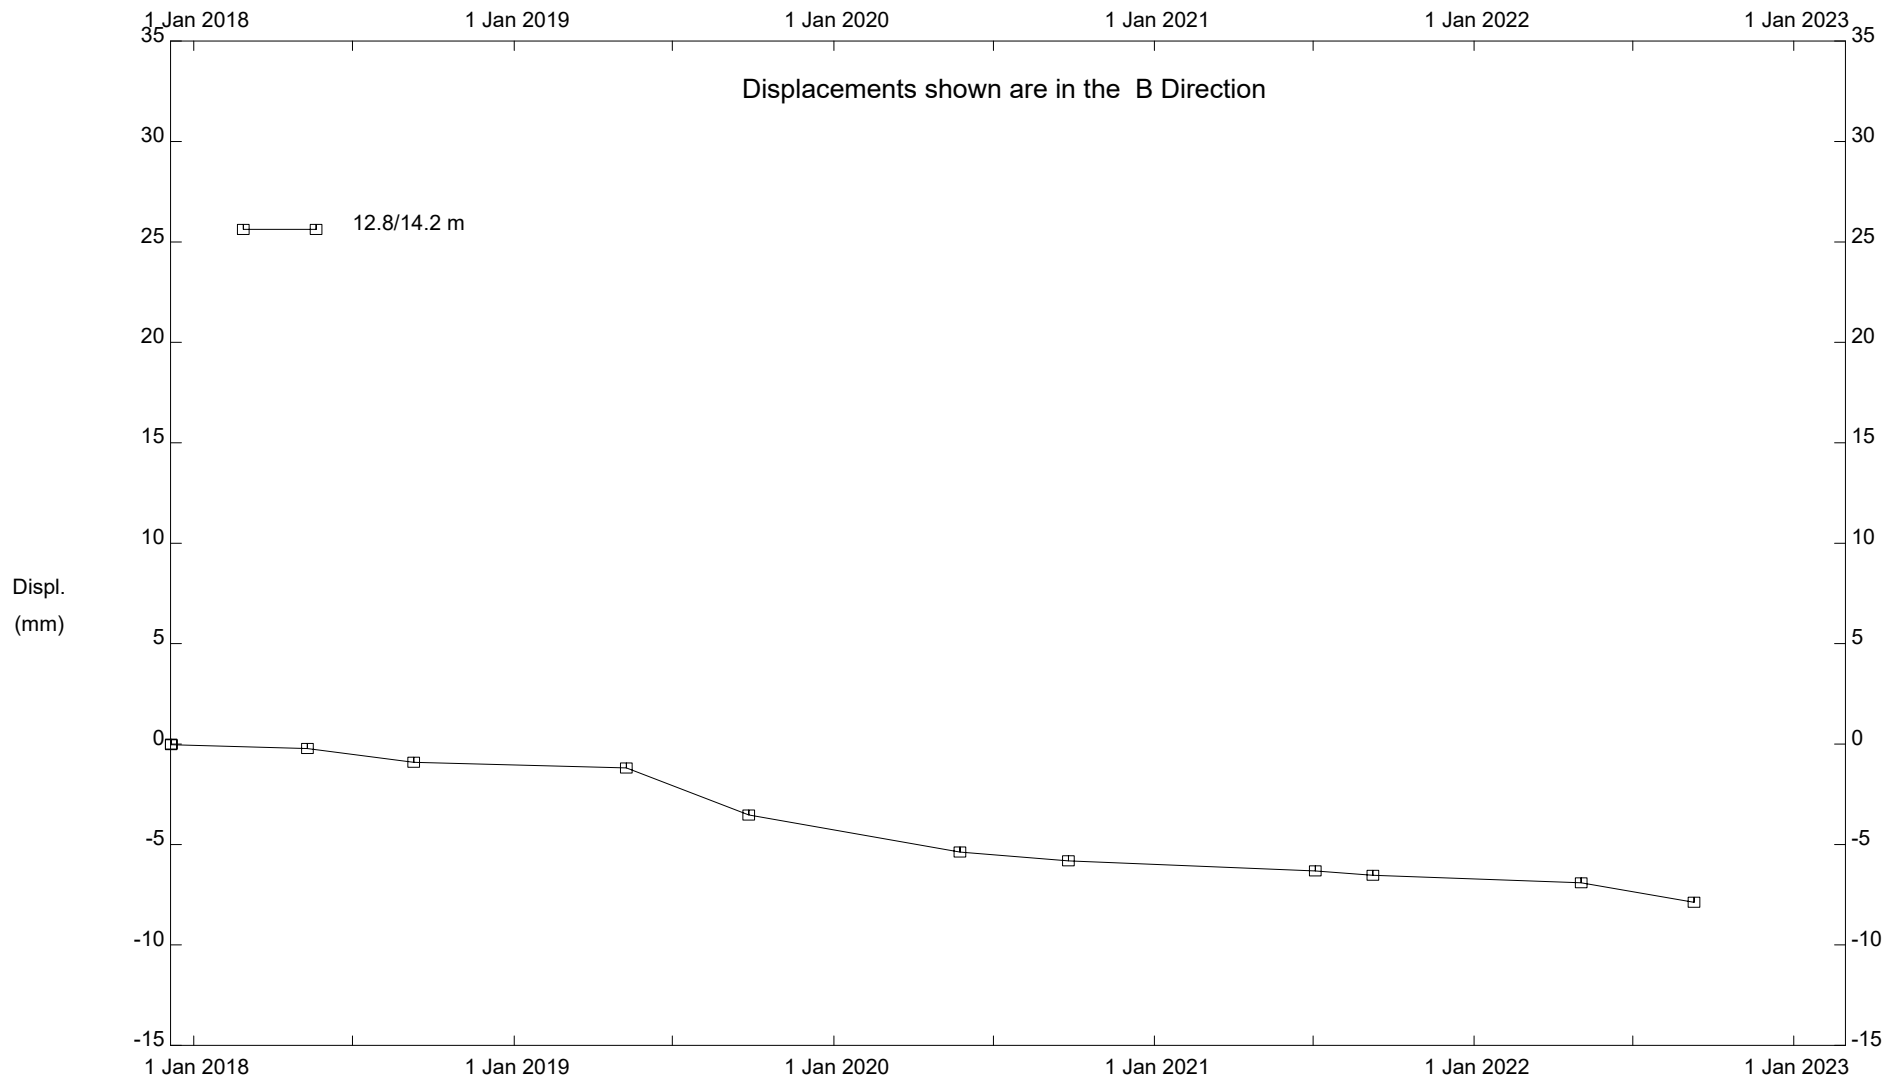
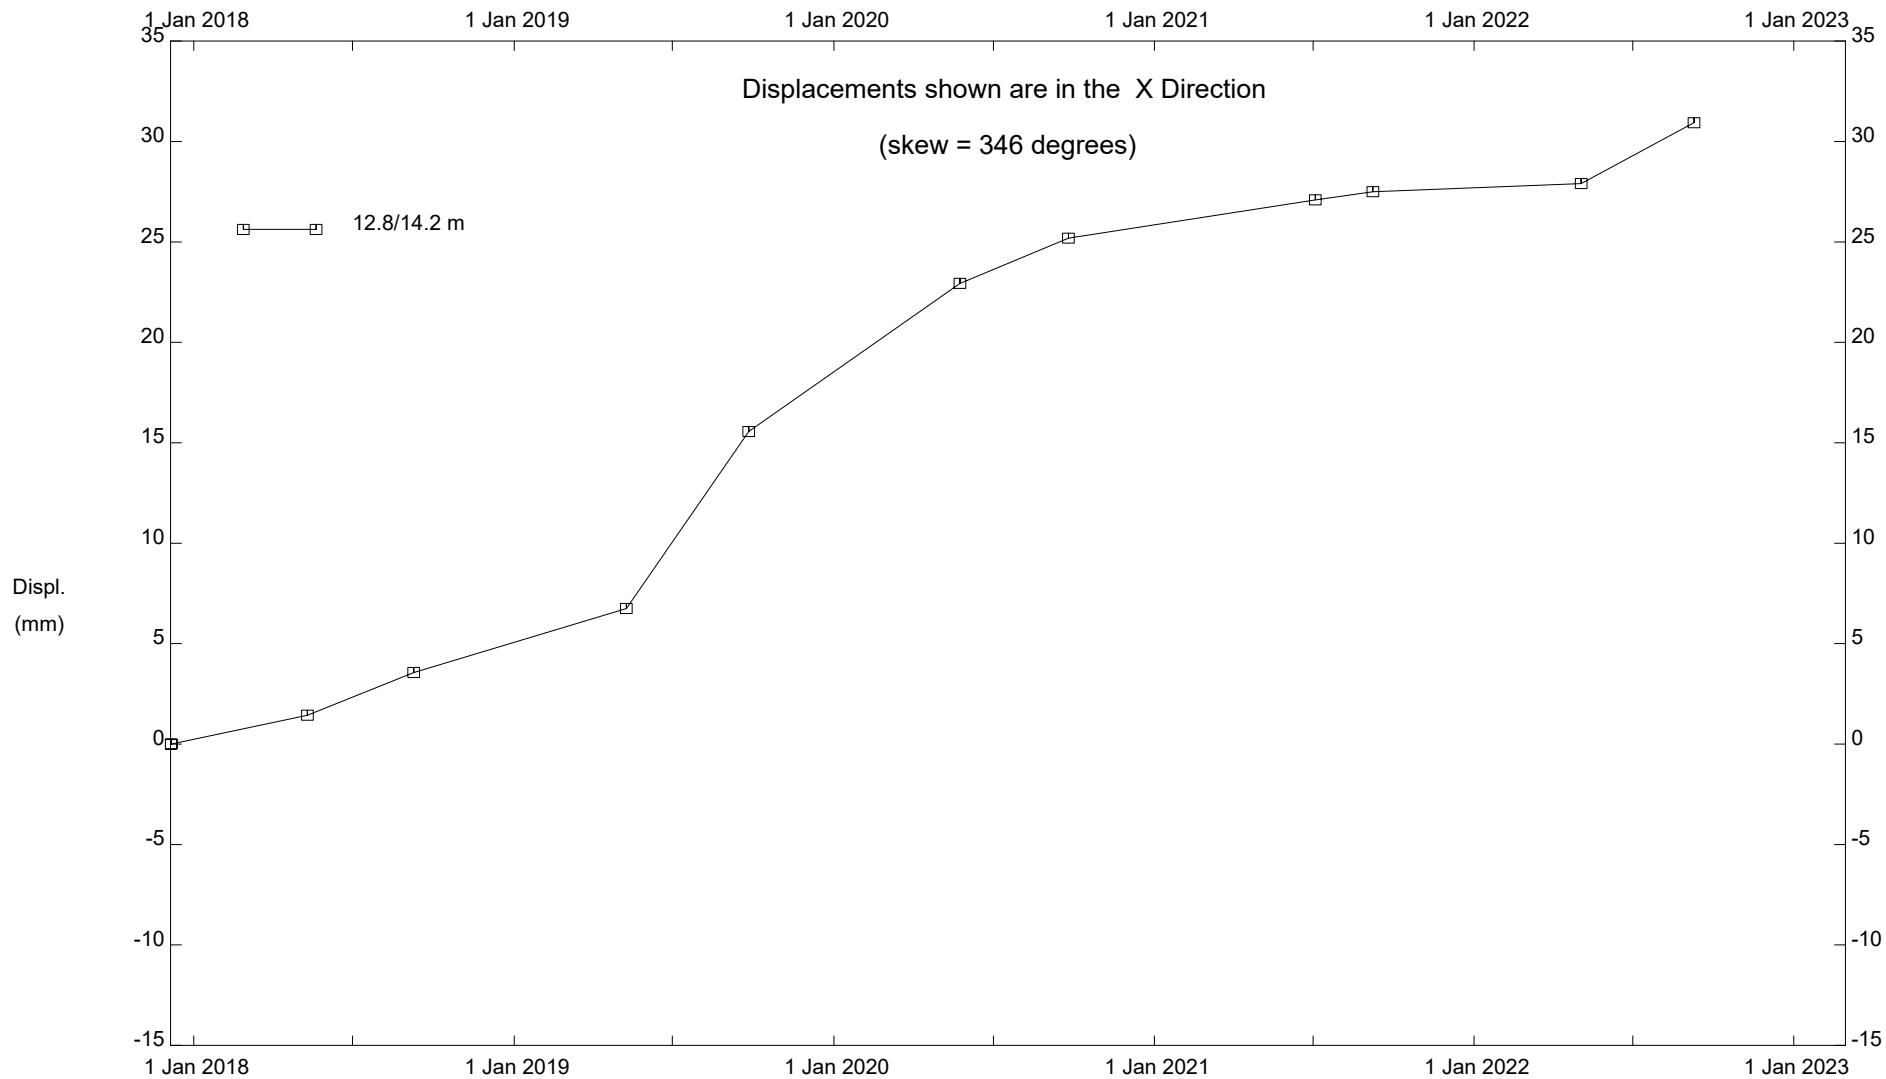
HWY 40:30 West of Wildhay River (NC83), Inclinator S17-02
 Alberta Transportation

SI17-02 shows 9 mm/yr in the rate of movement during this reading cycle with 31 mm of cumulative movement.
