To:	Amy Driessen Alberta Transportation	From:	Leslie Cho and Xiteng Liu Stantec Consulting Ltd.
File:	123315222	Date:	October 7, 2022

Reference: North Central Region, Edson, Site NC083 - Highway 40:30 West of Wildhay River, Fall 2022 Instrumentation Monitoring Report

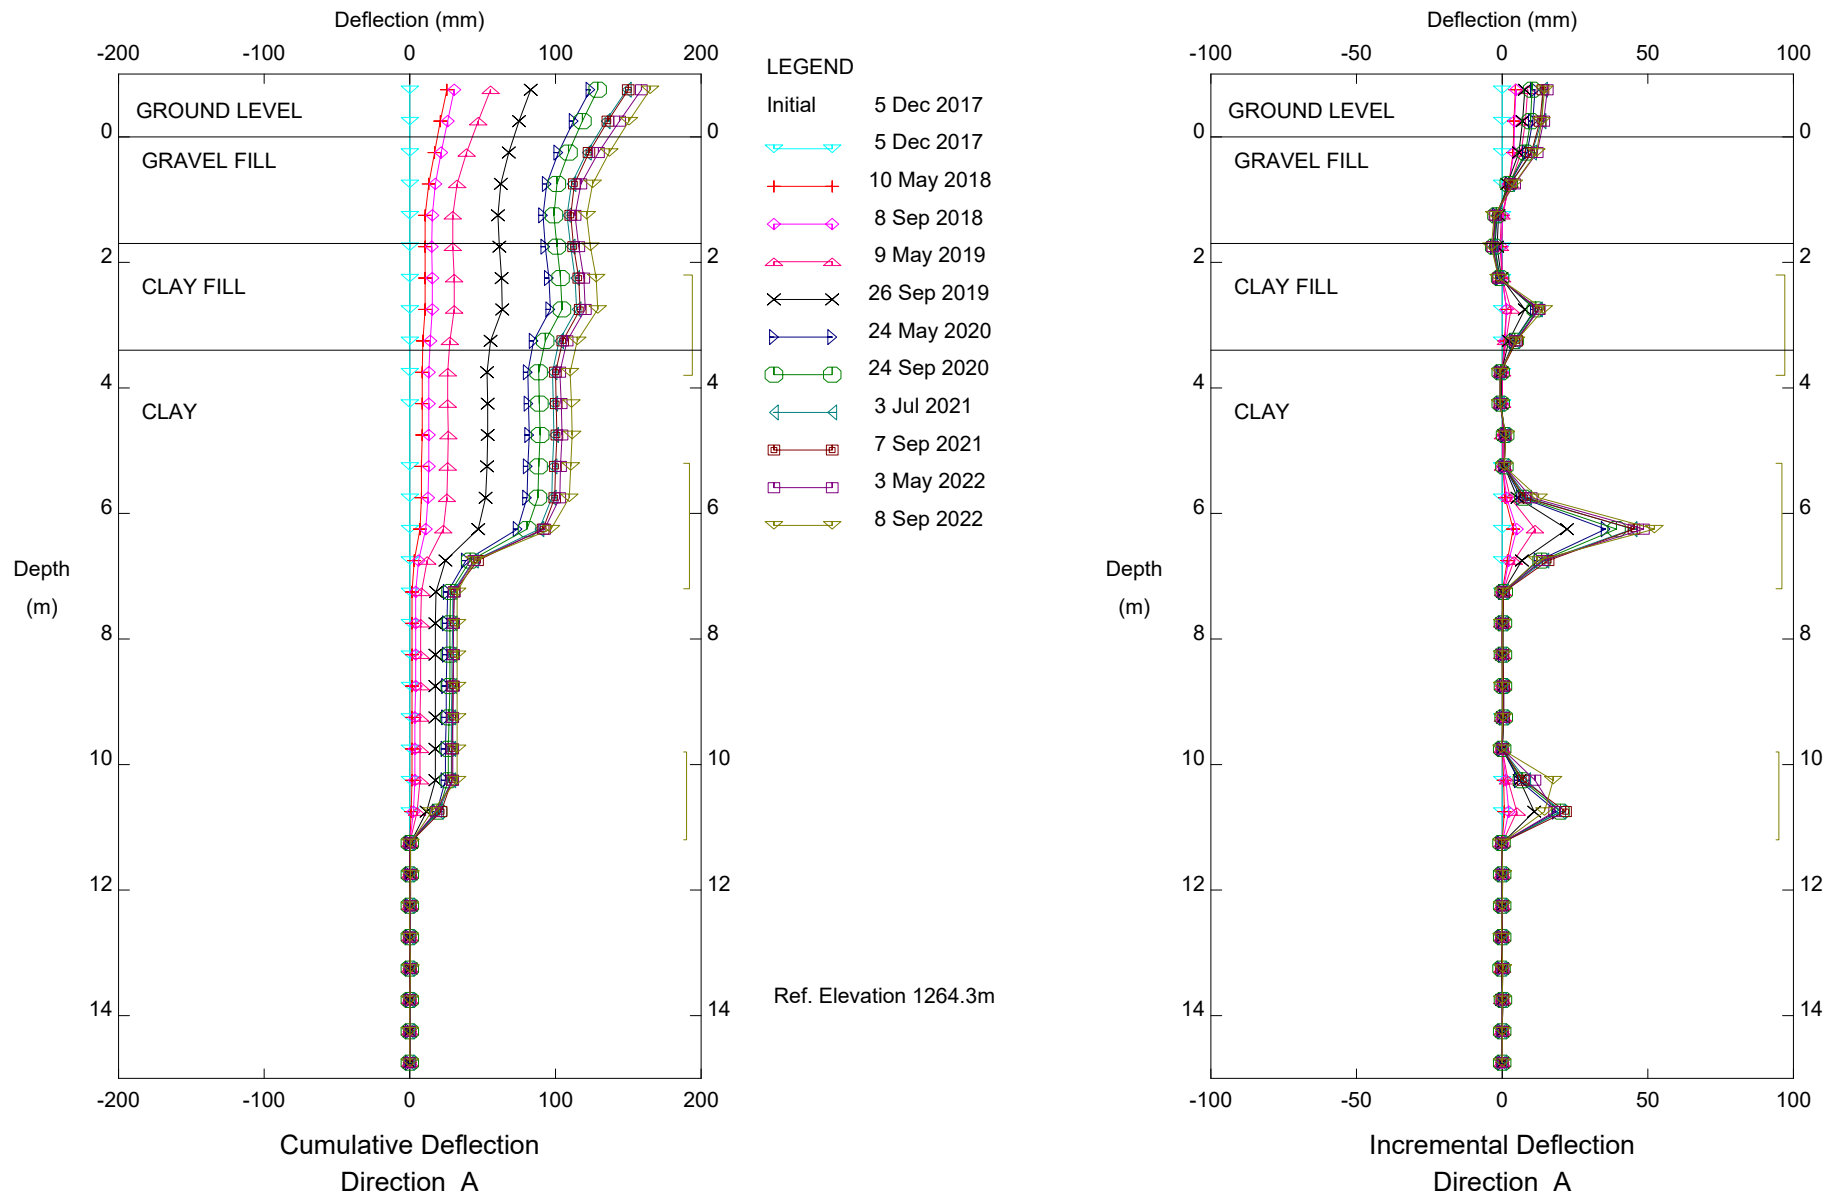
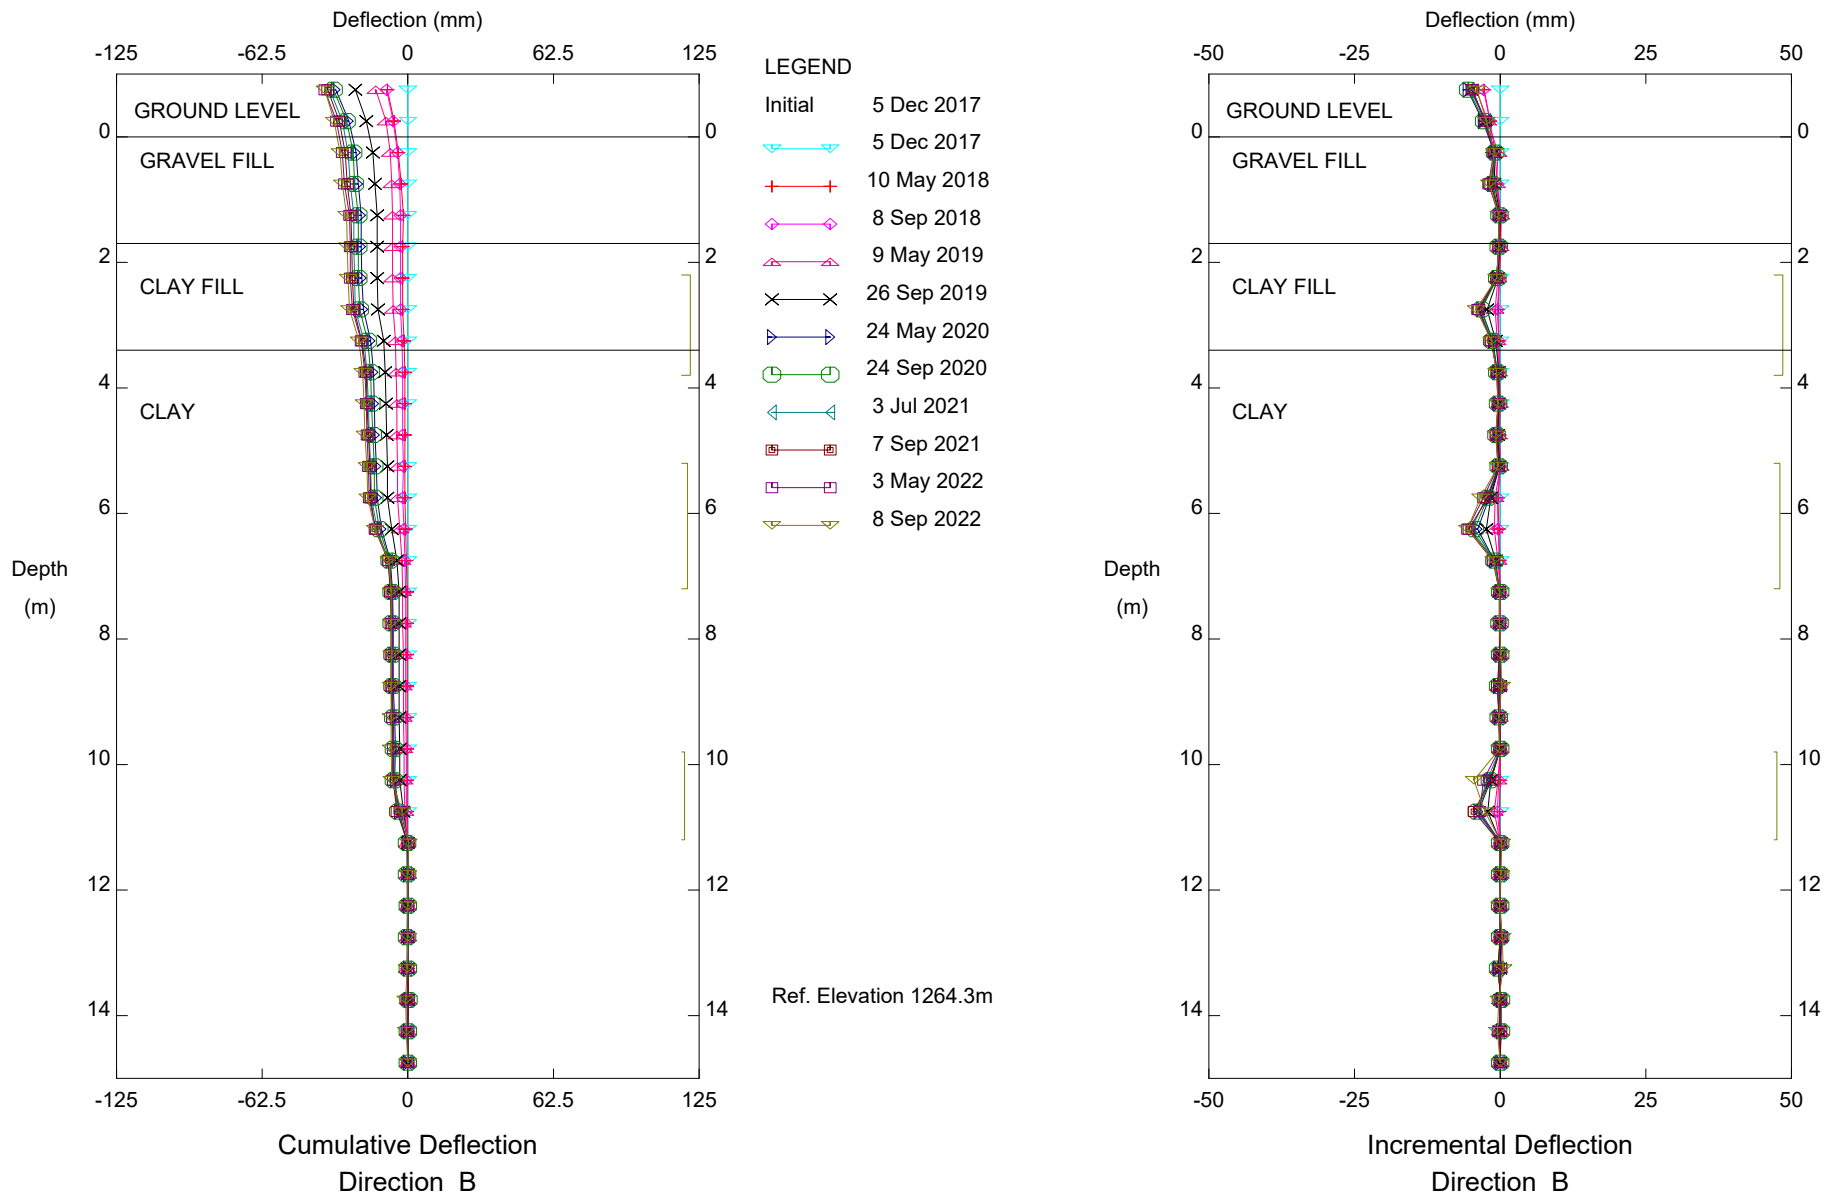
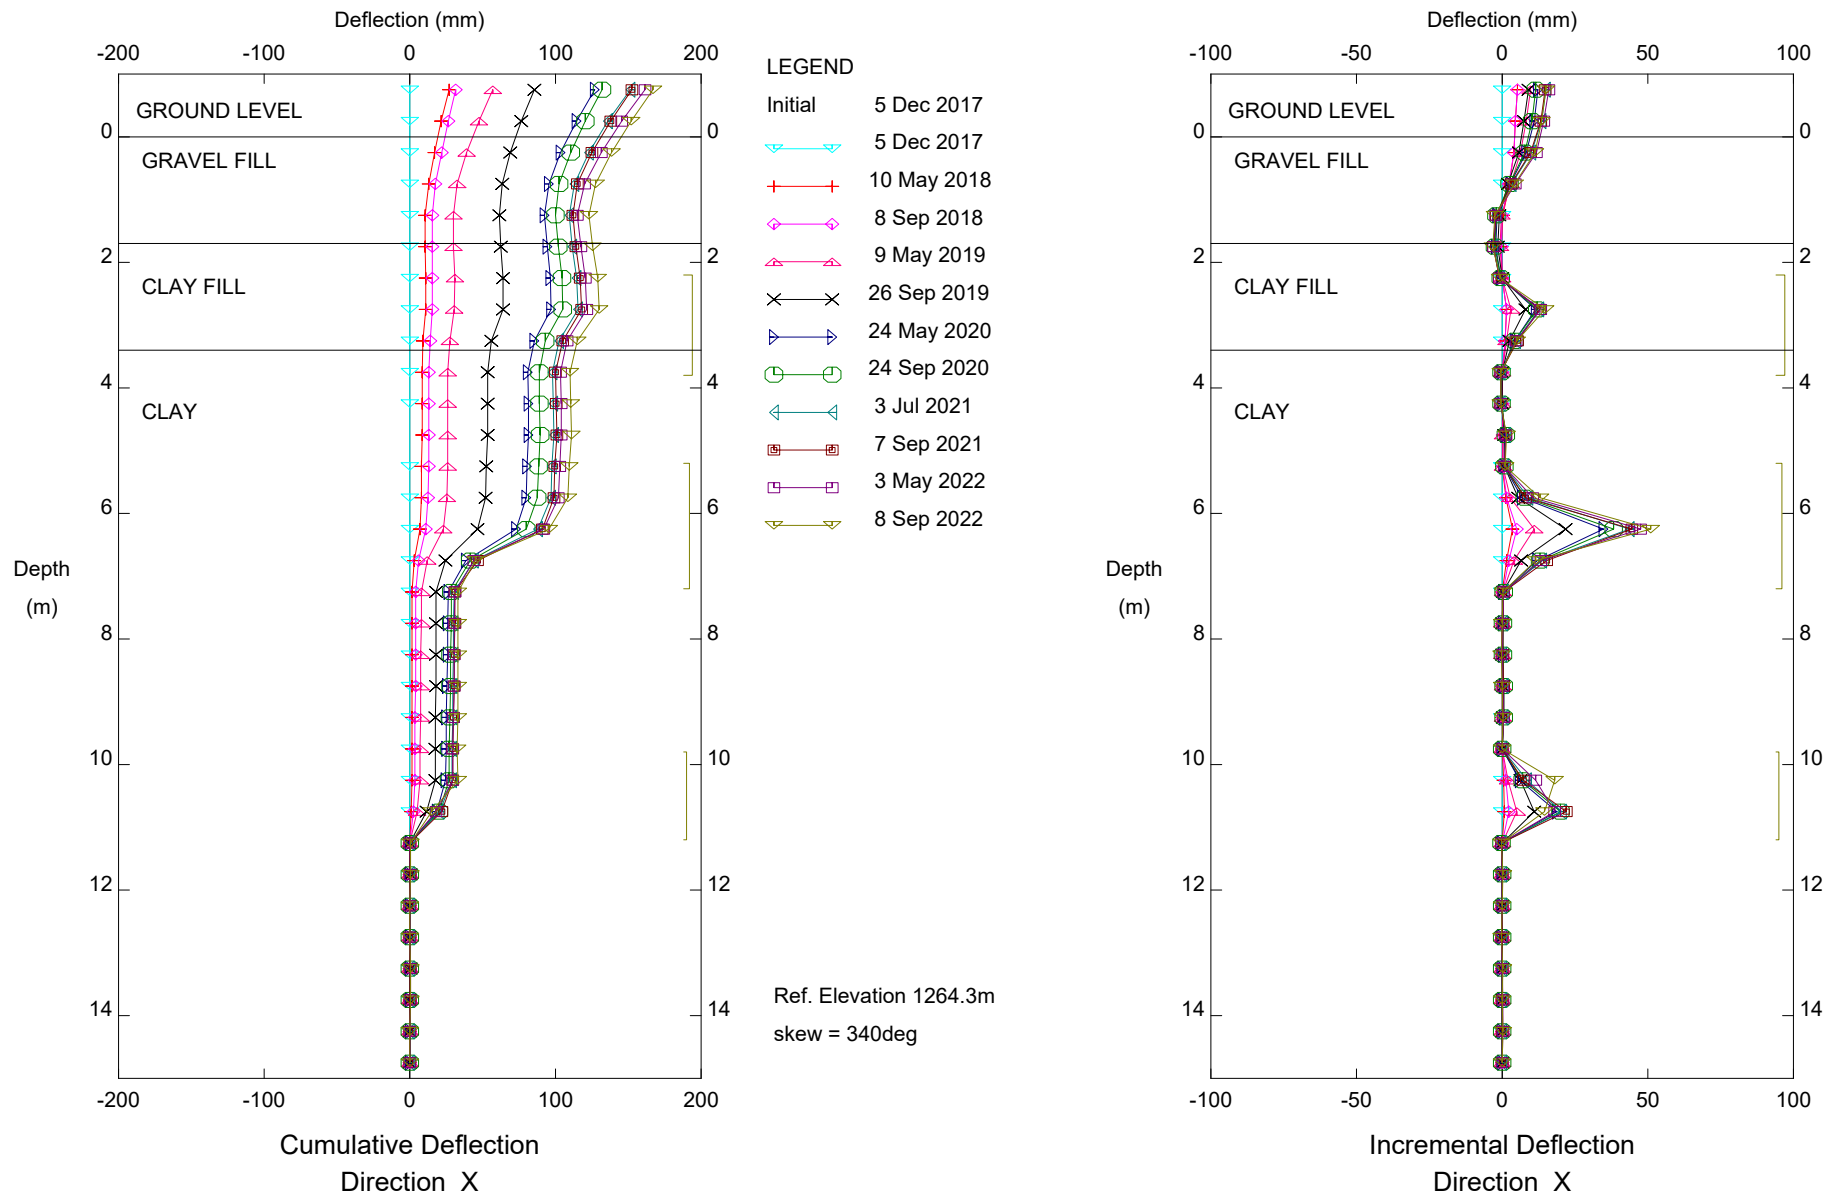
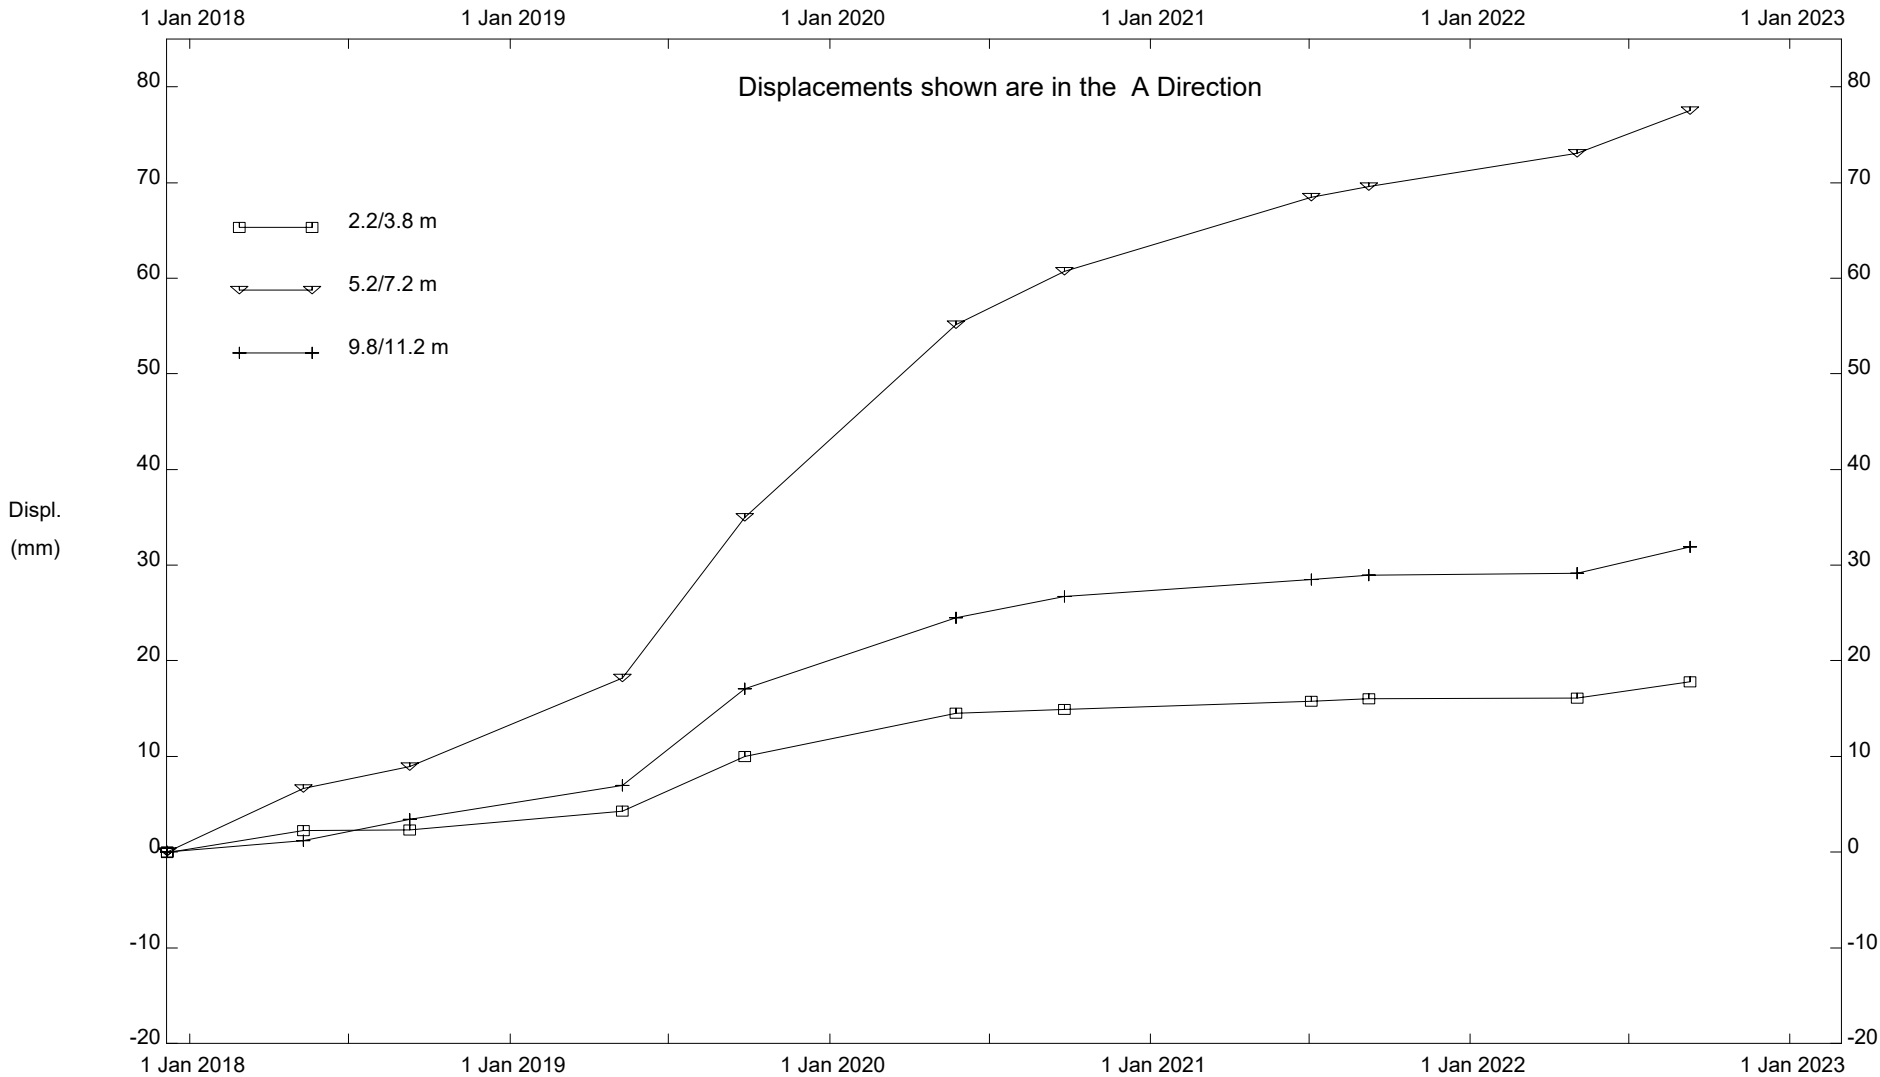
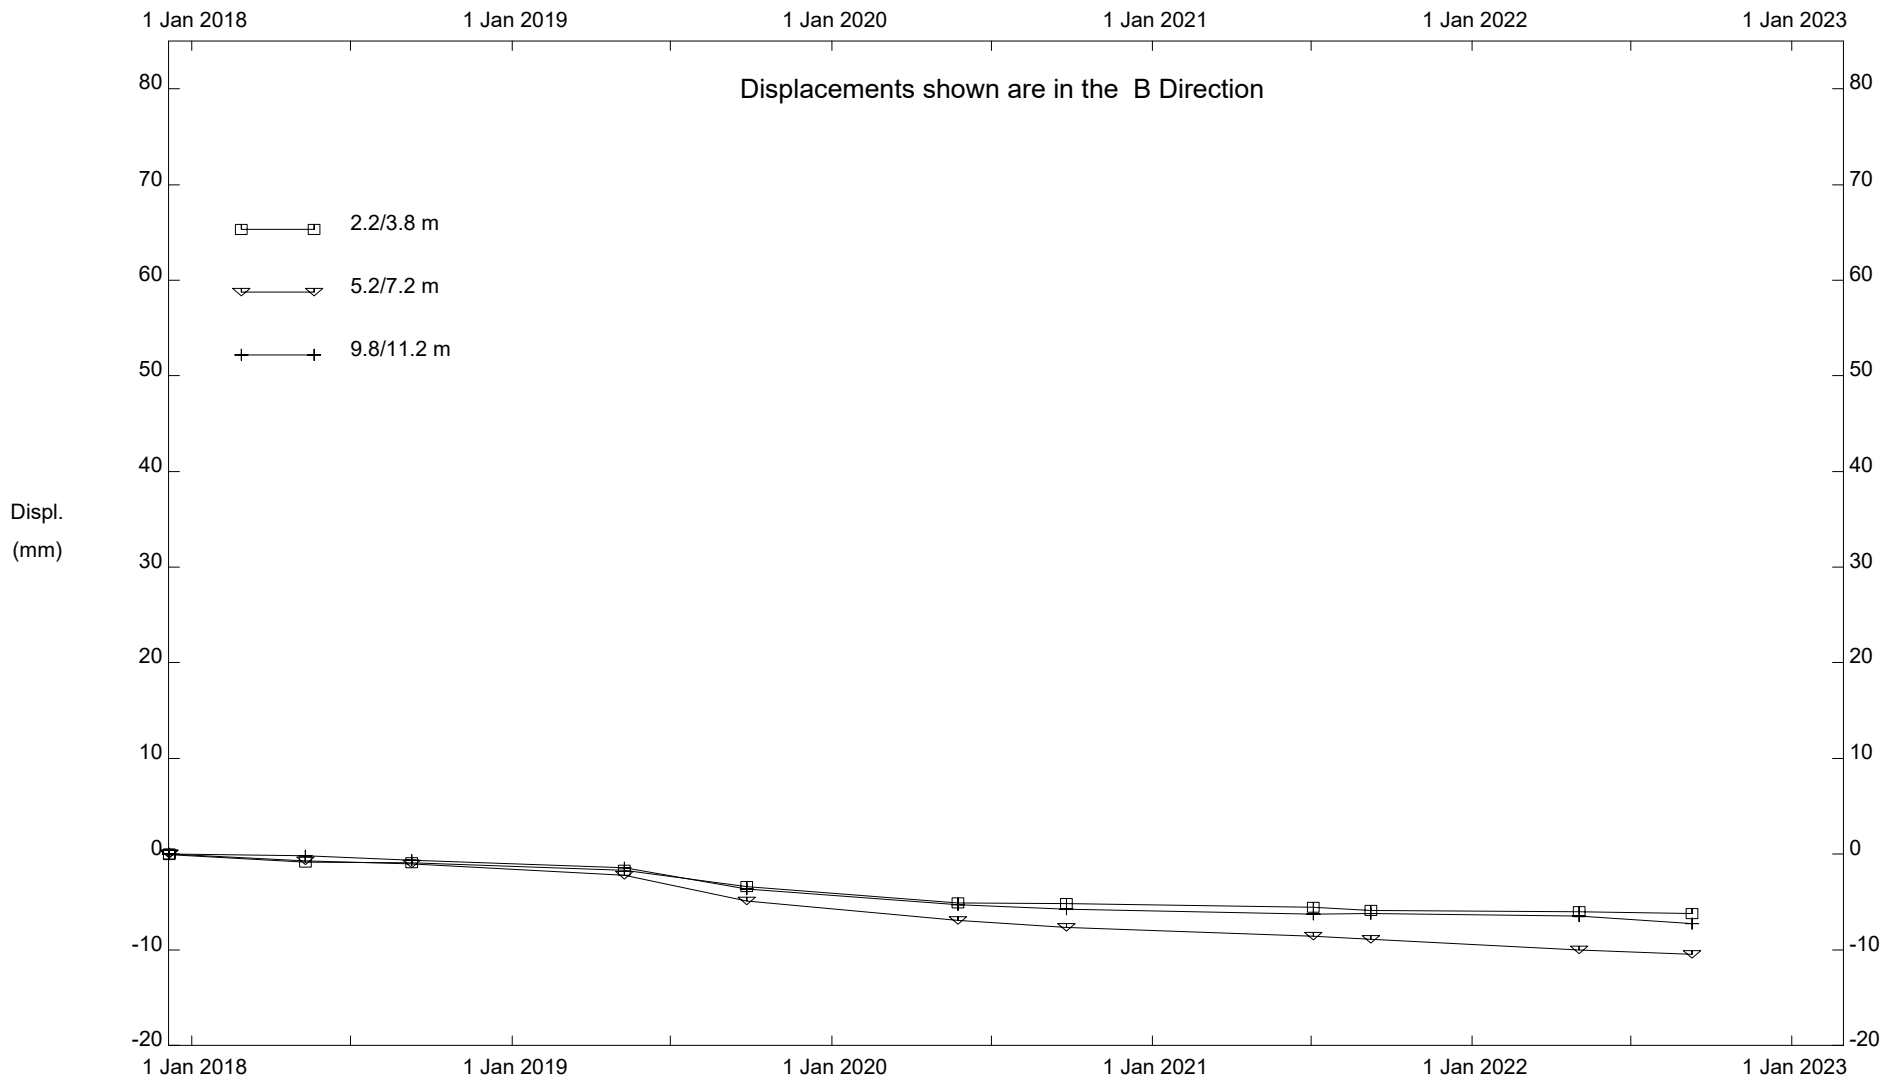
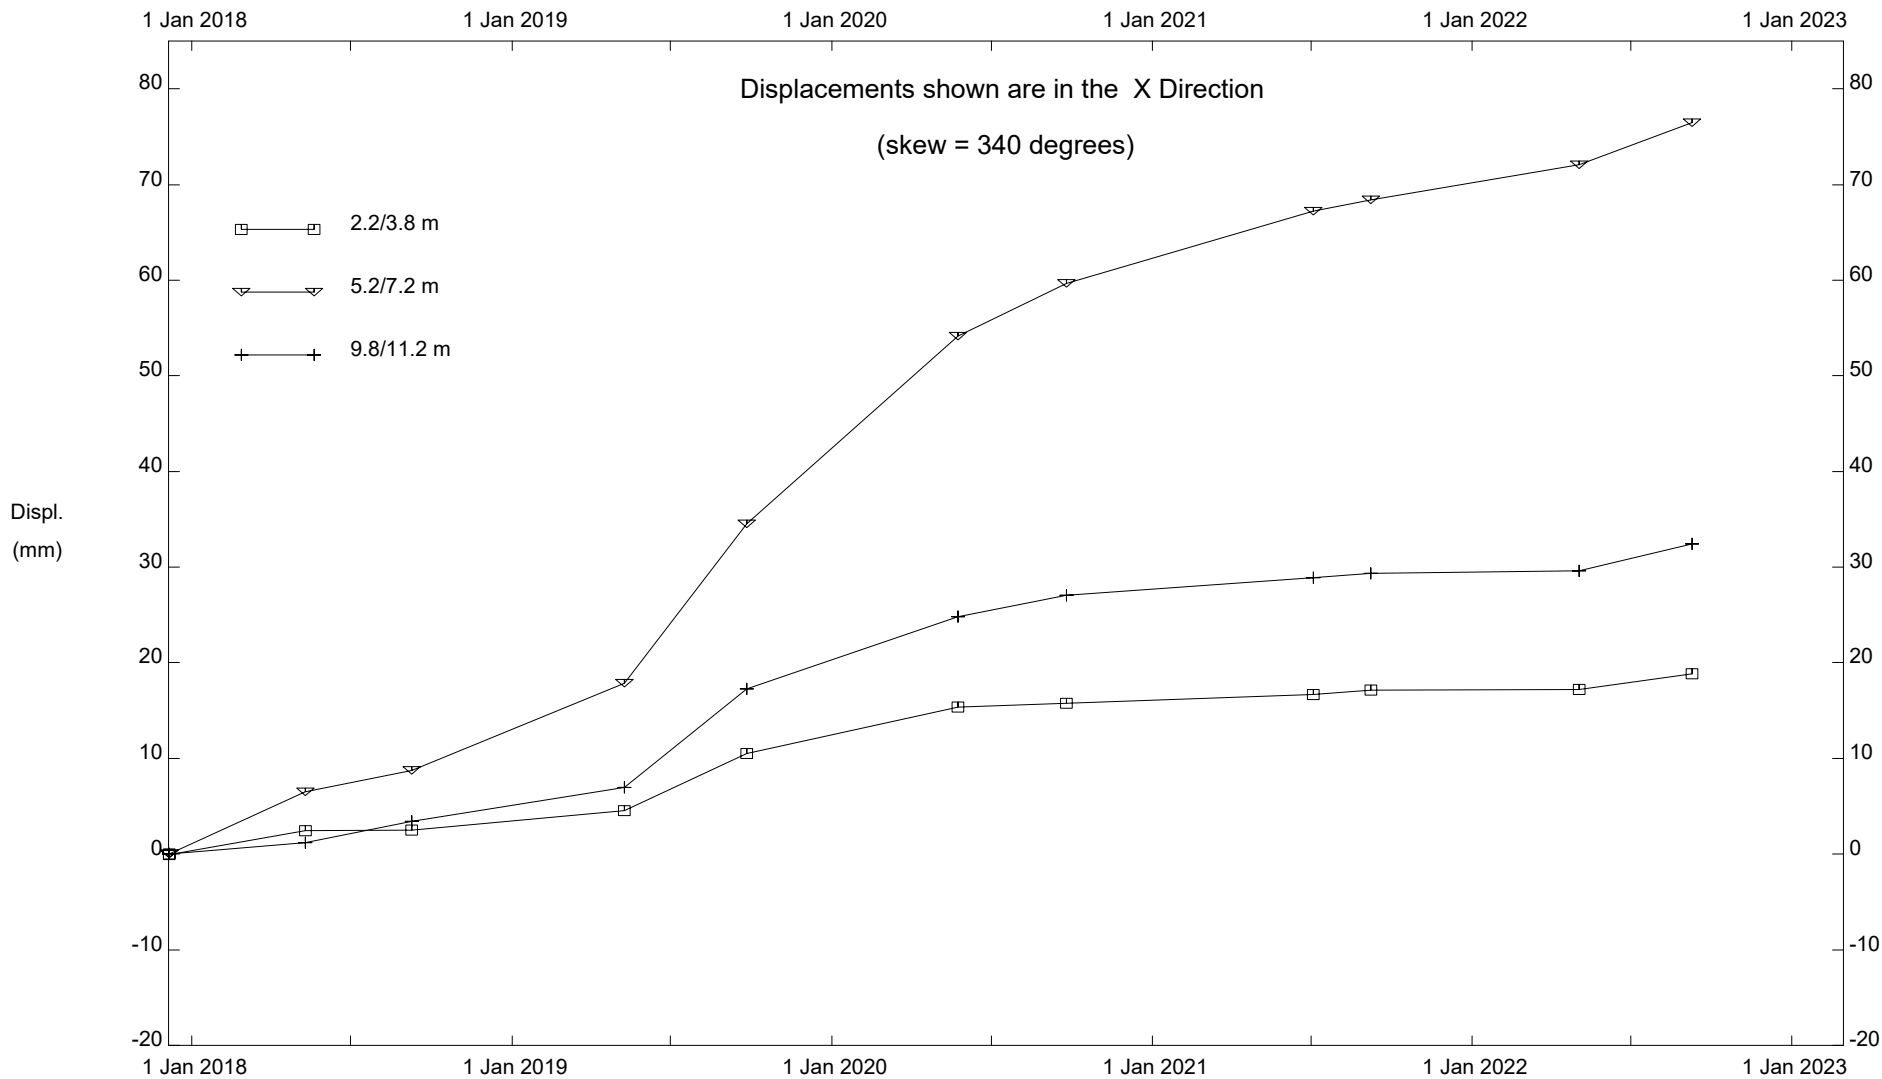
HWY 40:30 West of Wildhay River (NC83), Inclinometer SI17-03
 Alberta Transportation

SI17-03 has three zones of movement at approximately 3 m, 6 m and 10 m bgs. The upper movement zone is located within the fill and shows an increase in rate of movement of 5 mm/yr since the previous reading cycle. The current rate of movement in the upper zone is 5 mm/yr.

The middle movement zone at 6 m bgs shows current movement rate of 13 mm/yr. This represents an increased rate of movement of 7 mm/yr since the previous reading cycle.

The lower movement zone at 10 m bgs shows an increase in rate of movement of 8 mm/yr since the previous reading cycle. The current rate of movement for this lower movement zone is 8 mm/yr.

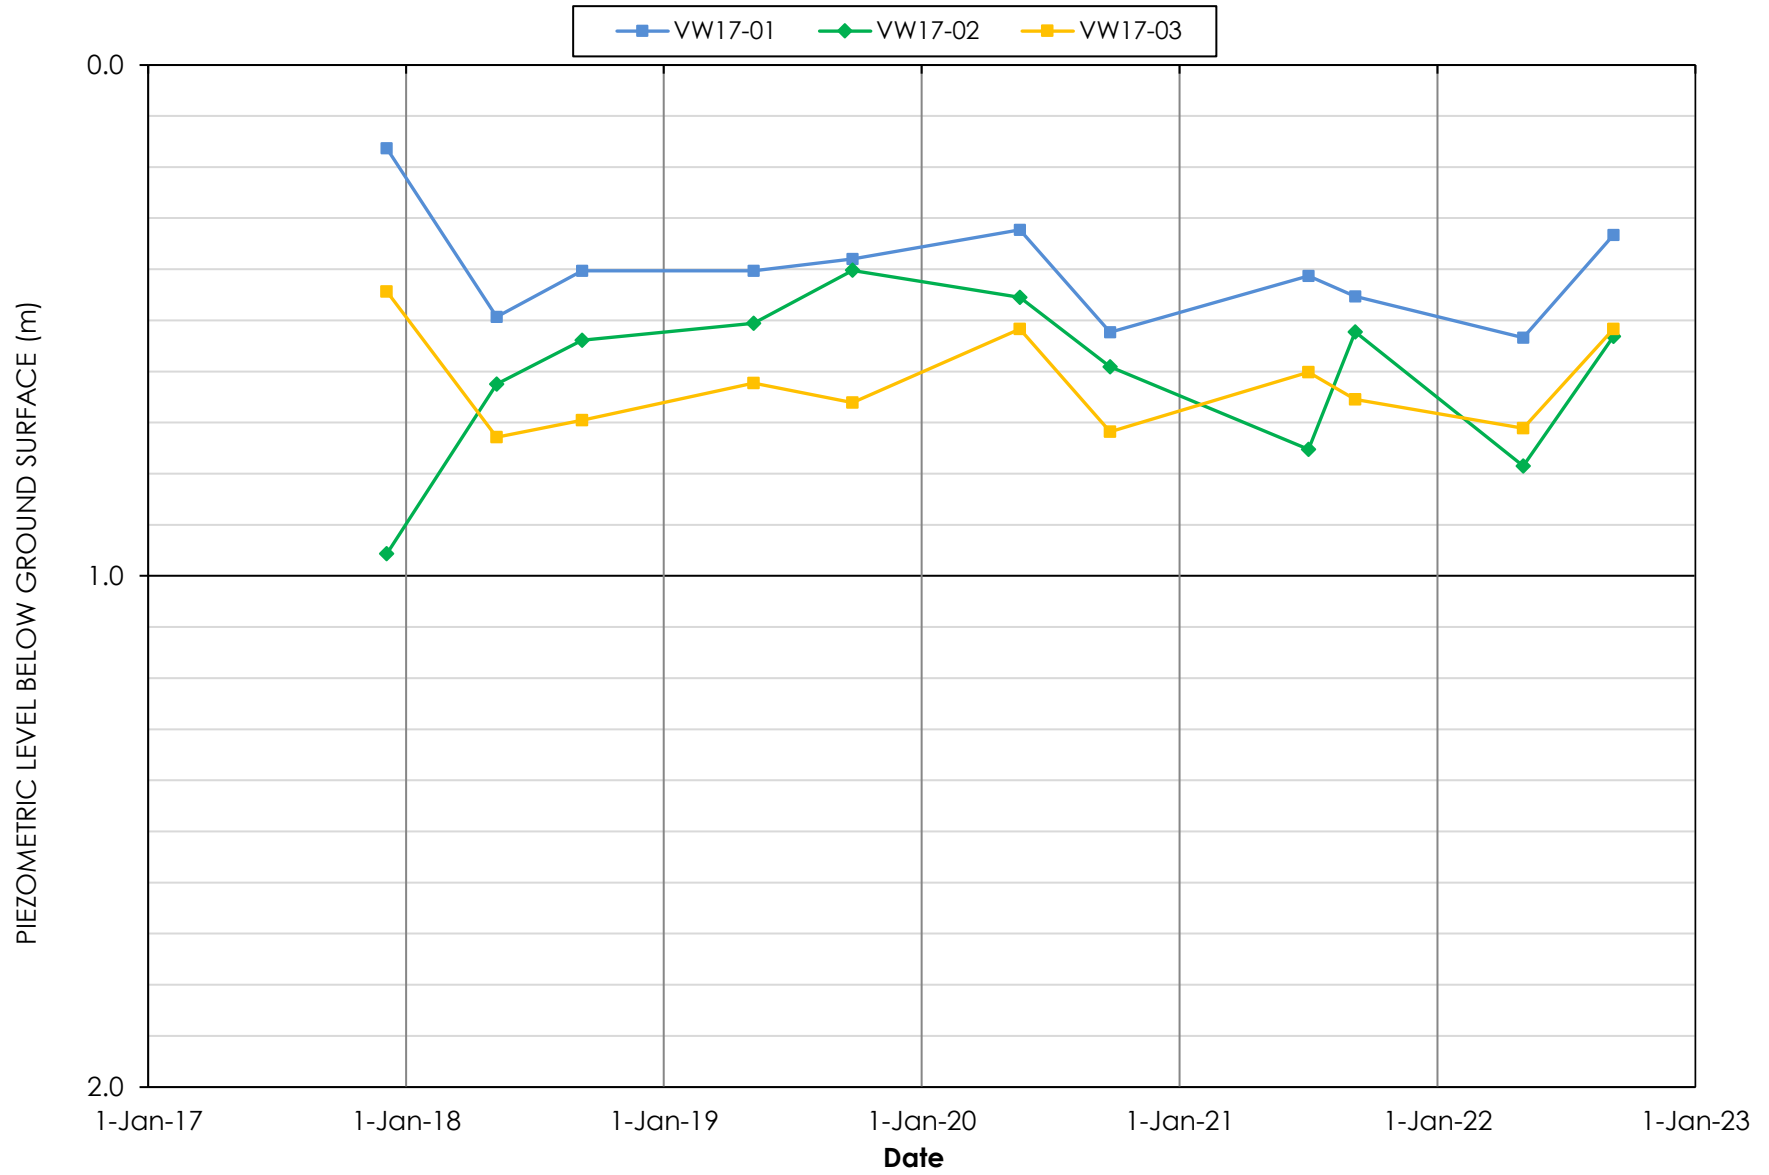
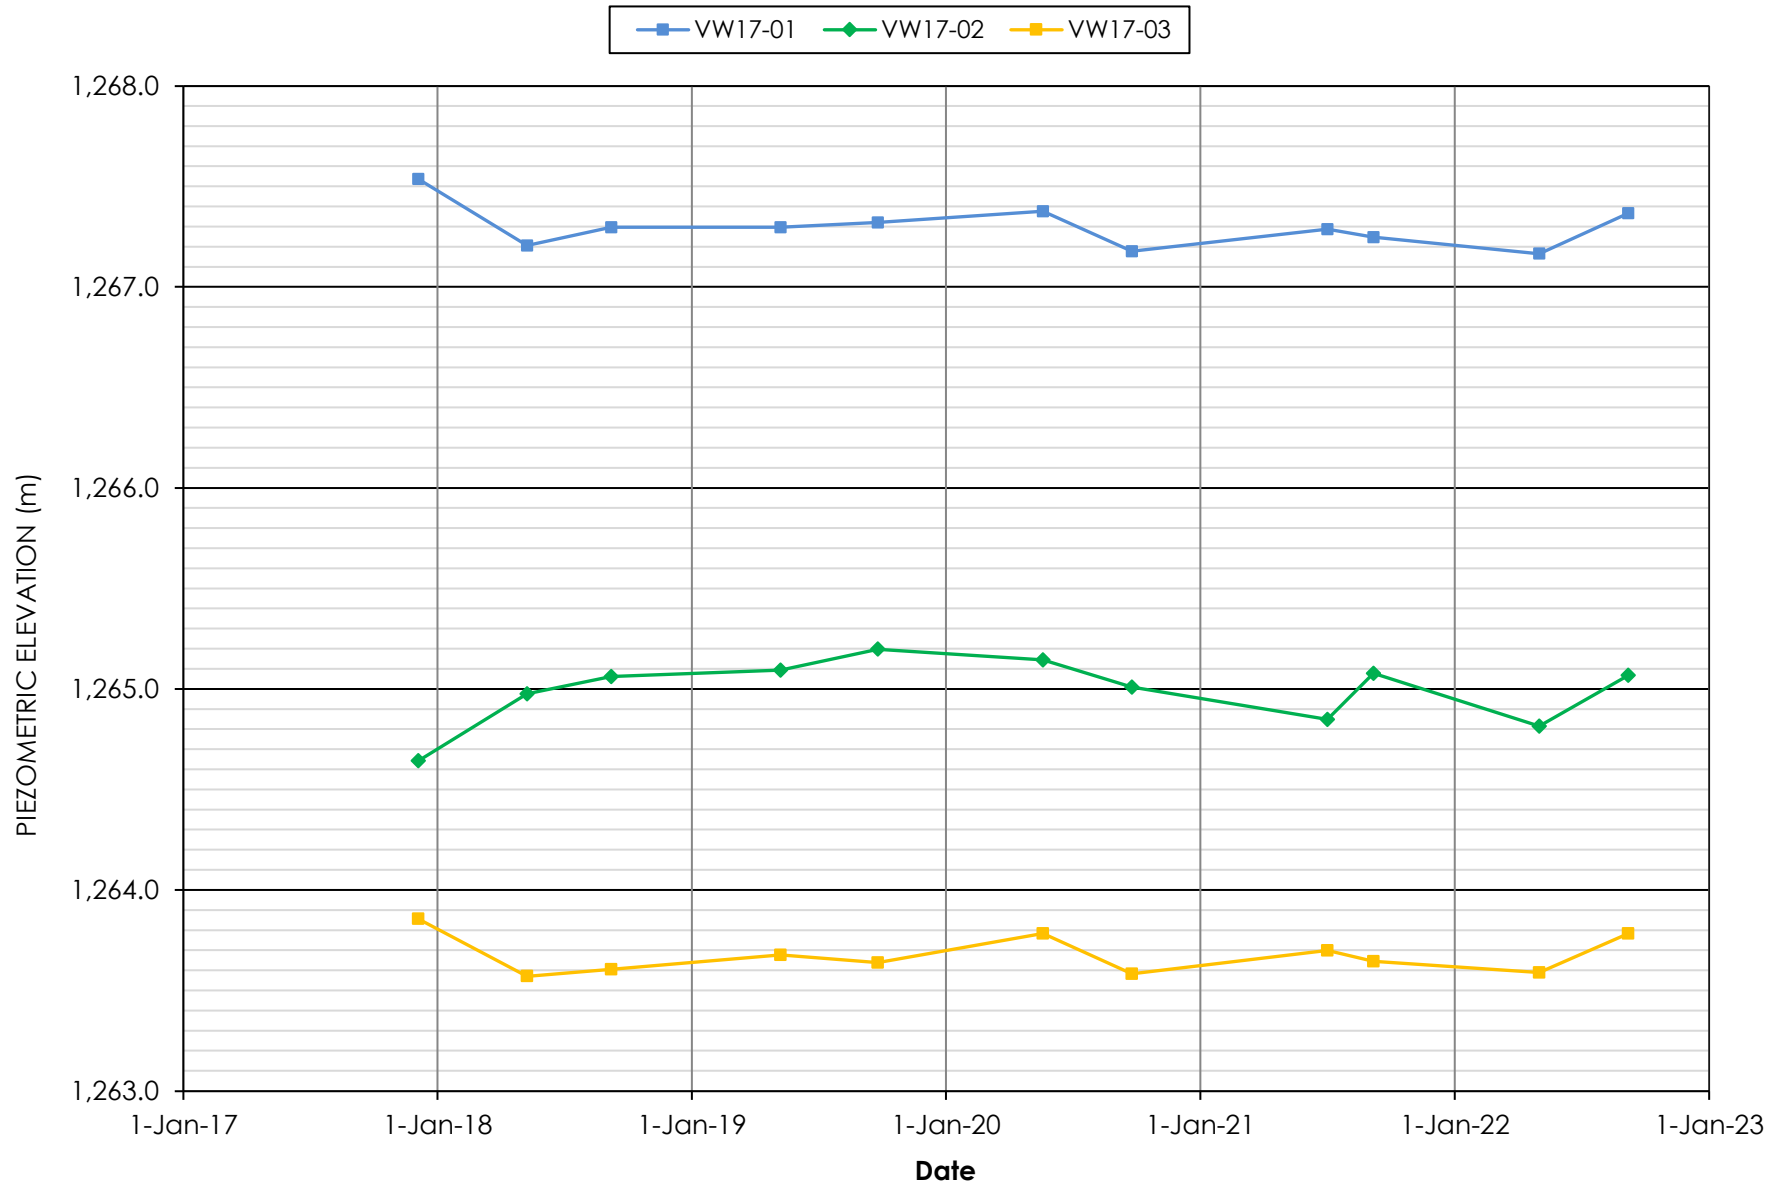
PIEZOMETER DATA

All piezometers show an increase in water level between 0.2 m and 0.3 m for the current reading cycle. The piezometric levels measured were between 0.3 m and 0.5 m below ground surface (bgs). In general, the piezometric levels have been in the same range since Spring 2018.
