SITE NUMBER AND NAME: NC083 – West of Wildhay River	HIGHWAY AND KM: 40:30, km 37.368	PREVIOUS INSPECTION: July 15, 2021	CURRENT INSPECTION: June 17, 2022
LEGAL DESCRIPTION: SE-08-53-27-W5	NAD83 COORDINATES: UTM11U 5935069N, 437757E		RISK ASSESSMENT: PF: 11 CF: 5 Total: 55
AVERAGE ANNUAL DAILY TRAFFIC (AADT): 1,250 (2021)		CONTRACTOR MAINTENANCE AREA (CMA): 508

2022 Site Inspection Photos at NC083

Client/Project: Alberta Transportation
 Geohazard Monitoring Program
 NC83 – West of Wildhay River

Figure No.: 1
 Title: **Site Plan**

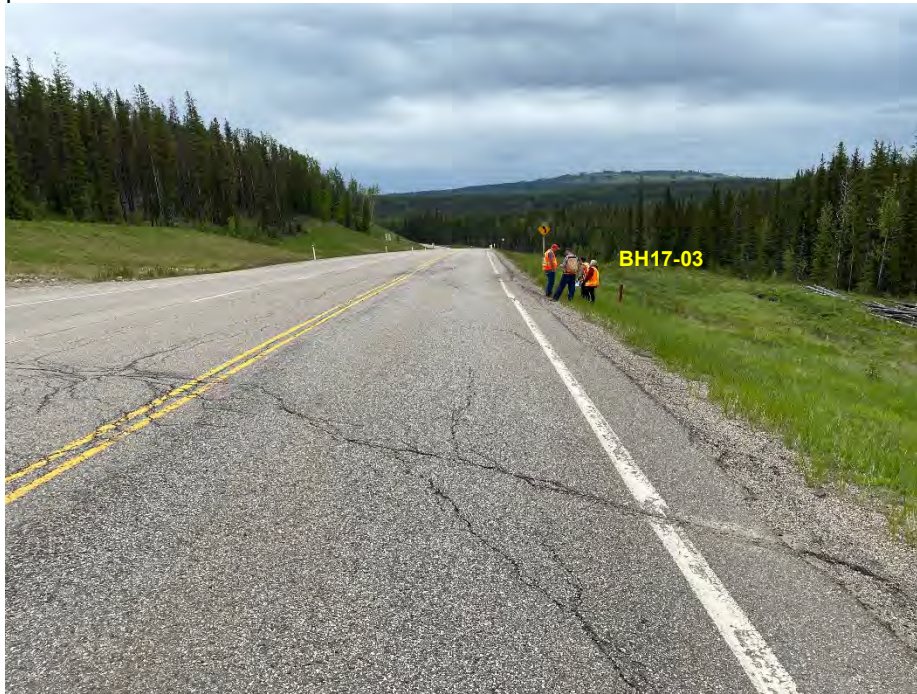
Photo 1: Pavement cracking in SBL. Looking southeast.

- All pavement cracks should be sealed to reduce surface water infiltration into the landslide.
- Riprap or gravel should be placed at the C/L culvert outlet. If the erosion is left unchecked, it could lead to further channeling and embankment movement.

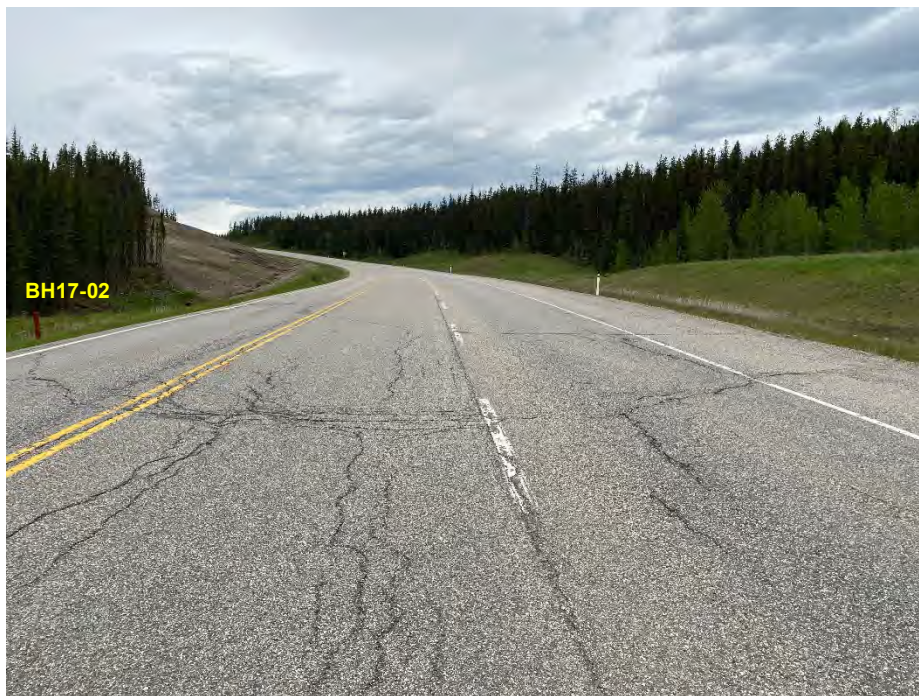
Photo 2: Pavement cracking near BH17-02. Looking northwest.

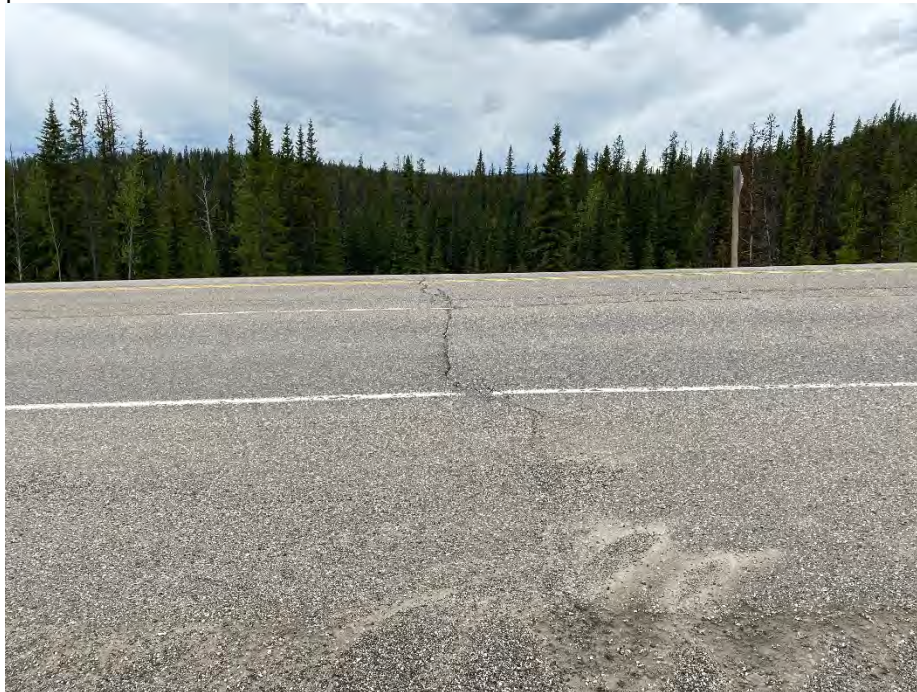
Photo 3: Pavement crack along C/L culvert alignment. Looking southwest.

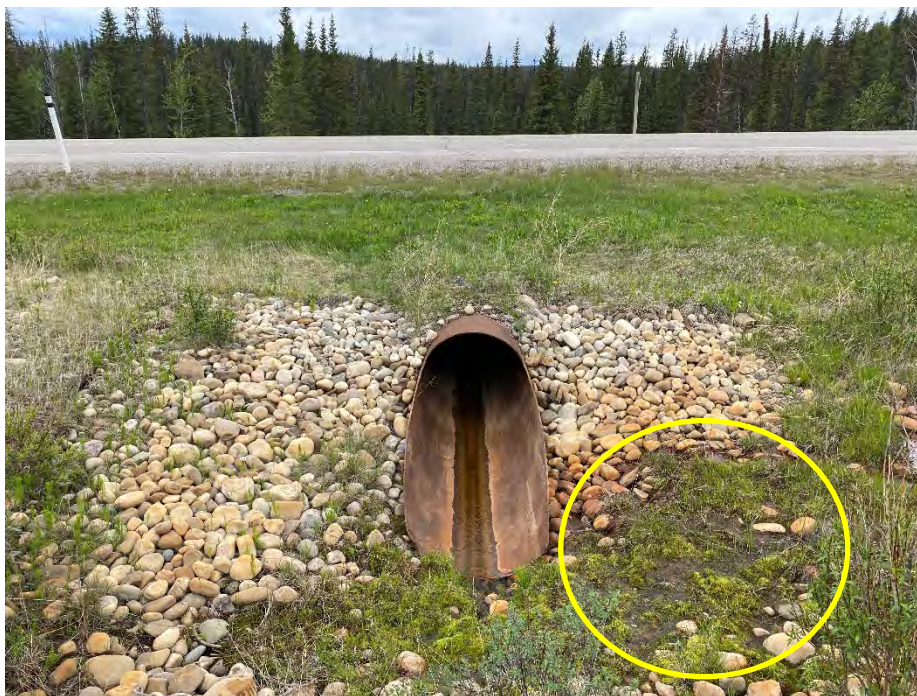
Photo 4: North ditch at C/L culvert inlet. Seepage location circled. Looking southwest.

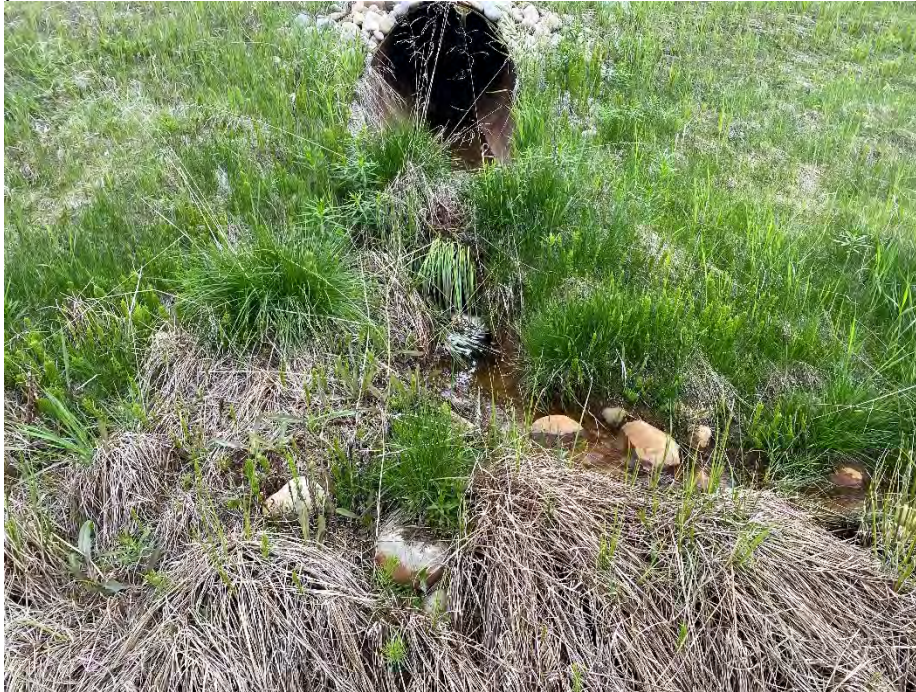
COMMENTS
<ul style="list-style-type: none"> • No significant changes to site conditions were observed. • Pavement crack pattern appeared mostly unchanged compared to the previous inspection and consisted of: <ul style="list-style-type: none"> – 50 mm high crack along SBL shoulder northwest of BH17-03. Vehicles may be breaking hard as they travel across the crack as evidenced by tire marks on the pavement. – Semi-circular crack along SBL between BH17-02 and BH17-03. – 20 mm wide pavement crack along the alignment of the C/L culvert. – Diagonal crack across all 3 lanes at the entrance to the gravel pit access road. • A new diagonal crack across all 3 lanes was observed near the gravel access road. • Both culverts at the site appear to be in good condition. • The south slope appeared to have a “hummocky” appearance and was soft and spongy to traverse. • An erosion channel about 400 mm wide and deep was observed at the C/L culvert outlet.

Photo 5: Erosion at C/L culvert outlet. Looking northwest.

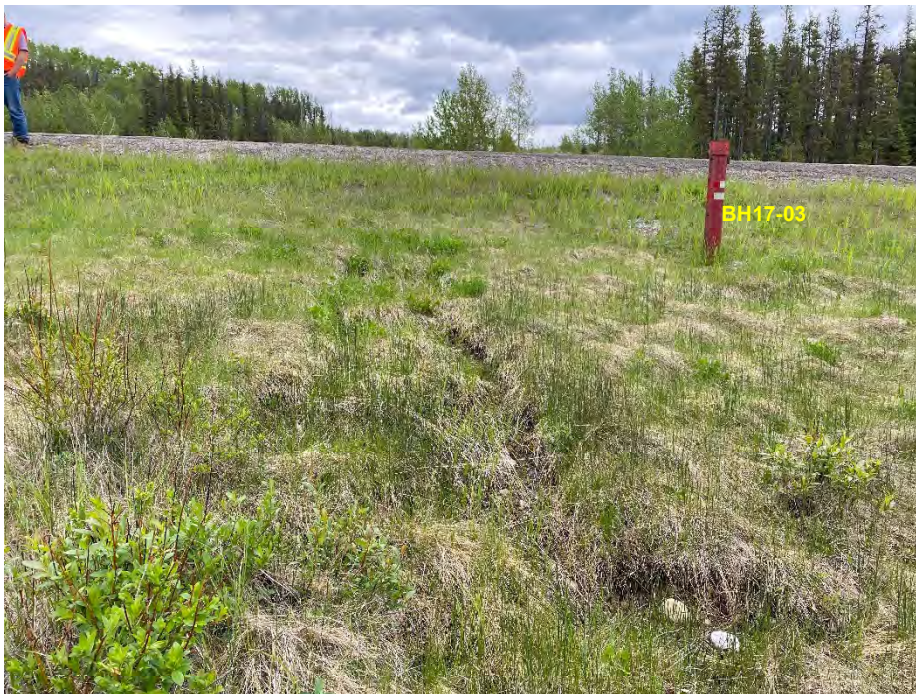
- Significantly more erosion features with ponded water were observed near the timber stockpile.
- Seepage was observed at the south slope in the previously observed vehicle tracks.
- All three SIs at the site continues to show movement with movement rates ranging from less than 1 mm/year to 5 mm/year. Piezometric levels remain high ranging from 0.4 m to 0.8 m below ground surface.

Photo 6: Seepage in vehicle track. 300 mm deep track. Looking northeast.

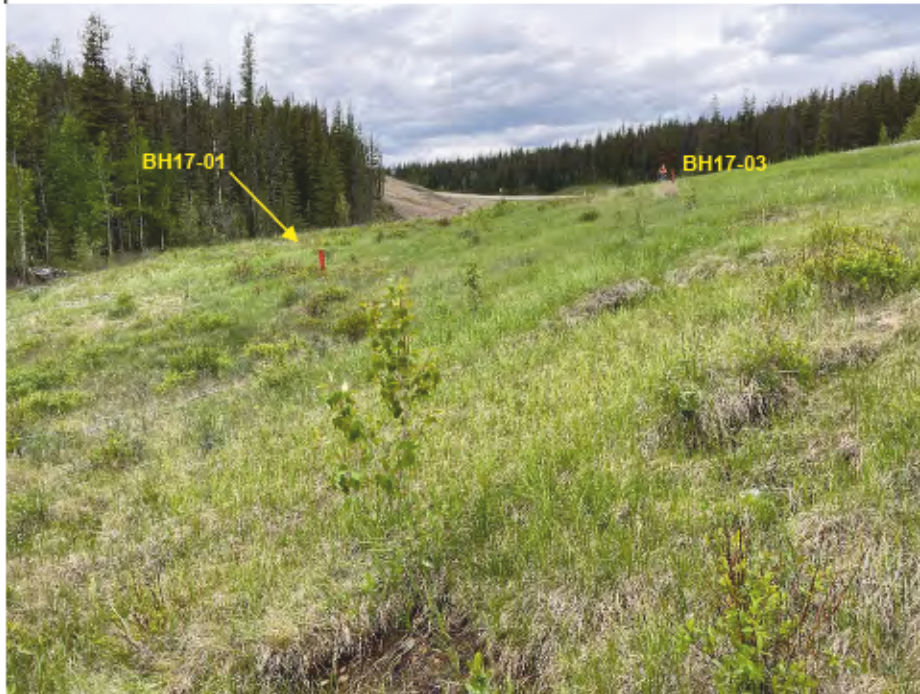
Photo 7: Overall view of south slope. Looking northwest.

- It is understood that this section of the highway is planned to be widened, and that slope stabilization will be included with the highway widening works. Remediation options could include installing a pile wall along the south edge of pavement or constructing a gravel toe berm south of the highway and/or considering light weight fill for the highway widening work. Any remediation measures undertaken should include drainage measures such as trench drains or drainage blanket underneath the embankment to reduce pore pressure build-up.

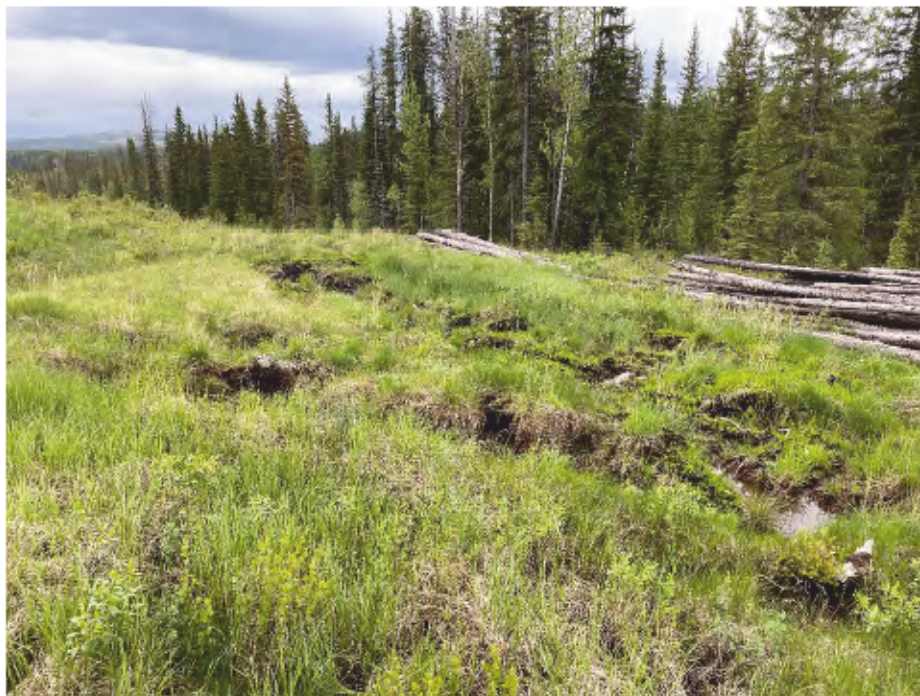
Photo 8: Erosion and ponded water in tree clearing area. Looking southeast.
