SITE NUMBER AND NAME: NC083 – West of Wildhay River	HIGHWAY AND KM: 40:30, km 37.368	PREVIOUS INSPECTION: July 17, 2022	CURRENT INSPECTION: May 30, 2023
LEGAL DESCRIPTION: SE-08-53-27-W5	NAD83 COORDINATES: UTM11U 5935069N, 437757E		RISK ASSESSMENT: PF: 11 CF: 5 Total: 55
AVERAGE ANNUAL DAILY TRAFFIC (AADT): 1,690 (2022)		CONTRACTOR MAINTENANCE AREA (CMA): 508

2023 Site Inspection Photos at NC083

Client/Project: Transportation and Economic Corridors
 Geohazard Monitoring Program
 NC83 – West of Wildhay River

Figure No.: 1
 Title: **Site Plan**

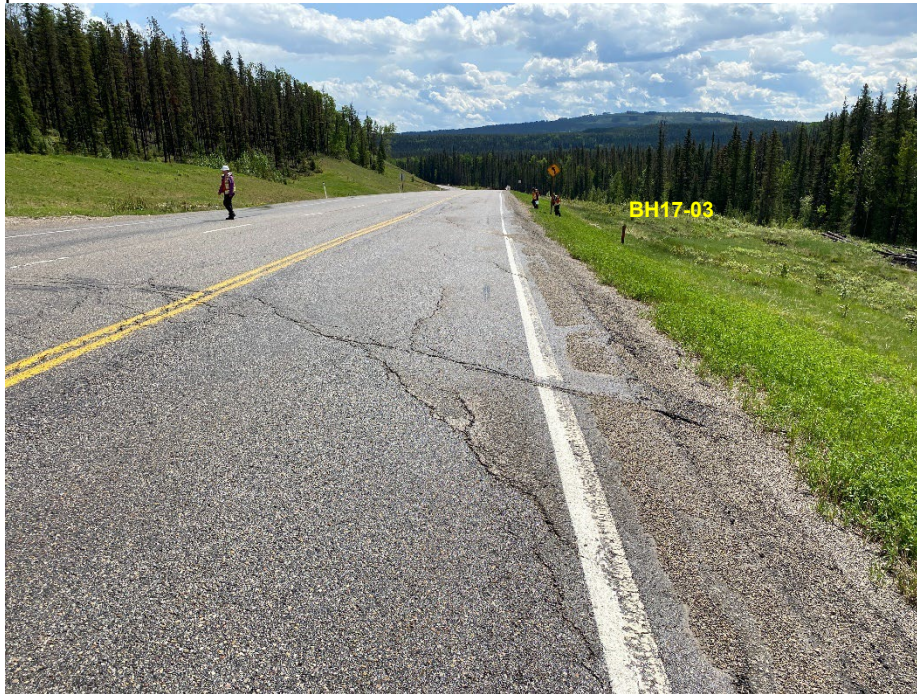
Photo 1: Pavement cracking in SBL near BH17-02. Looking southeast.

- All pavement cracks should be sealed to reduce surface water infiltration into the landslide.
- Riprap or gravel should be placed at the C/L culvert outlet. If the erosion is left unchecked, it could lead to further channeling and embankment movement.

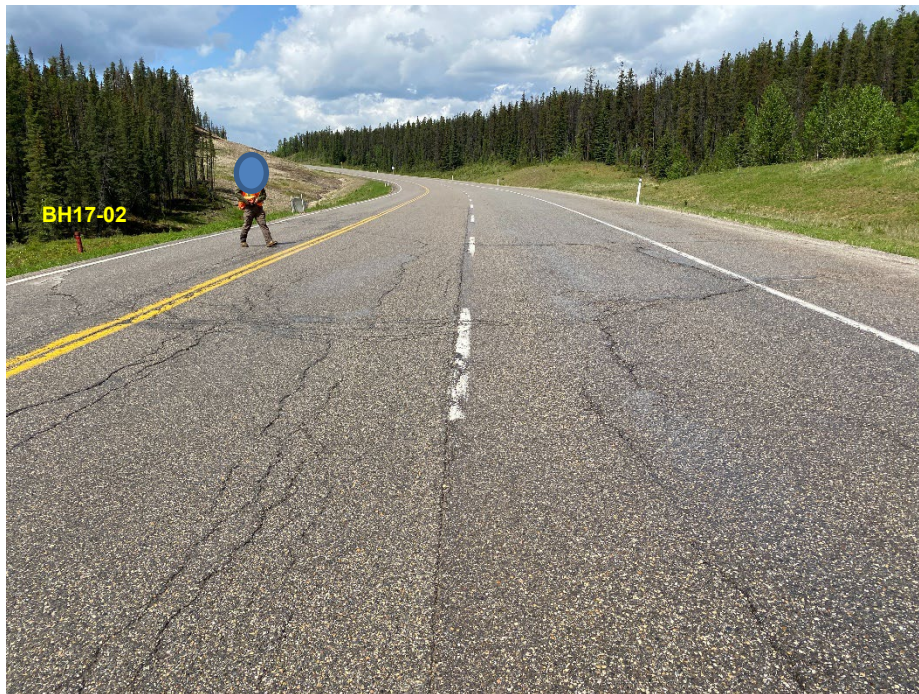
Photo 2: Pavement cracking in NBL near BH17-02. Looking northwest.

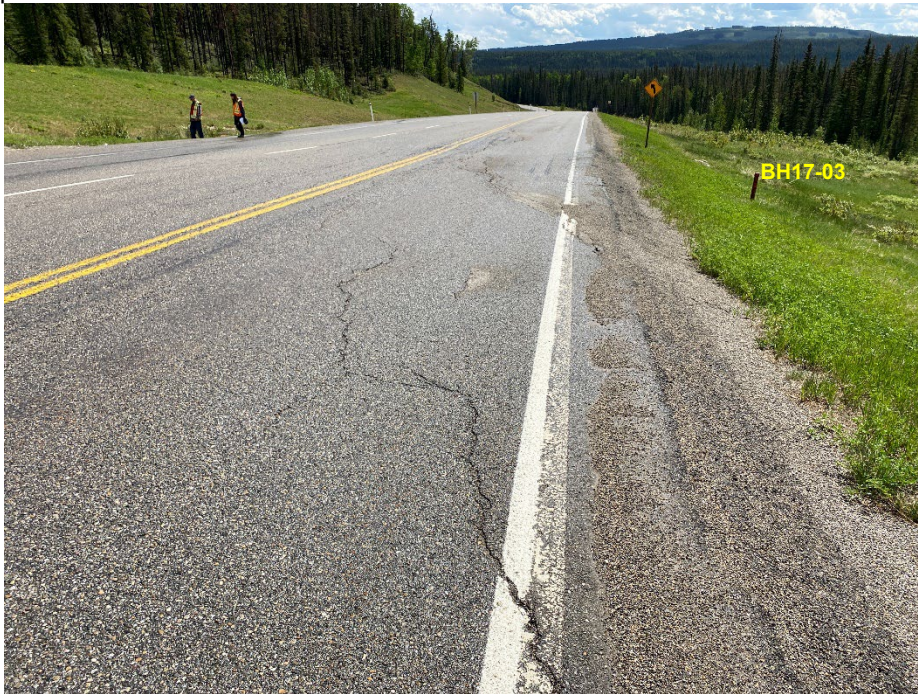
- Reflecting diagonal crack along SBL shoulder northwest of BH17-03, northwest of the crack noted above (Photo 3).
- 20 mm wide pavement crack along the alignment of the C/L culvert (Photo 5).

Photo 3: Pavement cracking in SBL between BH17-02 and BH17-03. Looking southeast.

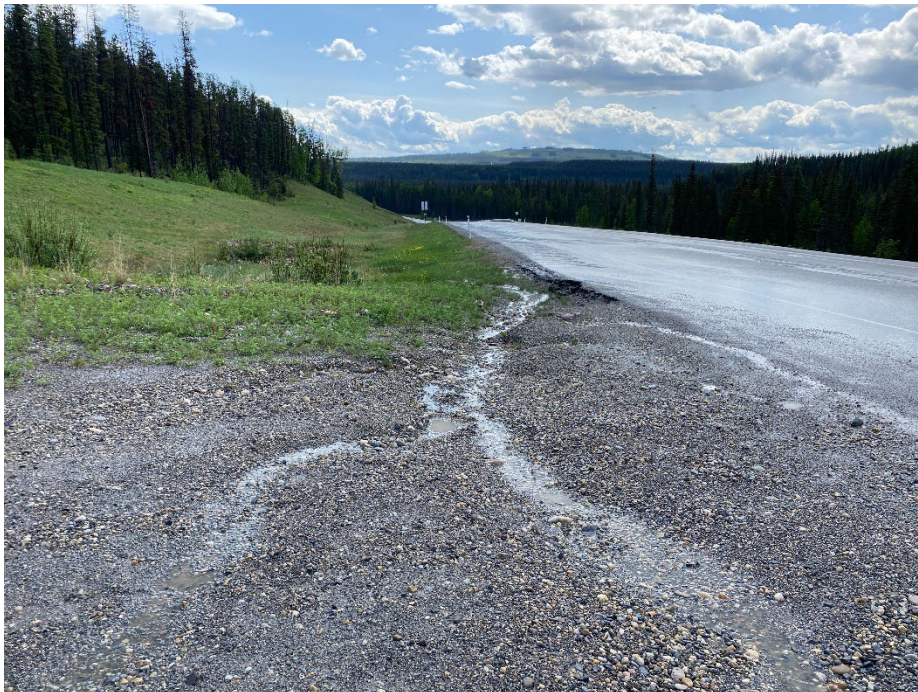
- An erosion channel was observed at the entrance to the gravel access road, where it followed the highway and entered the east ditch where it had eroded. The edge of pavement at this location was also broken over several meters (Photo 4).

Photo 4: Surface water eroding gravel and edge of pavement at east corner of entrance to gravel pit. Looking southeast.

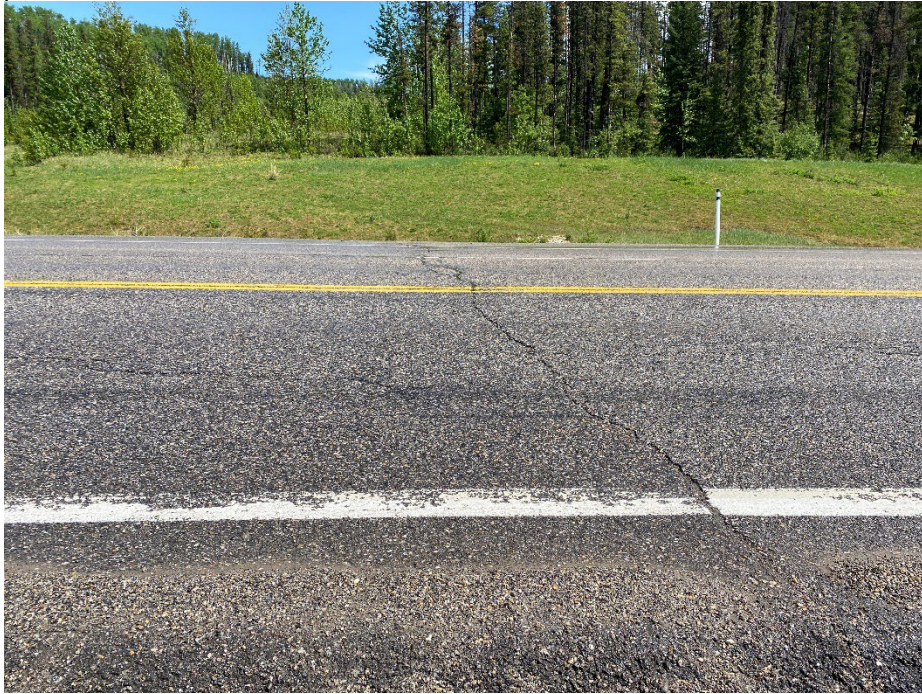
Photo 5: Pavement crack along C/L culvert alignment. Looking northeast.

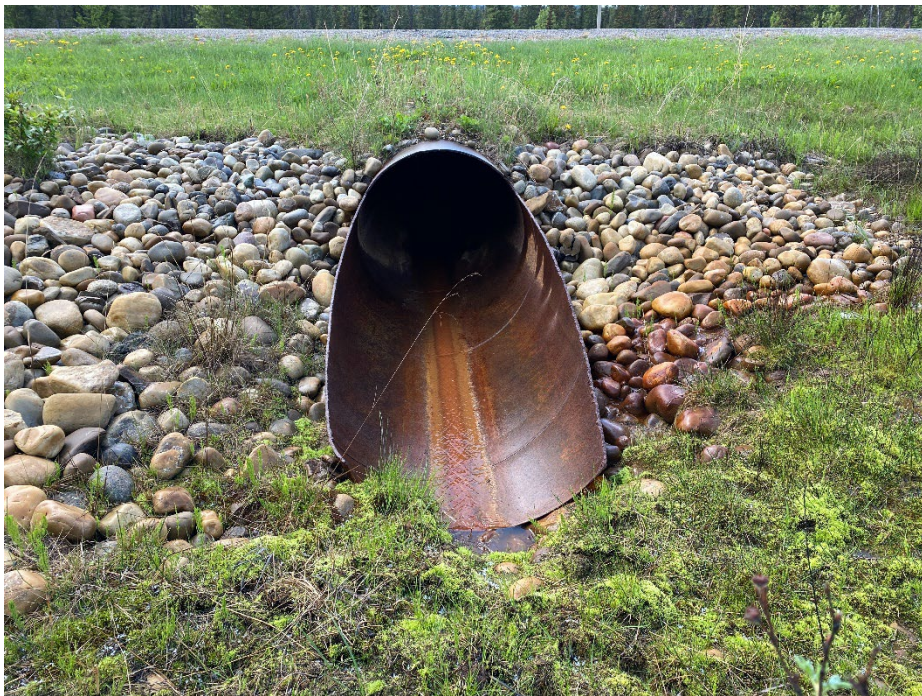
- Both culverts at the site appear to be in good condition. An erosion channel about 400 mm wide and deep was observed at the C/L culvert outlet, which is blocked by vegetation (Photos 6 and 7).

Photo 6: North ditch at C/L culvert inlet. Looking southwest.

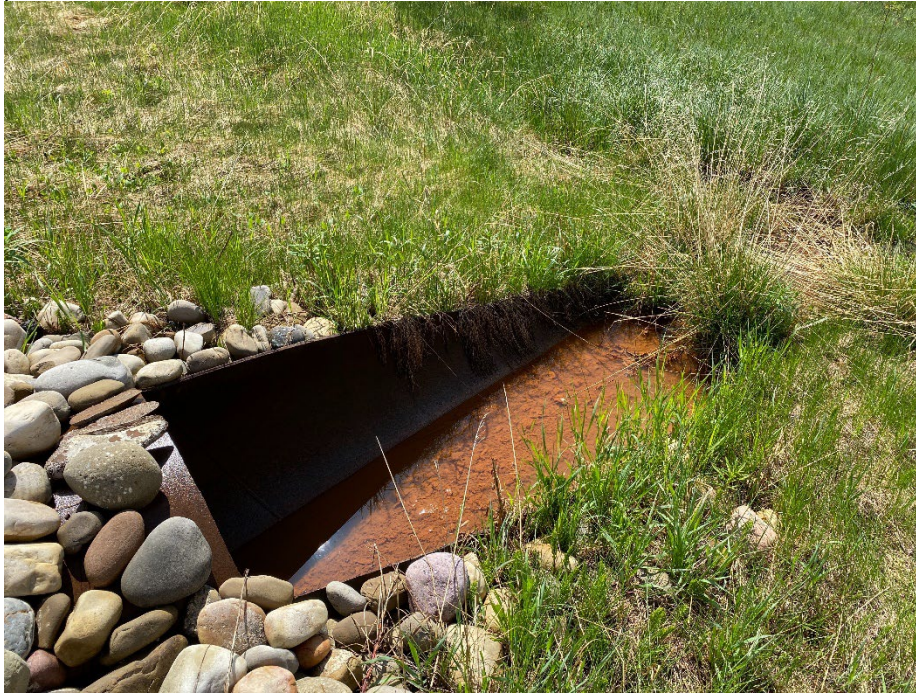
Photo 7: Vegetation blocking C/L culvert outlet. Looking southeast.

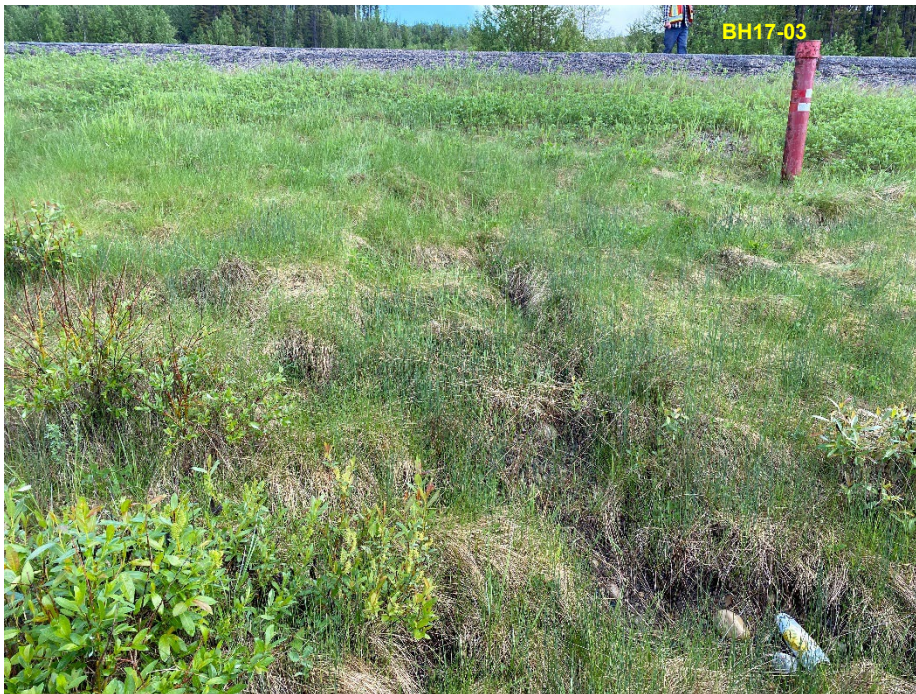
- Seepage was observed at the south slope in the previously observed vehicle tracks (Photo 8).
- All three SIs at the site continues to show movement with movement rates ranging from less than 1 mm/year to 6 mm/year. Piezometric levels remain high ranging from 0.4 m to 0.8 m below ground surface.

Photo 8: Seepage in vehicle track. 300 mm deep track. Looking northeast.

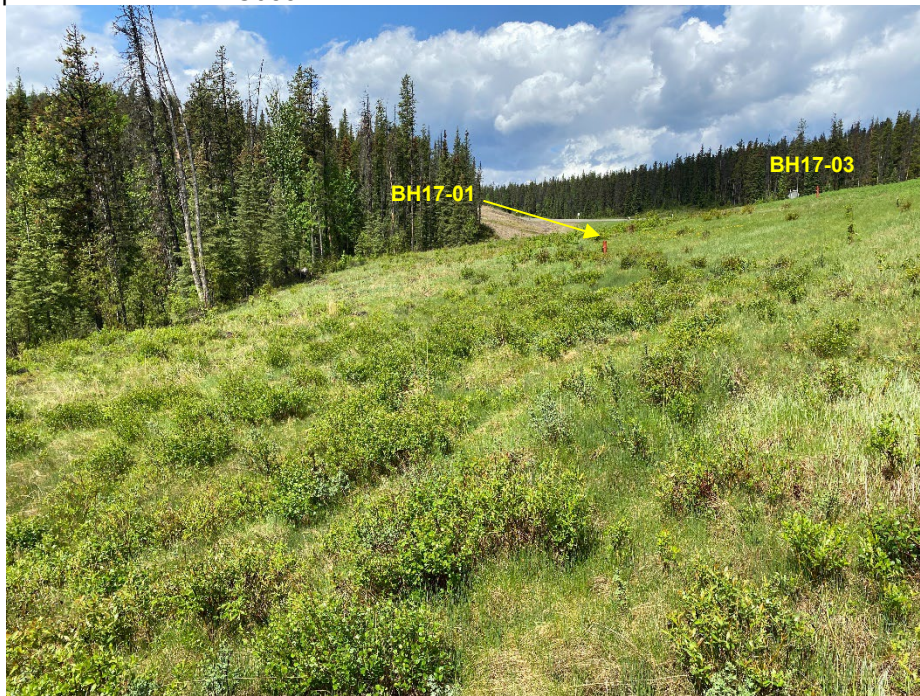
- The south slope appeared to have a “hummocky” appearance and was soft and spongy to traverse (Photo 9).
- Significantly more erosion features with ponded water were observed near the timber stockpile (Photo 10).

Photo 9: Overall view of south slope. Looking northwest.

- It is understood that this section of the highway is planned to be widened, and that slope stabilization will be included with the highway widening works. Remediation options could include installing a pile wall along the south edge of pavement or constructing a gravel toe berm south of the highway and/or considering light weight fill for the highway widening work. Any remediation measures undertaken should include drainage measures such as trench drains or drainage blanket underneath the embankment to reduce pore pressure build-up.

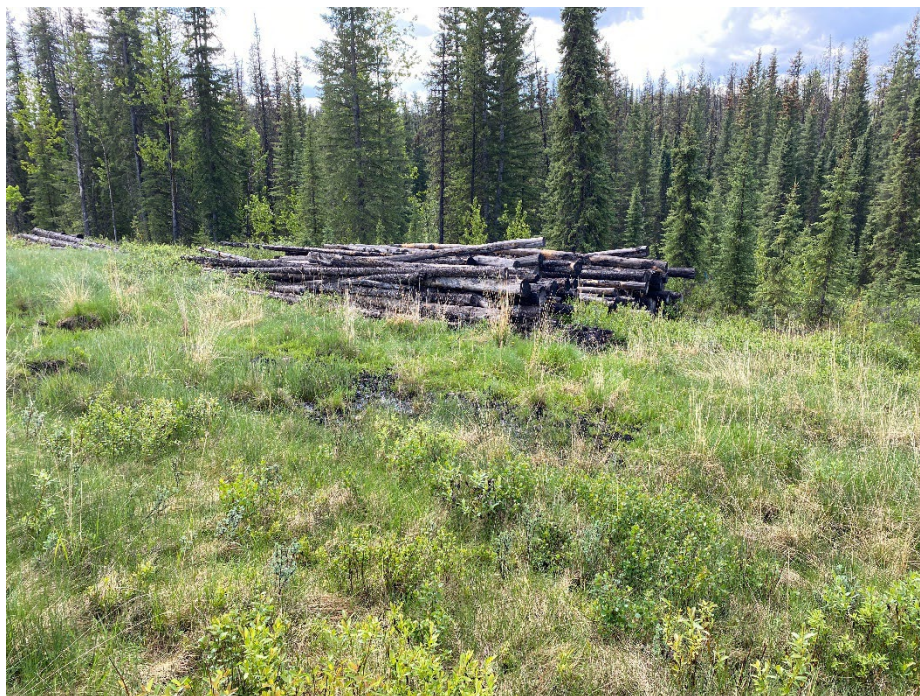
Photo 10: Erosion and ponded water in tree clearing area. Looking southeast.
