To:	Amy Driessen	From:	Leslie Cho and Xiteng Liu
	Transportation and Economic Corridors		Stantec Consulting Ltd.
File:	123315222	Date:	October 18, 2024

**Reference: North Central Region, Edson, Site NC083 - Highway 40:30 West of Wildhay River, Fall 2024 Instrumentation Monitoring Report**

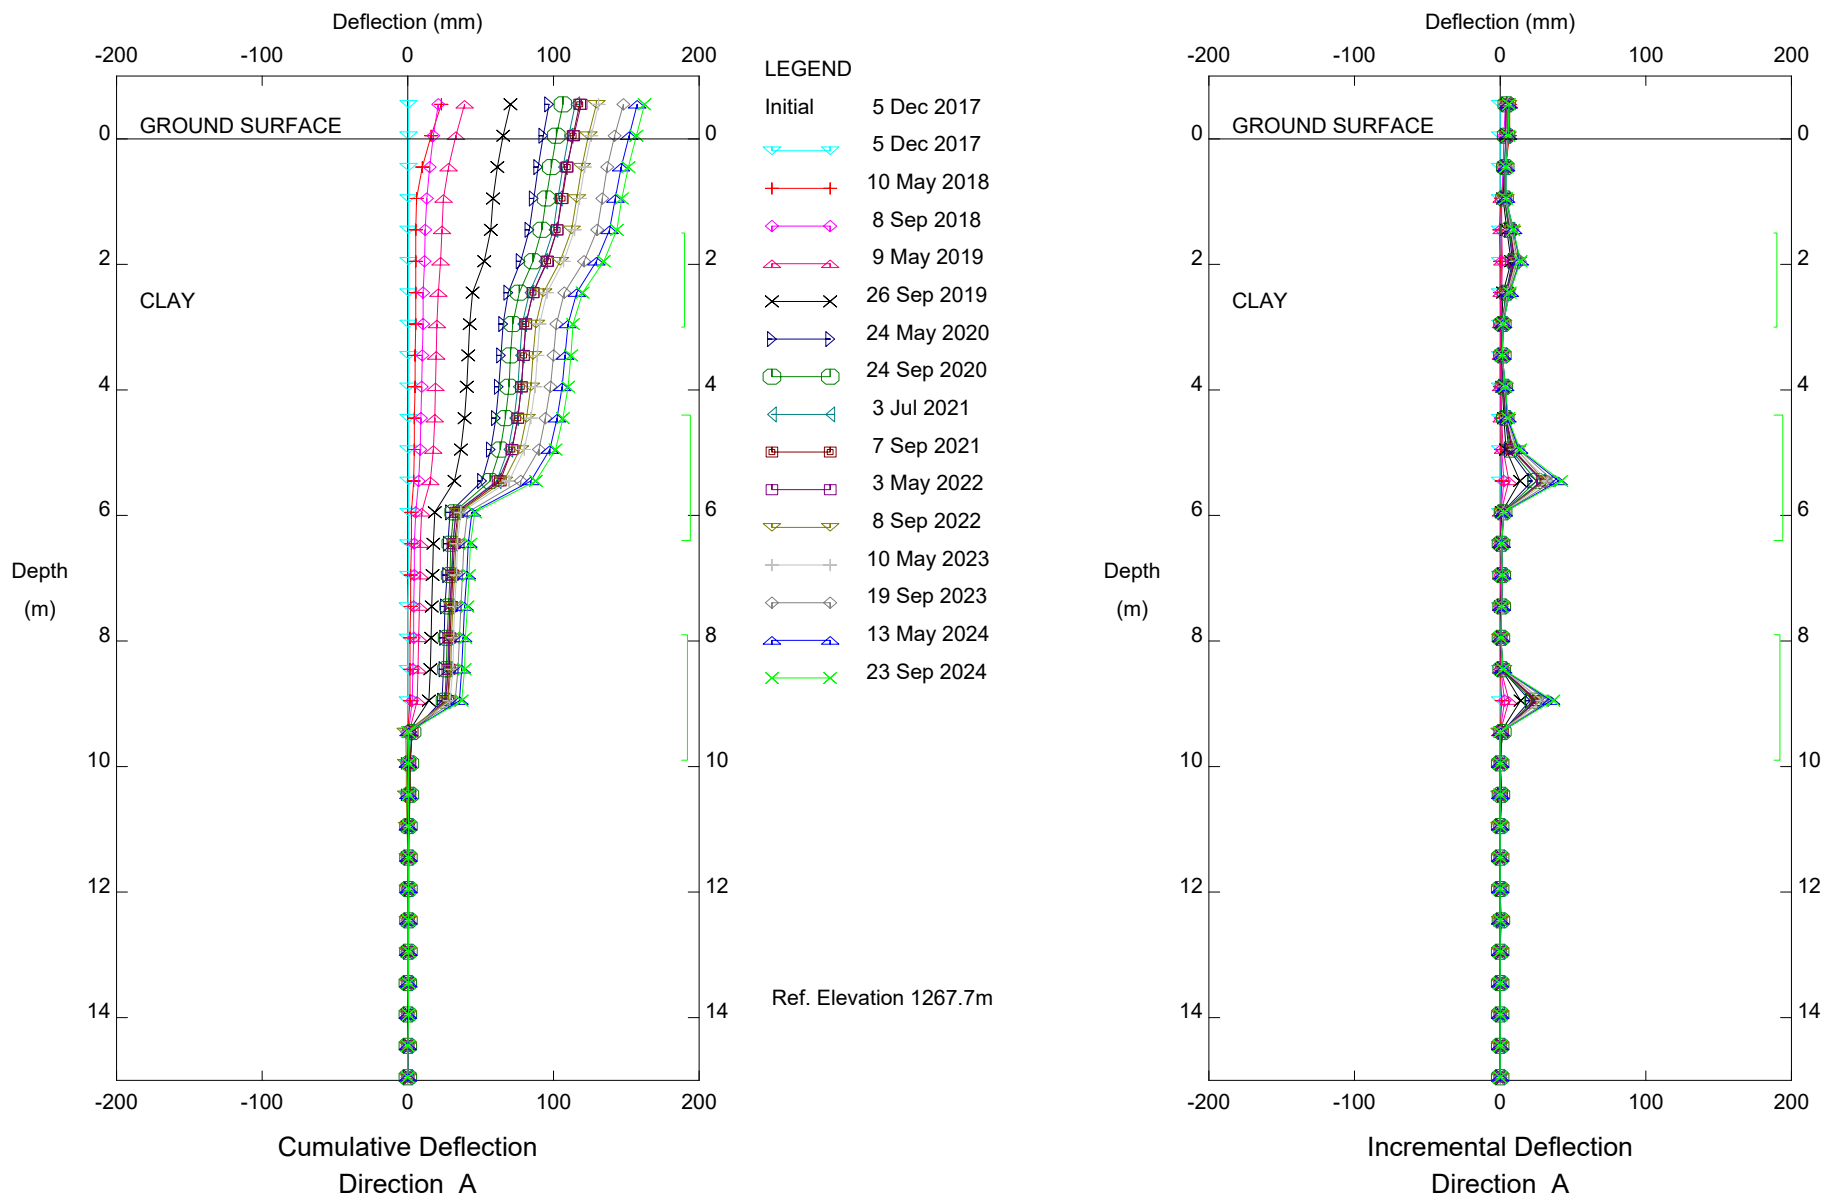
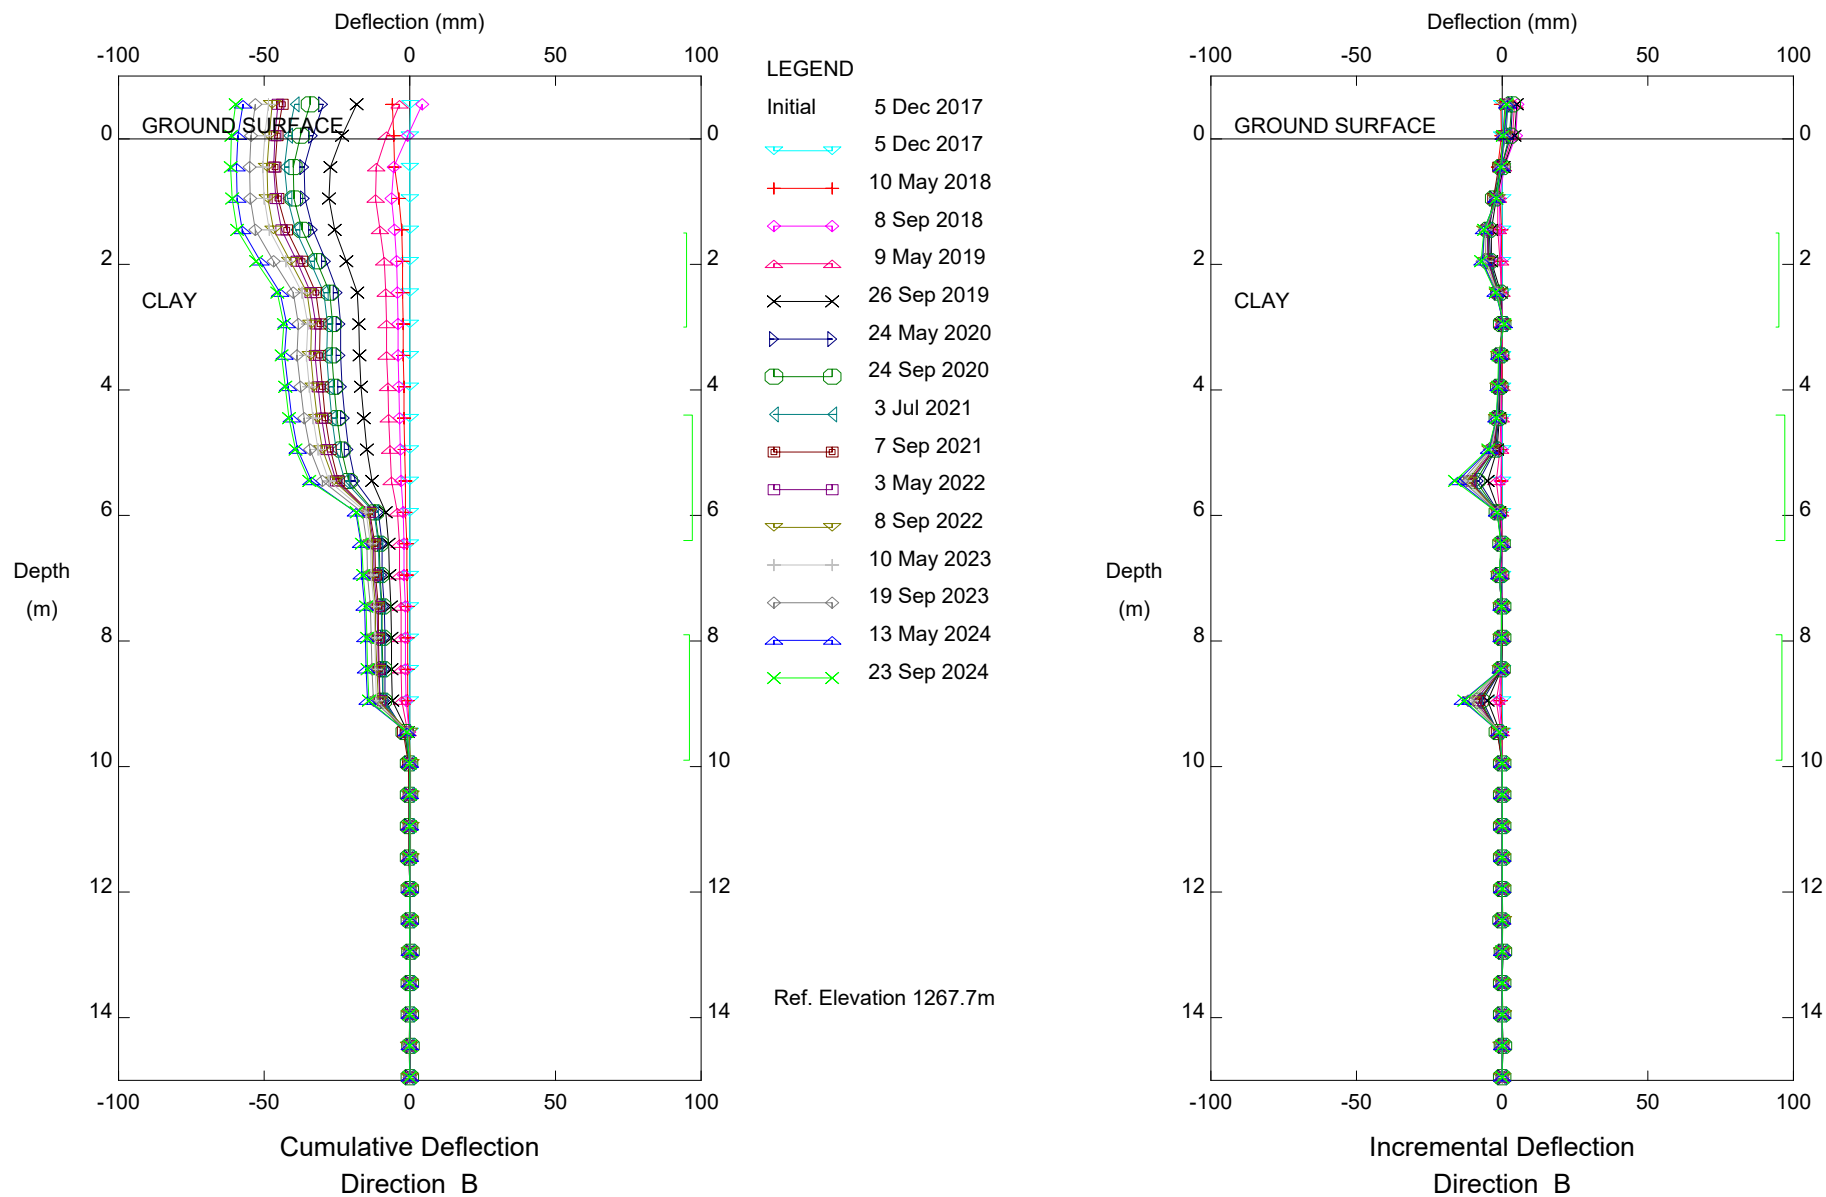
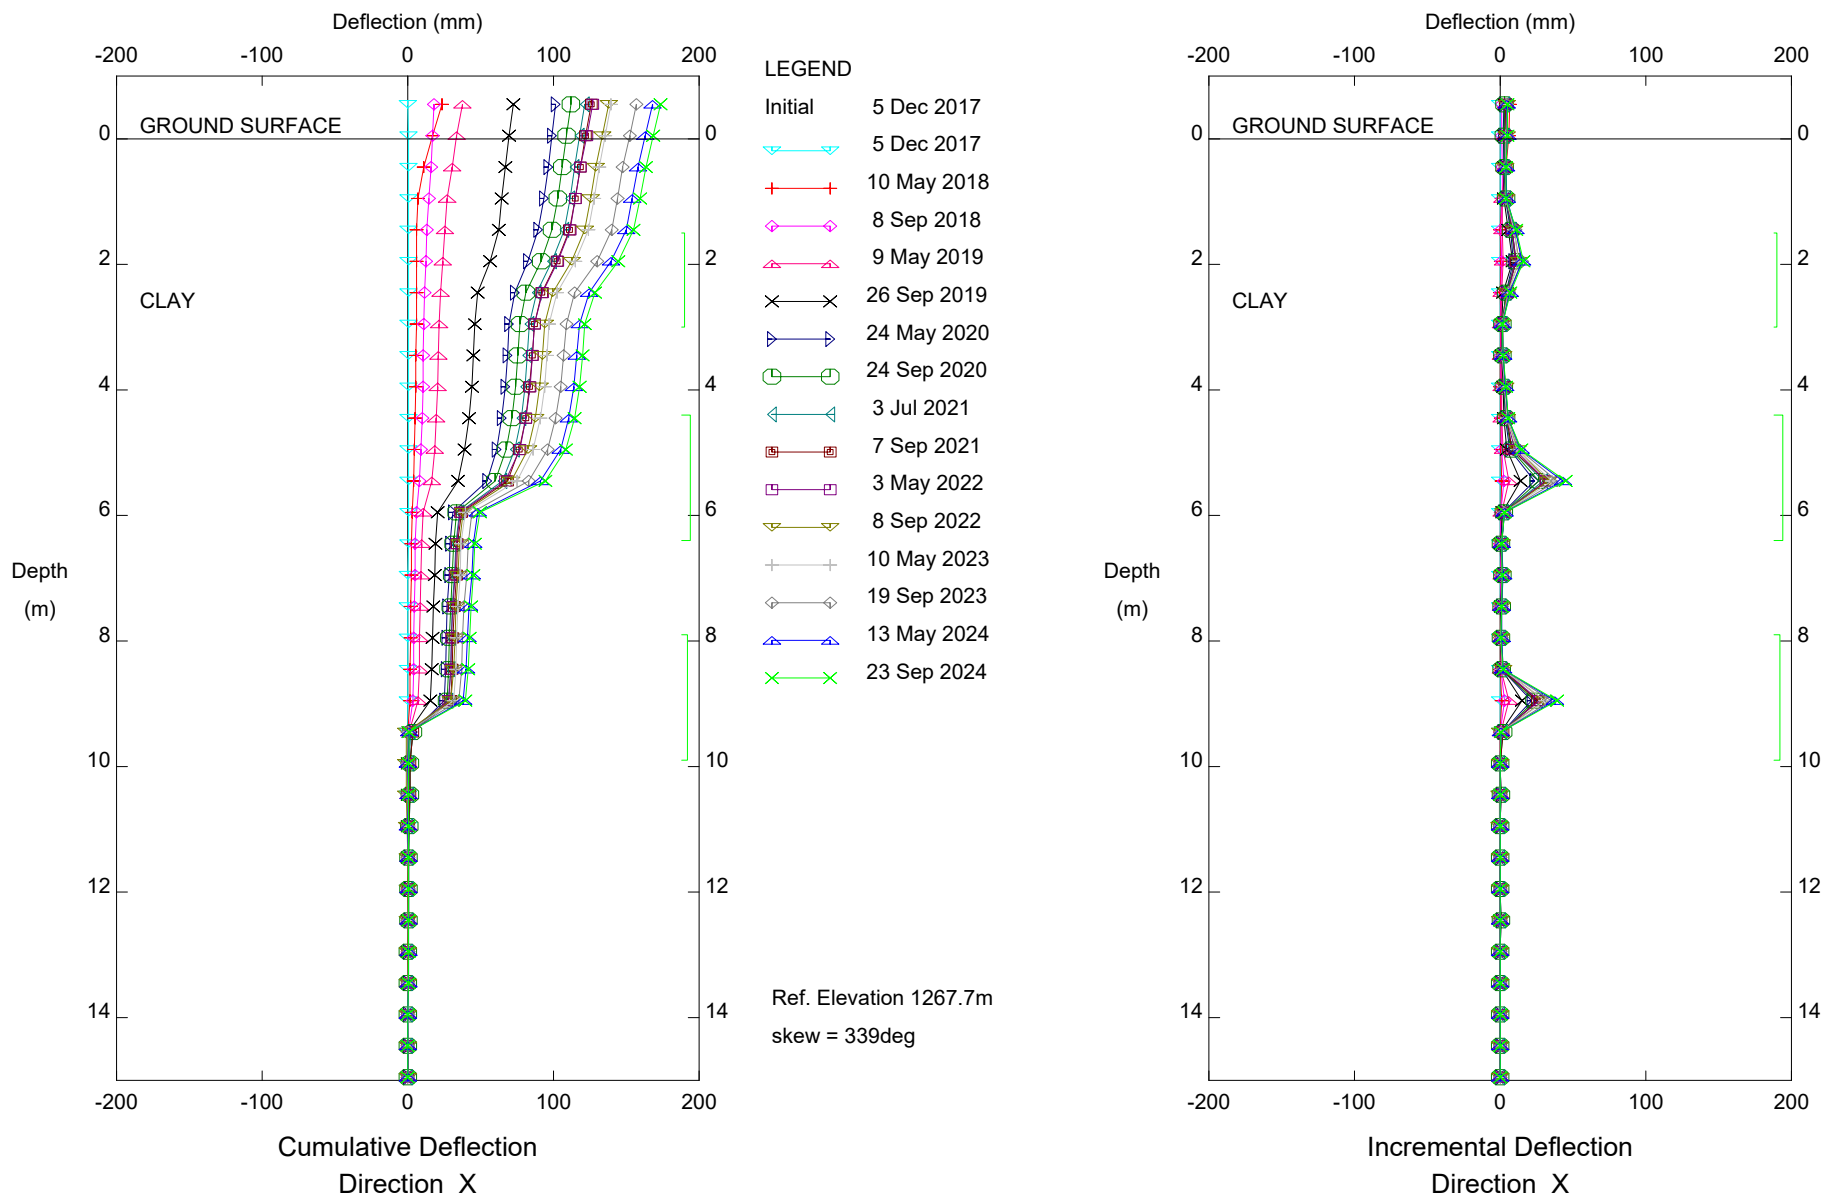
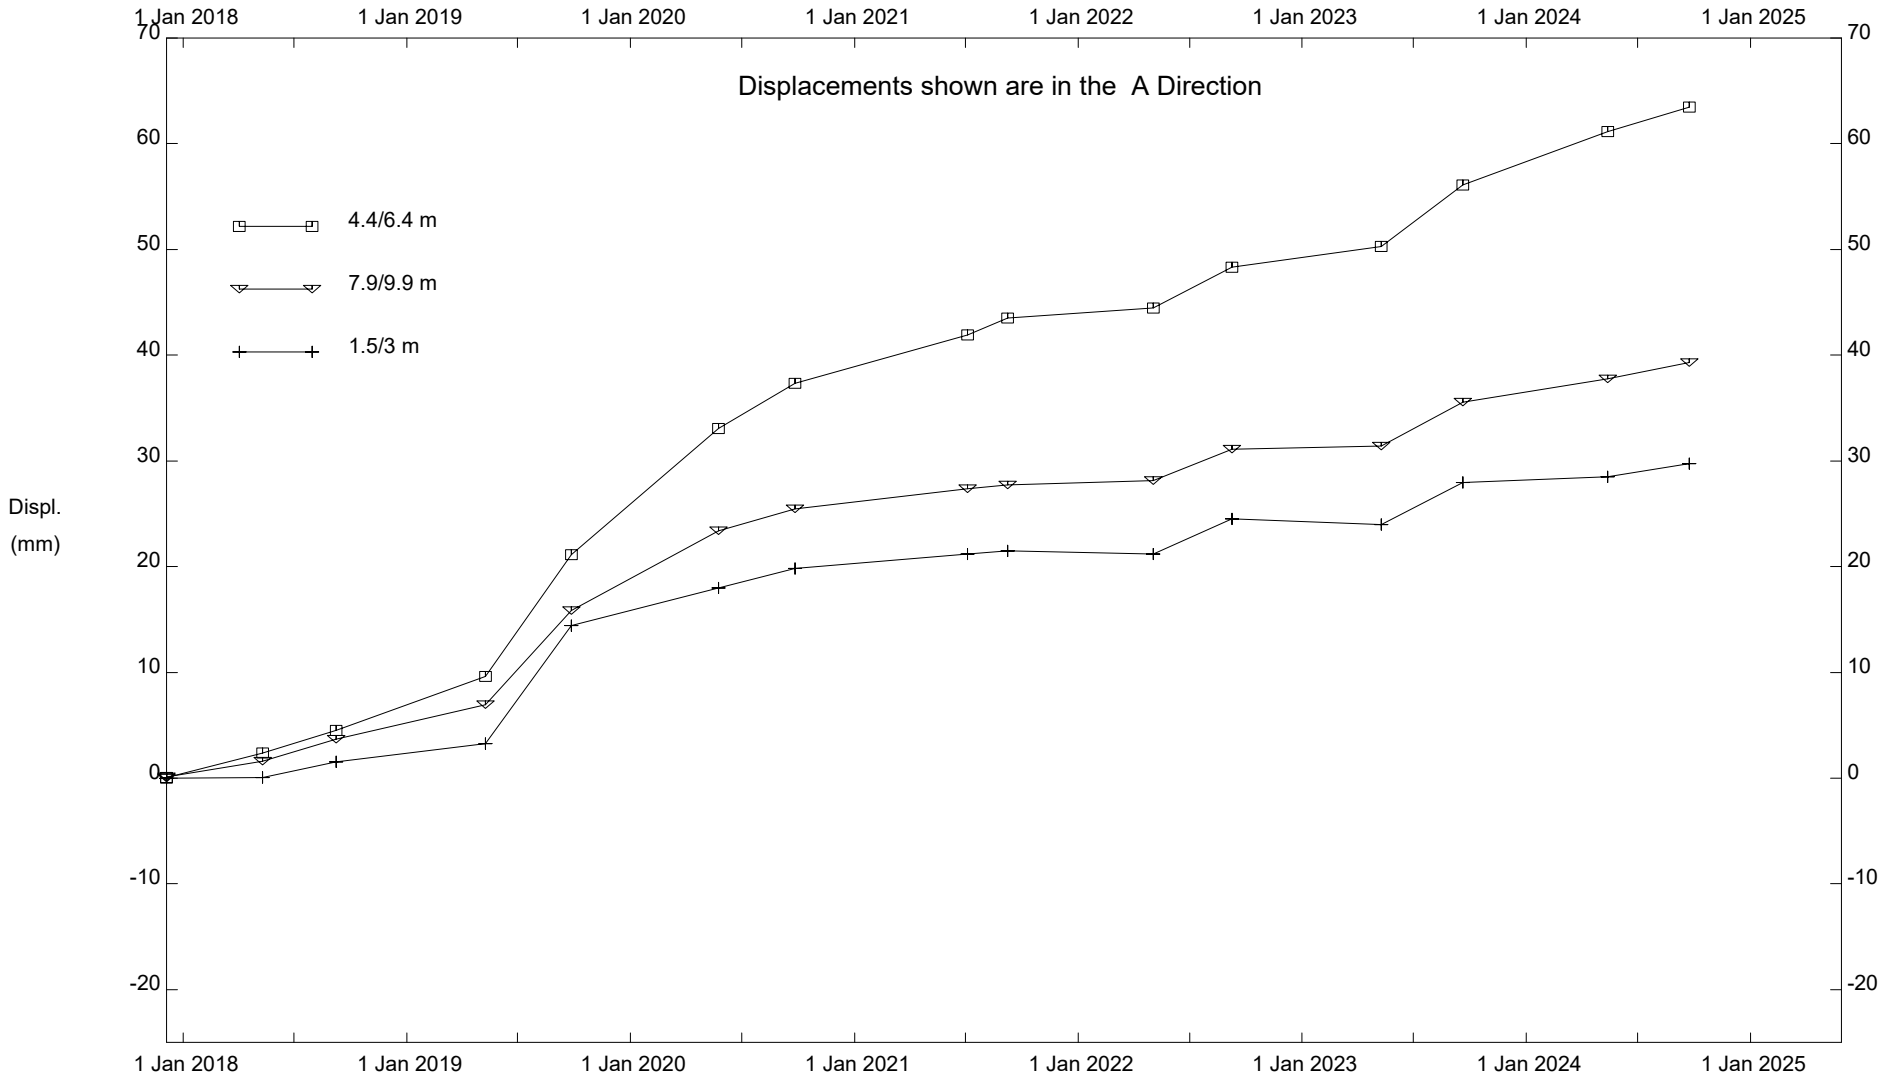
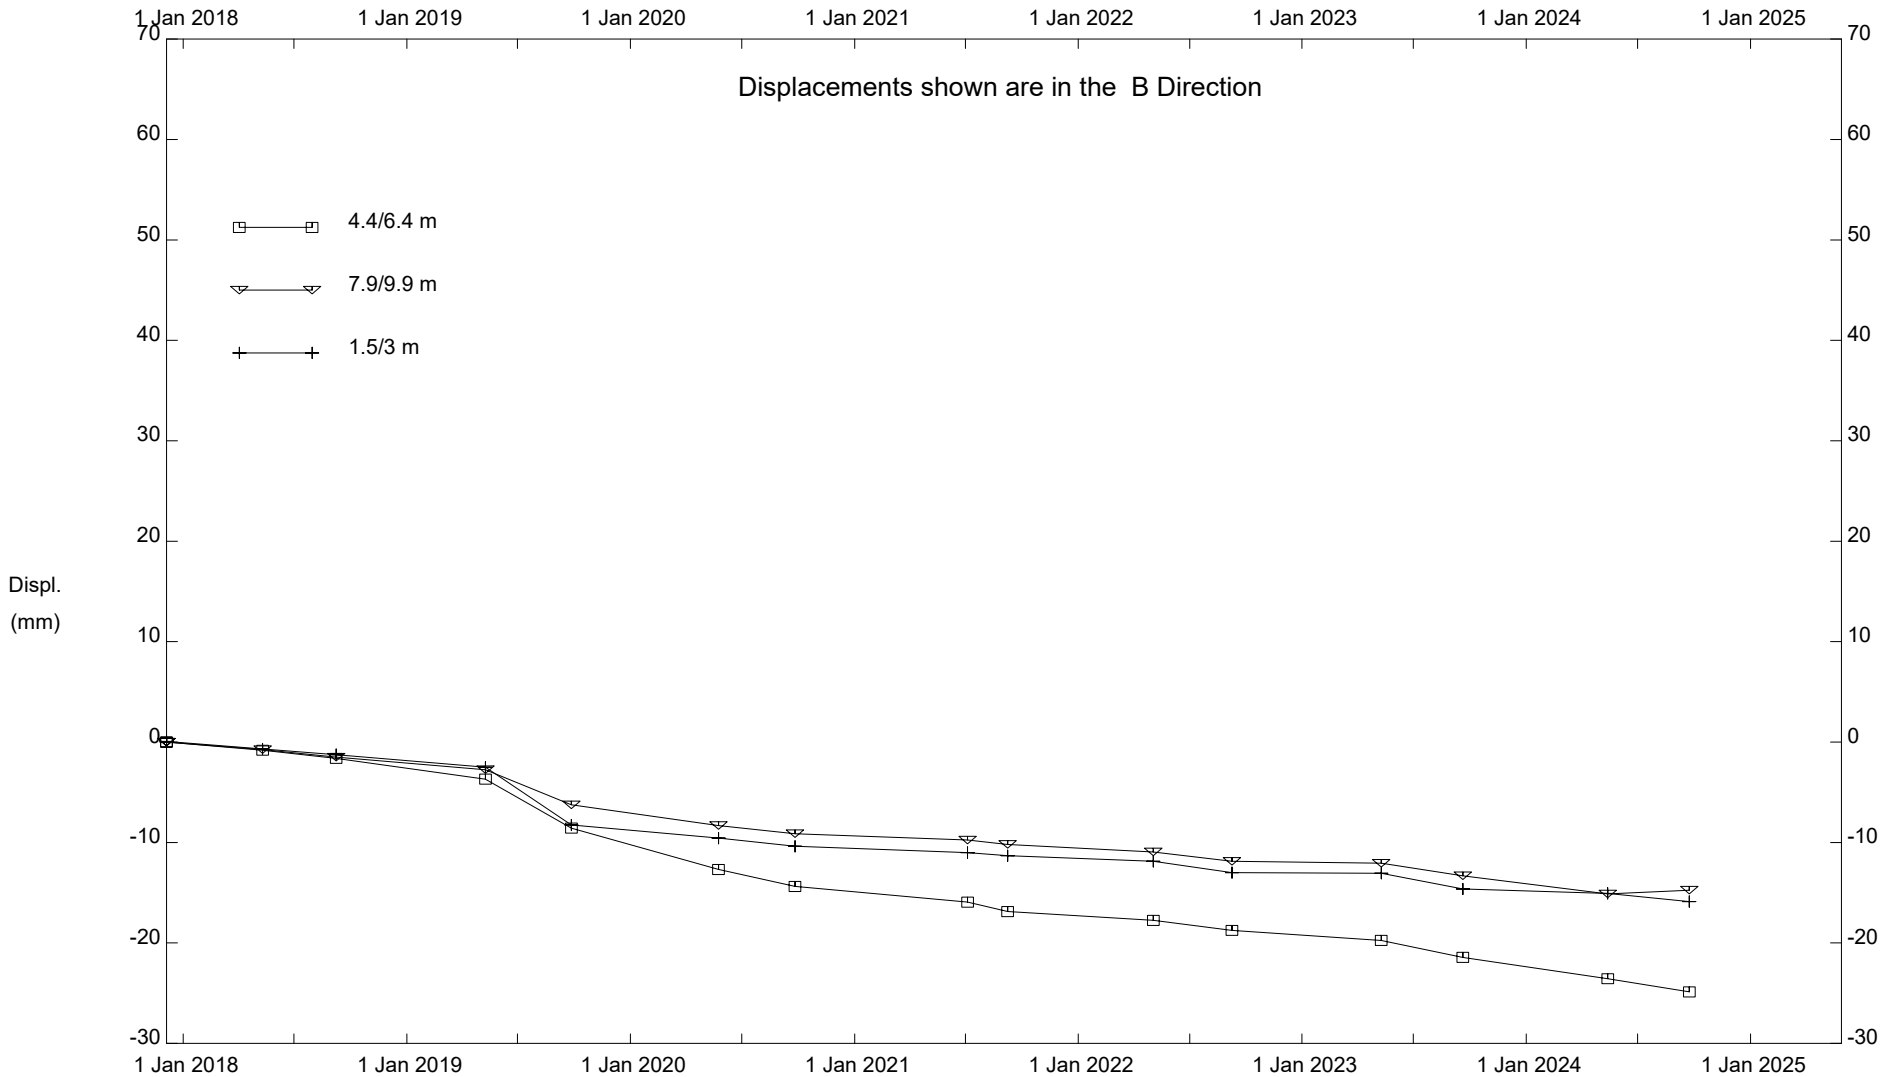
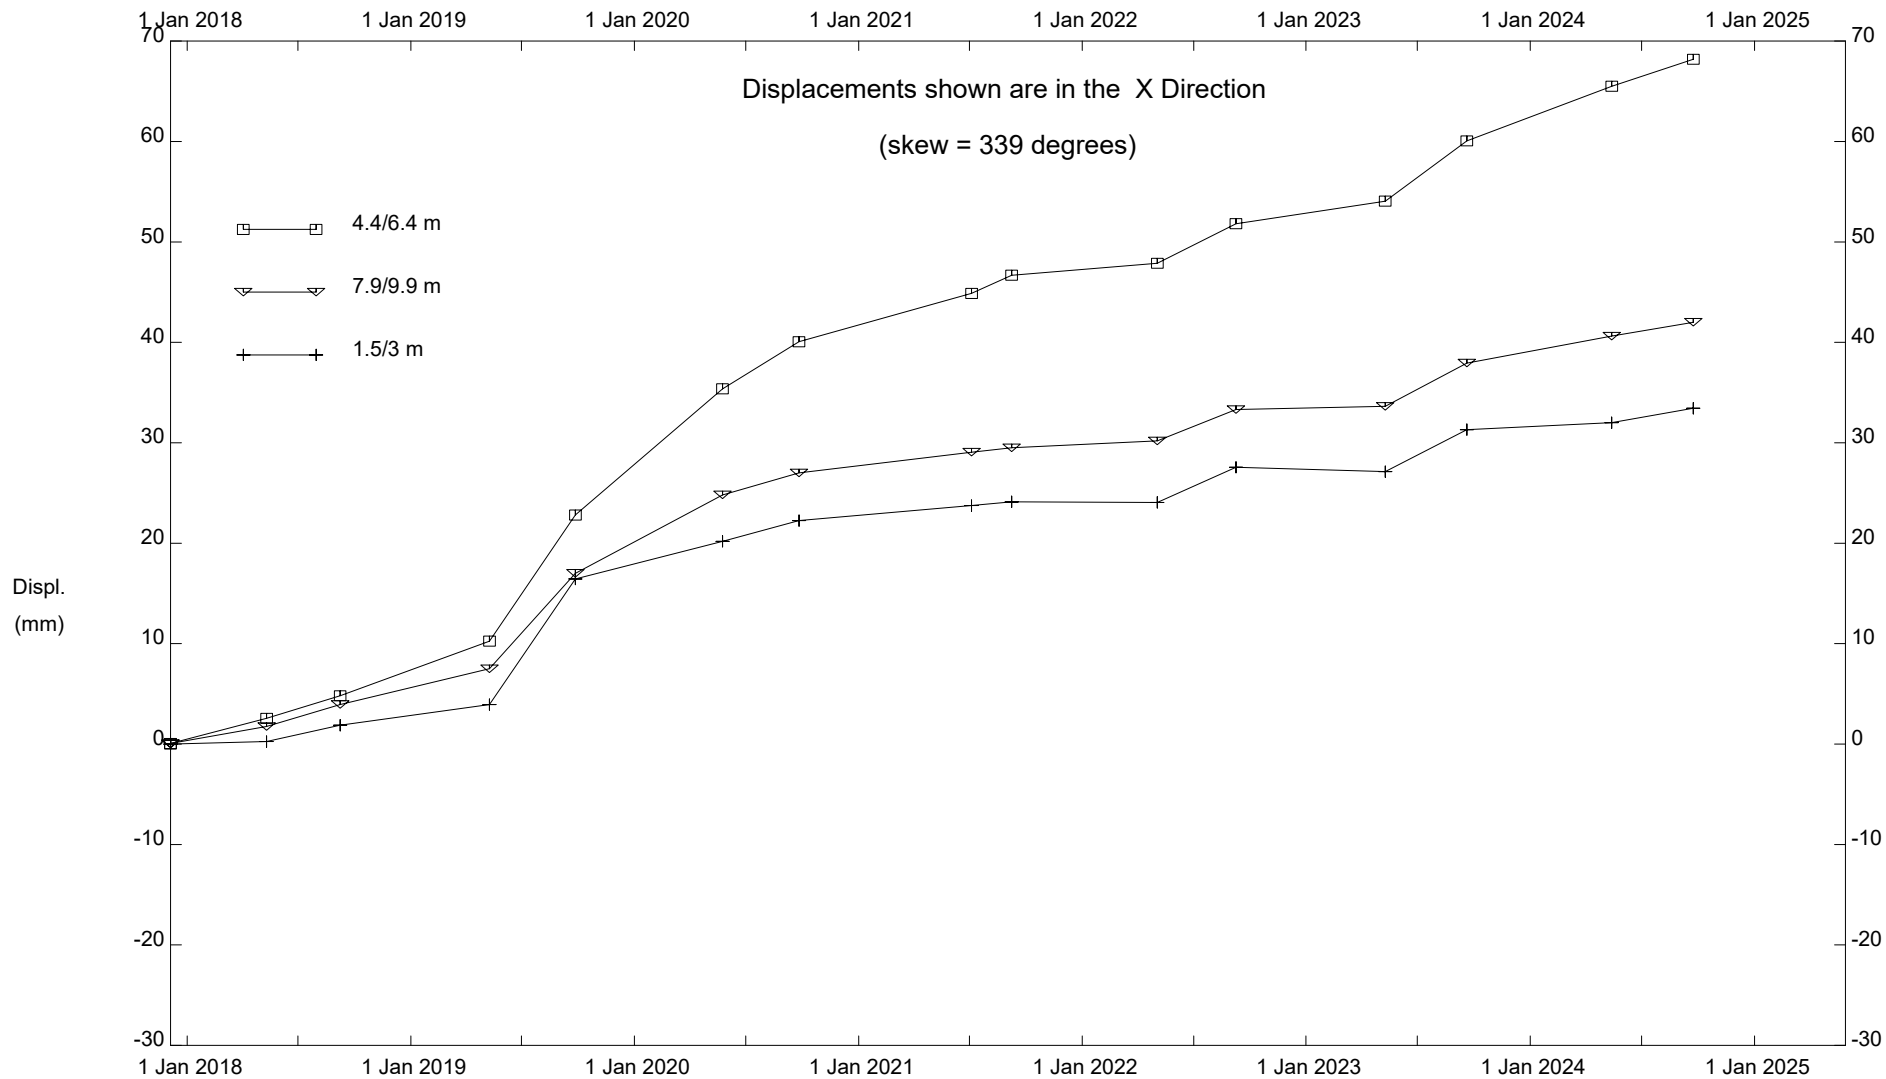
HWY 40:30 West of Wildhay River (NC83), Inclinometer SI17-01  
 Transportation & Economic Corridors

SI17-01 shows three zones of movement at depths of 1.5 m to 3 m, 4.4 m to 6.4 m and 7.9 m to 9.9 m below ground surface (bgs). Since initialization in December 2017, SI17-01 has accumulated 33 mm, 68 mm and 42 mm of movement in the upper, middle and lower shear zones, respectively. Their current respective rates of

movement for the three zones are 5 mm/yr, 8 mm/yr and 4 mm/yr. All three shear zones showed similar rates of movement compared to the last reading cycle in Spring 2024.
