To:	Amy Driessen	From:	Leslie Cho and Xiteng Liu
	Transportation and Economic Corridors		Stantec Consulting Ltd.
File:	123315222	Date:	October 18, 2024

**Reference: North Central Region, Edson, Site NC083 - Highway 40:30 West of Wildhay River, Fall 2024 Instrumentation Monitoring Report**

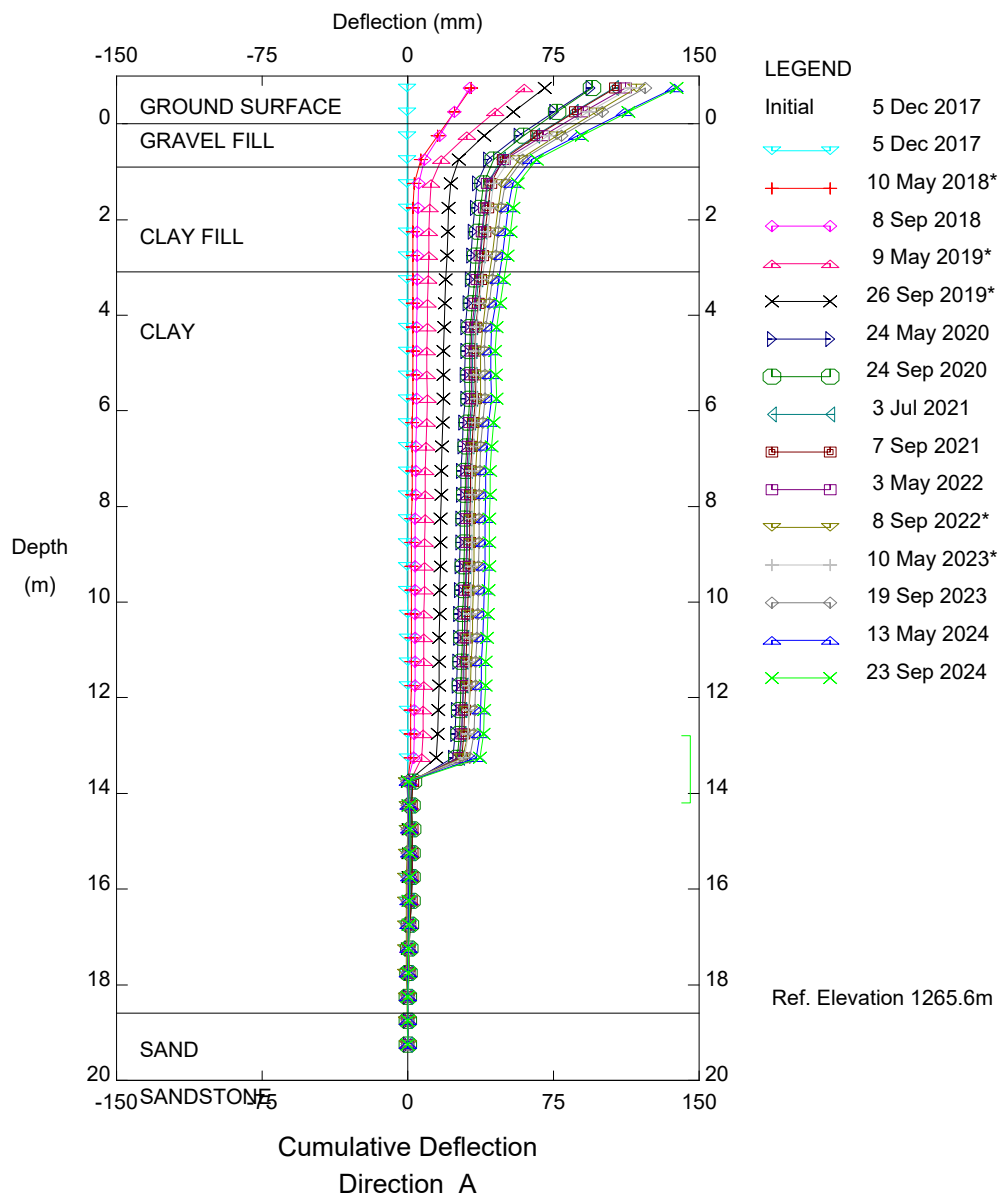
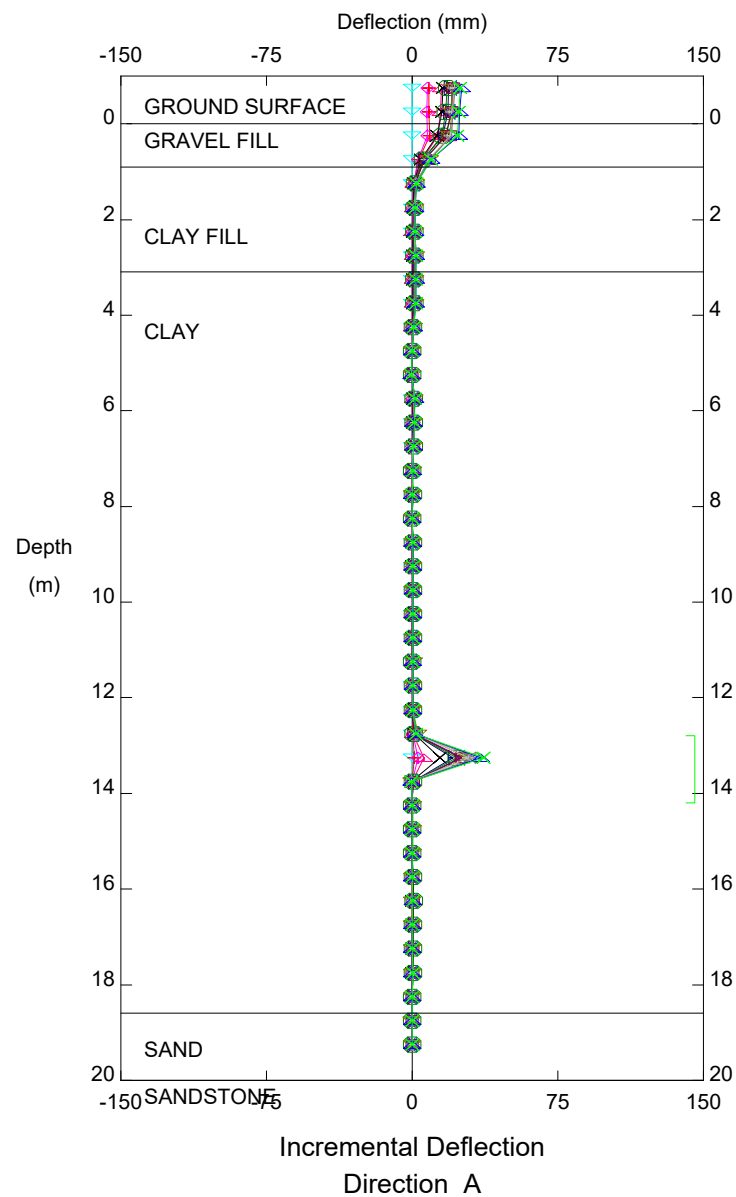
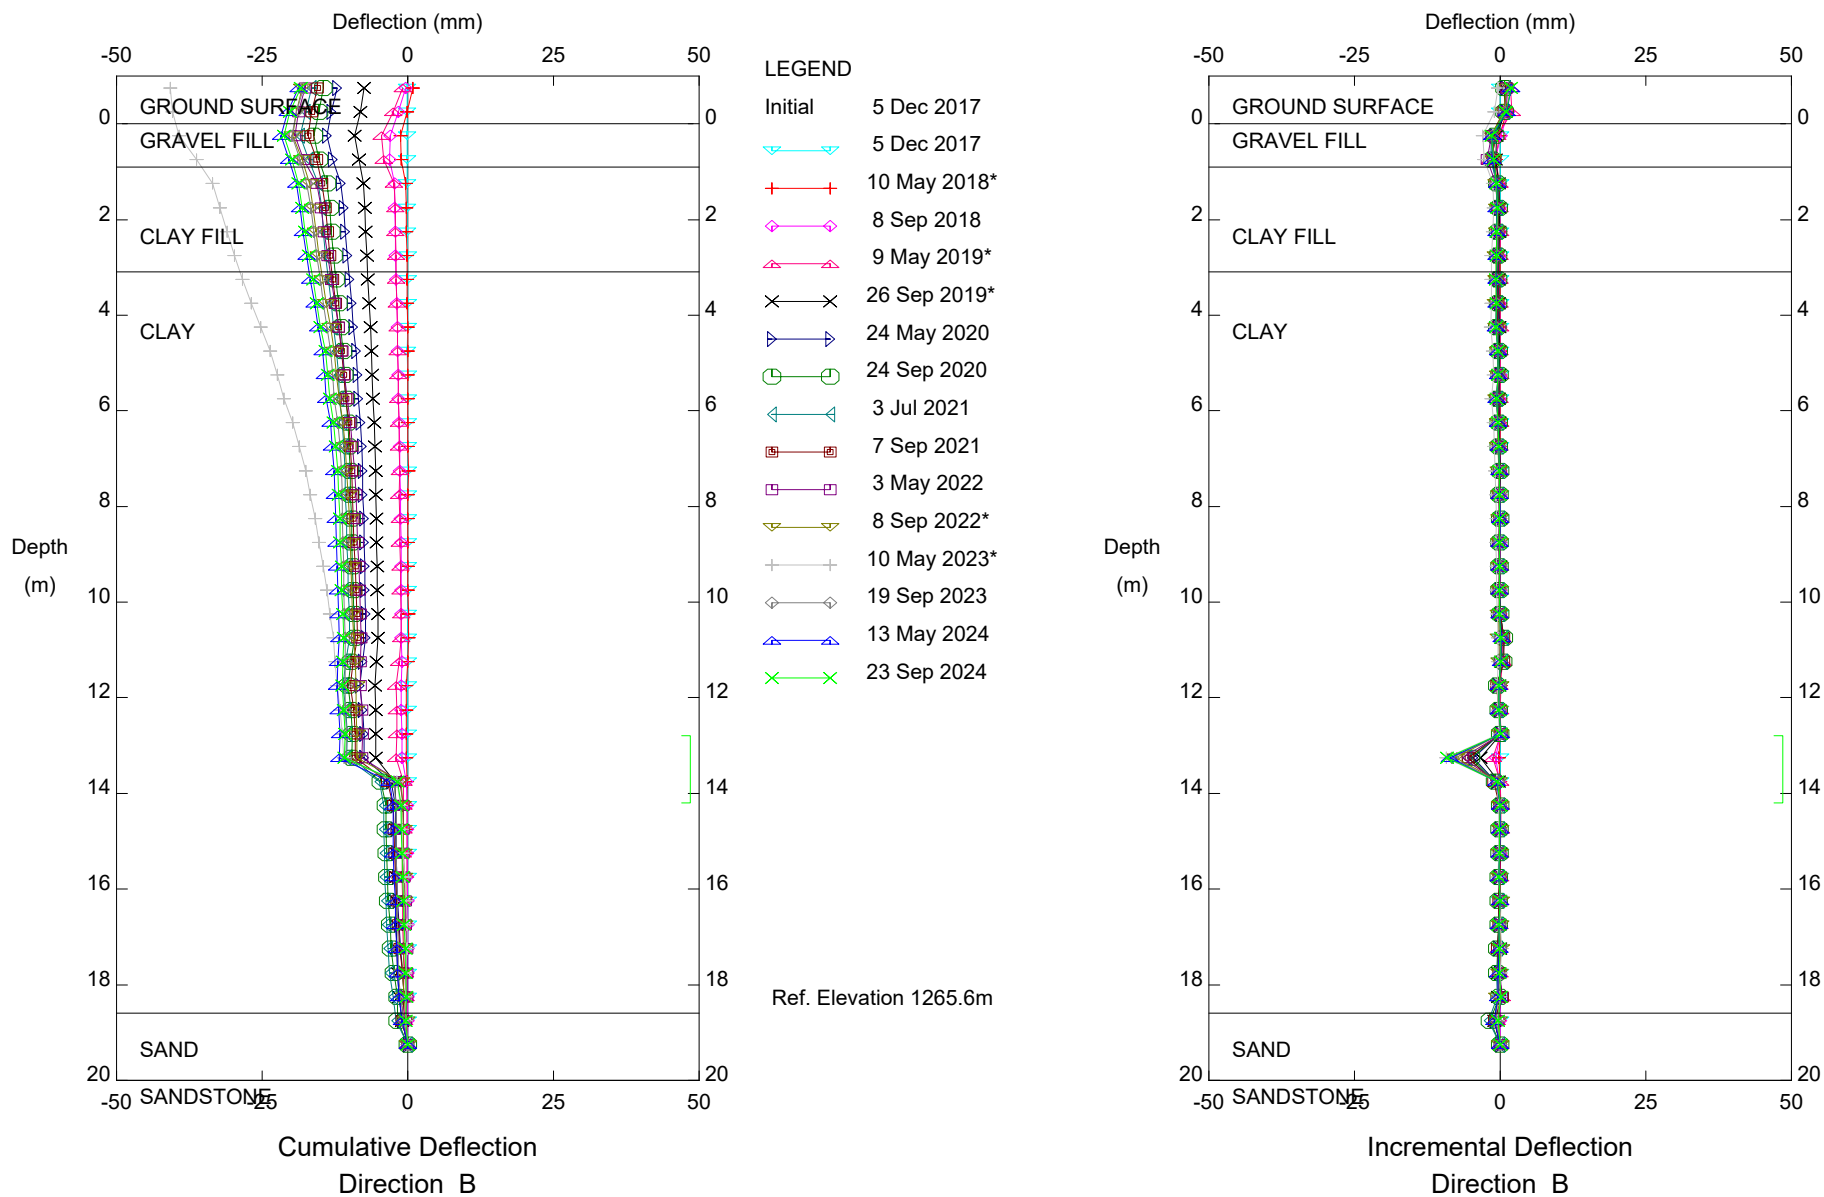
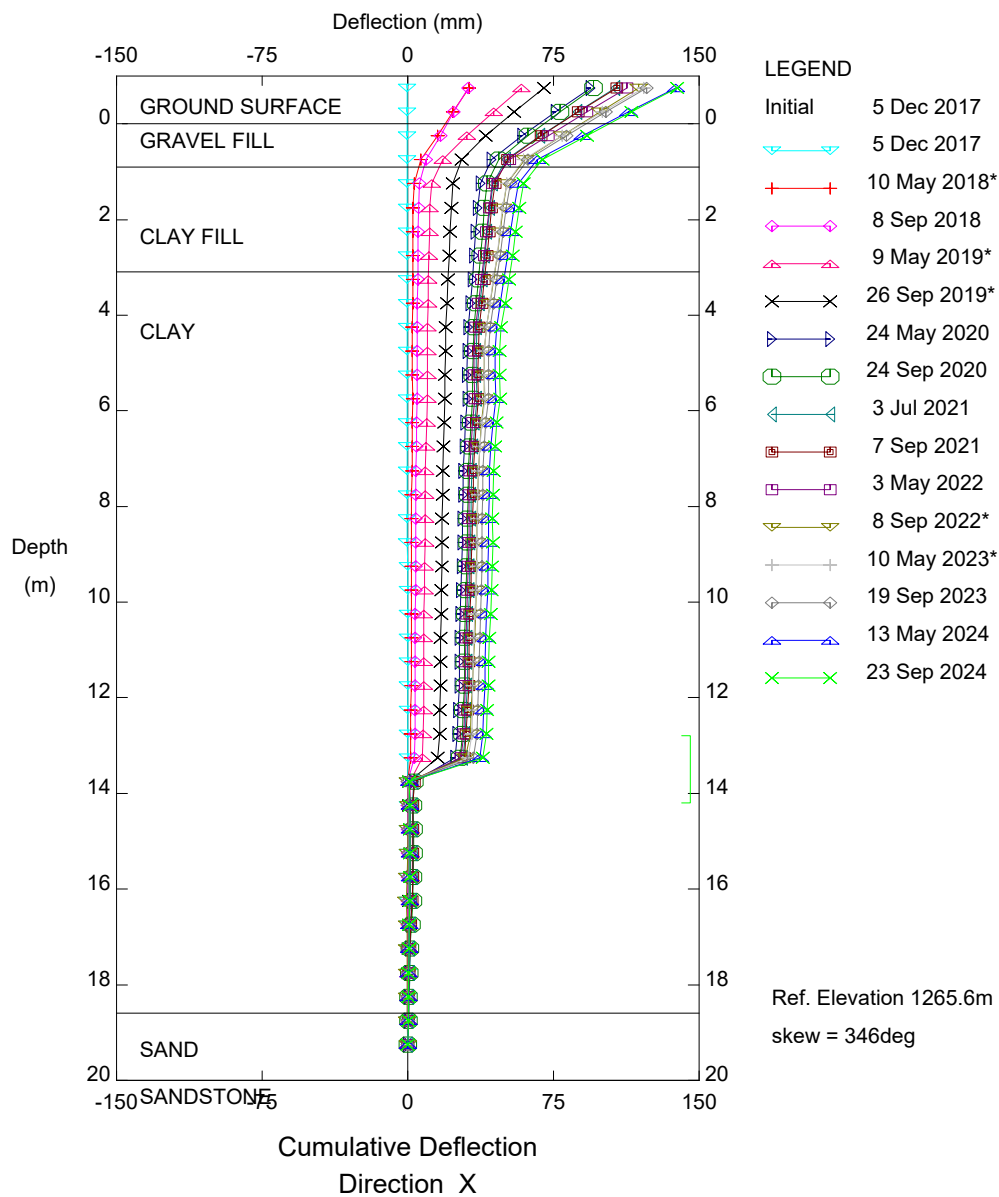
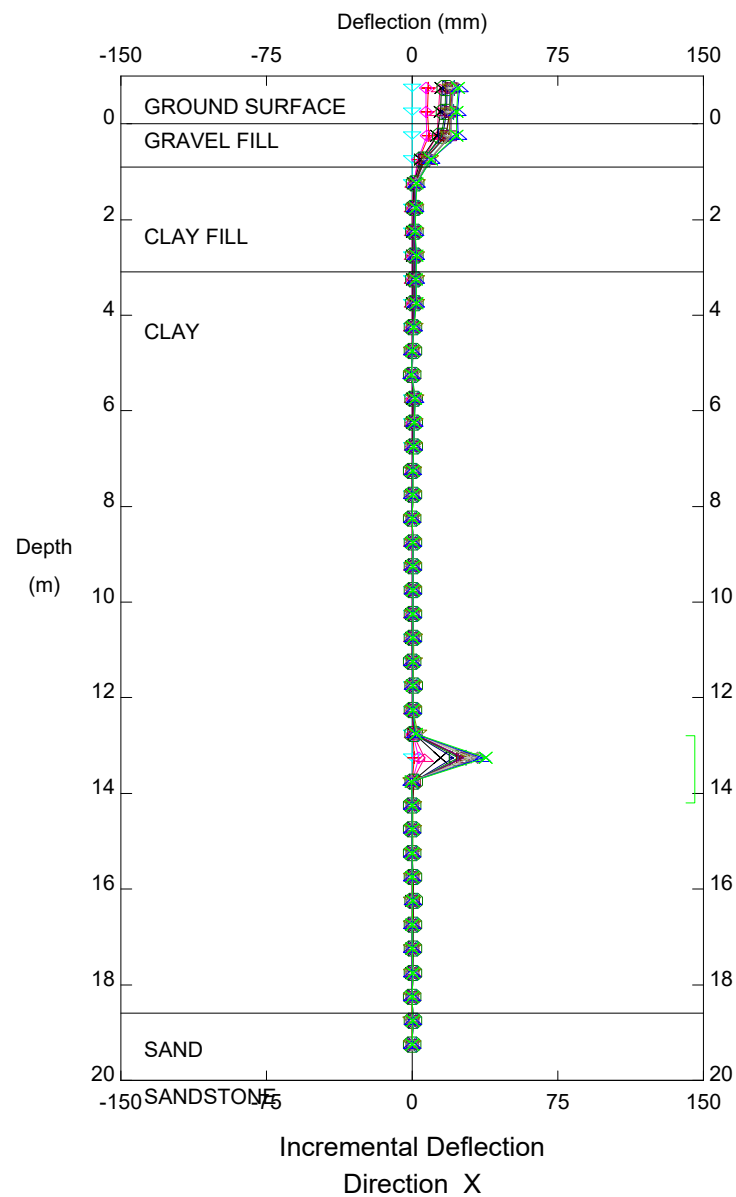
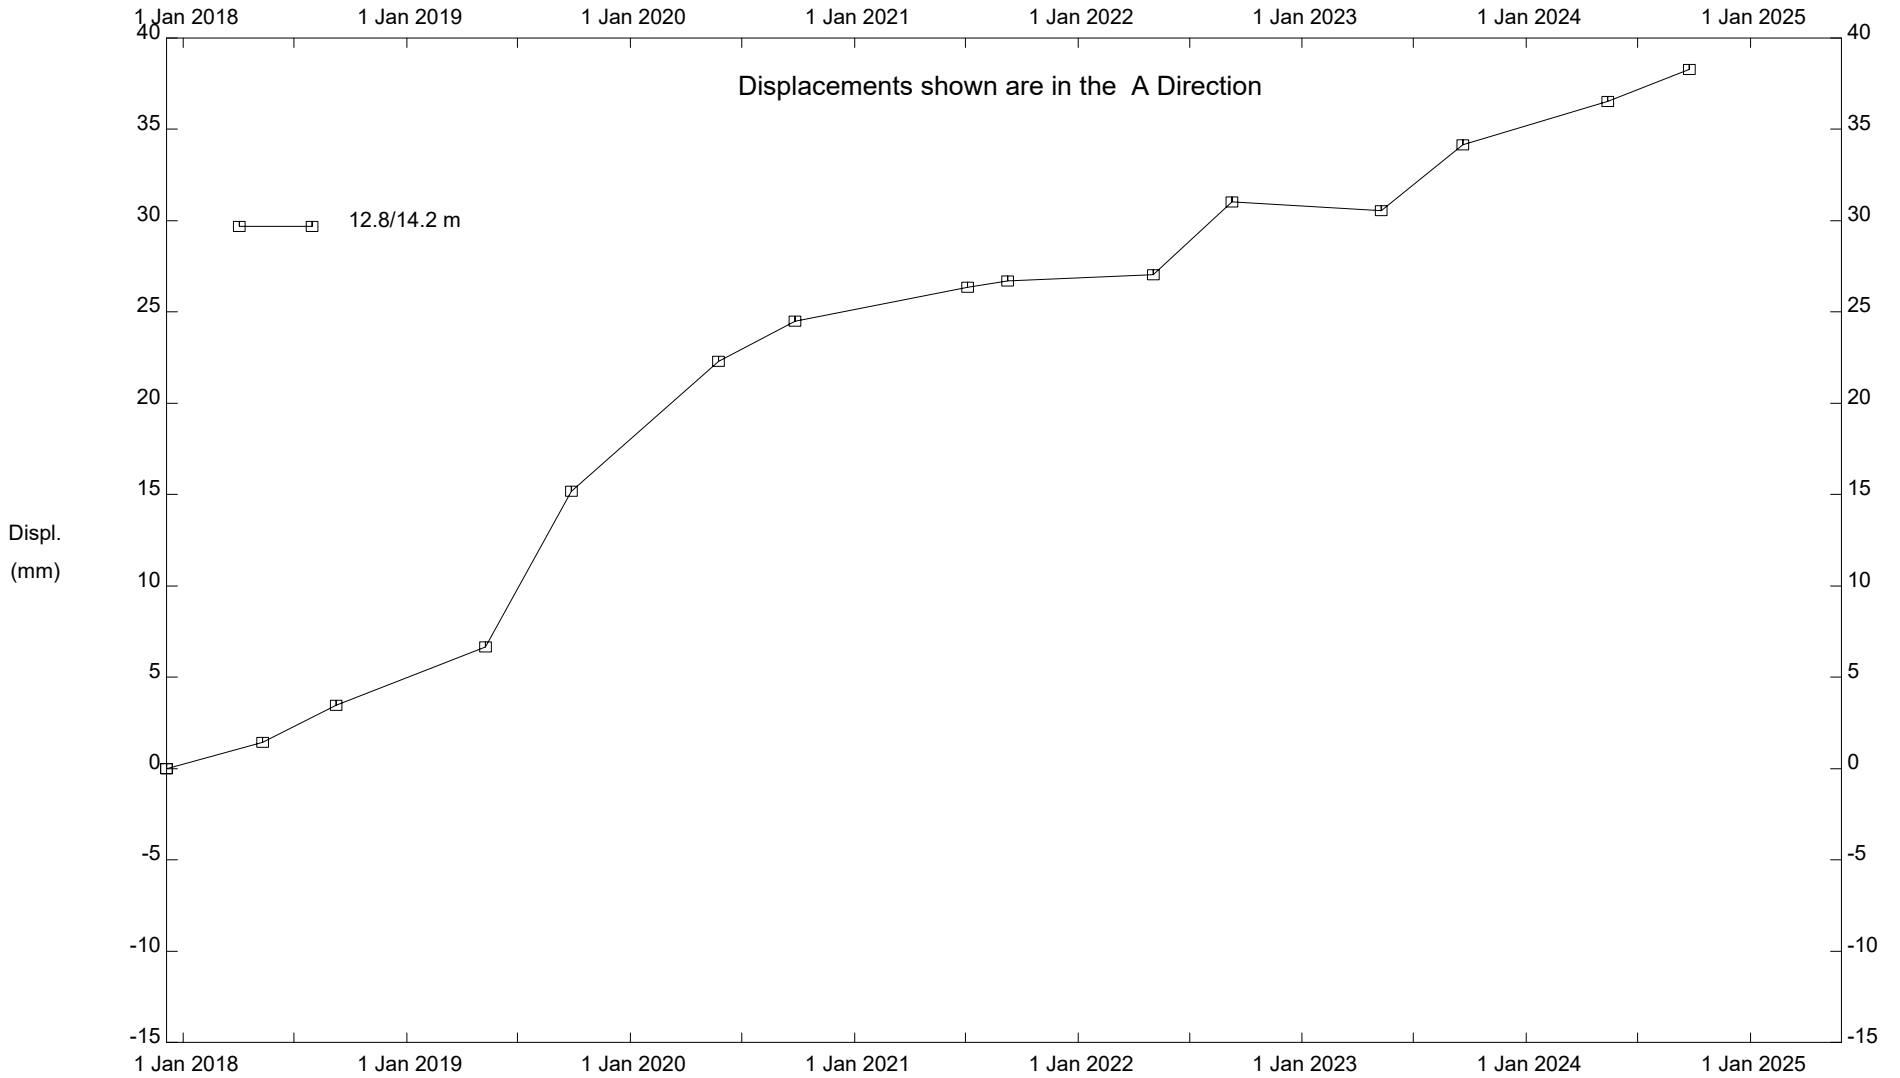
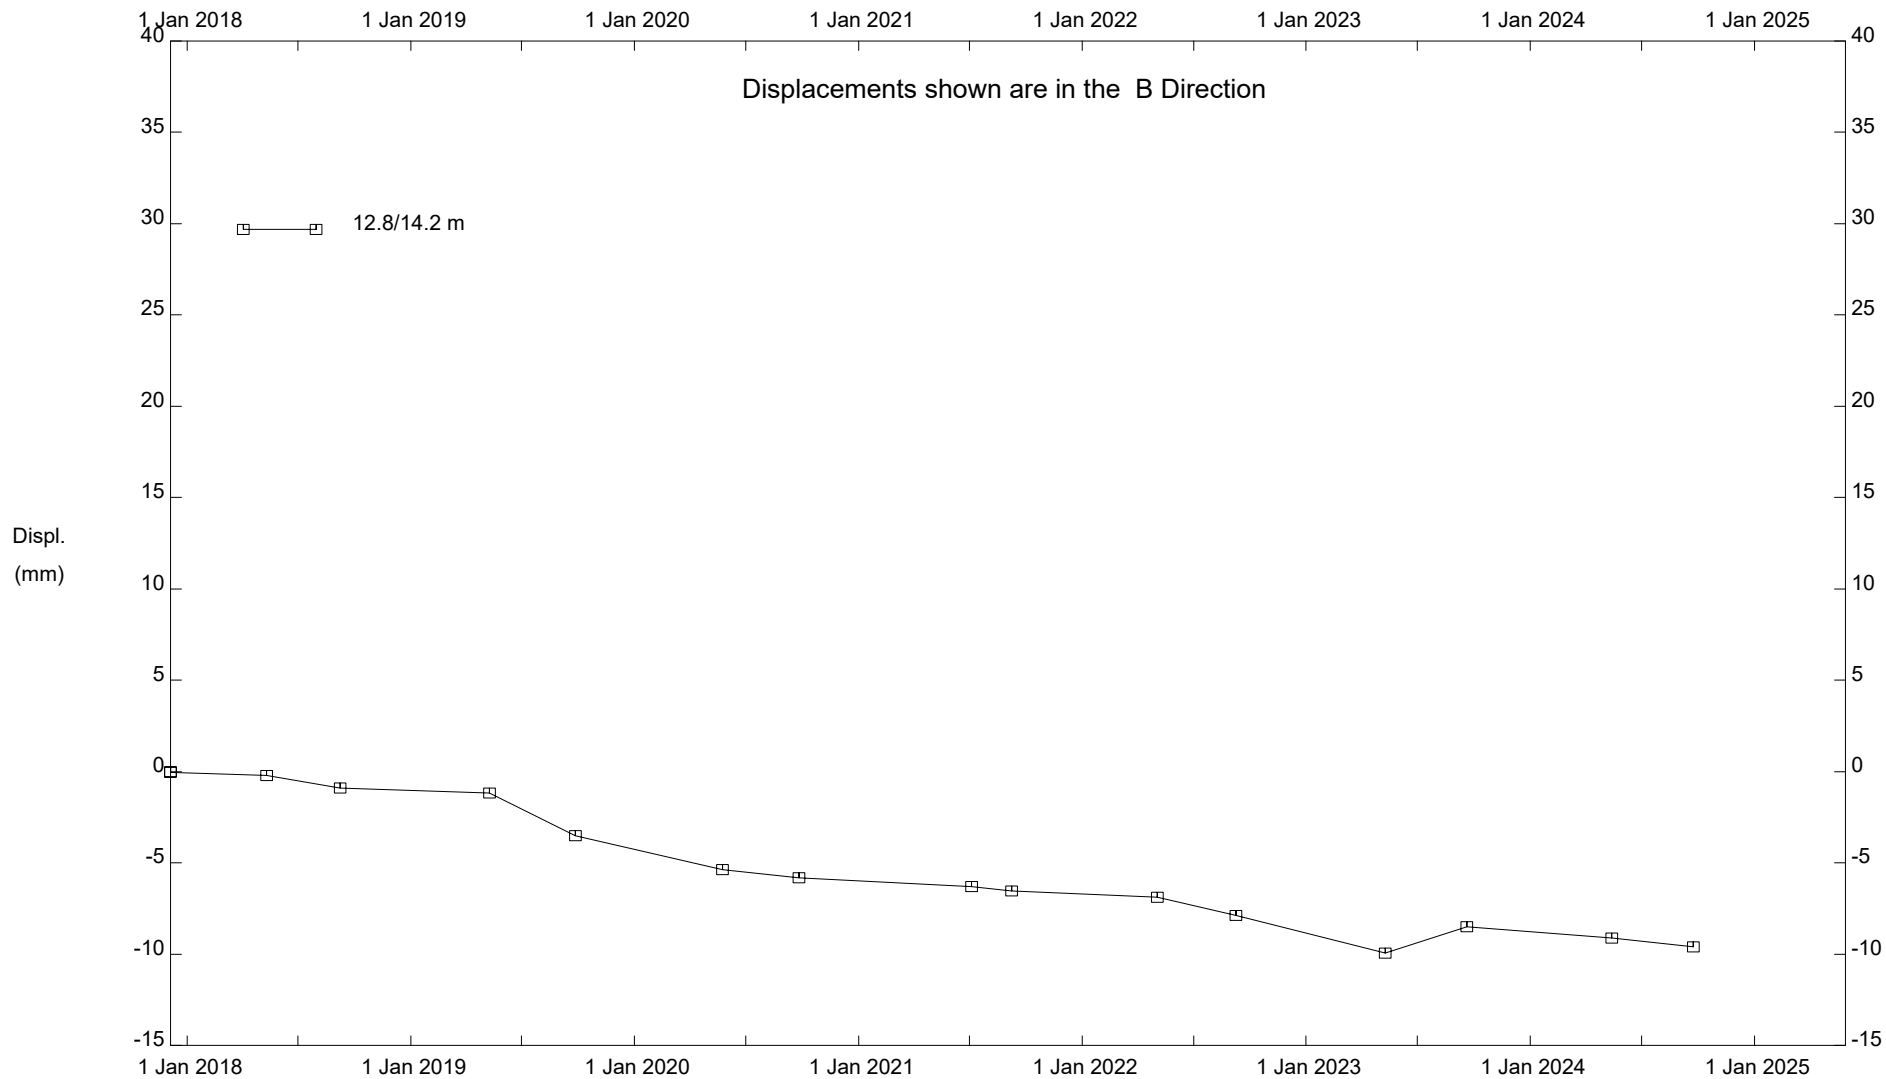
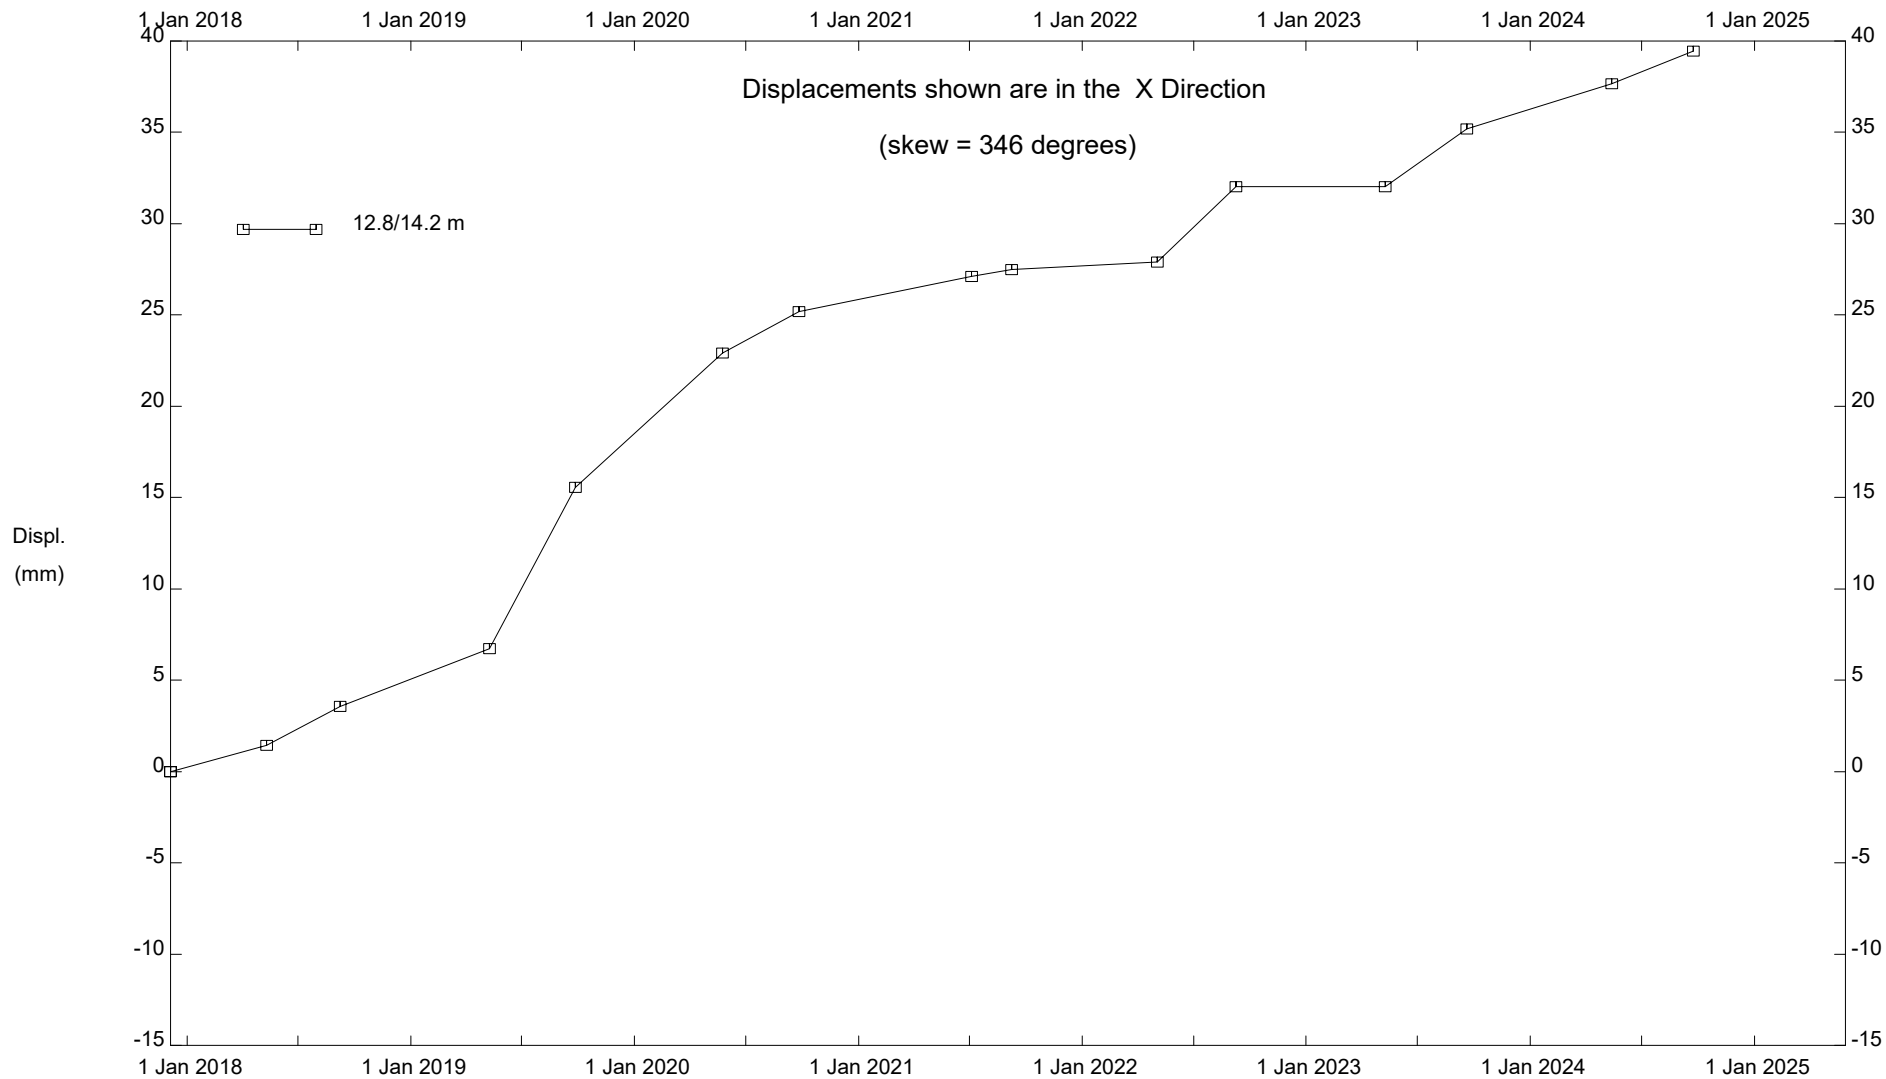
HWY 40:30 West of Wildhay River (NC83), Inclinator S117-02

**SI17-02** shows approximately 9 mm/yr in the rate of movement during this reading cycle with 39 mm of cumulative movement.
