To:	Amy Driessen	From:	Leslie Cho and Xiteng Liu
	Transportation and Economic Corridors		Stantec Consulting Ltd.
File:	123315222	Date:	October 18, 2024

**Reference: North Central Region, Edson, Site NC083 - Highway 40:30 West of Wildhay River, Fall 2024 Instrumentation Monitoring Report**

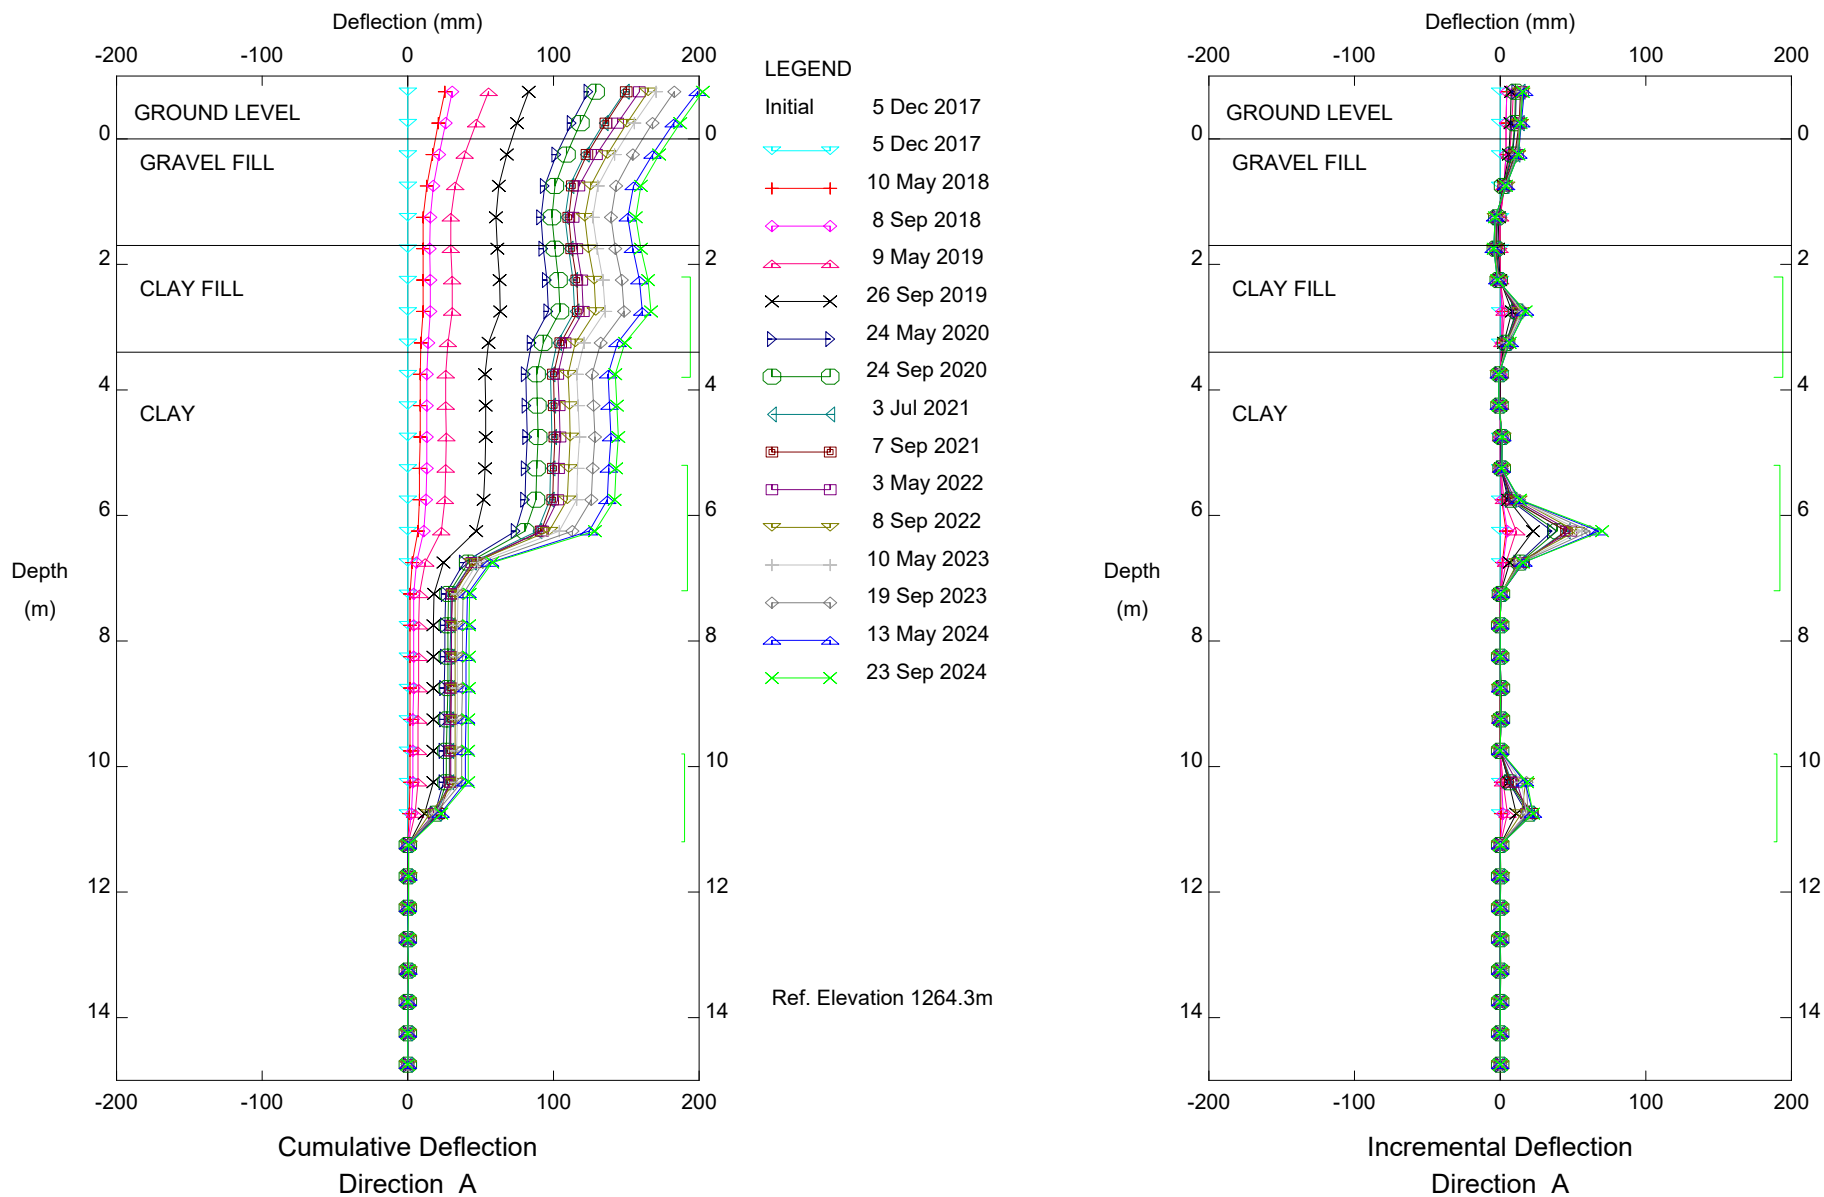
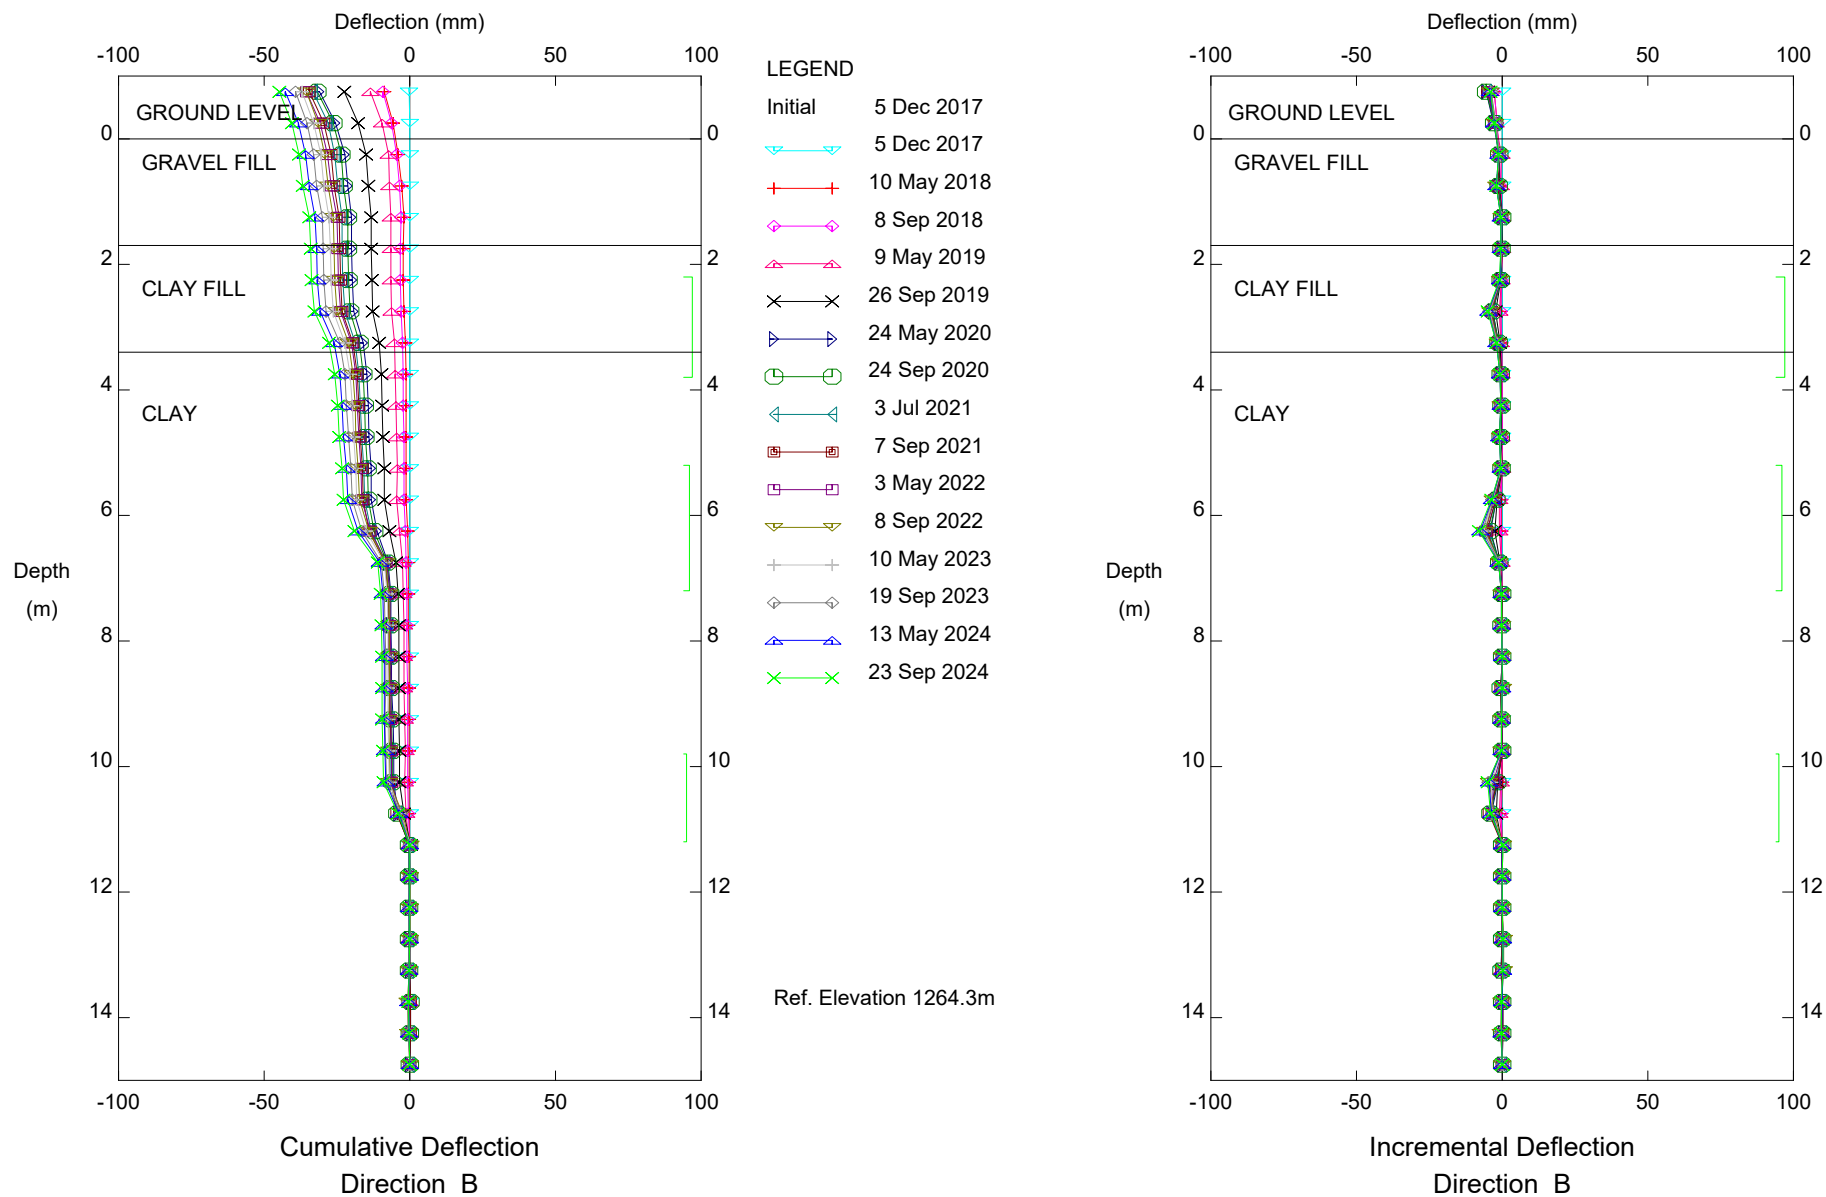
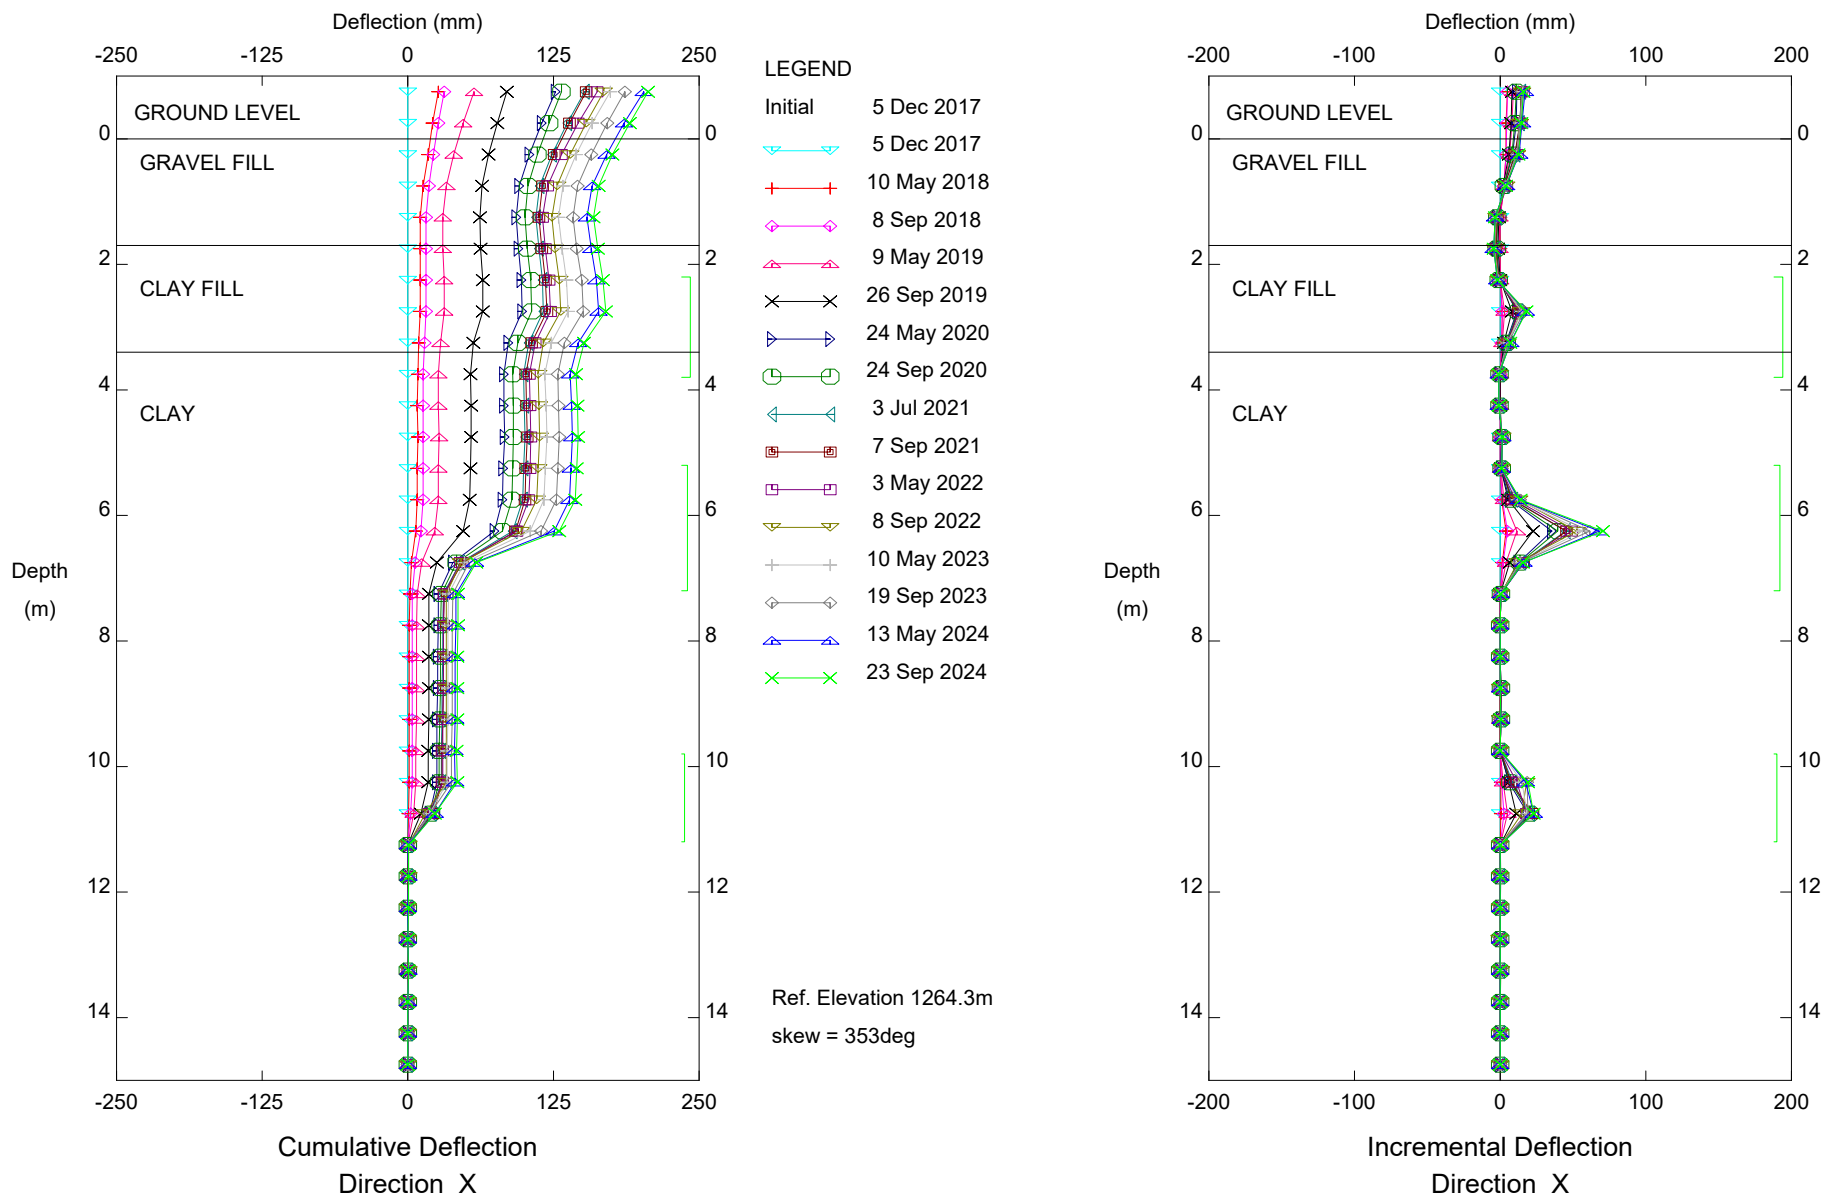
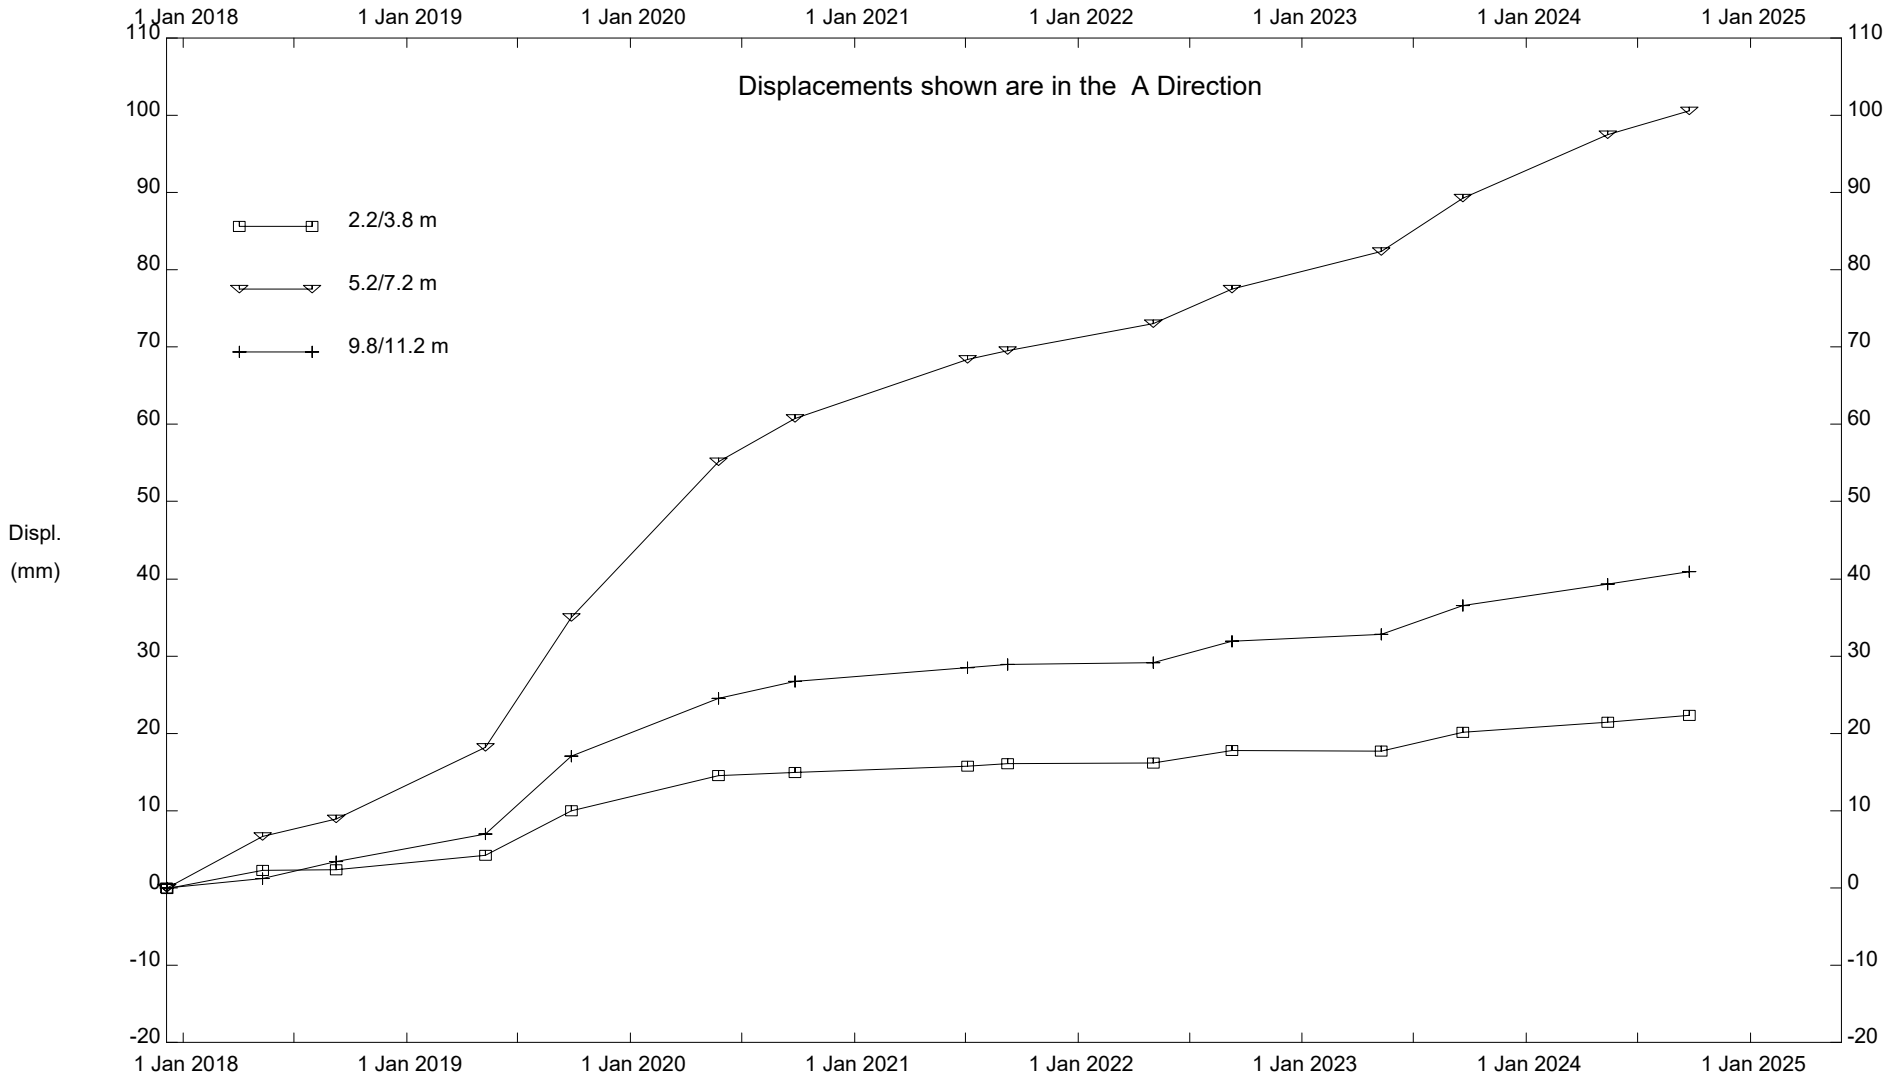
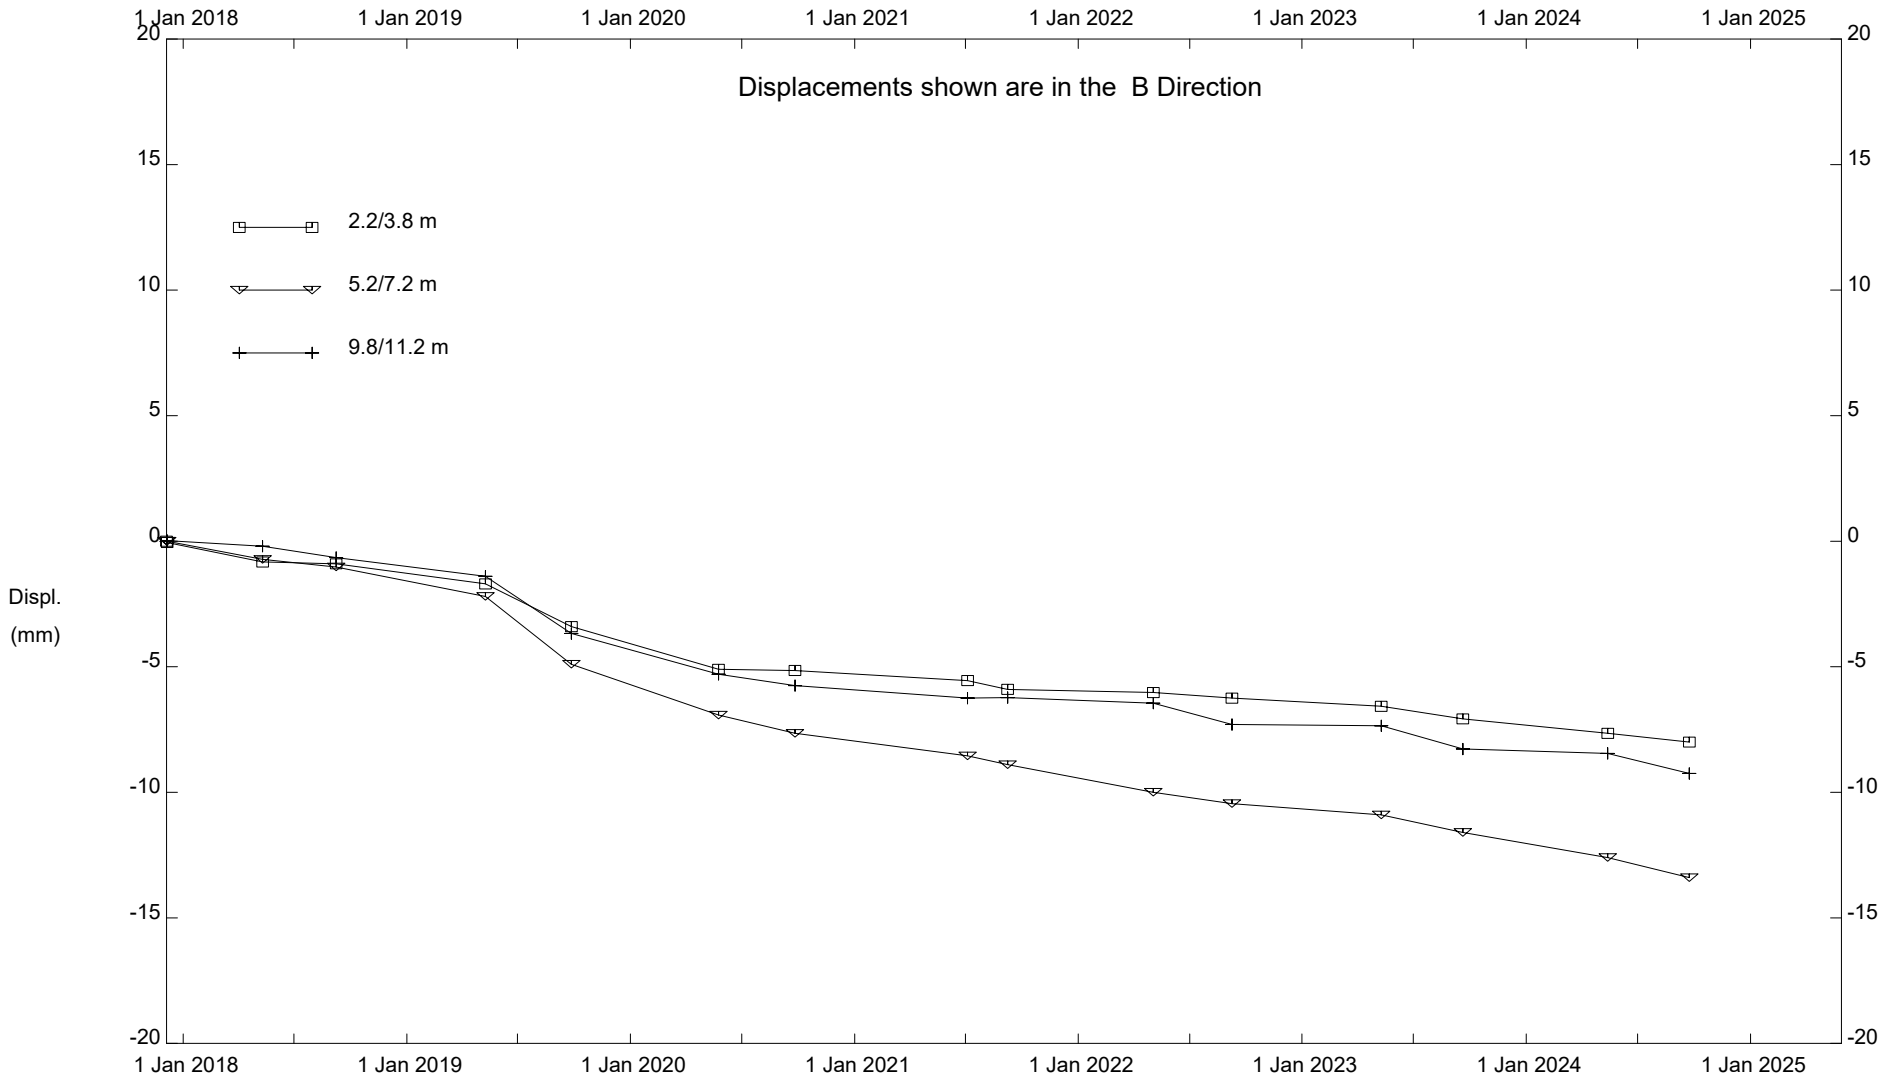
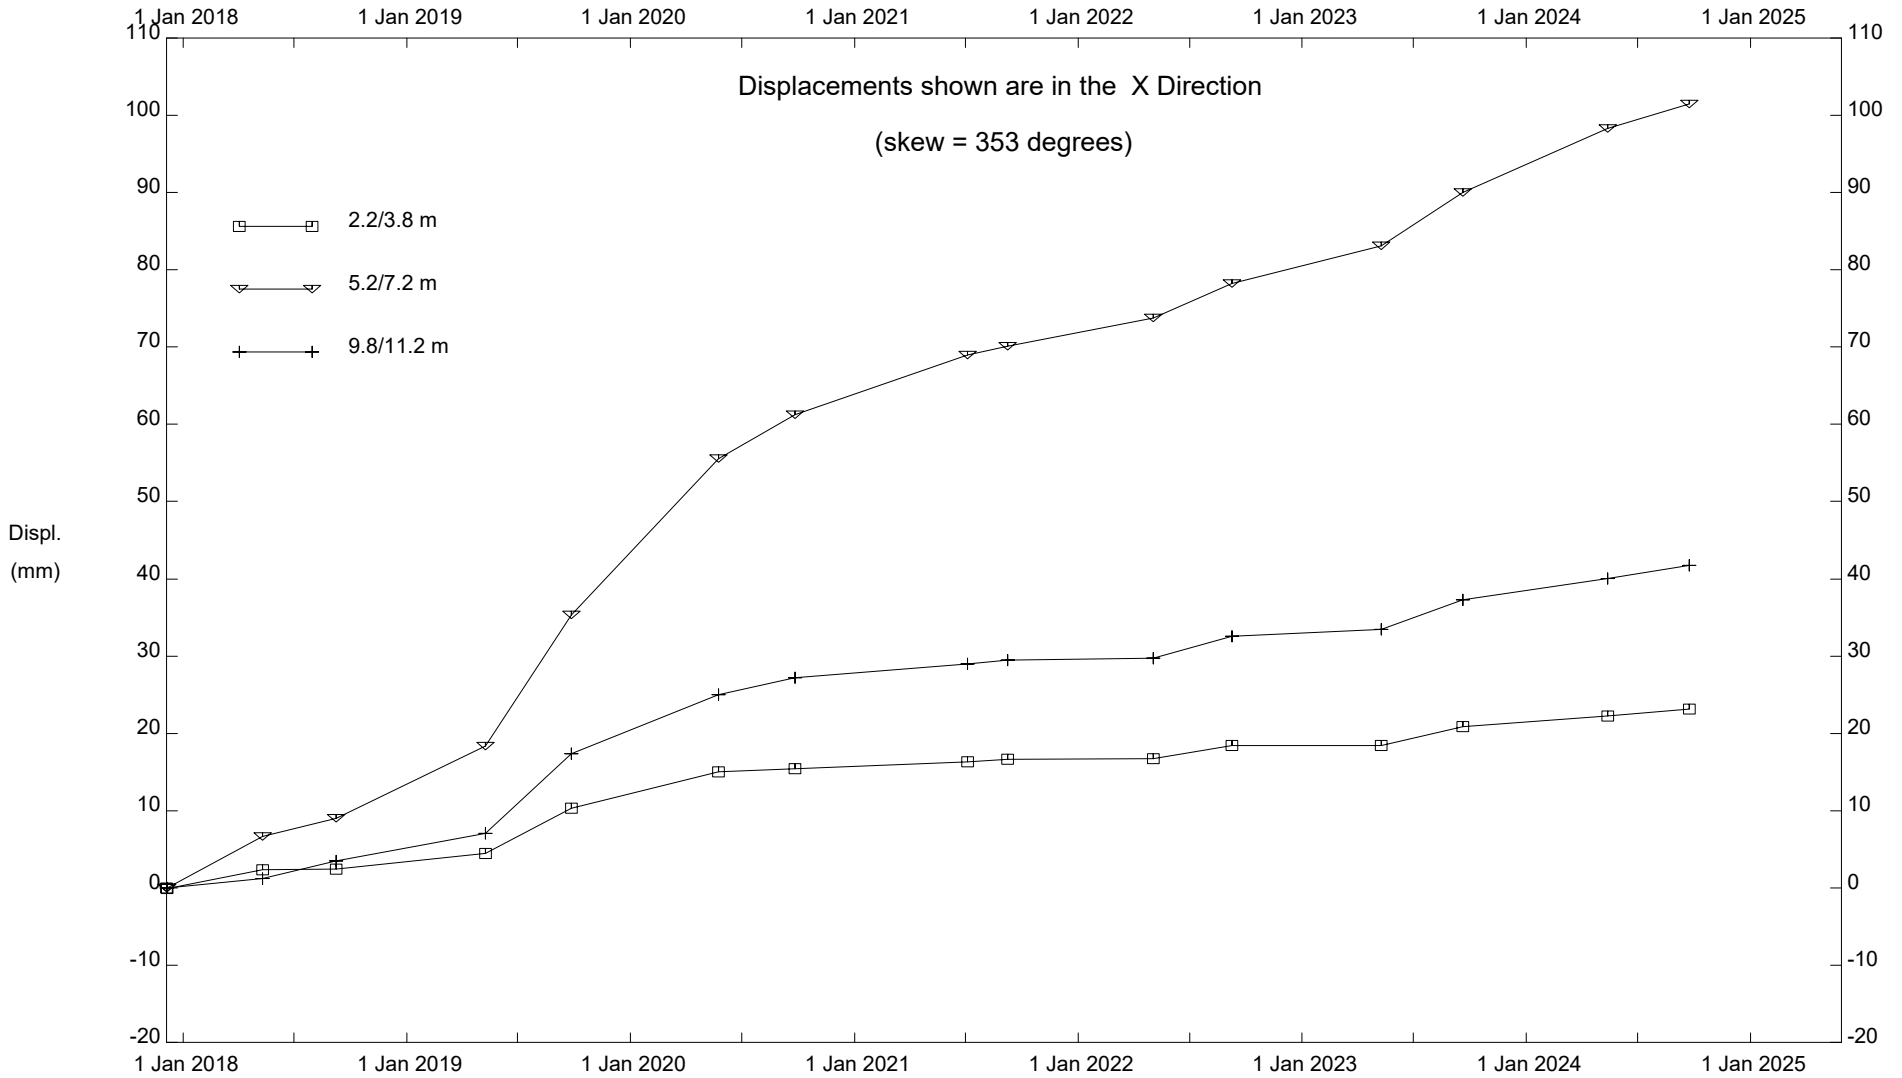
HWY 40:30 West of Wildhay River (NC83), Inclinometer SI17-03  
 Transportation & Economic Corridors

**SI17-03** has three zones of movement at depths of 2.2 m to 3.8 m, 5.2 m to 7.2 m and 9.8 m to 11.2 m bgs. The upper movement zone is located within the fill and shows a rate of movement of about 3 mm/yr. The middle movement zone at 6 m bgs shows current movement rate of 9 mm/yr corresponding to a decrease of 3 mm/yr. The lower movement zone shows a current rate of movement of 5 mm/yr.

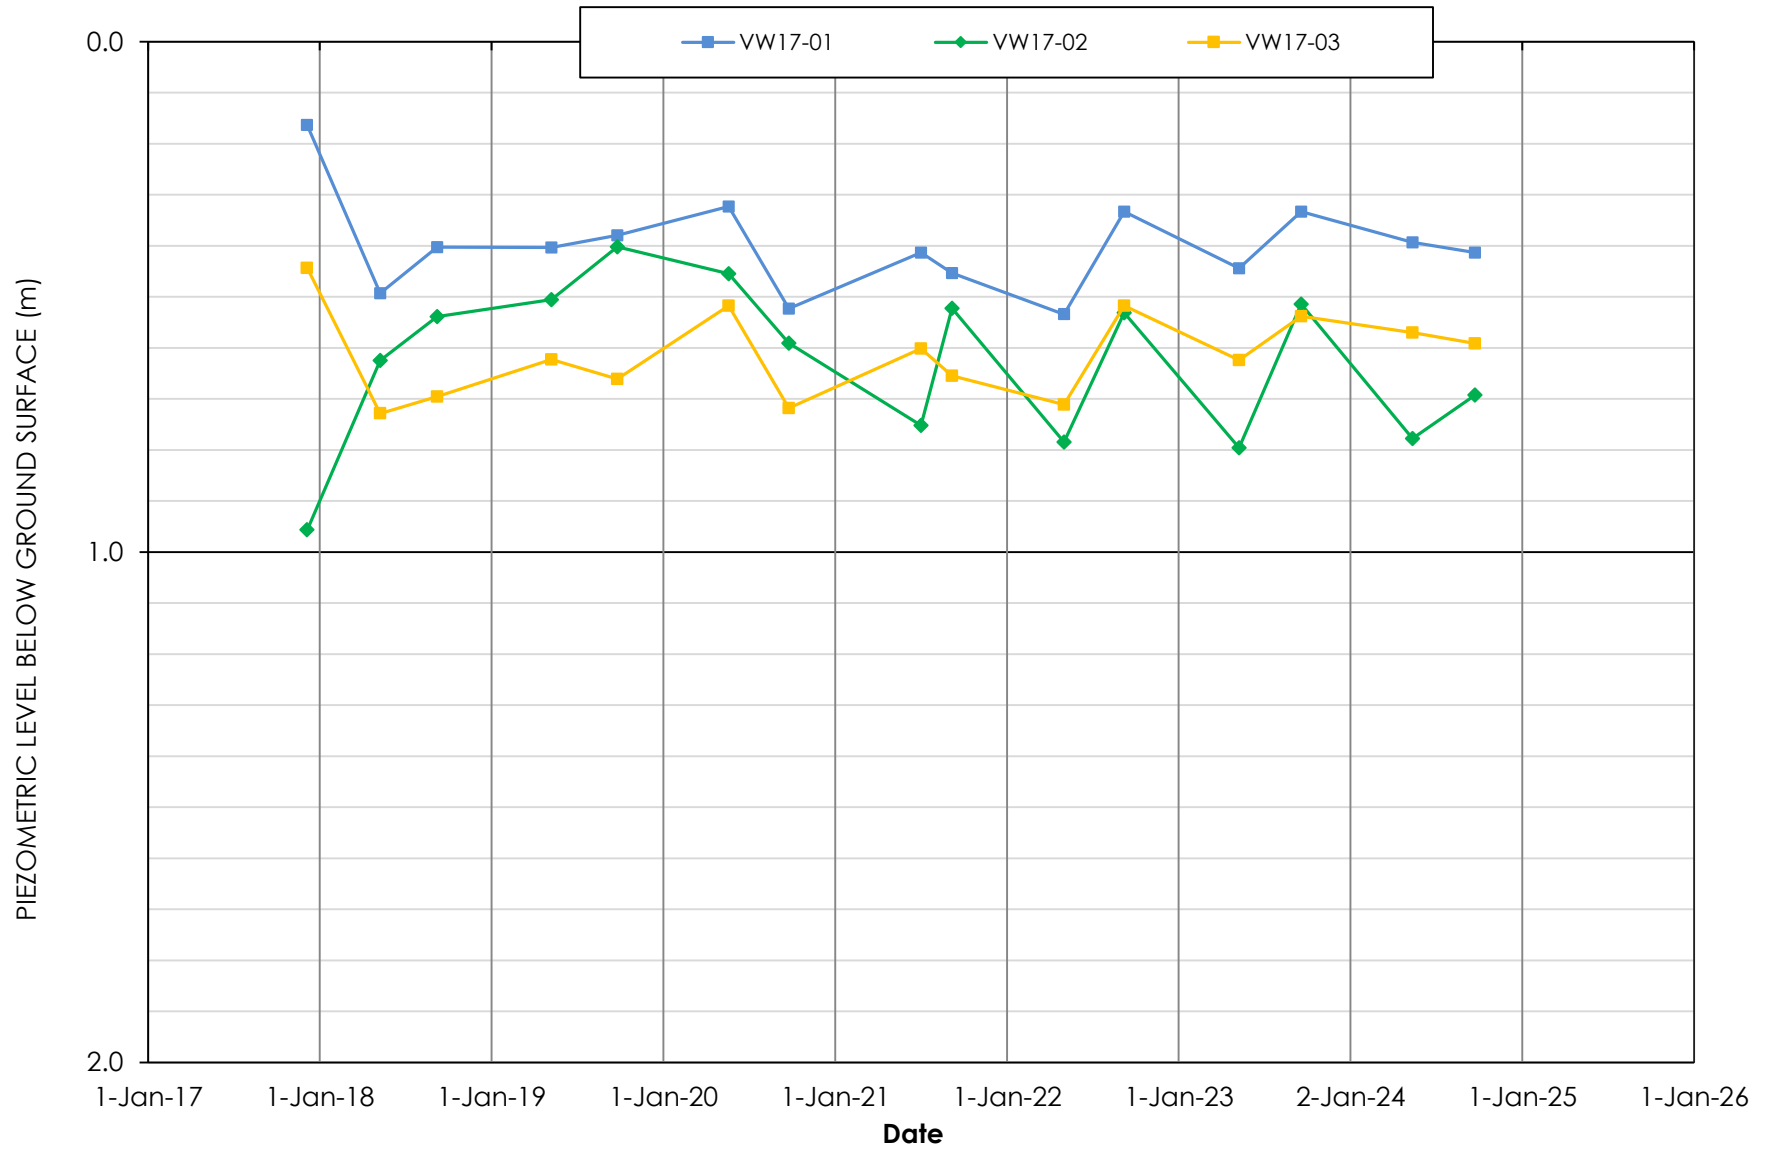
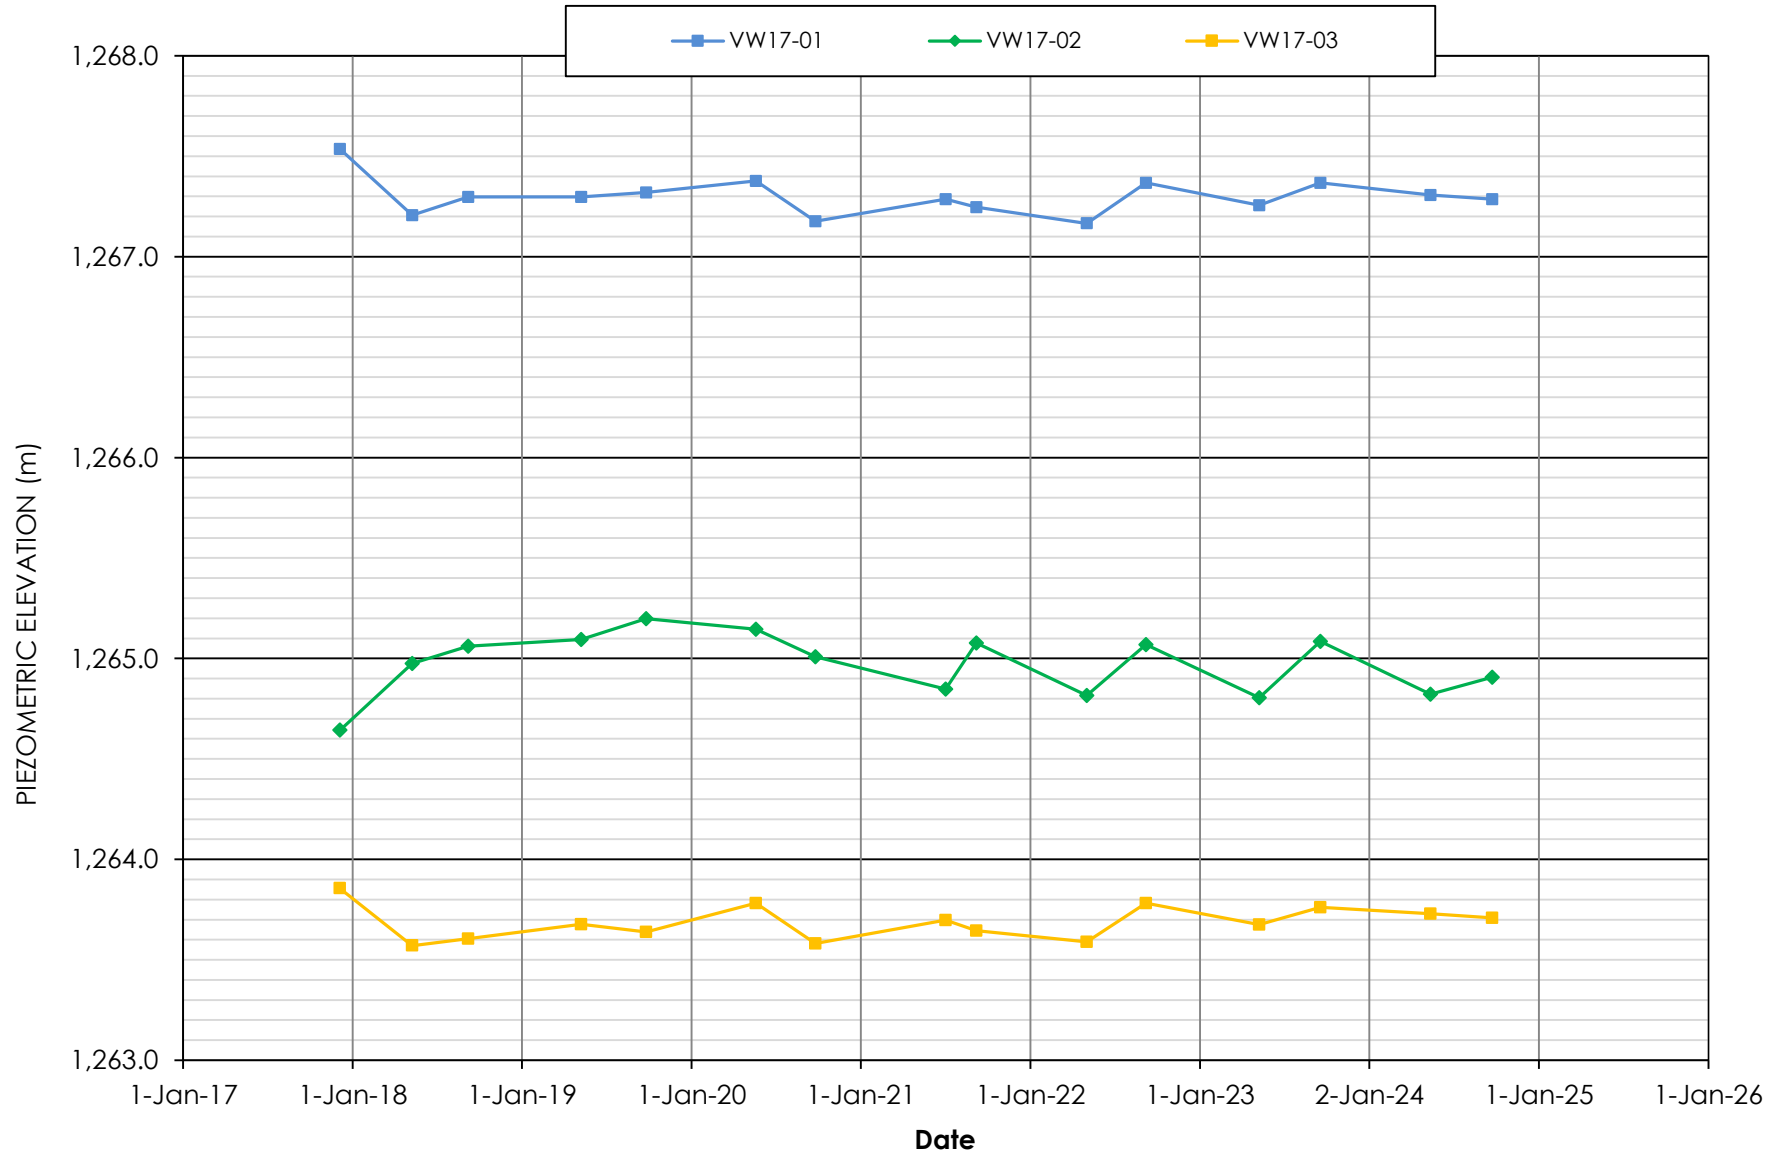
### PIEZOMETER DATA

The piezometers showed a change in water level ranging from decrease of less than 0.1 m to an increase of about 0.1 m for the current reading cycle. The piezometric levels measured were between 0.4 m and 0.7 m below ground surface (bgs). In general, the piezometric levels have been in the same range since Spring 2018. Seasonal fluctuations of higher groundwater table in the fall are observed in the piezometers.
